NBS SPECIAL PUBLICATION **592**

U.S. DEPARTMENT OF COMMERCE / National Bureau of Standards

An Investigation of the Miyagi-ken-oki, Japan, Earthquake of June 12, 1978

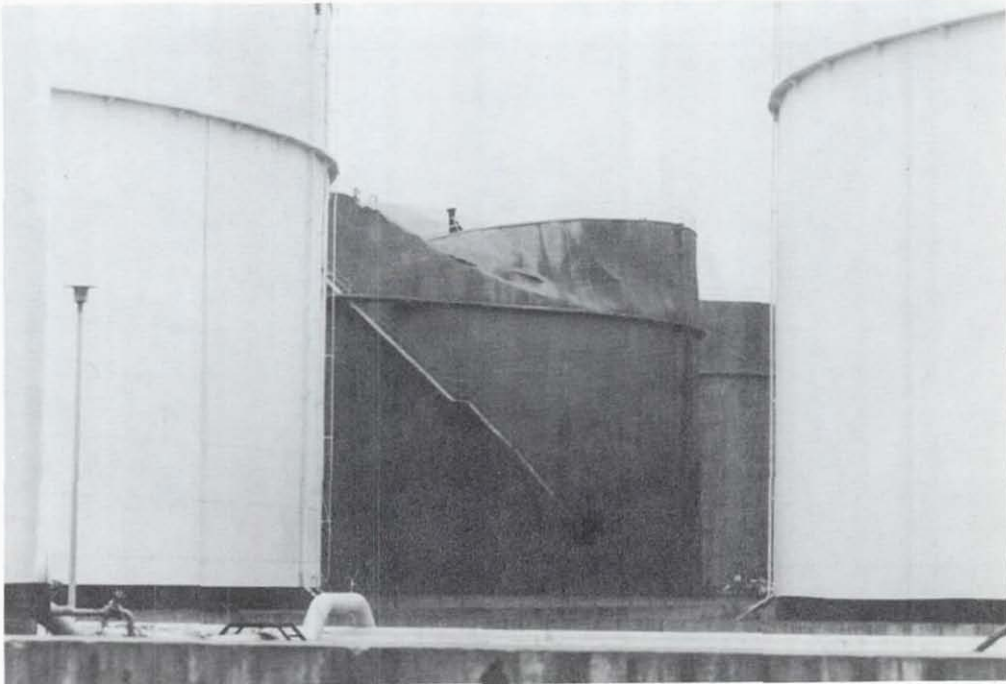
Figure 6.42 Sendai Refinery, Tohoku Oil Company, Ltd.: one of the three failed storage tanks. The damage illustrated is due to suction caused by rapid evacuation of the oil through the ruptured connection of the base and wall of the tank. The several tanks, of similar size, in the foreground are thought to be undamaged.

At the time of the investigation a thick film of oil still covered much of the refinery grounds. Thus, the fire hazard was great, and the investigating team was unable to observe the details of the damage to the tanks. It is believed that the tanks shown in Figures 6.42 through 6.44 failed at their bases. The oil drained rapidly, causing a vacuum inside, which imploded the tanks. Three other tanks suffered damage and will need repair.

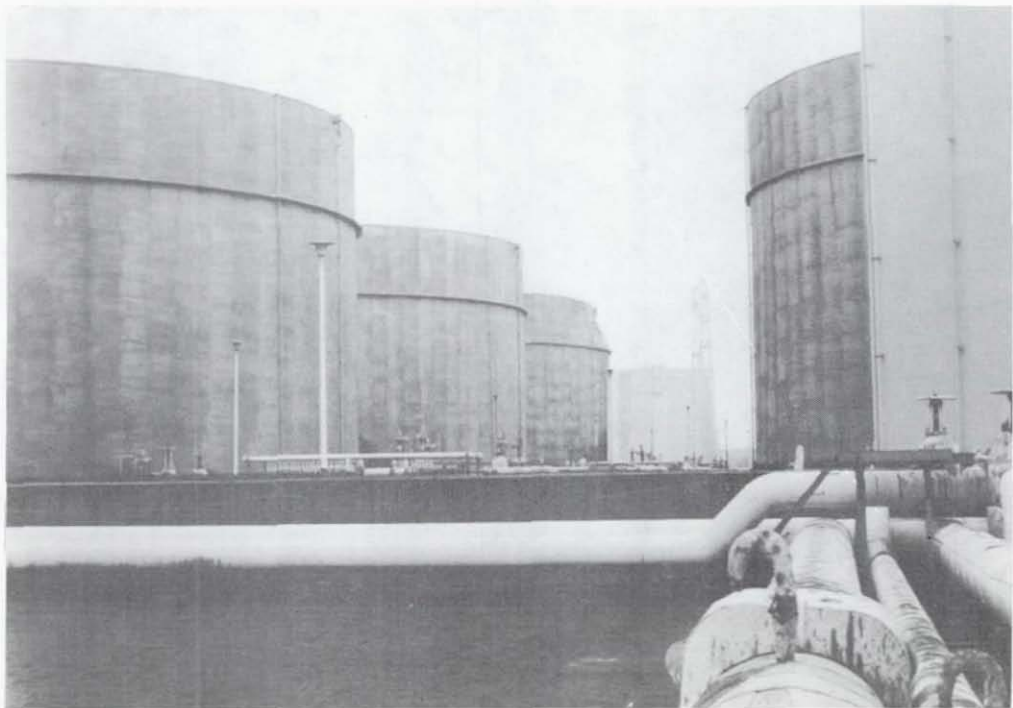
Figure 6.43 Sendai Refinery, Tohoku Oil Company, Ltd. Two other failed TC oil storage tanks.

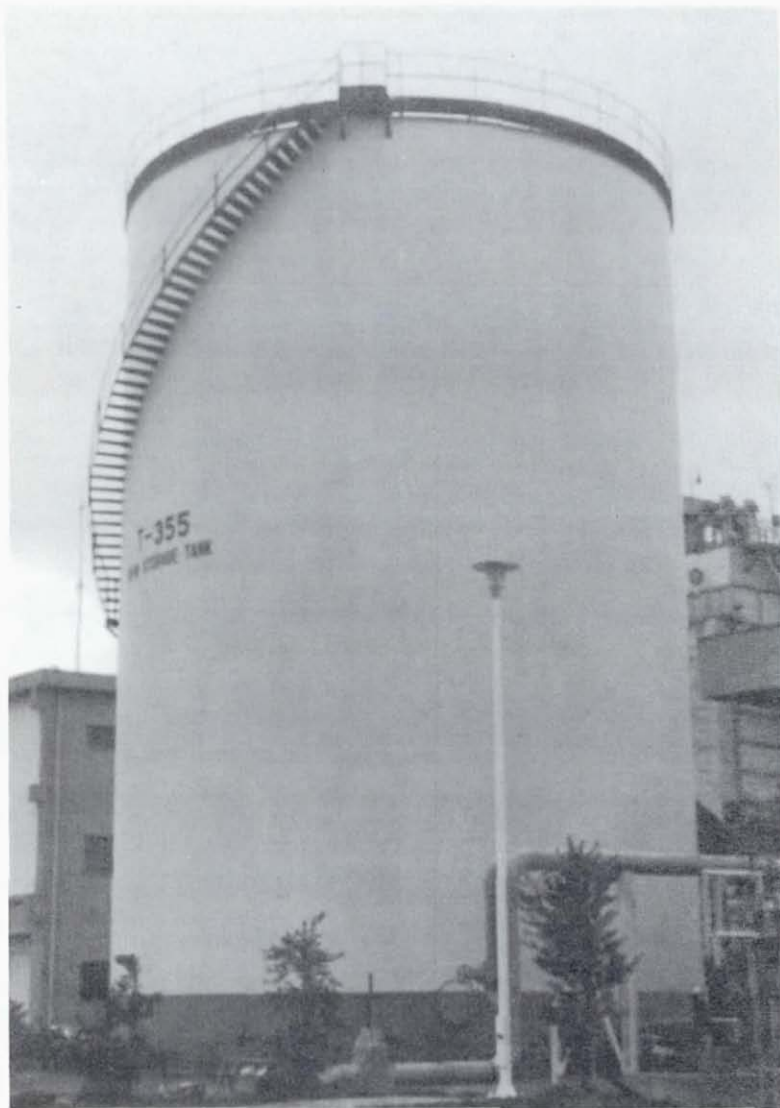
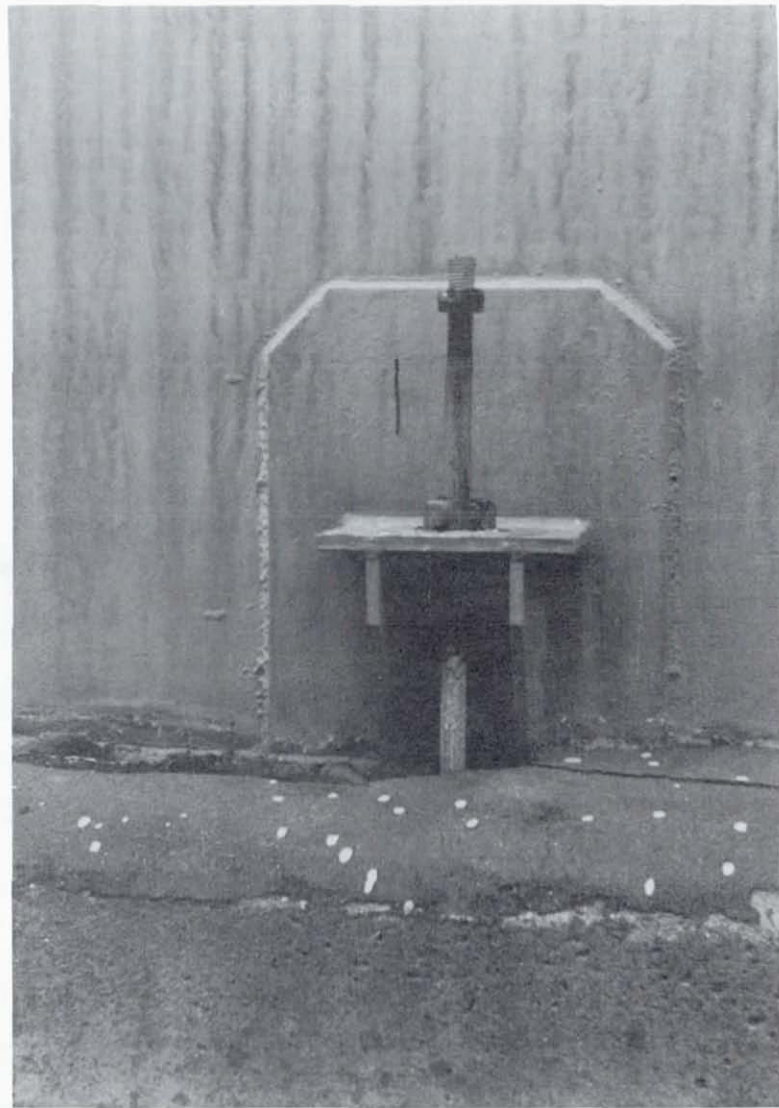
Figure 6.45 Sendai Refinery, Tohoku Oil Company, Ltd. A large water storage tank (left) near the main refinery complex appeared to have experienced significant rocking. Detail (right) of one of the pulled-out, or stretched, anchor bolts of the water storage tanks shown at left.

Another large water storage tank experienced interesting damage (Figure 6.45). The welded steel plate tank was anchored with bolts, spaced at approximately 6 ft (2 m), and embedded in a continuous concrete pad. The bolts around the entire circumference were stretched, or more likely, pulled out from their embedment from 1 to 6 in (2.5 to 15 cm). However, there was no apparent buckling or other damage to the steel base of the tank.

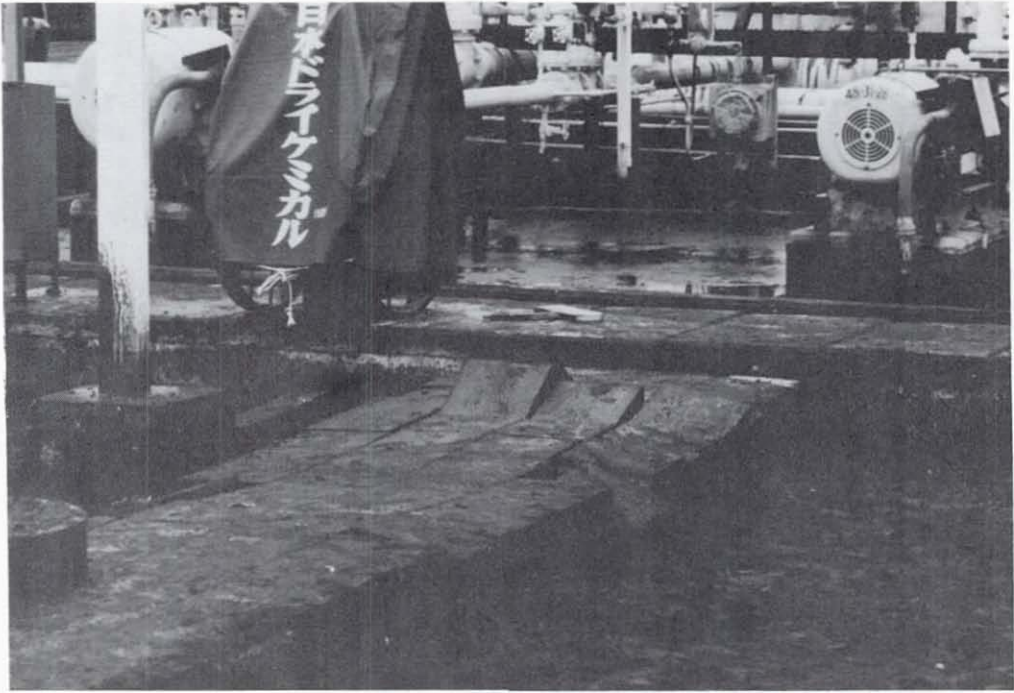
Figure 6.48 Sendai Refinery, Tohoku Oil Company, Ltd.: ground settlement at the refinery.

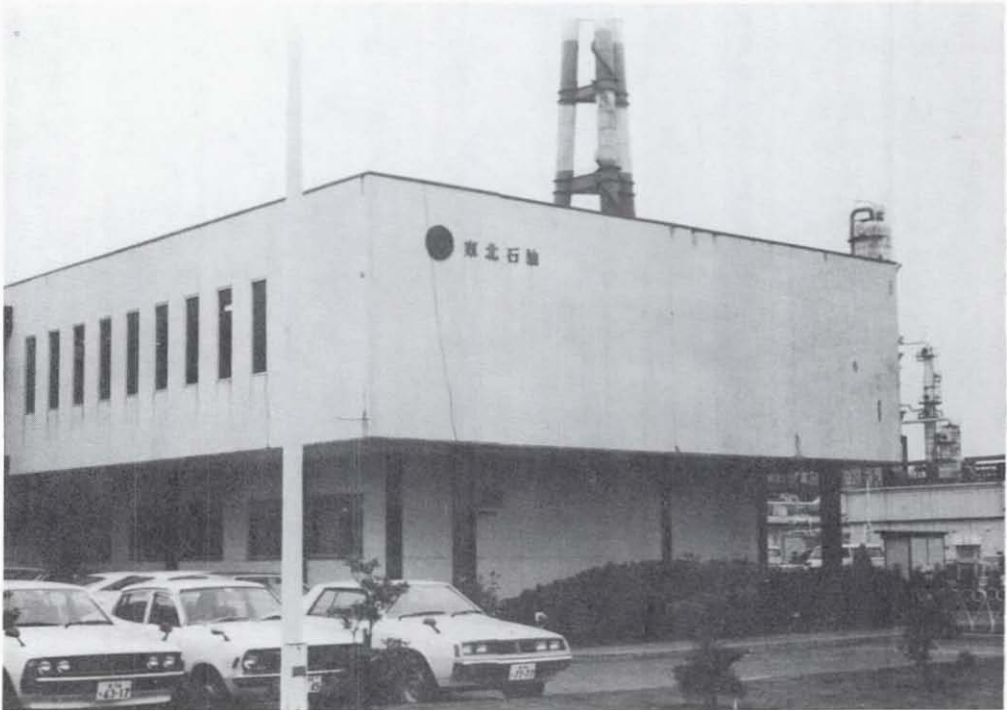
Figure 6.49 Sendai Refinery, Tohoku Oil Company, Ltd.: A wing of the damaged steel-framed administration building. Damage was obvious only to the architectural finishes.

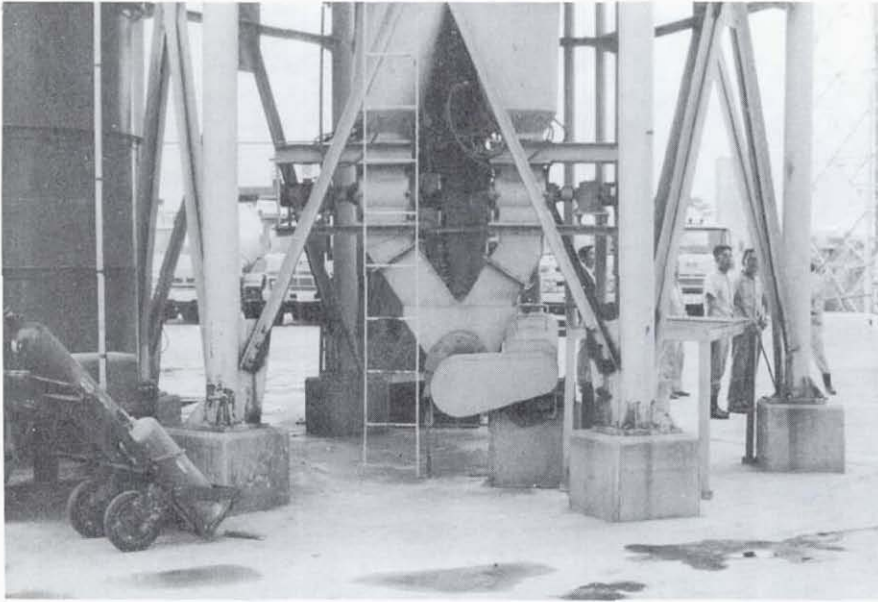
Figure 6.50 Concrete Batch Plant, Sendai: view of the repaired supporting substructure of a cement bin and related equipment. The sheared bolts at the brace connections have been removed and the braces have been welded to the gusset plates. Some of the buckled braces have been replaced entirely.

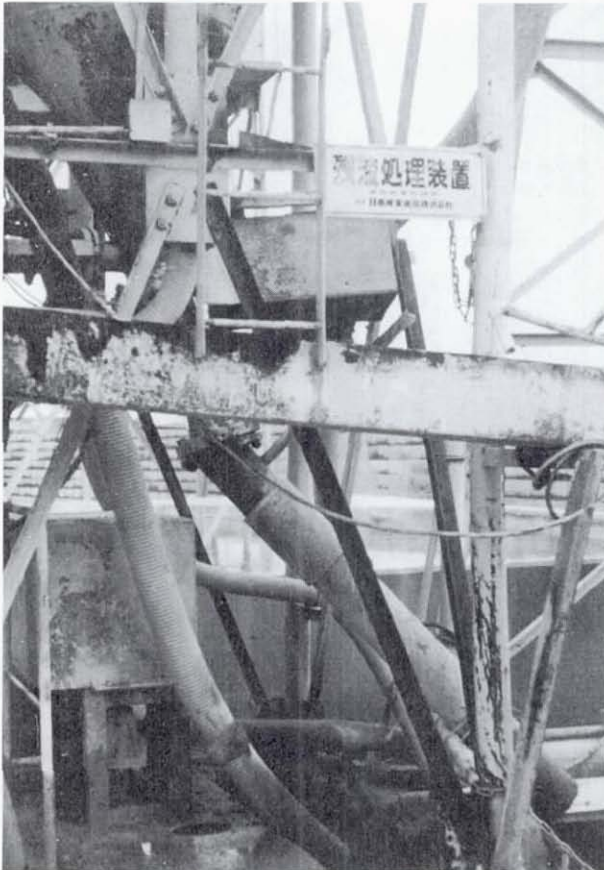
Figure 6.51 Concrete Batch Plant, Sendai: a detail of a replaced, and presumably buckled, diagonal brace. A number of similar repairs were carried out within two days after the earthquake.

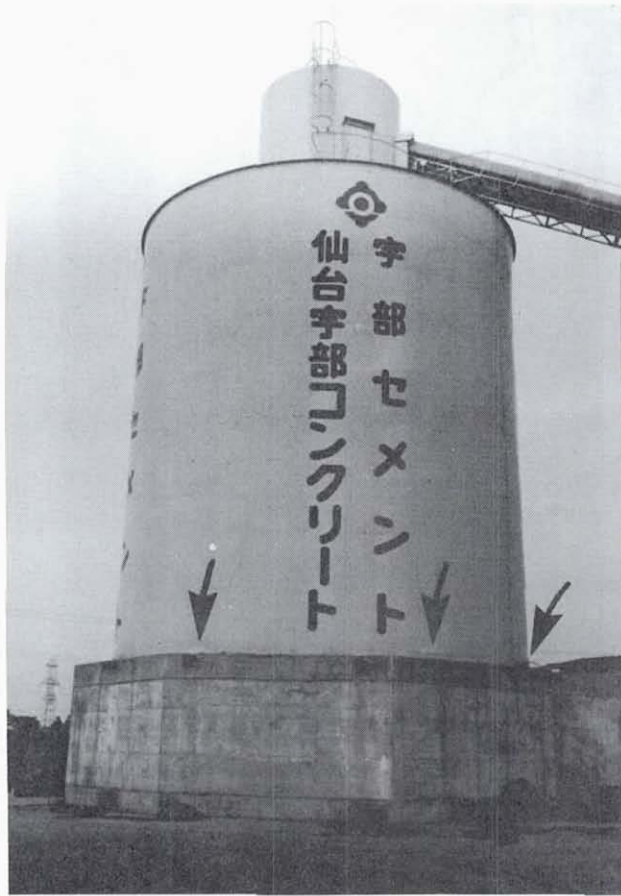
A large welded steel plate storage tank, containing sand and gravel, and reportedly full during the earthquake, which was supported on a massive concrete pedestal, suffered buckling along several locations at the base of the steel plate (Figures 6.52 and 6.53). It seems apparent that the buckling was caused by overturning forces, rather than by sloshing of the contents. The tank and its superstructure and support structure did not experience any other damage.

Figure 6.52 Concrete Batch Plant, Sendai: a large gravel-and-sand-storage tank experienced buckling of the welded steel plate at its base.

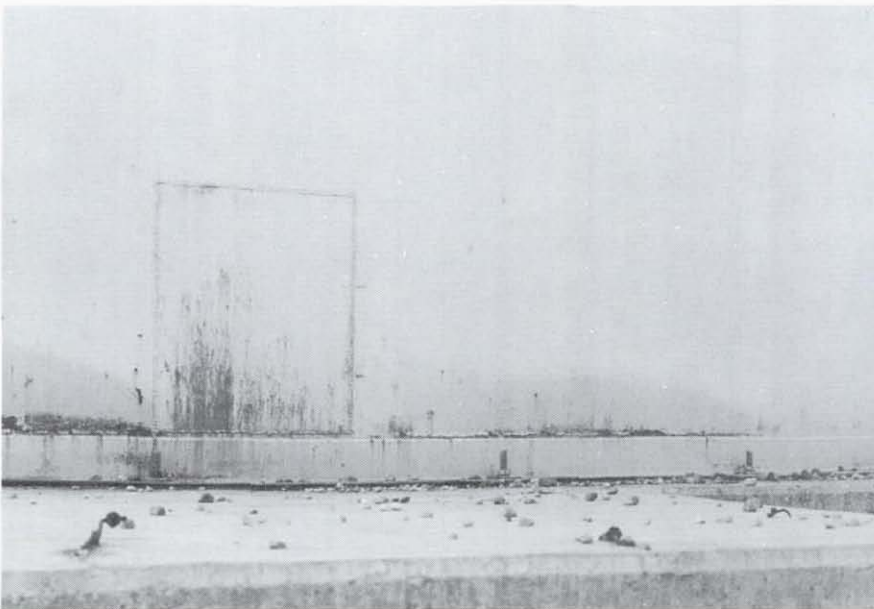
Figure 6.53 Concrete Batch Plant, Sendai: a detailed view of the damaged base of the sand and gravel storage tank. Note the closely spaced anchor bolts. Similar damage occurred at several locations along the circumference.

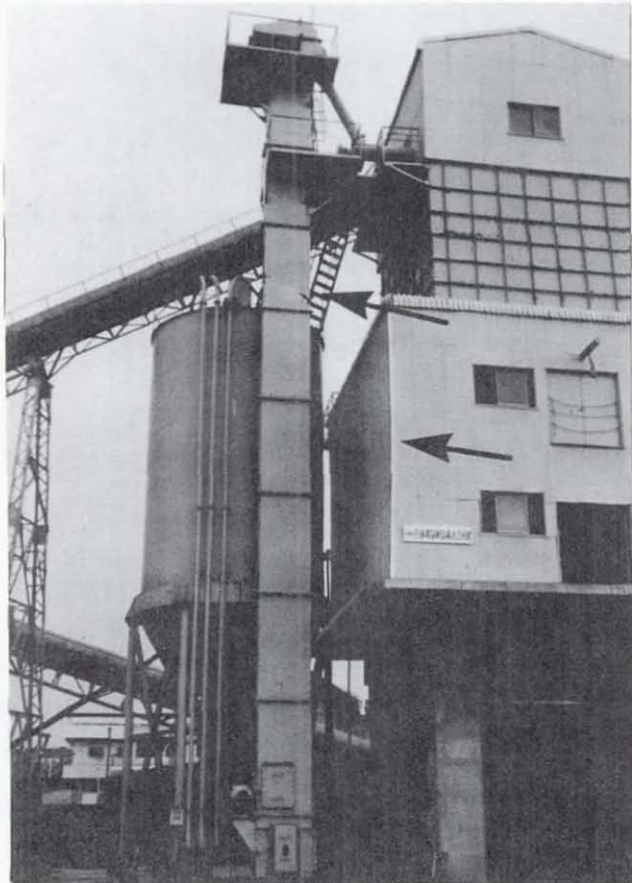
One of the light steel-framed structures at the plant was damaged, as shown in Figure 6.54, apparently because of inadequate lateral bracing. The differential displacement caused by the failure of the structure was responsible for damage to a connecting vertical steel stack and associated piping. The stiffer first floor reinforced concrete structure was undamaged. A similar structure, Figure 6.55, located in the immediate vicinity of the plant and properly braced with light steel cable or rod braces, did not suffer damage. The latter type of construction is quite common in Sendai, and generally appeared to experience no significant damage.

Figure 6.54 Concrete Batch Plant, Sendai: displacement due to damage to the light, unbraced steel superstructure damaged the vertical stack and the conveyor belt structure.

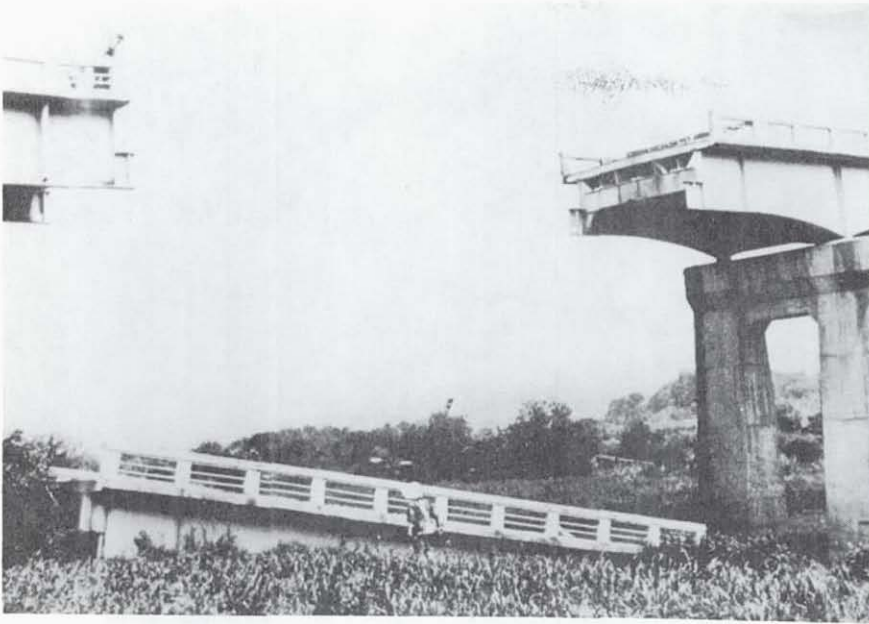
Figure 7.3 Kin-noh Bridge. View of the collapsed suspended plate girder span. Similar damage occurred to bridges in the 1971 San Fernando and 1976 Guatemala earthquakes because of lack of superstructure restraint and small bearing seats. Suspended spans are no longer used in seismically active areas. (Courtesy J.M.O.C.)

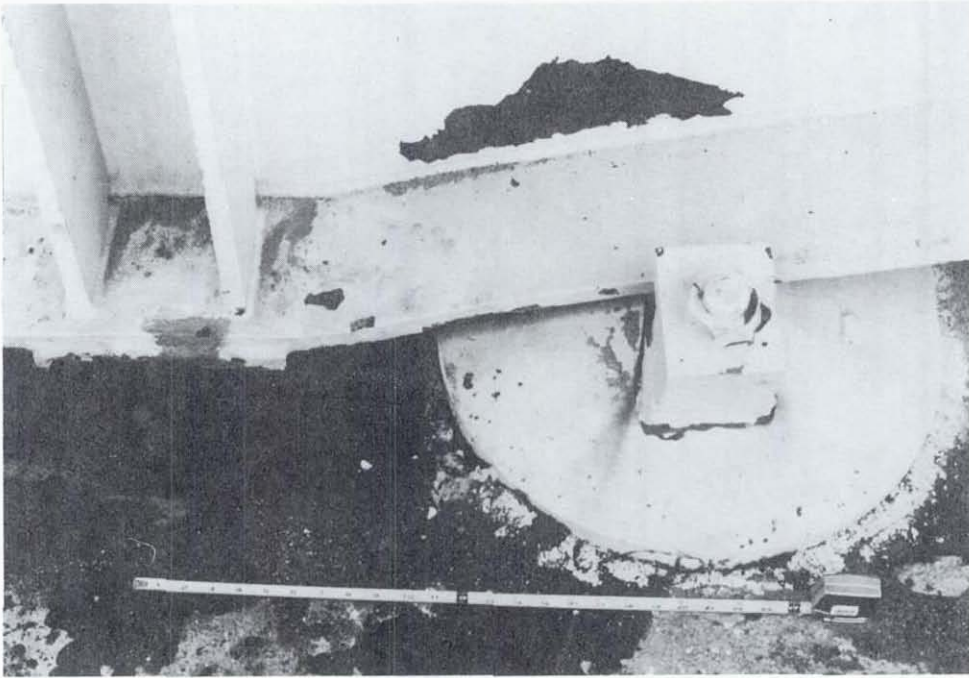
Figure 7.5 Kin-noh Bridge. The girders at Pier 8 displaced longitudinally toward the abutment 55 cm allowing the unrestrained suspended span to drop off the 45 cm hinge seat. The movable girder bearing plate came to rest at the edge of the pier cap. The fixed bearing on Pier 7, the opposite side of the suspended span, displaced longitudinally 0.5 cm.

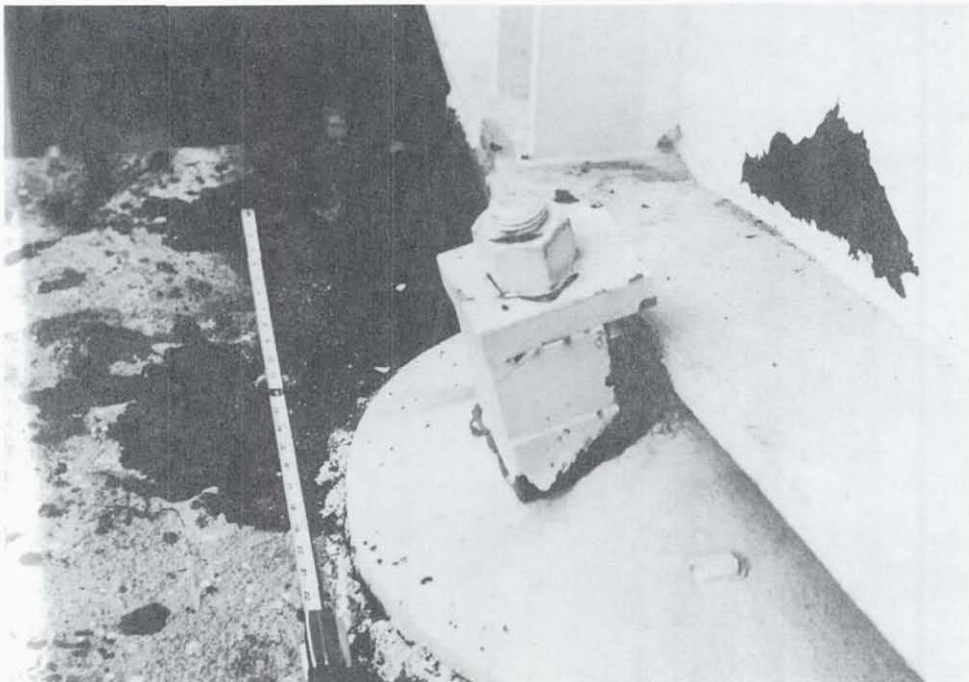
Figure 7.6 Kin-noh Bridge. Evidence of minor transverse displacement of the main girder with broken keeper. This reportedly occurred at the time of the February 20 earthquake.

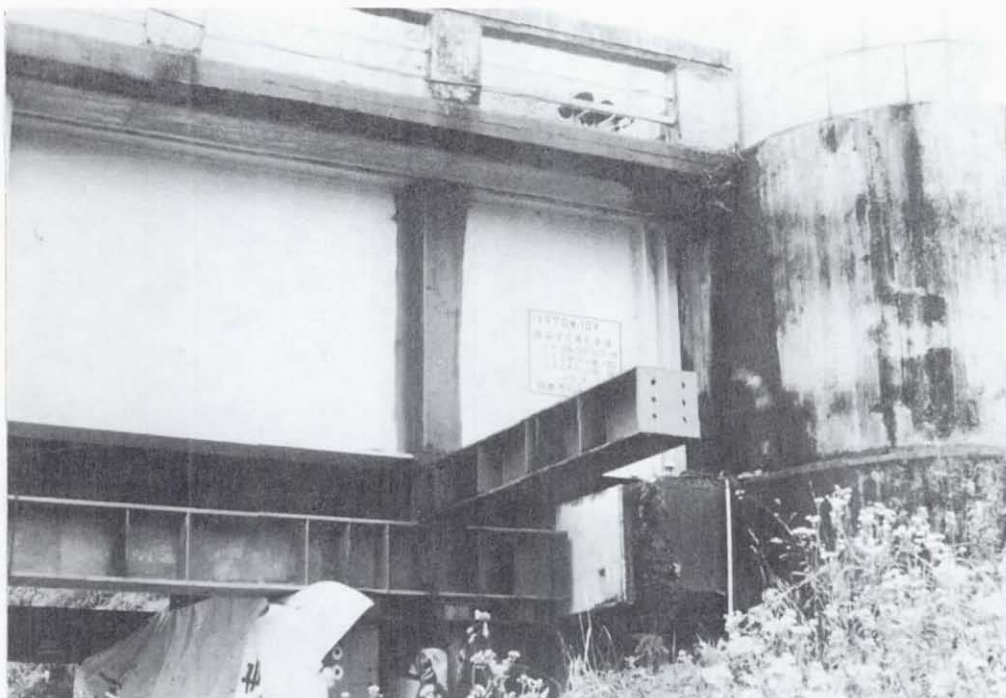
Figure 7.7 Kin-noh Bridge. Damaged abutment from the February 20, 1978, 6.7 magnitude earthquake. New web stiffener at point of temporary shoring.

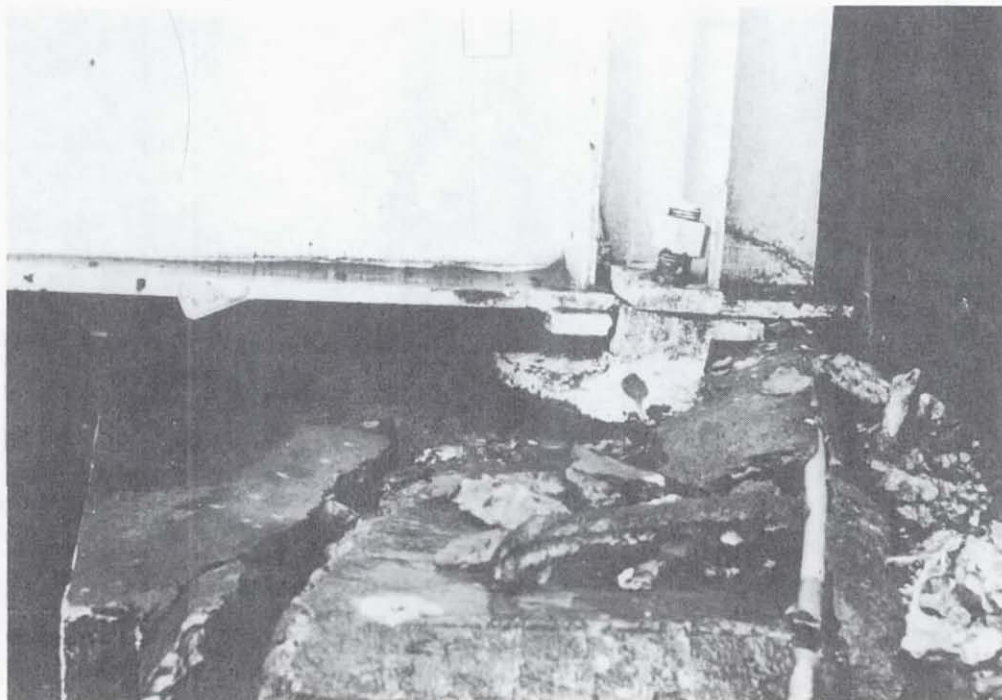
Figure 7.8 Kin-noh Bridge. Detail of bearing damage and abutment ledge failure, from February earthquake. Note extension of anchor bolt caused by 20 cm displacement of span towards abutment.

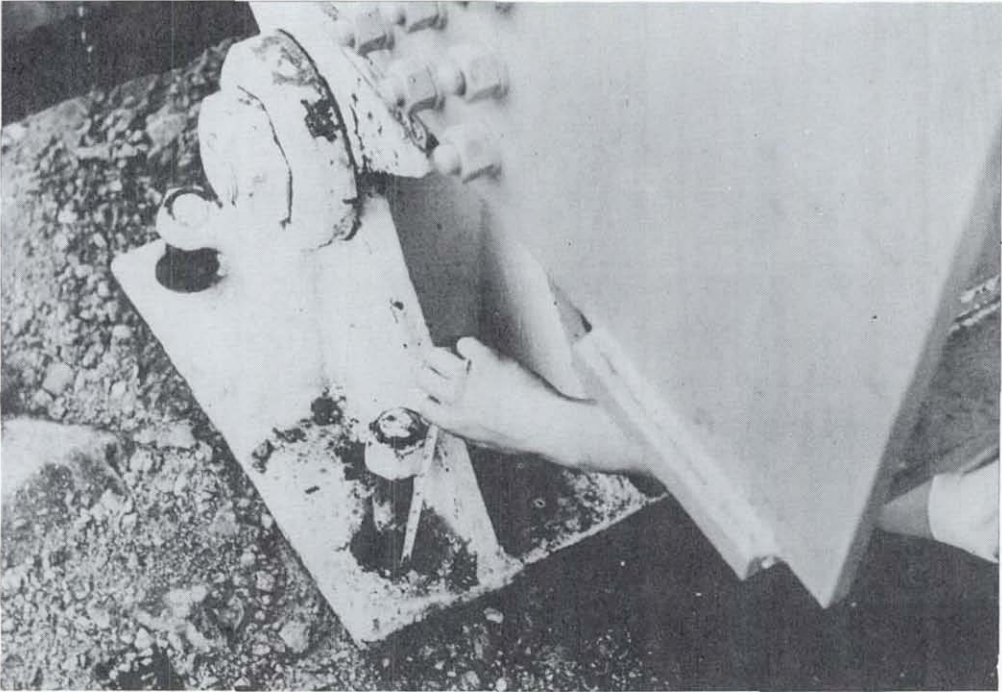
Figure 7.9 Kin-noh Bridge. Extension of anchor bolts at Pier 6. The foreground shows a portion of repaired lower chord truss member.

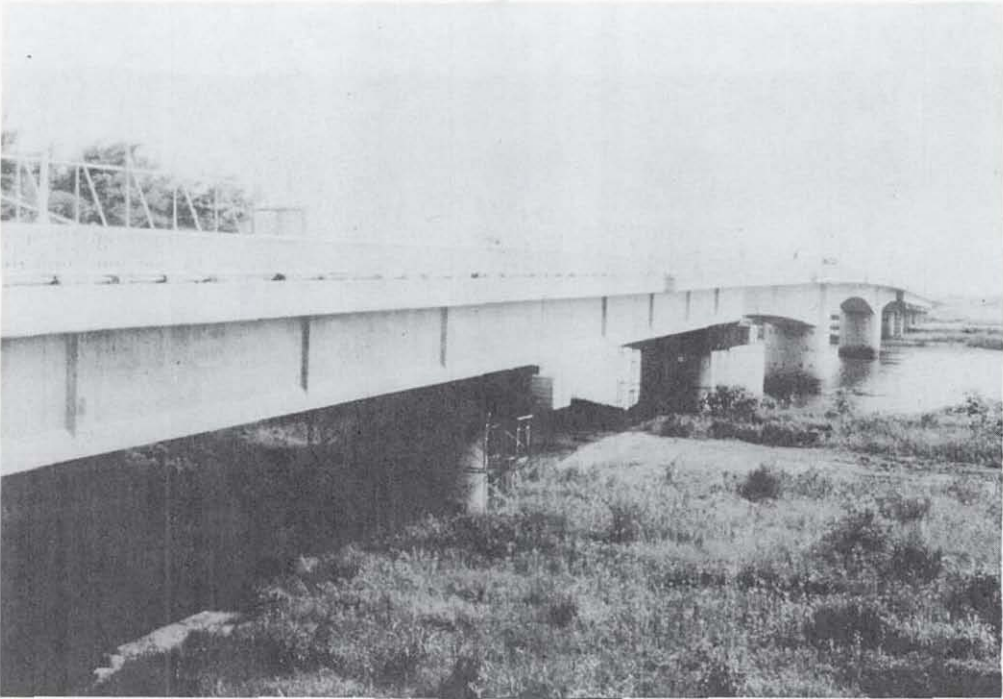
Figure 7.11 General view of the Yuriage Bridge showing the first two columns which were heavily damaged.

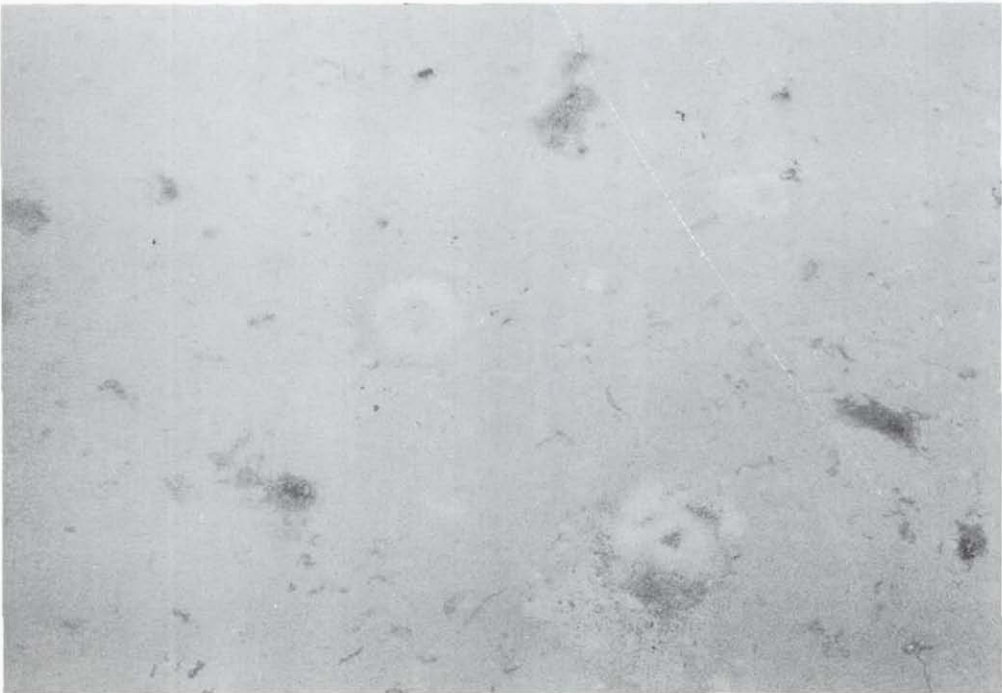
Figure 7.12 Yuriage Bridge. Liquefaction in the flood plan below the bridge.

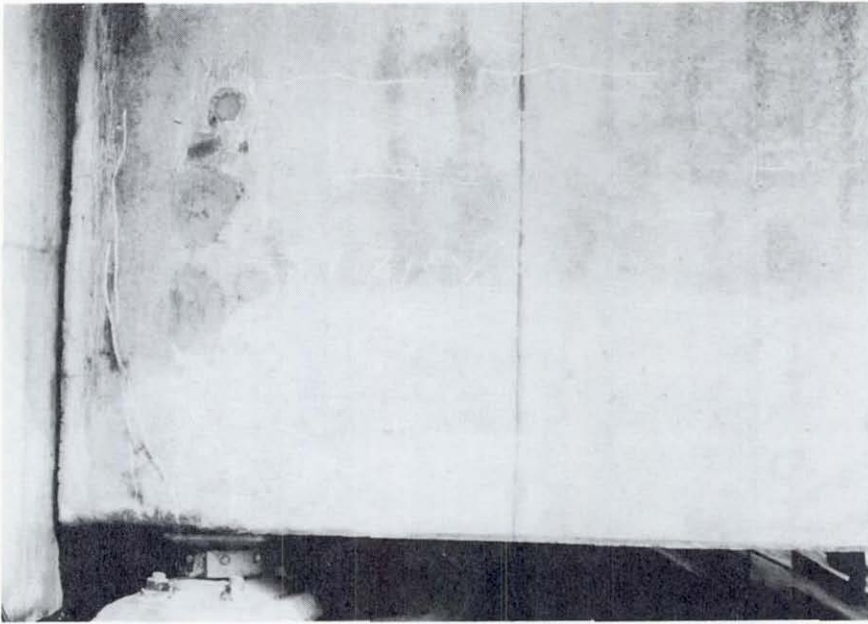
Figure 7.13 Yuriage Bridge. Evidence of light girder impacting with the abutment and pronounced shear cracking of exterior girder at the bearing.

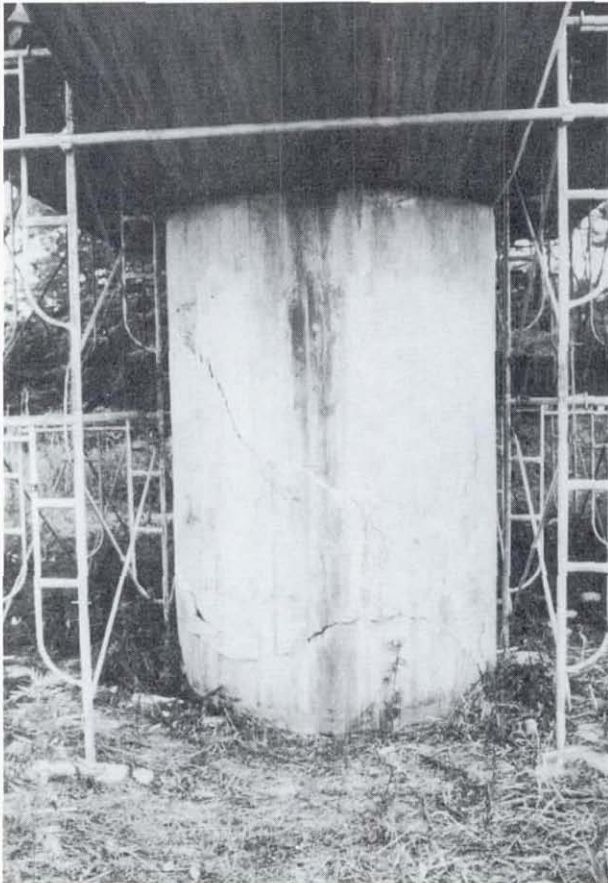
Figure 7.14 Yuriage Bridge. Pier 1, founded on a caisson 19 m deep and 2 m by 4 m in plan, suffered heavy shear cracking. The pier cap was reported to have settled uniformly 5 cm.

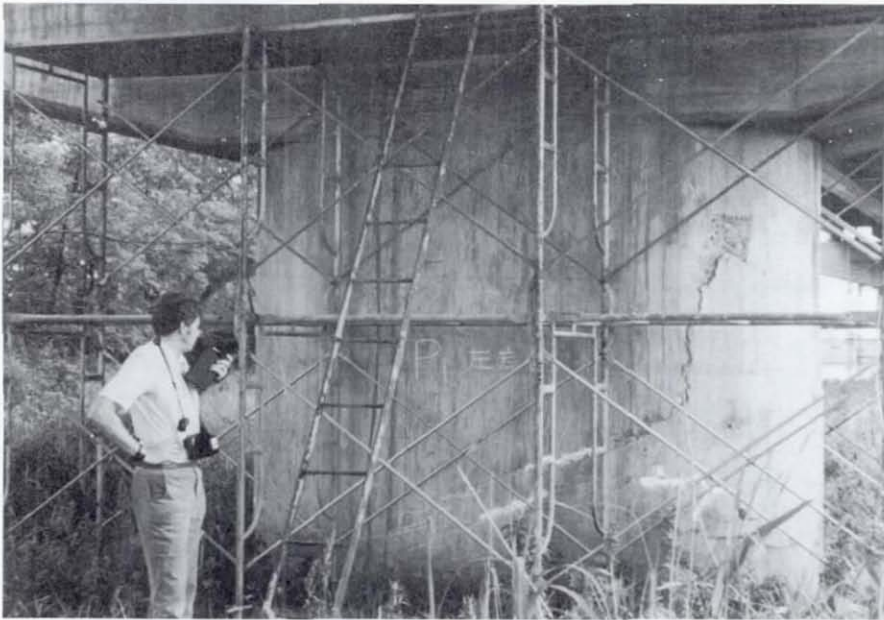
Figure 7.15 Yuriage Bridge. The face of Pier 1 showing severe distress. The plaster of paris patchwork is used to determine if additional pier cracking has occurred.

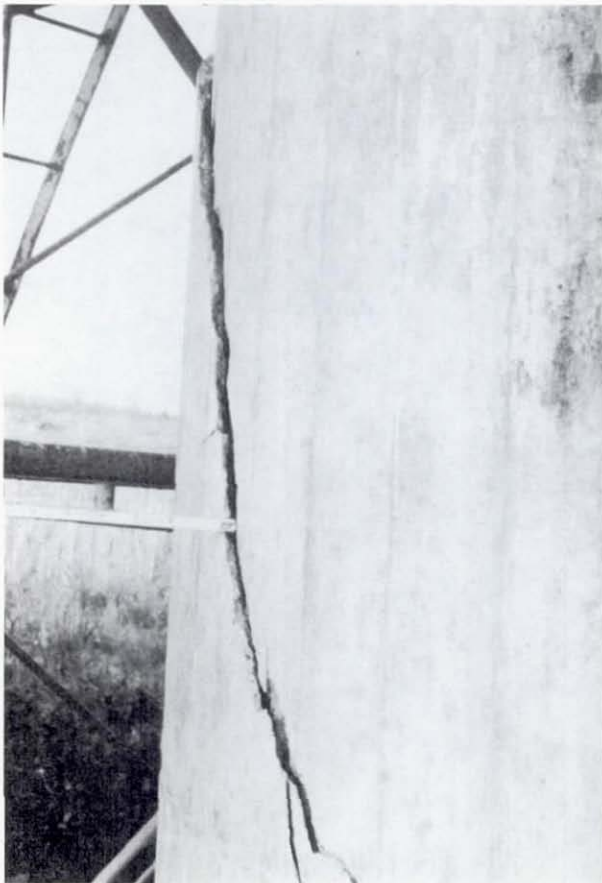
Figure 7.16 Yuriage Bridge. Detail showing 1 cm offset of cracking, indicating torsion in pier.

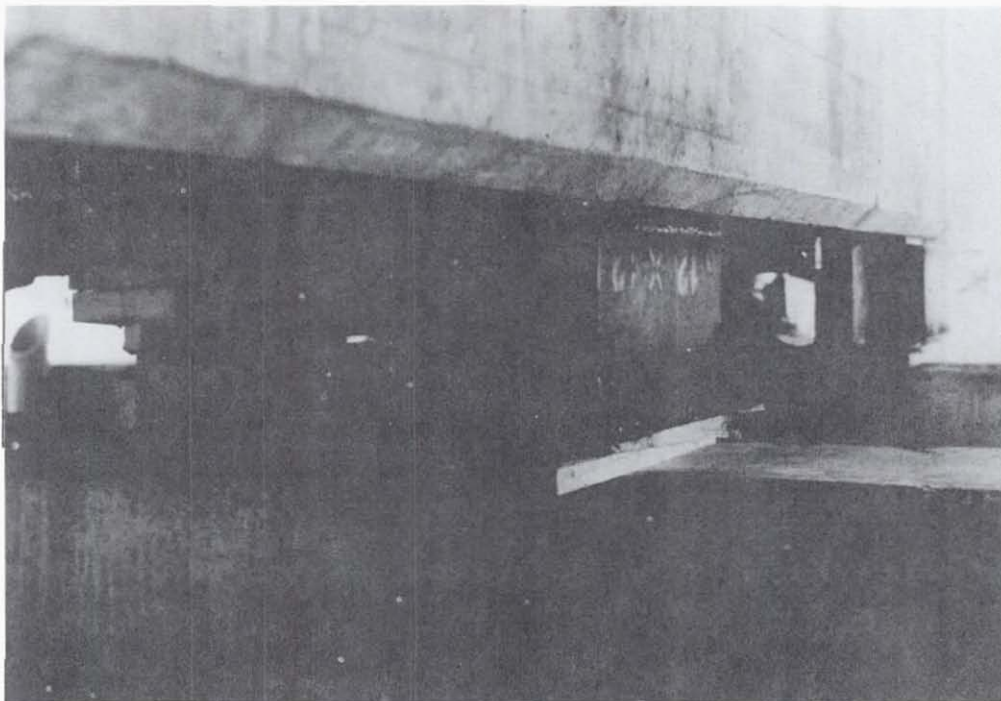
Figure 7.17 Yuriage Bridge. Temporary girder supports at Pier 1. Bearings showed evidence of girder displacement - broken keeper and containment plates.

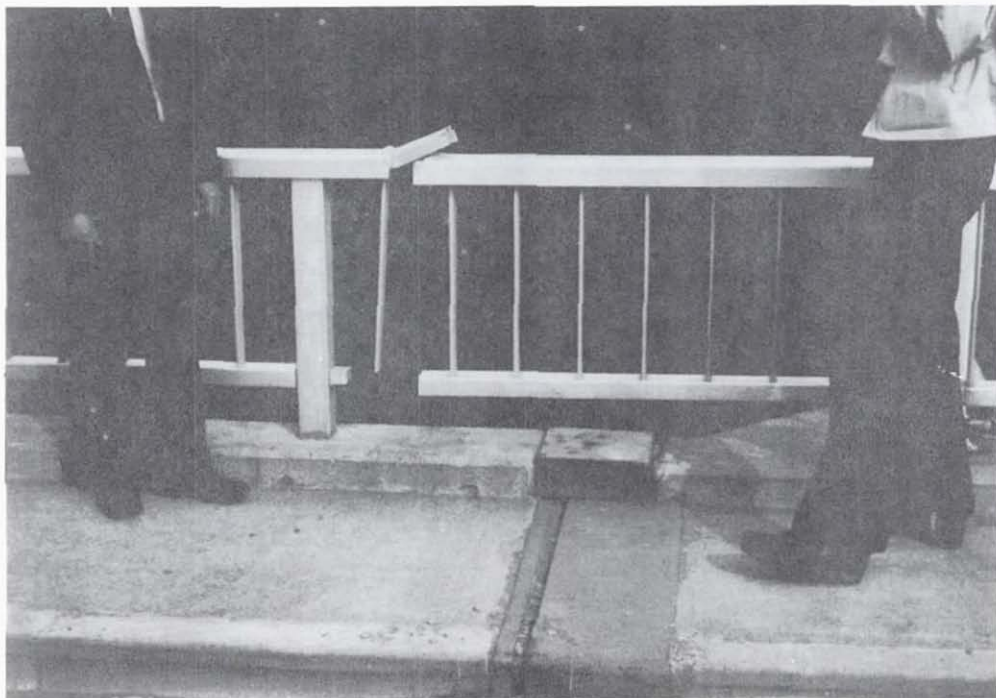
Figure 7.18 Yuriage Bridge. Evidence of 8 cm of longitudinal movement as shown at the handrail expansion joint, Pier 2. However, there was no evidence of damage to the girders or the second pier.

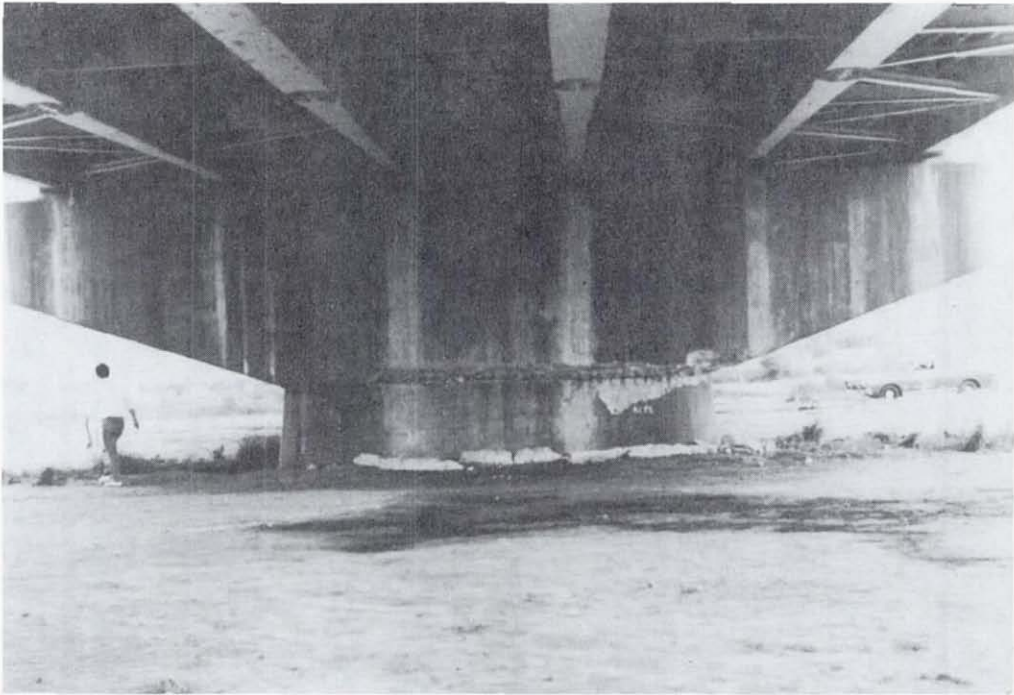
Figure 7.22 Sendai Ohashi Bridge. Typical pier damage at the construction joint between pier and cap. The vertical rebar are buckled across the joint. Significant concrete spalling is evident. Horizontal cracking around the pier was discovered upon excavation of soil around the piers. (Courtesy J.M.O.C.)

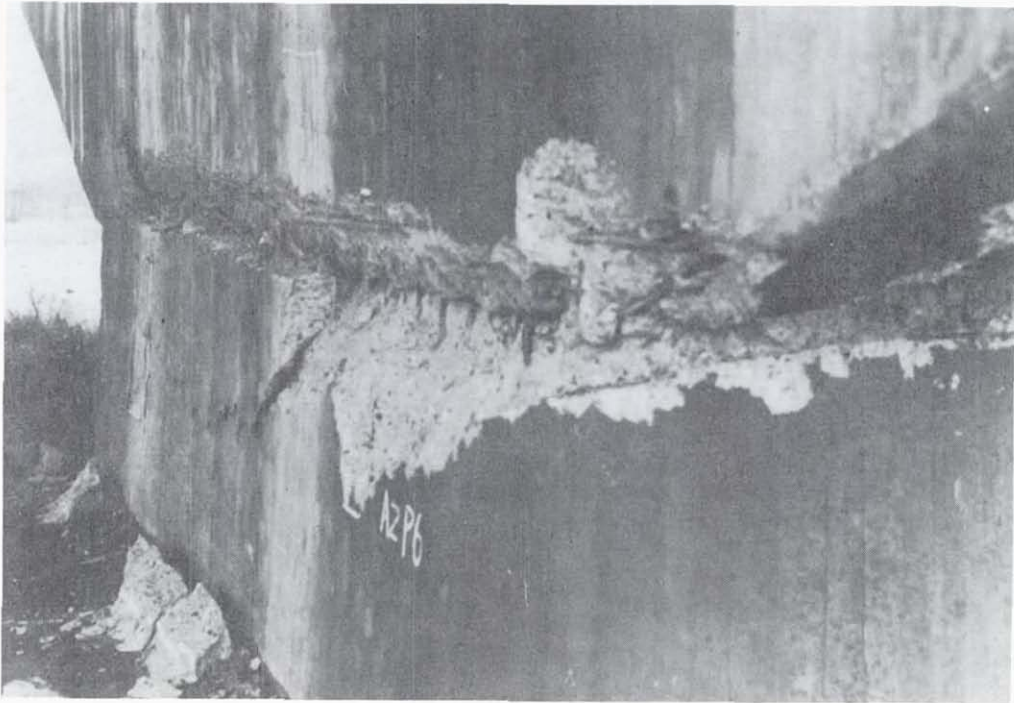
Figure 7.23 Sendai Ohashi Bridge. Detail showing buckled vertical rebar at the construction joint. Strong motion records in Sendai indicated approximately 100 gal. vertical accelerations. (Courtesy J.M.O.C.)

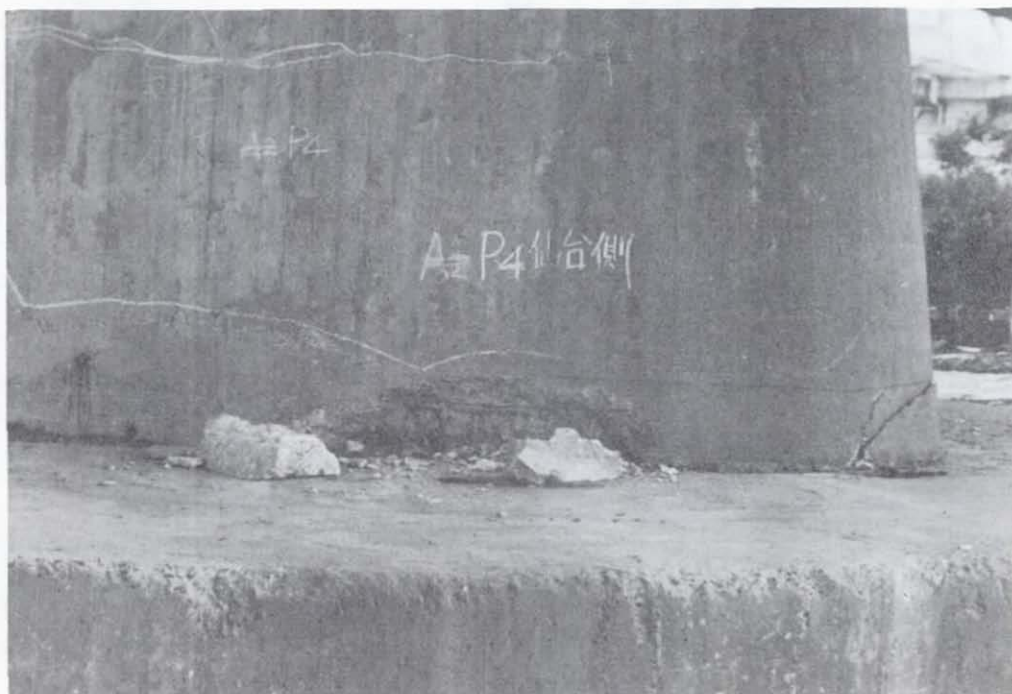
Figure 7.25 Sendai Ohashi Bridge. Typical damage being repaired at the base of the pier. Note the outward buckling of the underformed vertical rebar. The concrete cover had been roughened, the footing strengthened, and additional rebar placed to strengthen the pier.

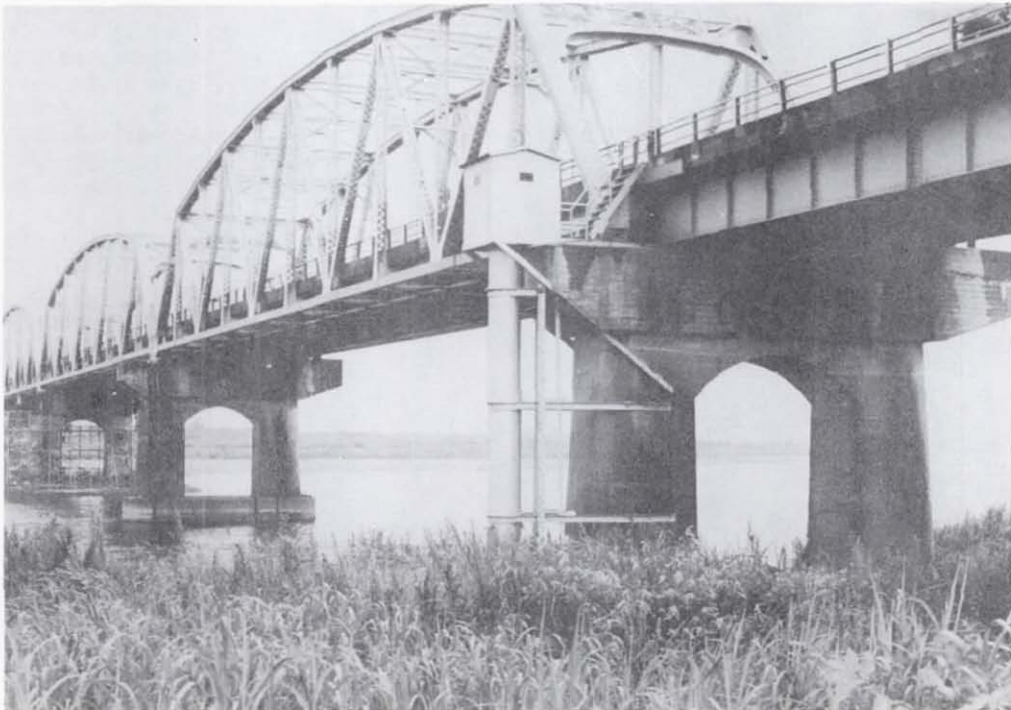
Figure 7.29 Abukuma Bridge. Outward buckling of vertical rebar at one of the damaged piers.

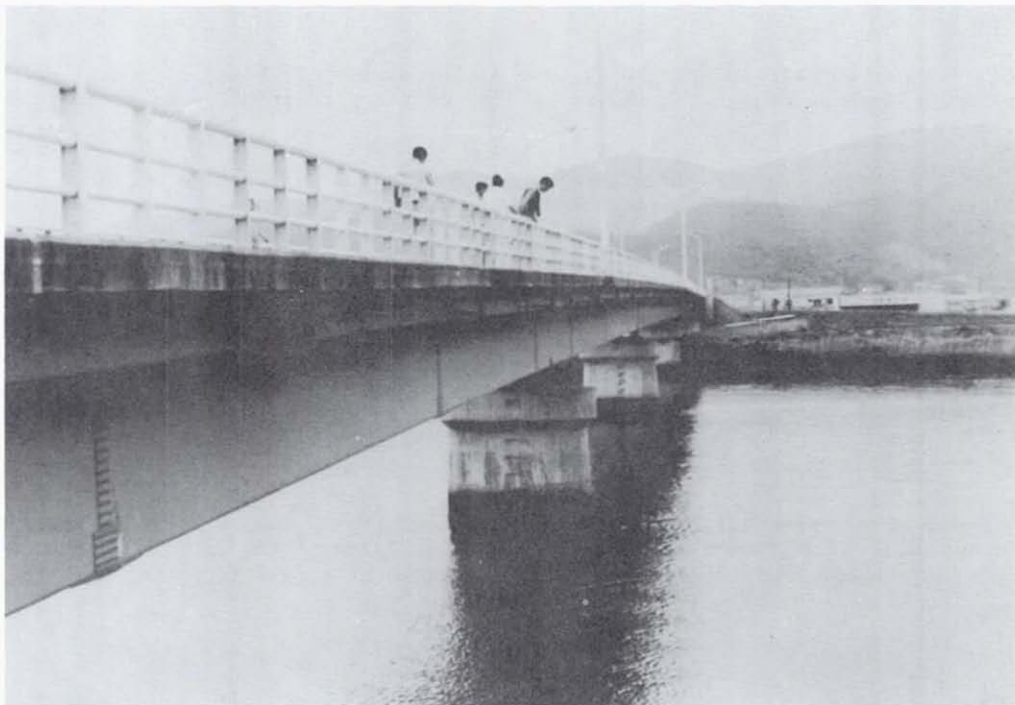
Figure 7.32 Kaihoku Bridge. Pier 2 showing the SMAC-B2 instrument (which recorded a peak acceleration greater than 500 gal. in the longitudinal direction) and the fixed bearing and hydraulic damper system.

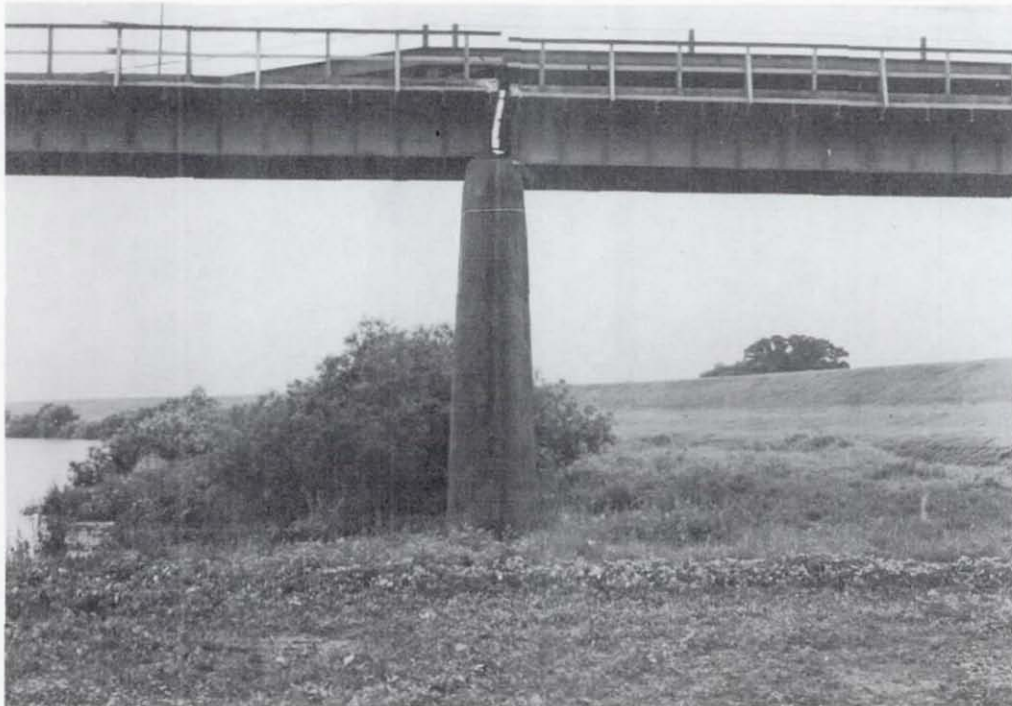
Figure 7.39 Vertical displacement of dislodged span.
