NBS SPECIAL PUBLICATION **592**

U.S. DEPARTMENT OF COMMERCE / National Bureau of Standards

An Investigation of the Miyagi-ken-oki, Japan, Earthquake of June 12, 1978

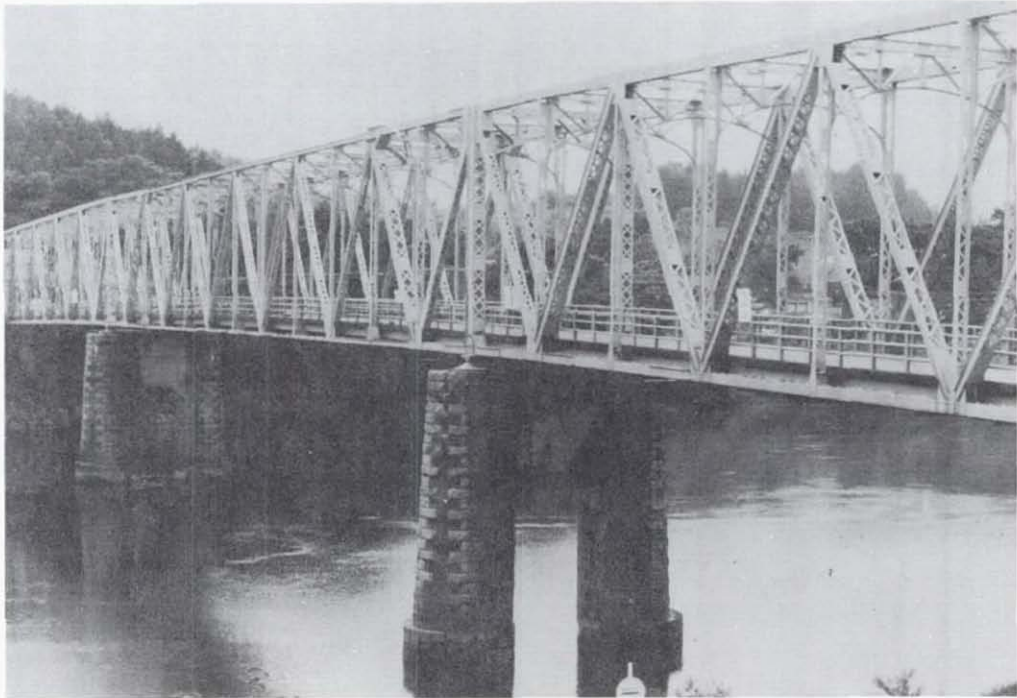
The Maiya Ohashi Bridge, Figure 7.40, is a three-span Gerber-truss bridge located on National Highway Route 342 approximately 62 km northeast of Sendai. The 181 meter long truss bridge, constructed in 1928, was closed to traffic because of a brittle fracture through the rivet holes of the top chord channel members at the first pier, Figure 7.41. Four steel plates had been welded around the top chord members. Some of the small steel angle top lateral bracing members were buckled in the vicinity of the pier, Figure 7.42. No damage was reported to either of the piers or abutments. The Maiya Bridge is scheduled to be replaced.

Figure 7.41 Maiya Ohashi Bridge. Steel plates welded to the top chord channel members. Note the clean fracture at a line passing through the centerline of the rivet holes of the lattice bracing and the permanent 2.5 cm separation.

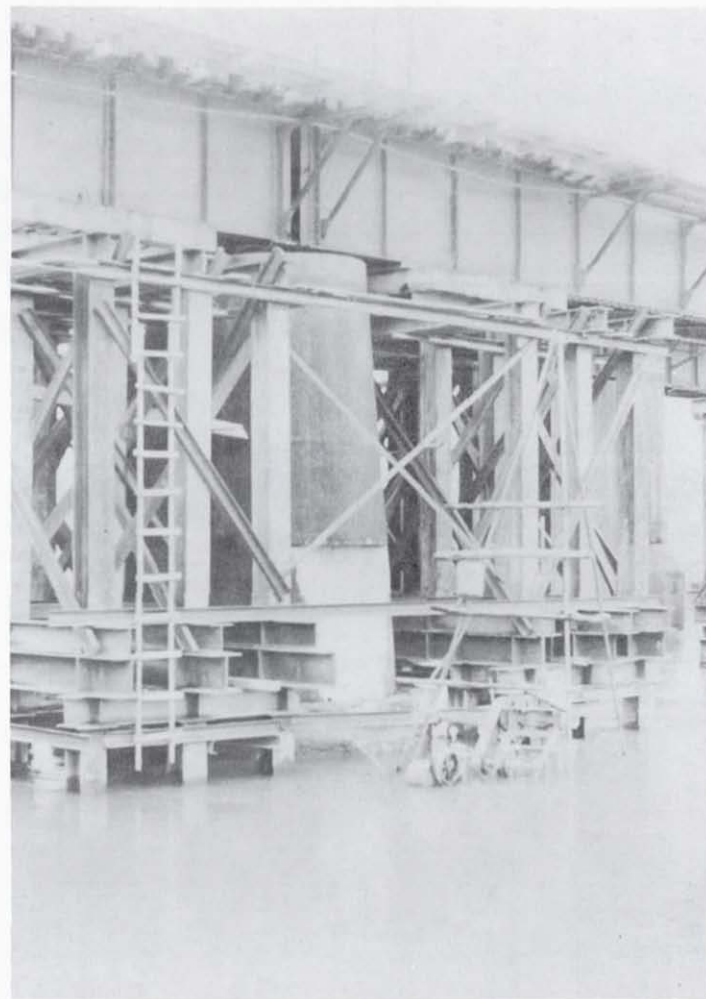
The Eai River Bridge (Figure 7.48), owned by the Japanese National Railways (JNR), is a dual eight-span steel plate girder structure 160 m in length, which is located 40 km northeast of Sendai. The superstructure is supported by massive unreinforced concrete gravity piers on caisson foundations. Ground acceleration in the area was estimated by the Ministry of Construction to be 200-250 gal. Two piers were severely damaged when large wedged shaped sections of concrete dropped out below a construction joint.

Figure 7.48 Eai River Bridge. Damaged pier of Eai River Rail Bridge. Temporary pier supports were constructed following the earthquake. Full train service was established approximately 10 days after the earthquake.

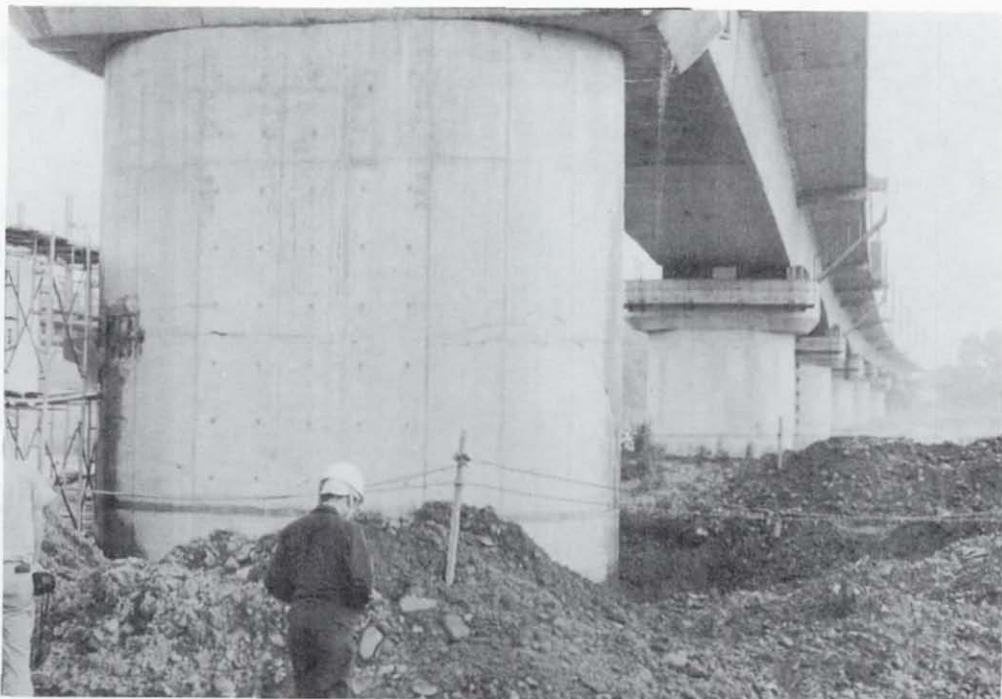
Figure 7.49 The Natori River Bridge is a three-span continuous single cell reinforced cast-in-place concrete box girder structure on 3 m x 6 m piers approximately 8 meters above grade. Typical damage included cracking in the central part of the pier where the gross cross-sectional area of vertical steel was reduced.

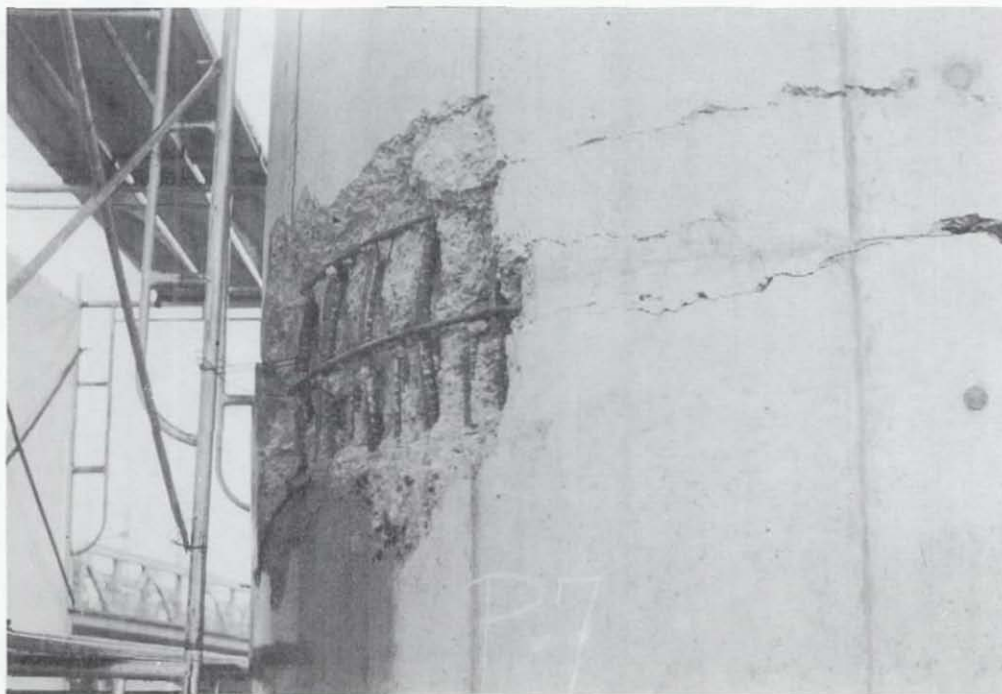
Figure 7.50 Natori River Bridge. Detail of spalled concrete at the Natori River Bridge site showing the buckled vertical rebar.

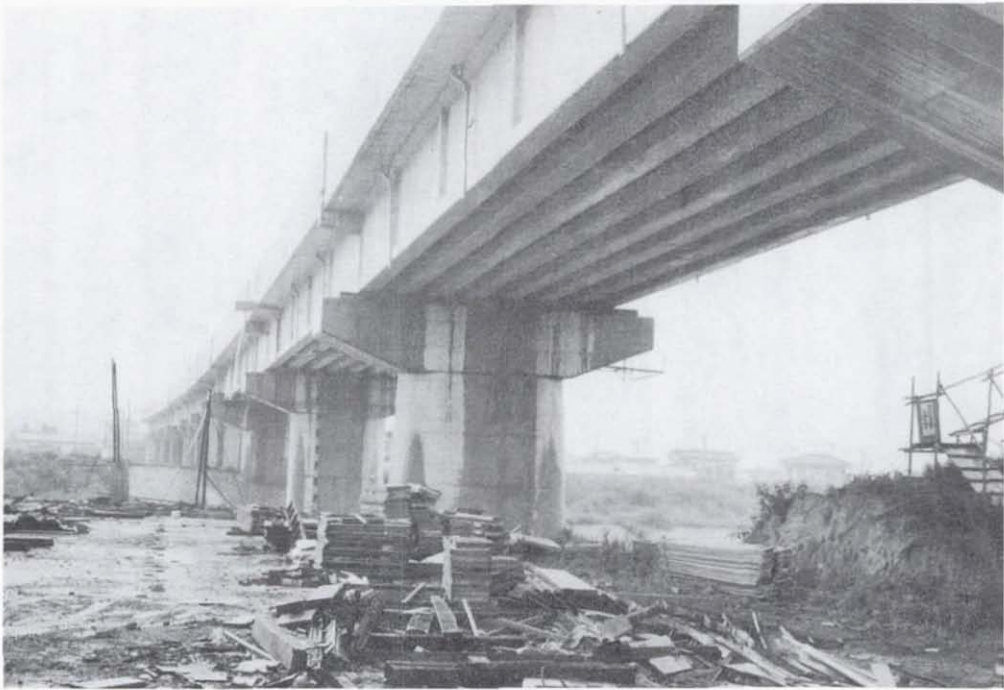
Figure 7.51 Typical structures which experienced pier cracking near the Rifu Construction Office of the Sendai Shinkansen Construction Bureau, JNR.

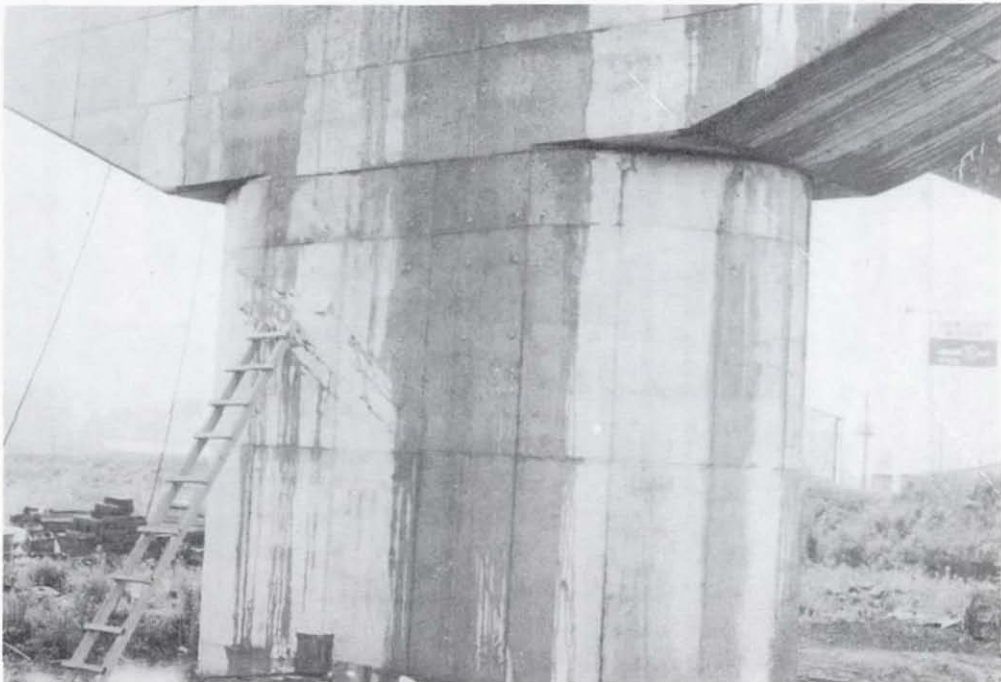
Figure 7.52 Shear cracking in the relatively lightly reinforced upper portion of the pier.

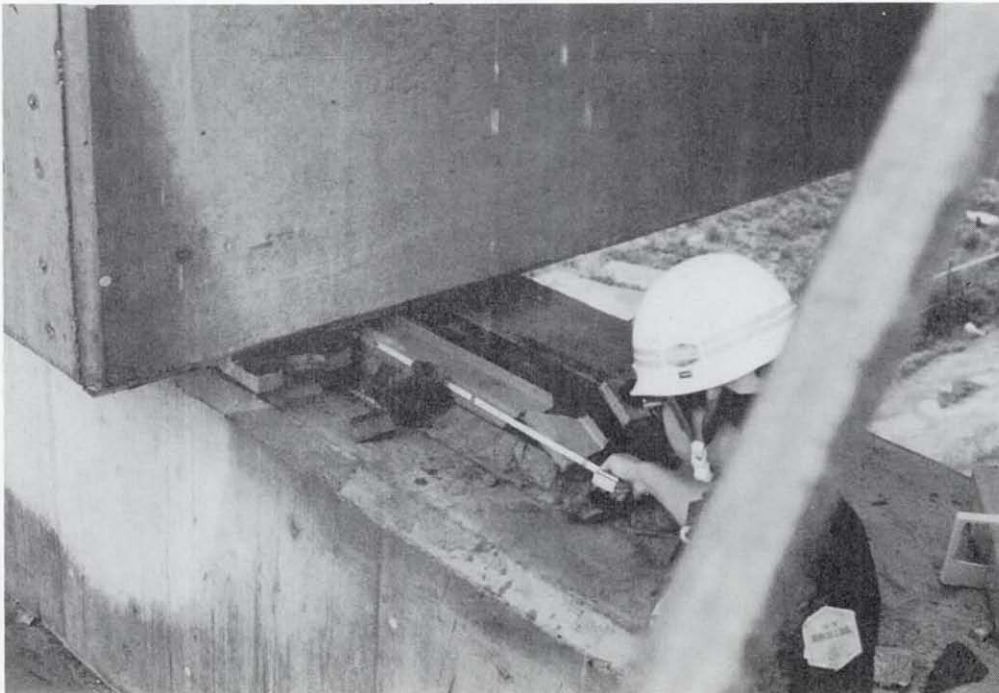
Figure 7.54 Failure of a bearing plate supporting a single cell box girder near the Higashi Sendai Construction Office. Girder displaced laterally 50 cm.

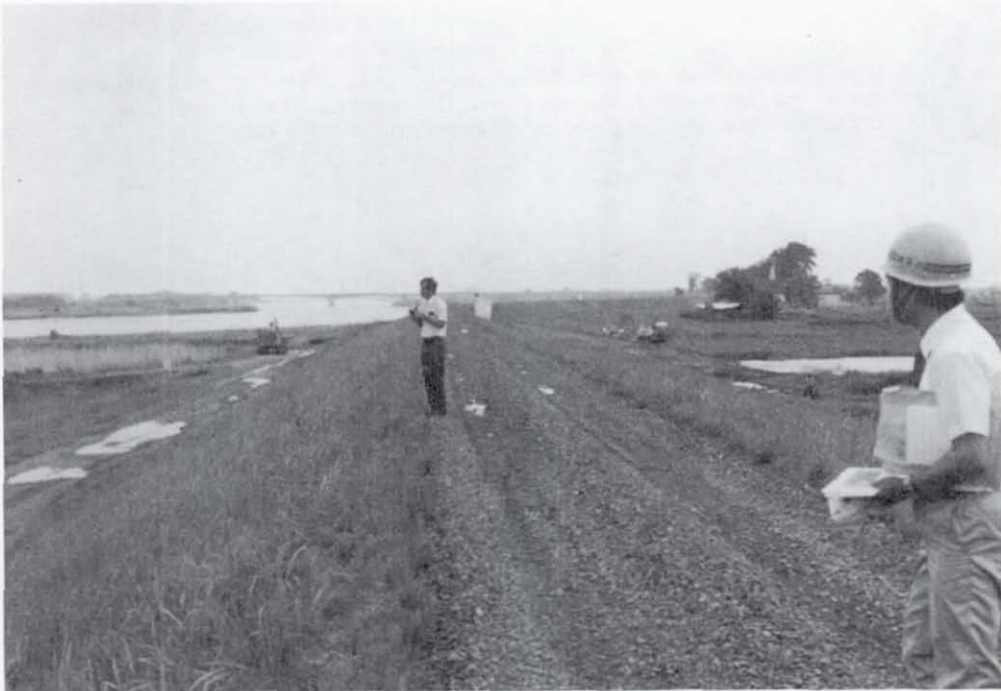
At Site 1, liquefaction caused slumping, lateral spreading, and settlement of up to 1.5 m along a 160-m-long section of the dike (Figures 8.2, 8.3, and 8.4). Longitudinal cracks several tens of meters long opened in the dike crest. Between the dike and the river, fissures striking obliquely to the dike formed, and sand was ejected from them (Figure 8.5). Other fissures trending parallel to the dike and the river formed near the river bank, more than 100 m from the base of the dike. The occurrence of fissures and sand boils in ground away from the dike indicates that liquefaction took place primarily in material beneath the dike and not in the dike material itself.

Figure 8.3 Site 1, Natori River. Slumping of dike on flank away from river. View north. (Photo courtesy Tohoku Regional Construction Bureau)

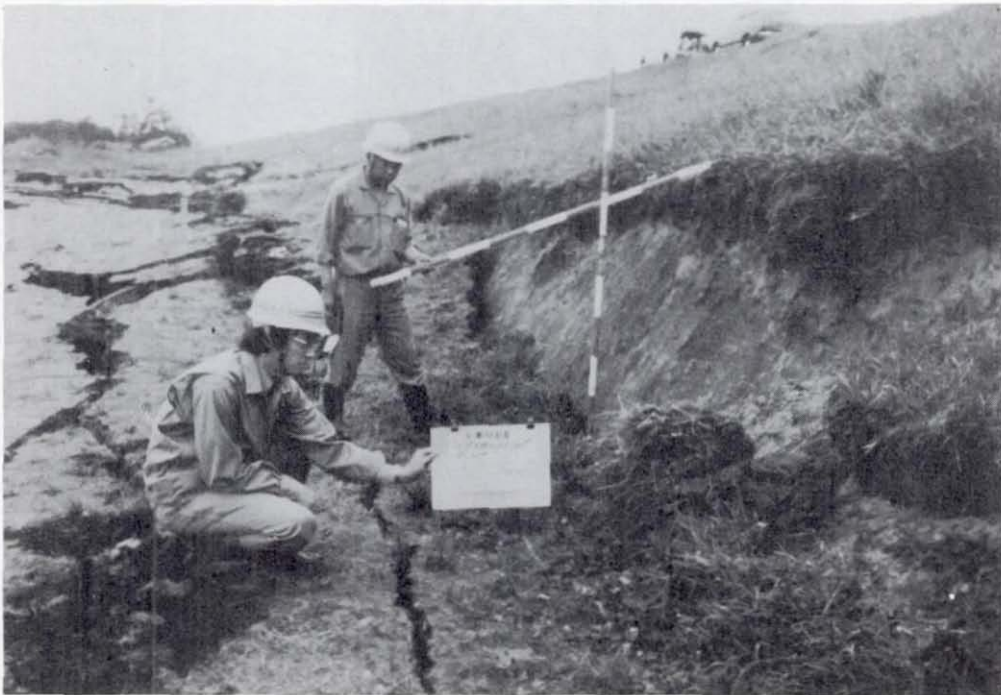
Figure 8.4 Site 1, Natori River--cracking, settlement, slumping, and lateral spreading induced by liquefaction. (From Tohoku Regional Construction Bureau, MOC, unpublished data)

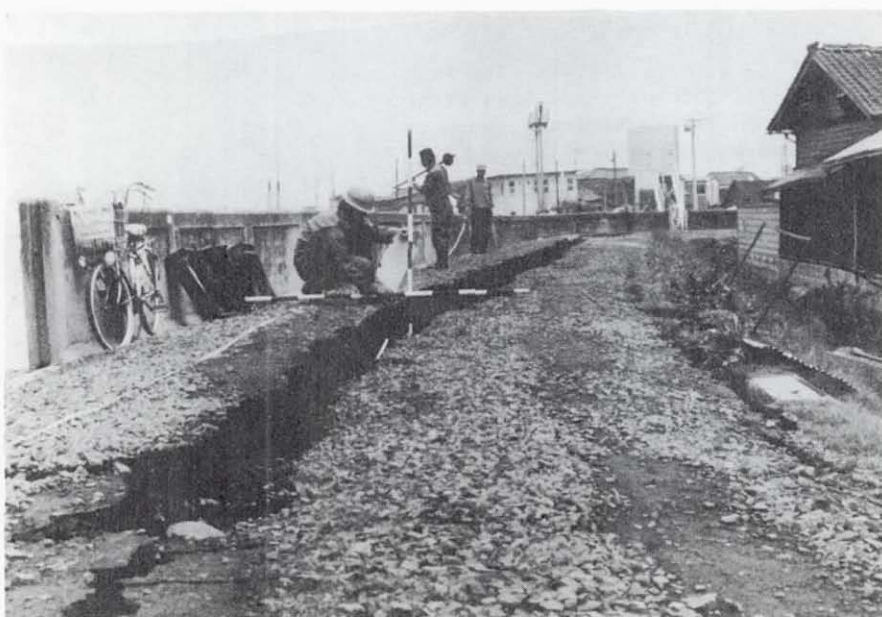
Figure 8.8 Site 2, Natori River. View is west across tributary of Natori River. Dike section shown in Figs. 8.6 and 8.7 is to right of houses in background of this figure. Note crack in concrete pavement in foreground is aligned with crack in retaining wall in background.

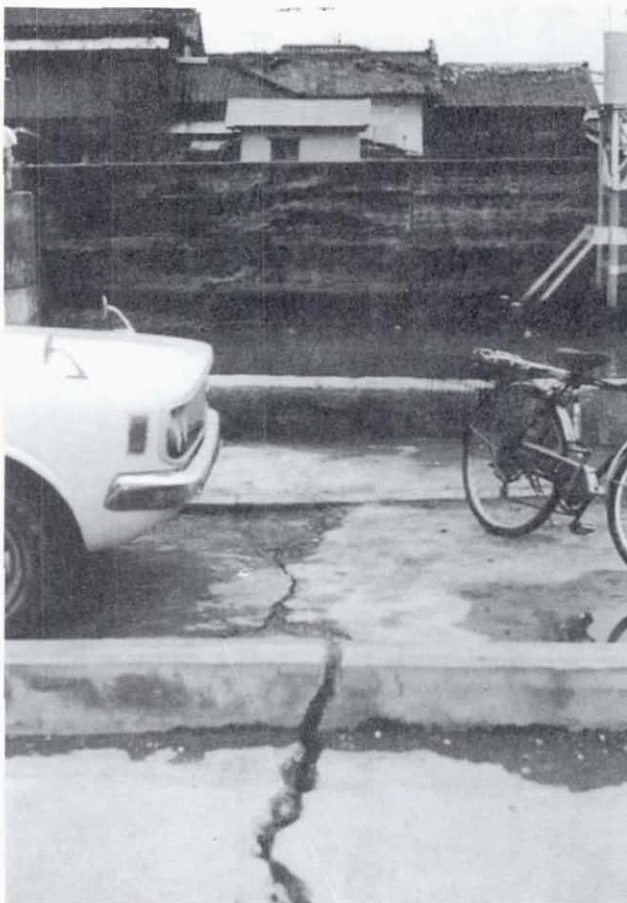
Figure 8.9 Site 2, Natori River--Retaining wall moved laterally and dike crest settled (From Tohoku Regional Construction Bureau, MOC, unpublished data)

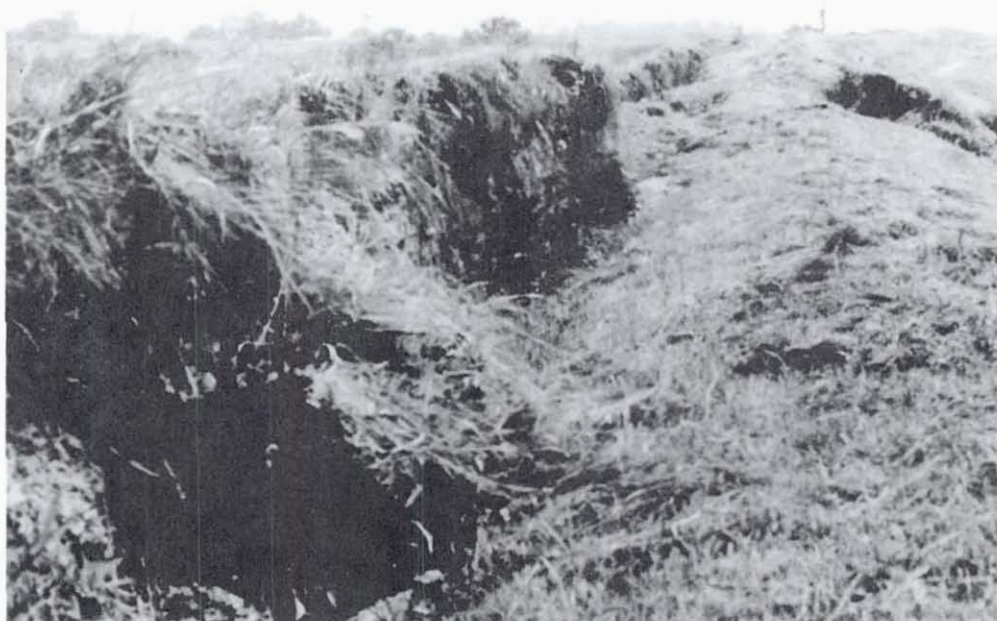
Figure 8.12 Site 3, Yoshida River. Scarps in dike caused by slumping. Note man in background for scale. (Photo courtesy K. Kawashima, PWRI)

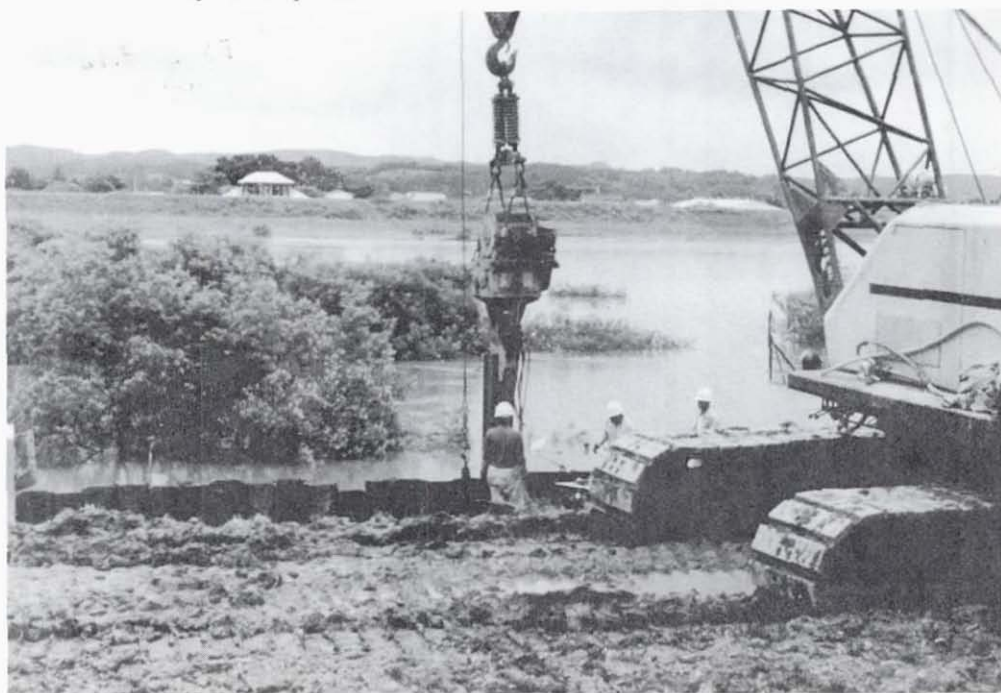
Figure 8.13 Site 3, Yoshida River. Steel sheet piles being placed by vibratory driver as part of repair process. Purpose of sheet piles is to reduce seepage under part of dike weakened by earthquake.

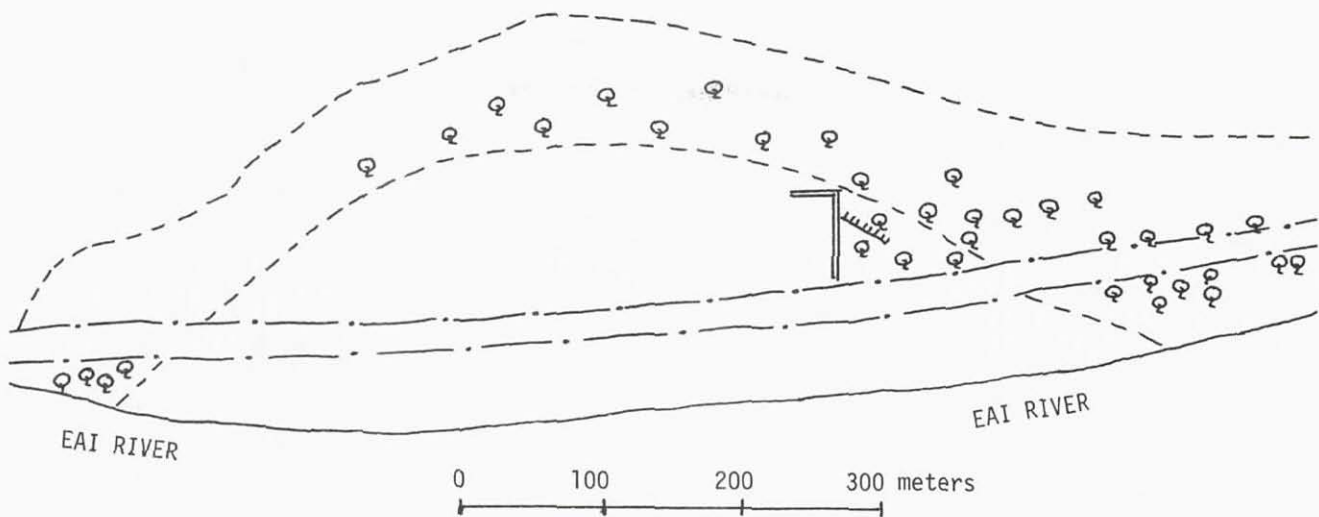
Figure 8.14 Site 4, Eai River--Most sand boils occurred in old river channel. Minor cracking of dike apparently occurred where dike crosses old channel, but cracks were repaired prior to visit. (After Tohoku Regional Construction Bureau, MOC, unpublished data)

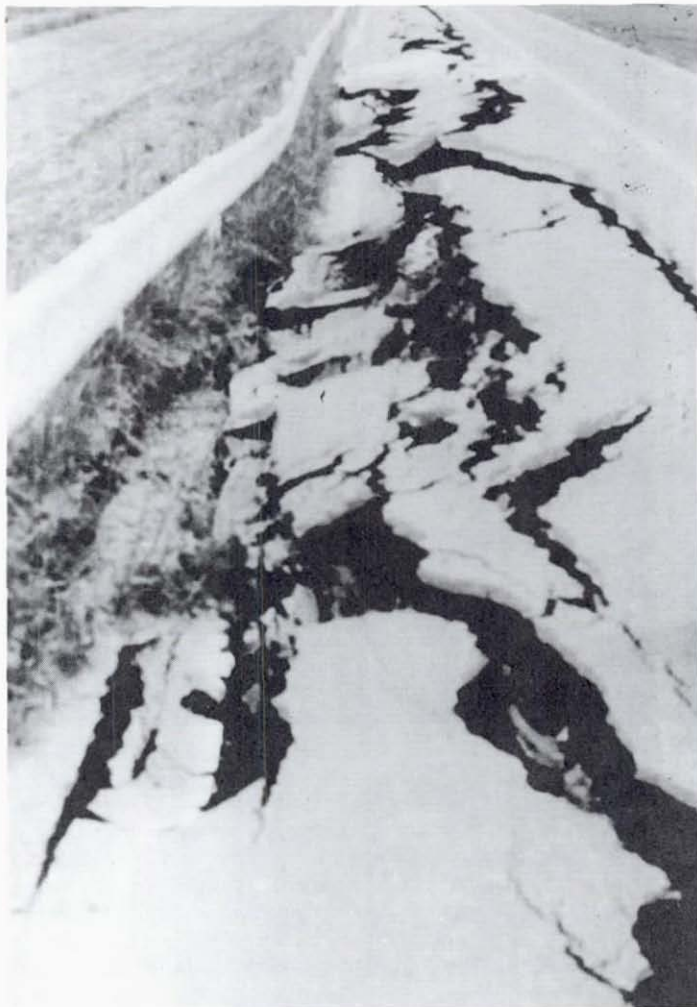
The dike and paved roadway at Site 6 settled up to 1.5 m and cracked over a distance of 4 km (Figures 8.17 and 8.18), and sand boils formed on both flanks of the dike, which is built over an old river channel. According to data from borings completed by the Tohoku Regional Construction Bureau, MoC, the soil under the damaged part of the dike is similar to the soil under an adjacent, undamaged section. To a depth of 8 in, the soils consist of gravels, sands, and silts with a few thin layers of clay. N-values (blows/foot from a standard penetration test) for most soil layers under both sections are less than 10. Reasons for the differences in behavior between damaged and undamaged sections are currently under study by Japanese engineers.

Figure 8.17 Site 6, New Kitakami River. View east along crest of dike and highway that are being repaired. Uneven nature of highway surface is due to liquefaction-induced differential settlement. Settlements of up to 1.5 m occurred along a distance of 4 km.

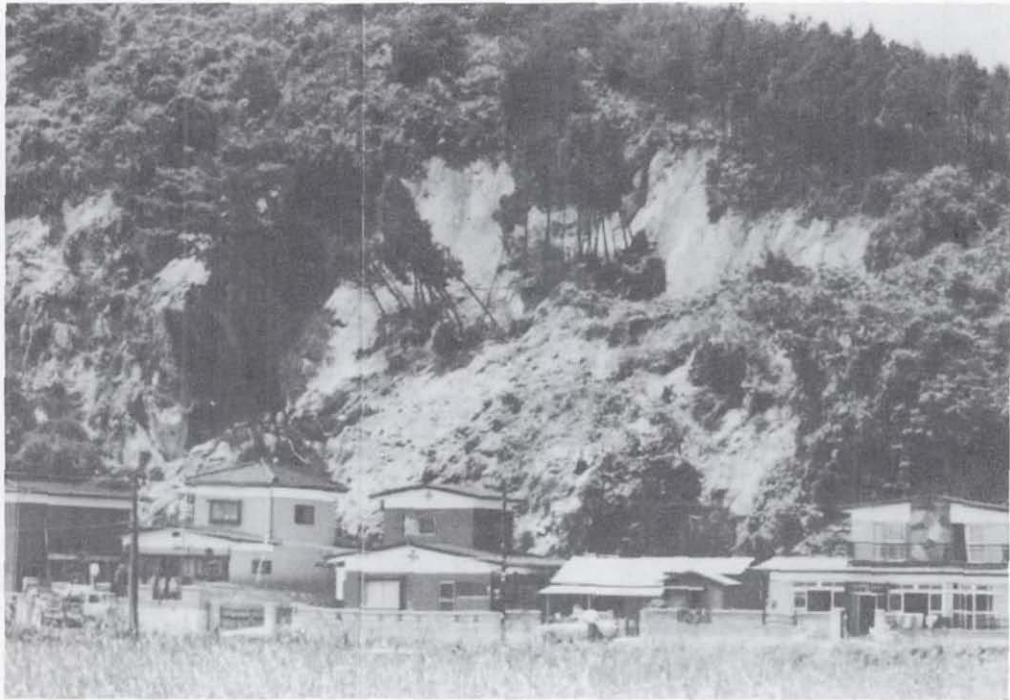
Two of the largest rock falls from the earthquake occurred near Takayamashita in Matsushima town west of the Takagi River on steep (greater than 45°) natural slopes. The larger of these rock falls (Figure 9.2) occurred in a deeply weathered and closely jointed Miocene tuff breccia (Geologic Map of Miyagi Prefecture) exposed in a 45-m scarp. The slope affected is approximately 110 m wide, and the volume of debris is about 6,000 m³. The rock fall damaged four houses built next to the slope. A close view of some of the damage to the house second from the left in Figure 9.2 is shown in Figure 9.3.

Figure 9.2 Rock fall on steep slopes of Miocene pumiceous tuff breccia near Takayamasuita. This rock fall damaged four houses close to the base of the slope. (Photograph courtesy of Y. Tsuruya, Slope Protection Division, Ministry of Construction).

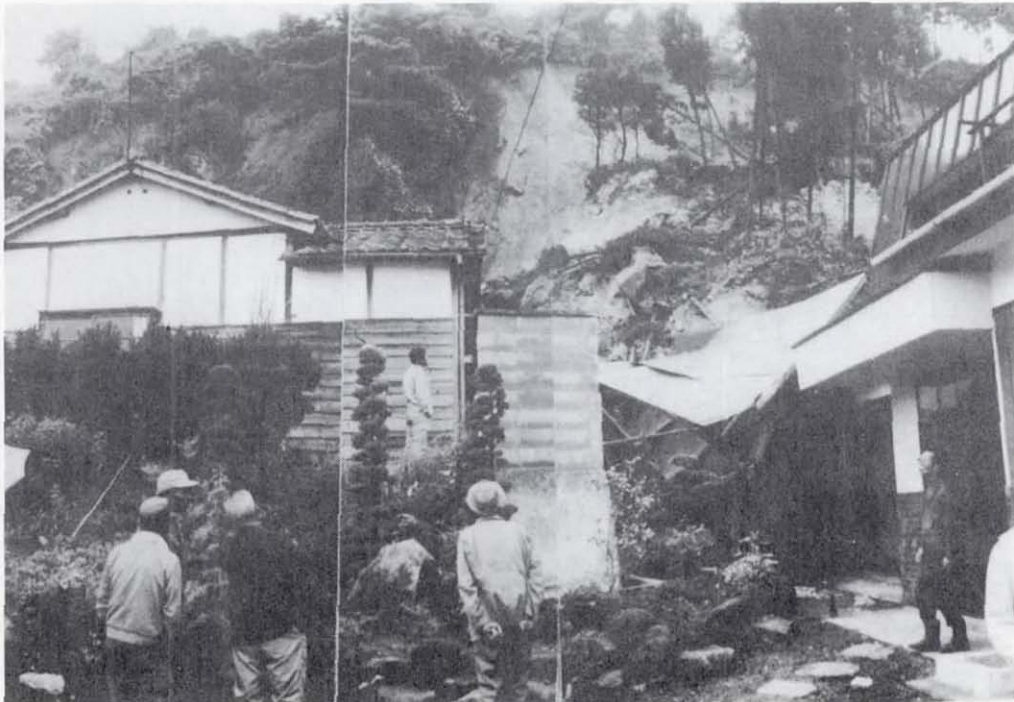
Figure 9.3 Closeup of rock fall damage to houses shown in left portion of figure 9.2. (Photograph courtesy of Y. Tsuruya)

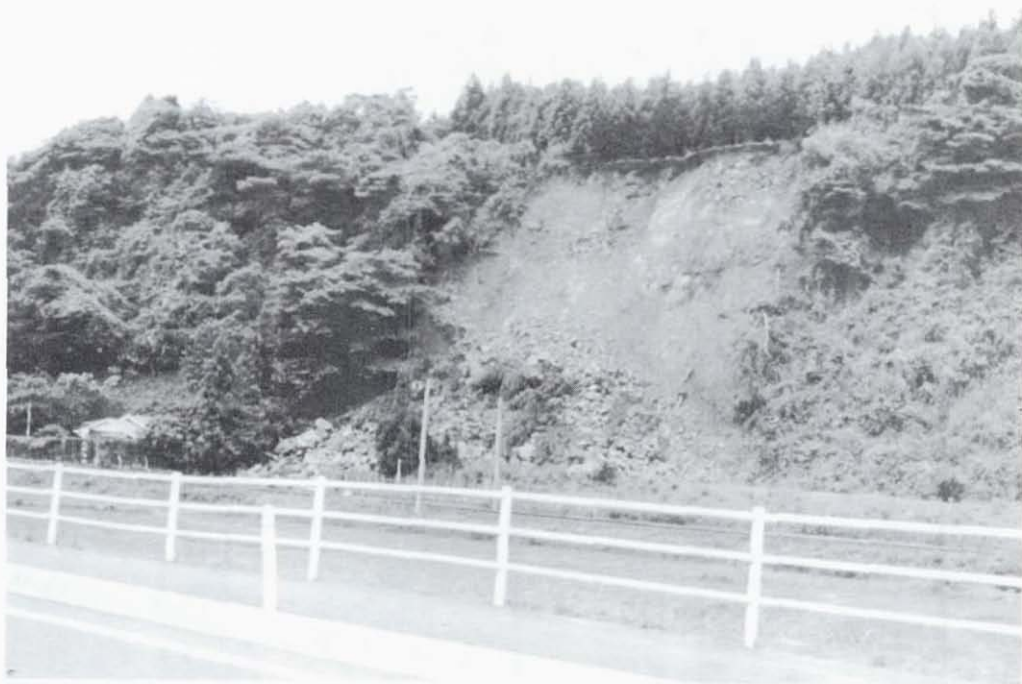
About 0.5 km to the north, a smaller rock fall occurred on a steep slope in dark brown volcanic rocks (Miocene tuffs (?)). The scarp is about 20 m high and about 50 m wide (Figure 9.4). The debris is blocky and includes boulders up to 2 m in diameter. The scarp reveals extensively fractured bedrock. The fractured surfaces probably provided planes of weakness along which the rock failed.

Figure 9.4 Rock fall on steep slopes in volcaniclastic sediments.

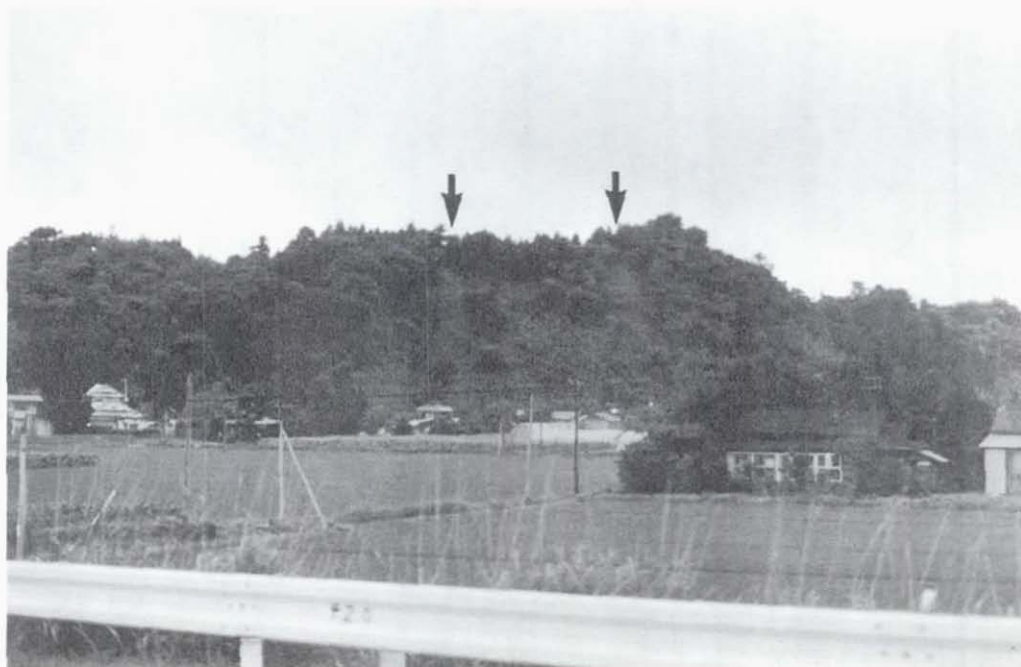
Three rock falls occurred on steep east-facing bluffs flanking a broad flood plain near the mouth of the Naruse River. All three were narrow failures, about 15 m wide, that occurred in dark brown volcanic rock similar to the smaller rock fall at Site No. 1. The slides extended from near the crest of the bluffs to the base, a height of approximately 30 m. Two of the slides are shown in Figure 9.5.

Figure 9.5 Rock falls (arrows) in steep bluffs bordering flood plain near mouth of Naruse River.

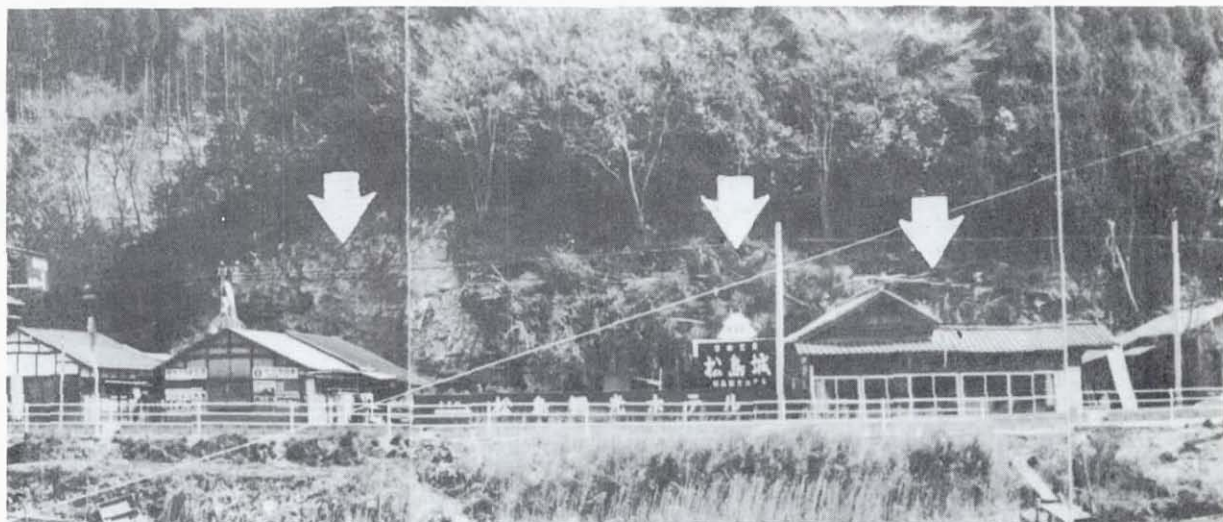
Near Atago in Matsushima, approximately 1.0 km east of the Site No. 1, rock falls from tuff, similar to the tuff forming the larger rock fall at Site No. 1, damaged outbuildings near three houses. About 500 m³ of debris was shaken from cut slopes 15 m in high beneath which houses and storage buildings were closely juxtaposed (Figure 9.6). Most of the damage was not to the houses proper but to attached storage sheds and outbuildings as shown in Figure 9.7.

Figure 9.6 Panoramic view of houses damaged by rock fall from adjacent cut slope in tuff*. Rightmost arrow points to area shown in figure 9.7. (Photograph courtesy of Y. Tsuruya).

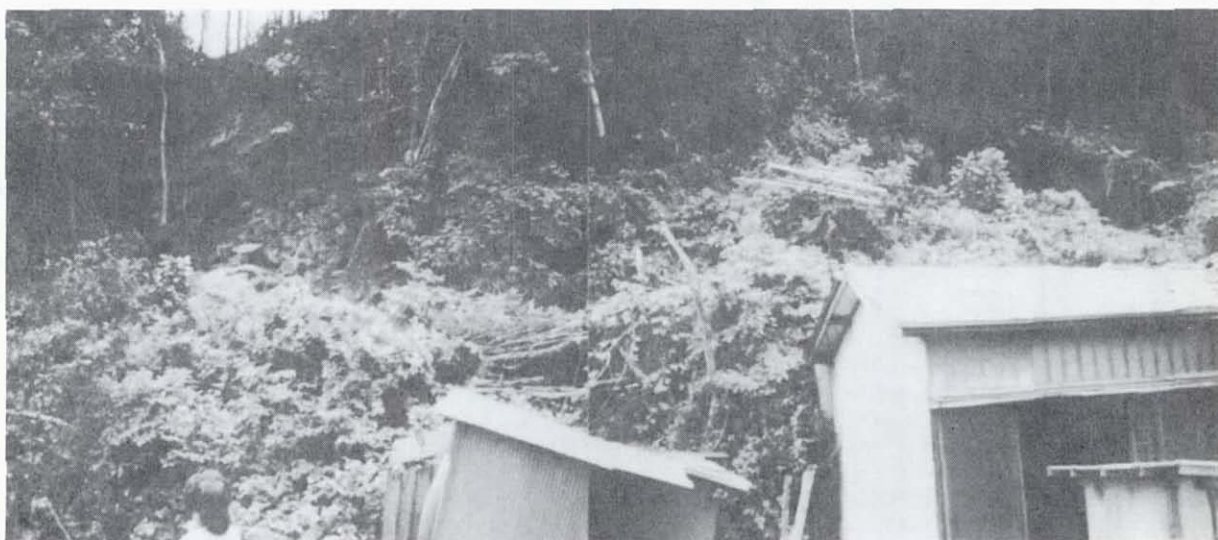
Figure 9.7 Closeup of rock fall and damage to buildings shown in right-hand portion of figure 9.6. (Photograph courtesy of Y. Tsuruya)

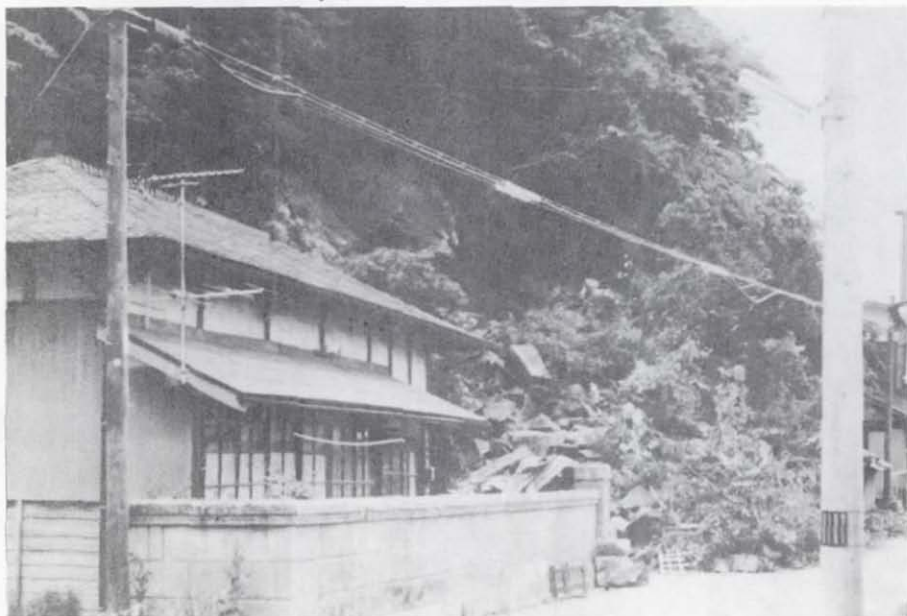
At Kakinoura in Matsushima, about 100 m³ of blocky debris was produced by a seismic-induced rock fall in tuff that damaged a concrete wall adjacent to a house. This rock fall occurred on the nose of a narrow ridge of about 35 m local relief. The slope failed along pre-existing fractures or joints and produced blocks of debris as long as 1.0 m. The size of the blocks reflects the fracture spacing of the rock. The rock fall and the house adjacent to the damaged concrete wall are shown in Figure 9.9. Two other small rock falls nearby did minor damage to walls of three other houses.

Figure 9.9 Rock fall in Miocene tuff causing damage to concrete wall adjacent to house. (Photograph courtesy of Y. Tsuruya)

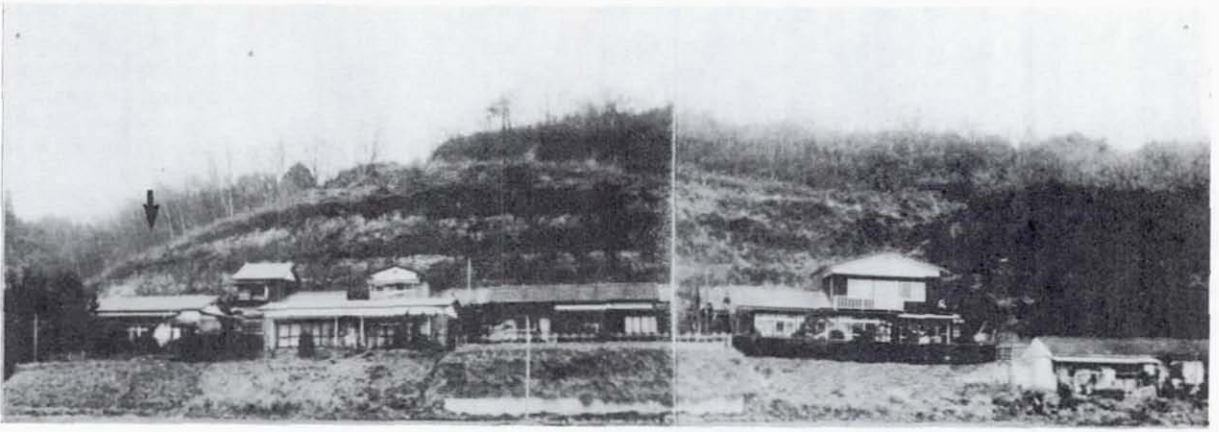
At Kitashionai, Murata, 25 km southwest of Sendai, another steep slope in tuff failed, generating a small rock fall damaging one house. Figure 9.10 shows several houses near the nearly vertical cut slope about 15 m high. One of these houses suffered damage to a retaining fence and part of the roof. A closeup of the rock fall and roof damage is shown in Figure 9.11.

Figure 9.10 Panorama of cut slope near Kitashiona in Miocene tuff which produced rock falls during earthquake damaging nearby houses. Arrow points to damaged house shown in closer view in figure 9.11. (Photograph courtesy of Y. Tsuruya)

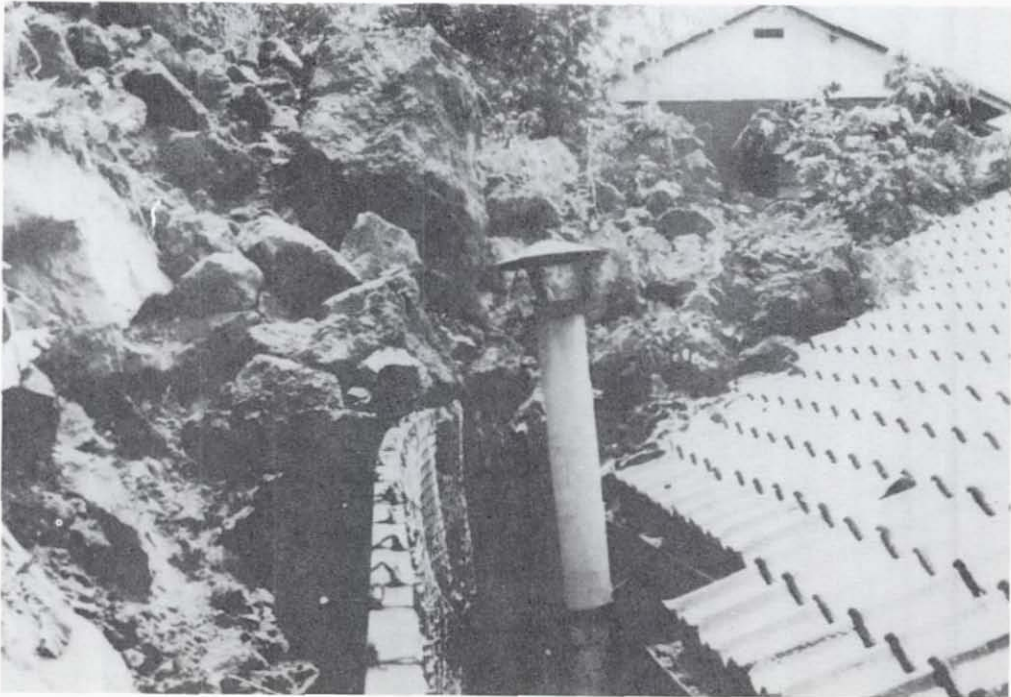
Figure 9.11 Rock fall damage to retaining wall and roof of house in left-hand portion (arrow) of figure 9.10. (Photograph courtesy of Y. Tsuruya)

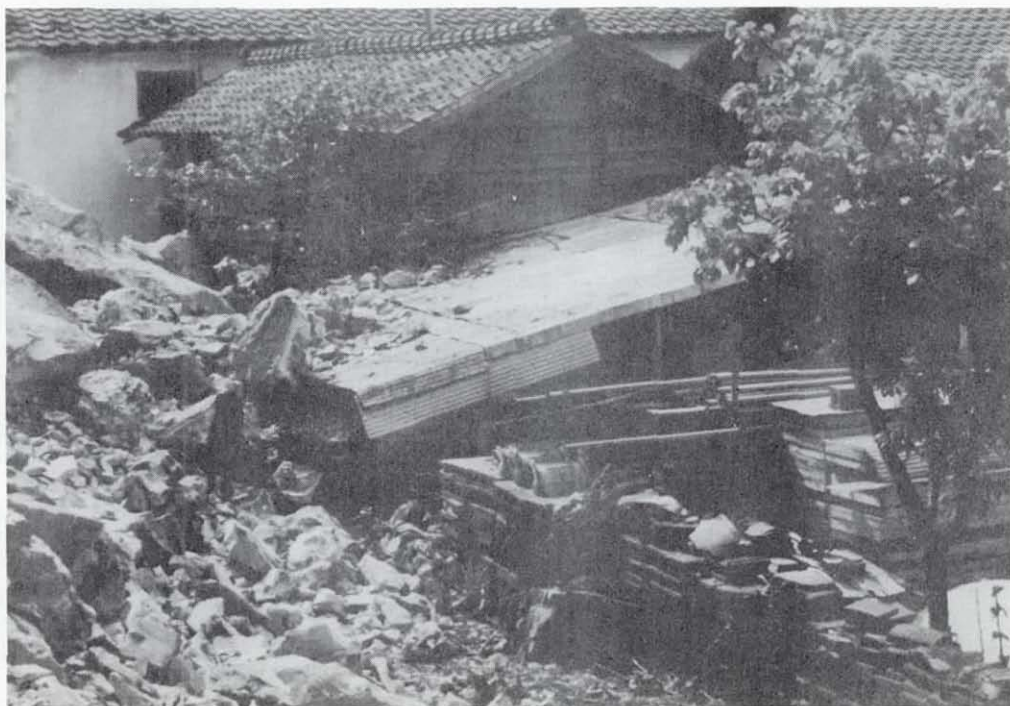
A rock fall of approximately 1000 m³ occurred at Hebinumayama, Sanbongi, on a 20 m high, 110 m long, nearly vertical cut-slope no more than 10 m from five houses at the base of the slope (Figure 9.12). The falling rock did minor damage to two houses and attached storage sheds (Figure 9.13). Rock fall occurred along the entire length of the slope which is composed of a bedded tuff containing numerous fractures. Here, as at Kakinoura, failure took place along the pre-existing fracture surfaces. Block size of the debris ranged from several centimeters to several meters.

Figure 9.13 Rock fall from slope shown in figure 9.12 impinging on storage shed next to slope.

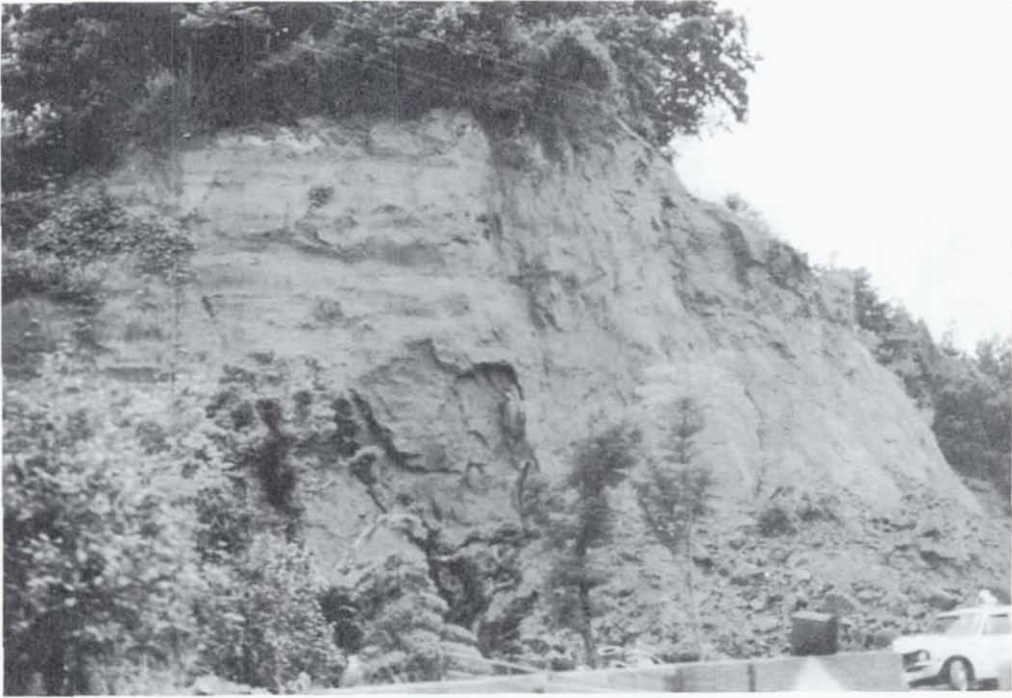
A typical roadcut failure (Figure 9.14) was derived from weakly cemented sandstone along a valley west of the Naruse River. The rock fall is less than 1 m thick, and slope height is about 10 m.

Figure 9.14 Rock fall from roadcut in weakly cemented sandstone.

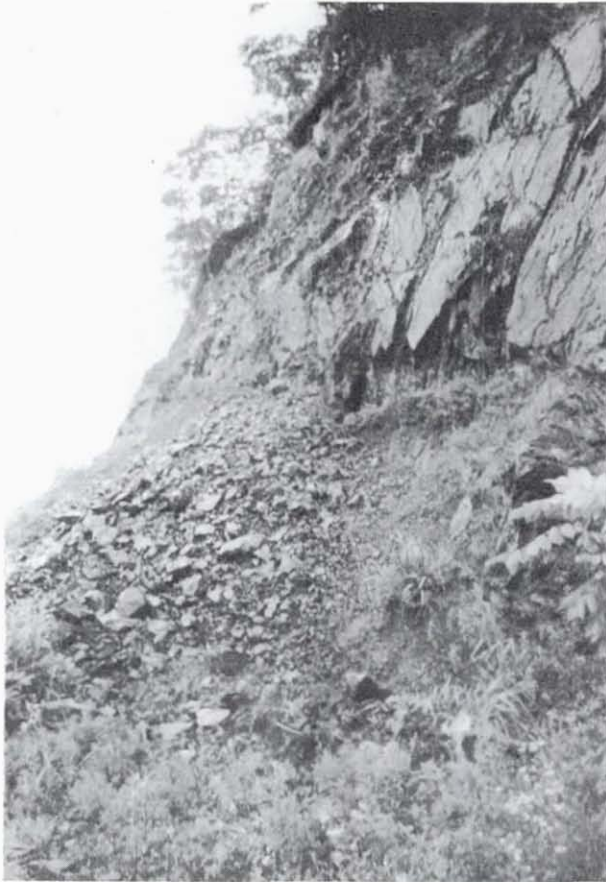
A rock fall in Triassic slate and fine-grained quartzite occurred on a steep roadcut slope on the north side of the New Kitakami River. The scarp of the rock fall is inclined at about 60° and is formed by prominent slaty cleavage planes (Figure 9.15). The blocky debris broke into pieces of up to 30 cm in longest dimension. Almost all of the debris consisted of blocks that had separated along pre-existing fractures.

Figure 9.15 Rock fall in roadcut. Note slaty cleavage planes that form the rock fall scarp.

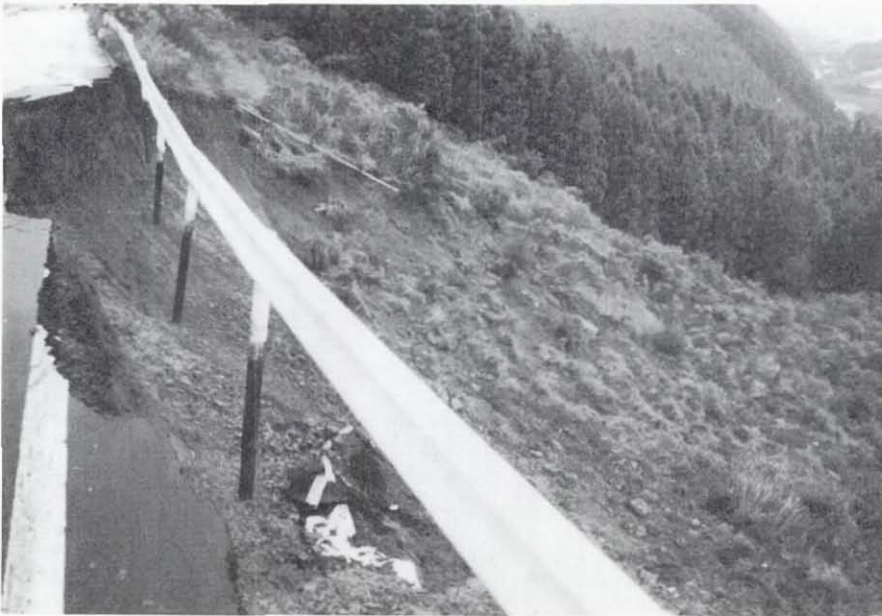
Figure 9.16 Slump in artificial fill along a highway on the Ajika Peninsula.

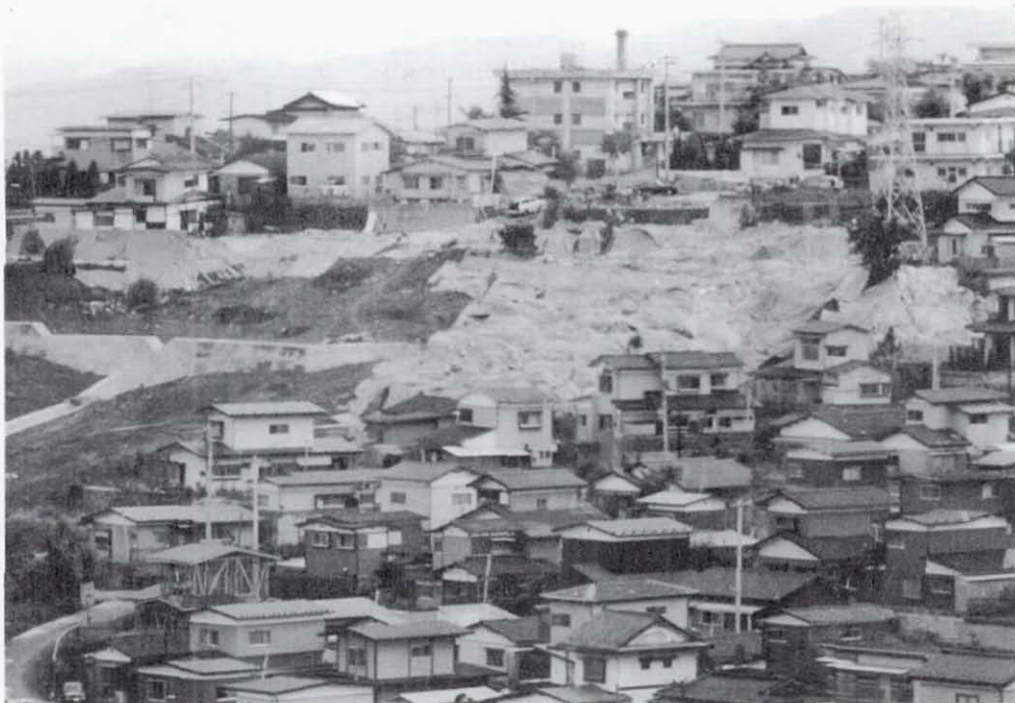
Figure 9.17 Rotational slump in artificial fill in Sendai (area covered by tarps) which destroyed one house and is threatening others. To left of slump is concrete slope protection dam (sabo works).
