NBS SPECIAL PUBLICATION **592**

U.S. DEPARTMENT OF COMMERCE / National Bureau of Standards

An Investigation of the Miyagi-ken-oki, Japan, Earthquake of June 12, 1978

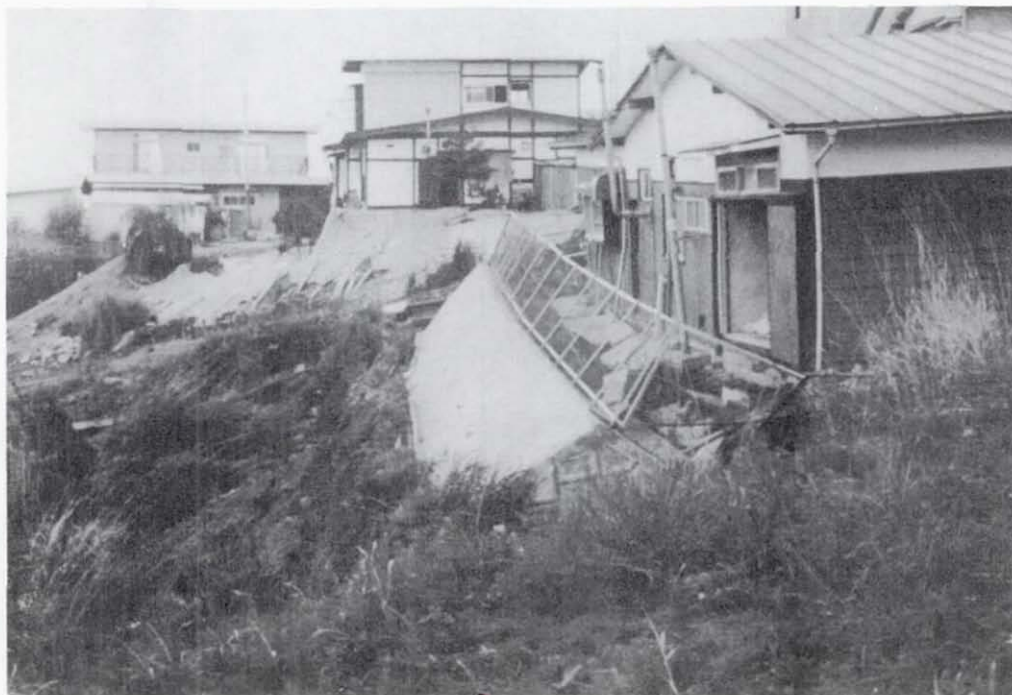
Figure 9.18 House near head of slump. House was removed due to undercutting by headwall scarp (Photograph courtesy of Y. Tsuruya).
