NBS BUILDING SCIENCE SERIES 165

**Engineering Aspects
of the September 19, 1985
Mexico Earthquake**

Following the September 19, 1985 Mexico earthquake, a team consisting of four engineers and one seismologist from the National Bureau of Standards (NBS) and the United States Geological Survey (USGS) was dispatched to Mexico City to provide technical advice to the US rescue effort and to assess structural damage. This report is primarily based on data gathered by the team, but it also contains a compilation of other available information. The report addresses the origin and characteristics of the observed ground motion, the ability of buildings designed in accordance with present and proposed seismic design provisions to resist this type of ground motion, and observed data on structural and foundation failures.

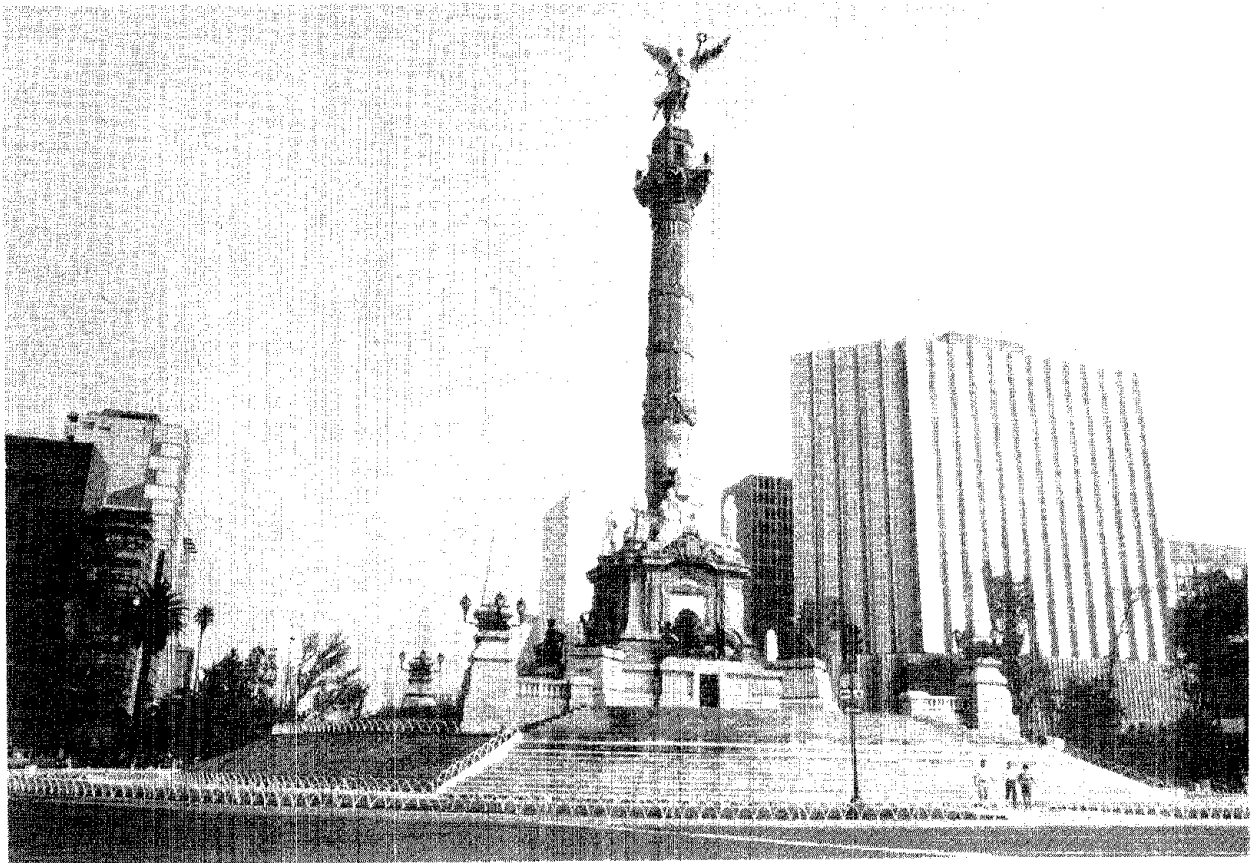
The clay deposits in the Mexico City area are slowly consolidating under the effect of their own weight, the weight of superimposed fill and structures, and the effect of groundwater withdrawal. Thus, the Lake Region of Mexico City is subsiding. Figure 3.12 illustrates the problem. The Monument of the Revolution, which is supported by end bearing timber piles, slowly emerges as the surrounding ground subsides. As the elevation difference increases, steps have to be added around the periphery of the monument.

Figure 3.12. Emergence of the Monument of the Revolution from the surrounding terrain.

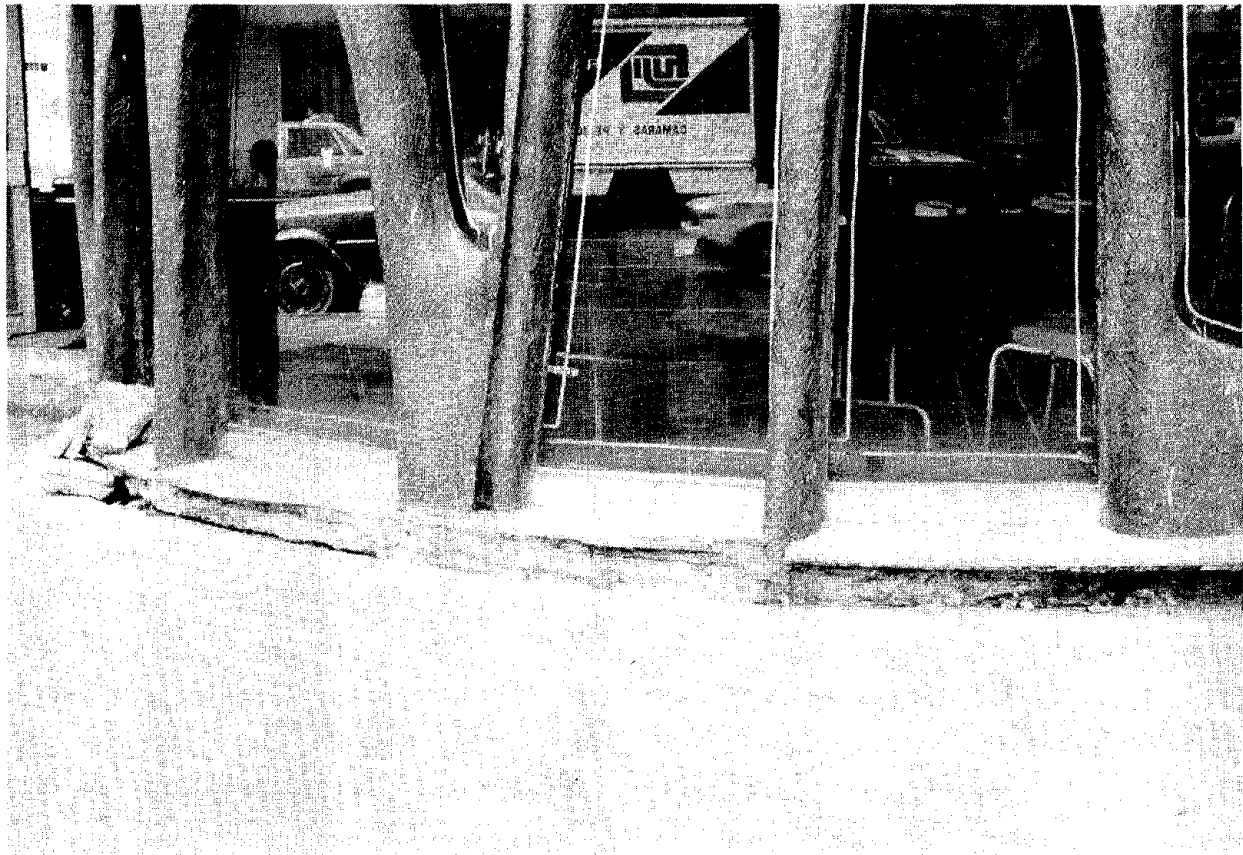
Figure 4.4. Differential displacement between sidewalk and building at the west corner of Versailles and Reforma.

Thus, it is reasoned that the phenomena observed in figures 4.1 through 4.4 are the result of a relaxation in the negative friction forces acting on the piles. This relaxation is the result of loss of shear strength. The loss of shear strength occurred because the clays are sensitive (refer to figure 3.9) and was caused by shear deformations associated with the relative motion between the piles and the surrounding soil. From available data [8] it is estimated that between 85 and 88 percent of the shear strength can be lost. This loss of shear strength does not necessarily lead to an overall foundation failure (it did not cause such a failure in the buildings shown in figures 20 to 23), particularly, since it also results in the relaxation of negative friction forces which the pile had to resist, but it is an important limit state, which should be considered in the design of earthquake-resistant structures founded on sensitive clays.

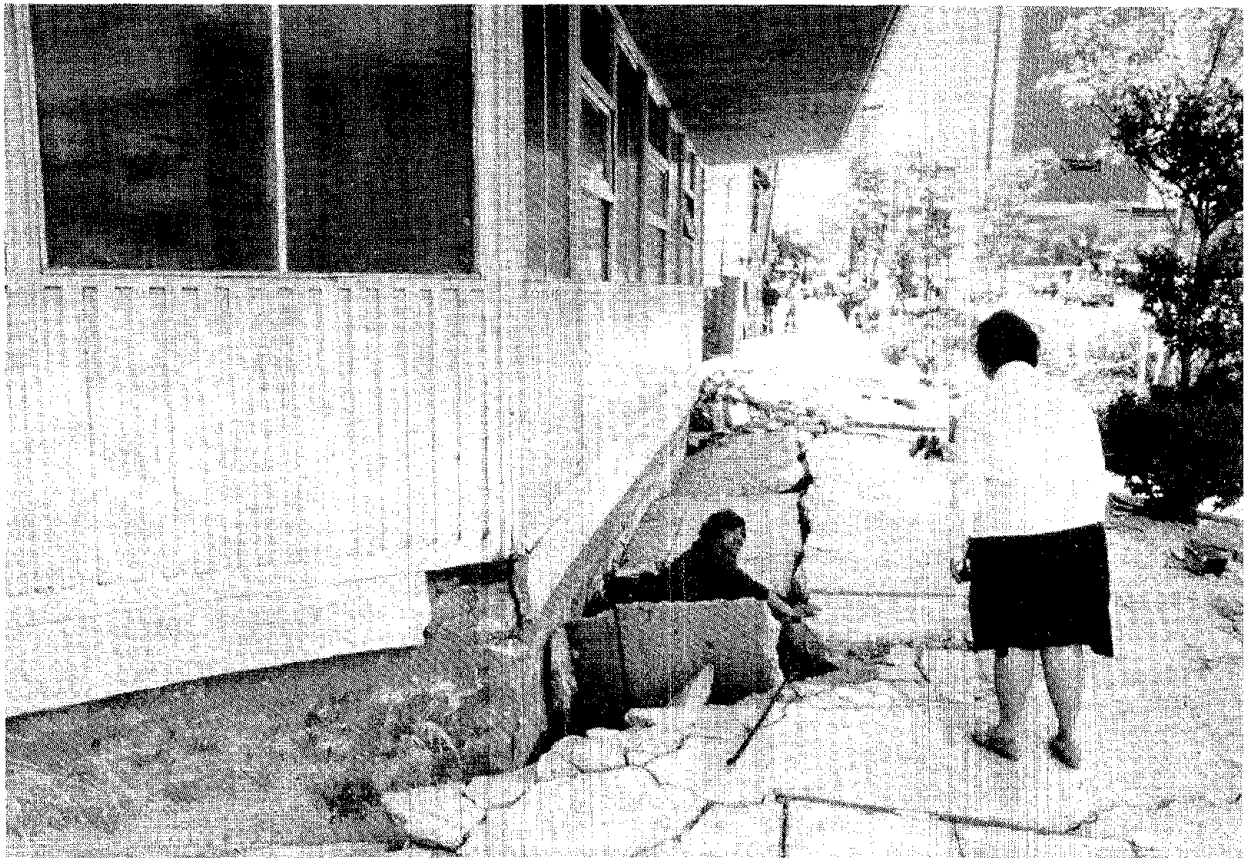
Figure 4.5 shows a tilted ten-story building in the southwest corner of the intersection of Lazaro Cardenas and Fernando. Relative displacements between the building and the sidewalk to the north are shown in figure 4.6, and figure 4.7 shows damage caused to adjacent two-story buildings by the tilting structure. This building is in the vicinity of the severely damaged Communications Center (SCT) where several buildings collapsed. Figure 4.8 shows another tilted building in the same general area in the northwest corner of the intersection of Xola and University. This ten-story building also suffered severe structural and cladding damage. Figure 4.9 shows two- and three-story buildings a short distance to the south on University and opposite the severely damaged Communications Center which apparently did not suffer damage. Likewise, many two-story residential buildings on University to the north of Xola, where two multi-story reinforced concrete buildings (one of them post-tensioned) collapsed, also appeared undamaged.

Figure 4.6. Relative displacement between sidewalk and tilted building at Lazaro Cardenas and Fernando.

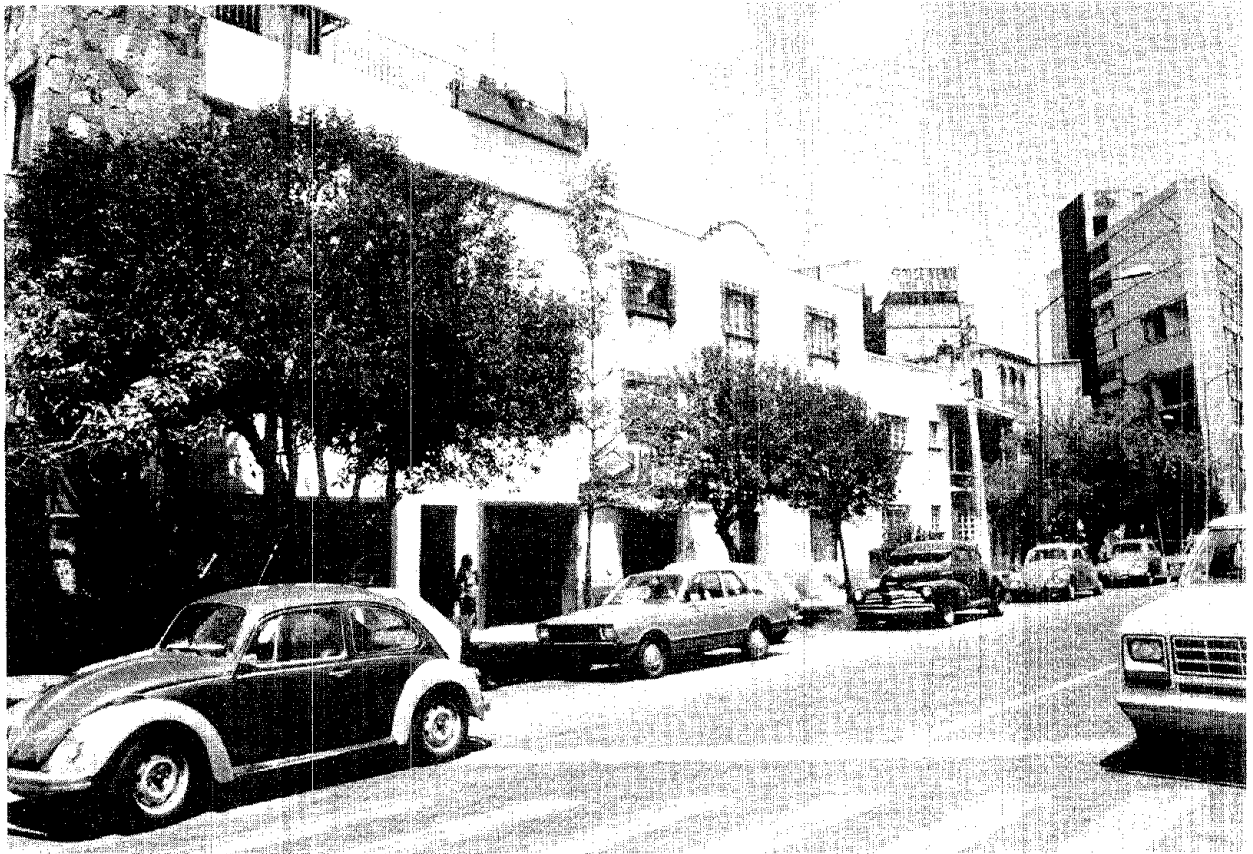
Figure 4.9. Undamaged two and three story buildings on University Boulevard opposite the severely damaged Communications Center.

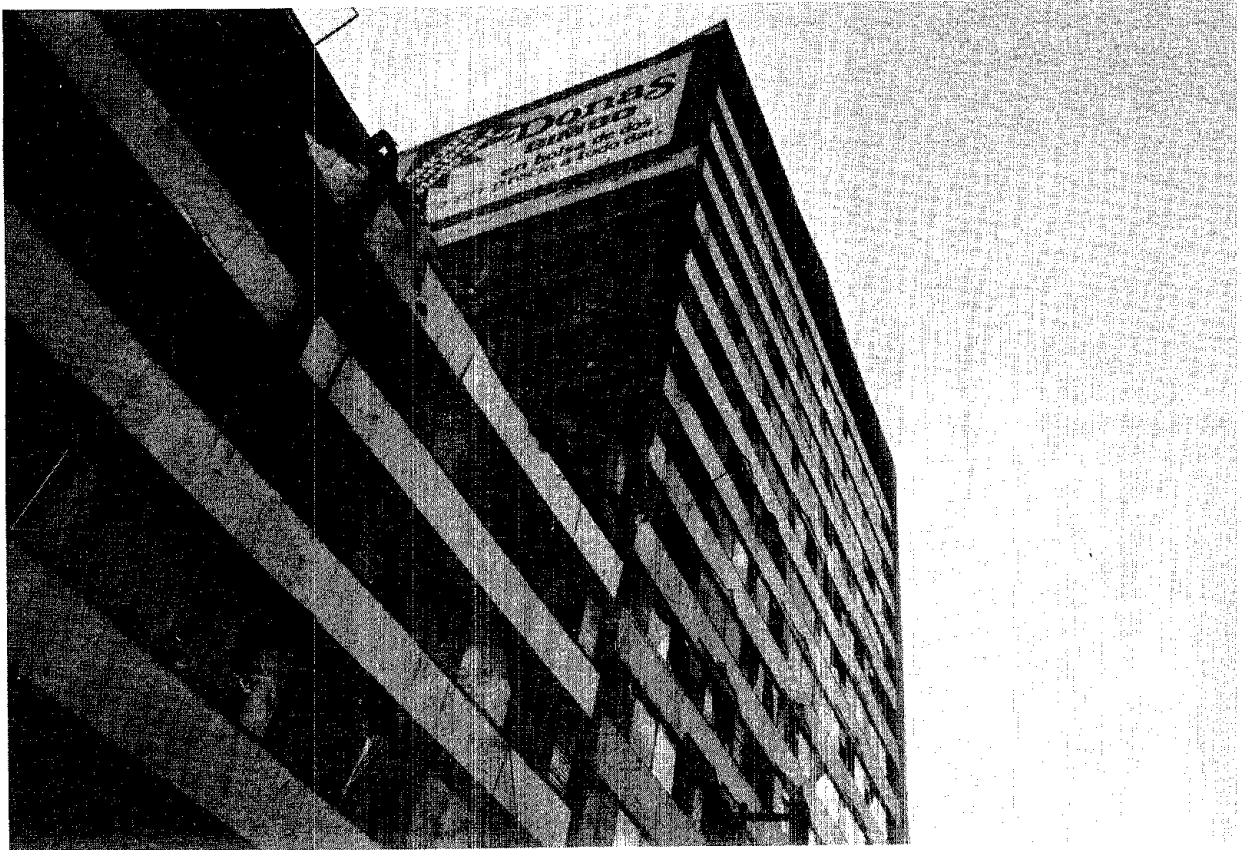
Many buildings were damaged as a result of distortions caused by differential foundation settlements. An example is shown in figures 4.14 and 4.15. The far corner (SW) of the building shown in figure 4.14 which is located on the south side of Teresa De Mier just to the east of Medico Militar settled more than the other corners. This differential settlement resulted in a warping distortion which can be seen in the wall shown in figure 4.15.

Figure 4.15. Warped wall on the north side of building on Teresa de Mier.

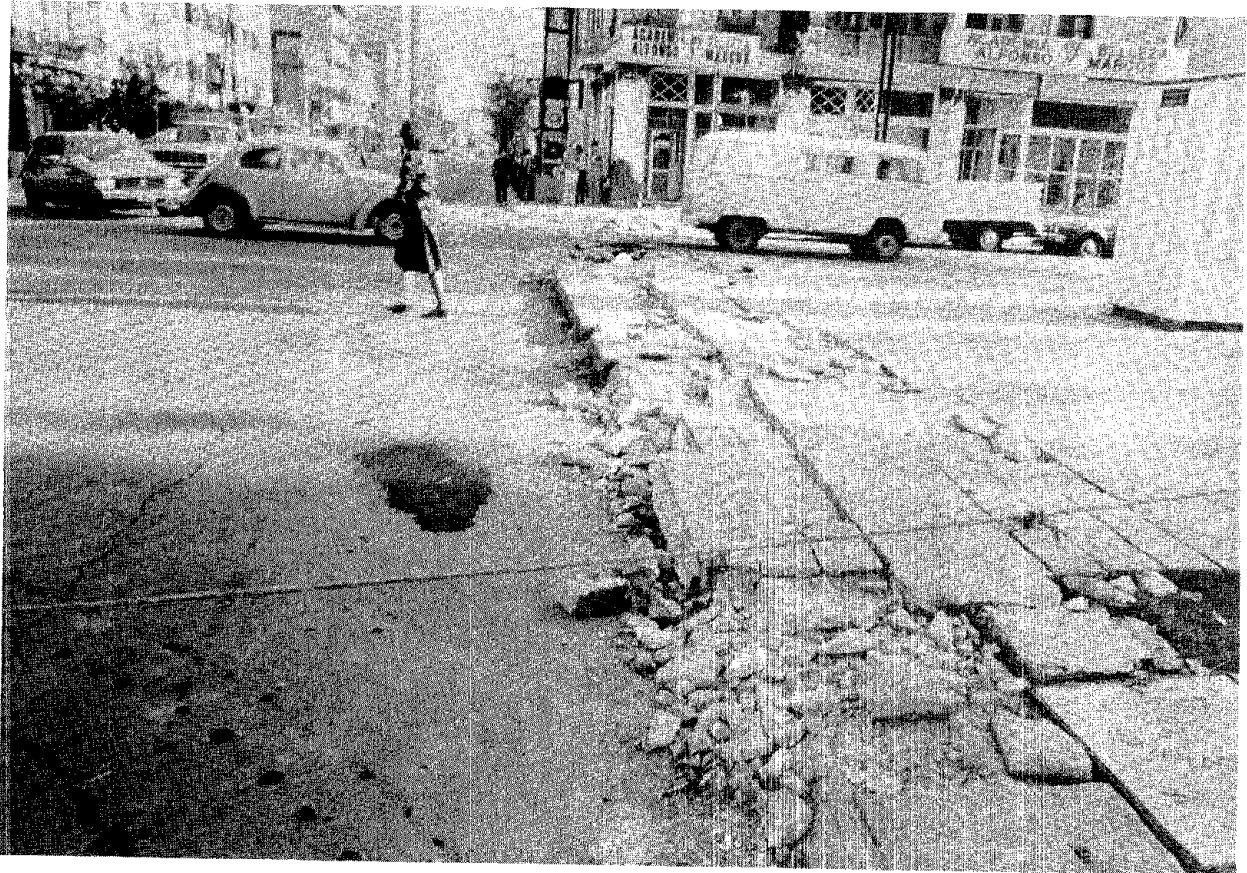
Figure 4.16. Soil disturbance over utility line at the intersection of Monterrey and Obregon.

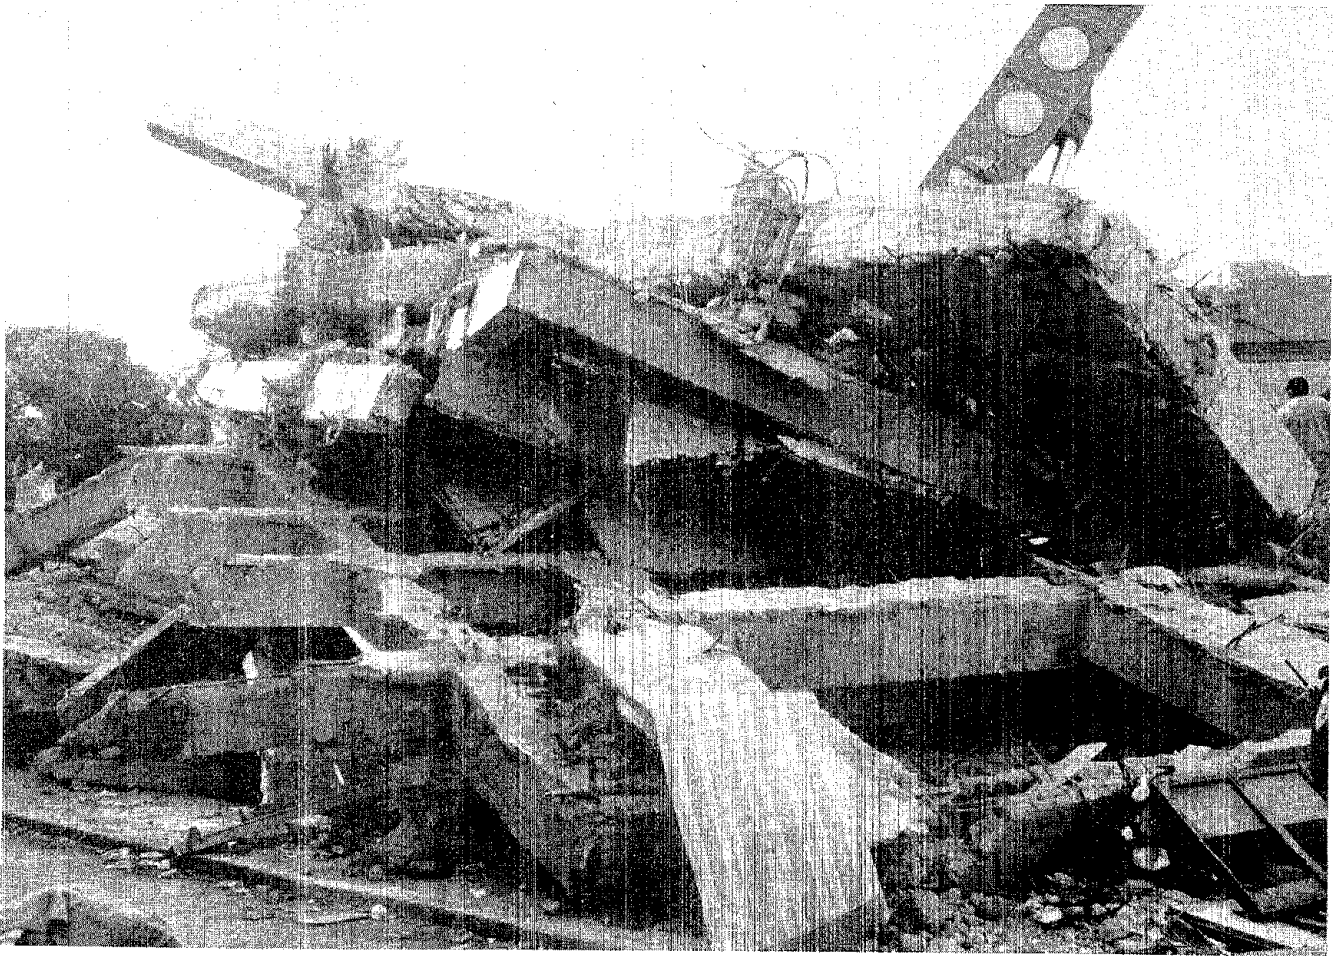
Figure 5.5. Debris from the collapsed Mexico General Hospital.

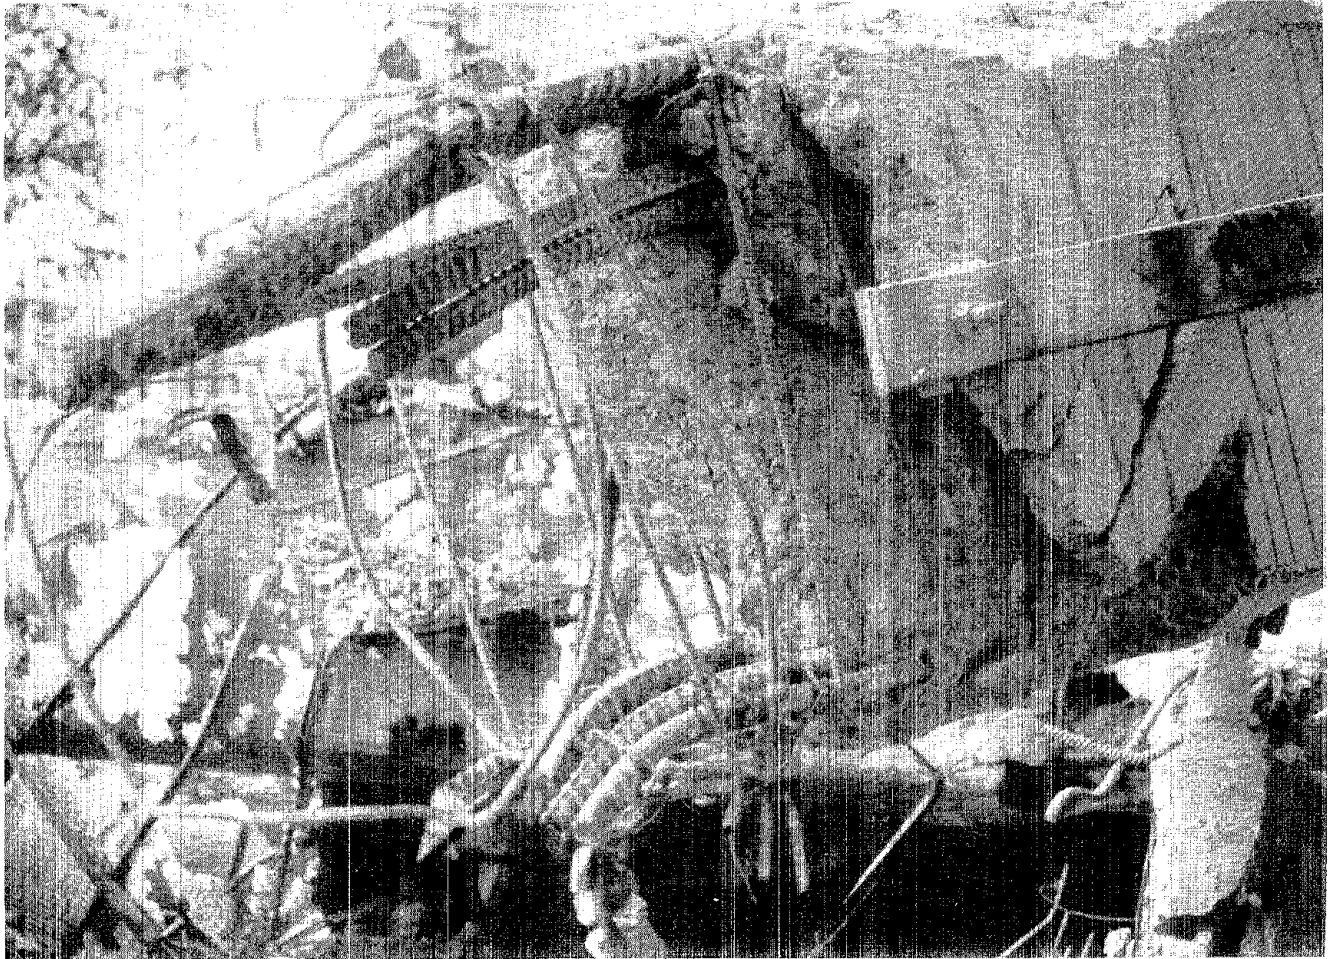
Figure 5.6 shows a close-up view of one of the edge columns. These were typically 14-in (30cm) deep by 12-in (25cm) wide. Closed stirrup confinement consisted of approximately #2 bars (visual evaluation) at 4-6-in (10-15cm) spacing. Following

Figure 5.6. Edge column of collapsed General Hospital.

current Mexico City building code specifications of 1976 [19], the required diameter of these stirrups, given the same spacing, should have been on the order of a #5 bar, which is five times the cross sectional area of steel that was provided.. However, this same code restricts the maximum hoop spacing to 2-3/4-in (7cm). The General Hospital structures were built prior to the adoption of the 1976 code. Of particular interest was the performance of the new parking garage (upper center, figure 5.4) also a frame type structure. In contrast to the personnel building, however, the corners of this building contained reinforced concrete shear walls (see figure 5.7) which safely withstood the lateral forces during the quake. Figure 5.8 shows hairline cracks near beam column connections of the parking garage building.

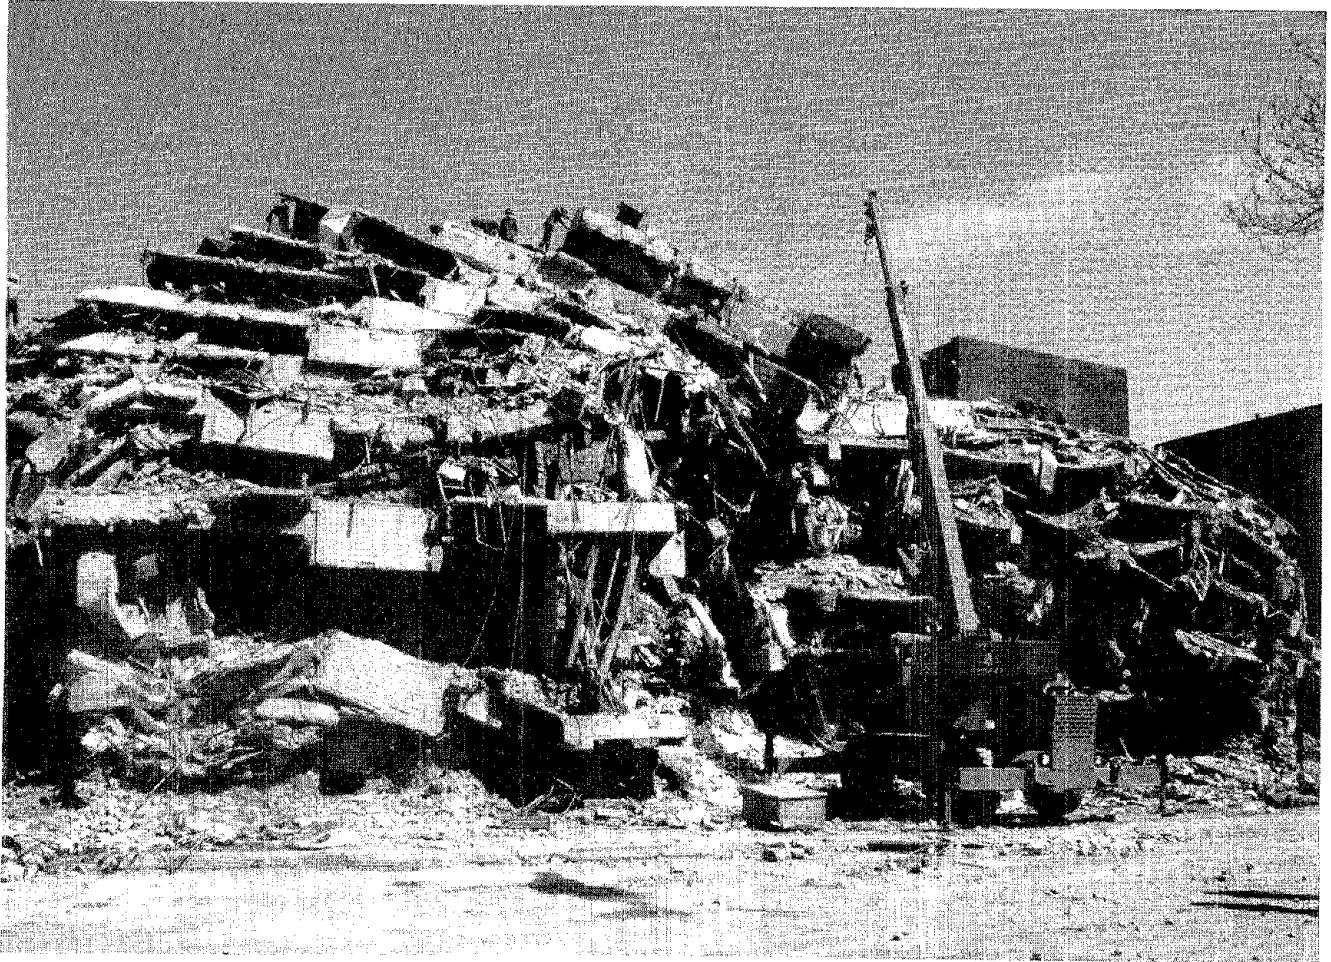
Yet in another hospital building, the Maternity wing of the Juarez Hospital, eight blocks south of the Presidential Palace, 400 medical personnel and patients, notably infants, were trapped. This nine story reinforced concrete frame structure collapsed towards the east also (figures 5.9 and 5.10) exhibiting localized failures at the beam to column joints of each floor. A close-up of various joint details (figure 5.11), indicates that the columns were generally well-proportioned to resist gravity loads. However, figure 5.11 and 5.13 clearly shows minimal to nonexistent confinement through the joints. Furthermore, many joints had longitudinal bar splices at these same critical moment locations. These factors probably contributed to joint failures after a relatively small number of cyclic load reversals.

Figure 5.10. View of collapsed maternity wing of the Juarez Hospital looking east.

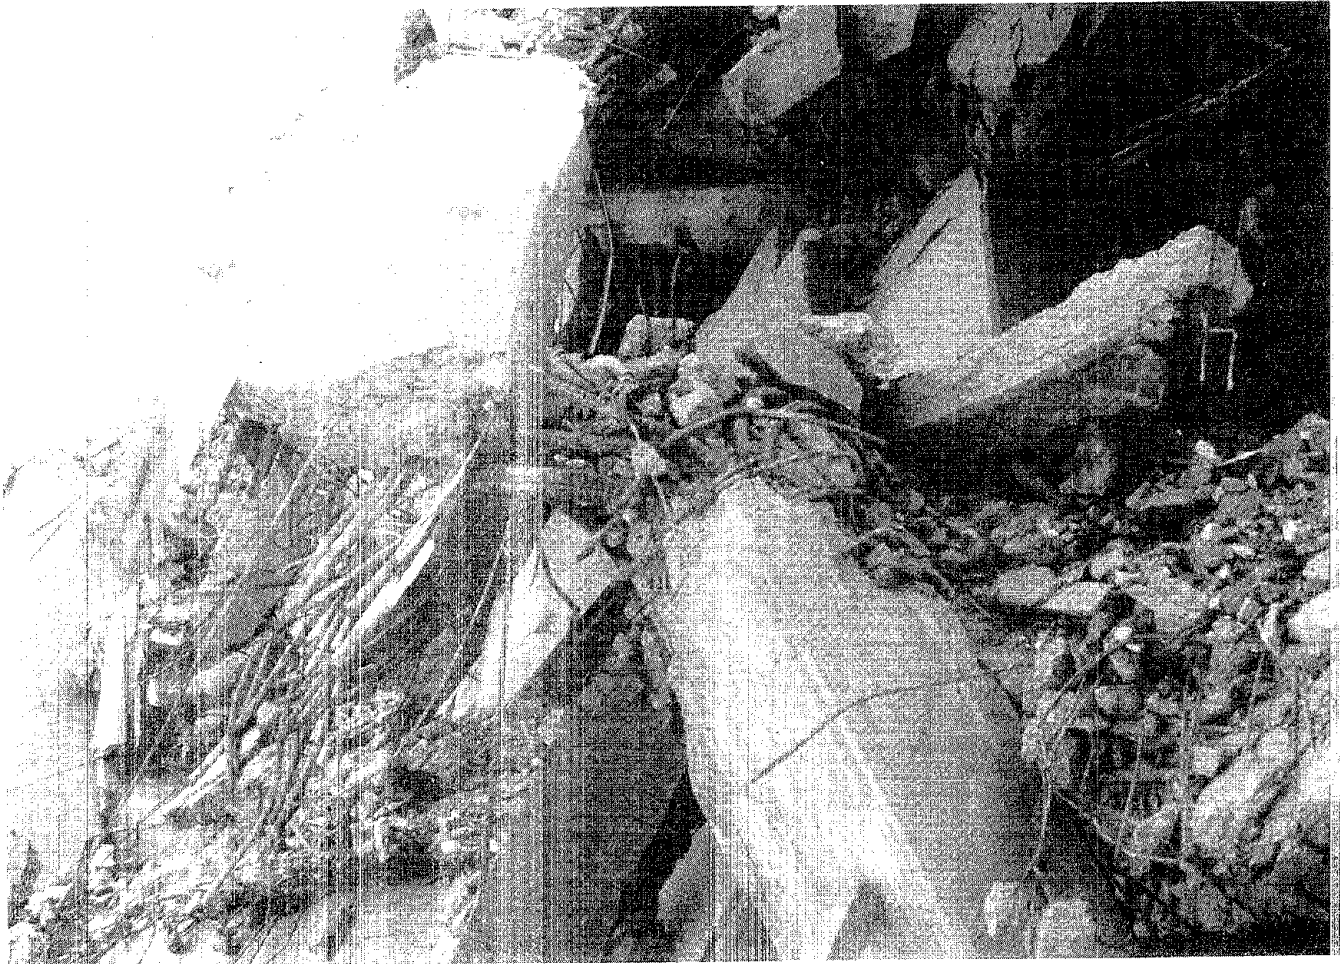
The lack of such confinement, and the presence of splices in such critically underconfined joints -- which could lead to a loss of vertical load bearing continuity as soon as the bond strength is lost following core breakup -- directly contributed to the failure of the Juarez Hospital. This particular structure received considerable media attention as rescue personnel

Figure 5.11. Close up joint details of collapsed Juarez Hospital indicating lack of sufficient confining reinforcement in the vicinity of the joint.

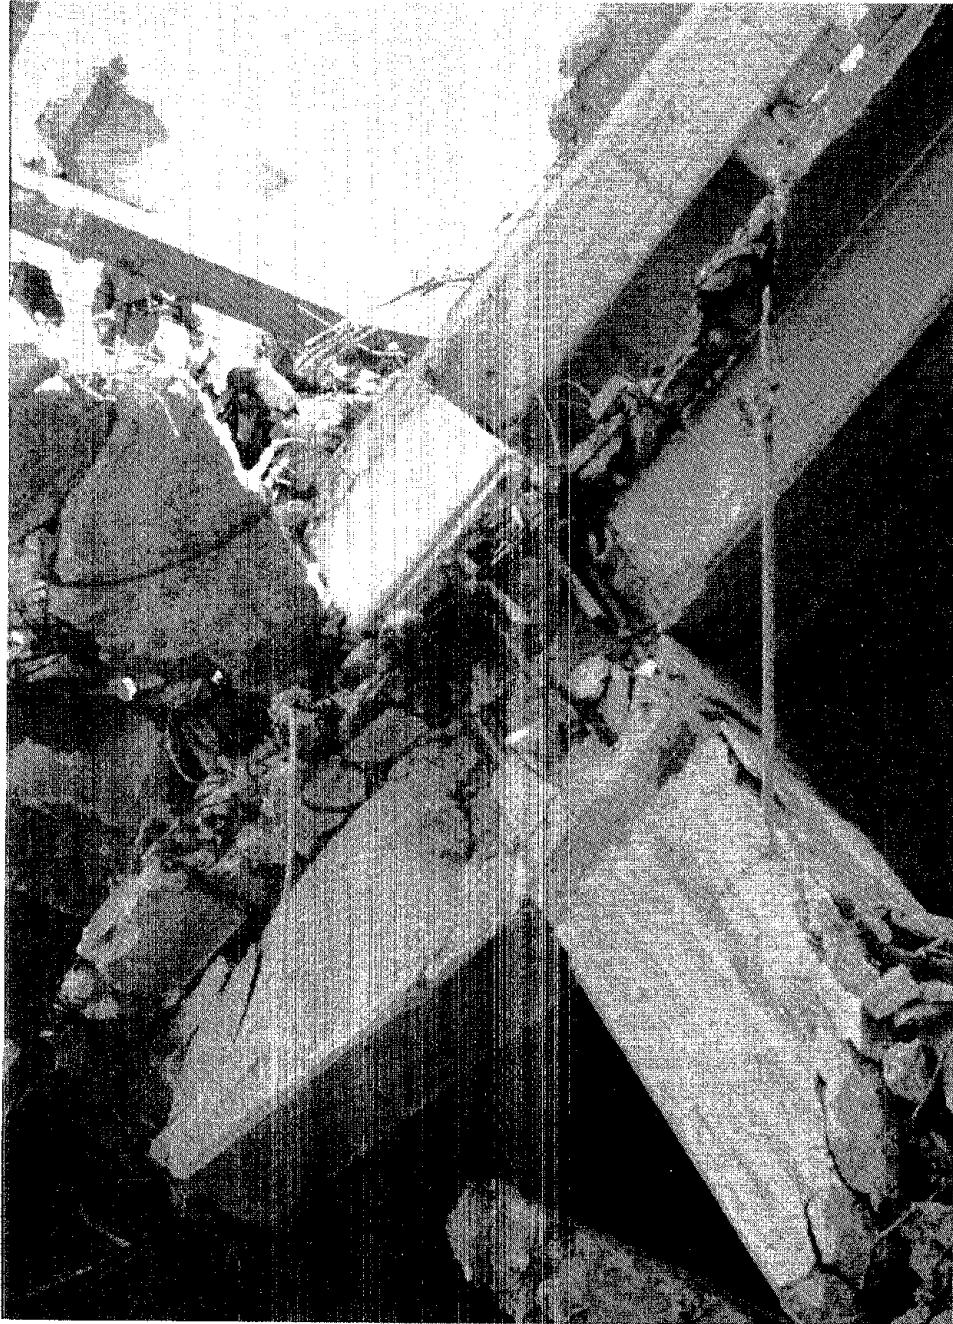
Figure 5.12. Joint details of collapsed Juarez Hospital indicating adverse effect of a splice.

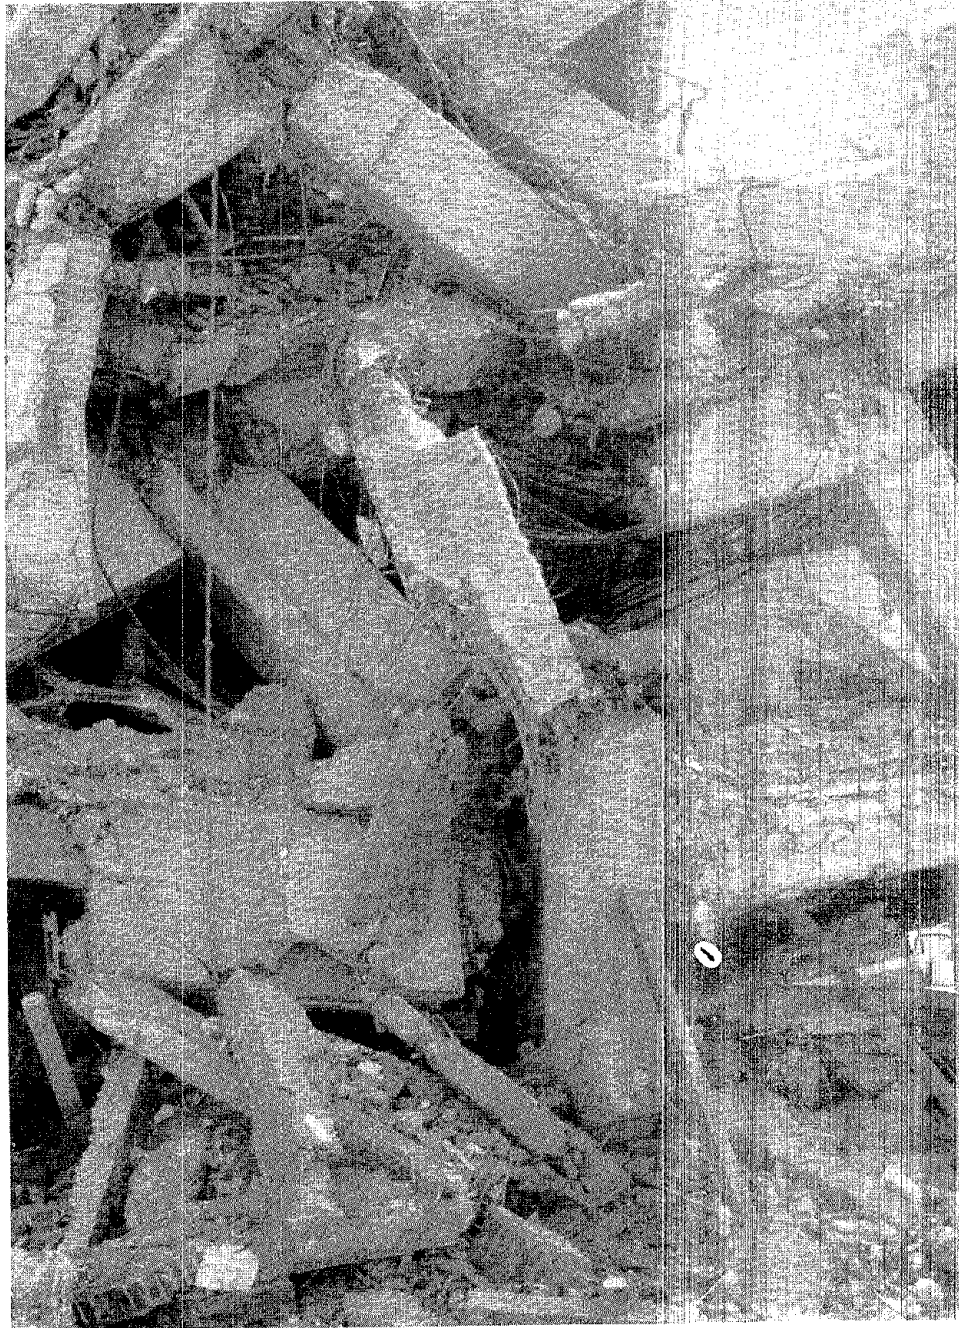
Figure 5.13. View looking south at Juarez Hospital showing how column hinging permitted rotation of successive floors toward the east.

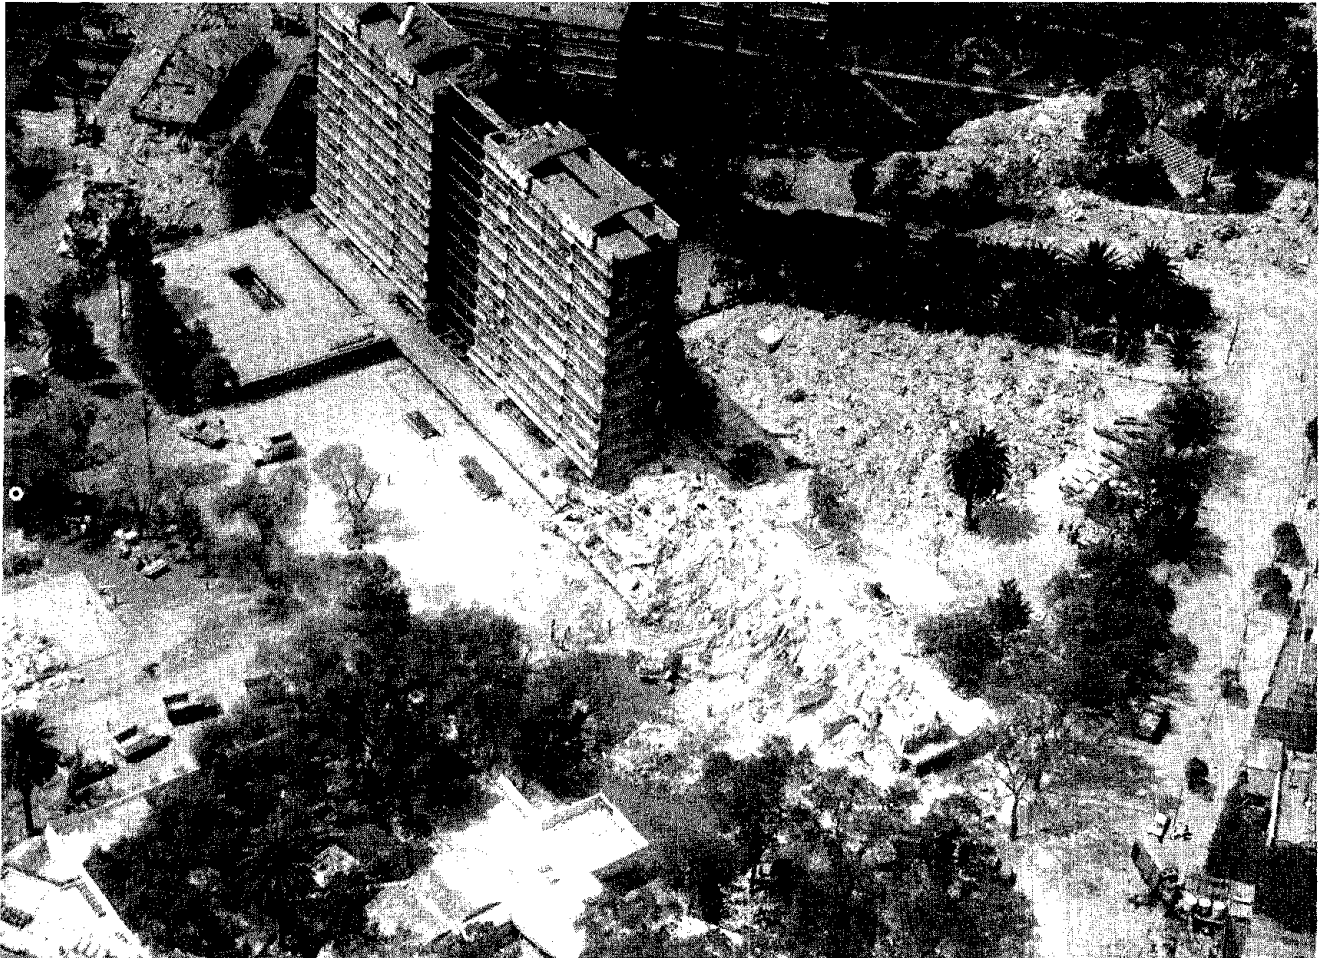
Figure 5.15. The southern two B towers of the Juarez Apartment complex which remained standing.

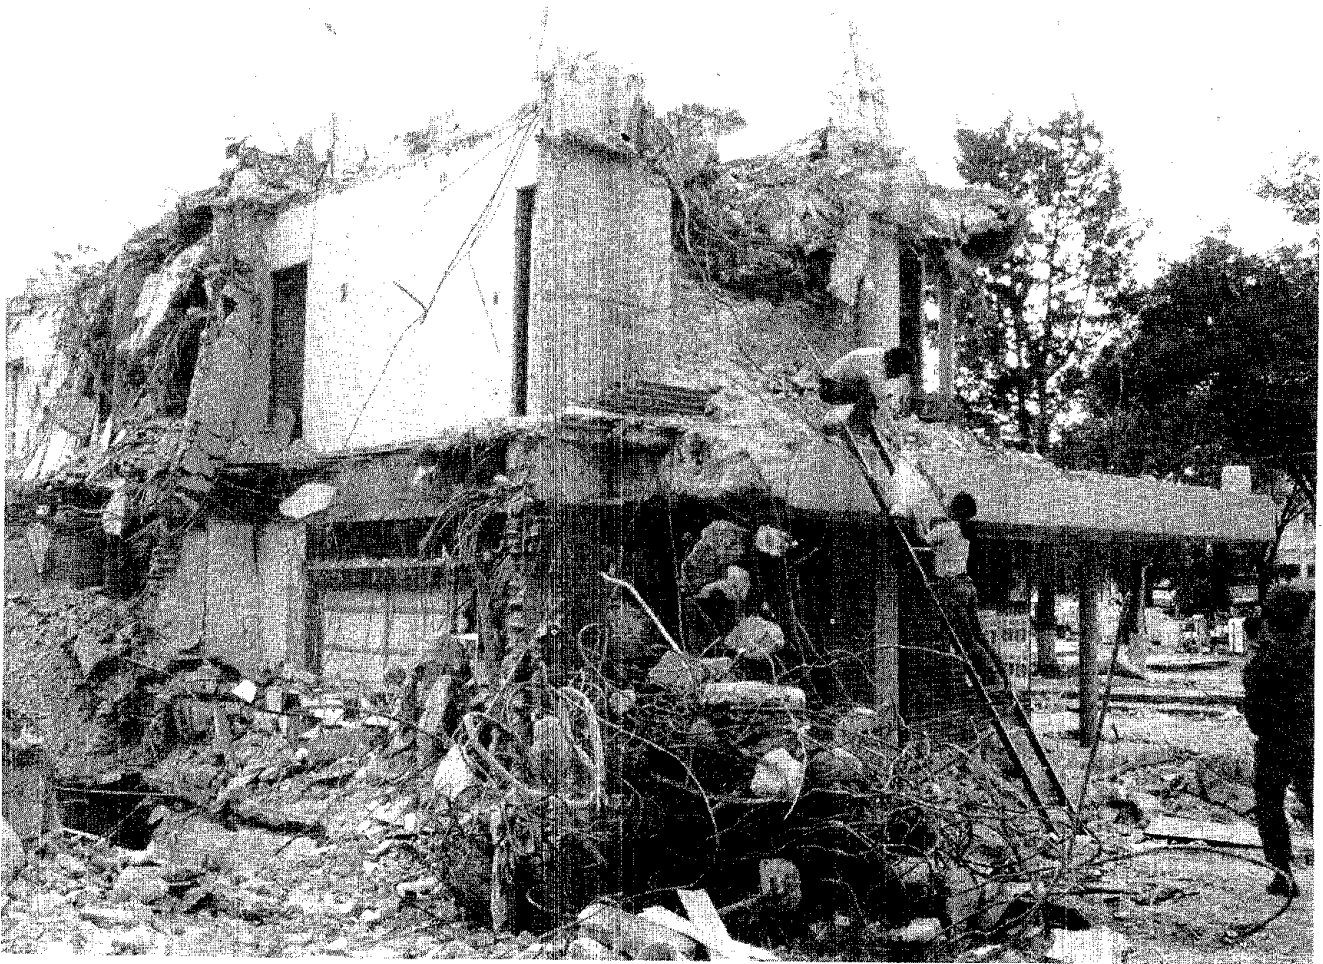
dynamited approximately three weeks following the quake. Figure 5.16 shows a close-up of the first two stories of this structure following removal of debris. It can be seen that the column width was increased in the east-west direction in an effort to stiffen the resistance of the structure in the narrow direction. Nonetheless, based on the debris pattern following the collapse, it appeared that failure of this building was initiated by hinging of the columns in the east-west direction. It is likely that the presence of the thin connecting walkway (see aerial photo, figure 5.15) with the neighboring two towers to the south permitted sufficient independence for each tower to oscillate individually in the east-west direction. This explains why the northern tower was able to collapse without affecting the two southern towers.

Figure 5.16. First two stories of Juarez apartment structure.

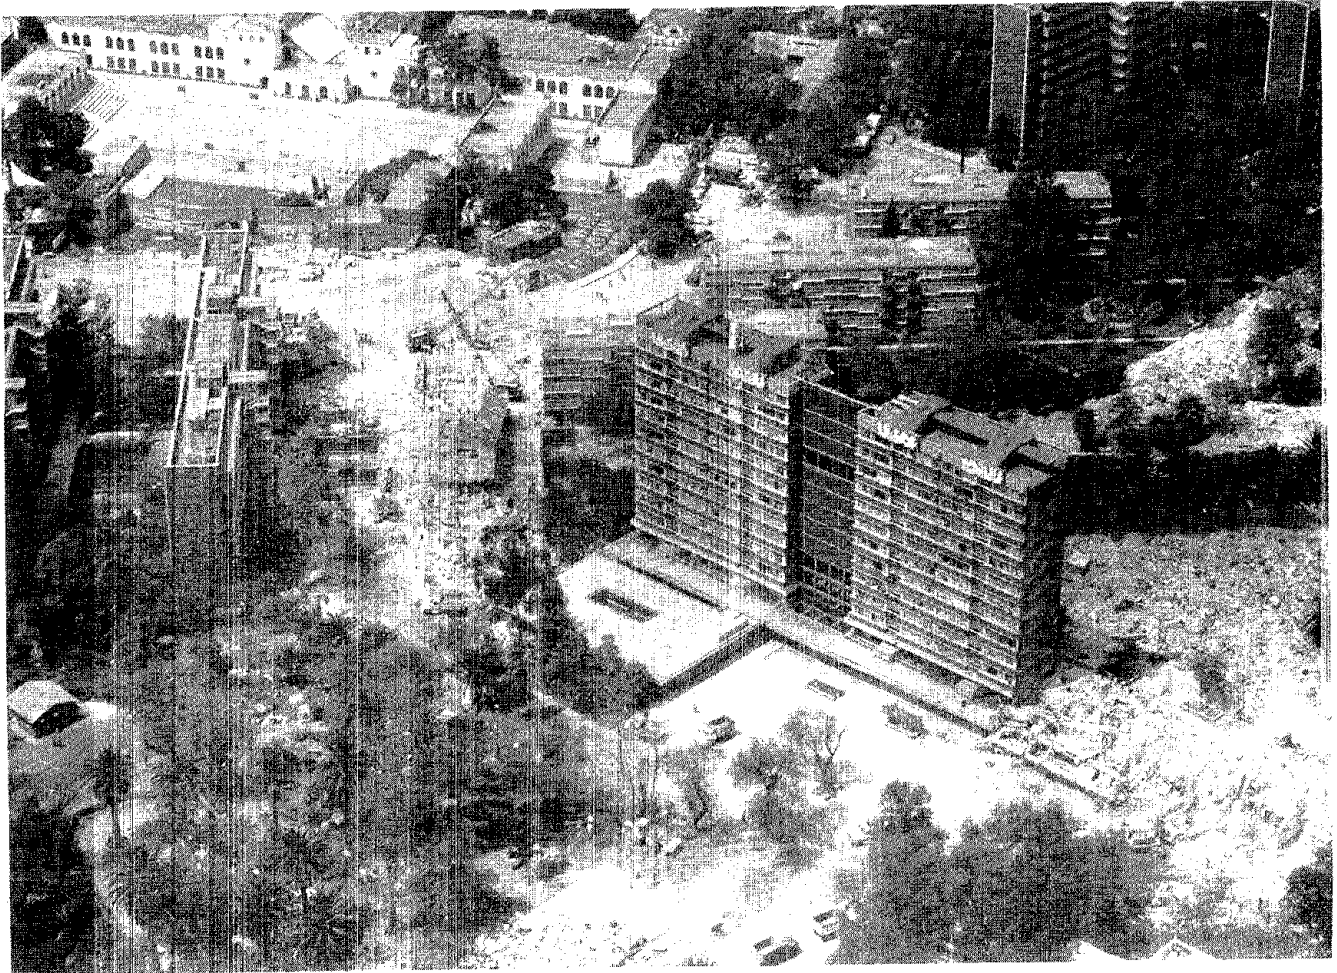
Figure 5.17 shows an aerial view of the collapsed eight-story apartment immediately to the south of the thirteen story complex. This structure was similar in many respects to the one described above, with the notable exception that the aforementioned four lane highway ran directly underneath the center of the building. The reinforced concrete tunnel structure and road foundations may have stiffened the overall foundation, and hence increased the efficiency with which ground accelerations were transmitted to the frame. Each member in this group of four buildings was cast as a continuous unit with no obvious construction joints that might otherwise cause separate portions of the building to act independently under seismic loading. Figures 5.18 shows the "pancake" nature of the collapse, indicating hinging in columns during the earthquake. The skewed stacking of the slabs towards the east indicates that ultimate failure likely occurred during an eastward excursion. Figures 5.19 and 5.20 show views of this same structure looking north-east and east, respectively. The exterior stair tower, which experienced a shear failure in the support pylon at the first story, can be seen on the left side of

Figure 5.17. Aerial view of collapsed eight story apartment building.

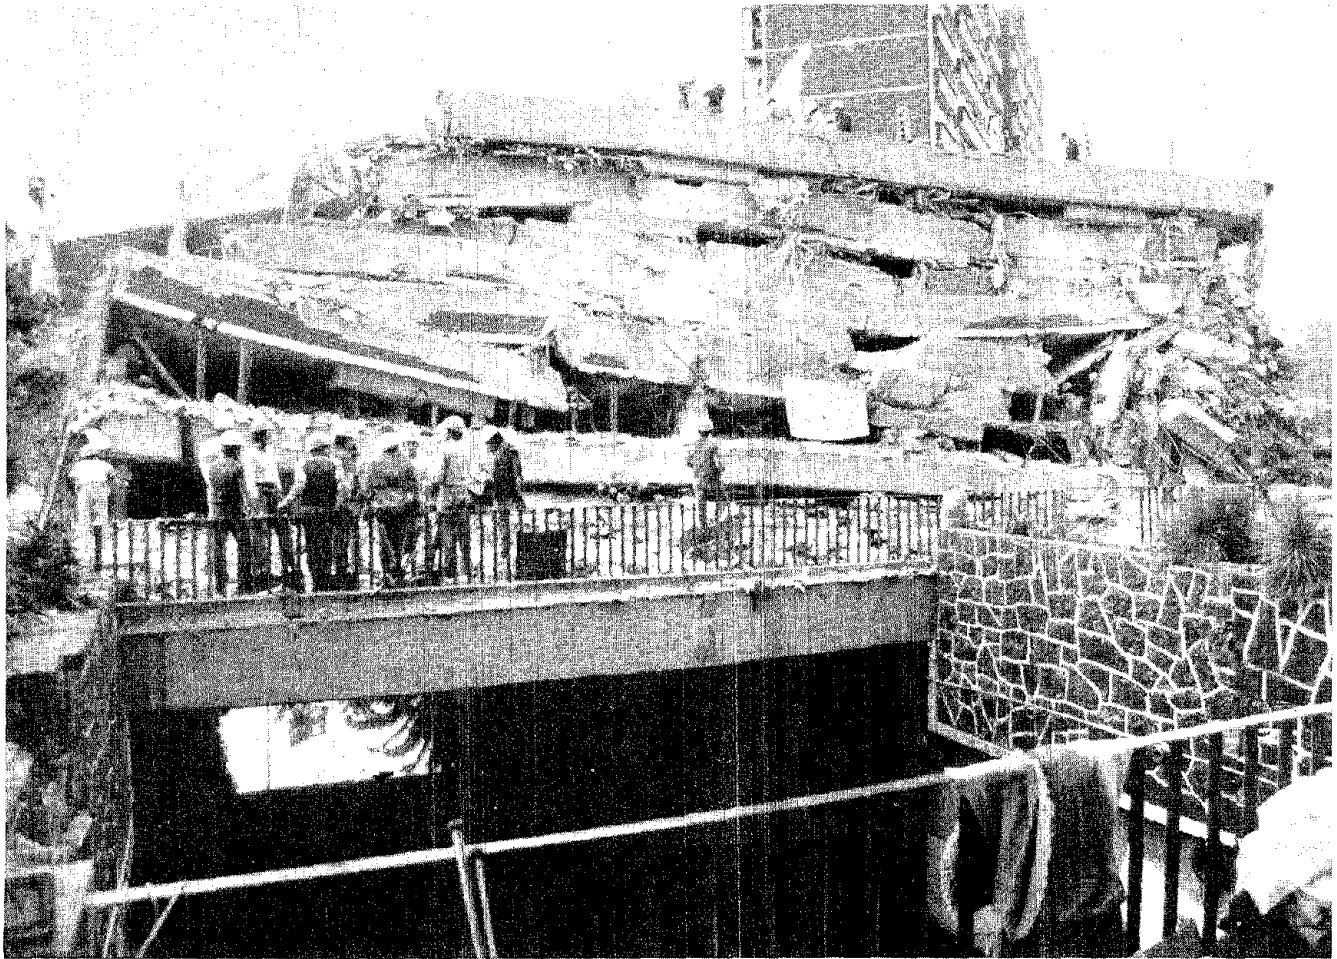
Figure 5.18. Pancake type collapse of eight story apartment.
