NBS BUILDING SCIENCE SERIES 165

**Engineering Aspects
of the September 19, 1985
Mexico Earthquake**

Following the September 19, 1985 Mexico earthquake, a team consisting of four engineers and one seismologist from the National Bureau of Standards (NBS) and the United States Geological Survey (USGS) was dispatched to Mexico City to provide technical advice to the US rescue effort and to assess structural damage. This report is primarily based on data gathered by the team, but it also contains a compilation of other available information. The report addresses the origin and characteristics of the observed ground motion, the ability of buildings designed in accordance with present and proposed seismic design provisions to resist this type of ground motion, and observed data on structural and foundation failures.

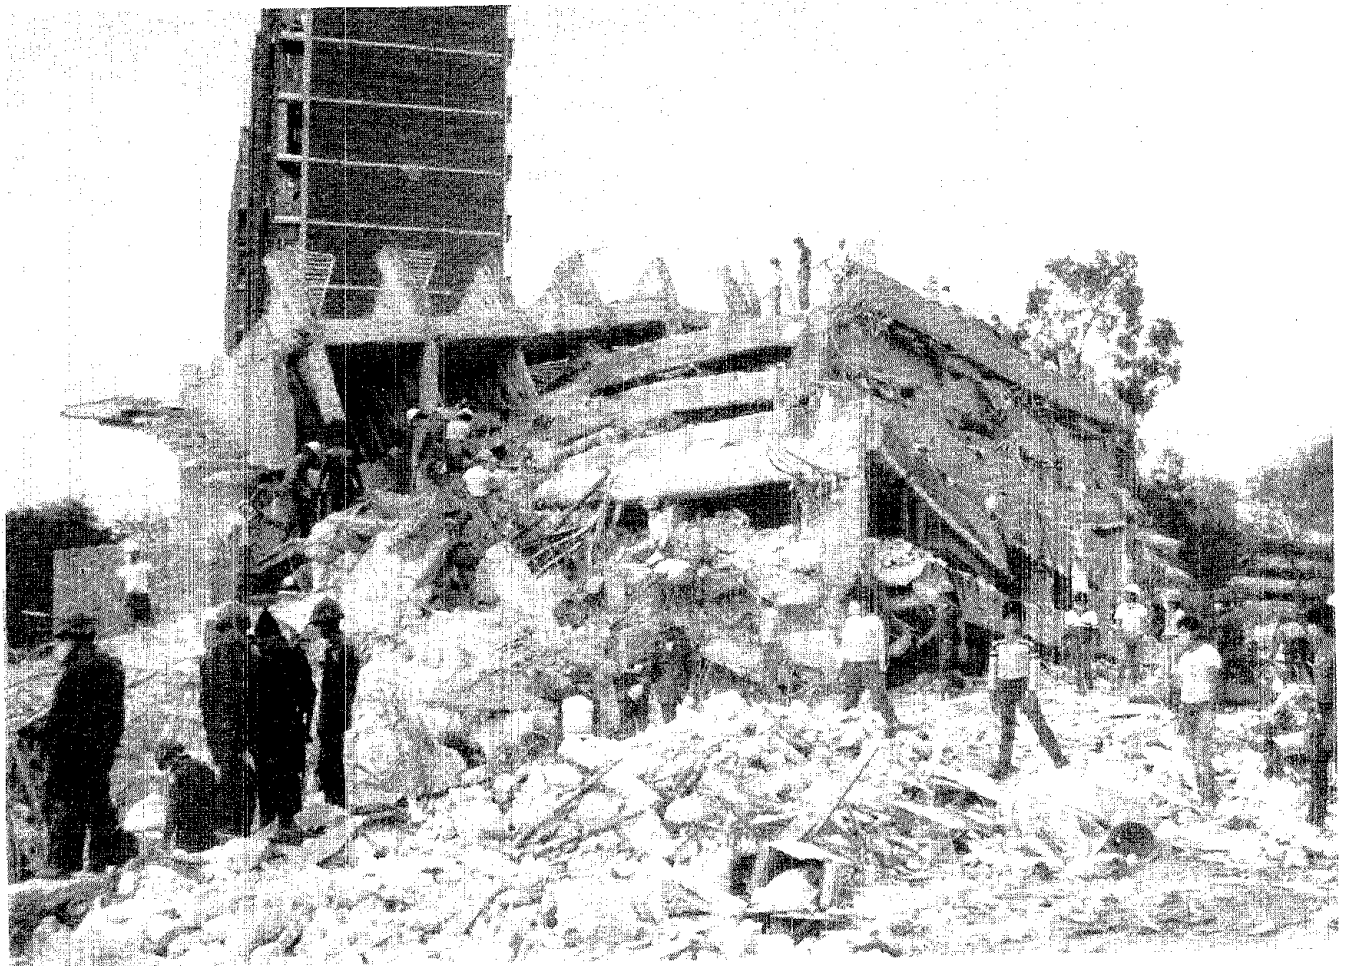
Figure 5.19. View of collapsed apartment looking northeast.

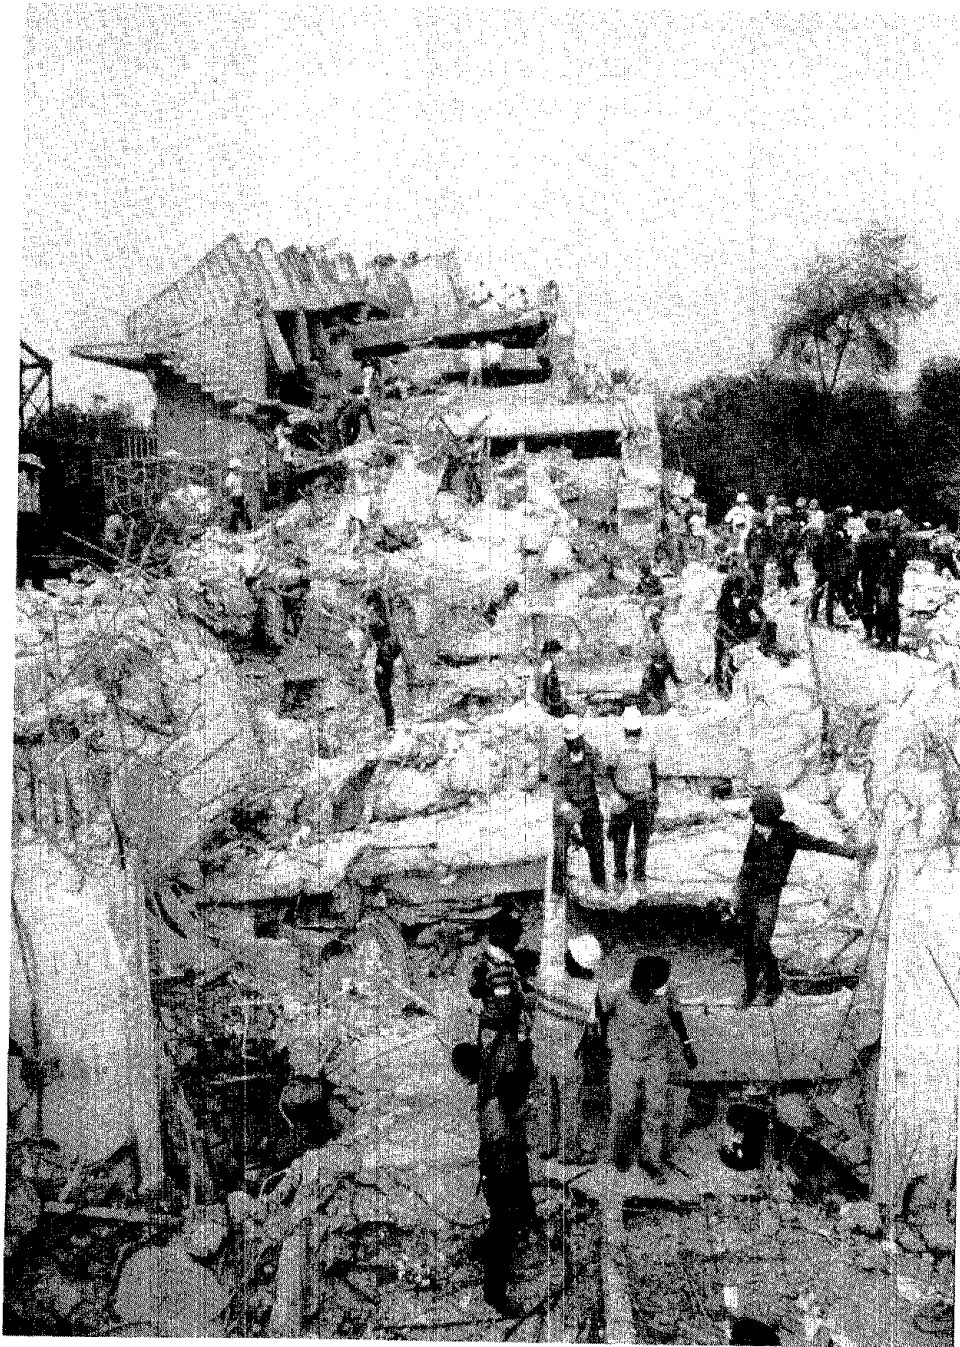
Figure 5.20. View of collapsed apartment structure looking east.

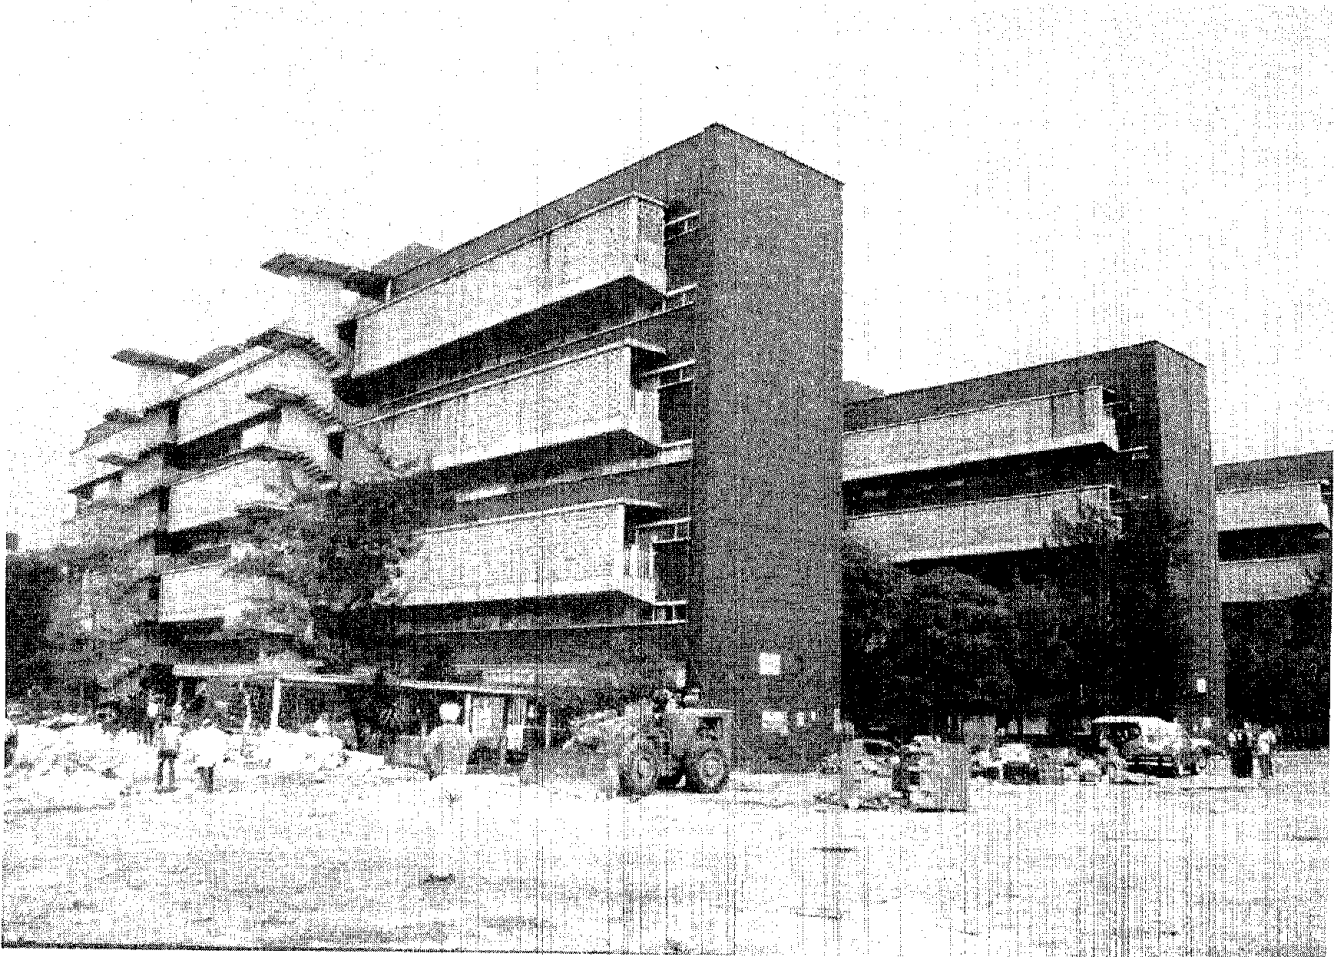
It is of particular interest to know why this particular building collapsed, while its three sister structures (figure 5.21) immediately to the south, did not. Part of the reason may be local variations in the soil consolidation, or perhaps differential-settlement induced stresses, as mentioned in Section 5.2.

Figure 5.21. Undamaged apartment building near identical structure which collapsed.

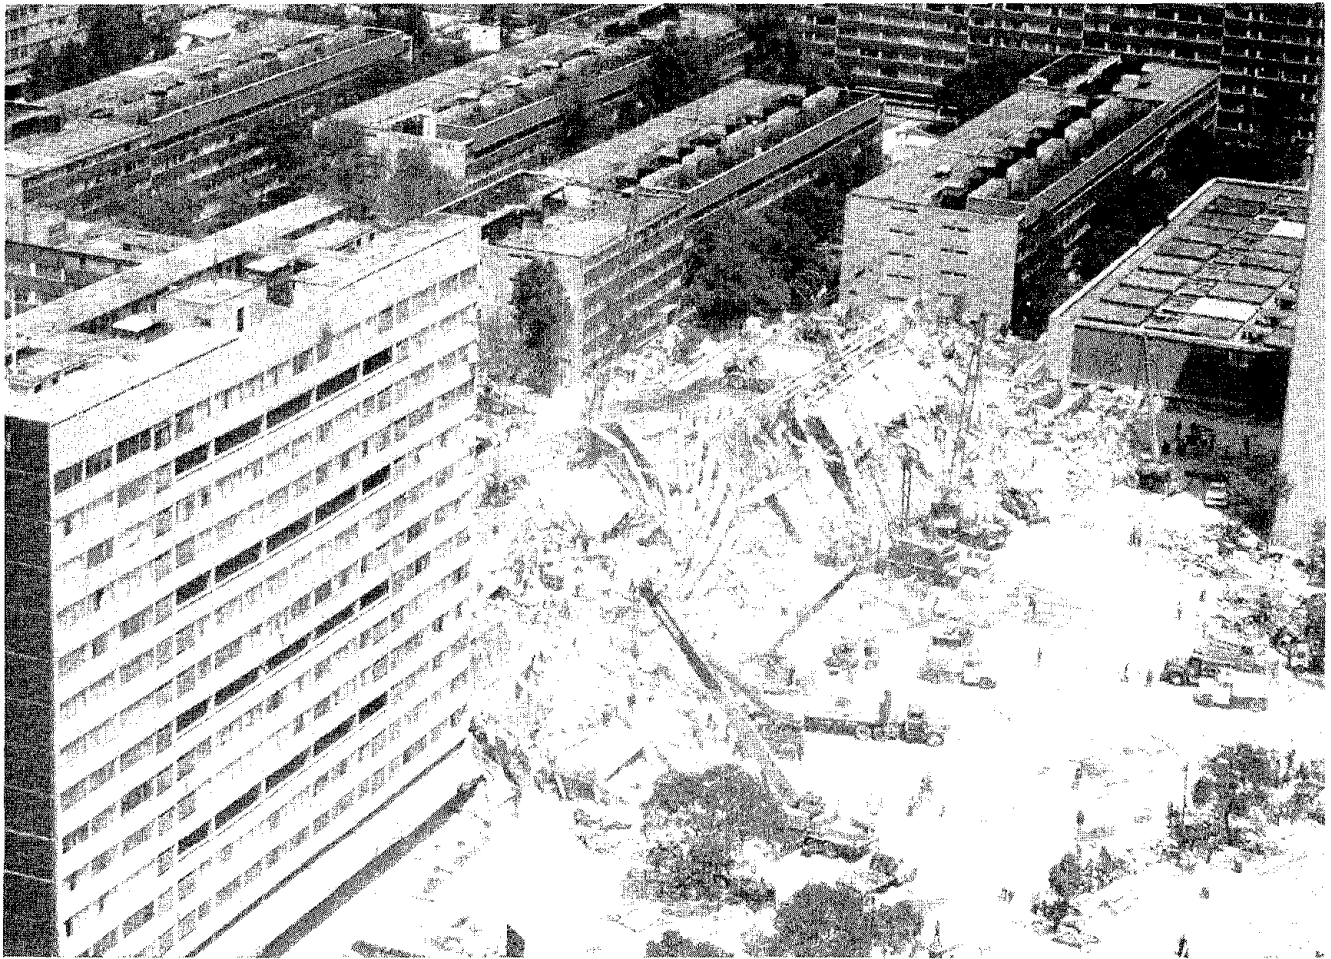
196 apartments (see figs. 5.28 and 5.29), apparently collapsed due to overturning when a failure was initiated on the east side of the structure near the foundation level. Supporting columns were then sheared or pulled from the ground on the west side of the structure (figure 5.30), leading to the toppling of the building towards the east.

Figure 5.28. Aerial view looking northwest of the Nuevo Leon Apartment Complex.

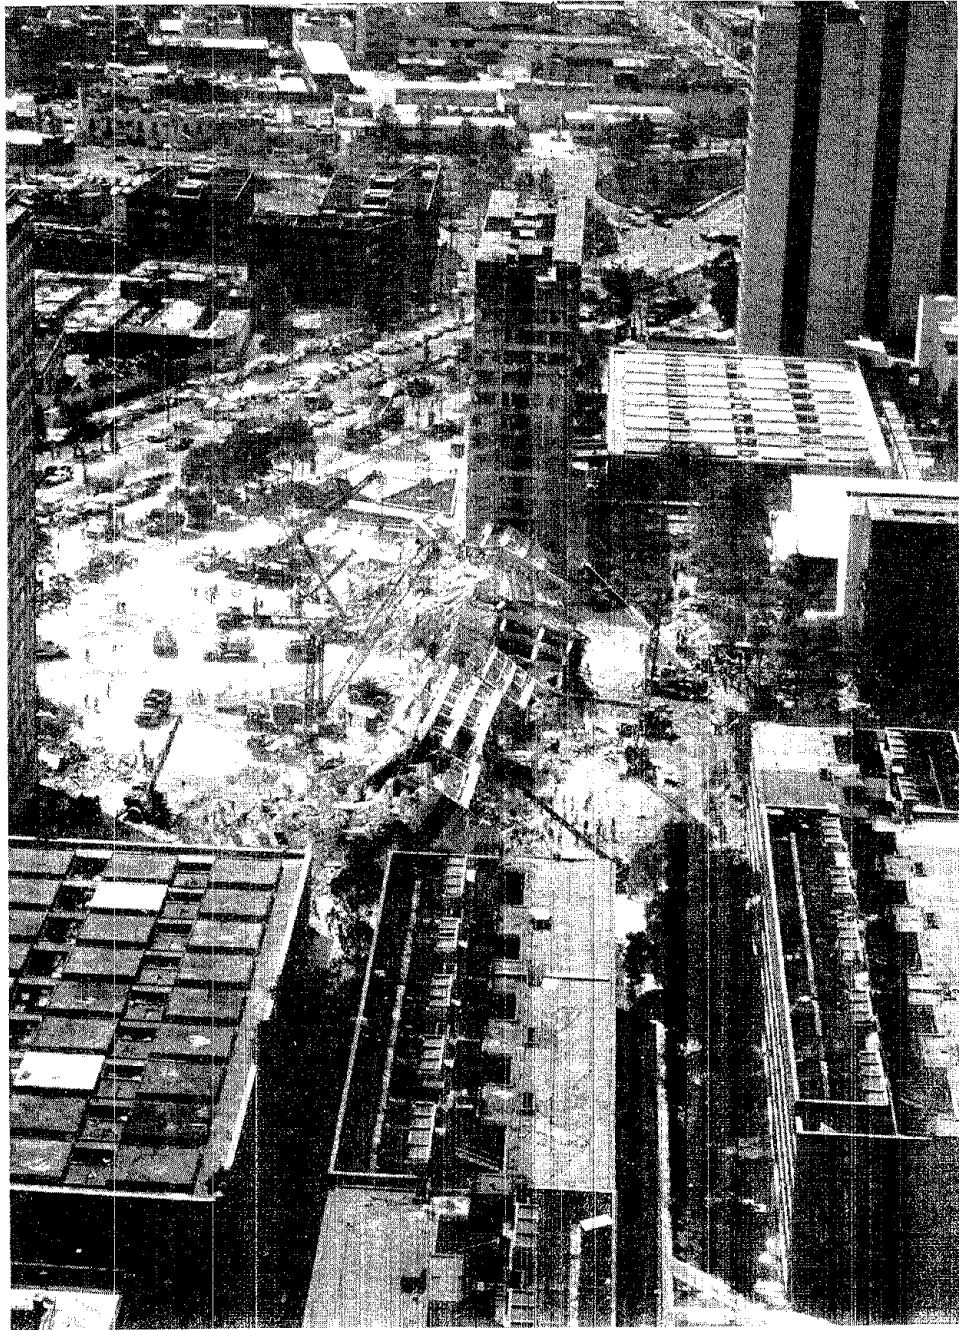
Figure 5.29. Aerial view looking south of the Nuevo Leon Apartment Complex.

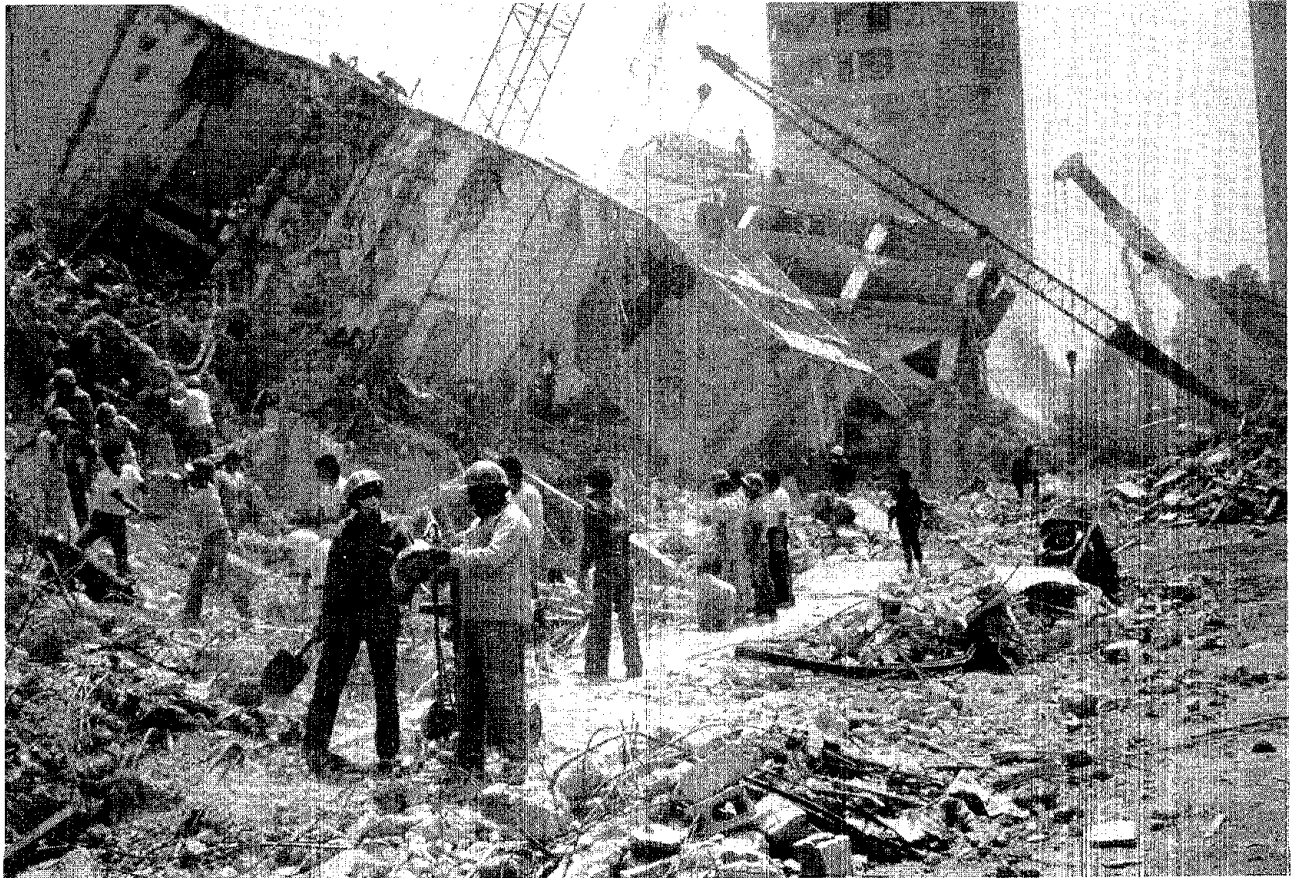
Although the floor levels behaved as flat slabs, they were in fact a special variety of waffle slab. This can be verified by inspection of figure 5.30 which shows the presence of porous blocks used to form the slab, revealed after the ceiling plaster spalled off during the final impact. Figure 5.31 shows the presence of regularly spaced reinforced concrete x-bracing as well as masonry infill walls which would have served to resist lateral forces during the earthquake. Figure 5.32, in fact, shows four structures identical to the Nuevo Leon building in the same vicinity which performed better during the quake.

Figure 5.30. West side of the collapsed Nuevo Leon Apartment Complex.

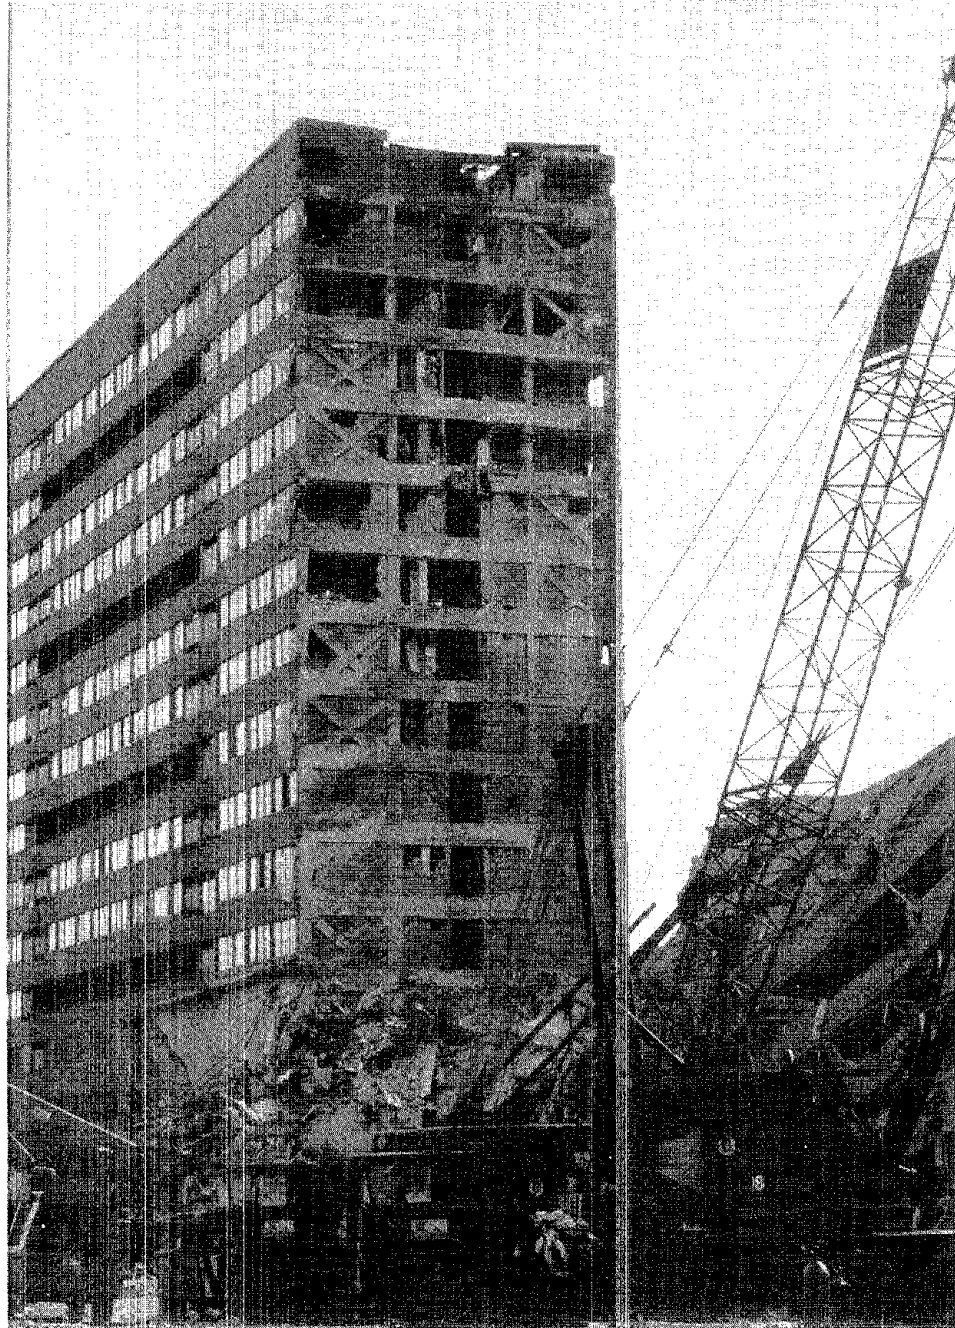
Figure 5.31. Concrete X-braces in remaining tower of Nuevo Leon Apartment Complex.

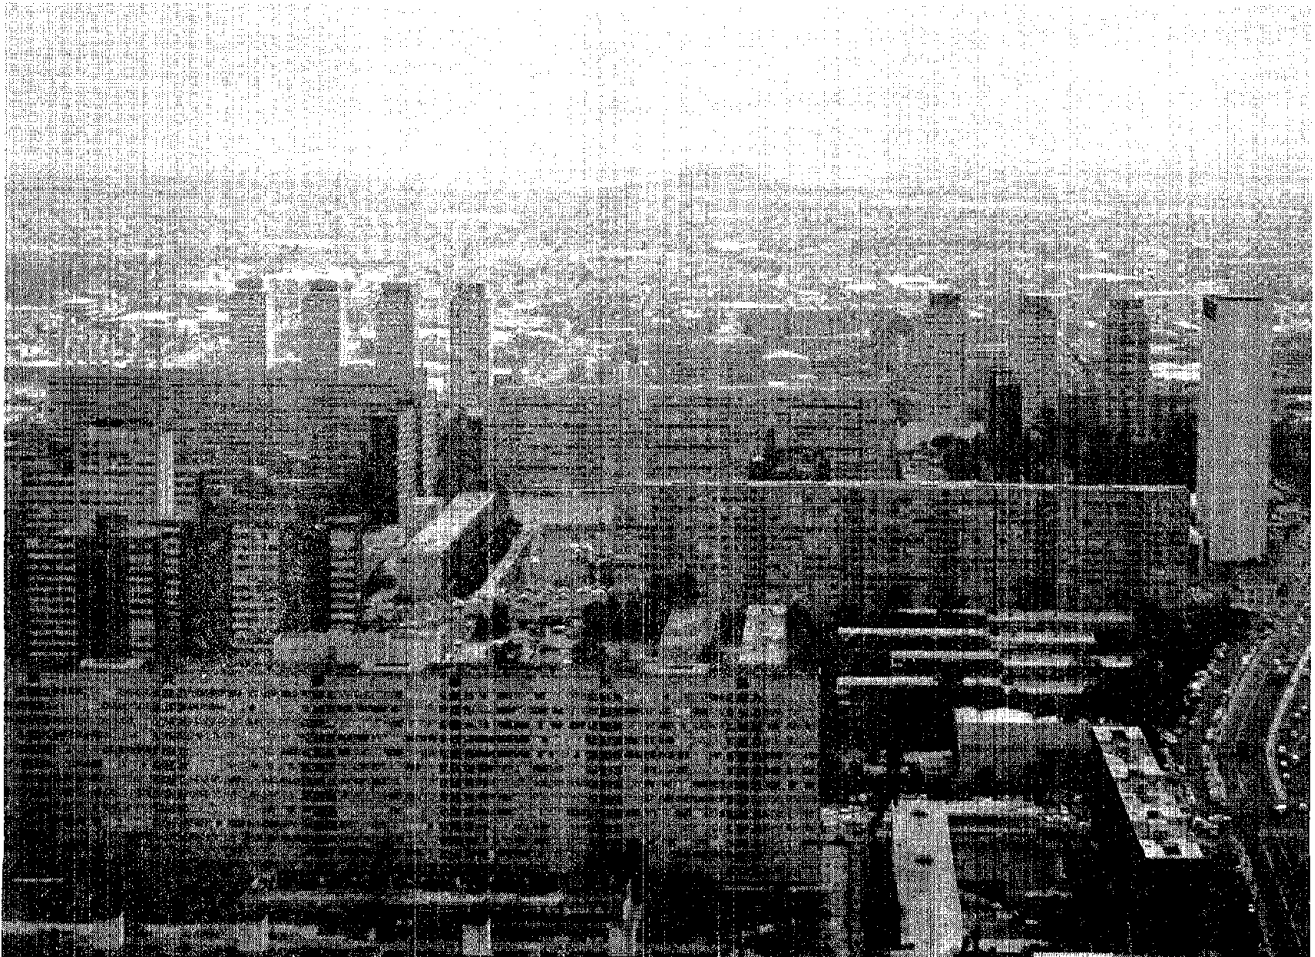
Figure 5.32. Four undamaged structures in the Tlatelalco Apartment Complex.

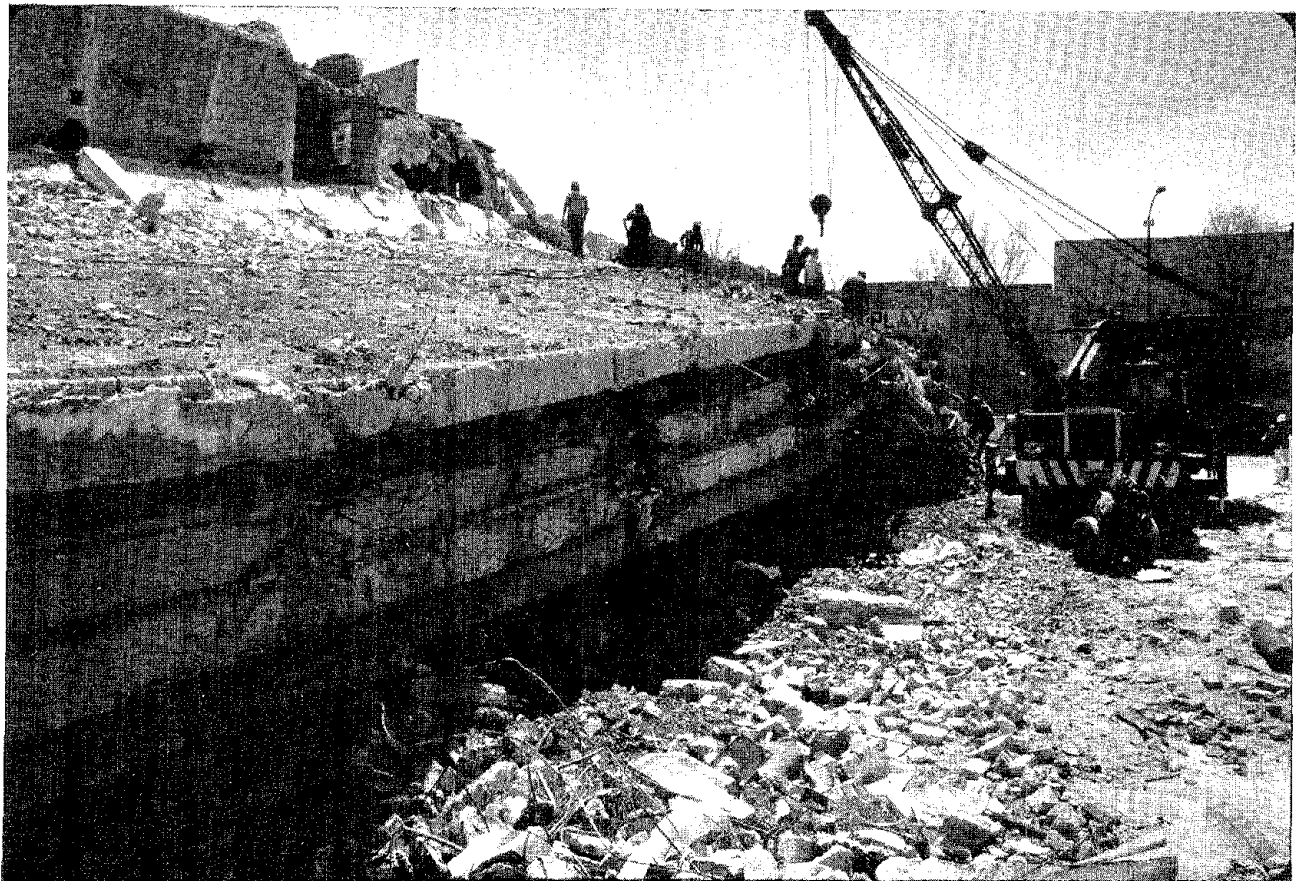
This asymmetry in column loading may have induced a failure of the first story east column line in the two northern structures, due to the relatively lower stiffness associated with the first floor lobby. Shearing of the columns would then occur either at underconfined joints or at the story mid-heights between the x-bracing. That the x-bracing proved effective is demonstrated by the relatively intact nature of large sections of the structure after failure. This is to be contrasted with figures 5.34 and 5.35 which show an office structure near the corner of Neva and Barragan streets, similar in many respects to the Noeva Leon building, with the exception of the lack of reinforced concrete x-bracing. The pancaking phenomenon is clearly evident.

Figure 5.35. Collapsed office building near the corner of Neva and Barragan Streets.

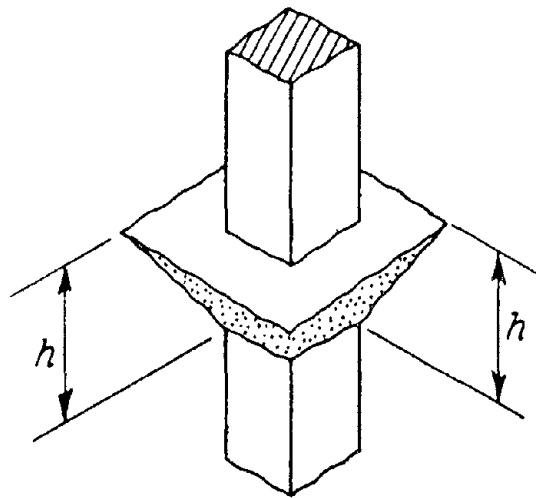
A typical example of flat plate structural failure is shown in figure 5.36, of the ten story Bancomer Building at the corner of Ave. Mier and 20 de Noviembre. This building was constructed recently, after the 1976 design code changes. In many cases the use of thin slabs precluded the placement of sufficient shear reinforcement in the vicinity of the slab-to-column junction. Under the reversed cyclic loading imposed by the earthquake, punching shear failures initiated a vertical progressive collapse, leaving the columns standing. Such failures were also seen at several other collapse sites involving flat plate construction. With the exception of projecting reinforcement at approximately 4 meter intervals, the columns appear bare in figure 5.36. Closer inspection showed that the floor plates slid down the columns, one on top of the other. The classical "shear cone" failure, shown in figure 5.37, is not visible here because the upper floors successively sheared off these cones from the top side as they fell.

Figure 5.37. Shear cone resulting from punching shear failure. Ref. [24].

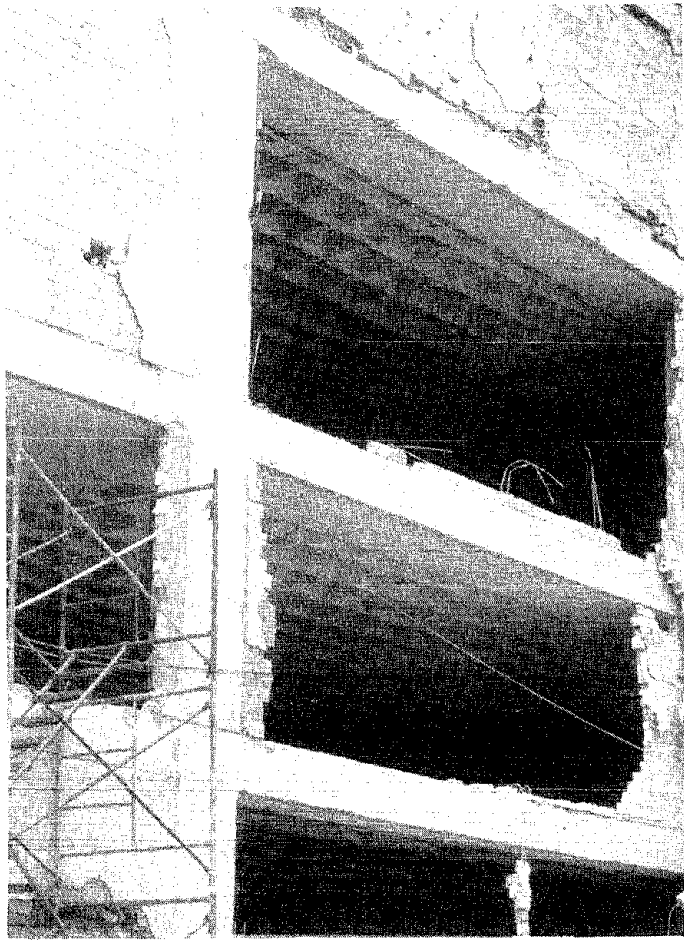
In many cases, the extent of damage to this type of structure was determined by the presence or absence of masonry exterior infill shear walls, as demonstrated in figures 5.38 a and b. The infill walls shown in figure 5.38a failed, and in the process absorbed a

(a) Waffle slab building in which masonry infill walls absorbed much of the earthquake energy.

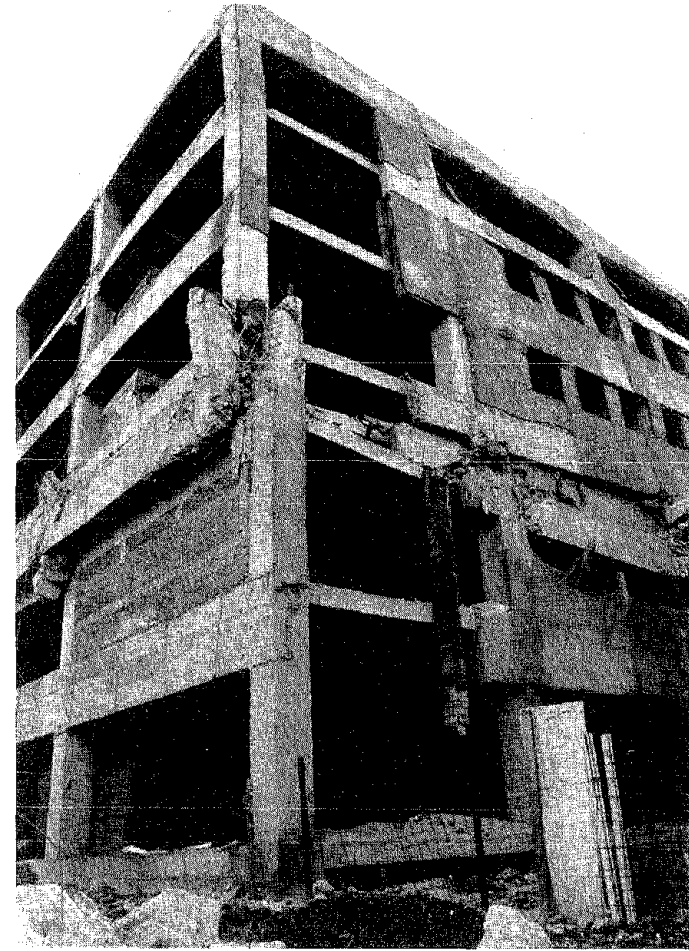
substantial amount of energy prior to buckling outward. On the other hand, the Banco Vencen building near the corner of Ave. Trujano and Hidalgo (figure 5.38 b) was under construction and masonry walls were in the process of being added to some of the upper floors, but were not complete enough to prevent column shear failures from occurring along the entire eastern side of the frame at the third story. Those portions of the building where the infill walls had been completed remained standing. A typical example of a failure of a waffle-slab structure with flexible columns was the 10-story apartment building at the corner of Ave. Dinamarca and Chapultepec shown in figures 5.39 a and b.

(b) Collapsed waffle slab building which was under construction.

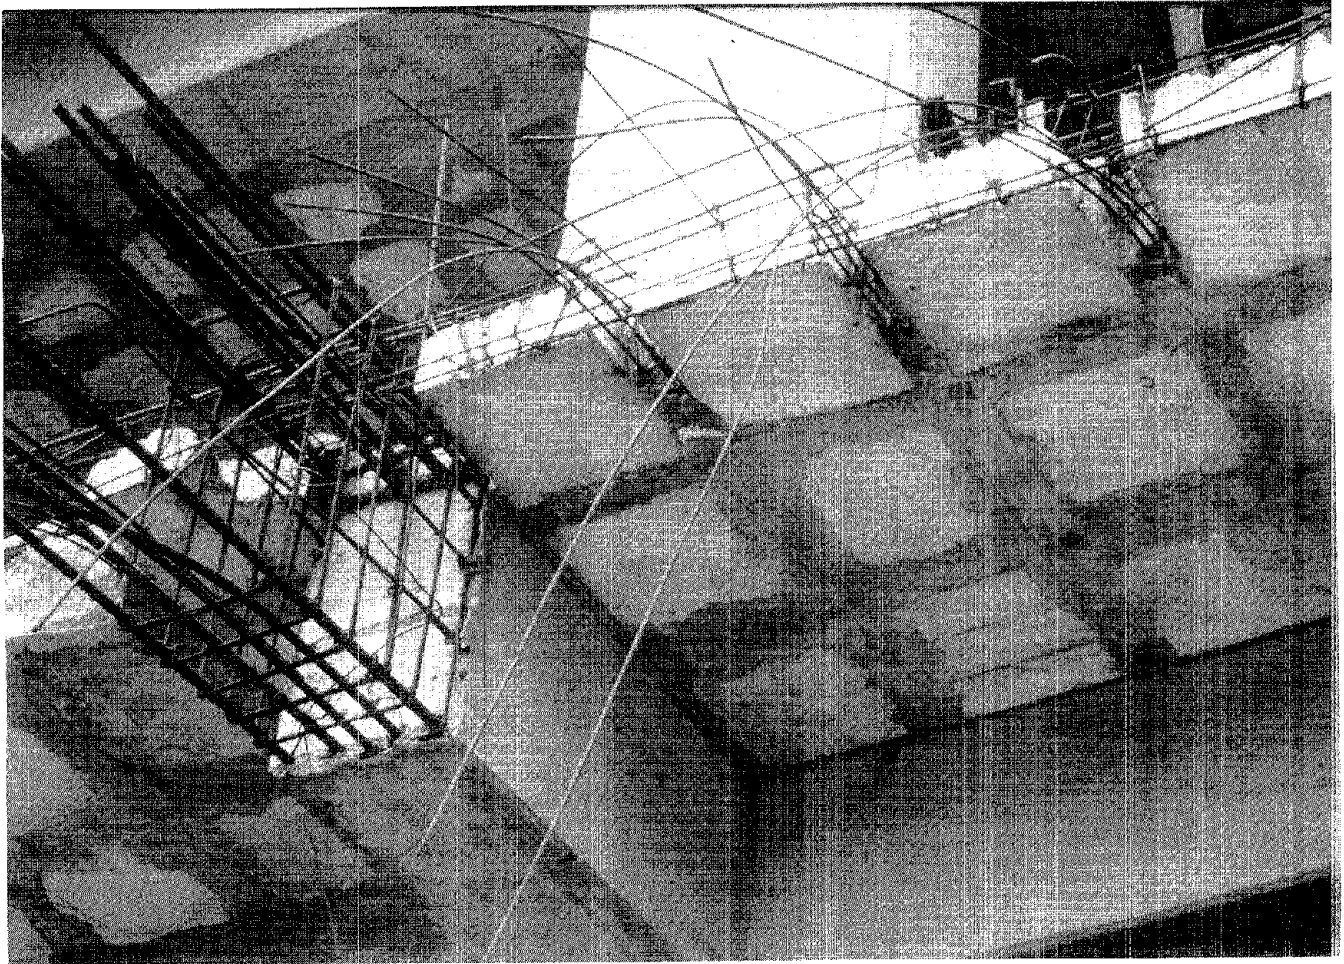
Two unusual variations in waffle slab construction bear mentioning, as they proved to be particularly poor performers during this earthquake. Figure 5.40 shows a new parking garage north of the U.S. Embassy on Ave. Reforma under construction, using rectangular cinder blocks in place of the traditional metal pan forms. The rationale behind this technique was to use readily available, inexpensive cinder block to form the blockout, thereby avoiding the expense of an inventory of metal pan forms while also leaving a smooth ceiling surface for finishing. These cinder blocks are spaced similarly to their metal counterparts, but are left in the structure permanently. Because they are cast into the slab the cinder blocks add to the mass of each floor level.

Figure 5.40. Parking garage under construction on Reforma, north of the U.S. Embassy.

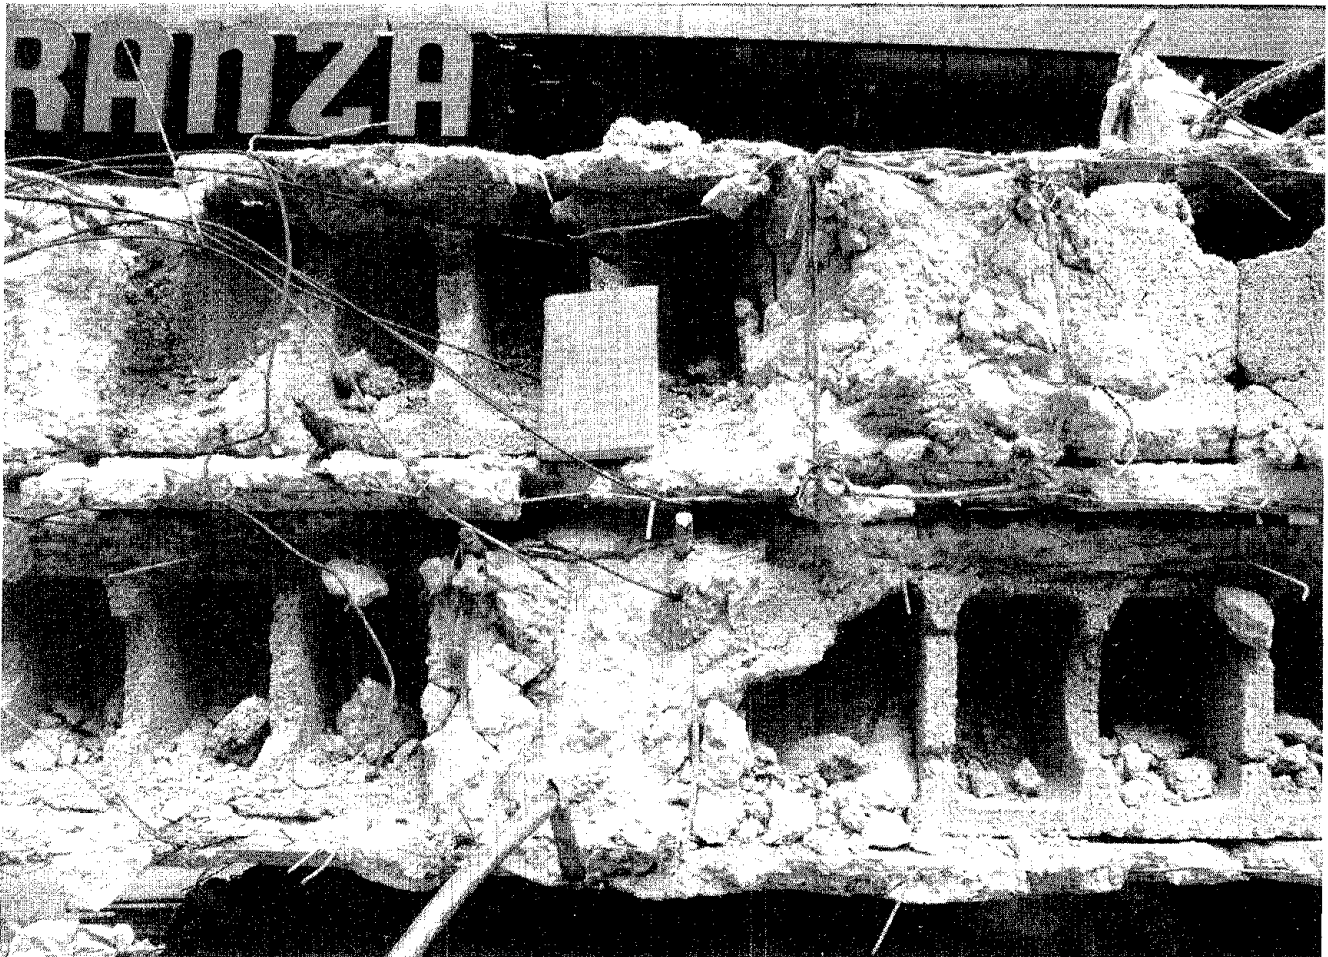
Yet another variation of this form of construction employed standard hollow cinder building block, as shown in figures 5.41. This type of slab was particularly prone to bond failure during reversed cyclic loading, leading to the "floor drop out" phenomenon shown in figures 5.42 and 5.43. In most cases, these same structures contained minimal slab reinforcement placed with

Figure 5.41. Waffle slab construction incorporating concrete block.

negligible cover. As the building underwent successive cycles of lateral loading, the bottom (tensile) cover concrete spalled off, leaving the tension reinforcement exposed in a grid-like pattern. With further shaking the cinder blocks simply began falling out, eventually leading either to the "floor drop out" phenomenon if sufficient shear reinforcement was present to resist a punching shear failure or, more likely, a progressive punching shear failure (see figure 5.43) similar to that observed in flat plate construction. It was apparent from the extensive and specific damage that special design procedures should be developed for this method of construction in future design codes.

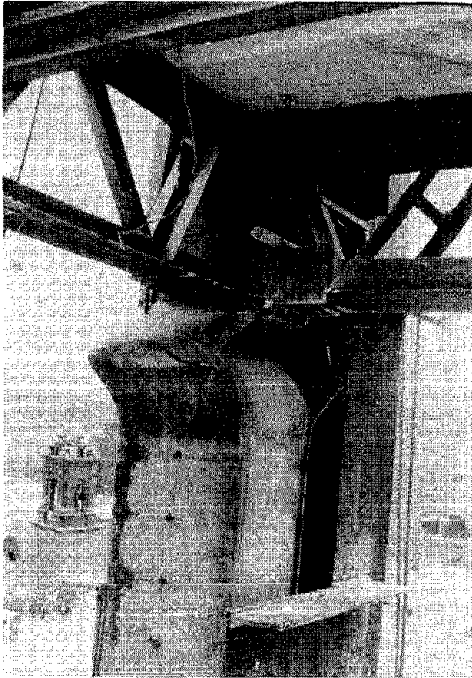
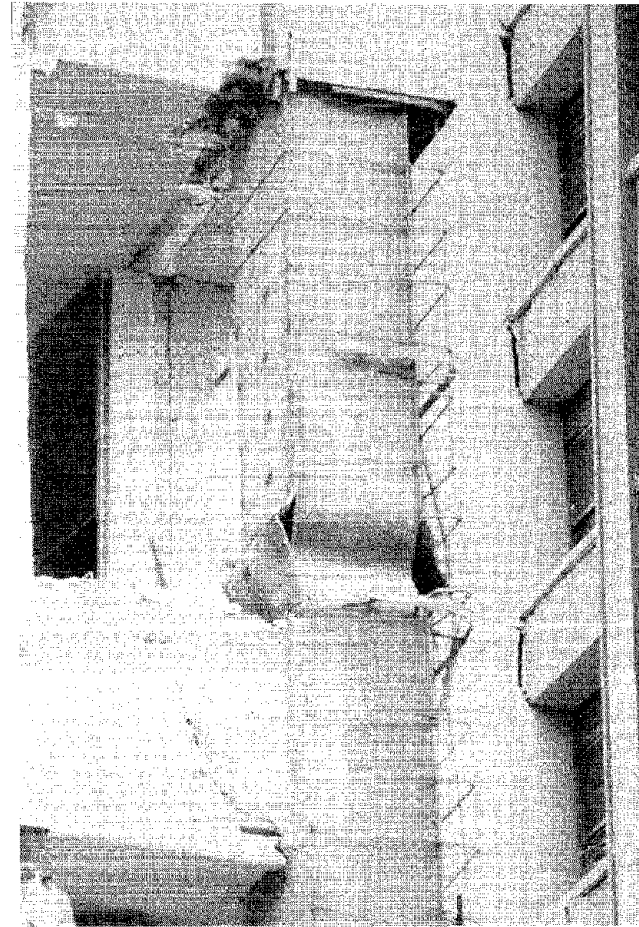
Figure 5.50. Box column buckling and truss beam to column connection details at Pino Suarez Complex.

(a) Detail of the moment resisting connection of truss beam to column. (courtesy Dr. R. Hanson)

(b) Buckled column on south side of center 23-story tower. (courtesy E. Martinez Romero)

buckled (see figure 5.50) indicating that they were not able to dissipate energy through inelastic action in the manner of typical rolled beam sections. This in turn had two adverse effects: primary ductility demand was transferred to the columns (for which they were not designed) and large lateral deflections gave rise to large P-delta effects, all of which served to overstress the southern, stiffer, column line. Eventually, local plate buckling -- amplified by weld tears at the plate joints -- occurred in the most highly stressed columns along the south face near the top of the common mezzanine.

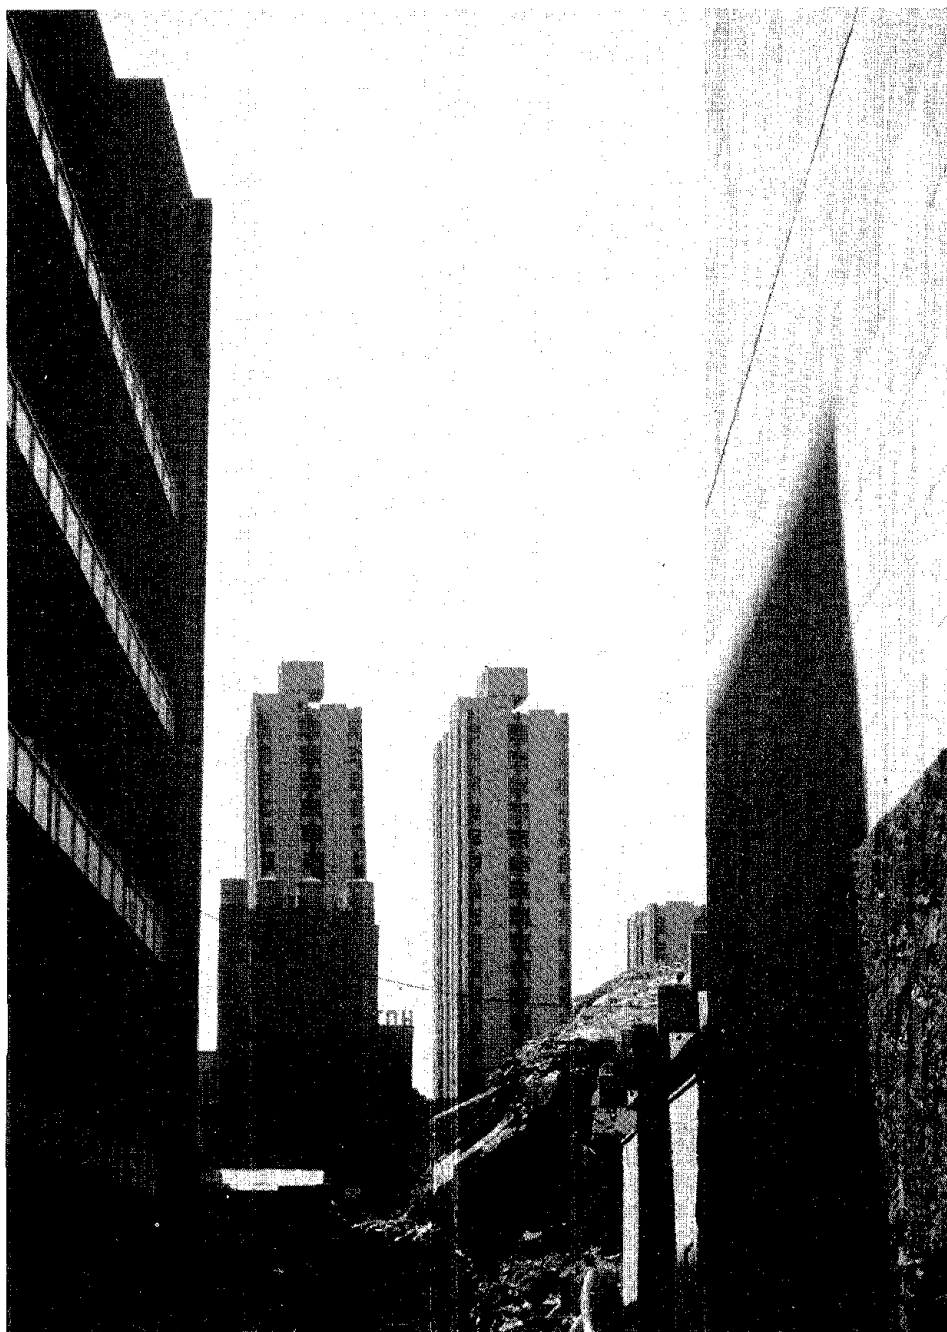
Buckling of columns, and deformations caused by other actions, induced substantial tilt towards the south, as can be seen in figure 5.52. It is highly probable that this situation existed in all three of the 23 story towers prior to the ultimate collapse of the southern-most tower. To complete the collapse mechanism, however, an additional failure was required. Figure 5.53 indicates that the final straw was likely a series of tensile fractures in the box-columns on the north side of the frame, presumably at a joint line near the second story. Lacking this crucial moment resisting element (viewing the structure as a whole) the tower was free to rotate southward, further crushing the southern column line in the process, and eventually impacting on its neighboring 14 story building. Both buildings were subsequently destroyed, leaving the two collapsed buildings in the configuration previously shown in figure 5.44.

Figure 5.52. Tilted central 23-story tower at Pino Suarez Complex. Southern side of structure is to left side.

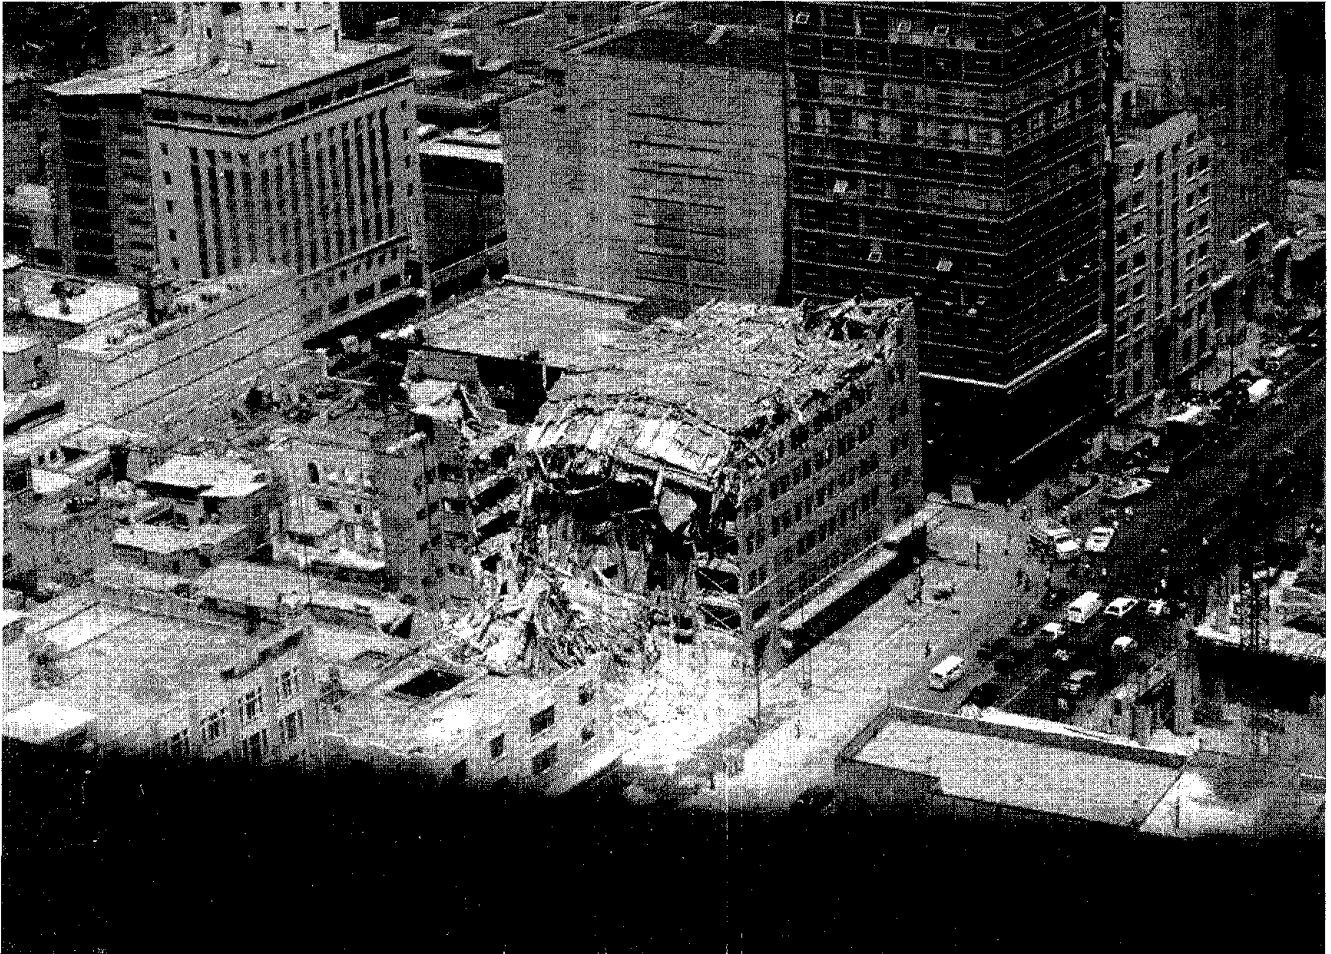
Figure 5.54. Aerial view of the Atlas Building, a typical steel frame structure constructed during the 1940's.

Other steel frame structures performed quite differently from the Pino Suarez Buildings, depending on their location, elevation, and proximity to adjacent buildings. One such example is the Atlas Building (figure 5.54), a 14-story concrete-encased steel frame structure constructed during the 1940's and located just south of Alameda Park on Avenida Lazaro Cardenas. During the 1957 quake this building suffered significant damage to moment-resisting knee braces (steel angles) and was later retrofitted with the diagonal cross bracing visible in figure 5.54.

During the 1985 earthquake the upper seven stories of the building collapsed. The front of the adjacent seven story structure was also destroyed by falling debris from the Atlas building. In the case of the Atlas Building, field evidence indicated that pounding was the principal cause of collapse of the upper floors.
