NBS BUILDING SCIENCE SERIES 165

**Engineering Aspects
of the September 19, 1985
Mexico Earthquake**

Following the September 19, 1985 Mexico earthquake, a team consisting of four engineers and one seismologist from the National Bureau of Standards (NBS) and the United States Geological Survey (USGS) was dispatched to Mexico City to provide technical advice to the US rescue effort and to assess structural damage. This report is primarily based on data gathered by the team, but it also contains a compilation of other available information. The report addresses the origin and characteristics of the observed ground motion, the ability of buildings designed in accordance with present and proposed seismic design provisions to resist this type of ground motion, and observed data on structural and foundation failures.

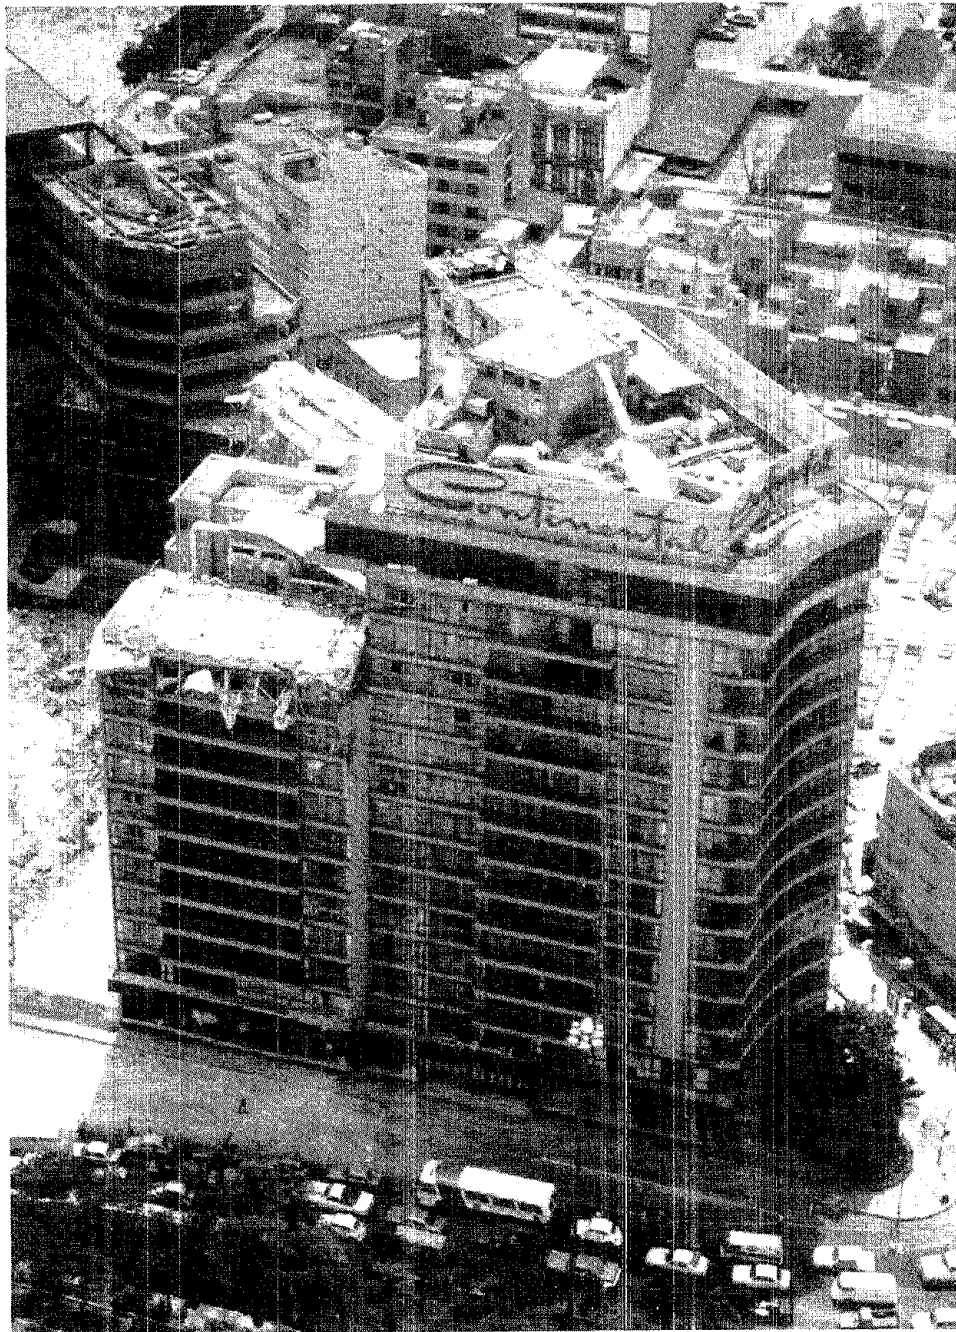
One variant on the pounding problem occurred where expansion joints existed within a structure and where it was possible for the separated substructures to vibrate independently, but where an insufficient "seismic gap" was provided to prevent pounding. An example of this type of failure was the Hotel Continental on Avenida Reforma. The building was V-shaped in plan, largely because of its street corner location, with two independent wings forming the "V" (see figure 5.60). The wing sections, each as tall as the main structure, apparently vibrated out of phase with the stiffer primary building and eventually suffered column failures due to pounding. This, in turn, led to the collapse shown in figure 5.61. Adequate separation between the wings of the building may have prevented such a failure.

Figure 5.60. Aerial view showing "V" shape of Continental Hotel on Paseo de la Reforma.

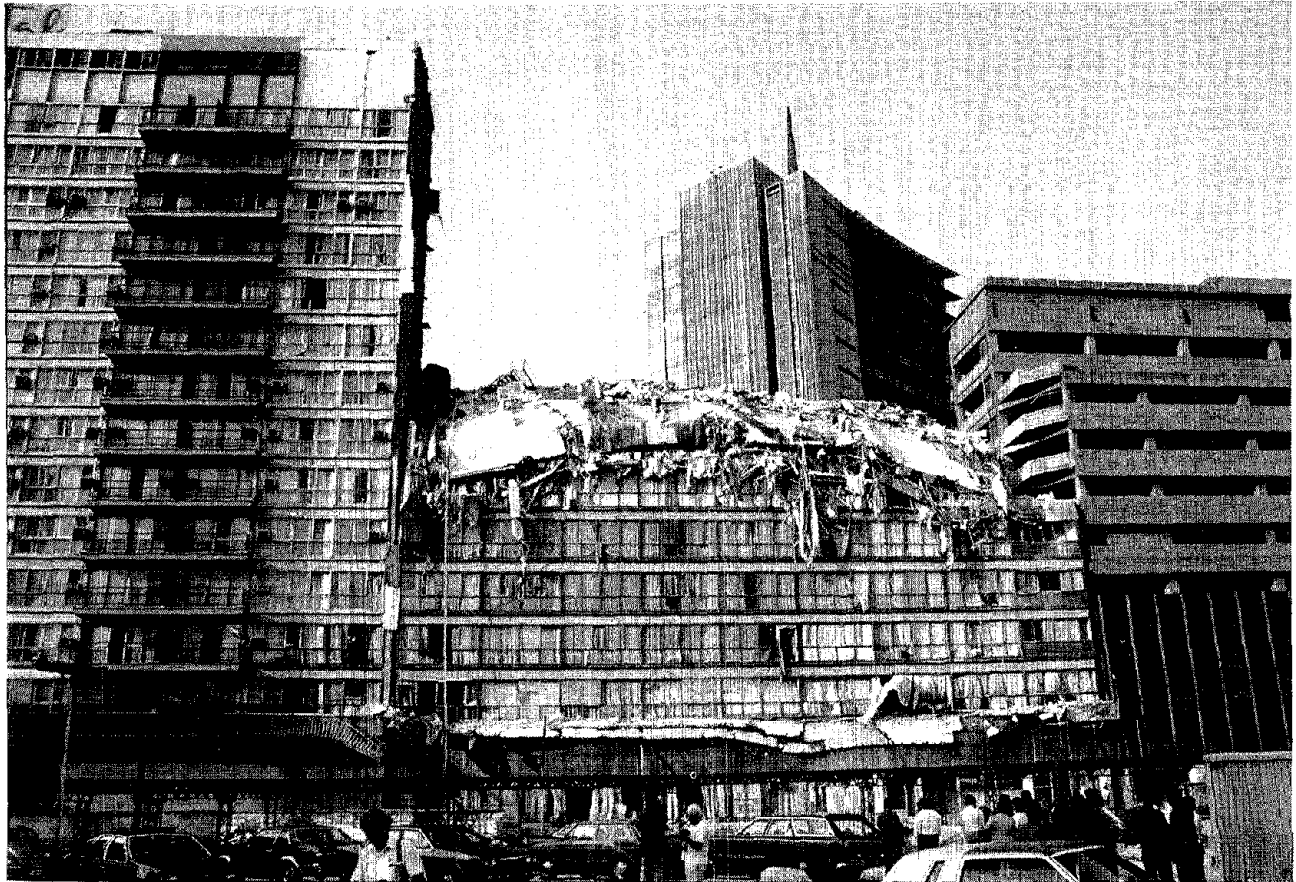
Figure 5.61. View looking north of collapsed southern wing of the Continental Hotel on Paseo de la Reforma. The entire complex was subsequently dynamited.

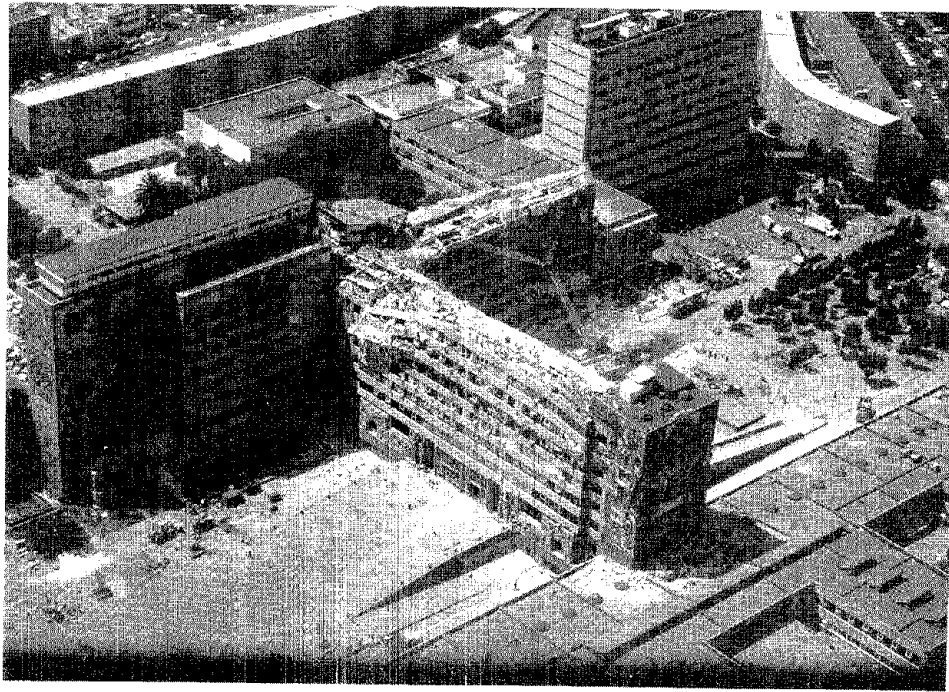
An example in which building configuration appeared to have led to torsional response during the Mexico Earthquake is illustrated by the 12-story SCT (Secretaria de Comunicaciones y Telegrafos) complex (figure 5.62) on Ave. Lazaro Cardenas, approximately two kilometers south of the central historic portion of the city. The earthquake precipitated a progressive collapse which started near the top of the building at the inside northwest (re-entrant) corner as shown in figure 5.63. The collapse was probably triggered by failure of one of the upper columns (which are often of smaller cross-section and lighter-weight concrete in Mexico City) and then propagated by means of corner column failures along the north face of the west wing and the west face of the north wing of the T as can be seen in figure 5.64. The resulting progressive slab collapse was arrested at the 8th floor, where the 7th floor columns were sufficient to resist the impact load from the collapsing upper stories.

Because of the unusual geometry of the building (essentially a T-shape) and because of the asymmetrical failure mode, a preliminary effort was made to understand the dynamic performance of the structure shortly after the NBS/USGS team returned to the United States in October 1985. A modal analysis was conducted on a simplified version of the building (as shown in the computer-generated image in figure 5.65), under the assumption that the complex could be modeled as a continuous T-shaped structure. This analysis indicated that the fundamental mode of vibration for the SCT building was torsional. From this it was concluded

(a) Aerial view looking north.

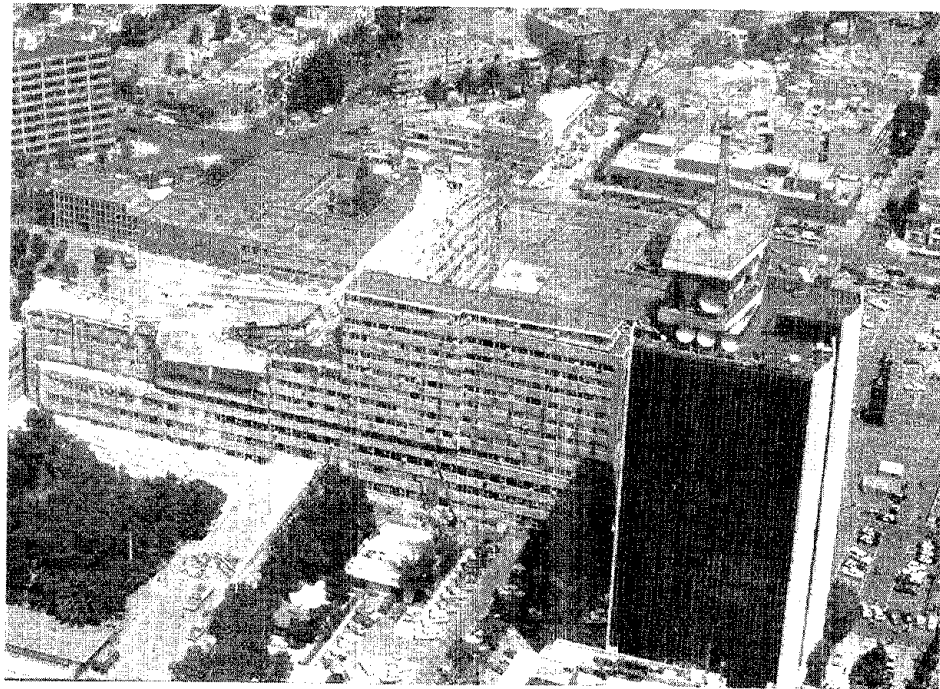
(b) Aerial view looking southwest.

Figure 5.62. Aerial view of SCT Communications Complex.

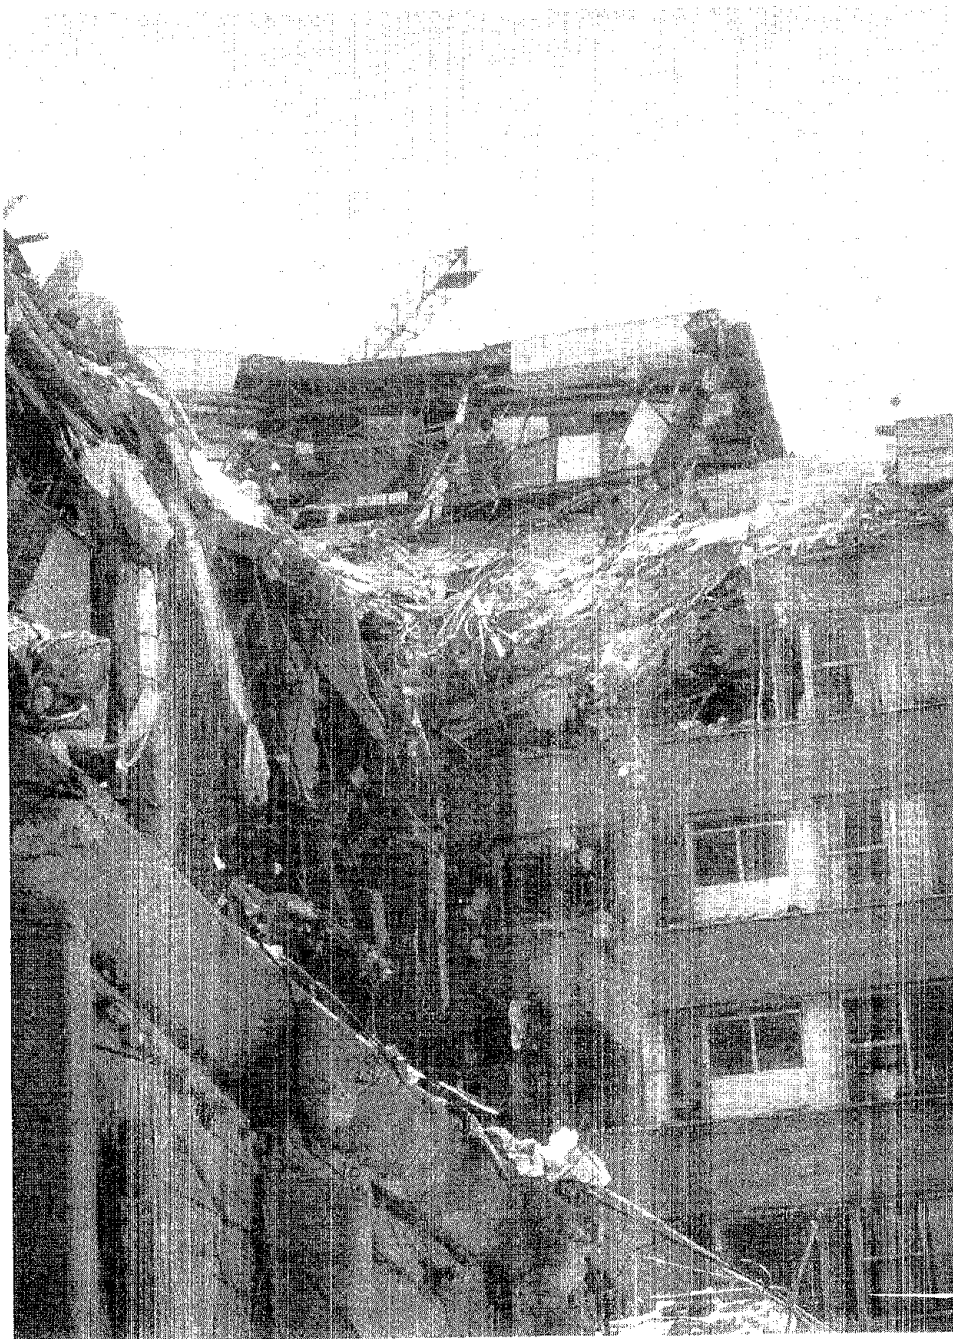
Figure 5.63. Northwest re-entrant corner of SCT Communications Building showing likely initiation point of collapse.

that large shearing forces would have been generated at the re-entrant corners leading to the initiation of the collapse.

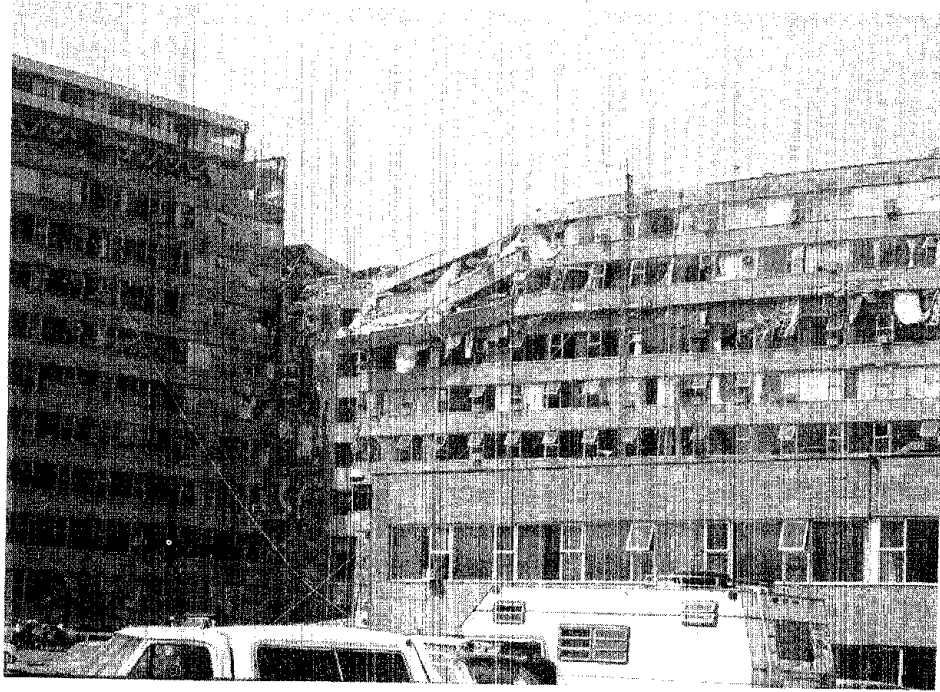
(a) East side of SCT Building.

Figure 5.64. SCT Communications Building showing extent of progressive collapse.

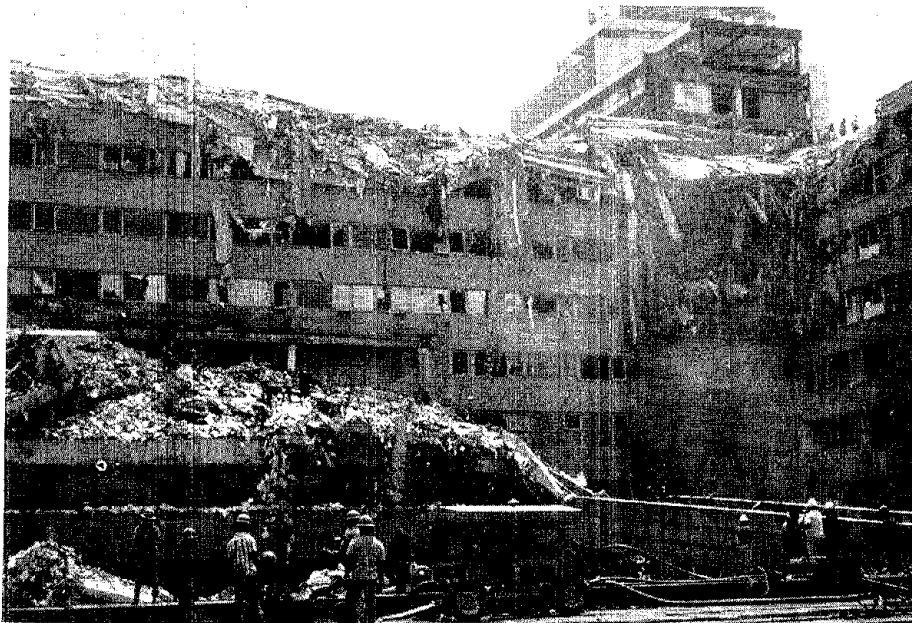
(b) West side of SCT Building.

Later discussions with Mexican engineers [36] indicated the presence of a vertical expansion joint between each of the wings, which partly explains why the damage did not progress into the eastern wing of the structure. This would have permitted independent vibration to take place in the various sections of the building leading inevitably to collisions between the various components (i.e., pounding). In either case, T-shaped section or construction joint with insufficient separation to prevent drift interaction, the brunt of the damage would have been sustained at the same junction location. The complex is undergoing renovation and the height was reduced to a uniform 5 stories as of September 1986. The nearby SCT tower sustained negligible damage and offices were in use shortly after the earthquake.

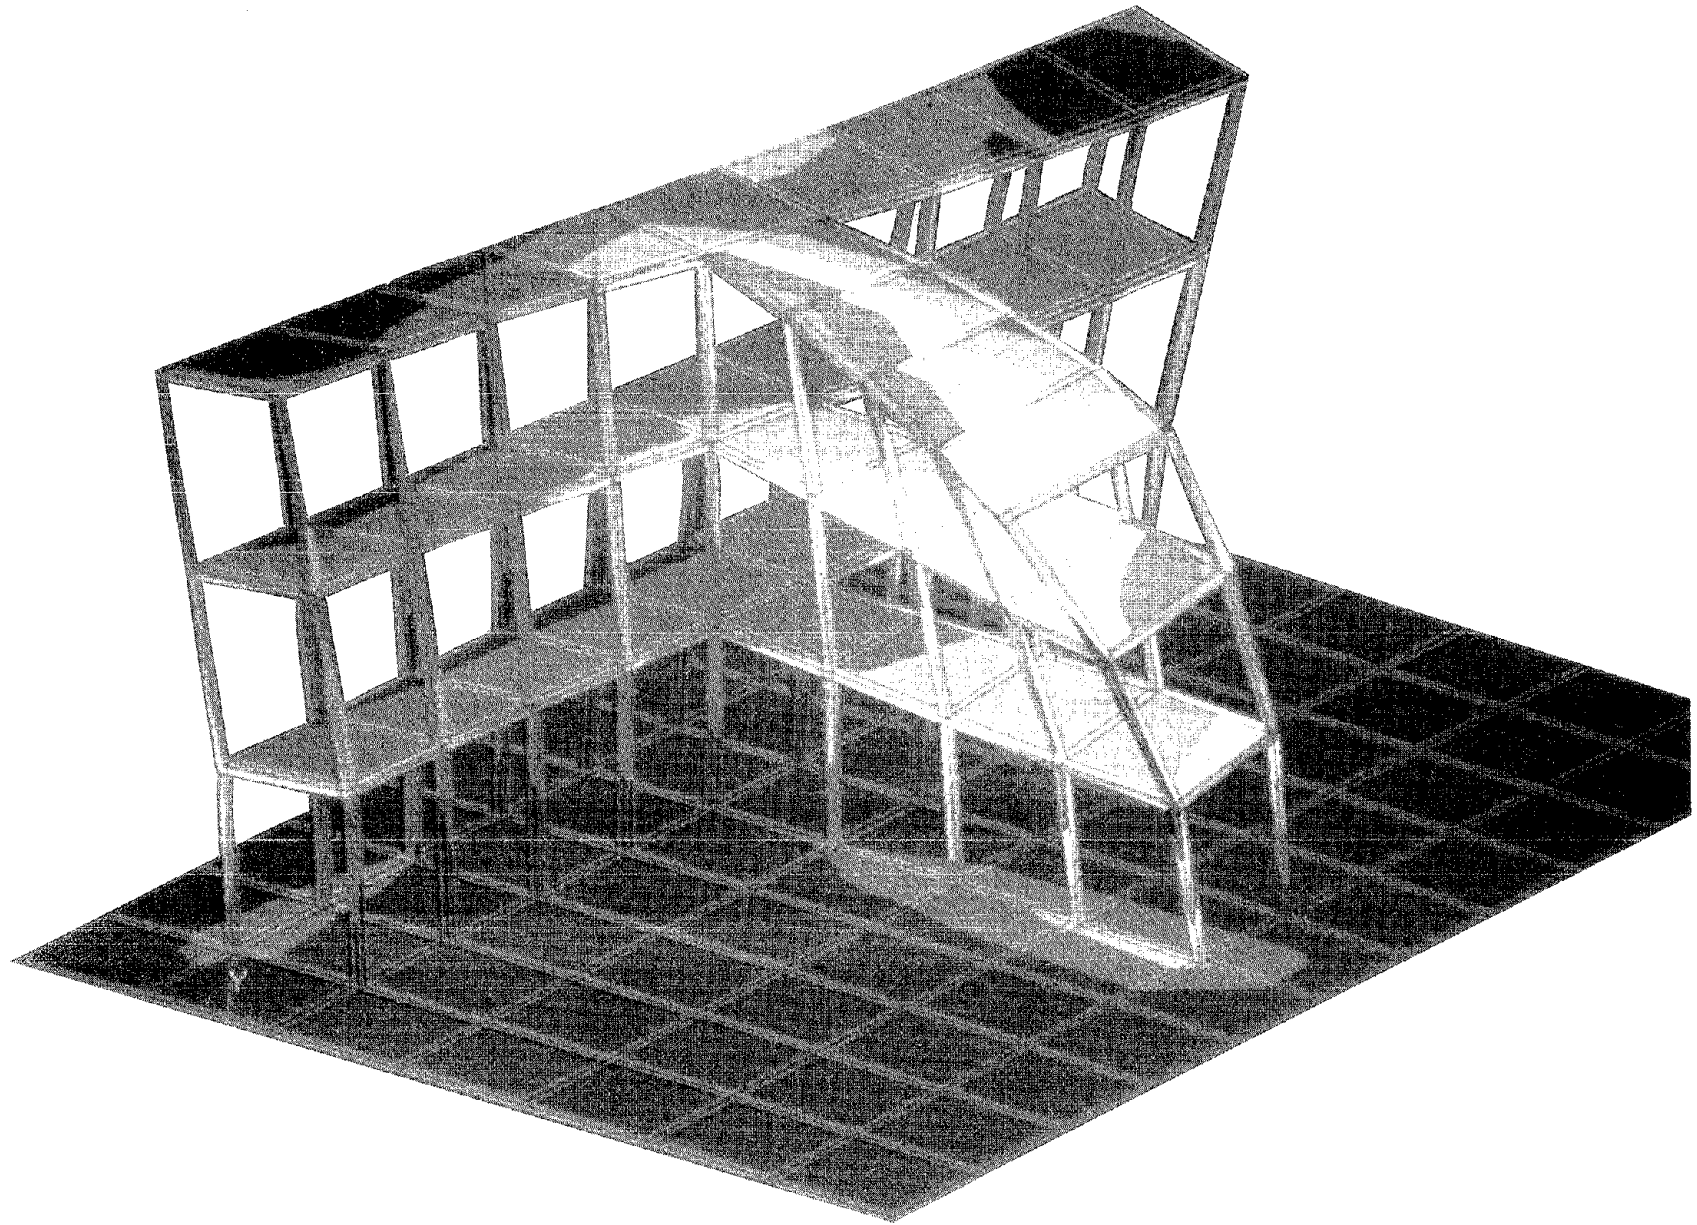
Figure 5.65. Computer generated image of primary (torsional) response mode of a simplified model of the SCT Building.

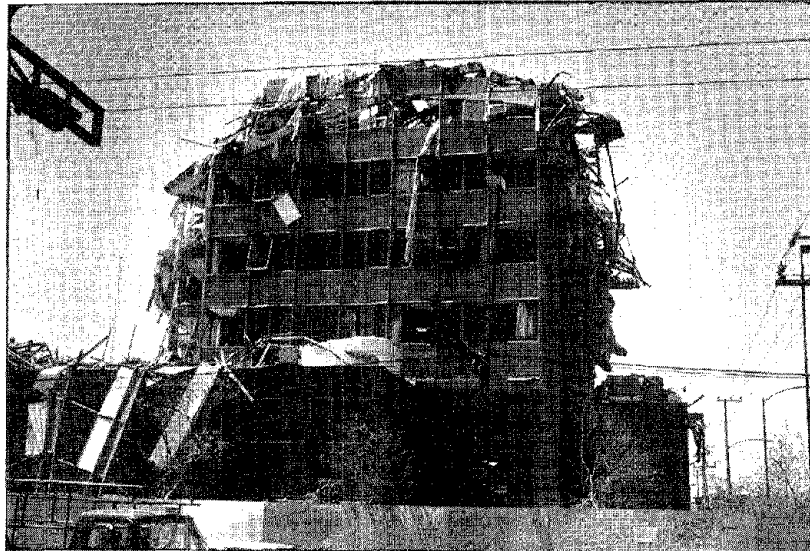
Lateral forces that a building must resist during an earthquake are greatest near the base of a structure. It is thus somewhat surprising that the third largest category of structural collapses listed in Table 4.1 was that of failures in the upper stories of buildings. In many cases observed during the field investigation (as for example the structures shown in figure 5.67), pounding was not a factor since there were no adjacent structures. This left only two likely reasons for the ubiquitous nature of this failure mode. The first is the apparently common practice of reducing column dimensions with story height in an effort to save on material costs (which in Mexico are of greater concern than labor costs). This practice is clearly demonstrated in figures 5.68 and 5.69 which show the upper story collapse initiating at the point of a general change (reduction) in column stiffness. In the case of the building shown in figure 5.68 (the eight story LACSA Building on the corner of Reforma and Marne Streets) the upper two story steel-framed penthouse was a later addition to the lower six story concrete frame. Figure 5.68 a indicates that most of the damage was confined to the penthouse.

(a) Upper story failure in office building on Ave. Lazaro Cardenas.

Figure 5.67. Typical upper story failures in building where pounding did not occur.

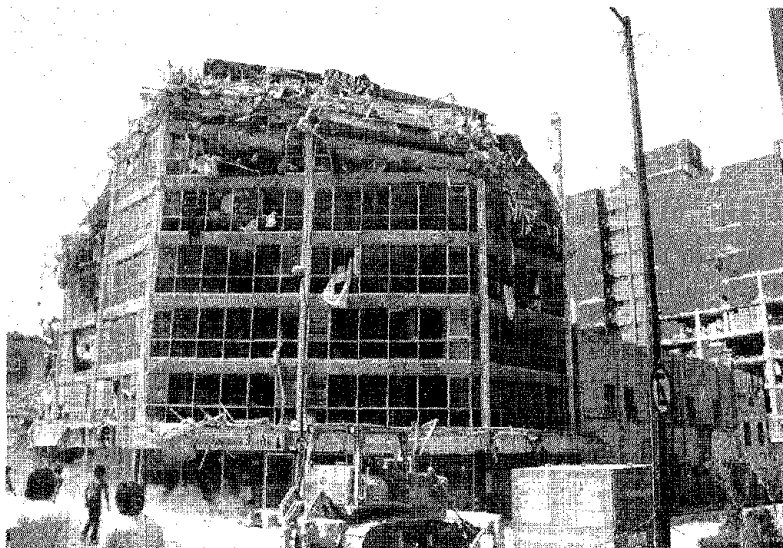
(b) Upper story failure in clothing store.

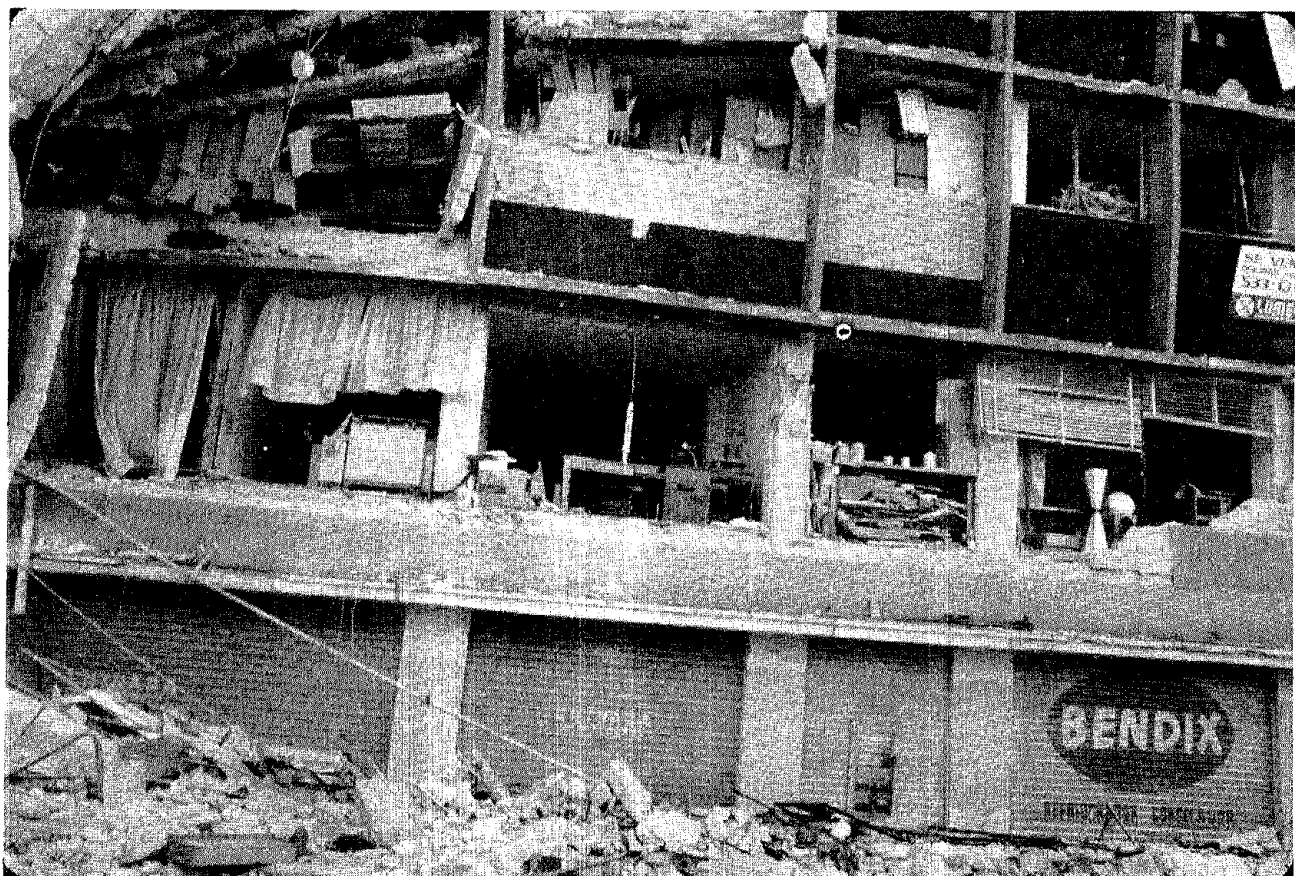
Figure 5.69. Commercial building showing large changes in column stiffness in upper stories.

The tendency to make room for additional office space by constructing "add-on" upper floors is common practice throughout Mexico, particularly where land is at a premium in urban centers. Because of the desirable nature of the lower stories for office space and living quarters, the add-on upper stories are often used to store merchandise or archival records, especially in the case of federal government buildings.

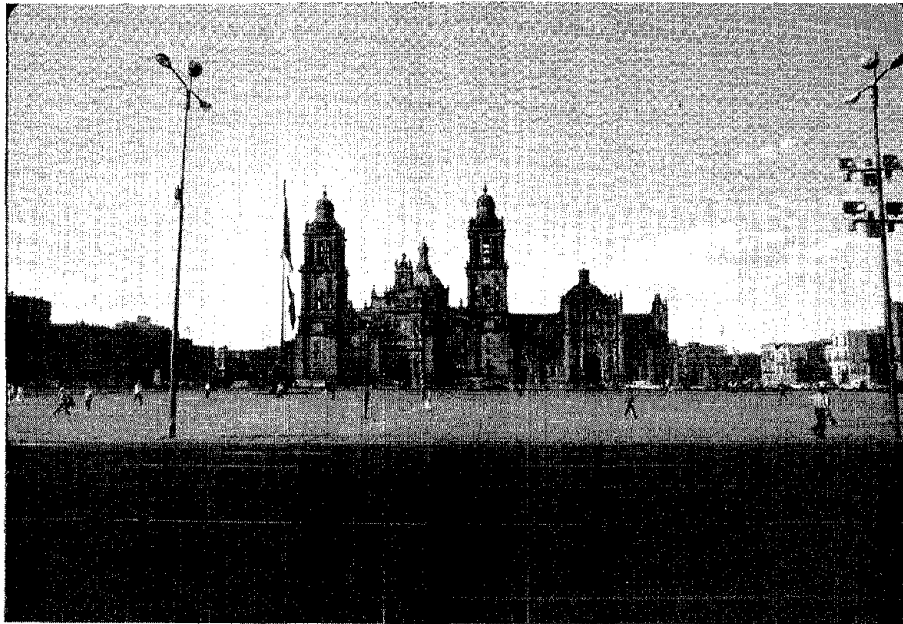
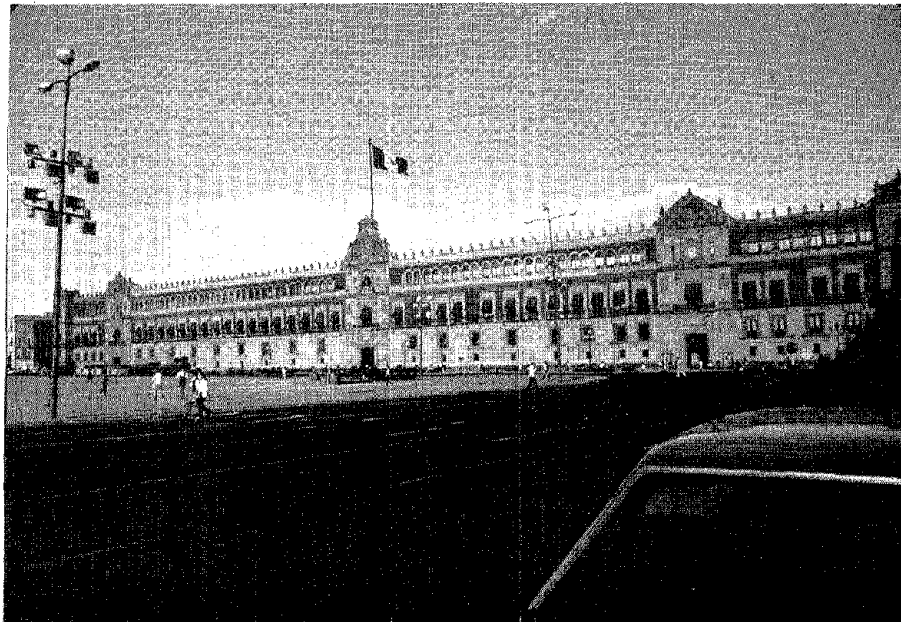
Some of the most effective "survivors" in terms of structural performance during the 1985 earthquake were the historic stone masonry churches and colonial office buildings (see figure 5.70). These buildings have withstood numerous previous earthquakes. In terms of structural behavior the endurance of these buildings may be attributable primarily to their exceptional stiffness. Since the height of these buildings is limited, these structures in general have short fundamental periods of vibration. Therefore, in the lakebed of Mexico City, these structures were out of the range of the spectral peaks of the earthquakes. Furthermore, over the years, powerful earthquakes removed the less earthquake resistant structures.

Figure 5.70. Colonial stone masonry structures (National Palace and Cathedral) have short natural periods of vibration and performed well in the earthquake.

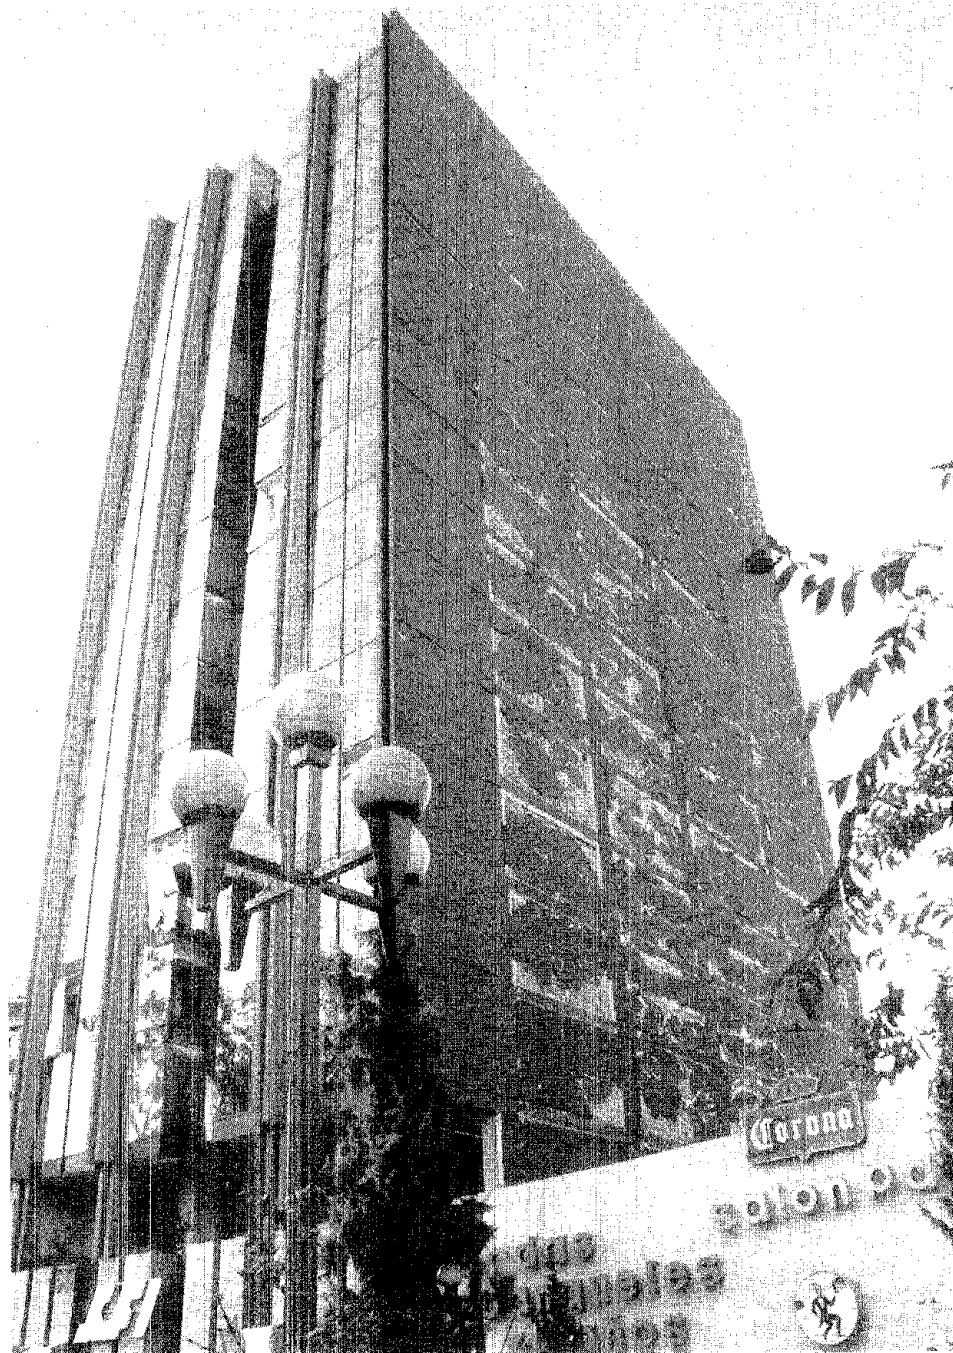
There are few modern buildings in Mexico City which employed reinforced masonry, as is commonly used in other parts of the world. Low rise, unreinforced masonry construction is very common for houses, apartments, and commercial buildings. The most general use of masonry in Mexico City, however, is for unreinforced infill walls for high rise frame structures (figure 5.71). While a number of medium and high rise buildings did suffer infill wall damage (figure 5.72), infill walls generally had a beneficial effect on structural performance [27]. This was accomplished by increasing the structure's lateral stiffness and thus reducing its fundamental period of vibration, and by providing or augmenting lateral-load resistance. Both of these

Figure 5.71. Typical high-rise reinforced concrete building with masonry infill walls.

effects served to improve performance under earthquake loading. Stiffening of structures was an advantage in Mexico City primarily due to the unusual soil conditions which produce ground motions with periods considerably longer than those experienced in most urban centers around the world. In those areas where relatively firm subsoil conditions exist, such stiffening could actually increase the lateral loads.
