NBSIR 87-3667

# The Whittier Narrows Earthquake of October 1, 1987 A Reconnaissance Report

By H. S. Lew

November 1987

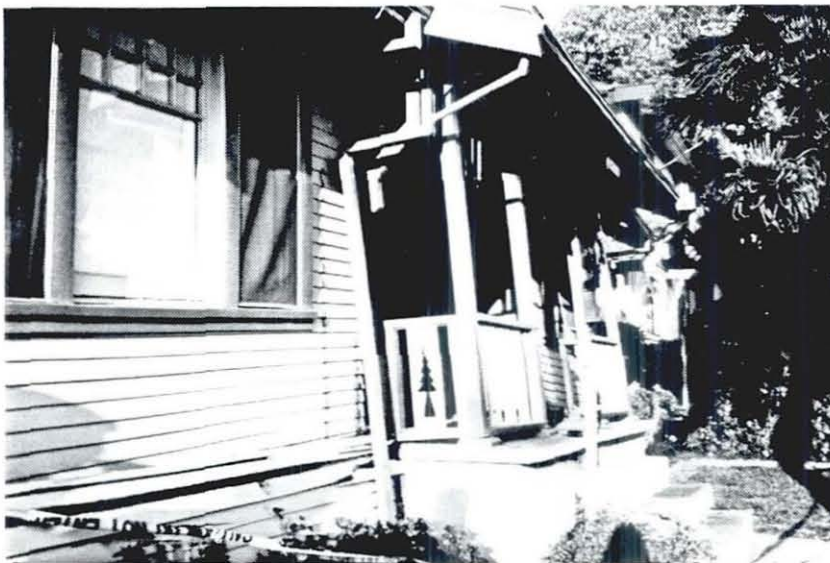
Photo 14 Close-up view of the house in Photo 13.

Photo 13 A wood-frame house adjacent to the house in Photo 11 on Beverly Blvd., Whittier, also sustained severe damage when the earthquake dislodged the house from its foundation wall.

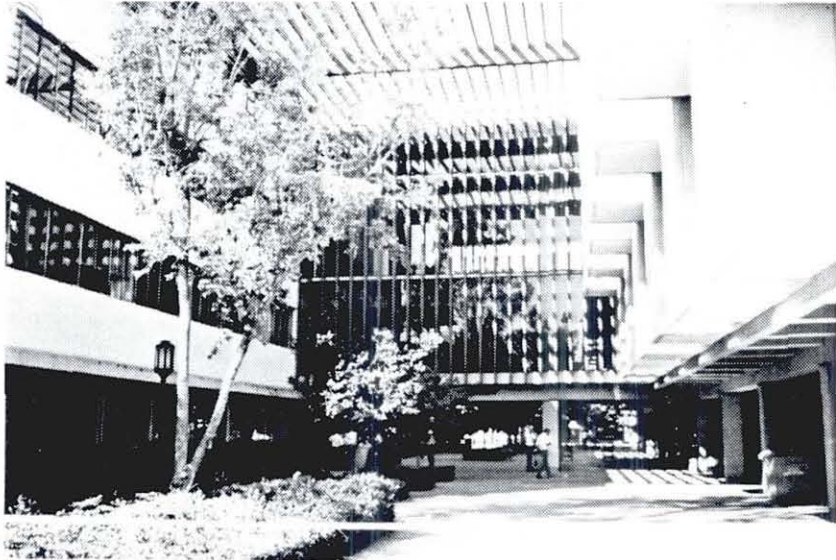
Photo 18 The library building complex on the campus of the California State University in Los Angeles. The two buildings are connected by a structurally-separated walkway structure.

sections of a building, and connection failures of a precast concrete fascia panel. A student died when she was crushed when this panel fell from a parking structure. Photos 18 through 24 illustrate some of the structural damage seen on the campus.

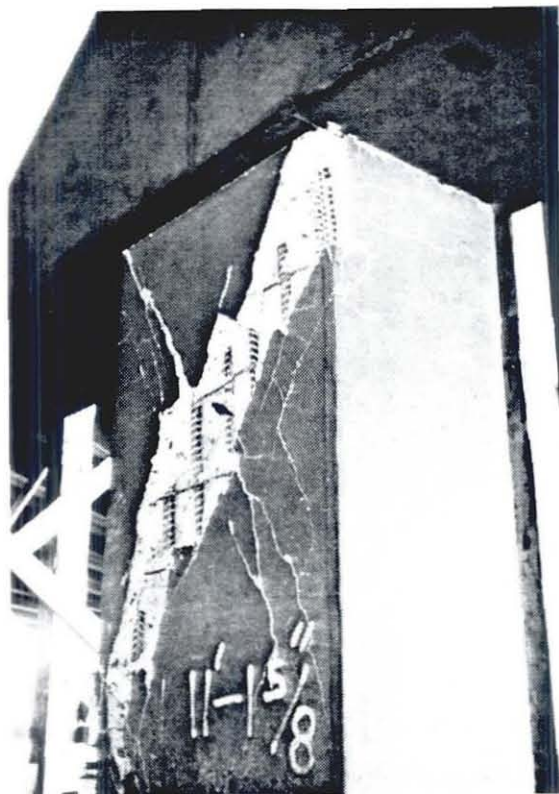
Photo 41

Immediately after the main shock, highway bridges were inspected by the California Department of Transportation (Cal Tran). Very little damage was sustained by most of the bridges near the epicenter except at the interchange of I-605 and I-5, where the columns in the center bent were severely damaged. The damaged bent supported 2 spans of precast concrete I-girders for the I-605 Freeway which crosses over the I-5 Freeway. Restraining cables installed by Cal Tran after the San Fernando earthquake, kept the precast girders from being dislodged from the bentcap. The interchange was closed to traffic for 22 hours after the main shock. Temporary shoring was placed on both sides of the damaged bent to support the precast girders. Photos 40 through 45 show the damaged overpass and columns and the temporary support system.

Close-up view of damaged column in the center bent.

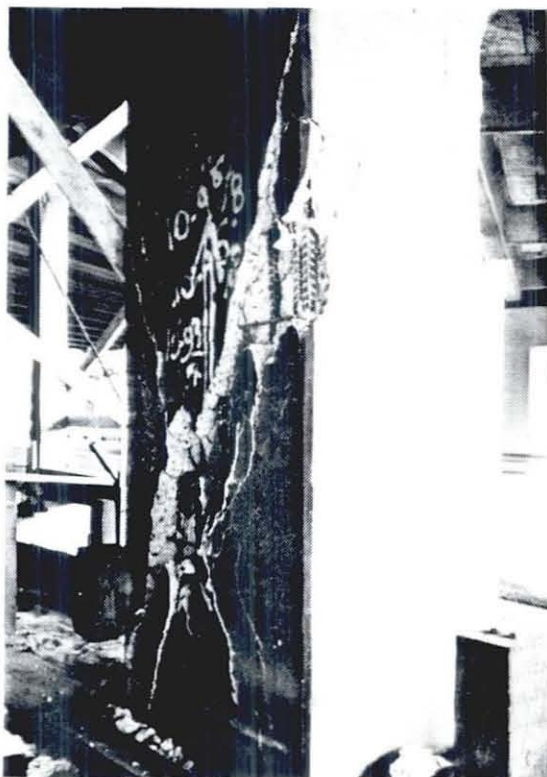
Photo 42

Close-up view of damaged column in the center bent.

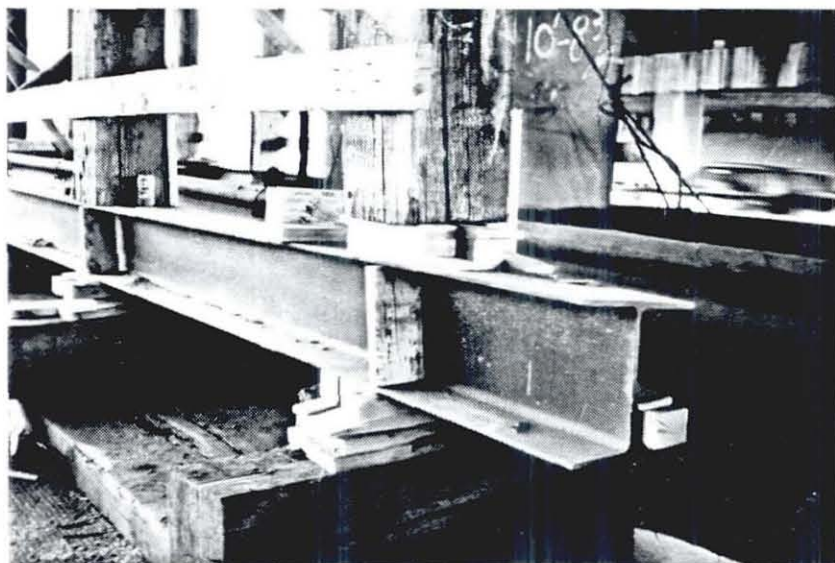
Photo 46

Support detail for individual shores.
