1994 Northridge Earthquake

Performance of Structures, Lifelines and Fire Protection Systems

NISTIR 5396

March 1994
Building and Fire Research Laboratory
National Institute of Standards and Technology
Gaithersburg, MD 20899

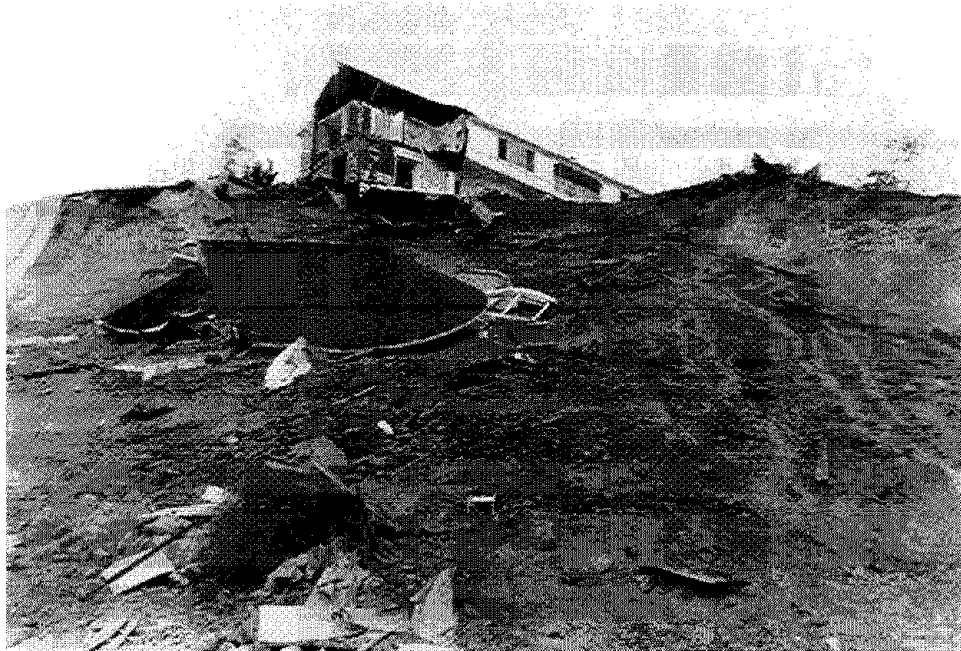
Figure 2.8 A landslide along the Pacific Coast Highway north of Santa Monica undermined the foundation of a house at the crest of the slope, bringing a portion of the house down.

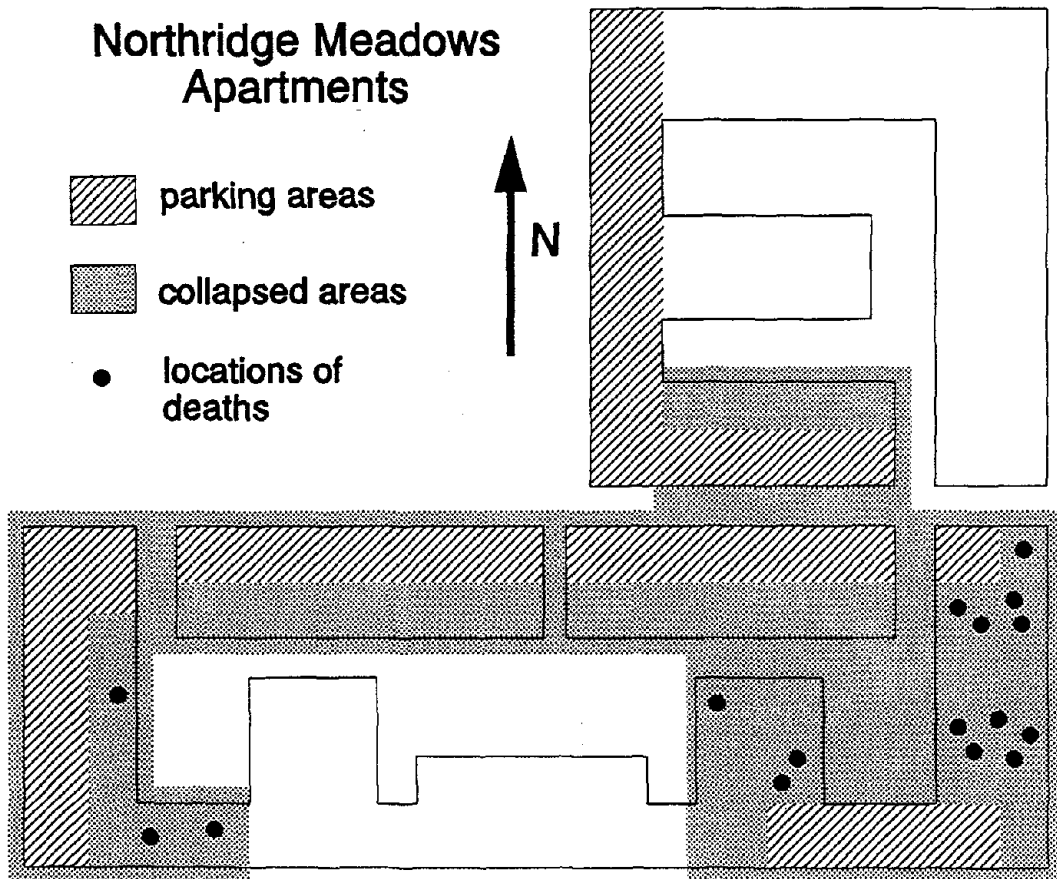
Collapses in a single apartment complex caused sixteen of the twenty-two deaths related to building failures (Los Angeles County Coroner, 1994). The Northridge Meadows complex, constructed in 1972 (Los Angeles Times, January 19, 1994), consisted of several three-story wood-frame buildings, arrayed around courtyards on two sides of a mid-block alley. About half of the units had open spaces for parking on the street level. Typically these were around the perimeter of the complex. Most of the interior courtyard-facing units had living space at the ground level rather than parking. About half of the buildings in the complex collapsed. In all of the collapses, the first story gave way while the second and third stories remained largely intact. The sixteen people killed were in first story apartments. All the buildings in the complex suffered some damage (Figures 3.3 and 3.4).

Figure 3.3 This plan of the Northridge Meadows apartment complex shows the distribution of parking and living spaces at the first level, and locations of deaths (source: Los Angeles Times, January 24, 1994). The shaded areas indicate the portions of the complex which collapsed.

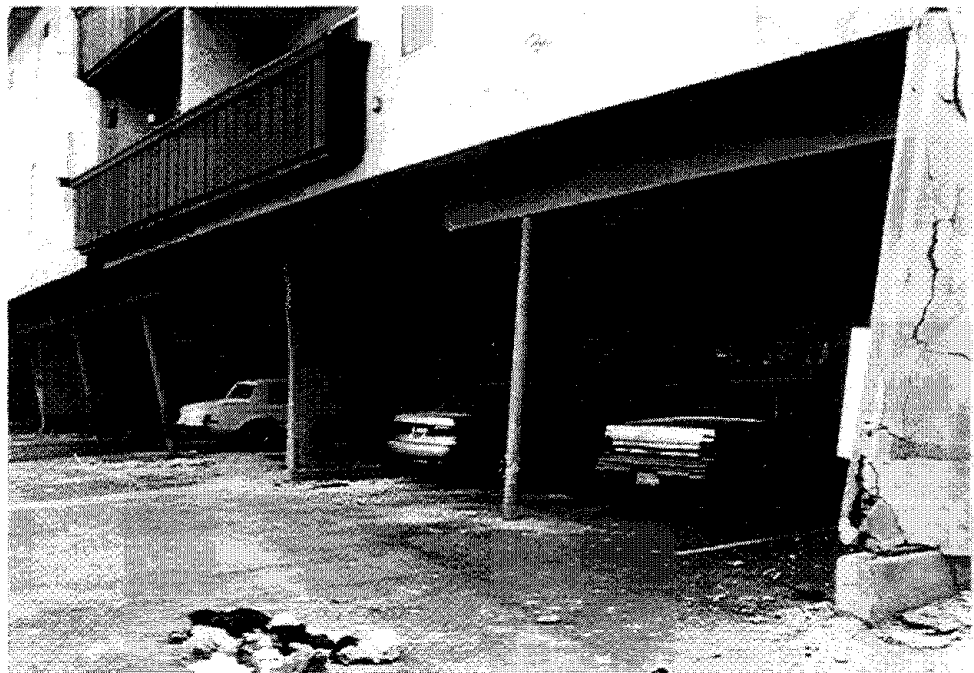
The upper stories of the collapsed buildings were displaced laterally and in some cases came to rest offset by as much as three meters from their original locations. The steel pipe columns, which hinged at their bases, apparently controlled the distance of the offset as they bent to the ground under the load of the building above (Figure 3.6). Collapses occurred in buildings aligned longitudinally east-west as well as those aligned north-south. At the southeast end of the complex, some building portions collapsed to the north, and other portions collapsed to the south, which indicates that no one extreme pulse of energy brought all the buildings down.

Figure 3.6 At Northridge Meadows, the first story steel pipe columns generally hinged near their bases but retained their length, controlling the displacement of the upper stories.

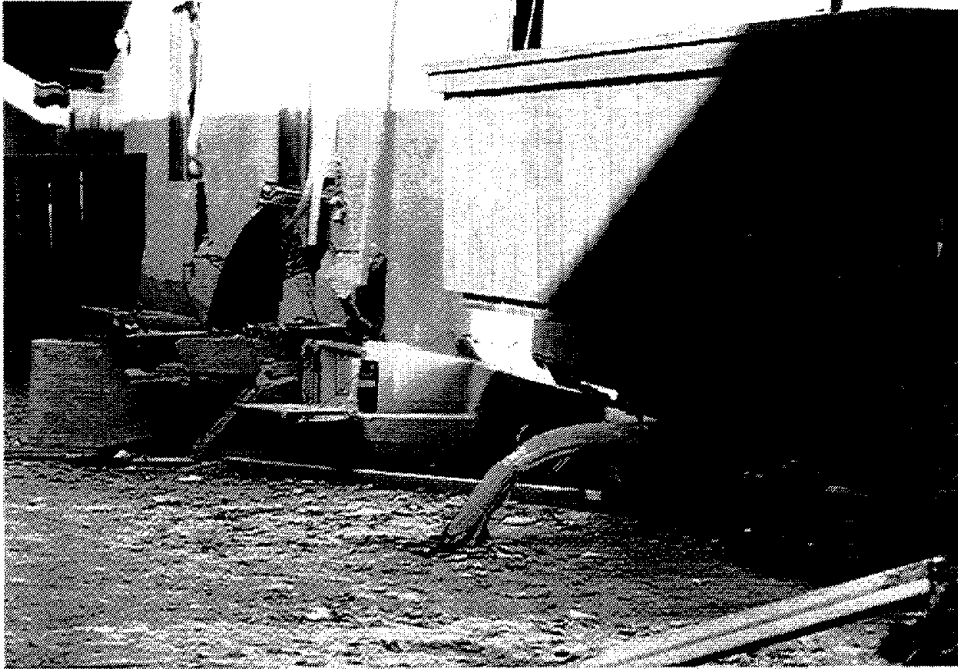
Figure 3.7 Racking, or leaning, of open first story parking areas was a common feature of damaged two and three-story apartment buildings.

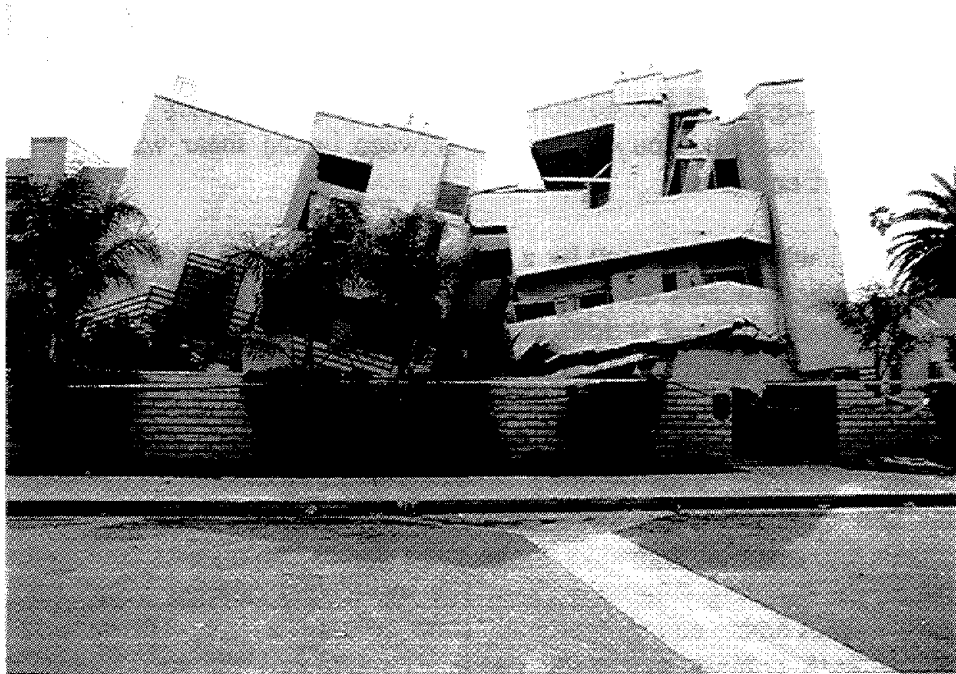
A more unusual collapse occurred in an apartment building of more recent vintage with the entire first story used for parking, located on Sherman Way in Sepulveda. In this building, the first story parking area was open only on the transverse ends. Concrete block walls formed the longitudinal walls at the first story and a row of concrete columns supported the mid-span of the flat plate concrete floor slab above. The two stories of living space over the parking level were wood-framed with a stucco facade. The entire line of mid-span concrete columns failed. The two halves of the upper stories settled in towards the middle (Figures 3.10 and 3.11), essentially destroying the structure.

Figure 3.10 The central row of concrete first-story columns in a three story apartment building on Sherman Way in Sepulveda collapsed, causing the wood-framed upper stories to settle inward.

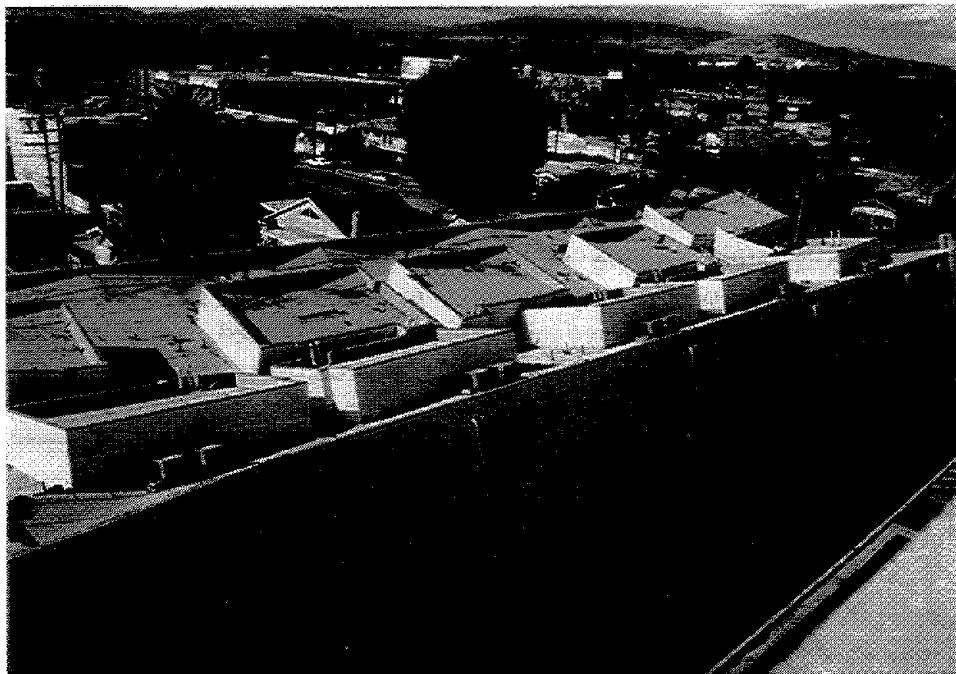
Figure 3.11 This overhead view of the partially-collapsed apartment building on Sherman Way shows the solid concrete masonry block perimeter walls along the longitudinal axis of the building. Access to the first story parking was limited to the transverse ends of the building. When the row of interior columns failed, both sides of the building settled in towards the middle.

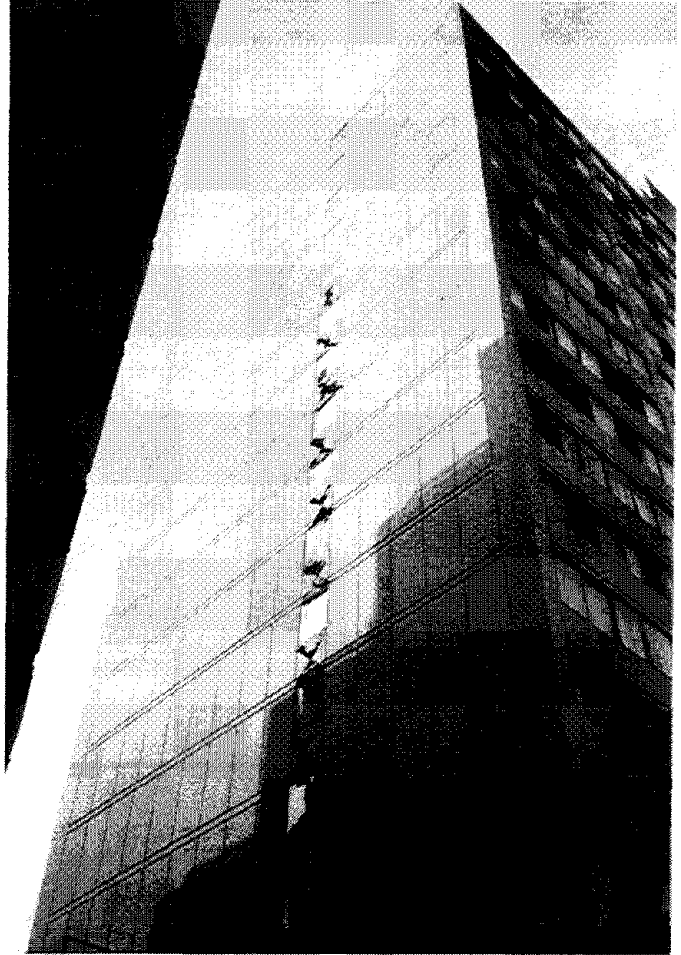
The transverse end walls are pierced by a single vertical row of window openings. The wall segments between the windows act as coupling beams linking the wall segments on either side. These coupling beams suffered serious diagonal cracking, increasing in severity from top to bottom of the building (Figure 3.12).

Figure 3.12 Champagne Towers apartment building in Santa Monica suffered a classic form of earthquake damage: shear failure of the coupling beams between linked shear walls at the transverse end of the building.

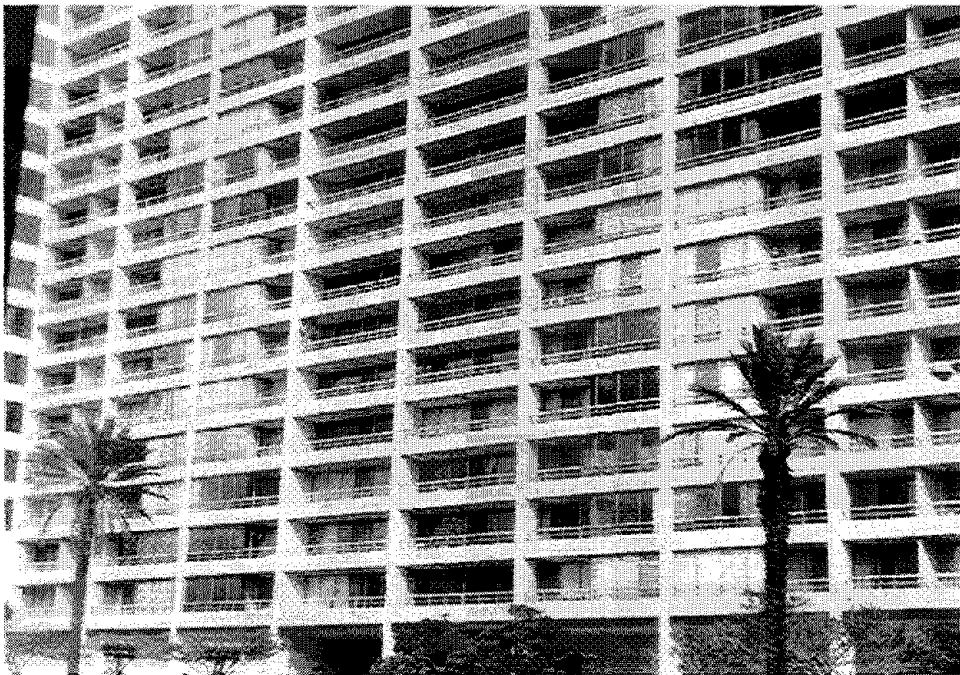
In the longitudinal direction, the lateral-force resistance is apparently provided by concrete moment frames. The front of the building shows no sign of damage (Figure 3.13). At the back, the columns and transverse wall ends are diagonally cracked (Figure 3.14). Doors in the transverse walls and open passageways connect the spaces behind these cracked columns in the middle third of the building (Figure 3.15). The solid infill railings which rise to about mid-height of the columns create an unintentional "short-column" effect. The solid railings made the bottom half of each column extremely rigid. This forced the top half of the column to accommodate all of the differential movement between stories. These shortened columns, apparently not detailed to accommodate the motion, failed in shear. At the front of the building, metal pipe railings are provided at the balconies rather than solid infill, as at the back. This may partially explain why there is no apparent damage at the front of the building.

Figure 3.13 The front of the 16-story Champagne Towers building had no apparent damage. Note the steel pipe railings at the balconies.

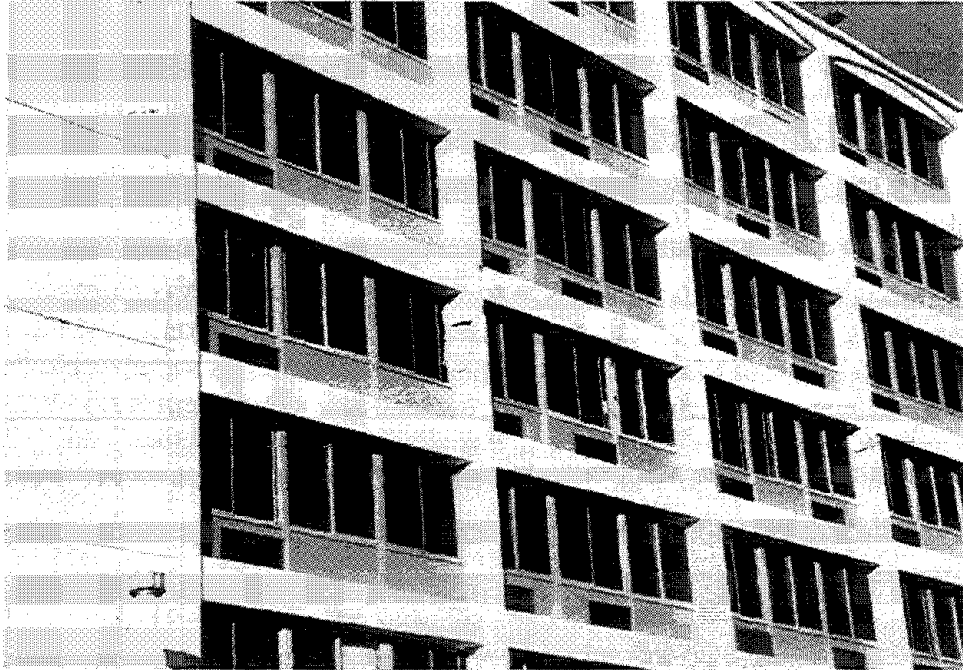
Several mid to high-rise concrete hotels in the Van Nuys area were damaged. Of particular interest is the seven-story Holiday Inn. The building has end shear walls in the transverse direction and a perimeter concrete moment resisting frame in the longitudinal direction. Columns in the lower two stories were damaged in the 1971 San Fernando earthquake. These were subsequently repaired with epoxy injection and strengthened. Damage caused by the 1994 quake was concentrated at the top of the fourth-floor columns (Figure 3.16). This seems to suggest that the dynamic characteristics of the building were changed due to the rehabilitation work in 1971. As a result, damage appears to have occurred in concrete members which did not sustain damage in the 1971 event. This building was instrumented with strong-motion recorders, and records are available from both the 1971 and 1994 quakes.

Figure 3.16 The bottom two stories of the concrete frame Holiday Inn in Van Nuys were damaged in the 1971 San Fernando quake and subsequently repaired. In the 1994 Northridge quake, damage was concentrated at the top of the fourth floor columns.

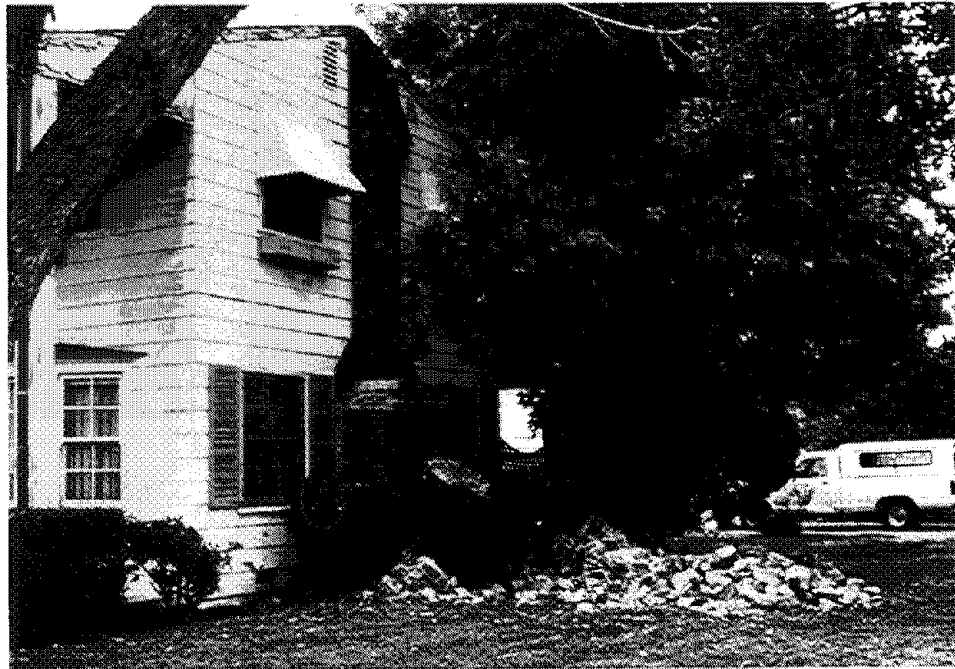
Figure 3.17 Failure of masonry chimneys was common.

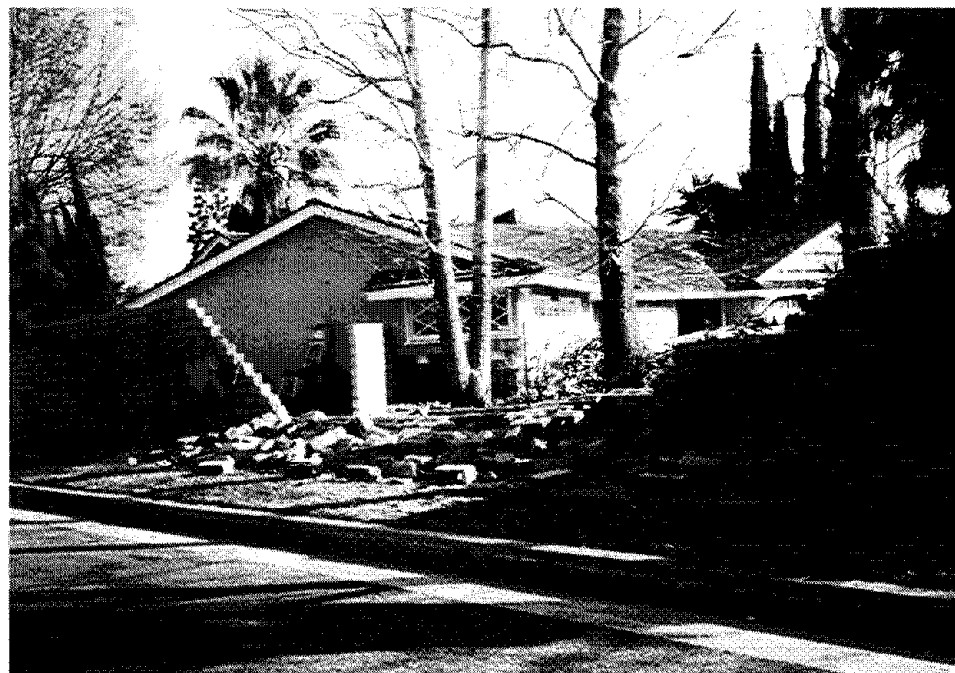
Figure 3.18 Damage to masonry privacy fences was ubiquitous. Many of these fences were tall enough to have been a serious threat to passersby when they failed. Luckily, due to the early morning hour of the quake, yards and sidewalks were essentially deserted.

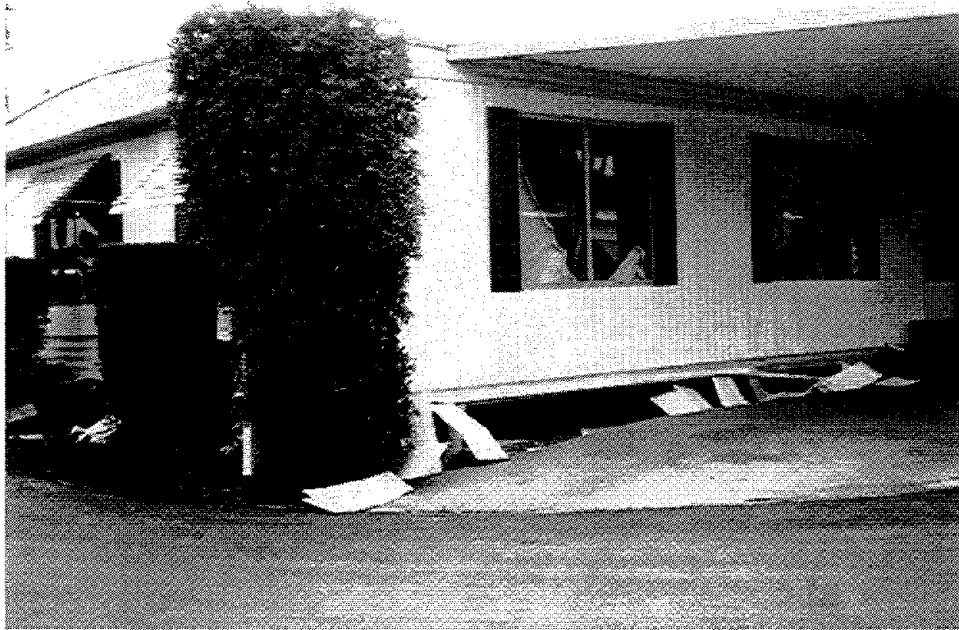
Figure 3.19
Damage to
manufactured
homes caused by
collapsed supports
was common.

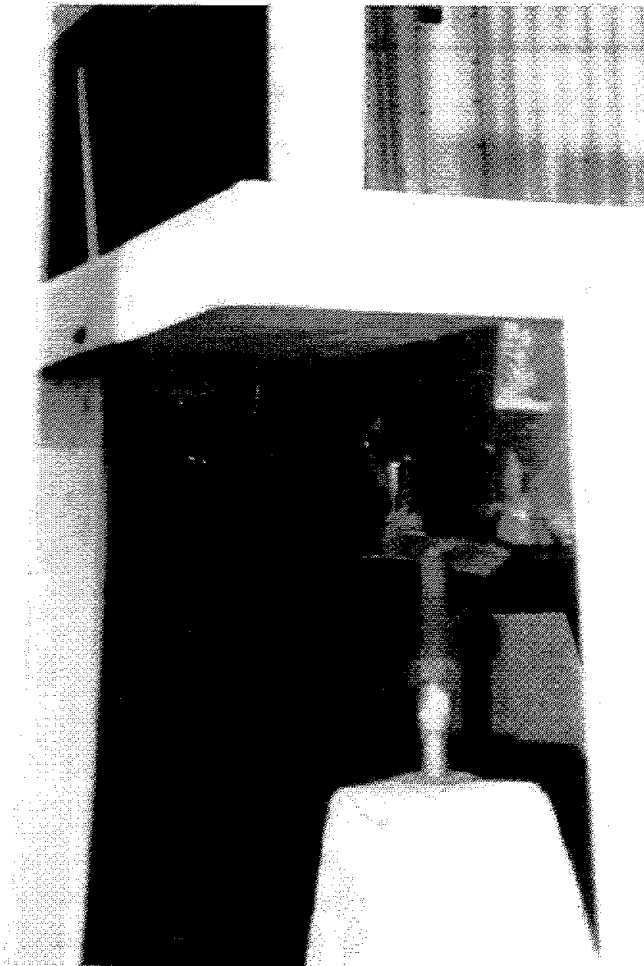
Figure 3.20 Small concrete base supports
are a common foundation system used to
support manufactured housing. This type
of system provided little resistance to
lateral forces.

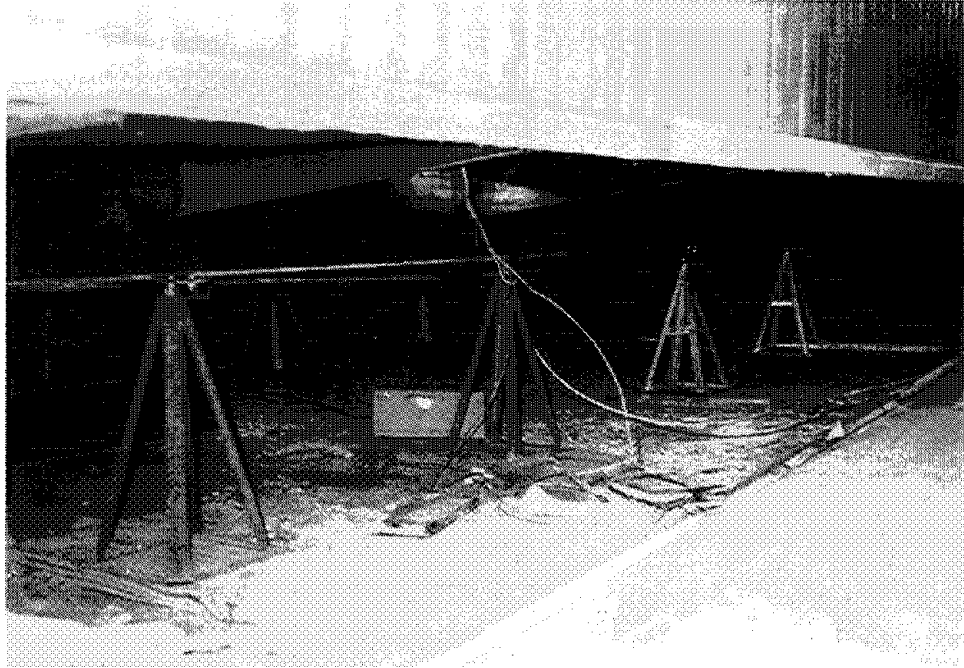
In some cases, the metal base supports were braced with small steel angle members. However, they were not adequately fastened to the supports and did not prevent the supports from rocking.

Figure 3.21 Another foundation system used for manufactured housing consists of supports constructed of small metal angles.

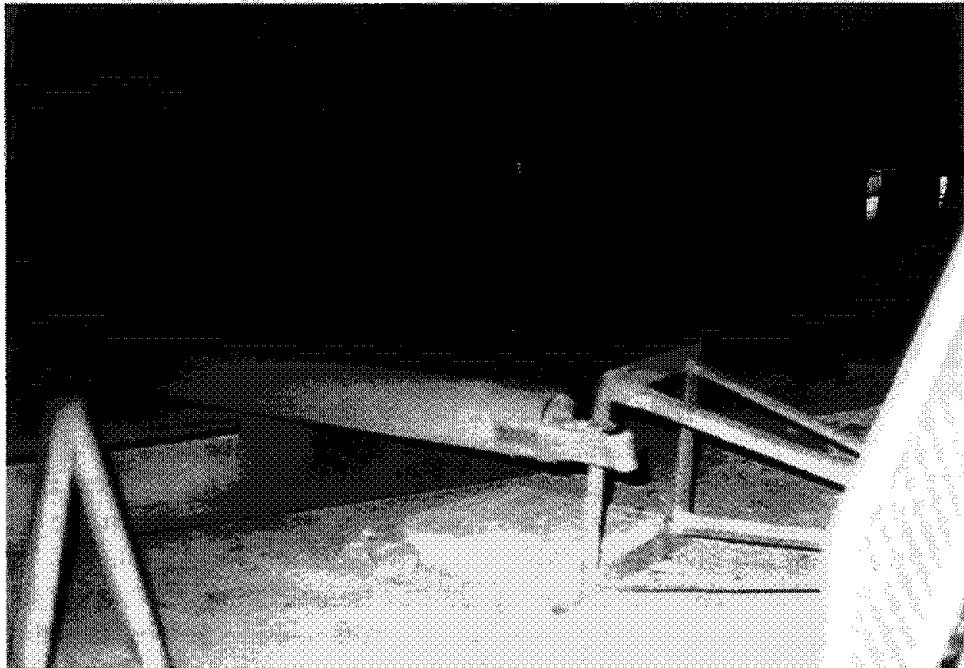
Figure 3.22 The metal supports under many homes tipped over, bringing down the houses above.

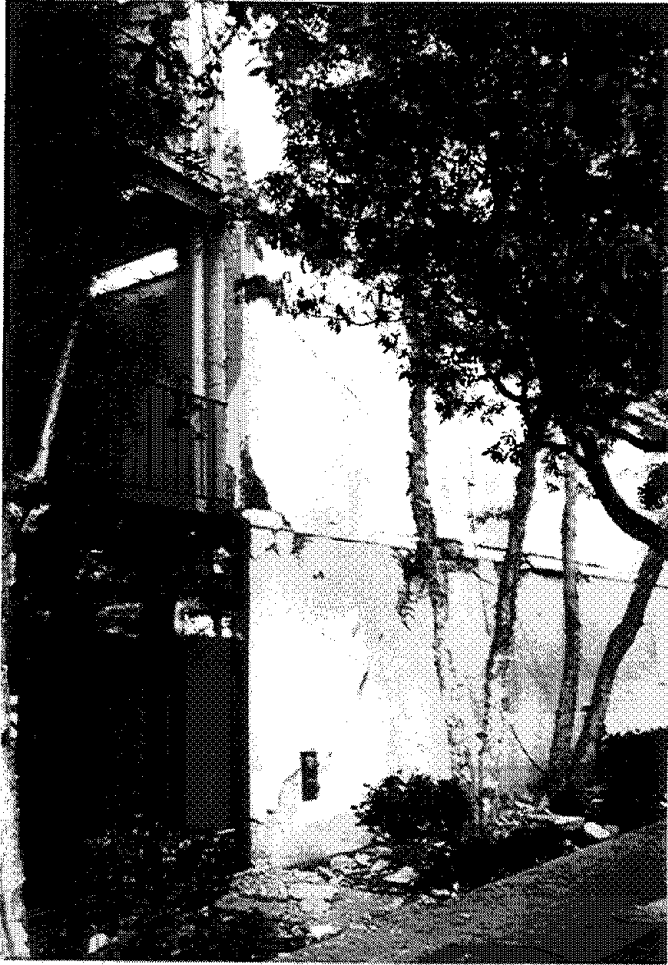
Figure 3.25 The concrete facade panels of the St. John's hospital parking garage had diagonal cracks and crushed toes.

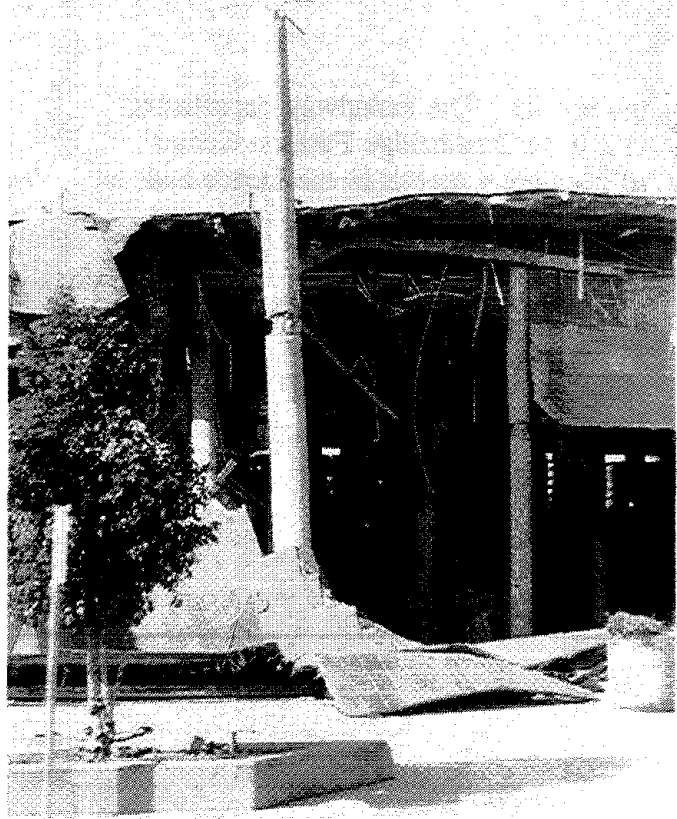
Figure 3.30 The Bullock's department store had an extremely irregular vertical geometry. At the northeast end it was shaped like a truncated pyramid.

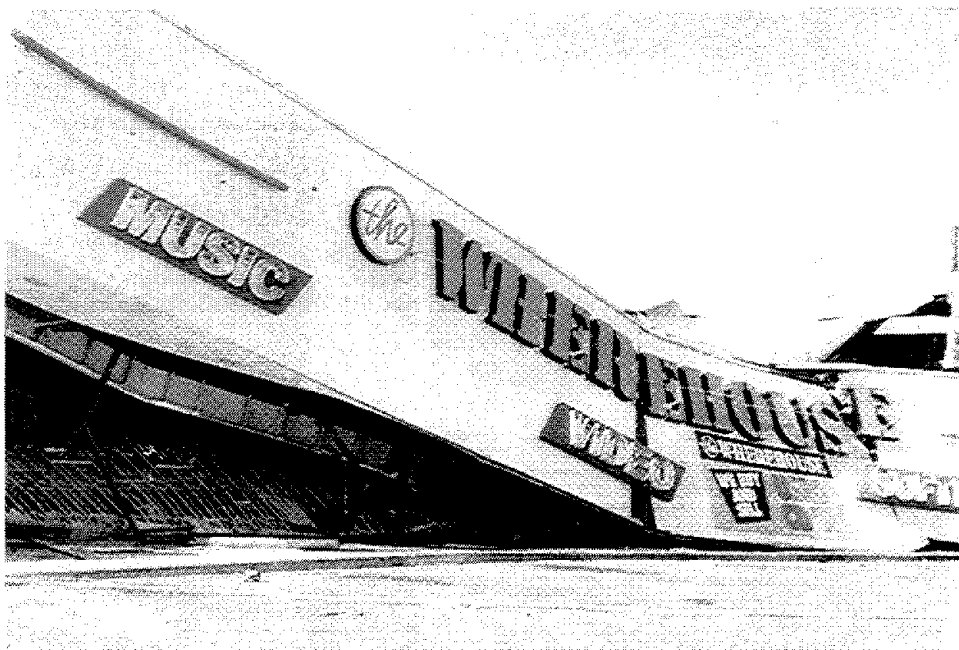
The area around the Northridge Fashion Center showed evidence of having been severely shaken. Significant damage of many types occurred. South of the Northridge Fashion Center, several single story retail structures were damaged; at least one, the Wherehouse, collapsed (Figure 3.32).

Figure 3.32 Many commercial buildings were damaged in the blocks south of the Northridge Fashion Center. The single-story Warehouse collapsed completely.

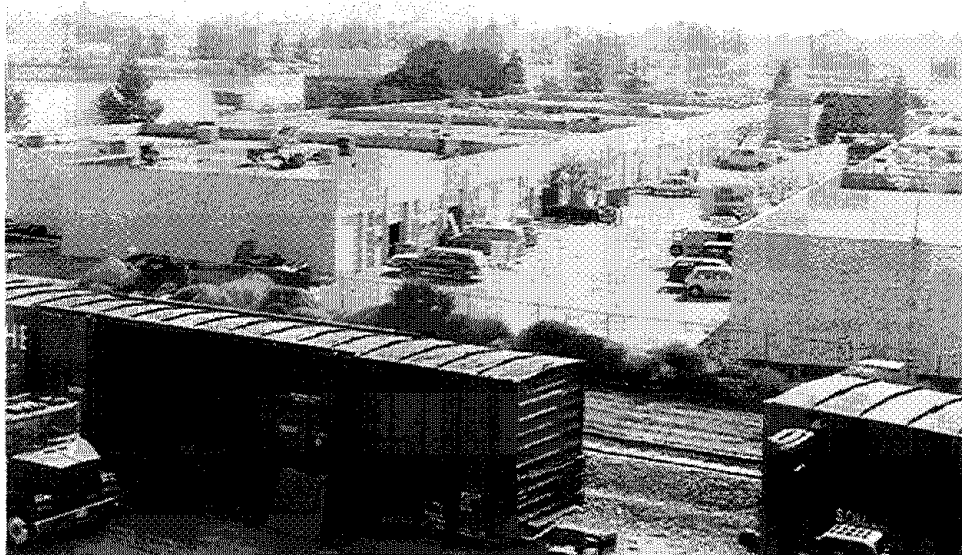
Figure 3.34 The single-story modern masonry commercial buildings directly south of the damaged Levitz furniture store and train derailment were apparently undamaged. All parapets and piers between garage openings appeared intact.

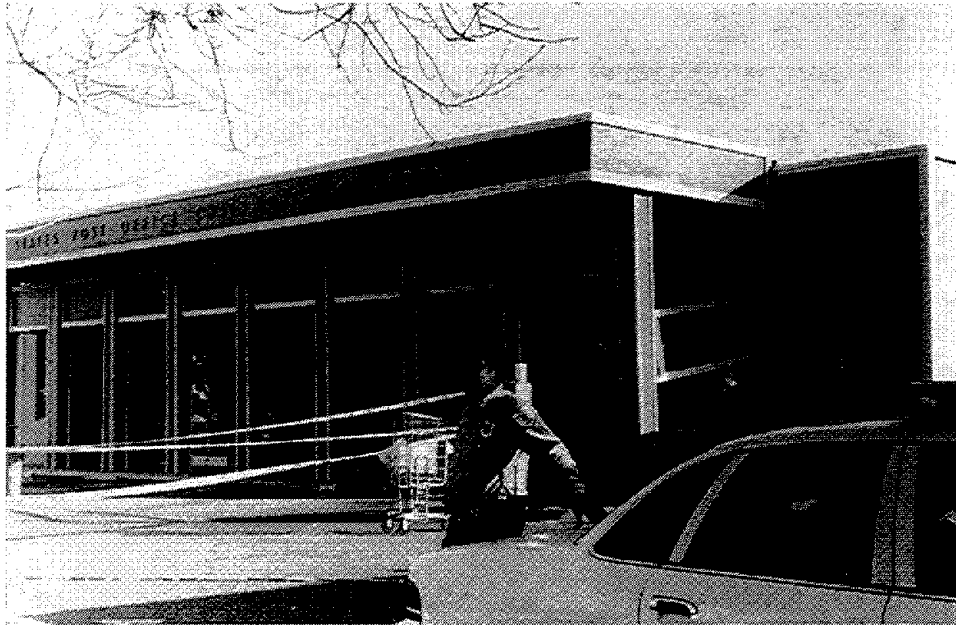
facade panel had become detached and interior ceiling panels had fallen (Figure 3.35). Mail was being collected in the parking lot.

Figure 3.35 The Chatsworth Post Office was closed due to damage. Mail was being collected in the parking lot.

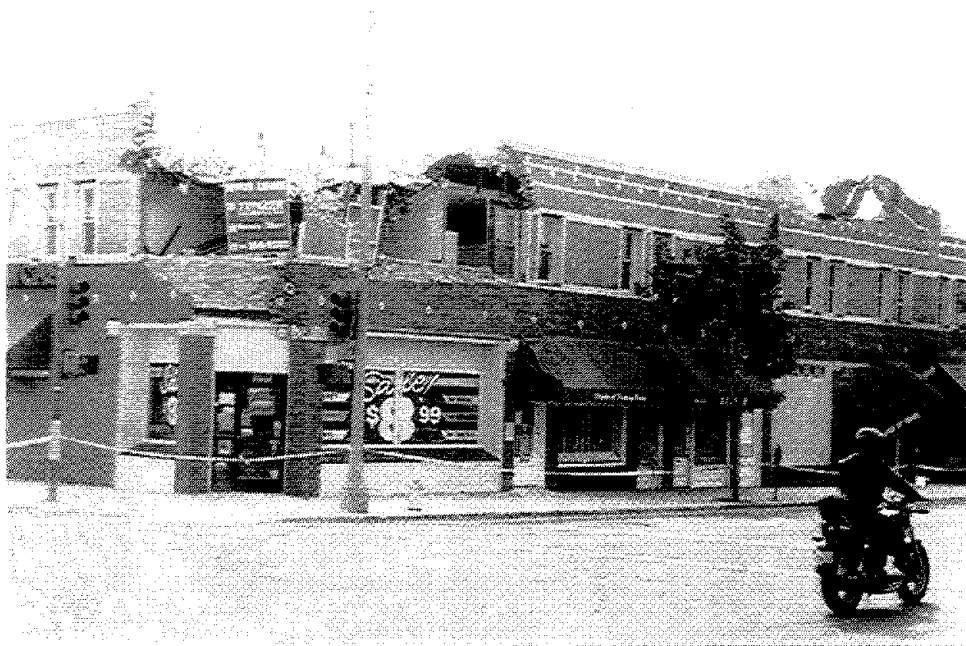
Figure 3.36 Damage to unreinforced masonry buildings, even those that had been rehabilitated, was common. Upper stories and corners were particularly vulnerable to damage. The rows of light-colored diamonds on the face of this building are the end plates of through-bolts used to connect the wall to the floor joists, a typical rehabilitation technique. The remains of parapet braces can be seen on the roof.

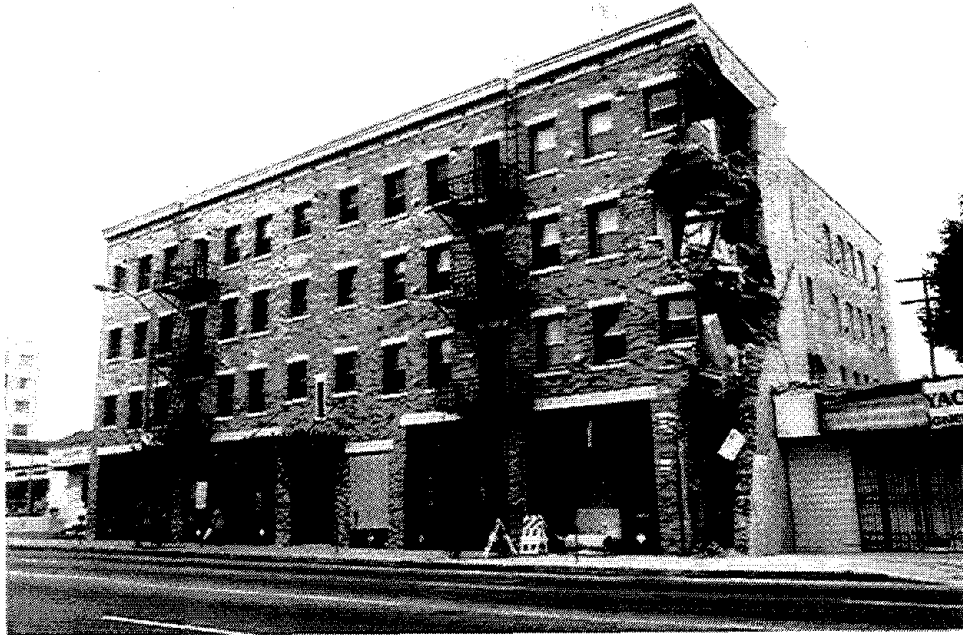
Figure 3.37 The corner of this rehabilitated unreinforced masonry apartment building in East Hollywood crumbled on all four stories.

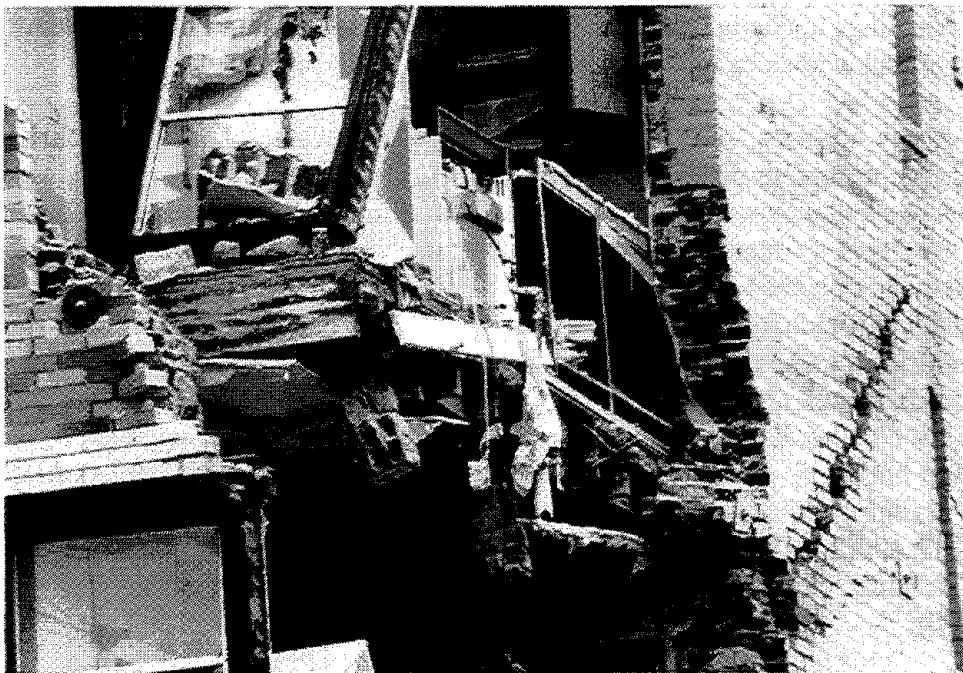
Figure 3.38 A close-up view of the third-story floor diaphragm of the building picture above shows (lower right) a rehabilitation bolt still holding a few bricks to the floor joists, after all the walls on three out of four sides of the bolts had disintegrated.

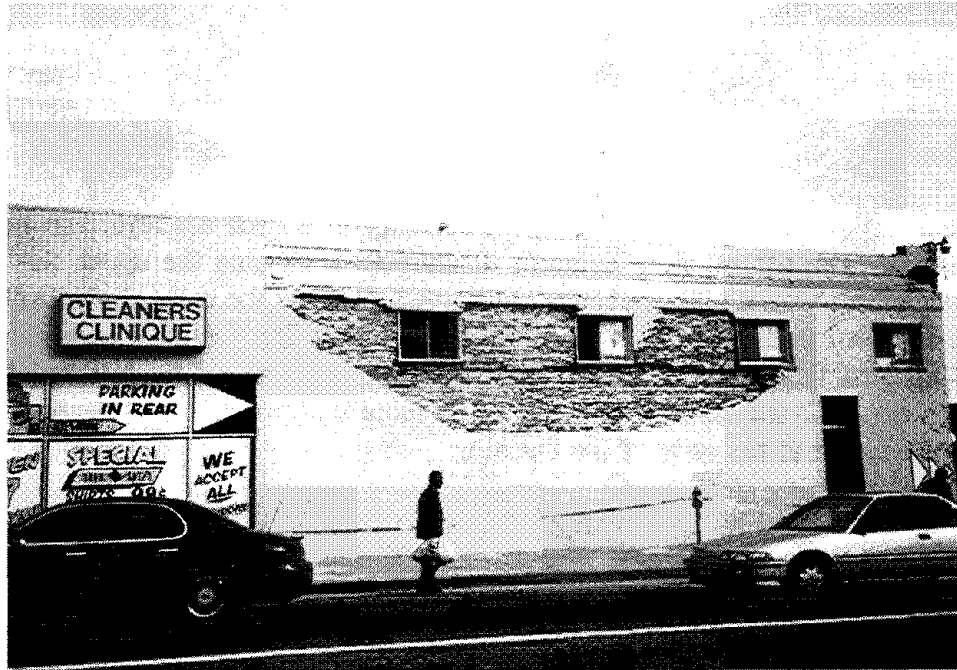
Figure 3.39 Only the exterior wythe of brick peeled off of this rehabilitated unreinforced masonry building in Santa Monica.

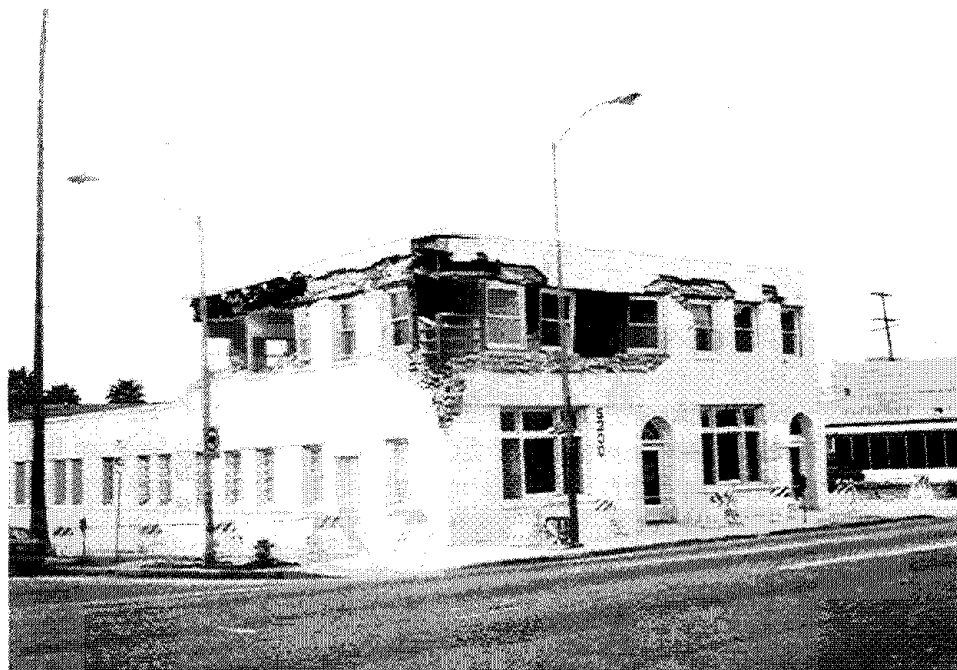
Figure 3.40 In other rehabilitated unreinforced masonry buildings, such as this two story structure in Hollywood, entire wall thicknesses were lost between rows of through-bolts.

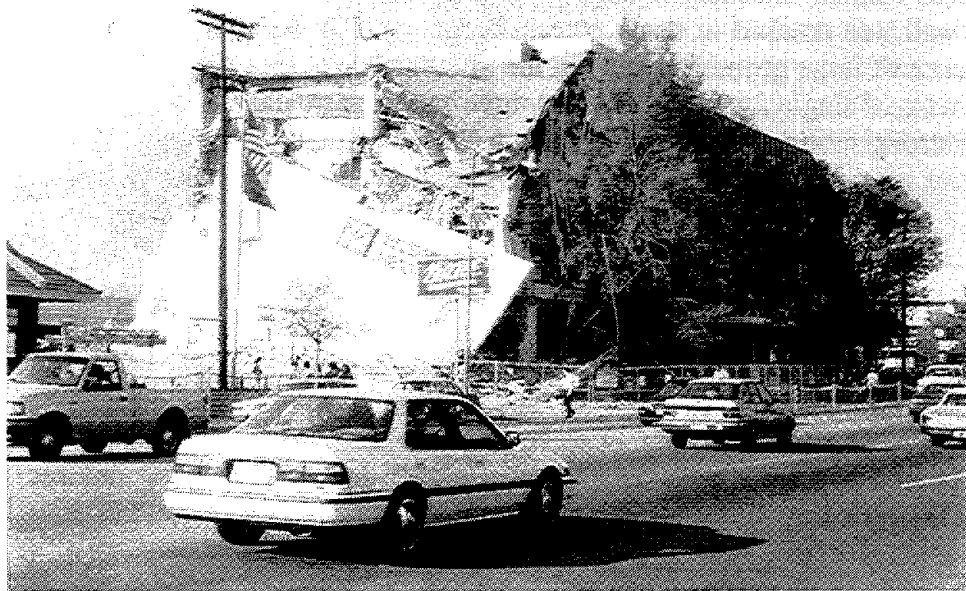
The concrete frame Kaiser Permanente office building on Balboa Boulevard in Northridge was badly damaged. The second story columns disintegrated, causing the upper stories to collapse onto the first story, which remained intact (Figure 3.41). At the ends of the building, damage to the frame caused partial collapses, but the mid-section of the building remained intact. The apparently nonstructural end walls became detached at both ends of the building and slid to the ground (Figures 3.42 and 3.43). The failure of these end walls may have contributed to the damage to the frame at the ends of the building.

Figure 3.42 Both end walls of the Kaiser Permanente building slid, partially intact, to the ground. The south wall is pictured here. Both ends of the building suffered damage to the concrete frame at all story levels, while the middle half of the building, except for the second story, remained intact.

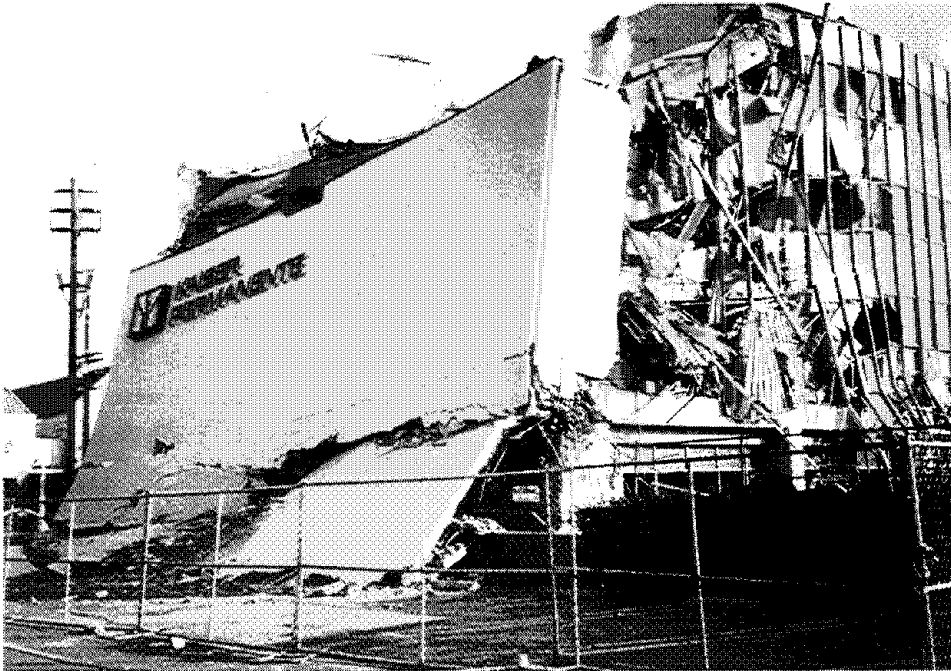
Figure 3.43
Damage at the
north end of the
building was similar
to damage at the
south.

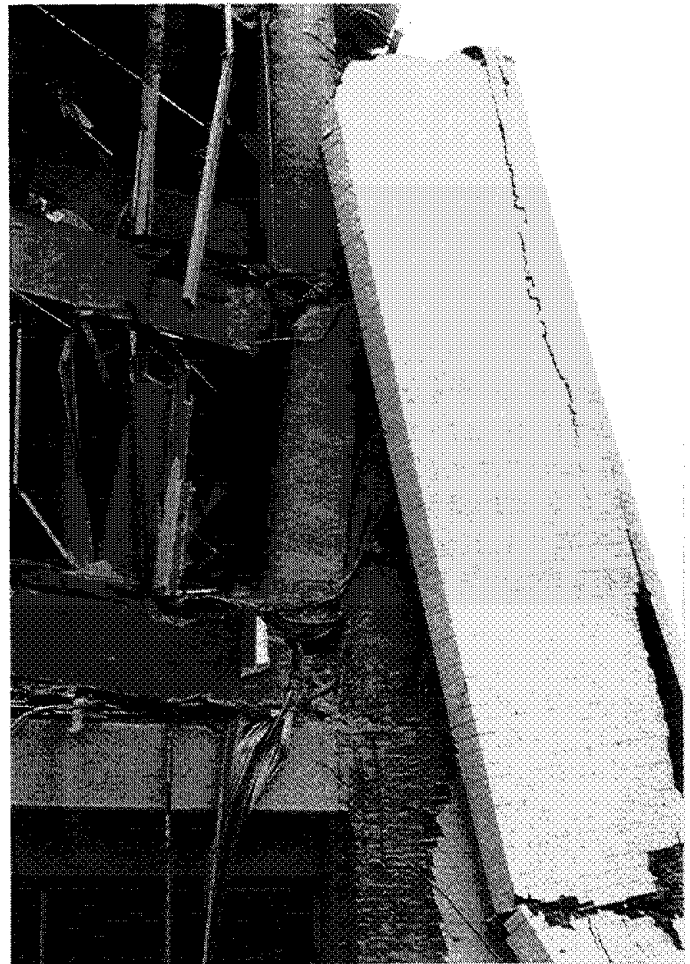
The bare frame exposed by the damage suggests that the buildings had a strong-beam/weak-column configuration (Figure 3.44). The damage appears to have initiated at the joints. At the damaged ends, the beams and columns remained essentially intact, but the joints disintegrated.

Figure 3.44 The exposed concrete
frame of the Kaiser Permanente
building, revealing deep beams,
suggests that the building had a strong-
beam, weak-column configuration.
Except for the second story columns,
the columns and beams remained intact
while the joints disintegrated.

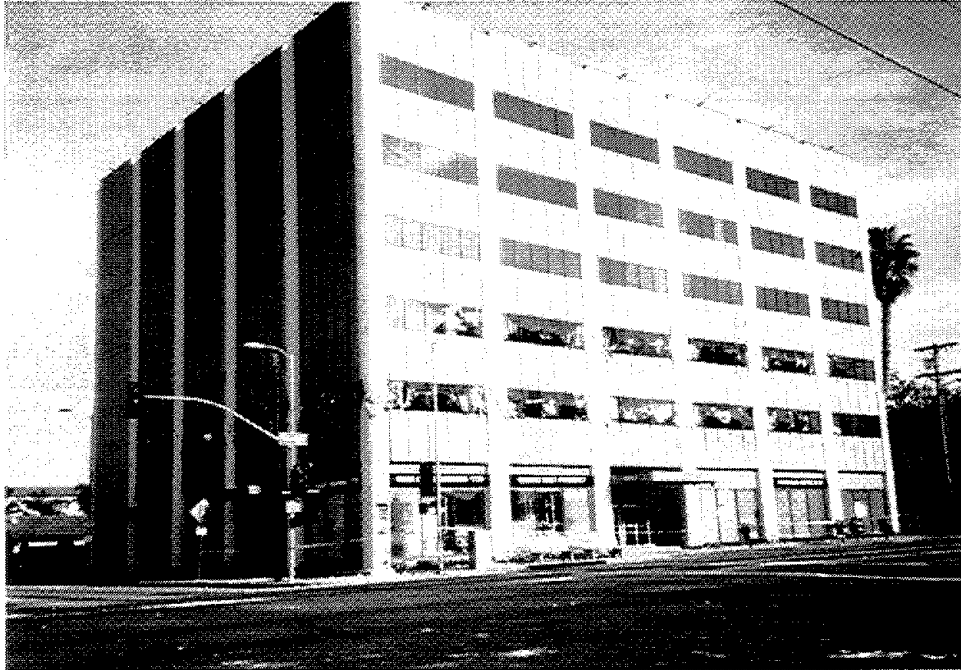
The L-shaped concrete frame Barrington Building in West Los Angeles also had damage concentrated in the second story columns (Figure 3.45). In this building, the horizontal architectural panels stiffened the lower half of the columns at each story, creating a short-column effect. The effectively shortened columns failed in shear between the windows, creating a pattern of X-cracking in the columns that diminished in severity towards the top (Figure 3.46). At the second story, the cracking was severe enough to cause a loss of vertical-load-carrying capacity; the bulging window frames indicate about a 50 to 100 mm reduction in height (Figure 3.47). The building was demolished within a few days of the quake.

Figure 3.45 The six-story L-shaped concrete-frame Barrington Building on Olympic Boulevard in West Los Angeles lost its vertical-load carrying capacity at the second story.

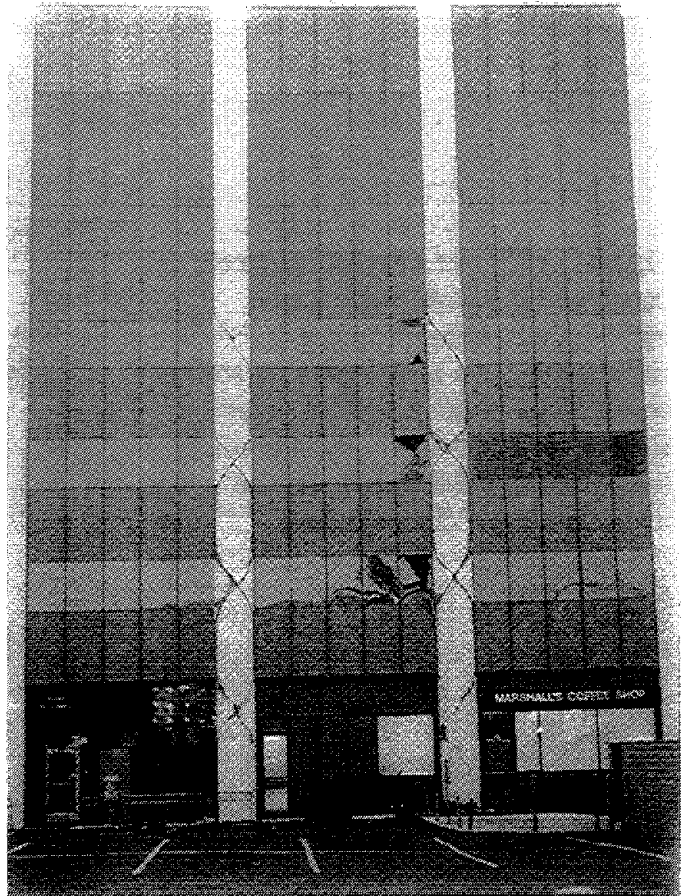
Figure 3.46 The stiff infill panels of the Barrington Building effectively shortened the concrete columns, forcing all the displacement into the column sections bounded by windows. Diagonal X-cracking decreased in severity towards the top of the building.
