1994 Northridge Earthquake

Performance of Structures, Lifelines and Fire Protection Systems

NISTIR 5396

March 1994
Building and Fire Research Laboratory
National Institute of Standards and Technology
Gaithersburg, MD 20899

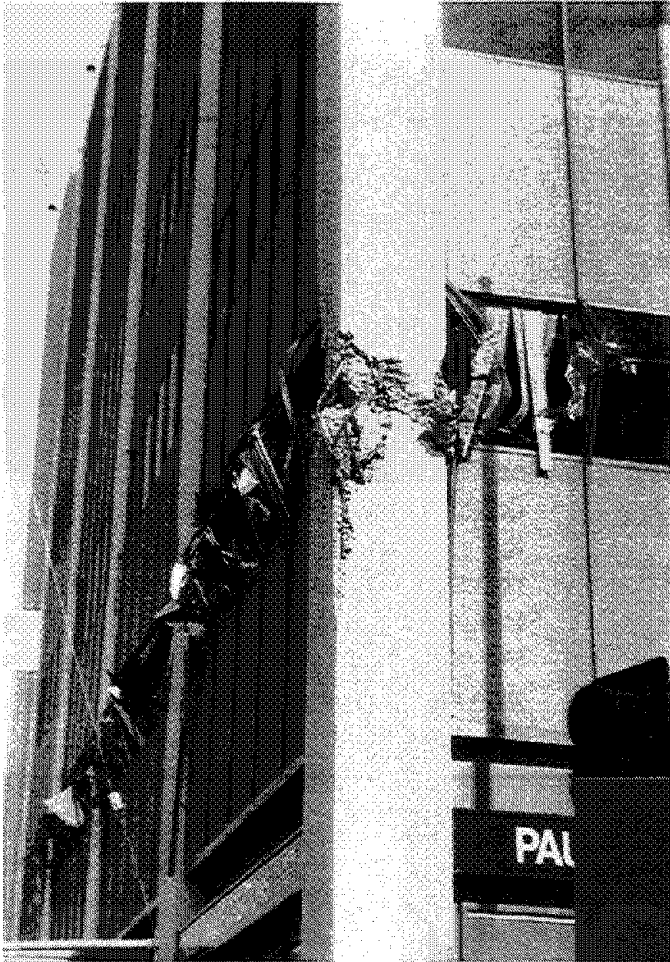
Figure 3.47 The cracking in the concrete columns at the second story was so extensive that the vertical-load carrying capacity of the building was affected. The building settled 50-100 mm at the second story, as these bulging window frames attest. The worst damage was at the southeast corner, the outside corner of the L-shape, pictured here. The building, which developed a slight list, was demolished within days of the quake.

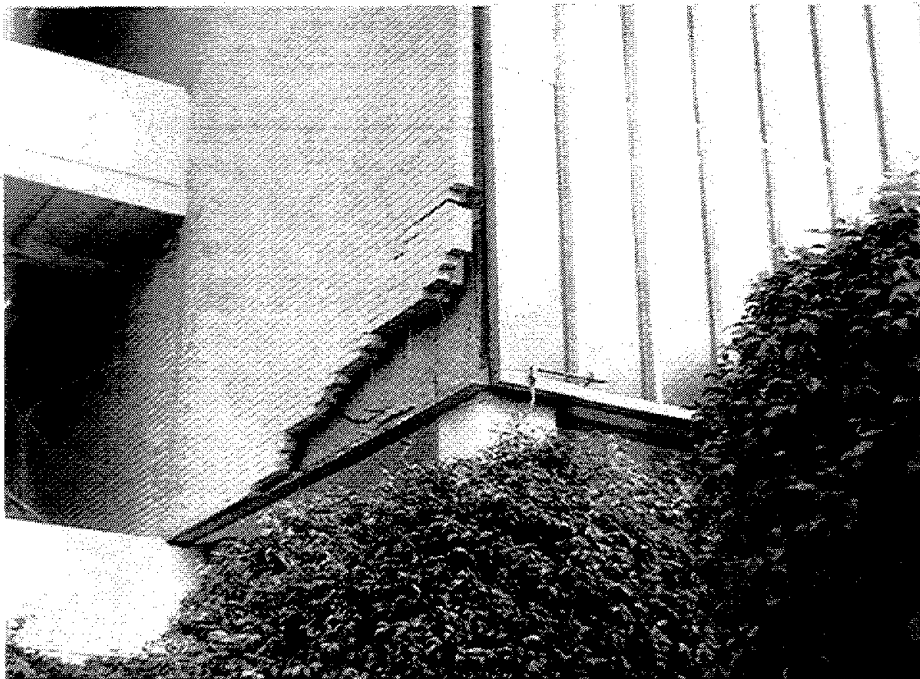
Figure 3.50 The similar west wall of was damaged, but did not peel away from the structure. This close up of the interface between the first and second stories shows that the masonry facade is supported on a steel angle. At the west end of the building, the facade was crushed at the toe where it is supported by the angle.

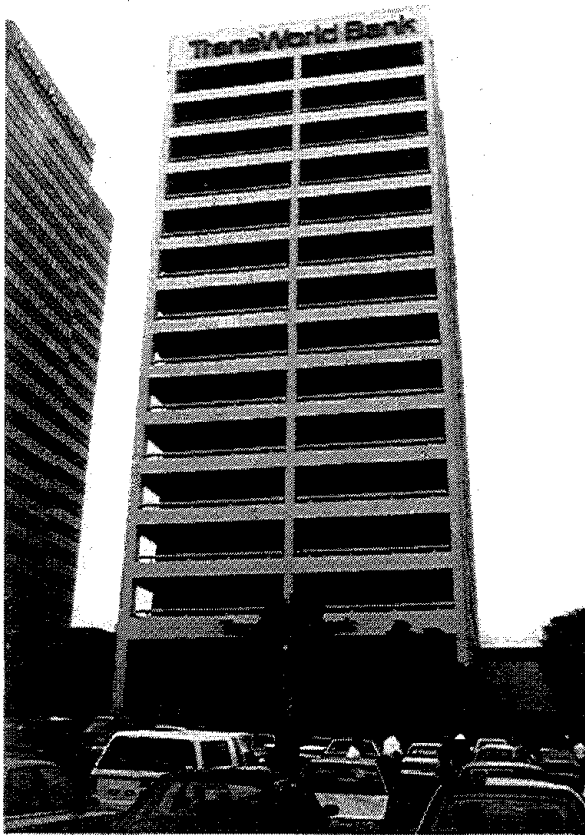
The business district along Ventura Boulevard in Sherman Oaks was another area with significant numbers of badly damaged buildings. The thirteen-story Trans World Bank Building is located at 15233 Ventura Boulevard (Figure 3.53). There is a two-level underground garage below the building and a mechanical penthouse on the roof. This reinforced concrete frame building was designed under the 1964 Los Angeles City code. Structural damage was in the first-story columns, primarily at the second-floor beam-column joints. Identical failures occurred during the 1971 San Fernando earthquake. The damaged joints were repaired with epoxy shortly after the 1994 earthquake (Figure 3.54).

Figure 3.54 The cracked beam-column joints between the first and second stories of the Trans World Bank building were repaired using epoxy injection.

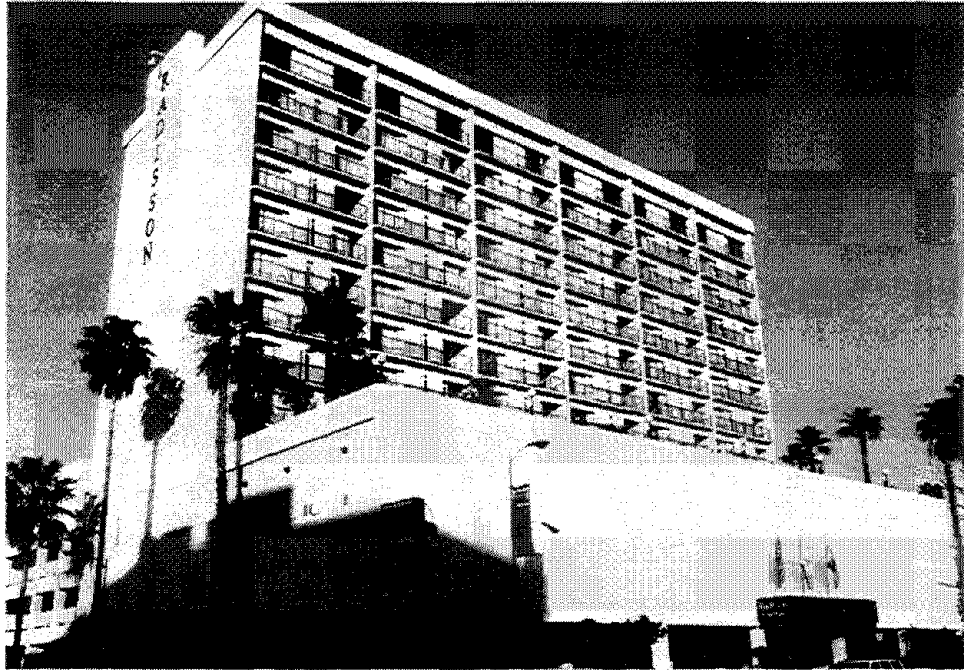
The Radisson Valley Center Hotel is located at 15433 Ventura Boulevard in Sherman Oaks (Figure 3.55). This thirteen-story concrete structure sustained serious damage to columns located at the first and fifth stories. Exterior columns which support the three-story appendage at the front of the hotel were also damaged (Figure 3.56)

Figure 3.55 The concrete Radisson Valley Center Hotel in Sherman Oaks had serious damage to the columns at the first and fifth stories.

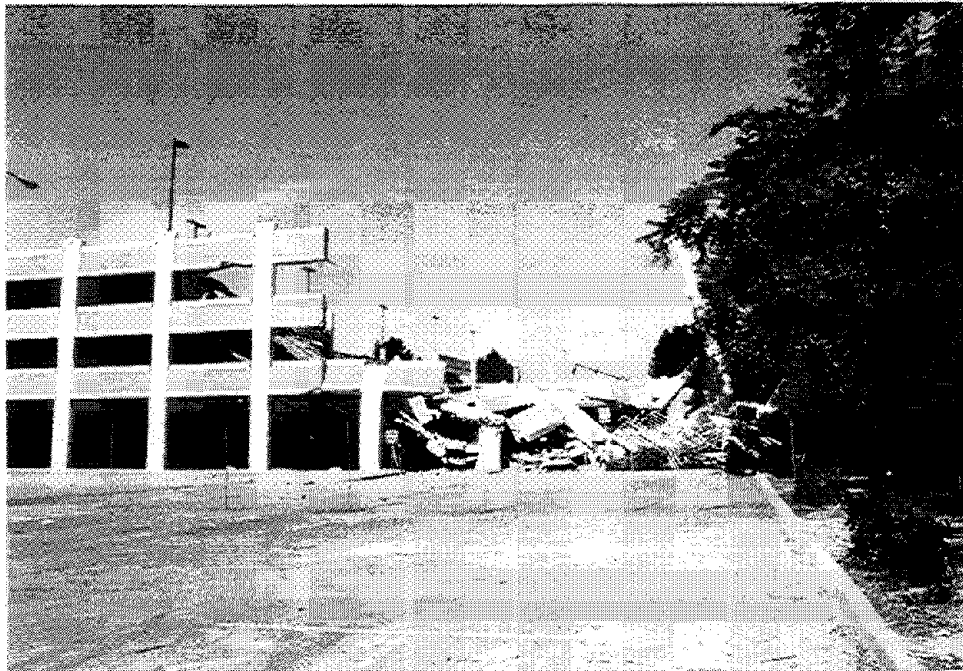
Figure 3.61 Some interior columns of the Northridge campus parking garage remained standing.

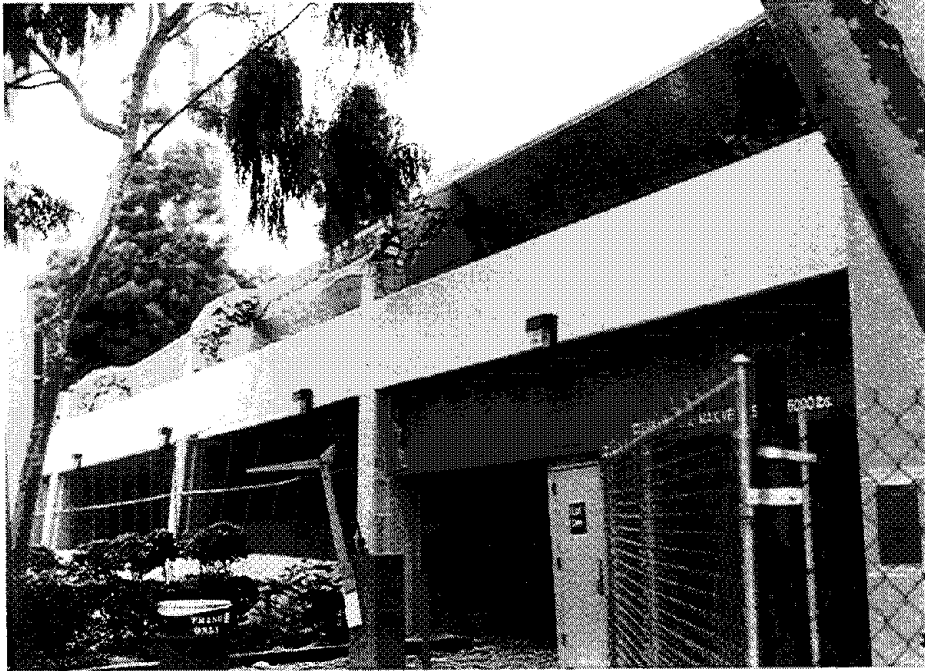
The five-level parking garage at the Kaiser Permanente medical complex on Cadillac Avenue in West Los Angeles experienced a similar collapse. All four facades were pulled inward, suggesting that an interior failure precipitated the damage (Figure 3.62). This garage was a post-tensioned cast-in-place concrete structure with shear walls providing the lateral-force resisting system at the east and west ends, and moment frames at the north and south perimeter. The shear walls were cracked horizontally throughout their height due to the out-of-plane bending (Figure 3.63). There was minor diagonal cracking, suggesting that the lateral load was not fully transmitted to the shear walls. The stair towers remained standing. Typically, these towers are structurally isolated from the post-tensioned slab to minimize potential deformations in the towers due to creep and shrinkage in the post-tensioned slabs.

Figure 3.62 The cast-in-place concrete parking garage at the Kaiser Permanente Hospital complex in West Los Angeles collapsed in on itself. The moment frame that provided lateral resistance on the south face of the structure could not resist the out-of-plane forces apparently caused by the collapse of interior elements.

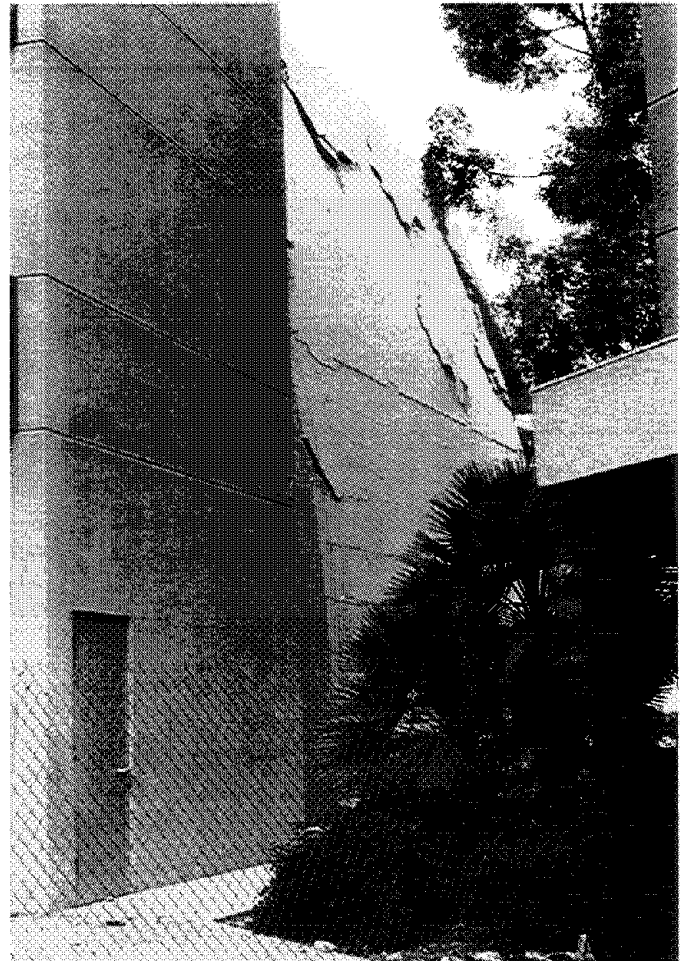
Figure 3.63 - At the east and west faces of the Kaiser Permanente Hospital parking garage, shear walls made up the lateral force resisting system. Both walls had horizontal cracks caused by the out-of-plane bending when the walls were pulled inward. Neither wall had major diagonal cracking, suggesting that the lateral load was never fully delivered to the walls. The stair towers remained erect. The east wall and stair tower are shown here.

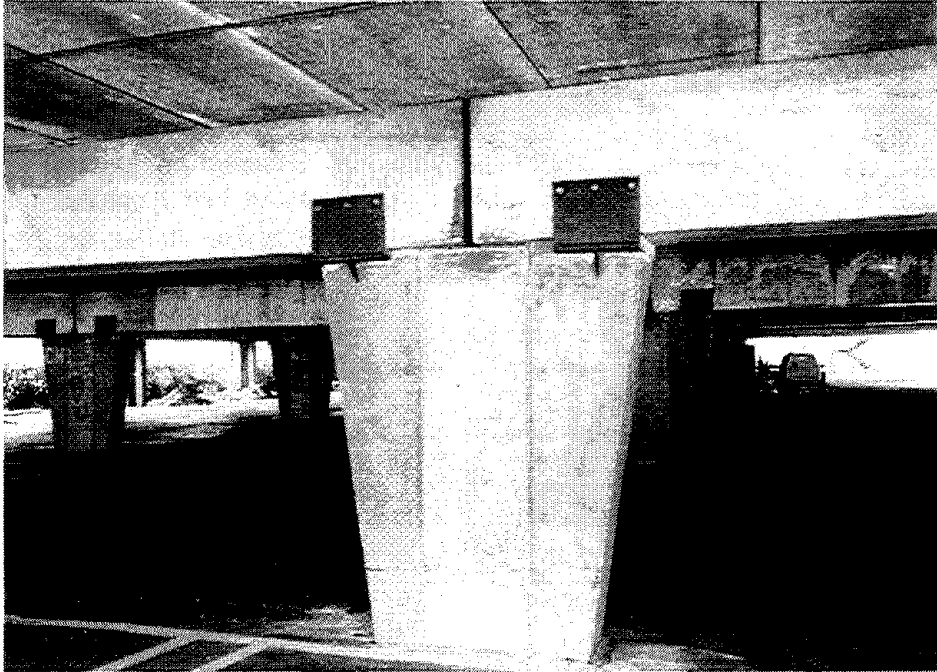
The two-level concrete parking structure adjacent to the Trans World Bank in Sherman Oaks had been seismically strengthened after suffering serious damage in the 1971 San Fernando quake. Flared extensions were cast next to the interior columns along their north-south axes (Figure 3.64), creating short wing walls supporting the precast beams. During the 1994 quake, the unrehabilitated exterior columns were badly cracked (Figure 3.65). The ramp was also heavily damaged. The interior columns were relatively undamaged.

Figure 3.64 The interior columns of the two-level parking garage at the Trans World Bank in Sherman Oaks had been seismically strengthened after it suffered damage in the 1971 San Fernando quake. The interior columns fared well in the 1994 Northridge quake.

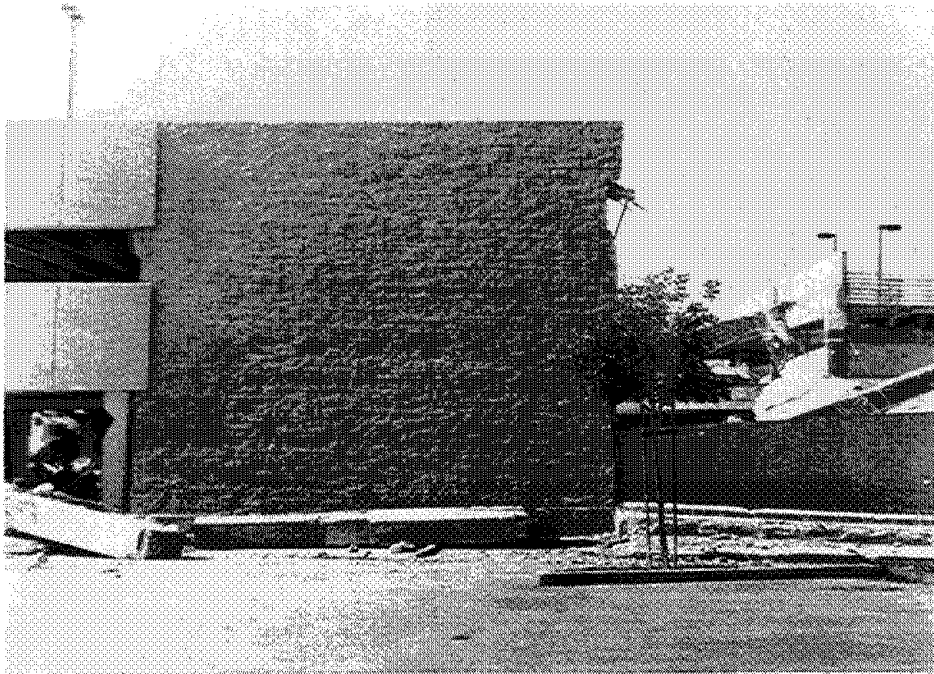
At the Northridge Fashion Center, three parking structures suffered damage. A large three-level concrete garage at the south end of the site, approximately ten years old, suffered an almost complete collapse. The largely pre-cast concrete structure had intermittent shear walls which remained standing (Figure 3.66). The lack of diagonal cracks in these walls suggests that, like the walls at the Kaiser Permanente garage, they were never fully loaded. A similar, but smaller, precast garage at the north end of the Northridge Fashion Center also partially collapsed (Figure 3.68). At the east end of the site, an older two-level cast-in-place concrete garage showed

Figure 3.66 At the Northridge Fashion Center, major portions of the three-level south parking garage collapsed. The garage was precast concrete with intermittent shear walls. Most of the shear walls remained standing, largely undamaged, indicating that the lateral load was not adequately transmitted to these walls.

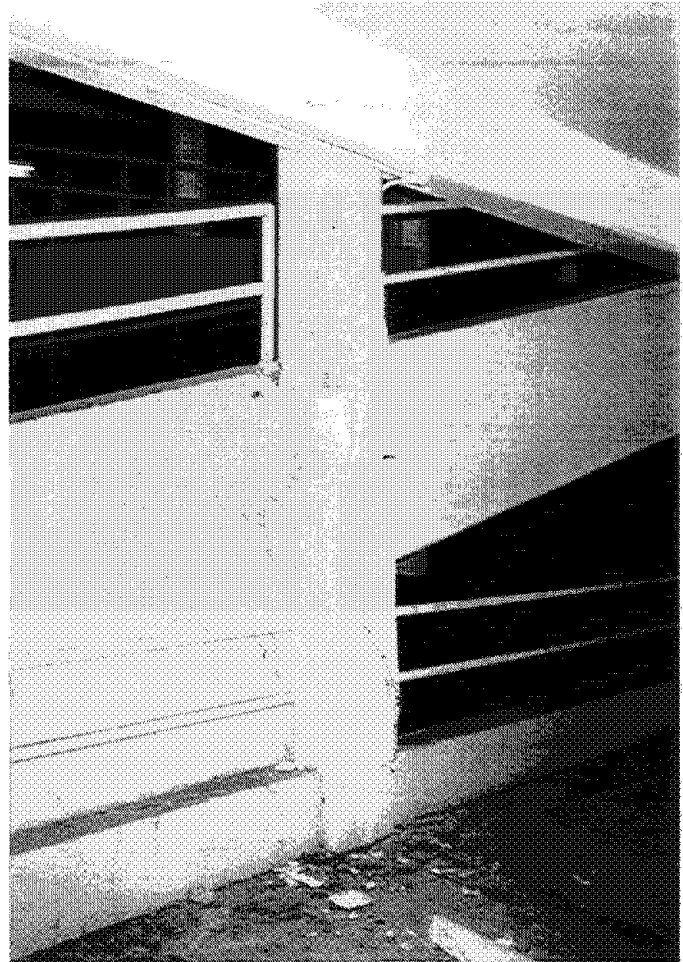
Figure 3.67 - In parking garages, ramps can cause unintentionally shortened columns, which are vulnerable to damage, as shown here.

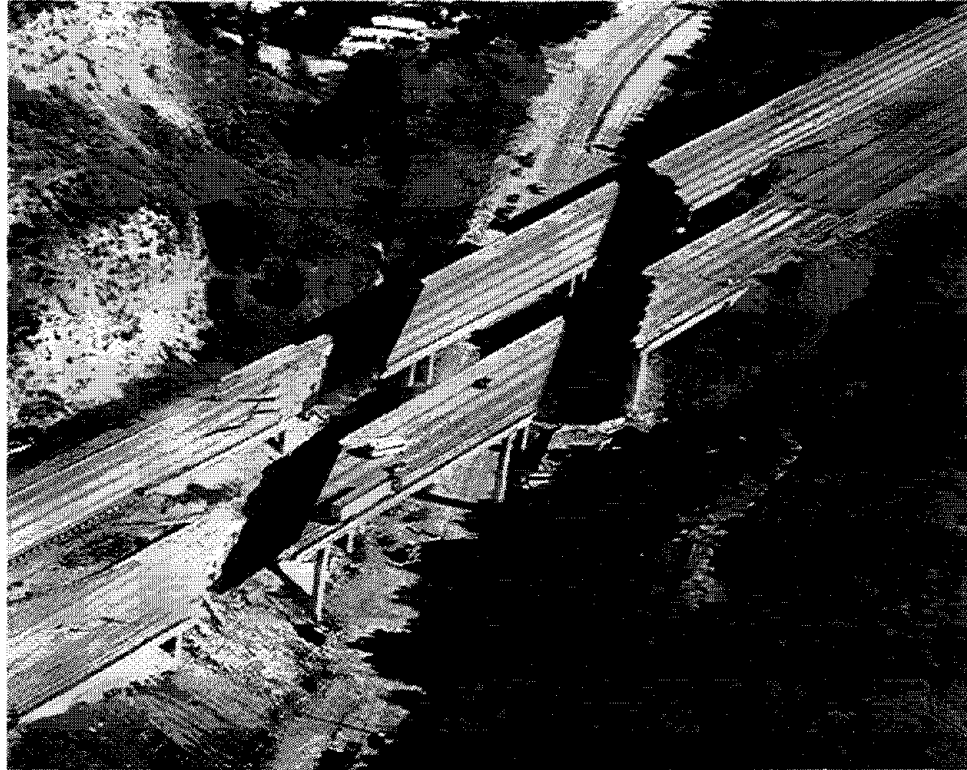
Despite the presence of cable restrainers at the hinges, failure of three of the four end spans of the bridge was apparently initiated by the spans falling off the hinge seats. The fourth end span, at the far western corner of the bridge, partially came off its hinge seat but did not collapse, as indicated in Figure 4.4. After support was lost at the hinges, a triangular portion of three of the end spans collapsed, as shown in Figure 4.4. Demolition of the remaining portions of the end spans was carried out very soon after the earthquake, as shown in Figure 4.2. It is likely that the skewed alignment of the bridge was an important contributing factor in this failure. The skewed alignment permitted rotation of the superstructure in a counter-clockwise direction, when viewed from above. The tall, flexible piers of the two center bents would have offered relatively little resistance to rotation in a horizontal plane. (EERC reconnaissance team members noted cracking patterns at the bases of the piers, which may have been evidence of such rotation [EERC, 1994, p. 5-4]). Rotation of the superstructure would have resulted in differential displacements at the hinges, and eventually unseating of the end spans at the hinges. Demolition of the bridge was completed a few days after the earthquake.

Figure 4.2: Aerial view of the bridge at Gavin Canyon, looking to the east, showing appearance of the four end spans shortly after demolition had begun

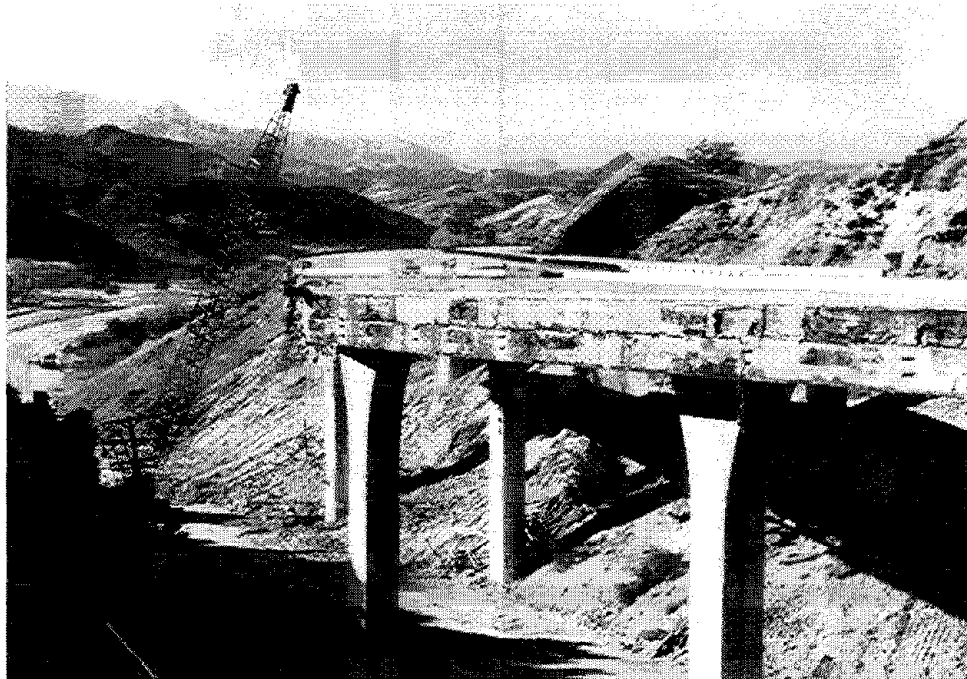
Figure 4.3: Ground level view of the southbound bridge at Gavin Canyon, looking to the northwest, showing the hinge bearing seat near Bent 3.

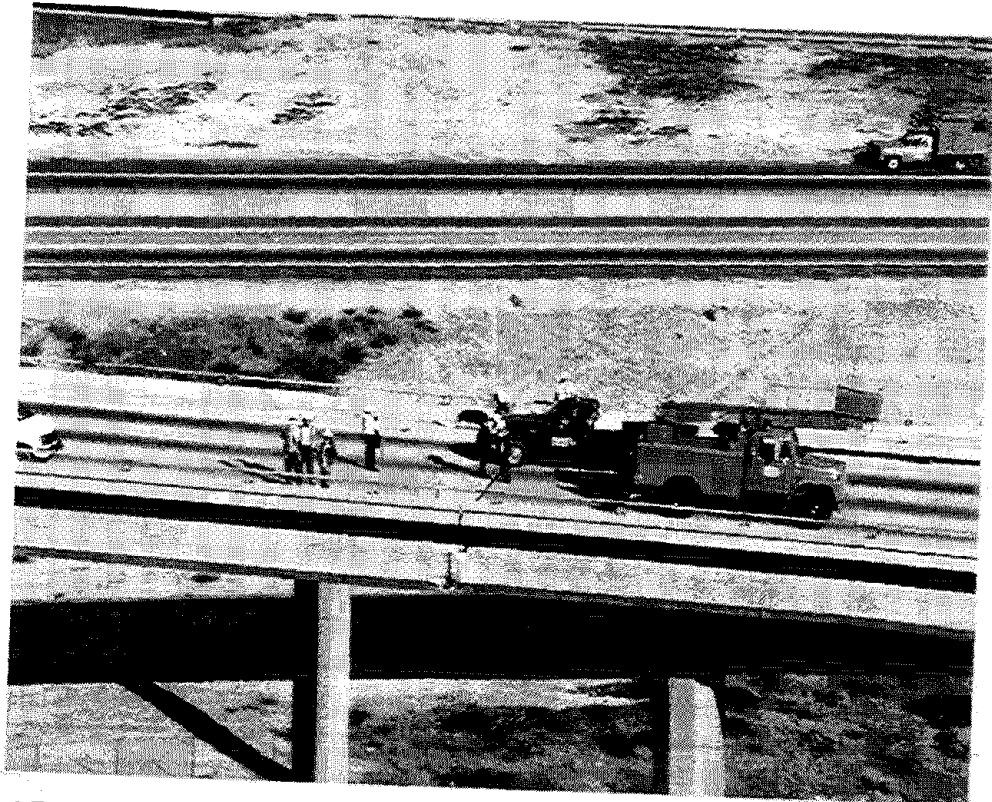
Figure 4.7 Example of pounding and offset at a hinge in the SR14/I5 interchange

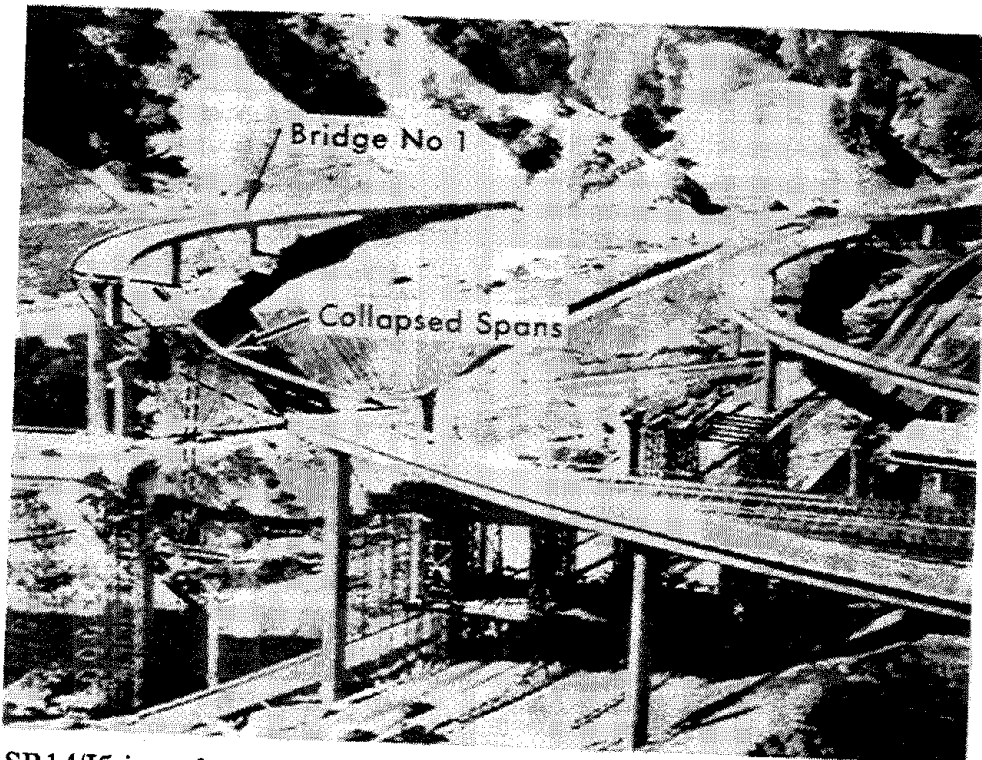
This interchange was designed in 1968 and was under construction in 1971 when portions were damaged by the San Fernando earthquake. At that time, one of the completed ramps in the interchange collapsed, and two ramps which were under construction were damaged. The portion which collapsed in 1971 was the South Connector Overcrossing, connecting southbound I5 with eastbound SR14. A photograph of the collapsed ramp, taken in 1971, is shown in Figure 4.8. This ramp was later rebuilt, with improved pier reinforcement, and it suffered no significant damage in the Northridge earthquake. The damaged portions of the other two ramps under construction in 1971 were repaired in place, but not strengthened; the portions not yet constructed were completed with limited seismic upgrading. Both of the ramps which partially collapsed in the Northridge earthquake were under construction at the time of the 1971 earthquake.

Figure 4.8 SR14/I5 interchange after the 1971 San Fernando earthquake. View looking to the west, showing collapsed South Connector Overcrossing

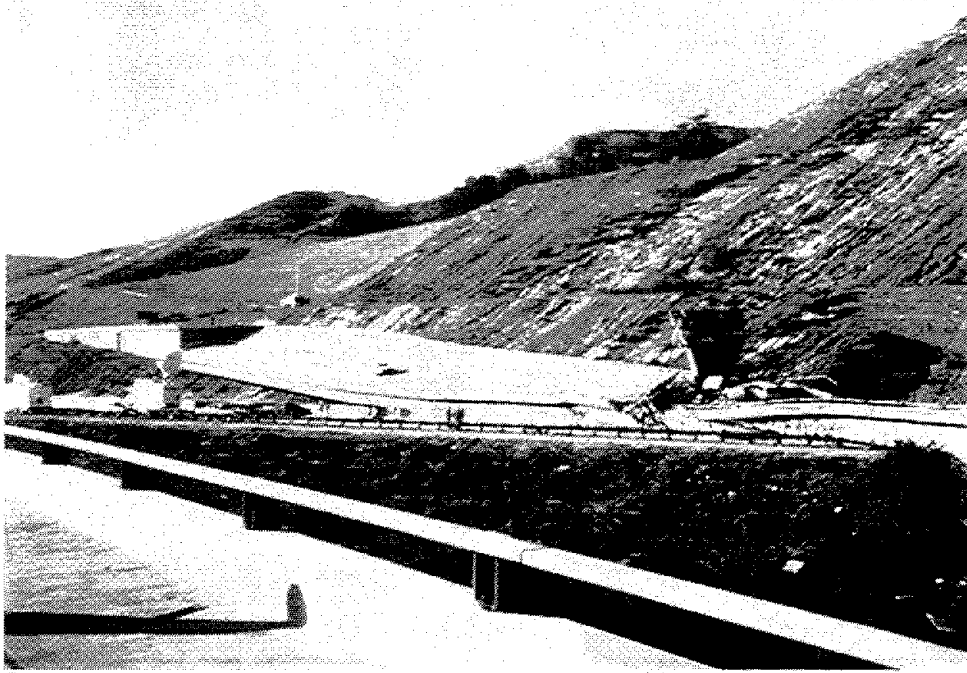
This ramp was designed in 1968 and constructed in 1971. Plan and elevation views of this ramp are shown in Figure 4.9. The structure consists of multiple-cell concrete box girders, most of which are post-tensioned, supported on single pier bents with flared tops. The portion of the ramp which collapsed was between Abutment 1 and the hinge located near Pier 4. A ground-level view of the collapsed span is shown in Figure 4.11, and a view of damaged Pier 3 is shown in Figure 4.12. The mode of failure of this ramp has not yet conclusively been determined, but the following scenario appears likely. Because Pier 2 was the shortest and stiffest pier in the structure, it probably attracted a large share of the horizontal seismic forces. The reinforcing details of the pier, shown in Figure 4.10, indicate that the pier contained quantities of lateral reinforcement which would be considered inadequate by current standards. Thus it is likely that Pier 2 was damaged and collapsed, pulling the superstructure off the seat at Abutment 1*. It was reported that Pier 2 had completely disintegrated in the collapse. This observation is consistent with the conjecture that the pier was initially severely damaged in shear, and was then so badly weakened that it was crushed in compression. Following the collapse of Pier 2, a failure of the superstructure was initiated by excessive shear and negative bending moment at Pier 3. The superstructure sheared off on either side of Pier 3, leaving the pier standing nearly intact, as shown in Figure 4.12. The span between Piers 3 and 4 then collapsed, pulling the superstructure off the hinge seat near Pier 4.

Figure 4.11 Overview of the collapse of the SR14/I5 Separation and Overhead, Ramp C, looking to the south at Abutment 1. Pier 3 can be seen at the right of the photograph (Courtesy of EERC)

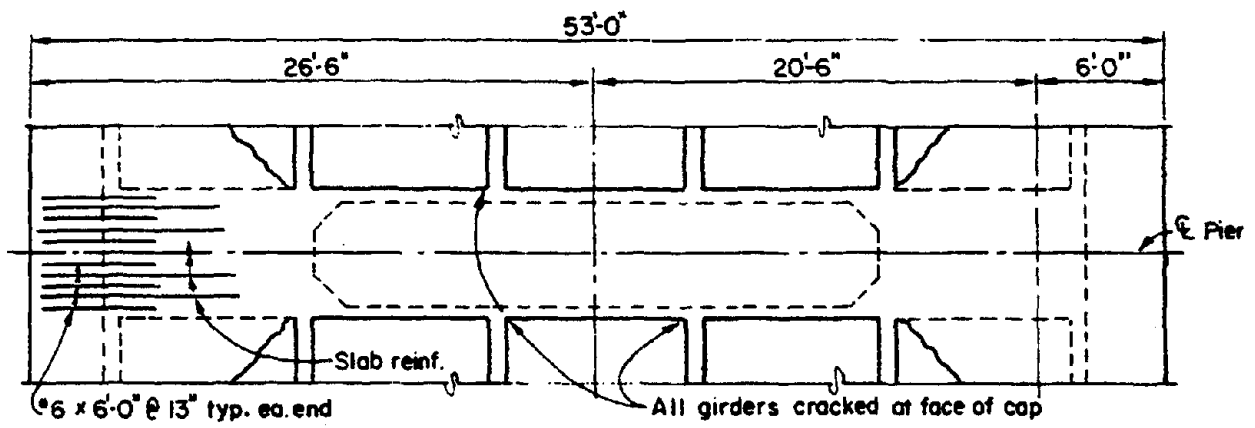
When the 1971 San Fernando earthquake occurred this ramp was under construction. Piers 2 and 3 had already been completed, and the bottom soffit and webs of the box girder between Abutment 1 and the hinge near Pier 4 had been cast and were resting on falsework. Settlement and shifting of the falsework resulted in damage to the parts of the ramp already constructed. After the San Fernando earthquake investigators noted cracking in the caps of Piers 2 and 3, consisting of cracks in the soffit slabs radiating 45 degrees from the pier corners, and vertical cracks in the box girder webs at the face of the pier cap, as shown in Figure 4.13 (State of California, 1971). It is not known how these cracks were treated in the repair work following the 1971 earthquake, or whether they were a contributing factor in the Northridge earthquake failure.

Figure 4.13 Cracking reported at Piers 2 and 3 following the 1971 San Fernando earthquake (Reproduced from State of California, 1971)

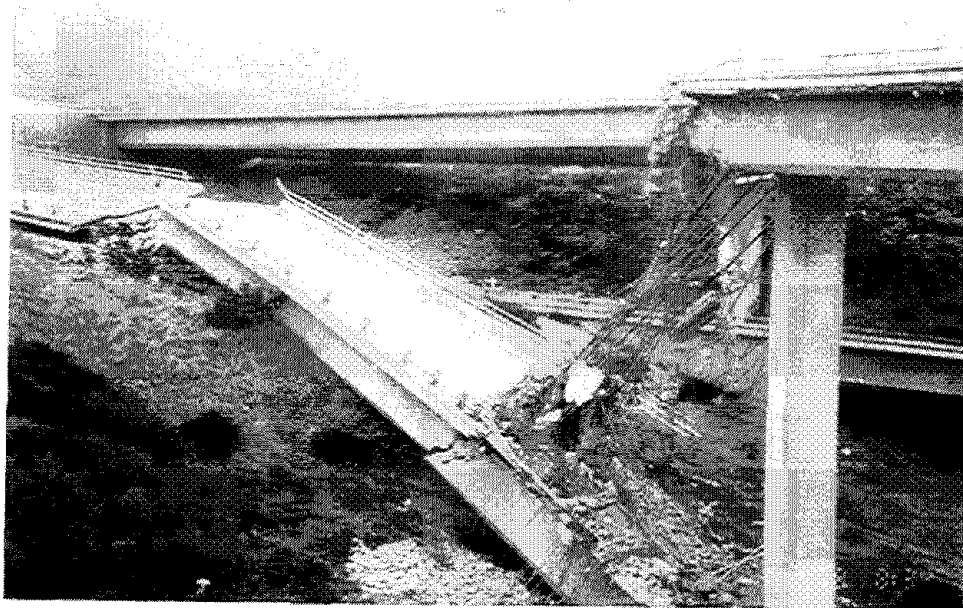
The collapse in the Northridge earthquake appears to have been initiated by the failure of Pier 2. After Pier 2 failed, the simply supported span between Abutment 1 and the hinge near Pier 2 collapsed, and, as shown in Figure 4.15, the superstructure failed in bending near Pier 3 due to a large negative moment. Pier 2 completely disintegrated, as shown in Figure 4.16. This is the shortest pier in the structure, so it is likely that it attracted a high level of lateral force, was damaged in shear, and finally collapsed in compression. Pier 10 is similar in height to Pier 1, but the quantities of lateral reinforcement in Pier 10 are greater than those in Pier 1, as illustrated in Figure 4.18. This is because Pier 2 had already been completed, but Pier 10 had not yet been constructed, when the 1971 earthquake occurred. Following the 1971 earthquake the plans for Pier 10 were revised to provide increased lateral reinforcement, as shown in Figure 4.18.

Figure 4.14 Collapsed portion of the SR14/I5 North Connector Overcrossing, looking east.. Pier 2 was at the left, near the broken hinge on the ground (Courtesy of EERC)

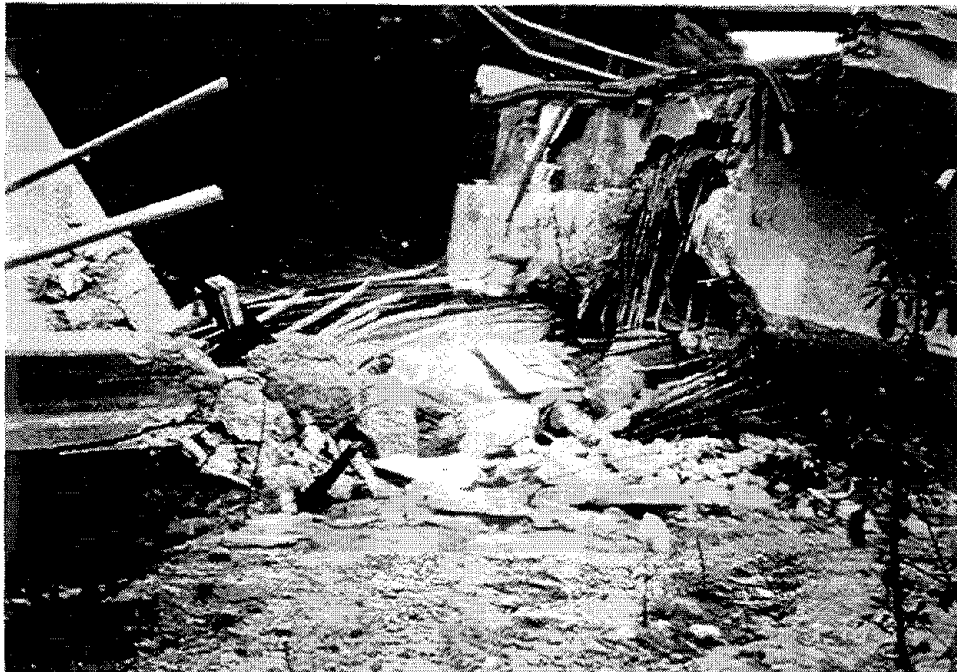
Figure 4.16 View of crushed Pier 2 and the hinge near Pier 2 (Courtesy EERC)

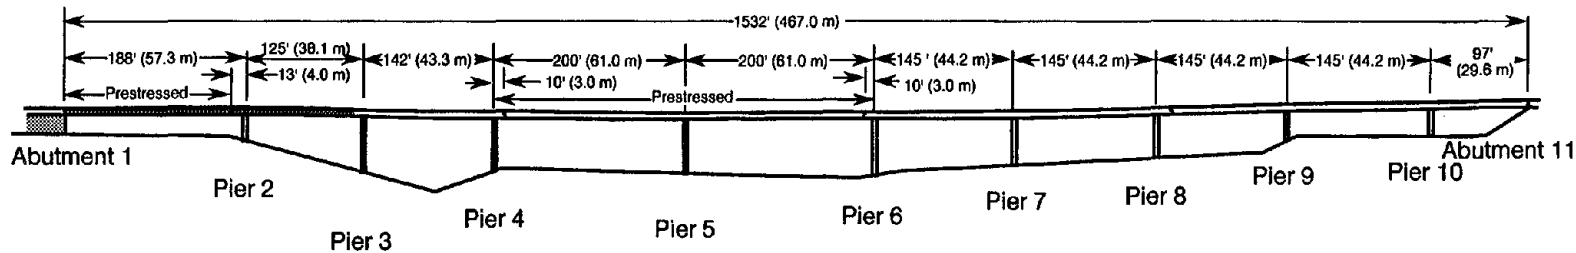
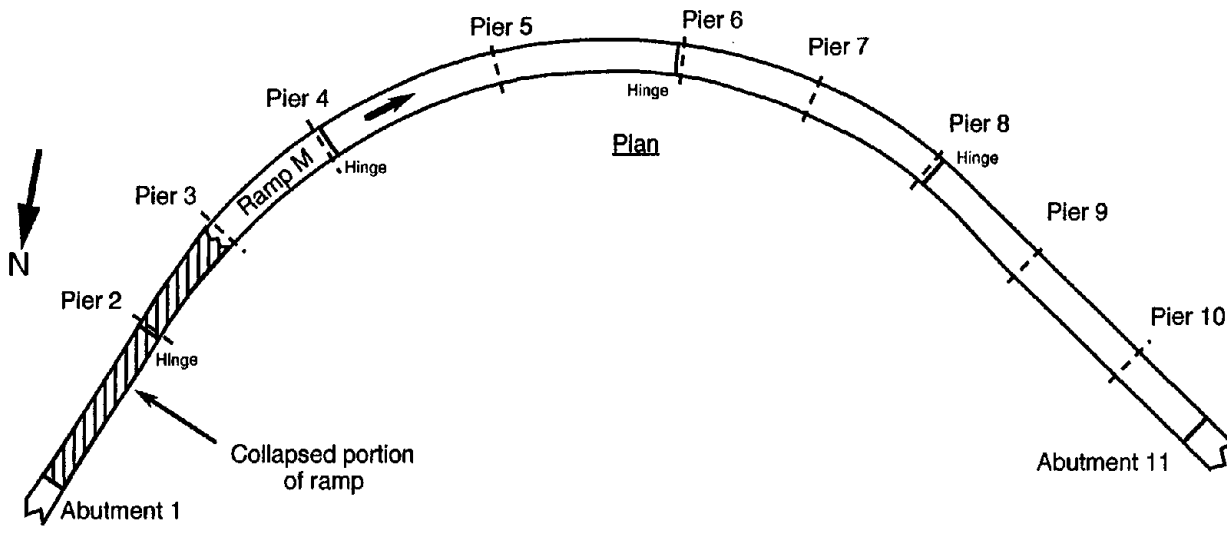
North Connector Overcrossing, Ramp M - SR14/I5 Interchange

Figure 4.17: Plan and elevation view of the SR14/I5 North Connector Overcrossing

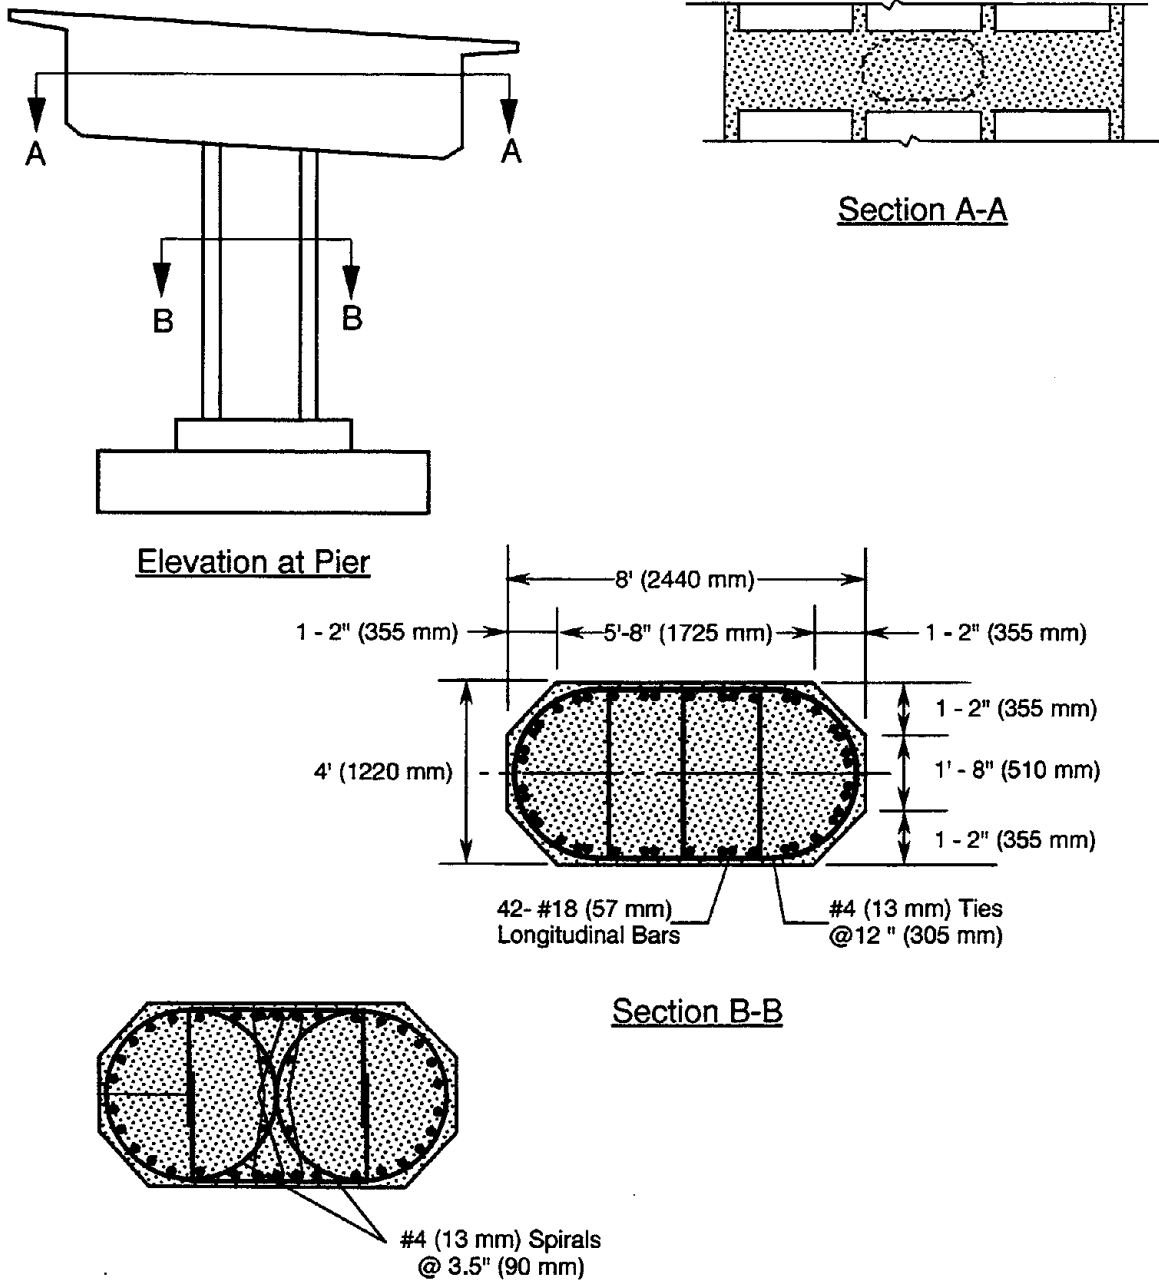
SR14/I5 North Connector O C Ramp M - Pier 2

Figure 4.18 Reinforcement details for Pier 2 of the SR14/I5 North Connector Overcrossing, Ramp M

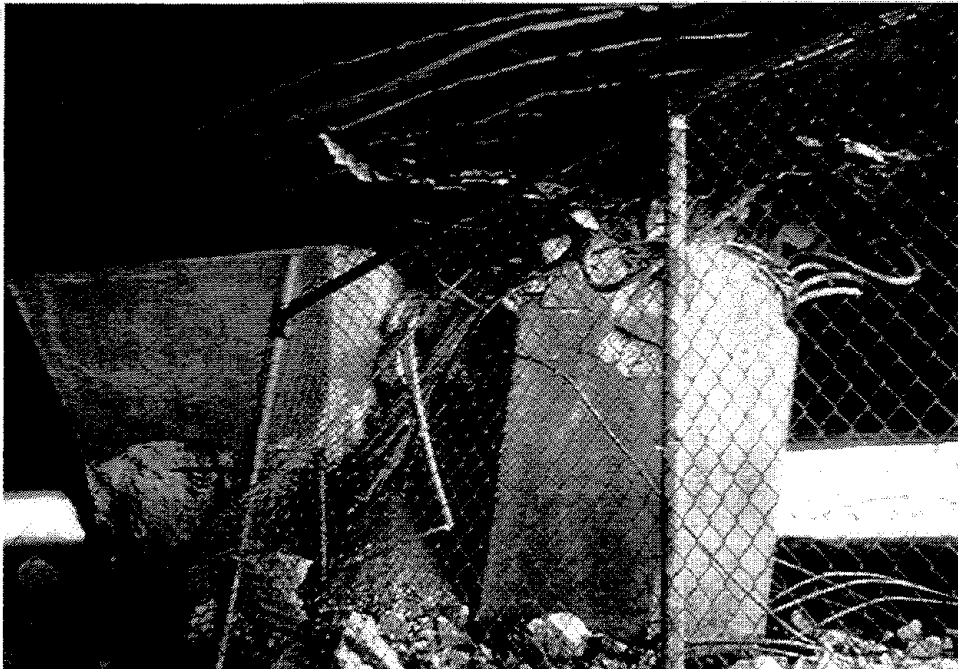
The likely failure mode of the bridge was that the piers initially suffered severe shear damage, followed by crushing of a number of piers in compression. The structure may also have shifted to the southwest, as constrained by the geometry of the abutments. Although unseating at Abutment 5 did occur, this was probably a secondary effect, as the seat lengths were generous by current standards. Rather, failure was probably initiated by damage to the piers. In this case the failure of piers has important theoretical implications, as the piers of this bridge contained quantities of lateral reinforcement similar to those required by current seismic design standards. Therefore, further research will be required to determine why the pier reinforcement was inadequate in this case.

Figure 4.22: Damage to a pier of the SR118 Mission-gothic Undercrossing, looking to the west at Bent 4 of the eastbound bridge, which collapsed (Courtesy of EERC)

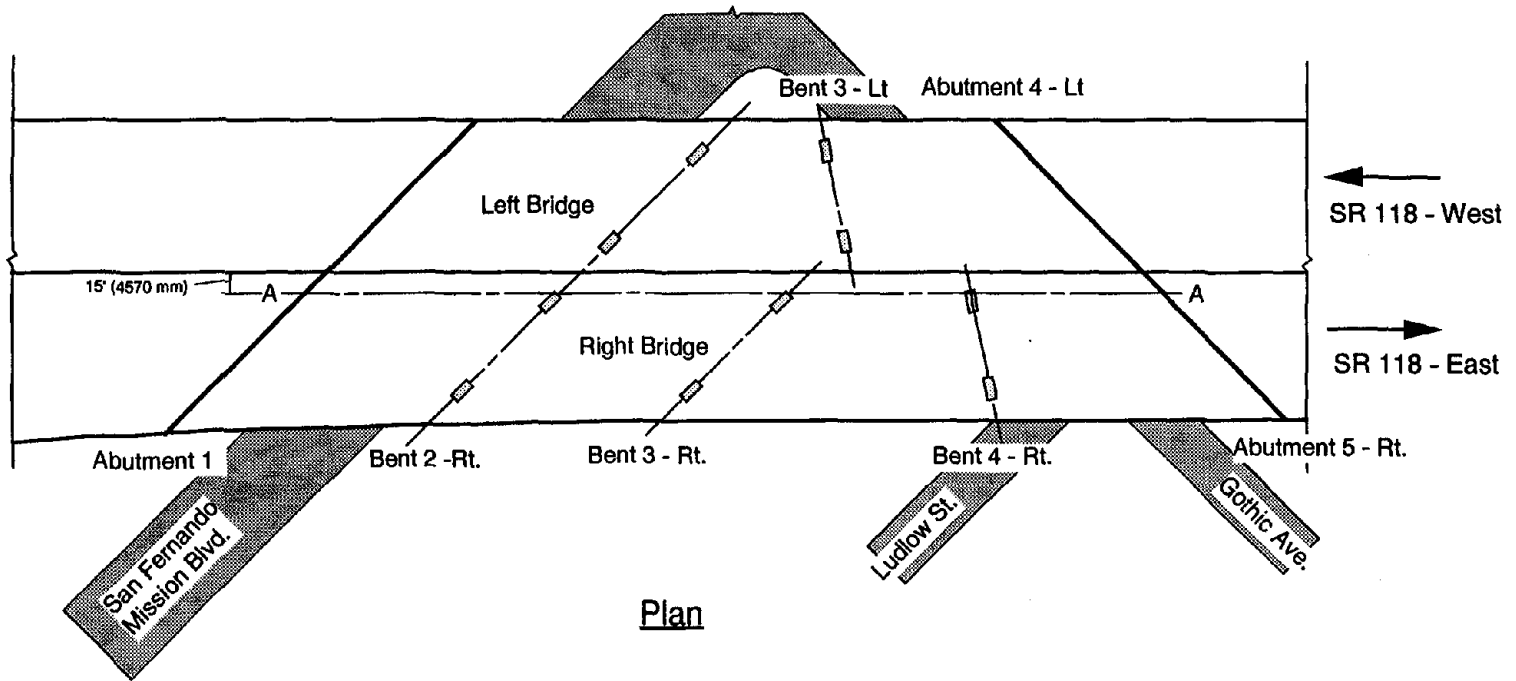
SR 118 - Mission-Gothic Undercrossing

The first important feature of the bridge is the its irregular geometry. Figure 4.23 shows that the plan shape of the bridge is a trapezoid. Thus, because of the orientations of the abutments, the structure was constrained to move in only one lateral direction during the earthquake, roughly to the southwest. Indeed, Figure 4.21 and 4.22 show that the superstructure moved in this direction, creating a diagonal shear failures in many of the piers. There is also a highly irregular placement of piers, dictated in part by the trapezoidal plan shape of the bridge, and in part by right-of-way restrictions. The irregular plan shape and placement of piers created asymmetric stiffness and mass distributions, which undoubtedly lead to some piers being more heavily loaded than others

Figure 4.23 Plan and elevation views of the SR 118 Mission-Gothic Undercrossing

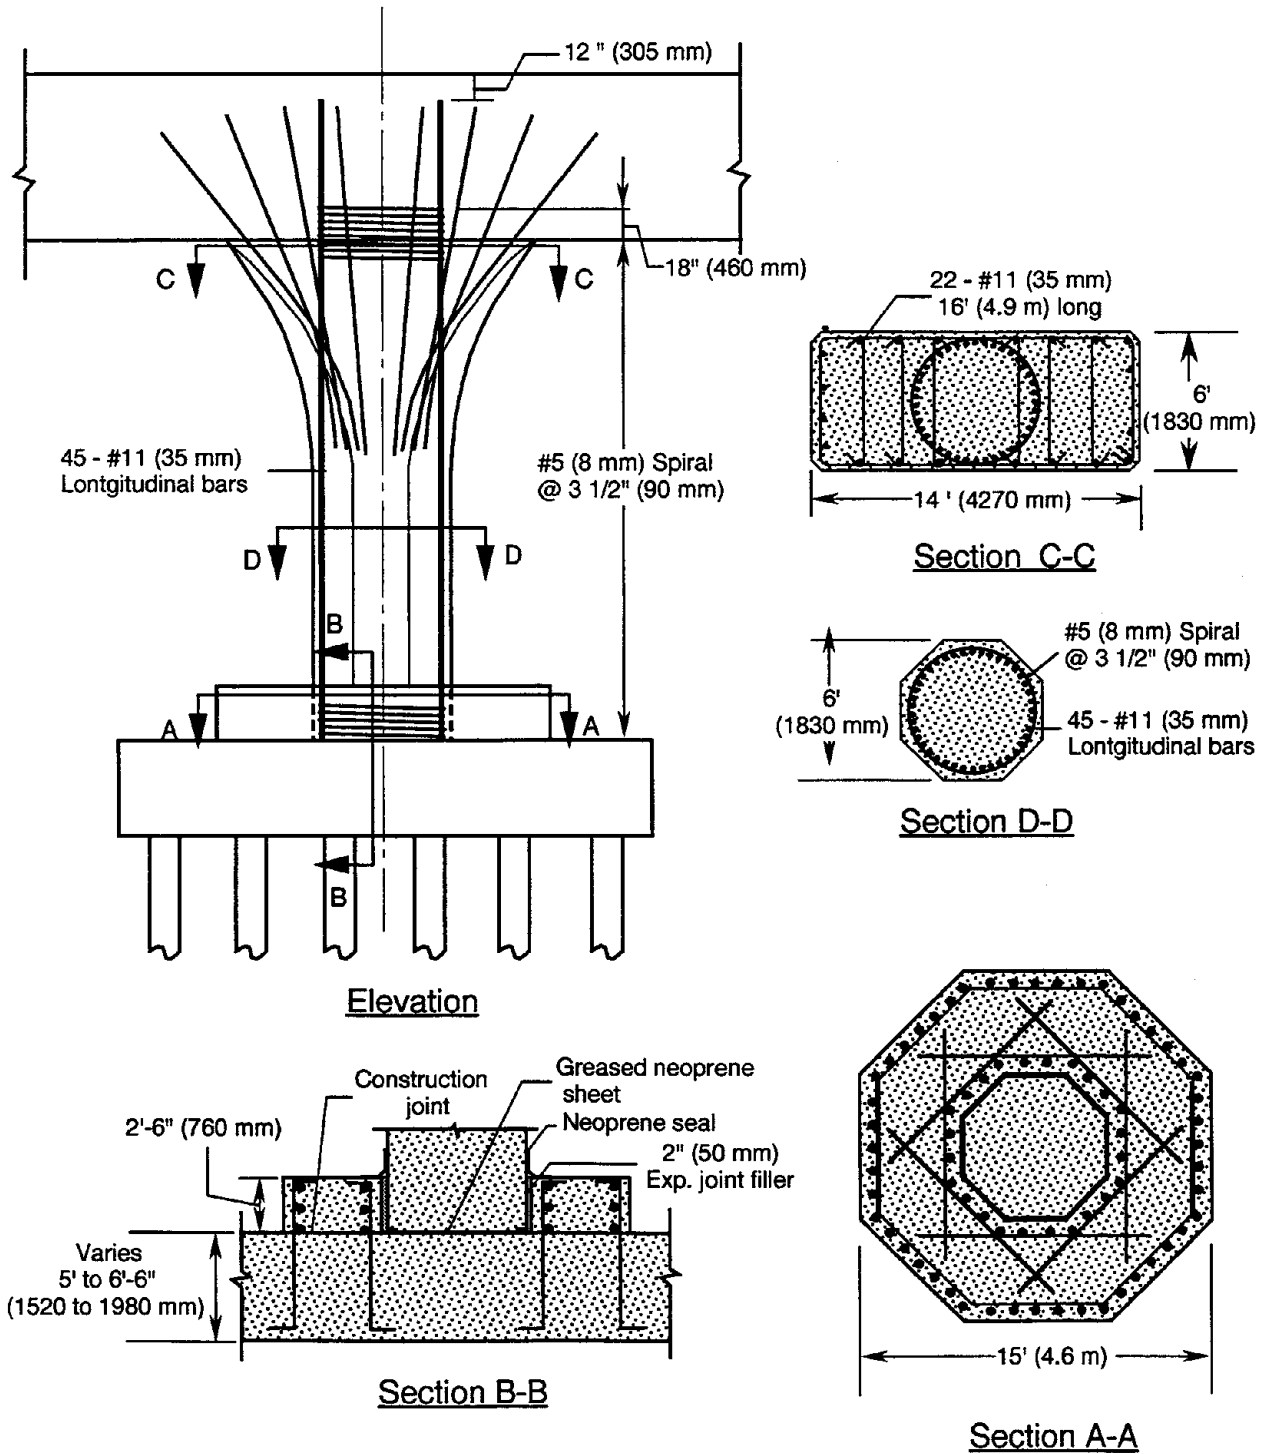
SR 118 - Mission-Gothic Undercrossing Pier Details

The second, and perhaps more important, feature of this bridge is the geometry of the bridge piers. Pier details are shown in Figure 4.24. The piers were all relatively short, roughly 7200 mm (24 feet) tall by 1800 mm (6 feet) across, making an aspect ratio of only 4:1. However the piers also featured architectural flares at the tops, roughly 3600 mm (12 feet) tall. These flares were intended to be non-structural features of the piers. It was believed that the flares would spall or otherwise deteriorate during earthquake loading so that they would not contribute to the bending stiffness of the piers. However, it is clear that in actual performance the flares created a zone of added stiffness, reducing the aspect ratio of the piers to approximately 3:1. Thus the piers were very stiff laterally, and were dominated by shear rather than bending. The detail at the footing/pier interface was also somewhat unusual for this bridge. Figure 4.24, Section B-B, shows that the base of the pier rested inside a collar at the top of the pier footing. This detail was intended to permit free translation of the pier base during post-tensioning operations of the superstructure, before the collar was cast. The detail also had the effect of creating a hinge at the pier base. It is not immediately apparent whether this hinge improved or worsened the seismic performance of the bridge, although for a given lateral force the bending moments at the tops of the piers were greater than if the hinges at the bases of the piers had not been present.

Figure 4.24 Pier details for the SR118 Mission-Gothic Undercrossing
