1994 Northridge Earthquake

Performance of Structures, Lifelines and Fire Protection Systems

NISTIR 5396

March 1994
Building and Fire Research Laboratory
National Institute of Standards and Technology
Gaithersburg, MD 20899

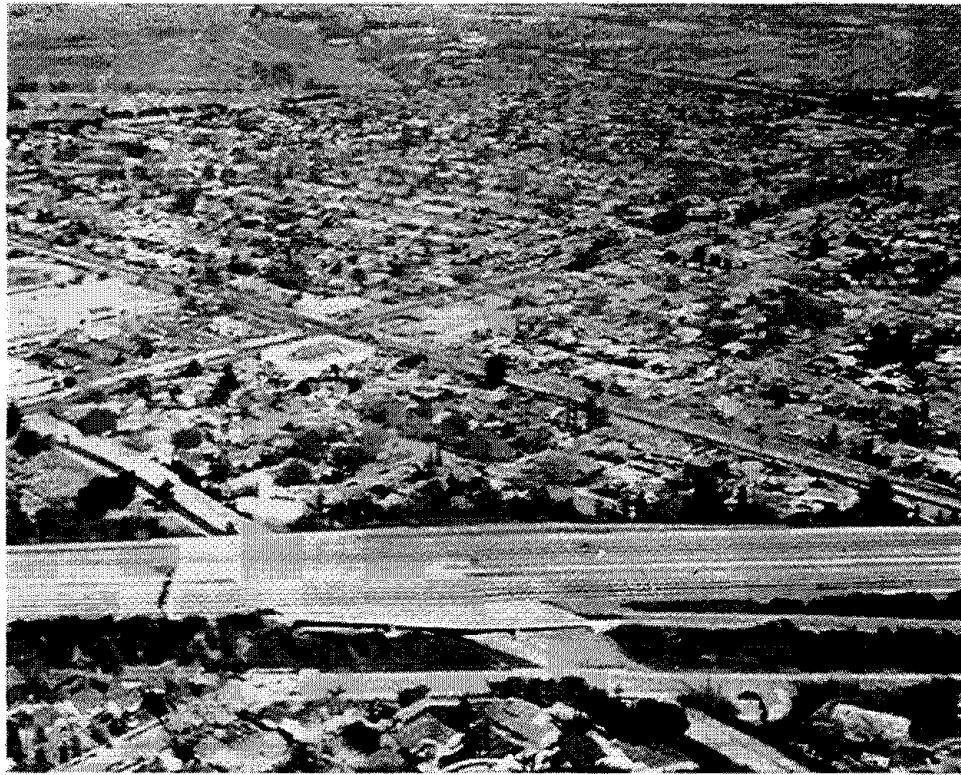
Figure 4.25 shows an aerial view, and 4.26 a ground-level view, of the SR118 bridge at Bull Creek Canyon Channel. The bridge did not collapse completely, but many of the piers were severely damaged, as shown in Figures 4.27 and 4.28. In addition to pier damage, there was significant damage to the abutments, including cracked wing walls, settlement of soil behind the abutments, and possible shifting of the abutments. Plan and elevation views of the bridge are shown in Figure 4.29, and pier details in Figure 4.30.

Figure 4.25 Aerial view of State Route 118 at Bull Creek Canyon Channel, looking to the north (Courtesy of FHWA)

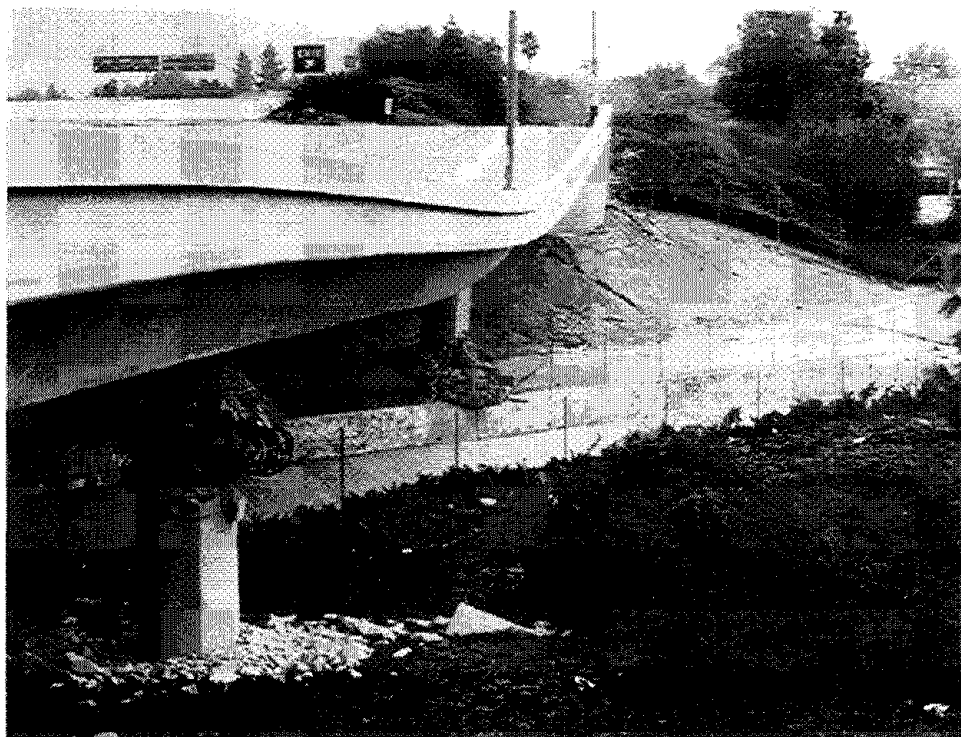
All ten of the piers in Bent 3 failed in combined shear and compression near their bases, as shown by Figures 4.27 and 4.28. In Bent 2, Piers on the south side of the span failed near their top end, as shown in the left foreground of Figure 4.26, and the damage became progressively less for piers to the north in Bent 2. The farthest north piers in Bent 2 showed relatively little damage - only diagonal shear cracks near the base, with no spalled concrete. This uneven distribution of damage to piers was probably caused by the asymmetric plan geometry of the bridge, as shown in Figure 4.29.

Figure 4.26 Ground-level view of State Route 118 at Bull Creek Canyon Channel, looking along the south edge, towards the east

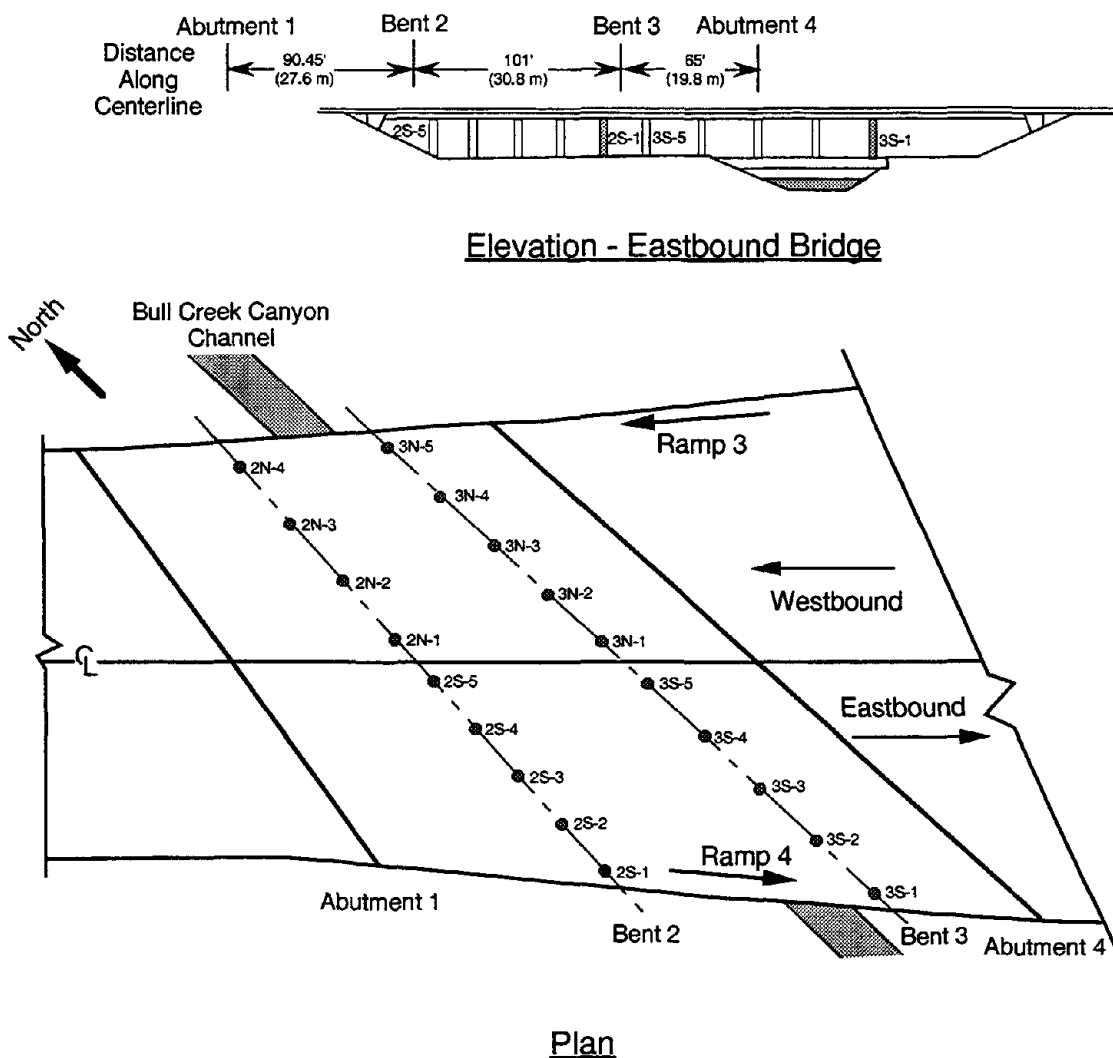
SR 118 Bull Creek Canyon Channel Bridge

Figure 4.29 Plan and elevation views of State Route 118 at Bull Creek Canyon Channel

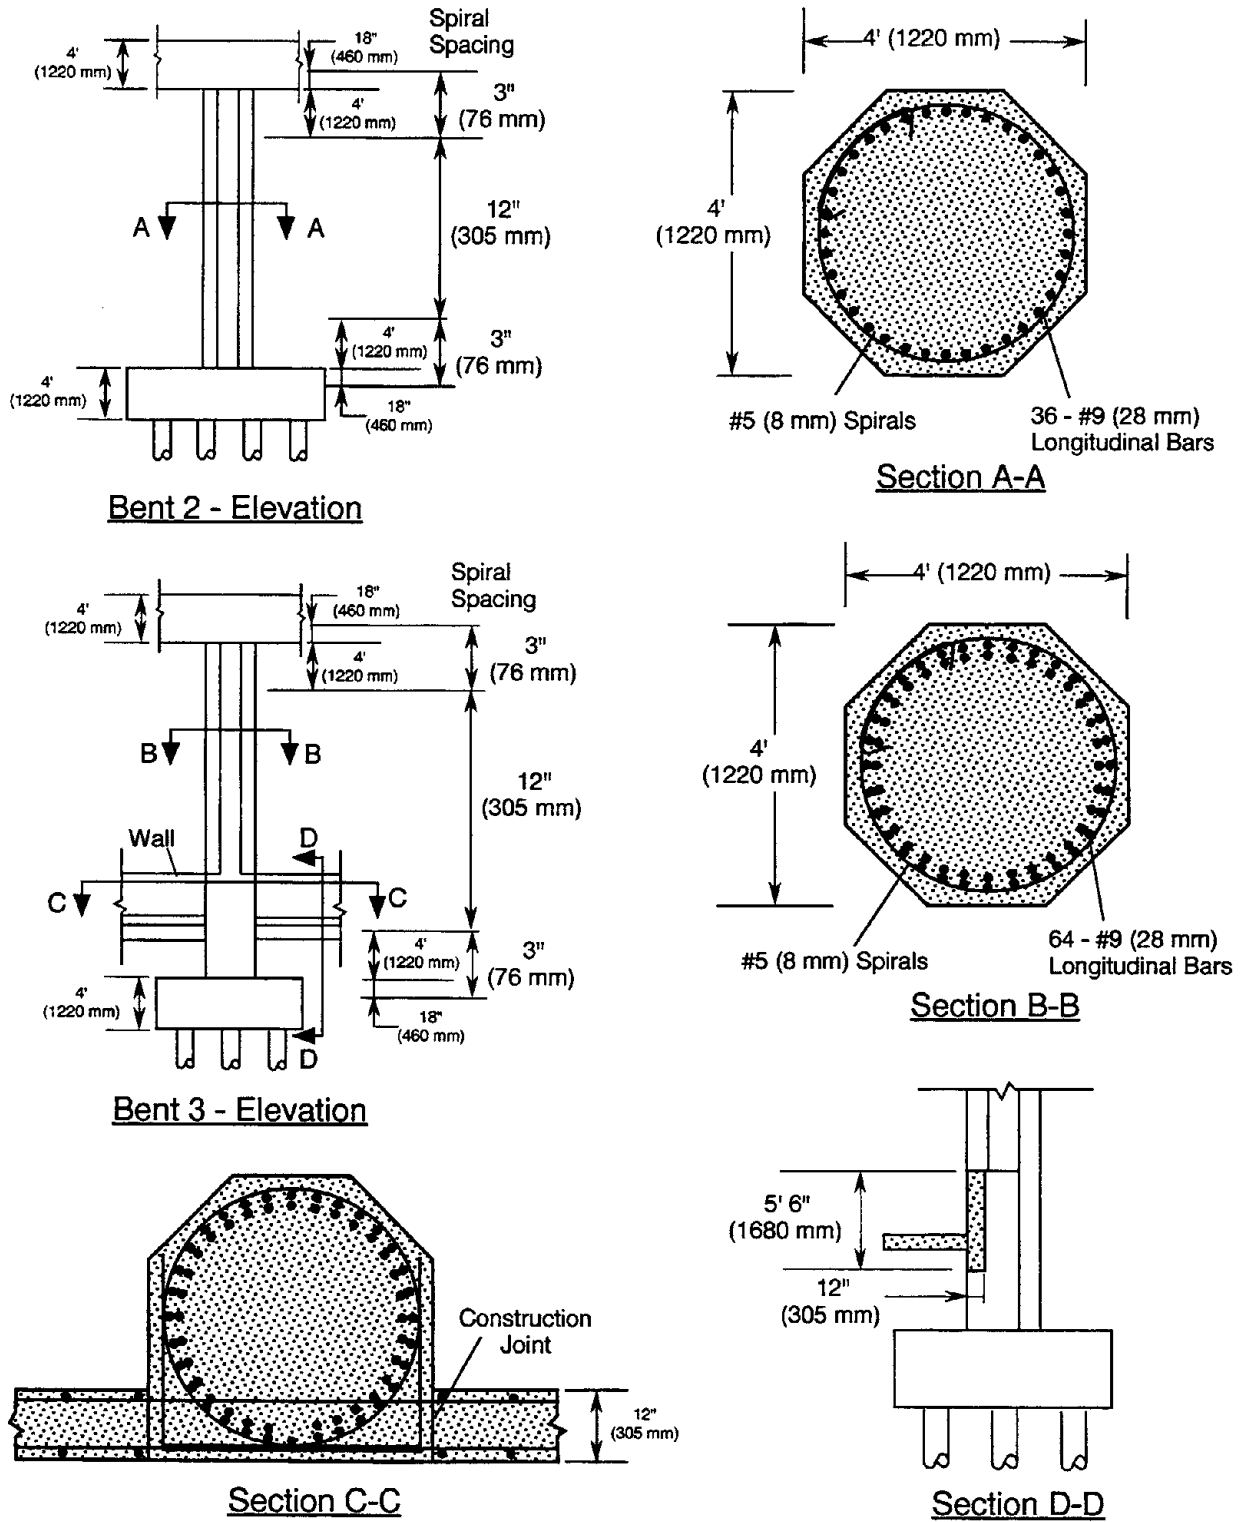
SR 118 Bull Creek Canyon Channel Bridge Piers

The confining reinforcement in the piers, shown in Figure 4.30, is inadequate by current standards. Spiral confining hoops were spaced at 76 mm (3 in.) near the top and bottom of each pier (presumably to provide confinement in potential plastic hinge regions), but the spacing was 305 mm (12 in.) over most of the pier height. All pier failures occurred in the zone of wide spiral spacing. Another factor contributing to pier failure was that the effective lengths of the piers were much shorter than the distance between the footings and the girder soffit. The lengths of piers varied between roughly 6000 and 9100 mm (20 and 30 ft.). In Bent 2, the effective pier lengths were decreased roughly one-third by compacted backfill soil above the pier footings. In Bent 3, the pier lengths were also decreased roughly one-third, but by a reinforced concrete channel liner wall, which was cast abutting the piers (Figure 4.30, Section C-C). The shortened effective pier length resulted in stiffer piers, which were more susceptible to shear-dominated failure than bending-dominated failure.

Figure 4.30 Pier details for State Route 118 at Bull Creek Canyon Channel

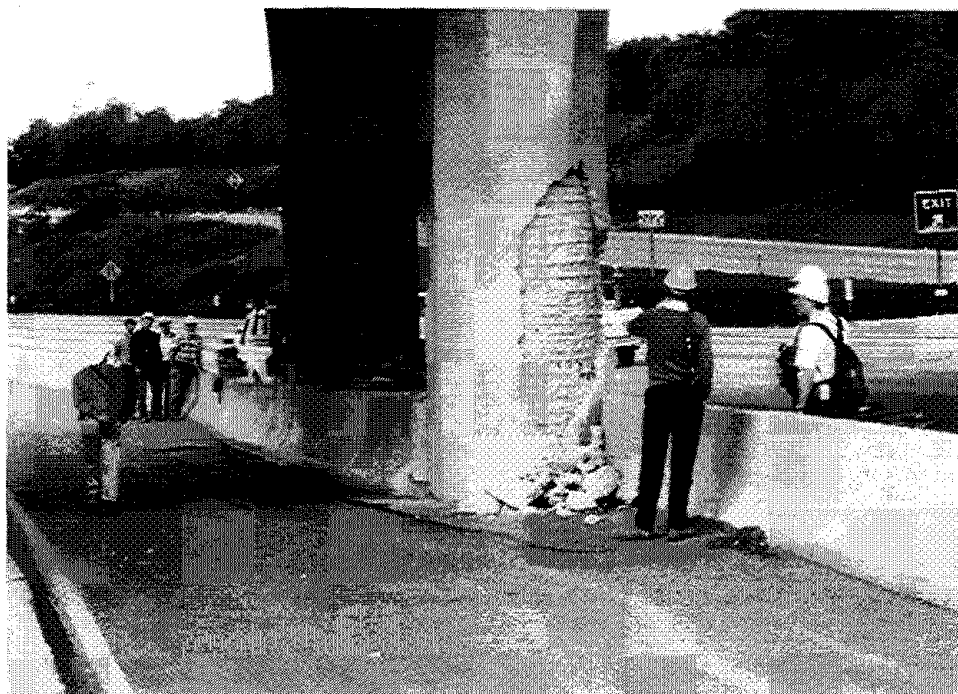
The good seismic performance of this bridge can probably be attributed to two factors. First, the central piers performed well because they contained adequate confining reinforcement and they were slender enough that they were not prone to a shear-dominated failure mode. Second, the overall geometry of the bridge is fairly compact, so that much of the lateral forces were carried by the abutments rather than the central piers. It is not common to see extensive seismic damage to short-span overpasses of this type.

Figure 4.31 SR118 Ruffner Ave. Overcrossing, easternmost central pier, looking to the west

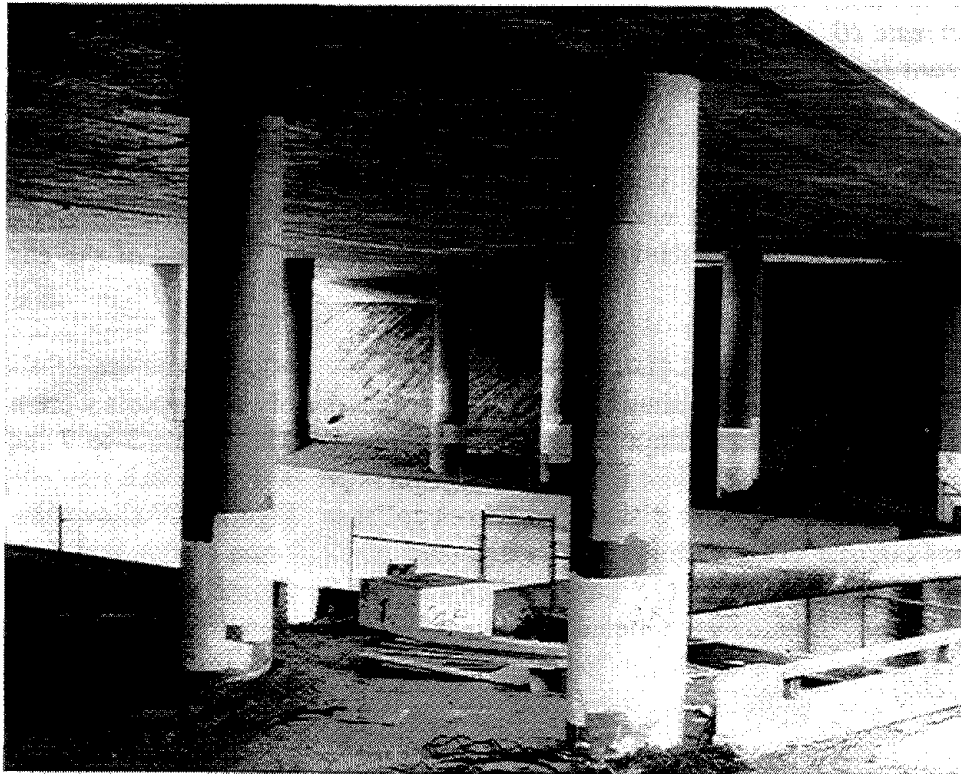
Between the two bridges which collapsed, I10 passes over Ballona Creek. Figure 4.33 is a view looking toward the southwest of the spans over the creek. There was essentially no damage to the supporting piers. Adjacent to the bridge over Ballona Creek, there is a westbound ramp which exits from I10 to Cadillac Ave. A portion of this ramp is supported by single piers which have been retrofitted with steel jackets, as shown in Figure 4.34. No damage was noted to these retrofitted piers. The Cadillac Ave. ramp represents the only case known to the authors where undamaged retrofitted piers were located close to major collapse sites. However, because the retrofitted Cadillac Ave. ramp piers were immediately adjacent to an older, non-retrofitted multispan bridge which was undamaged (the Ballona Creek overpass), it is not known whether the Cadillac Ave. ramp piers were subjected to the same levels of lateral forces as piers at the two collapse sites at La Cienega-Venice and Fairfax-Washington.

Figure 4.33 I10 Bridge over Ballona Creek, looking to the southwest

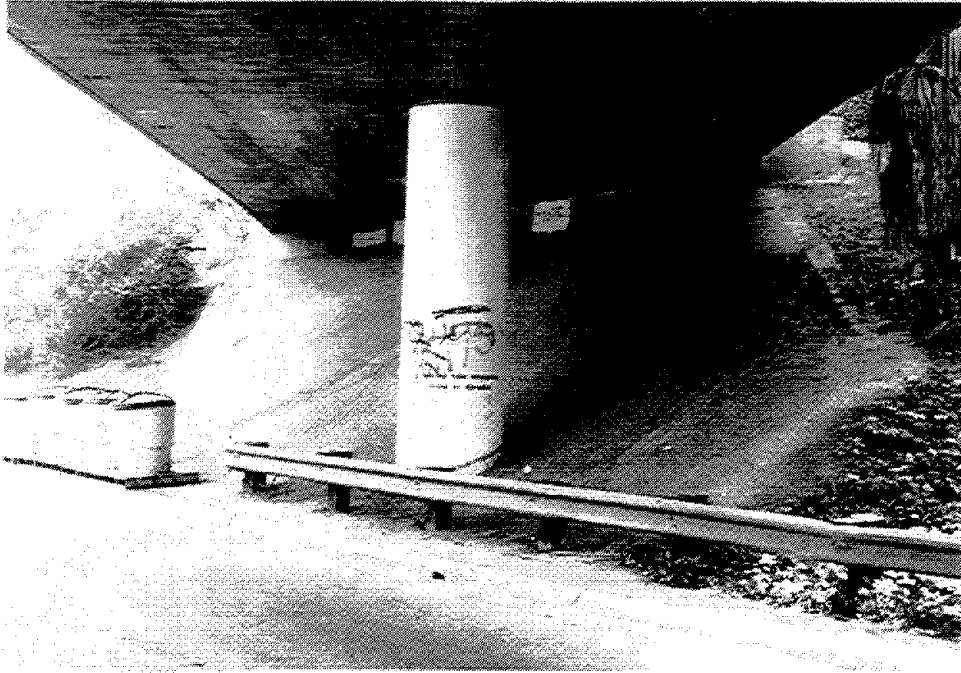
Figure 4.34 Cadillac Ave. ramp; view to east showing jacketed pier

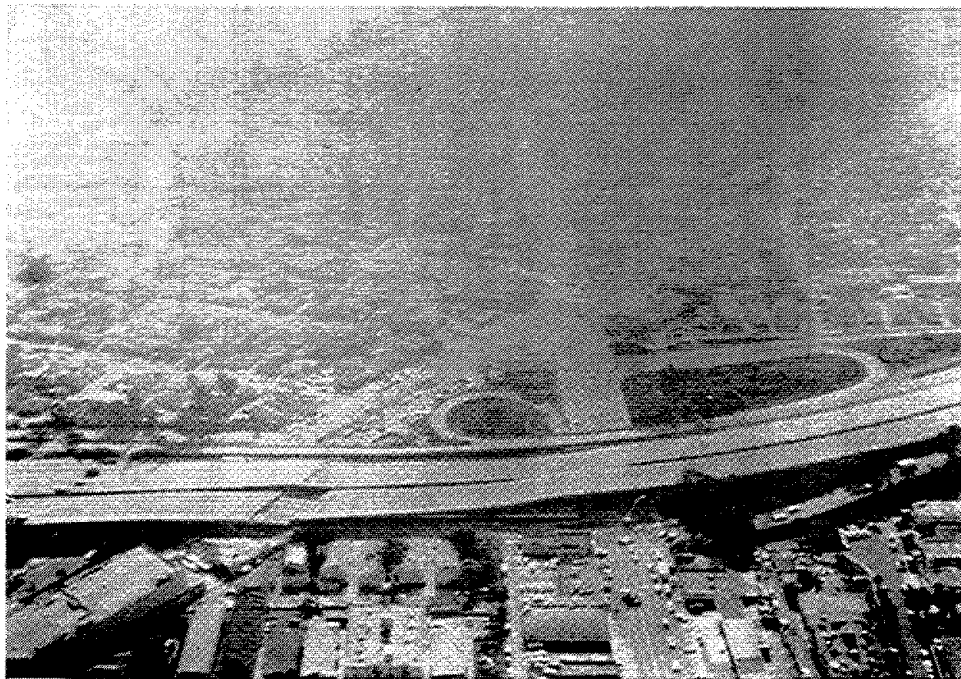
Figure 4.35 is an aerial view of I10 where it passes over La Cienega Blvd. and Venice Blvd. The view is toward the south, and Venice Blvd. is the diagonal street on the left side of the photograph. The portion of the westbound lane which collapsed to ground level can be seen. However, there was extensive damage to most of the supporting piers of the eastbound and westbound lanes.

Figure 4.35 Aerial view (looking south) of I10 Separation at La Cienega Blvd. and Venice Blvd., (Courtesy of FHWA)

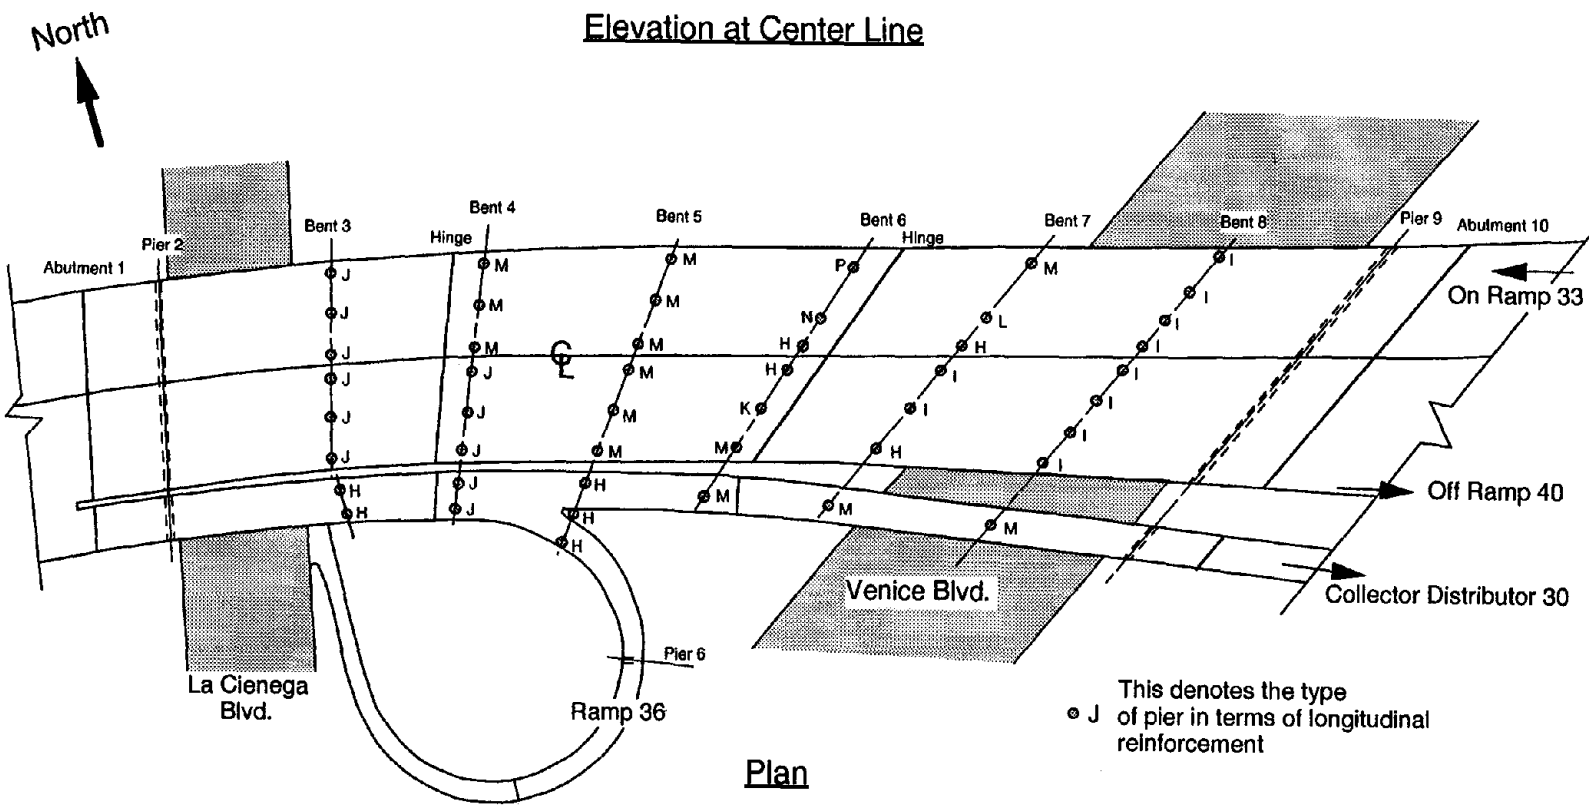
I-10 La Cienega-Venice Separation

Figure 4.36 shows elevation and plan views of the nine-span bridge structure. Solid wall piers provided support adjacent to the abutments, and the remainder of the supports were multiple-pier bents. Two expansion joints (hinges) were provided as shown. Bents 3 to 7 included three supporting piers for each lane, while Bent 8 had four piers per lane. The exit ramp to La Cienega Blvd. and the eastbound collector-distributor did not collapse. Figure 4.37 shows the pier details. The piers had circular cross sections with a diameter of 1220 mm (4 ft.), and the longitudinal reinforcement consisted of #11 (35 mm) or #18 (57 mm) deformed bars. The different pier reinforcement configurations were identified by pier "types" as shown in Figure 4.37. These pier types are indicated in the plan shown in Figure 4.36. The lateral reinforcement consisted of #4 bars (13 mm) at 305 mm (12 in.) vertical spacing.

Figure 4.36 Elevation and plan of I10 Separation at La Cienega Blvd. and Venice Blvd.

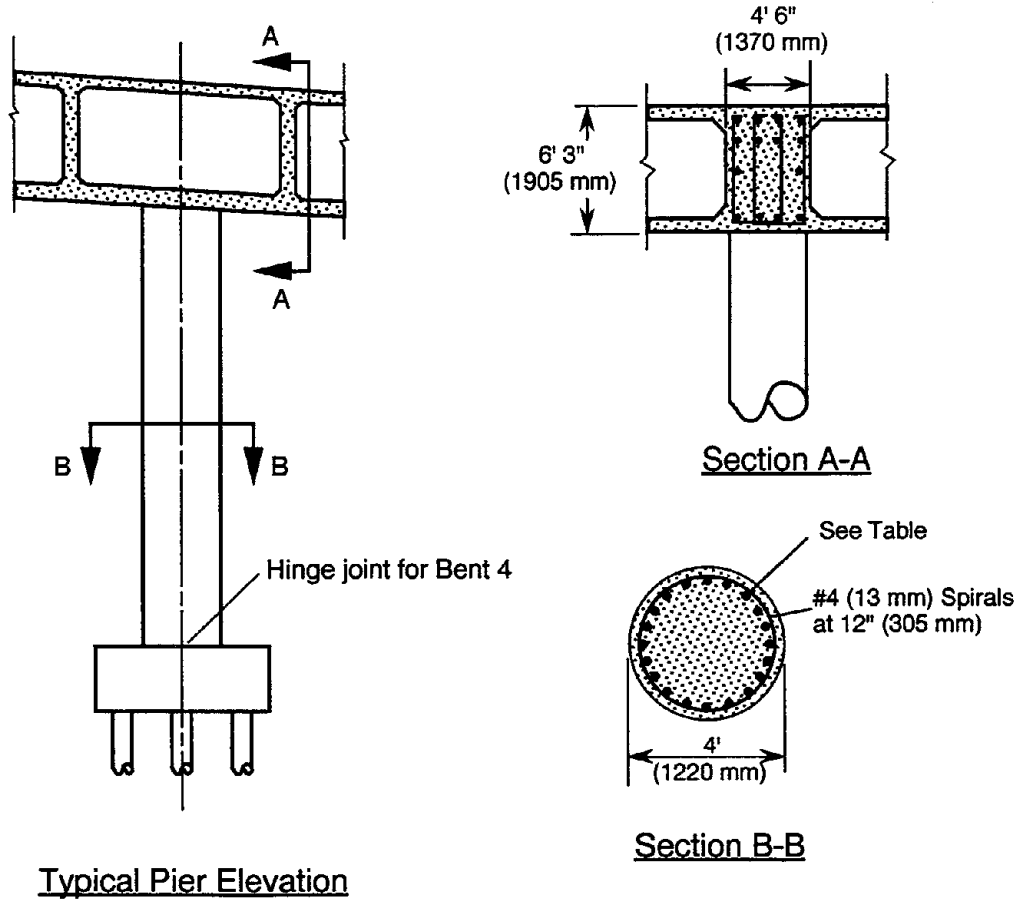
I-10 La Cienega-Venice Separation Pier Details

Figure 4.37 Pier details for I10 Separation at La Cienega Blvd. and Venice Blvd.

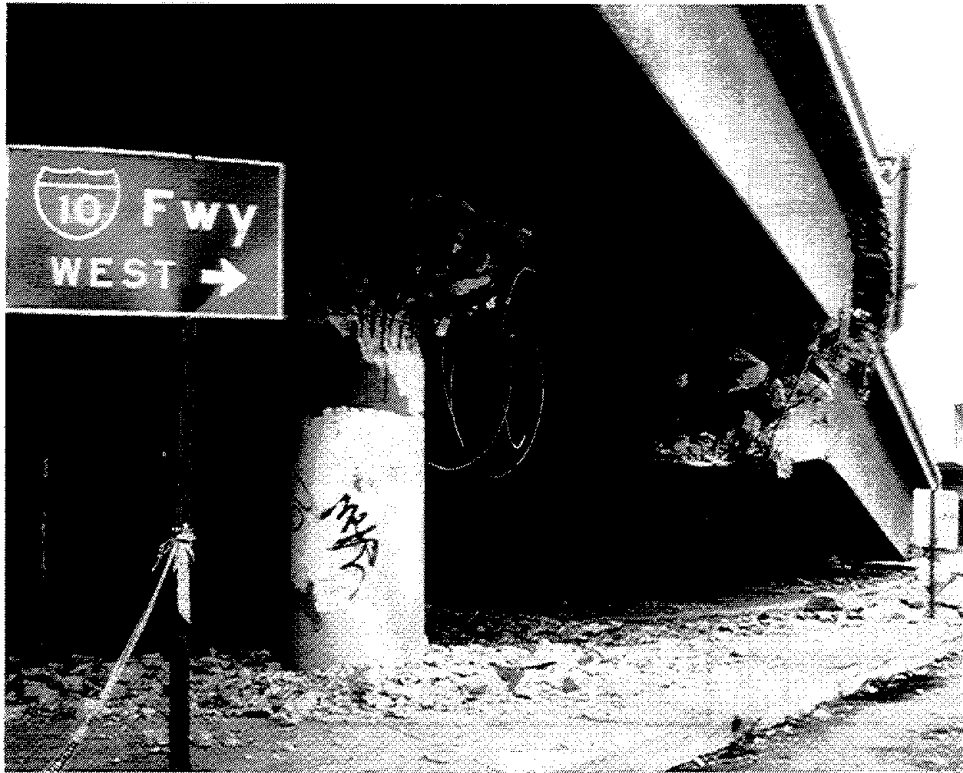
Figure 4.38 is a ground-level view of the portion of the westbound lane that collapsed to the ground at the hinge located between Bents 7 and 6. The pier in the foreground is the northernmost pier of Bent 7. It is seen that there was extensive column shortening due to the failure of the lateral reinforcement to provide adequate confinement of the core concrete. Fractured lateral reinforcement can be seen to the right of the failed portion of the pier. Figure 4.39 shows the other two piers of Bent 7 which supported the westbound lane. Extensive failure and column shortening is evident. The concrete block wall behind the piers is part of a storage

In summary, the bridge structure spanning La Cienega Blvd. and Venice Blvd. was extensively damaged. The failure is attributed to the small amount of lateral pier reinforcement. As the piers cracked due to the lateral loading, the lack of adequate confinement resulted in a reduction of the vertical load capacity because of core concrete loss and buckling of the longitudinal bars. Had it not been for the storage building located beneath the bridge, it is likely that more spans would have collapsed to the ground.

Figure 4.38 Collapsed westbound lane of I10 at Venice Blvd.; pier of Bent 7 in foreground

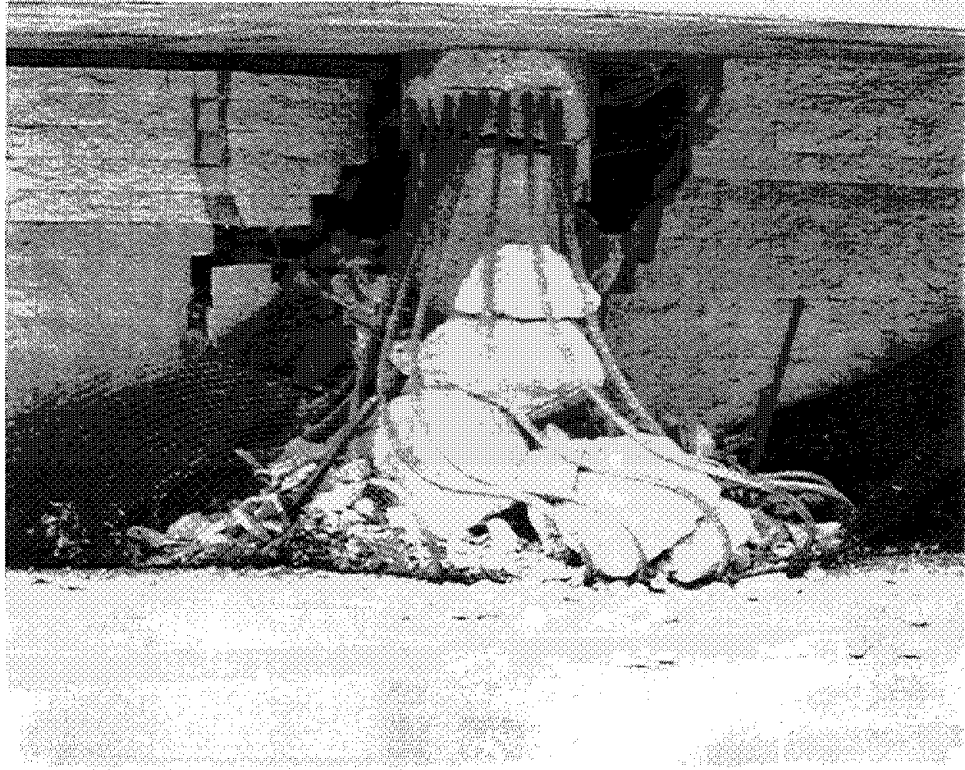
Figure 4.40 shows the northernmost pier of Bent 6, located just to the west of the hinge. This pier totally disintegrated, but the storage building prevented the roadway from collapsing to the ground. Figure 4.41 shows the southernmost pier supporting the eastbound lane at Bent 3. The top of the pier is severely damaged and it is likely that the storage building prevented the total collapse of the roadway.

Figure 4.40 Northernmost pier of Bent 6 supporting westbound lane of I10 (west of Venice Blvd.)

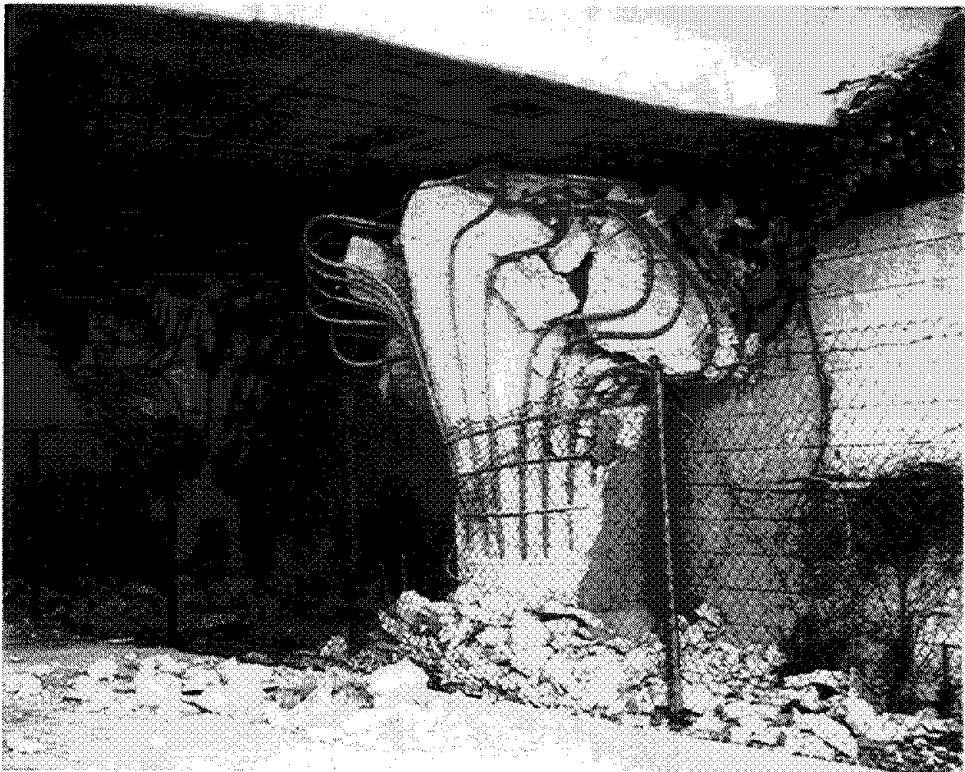
Figure 4.41 Piers of Bent 3 supporting eastbound lane of I10 at La Cienega Blvd.

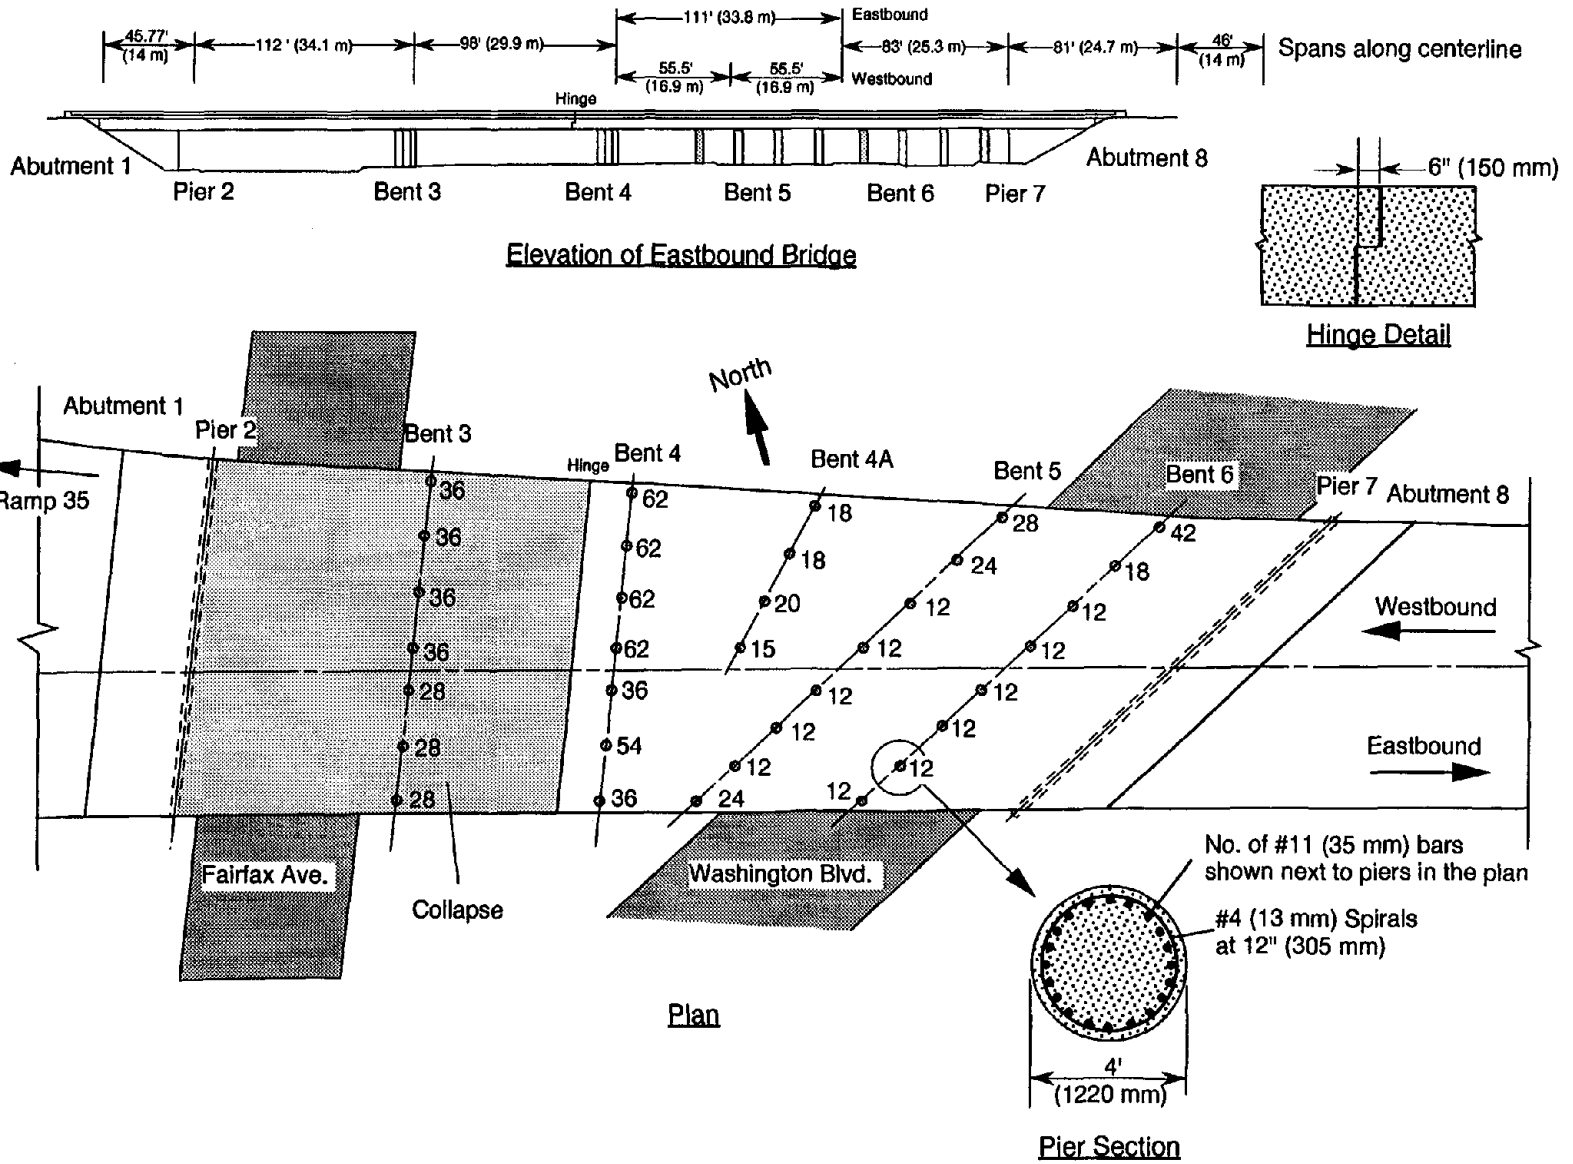
I-10 Fairfax-Washington Undercrossing

Figure 4.42 shows the elevation and plan of the Fairfax Ave.-Washington Blvd. Undercrossing. The eastbound and westbound lanes of I10 were supported by solid wall piers adjacent to the abutments and by multiple-pier bents at the remaining locations. A construction joint (hinge) was located to the west of Bent 4. Because of the skewed alignment of I10 relative to Washington Blvd., the westbound lane of I10 was designed with an additional bent (Bent 4A) compared with the eastbound lane. The piers were of circular cross section with a diameter of 1220 mm (4 ft.). The longitudinal reinforcement consisted of #11 (35 mm) deformed bars. The number of longitudinal bars in each pier is shown adjacent to the pier locations in Figure 4.42. It can be seen that the piers in Bent 4 had significantly more longitudinal bars compared with the other piers. The lateral reinforcement was #4 (13 mm) bars at a vertical spacing of 12 in. (305 mm).

The earthquake caused partial collapse of two spans of the eastbound and westbound lanes on either side of Bent 3 (Figure 4.42). When the reconnaissance team arrived at the site, the collapsed spans had been completely removed and workmen were preparing to open up traffic on Fairfax Ave. Hence it was not possible to examine the collapsed structure. Conversations with Caltrans engineers at the site revealed that the piers in Bent 3 had failed and caused the girders to sag at this location. However, cable restrainers at the hinge west of Bent 4 prevented the girders from falling off of the hinge seats (Figure 4.43). Figure 4.44 is a photograph provided by EERC which shows the westbound lane of I10 over Fairfax Ave. It can be seen that the piers in Bent 3 shortened and caused the girder to sag. It can also be seen that the span to the west of Pier 2 lifted off of the abutment. Figure 4.45 is a close up view of one of the piers in Bent 3. The failure mode is similar to that observed at Venice Blvd. and La Cienega Blvd. When the piers were subjected to lateral ground motions, the lateral reinforcement was not able to adequately confine the core concrete. As a result of lateral load damage, there was a loss of axial load capacity and the piers shortened under the action of the vertical loads. As mentioned, the piers at Bent 4 had considerably more longitudinal reinforcement than the other piers. Examination of the piers in Bent 4 revealed varying degrees of diagonal cracking and spalling of the concrete cover. At the time of the site visit, these piers were surrounded with wooden shoring as a precautionary measure during the demolition of the collapsed spans.

Figure 4.42 Elevation and plan of I10 at the Fairfax Ave./Washington Blvd. Under Crossing

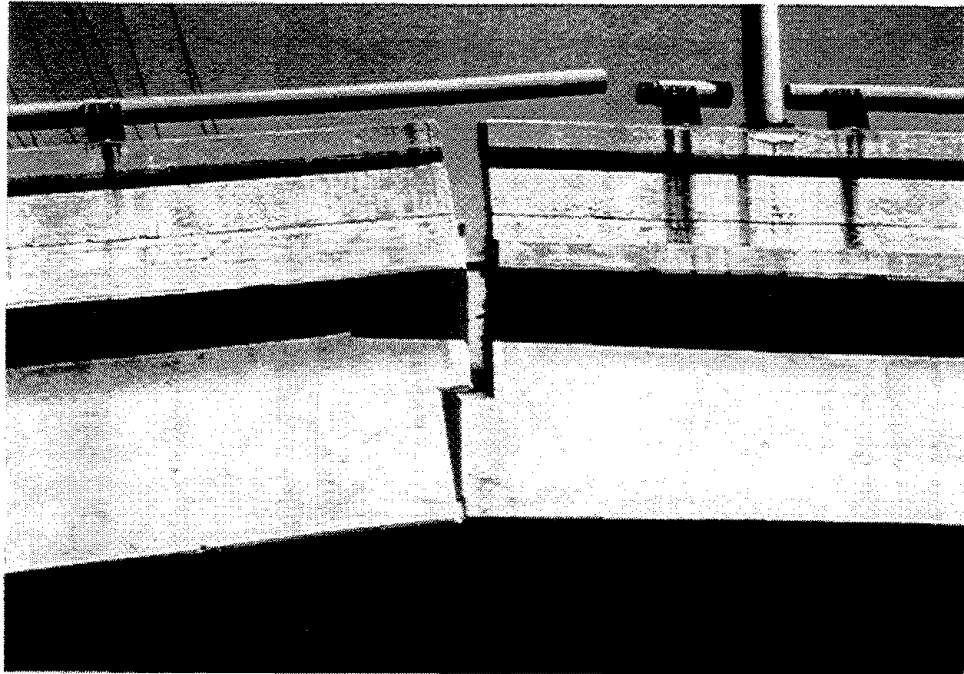
Figure 4.43 Hinge adjacent to Bent 4 of I 10 at Fairfax Ave.; cable restrainers prevented loss of support (Courtesy of EERC)

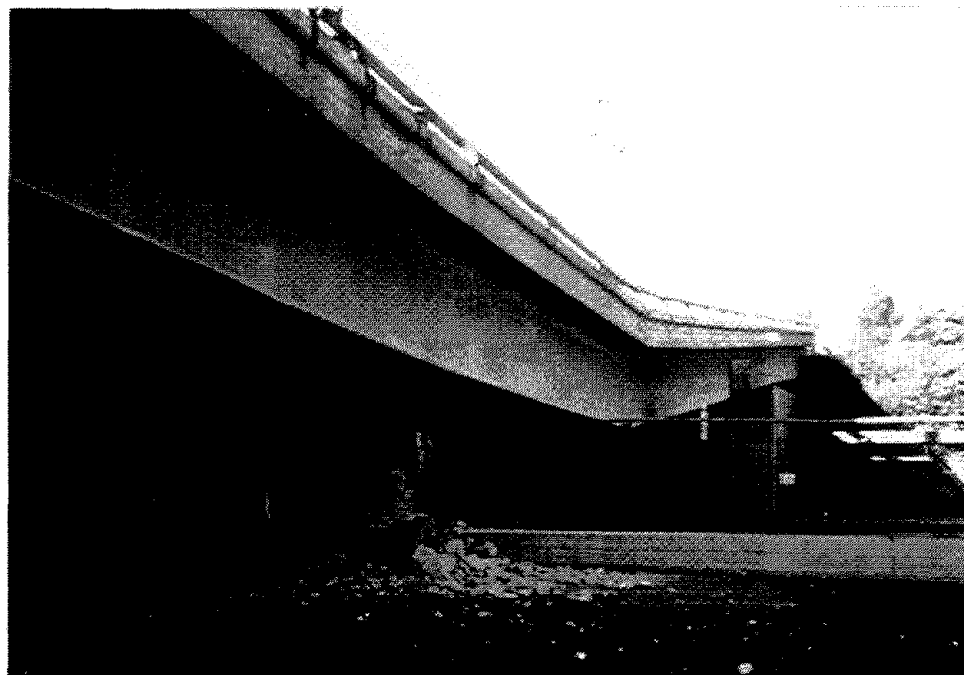
Figure 4.44 View of collapsed span of I10 over Fairfax Ave.; note rotation of girder over Pier 2 (Courtesy of EERC)

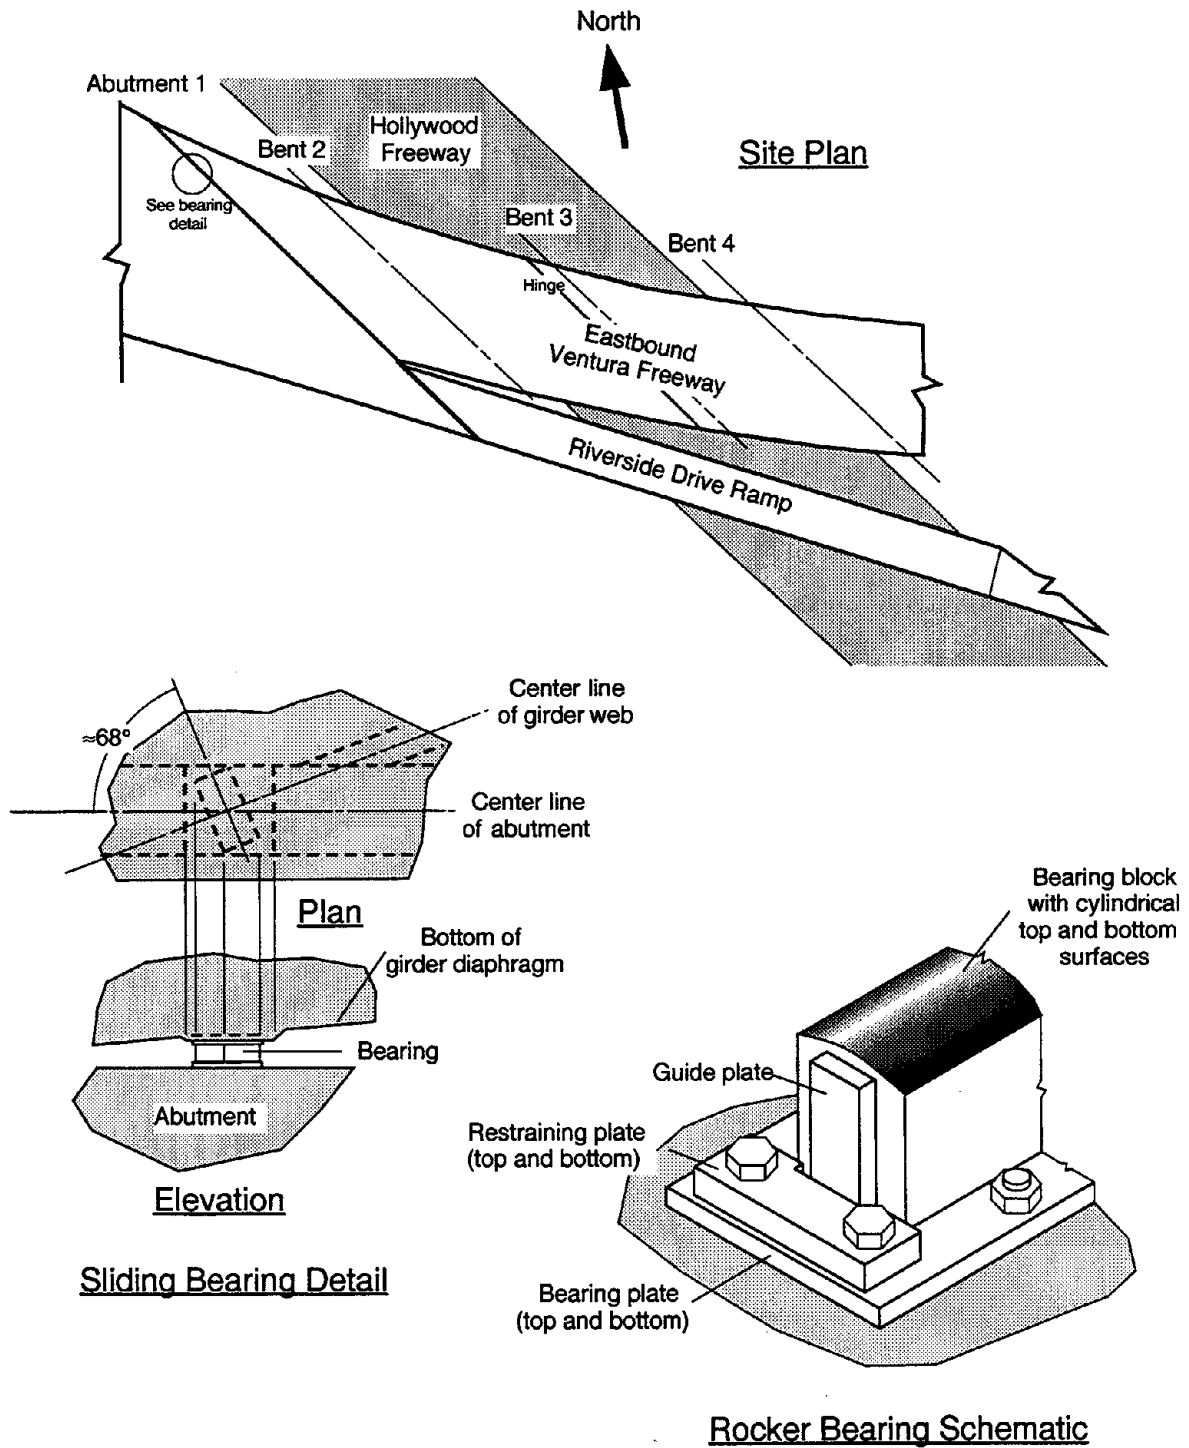
Figure 4.46 shows a simplified plan of the eastbound lane of the Ventura Freeway and the Riverside Drive ramp. Figure 4.47 is a ground level view of the eastbound lane as seen from the northbound lane of the Hollywood Freeway. At Abutment 1 (Figure 4.46), bearing supports are provided at the locations of the webs in the box girder. As shown in Fig, 4.46, the longitudinal axes of the bearings are aligned at right angles to the longitudinal axes of the girder webs. The four bearings on the north side of the eastbound lane of Ventura Freeway are of the sliding-type. Figure 4.48 shows the type of damage that was observed at these locations. Apparently, the dynamic frictional resistance of the bearing resulted in forces sufficient to spall off the shell of the abutment. The remainder of the bearings supporting the eastbound lane and the Riverside Drive ramp are of the rocker type. Figure 4.46 shows a schematic of this type of bearing. A steel bearing block with cylindrical surfaces is located between steel plates set into the abutment and girder end diaphragm. The blocks are kept in position with a system of guide plates and restraining plates as shown in Figure 4.46. All of the rocker bearings showed some type of earthquake damage. The bolts for the restraining plates were sheared off at many locations, and the sheared bolt heads were found at distances of up to several meters from their original position. Some of the bearing blocks were skewed from their original positions (Figure 4.49). In one case, the bearing block had tipped over resulting in a complete loss of support at that location (Figure 4.50).

Figure 4.46 Eastbound lane of Ventura Freeway crossing over Hollywood Freeway; site plan and bearing details

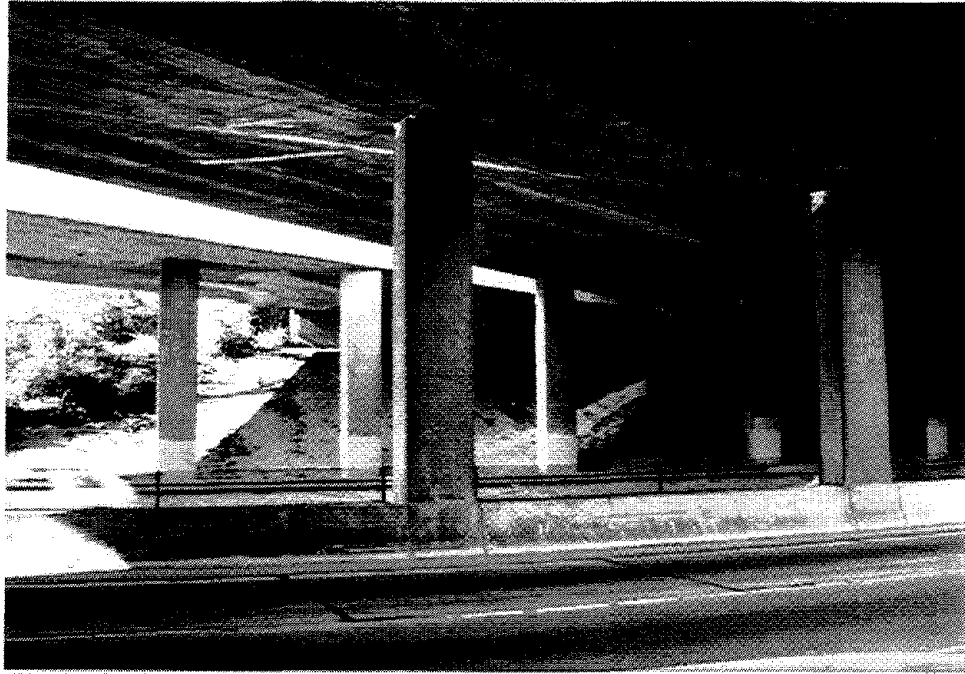
Figure 4.47 Eastbound lane of Ventura Freeway as seen from the northbound lane of Hollywood Freeway

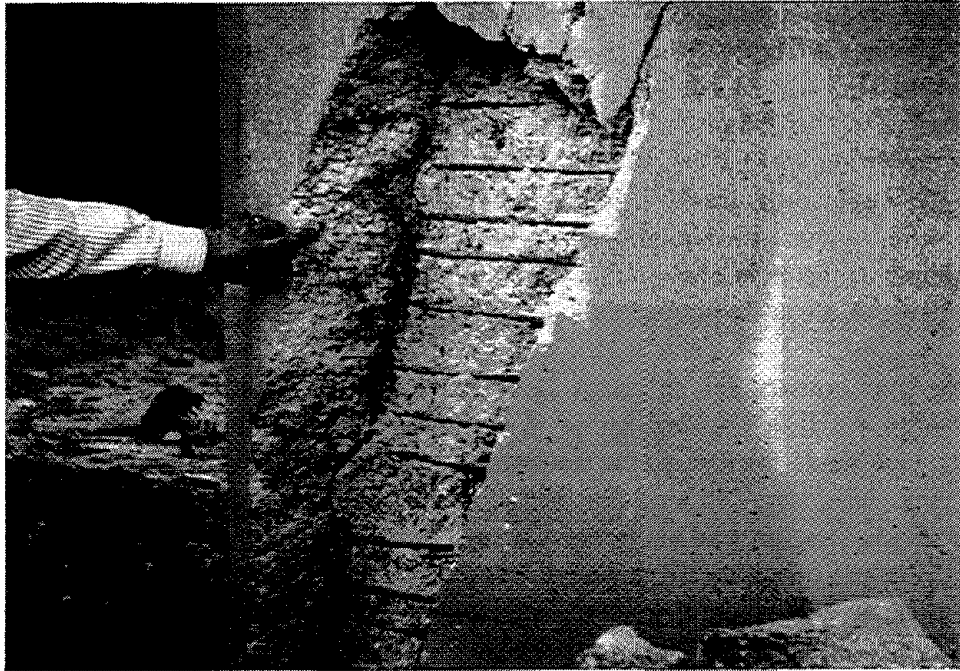
This is a long, curved ramp structure with piers of varying height. The last pier before the west abutment, adjacent to Sharp Avenue, exhibited severe shear cracking. This was one of the shortest and stiffest piers in the structure, so it probably attracted large lateral forces. Damage to the pier is shown in Figures 4.51 and 4.52. Note that when the photos in Figures 4.51 and 4.52 were taken the loose cover concrete had been removed by Caltrans workers to inspect damage to the core. It appeared that cracks extended into the core of the pier. The pier is octagonal in cross section, measuring 2440 mm (8 ft.) across, and has a flared section at the top. Longitudinal reinforcement consists of 64 #11 (36 mm) bars (EERC 1994). This pier contains high levels of shear reinforcement: #4 (13 mm) spirals spaced at 89 mm (3.5 in.). Damage to the abutment just to the west of this pier was also observed. This damage was apparently due to pounding between the superstructure and the abutment.

Figure 4.52 Close-up view of the westernmost pier at the Interstate 5, State Route 118, Southwest Connector, looking to the southeast. Loose cover concrete has been removed by Caltrans.

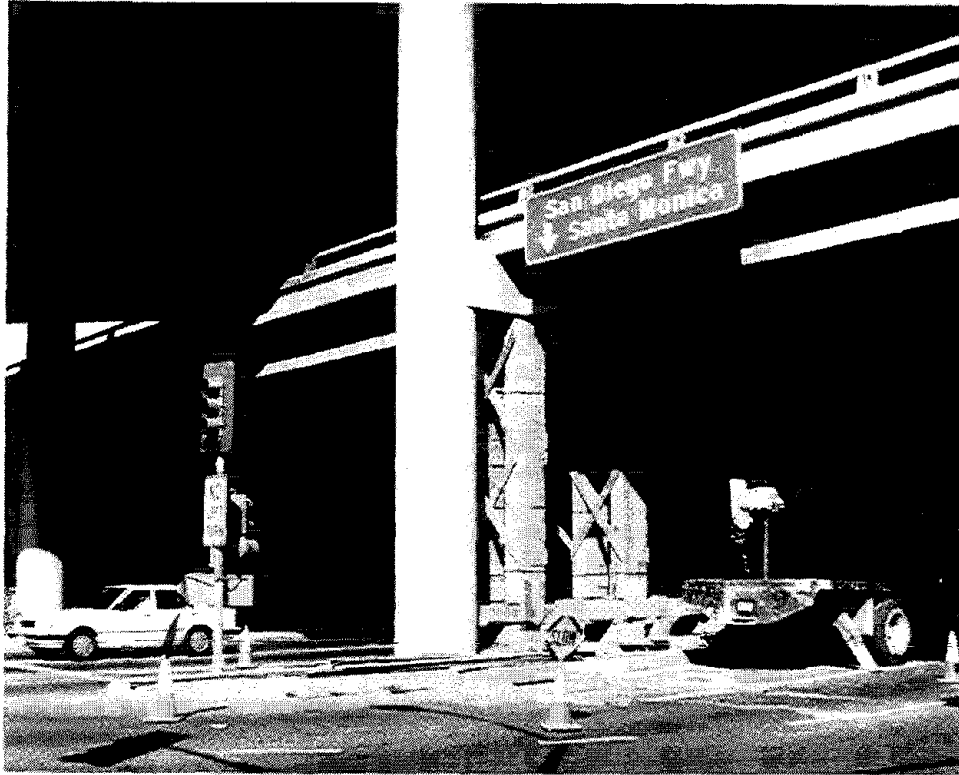
The damage observed in the Northridge earthquake possibly arose from three factors. First, the joint regions where cracking occurred are not as heavily reinforced as they would be under current design standards. Second, the structural hinges at the bases of most outrigger piers tended to increase the moments imposed on the outrigger joints. Third, the Jefferson Blvd. Undercrossing shares piers with the SR90 ramp above, as shown schematically in Figure 4.55. The upper SR90 structure is more flexible than the lower Jefferson Blvd. Undercrossing, possibly resulting in further concentrations of moments at the outrigger joints.

Figure 4.53 Overview of the outrigger joint at the SR90/I405 interchange, Jefferson Boulevard Undercrossing, center bent, west side, looking to the north
