1994 Northridge Earthquake

Performance of Structures, Lifelines and Fire Protection Systems

NISTIR 5396

March 1994
Building and Fire Research Laboratory
National Institute of Standards and Technology
Gaithersburg, MD 20899

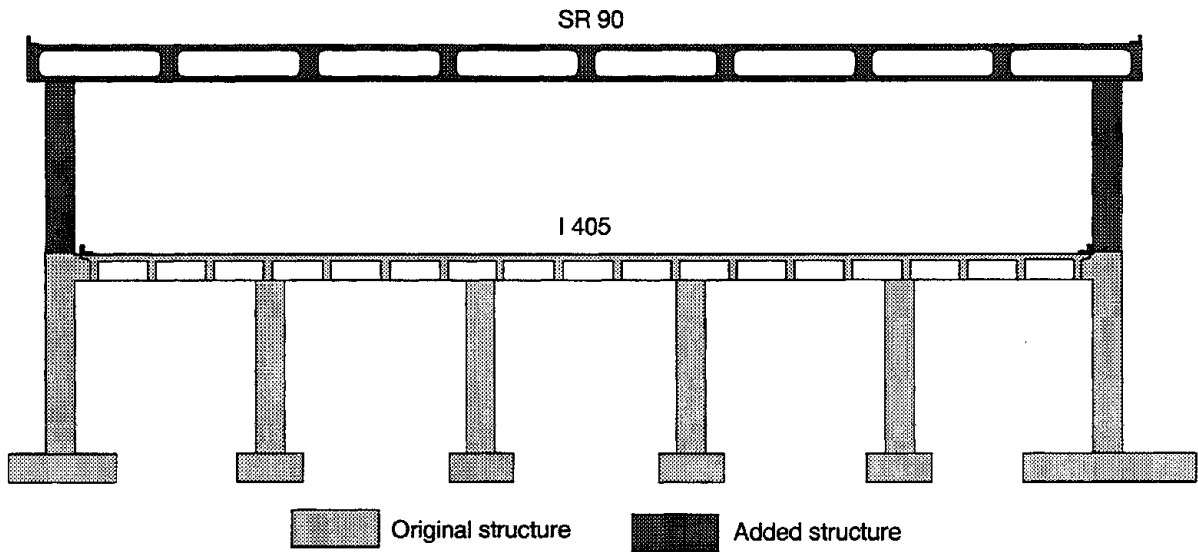
This bridge was constructed in about 1961, so generally speaking it does not meet current seismic design standards. The bridge is somewhat unusual because in the original design allowances were made for future construction of the ramps of the SR90/I405 interchange passing overhead: the outermost piers of the bridge were more heavily reinforced to allow for later extensions of the height of those piers. The reinforcement in the exterior piers consisted of 22 #18 bars (57 mm) longitudinally, and #5 bar (16 mm) spiral hoops spaced at 114 mm (4.5 inches); the inner piers were reinforced with 14 #9 bars (29 mm) longitudinally, and #4 (13 mm) spirals spaced at 305 mm (12 in.). The exterior piers were later extended in height, as can be seen in Figure 4.53. It is not clear how structural continuity was achieved between the original exterior piers and the pier extensions, since no explicit provisions were made in the original design for extending the longitudinal reinforcement.

Figure 4.55 Schematic cross section, showing columns shared by SR90 and the Jefferson Boulevard Undercrossing

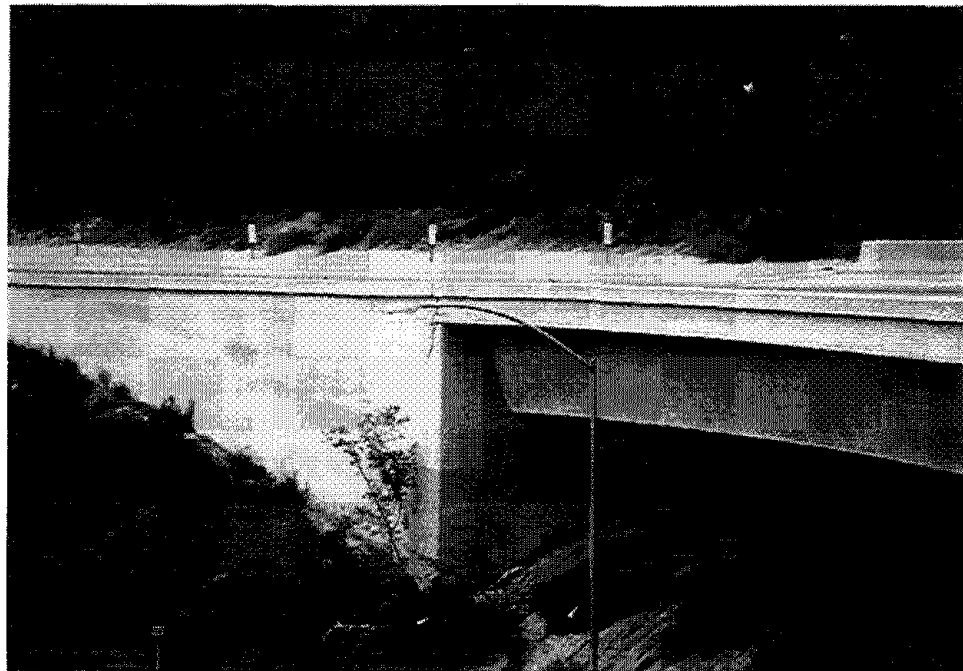
In the Northridge earthquake, bridge abutment damage ranged from minor settlement of backfill soil at the approaches, to cracking of wing walls, to permanent displacement of the entire abutment. For example, at the intersection of State Route 118 and Interstate 210, there was damage to the abutment at the east end of the long elevated structure connecting eastbound SR118 with northbound I210. An overview of the abutment is shown in Figure 4.56, and a close-up of some of the abutment sidewall cracking is shown in Figure 4.57. At the interchange of US101, SR134 and SR170, at the Riverside Drive Offramp Overcrossing (Caltrans bridge No. 53-1493S, described above) the abutments at both ends of the offramp exhibited severe cracking in the wing walls. Damage to concrete abutment piles was reported (EERC, 1994) at the Las Virgenes Overcrossing on US101 (Caltrans bridge No. 53-1442). There were many other cases of bridge abutment damage observed by the reconnaissance team, and reported by other investigators, which are too numerous to list here.

Figure 4.56 Overview of abutment at the east end of the ramp connecting eastbound SR118 with northbound I210

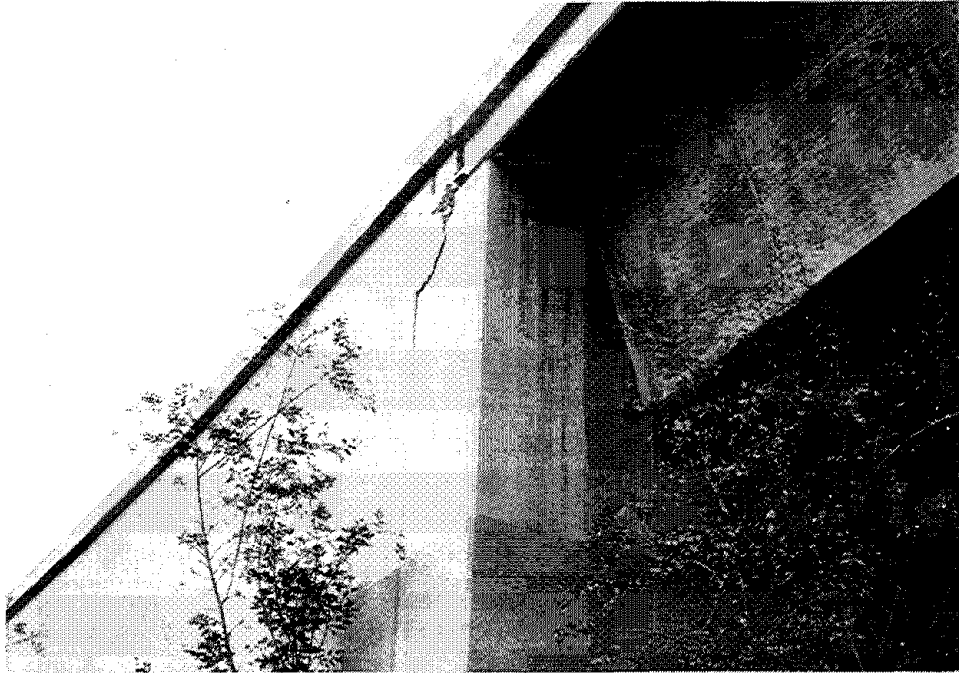
Figure 4.57 Close-up of abutment wall cracking at the east end of the ramp connecting eastbound SR118 with northbound I210

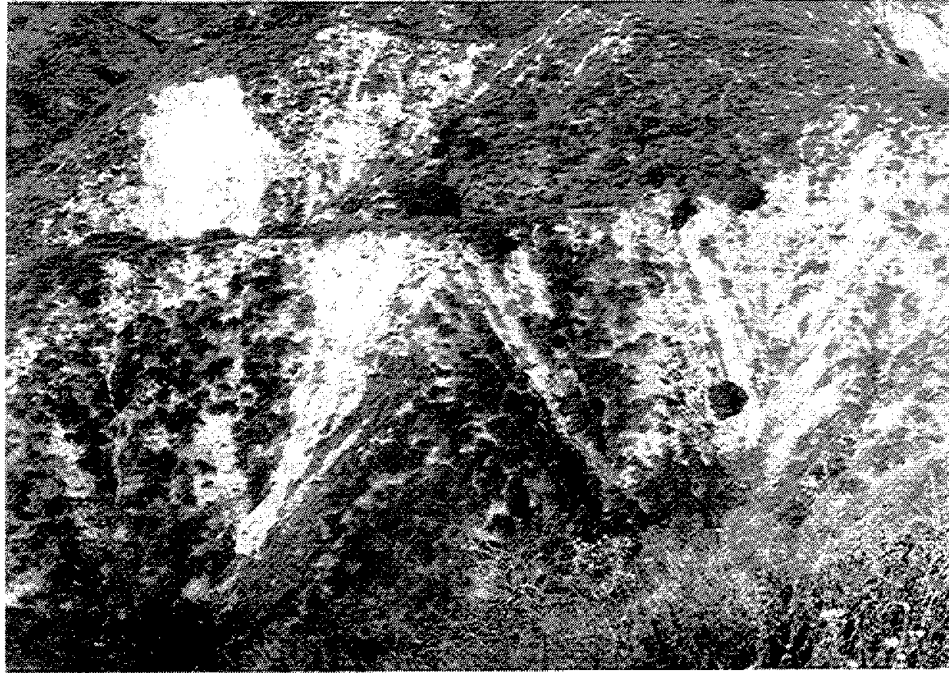
Among the numerous situations that contributed to the disruption of the water supply system was damage to one of the four damaged pipelines, Los Angeles Aqueduct No. 2 at Terminal Hill. Aqueduct No. 2 is made of 2.1-m (77 in.) diameter steel pipes. (Pipeline diameters range from 1.4 to 3 m (54 to 120 in.)) Terminal Hill is located about 20 km (12.5 miles) north-northwest of the epicenter, southwest of the intersection of I-5 and SR14. There is no strong motion record available for the site. However, two stations maintained by the California Division of Mines and Geology (CDMG) and the U.S. Geological Survey (USGS) about 5 km (3 miles) south of the site showed peak ground accelerations over 0.9g, indicating that the site probably was strongly shaken by the earthquake. Another indication of strong shaking can be seen from the numerous landslides along the mountainside to the north of the site (Figure 5.1).

Figure 5.1 Strong shaking at Aqueduct No. 2 at Terminal Hill can be inferred from the numerous landslides along the mountain slopes to the north of the site.

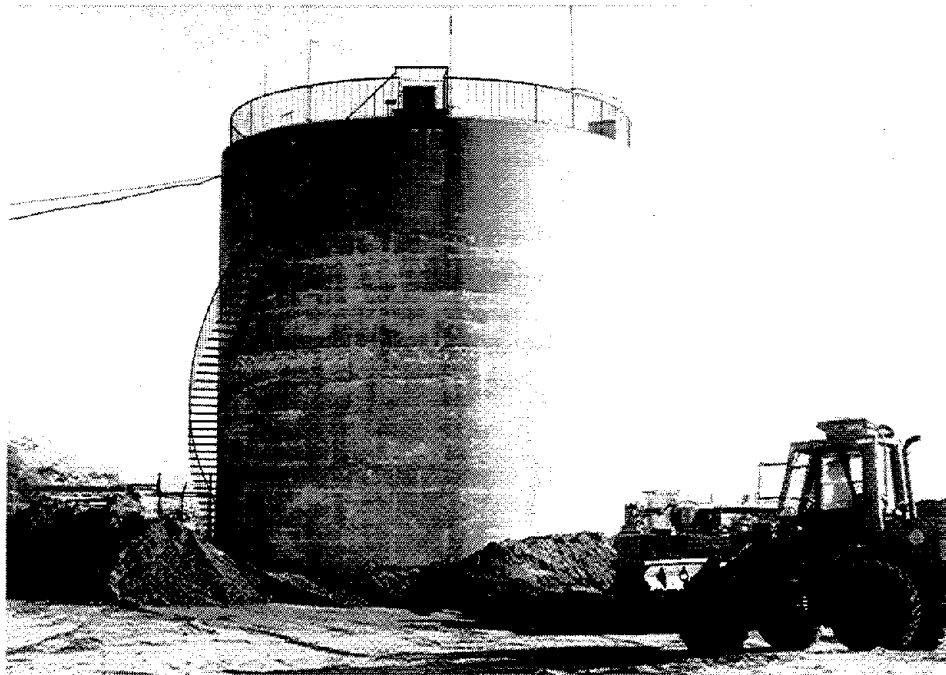
Figure 5.2 The reinforced concrete surge tank at Terminal Hill performed well during the earthquake--no damage was observed.

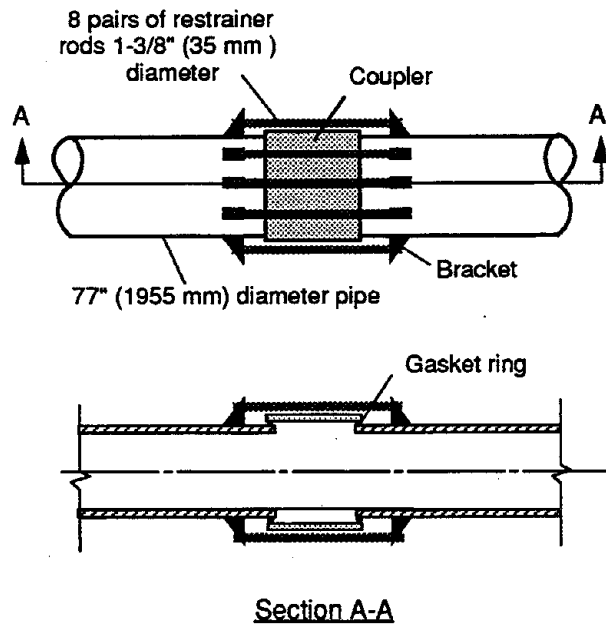
Figure 5.4 Schematic drawing of connection of the two steel pipe sections which were pulled apart during the earthquake.

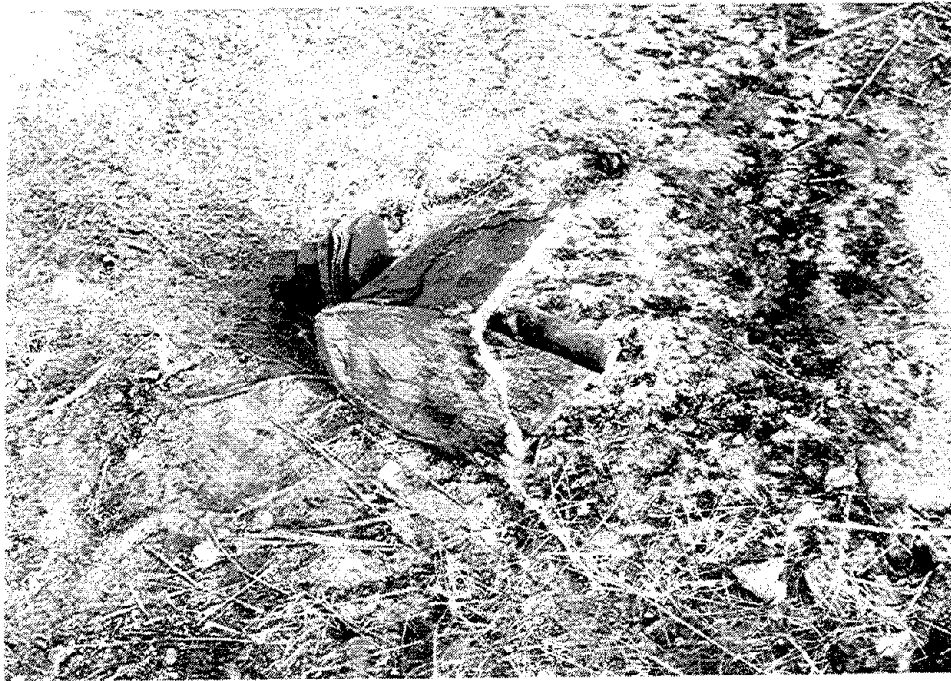
The reinforced concrete relief tank (surge chamber) on top of the hill appeared to perform well through the earthquake--no damage was observed (Figure 5.2). A steel pipe brings water up from the canyon below (Figure 5.3). The pipe is supported on concrete saddles built along the mountain slope. In a few places, the pipe separated from the saddles creating 50 to 80 mm (2 to 3 in.) gaps. In at least one location, the pipe crashed into the saddle. In two other locations, the pipe sections bulged 80 mm and 150 mm (3 and 6 in.) respectively. However, no rupture or leakage was noticed. The ruptured section of the 2.1-m pipe is located near top of the hill. The two sections where the rupture occurred were connected together using a mechanical coupling system (Figure 5.4). To restrain the relative movement between the two pipe sections during strong shaking, the sections were connected by eight pairs of restrainer rods 35 mm (1-3/8 in.) in diameter and 2.2 m (7 ft) long. The rods were attached to brackets, which were welded to the pipes. These welds broke due to strong shaking (Figure 5.5) and resulted in the separation of the two pipe sections.

Figure 5.5 Welds of the restrainers broke as the result of strong shaking.

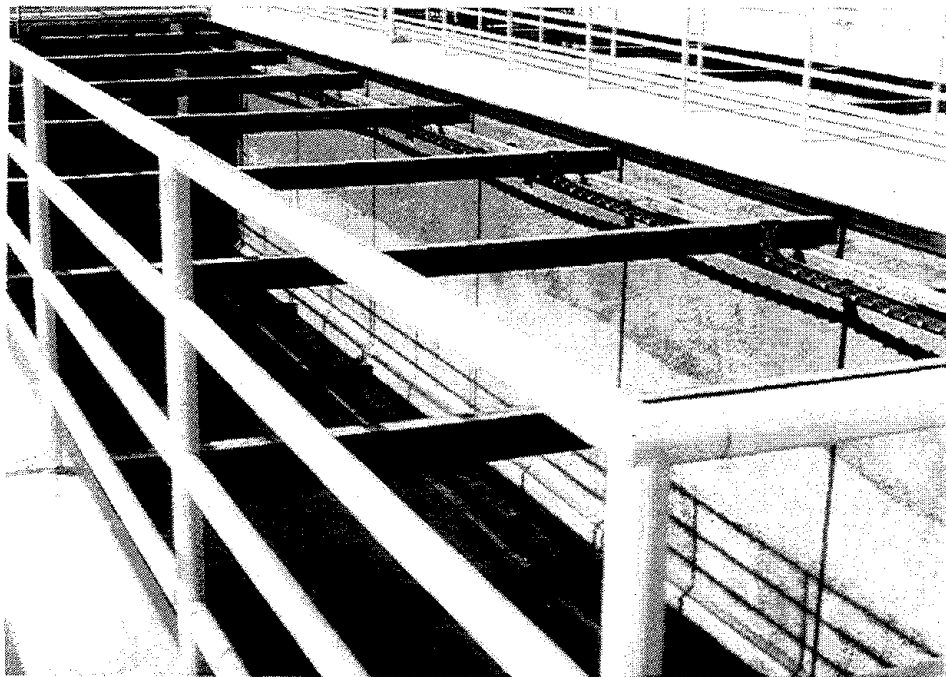
The earthquake resulted in damage to five out of twenty-two final clarifier tanks built in 1991 as the Phase II expansion. Twenty-two Phase I tanks built in 1983 survived the earthquake without damage. Figure 5.6 shows a typical undamaged final clarifier tank. The scrapers are supported by railings attached to the walls with brackets. Chains are used to move the scrapers. All these components were made of plastics in the Phase II construction, whereas the brackets were made of metal and railings and scrapers were made of redwood in Phase I. Pins about 10 mm (3/8 in.) in diameter and 19 mm (3/4 in.) long connected the brackets to the railings. In the tanks where the system failed, it is suspected that the pins dislodged as the result of wave action in the tank and displaced the railing, therefore jamming the movement of the chain, which disabled the system (Figure 5.7).

Figure 5.6 Undamaged clarifier tank at the Tillman Water Reclamation Plant.

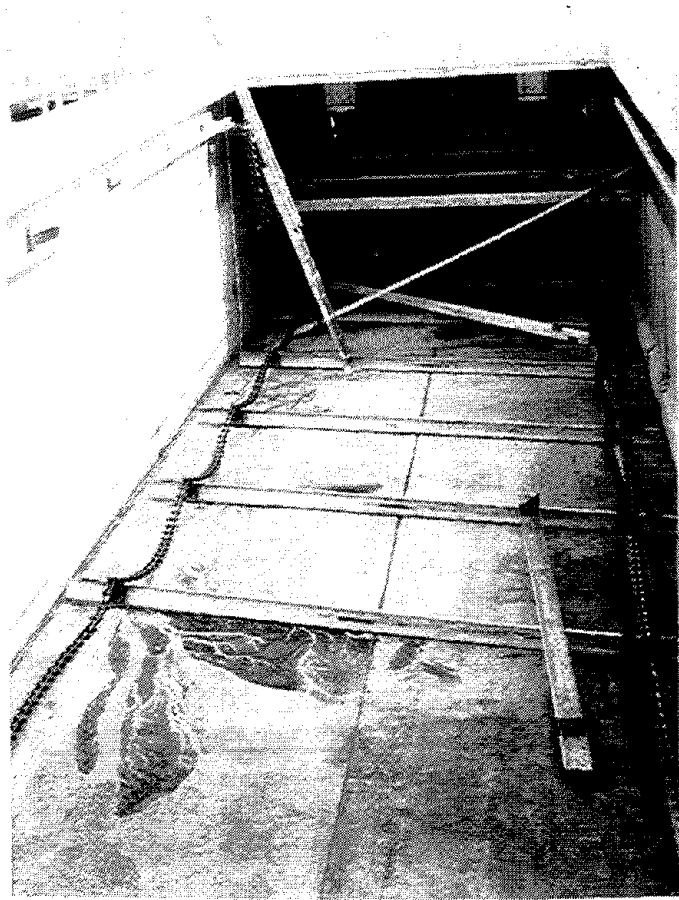
Figure 5.7 A damaged sludge scraper in a clarifier tank at the Tillman Water Reclamation Plant.

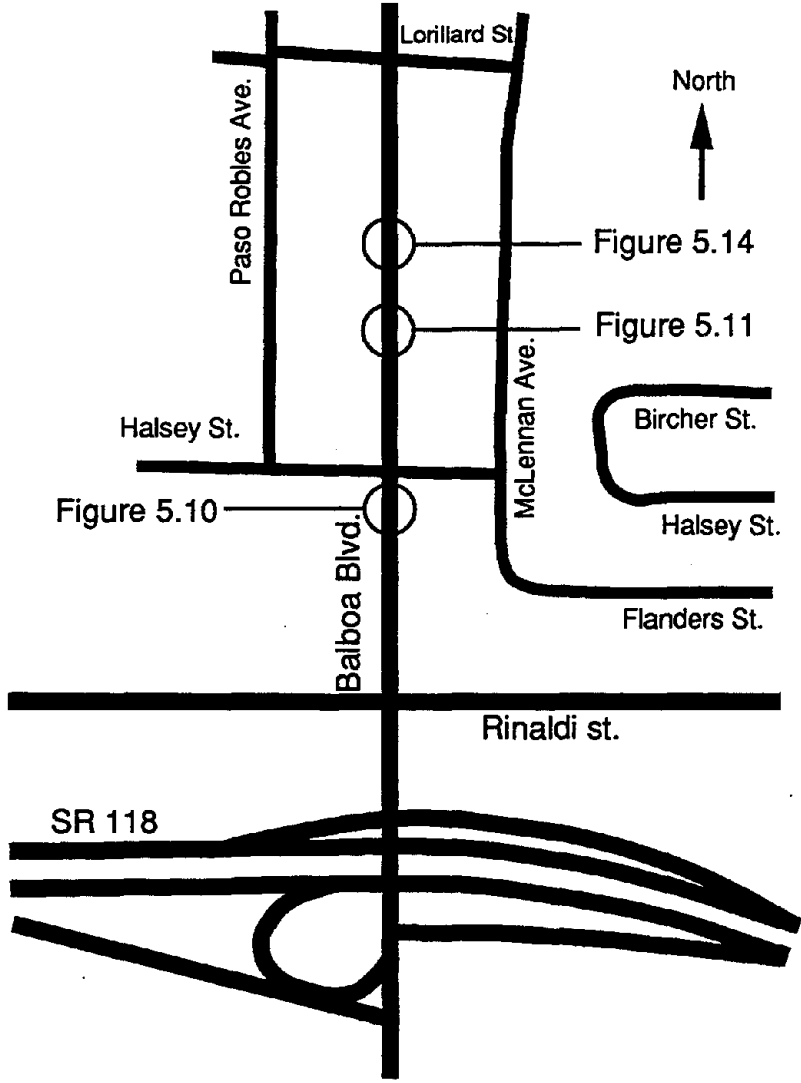
The rupture of a 0.6-m (22-in.) gas main occurred along Balboa Boulevard between Rinaldi Street to the south and Lorillard Street to the north, about 0.5 km (0.3 miles) north of the intersection of Balboa Boulevard and SR118 (Figure 5.8). Along this stretch, compressional ground failures occurred between Rinaldi Street and Halsey Street, and extensional ground failures occurred between Bircher Street and Halsey Street. Ground extension at this location is prominently exhibited by the transverse cracks in the pavement as shown in Figure 5.9. Further, lateral spreading of 25 to 100 mm (1 to 4 in.) toward the west was observed along the sidewalk on the west side of Balboa Boulevard north of Halsey Street, whereas no lateral spreading was observed on the east side of Balboa Boulevard.

Figure 5.8 Location of the 0.6-m gas main rupture on Balboa Boulevard.

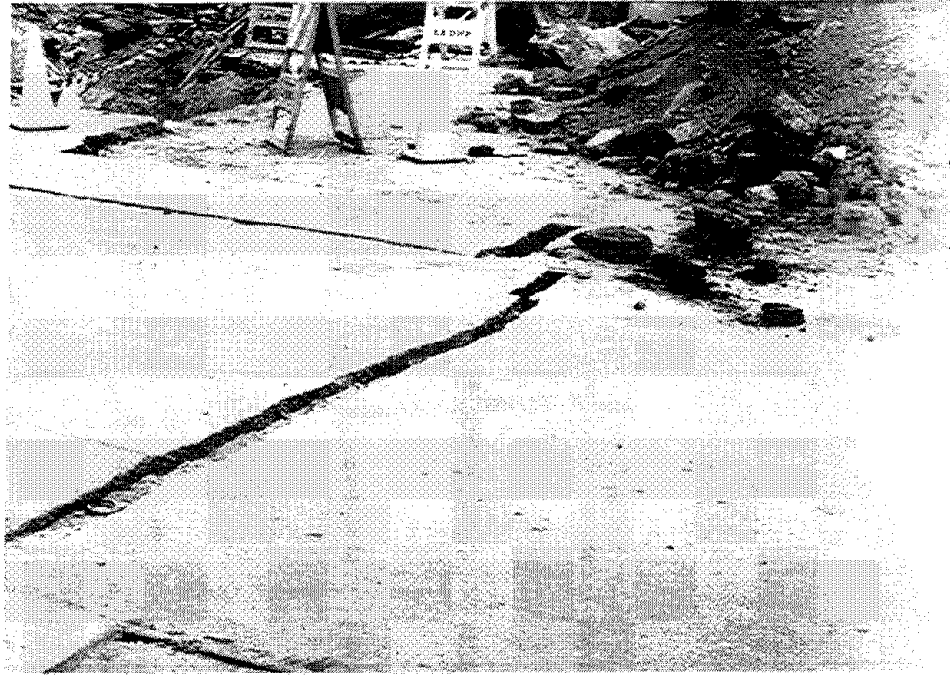
Figure 5.9 Ground extension at the gas fire site on Balboa Boulevard can be seen by the transverse cracks in the pavement.

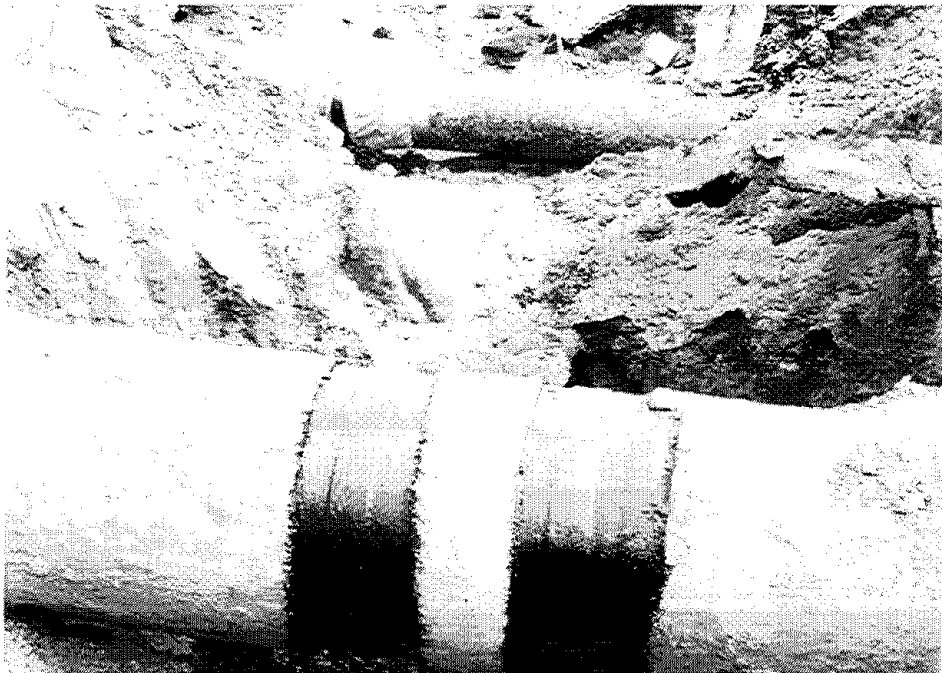
About one block north, the ground extension caused rupture of the same 0.6-m (22-in.) gas main and a 1.2-m (48-in.) water main (Figure 5.11). These pipes were pulled apart as the result of the ground extension. The rupture of the gas main caused a major fire at the site that destroyed five houses (Figures 5.12 and 5.13). The loss of both water mains at this location and the difficult access to the site due to the fire and flooding in the street made fire fighting difficult.

Figure 5.11 Ground extension along Balboa Boulevard resulted in the rupture of the same gas main and water main shown in Figure 5.10. The rupture of the gas main here caused a major fire that engulfed five houses.

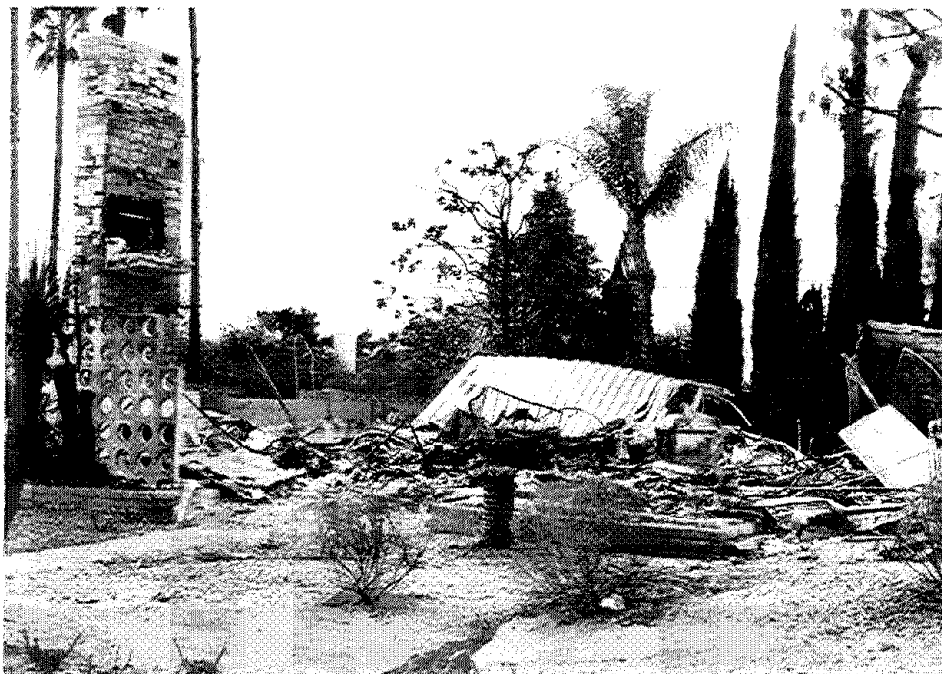
Figure 5.12 Houses destroyed by a fire resulting from the rupture of the 0.6-m gas main along Balboa Boulevard.

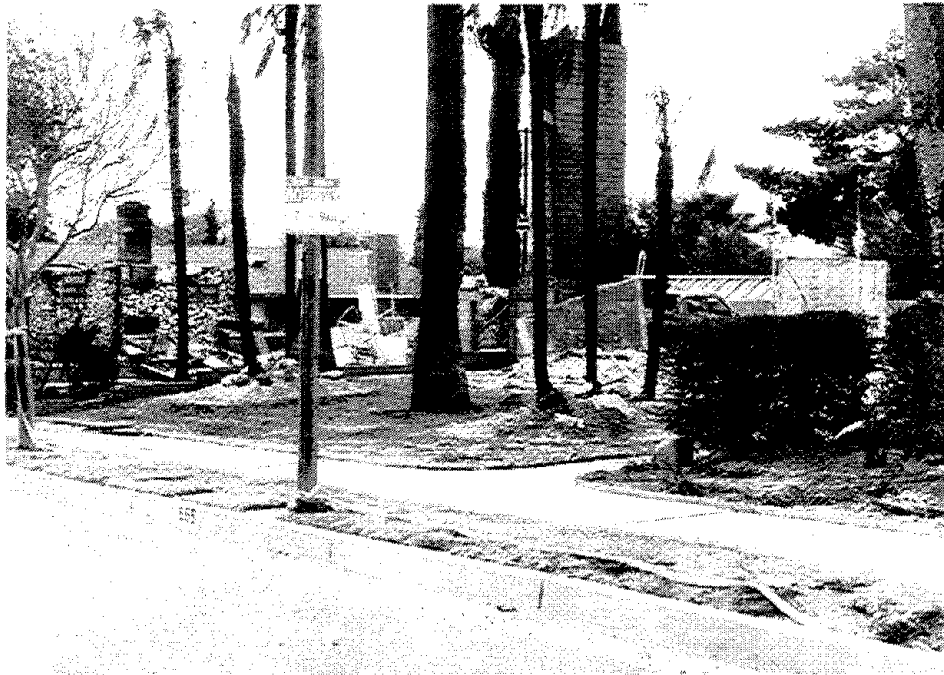
Figure 5.13 Houses destroyed by a fire resulting from the rupture of the 0.6-m gas main along Balboa Boulevard.

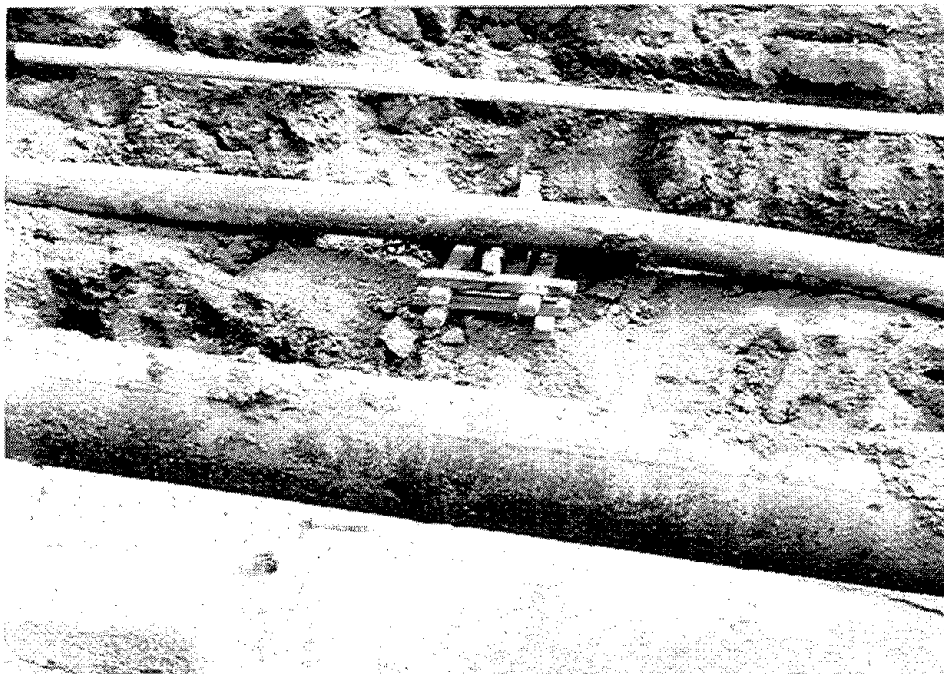
Figure 5.14 Some of the buried pipelines located near the intersection of Balboa Boulevard and Bircher Street--the potential hazard of co-location of lifeline systems. At this site are three water lines (two of them main lines); three gas lines; two sewers; one crude oil line; overhead power, telephone, and cable TV lines; the street lighting system; and the street itself.

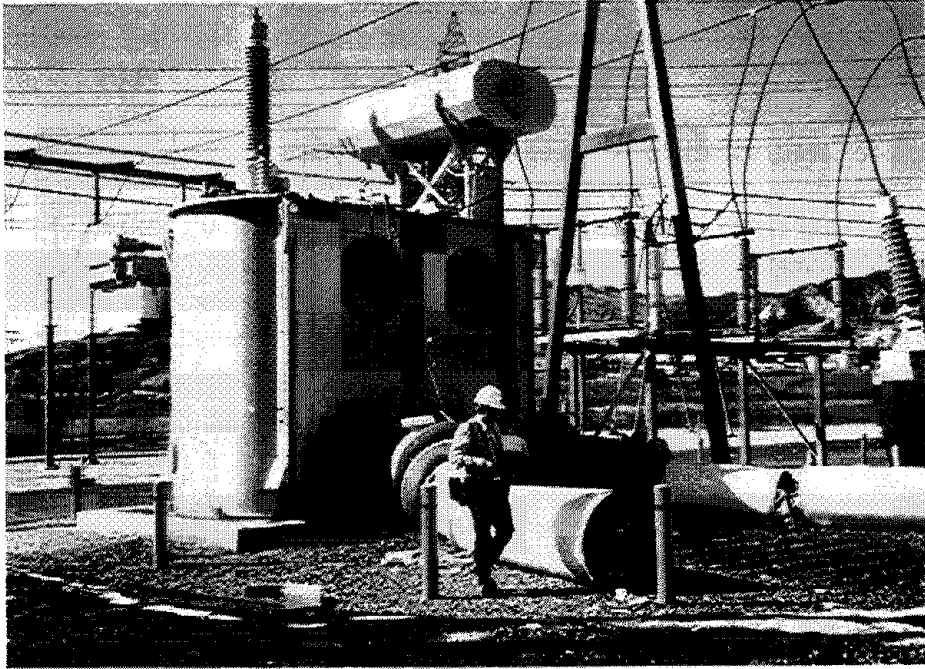
Some transmission towers suffered significant damage, many as the result of foundation failure. Damage to several high voltage substations near the epicenter, such as Sylmar, Pardee, and Rinaldi, led to the widespread power outage in the Los Angeles basin, as well as the isolated outages throughout seven western states (Figure 5.15). As happened during the 1971 San Fernando earthquake, porcelain elements of equipment of 230 kV and 500 kV classification suffered the most damage (Figure 5.16). This highlights the urgent need for developing new materials that would be more earthquake resistant to replace porcelain, which is very brittle. Furthermore, most of the 230 kV circuit switchers, similar to those in the forefront of Figure 5.17, at the Sylmar substation, were damaged. However, none were damaged during the 1971 earthquake, a possible indication of much stronger ground shaking by the Northridge earthquake. Most of the capacitor banks, similar to those in the background in Figure 5.17, performed well in this earthquake, whereas most collapsed during the 1971 quake. Better performance of the capacitor banks is the result of higher seismic requirements in equipment qualification and in installation practices.

Figure 5.15 Damage to DC equipment at several high voltage substations, such as this one at Sylmar, led to widespread power outages in the Los Angeles area as well as isolated outages throughout seven western states. (Photo courtesy of Edward Matsuda, Pacific Gas and Electric Company.)

- Improved methods for avoiding damage to high voltage substations should be supported. New materials should be developed to replace the brittle porcelain insulators. Better switch systems should be developed and installed to prevent blackouts in areas serviced by the system. Failures of foundations for transmission towers should be more thoroughly investigated.

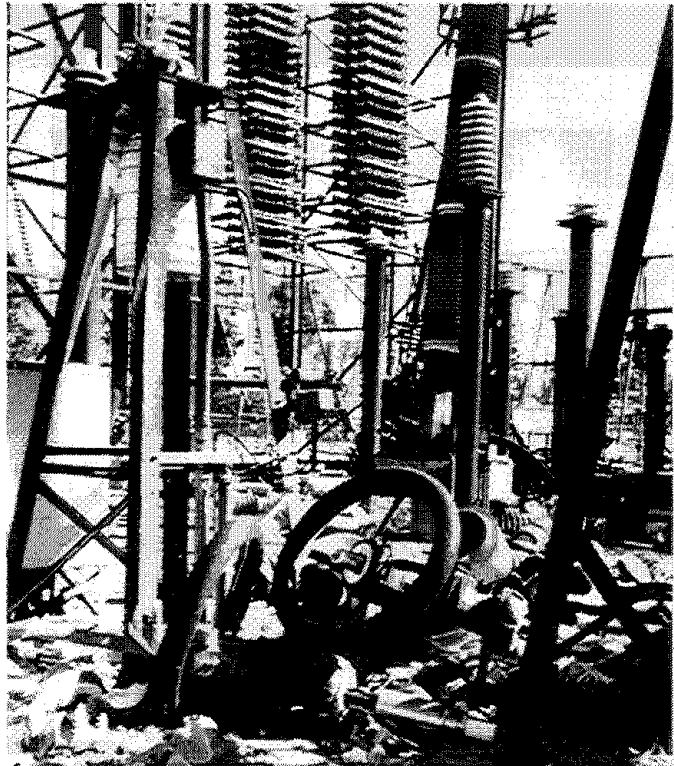
Figure 5.16 Porcelain is an integral part of high voltage electrical equipment due to insulation requirements and is also the most vulnerable to damage during strong earthquake shaking. (Photo courtesy of Edward Matsuda, Pacific Gas and Electric Company.)

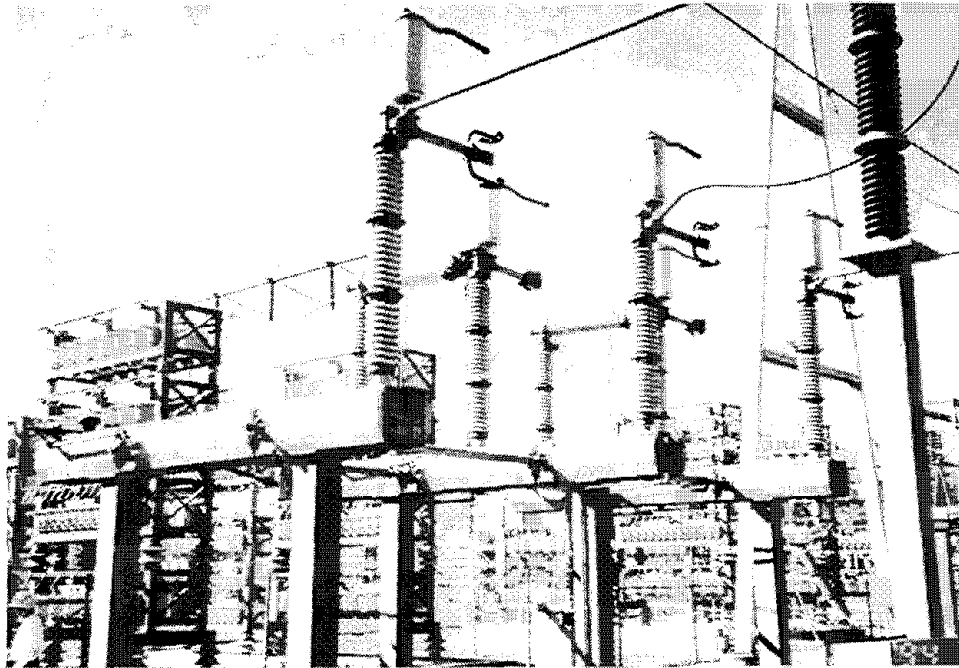
Figure 5.17 Most of the 230 kV circuit switchers (in the forefront) at the Sylmar substation were damaged. Most of the capacitor banks (in the background) performed well in this earthquake, whereas most collapsed during the 1971 quake. (Photo courtesy to Edward Matsuda of Pacific Gas and Electric Company.)

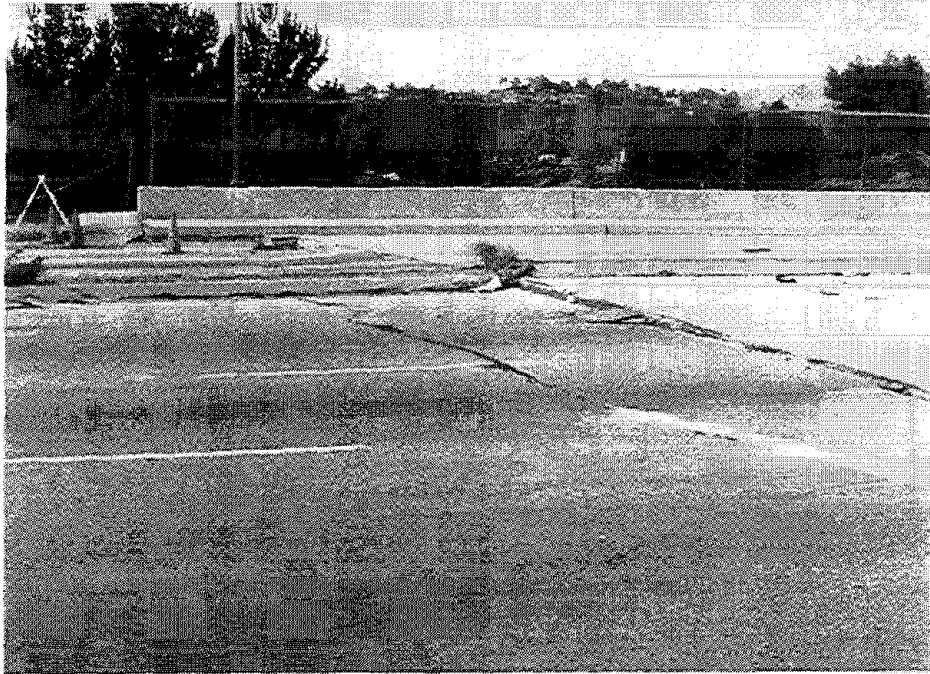
Strong ground shaking and lateral movement of subgrade materials resulted in numerous ruptures of asphalt pavement and concrete sidewalks in the epicentral area (Figures 5.19 and 5.20). In some instances, local traffic was interrupted temporarily waiting for the repair of these cracks. In most cases, the damage was minor and local traffic was not interrupted. The south approach of Balboa Boulevard at SR118 caved in because of loss of abutment fill due to a water main break (Figure 5.21). This bridge was closed for traffic due to some structural damage to the piers and the loss of the south abutment fill.

Figure 5.20 Transverse cracks in pavement near the intersection of Balboa Boulevard and SR118.

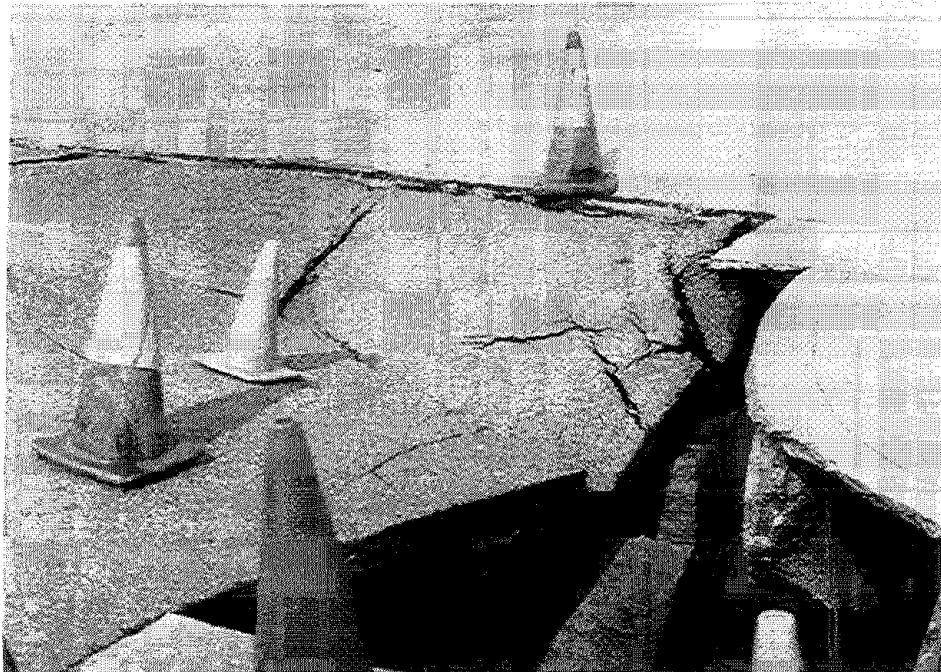
Figure 5.21 The approach of Balboa Boulevard at SR118 caved in due to the loss of the abutment fill because of a water main break.

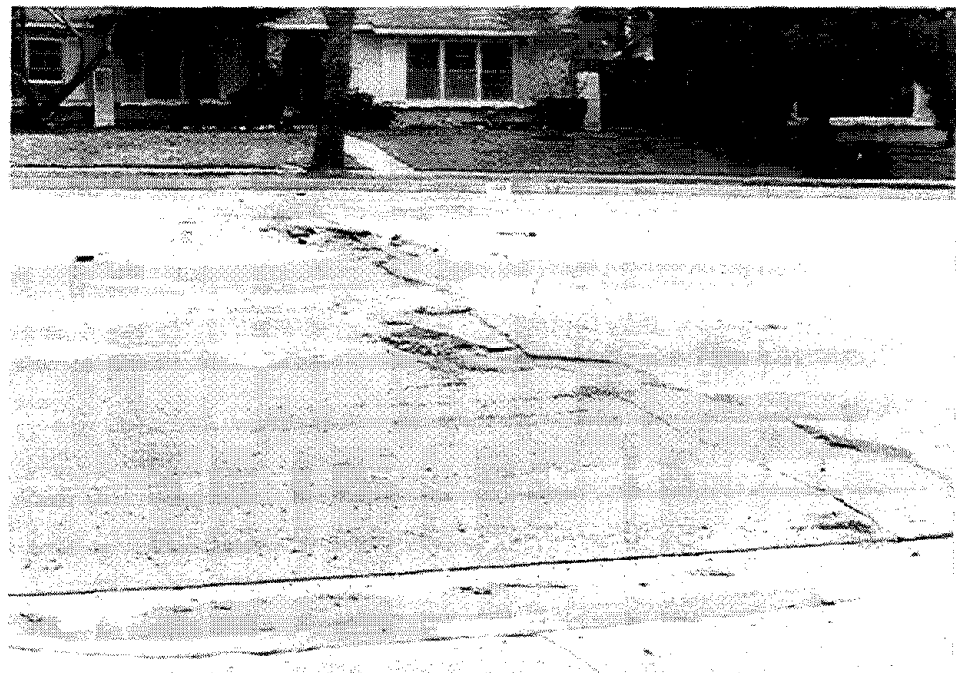
Figure 5.19
Transverse cracks
in pavement along
Balboa Boulevard
in Northridge area.

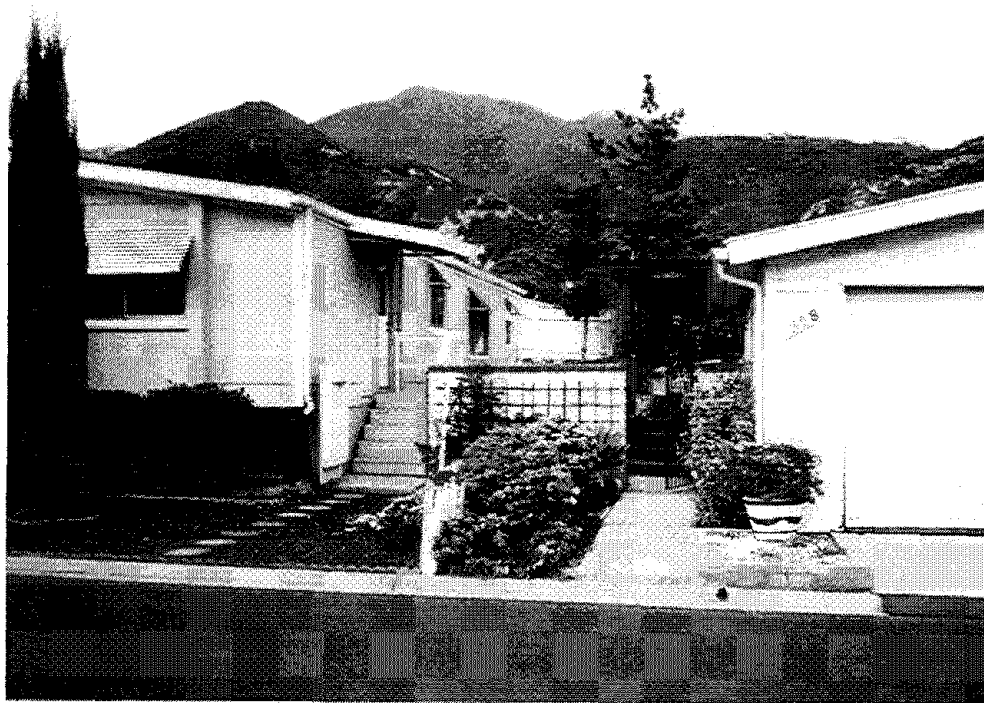
Building-to-building fire spread was limited to three manufactured housing developments (mobile home parks). Figure 6.8 shows the typical spacing between units in one of these developments. Figure 6.9 shows an area of the development destroyed by fire. Observations made at this development after the fires indicates the method of unit-to-unit fire spread was primarily through windows. Once a unit became completely involved in fire, the thermal radiation was sufficient to either cause the breakage of windows in an adjacent unit or ignite combustibles within the unit directly through the windows. The fire department reported low water pressure in the area which combined with multiple independent fires and limited resources hindered fire fighting operations. The fire spread was stopped either by separation such as roads and open areas or by fire department operations.

Figure 6.8 Typical unit spacing in a manufactured housing development.

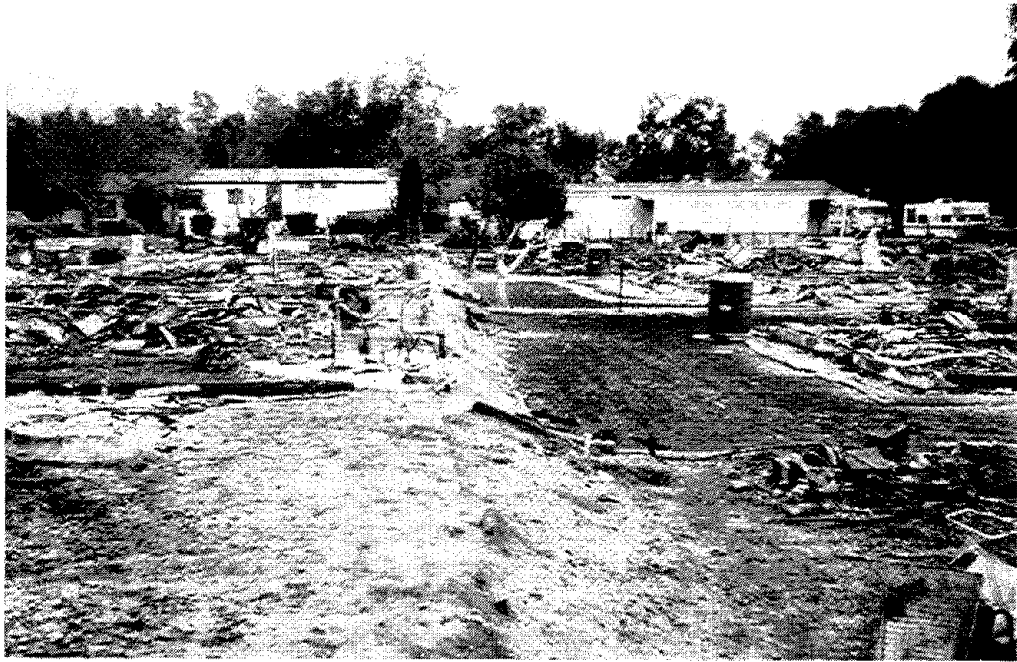
Figure 6.9 Impact of a multiple unit fire in a manufactured housing development.

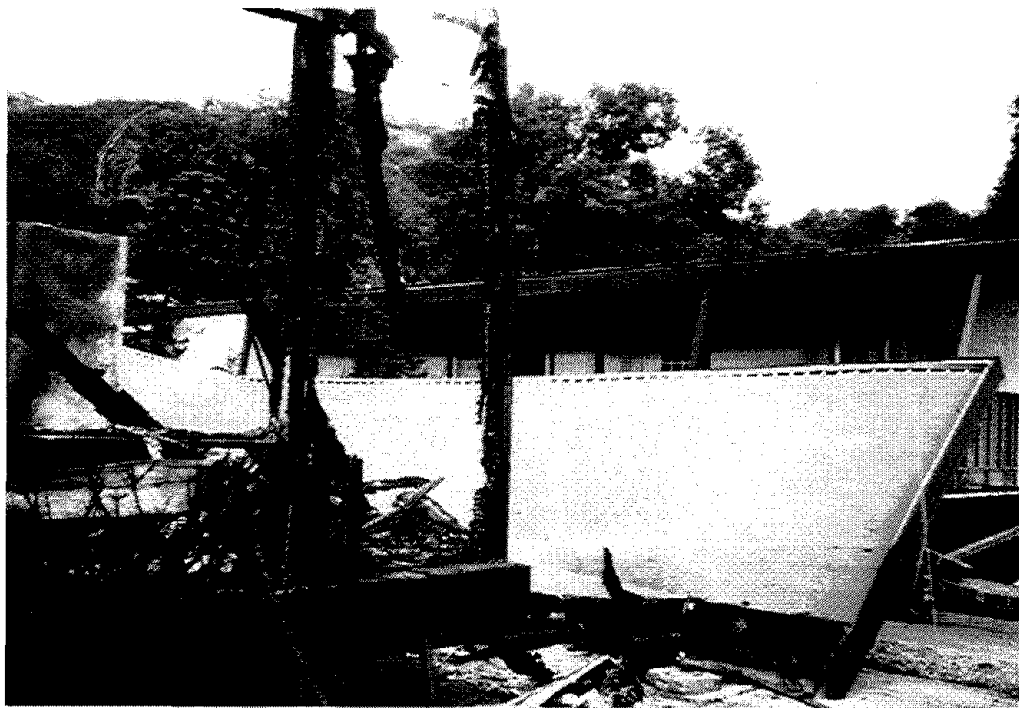
A unique aspect of the construction of these manufactured units played a role in limiting the spread and assisting fire department actions. As the units burned from the inside, the carport roofs collapsed from the building side, coming to rest on the outside supporting columns. In this way the carport roofs formed fire breaks as shown in Figure 6.10. Although these roofs would not necessarily have survived the fire by themselves, they reduced the fire exposure on adjacent units and thus enhanced fire fighting operations.

Figure 6.10 Collapsed roof which acted as a fire break in a manufactured housing development.
