1994 Northridge Earthquake Performance of Structures, Lifelines, and Fire Protection Systems

Building and Fire Research Laboratory
National Institute of Standards and Technology
Gaithersburg, MD 20899-0001

May 1994

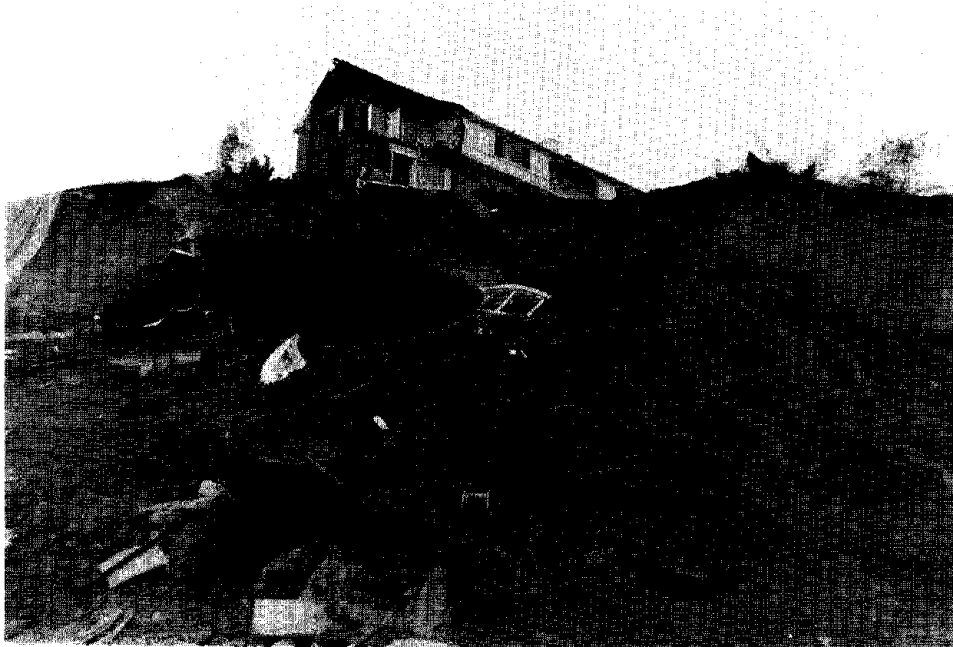
Landslides, rock slides and slope failures were the most visible geotechnical effect caused by the earthquake. Landslides along the Pacific coast in Santa Monica and Malibu damaged several buildings (fig. 2.8). Rockfalls in the Santa Monica, Santa Susana, and San Gabriel Mountains closed roads. Mulholland Drive in Sherman Oaks was temporarily closed because of the threat of slope failure.

Figure 2.8. A landslide along the Pacific Coast Highway north of Santa Monica undermined the foundation of a house at the crest of the slope, bringing a portion of the house down.

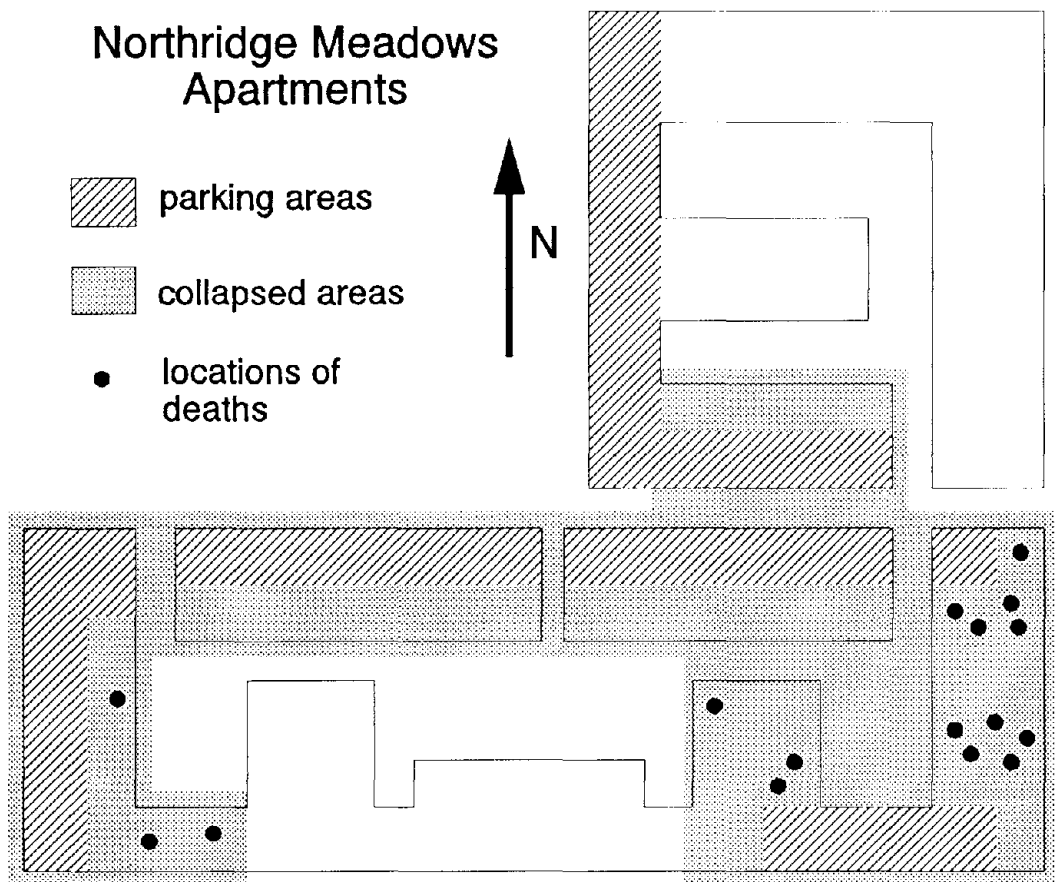
Figure 3.3. This plan of the Northridge Meadows apartment complex shows the distribution of parking and living spaces at the first level, and locations of deaths (source: Los Angeles Times, January 24, 1994). The shaded areas indicate the portions of the complex which collapsed.

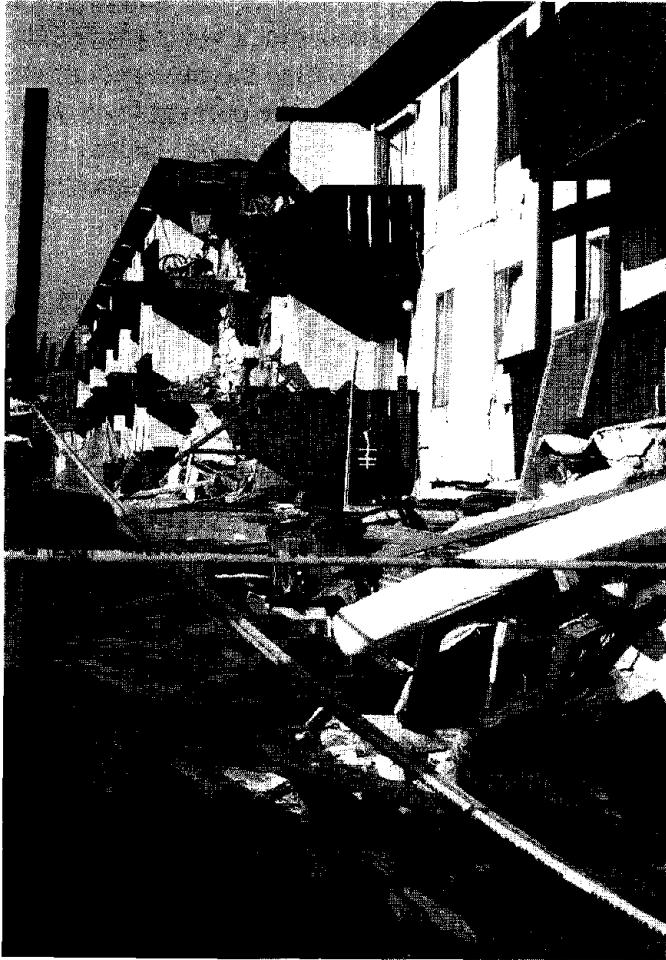
Collapses in a single apartment complex caused sixteen of the twenty-two deaths related to building failures [12]. The Northridge Meadows complex, constructed in 1972 (Los Angeles Times, January 19, 1994), consisted of several three-story wood-frame buildings, arrayed around courtyards on two sides of a mid-block alley. About half of the units had open spaces for parking on the street level. Typically these were around the perimeter of the complex. Most of the interior courtyard-facing units had living space at the ground level rather than parking. About half of the buildings in the complex collapsed. In all of the collapses, the first story gave way while the second and third stories remained largely intact. The 16 people killed were in first story apartments. All the buildings in the complex suffered some damage (figs. 3.3 and 3.4).

Figure 3.4. At the Northridge Meadows apartment complex near the epicenter the first story in several of the buildings collapsed, killing sixteen people. The second and third stories remained essentially intact. Large portions of the first story in these buildings were open space for parking. This type of collapse occurred in a significant number of similar apartment buildings throughout the affected area.

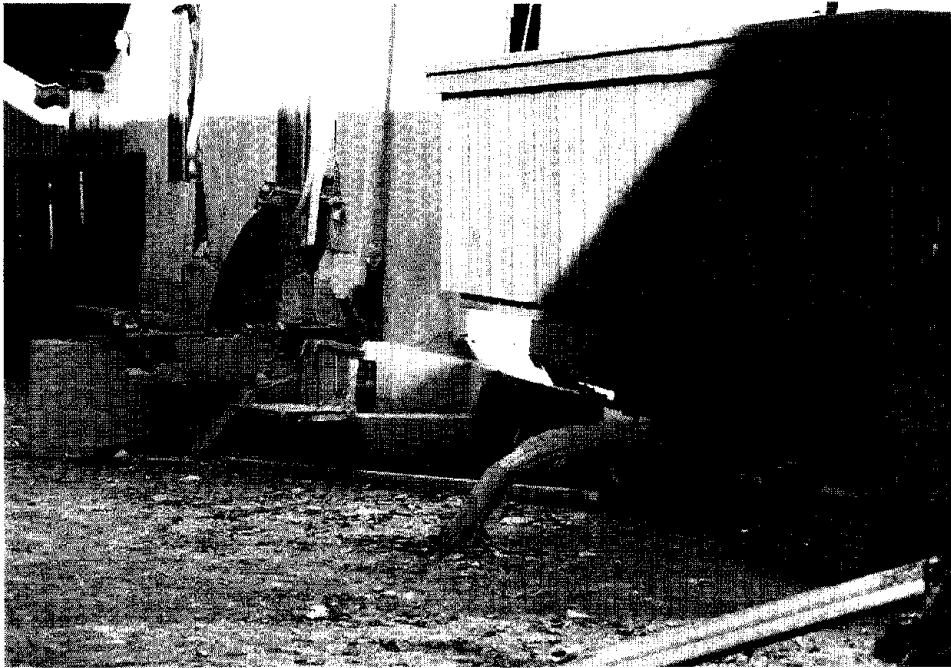
The upper stories of the collapsed buildings were displaced laterally and in some cases came to rest offset by as much as three meters from their original locations. The steel pipe columns, which hinged at their bases, apparently controlled the distance of the offset as they bent to the ground under the load of the building above (fig. 3.6). Collapses occurred in buildings aligned longitudinally east-west as well as those aligned north-south. At the southeast end of the complex, some building portions collapsed to the north, and other portions collapsed to the south, which indicates that no one extreme pulse of energy brought all the buildings down.

Figure 3.6. At Northridge Meadows, the first story steel pipe columns generally hinged near their bases but retained their length, controlling the displacement of the upper stories.

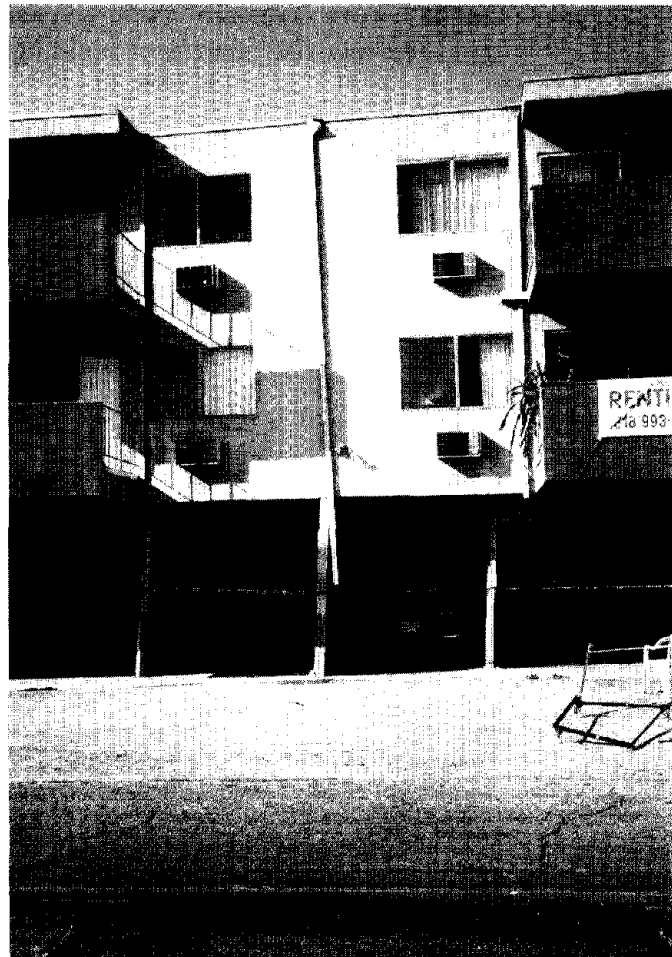
Figure 3.7. Racking, or leaning, of open first story parking areas was a common feature of damaged two and three-story apartment buildings.

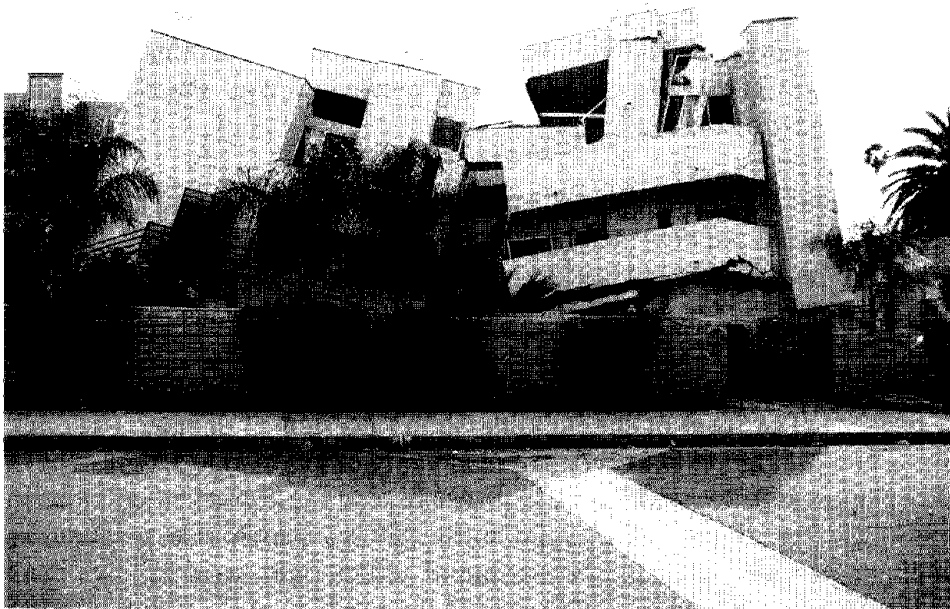
entire first story used for parking, located on Sherman Way in Sepulveda. In this building, the first story parking area was open only on the transverse ends. Concrete block walls formed the longitudinal walls at the first story and a row of concrete columns supported the mid-span of the flat plate concrete floor slab above. The two stories of living space over the parking level were wood-framed with a stucco facade. The entire line of mid-span concrete columns failed. The two halves of the upper stories settled in towards the middle (figs. 3.10 and 3.11), essentially destroying the structure.

Figure 3.10. The central row of concrete first-story columns in a three story apartment building on Sherman Way in Van Nuys collapsed, causing the wood-framed upper stories to settle inward.

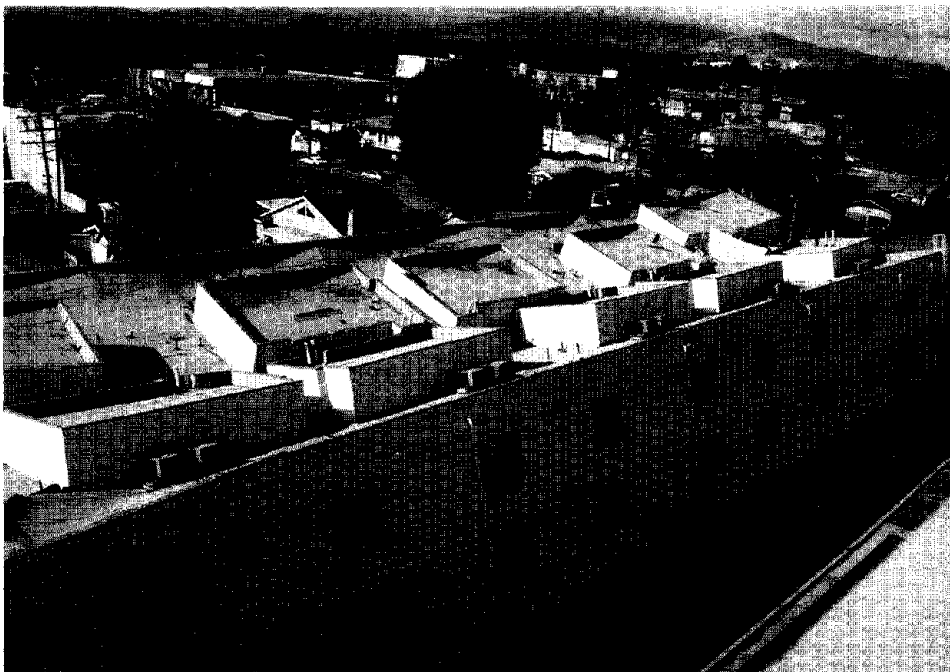
Figure 3.11. This overhead view of the partially-collapsed apartment building on Sherman Way shows the solid concrete masonry block perimeter walls along the longitudinal axis of the building. Access to the first story parking was limited to the transverse ends of the building. When the row of interior columns failed, both sides of the building settled in towards the middle.

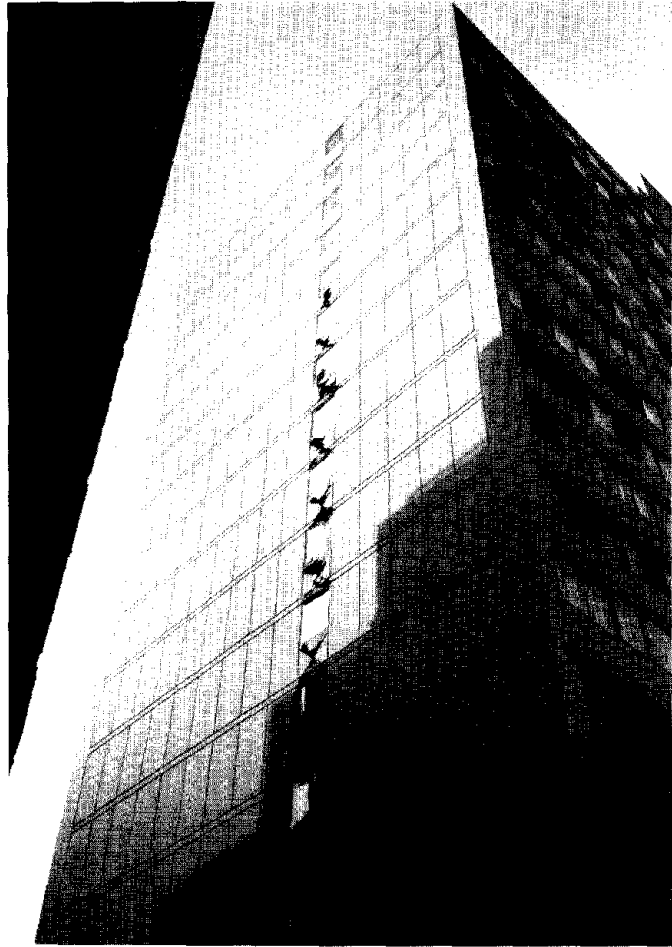
The transverse end walls are pierced by a single vertical row of window openings. The wall segments between the windows act as coupling beams linking the wall segments on either side. These coupling beams suffered serious diagonal cracking, increasing in severity from top to bottom of the building (fig. 3.12).

Figure 3.12. Champagne Towers apartment building in Santa Monica suffered a classic form of earthquake damage: shear failure of the coupling beams between linked shear walls at the transverse end of the building.

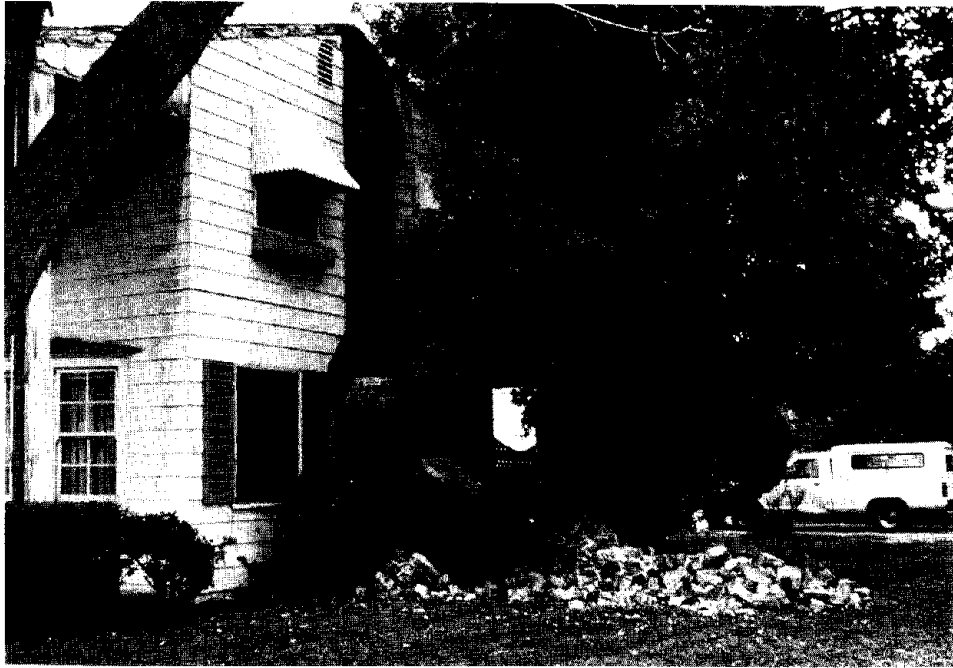
The most common and easily visible damage to single family homes was damaged and collapsed masonry chimneys (fig. 3.17). In some cases, the chimney fell onto and through the roof. Cracked stucco, fallen roof tiles, and racked garage door openings were visible throughout the affected area. Some houses shifted on their foundations. In the epicentral area, damage to concrete masonry fences at the edges of lots was almost universal (fig. 3.18). Piles of debris outside many homes attested to widespread interior nonstructural and contents damage.

Figure 3.17. Failure of masonry chimneys was common.

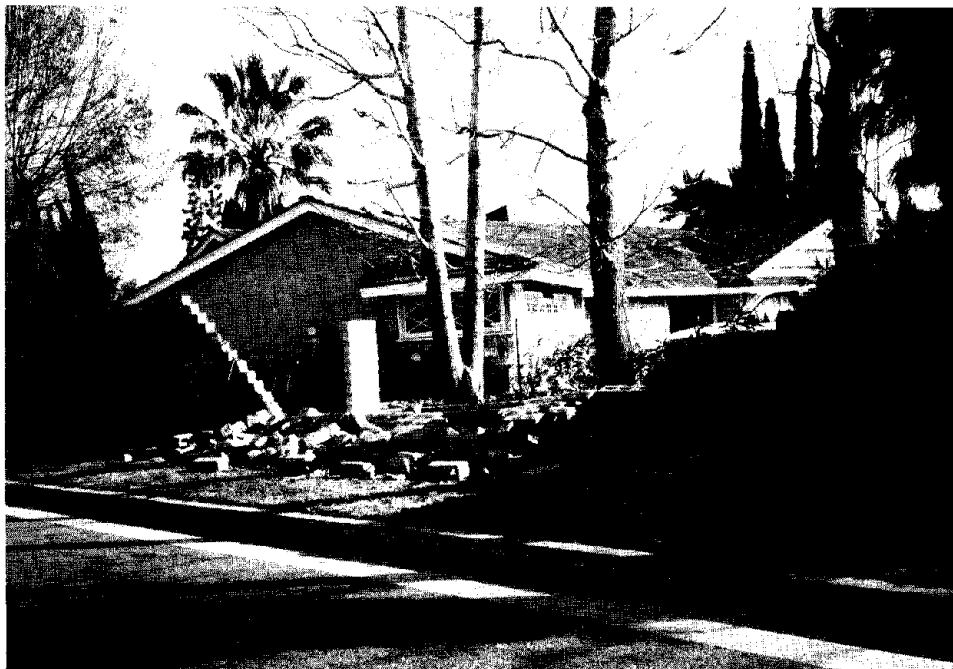
Figure 3.18. Damage to masonry privacy fences was ubiquitous. Many of these fences were tall enough to have been a serious threat to passersby when they failed. Luckily, due to the early morning hour of the quake, yards and sidewalks were essentially deserted.

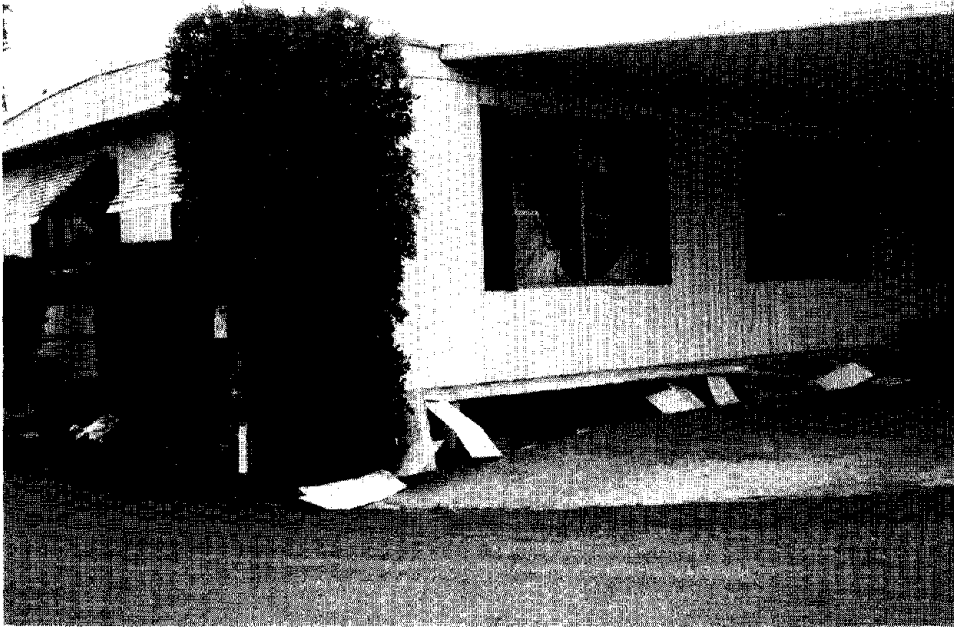
The vulnerability of mobile homes to earthquake ground shaking was demonstrated once again by the Northridge earthquake. For example, in a trailer park near the epicenter, at the intersection of Nordhoff Street and Tampa Avenue, nearly every home had moved on its supports. These types of homes are usually supported on small concrete and metal base supports (figs. 3.19, 3.20, and 3.21). These supports provide little resistance to lateral movements, and toppled during the quake (fig. 3.22). The identical failure was observed in the 1971 San Fernando earthquake. It is clear that no improvements in the practice of supporting manufactured homes adequately against lateral loads have been made during the past twenty-three years.

Figure 3.19. Damage to manufactured homes caused by collapsed supports was common.

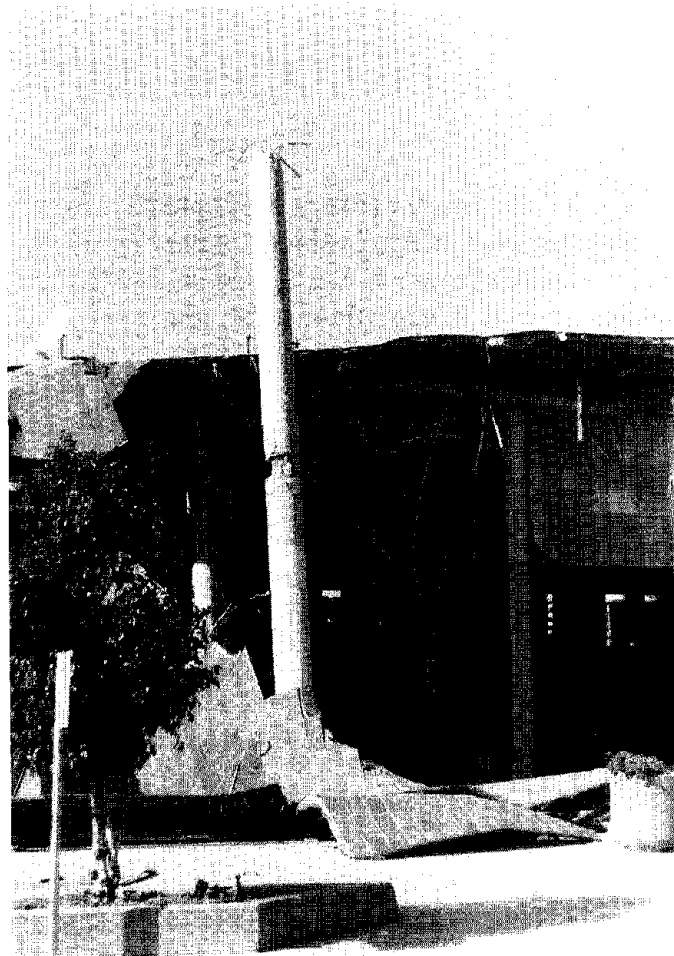
Figure 3.30. The Bullock's department store had an extremely irregular vertical geometry. At the northeast end it was shaped like a truncated pyramid.

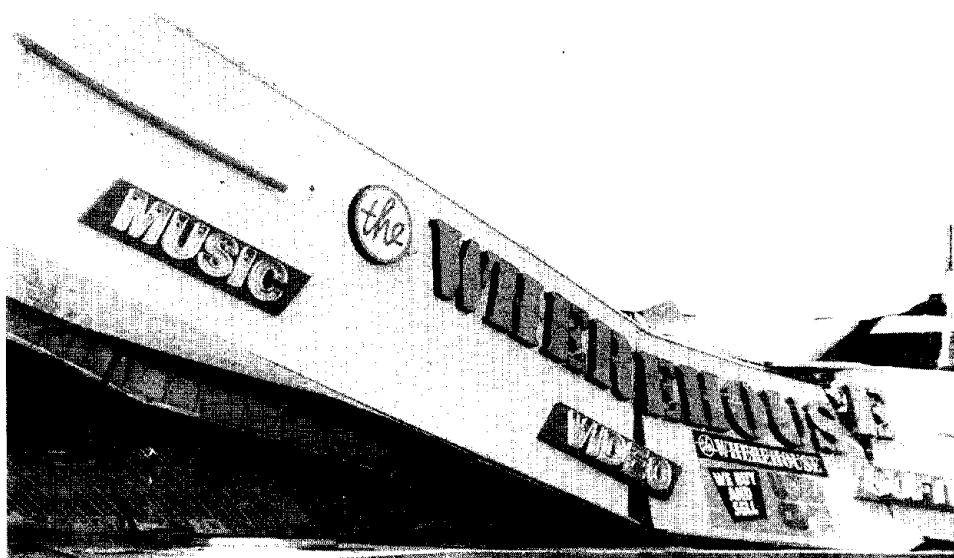
The area around the Northridge Fashion Center showed evidence of having been severely shaken. Significant damage of many types occurred. South of the Northridge Fashion Center, several single story retail structures were damaged; at least one, the Wherehouse, collapsed (fig. 3.32).

Figure 3.32. Many commercial buildings were damaged in the blocks south of the Northridge Fashion Center. The single-story Warehouse collapsed completely.

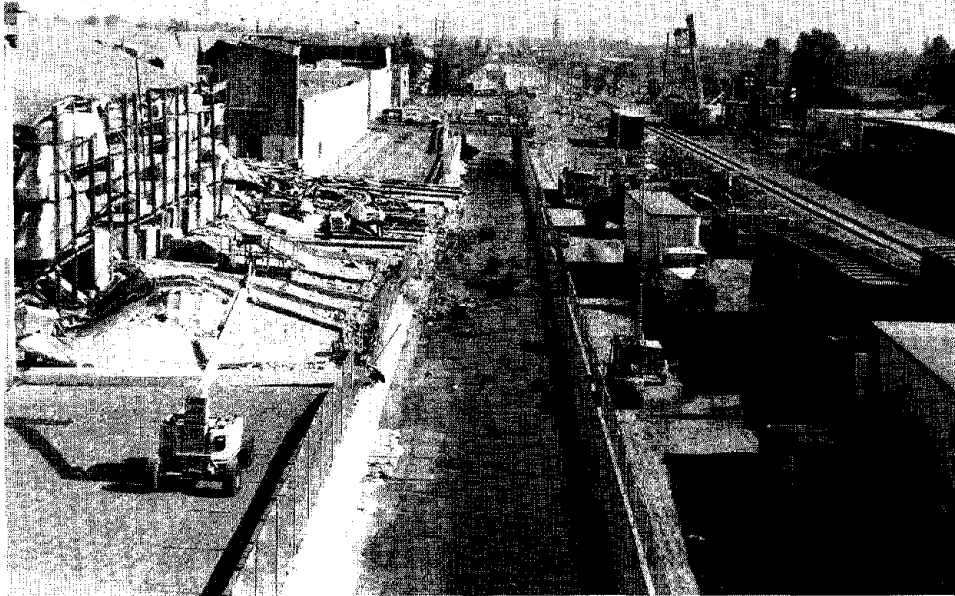
Figure 3.33. The south wall of the concrete tilt-up Levitz furniture store/warehouse south of the Northridge Fashion Center fell away from the building into the alley and stream channel. The damaged roof was being supported by the racks of furniture. On the south side of the stream channel a freight train derailed during the earthquake. That clean-up effort was still underway three days after the quake.

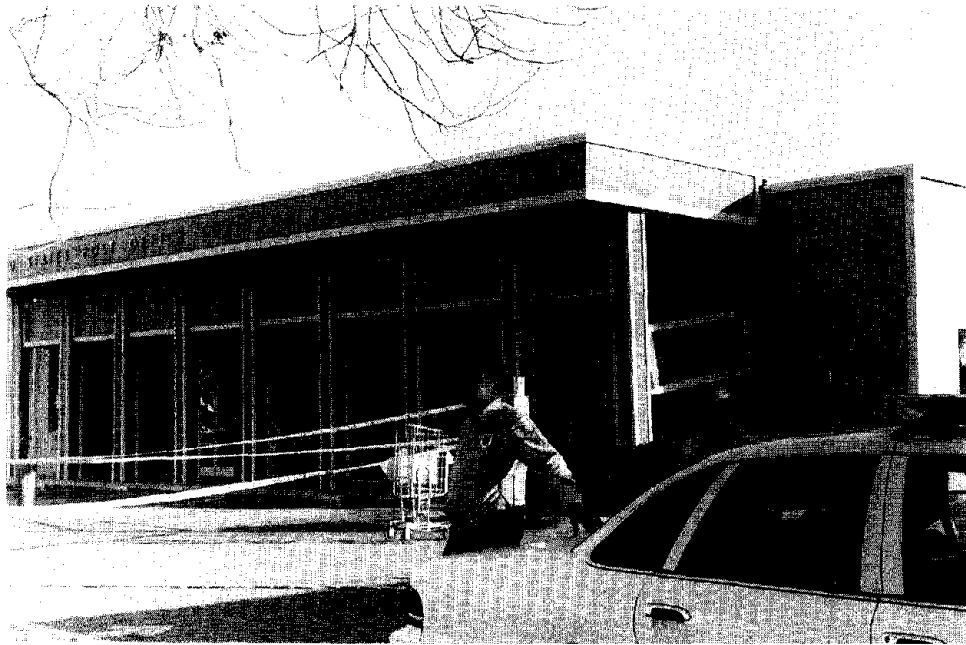
facade panel had become detached and interior ceiling panels had fallen (fig. 3.35). Mail was being collected in the parking lot.

Figure 3.35. The Chatsworth Post Office was closed due to damage. Mail was being collected in the parking lot.

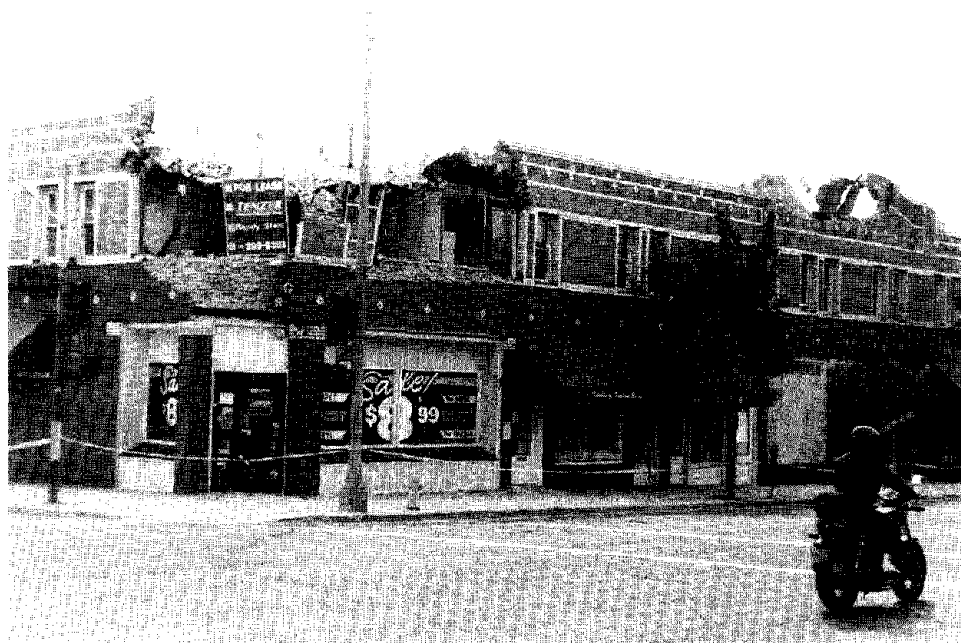
Figure 3.36. Damage to unreinforced masonry buildings, even those that had been rehabilitated, was common. Upper stories and corners were particularly vulnerable to damage. The rows of light-colored diamonds on the face of this building are the end plates of through-bolts used to connect the wall to the floor joists, a typical rehabilitation technique. The remains of parapet braces can be seen on the roof.

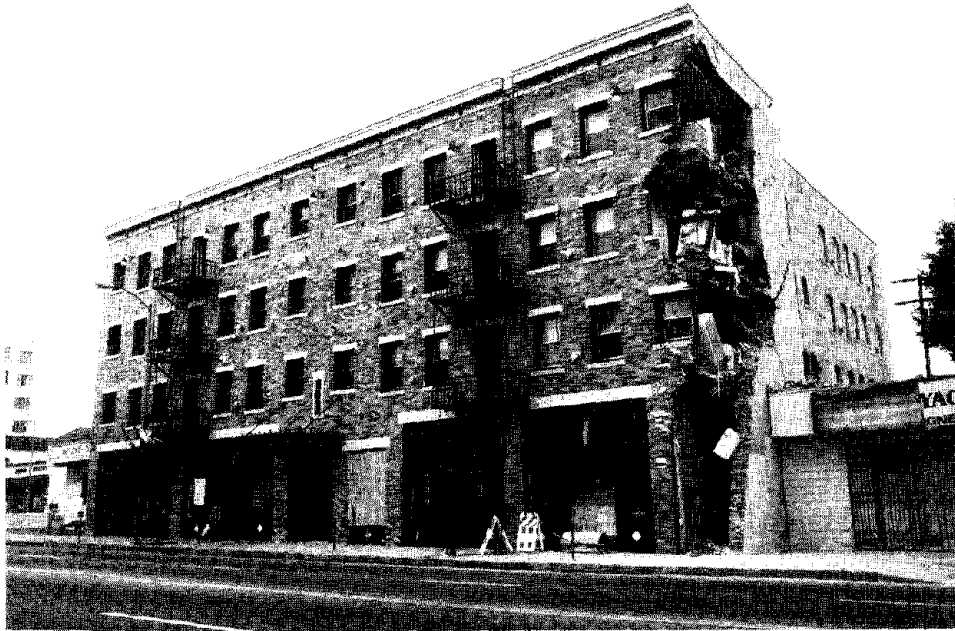
Figure 3.37. The corner of this rehabilitated unreinforced masonry apartment building in East Hollywood crumbled on all four stories.

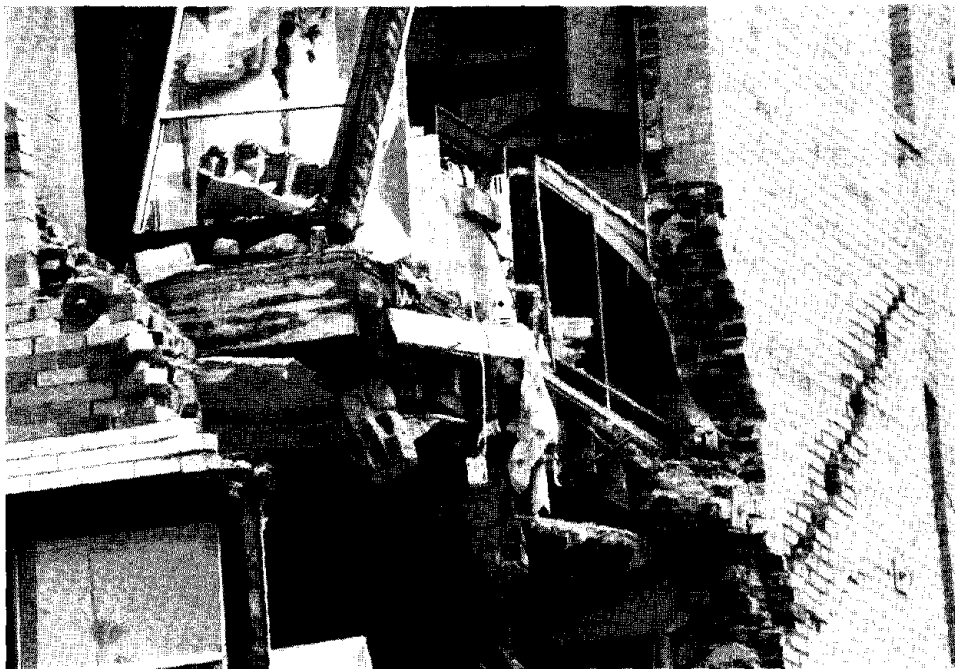
Figure 3.38. A close-up view of the third-story floor diaphragm of the building picture above shows (lower right) a rehabilitation bolt still holding a few bricks to the floor joists, after all the walls on three out of four sides of the bolts had disintegrated.

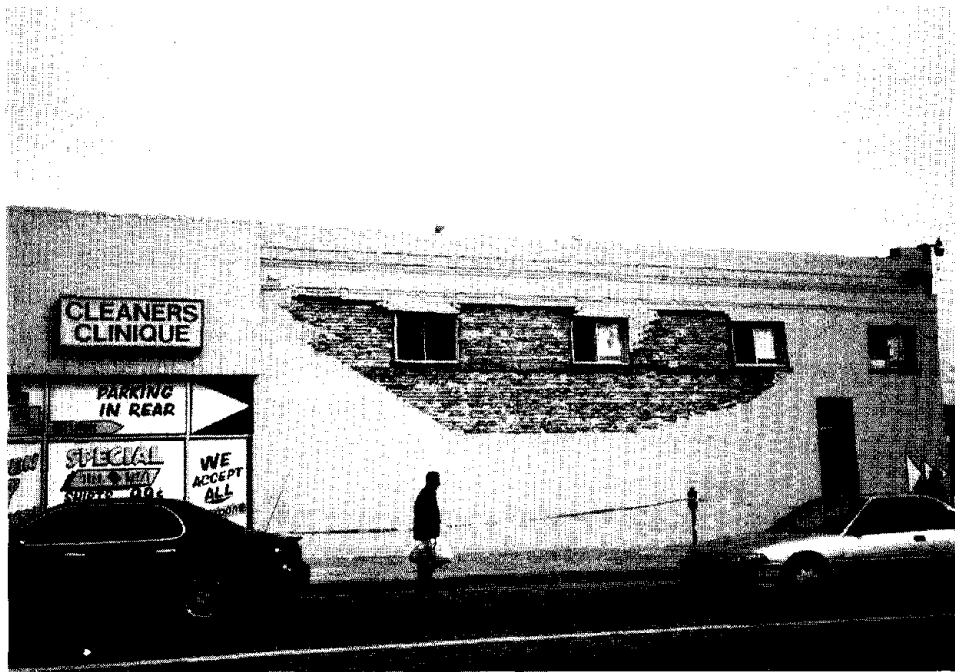
Figure 3.39. Only the exterior wythe of brick peeled off of this rehabilitated unreinforced masonry building in Santa Monica.

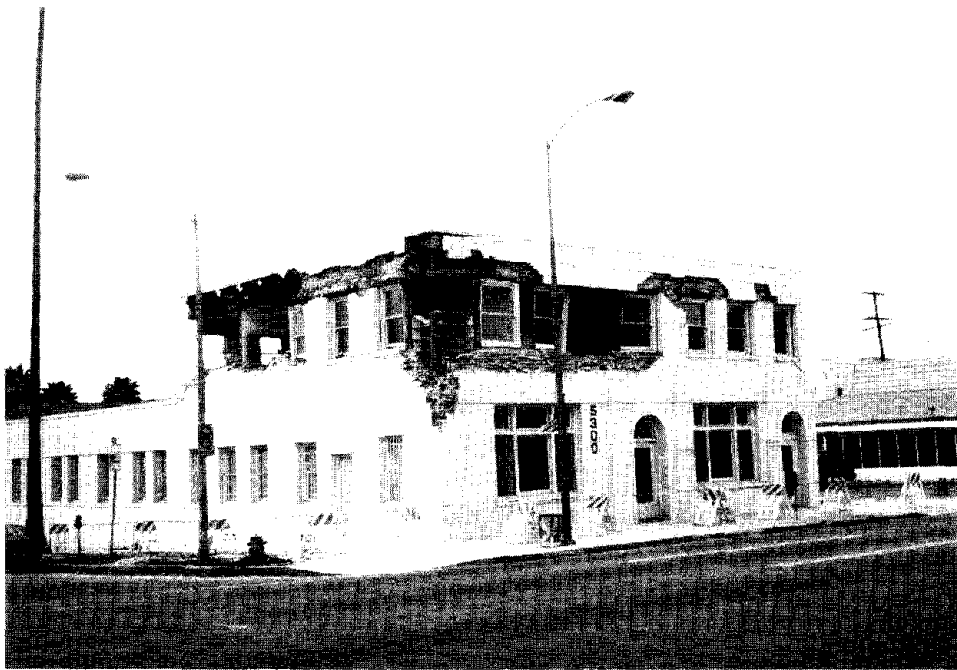
Figure 3.40. In other rehabilitated unreinforced masonry buildings, such as this two story structure in Hollywood, entire wall thicknesses were lost between rows of through-bolts.

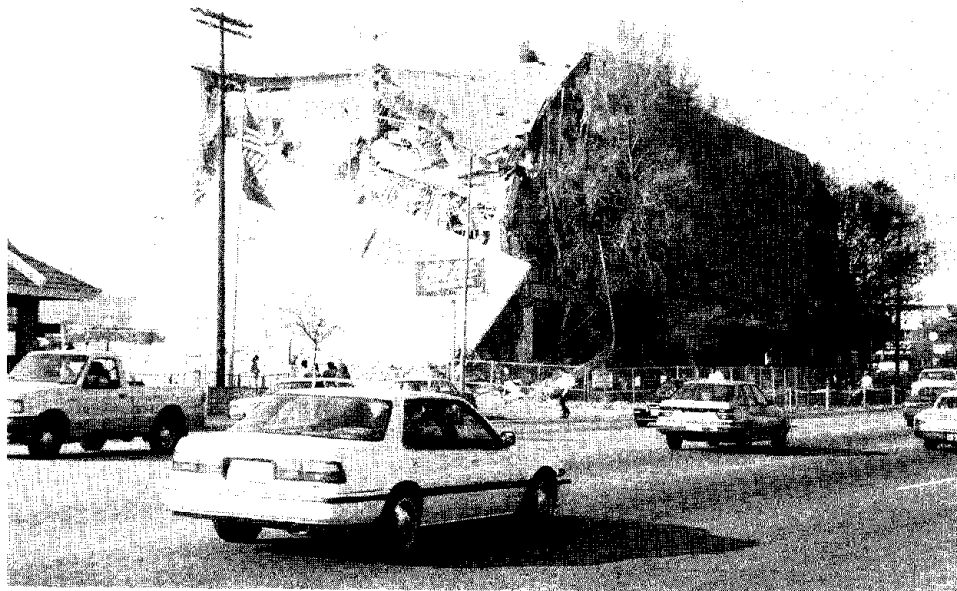
The concrete frame Kaiser Permanente office building on Balboa Boulevard in Granada Hills was badly damaged. The second story columns disintegrated, causing the upper stories to collapse onto the first story, which remained intact (fig. 3.41). At the ends of the building, damage to the frame caused partial collapses, but the mid-section of the building remained intact. The apparently nonstructural end walls became detached at both ends of the building and slid to the ground (figs. 3.42 and 3.43). The failure of these end walls may have contributed to the damage to the frame at the ends of the building.

Figure 3.42. Both end walls of the Kaiser Permanente building slid, partially intact, to the ground. The south wall is pictured here. Both ends of the building suffered damage to the concrete frame at all story levels, while the middle half of the building, except for the second story, remained intact.

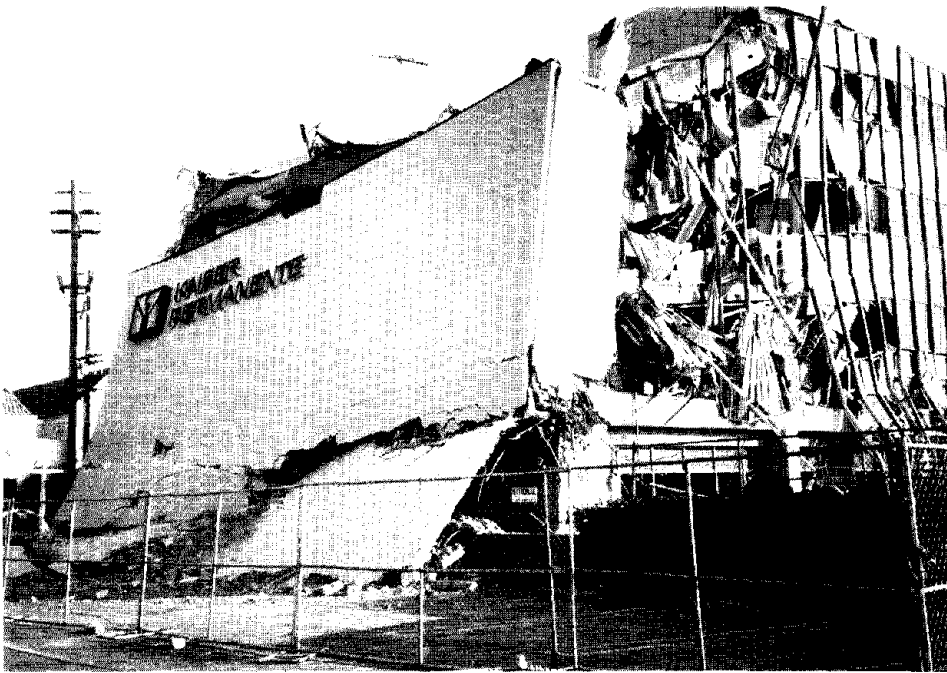
Figure 3.43. Damage at the north end of the building was similar to damage at the south.

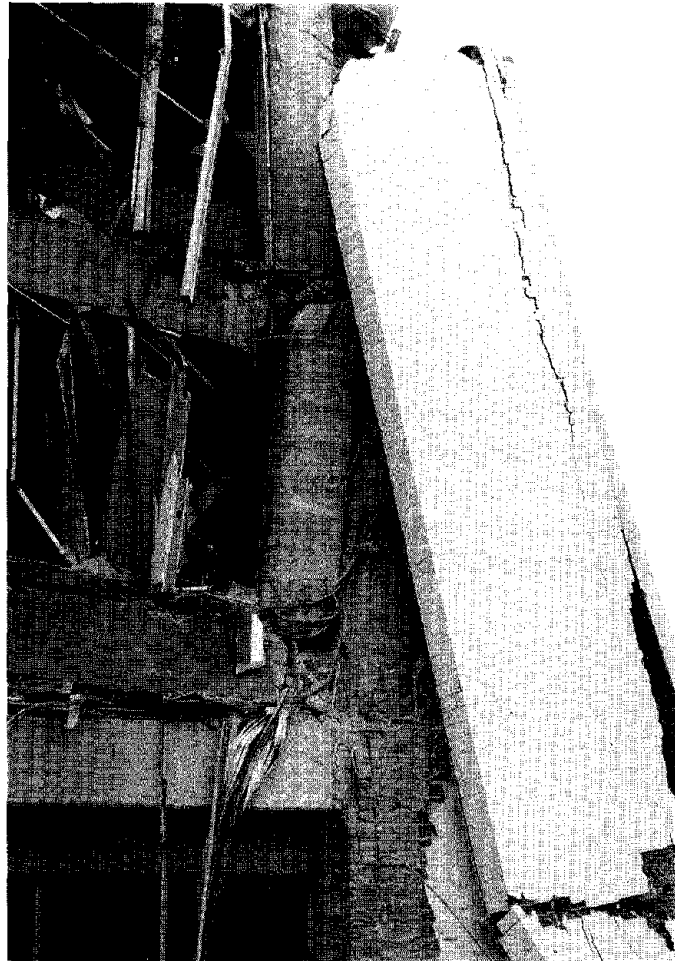
The bare frame exposed by the damage suggests that the buildings had a strong-beam/weak-column configuration (fig. 3.44). The damage appears to have initiated at the joints. At the damaged ends, the beams and columns remained essentially intact, but the joints disintegrated.

Figure 3.44. The exposed concrete frame of the Kaiser Permanente building, revealing deep beams, suggests that the building had a strong-beam, weak-column configuration. Except for the second story columns, the columns and beams remained intact while the joints disintegrated.

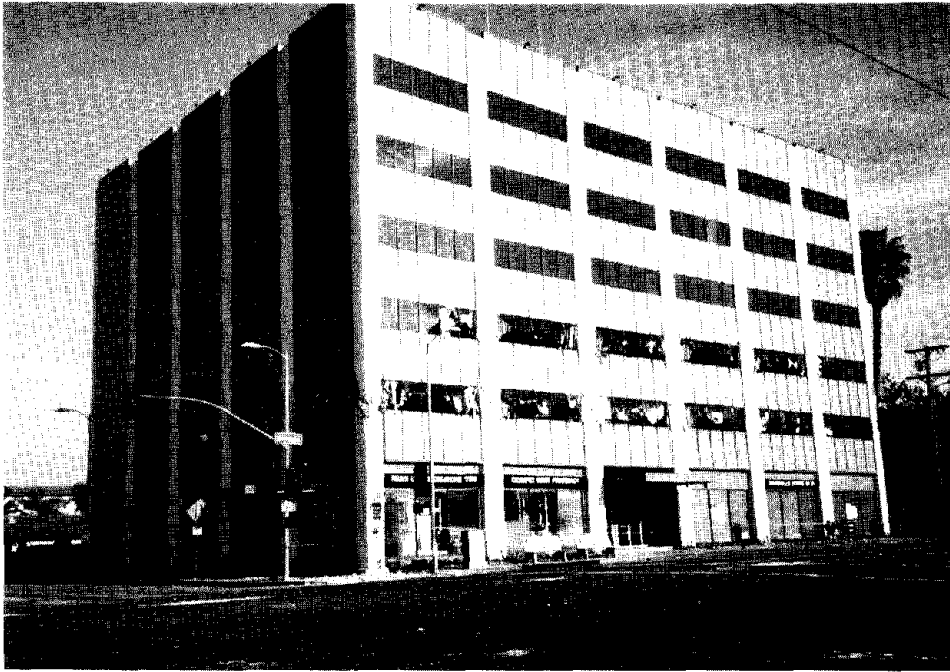
The L-shaped concrete frame Barrington Building in West Los Angeles also had damage concentrated in the second story columns (fig. 3.45). In this building, the horizontal architectural panels stiffened the lower half of the columns at each story, creating a short-column effect. The effectively shortened columns failed in shear between the windows, creating a pattern of X-cracking in the columns that diminished in severity towards the top (fig. 3.46). At the second story, the cracking was severe enough to cause a loss of vertical-load-carrying capacity; the bulging window frames indicate about a 50 to 100 mm reduction in height (fig. 3.47). The building was demolished within a few days of the quake.

Figure 3.45. The six-story L-shaped concrete-frame Barrington Building on Olympic Boulevard in West Los Angeles lost its vertical-load carrying capacity at the second story.

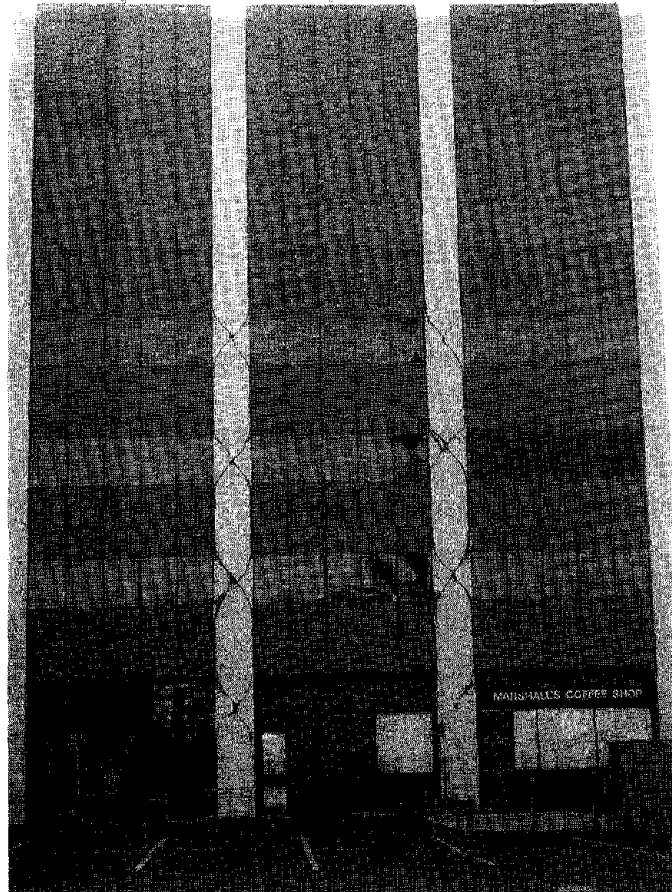
Figure 3.46. The stiff infill panels of the Barrington Building effectively shortened the concrete columns, forcing all the displacement into the column sections bounded by windows. Diagonal X-cracking decreased in severity towards the top of the building.

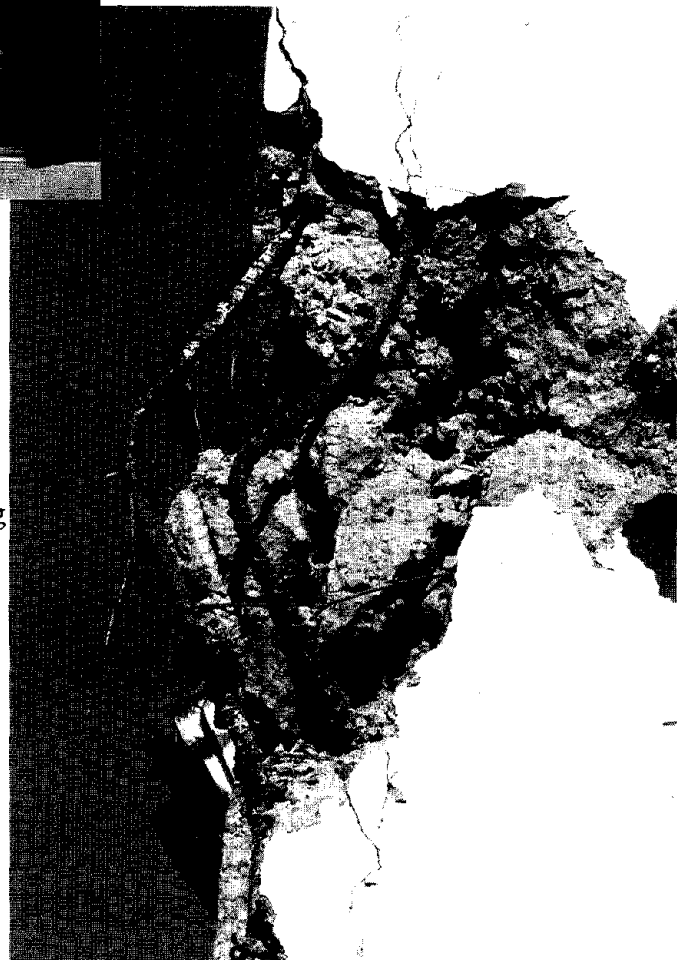
The column-shortening effect of the infill panels was apparently not considered in the design. Where column reinforcing was exposed, transverse bars of undeformed steel spaced at about 300 mm on center could be seen (fig. 3.48), not sufficient to provide confinement of the concrete in a region of high shear.

Figure 3.48. A close up of the damaged southeast corner of the Barrington Building shows the widely spaced, undeformed bars used for transverse reinforcement.

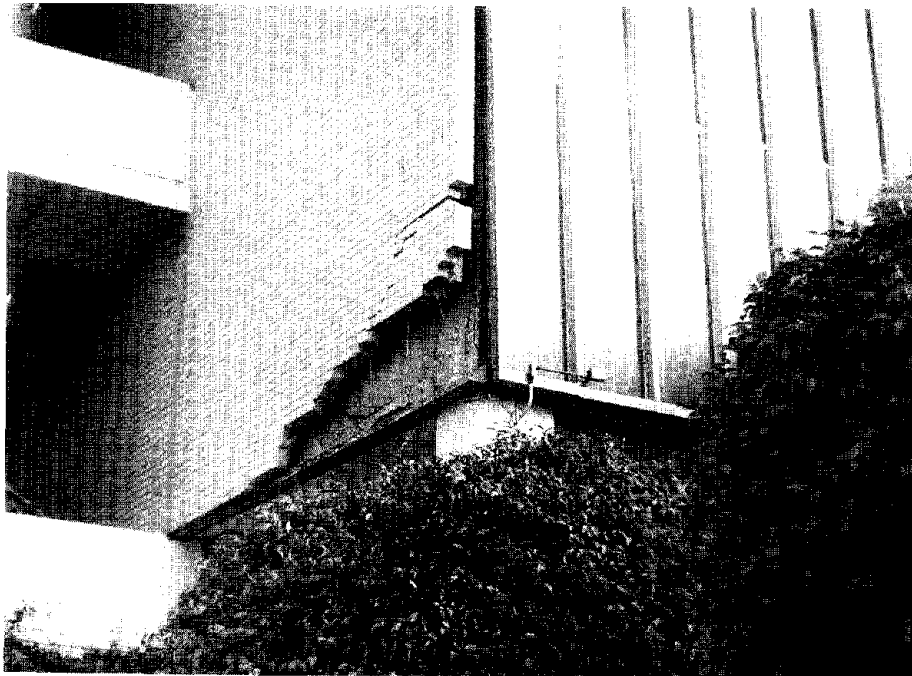
A five-story steel and concrete office building occupied by the Digital Equipment Corporation on Sherman Way lost the enclosing masonry end wall and stair tower (fig. 3.49) on the east side of the building. The corresponding wall on the west side of the building was damaged, but remained standing. The masonry facade did not continue to the ground, but was supported on a steel angle at the level of the second-story floor. On the west side of the building, this wall was crushed at the toe (fig. 3.50). On the east side of the building, the entire wall came off the supporting angle. The connections between the wall and the building frame appeared to be minimal (fig. 3.51). Other than these end walls, the building performed well. In the longitudinal direction, only a few panes of glass were broken on the first story.

Figure 3.49. The east end wall and stair tower of a five-story apparently steel-framed office building on Sherman Way in Reseda collapsed. The enclosing masonry wall became detached from the structure and slid to the ground, with the upper stories remaining intact. The doorway opening in the wall, shown here resting at about the second story level, originally provided access from the top story to the stair tower.

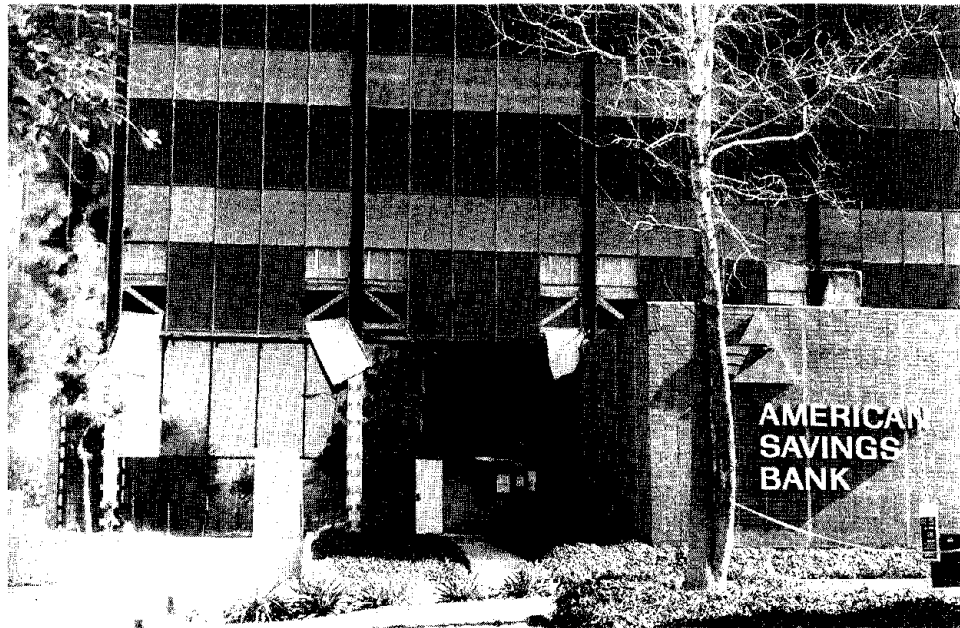
A steel-frame office building on the west side of Topanga Canyon Boulevard in Canoga Park, housing the American Savings Bank, experienced significant movement in its first story columns, apparently swaying in a north-south direction during the quake. It did not return to its original position, but suffered a permanent offset to the north (fig. 3.52). A nearly identical building on the same site, oriented at right angles to the first, had only minor damage to glass at the first

Figure 3.52. The first-story columns of the steel-framed building housing the American Savings Bank on Topanga Canyon Road in Canoga Park flexed during the quake and ended up slightly displaced from their original positions.

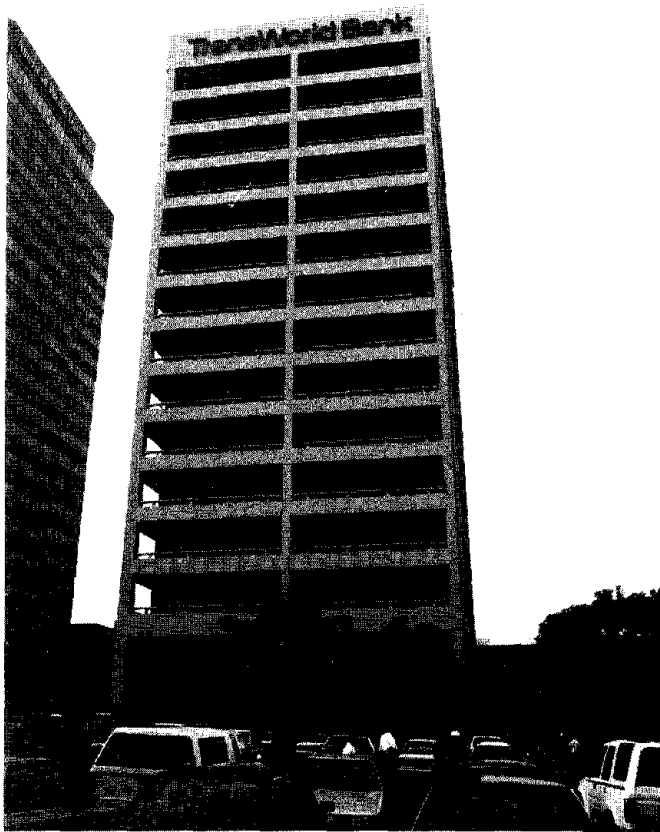
The business district along Ventura Boulevard in Sherman Oaks was another area with significant numbers of badly damaged buildings. The 13-story Trans World Bank Building is located at 15233 Ventura Boulevard (fig. 3.53). There is a two-level underground garage below the building and a mechanical penthouse on the roof. This reinforced concrete frame building was designed under the 1964 Los Angeles City code. Structural damage was in the first-story columns, primarily at the second-floor beam-column joints. Identical failures occurred during the 1971 San Fernando earthquake. The damaged joints were repaired with epoxy shortly after the 1994 earthquake (fig. 3.54).

Figure 3.53. The Trans World Bank building, in Sherman Oaks, was damaged in both the 1971 San Fernando and 1994 Northridge earthquakes.
