1994 Northridge Earthquake Performance of Structures, Lifelines, and Fire Protection Systems

Building and Fire Research Laboratory
National Institute of Standards and Technology
Gaithersburg, MD 20899-0001

May 1994

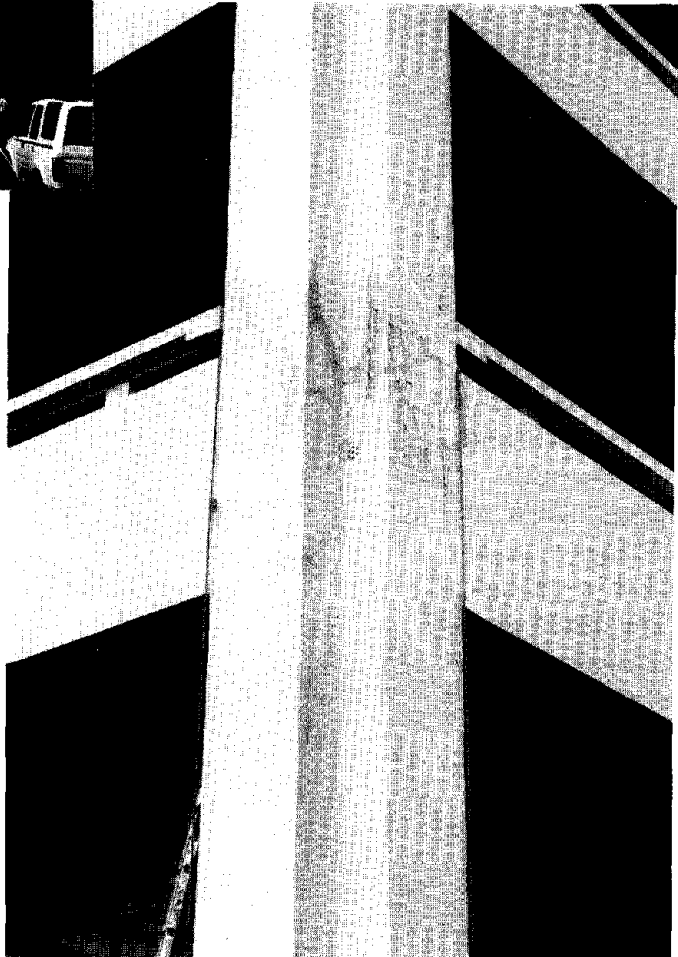
Figure 3.54. The cracked beam-column joints between the first and second stories of the Trans World Bank building were repaired using epoxy injection.

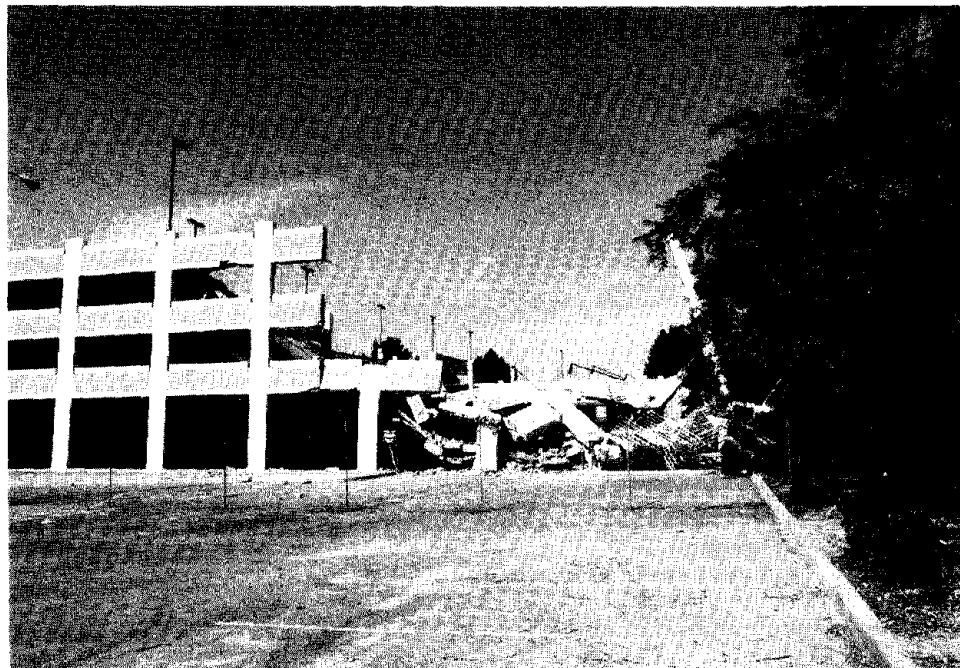
The collapse apparently started at the interior of the building. The exterior perimeter frame was pulled over towards the center of the structure (fig. 3.60), suggesting that interior beams had lost their vertical support, causing the floor plates to collapse and pull the exterior walls in with them. While some interior columns had collapsed, others were left intact, jutting up above the fallen floor slabs (fig. 3.61).

Figure 3.61. Some interior columns of the Northridge campus parking garage remained standing.

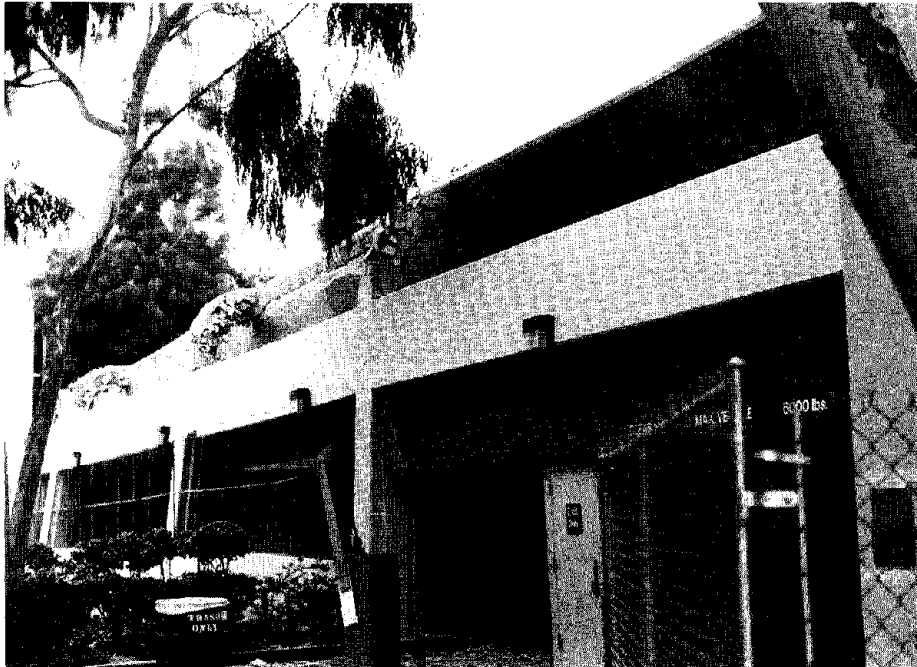
The five-level parking garage at the Kaiser Permanente medical complex on Cadillac Avenue in West Los Angeles experienced a similar collapse. All four facades were pulled inward, suggesting that an interior failure precipitated the damage (fig. 3.62). This garage was a post-tensioned cast-in-place concrete structure with shear walls providing the lateral-force resisting system at the east and west ends, and moment frames at the north and south perimeter. The shear walls were cracked horizontally throughout their height due to the out-of-plane bending (fig. 3.63). There was minor diagonal cracking, suggesting that the lateral load was not fully transmitted to the shear walls. The stair towers remained standing. Typically, these towers are structurally isolated from the post-tensioned slab to minimize potential deformations in the towers due to creep and shrinkage in the post-tensioned slabs.

Figure 3.62. The cast-in-place concrete parking garage at the Kaiser Permanente Hospital complex in West Los Angeles collapsed in on itself. The moment frame that provided lateral resistance on the south face of the structure could not resist the out-of-plane forces apparently caused by the collapse of interior elements.

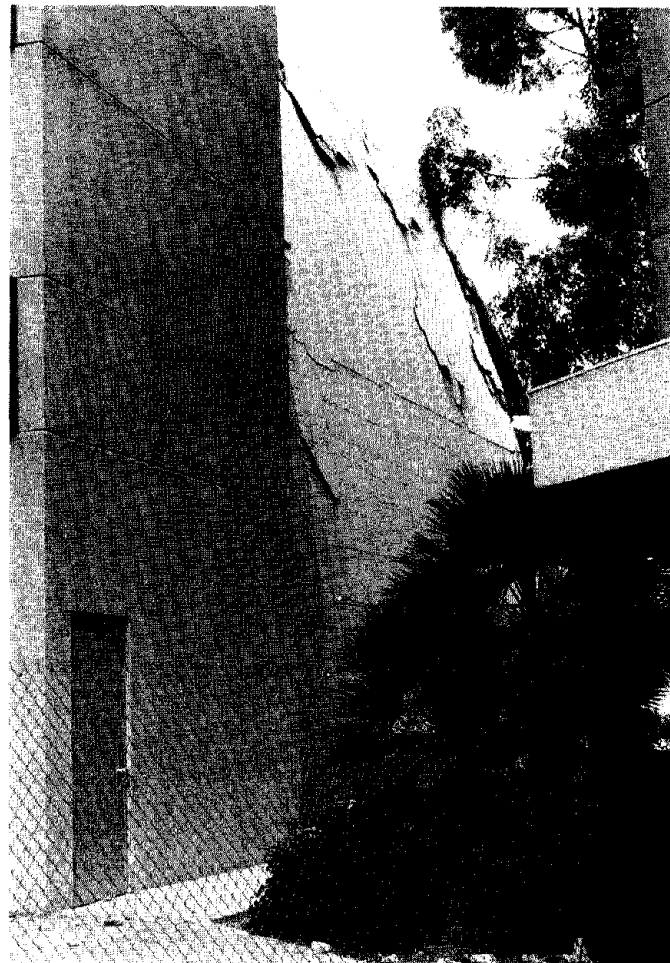
Figure 3.63. At the east and west faces of the Kaiser Permanente Hospital parking garage, shear walls made up the lateral force resisting system. Both walls had horizontal cracks caused by the out-of-plane bending when the walls were pulled inward. Neither wall had major diagonal cracking, suggesting that the lateral load was never fully delivered to the walls. The stair towers remained erect. The east wall and stair tower are shown here.

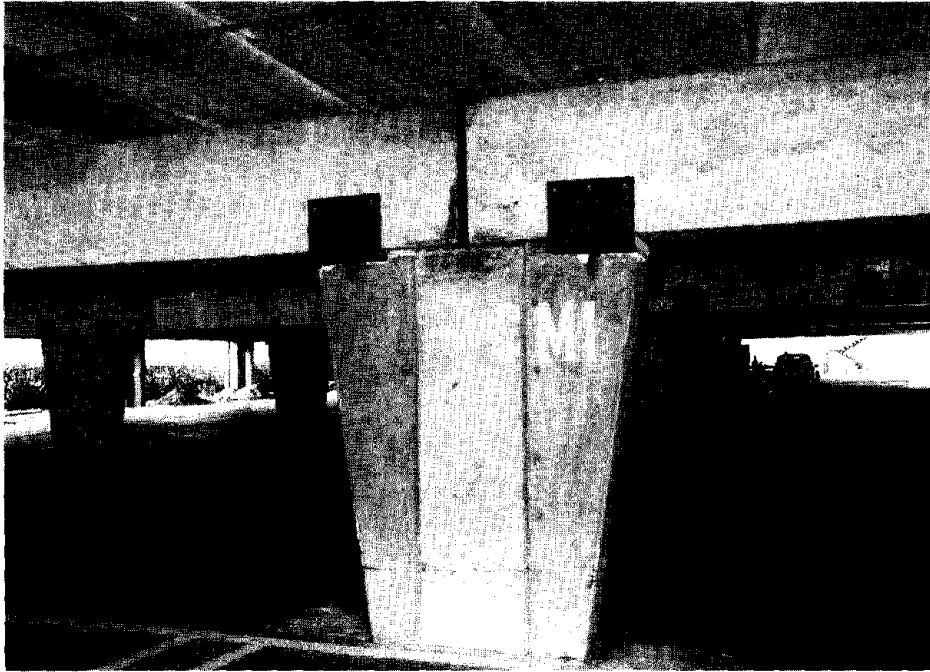
The two-level concrete parking structure adjacent to the Trans World Bank in Sherman Oaks had been seismically strengthened after suffering serious damage in the 1971 San Fernando quake. Flared extensions were cast next to the interior columns along their north-south axes (fig. 3.64), creating short wing walls supporting the precast beams. During the 1994 quake, the unrehabilitated exterior columns were badly cracked (fig. 3.65). The ramp was also heavily damaged. The interior columns were relatively undamaged.

Figure 3.64. The interior columns of the two-level parking garage at the Trans World Bank in Sherman Oaks had been seismically strengthened after it suffered damage in the 1971 San Fernando quake. The interior columns fared well in the 1994 Northridge quake.

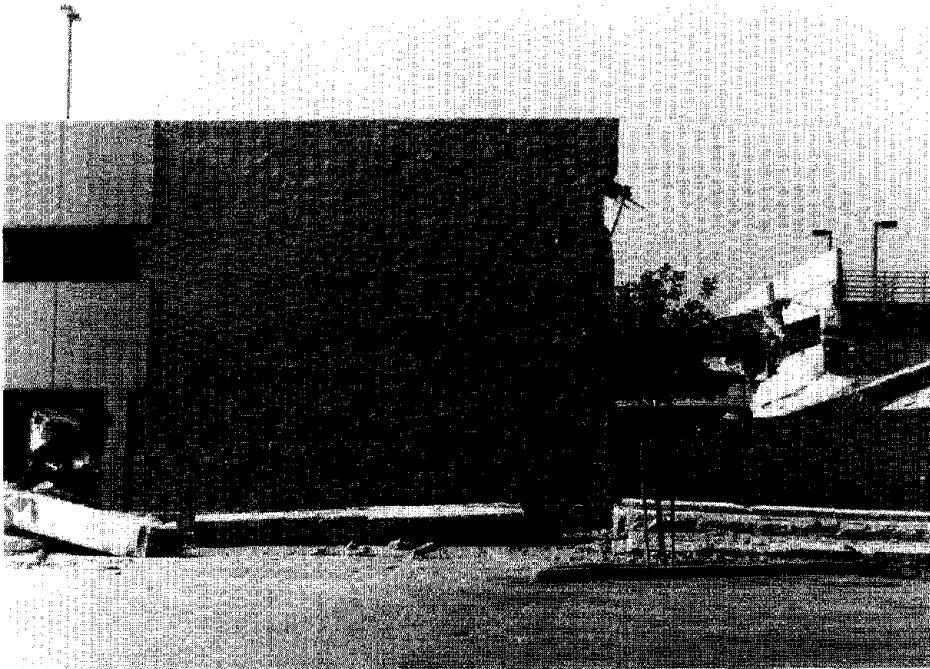
At the Northridge Fashion Center, three parking structures suffered damage. A large three-level concrete garage at the south end of the site, approximately 10 years old, suffered an almost complete collapse. The largely pre-cast concrete structure had intermittent shear walls which remained standing (fig. 3.66). The lack of diagonal cracks in these walls suggests that, like the walls at the Kaiser Permanente garage, they were never fully loaded. A similar, but smaller, precast garage at the north end of the Northridge Fashion Center also partially collapsed (fig. 3.68). At the east end of the site, an older two-level cast-in-place concrete garage showed

Figure 3.66. At the Northridge Fashion Center, major portions of the three-level south parking garage collapsed. The garage was precast concrete with intermittent shear walls. Most of the shear walls remained standing, largely undamaged, indicating that the lateral load was not adequately transmitted to these walls.

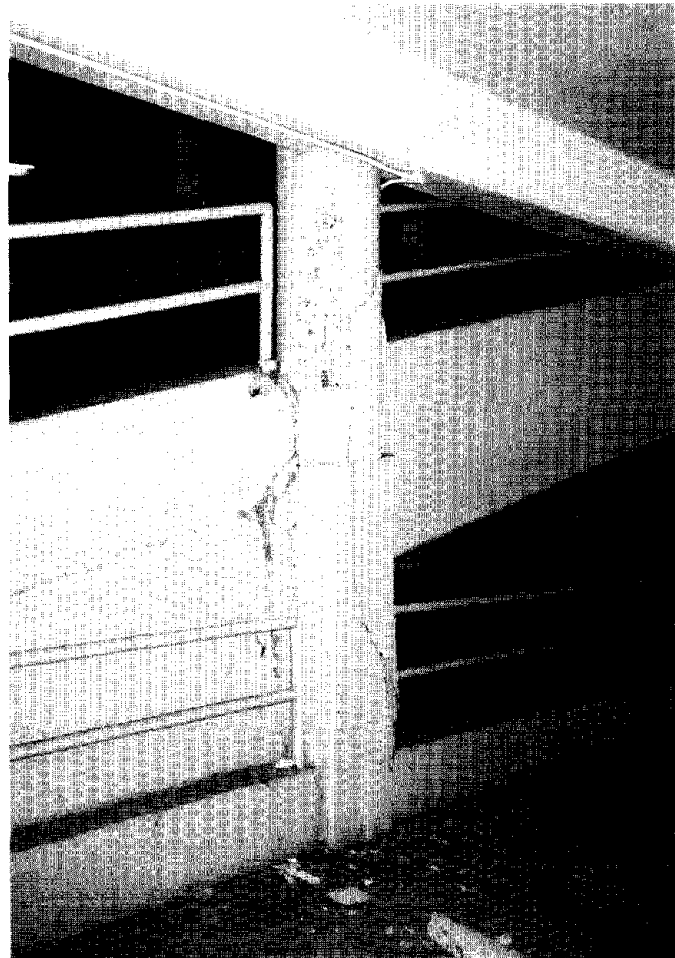
Common types of damage in other parking garages included shear-failure in unintentional short columns created by ramps or split-level decks (fig. 3.67) and collapsed decks caused by inverted-T's or concrete planks pulling off supports (fig. 3.68).

Figure 3.67. In parking garages, ramps can cause unintentionally shortened columns, which are vulnerable to damage, as shown here.

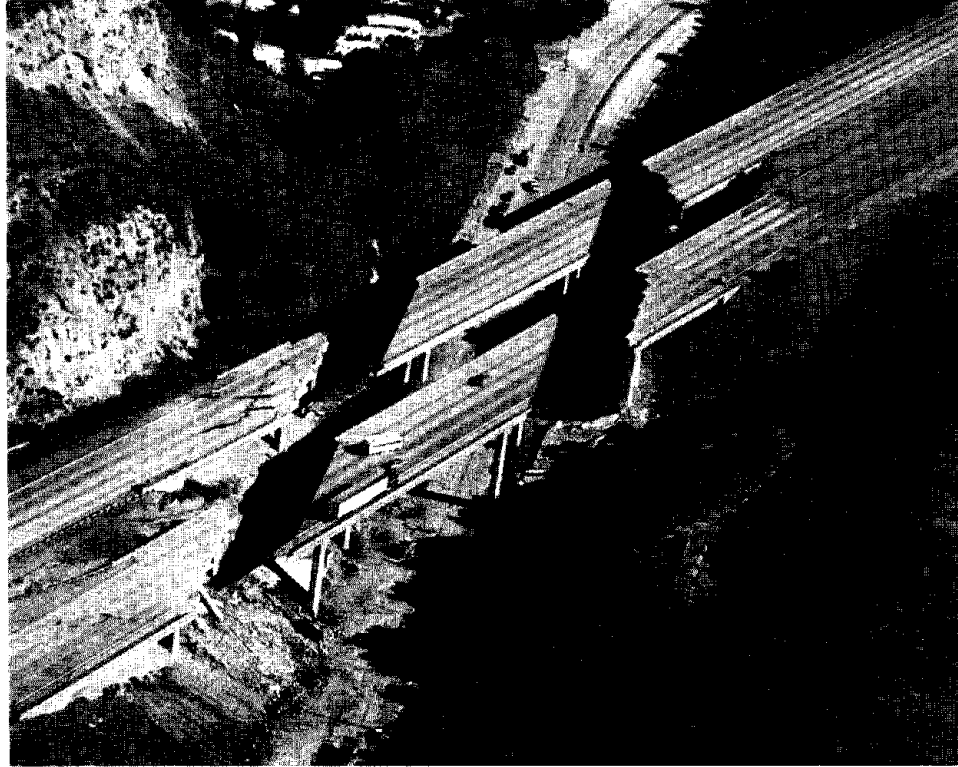
This bridge was designed in 1964 and constructed in 1967. It carries Interstate 5 over Gavin Canyon, about 3 km (2 mi) north of the intersection of Interstate 5 and State Route 14. An aerial photograph of the damaged bridge, after demolition had begun, is shown in figure 4.2, and a ground level view is shown in figure 4.3. Schematic structural drawings are shown in figures 4.4 and 4.5. The structure consists of two parallel bridges, with about a 66 degree skew alignment. Each bridge is composed of five spans. Each bridge has four two-pier bents, and there is a structural hinge near each of the two center bents (figs. 4.3 and 4.4). The superstructure consists of reinforced concrete box girders, and the central portion (between hinges) is post-tensioned. The bridge survived the 1971 San Fernando earthquake with virtually no damage. In 1974, the hinges were retrofitted with cable restrainers, as shown in figure 4.5. The seat length at the hinges is 200 mm (8 in), which by current design standards would be considered inadequate, especially for a structure of this size and flexibility.

Despite the presence of cable restrainers at the hinges, failure of three of the four end spans of the bridge was apparently initiated by the spans falling off the hinge seats. The fourth end span, at the far western corner of the bridge, partially came off its hinge seat but did not collapse, as indicated in figure 4.4. After support was lost at the hinges, a triangular portion of three of the end spans collapsed, as shown in figure 4.4. Demolition of the remaining portions of the end spans was carried out very soon after the earthquake, as shown in figure 4.2. It is likely that the skewed alignment of the bridge was an important contributing factor in this failure. The skewed alignment permitted rotation of the superstructure in a counter-clockwise direction, when viewed from above. The tall, flexible piers of the two center bents would have offered relatively little resistance to rotation in a horizontal plane. (EERC reconnaissance team members noted cracking patterns at the bases of the piers, which may have been evidence of such rotation [5]). Rotation of the superstructure would have resulted in differential displacements at the hinges, and eventually unseating of the end spans at the hinges. Demolition of the bridge was completed a few days after the earthquake.

Figure 4.2. Aerial view of the bridges at Gavin Canyon, looking to the east, showing appearance of the four end spans shortly after demolition had begun.

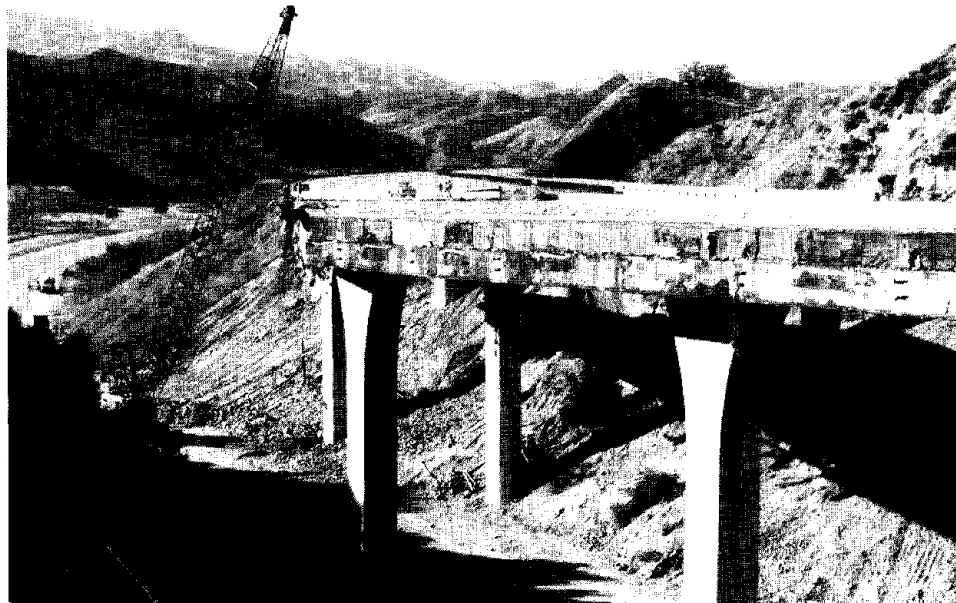
Figure 4.3. Ground level view of the southbound bridge at Gavin Canyon, looking to the northwest, showing the hinge bearing seat near Bent 3.

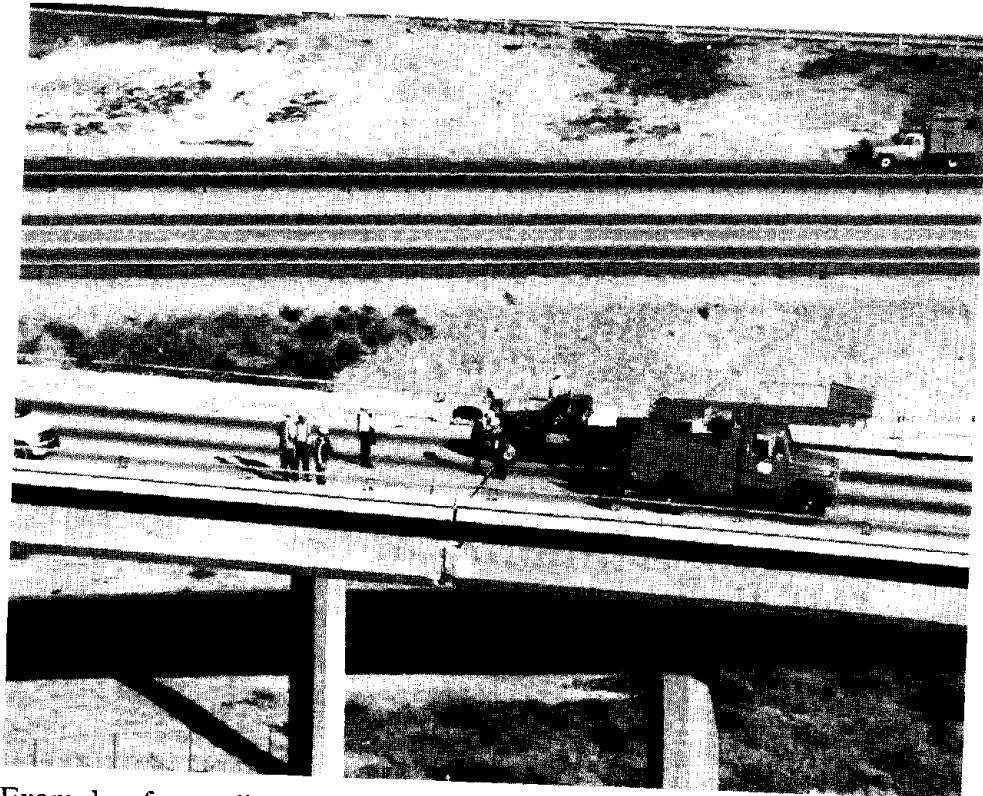
Figure 4.7. Example of pounding and offset at a hinge in the SR14/15 interchange.

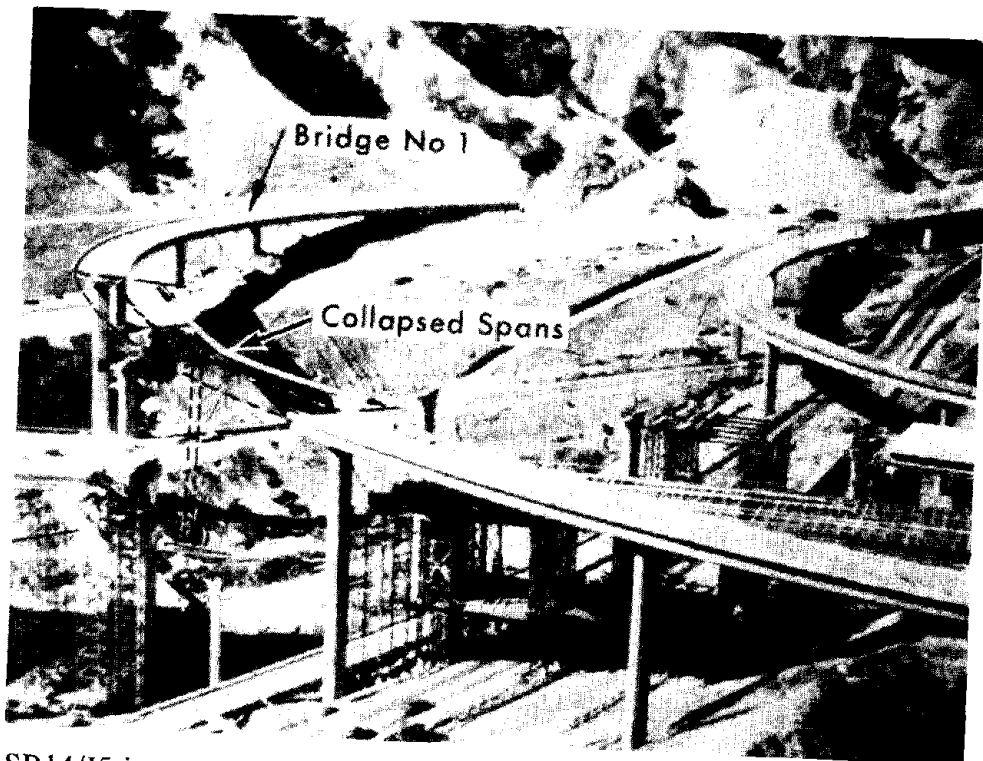
This interchange was designed in 1968 and was under construction in 1971 when portions were damaged by the San Fernando earthquake. At that time, one of the completed ramps in the interchange collapsed, and two ramps which were under construction were damaged. The portion which collapsed in 1971 was the South Connector Overcrossing, connecting southbound I5 with eastbound SR14. A photograph of the collapsed ramp, taken in 1971, is shown in figure 4.8. This ramp was later rebuilt, with improved pier reinforcement, and it suffered no significant damage in the Northridge earthquake. The damaged portions of the other two ramps under construction in 1971 were repaired in place, but not strengthened; the portions not yet constructed were completed with limited seismic upgrading. Both of the ramps which partially collapsed in the Northridge earthquake were under construction at the time of the 1971 earthquake.

Figure 4.8. SR14/15 interchange after the 1971 San Fernando earthquake. View looking to the west, showing collapsed South Connector Overcrossing.

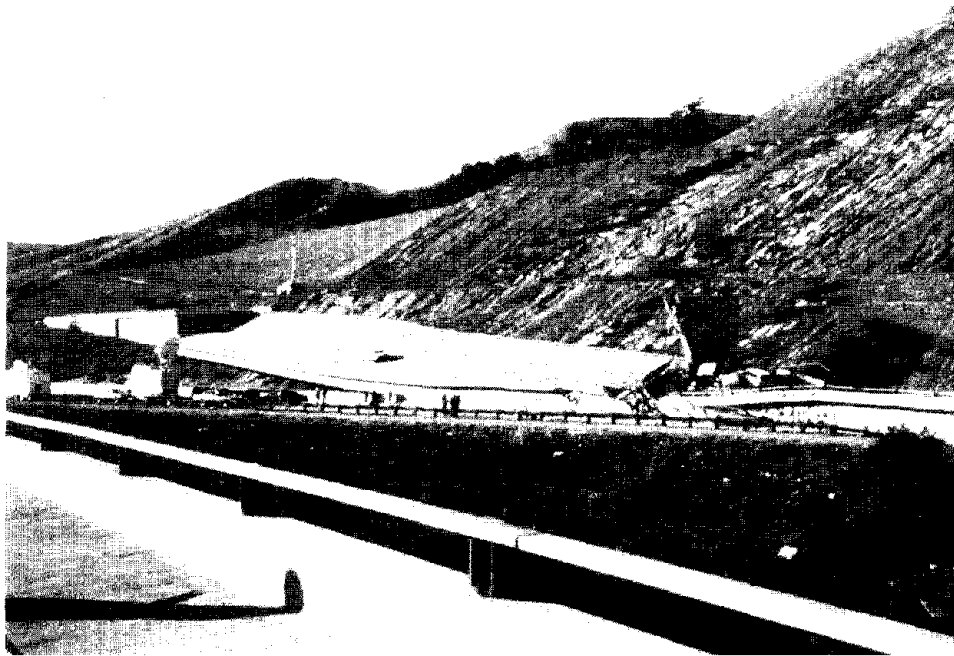
² It has been suggested that the superstructure was first pulled off the abutment seat, transferring excessive loads to Pier 2, causing it to fail. However, this appears unlikely as the bearing seat length at Abutment 1 was rather long: 24 inches (610 mm).

Figure 4.11. Overview of the collapse of the SR14/I5 Separation and Overhead, Ramp C, looking to the south at Abutment 1. Pier 3 can be seen at the right of the photograph (Photo courtesy of EERC).

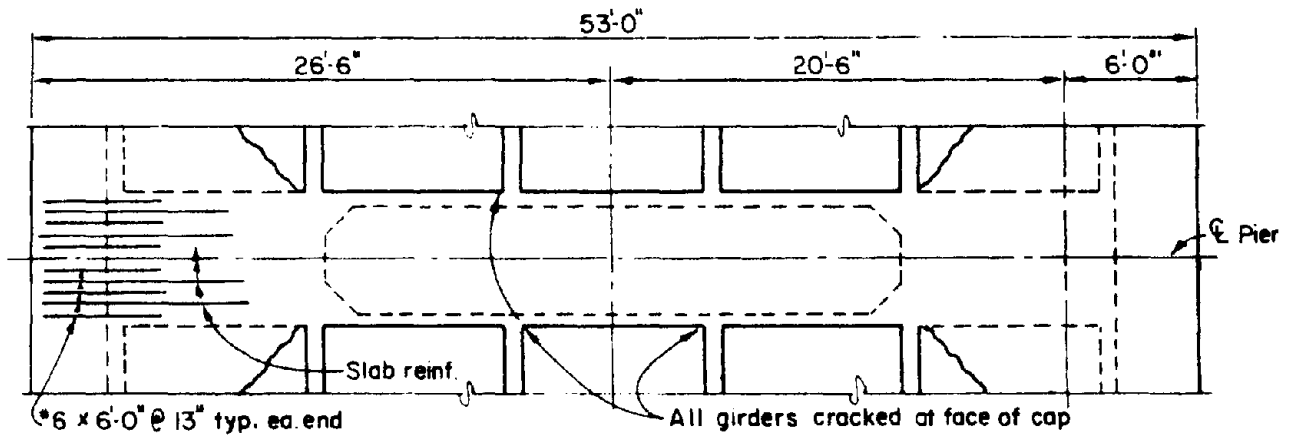
Figure 4.13. Cracking reported at Piers 2 and 3 following the 1971 San Fernando earthquake (reproduced from "The San Fernando Earthquake: Field Investigation of Bridge Damage," State of California, 1971).

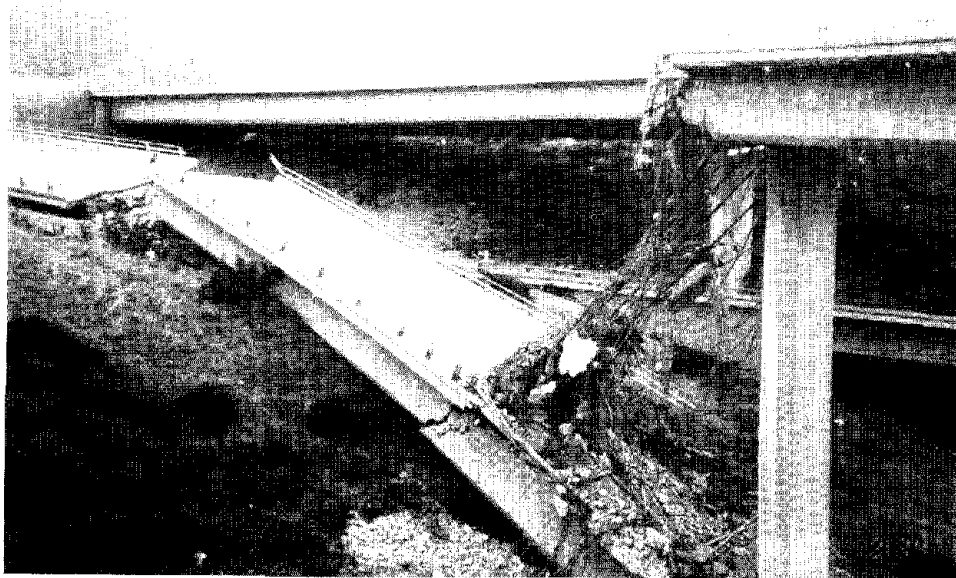
This ramp was designed in 1968 and constructed in 1971. Photographs of the collapsed portion of the ramp are shown in figures 4.14 and 4.15. Plan and elevation views of this ramp are shown in figure 4.17. The portion of the ramp which collapsed was located between Abutment 1 and Pier 3. As with the Separation and Overhead Ramp C, described above, this ramp was under construction in 1971. However, unlike Ramp C, this ramp was nearly completed when the San Fernando earthquake occurred. Only the portion from the hinge near Pier 8 to Abutment 11 remained to be constructed. The portion which collapsed in the Northridge earthquake, between Abutment 1 and Pier 3, was already constructed when the San Fernando earthquake occurred. Only minor damage to this ramp was reported following the 1971 earthquake [23]. This damage consisted of permanent offsets at the hinges near Piers 4 and 6.

The collapse in the Northridge earthquake appears to have been initiated by the failure of Pier 2. After Pier 2 failed, the simply supported span between Abutment 1 and the hinge near Pier 2 collapsed, and, as shown in figure 4.15, the superstructure failed near Pier 3 due to a large negative moment. Pier 2 completely disintegrated, as shown in figure 4.16. This is the shortest pier in the structure, so it is likely that it attracted a high level of lateral force, was damaged in shear, and finally collapsed in compression. Pier 10 is similar in height to Pier 1, but the quantities of lateral reinforcement in Pier 10 are greater than those in Pier 1, as shown in figure 4.18. This is because Pier 2 had already been completed, but Pier 10 had not yet been constructed, when the 1971 earthquake occurred. Following the 1971 earthquake the plans for Pier 10 were revised to provide increased lateral reinforcement, as shown in figure 4.18.

Figure 4.14. Collapsed portion of the SR14/15 North Connector Overcrossing, looking east. Pier 2 was at the left, near the broken hinge on the ground (Photo courtesy of EERC).

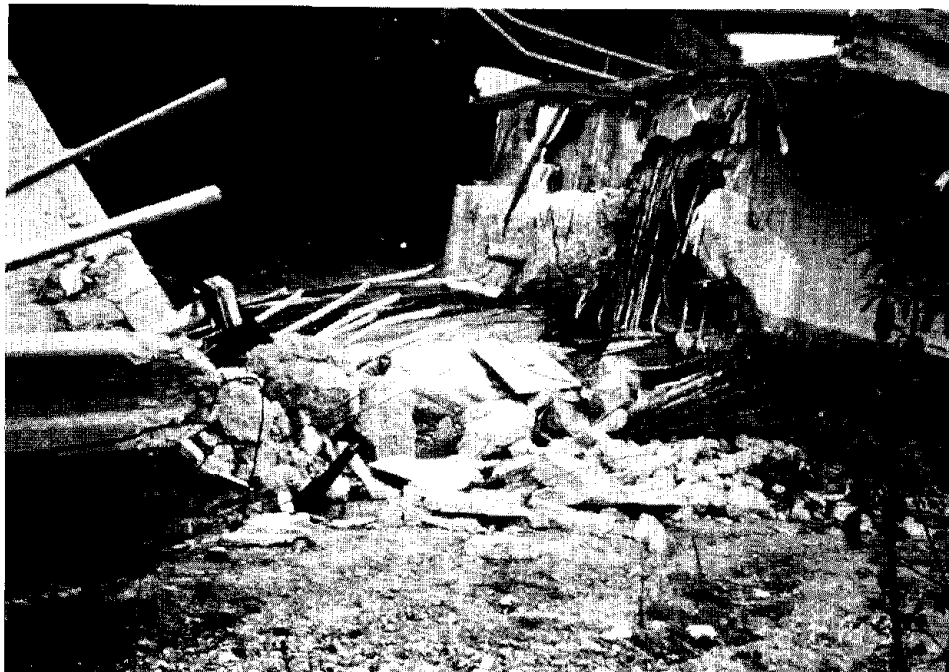
Figure 4.16. View of crushed Pier 2 and the hinge near Pier 2 (Photo courtesy EERC).

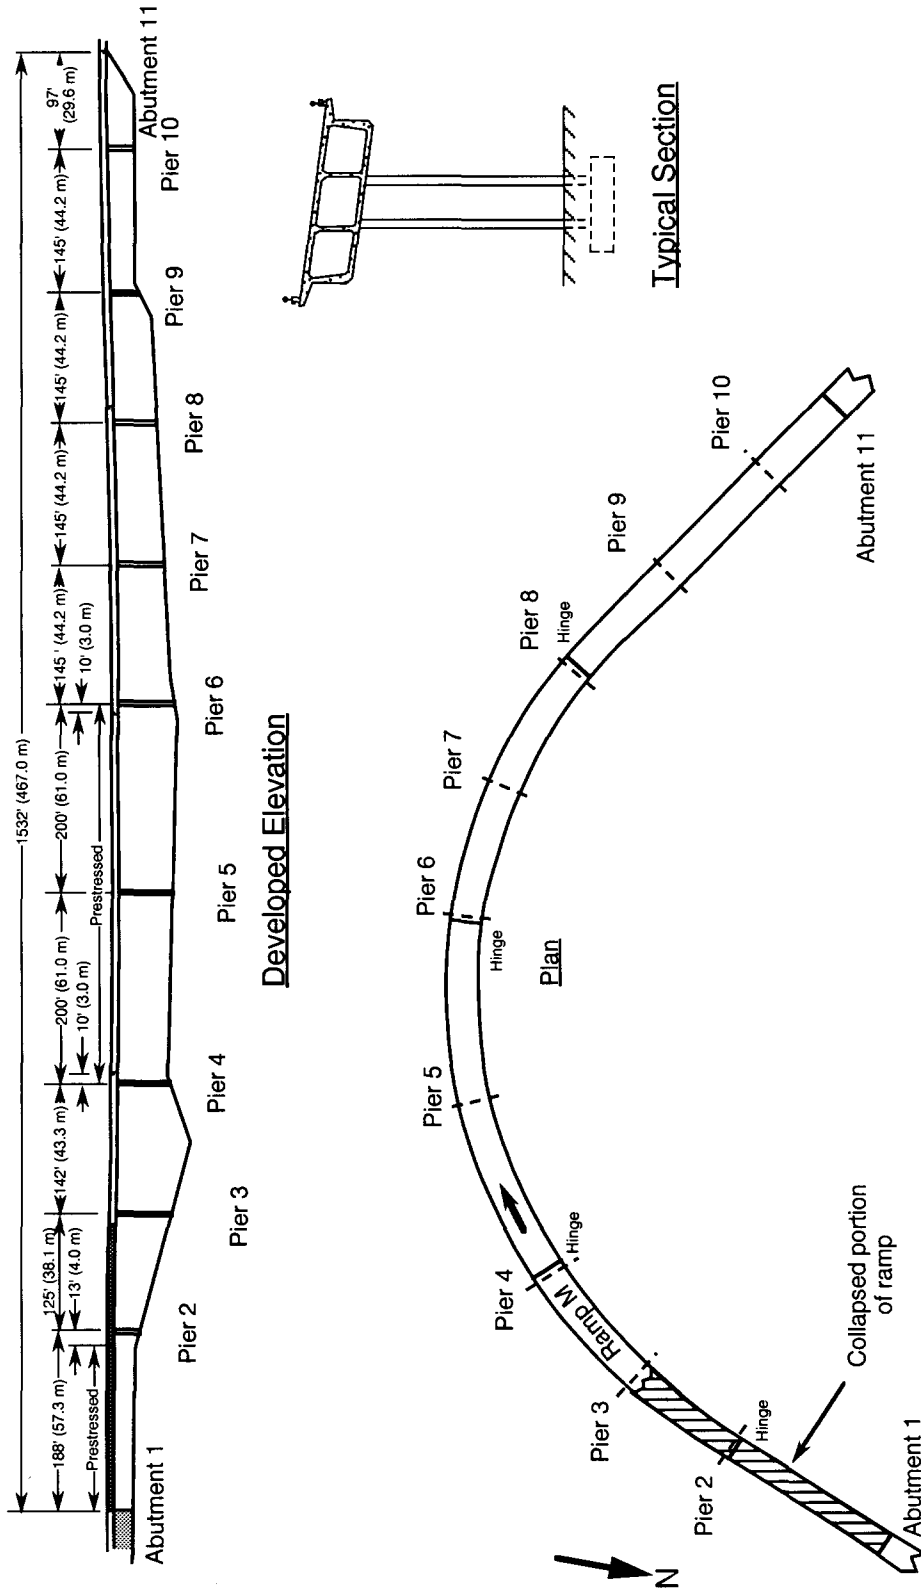
North Connector Overcrossing, Ramp M - SR14/I5 Interchange

Figure 4.17. Plan and elevation view of the SR14/I5 North Connector Overcrossing.

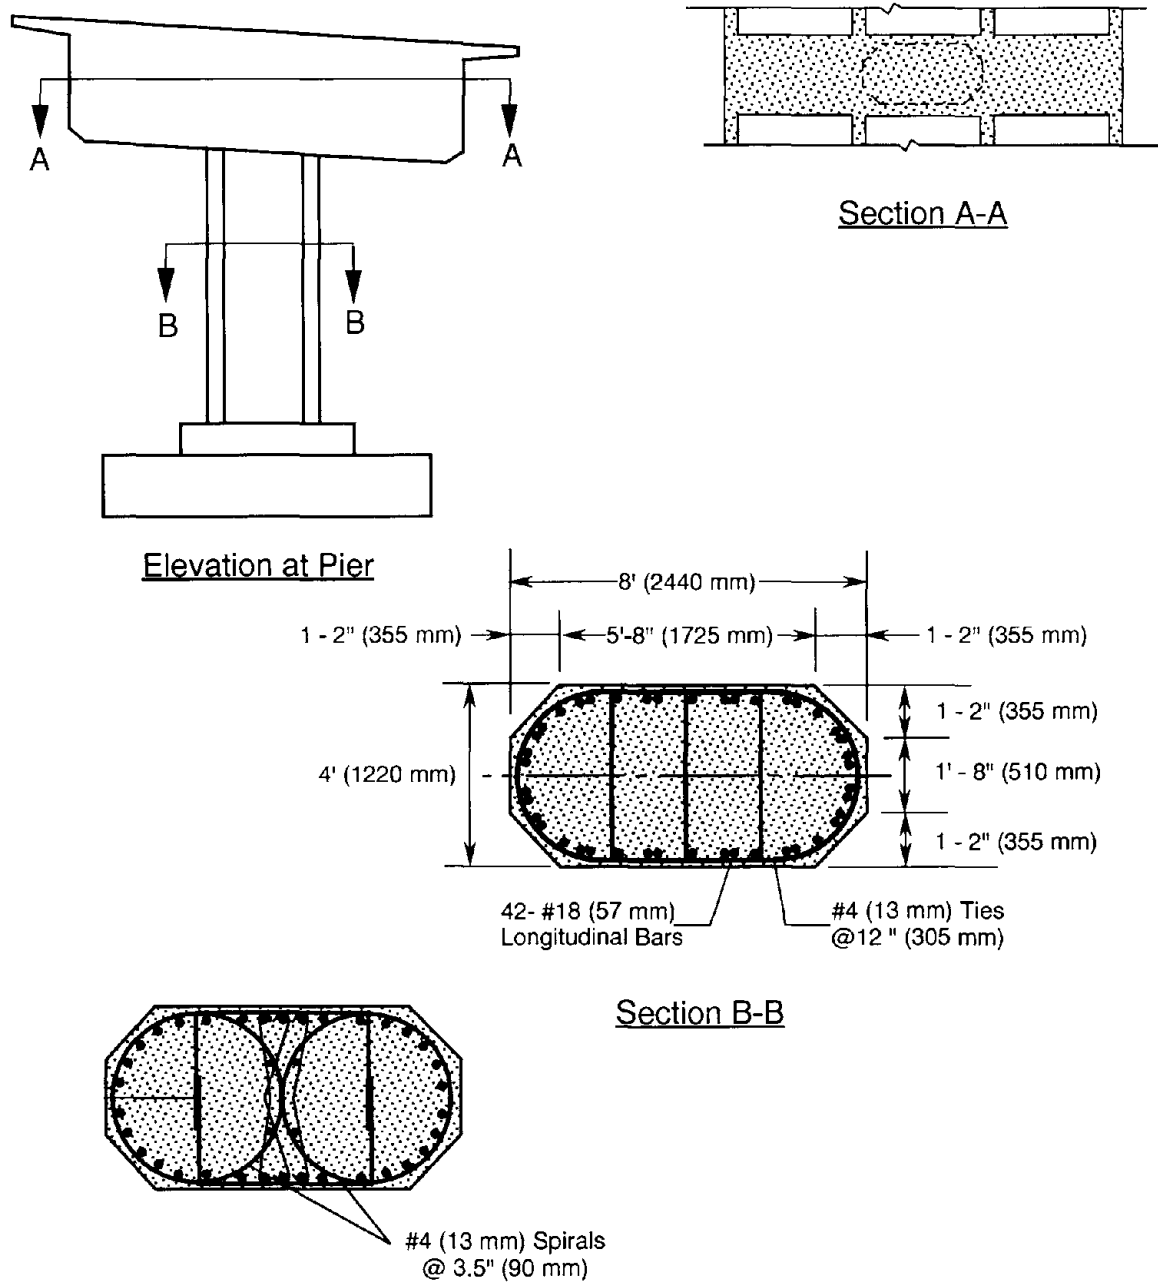
SR14/I5 North Connector O C Ramp M - Pier 2

Figure 4.18. Reinforcement details for Pier 2 of the SR14/I5 North Connector Overcrossing, Ramp M.

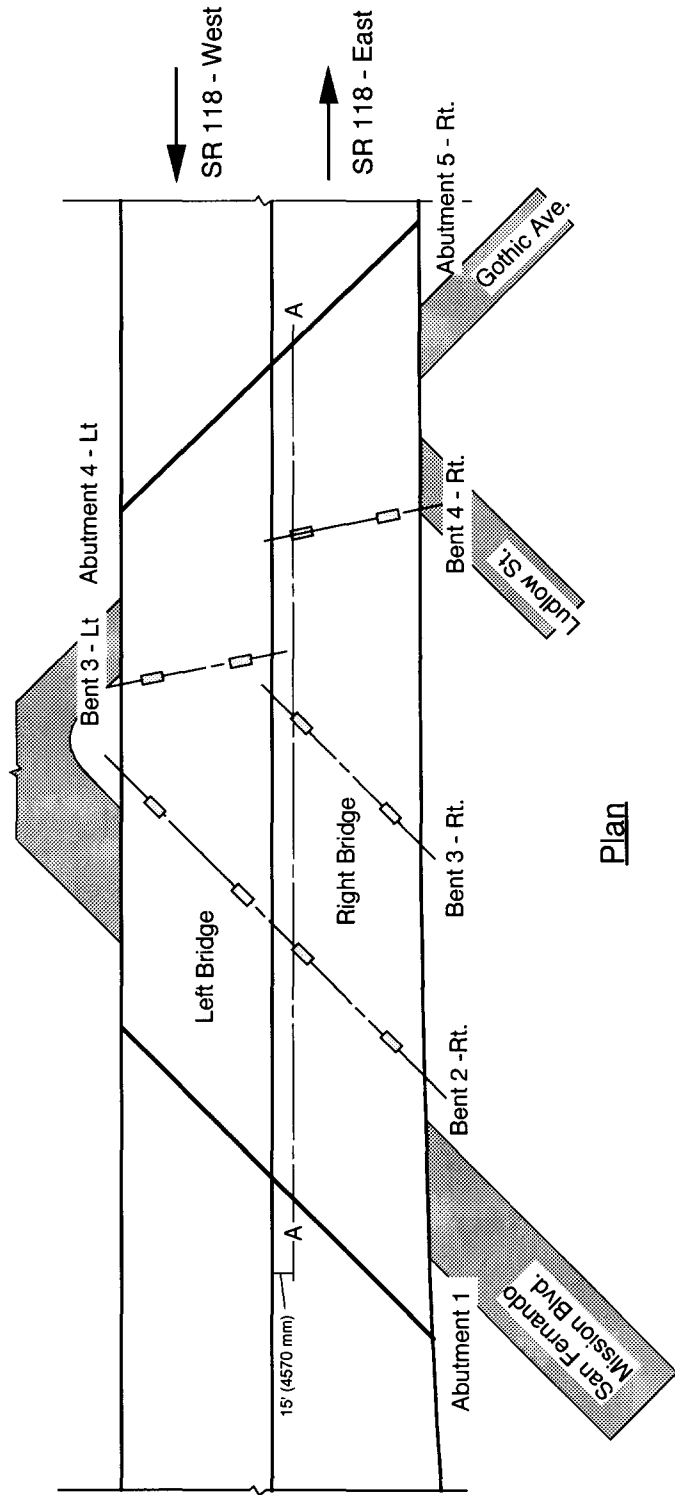
The first important feature of the bridge is its irregular geometry. Figure 4.23 shows that the plan shape of the bridge is a trapezoid. Thus, because of the orientations of the abutments, the structure was constrained to move in only one lateral direction during the earthquake, roughly to the southwest. Indeed, figures 4.21 and 4.22 show that the superstructure moved in this direction, creating a diagonal shear failures in many of the piers. There is also a highly irregular placement of piers, dictated in part by the trapezoidal plan shape of the bridge, and in part by right-of-way restrictions. The irregular plan shape and placement of piers created asymmetric stiffness and mass distributions, which undoubtedly lead to some piers being more heavily loaded than others during the earthquake. Detailed analyses will be required to determine how lateral earthquake loads were distributed among the piers.

Figure 4.23. Plan and elevation views of the SR118 Mission-Gothic Undercrossing.

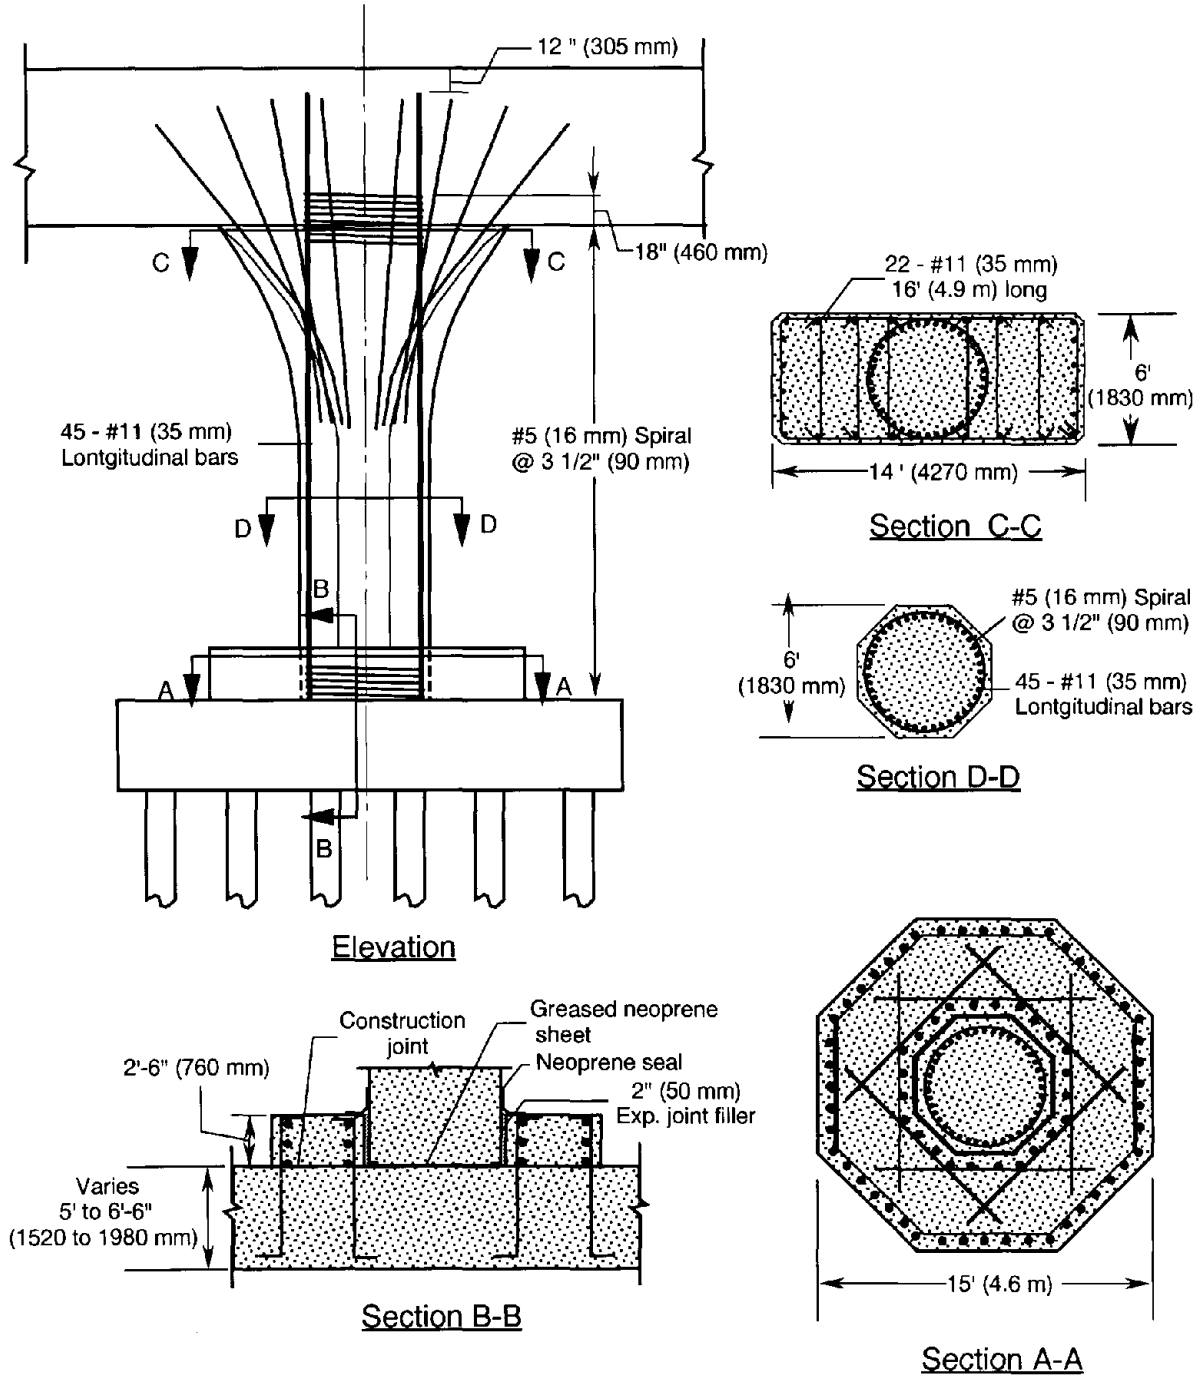
SR 118 - Mission-Gothic Undercrossing Pier Details

The second, and perhaps more important, feature of this bridge is the geometry of the bridge piers. Pier details are shown in figure 4.24. The piers were all relatively short, roughly 7200 mm (24 ft) tall by 1800 mm (6 ft) across, making an aspect ratio of only 4:1. However the piers also featured architectural flares at the tops, roughly 3600 mm (12 ft) tall. These flares were intended to be non-structural features of the piers . It was believed that the flares would spall or otherwise deteriorate during earthquake loading so that they would not contribute to the bending stiffness of the piers. However, it is clear that in actual performance the flares created a zone of added stiffness, reducing the aspect ratio of the piers to approximately 3:1. Thus the piers were very stiff laterally, and were dominated by shear rather than bending. The detail at the footing/pier interface was also somewhat unusual for this bridge. Figure 4.24, section B-B, shows that the base of the pier rested inside a collar at the top of the pier footing. This detail was intended to permit free translation of the pier base during post-tensioning operations of the superstructure, before the collar was cast. The detail also had the effect of creating a hinge at the pier base. It is not immediately apparent whether this hinge improved or worsened the seismic performance of the bridge, although for a given lateral force the bending moments at the tops of the piers were greater than if the hinges at the bases of the piers had not been present.

Figure 4.24. Pier details for the SR118 Mission-Gothic Undercrossing.

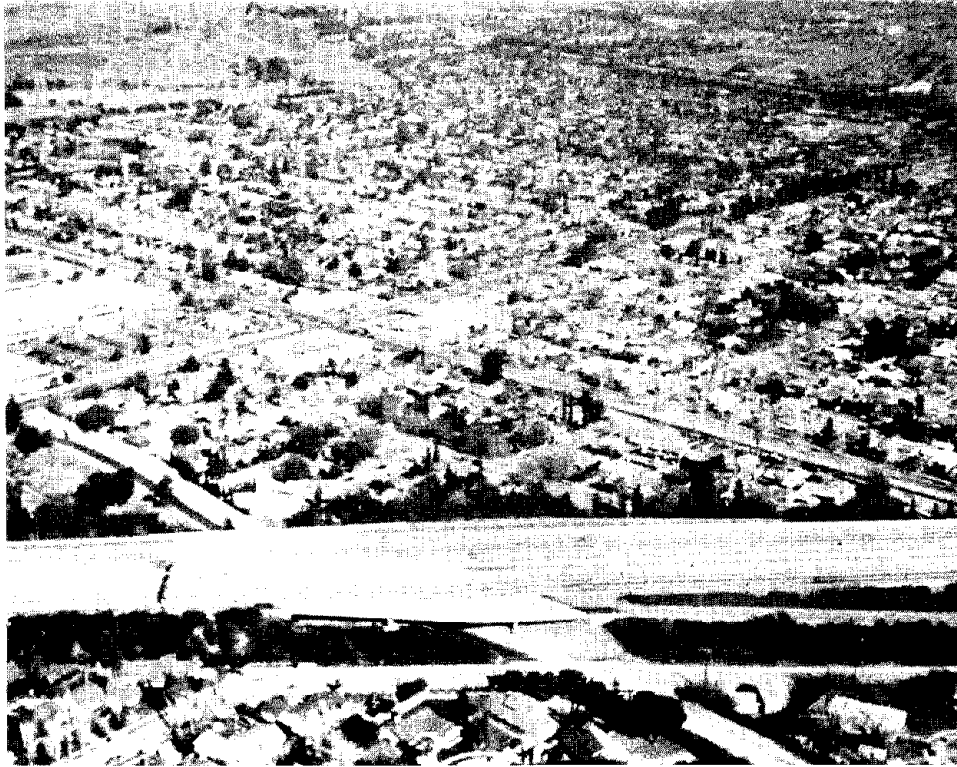
Figure 4.25 shows an aerial view, and 4.26 a ground-level view, of the SR118 bridge at Bull Creek Canyon Channel. The bridge did not collapse completely, but many of the piers were severely damaged, as shown in figures 4.27 and 4.28. In addition to pier damage, there was significant damage to the abutments, including cracked wing walls, settlement of soil behind the abutments, and possible shifting of the abutments. Plan and elevation views of the bridge are shown in figure 4.29, and pier details in figure 4.30.

Figure 4.25. Aerial view of State Route 118 at Bull Creek Canyon Channel, looking to the north (Photo courtesy of FHWA).

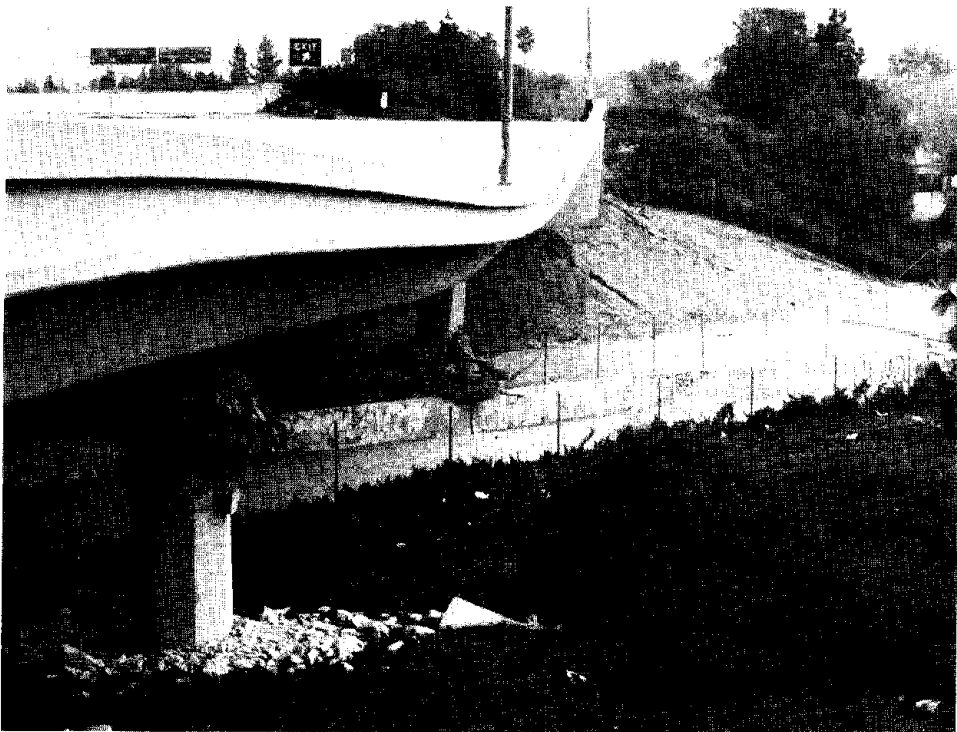
All ten of the piers in Bent 3 failed in combined shear and compression near their bases, as shown by figures 4.27 and 4.28. In Bent 2, Piers on the south side of the span failed near their top end, as shown in the left foreground of figure 4.26, and the damage became progressively less for piers to the north in Bent 2. The farthest north piers in Bent 2 showed relatively little damage - only diagonal shear cracks near the base, with no spalled concrete. This uneven distribution of damage to piers was probably caused by the asymmetric plan geometry of the bridge, as shown in figure 4.29.

Figure 4.26. Ground-level view of State Route 118 at Bull Creek Canyon Channel, looking along the south edge, towards the east.

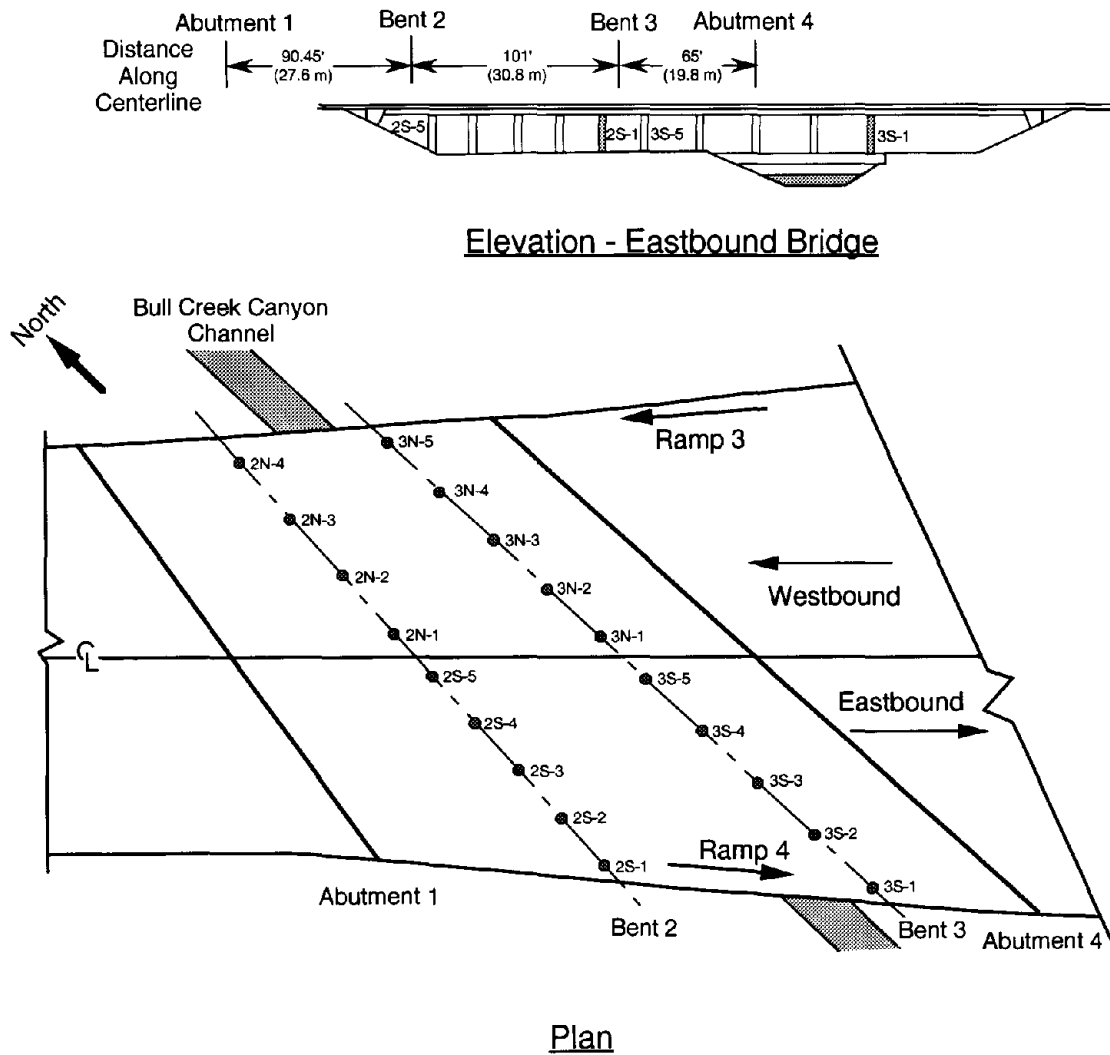
SR 118 Bull Creek Canyon Channel Bridge

Figure 4.29. Plan and elevation views of State Route 118 at Bull Creek Canyon Channel.
