1994 Northridge Earthquake Performance of Structures, Lifelines, and Fire Protection Systems

Building and Fire Research Laboratory
National Institute of Standards and Technology
Gaithersburg, MD 20899-0001

May 1994

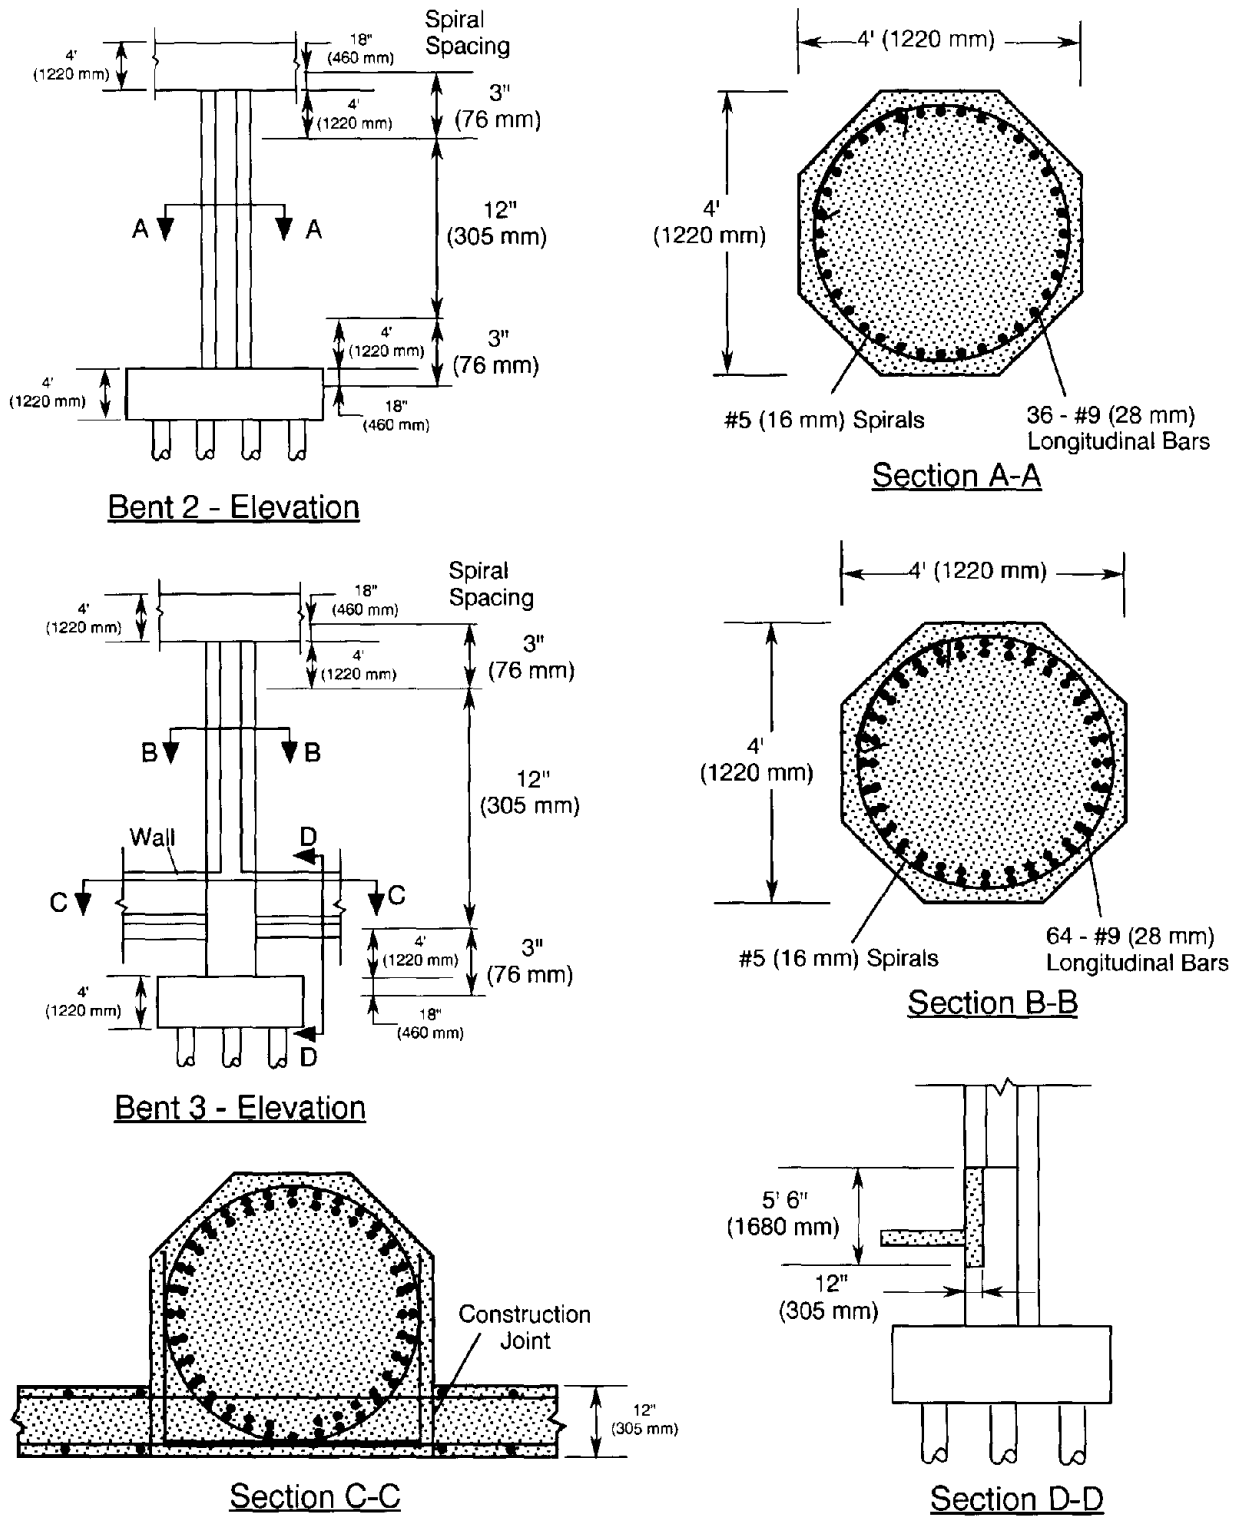
SR 118 Bull Creek Canyon Channel Bridge Piers

The confining reinforcement in the piers, shown in figure 4.30, is inadequate by current standards. Spiral confining hoops were spaced at 76 mm (3 in) near the top and bottom of each pier (presumably to provide confinement in potential plastic hinge regions), but the spacing was 305 mm (12 in) over most of the pier height. All pier failures occurred in the zone of wide spiral spacing. Another factor contributing to pier failure was that the effective lengths of the piers were much shorter than the distance between the footings and the girder soffit. The lengths of piers varied between roughly 6000 and 9100 mm (20 and 30 ft). In Bent 2, the effective pier lengths were decreased roughly one-third by compacted backfill soil above the pier footings. In Bent 3, the pier lengths were also decreased roughly one-third, but by a reinforced concrete channel liner wall, which was cast abutting the piers (fig. 4.30, section C-C). The shortened effective pier length resulted in stiffer piers, which were more susceptible to shear-dominated failure than bending-dominated failure.

Figure 4.30. Pier details for State Route 118 at Bull Creek Canyon Channel.

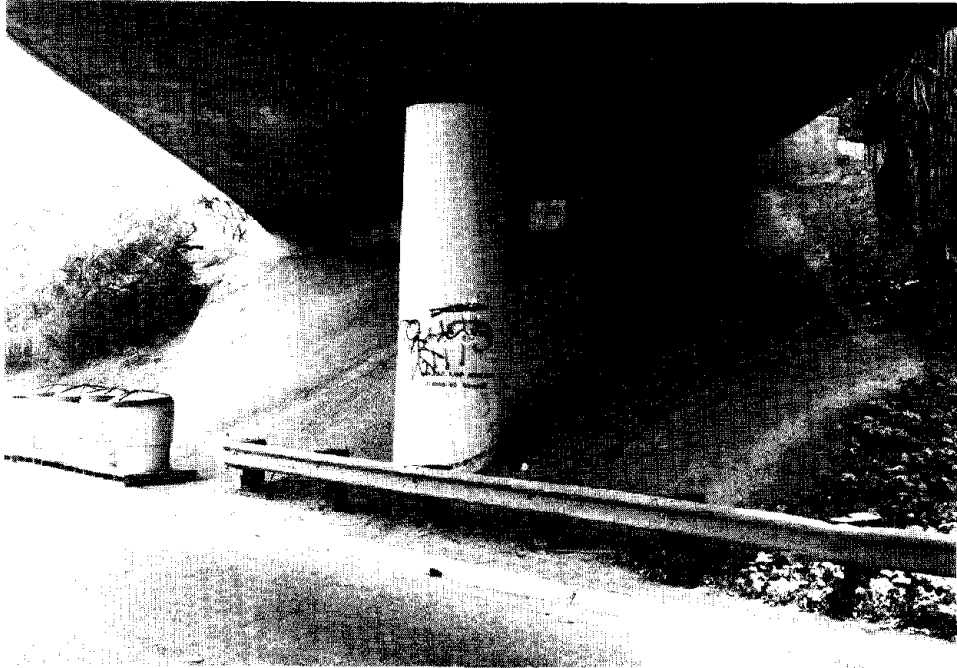
Figure 4.34. Cadillac Ave. ramp; view to east showing jacketed pier.

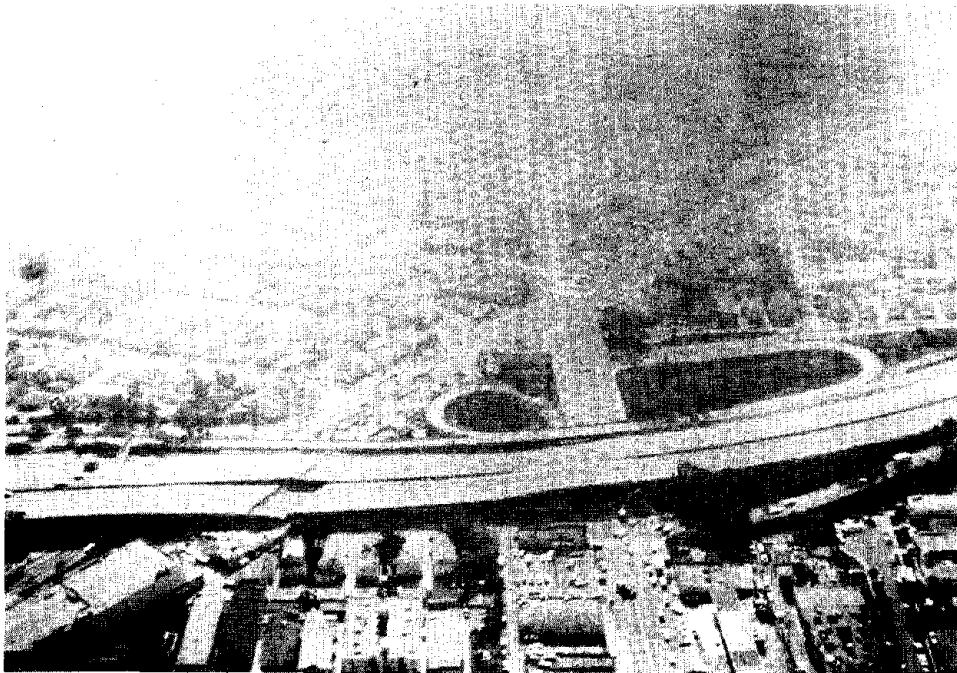
Figure 4.35 is an aerial view of I10 where it passes over La Cienega Blvd. and Venice Blvd. The view is toward the south, and Venice Blvd. is the diagonal street on the left side of the photograph. The portion of the westbound lane which collapsed to ground level can be seen. However, there was extensive damage to most of the supporting piers of the eastbound and westbound lanes.

Figure 4.35. Aerial view (looking south) of I10 Separation at La Cienega Blvd. and Venice Blvd., (Photo courtesy of FHWA).

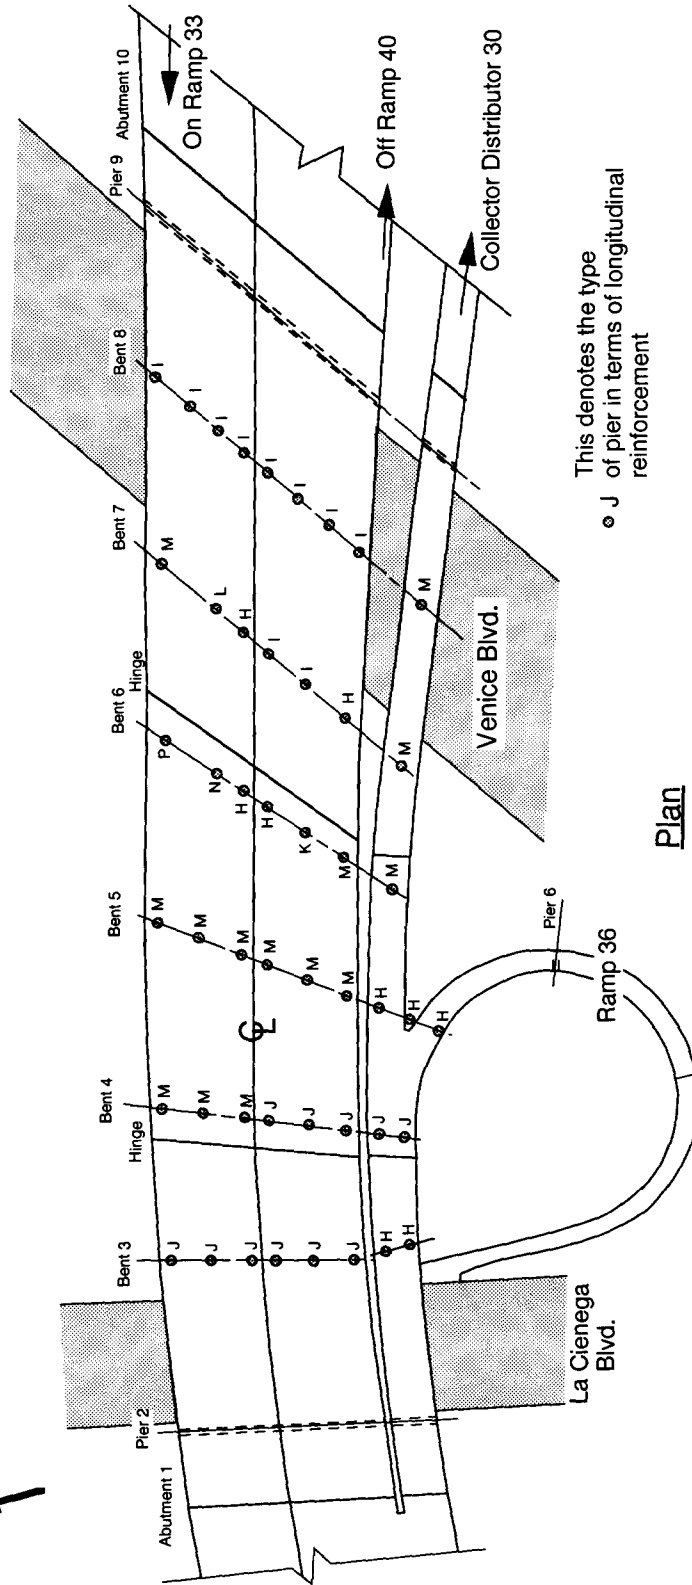
I-10 La Cienega-Venice Separation

Figure 4.36 shows elevation and plan views of the nine-span bridge structure. Solid wall piers provided support adjacent to the abutments, and the remainder of the supports were multiple-pier bents. Two expansion joints (hinges) were provided as shown. Bents 3 to 7 included three supporting piers for each lane, while Bent 8 had four piers per lane. The exit ramp to La Cienega Blvd. and the eastbound collector-distributor did not collapse. Figure 4.37 shows the pier details. The piers had circular cross sections with a diameter of 1220 mm (4 ft), and the longitudinal reinforcement consisted of #11 (35 mm) or #18 (57 mm) deformed bars. The different pier reinforcement configurations were identified by pier "types" as shown in figure 4.37. These pier types are indicated in the plan shown in figure 4.36. The lateral reinforcement consisted of #4 bars (13 mm) at 305 mm (12 in) vertical spacing.

Figure 4.36. Elevation and plan of I10 Separation at La Cienega Blvd. and Venice Blvd.

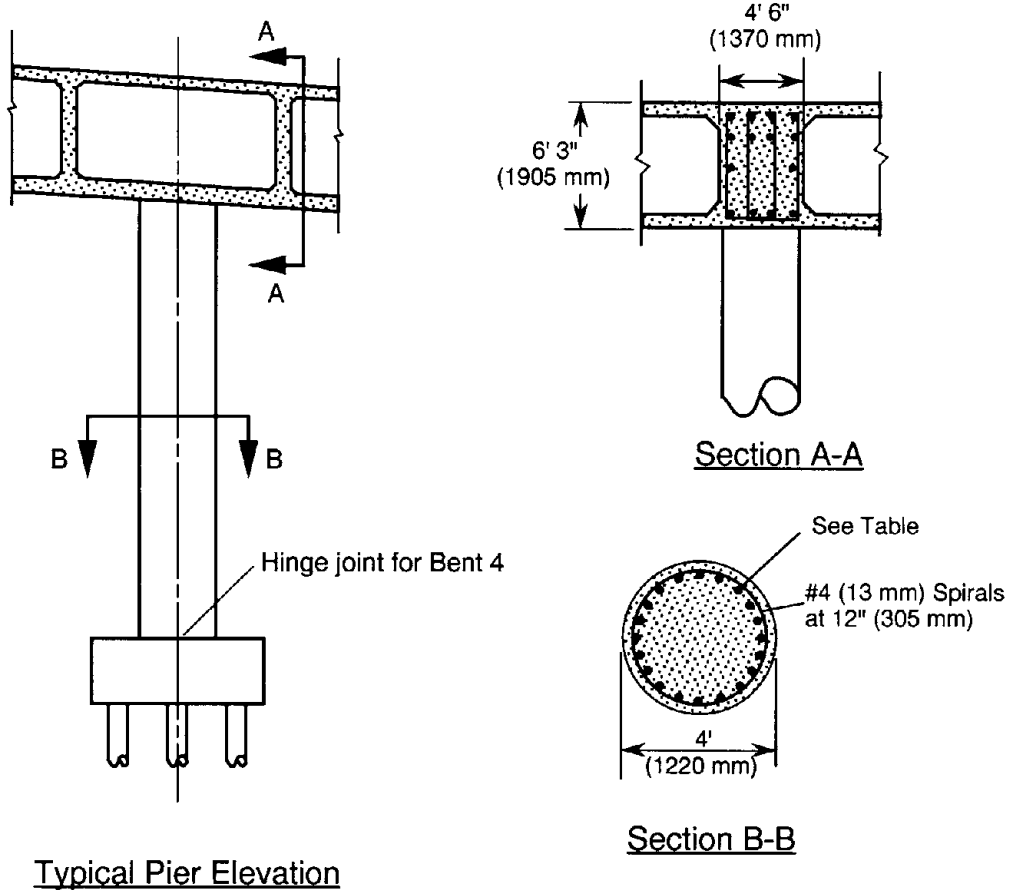
I-10 La Cienega-Venice Separation Pier Details

Figure 4.37. Pier details for I10 Separation at La Cienega Blvd. and Venice Blvd.

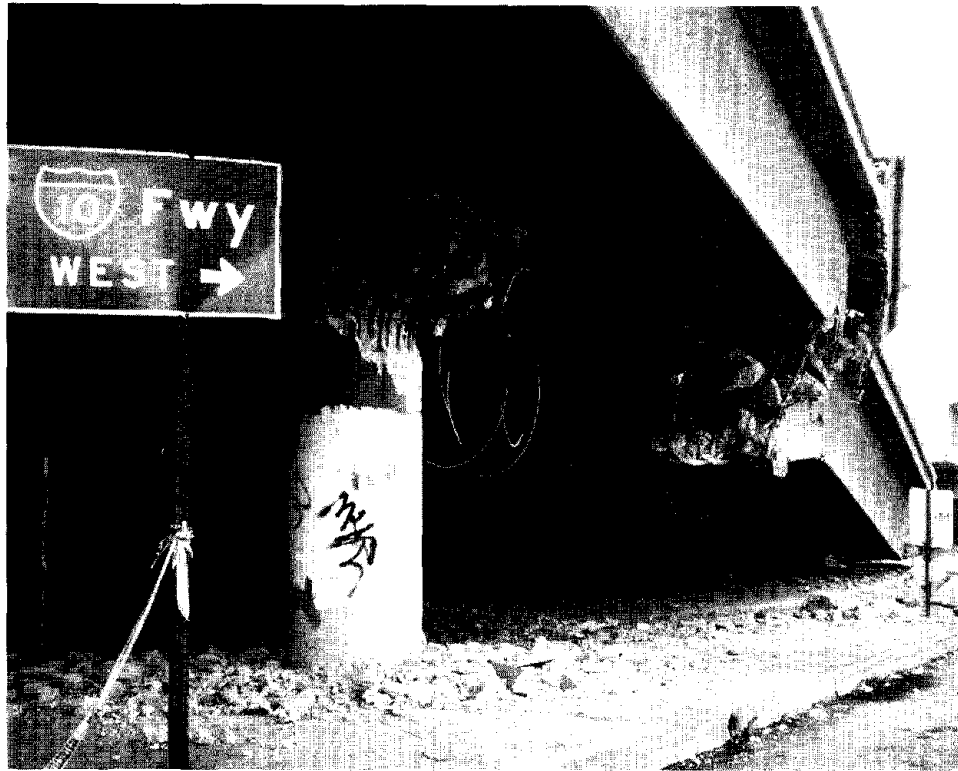
Figure 4.38 is a ground-level view of the portion of the westbound lane that collapsed to the ground at the hinge located between Bents 7 and 6. The pier in the foreground is the northernmost pier of Bent 7. It is seen that there was extensive column shortening due to the failure of the lateral reinforcement to provide adequate confinement of the core concrete. Fractured lateral reinforcement can be seen to the right of the failed portion of the pier. Figure 4.39 shows the other two piers of Bent 7 which supported the westbound lane. Extensive failure and column shortening is evident. The concrete block wall behind the piers is part of a storage building that was constructed beneath the bridge structure. The storage building extended from

Venice Blvd. to La Cienega Blvd. The piers of Bent 7 which supported the eastbound lane suffered relatively minor damage, and the roadway to the east of Bent 7 remained largely at its original elevation.

Figure 4.38. Collapsed westbound lane of I10 at Venice Blvd.; pier of Bent 7 in foreground.

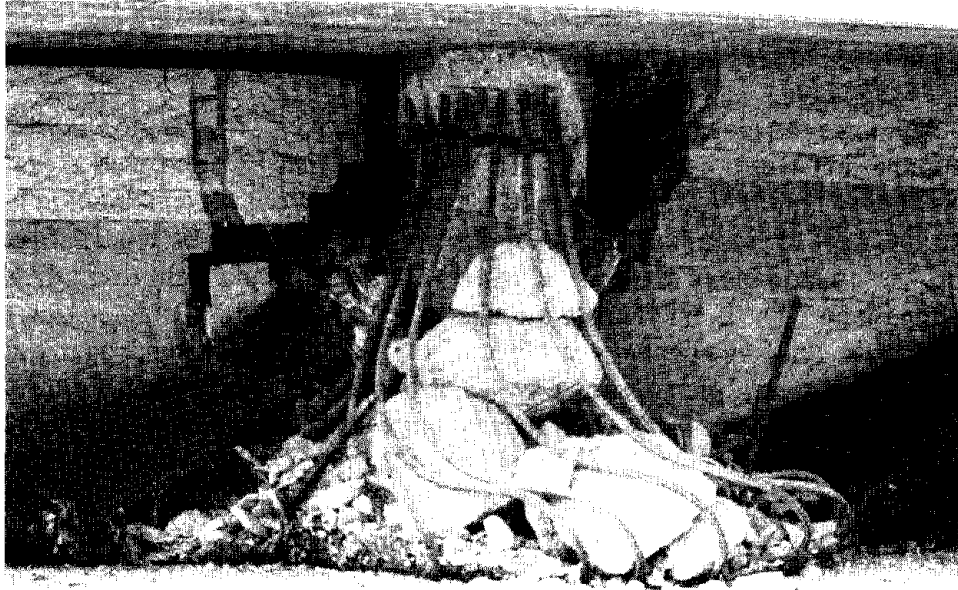
Figure 4.40 shows the northernmost pier of Bent 6, located just to the west of the hinge. This pier totally disintegrated, but the storage building prevented the roadway from collapsing to the ground. Figure 4.41 shows the southernmost pier supporting the eastbound lane at Bent 3. The top of the pier is severely damaged and it is likely that the storage building prevented the total collapse of the roadway.

Figure 4.40. Northernmost pier of Bent 6 supporting westbound lane of I10 (west of Venice Blvd.).

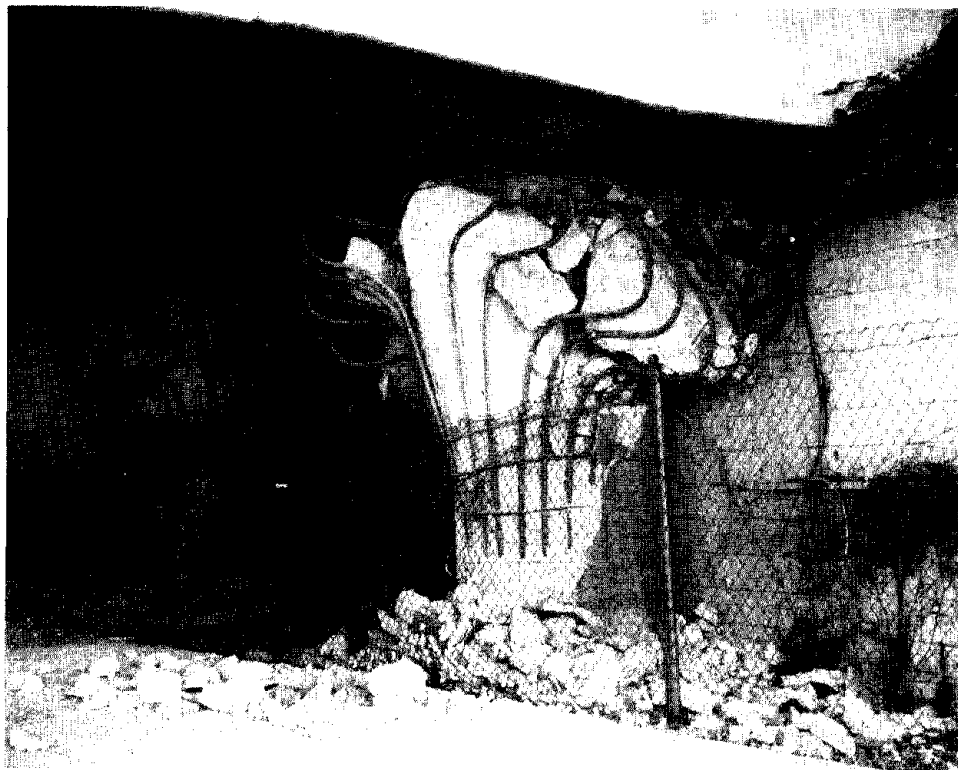
In summary, the bridge structure spanning La Cienega Blvd. and Venice Blvd. was extensively damaged. The failure is attributed to the small amount of lateral pier reinforcement. As the piers cracked due to the lateral loading, the lack of adequate confinement resulted in a reduction of the vertical load capacity because of core concrete loss and buckling of the longitudinal bars. Had it not been for the storage building located beneath the bridge, it is likely that more spans would have collapsed to the ground.

Figure 4.41. Piers of Bent 3 supporting eastbound lane of I10 at La Cienega Blvd.

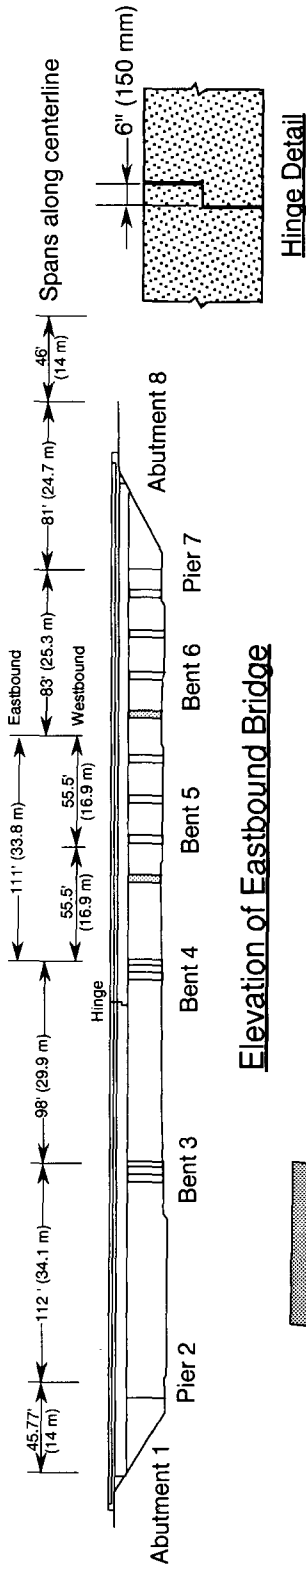
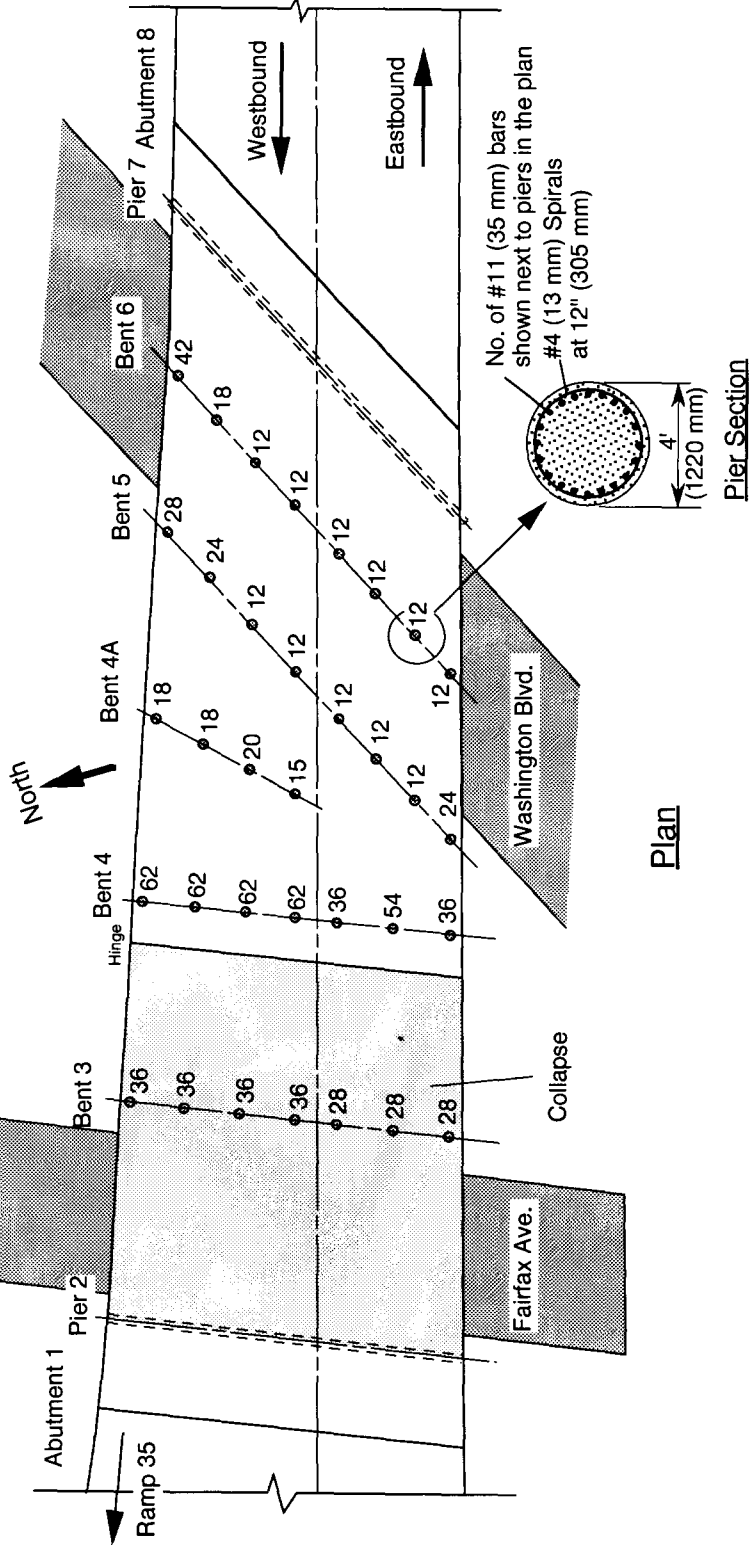
I-10 Fairfax-Washington Undercrossing

Figure 4.42 shows the elevation and plan of the Fairfax Ave.-Washington Blvd. Undercrossing. The eastbound and westbound lanes of I10 were supported by solid wall piers adjacent to the abutments and by multiple-pier bents at the remaining locations. A construction joint (hinge) was located to the west of Bent 4. Because of the skewed alignment of I10 relative to Washington Blvd., the westbound lane of I10 was designed with an additional bent (Bent 4A) compared with the eastbound lane. The piers were of circular cross section with a diameter of 1220 mm (4 ft). The longitudinal reinforcement consisted of #11 (35 mm) deformed bars. The number of longitudinal bars in each pier is shown adjacent to the pier locations in figure 4.42. It can be seen that the piers in Bent 4 had significantly more longitudinal bars compared with the other piers. The lateral reinforcement was #4 (13 mm) bars at a vertical spacing of 305 mm (12 in).

The earthquake caused partial collapse of two spans of the eastbound and westbound lanes on either side of Bent 3 (fig. 4.42). When the reconnaissance team arrived at the site, the collapsed spans had been completely removed and workmen were preparing to open up traffic on Fairfax Ave. Hence it was not possible to examine the collapsed structure. Conversations with Caltrans engineers at the site revealed that the piers in Bent 3 had failed and caused the girders to sag at this location. However, cable restrainers at the hinge west of Bent 4 prevented the girders from falling off of the hinge seats (fig. 4.43). Figure 4.44 is a photograph provided by EERC which shows the westbound lane of I10 over Fairfax Ave. It can be seen that the piers in Bent 3 shortened and caused the girder to sag. It can also be seen that the span to the west of Pier 2 lifted off of the abutment. Figure 4.45 is a close up view of one of the piers in Bent 3. The failure mode is similar to that observed at Venice Blvd. and La Cienega Blvd. When the piers were subjected to lateral ground motions, the lateral reinforcement was not able to adequately confine the core concrete. As a result of lateral load damage, there was a loss of axial load capacity and the piers shortened under the action of the vertical loads. As mentioned, the piers at Bent 4 had considerably more longitudinal reinforcement than the other piers. Examination of the piers in Bent 4 revealed varying degrees of diagonal cracking and spalling of the concrete cover. At the time of the site visit, these piers were surrounded with wooden shoring as a precautionary measure during the demolition of the collapsed spans.

Figure 4.42. Elevation and plan of I10 at the Fairfax Ave./Washington Blvd. Undercrossing.

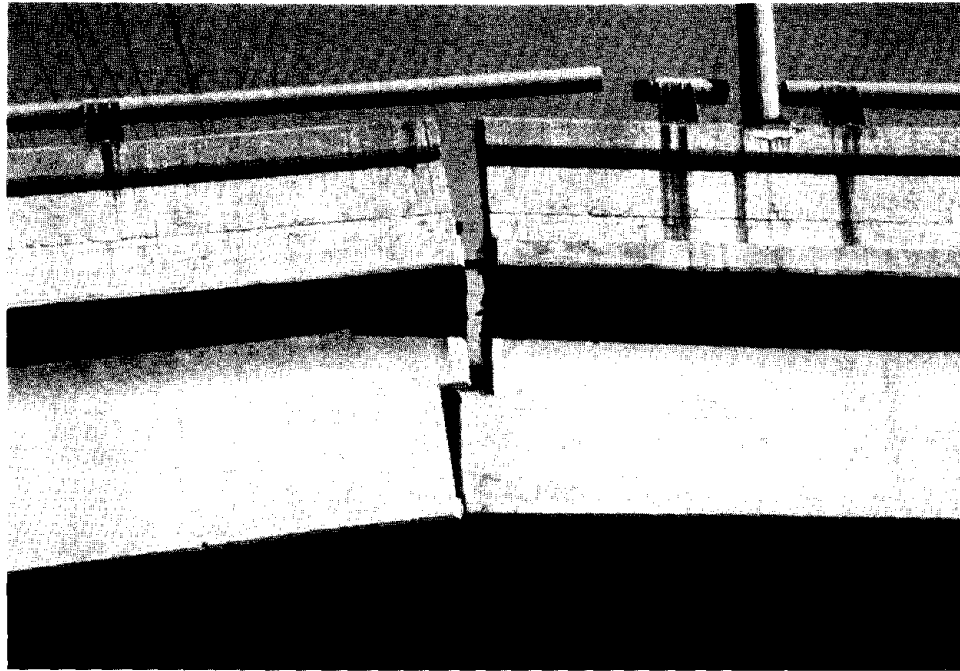
Figure 4.43. Hinge adjacent to Bent 4 of I 10 at Fairfax Ave.; cable restrainers prevented loss of support (Photo courtesy of EERC).

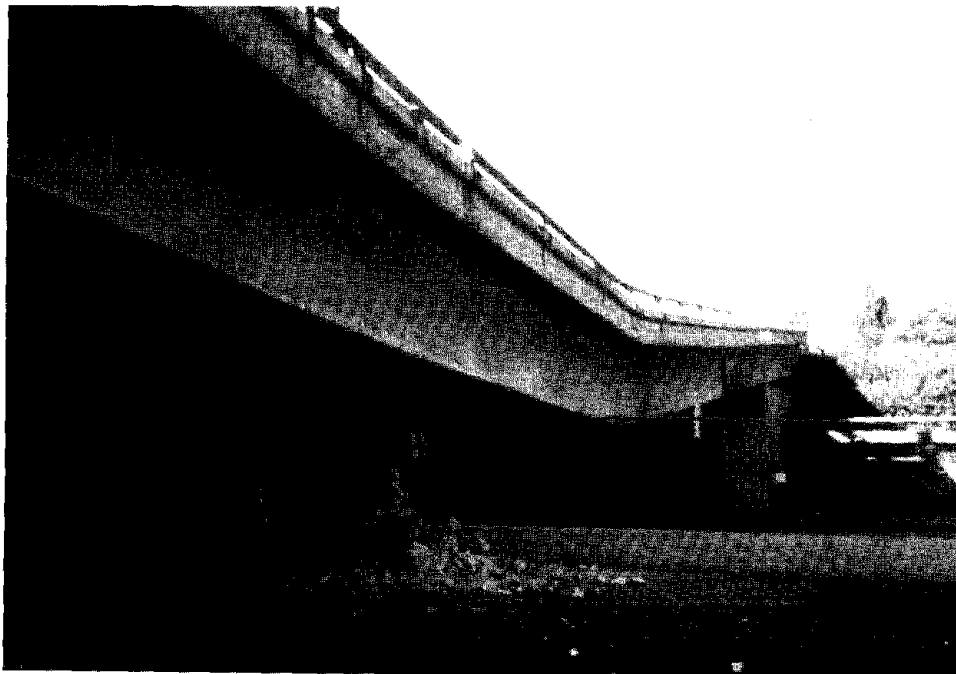
Figure 4.44. View of collapsed span of I10 over Fairfax Ave.; note rotation of girder over Pier 2 (Photo courtesy of EERC).

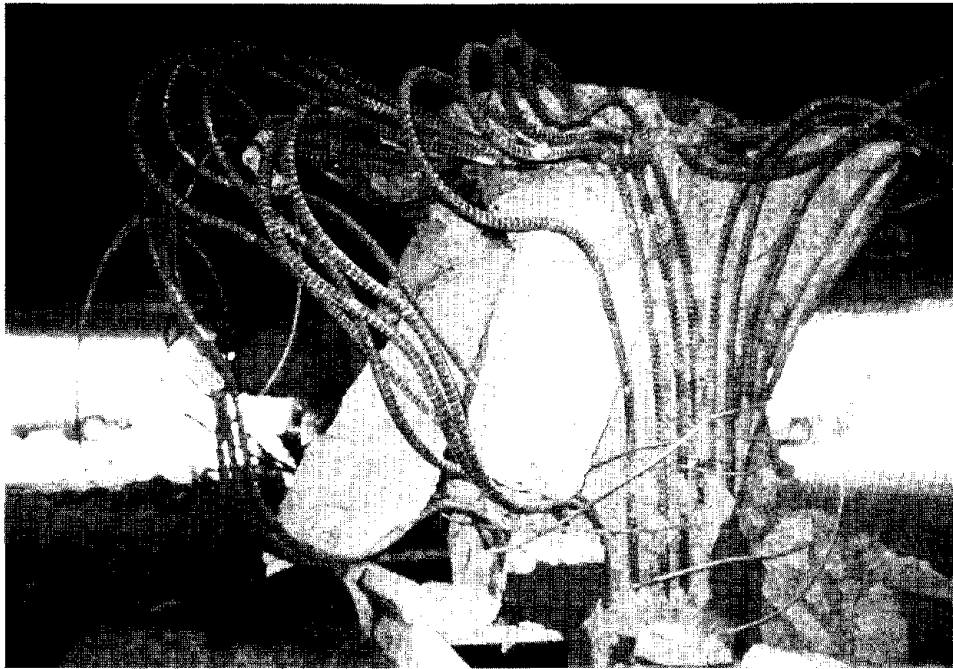
Figure 4.45. Failed column in Bent 3 of I10 at Fairfax Ave. (Photo courtesy of EERC).

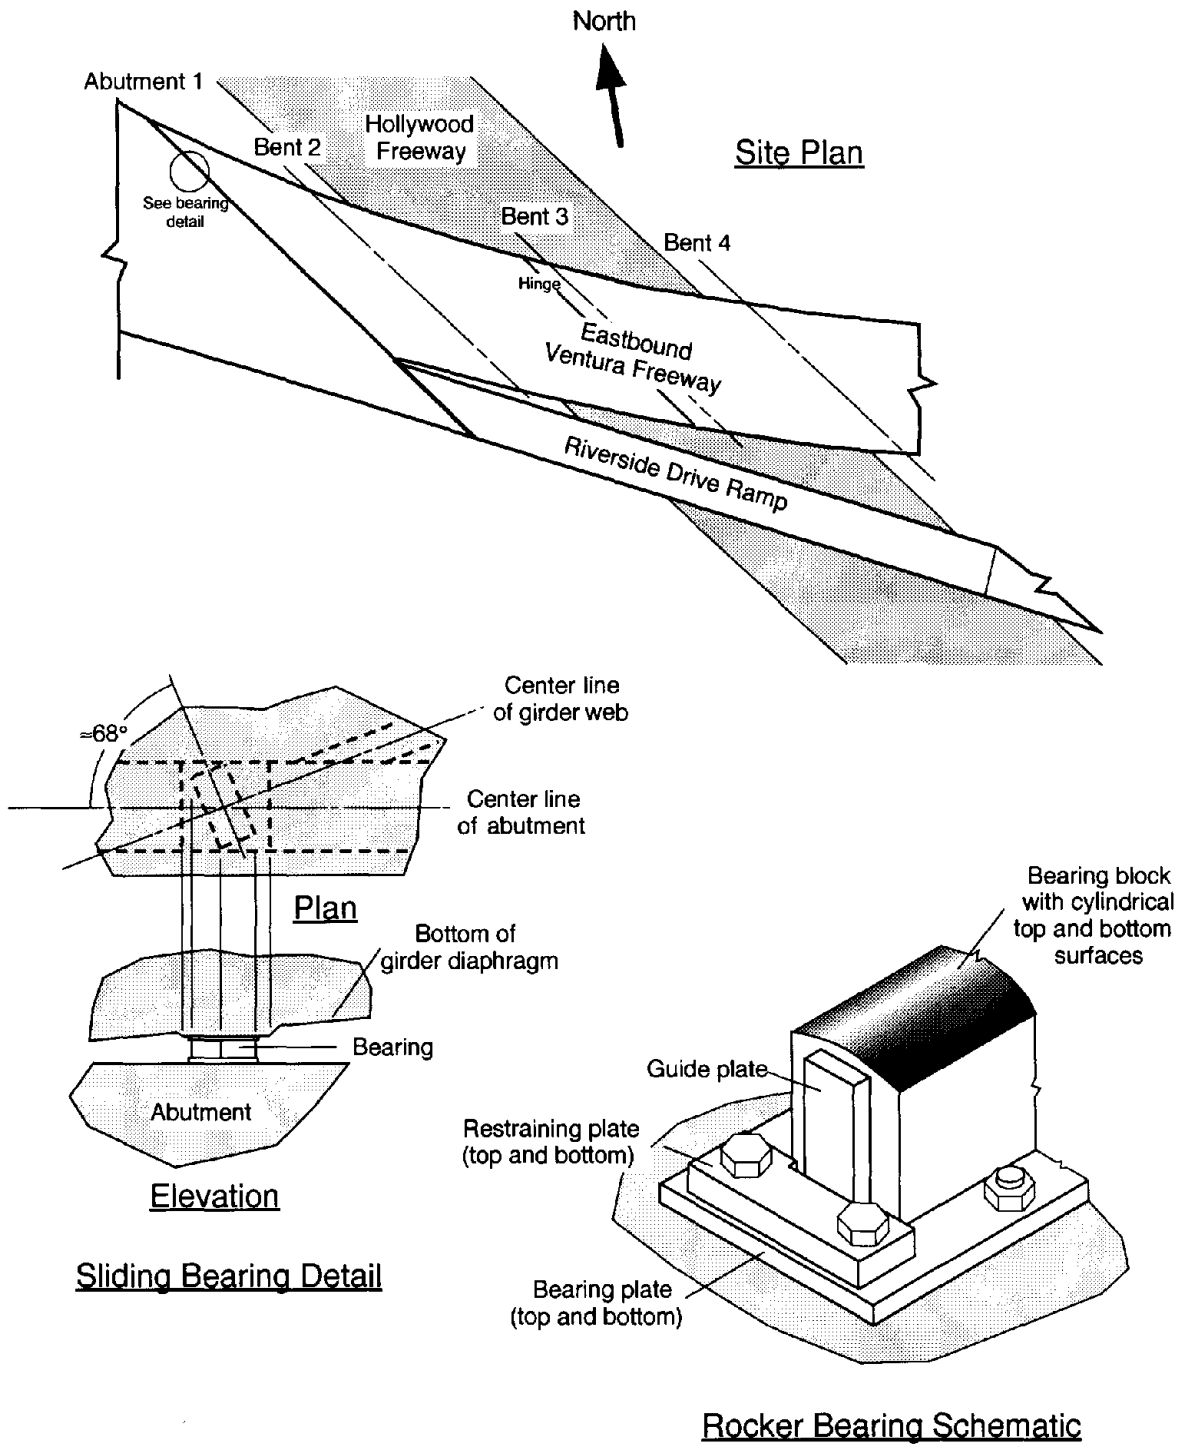
Figure 4.46 shows a simplified plan of the eastbound lane of the Ventura Freeway and the Riverside Drive ramp. Figure 4.47 is a ground level view of the eastbound lane as seen from the northbound lane of the Hollywood Freeway. At Abutment 1 (fig. 4.46), bearing supports are provided at the locations of the webs in the box girder. As shown in figure 4.46, the longitudinal axes of the bearings are aligned at right angles to the longitudinal axes of the girder webs. The four bearings on the north side of the eastbound lane of Ventura Freeway are of the sliding-type. Figure 4.48 shows the type of damage that was observed at these locations. Apparently, the dynamic frictional resistance of the bearing resulted in forces sufficient to spall off the shell of the abutment. The remainder of the bearings supporting the eastbound lane and the Riverside Drive ramp are of the rocker type. Figure 4.46 shows a schematic of this type of bearing. A steel bearing block with cylindrical surfaces is located between steel plates set into the abutment and girder end diaphragm. The blocks are kept in position with a system of guide plates and restraining plates as shown in figure 4.46. All of the rocker bearings showed some type of earthquake damage. The bolts for the restraining plates were sheared off at many locations, and the sheared bolt heads were found at distances of up to several meters from their original position. Some of the bearing blocks were skewed from their original positions (fig. 4.49). In one case, the bearing block had tipped over resulting in a complete loss of support at that location (fig. 4.50).

Figure 4.46. Eastbound lane of Ventura Freeway crossing over Hollywood Freeway; site plan and bearing details.

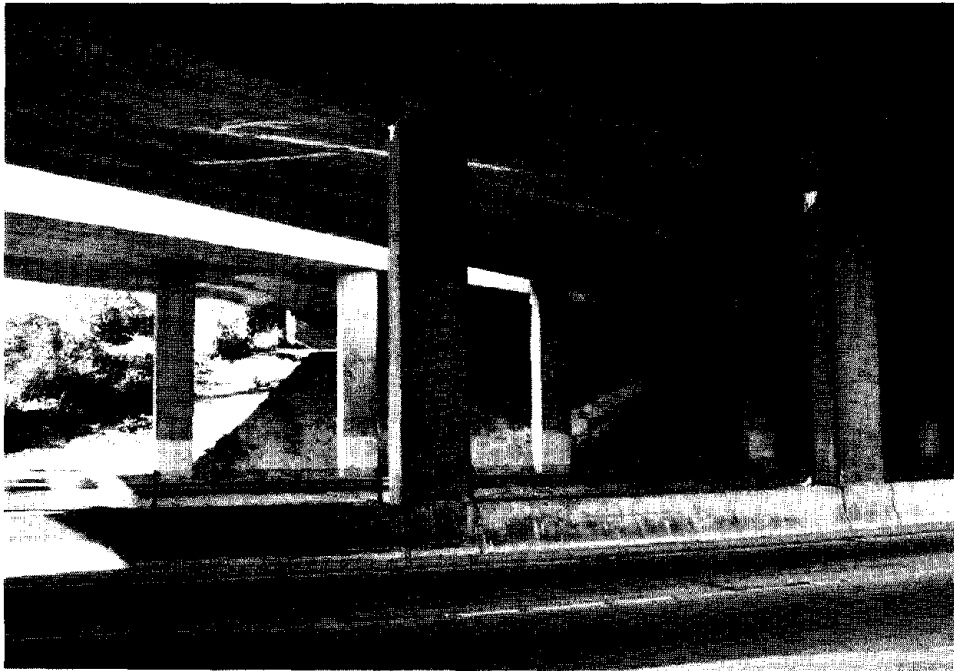
Figure 4.47. Eastbound lane of Ventura Freeway as seen from the northbound lane of Hollywood Freeway.

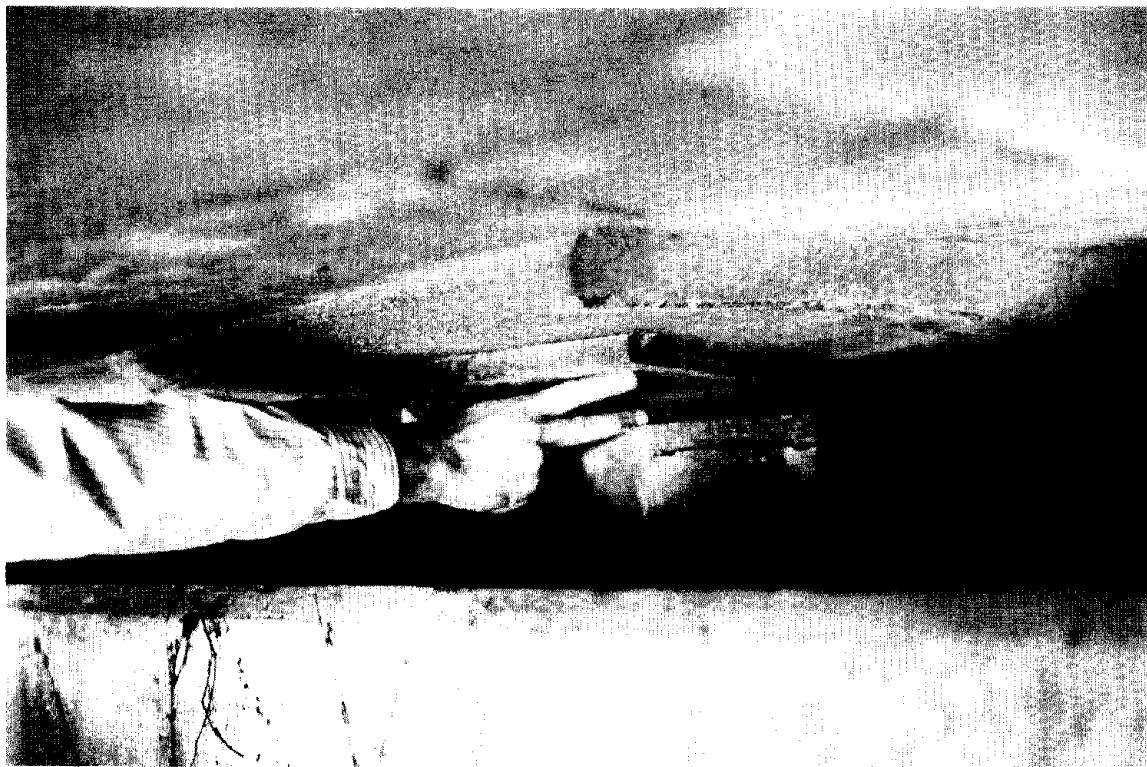
These observations highlight the unsuitability of rocker-type bearings to withstand the effects of seismic deformations. Because of redundancy, the failure of one bearing may not result in serious damage to the supported girder. However, multiple bearing failures could drastically alter the forces in the girder, and these forces could exceed the girder capacity.

Figure 4.50. Bearing block tipped over at this location resulting in loss of support to girder.

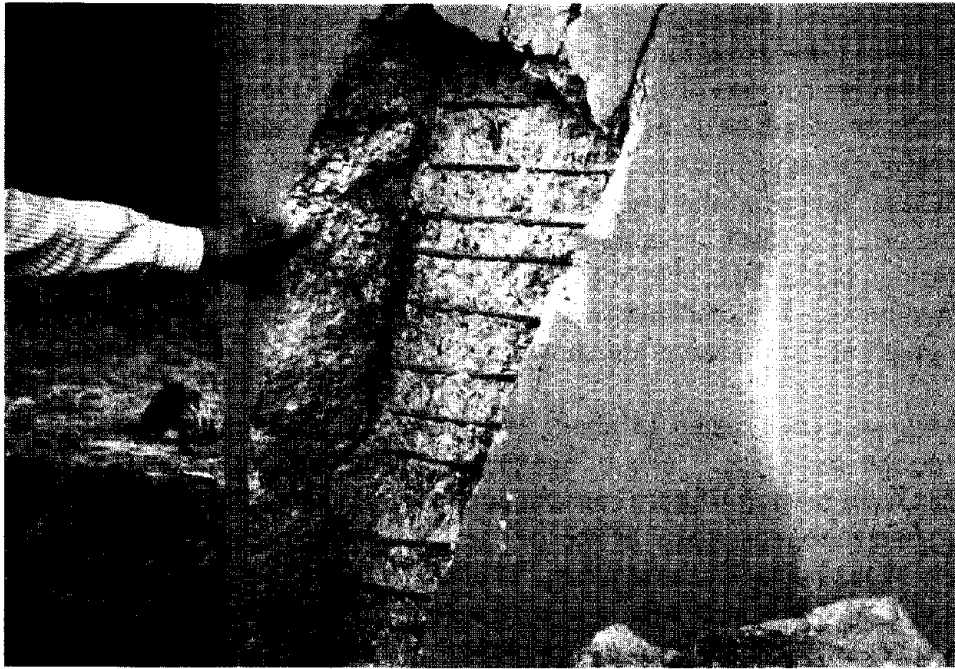
This is a long, curved ramp structure with piers of varying height. The last pier before the west abutment, adjacent to Sharp Avenue, exhibited severe shear cracking. This was one of the shortest and stiffest piers in the structure, so it probably attracted large lateral forces. Damage to the pier is shown in figures 4.51 and 4.52. Note that when the photos in figures 4.51 and 4.52 were taken the loose cover concrete had been removed by Caltrans workers to inspect damage to the core. It appeared that cracks extended into the core of the pier. The pier is octagonal in cross section, measuring 2440 mm (8 ft) across, and has a flared section at the top. Longitudinal reinforcement consists of 64 #11 (36 mm) bars (EERC 1994). This pier contains high levels of shear reinforcement: #4 (13 mm) spirals spaced at 89 mm (3.5 in). Damage to the abutment just to the west of this pier was also observed. This damage was apparently due to pounding between the superstructure and the abutment.

Figure 4.52. Close-up view of the westernmost pier at the Interstate 5, State Route 118, Southwest Connector, looking to the southeast. Loose cover concrete has been removed by Caltrans.

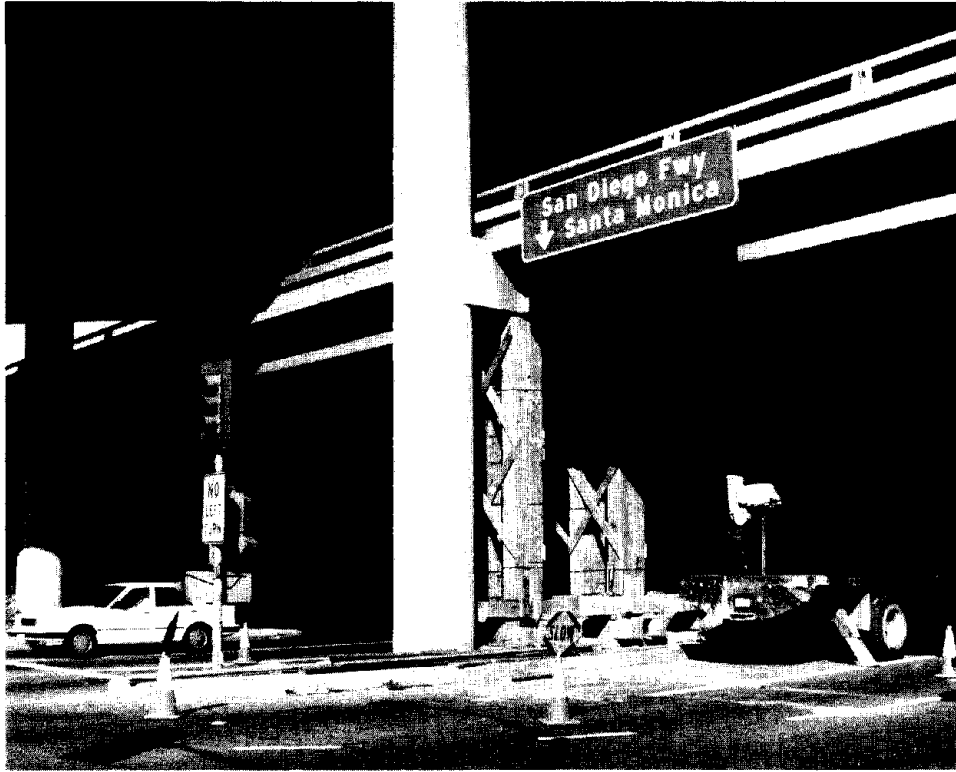
The damage observed in the Northridge earthquake possibly arose from three factors. First, the joint regions where cracking occurred are not as heavily reinforced as they would be under current design standards. Second, the structural hinges at the bases of most outrigger piers tended to increase the moments imposed on the outrigger joints. Third, the Jefferson Blvd. Undercrossing shares piers with the SR90 ramp above, as shown schematically in figure 4.55. The upper SR90 structure is more flexible than the lower Jefferson Blvd. Undercrossing, possibly resulting in further concentrations of moments at the outrigger joints.

Figure 4.53. Overview of the outrigger joint at the SR90/I405 interchange, Jefferson Boulevard Undercrossing, center bent, west side, looking to the north.

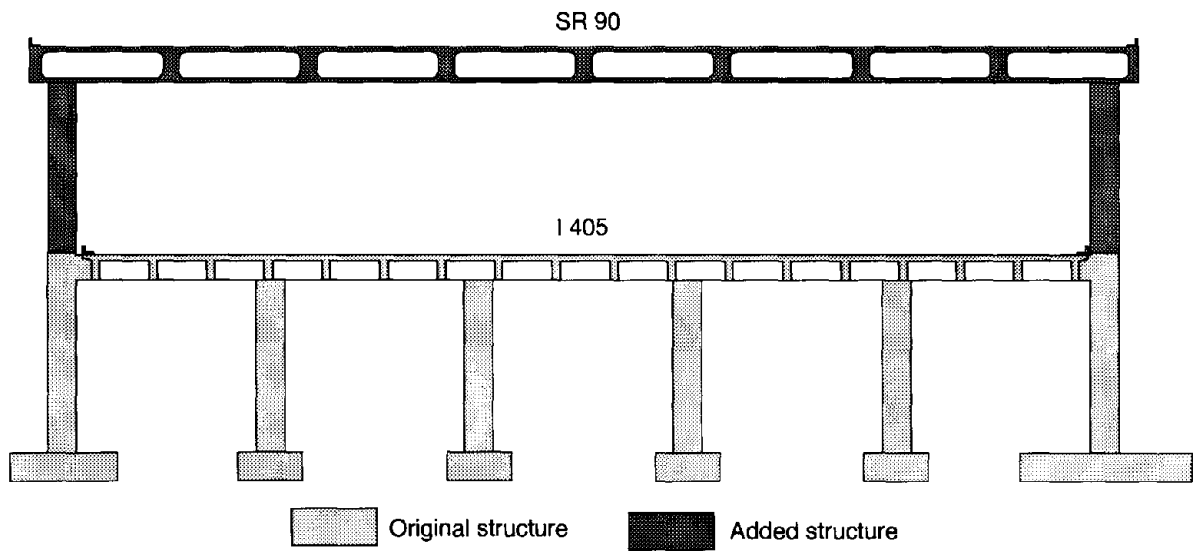
This bridge was constructed in about 1961, so generally speaking it does not meet current seismic design standards. The bridge is somewhat unusual because in the original design allowances were made for future construction of the ramps of the SR90/I405 interchange passing overhead: the outermost piers of the bridge were more heavily reinforced to allow for later extensions of the height of those piers. The reinforcement in the exterior piers consisted of 22 #18 bars (57 mm) longitudinally, and #5 bar (16 mm) spiral hoops spaced at 114 mm (4.5 in); the inner piers were reinforced with 14 #9 bars (29 mm) longitudinally, and #4 (13 mm) spirals spaced at 305 mm (12 in). The exterior piers were later extended in height, as can be seen in figure 4.53. It is not clear how structural continuity was achieved between the original exterior piers and the pier extensions, since no explicit provisions were made in the original design for extending the longitudinal reinforcement.

Figure 4.55. Schematic cross section, showing columns shared by SR90 and the Jefferson Boulevard Undercrossing.

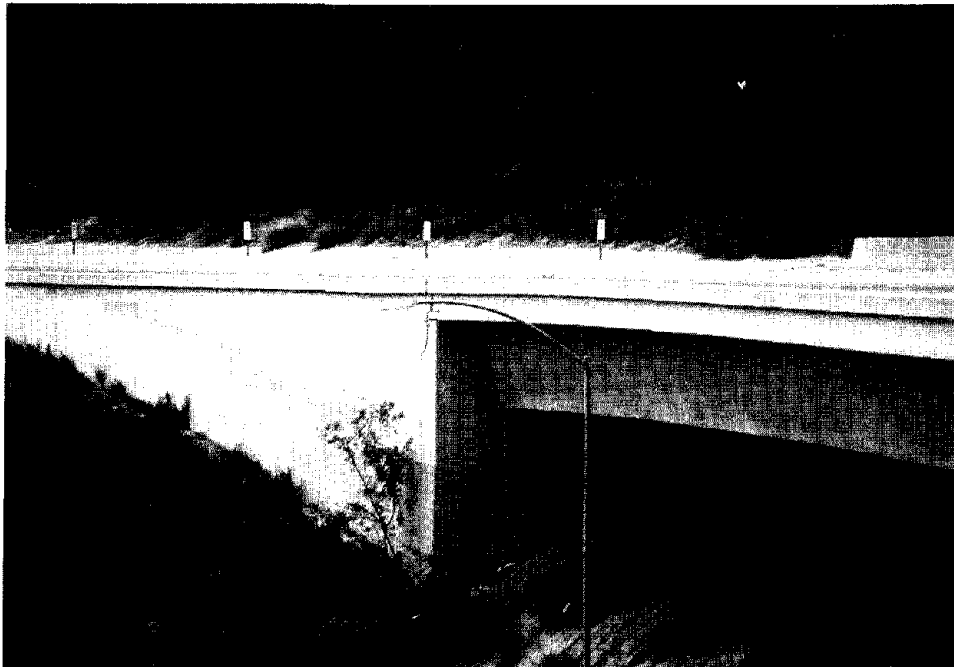
In the Northridge earthquake, bridge abutment damage ranged from minor settlement of backfill soil at the approaches, to cracking of wing walls, to permanent displacement of the entire abutment. For example, at the intersection of State Route 118 and Interstate 210, there was damage to the abutment at the east end of the long elevated structure connecting eastbound SR118 with northbound I210. An overview of the abutment is shown in figure 4.56, and a close-up of some of the abutment sidewall cracking is shown in figure 4.57. At the interchange of US101, SR134 and SR170, at the Riverside Drive Offramp Overcrossing (Caltrans bridge No. 53-1493S, described above) the abutments at both ends of the offramp exhibited severe cracking in the wing walls. Damage to concrete abutment piles was reported [5] at the Las Virgenes Overcrossing on US101 (Caltrans bridge No. 53-1442). There were many other cases of bridge abutment damage observed by the reconnaissance team, and reported by other investigators, which are too numerous to list here.

Figure 4.56. Overview of abutment at the east end of the ramp connecting eastbound SR118 with northbound I210.

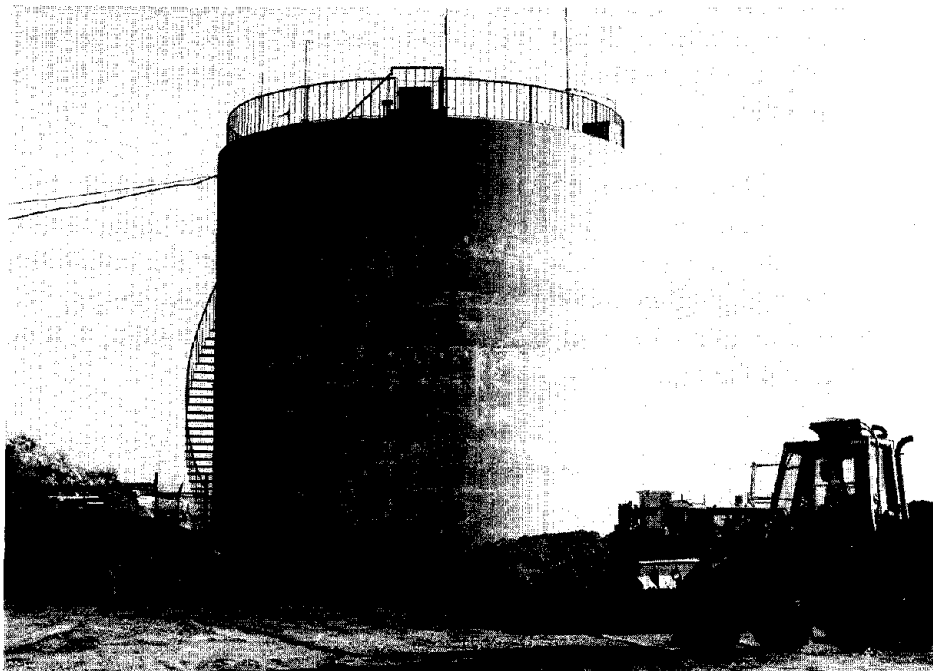
Figure 5.2. The reinforced concrete surge tank at Terminal Hill performed well during the earthquake--no damage was observed.

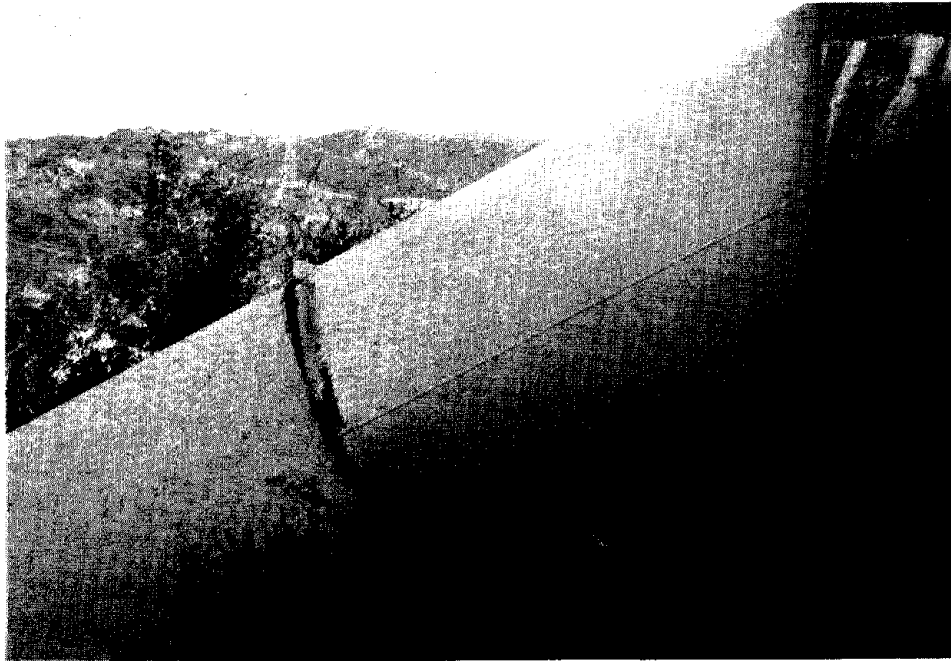
The reinforced concrete relief tank (surge chamber) on top of the hill appeared to perform well through the earthquake--no damage was observed (fig. 5.2). A steel pipe brings water up from the canyon below (fig. 5.3). The pipe is supported on concrete saddles built along the mountain slope. At a few places, the pipe separated from the saddles creating 50 to 80 mm (2 to 3 in) gaps. In at least one location, the pipe crashed vertically into the saddle. At two other locations, the pipe sections bulged 80 mm and 150 mm (3 and 6 in), however, no rupture or leakage was noticed. The ruptured section of the 2.1-m pipe is located near the hilltop. The two sections where the rupture occurred were connected using a mechanical coupling system (fig. 5.4). The pipe sections were connected by eight pairs of restrainer rods 35 mm (1-3/8 in) in diameter and 2.2 m (7 ft) long. The rods were attached to brackets, which were welded to the pipes. These welds broke during the earthquake (fig. 5.5) and resulted in the separation of the two pipe sections.

Figure 5.3. The steel pipeline at Terminal Hill separated from its supporting saddle at several places and pipe sections bulged at other locations along the alignment.

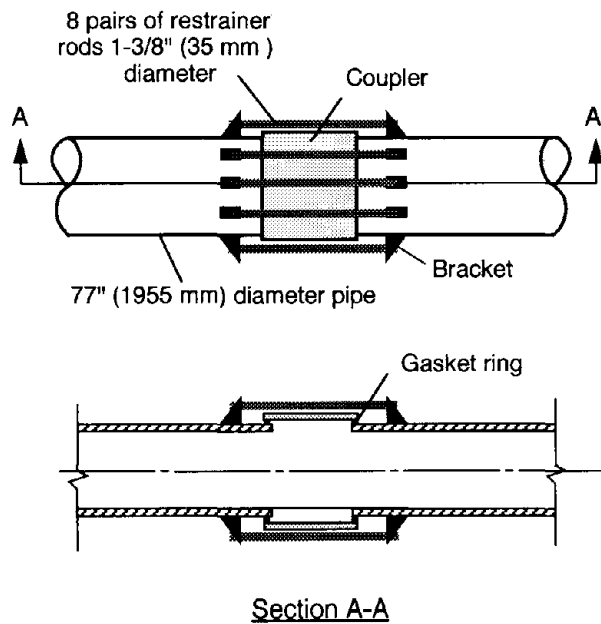
Figure 5.4. Schematic drawing of connection of the two steel pipe sections which were pulled apart during the earthquake.
