1994 Northridge Earthquake Performance of Structures, Lifelines, and Fire Protection Systems

Building and Fire Research Laboratory
National Institute of Standards and Technology
Gaithersburg, MD 20899-0001

May 1994

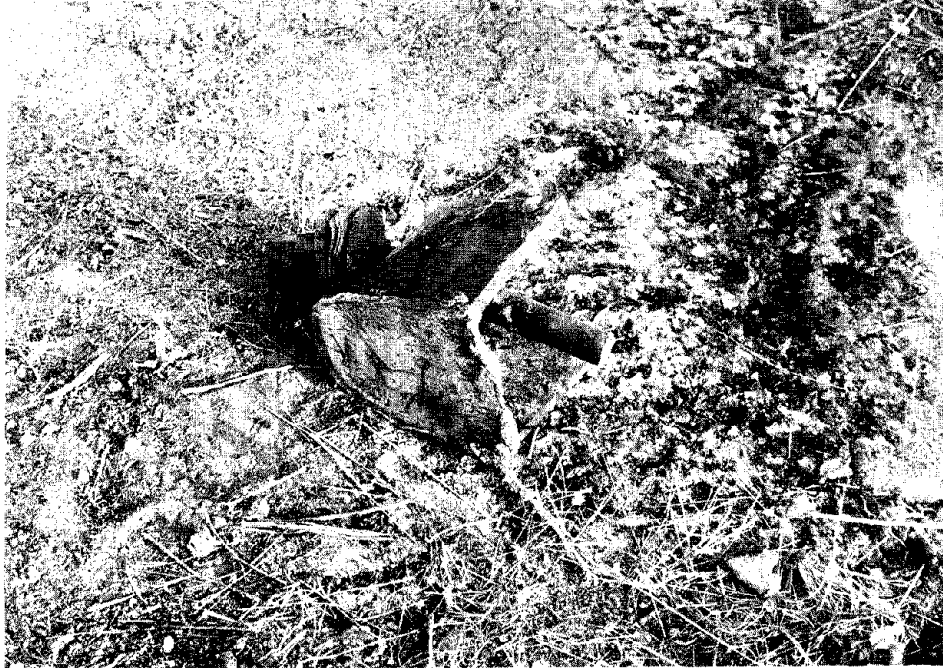
The reinforced concrete relief tank (surge chamber) on top of the hill appeared to perform well through the earthquake--no damage was observed (fig. 5.2). A steel pipe brings water up from the canyon below (fig. 5.3). The pipe is supported on concrete saddles built along the mountain slope. At a few places, the pipe separated from the saddles creating 50 to 80 mm (2 to 3 in) gaps. In at least one location, the pipe crashed vertically into the saddle. At two other locations, the pipe sections bulged 80 mm and 150 mm (3 and 6 in), however, no rupture or leakage was noticed. The ruptured section of the 2.1-m pipe is located near the hilltop. The two sections where the rupture occurred were connected using a mechanical coupling system (fig. 5.4). The pipe sections were connected by eight pairs of restrainer rods 35 mm (1-3/8 in) in diameter and 2.2 m (7 ft) long. The rods were attached to brackets, which were welded to the pipes. These welds broke during the earthquake (fig. 5.5) and resulted in the separation of the two pipe sections.

Figure 5.5. Welds of the restrainer brackets broke as the result of strong shaking.

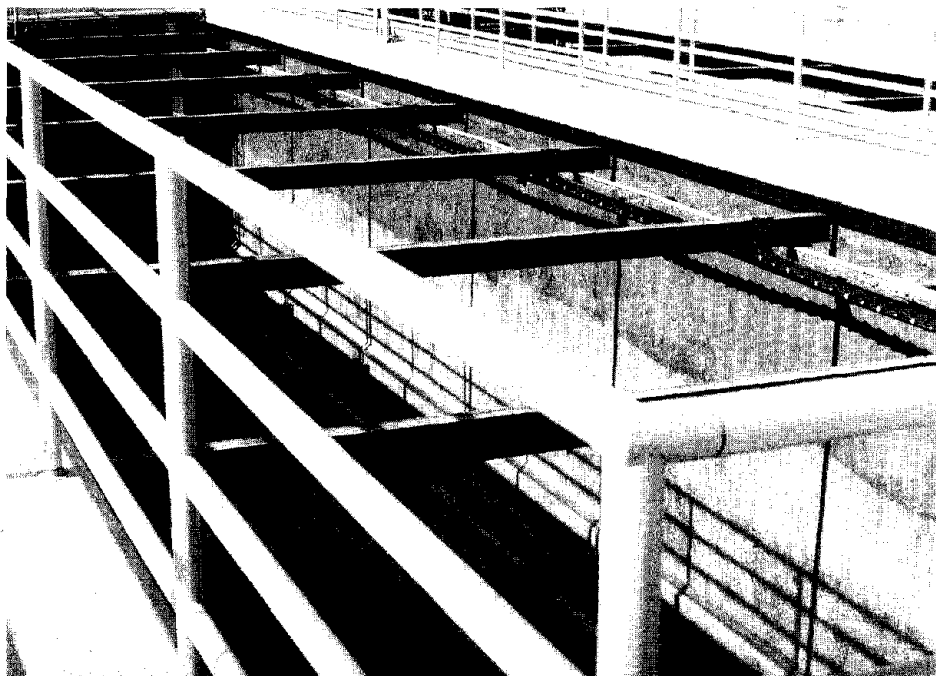
Figure 5.6. Undamaged clarifier tank at the Tillman Water Reclamation Plant.

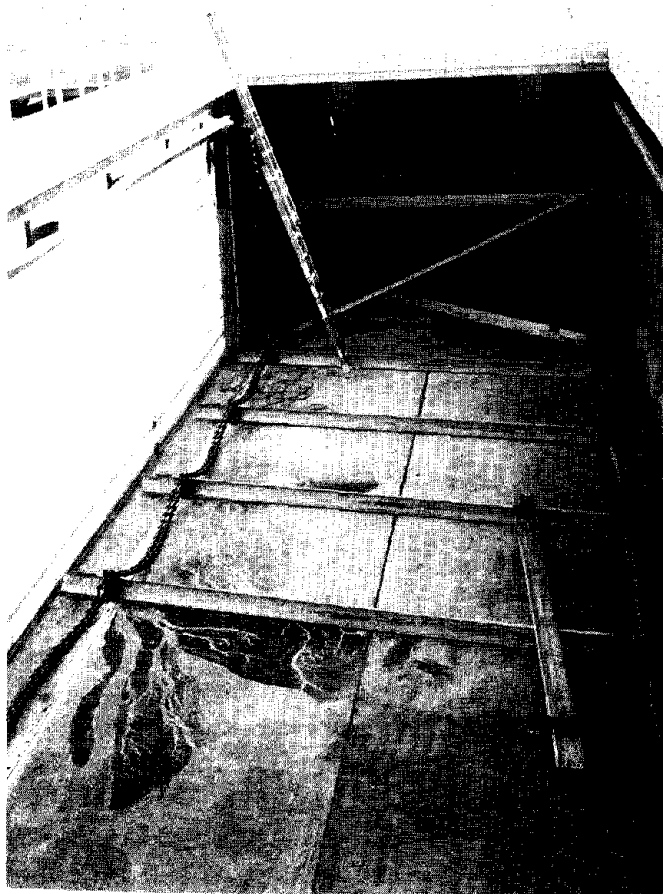
The earthquake resulted in damage to five out of twenty-two final clarifier tanks built in 1991 as part of the Phase II expansion. Twenty-two Phase I tanks built in 1983 were not damaged. Figure 5.6 shows a typical undamaged final clarifier tank. The scrapers are supported by railings attached to the walls with brackets. Chains are used to move the scrapers. All these components were made of plastic in the Phase II construction, whereas the brackets were made of metal and railings and sludge scrapers were made of redwood in the Phase I construction. Pins about 10 mm (3/8 in) in diameter and 19 mm (3/4 in) long connected the brackets to the railings. In the tanks where there was damage, it is suspected that the pins dislodged due to wave action in the tank and the railing became displaced. This caused jamming of the chain movement, which disabled the system (fig. 5.7).

Figure 5.7. A damaged sludge scraper in a clarifier tank at the Tillman Water Reclamation Plant.

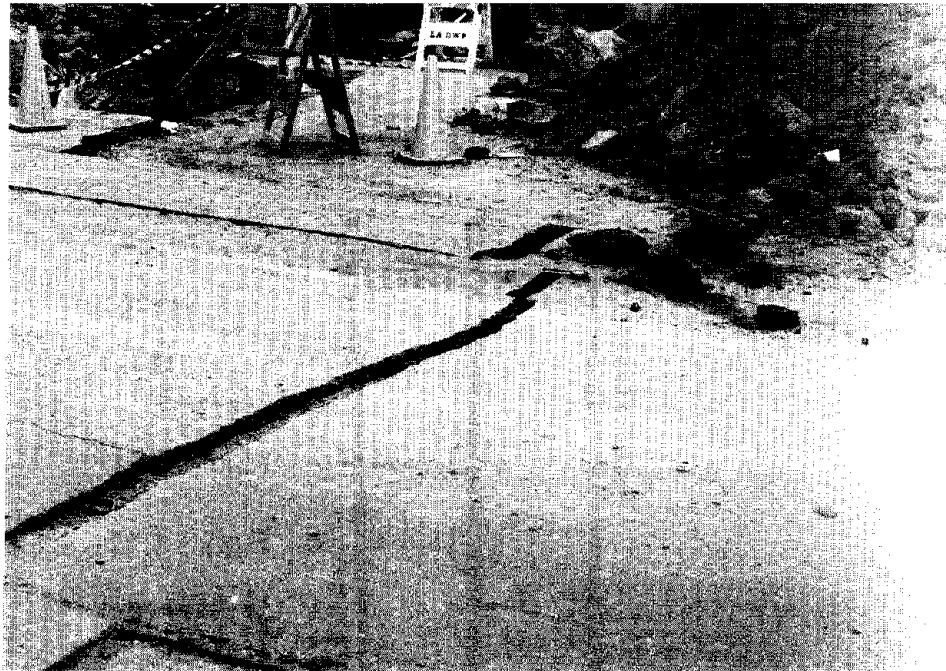
Figure 5.9. Ground extension at the gas fire site on Balboa Boulevard can be seen by the transverse cracks in the pavement.

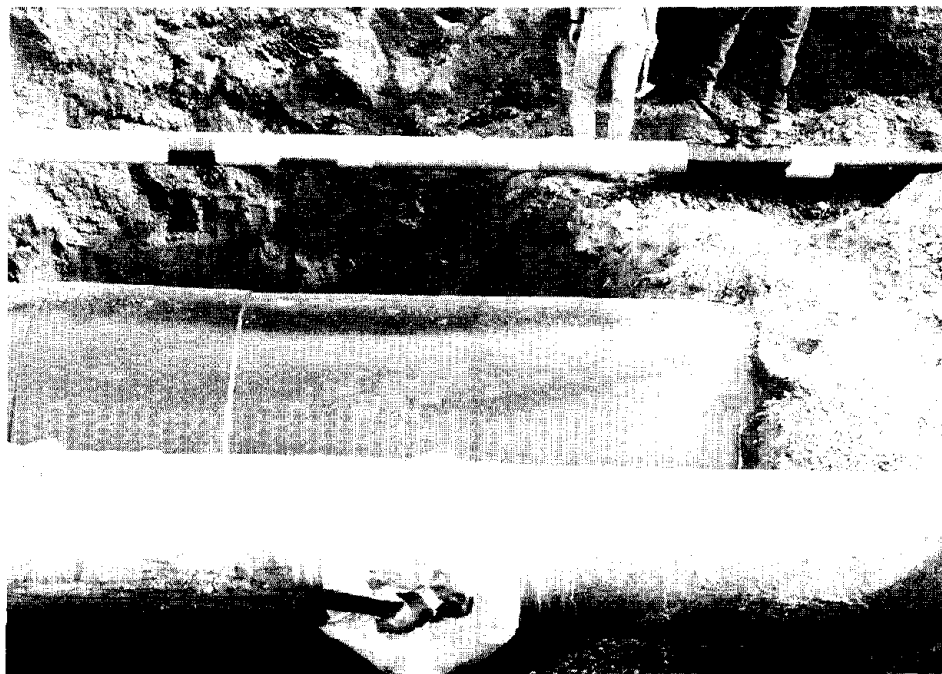
Three pipelines ruptured as the result of ground contraction; a 150-mm (6-in) gas distribution line, the 1.8-m (68-in) Rinaldi trunk water line, and a 0.6-m (22-in) gas main (fig. 5.10). The Rinaldi trunk line was of post-1971 construction, and the gas main was of 1930 vintage. These pipes showed a shortening of 125 to 150 mm (5 to 6 in).

Figure 5.10. Ground contraction along Balboa Boulevard caused the rupture of a gas distribution line (top), the Rinaldi trunk 1.8-m (68 in) water main (center), and a gas main (bottom). The pipes were being repaired at the time this photograph was taken.

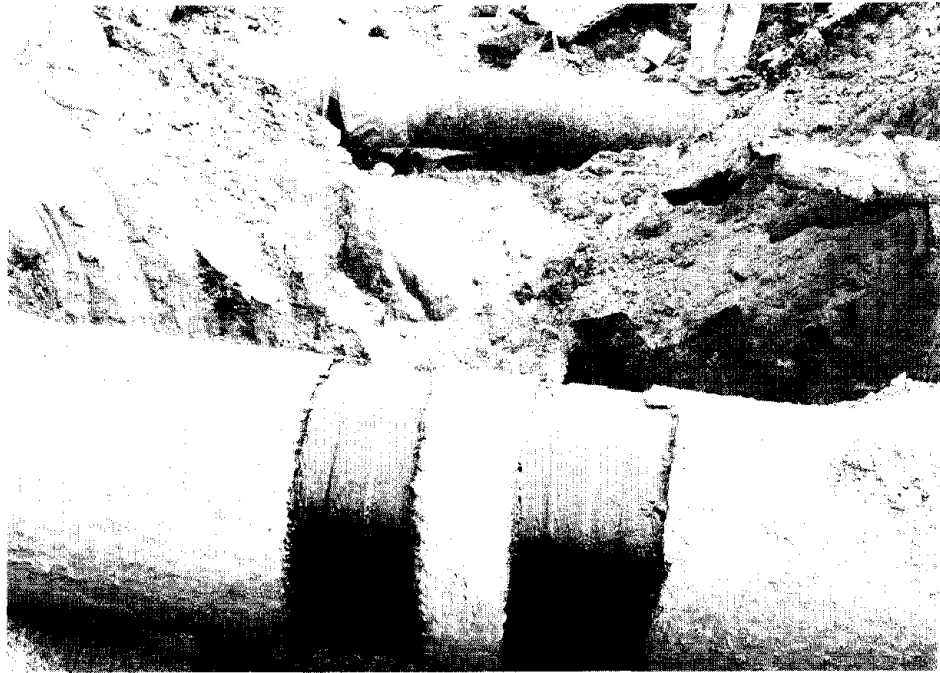
About one block north, the ground extension caused rupture of the same 0.6-m (22-in) gas main and a 1.2-m (48-in) water main (fig. 5.11). These pipes were pulled apart as the result of the ground extension. The rupture of the gas main caused a major fire at the site that destroyed five houses (figs. 5.12 and 5.13). The loss of both water mains at this location and the difficult access to the site due to the fire and street flooding made fire fighting difficult.

Figure 5.11. Ground extension along Balboa Boulevard resulted in the rupture of the same gas main shown in figure 5.10 (top) and a 1.2-m (48 in) water main (bottom). The rupture of the gas main here caused a major fire that engulfed five houses.

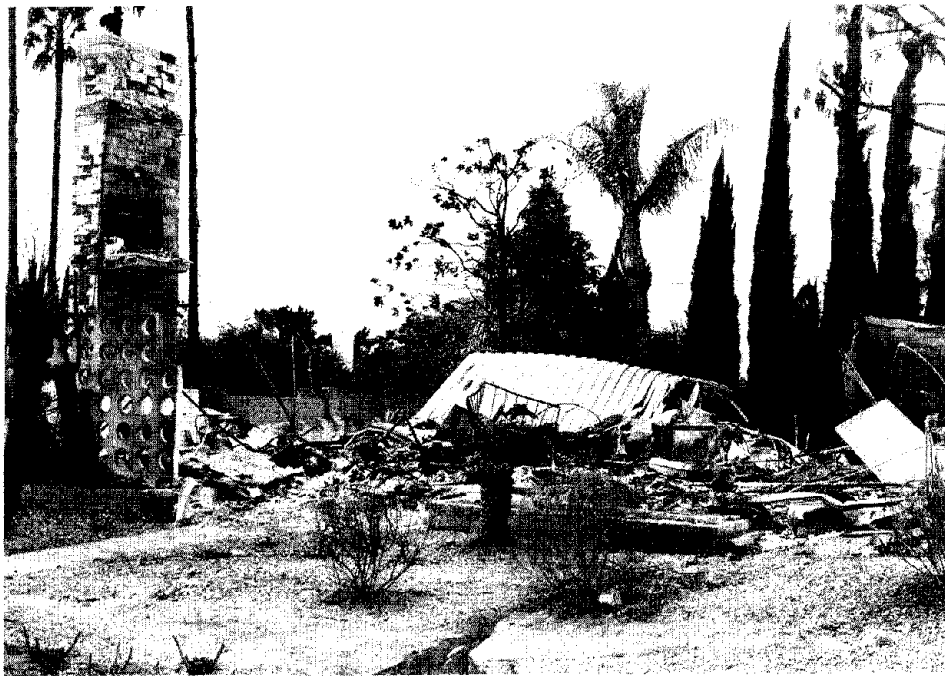
Figure 5.12. Houses destroyed by a fire resulting from the rupture of the 0.6-m gas main along Balboa Boulevard.

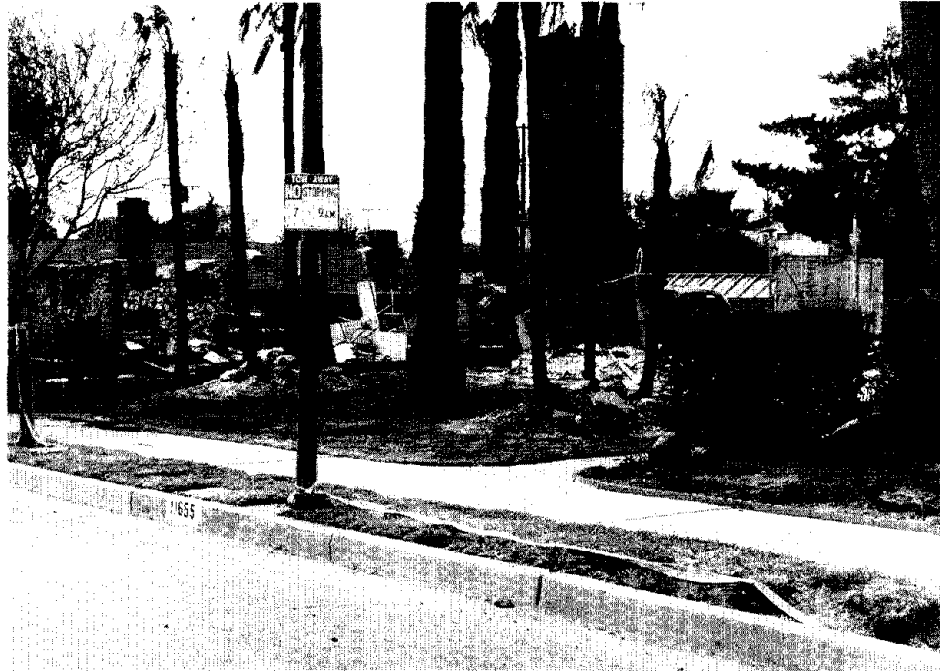
Figure 5.13. Houses destroyed by a fire resulting from the rupture of the 0.6-m gas main along Balboa Boulevard.

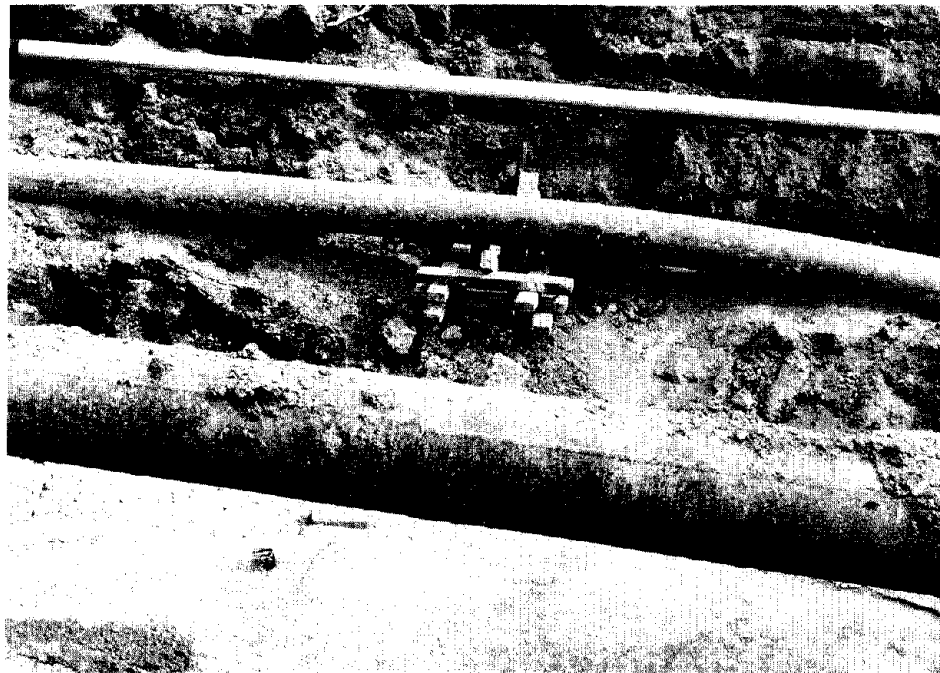
An excavated section just north of the fire site revealed some additional underground lines (fig. 5.14). The 460-mm (18-in) crude oil line in the middle of the photo performed well. The 150-mm (6-in) gas distribution line shown at the top of the photo is a replaced section.

Figure 5.14. Some of the buried pipelines located near the intersection of Balboa Boulevard and Bircher Street showing the potential hazard of co-location of lifeline systems. At this site are three water lines (two of them main lines); three gas lines; two sewers; one crude oil line; overhead power, telephone, and cable TV lines; the street lighting system; and the street itself.

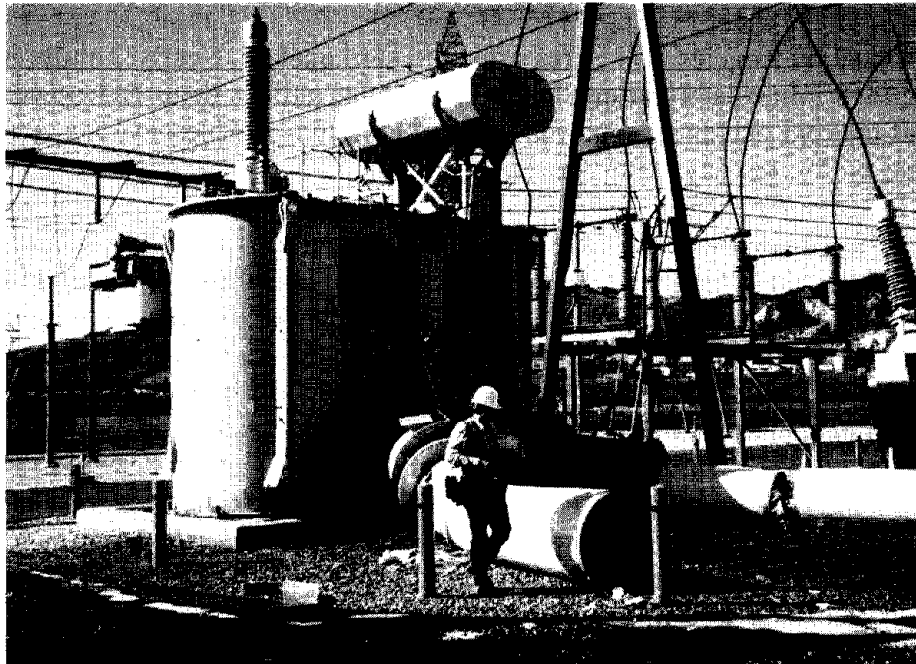
Some transmission towers suffered significant damage, many as the result of foundation failure. Damage to several high voltage substations near the epicenter, such as Sylmar, Pardee, and Rinaldi, led to the widespread power outage in the Los Angeles basin, as well as isolated outages throughout seven western states (fig. 5.15). As happened during the 1971 San Fernando earthquake, porcelain elements of 230-kV and 500-kV equipment suffered the most damage (fig. 5.16). This highlights the urgent need for developing new earthquake-resistant materials to replace porcelain, which is very brittle. Furthermore, most of the 230-kV circuit switchers, similar to those at the Sylmar substation shown in figure 5.17, were damaged. However, none were damaged during the 1971 earthquake, a possible indication of much stronger ground shaking by the Northridge earthquake. Most of the capacitor banks, similar to those in the background in figure 5.17, performed well in this earthquake, whereas most collapsed during the 1971 quake. Better performance of the capacitor banks is the result of stricter seismic requirements in equipment qualification and in installation practices.

Figure 5.15. Damage to DC equipment at several high voltage substations, such as this one at Sylmar, led to widespread power outages in the Los Angeles area as well as isolated outages throughout seven western states. (Photo courtesy of Edward Matsuda, Pacific Gas and Electric Company.)

- Improved methods for avoiding damage to high voltage substations should be developed. New materials are needed to replace the brittle porcelain insulators. Better switch systems should be developed and installed to prevent blackouts. Failures of foundations for transmission towers should be thoroughly investigated.

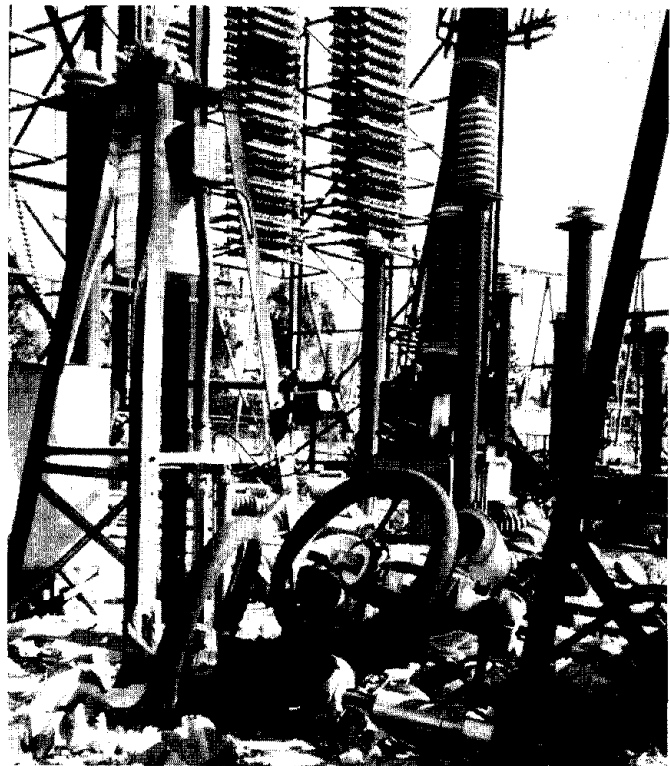
Figure 5.16. Porcelain is an integral part of high voltage electrical equipment due to insulation requirements and is also the most vulnerable to damage during strong earthquake shaking. (Photo courtesy of Edward Matsuda, Pacific Gas and Electric Company.)

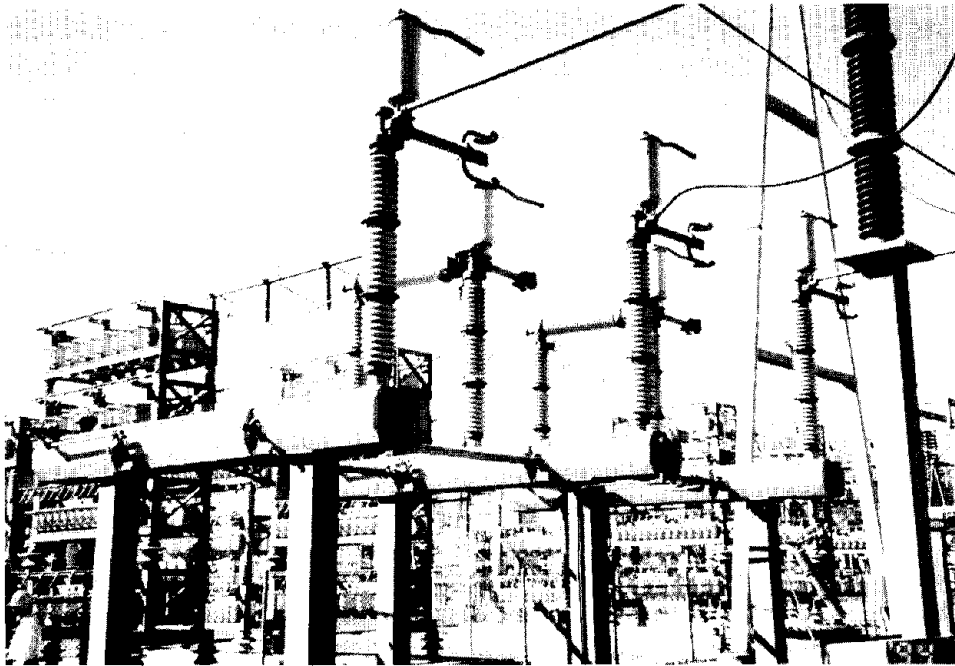
Figure 5.17. Most of the 230-kV circuit switchers (in the forefront) at the Sylmar substation were damaged. Most of the capacitor banks (in the background) performed well in this earthquake, whereas most collapsed during the 1971 quake. (Photo courtesy of Edward Matsuda of Pacific Gas and Electric Company.)

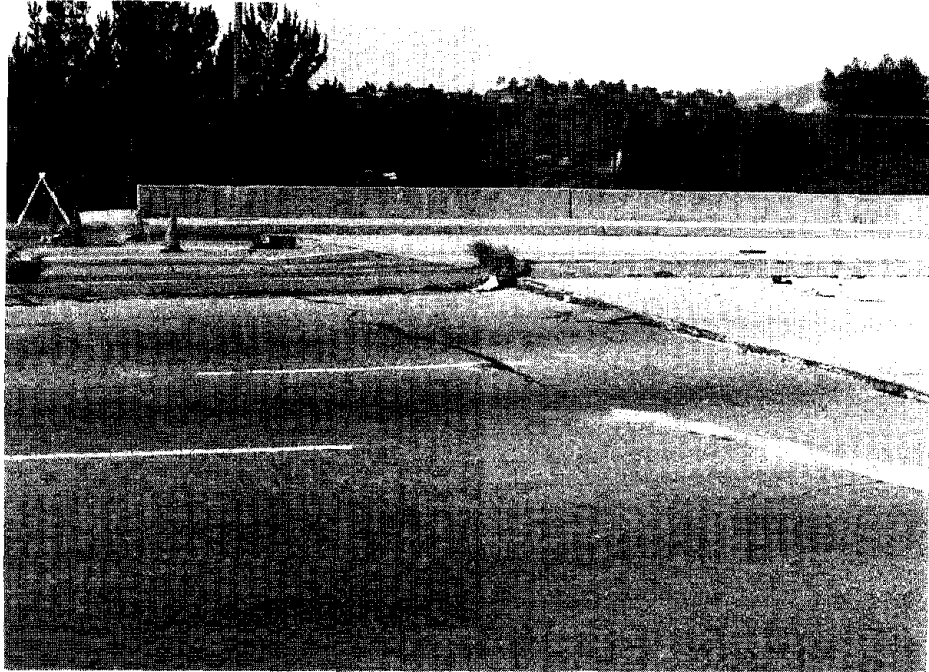
Figure 5.20. Transverse cracks in pavement near the intersection of Balboa Boulevard and SR118.

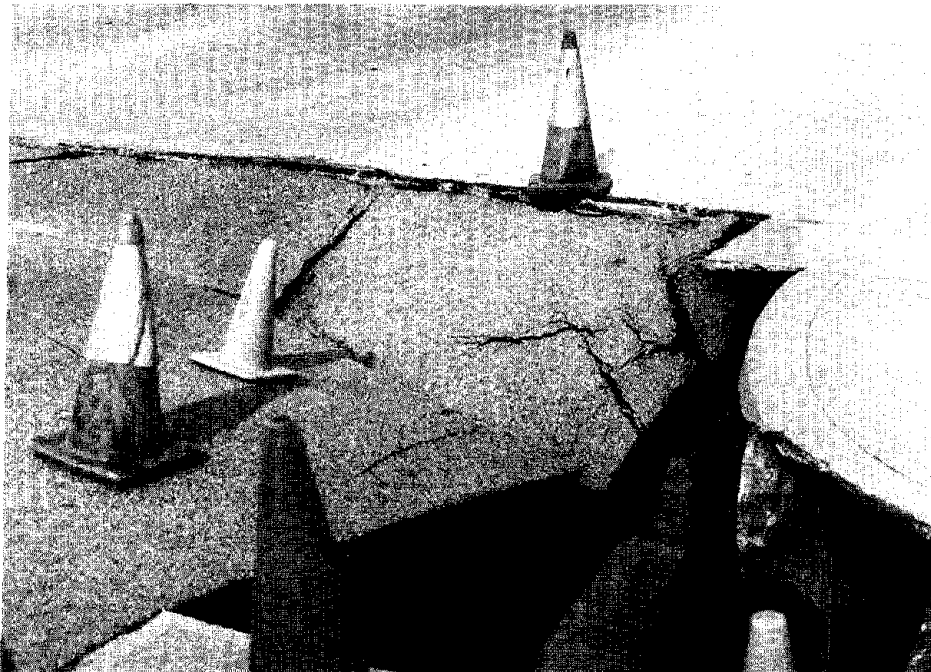
Figure 5.21. The approach of Balboa Boulevard at SR118 caved in due to the loss of the abutment fill because of a water main break.

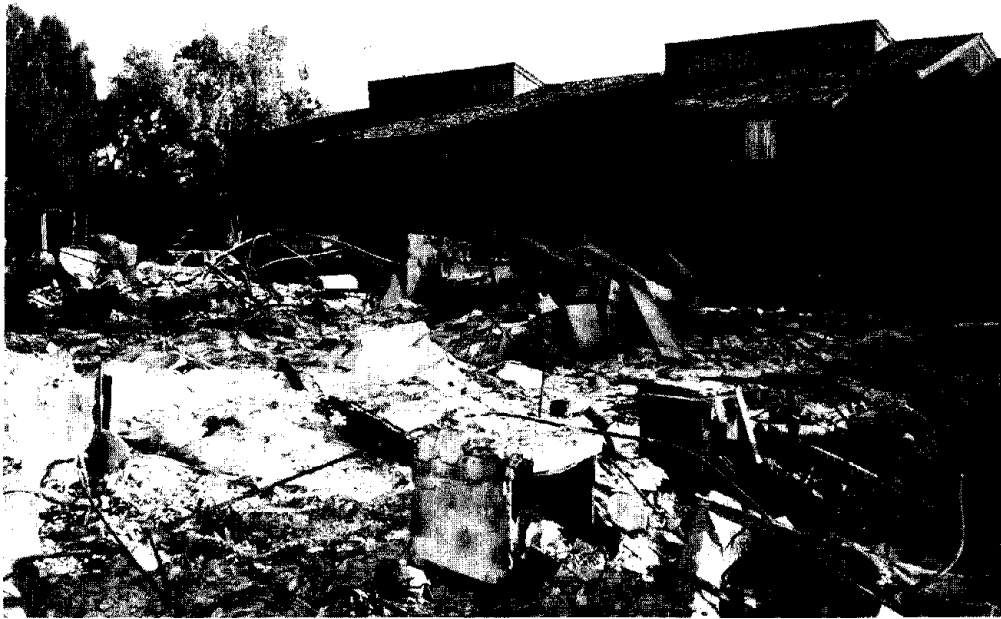
Figure 6.6. Multi-family residential building destroyed by fire.

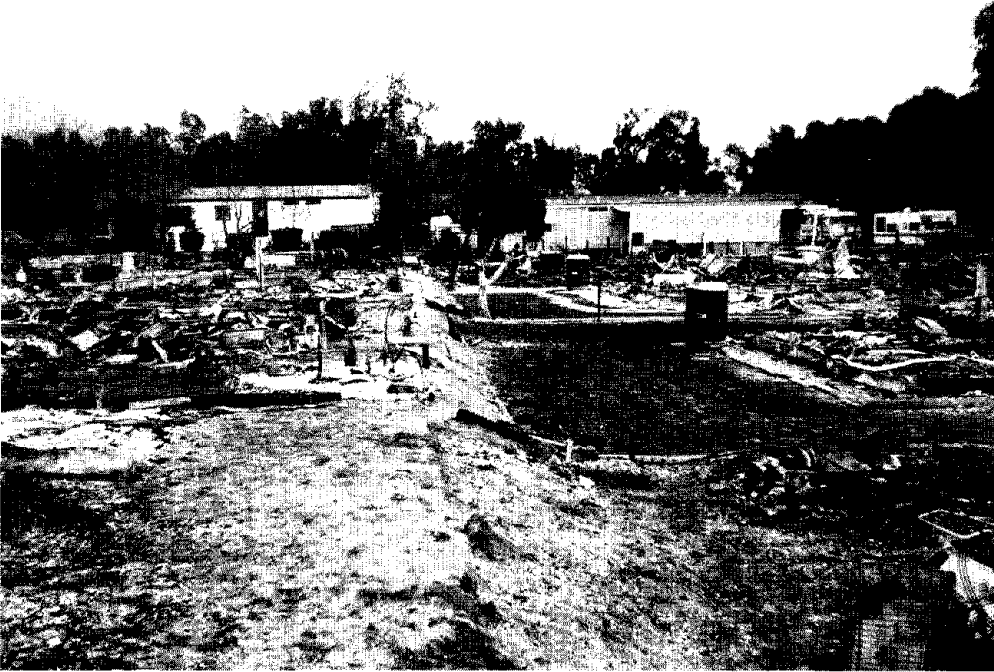
Building-to-building fire spread was limited to three manufactured housing developments (mobile home parks). Figure 6.8 shows the typical spacing between units in one of these developments. Figure 6.9 shows an area of the development destroyed by fire. Observations made at this development indicate that the method of unit-to-unit fire spread was primarily through windows. Once a unit became completely involved in fire, the thermal radiation was sufficient to cause the breakage of windows in an adjacent unit or to ignite combustibles within the unit directly through the windows. The fire department reported low water pressure in the area which combined with multiple independent fires and limited resources hindered fire fighting operations. The fire spread was stopped either by separation such as roads and open areas or by fire fighting operations.

Figure 6.9. Impact of a multiple unit fire in a manufactured housing development.

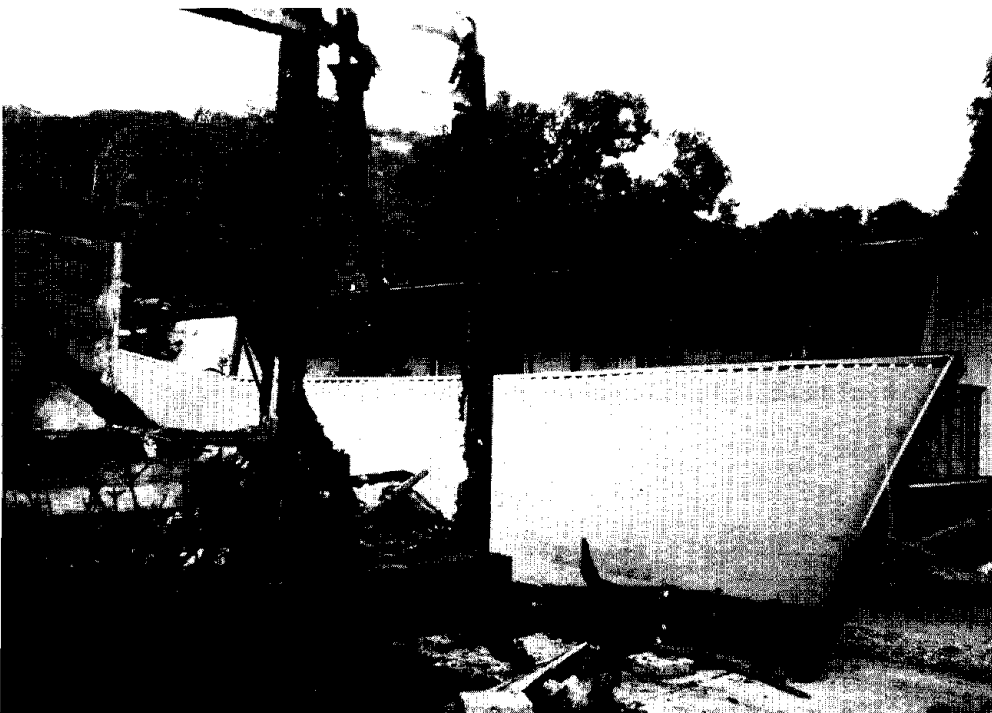
A unique aspect of the construction of these manufactured units played a role in limiting fire spread and assisting fire department actions. As the units burned from the inside, the carport roofs collapsed from the building side, coming to rest on the outside supporting columns. In this way the carport roofs formed fire breaks as shown in figure 6.10. Although these roofs would not necessarily have survived the fire by themselves, they reduced the fire exposure on adjacent units and thus enhanced fire fighting operations.

Figure 6.10. Collapsed roof which acted as a fire break in a manufactured housing development.
