**NORTHRIDGE EARTHQUAKE: LIFELINE
PERFORMANCE AND POST-EARTHQUAKE
RESPONSE**

Date: Apr 97

Authors: A. J. Schiff.

Performing Organization: American Society of Civil Engineers, New York. Technical Council on Lifeline Earthquake Engineering.

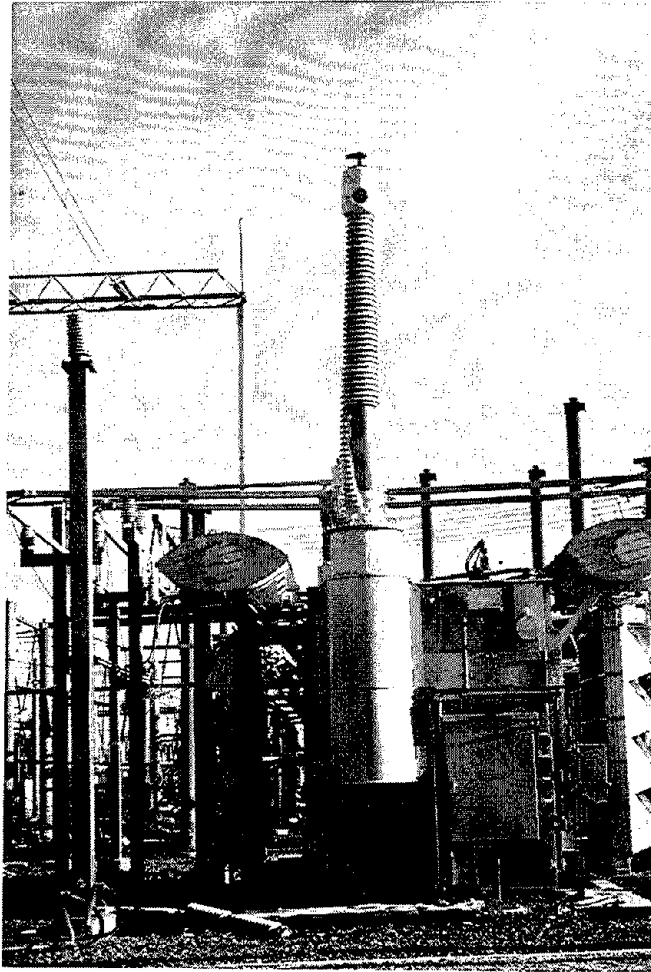
Approximately forty-two bushings required maintenance or had to be replaced in the main event and seven others were damaged in an aftershock. Four transformer bushing failure modes were observed: cracked porcelain, shifting of upper porcelain relative to its mounting flange, damage to bushing support or turret, and internal degradation of bushing. Two 500 kV bushings experienced massive failures to porcelain, Figs. 3.4 and 3.5. These failures were probably due to large loads associated with the dynamic response of the bushing. The natural frequency of the bushing mounting, including the contribution of the turret, and the site motion may have contributed to the porcelain failure and oil leaks. Interaction loads with connecting conductors probably did not significantly contribute to these failures.

Fig. 3.4 Cracked 500 kV transformer bushing.

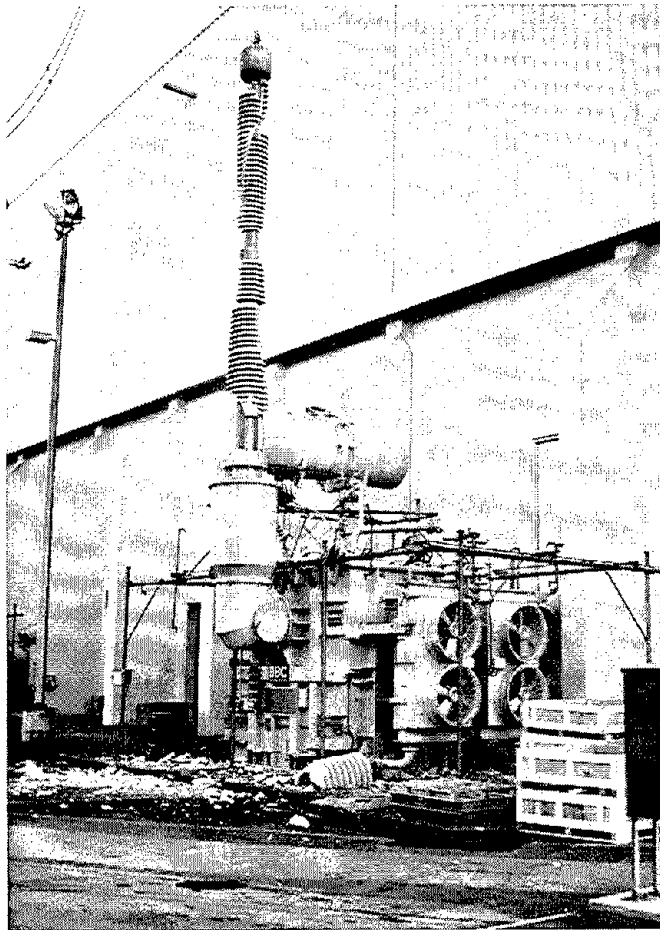
Fig. 3.5 Shattered reactor bushing.

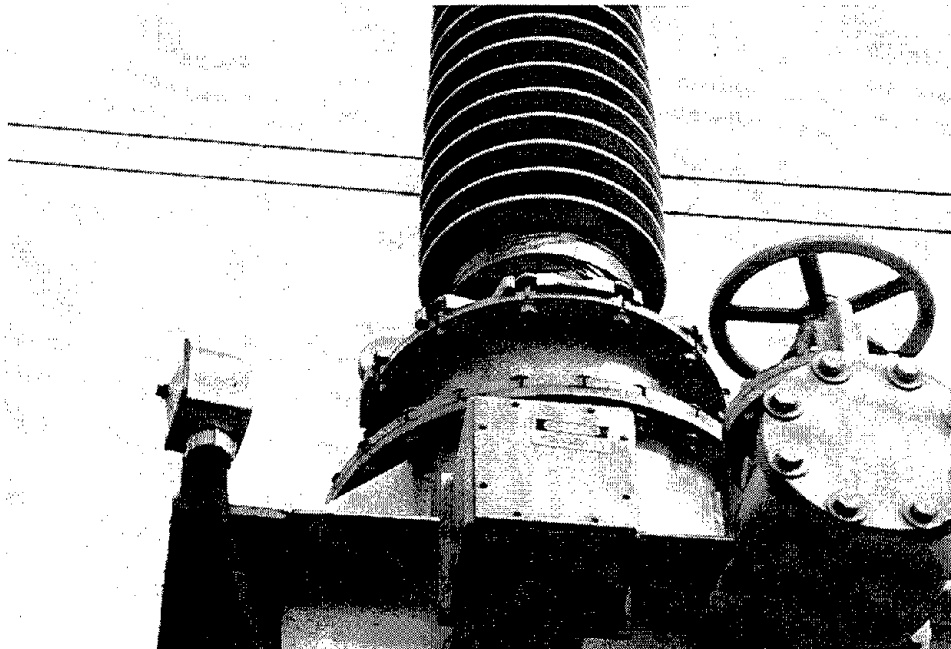
The second failure mode, which was much more common, was the rocking and slipping of the upper part of the transformer-bushing porcelain relative to its mounting flange, Fig. 3.6. In some cases the bushing re-seated itself and did not leak, but more often there was an offset and there were leaks at the interface between the porcelain and the flange. If the oil leak at the bushing is very small and the transformer is needed, it may be used with the leak until the units can be taken out of service and a repair made. Several factors contributed to these failures which were controlled by specific conditions at the transformer. Many failures were probably due to inertial loads imposed by the ground motion. In some cases, the flexibility of the turret, which

Fig. 3.6 Transformer bushing with porcelain slipped relative to its mounting flange.

To repair a slipped bushing, it must be removed and restored at an appropriate maintenance facility, a lengthy process that can take about 6 weeks. To make a temporary repair to get the transformer back in service quickly, the oil around the base of the bushing is removed with a solvent and fast setting epoxy is applied to a thin wrap of linen around the porcelain-flange interface. If the leak persists, a vacuum line can be attached to the top of the bushing, and the cleaning and epoxy process repeated one or more times in an attempt to stop the leak. Bushings repaired in this way are then removed and restored when service conditions permit.

Because of potential problems observed in this earthquake associated with offset bushings, maintenance personnel now have bushing offset criteria, which, if exceeded, require that the bushing be removed for restoration. Prior to this time, if leaks could be stopped and the transformer was needed, it was kept in service. Because of the vulnerability of slipping at the porcelain-flange interface, some bushing manufacturers ship their bushings with retainer rings at the porcelain-flange interface. At one facility, this retainer ring was left on after the bushing was installed prior to the earthquake. This bushing survived the earthquake undamaged, while others at the site had slipped. The use of retainer rings as a retrofit is being used as a means to improve bushing performance; however, there are several technical issues associated with this retrofit. These issues include concern about contact stress concentration between the retainer ring and the bushing porcelain, effects of retainer ring corrosion, and distortion of the electric fields and resulting electrical stresses associated with the retainer ring. Because of their importance, some transformer bushings are in the process of being replaced with bushings made of composite material. A set of interim test requirements have been established which these bushings must satisfy that take into account system amplification and require an acceleration at the base of the turret of twice that of the ground design spectra. One of the difficulties in satisfying seismic specifications for transformer bushings is that they can not be tested on the transformer as an assembled unit, the preferred method of qualifying vulnerable equipment. This can not be done because of transformers' large size and weight - most transmission transformers weigh in excess of 500,000 pounds.

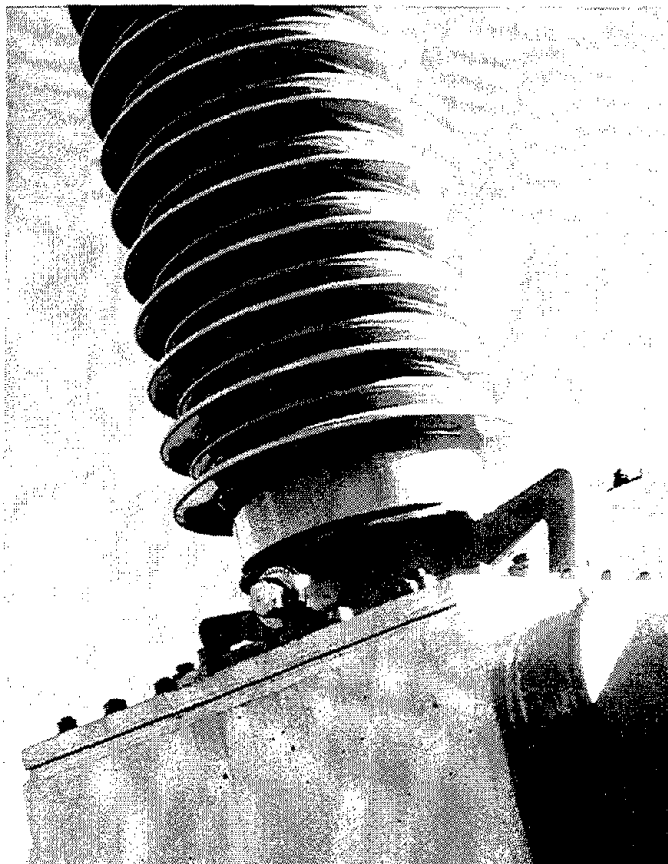
The third failure mode was the failure of the bushing support flange or turret. The failure of the flange support shown in Figs. 3.7 was probably due to a flaw in the casting, as this type of failure has not been observed before. The failure of the turret anchor bolts shown in Fig. 3.8 on a spare transformer was caused by the overload.

Fig.3.7 Fractured transformer bushing flange support.

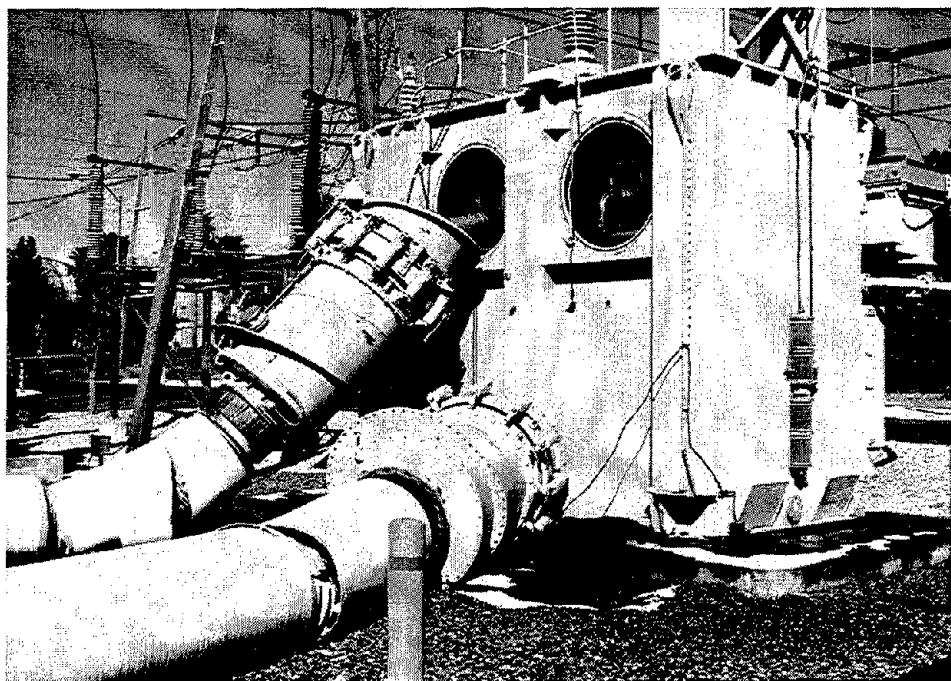
Fig.3.8 Bushing-turret mounting-bolts failed.

When installed, the turret is supported by the wall that the turret penetrates. The peak vertical acceleration recorded at this site was 0.83 g, well above the 0.5 g design value.

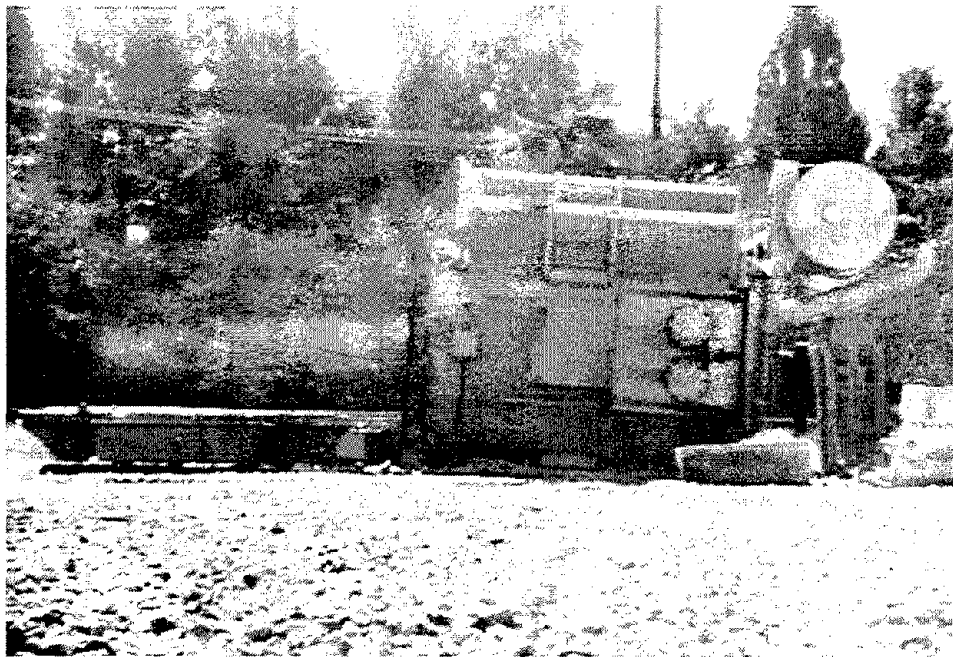
There were five types of transformer anchorage/support failures: welds to embedments failed, a weld tore the transformer case causing a leak, anchor bolts stretched and/or deformed, transformers and their foundation pads rocked, and two older transformers in storage at a site were inadequately anchored and tipped over, Fig. 3.9. Figure 3.10 shows one of two welds that failed at one end of a transformer. The transformer near the weld moved about 14 inches. The welds at the other end of the transformer did not fail. A mop that must have been near the transformer was found under the transformers so that the transformer must have lifted at least 1/2 inch off of the pad at the end with the failed weld. This is particularly interesting in that the heavy box-like construction of a transformer case suggests a very stiff structure that would not significantly deform. Several transformers that were bolted stretched their anchor bolts, Fig. 3.11. This 800,000 pound transformer had four-2" bolts along each side and one at each end. The bolts along one side stretched about 1/10", and due to the chair design experienced shear deformations of about 1/2". The motion and impact of the loose anchorage may have contributed to the slip in the transformer bushings.

Fig. 3.9 Old spare transformer with inadequate anchorage tipped over.

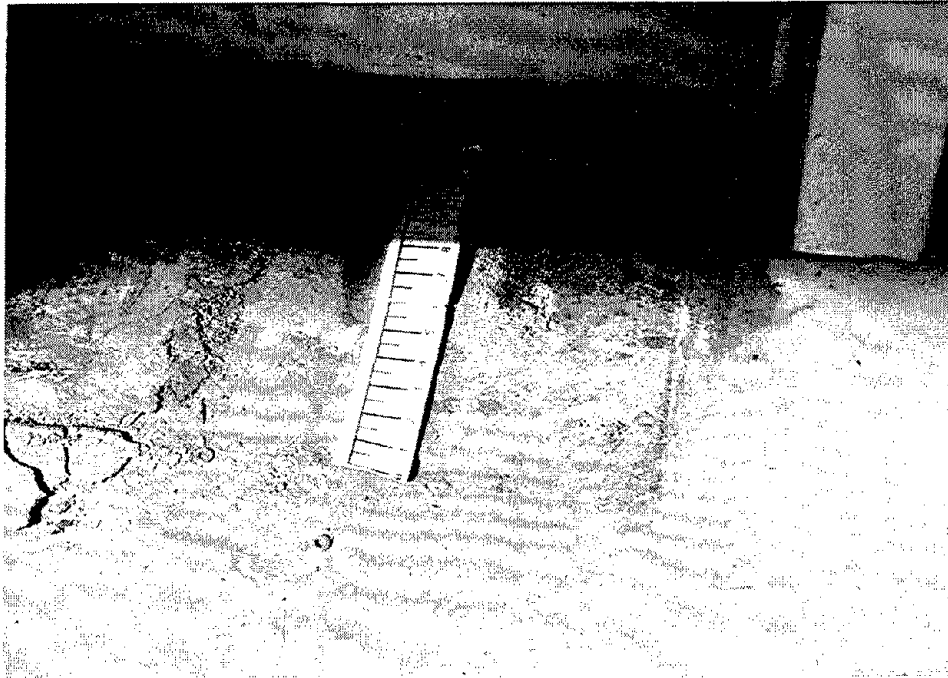
Fig. 3.10 Transformer weld failed and transformer moved 14".

retrofit to the transformer shown in Fig. 3.10 is shown in Fig. 3.12. The base plate is held to the pad by four studs held with epoxy in holes in the pad. The base of the transformer is also welded to the anchor base plate. The original welds between the bottom of the transformer case and embedments in the foundation pad were also replaced with heavier welds. Figure 3.13 shows retrofits to transformer anchorage that showed signs of distress to ground motions of 0.15 g.

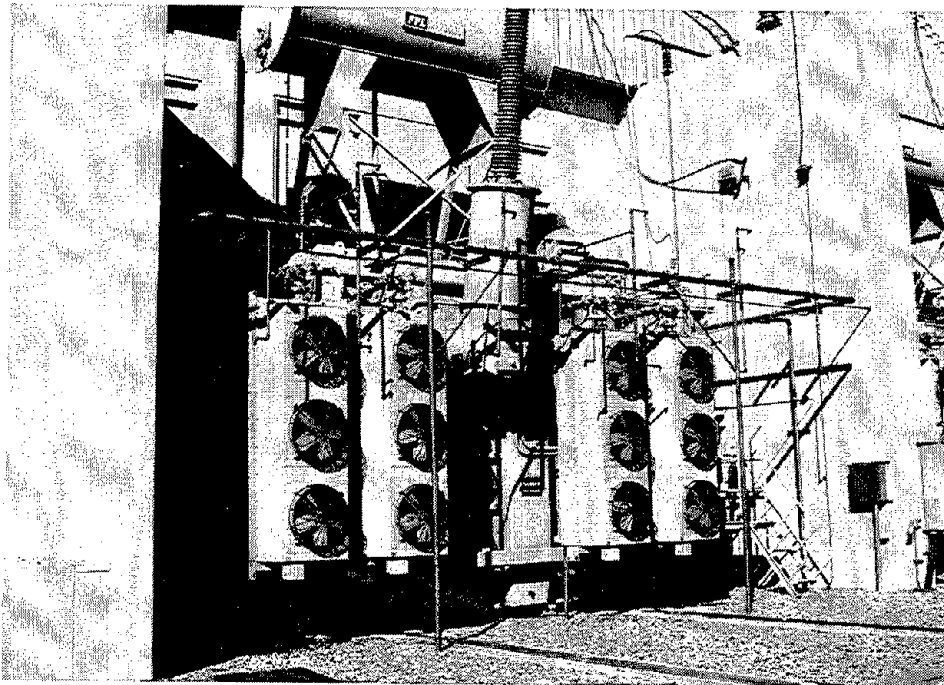
Fig. 3.11 Large transformer stretched and deformed its 2" anchor bolts.

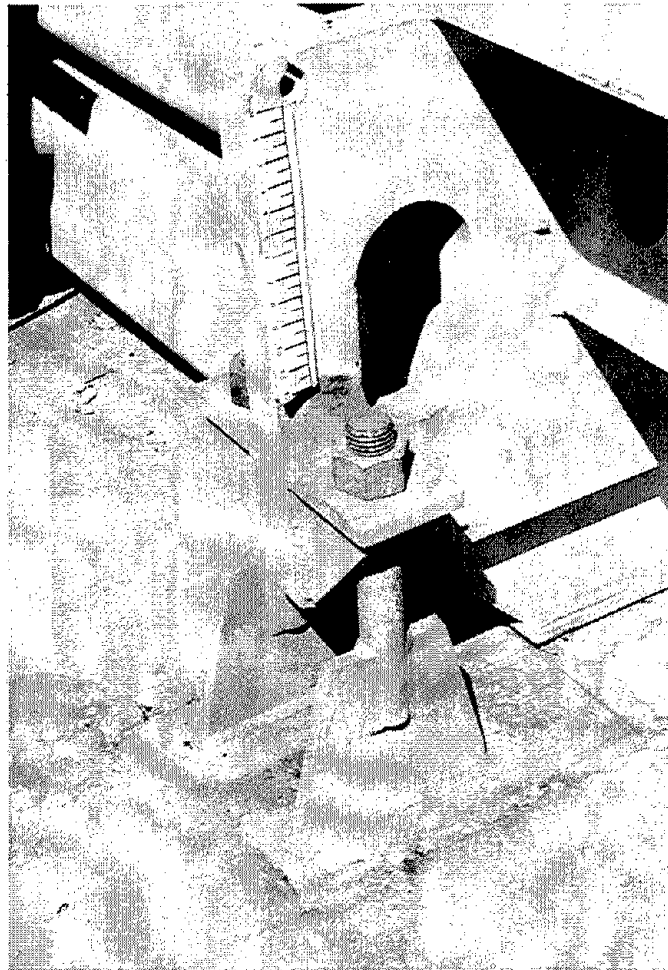
Fig. 3.12 Retrofit anchor is connected to tap provided by manufacturer to move the transformer.

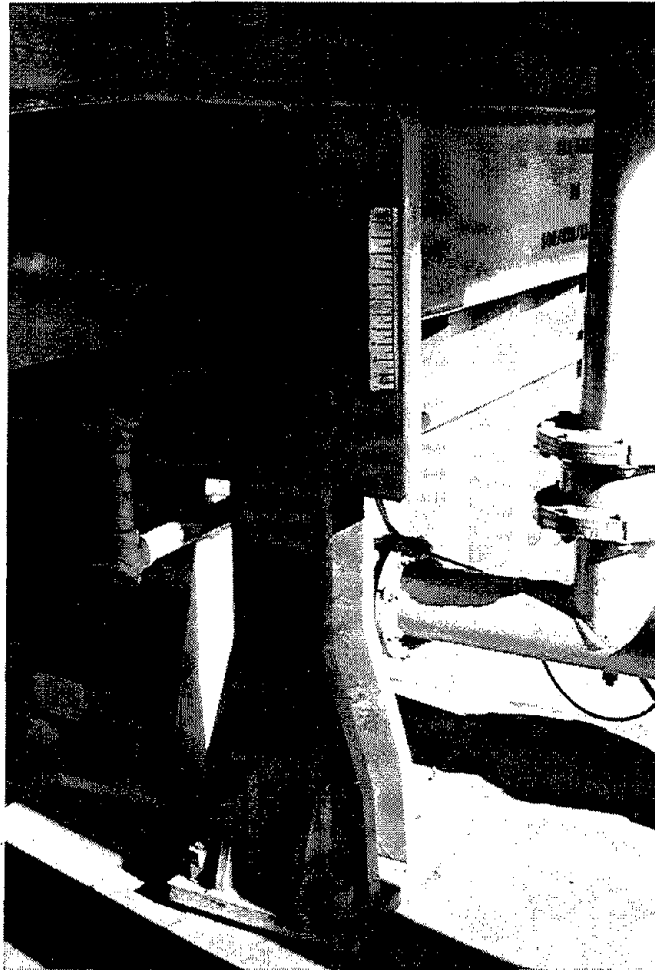
The concrete around embedded plates in transformer pads at a low acceleration site (0.15 g) developed cracks. As a precautionary measure the anchorage has been strengthened. Most of the modifications to strengthen anchorage have connected the

Fig.3.13 Distressed anchorage strengthened with linkage to existing tab.

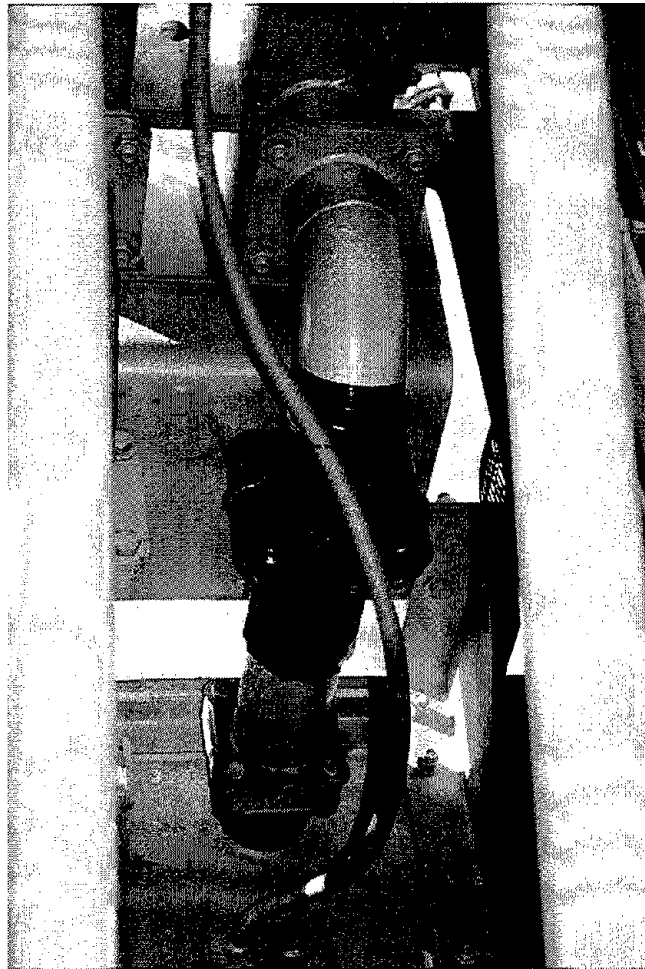
In past earthquakes, unbraced, manifold-mounted radiators have developed leaks in the piping system, usually at the upper flange connecting the radiator to the transformer body. These leaks have usually been stopped by tightening the flange bolts, but flanges can be deformed sufficiently so that bolt tightening does not stop the leak. In this earthquake a rubber-like boot was placed around a leaking transformer-radiator connection to contain the leak, so that the transformer could be quickly returned to service, Fig. 3.14. This was an innovative use of a transmission-line splice shroud, normally used by line crews. It consists of a plastic sheet that is wrapped around the

Fig.3.14 Transmission-line splice shroud used to stop leaking transformer radiator connection.

pipe coupling. A metal strip joins and seals the longitudinal edges, a heat gun shrinks the material around the pipe and tape seals the ends where the pipe leaves the shroud. The use of this technique can avoid disruption, as it allows a transformer with damage that would normally require that it be shut down to continue to operate.

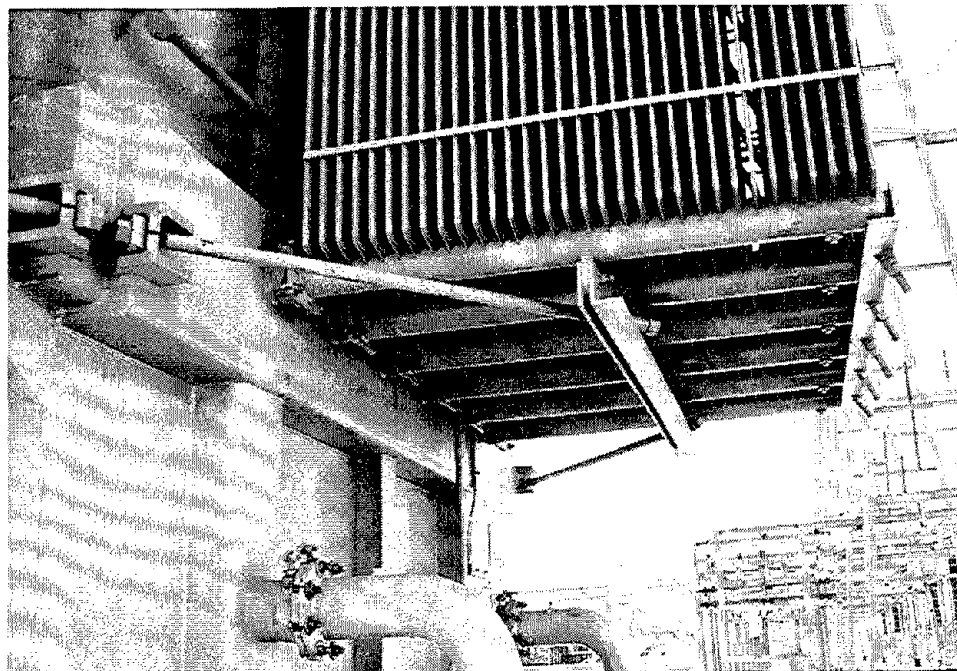
Fig.3.15 Diagonal bracing added to radiators to reduce moments on pipe connections.

In this earthquake, large, single-element radiators caused some pipes to crack where they are connected to the transformer body. This occurred at a site with a peak ground acceleration of only 0.15 g. These radiators have been retrofitted by adding bracing at the top and bottom to increase lateral stiffness of the radiators and diagonal braces from the top of the transformer to the radiators to improve vertical support, Fig. 3.15.

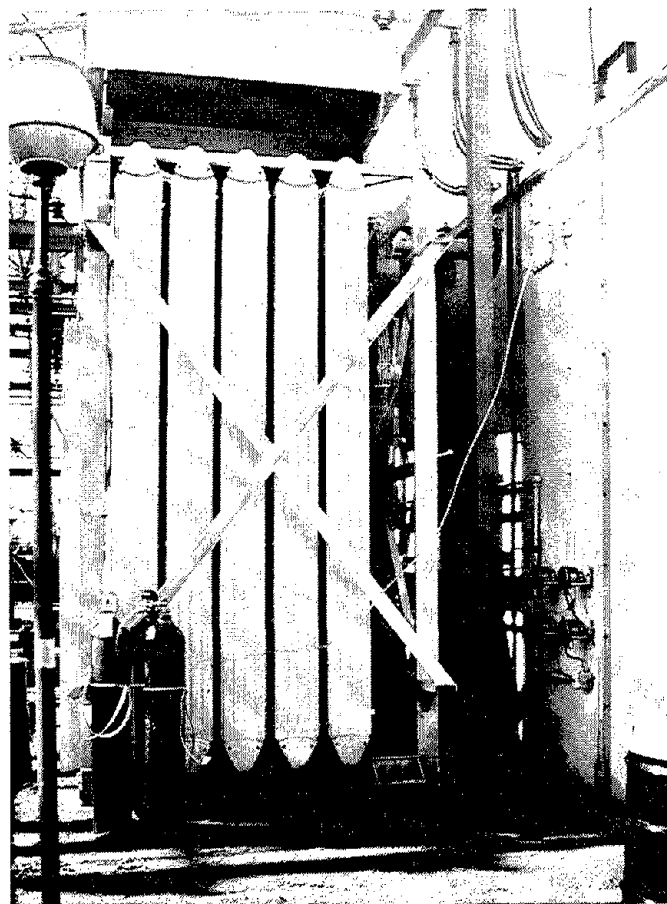
Substations located adjacent to residential areas often have acoustical enclosures for transformers. When this is done, the radiators are typically located outside of the enclosure and are self-supported, Fig. 3.16. In one case, the motion of the radiator

Fig. 3.16 Self-supporting radiator outside of acoustical transformer enclosure.

relative to the transformer caused the Dresser coupling between the transformer case and the top of the radiator to fail.

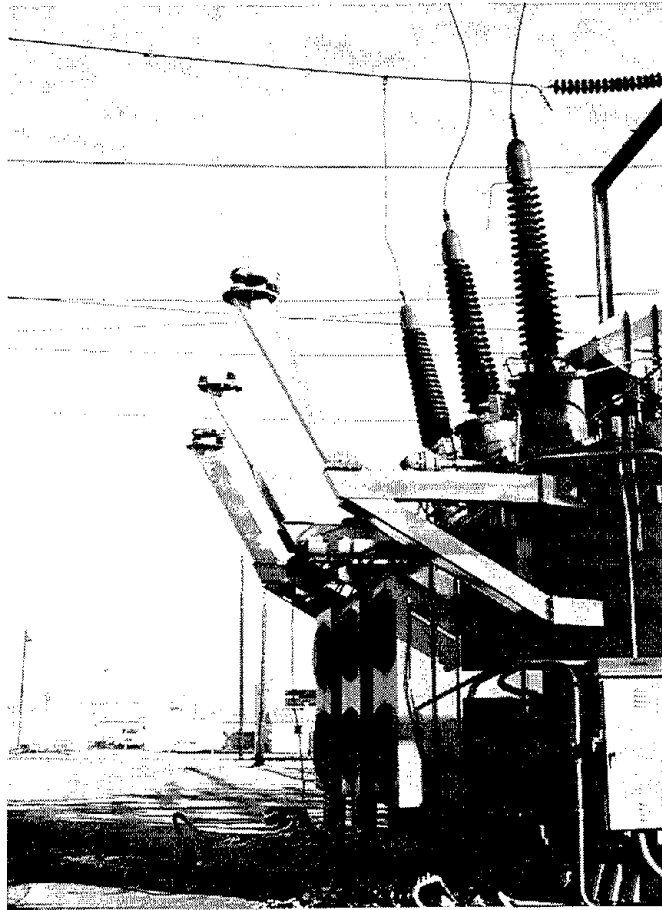
Lightning arresters have two failure modes: the standoffs fail or the body of the lightning arrester fails at the lower porcelain-flange interface. Figure 3.17 show the A and C phases failed in the body of the lightning arrester and the B phase failed at the standoffs. Lightning arresters are one of the most vulnerable items in a substation. Boom-supported and frame-supported units are the most vulnerable and the amplification of the support structure probably contributes to their failure. In many situations, interaction loads from conductors contribute to the failure. About half of the failures are in the standoffs and half in the body of the lightning arrester.

Fig. 3.17 Lightning arresters were supported on boom off of transformer failed at standoff or body of lightning arrester.

Damaged lightning arresters are typically cut from the line and the transformer put back into service without the lightning arrester. In California, lightning storms are relatively rare. In regions with frequent thunder storms, utilities may not take the risk of operating without lightning arresters.

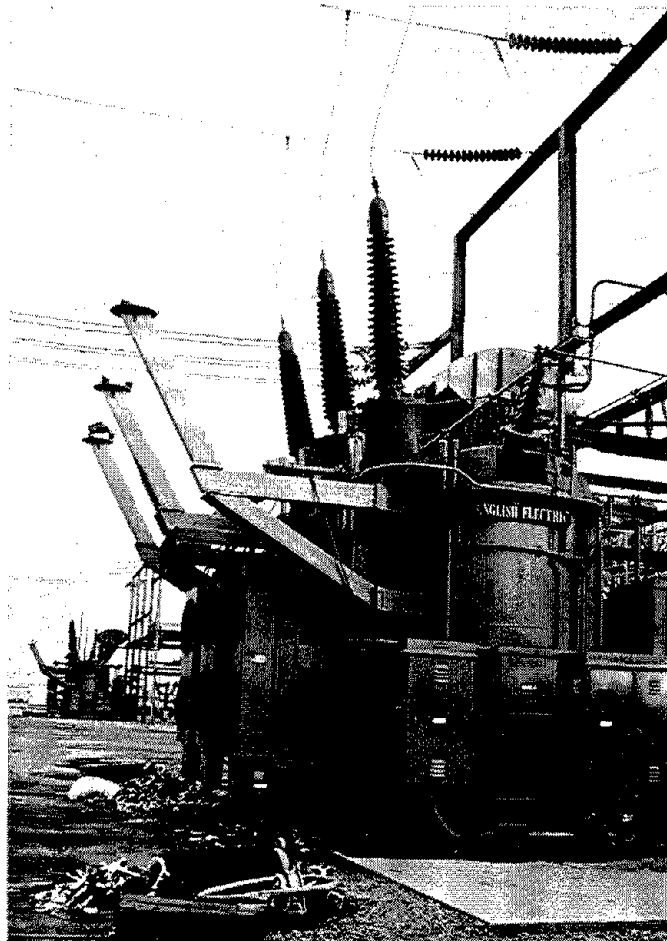
As noted below, lightning arresters can be removed and the system can continue to operate. The failure of the lightning arresters could have a serious impact, however. Some lightning arresters are positioned near the bushing so that if it failed, it could hit and damage the bushing. There are two ways to connect the lightning arrester to the system: a conductor directly to the bushing, or a conductor to the conductor connected to the bushing. Figure 3.18 shows the A and C phase lightning arresters connected to the bushing conductor and the B phase connected directly to the bushing. This was done because of lack of clearance due to the orientation of the overhead conductors. When the lightning arrester is connected directly to the bushings, it will have a tendency to fall towards the bushing if it fails. Even if it does not strike the bushing, the impact of the falling lightning arrester can damage the bushing conductor mounting hardware, Fig. 3.19.

Fig.3.19 The bushings mounting post was bent when lightning arrester failed, fell, and conductor pulled on post .

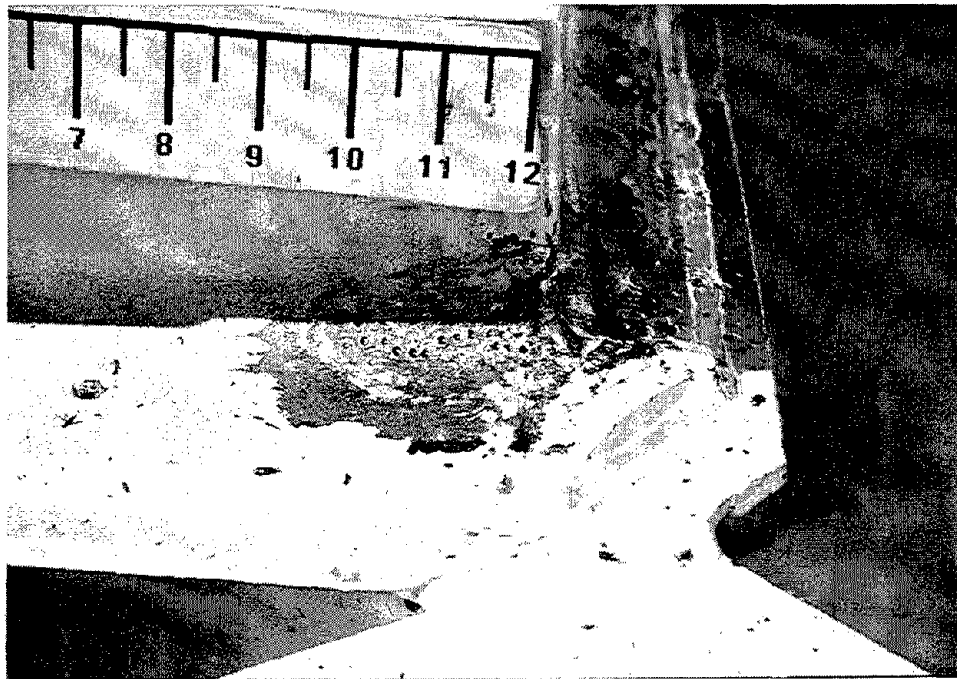
At one site with moderate ground motion, welds used to fabricate the transformer case cracked, causing a minor, but persistent leak, Fig 3.20. The leak was stopped by using a center punch to make indentations on each side and adjacent and parallel to the crack moving metal to close the crack.

Fig. 3.20 Earthquake induced stress caused a weld to crack and leak oil.

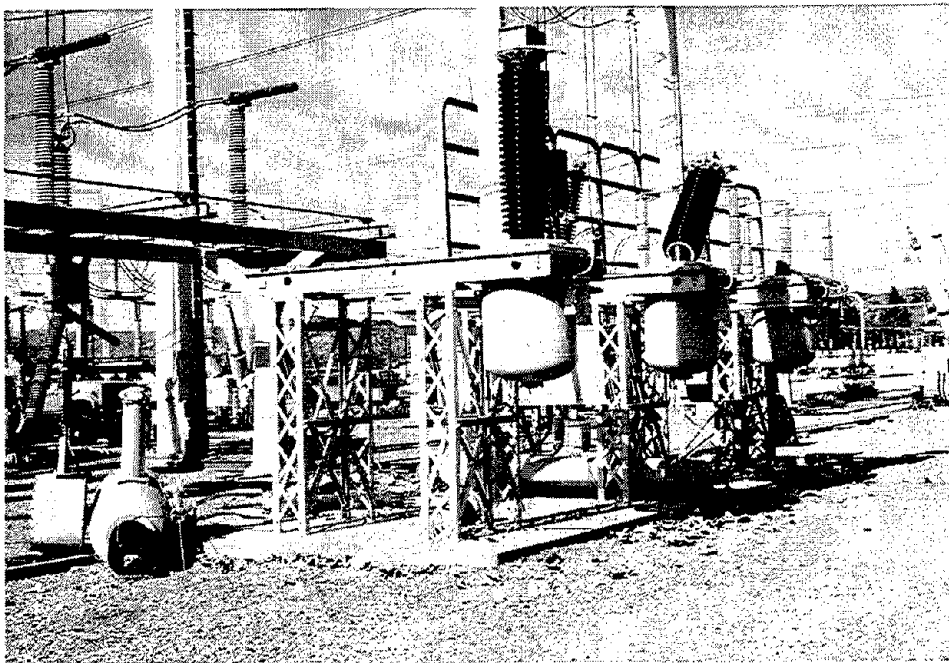
The performance of older live-tank breakers in this earthquake was consistent with past performance. That is, these units failed when subjected to moderate earthquake motions and were damaged or failed in small ground motions. Two designs were severely damaged by ground motions with a peak acceleration of 0.56 g, Figs. 3.21 and 3.22. The units shown in the right side of Fig. 3.22 are of the design that failed.

Fig. 3.21 Live-tank circuit breakers support the heavy interrupter head on a porcelain column that frequently fails.

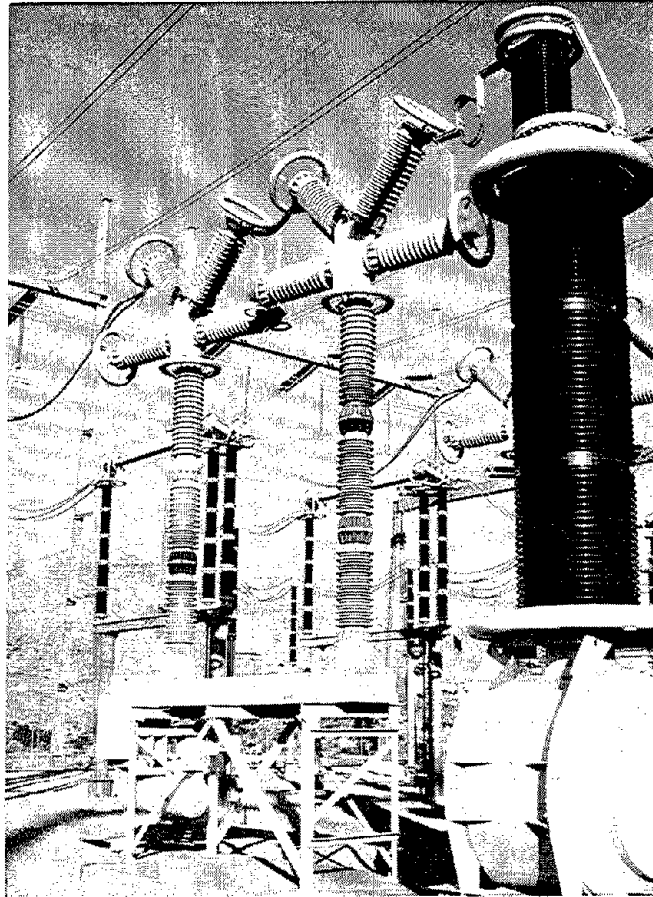
Fig. 3.22 Leaking live-tank column gasket will cause a loss of pressure that will prevent the circuit breaker from operating.

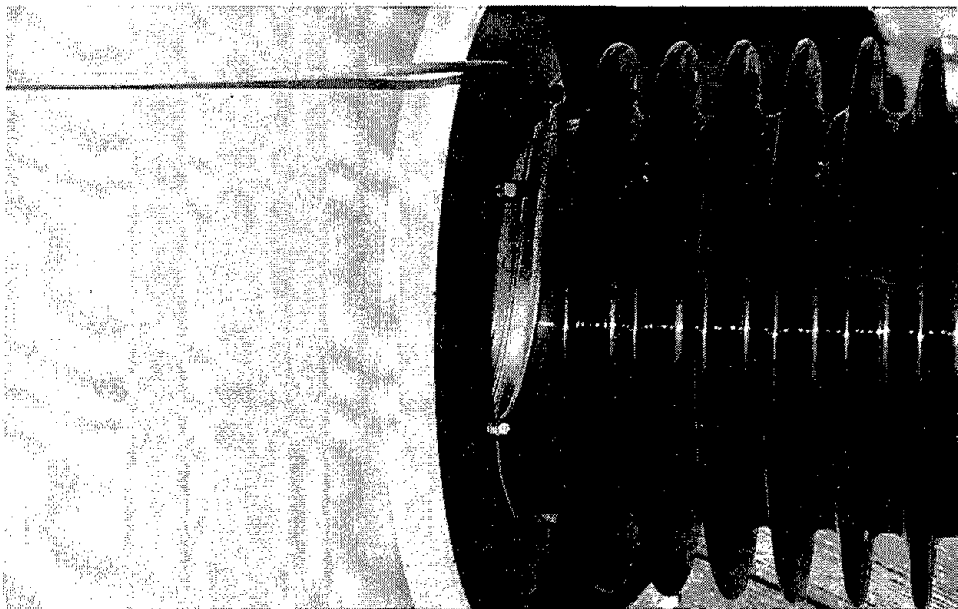
At another site with a peak ground acceleration of 0.15 g, one of 3 units of a particular design had blown gaskets that developed a leak, Fig. 3.23. Based on this data and that observed in other earthquakes, the relative motion between interrupter heads can cause the gaskets to blow before the columns fail.

Fig. 3.23 Motion between interrupter heads can cause the interrupter head bushing gasket to blow.

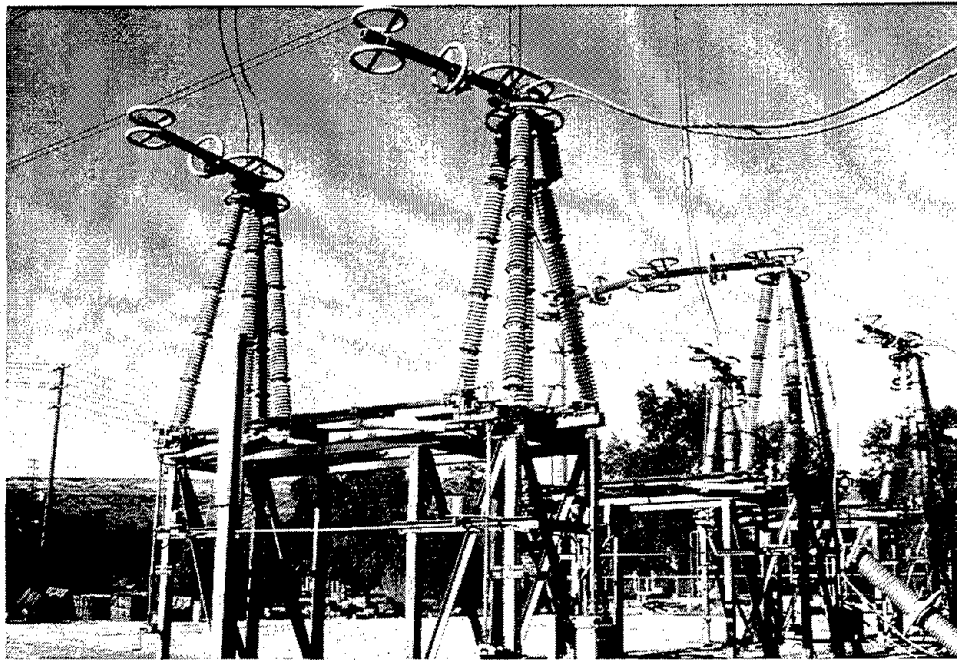
Fig. 3.24 This 500 kV center break disconnect switch is unusual in that it has tripod arm supports.

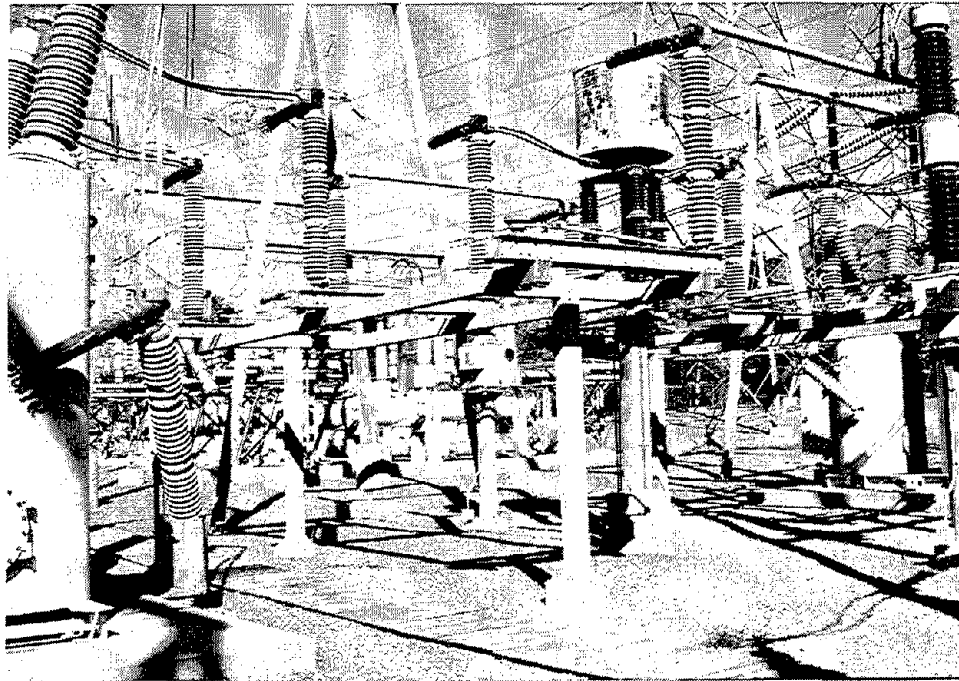
Disconnect switches failed from one of five failure modes in this earthquake. The most common is the failure of one or more of the post insulator columns used to

fabricate the units, Fig. 3.25. A second failure mode is the deformation or slipping of the operating mechanism so that the disconnect switches of the center break type do not close. In this failure mode the switches appear to be aligned properly but are not completely closed. A third failure mode is that the base plate that supports the post insulator stack on a center break type is deformed so that insulator stacks are out of plumb. When the switch is in the closed position the arms are spread and electrical contact is not made, Fig. 3.26. Figure 3.27 show that the aluminum base plate is deformed. This is an unusual failure in that there is usually catastrophic failure of porcelain members rather than damage to metal components. The fourth failure mode was the failure of post insulator columns that formed a tripod, Fig. 3.24. The failure pattern in these switches suggested that stresses associated with the assembly of the unit may have contributed to the failure. Finally, the fifth failure mode was associated with a manufacturing flaw in center-break units, in which tack welds used to hold a part served to initiate a fatigue crack in the support shaft. In this case the manufacturer provided new parts in which a different assembly method was used.

Fig. 3.25 The most common disconnect switch failure is the fracture of post insulators.

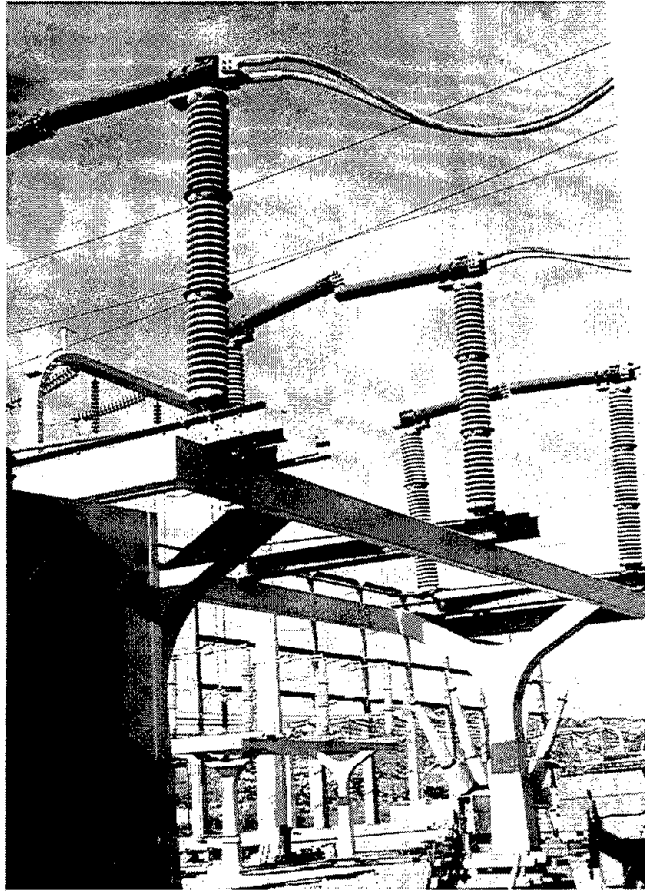
Fig. 3.26 Deformation of the plate supporting the post insulator stack prevented disconnect switch from closing.

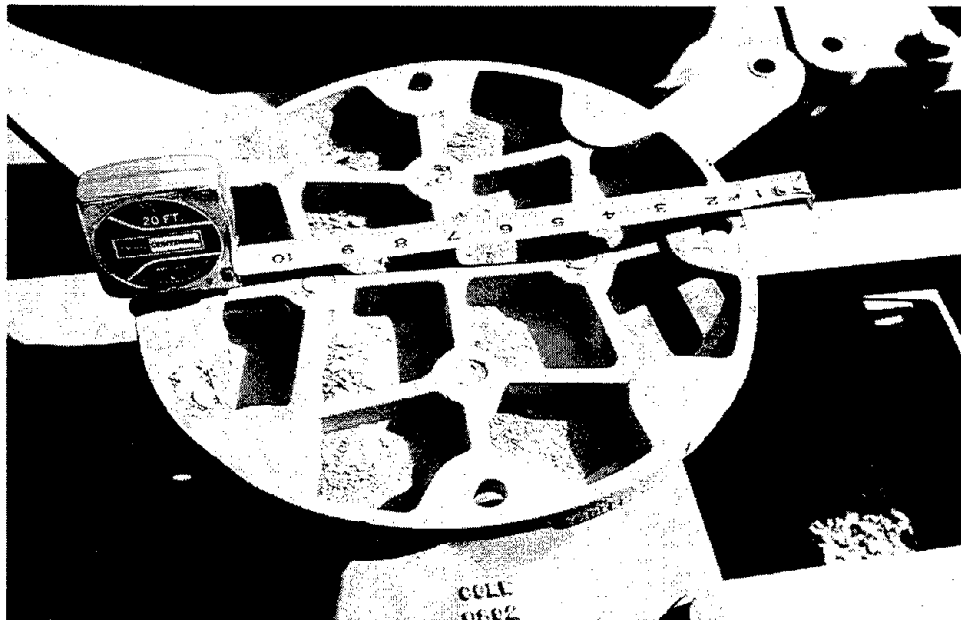
Fig. 3.27. The deformation of the cast aluminum base plate has not been seen in other earthquakes.

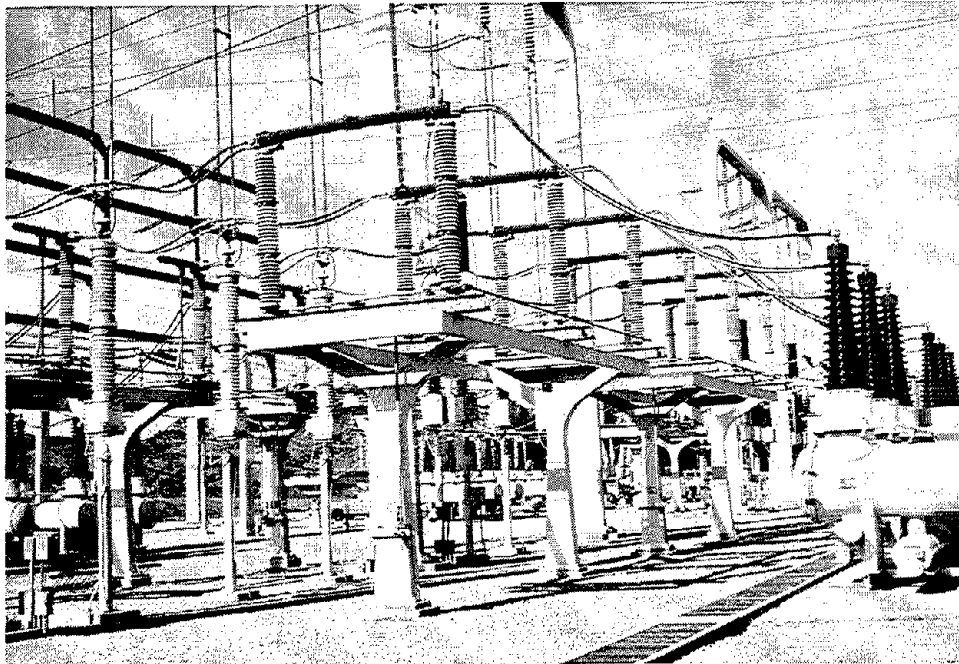
There were two emergency response actions taken to restore disconnect switch function, that is, to make contact across damaged disconnect switches. Because of the large number of damaged post insulators used to fabricate switches, it was common to cannibalized partially damaged switches or bus supports to get replacement post insulators. In one switch design, the stack of post insulators is tapered, that is, the insulators at the top are smaller than those at the bottom. Since the lowest insulator typically fails, there was a shortage of this particular element. While a flexible conductor could have been used to jump across a switch, none of these were observed. A second emergency procedure was to use cotton rope to hold deformed disconnect switch parts together to complete a connection so that service could be restored, Fig. 3.28.

Fig. 3.28 An emergency operating procedure uses cotton rope to hold the disconnect switch arms together.

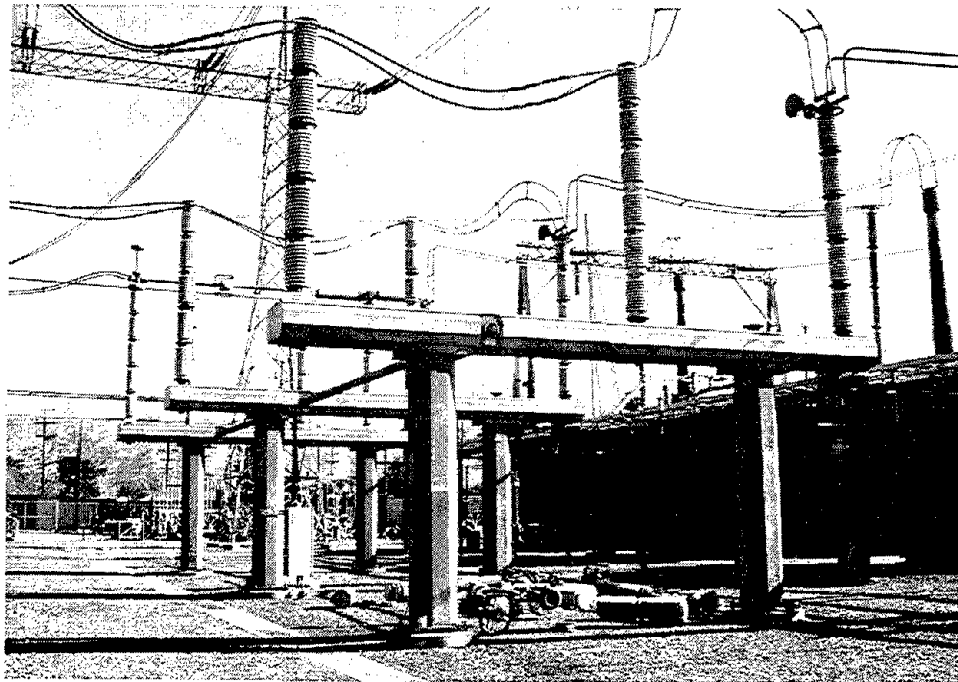
Circuit switchers at several sites were severely damaged. At one location, where they connected a transmission line to transformers, conductor was strung across the damaged circuit switchers to restore service, Fig 3.29.

Fig. 3.29 Emergency procedure is shown stringing conductor across damaged circuit switchers to connect a transmission line to a transformer bank.

Because of the inability to find circuit switchers that meet current seismic specifications, the plan is to replace these devices with circuit breakers and disconnect switches.

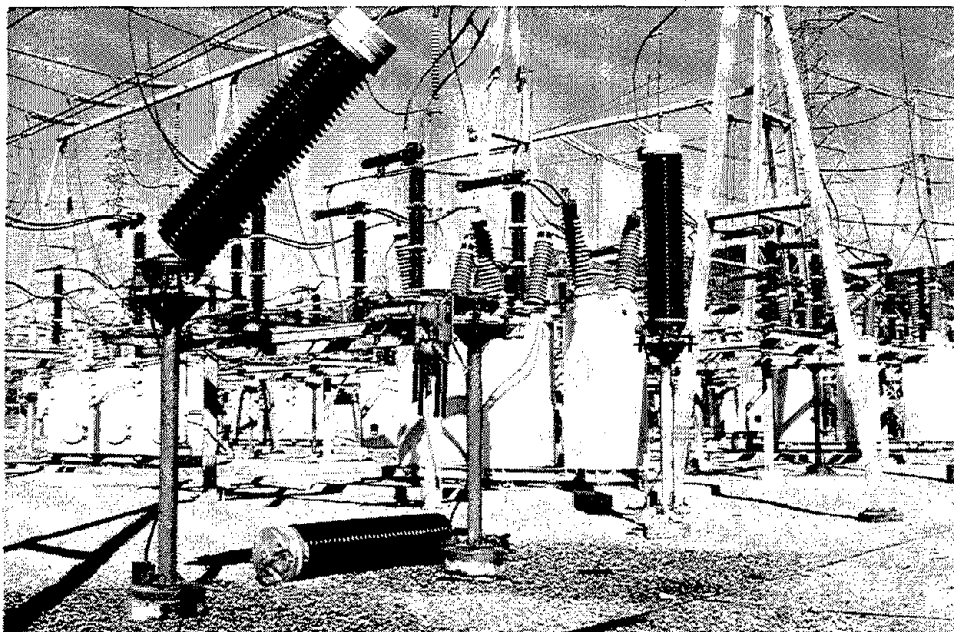
Potential transformers, current-voltage transformers, and some current transformers have similar structural forms, that is, they have long cylindrical porcelain members supported on steel columns or suspended from above. Units supported from below frequently failed where the porcelain joins its lower mounting flange, Fig 3.30. Some units supported from below used Bellville washers to change frequencies and/or increase damping. The performance of these units was mixed. Units with stiff (above about 8 Hz.) steel support columns performed well while those with standard columns with frequencies below 6 Hz. frequently failed. Suspended units had a different failure mode. The lower aluminum angle restraint anchor attachments on many of these units failed, and their swinging motion tended to damage low voltage electrical connections, Fig 3.31. The violent character of these motions is indicated by damage to the anchorage of restraint columns, Fig. 3.32. A review of the damage pattern suggests that the length of the suspension system influenced the response, so that there may have been a tuning of the system to the ground motion. Even in units where lower restraints did not fail, adjacent equipment was damaged in about 25% of the cases due to interaction effects. When the lower restraints failed, the damage to adjacent equipment rose to 78%. The damage associated with more massive suspended items, such as wave traps, was about three times that associated with lighter suspended items, such as current-voltage transformers. It is interesting to note that the porcelain on suspended units is seldom damaged.

Fig. 3.30 Porcelain of a potential transformer failed at its lower support.

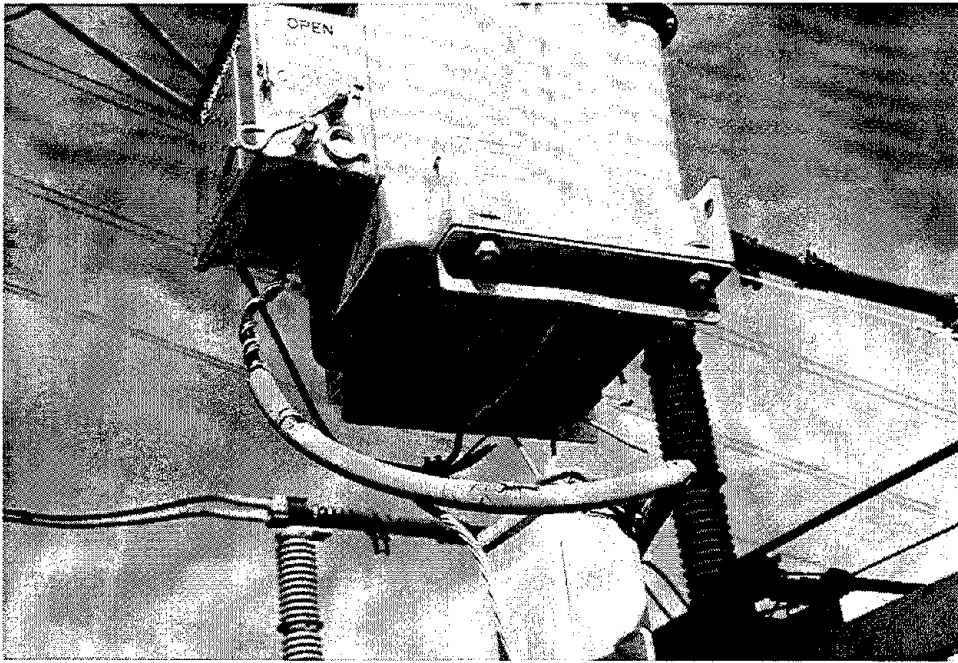
Fig. 3.31 Aluminum angle used to restrain suspended current-voltage transformers frequently failed.

When damaged current-voltage transformers are typically removed from the system and the system continues to operate. Suspended units with damaged restraints were often temporarily restrained with rope.

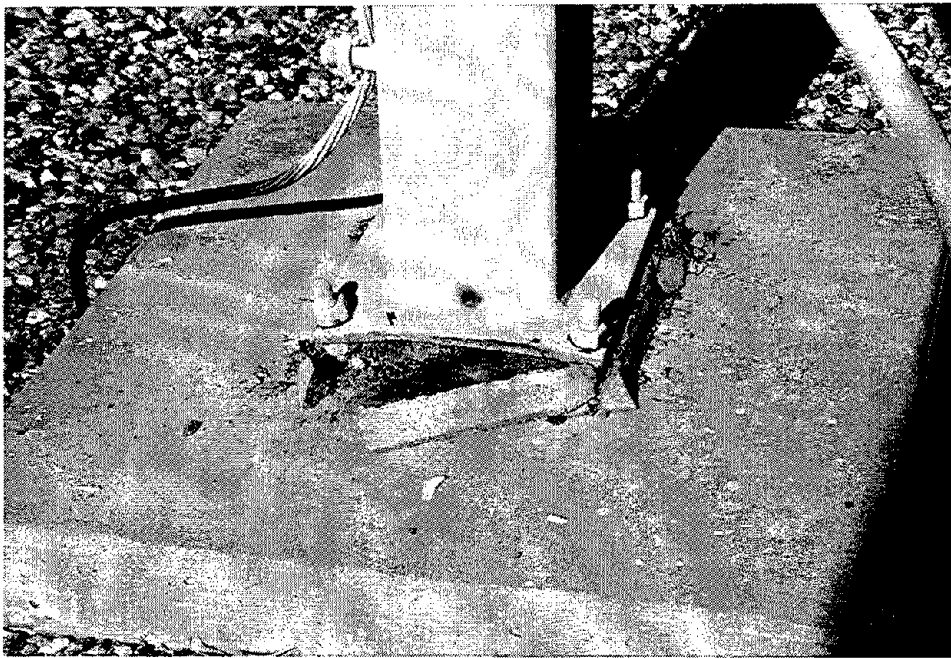
Fig. 3.32 Violent motion of suspended current-voltage transformers damaged base of column restraints.
