**NORTHRIDGE EARTHQUAKE: LIFELINE
PERFORMANCE AND POST-EARTHQUAKE
RESPONSE**

Date: Apr 97

Authors: A. J. Schiff.

Performing Organization: American Society of Civil Engineers, New York. Technical Council on Lifeline Earthquake Engineering.

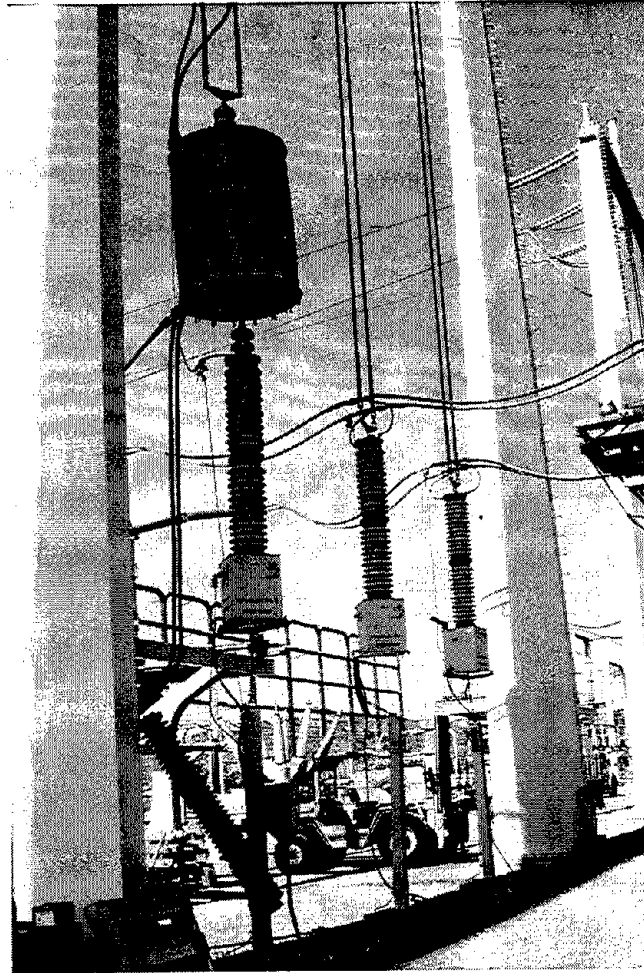
The performance of suspended units in this earthquake has been good, in the sense that most units were not damaged. However, their swinging motion often caused severe damage to adjacent equipment, Fig 3.33. Two suspended units had internal structural failures and fell to the ground. Support post insulators on units supported from below frequently fail, Fig. 3.34, or structural connections above the post insulators fail, Fig 3.35. Failures were often in aluminum bolts.

Fig. 3.33 Motion of a suspended wave trap damaged an nearby disconnect switch.

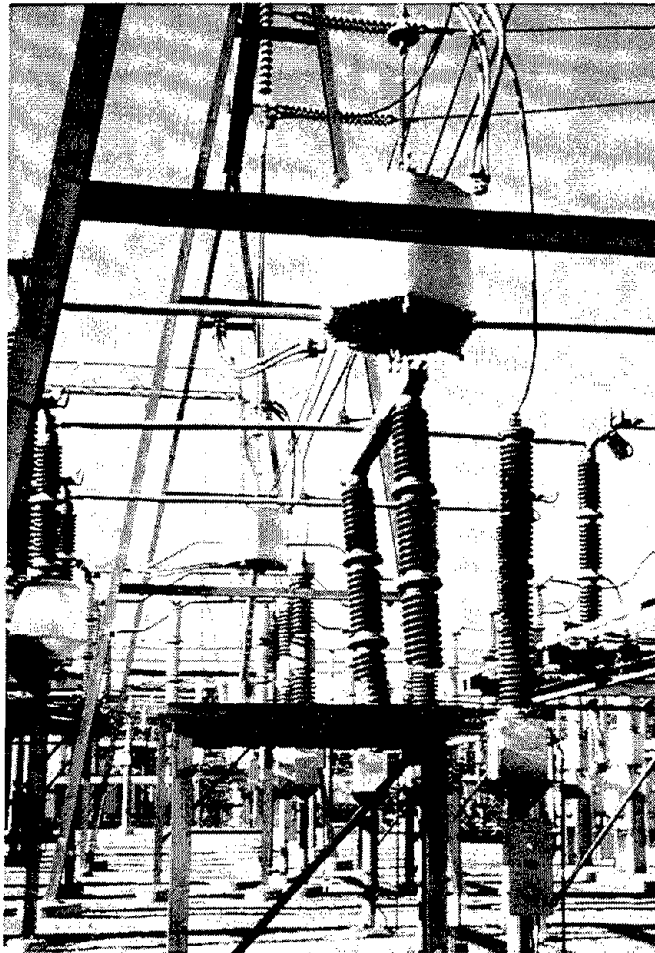
Fig.3.34 A 230 kV suspended wave trap failed post insulator restraints below the wave trap.

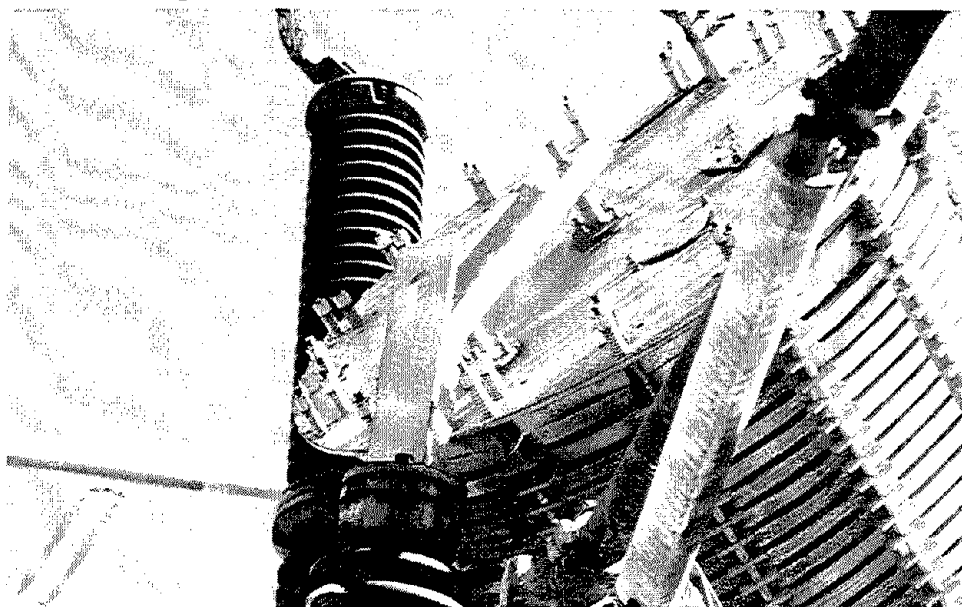
Fig.3.35 Channel supporting wave traps failed just above the weld to the top of the post insulator.

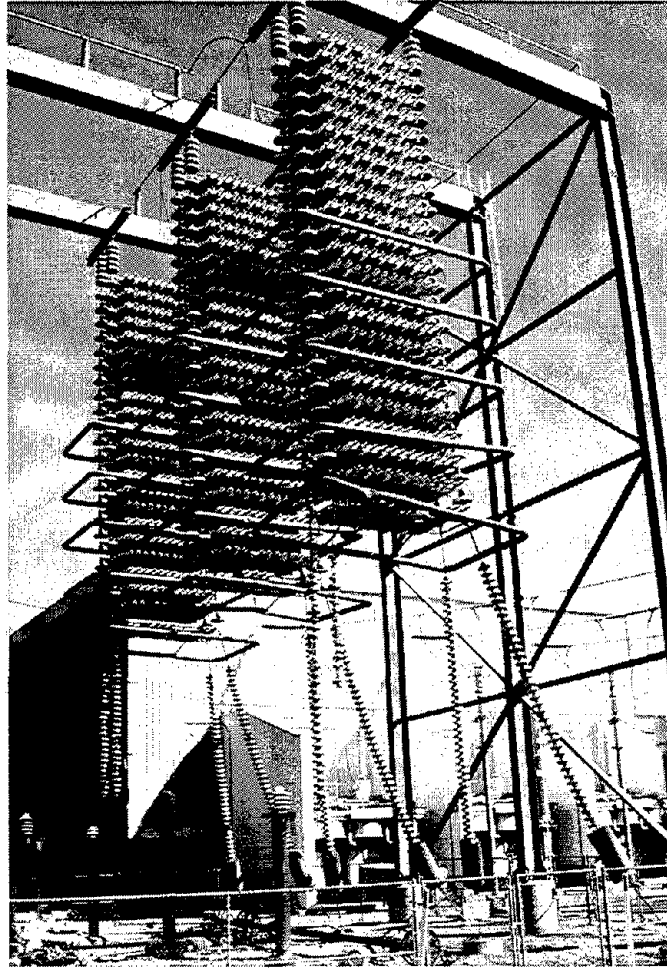
structure welds, had been replaced and were not damaged in this earthquake. Harmonic filter capacitors associated with Valve Hall 7 and 8 at Sylmar West were added after 1971. These capacitors were suspended, and in the earthquake broke their lower restraints, but were otherwise undamaged, Fig. 3.36.

Fig. 3.36 Suspended harmonic filter capacitors failed their lower restraints, but were otherwise undamaged.

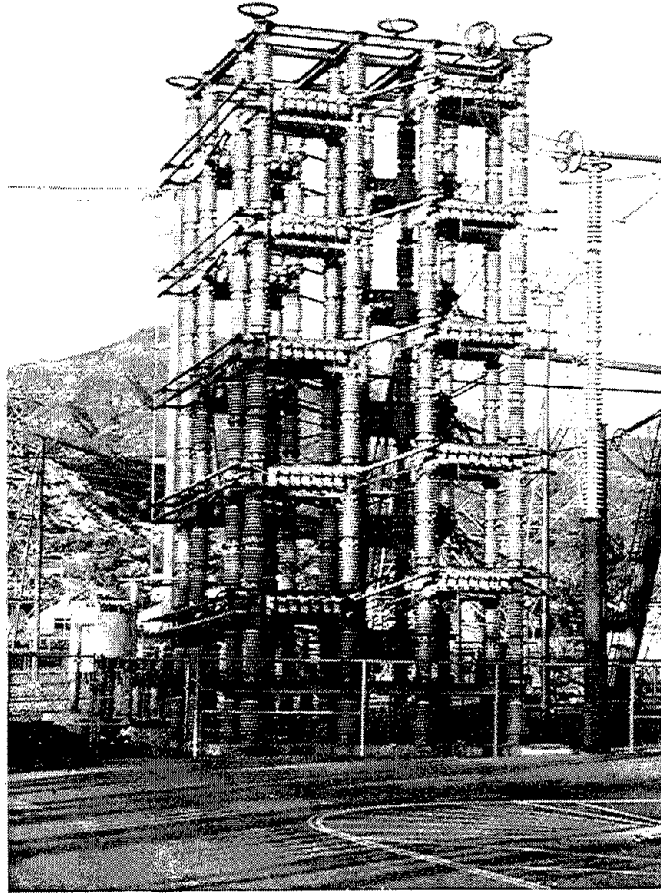
Harmonic filter capacitors at Sylmar East were in a support structure made of post insulators. In the earthquake several post insulators fail, but the structure did not collapse, Fig. 3.37. The power factor correction capacitor racks are of different sizes to meet different electrical requirements. The base support porcelain members of the tallest racks at two locations on the site failed, Fig. 3.38. It is not known if the structural frequency was coincident with spectral content of the ground motion or if the taller structure overloaded its supports.

Fig. 3.37 Harmonic filter capacitor support structure was damaged, but did not collapse.

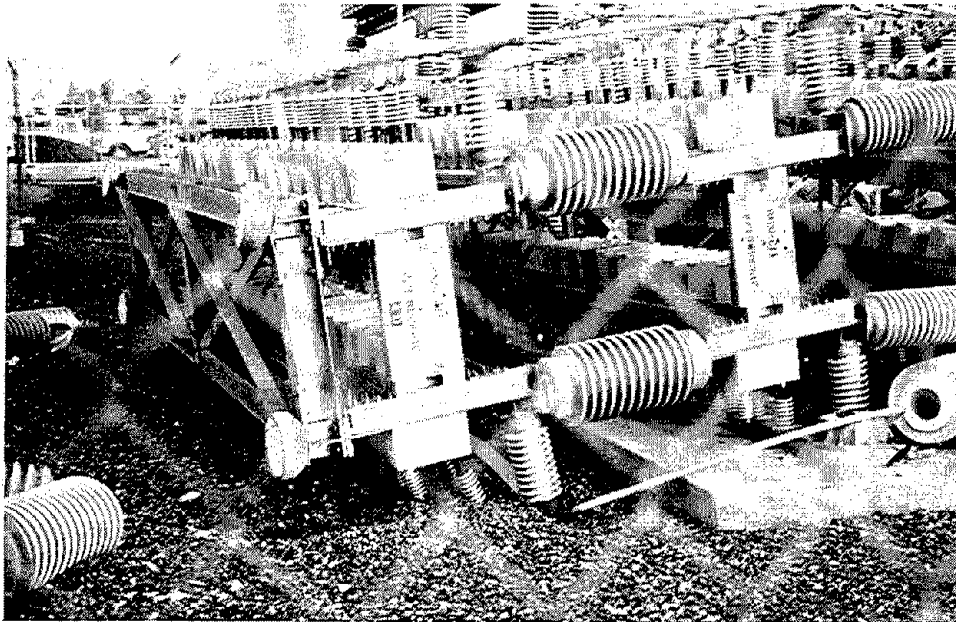
Fig. 3.38 The lower post insulators on the tallest power factor correction capacitors failed.

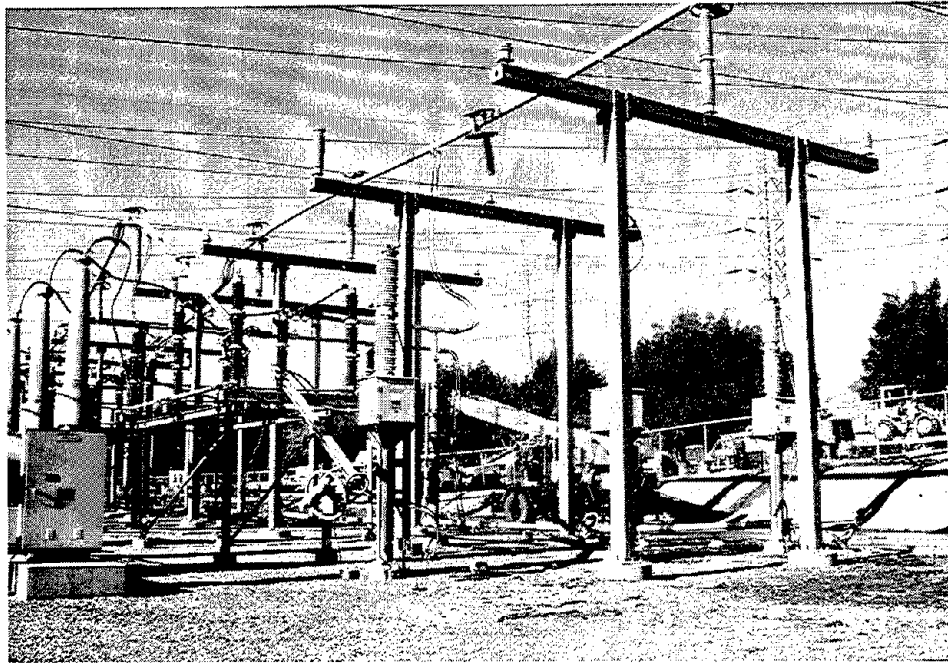
Most of the high voltage bus and conductor used are flexible-type rather than rigid-type fabricated from aluminum pipe or heavy extruded aluminum sections. While there were exceptions, rigid bus in general performed poorly in that relative motion between equipment connected with rigid bus frequently damaged the porcelain member to which it was attached. A 230 kV bus at a major substation had a unique configuration in that the bus, which was a heavy aluminum H section, was suspended by short lengths of chain to allow it to swing. Its performance was very poor, Fig. 3.39. Rigid bus was also frequently used at line drops between disconnect switches, Fig. 3.40. An evaluation of the damage pattern suggests that the rigid bus in this configuration contributed to the failure of disconnect switches. Straight runs of rigid bus have little flexibility to accommodate motion between equipment. Incorporation of a dog-leg bend into straight runs of rigid bus will allow it to accommodate deflection between its ends.

Fig.3.39 Post insulators supporting rigid bus failed causing major disruption at the substation.

One utility plans to replace its rigid bus with flexible bus. Also, at bus drop to rigid bus between disconnect switches will be modified by adding flexible links at the end of

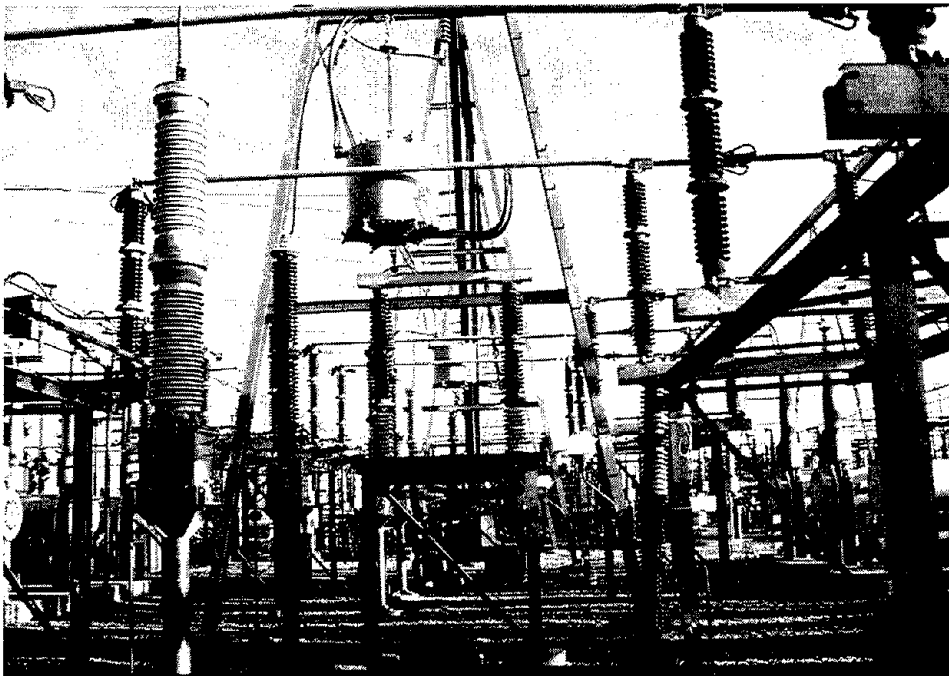
Fig.3.40 Rigid bus used to connect disconnect switches at line drop contributed to disconnect switch damage.

each run. Specifications for new construction also call for more slack in conductor between substation equipment.

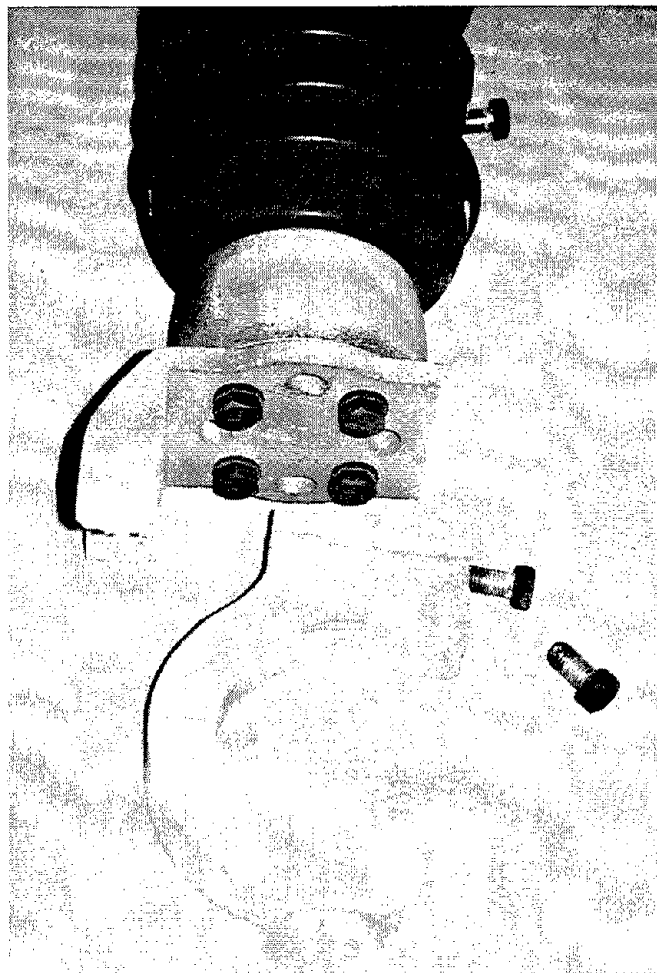
Many of the substations have rigid low-voltage bus. Its performance has been poor due to brittle failure of the cast-aluminum hardware used to connect and support conductors, Fig. 3.41. To restore service, cotton rope was used to tie the bus to post insulators, thus replacing the function of the damaged hardware, Fig. 3.42. As a result of this damage, recommendations have been made that specifications for the hardware be increased to reflect the brittle failures observed.

Fig. 3.41 Cast aluminum hardware used to support low voltage bus frequently failed.

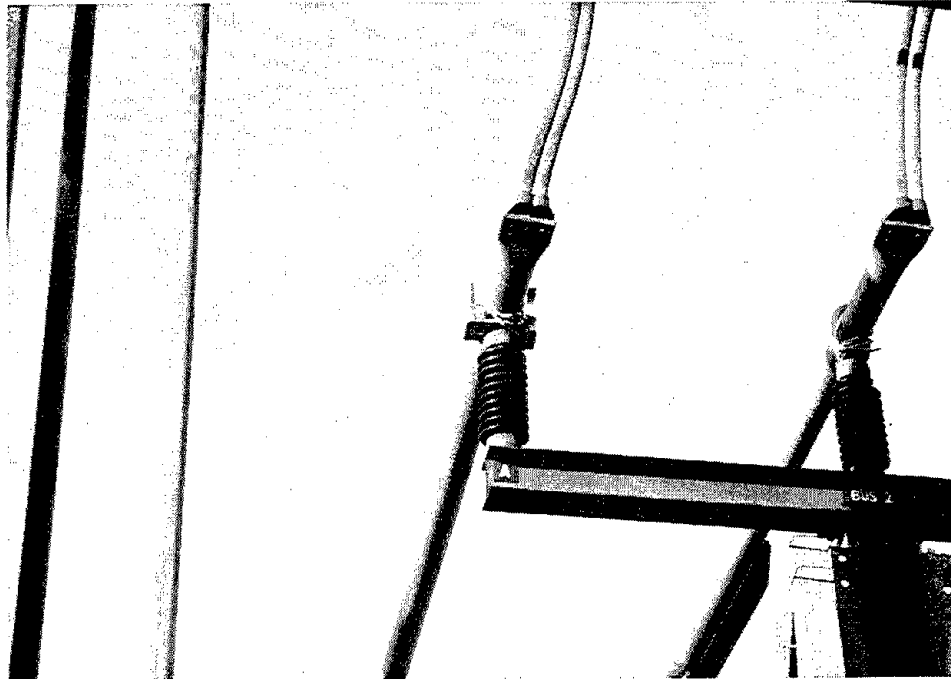
Fig. 3.42 An emergency procedure was to use rope to hold bus to supports.

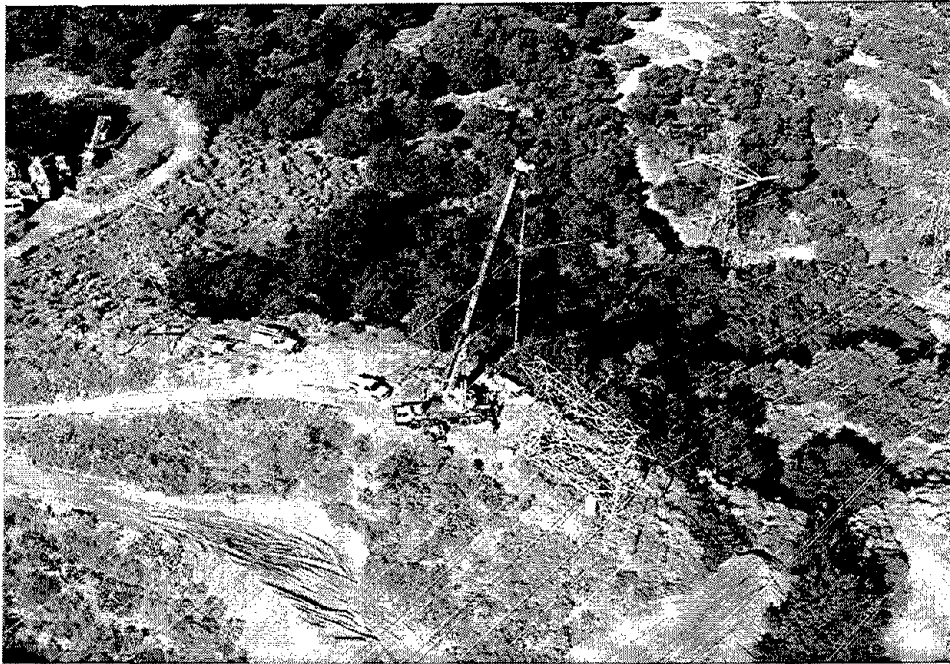
The earthquake performance of transmission towers has been very good. Several towers were damaged in this earthquake and three failures caused the loss of four circuits. A large construction crane was rigged to support one 230 kV circuit to restore a circuit to a pumped-storage facility. It was used until a replacement tower could be constructed, Fig. 3.43. Temporary supports were rigged for the other two circuits. At one substation that experienced liquefaction several large dead-end transmission towers were severely damaged. These inverted "U" shaped towers were fabricated out of plate to form large tubes. Several towers tipped slightly due to liquefaction, Fig. 3.44, and one leg of one tower had brittle fractures through its entire section near its base plate weld, Fig. 3.45. The footing of this tower was 34 feet deep. Bus support structures has a brittle fractures near welds and one had a crack through its 4" base plate.

Fig. 3.43 A crane was used to temporarily replace a failed transmission tower to restore service.

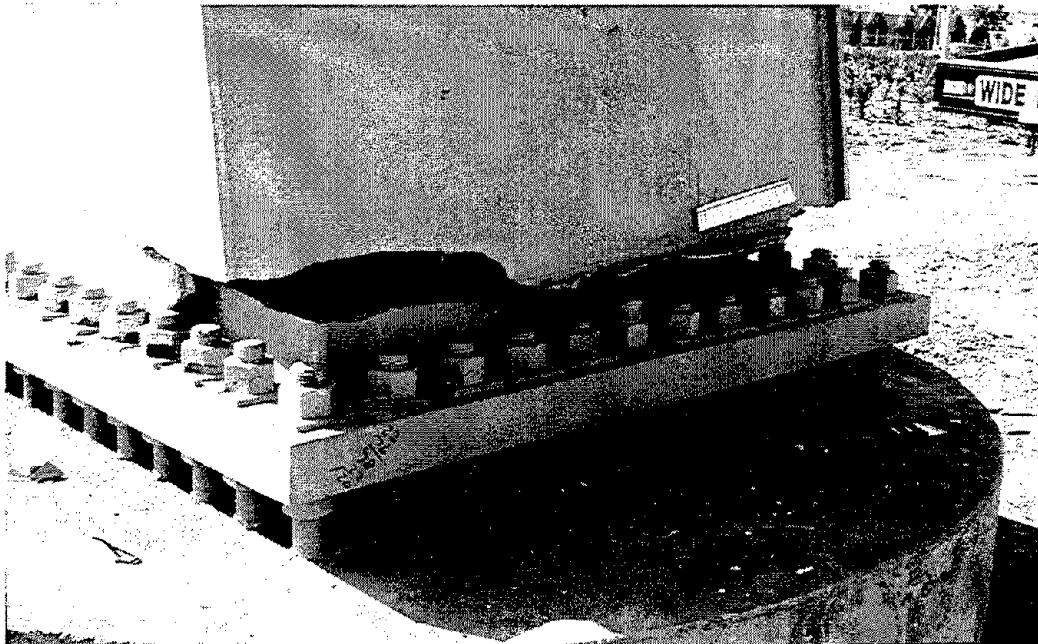
Fig. 3.45 Brittle fracture of dead-end structure associated with soil liquefaction.

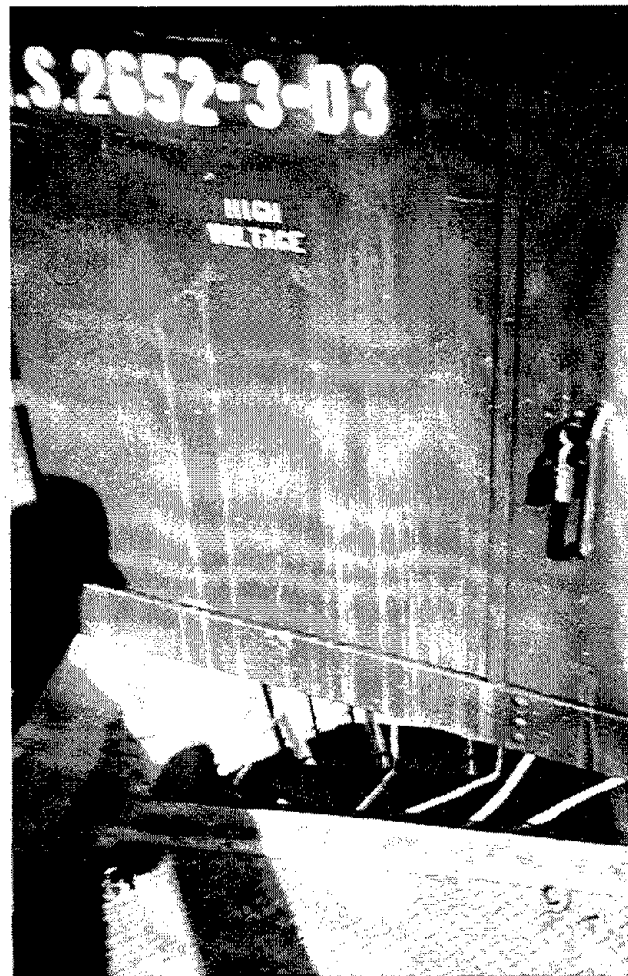
Fig. 3.46 Pad supported distribution transformers moved, but did not cause disruption.

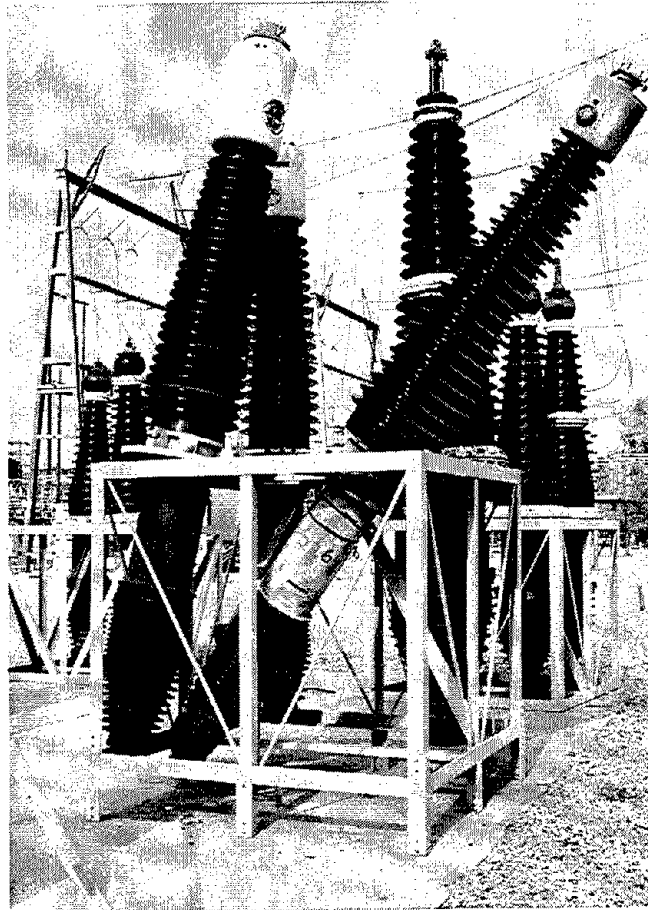
Fig. 3.48 Spare bushings stored at an older facility were not adequately anchored to their rack.

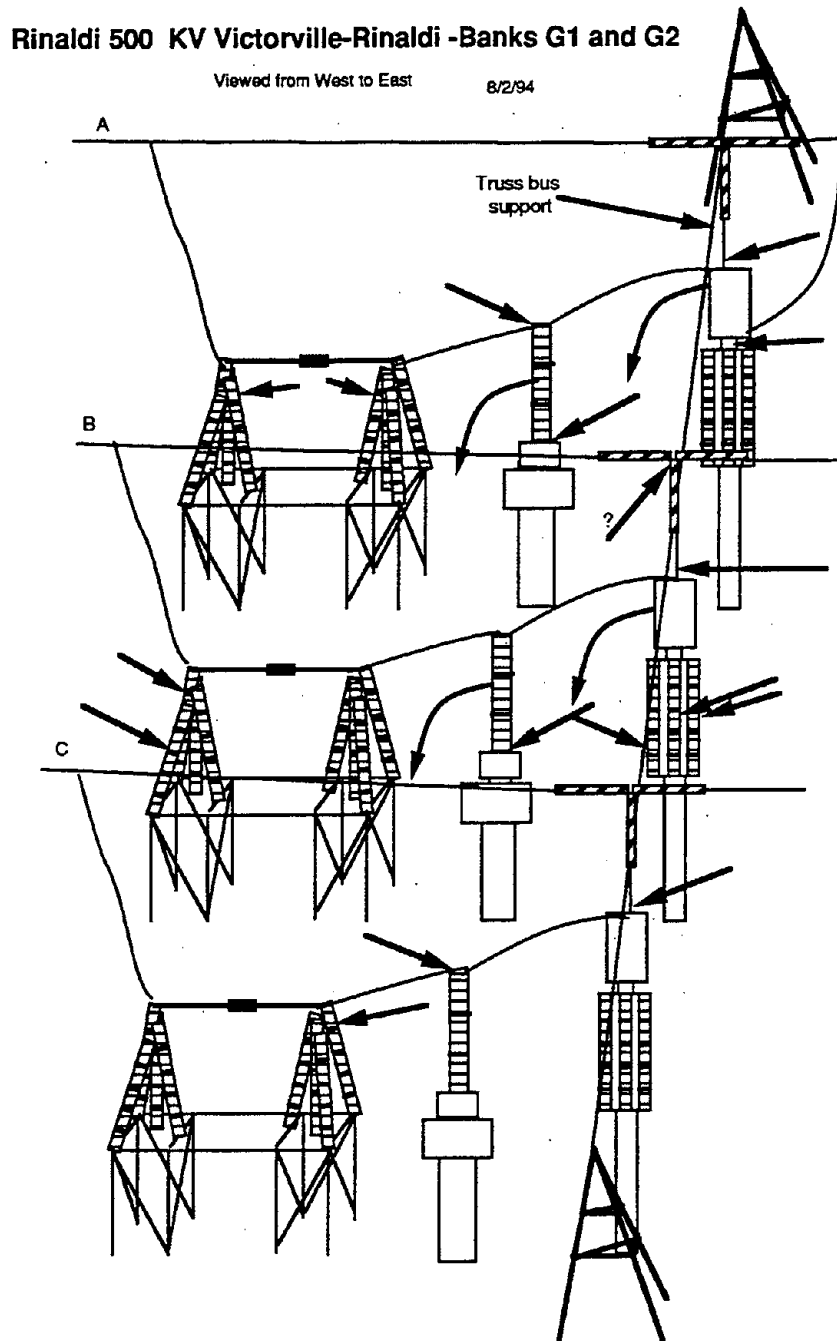
Fig.3.51 Schematic diagram showing damage to 500 kV switchyard at Rinaldi Substation - Part 2.

In the 500 kV switchyard, suspended wave traps interacted with and damaged adjacent equipment. In the 230 kV switchyard post insulators supporting the rigid bus failed and sections of the bus fell on disconnect switches. There were also problems of equipment interaction with traditional pipe-type rigid bus. Several transformer bushings were damaged, but this data has not yet been tabulated. Figures 3.51 and 3.52 are detailed schematic diagrams showing damage to the 500 kV and 230 kV switchyards. Table 3.1 shows a summary of equipment performance.

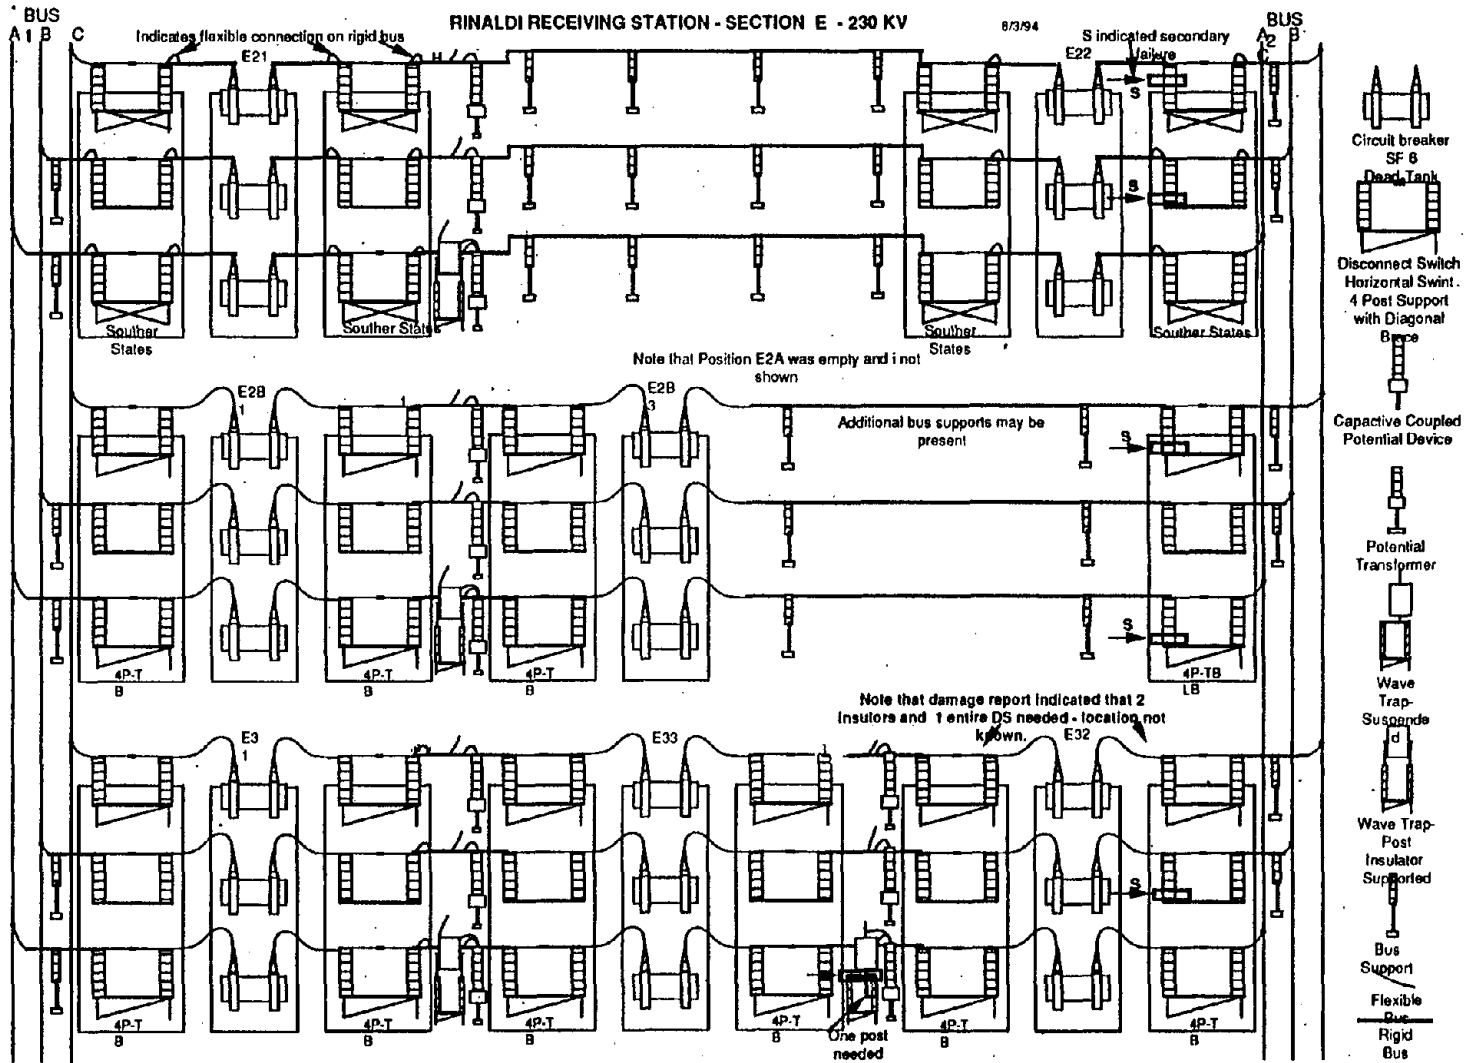
Fig. 3.52 Schematic diagram showing damage to 230 kV switchyard at Rinaldi Substation - Part 1. Note that boxes and arrows indicate damage locations.

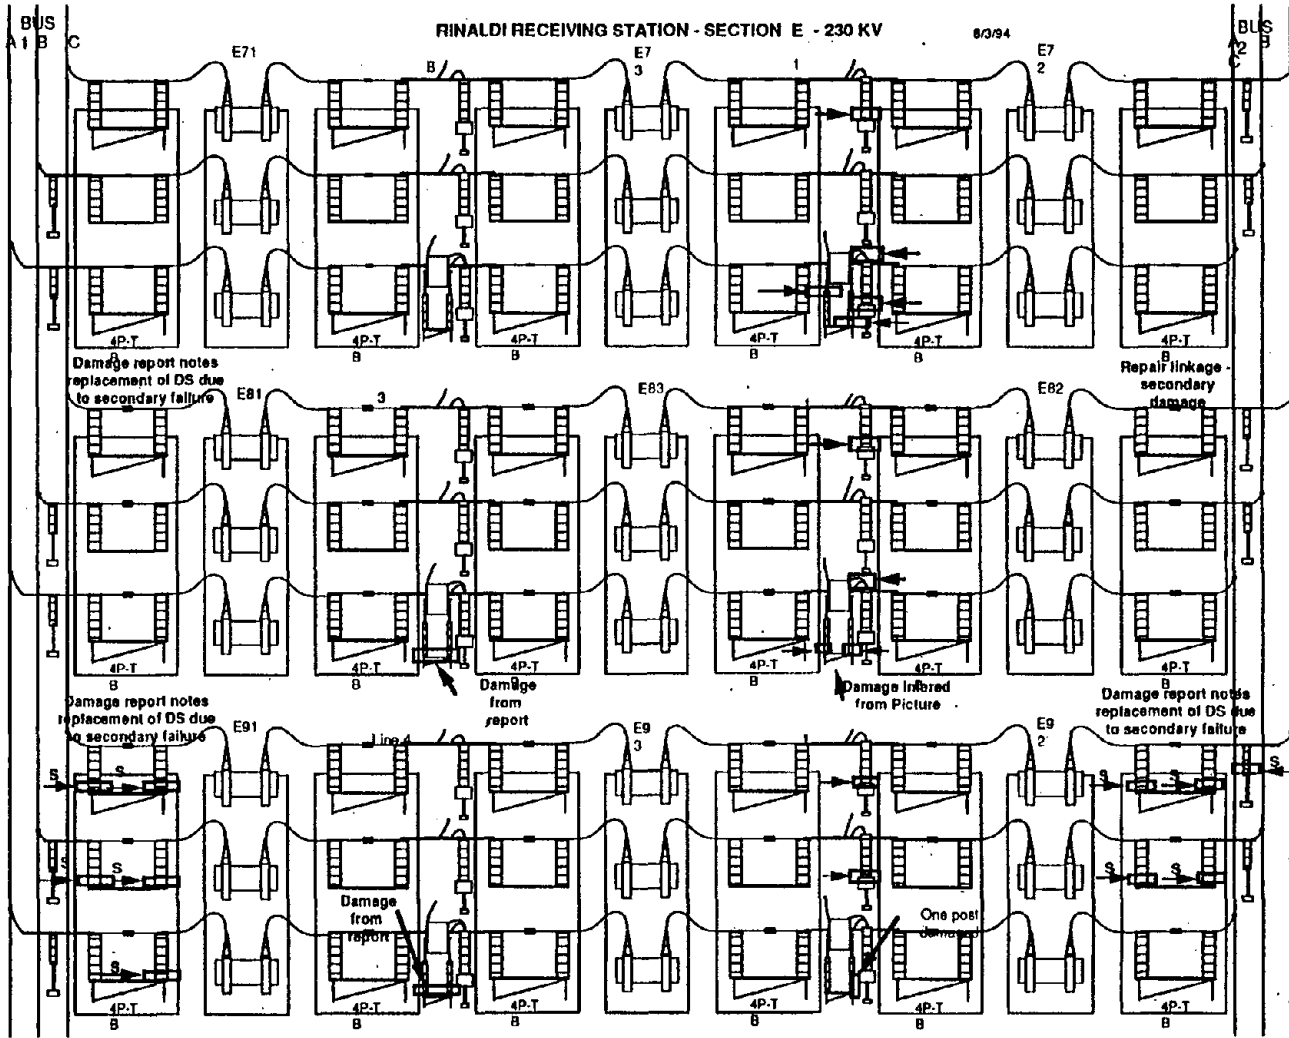
Fig. 3.52 Schematic diagram showing damage to 230 kV switchyard at Rinaldi Substation - Part 2.

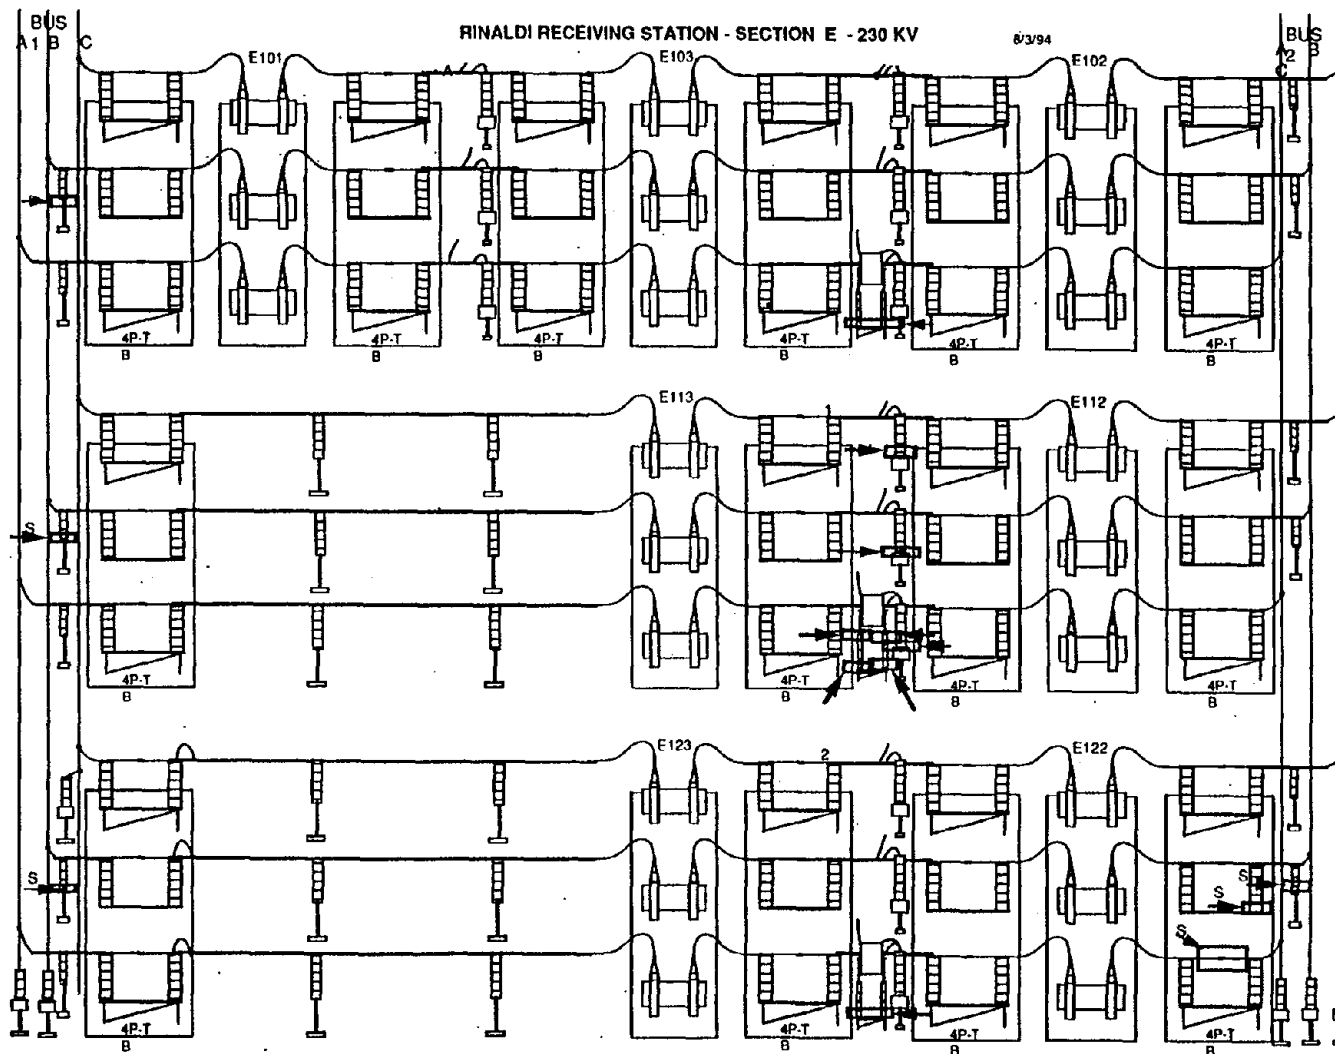
Fig. 3.52 Schematic diagram showing damage to 230 kV switchyard at Rinaldi Substation - Part 3.

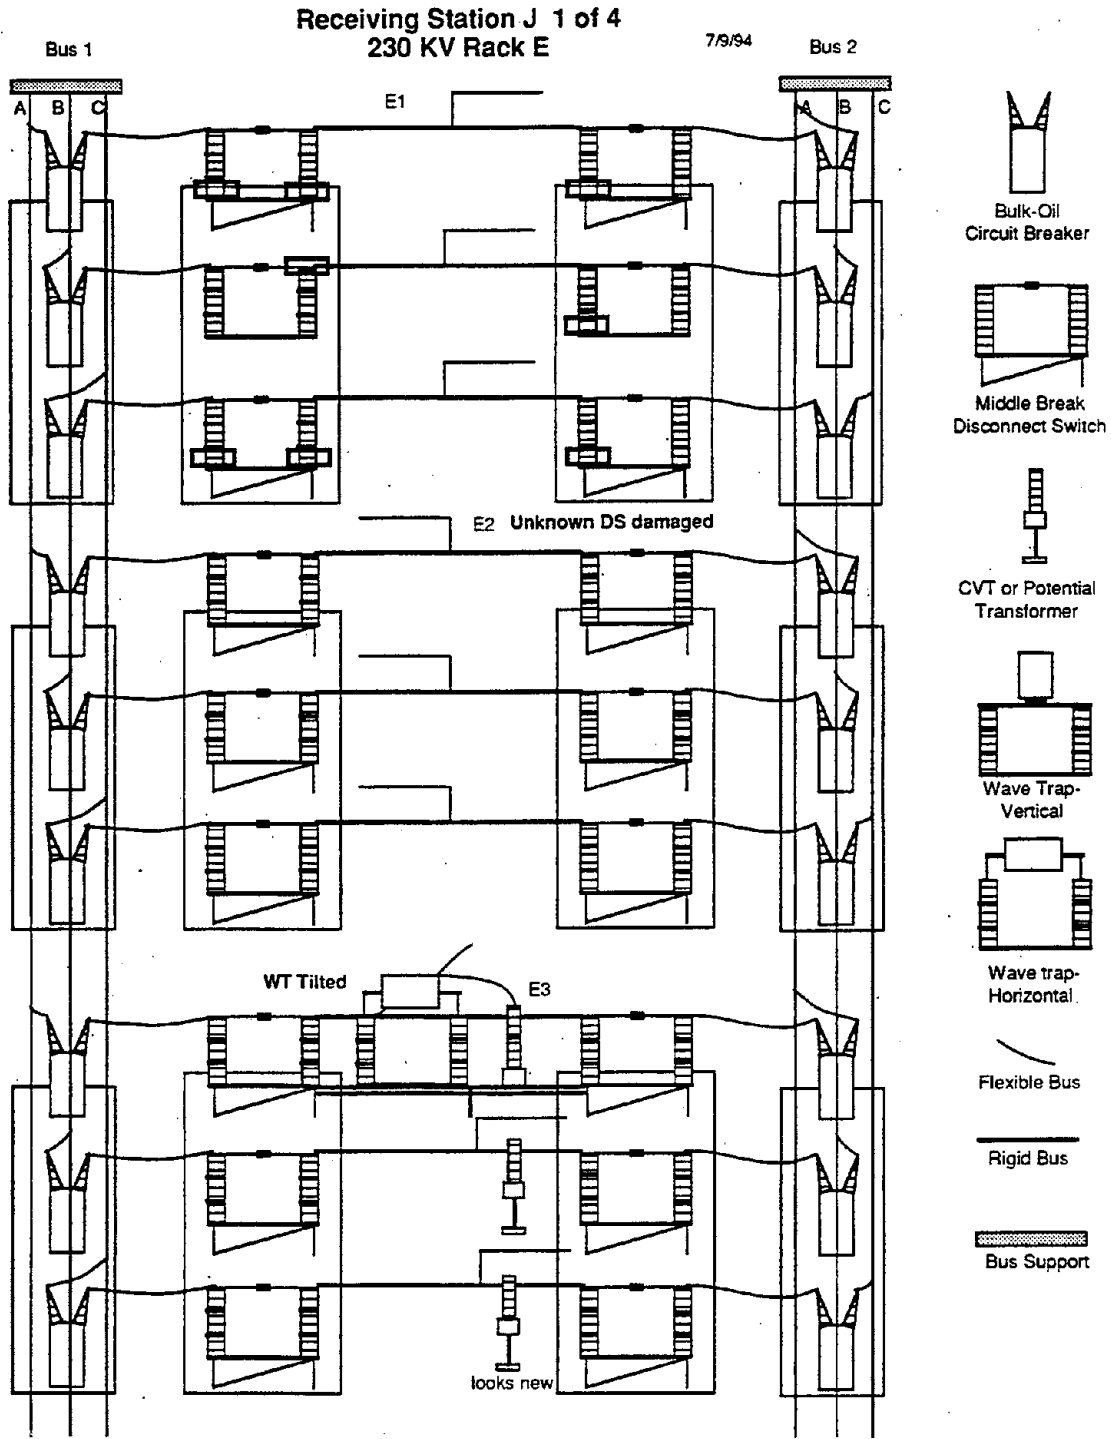
There was damage to transformer bushings and lightning arrester, two lengths of flexible conductor between dead-end structures fell when insulator strings failed, and porcelain on disconnect switches failed. Figures 3.53 and 3.54 are detailed schematic diagram showing damage to the 230 kV switchyard and transformers. Table 3.2 shows a summary of equipment performance.

Fig. 3.53 Schematic diagram showing damage to 230 kV switchyard at Receiving Station J - Part 1.

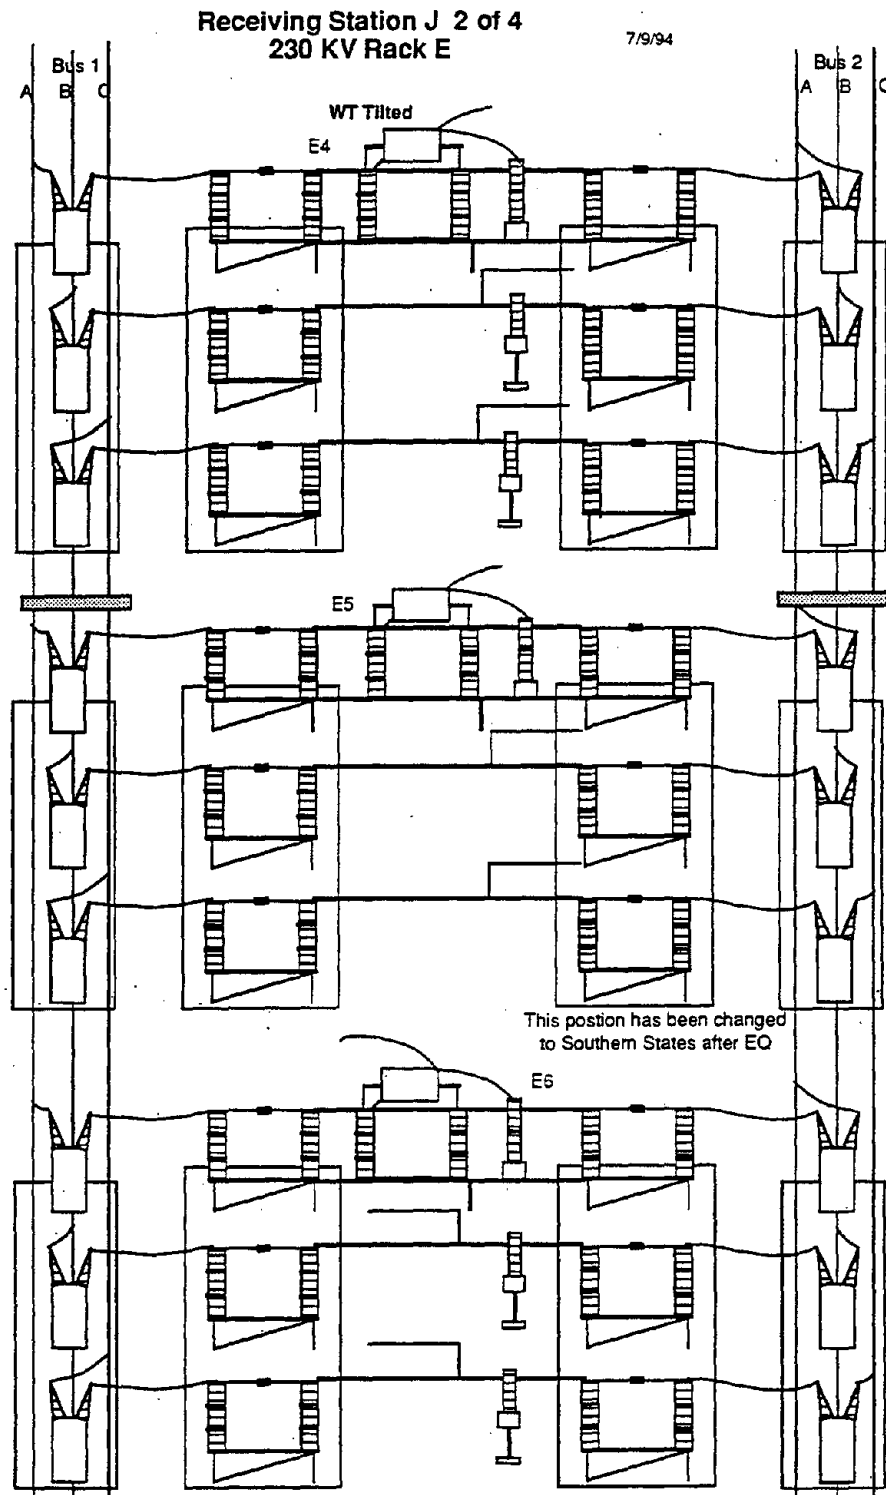
Fig. 3.53 Schematic diagram showing damage to 230 kV switchyard at Receiving Station J - Part 2.

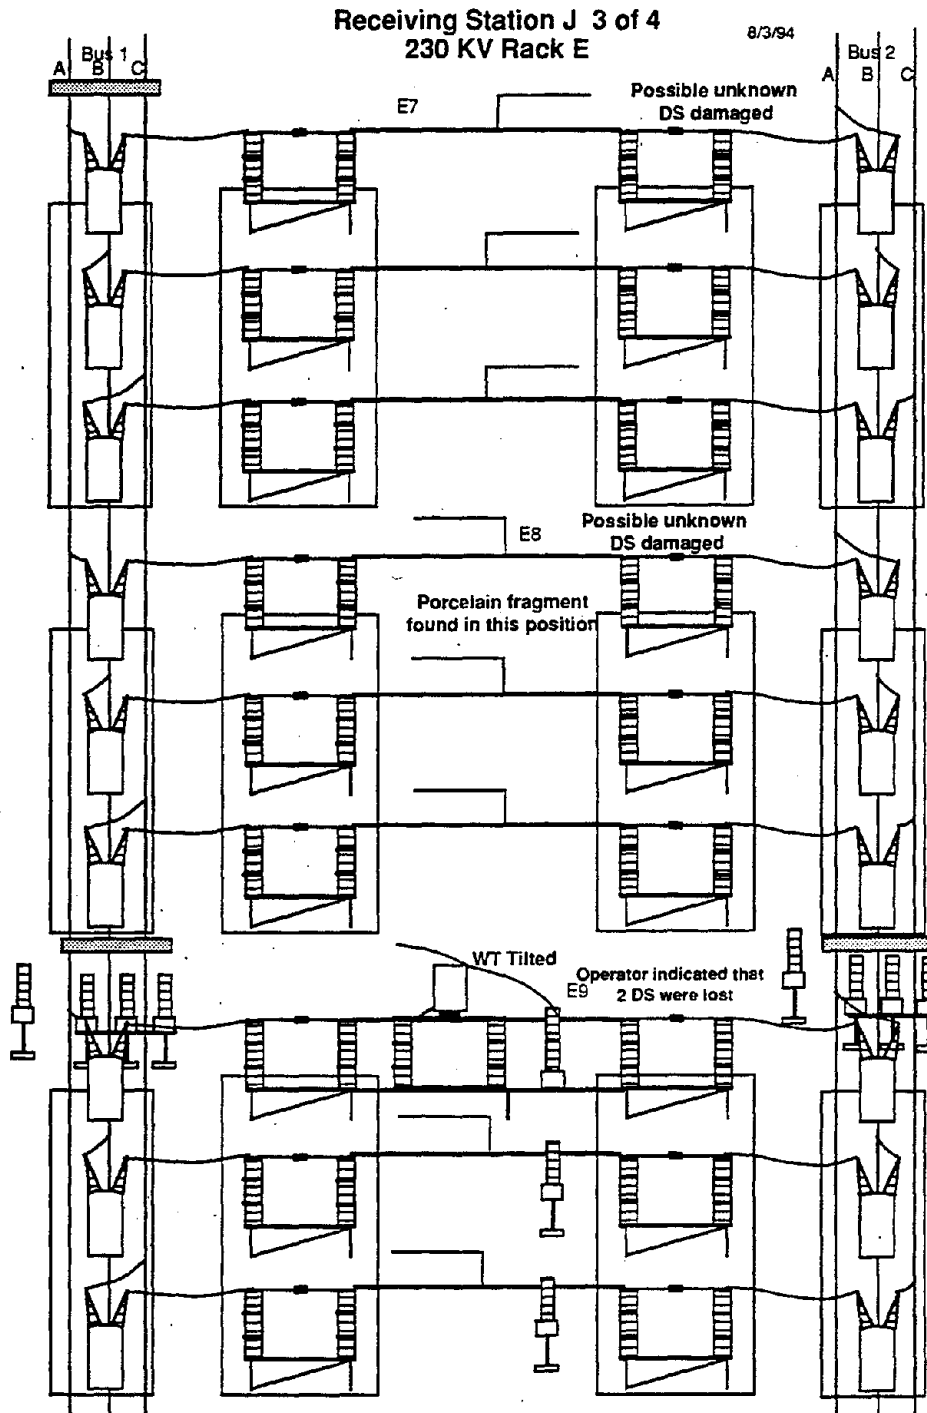
Fig. 3.53 Schematic diagram showing damage to 230 kV switchyard at Receiving Station J - Part 3.

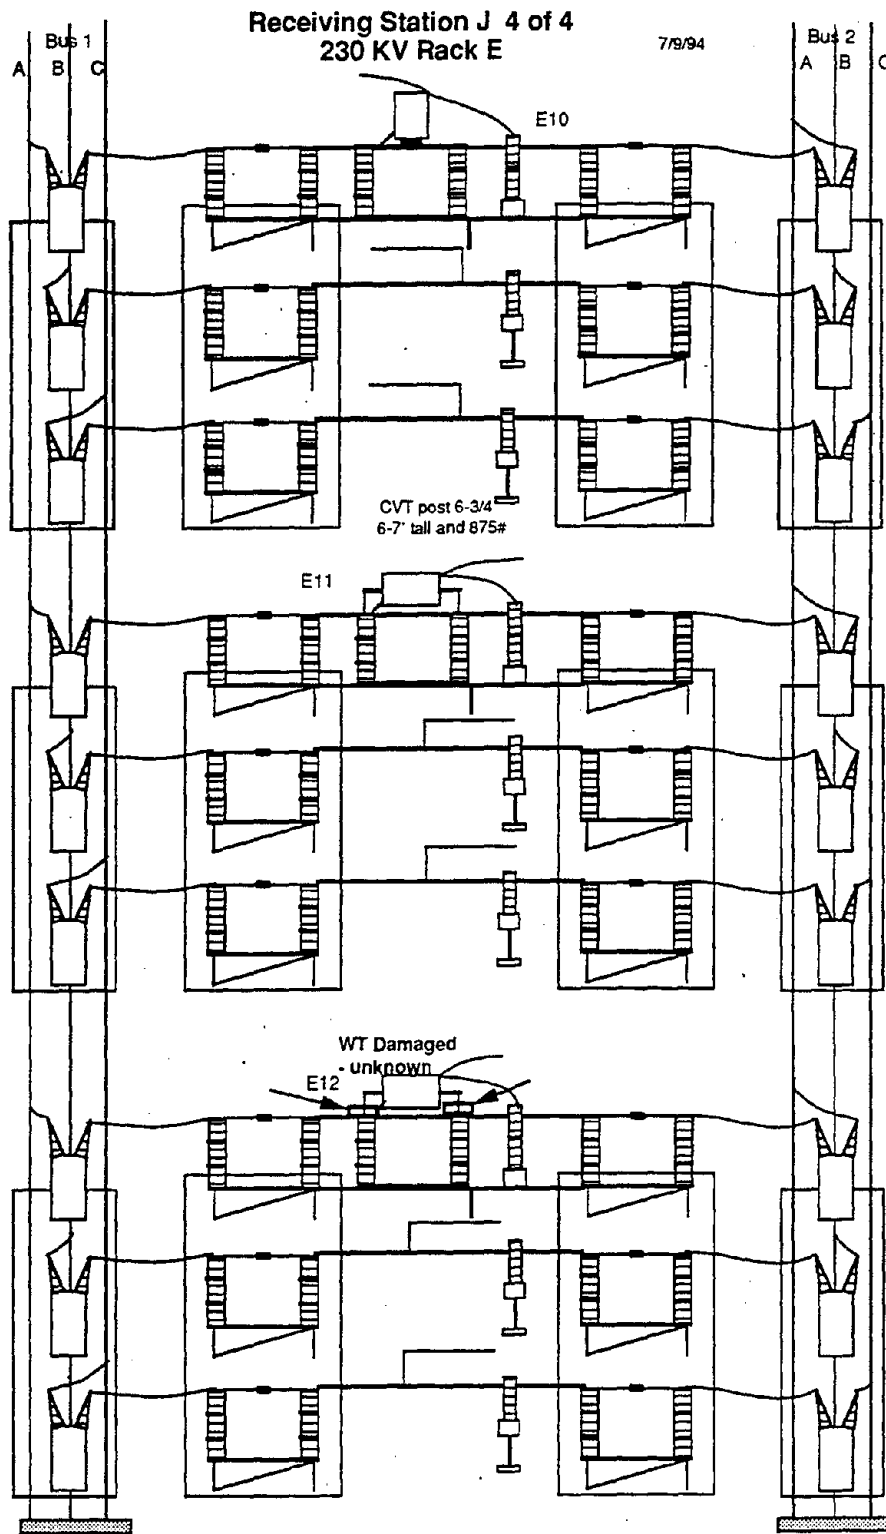
Fig. 3.53 Schematic diagram showing damage to 230 kV switchyard at Receiving Station J - Part 4.
