**NORTHRIDGE EARTHQUAKE: LIFELINE
PERFORMANCE AND POST-EARTHQUAKE
RESPONSE**

Date: Apr 97

Authors: A. J. Schiff.

Performing Organization: American Society of Civil Engineers, New York. Technical Council on Lifeline Earthquake Engineering.

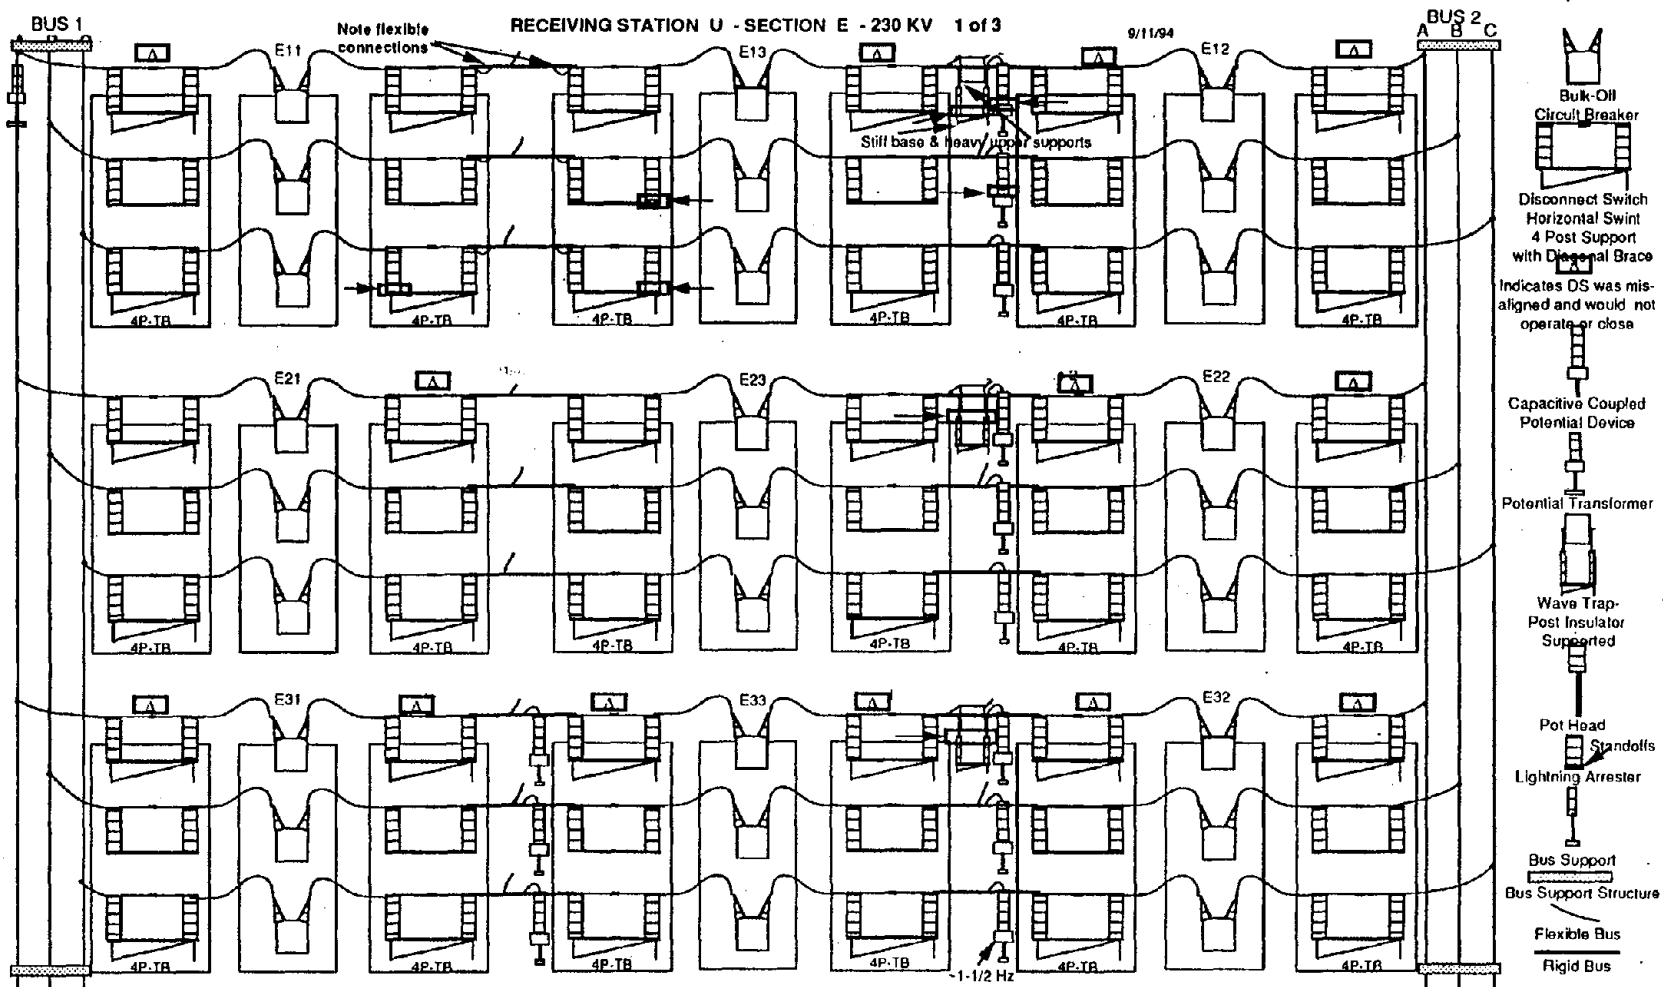
Receiving Station U is a 230 kV substation with a breaker-and-a-half bus configuration. Strong motion data was not recorded at the site. There was damage to transformer bushings, lightning arresters, a wave trap, wave trap supports and disconnect switches. Figures 3.55 and 3.56 are detailed schematic diagram showing damage to the 230 kV switchyard and transformers. Table 3.4 shows a summary of equipment performance.

Fig. 3.55 Schematic diagram showing damage to 230 kV switchyard at Receiving Station U - Part 1.

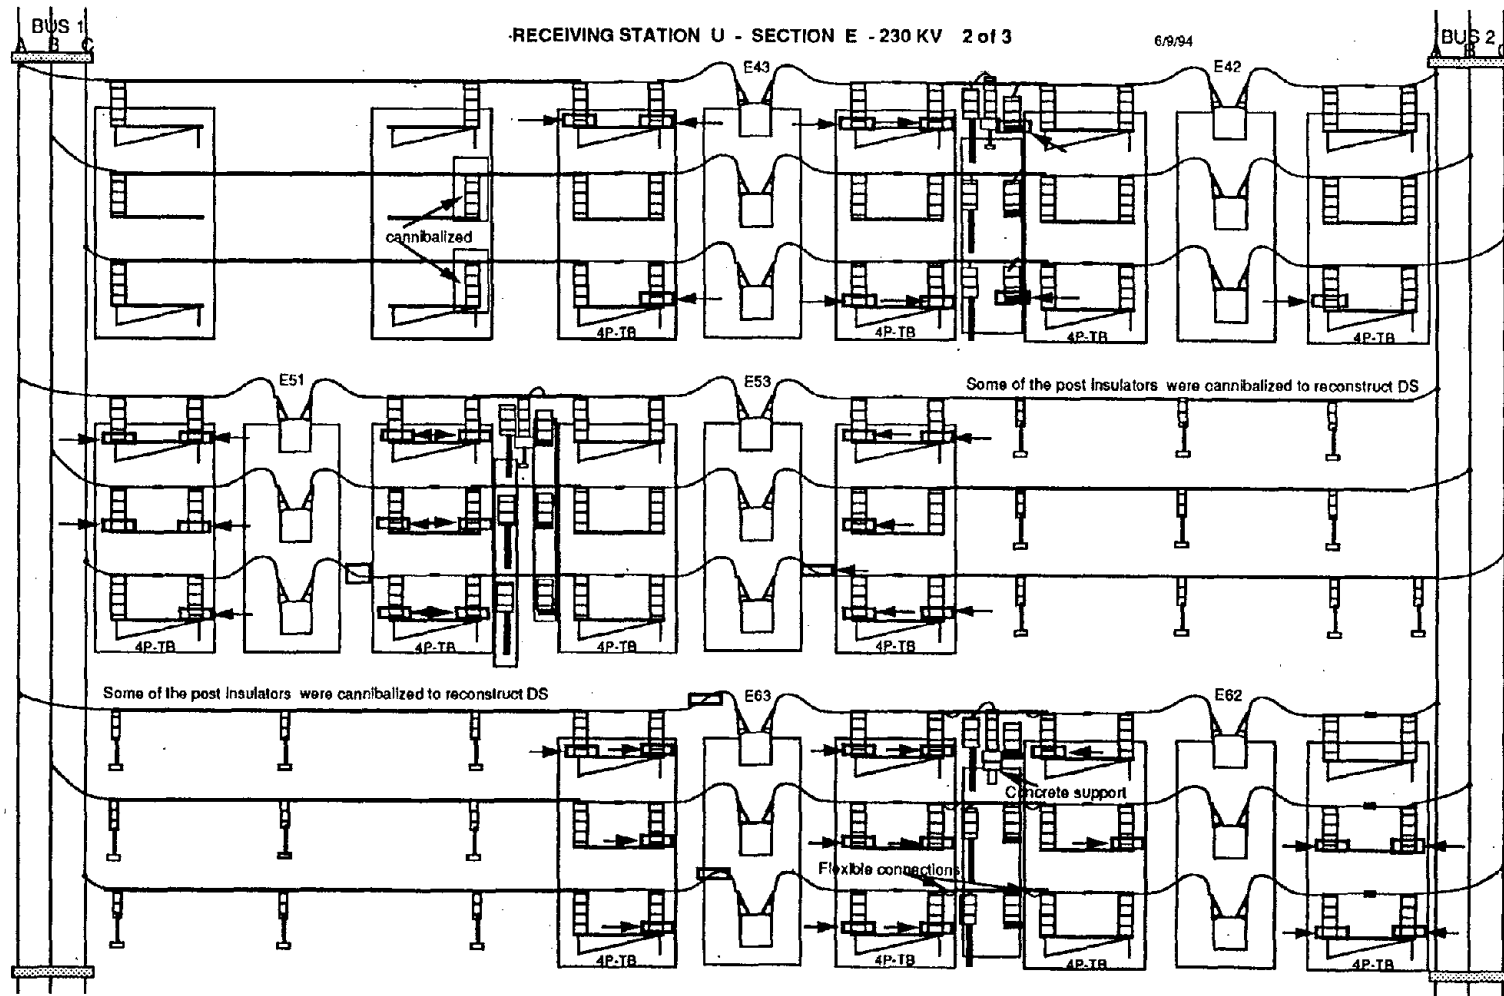
Fig.3.55 Schematic diagram showing damage to 230 kV switchyard at Receiving Station U - Part 2.

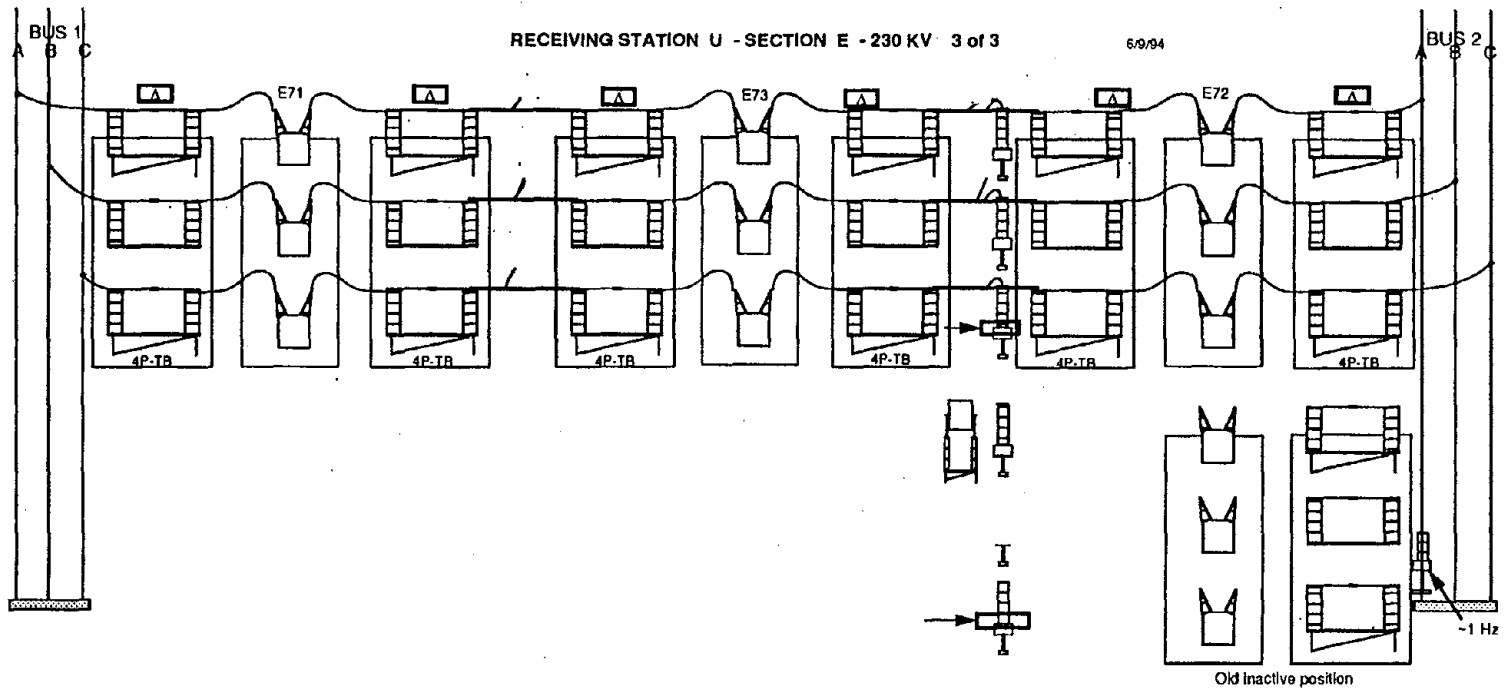
Fig.3.55 Schematic diagram showing damage to 230 kV switchyard at Receiving Station U - Part 3.

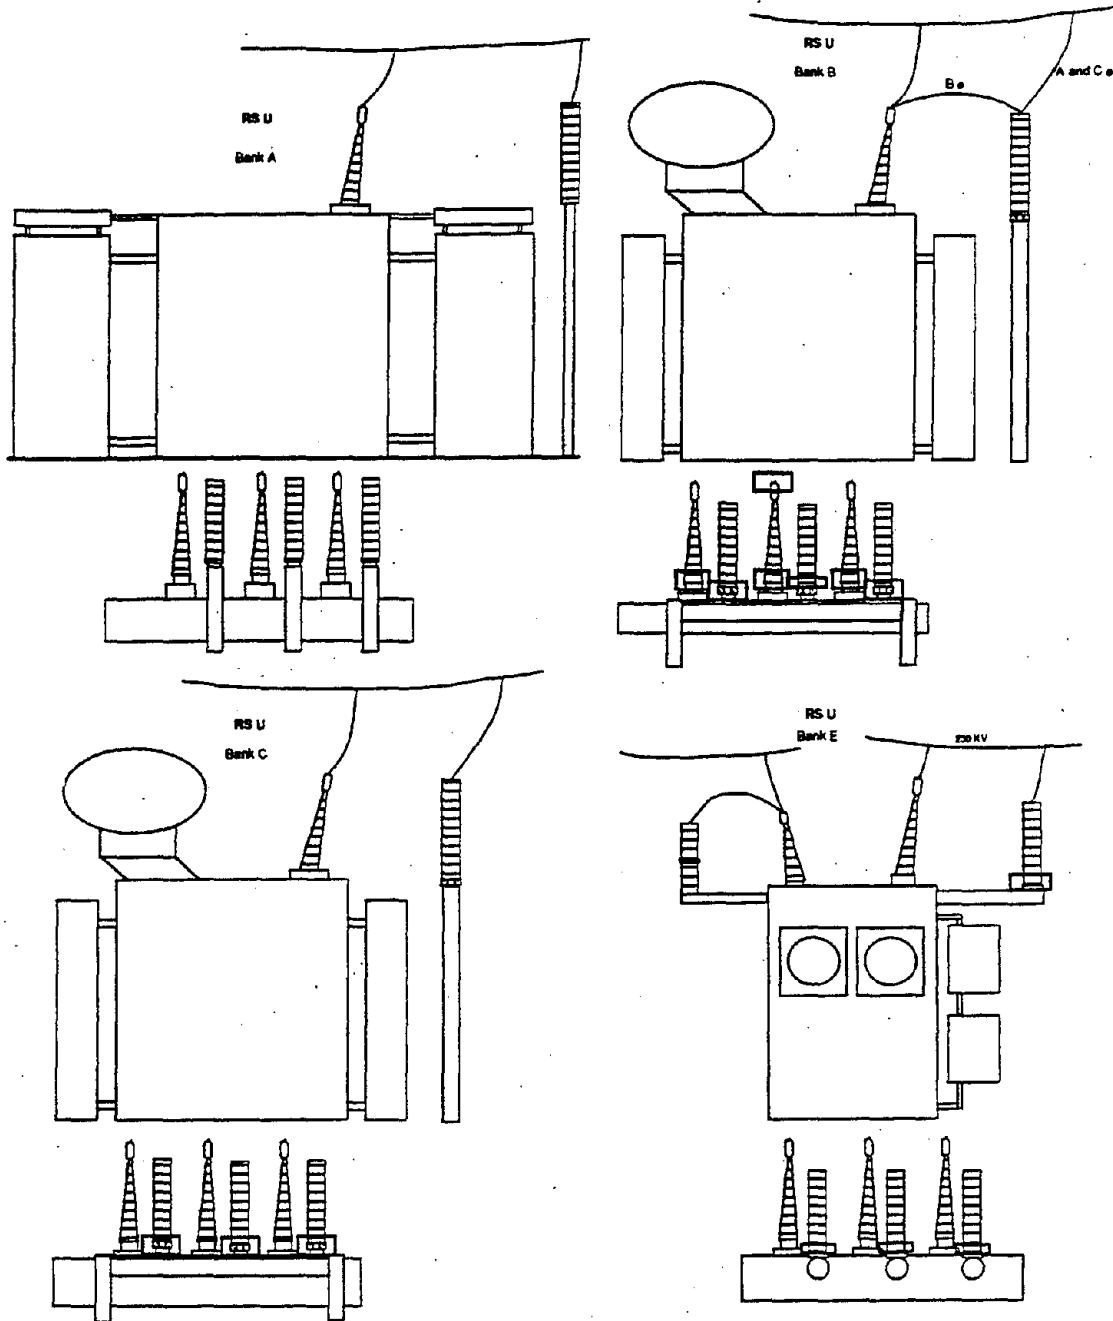
Fig.3.56 Schematic diagram showing damage to transformers at Receiving Station U.

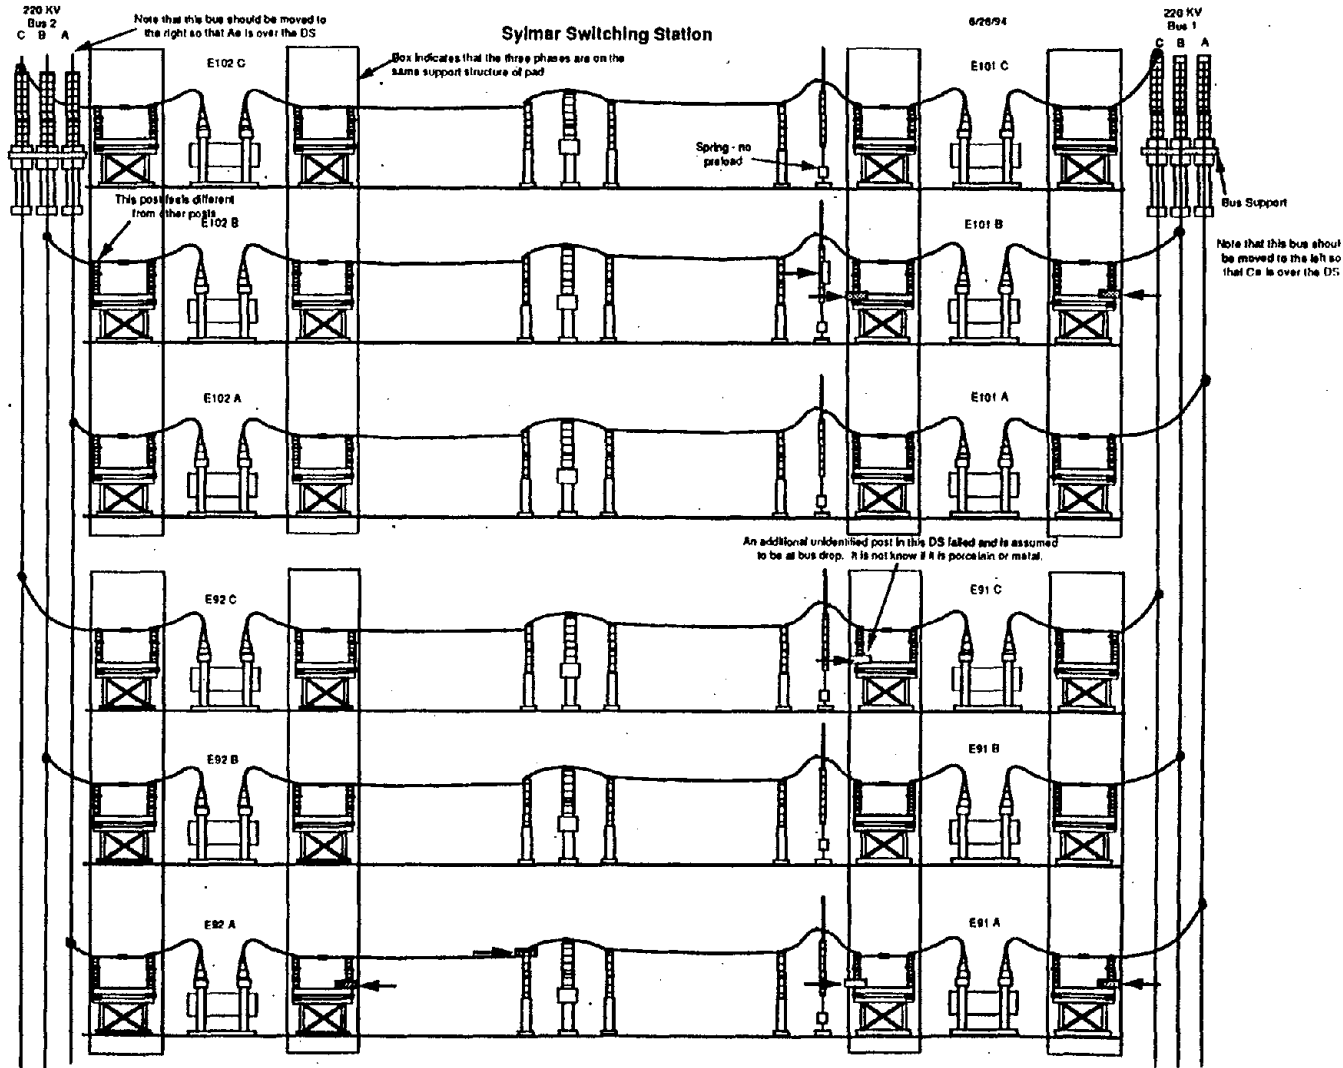
Sylmar Switching Station is a 230 kV switchyard with a breaker-and-a-half bus configuration. The welds at one end of one of the transformers failed, but operation was not effected. Figure 3.60 is a detailed schematic diagrams showing damage to the 230 kV switchyard. Table 3.6 shows a summary of equipment performance.

Fig.3.60 Schematic diagram showing damage to 230 kV switchyard at Sylmar Switching Station - Part 1.

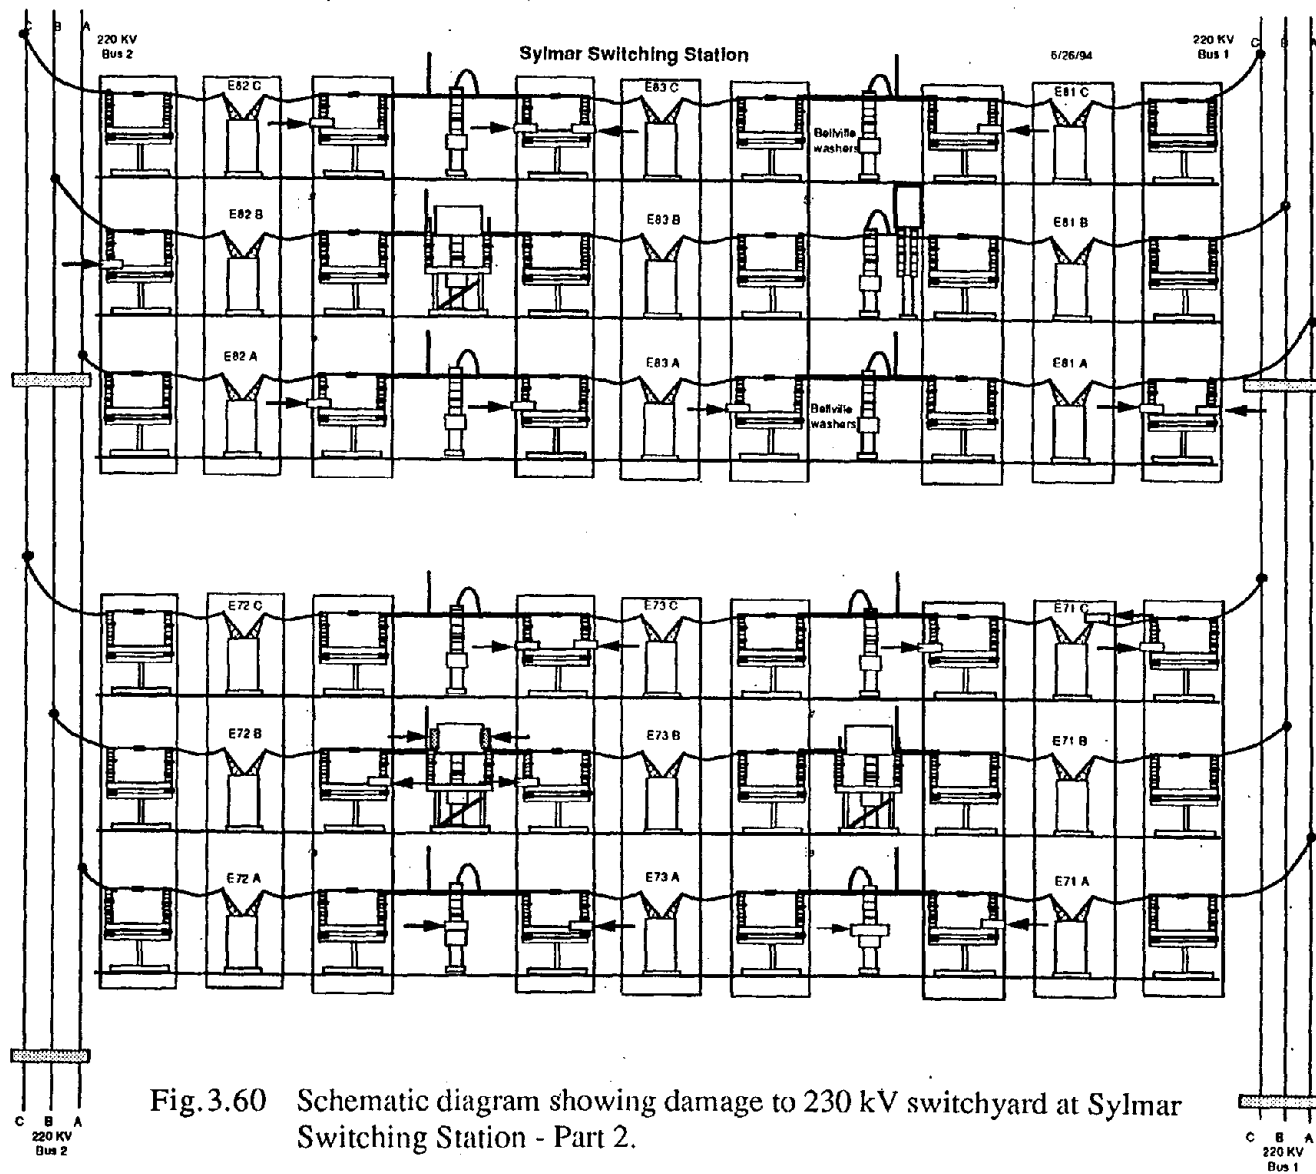
Fig. 3.60 Schematic diagram showing damage to 230 kV switchyard at Sylmar Switching Station - Part 2.

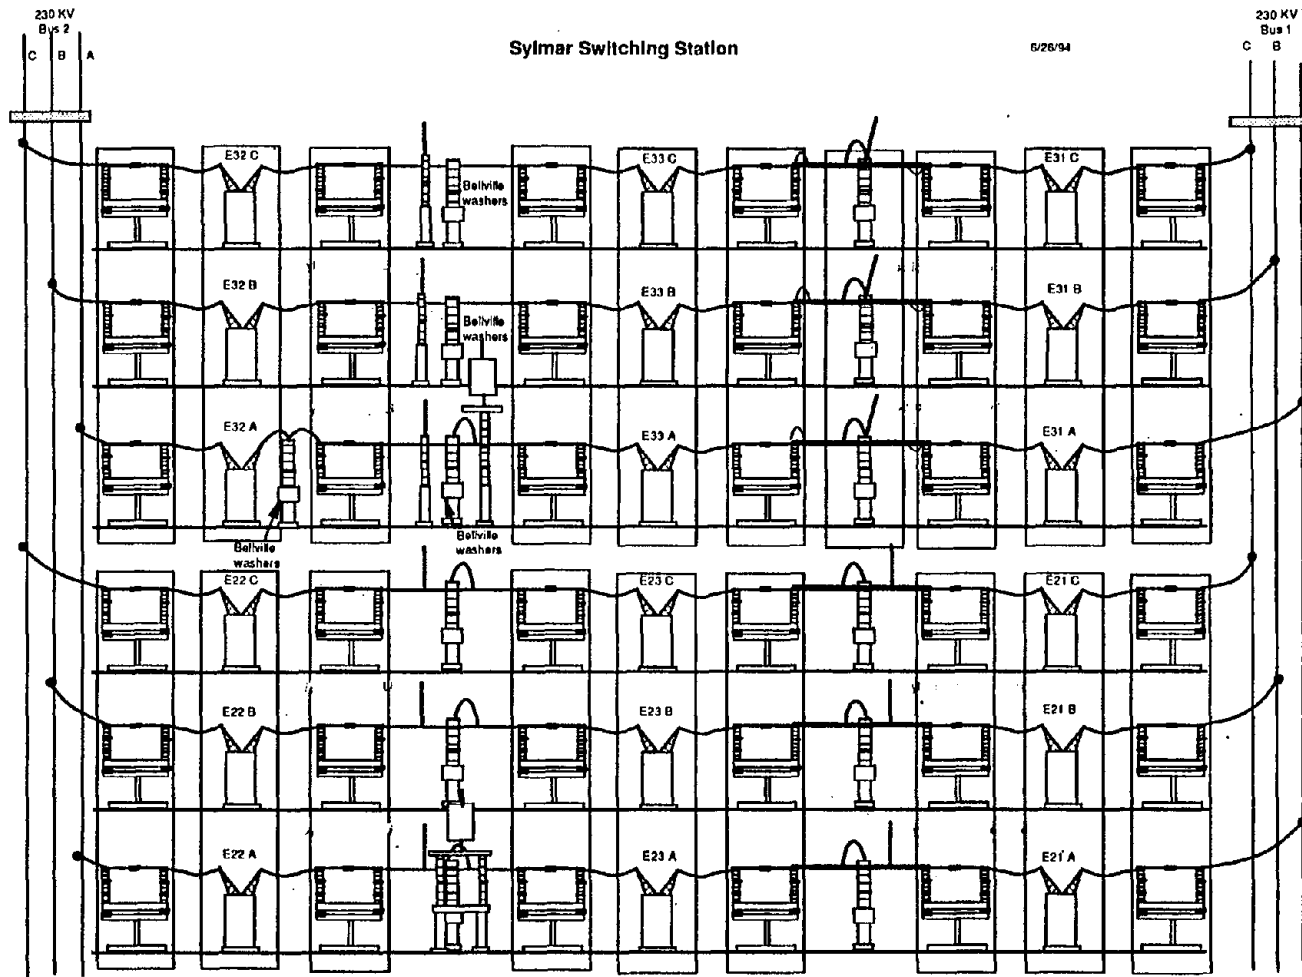
Fig. 3.60 Schematic diagram showing damage to 230 kV switchyard at Sylmar Switching Station - Part 3.

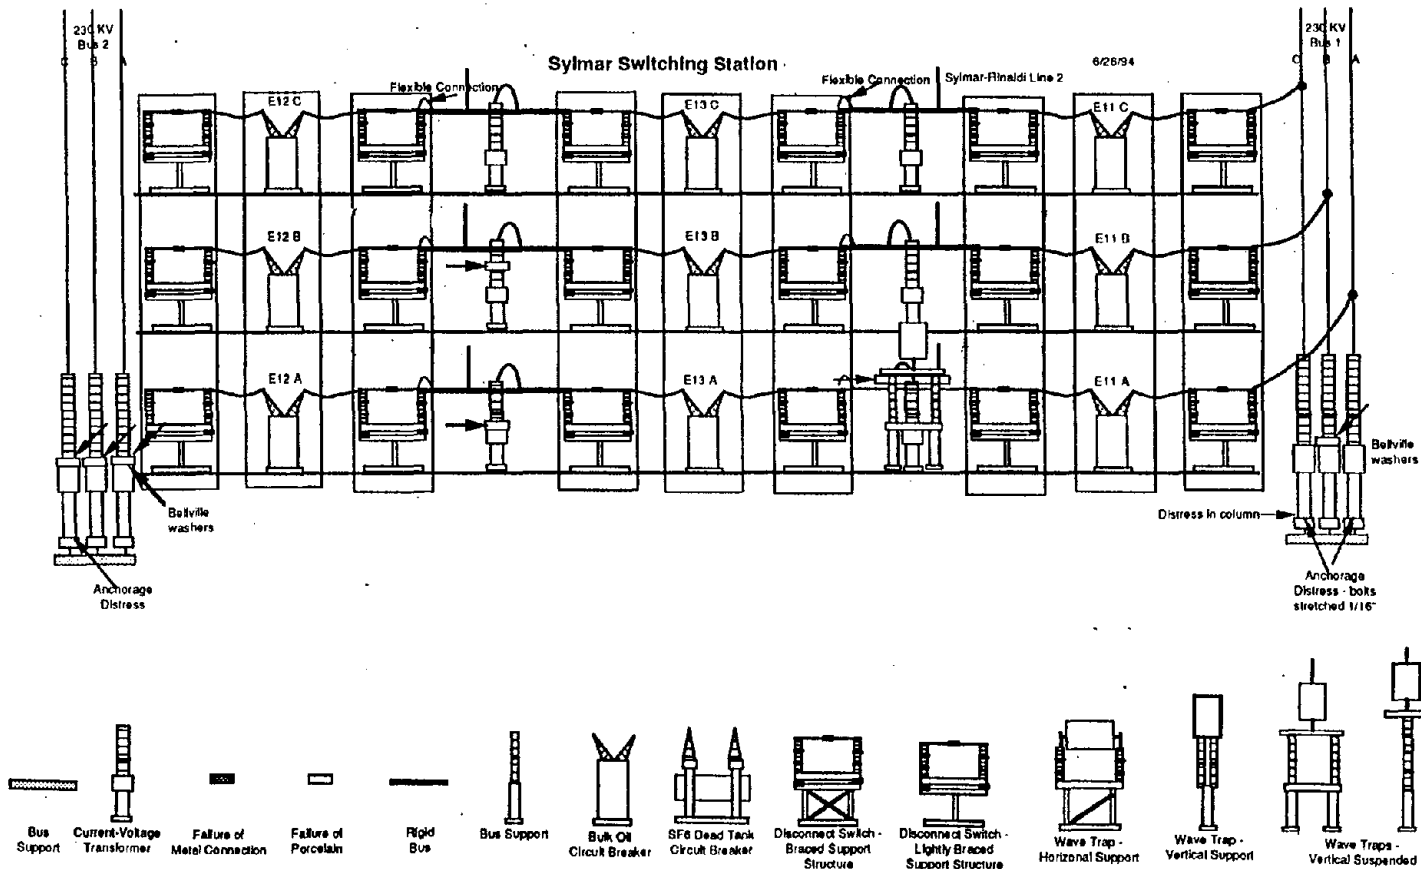
Fig. 3.60 Schematic diagram showing damage to 230 kV switchyard at Sylmar Switching Station - Part 4.

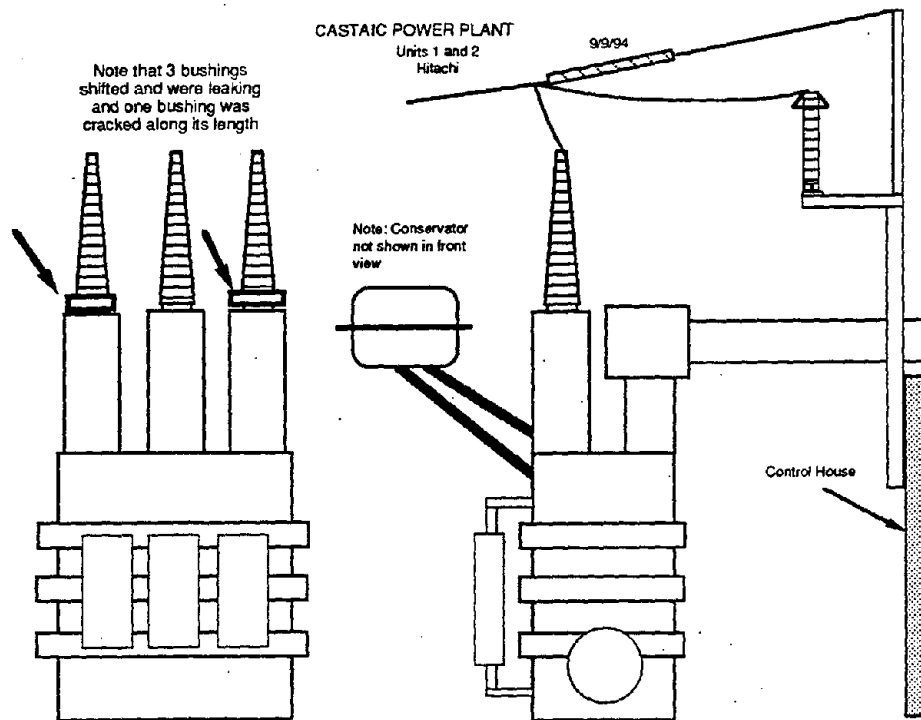
Fig. 3.62 Schematic diagram showing damage to 230 kV transformers at Castaic Generating Station.

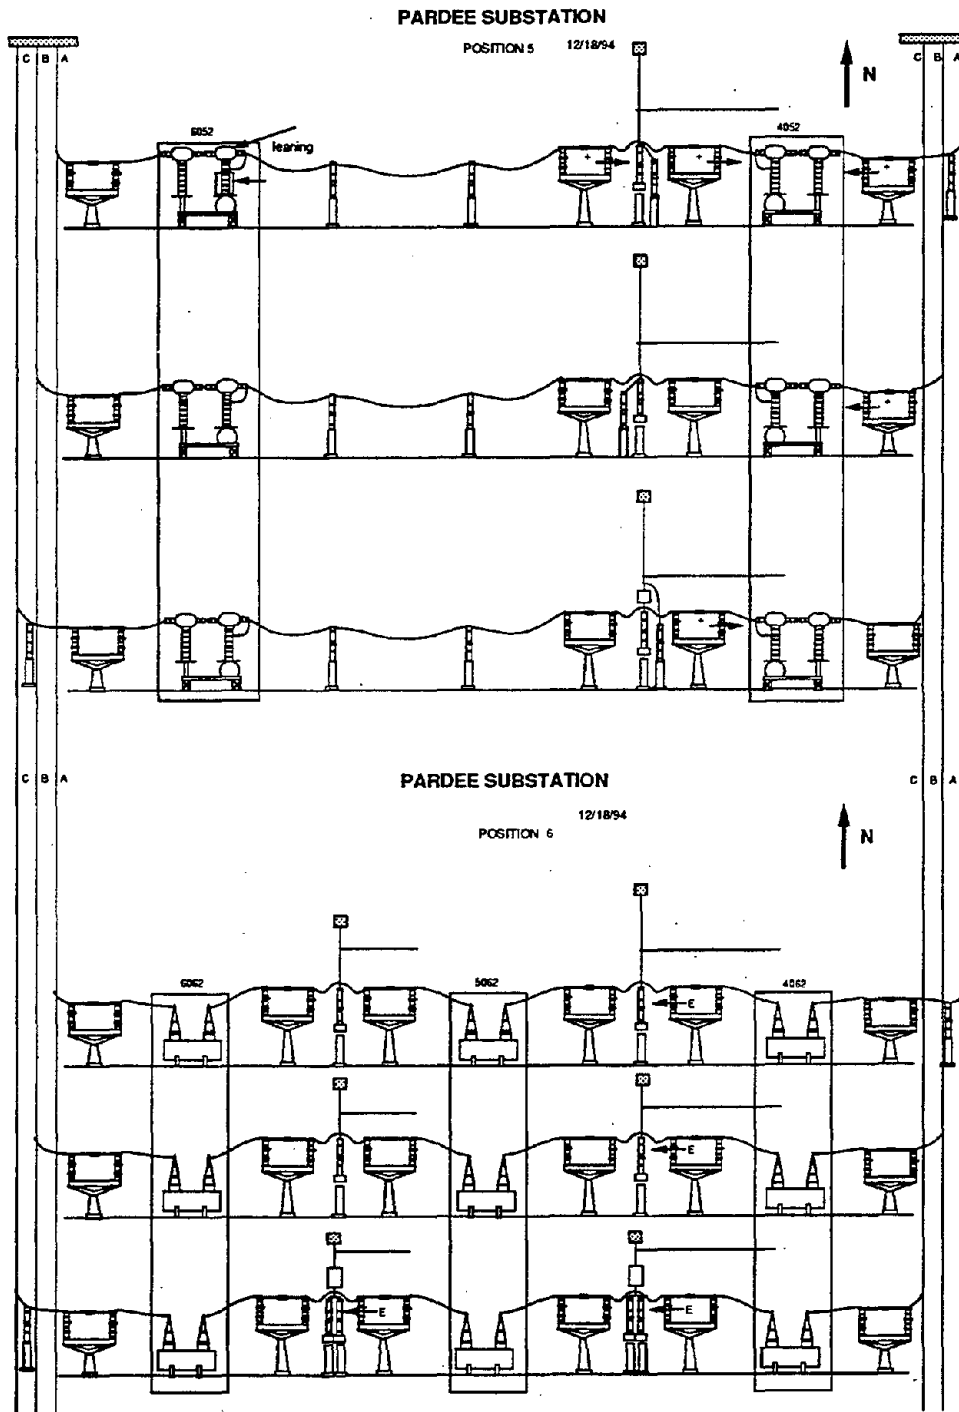
Pardee is a 230 kV switching station and has no transformers. There was a strong motion recording at the site with a peak acceleration of 0.56 g. Ground motion records and spectra for the main event are given in Fig. 3.63. The switchyard has a breaker-and-a-half bus configuration. All live-tank circuit breakers were damaged. Disconnect switches were damaged in an unusual way in that the plate that supported the post insulator stacks deformed so that the disconnect switches could not be closed. Dead-end structures were damaged. Figure 3.64 is a detailed schematic diagram showing damage to the 230 kV switchyard. Table 3.8 shows a summary of equipment performance.

Fig. 3.64 Schematic diagram showing damage to 230 kV switchyard at Pardee Substation - Part 1.

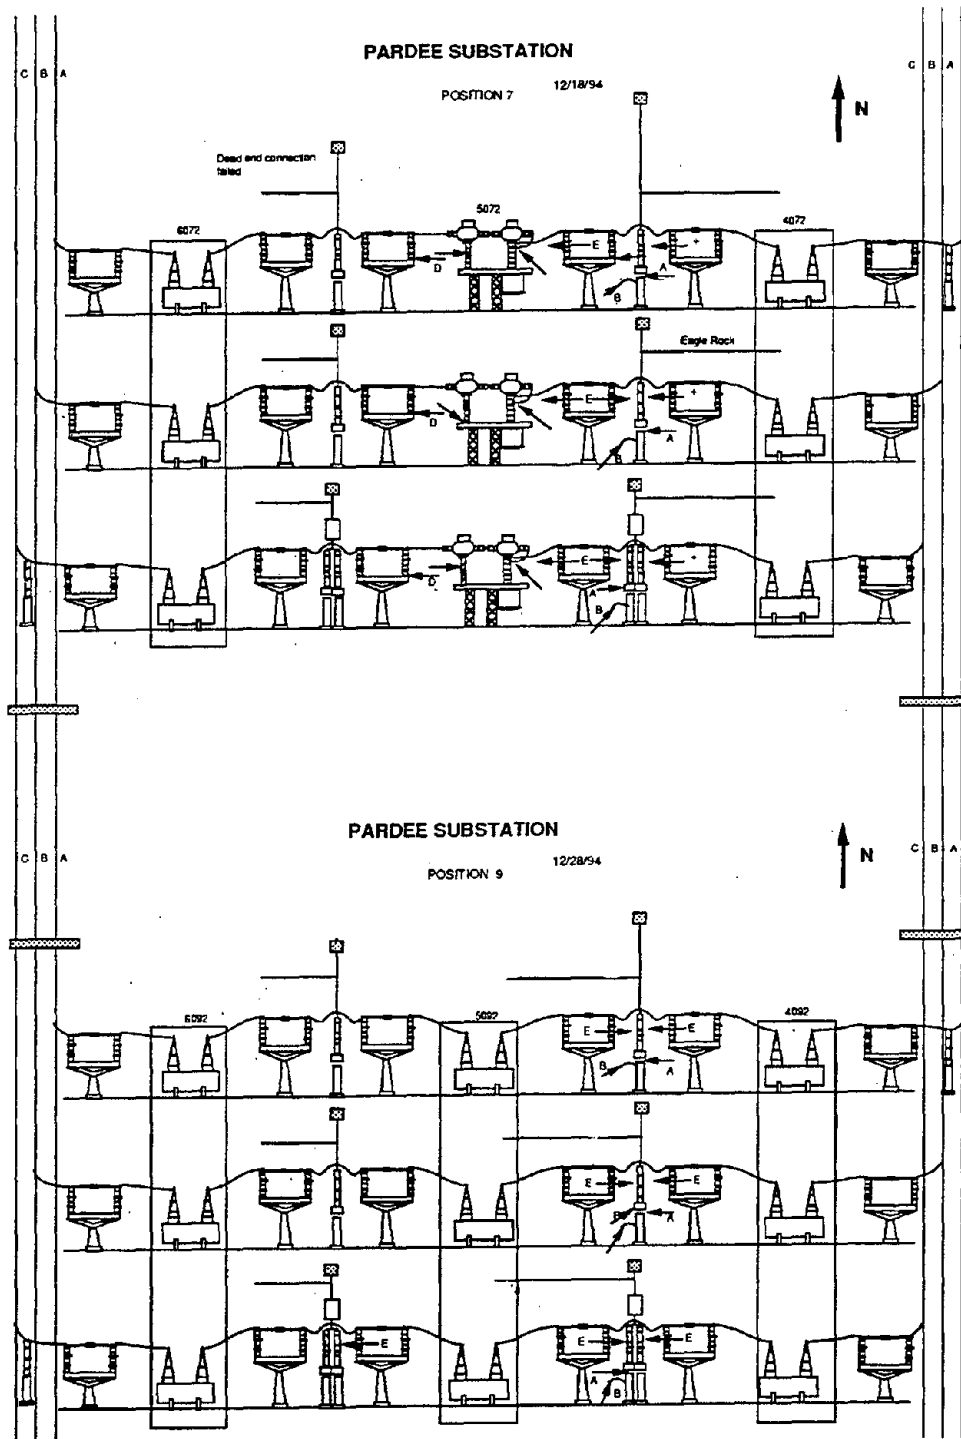
Fig. 3.64 Schematic diagram showing damage to 230 kV switchyard at Pardee Substation - Part 2.

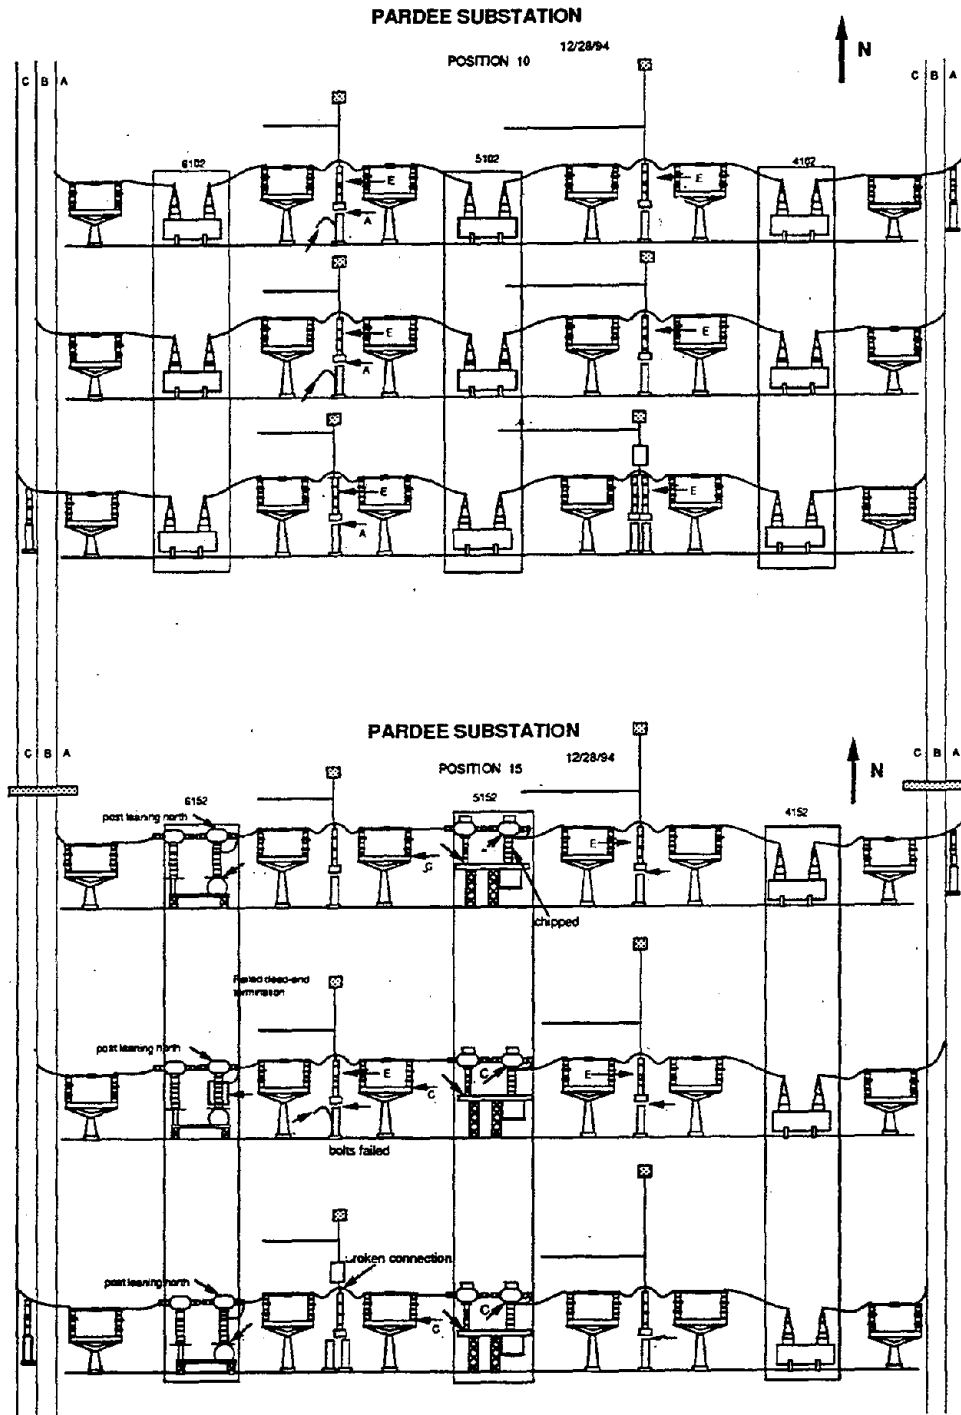
Fig. 3.64 Schematic diagram showing damage to 230 kV switchyard at Pardee Substation - Part 3.

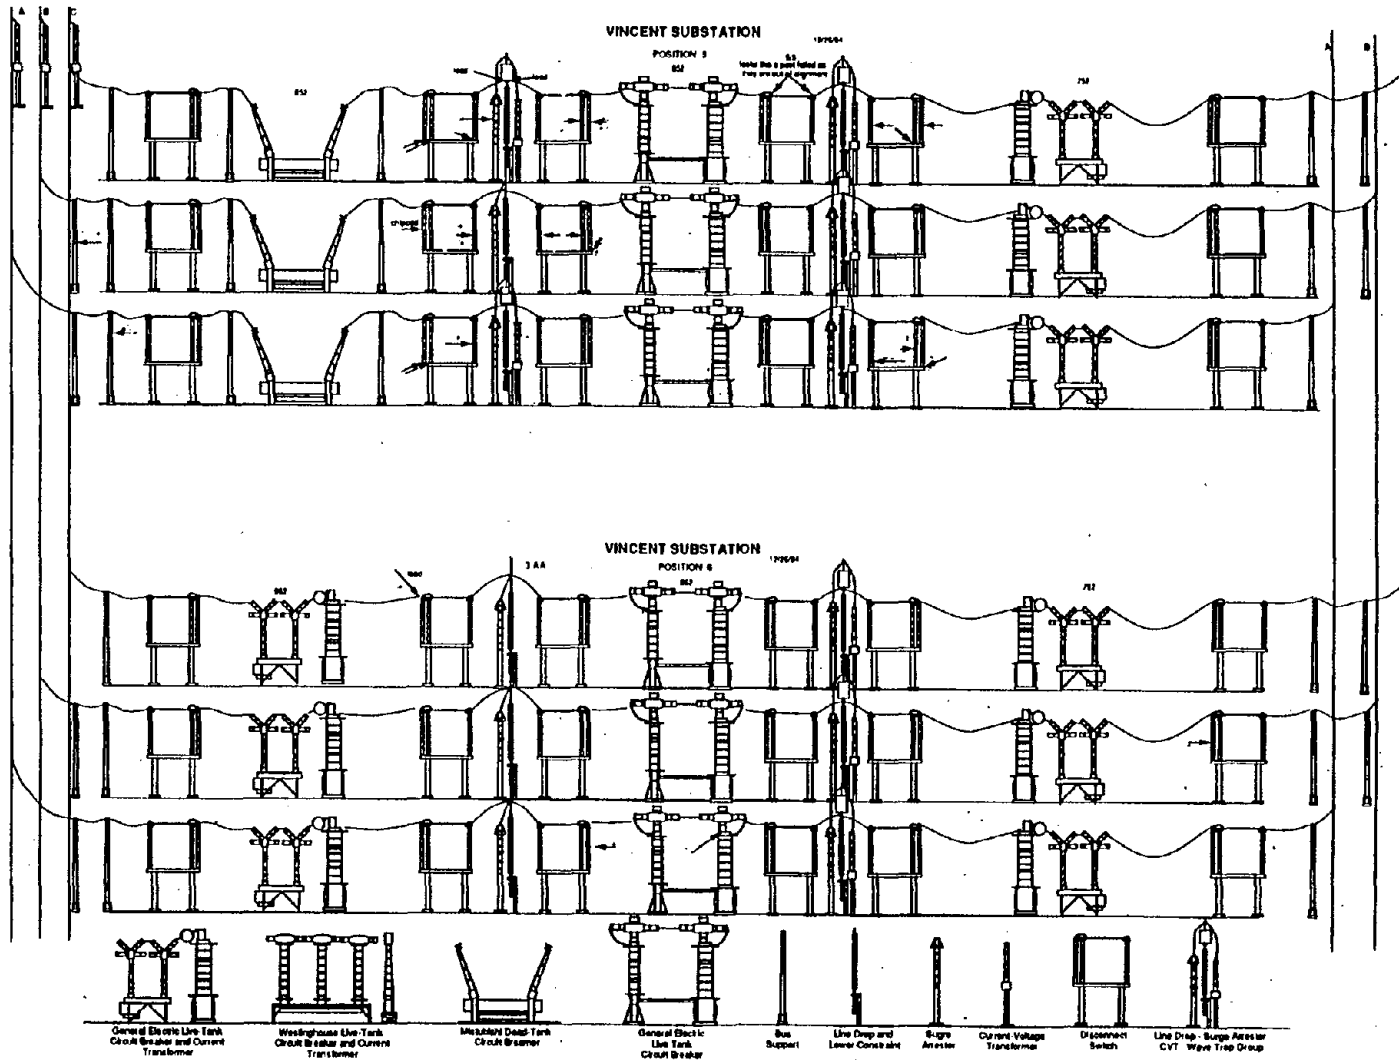
Vincent Substation is a 500 kV substation with a breaker-and-a-half bus configuration. Ground motion records and spectra for the main event are given in Fig. 3.65. There was damage to transformer radiators, anchorage, and lightning arresters, but a detailed analysis is not yet complete. Figure 3.66 is a detailed schematic diagram showing damage to the 230 kV switchyard. Table 3.9 shows a summary of equipment performance.

Fig. 3.66 Schematic diagram showing damage to 500 kV switchyard at Vincent Substation - Part 1.

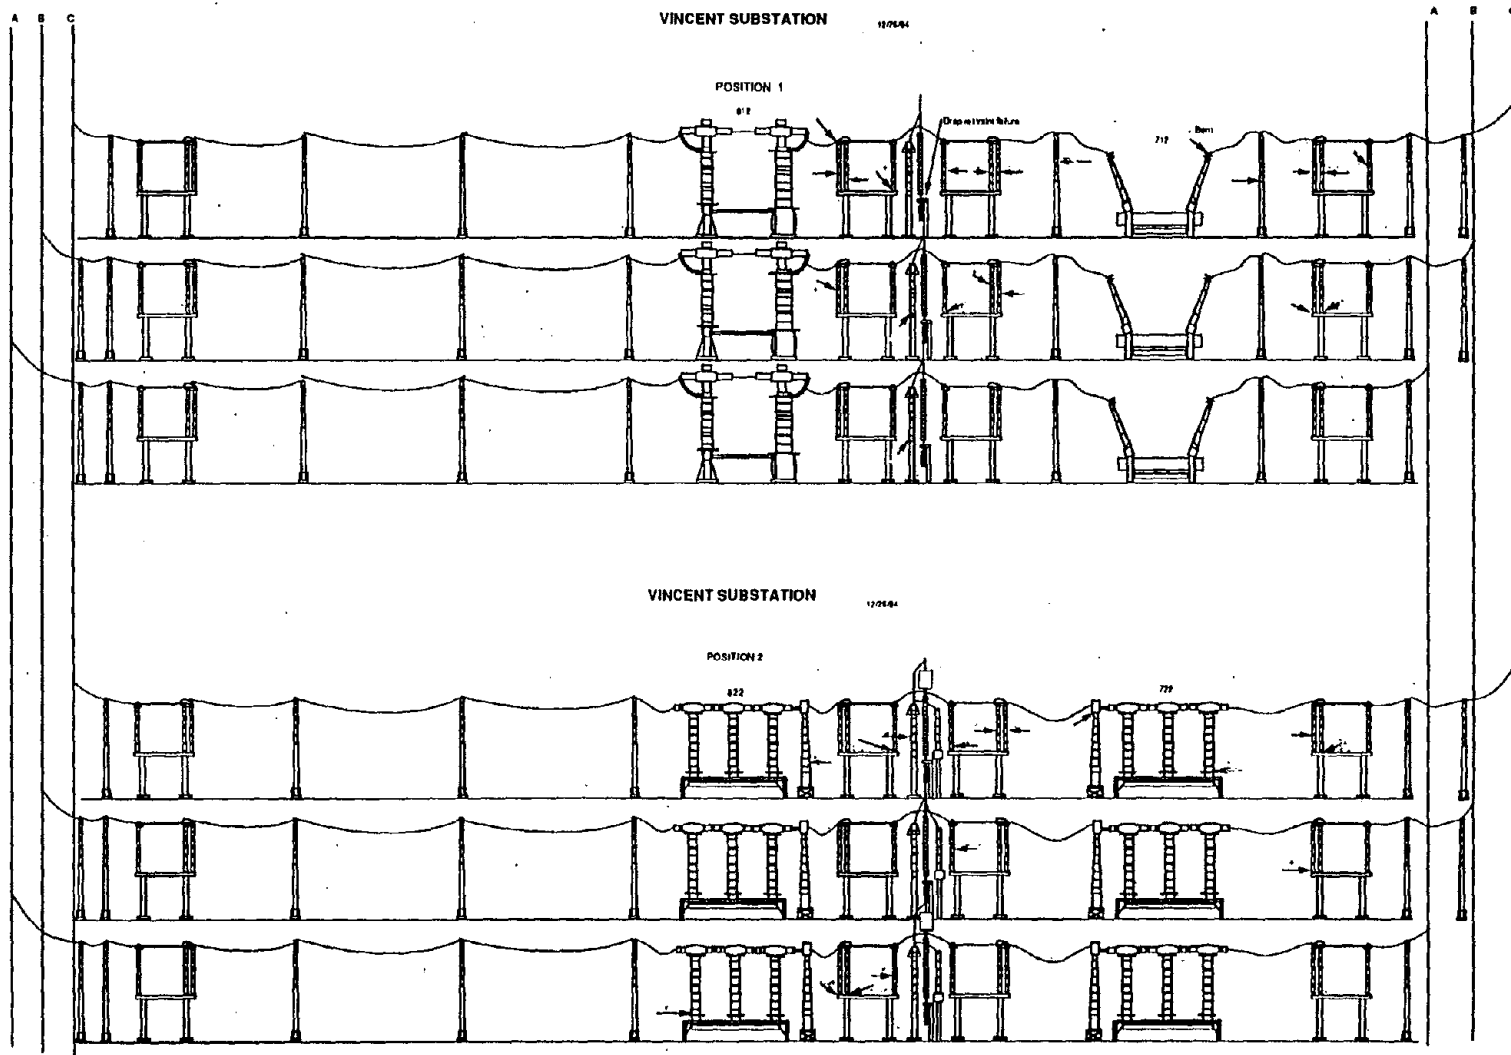
Fig.3.66 Schematic diagram showing damage to 500 kV switchyard at Vincent Substation - Part 2.

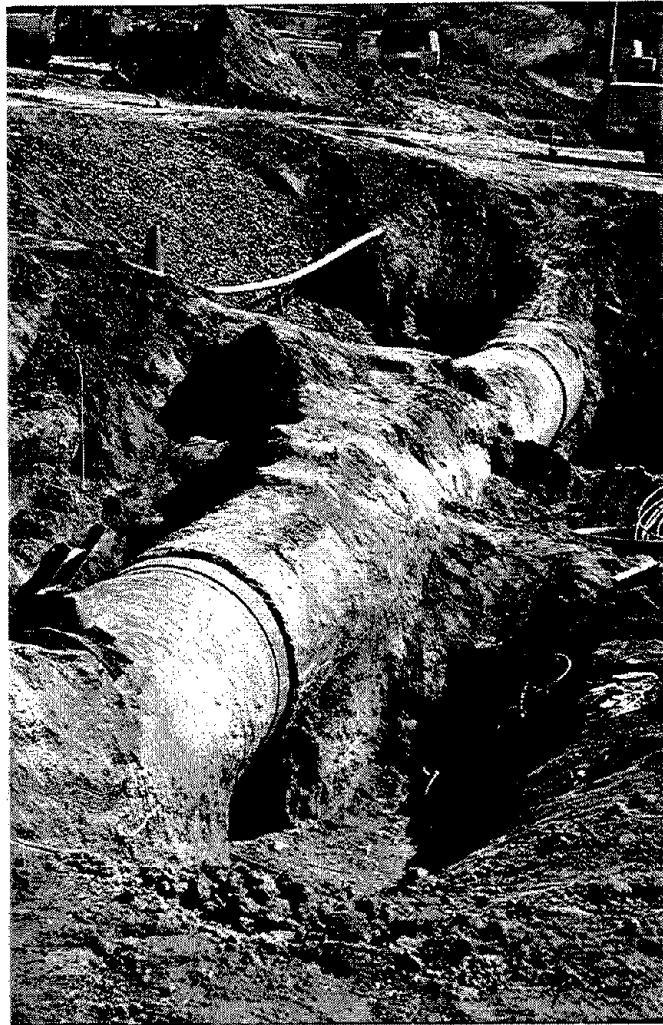
39-in. (990-mm) and 33-in (838-mm) modified prestressed concrete cylinder pipe (MPCCP). One repair occurred on the 54-in (1370-mm) MPCCP inlet pipe to the plant from Castaic Reservoir. Breaks occurred at welded fabricated compound (horizontal and vertical) bends and on long horizontal reaches where the rubber gasket joints pulled apart, Fig. 4.2.

Fig. 4.2 Excavating pulled joints and repair of 54-inch MPCCP with rubber gasket joints near Rye Canyon.

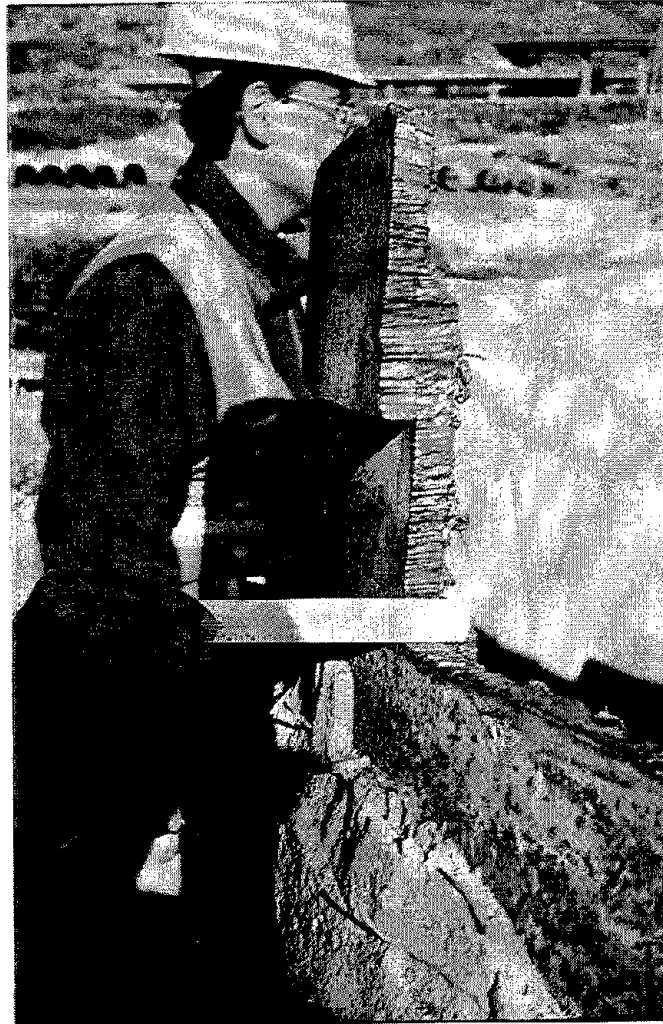
The State Water Project-West Branch supplies the Jensen Water Treatment Plant from the Castaic Reservoir via the Foothill Feeder (Newhall and Balboa Tunnels). At the south portal of the Balboa Tunnel the 170-in (4320-mm) tunnel line branches into two-85-in (2160-mm) by 13/16-in (20-mm) welded steel pipes (WSP) at the inlet to the treatment plant. The west pipe performed satisfactorily; however, the east pipe circumferentially cracked on the curved portion of a long bell, Fig. 4.4. The pipe was joined by an inside welded bell and spigot joint. The northerly part of the round crack moved horizontally about 3-in (76-mm) east with respect to the southerly part. Vertical movement was about 1/2-in (38-mm).

Fig. 4.4 Jensen influent 85-inch welded bell and spigot joint. Cut out cross section of circumferentially cracked, at the curved section of the bell.

An approximately 10-feet (3.0-meters) of the damaged pipe was removed and replaced by two-5-ft (1.5-m) lengths of pipe fabricated at the MWD yard. The closure was made by three welded butt straps joints and completed the evening of January 19th, Fig. 4.5. The MWD East Valley Feeder and pumping plant was activated to provide supply from the Colorado River Aqueduct/State Water Project - East Branch to the areas in western Los Angeles County and eastern Ventura Counties, affected by this outage.

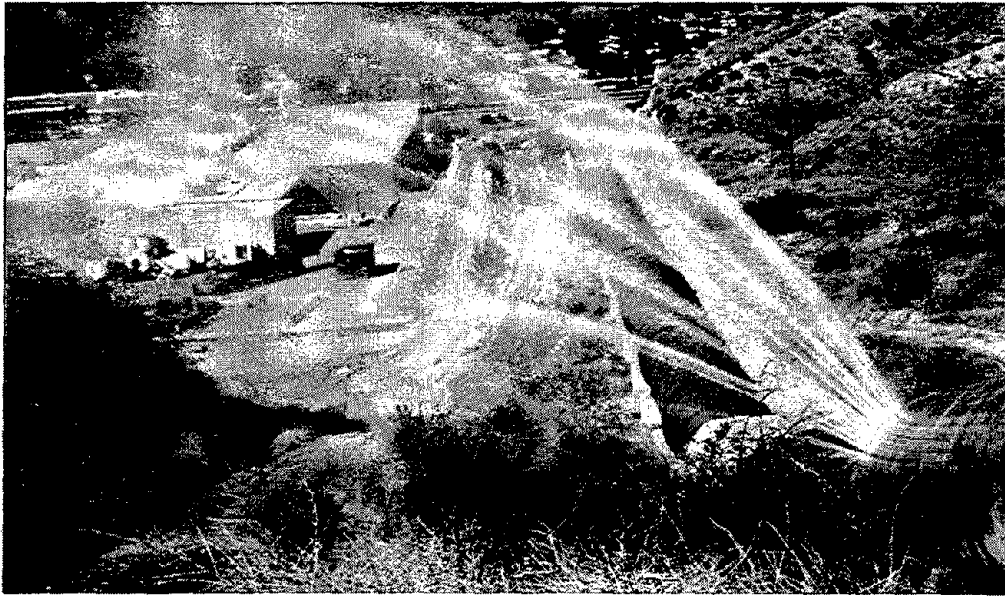
At the south end of Aqueduct No. 1 Soledad (inverted) Siphon at two locations occurred the partial cracking of the curved portion of the bell of an 120-in (3050-mm) by 3/8-in (10-mm) welded steel pipe, Fig. 4.6. The pipe was welded on the outside of a bell and spigot joint and was above ground and supported by concrete saddles, Fig. 4.7. The circumferential cracks were about 5-ft (1.5-m) long on the top of the pipe. The repair was made by removing a coupon of the damaged joints and replacing it with a welded steel plates, Fig. 4.8. At Quigley (inverted) Siphon there was split in the top of the 120-in (3050-mm) riveted steel pipe which was welded shut.

Fig. 4.6 Soledad Siphon 120-inch WSP leak. (LADWP)

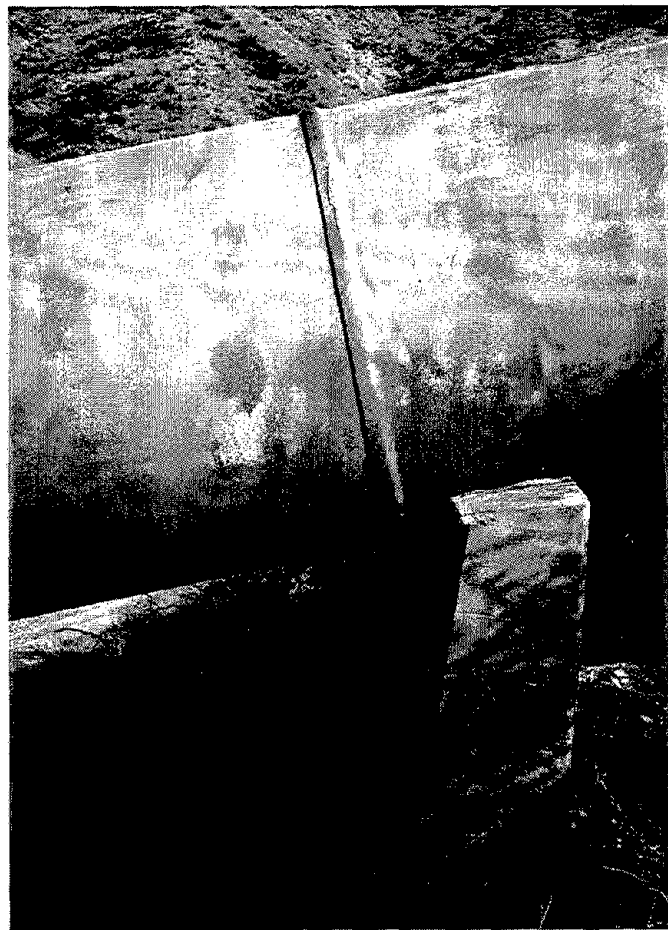
Fig. 4.7 Soledad Siphon 120-inch WSP, with split bell, supported by concrete saddles.
