**NORTHRIDGE EARTHQUAKE: LIFELINE
PERFORMANCE AND POST-EARTHQUAKE
RESPONSE**

Date: Apr 97

Authors: A. J. Schiff.

Performing Organization: American Society of Civil Engineers, New York. Technical Council on Lifeline Earthquake Engineering.

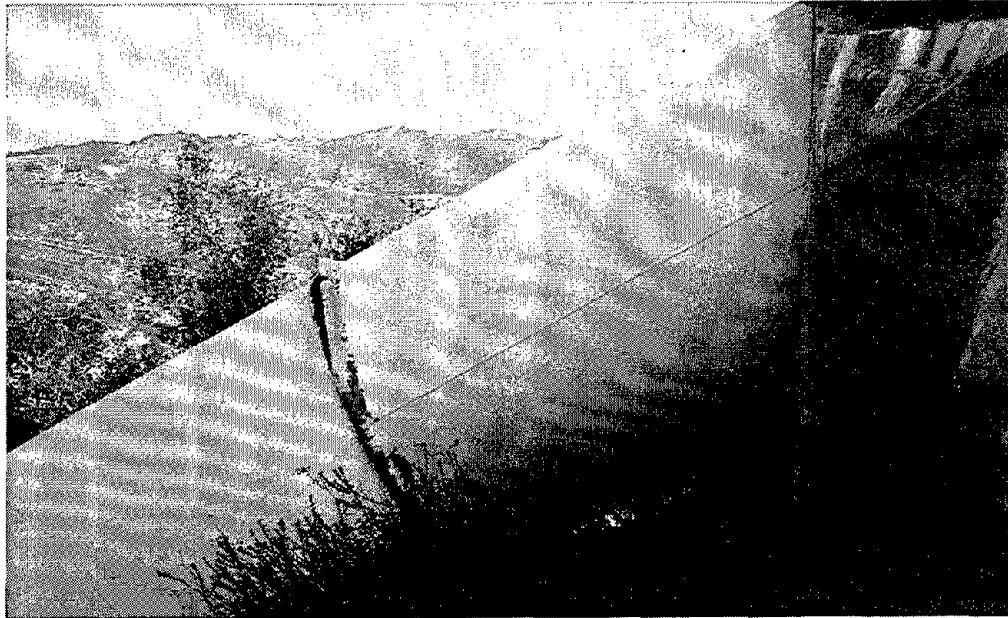
Two 6-in (130-mm) compression bulges appeared on the north slope of Terminal Hill in the 77 in (1955 mm) pipe in above ground pipe supported on concrete saddles, Fig. 4.14. This represented almost 2-feet (0.6-m) of compression in the pipeline. At these bulges there were no leaks although significant movement occurred, Fig. 4.15. At Quigley Canyon a circumferential tear in the top of the buried 77-in (1955-mm) welded steel pipe was repaired by welding a interior patch plate.

Fig. 4.14 North slope of Terminal Hill 77-inch WSP supported on concrete saddles.

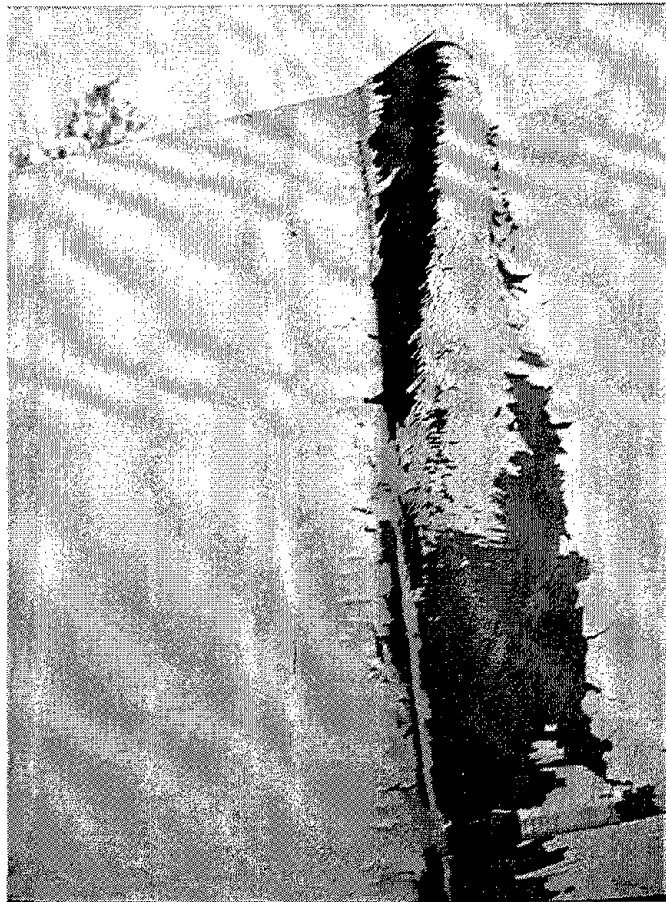
Fig. 4.15 Compression bulge on 77-inch pipe at welded bell and spigot joint. Pipeline continued in service and did not leak.

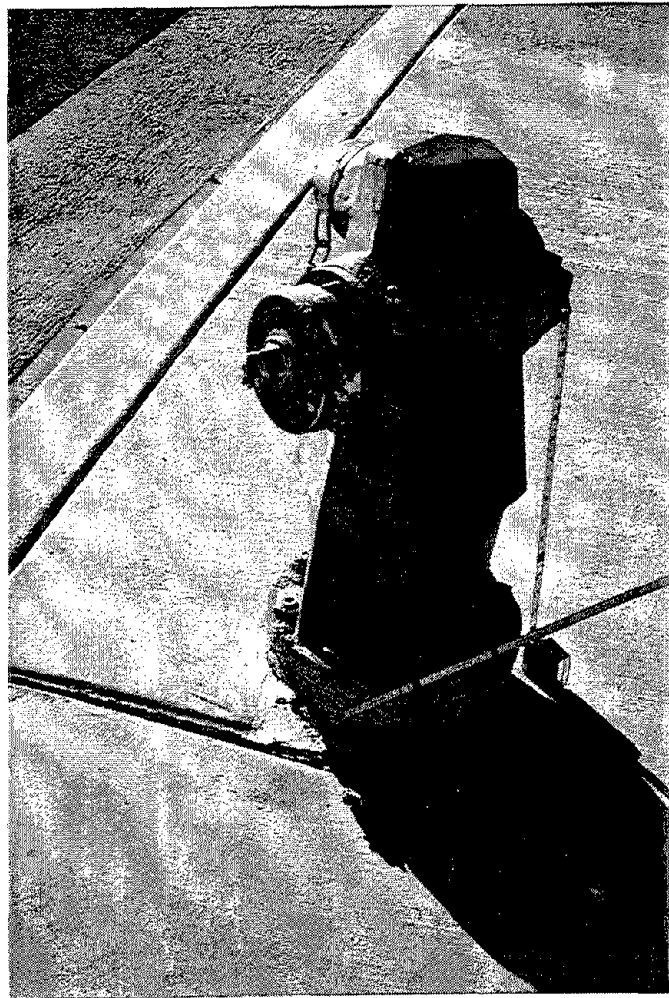
Fig. 4.16 Typical broken fire hydrant.

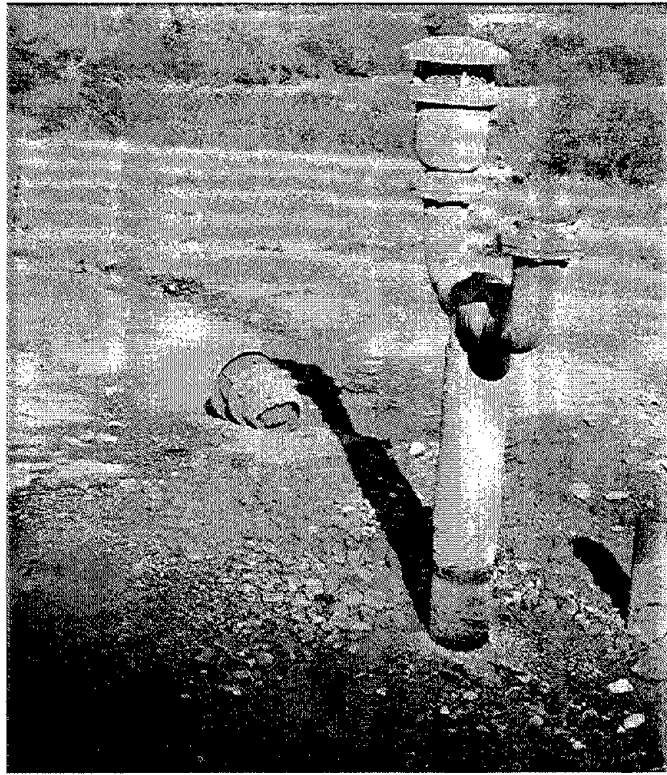
Fig. 4.17 Typical damaged to air and vacuum valves installation.

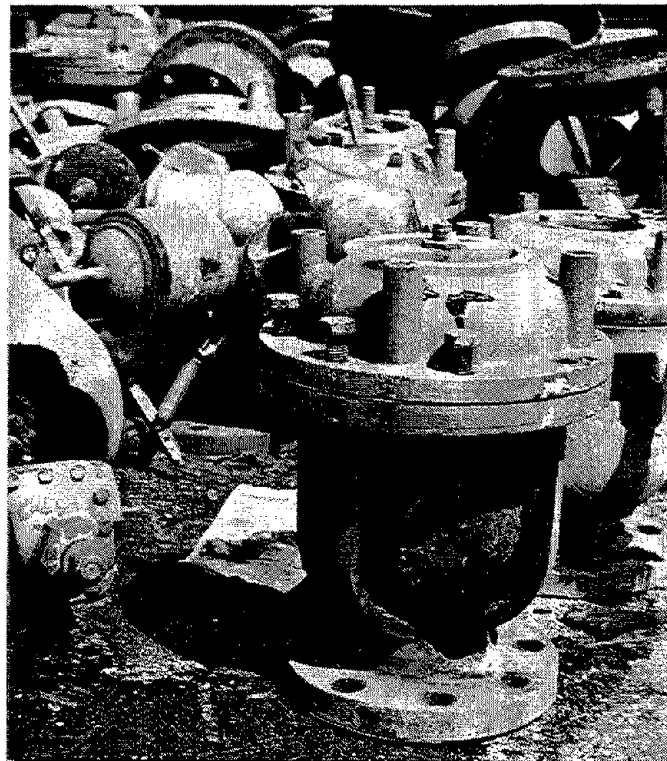
Fig. 4.18 Broken air and vacuum valves.

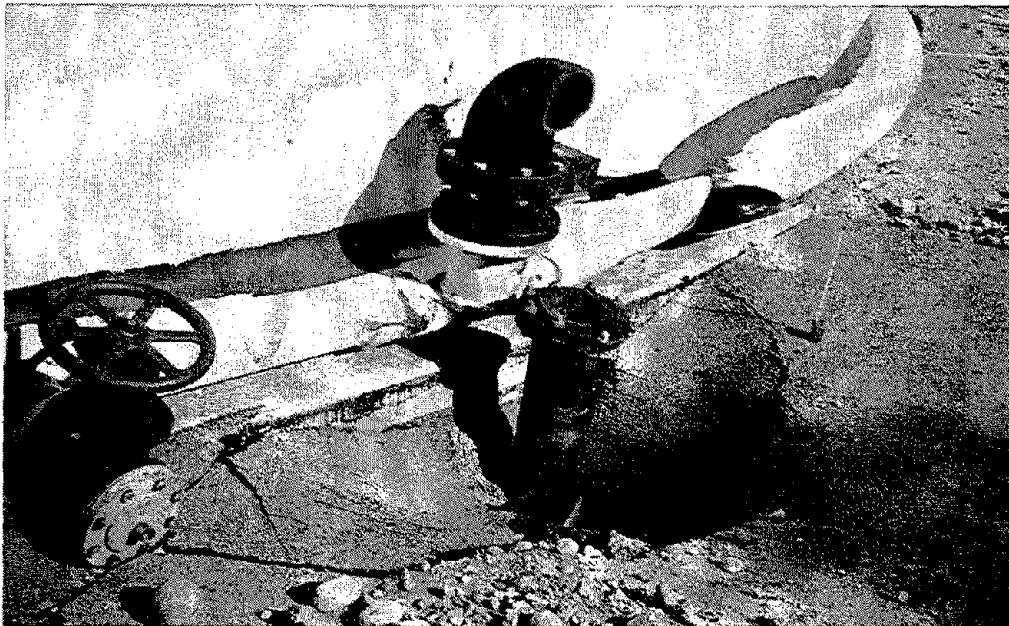
Fig. 4.21 Damaged 0.85 mg welded steel tank in Newhall area. Cast iron fittings failed and tank wall is torn across elephant foot buckle. Anchor straps are coned by the elephant foot buckle.

due to the use of cast iron fittings and inadequate flexibility to accommodate the movement of the tank, which was typically lifting rather than sliding. The roofs and upper parts of side walls on several tanks were damaged due to sloshing. Several examples of elephant foot buckling were observed.

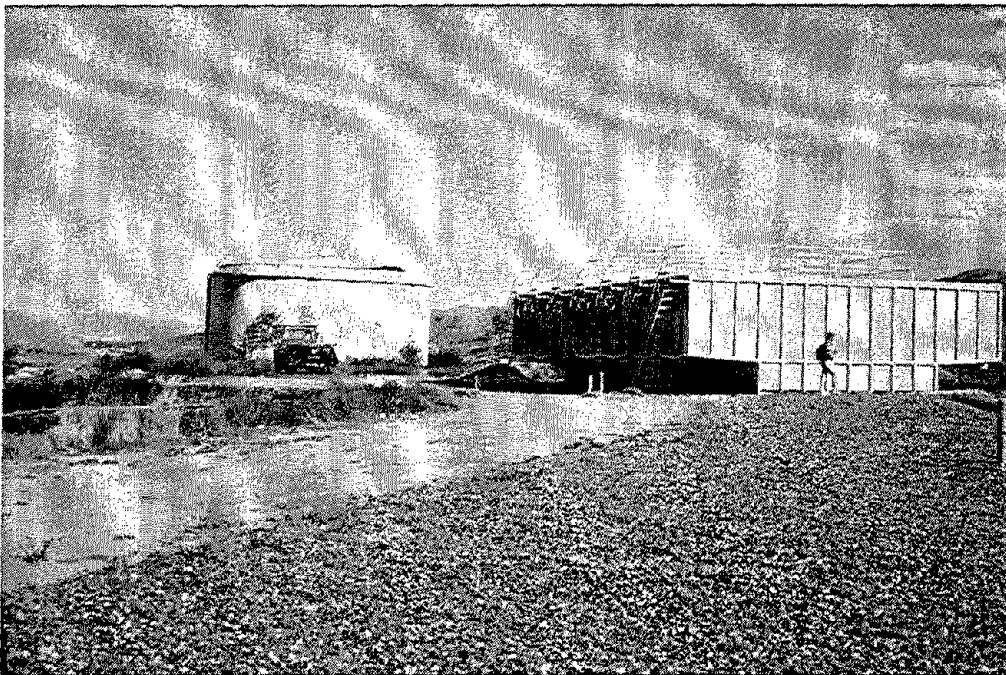
Fig. 4.23 Roof and upper part of walls are damaged of tank shown in Fig. 4.21. Temporary portable tank can be seen at left.

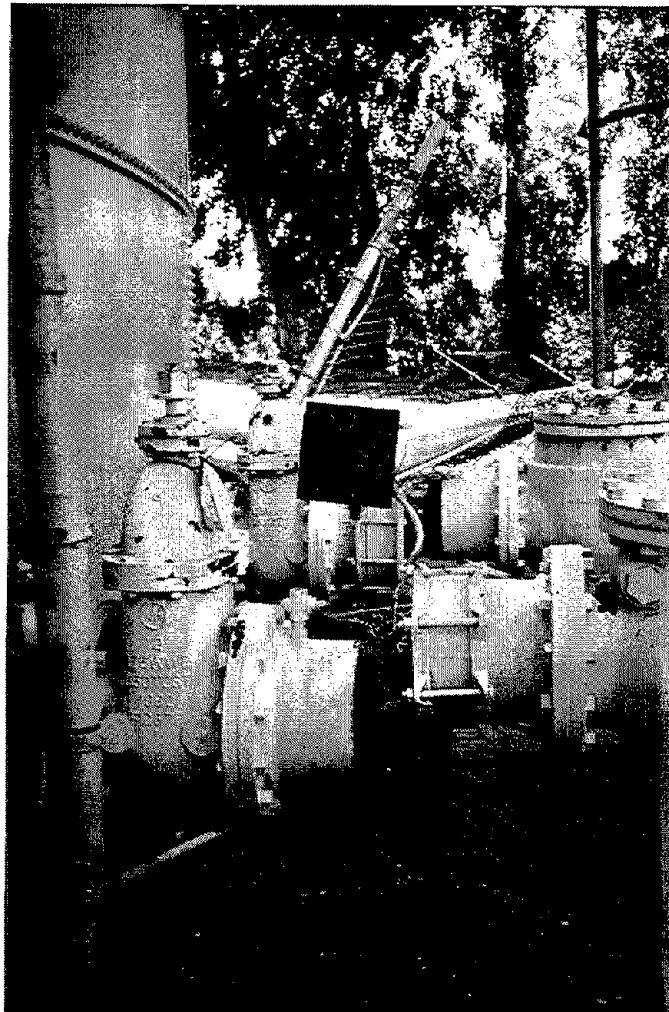
Tanks in the San Fernando Valley which had significant damage were in the Santa Monica Mountains south of Northridge. Inlet-outlet piping and valve damage, Fig. 4.24, erosion, Fig. 4.25 and roof problems, Fig. 4.26, were again the major causes of functional failure. All of these tanks have been repaired and returned to service. A damaged 1929 riveted steel tank in the Granada hills area has been removed.

Fig. 4.24 Dresser coupling failed at the tank inlet and outlet. (A. Gibson)

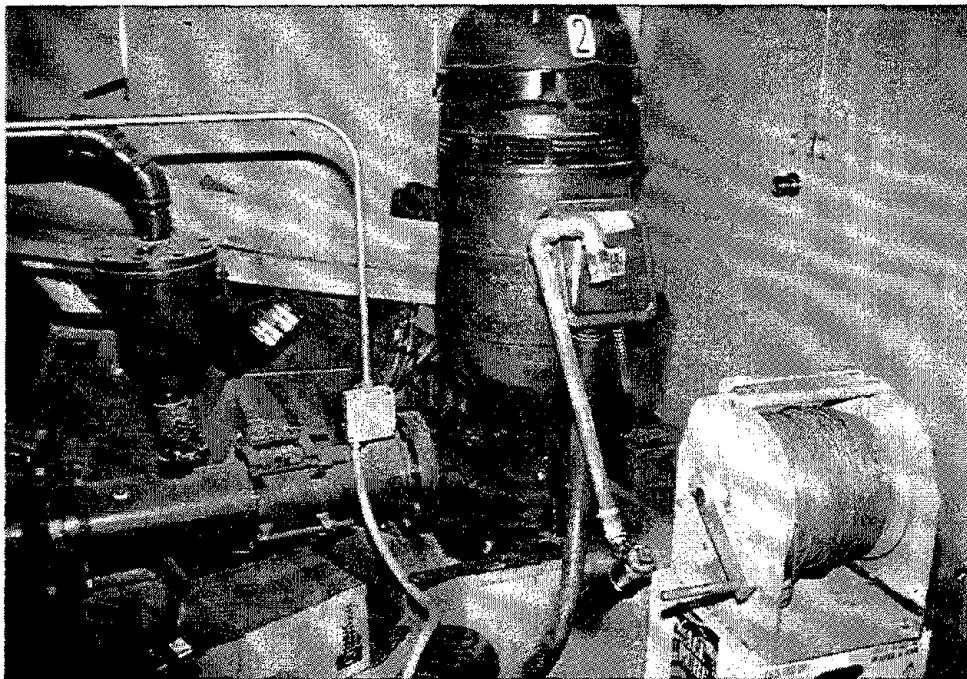
There was no reported damage to booster pumping facilities or groundwater wells, other than loss of commercial power, Fig. 4.27. Many wells did not have emergency power. Pumping stations with emergency power supply worked well. There was minor damage to the enclosures housing these facilities. The lack of damage to wells was important alternative supply to areas who lost their imported supplies.

Fig. 4.27 This typical well pump installation had no damage.

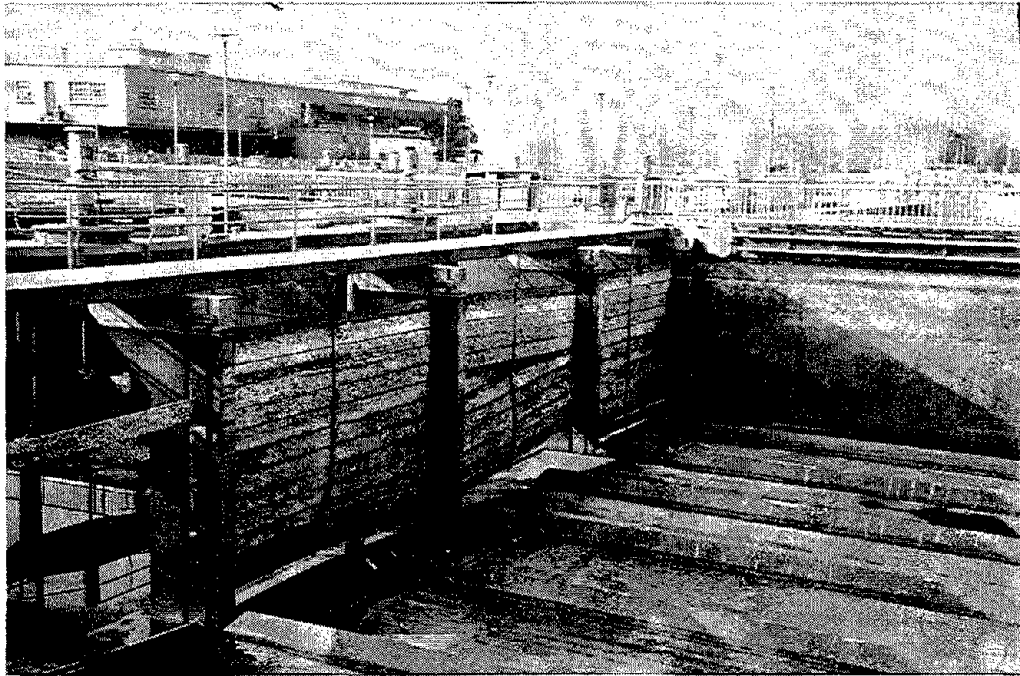
Fig. 4.31 Floating wood baffles dislodged by sloshing at water treatment plant. (MWD)

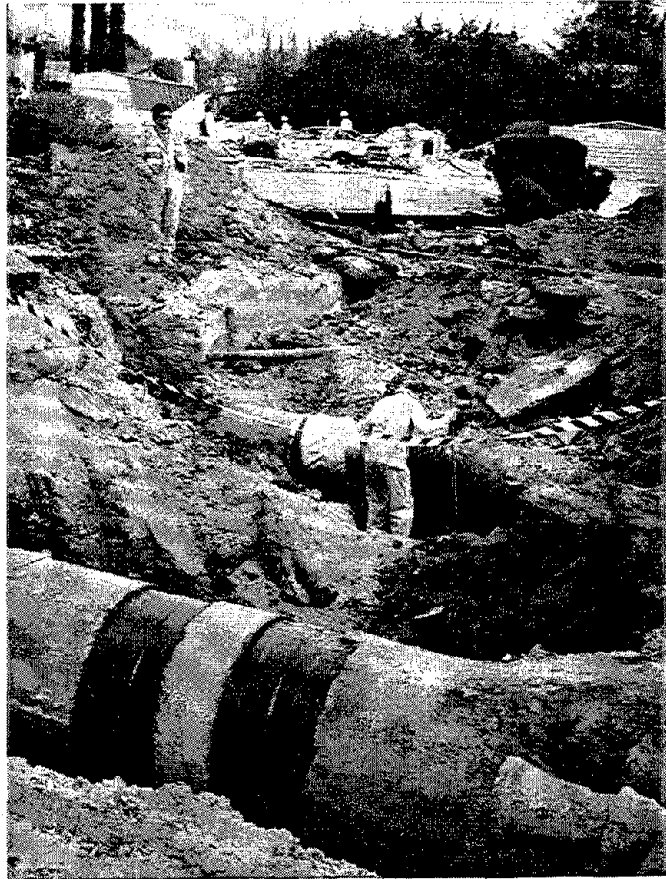
Fig. 4.33 Damaged pipes under Balboa Blvd. south of Lorillard St. in tension zone.

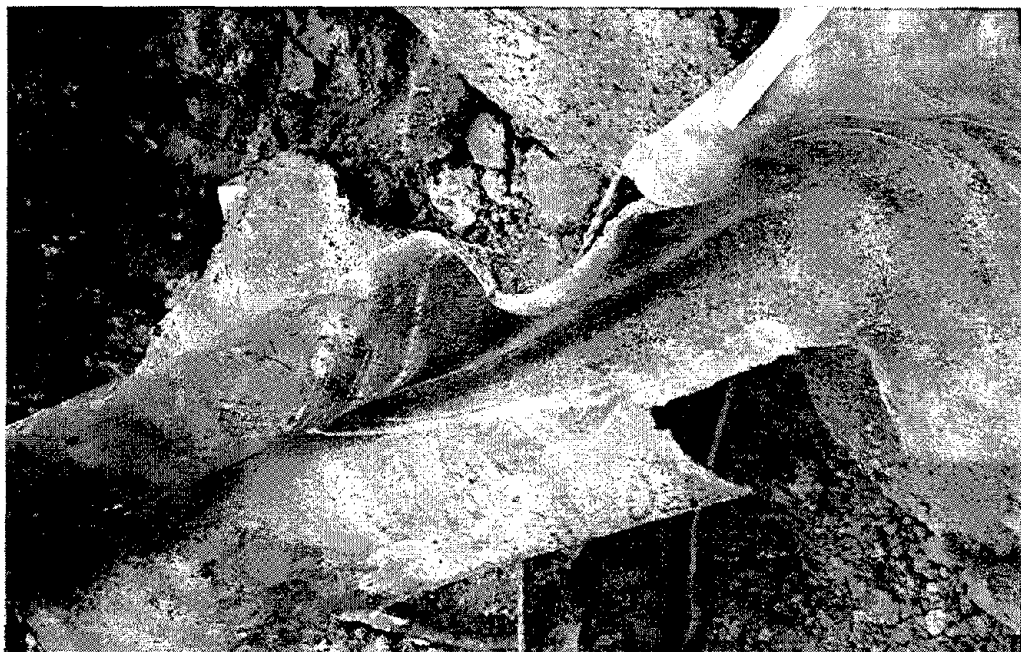
Fig. 4.34 Balboa Blvd. at Halsey St. compression zone 68-inch WSP buckled bell and spigot joint.

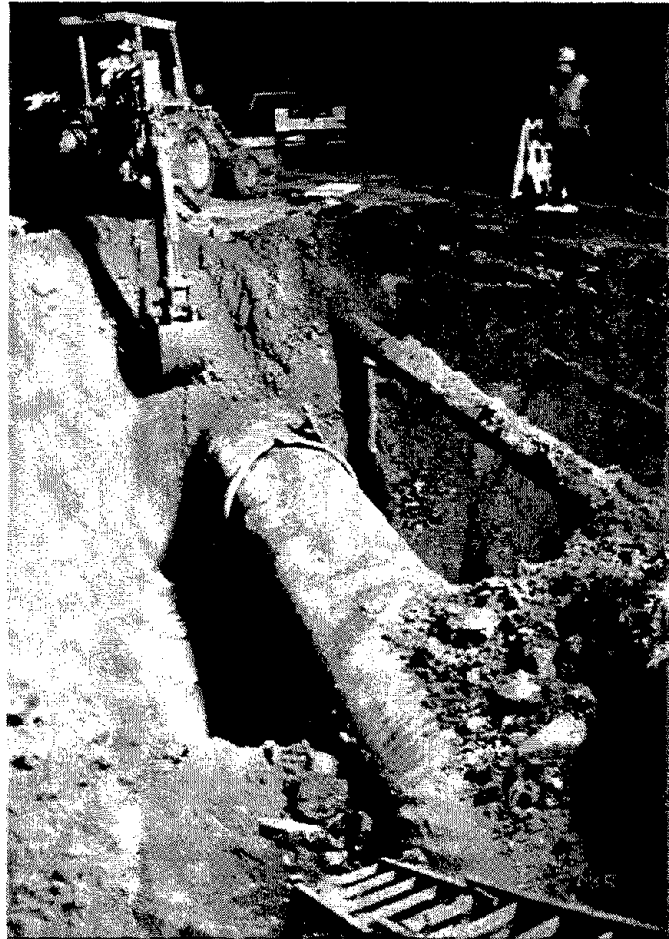
Fig. 4.35 Balboa Blvd. at Halsey St. compression zone, back hoe uncovering compression damage 48-inch WS pipe. (LADWP)

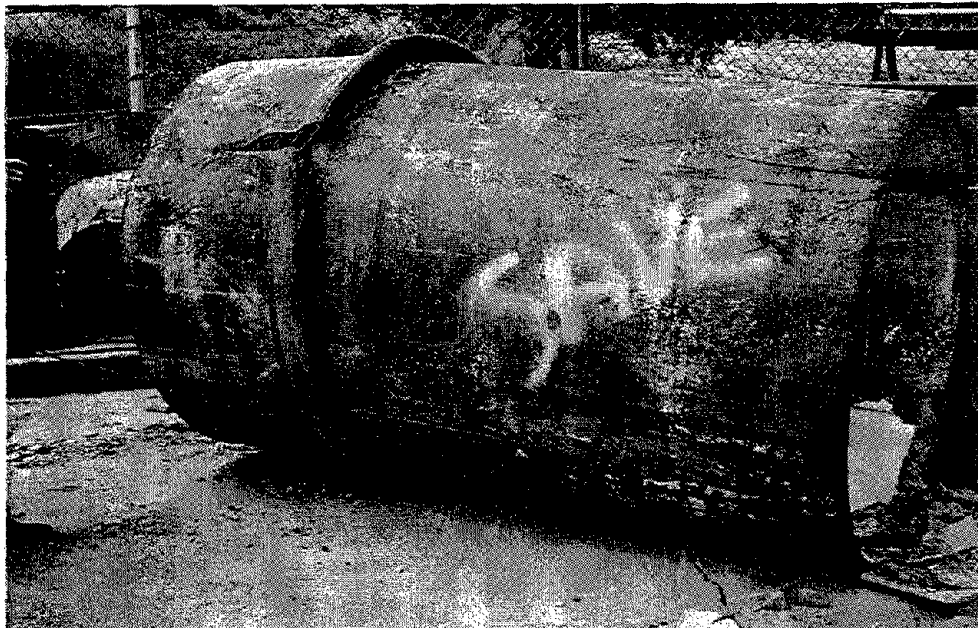
Fig. 4.36 48-inch welded steel bell and spigot joint from Balboa Blvd. at Halsey St.

Many of the pipe failures appear to be related to cracks in bells that are probably associated with their method of fabrication. There is a need to study the seismic strength of welded steel bell and spigot joints and methods to improve the seismic performance of the joint. The joint performance should be compared with the current (AWWA) Standard for Welded Steel Pipe.

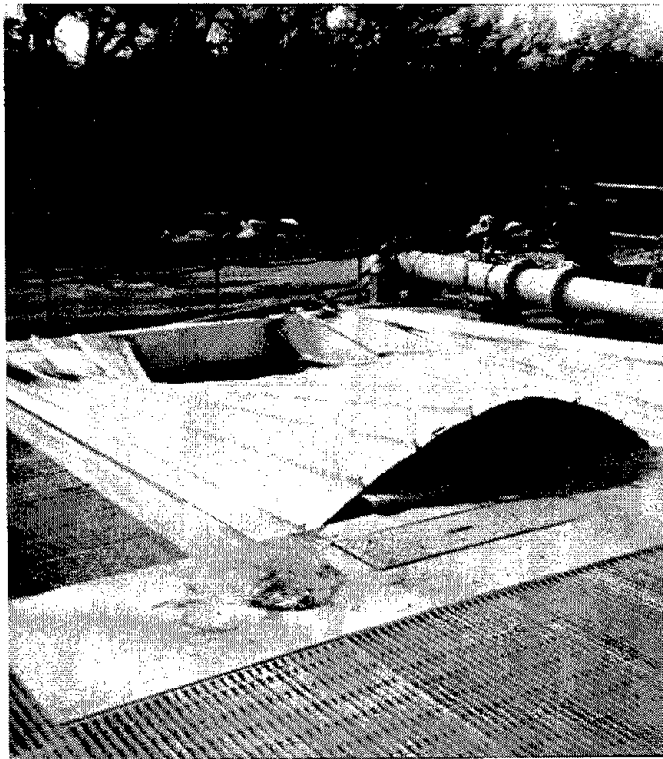
Fig. 5.2 Valencia Plant filter backwash wet well cover damage due to sloshing.
(LA Co. SAN)

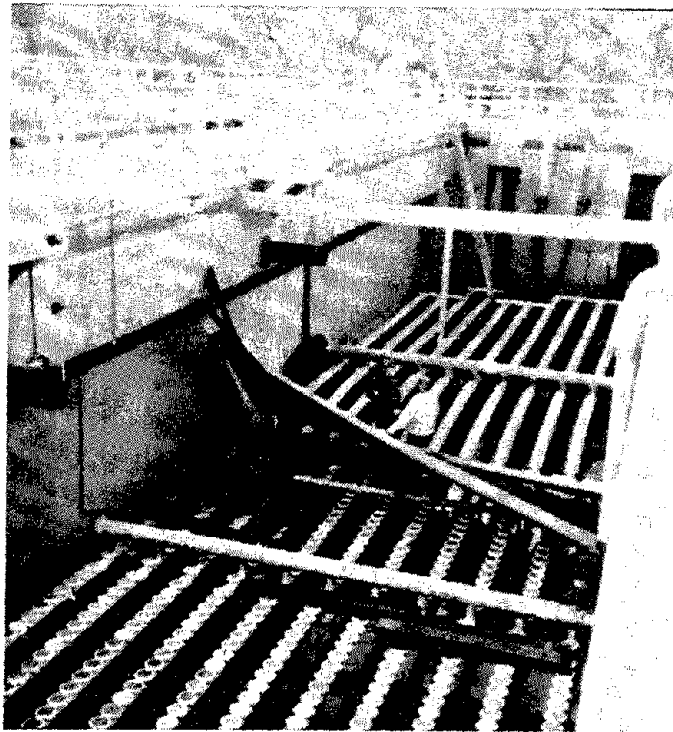
Fig. 5.3 Valencia Plant aeration tank damaged PVC aeration header and grid piping due to failure of pipe support to concrete wall. Header support moved 8 feet is laying against wall at the top of photo. (LA Co. SAN)

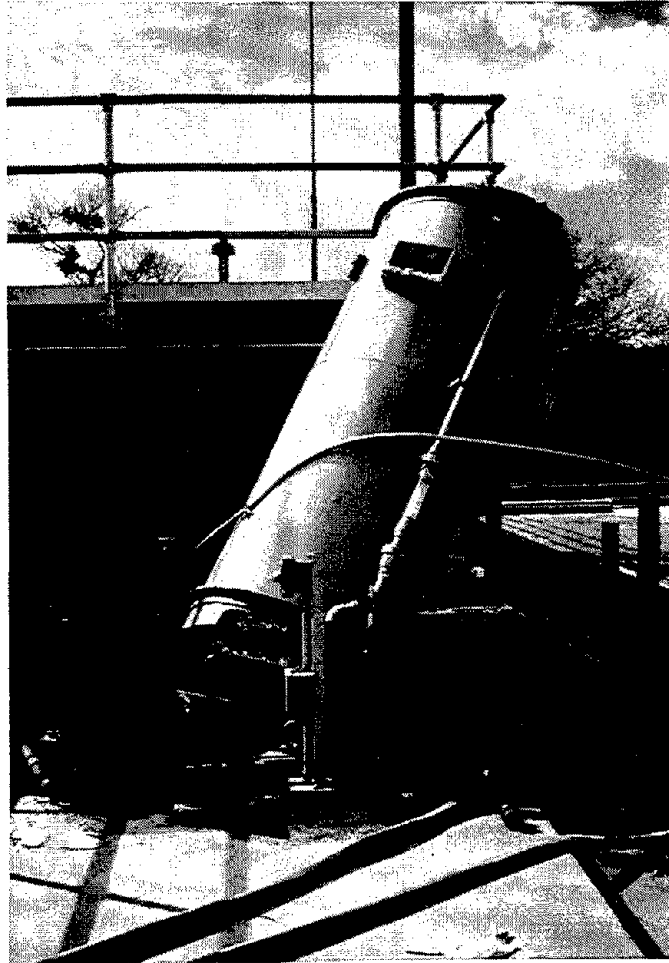
Fig. 5.4 Valencia Plant destroyed air scrubber. (LA Co. SAN)

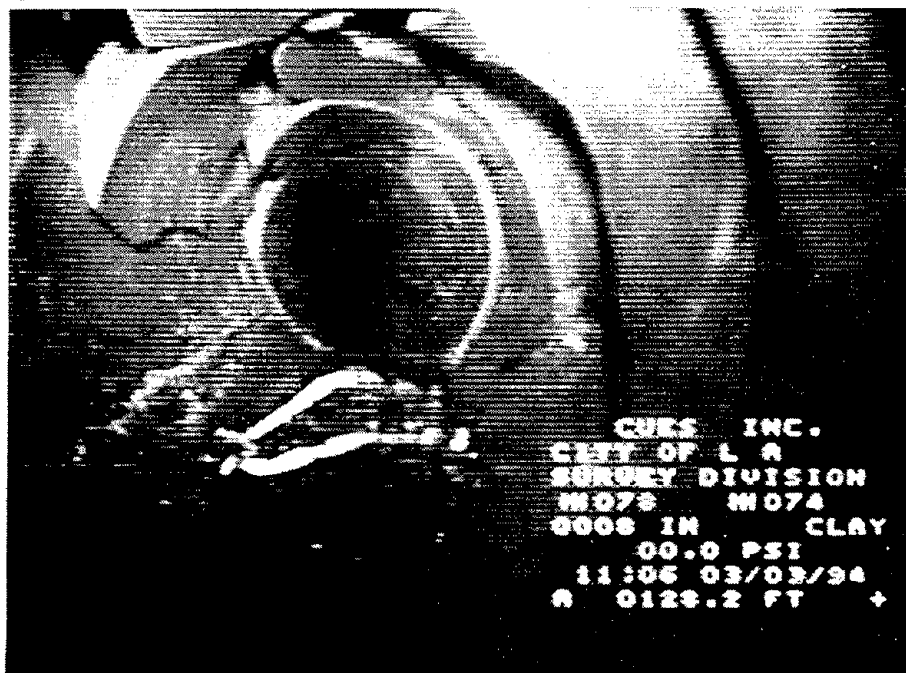
Fig. 5.7 Television photo of the interior of 8-inch VCP sewer. (LADPW)

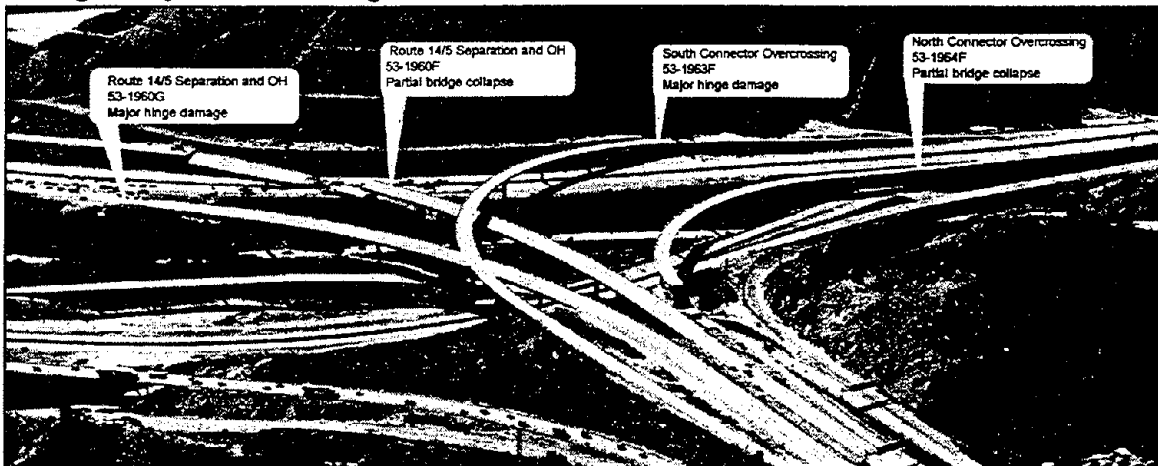
Figure 7.6. Bridge Damage at Location #2 - Route 14/5 Interchange.

This interchange was under construction during the 1971 San Fernando Earthquake. The bridges were long, curving connector structures. Several bridges were damaged and replaced. The bridges are mostly long, curving connector structures. The site is surrounded by mountains and the bridges are supported by sandstone with some structural fills at the approaches. This site is about eight miles from the epicenter of the Northridge Earthquake and the peak ground acceleration is fairly close to that experienced at Gavin Canyon, two miles to the north. The Lamont-Doherty Earth Observatory took readings of aftershocks at this site and noted a large variation in ground motion. Whether this variation contributed to structural damage has yet to be investigated.

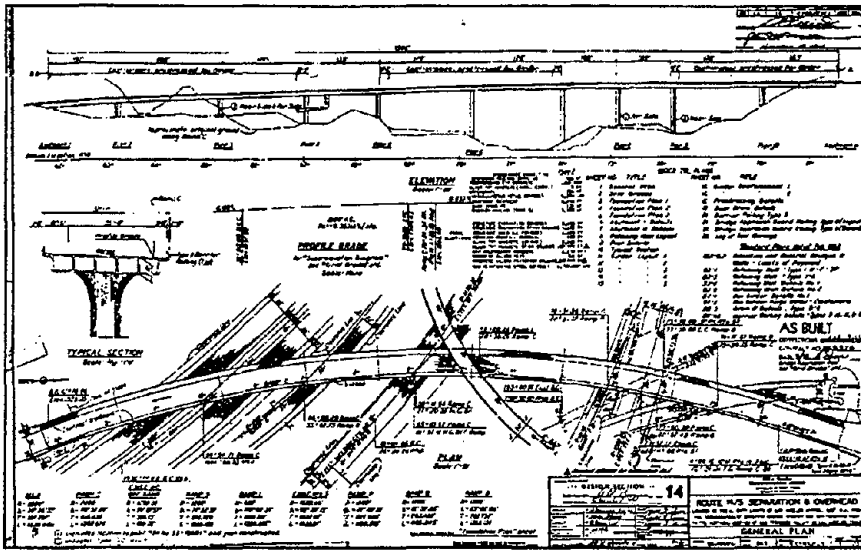
Figure 7.7. General Plan of Route 14/5 Separation and OH.

Figure 7.7 shows that Frame #1 was short and stiff while Frame #2 was tall and flexible. In particular, Pier #2 was very short and had a large flare that further increased its stiffness. This extremely stiff column failed because it was unable to displace elastically to the same degree as the other columns. The ground around the columns of frame #2 show that it moved to the left (outwardly) about 6 inches during the earthquake. This apparently unseated stiff frame #1. Thus, the superstructure at Pier #2 and at Hinge #1 fell leaving Pier #3 standing. This was because there was no continuous reinforcement through the bent cap and perhaps because of the previously formed soffit cracks during the San Fernando Earthquake.

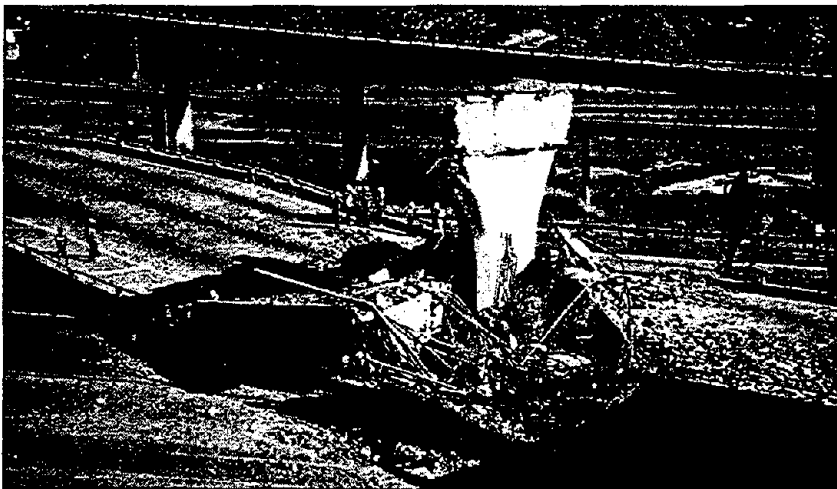
Figure 7.8. Damage at Pier #3 to Rte 14/5 Separation & OH.

This bridge is 8.2 miles from the epicenter of the Northridge Earthquake. A peak ground acceleration of at least 0.7g was estimated for this site. The first frame of the bridge collapsed and fell to the east. The only damage to abutment #1 was the failure of the right shear key as the superstructure moved to the right. At pier #2 the longitudinal column reinforcement remained attached to the bent cap while the column concrete was in rubble. Pier #3 remained standing while the superstructure on both sides of pier #3 and the bent cap lay on the ground. At hinge #1, all the restrainers and equalizing bolts had failed in tension and there were concrete spalls indicating banging of the hinge.

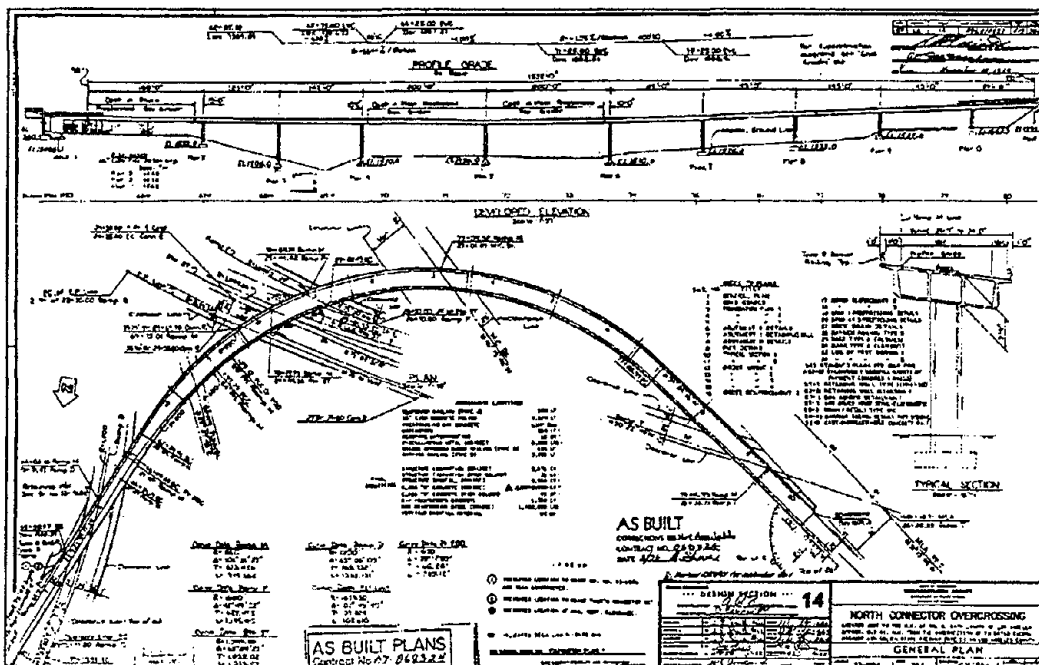
Figure 7.9. General Plan of North Connector OC.

The first two spans along with Pier #2 fell during the earthquake. There was also a great deal of movement at hinge #2. There was no damage at Pier #3.

Pier #1 was too short and stiff to handle the bridge's displacement and failed, dropping the first two spans. Perhaps the end diaphragm abutment at the other end of the bridge, along with a frame with more piers, reduced the displacement, protecting short, stiff Pier #10 from a similar fate. Also the restrainers at hinge #1 don't appear to have prevented the movement at this end of the bridge.

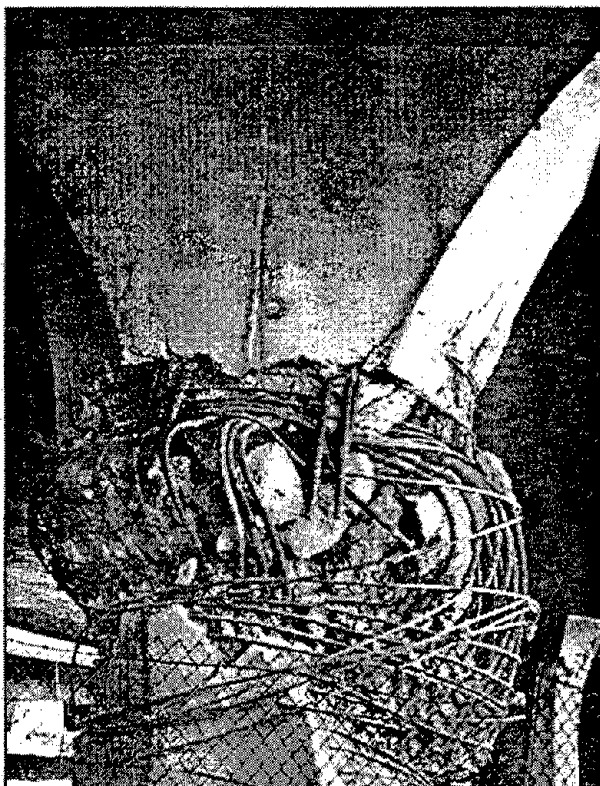
Fig 7.13 Left Bridge of Mission Gothic UC.

Both bridges suffered serious damage during the earthquake. The right bridge had a collapse of spans three and four. The columns at Bents #3 and #4 broke off below the flares, dropping the superstructure and unseating it at Abutment #4. The superstructure remained seated at Abutment #1 although there was 13 inches of transverse movement. At Bent #2, the left column also failed below the flare; however, the right column broke the bottom pin instead. The left bridge didn't collapse; however, most of the columns failed below the flare. There was two inches of transverse movement at Abutment #1 and over 10" at Abutment #4.

There were two factors that controlled the dynamic behavior of these bridges. The first was the unusual geometry that allowed movement only to the south during the earthquake. This directional bias forced some columns to move in their stiff direction, which allowed only minimal elastic displacement. The other factor is the large flares that reduced the elastic length of the columns, causing a much greater plastic shear to develop ($V_p=M_p/L$). Thus, the largest plastic shear failed the weakest column section just below the flares and in one case at the column pin. Other factors that influenced the bridge damage was the wide spacing between columns, which forced fewer columns to carry more of the seismic load and a larger dead load. The progression of events after the damage at Bent #4 of the right bridge and Bent #3 of the left bridge is harder to determine. Probably, the increased displacements that occurred after these bents failed, broke the rest of the columns, and dropped the right superstructure from the east abutment.

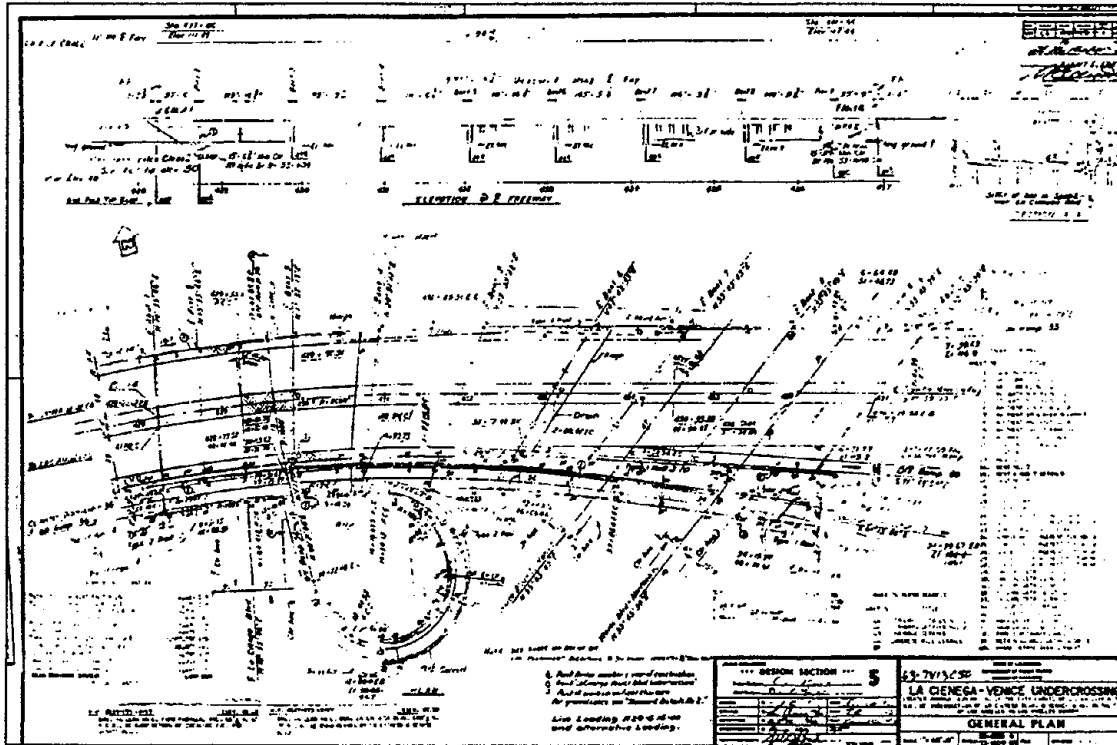
Figure 7.17. General Plan for La Cienega - Venice Undercrossing.

Most of the columns were severely damaged by the earthquake. Both superstructures dropped onto masonry storage buildings that were under the bridges. All of the columns at Bent #7 on the left bridge failed, 2 at the top and the middle one at the bottom. These columns were designed to be fixed at the bottom. Span #6 of the left bridge fell off of the hinge seat. The restrainers at that hinge sheared or were pulled through the concrete diaphragm. A separate but adjacent collector ramp structure also suffered some column damage. The column foundations were exposed after the earthquake and were found to be in excellent shape.

These bridges collapsed due to column failures. Specifically, #4 hoops at 12 inches failed before a plastic hinge could form and because they could not resist the large shear forces during the earthquake. In every column, failure began with rupturing of the #4 hoops, usually near the top or bottom plastic hinge zones. This is not surprising considering when these bridges were built. A seismic retrofit project for these bridges was about to begin at the time of the earthquake.

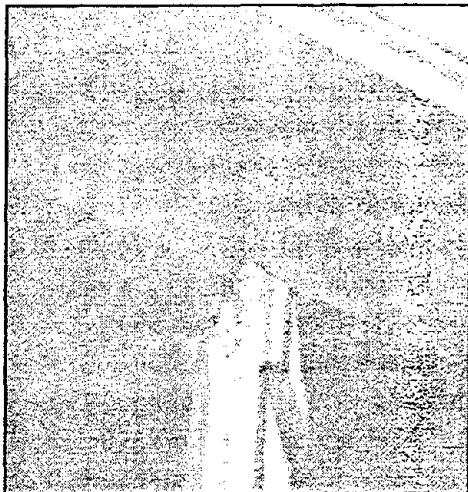
Fig. #7.22. Santa Clara River Br.

The Santa Clara River Bridge (Br. #53-0687L) is a highly skewed, 741 foot long, 7 span structure. During the earthquake, many of the anchor bolts connecting the

girders to the concrete piers pulled out (see Fig 7.22). There was also banging and spalling of the abutments. The most interesting damage was cracking of the girders where they connected to the cross frames. The cross frames were staggered due to the bridges skew. These cracks were probably initiated through fatigue and propagated by the earthquake. It has long been known that staggered cross frames are a serious maintenance problem for steel bridges. Pico-Lyons Overcrossing (Br. #53-1783) is a 2 span continuous plate girder bridge. During the earthquake the restrainers, anchor bolts,

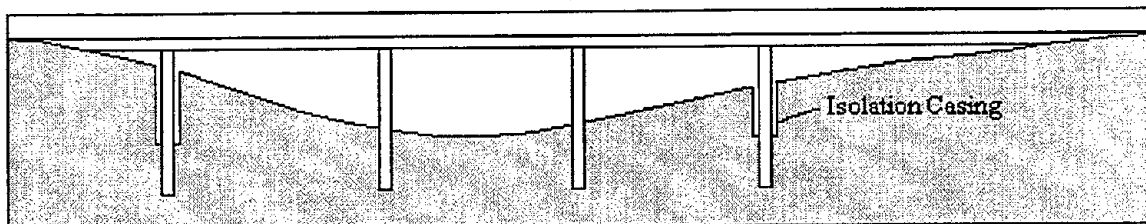
Figure 7.23. Maintaining Constant Column Stiffness by Using 'Isolation Casings'.

Much effort was spent on this issue after the Northridge Earthquake. In particular, the original structures on the 5/14 Interchange had problems with stiff columns adjacent to more flexible columns attracting very large forces. Caltrans wanted to make sure that problem wasn't repeated in the replacement structures. What makes this difficult, of course, is that length plays such a significant role in column stiffness ($k=L^3/nEI$). This problem was solved for 5/14 by varying the length and width of columns with drilled shaft foundations and using 'isolation casings' to give the columns more equal stiffness (see Figure 7.3).

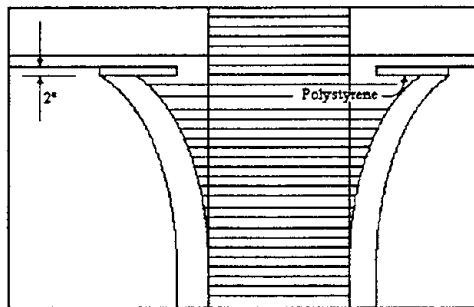
Fig 7.25. Old Column Flare.

damage had at that time occurred due to flares. The problem was that engineers had long assumed that the flare was a non-structural element that would spall off during an earthquake. In reality the flare, was reducing the length of the column and increasing the plastic shear demand. A 2 inch gap between the soffit and the flare was one solution used to address these problems (see Fig 7.25).

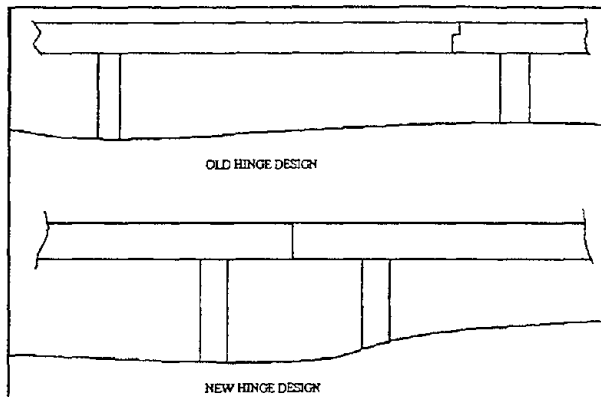
Figure 7.29. Old and New Hinges.

Hinges have long been a problem for Caltrans. The phase 1 retrofit program began after the 1971 San Fernando Earthquake to prevent large hinge movements with cable and rod restrainers. These retrofits had some success in controlling large movements during the Northridge Earthquake. But the current hinge design makes it extremely difficult to make repairs and replace damaged bearings.

Newer, more repairable hinge details are being developed. Another new expansion joint design provides much better seismic response with no danger of unseating (see figure 7.29). This new design was used on a replacement bridge in the 5/14 interchange. This hinge may be particularly appropriate at locations where large displacements are expected.

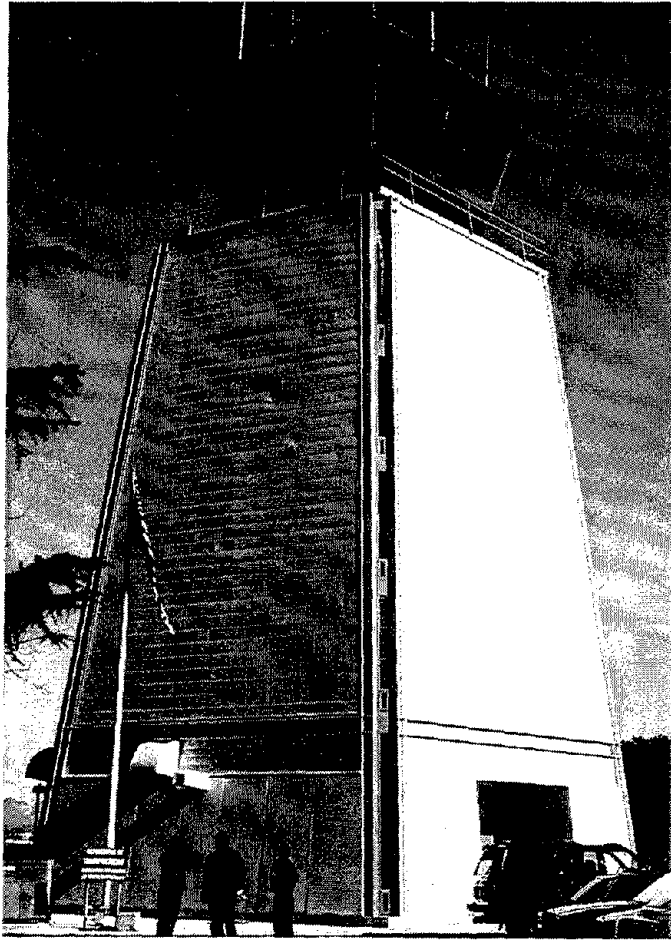
Figure 10.2 shows an overview of the control tower and cab. The gashes in the tower siding were caused by the window as it fell, suggesting that they came out as a unit or fractured and large pieces fell to the ground. A fragment of the window is shown in Fig. 10.3. Each of the five sides of the cab has two window panes separated

Fig. 10.2 Overview of the Van Nuys control tower with gashes in siding caused by windows falling from the cab.

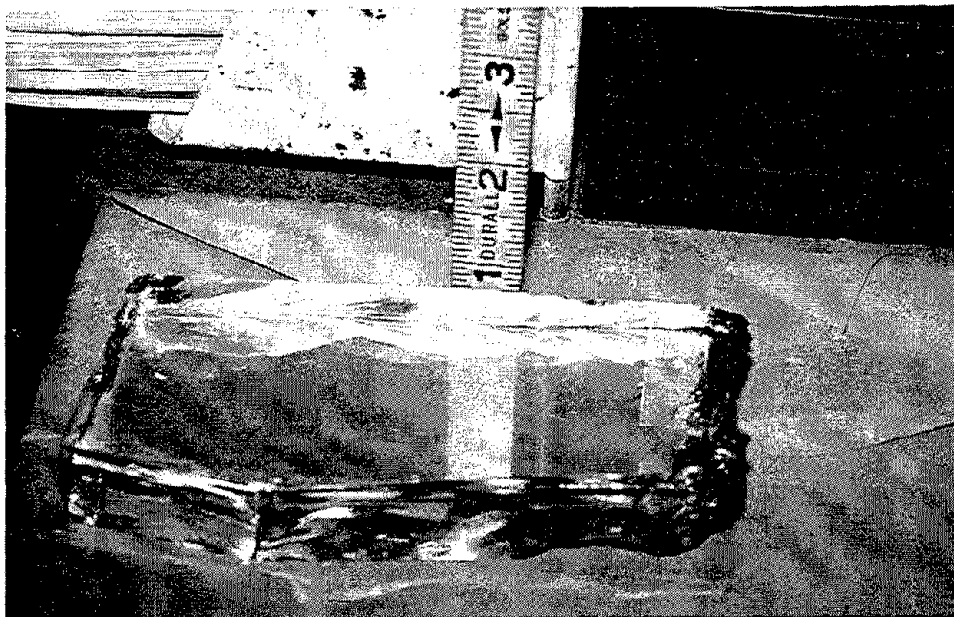
Fig. 10.3 Fragment of control tower window glass that is 3/4" (2 cm) thick.

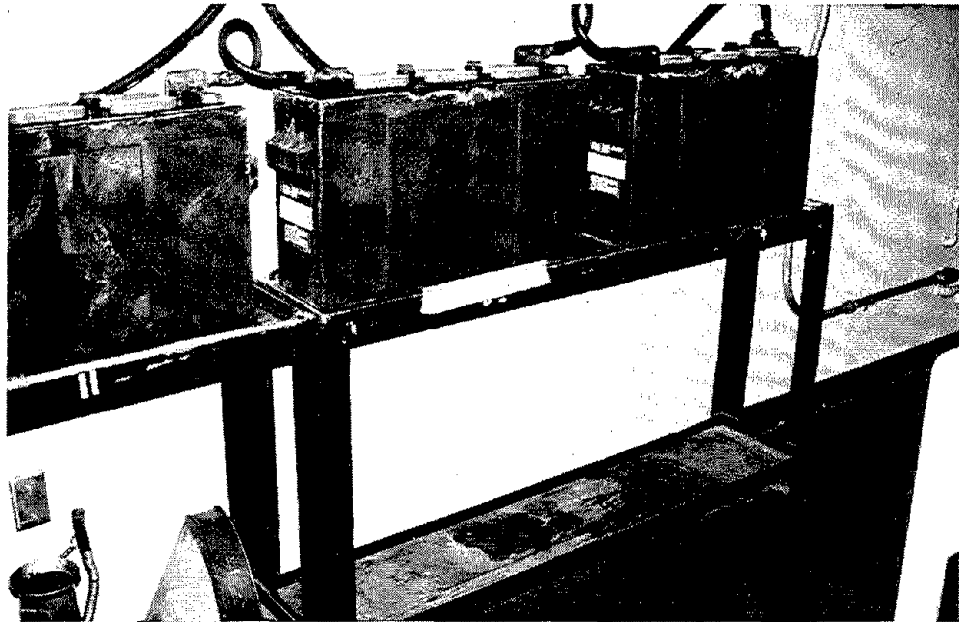
The control tower engine-generator was anchored at the time of the visit, but was unanchored at the time of the earthquake. The batteries used to start the engine-generator were not secured to their battery rack and the rack was not anchored, Fig. 10.5. The utility transformer that supplied power to the control tower is located adjacent to the tower was unanchored, but did not move during the earthquake. The control tower is normally closed during the early morning hours. A uninterruptible power supply in the base of a cabinet was unanchored, but continued to operate, Fig. 10.6. Air handling equipment in the tower was on vibration isolators that were unanchored and appeared to have moved as much as 4" (10 cm) as a result of the earthquake, Fig. 10.7.

Fig. 10.5 Batteries used to start the emergency engine-generator are unsecured to their rack and the rack is not anchored.

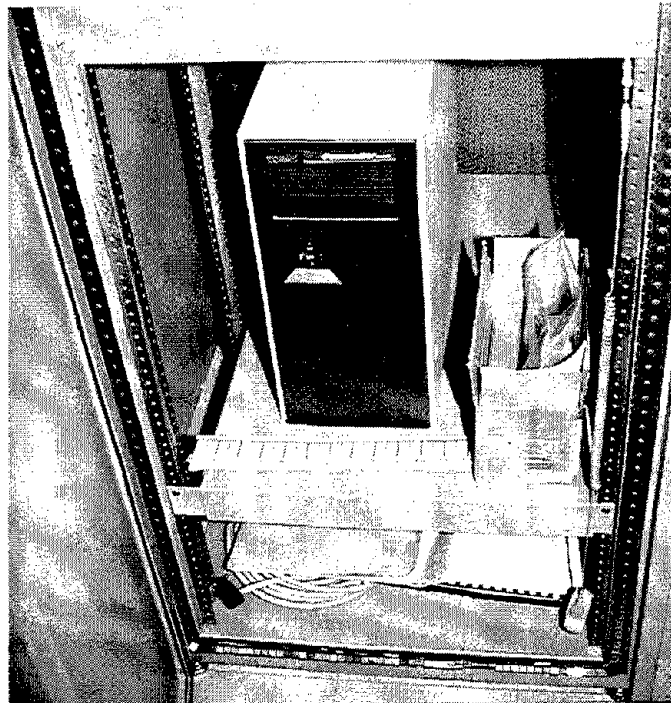
Fig. 10.6 A uninterruptible power supply in the bottom of a cabinet was unanchored. It did not move and continued to operate after the earthquake.

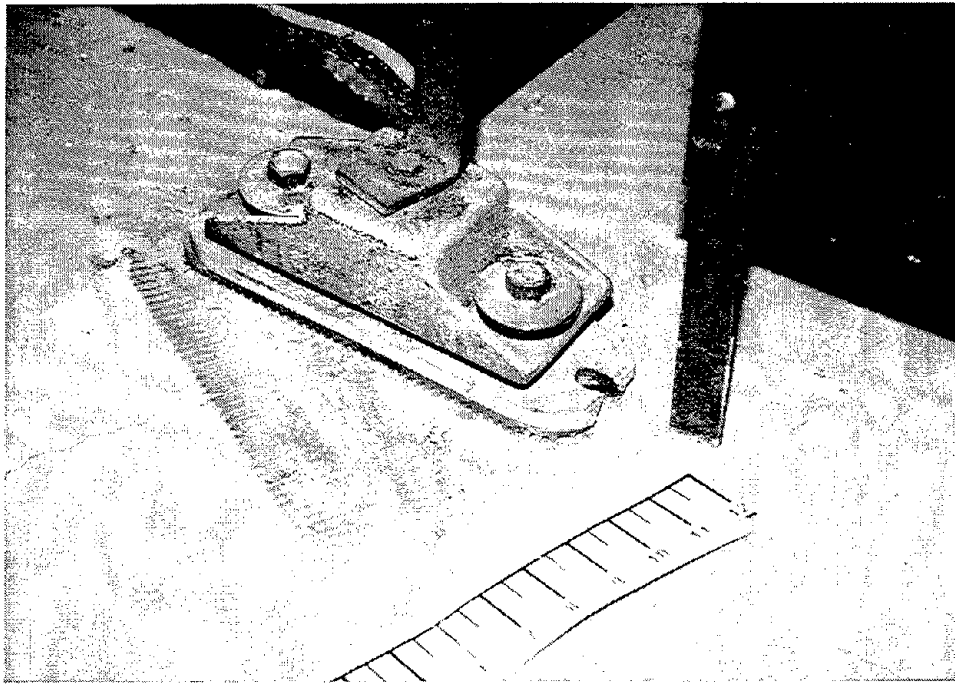
Fig. 10.7 Vibration isolation pad used to support air handling equipment was unanchored and moved about 4' (10 cm).
