**NORTHRIDGE EARTHQUAKE: LIFELINE
PERFORMANCE AND POST-EARTHQUAKE
RESPONSE**

Date: Apr 97

Authors: A. J. Schiff.

Performing Organization: American Society of Civil Engineers, New York. Technical Council on Lifeline Earthquake Engineering.

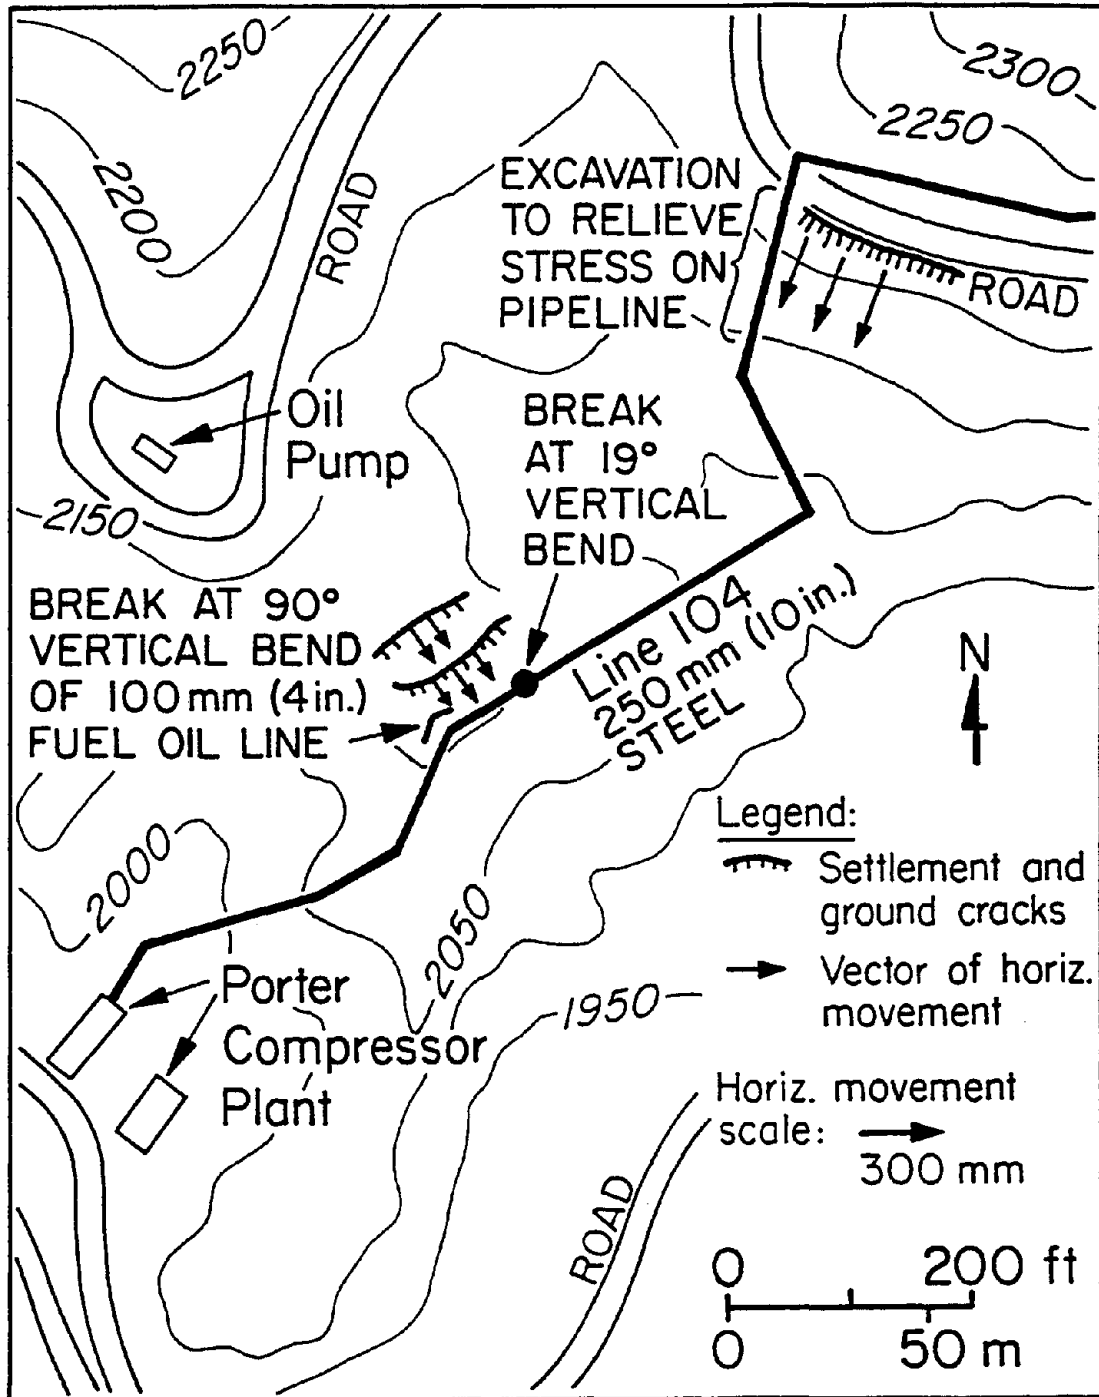
Figure 12-3 shows a plan view of Line 104 in Aliso Canyon relative to the site topography. The rock in the area covered by the figures is highly fractured, friable siltstone and sandstone with 0.6 to 3 m (2 to 10 ft) of silty sand cover in many places. Pipe damage appears to be related to slope displacement perpendicular to the pipeline, which also caused an adjacent 100-mm- (4-in.)-diameter, steel fuel oil line to fail at an aboveground vertical bend. Slope displacement adjacent to the access road in the northeast part of the figure threatened Line 104, and the pipeline was excavated in the slope area to free it from the adjacent soil.

Fig. 12-3. Plan view of Line 104 in the Aliso Canyon Gas Storage Field.

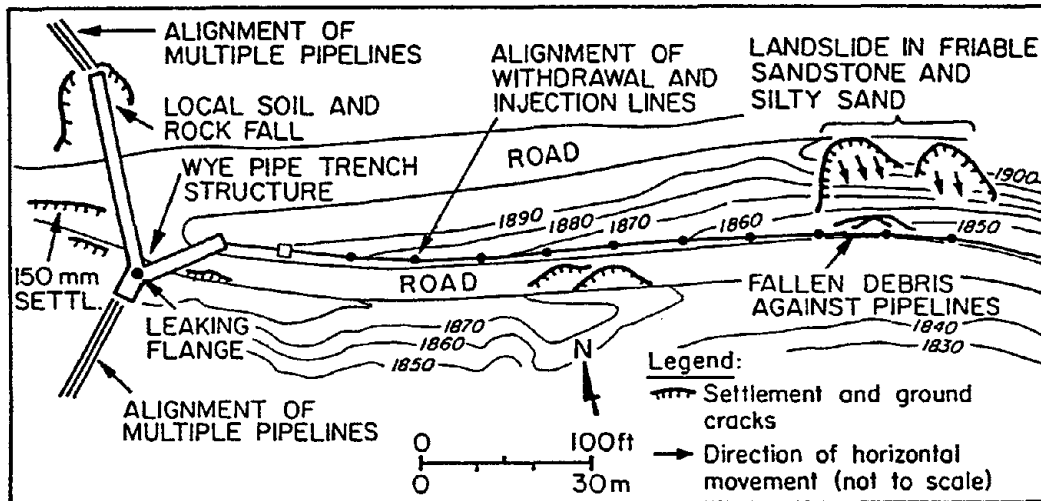
Figure 12-4 shows a plan view of surficial ground movement and gas facilities near the location of a leaking flange in Aliso Canyon. Downslope movement at the Wye structure caused deformation at the flange of a withdrawal pipeline, thereby breaking the seal at the gasket. Local soil and rock failure exposed the drilled shaft foundations of aboveground pipeline supports north of the Wye structure. Withdrawal and injection lines along the access road were deformed by fallen debris in the landslide area at the eastern side of the figure.

Fig. 12-4. Plan view of Wye pipe trench structure and aboveground pipelines influenced by local landslide activity at Aliso Canyon Gas Storage Field.

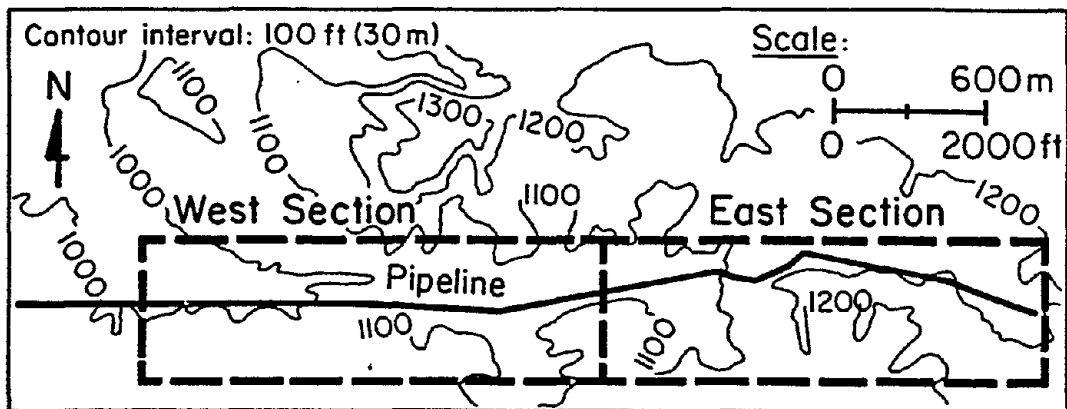
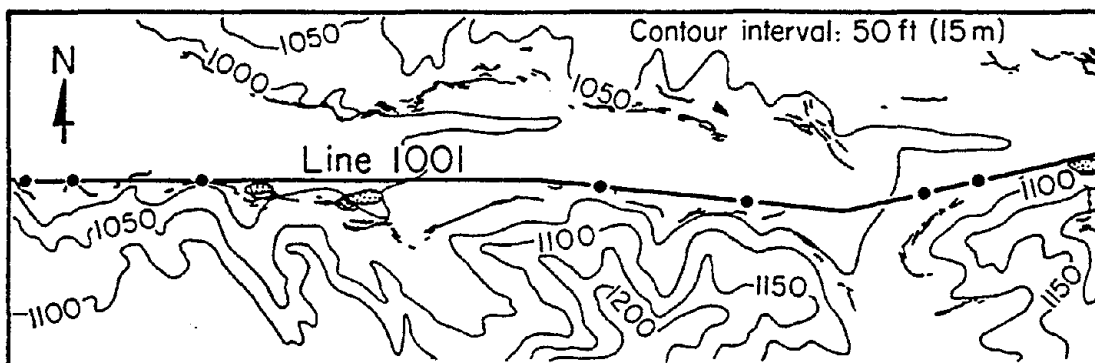
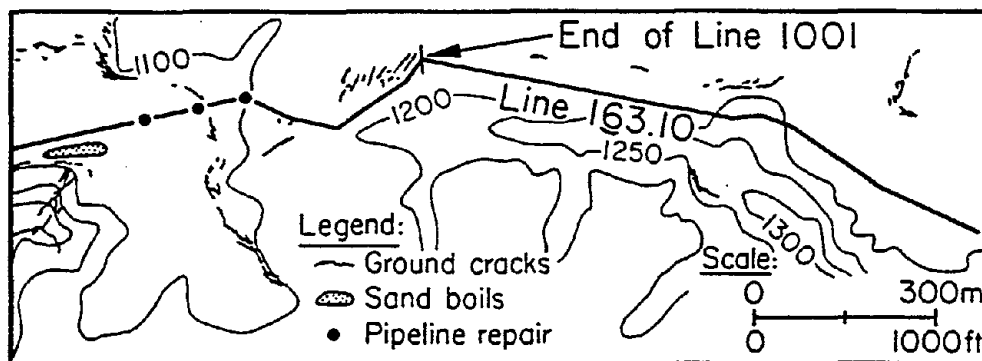
Figure 12-5 shows the location of Line 1001 in Potrero Canyon in relation to ground deformation features and sand boil locations mapped by Rymer, et al. (1995). Ten locations of pipeline repair are shown in the figure, all of which were separations and cracks at oxy-acetylene welds. Approximately half the locations of pipeline repair coincide with mapped ground cracks.

Fig. 12-5. Map of locations of pipeline repair and ground deformation features in Potrero Canyon. [Based on map prepared by Rymer, et al. 1995.]

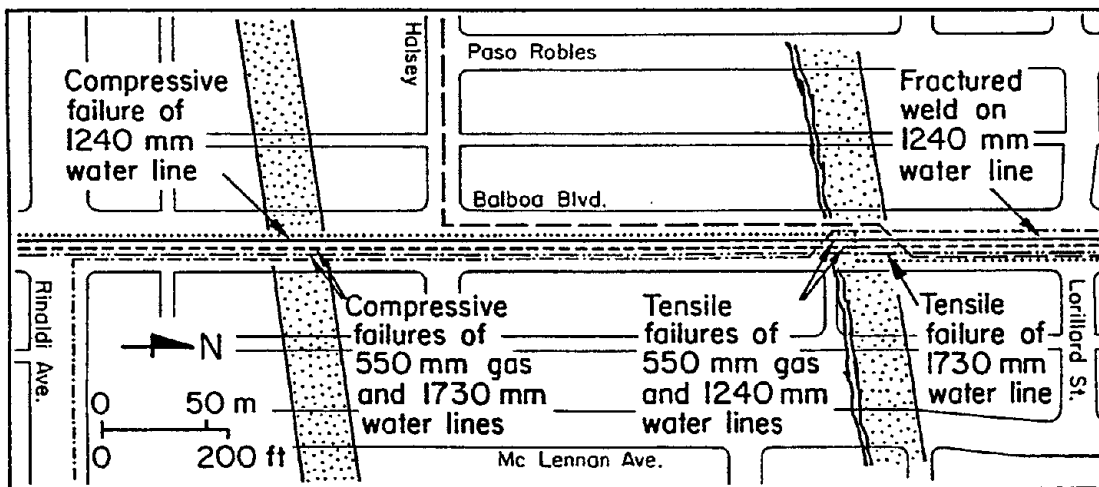
Figures 12-6 and 12-7 show maps of the pipelines in Balboa Blvd. near the zones of permanent ground deformation. There were six transmission and water trunk lines at this site. There were two 750-mm- (30-in.)-diameter gas transmission lines with 9.5-mm-(0.375-in.)-thick wall, constructed of X-52 steel in the 1950s which were not damaged. There was a 400-mm- (16-in.)-diameter petroleum pipeline, operated by the Mobil Oil Corporation, which was not damaged. The pipeline was composed of X-52 steel and installed in 1991. Two water trunk lines, the 1,240-mm- (49-in.)-diameter Granada and the 1,730-mm- (68-in.)-diameter Rinaldi Trunk Lines, failed in tension and compression in the tensile and compressive zones of ground deformation, respectively.

Gas pipeline damage on Balboa Blvd. occurred in Line 120, a 550-mm- (22-in.)-diameter steel pipeline constructed in 1930 with unshielded electric arc girth welds. At the time of the earthquake, the line was operated at about 1.2 MPa (175 psi). The pipe had a wall thickness of 7.2 mm (0.281 in.) and was composed of Grade B steel. The pipeline failed in tension in a zone of tensile ground deformation about 300 m (900 ft) north of a zone of compressive ground deformation where the pipe failed by compressive wrinkling.

Fig. 12-7. Map of major pipelines, ground deformation zones, and locations of pipeline damage on Balboa Boulevard.

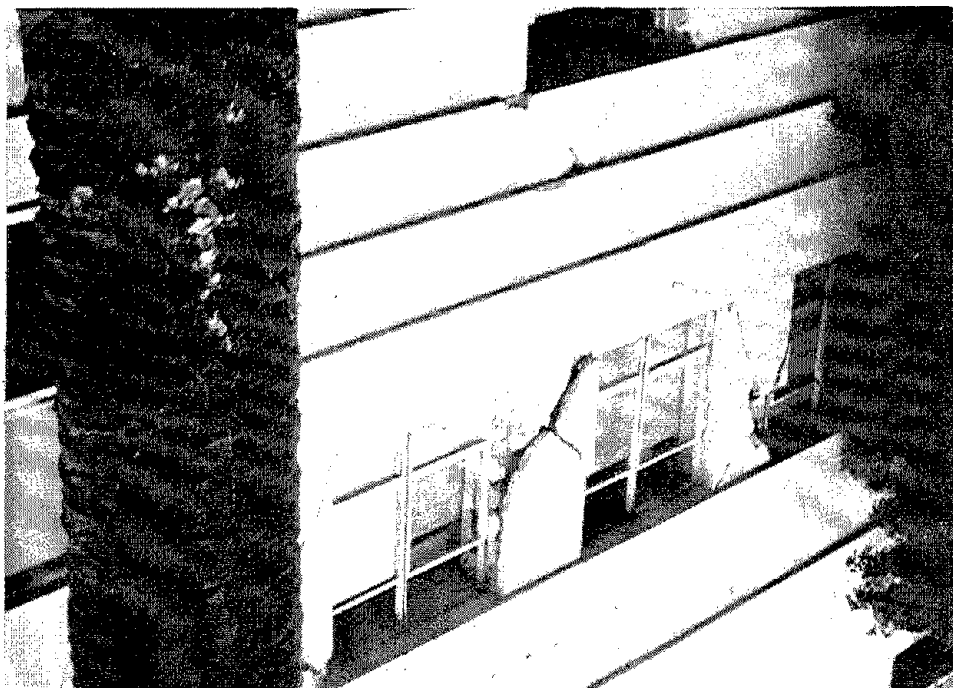
The red tagged north wing was a non-ductile reinforced concrete frame built in 1954. This wing, which is long in the east-west direction, had a soft second story. Significant structural damage occurred in this wing. This included shear cracks in the exterior window pier columns, and interior beam, floor and column damage, Fig. 15.1.

Figure 15.1. St. John's Hospital. Shear cracks in columns of soft story of north wing.

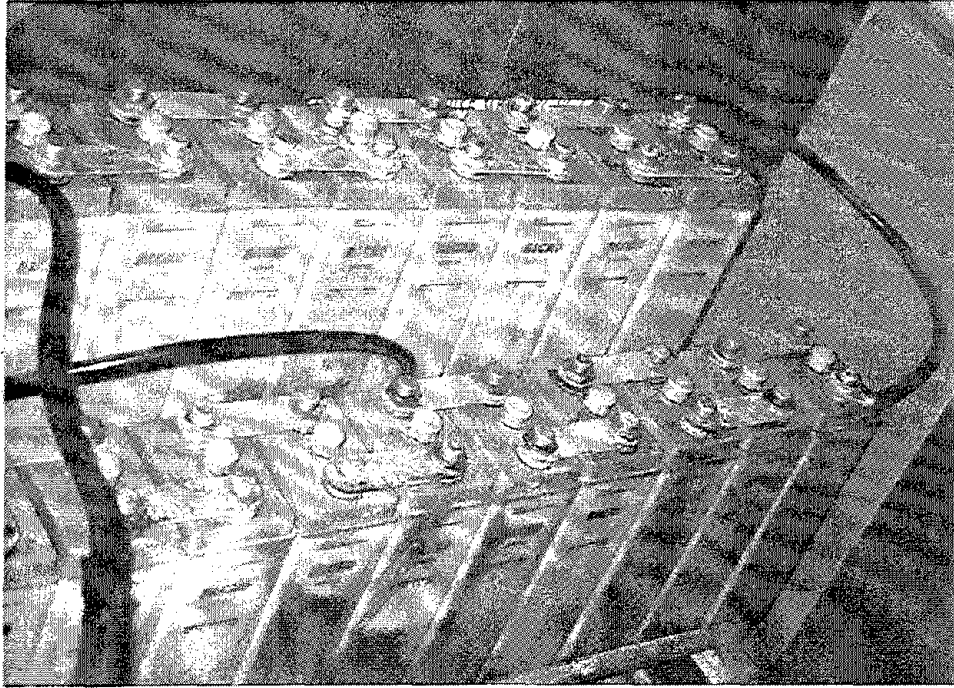
The facility lost commercial electrical power for a period of about 12-14 hours. During the earthquake, many of the batteries which are used to start the emergency generators toppled over and snapped their cables. The batteries were not restrained in their racks, Fig. 15.2. However, personnel were able to start up all six generators. All generators are shock mounted and their cooling water systems had no leaks, Fig. 15.3. The generators operated properly until numerous electrical grounds occurred as a result of interior water leaks in the facility. (These leaks occurred when interior nonload bearing partition walls were damaged by the pounding of the various wings of Building #3 at their joints with the main body of the structure.) These electrical grounds caused almost all circuit breakers to trip open. Thus most functions in the entire facility were without any electrical power. This condition lasted for two days, until the grounds were repaired and the facility was energized one building at a time. Power was restored to all but two buildings by about 60 hours after the earthquake. However, Bldgs. #3 and #99, remained without electrical power for five days, because switchgear and transformers had been knocked off their supports. For example, one 750 KVA transformer sheared its 0.75 inch (2 cm) anchor bolts and the support pad underneath one 300 KVA transformer sank. In total, there was over \$1.5 million in electrical equipment damage.

Figure 15.2. VA Hospital. Emergency generator batteries, which were not restrained at top and bottom, toppled over.

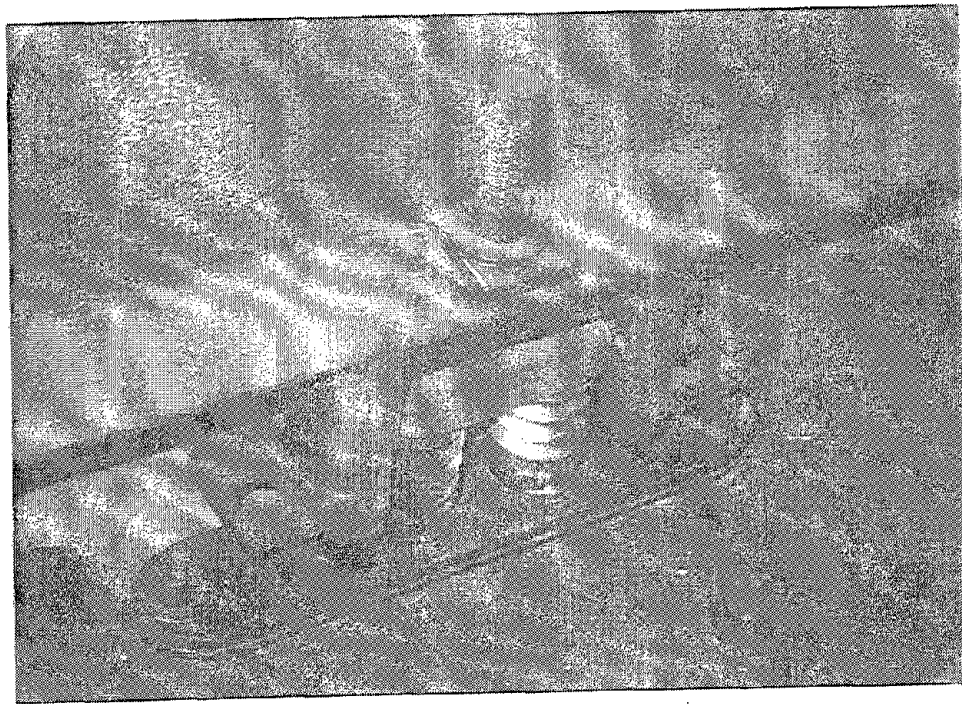
Figure 15.3. VA Hospital. Shock mounting for emergency generators.

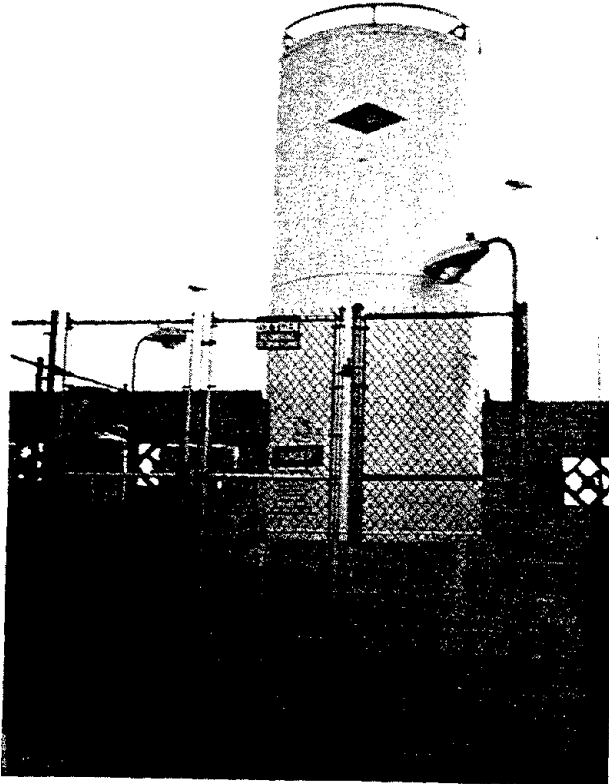
It was observed that medical gas cylinders were restrained by chains. But one set toppled over when the chain broke as a result of the earthquake. One large liquid oxygen tank, measuring about 8 feet (2.4 m) in diameter and about 15 feet (4.6 m) tall, and restrained by a single 1.0 inch (2.5 cm) diameter anchor bolt on each of its three legs, suffered no damage, Figs. 15.4 and 15.5.

Figure 15.4. VA Hospital.
Liquid oxygen tank. (Left)

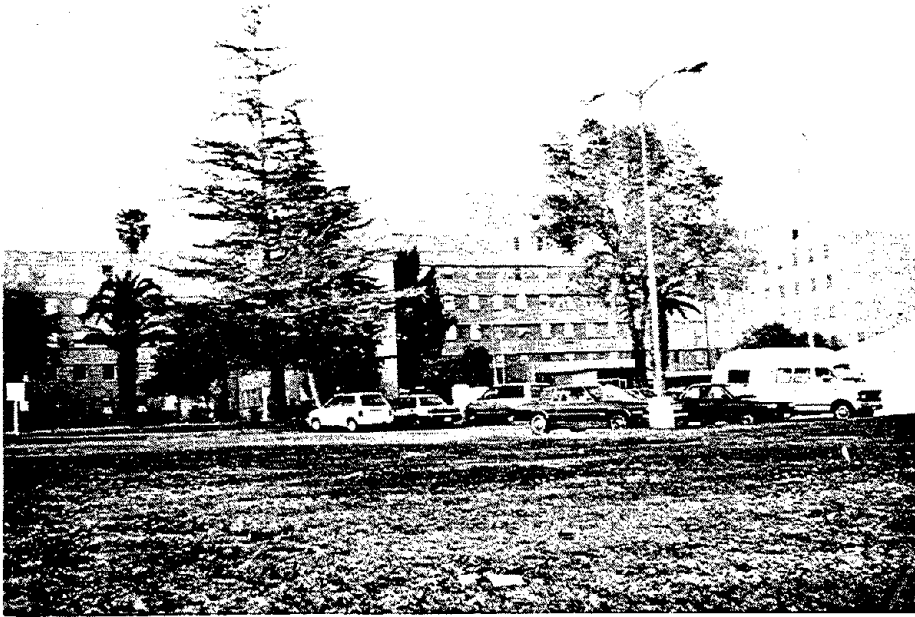
Building #3 suffered major damage and all patients in it were evacuated. It is a reinforced concrete frame structure with reinforced masonry infill walls. It has a main wing, which is six stories plus a penthouse, and several five story wings, Fig. 15.6. Seismic joints are located at the intersections of the wings with the main wing and with each other, Fig. 15.7. Significant pounding damage occurred at the joints between the southeast and east wings, between the west and southwest wings, and between the main wing and the southwest wing, Fig. 15.8. At these locations, the joints opened a larger amount in the upper stories and consequently the exterior pounding was worse in the upper stories. It was also observed that the interior lifeline damage was worse in the upper floors of the structure than at the first floor. For example, on the fifth floor, the cover plate over the seismic joint between the main wing and the southwest wing, buckled upward over 6 inches (15 cm). This would significantly impede the movement of patients on rolling stretchers. At this same location on the first floor, the plate moved horizontally less than 1 inch (2 cm).

Figure 15.6. VA Hospital. View of south side of building #3.

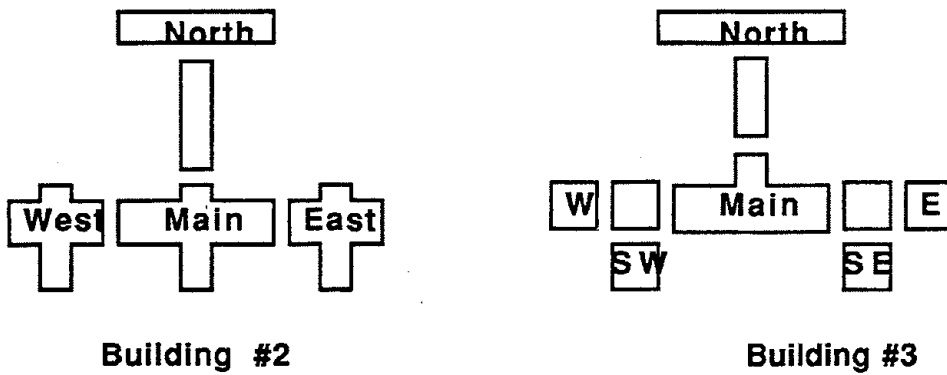
Building #2 is located about 200 feet from Bldg. #3. Compared to Bldg. #3, it is similar in plan, and oriented in the same direction with respect to the epicenter, Fig. 15.7. The main wing is five stories plus a penthouse, and the wings are four stories. But the major difference between Bldgs. #2 and #3 is that the seismic joints in Bldg. #2 are along the main wing, not at the intersections of the main wing with the other wings, as in Bldg. #3. At the intersection between the main and east wings, the seismic joint opened up by about 4 inches (10 cm), nearly uniformly from top to bottom. There was no evidence of pounding at the main wing joints, nor anywhere else in Bldg. #2. The east and southeast wings essentially formed a cruciform which responded as one structure to the ground motion. The west and southwest wings performed similarly. Bldg. #2 had several broken glass windows, but no major damage. This building remained occupied and operational.

Figure 15.7. VA Medical Center. Plan view of Buildings #2 and #3.

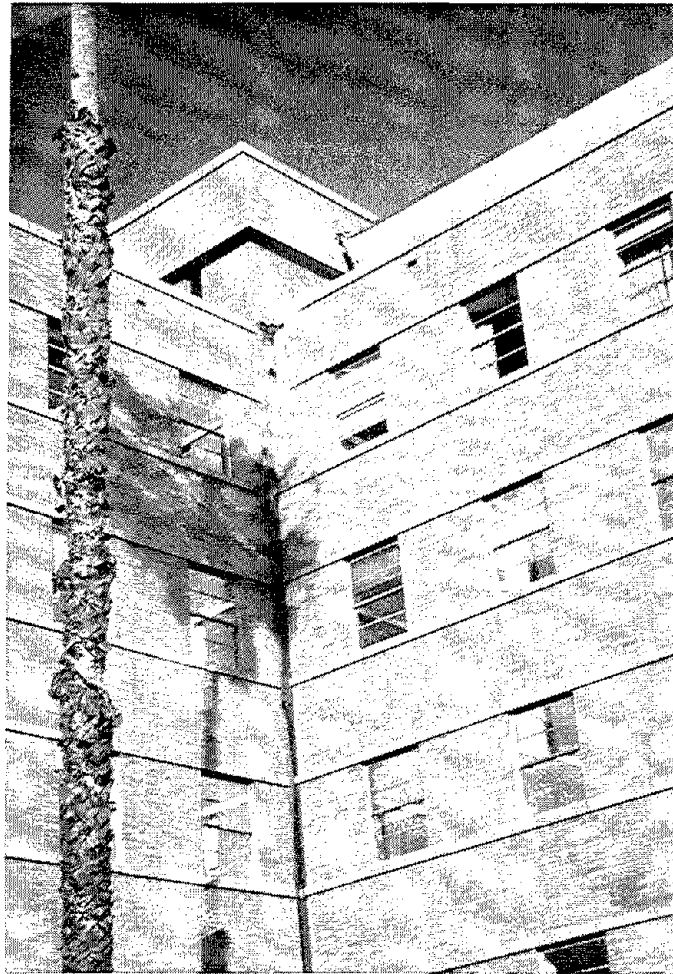
The pounding caused significant damage to the floor diaphragms and nonload bearing partition walls. The concrete cover on many floor joists was spalled off and the reinforcement bars were buckled. The fracture of brittle partition walls caused many leaks in the interior plumbing system. These leaks caused many electrical shorts and grounds, which caused circuits breakers to trip open and prevented the energizing of circuits when emergency electrical power was available.

Figure 15.8. VA Hospital. Bldg. #3. Pounding damage at seismic joint between southwest and west wings.

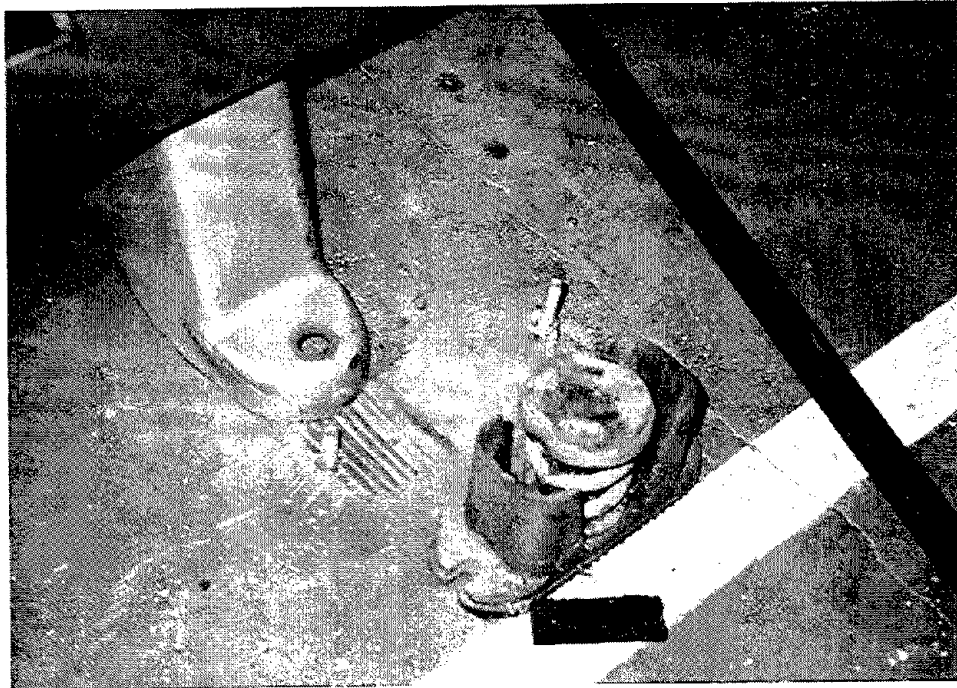
Building #40 contains the boiler plant and the chill water plant. In this building there was no damage to any chill water equipment since most equipment was bolted to the floor. However, the 12 inch (30 cm) chill water pipe out of the plant developed leaks at a flanged joint located about 8 feet (2.4 m) outside of the building. One horizontal air compressor tank jumped out of its spring-shoe supports, while an identical unit next to it did not move because it was solidly bolted to the floor, Figs. 15.9 and 15.10.

Figure 15.9. VA Hospital. Air compressor tank jumped out of this spring-shoe support.

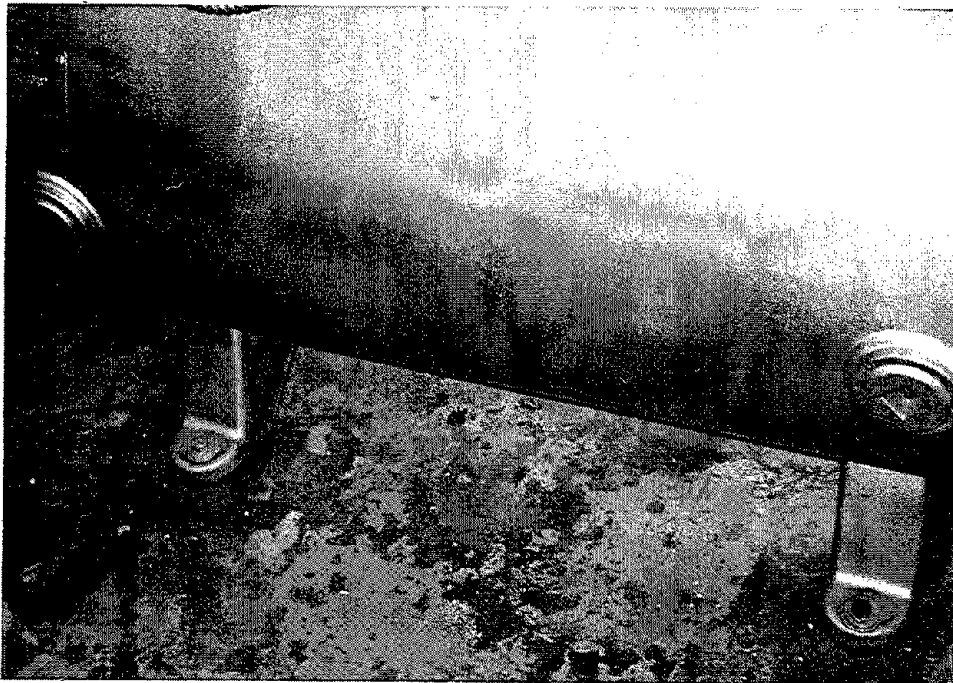
Figure 15.10. VA Hospital. Air compressor tank bolted solidly to floor.

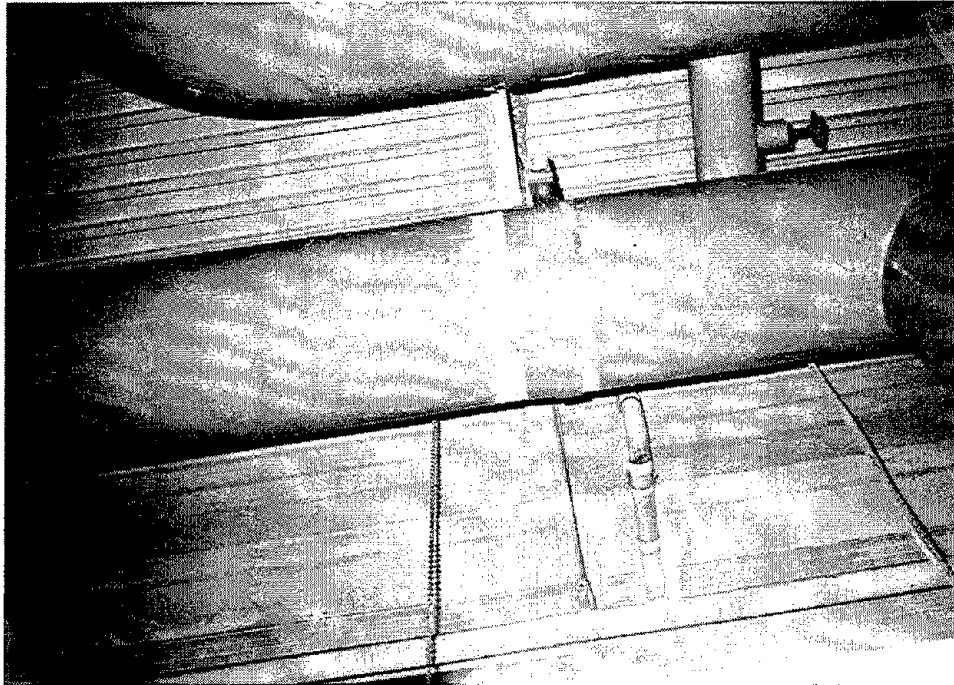
At several locations, it was observed that there was about 4 inches (10 cm) of relative axial displacement between pipe hangers and the supported chill water lines, Fig. 15.11.

Figure 15.11. VA Hospital. View looking upward of relative axial motion between chill water pipe and pipe hanger.

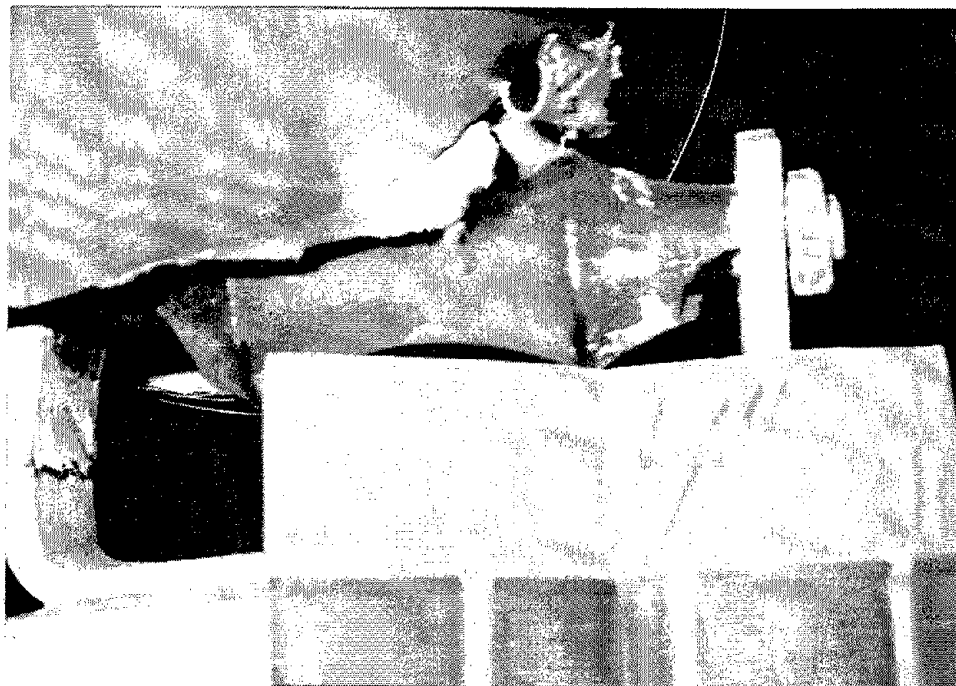
At one location, a 12 inch (30 cm) steam pipe had moved about 4 inches (10 cm) laterally on a roller support, Fig. 15.12.

Figure 15.12. VA Hospital. A 12 inch diameter steam pipe moved laterally off its roller support.

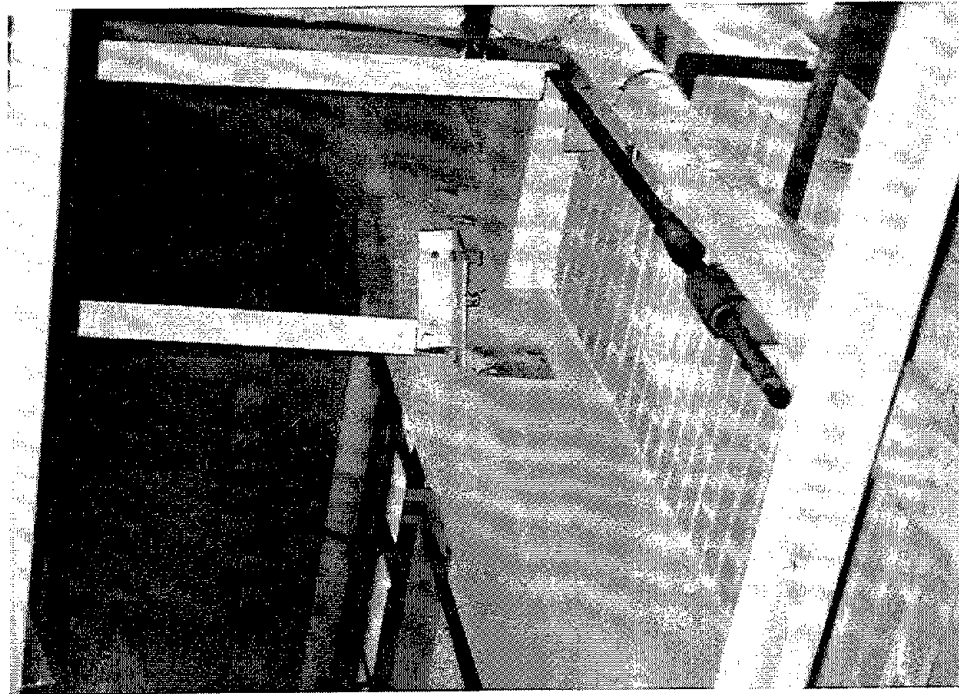
One of the two boilers lifted off its supports causing cracks in the refractory brick. One support for a catwalk pulled out of a concrete column. The support pad was anchored by two 0.5 inch (13 mm) bolts, Fig. 15.13.

Figure 15.13. VA Hospital. Bldg. #40. Support pad for a catwalk pulled out of its support column.

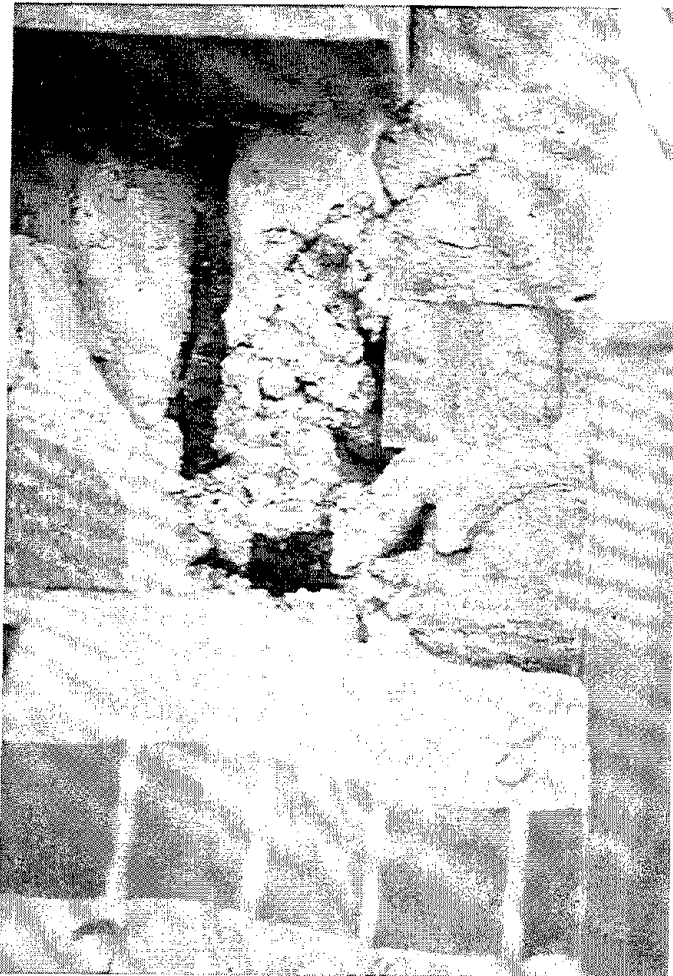
Figure 15.18. VA Hospital. Bldg. #40. Exterior of infill wall at northeast corner. Double wythe solid grouted, reinforced. (Left)

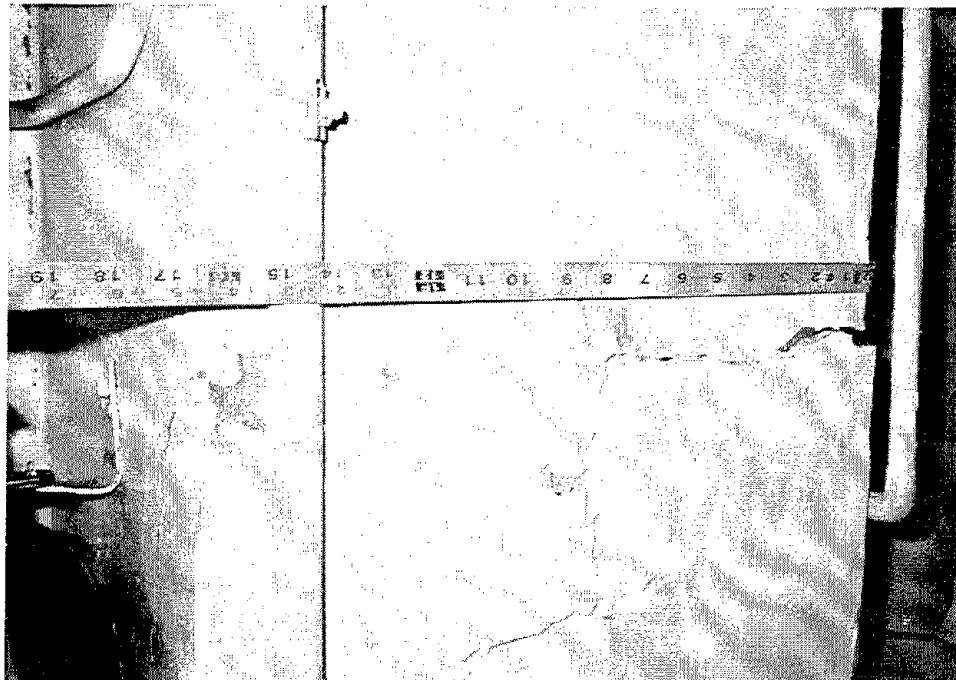
Figure 15.19. VA Hospital Bldg. #40. Interior column along north wall. Crack through entire cross section. (Below)

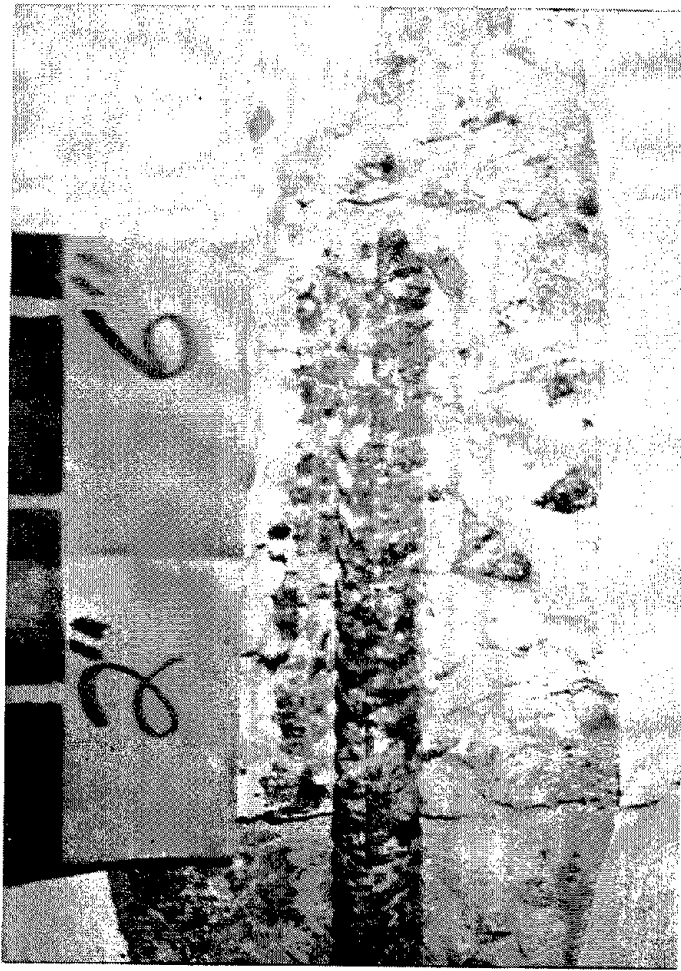
The portion of Building #40 containing the boiler plant was built in 1954 with a reinforced concrete frame and reinforced clay brick infill walls about 40 feet (12 m) high. The walls are double wythe, solid grouted, with #3 horizontal bars and #4 vertical bars. The part of the building containing the chill water plant was of more recent construction with solid grouted reinforced concrete masonry block walls about 20 feet (6 m) high. A seismic joint is at the intersection of the two parts. There were large diagonal shear cracks in the clay brick walls indicating that severe pounding occurred at this joint. The frame in the older part is stiffer along the west side than along the east side. See Figs. 15.14 and 15.15. Consequently, there was an eccentricity between the center of mass and center of stiffness of the building. Thus torsion occurred causing large cracks in the masonry at the northeast corner. See Figs. 15.16 and 15.17. At this corner, several bricks were knocked completely out of the wall so that the entire two wythes were exposed. See Fig. 15.18. Additionally, two 16x18 inch (40x46 cm) reinforced concrete columns along the north wall suffered cracks completely through their cross-section. See Fig. 15.19. On one of these columns, some concrete spalled off at a 6 inch (15 cm) lap splice, and the #7 reinforcement bars buckled, Figs. 15.20 and 15.21. There were no lateral ties observable in the columns.

Figure 15.20. VA Hospital Bldg. #40. Same interior column as Figure 15.19 along north wall. Concrete spalled at 6 inch lap splice.

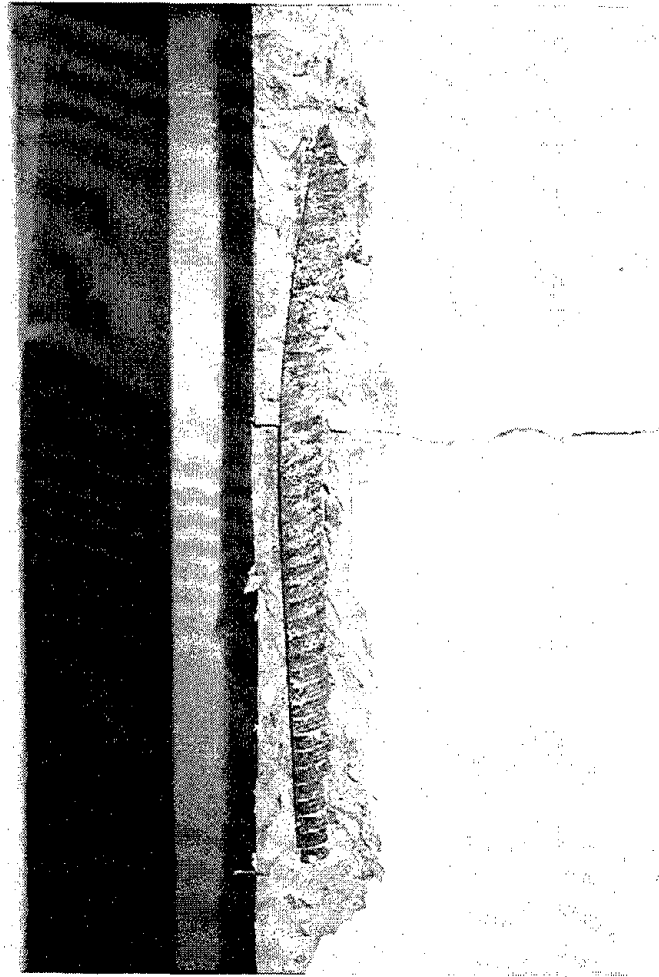
Figure 15.21. VA Hospital Bldg. #40. Same interior column as Figure 15.19 along north wall. Reinforcement bar (#7) buckled due to lack of lateral ties.
