NIST-GCR-98-743

FIRE-RELATED ASPECTS OF THE NORTHRIDGE EARTHQUAKE

**Charles Scawthorn, Andrew D. Cowell
and Frank Borden**

October 1996

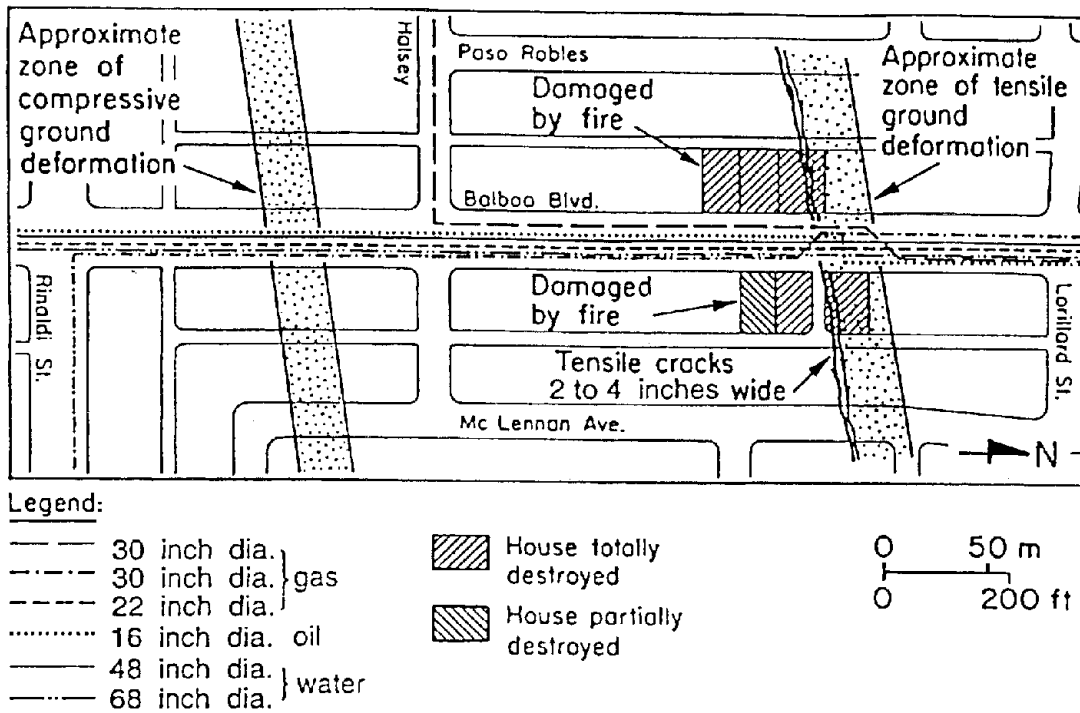
Figure 2-6: Map of major pipelines, fire damage and ground deformation on Balboa Blvd. (after Holzer et al, 1996)

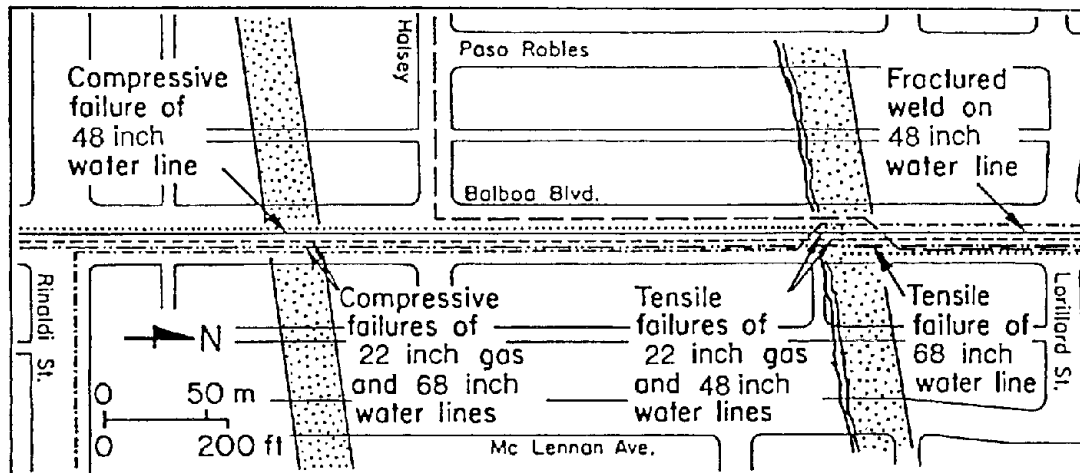
Figure 2-7: Map of major pipelines, ground deformation zones and pipeline damage, Balboa Blvd. (after Holzer et al, 1996)
