The Marmara, Turkey Earthquake of August 17, 1999: Reconnaissance Report

Edited by
Charles Scawthorn¹

Technical Report MCEER-00-0001

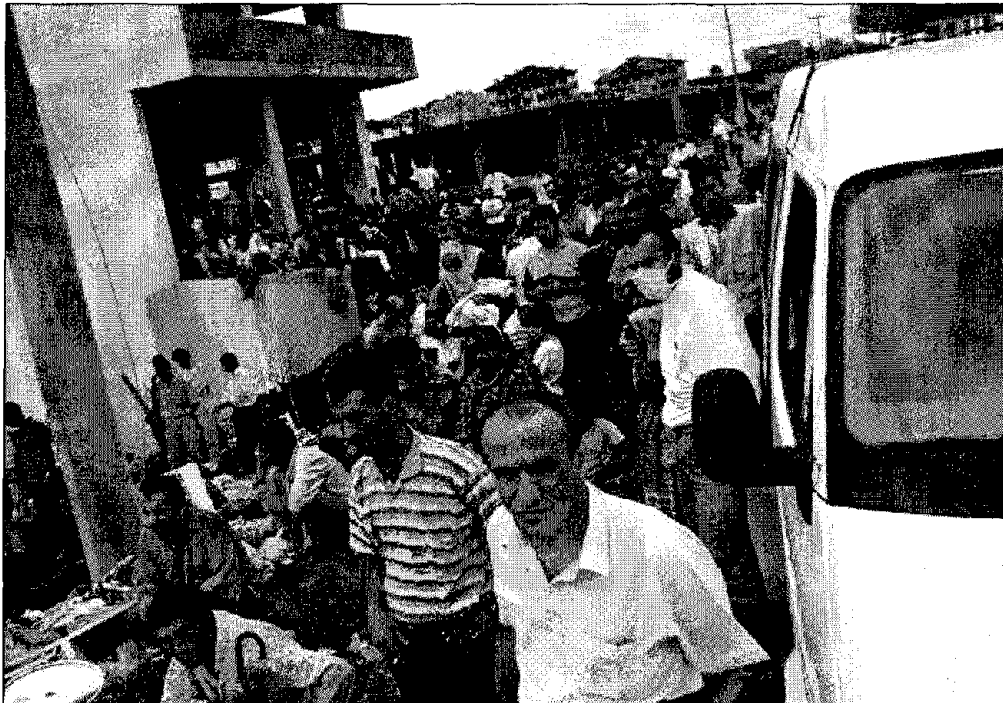
Figure 1-1 Crowd observing a rescue on Aug. 24 east of Gölcük – asked to remain silent and motionless so that rescuers can listen for the victim, buried in a 'pancake' collapse

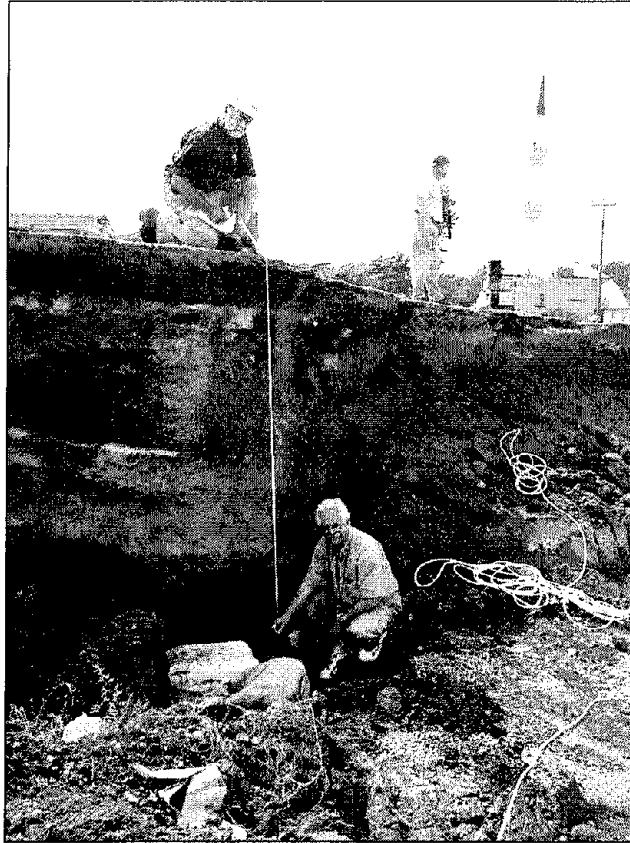
that form two major *dilational (release) stepovers* 4 to 6 km wide (Figure 2-3a). (The tectonic movement of these dilational stepovers contributed to the substantial subsidence of the coastal areas of Gölcük). One of the above en-echelon fault segments bends to the southwest (Figure 2-3a) forming thus a *restraining bend* that explains the large dip-slip (i.e., vertical slip) movements (~2.0 m) observed west of Gölcük (see Figure 2-7).

Figure 2-7 Approximately 2.2 m vertical offset measured on main fault, Gölcük

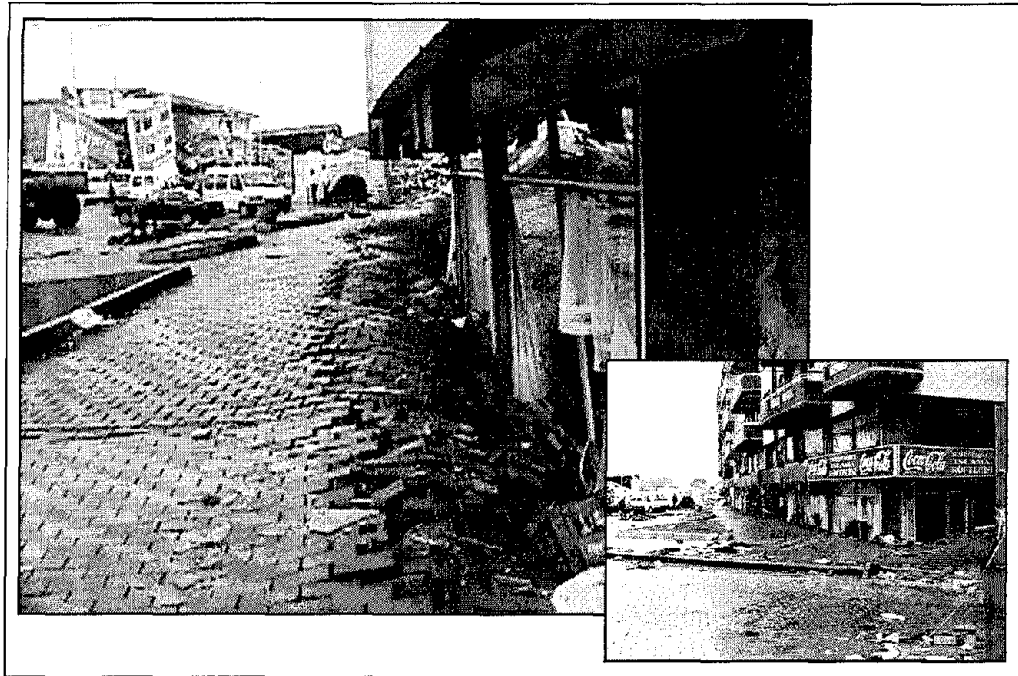
Figure 3-3 Building in Adapazari that sank 1.5 m uniformly into the ground when the soil beneath it liquefied and was pushed outward from beneath the building. Magnitudes of sinking were generally proportional to weight of building.

ings were affected; in many city blocks, the majority of buildings sank. Buildings in Adapazari locally sank as much as 1.5 m (Fig. 3-3). The part of Adapazari in which buildings settled is an area built on young flood-plain deposits of the Sakarya River. The groundwater table in these deposits is shallow, only about 1–2 meters. Although most buildings simply sank upright into the soil, a few were also overturned, which exposed their foundations (Fig. 3-4). The sunken buildings in many cases were less damaged from shaking than adjacent buildings that were on soils that did not liquefy during the earthquake. In addition, items on shelves in many stores in the settled buildings were not even dislodged. This suggests that once the foundation soils liquefied, seismic waves were unable to propagate through the liquefied soil and shake the buildings that settled as violently as adjacent buildings on non-liquefied soil. Sand boils were the primary surface evidence of liquefaction (Fig. 3-5); these sand boils vented onto sidewalks adjacent to buildings and into the first floor of buildings that settled. Many sidewalks around the buildings that settled were heaved upward, indicating bearing capacity failure after liquefaction and displacement of liquefied material outward from beneath buildings as they sunk into the ground. Settling also appears to be proportional to the weight of the building; multistory buildings sank more than adjacent single-story buildings. Delayed building settlements were also reported for foundations on silt that developed high pore pressures, but only experienced marginal liquefaction.

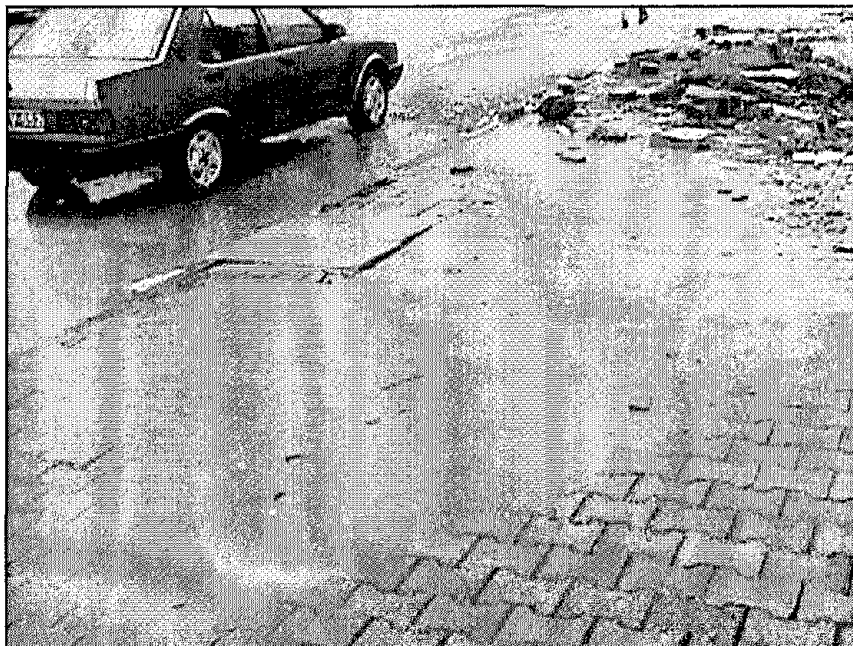
Figure 3-5 Sand boil on sidewalk in Adapazarı. Sand ejected from underground when sandy soils beneath the ground-water table liquefied during the earthquake.

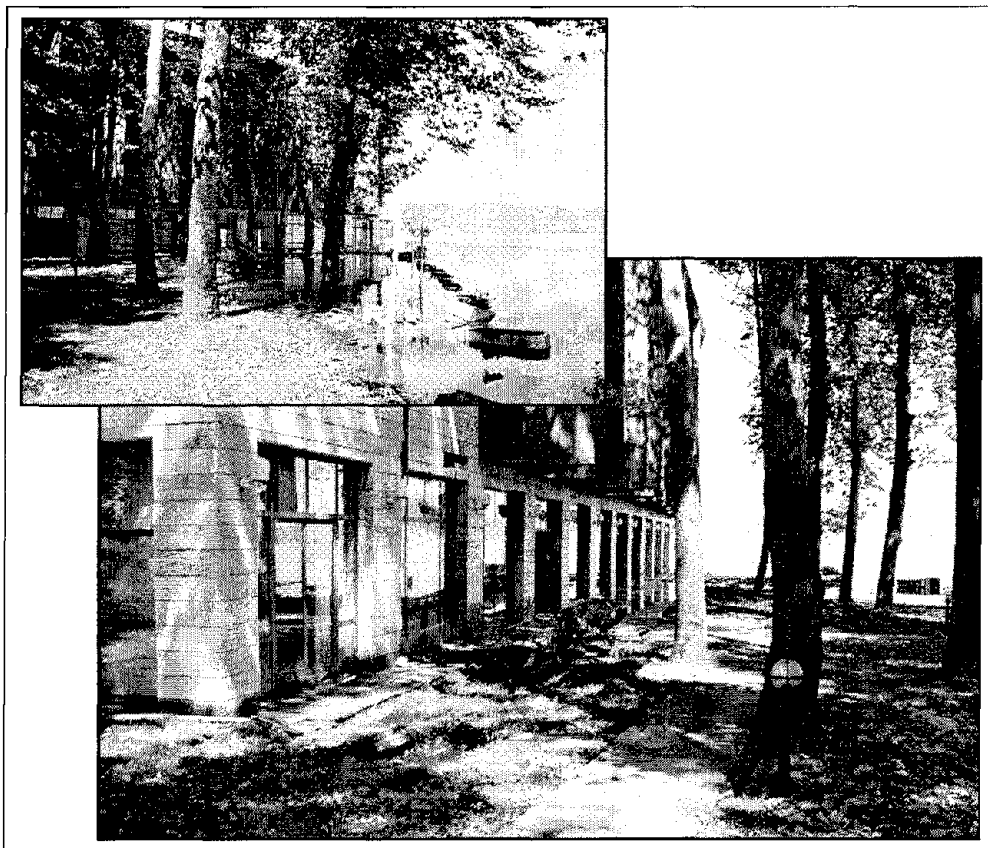
had prograded into Lake Sapanca, sank about 0.3 m into the ground. The regional land surface around the hotel also lowered causing the shoreline to submerge (Figs. 3-6, 3-7). In addition, the hotel was displaced about 0.5 m toward the lake by a lateral spread along the shoreline of the lake. Large quantities of subsurface sand vented to the surface and covered much of the driveway and the landscaping around the hotel.

Figure 3-6 Submergence of shoreline at Lake Sapanca and settlement of Sapanca Hotel. "Moat" adjacent to wall indicates the hotel has sunk into the ground because of liquefaction of underlying sandy soil.

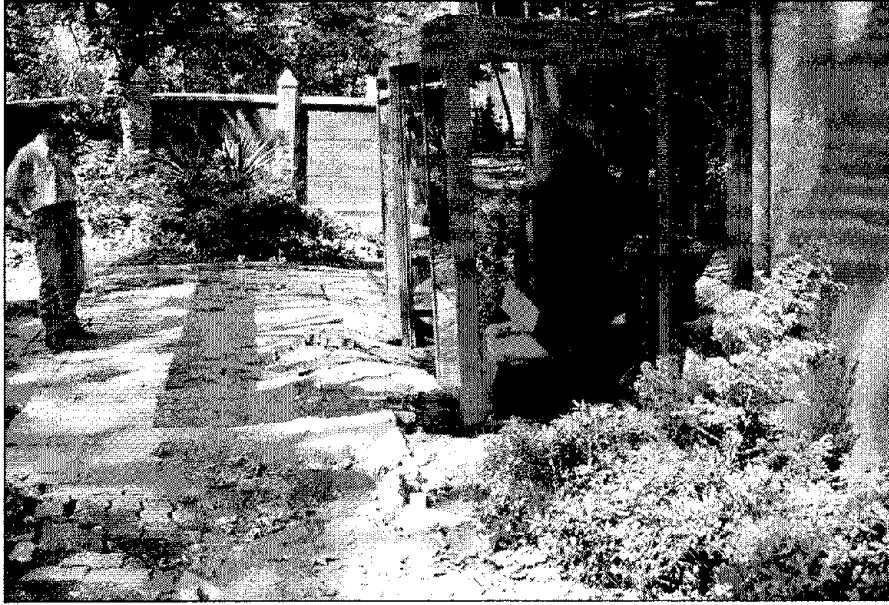
Figure 3-7 Sunken entryway into Sapanca Hotel created when building sank into liquefied soil

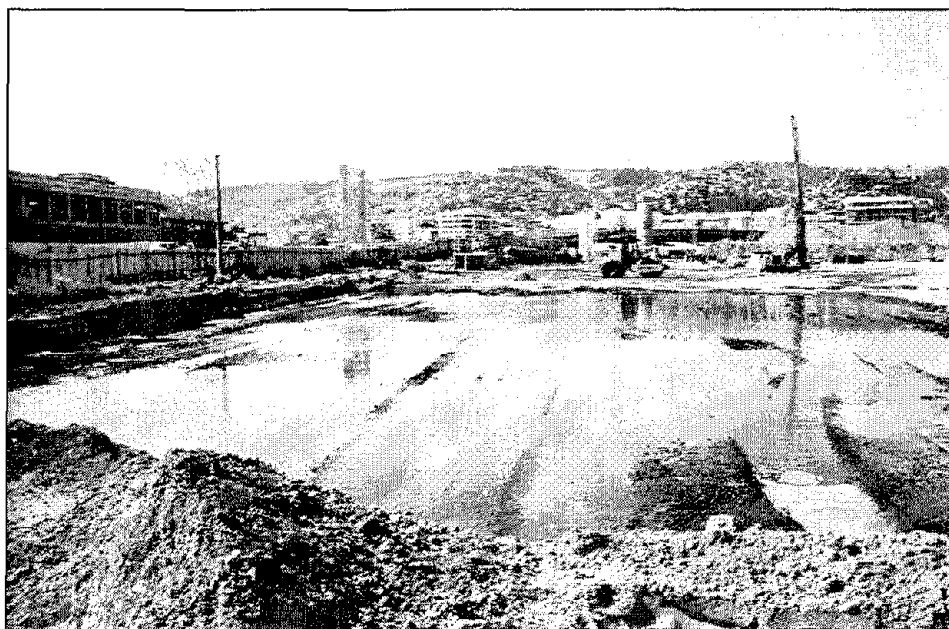
The Lot C area was found inundated with water the morning following the earthquake, as may be seen in Figure 3-9. Field inspection supported the conclusion that the surface water was discharged from the wick drains as a result of the seismically induced pore pressure generation leading to liquefaction of the sand layer. By comparing settlement readings obtained immediately before and following the earthquake, the seismically in-

Figure 3-9 Lot C area of Carrefour site showing ground surface inundated with water following the morning of the earthquake. Water is attributed to pore pressure buildup and subsequent drainage of the underlying loose sand layer through wick drains that were in place at the time of the earthquake.

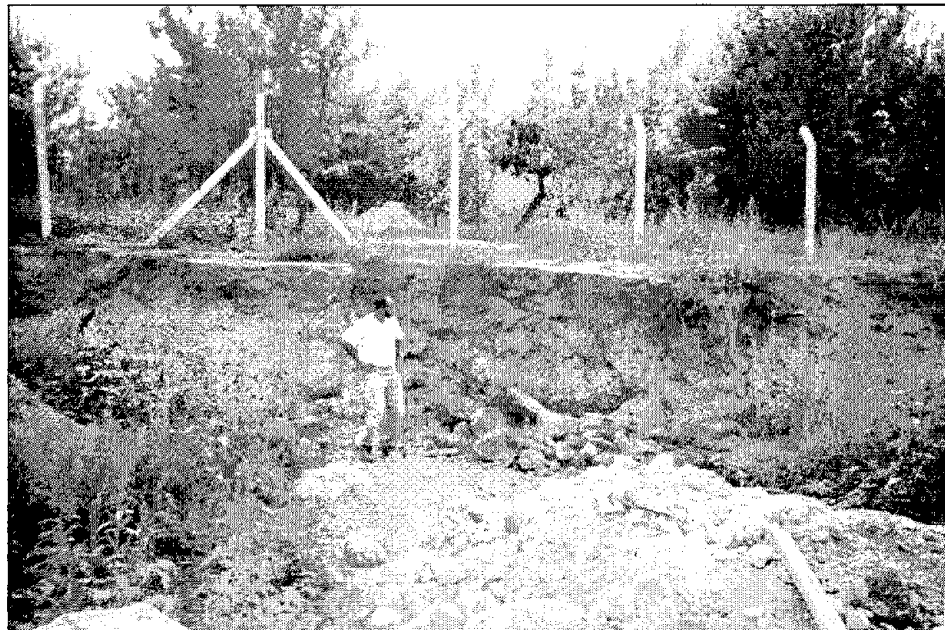
Figure 3-10 Vertical displacement of approximately 2.5 meters due to fault movements adjacent to the Ford-Otosan Plant east of Gölcük

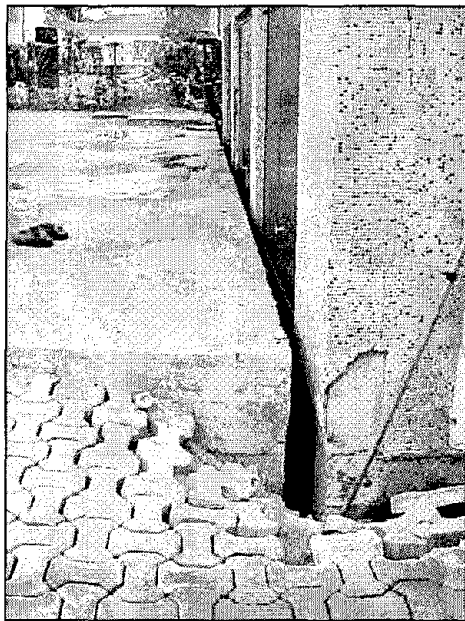
Figure 3-11 Example of building settlement in Adapazarı due to volume change of liquefied soil. Near vertical settlement of 48 cm was measured at the corner of the building.

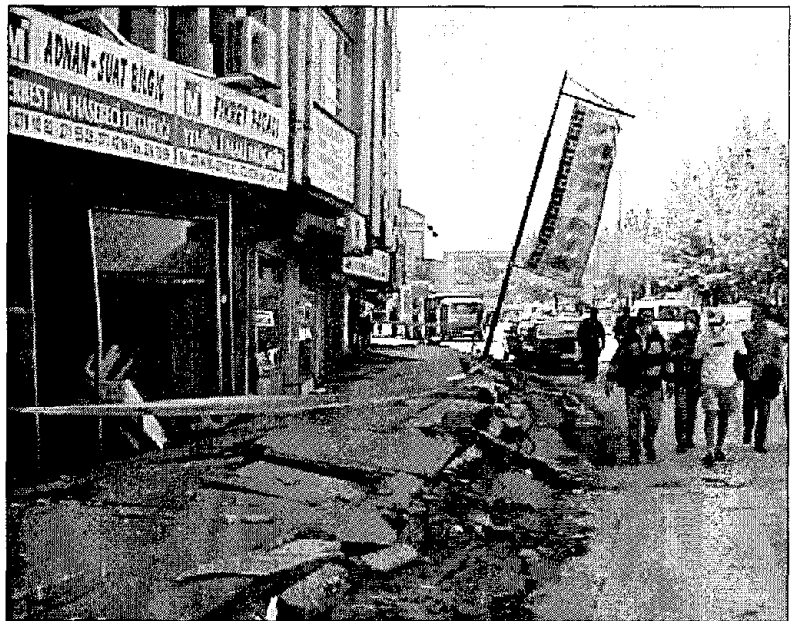
Figure 3-12 Example of settlement in Adapazarı as a result of bearing failure of the foundation soil as evidenced by ground heaving adjacent to the buildings

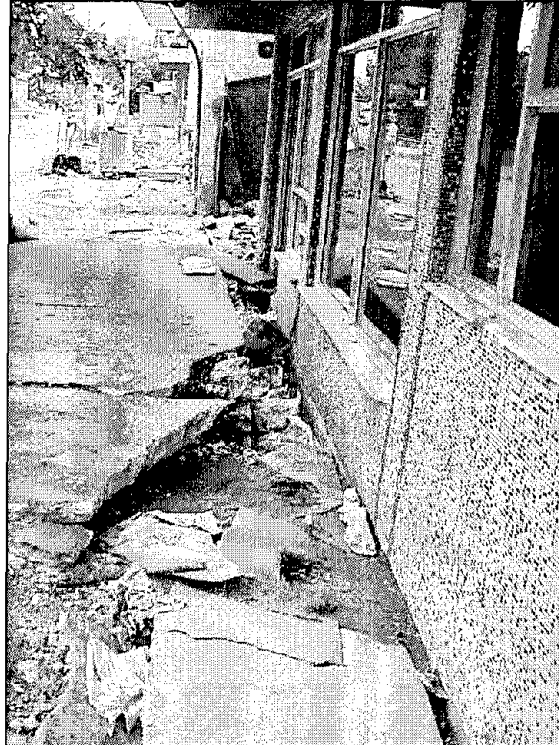
3. Shallow foundation movements were associated with three types of soil deformation, in the following decreasing order of frequency:
 - Settlement due to volume change. Settlements of up to about 50 cm were observed, with no evidence of soil bearing failure. Fig. 3-11 is an example of this type of behavior.
 - Bearing failure. Heave of the ground surface was observed in areas around the building or of interior floor slabs. Fig. 3-12 is an example of this type of failure.
 - Lateral movement. This was essentially a rigid body type displacement. The largest observed movement in Bray and Stewart's study, shown in Fig. 3-13, was 44 cm settlement, 50-55 cm laterally to the west (away from the sidewalk) and 100 cm laterally to the south (away from the photographer).

Figure 3-13 Building that experienced about 100 cm of lateral displacement

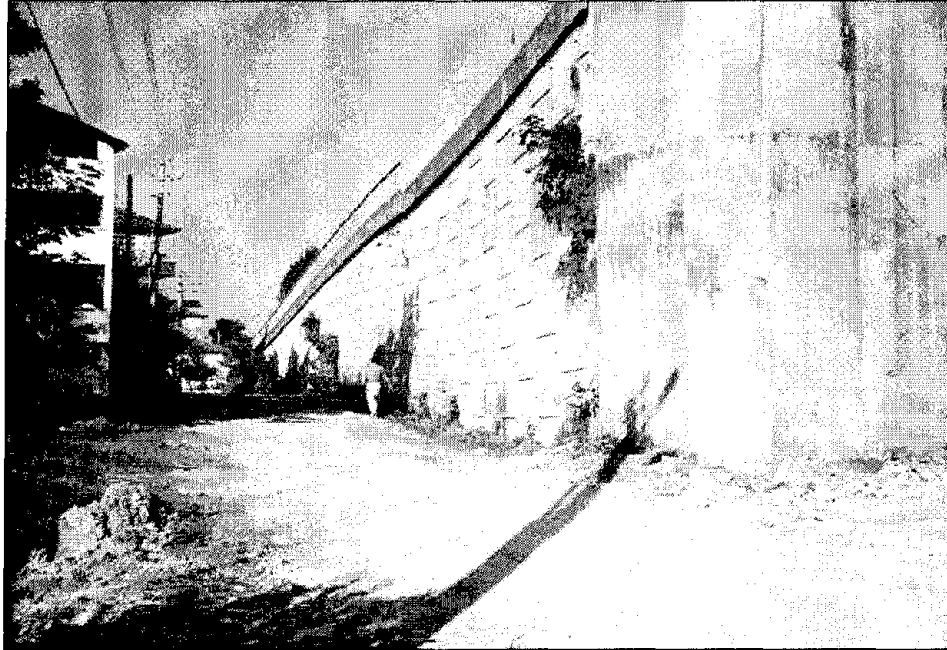
Methods of ground improvement that had been used for the different projects included preloading, wick drains, jet grouting, stone columns, compacted fills and earth reinforcement. Overall, the ground treatment and soil reinforcement were generally effective in mitigating earthquake-induced damage, especially liquefaction related ground movements. The fault rupture crossed the site of the Arifiye bridge (see Fig. 3-15) producing large displacements, of the order of 3.5 m laterally and 0.45 m vertically, and causing collapse of the four simple spans crossing the TEM. In spite of these large movements, the distorted reinforced earth abutments retained their integrity and did not fail, as may be seen in Fig. 3-16.

Figure 3-16 Reinforced earth wing walls and bridge abutment for the Arifye Bridge overpass. The reinforced earth structure retained its integrity in spite of the large deformations.

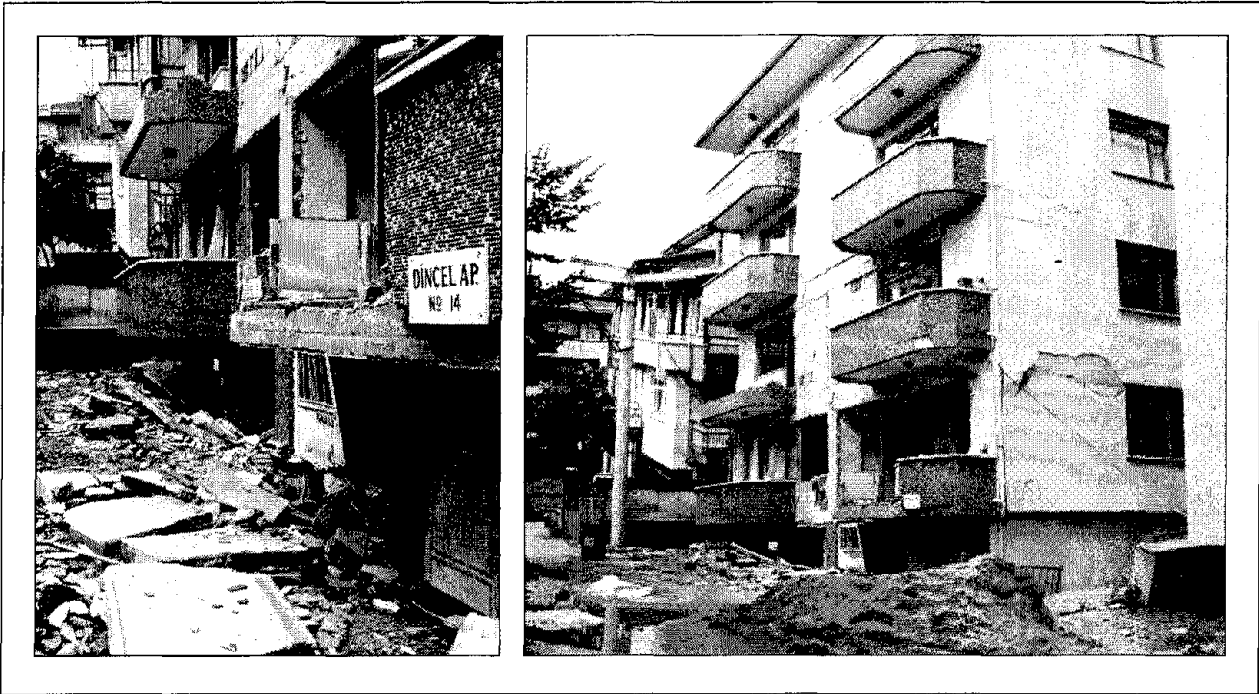
Figure 4-1 Damage due to foundation failure

An example of severe settlement is shown in Figure 4-1. Taking the distance from balcony to balcony as a reference, one may observe the short-distance left between the second floor balcony and ground level. This provides a qualitative measure of the magnitude of settlement that occurred. Figure 4-2 also shows the extent of ground heave all around the building as the soil under the building is pushed outward during settlement.

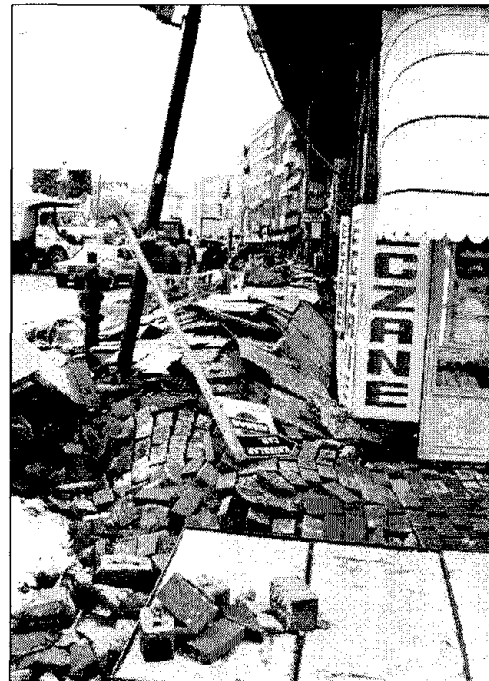
Figure 4-2 Ground heave was extensive all around this building

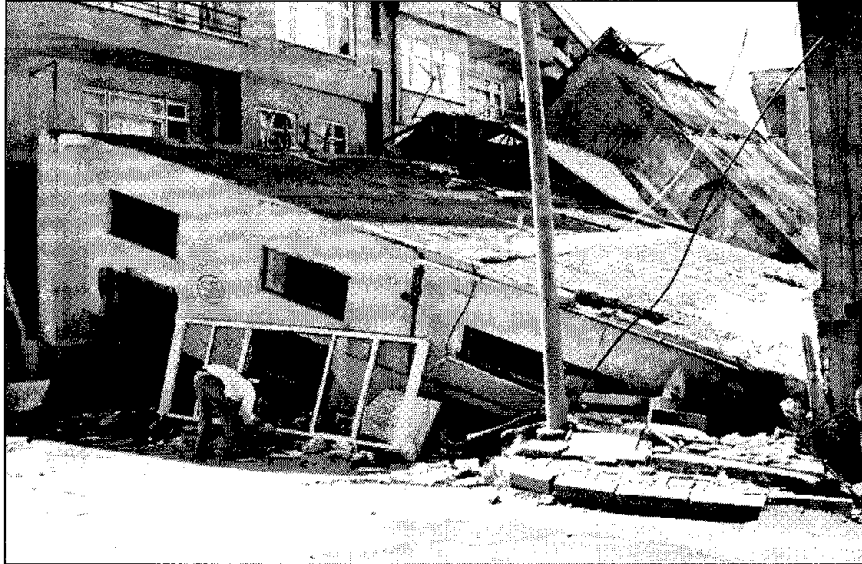
Examples of overturned buildings are shown in Figures 4-3 and 4-4. In the latter case, force vectors are superimposed on the building to illustrate its significant resistance to lateral loads (Figure 4-4b). As shown in that figure, the resultant weight of the structure, schematically located at the center of gravity of the above-ground portion of the toppled building, can be decomposed into its components perpendicular and parallel to the building's original vertical axis. Calculations indicate that the building, in its new

Figure 4-3 Overturned building due to foundation failure

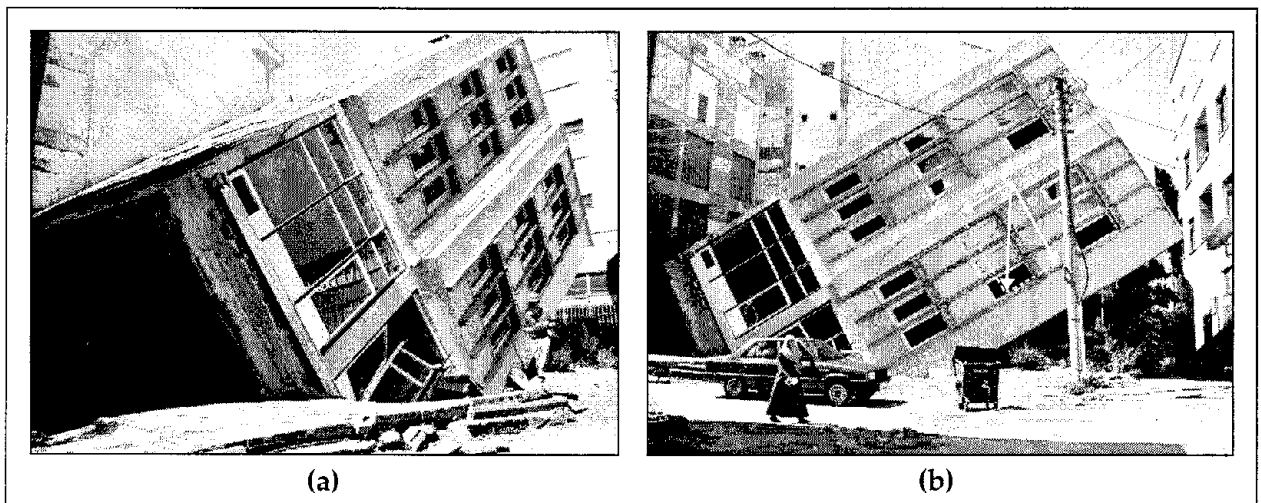
Figure 4-4 Overturned building due to foundation failure

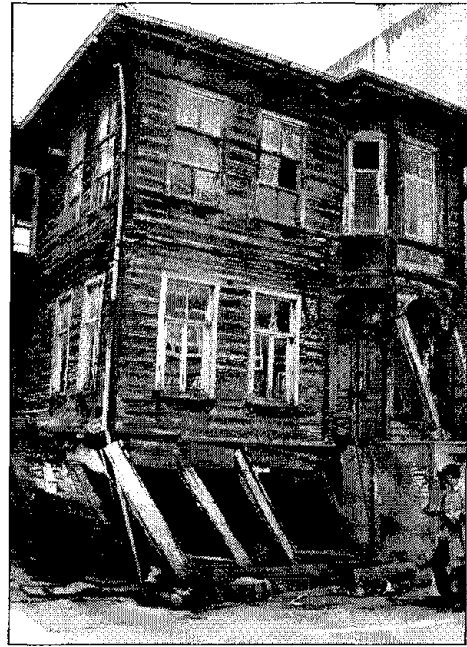
During the earthquake, the presence of a soft story increases deformation demands very significantly, and puts the entire burden of energy dissipation on the first-story structural elements, as opposed to distributing the burden along the entire height of the building. Many failures and collapses can be attributed to the increased deformation demands caused by soft stories, coupled with lack of deformability of poorly designed columns. Examples of soft-story failures can be seen in Figures 4-5 to 4-9. The timber building shown in Figure 4-5, having a wide obstruction-free ground floor used as a parking garage, has nearly collapsed and clearly illustrates how significant damage can concentrate in the soft-story of such buildings.

Figure 4-5 Failure of soft first story in a timber building

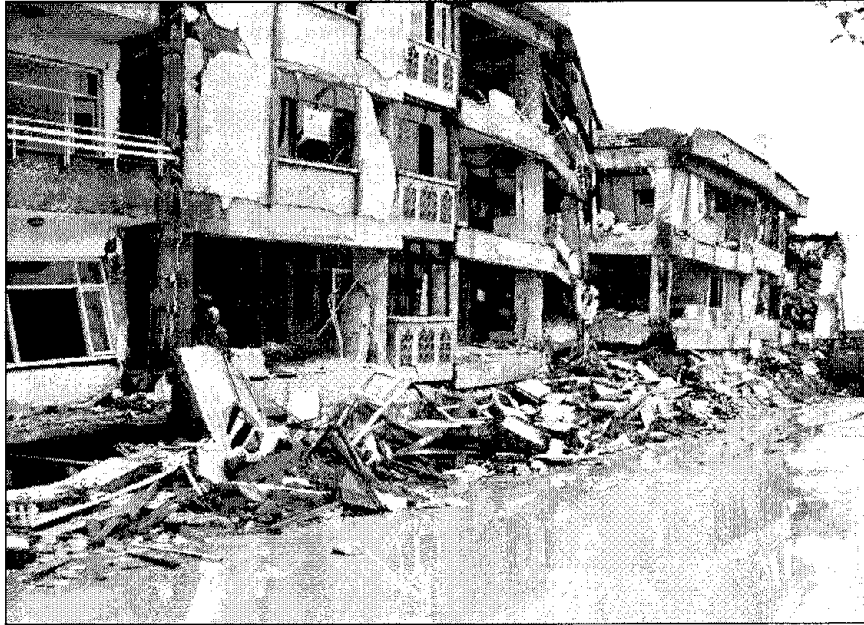
Figure 4-7 Failure of soft first story

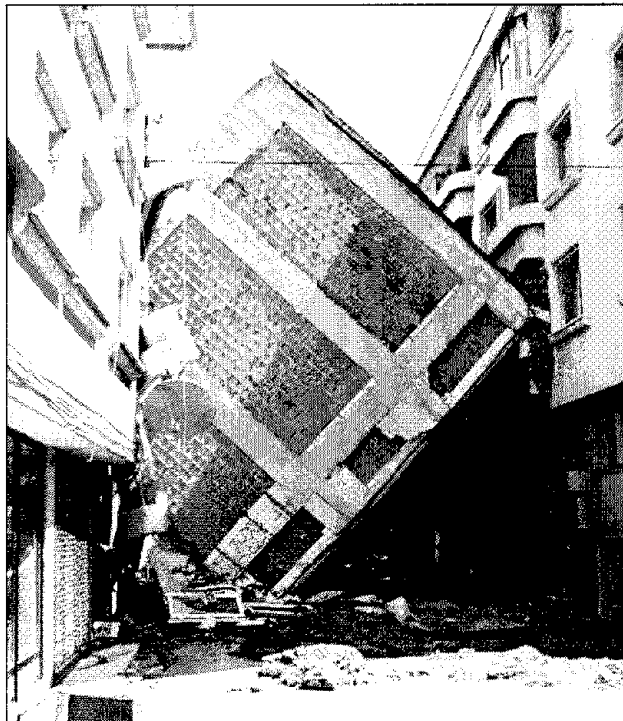
Figure 4-8 Failure of soft first story

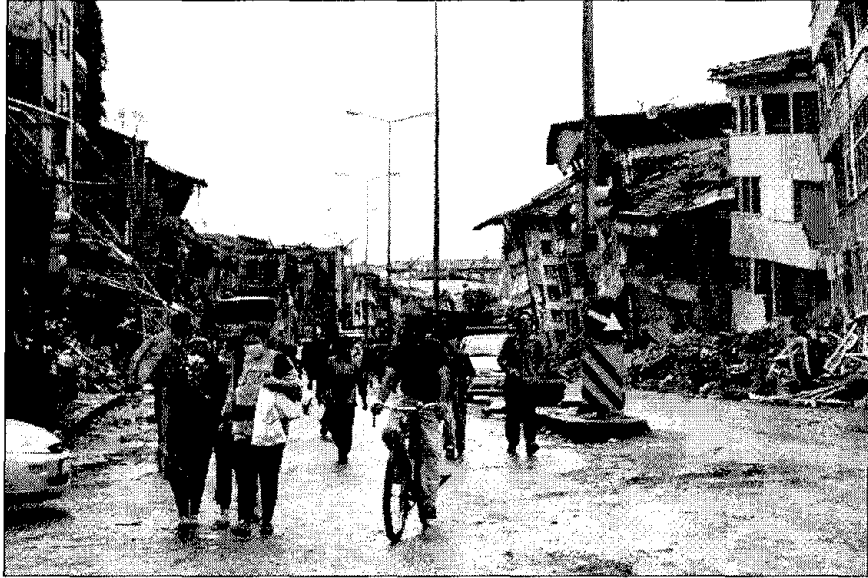
Soft-story buildings having open street facade and solid back-walls tend to collapse toward the street as a result of the torsional plan eccentricity. Story sway is greater on the more flexible facade side, resulting in greater displacement and ductility demands on the more vulnerable columns on the facade side (Figure 4-8). This was particularly evident on a commercial street where nearly all the buildings collapsed towards the street (Figure 4-9).

Figure 4-9 Buildings in this commercial area collapsed towards the street due to open facades (soft story) and walls on back side adding torsional eccentricity

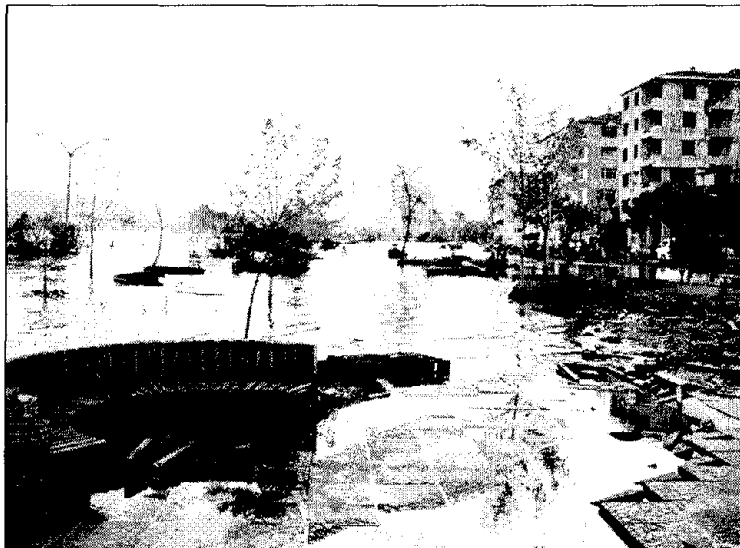
Soft-story failures combined with ground failures were also observed along the waterfront in Gölcük. As shown in Figure 4-10, the water of the Marmara Sea submerged parts of the waterfront as a result of ground lateral spreading. Some buildings located along the waterfront (e.g., Figure 4-11) were thus impacted by both geotechnical and structural deficiencies.

Figure 4-10 Marmara Sea submerged parts of the waterfront as a result of ground lateral spreading

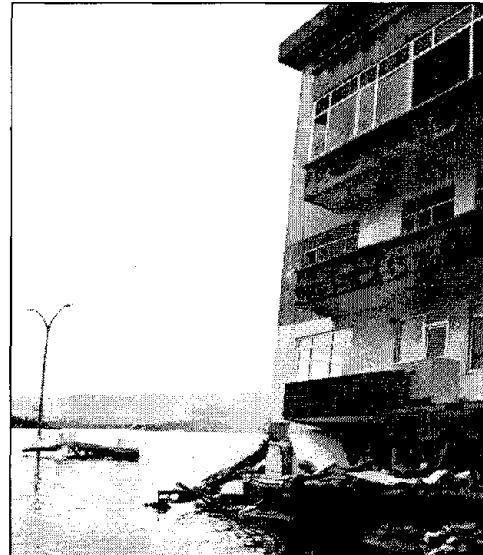
Figure 4-11 Some waterfront buildings were impacted by both geotechnical and structural failures

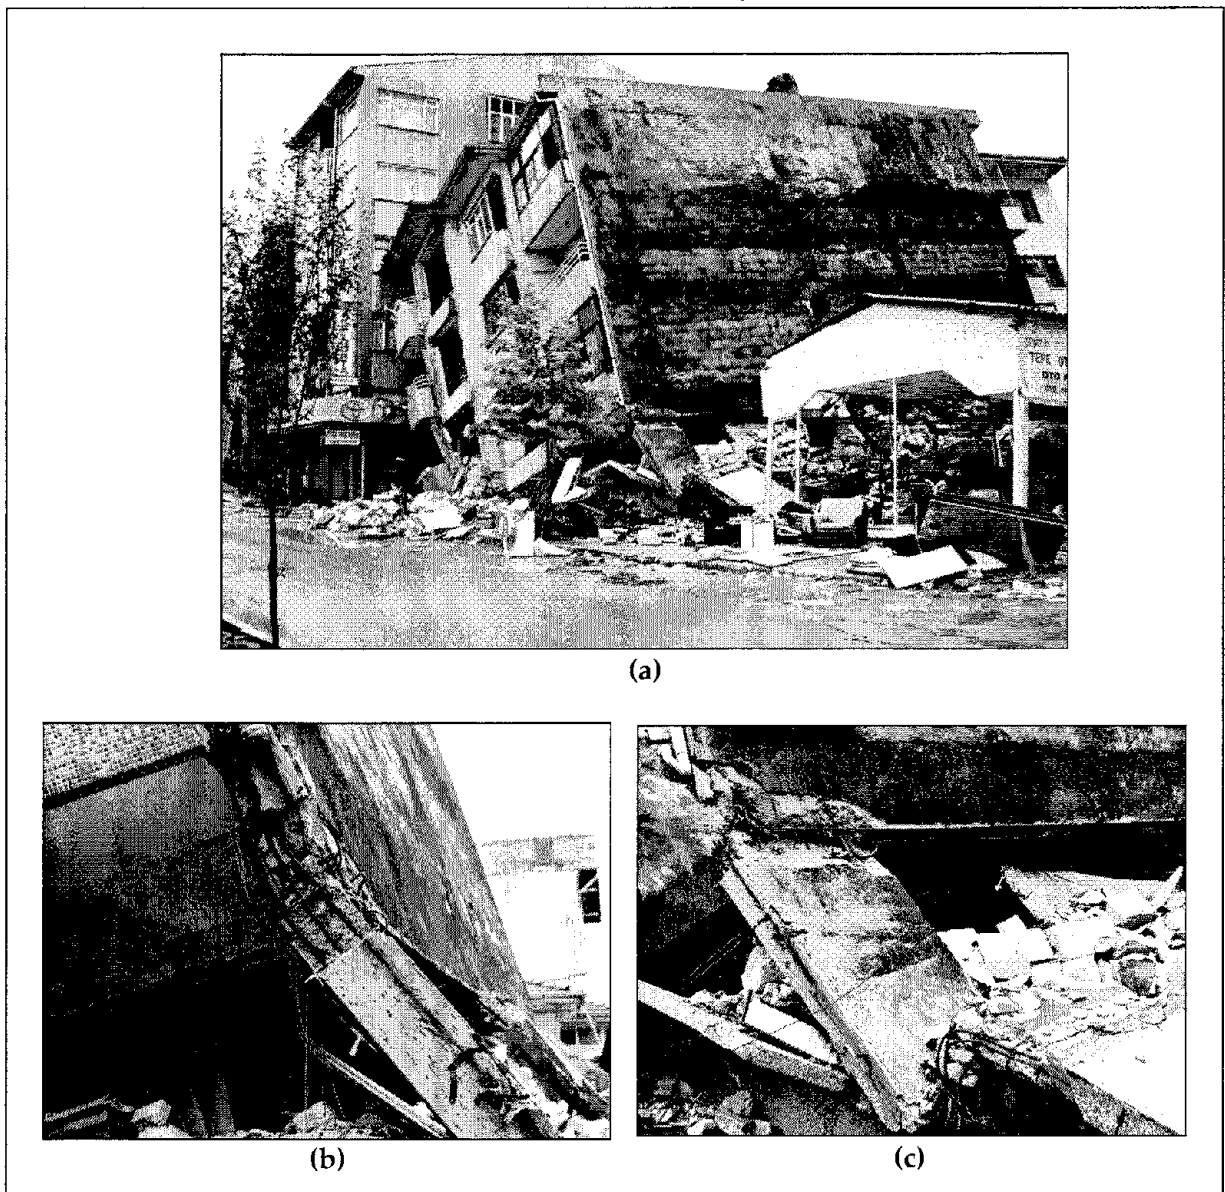
In most frame structures, the beams were strong and remained elastic, and the columns were weaker and suffered damage and failure in the form of compression crushing, plastic hinging, or shear failure. In many cases, relatively deep beams were used with flexible columns, contributing to a strong-beam weak-column behavior. This undesirable behavior is illustrated in Figure 4-12 and 4-13. In Figure 4-12, for example, the column depths are sizeable along the building alley sides, but they are narrow and thereby less able to resist by flexure the seismically-induced horizontal forces parallel to the front street, particularly when compared to the beam depth and strength at the story above. Not surprisingly, the building collapsed swaying in the direction of weakest column flexural strength.

Figure 4-12 Damage due to strong beams and weak columns

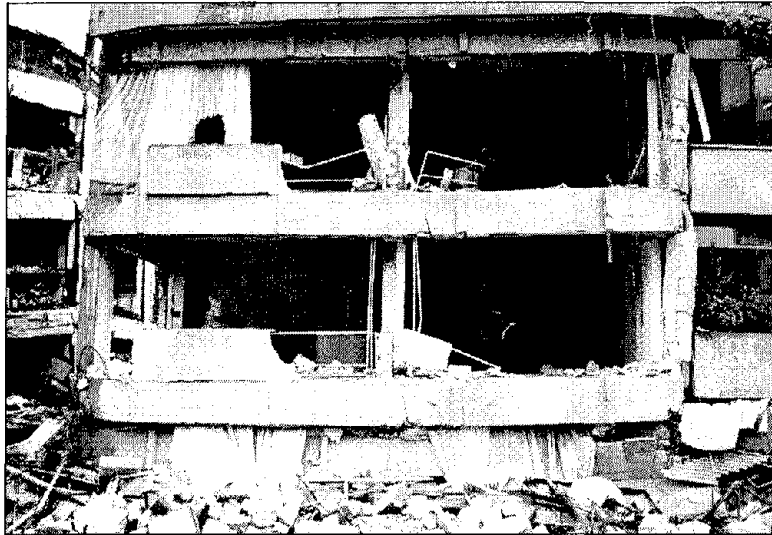
Figure 4-13 Damage due to strong beams and weak columns

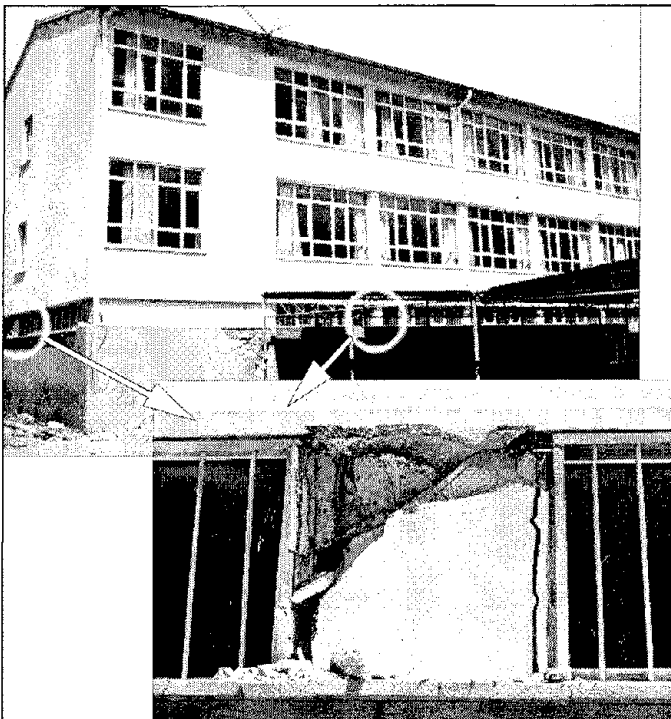
Figure 4-14 Damage due to short (trapped) columns

Column damage varied as a function of column geometry and detailing. Examples in Figure 4-14 and 4-15 illustrate shear failure in short captive columns “trapped” between partial height infills, and flexural failure in non-ductile reinforced concrete plastic hinges, respectively.

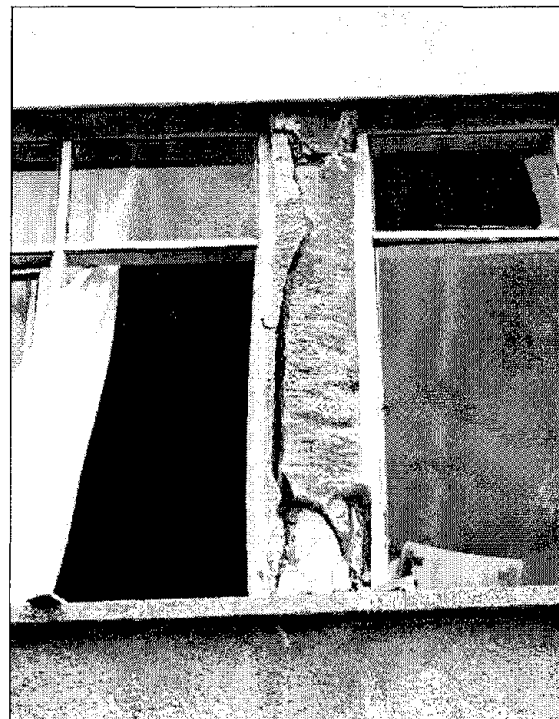
Figure 4-15 Damage due to flexural failure in non-ductile plastic hinges

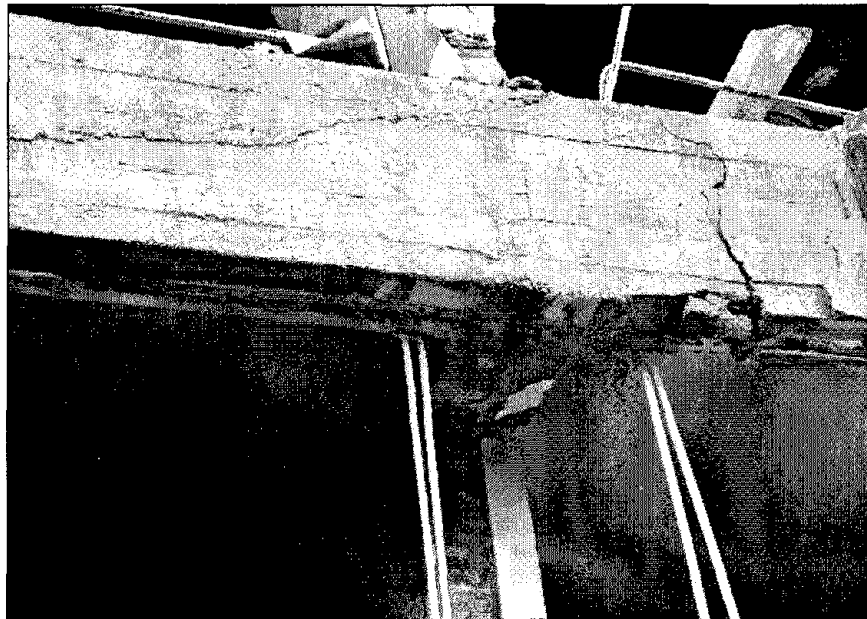
Most of the structural damage observed in frame buildings was concentrated at column ends. Unfortunately, confinement reinforcement was virtually nonexistent in these members, making them unable to maintain the required ductility. A number of detailing deficiencies were observed in the damaged structures. This included lack of anchorage of beams and columns reinforcement, insufficient splice lengths, use of 90° hooks, poor concrete quality, less than full height masonry infill partitions, and frequent combinations of many of the above. These errors were often compounded by geometric irregularities such as eccentric beam-to-column connections that induced severe torsion in short perpendicular stub beams (Figure 4-16).

Figure 4-16 Damage due to eccentric beam-to-column connections

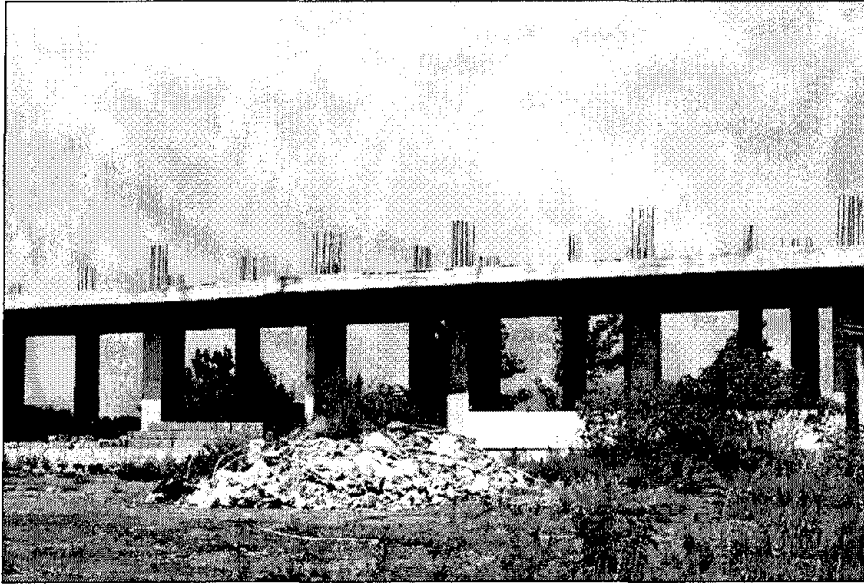
The construction sequence adopted in Turkey’s residential buildings is partly responsible for some significant failures due to lack of column reinforcement anchorage. Typically, residential buildings are constructed over a large number of years, one story at the time. Families do not wait for completion of the entire building prior to occupancy, and usually elect to live in the lower completed stories. Additional stories are added as the need arises. Figure 4-17 illustrates a one-story building during construction. Note the column vertical reinforcement extended above the roof line. Infill walls will be added to the first story and residents will move in, and this reinforcement will be left extending above the slab until the day (maybe years ahead) when construction will resume to add another story. As a result of this practice, and because smooth bars are frequently used, anchorage of the column

Figure 4-17 One-story building during construction with column bars extended above roof slab to accommodate possible construction of other stories in future years

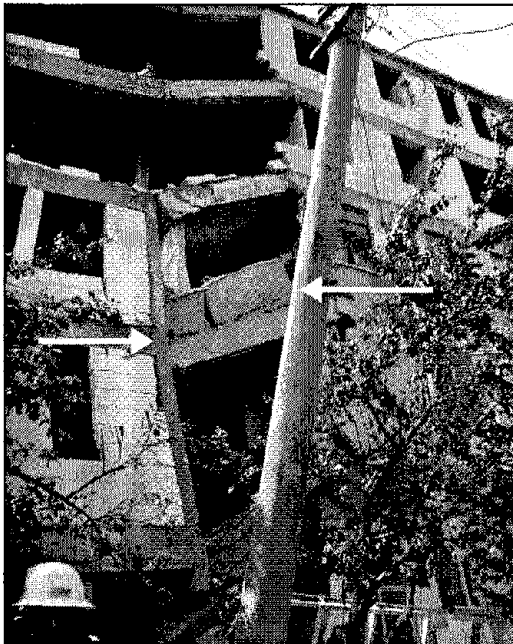
A number of buildings sitting directly on the fault were also destroyed by the relative movements of the fault (Figure 4-19). However, numerous buildings immediately adjacent to the fault survived without structural damage. For residential buildings, this is generally attributable to the additional strength unintentionally provided by the infills, as indicated previously. Industrial buildings similarly located, however, survived on the merit of their explicit design. For example, an industrial complex being constructed 100 feet from the fault had very well confined columns. Extensive ground settlements induced large structural permanent displacements to parts of the structure, but damage was generally limited to minor spalling as the spacing of the column's transverse reinforcement was adequate to ensure ductile behavior (Figure 4-20).

Figure 4-19 Collapsed five story building intersected by faulting. Arrows show where fault intersected the building, with attendant differential settlement.

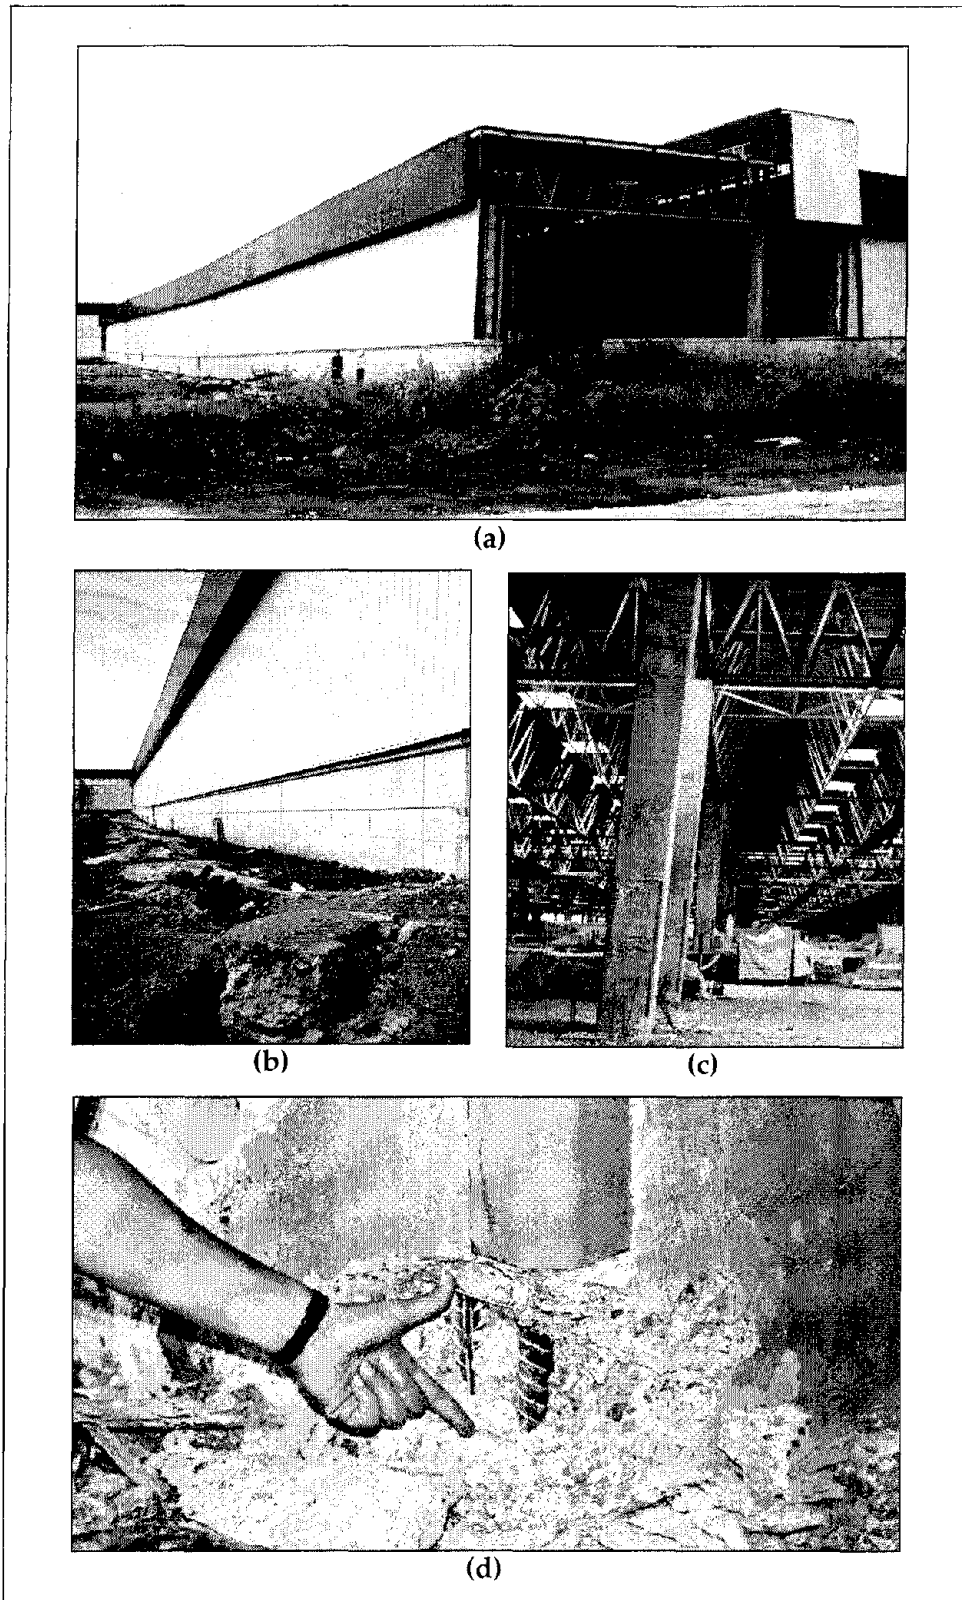
Figure 4-20 Industrial facility near the fault: (a-b) Global views of damage due to large ground settlements; (c-d) leaning column with limited damage at base as a result of ductile details (spacing of transverse reinforcement is indicated by thumb and index fingers)
