The Marmara, Turkey Earthquake of August 17, 1999: Reconnaissance Report

Edited by
Charles Scawthorn¹

Technical Report MCEER-00-0001

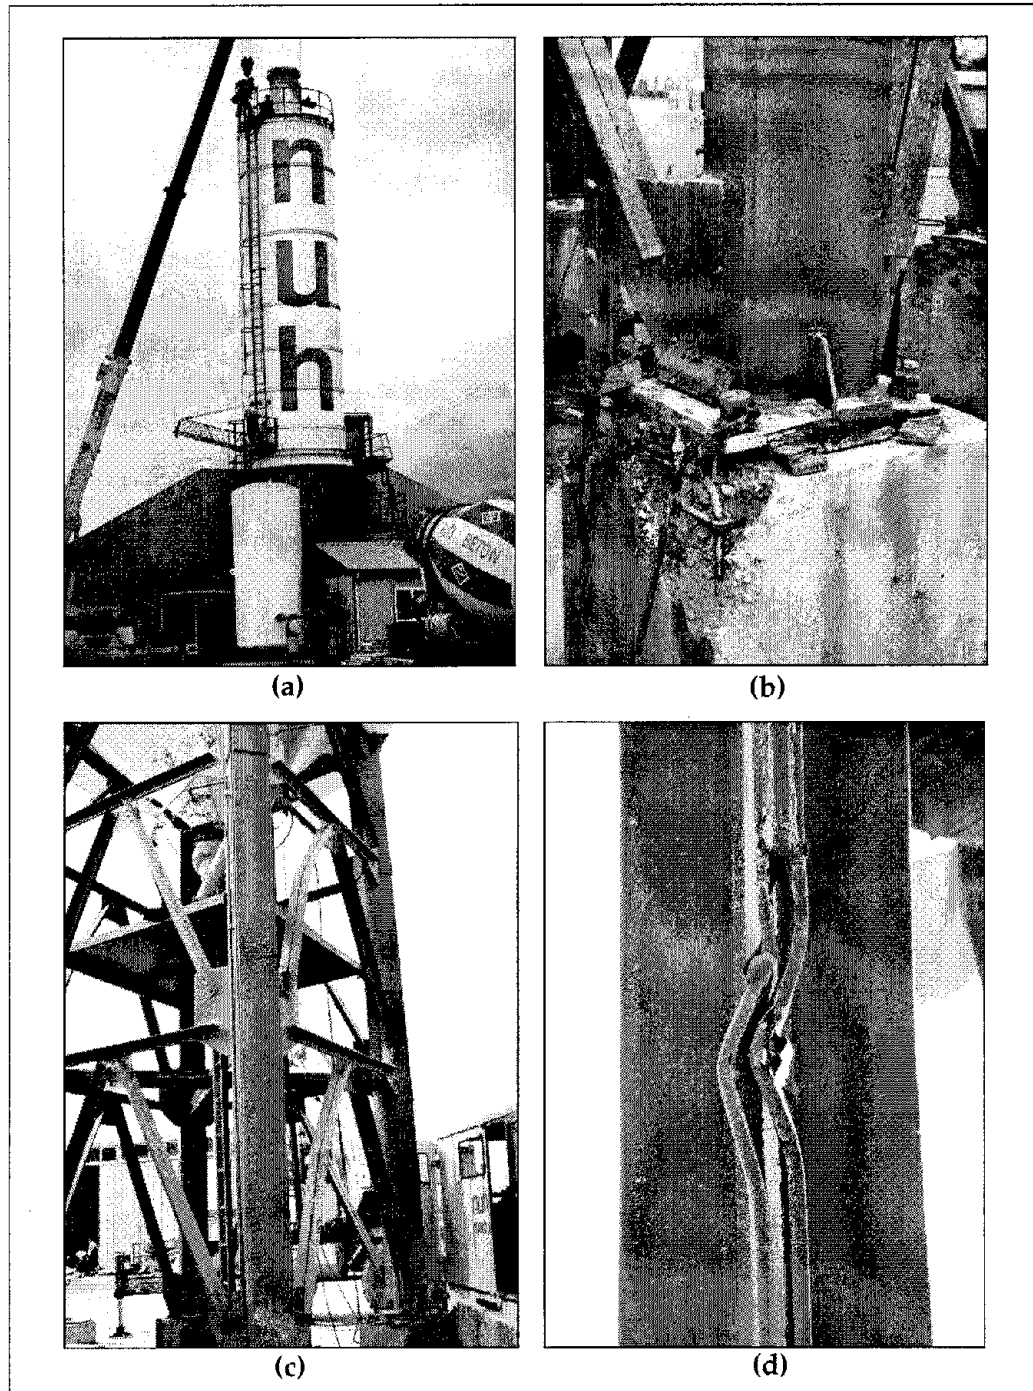
An interesting comparison between ductile and non-ductile steel details for nearly identical structures is shown in Figures 4-21 and 4-22. In Figure 4-21, the anchor bolts of the tank supports of the NUH concrete producing facility yielded in tension, and concrete of the 2.8 m deep pedestals spalled under the compression impact. Although this is not a ductile detail, the braces would be in partial compliance with the AISC seismic design provisions.

Figure 4-21 Damage to steel structures at NUH concrete plant: (a) global view; (b) spalled pedestal; (c) global buckling of braces; (d) local buckling at brace mid-length

The 2,400 mm long braces are 2L80x80x8 back-to-back 10 mm from each other with batten plates at the 1/3 points, resulting in members having slenderness KL/r of 97 and b/t of 10; note that the AISC limits for ductile concentrically braced frames are 101 and 7.35 respectively for Grade 50 steel, 120 and 8.7 for Grade 36 steel. Connections were also stronger than $A_g F_y$ of the members. Hence, these braces partially met (intentionally or not) the AISC 1997 requirements for ductile concentrically braced frames (DCBF). Inelastic action developed in

the braces, allowing ductile structural response through dissipation of hysteretic energy in a stable manner, with the exception of the deficient anchor bolts detail and somewhat premature local buckling, and the braced frame survived. Global brace buckling, and local buckling at the brace mid-length plastic hinge (Figure 4-21d) illustrate this ductile plastic response. Also typical of braced-frame with Chevron brace configurations, buckling of the diagonal in compression occurred prior to yielding in tension; this led to force redistribution within the structure and resulted in plastic hinging at mid-span of the horizontal member and slight permanent vertical deformations was visible at that point. This typical mechanism of Chevron braced frames is well known and explained in greater detail elsewhere (Bruneau et al., 1997).

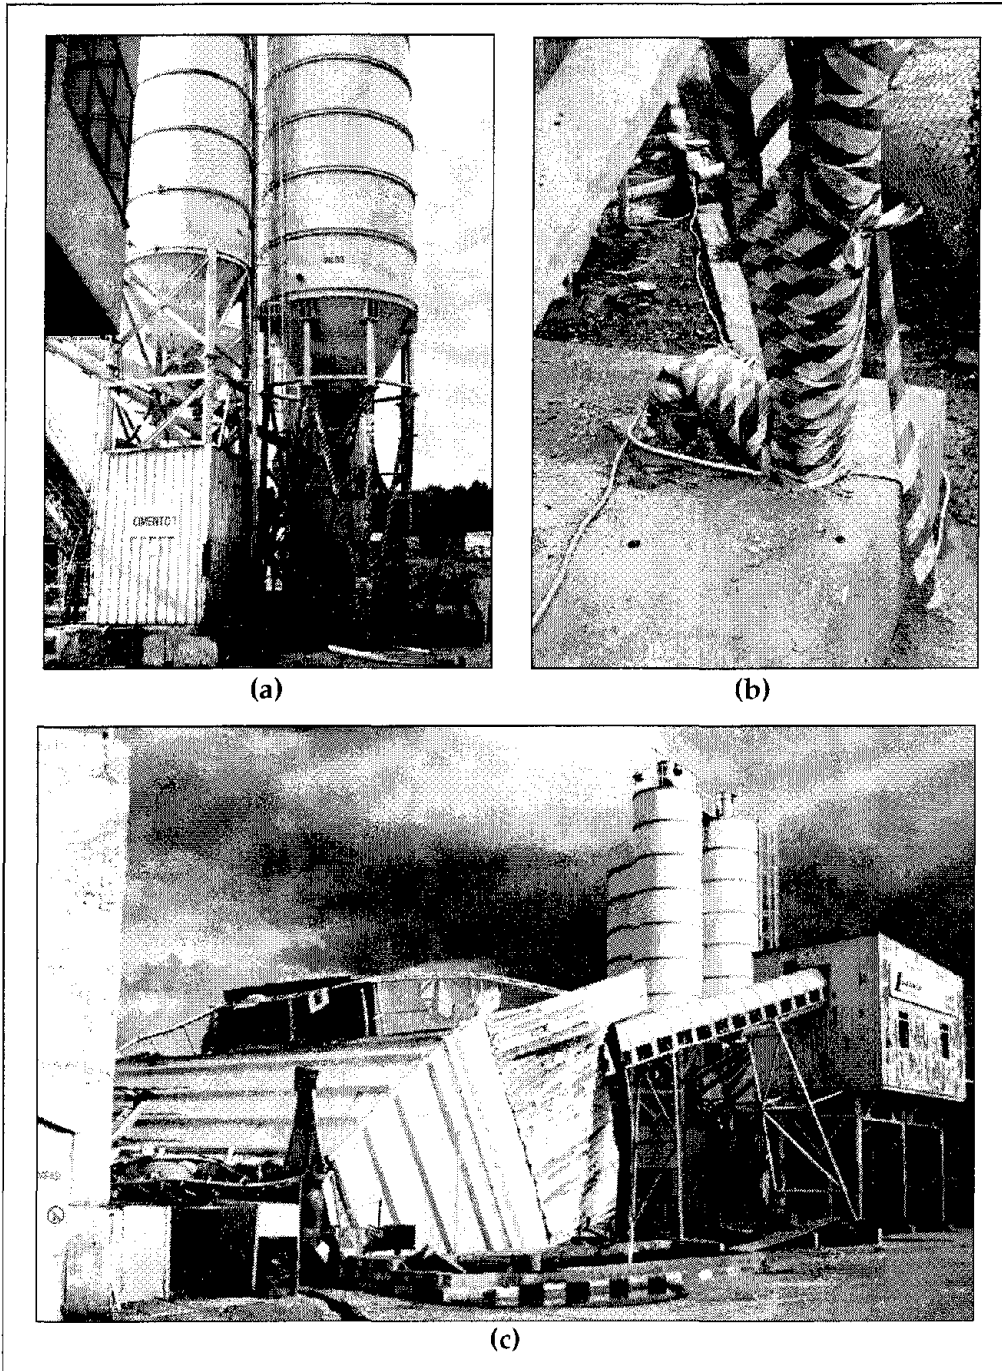
Figure 4-22 Damage to steel structures at Lafarge concrete plant:
(a) global view; (b) buckled leg; (c) overturned sand bin.

By comparison, structures serving the same purpose at the Lafarge concrete plant suffered excessive damage. In this case, all members of the braced towers were hollow structural circular steel members, 150 mm in diameter and approximately 3 mm thick, for a resulting D/t slenderness ratio of 50, greatly in excess of the limit of 26 imposed for Grade 50 steel braces by the aforementioned AISC seismic provisions. However, braces did not buckle in this particular case. Because the lower brace was connected to the tower leg 16" above the base, the tower behaved as a rigid braced structure supported on a 16" tall moment frame, and the tower leg buckled at that location under the combined axial and flexural stresses resulting from this localized severe eccentricity (Figure 4-22). Steel locally fractured in some locations as a result of the large strains induced by this collapse. Note that the most severely damage tower was estimated to be 85-90% full (85 m³ out of a 110 m³ capacity) at the time of the earthquake, while the other towers were approximately 65% and 90% full. Incidentally, a gravel and sand bin (approximately 25% full) adjacent to these towers, overturned and collapsed. It was supported on six legs, each tied with a 24 mm diameter bolt to a concrete base. The legs buckled on one side, and the anchor bolts pulled out of the foundation or tore out of the leg as the bin collapsed (Figure 4-22c). Note that damage or collapse of elevated reservoirs was common throughout the affected area (Figure 4-23).

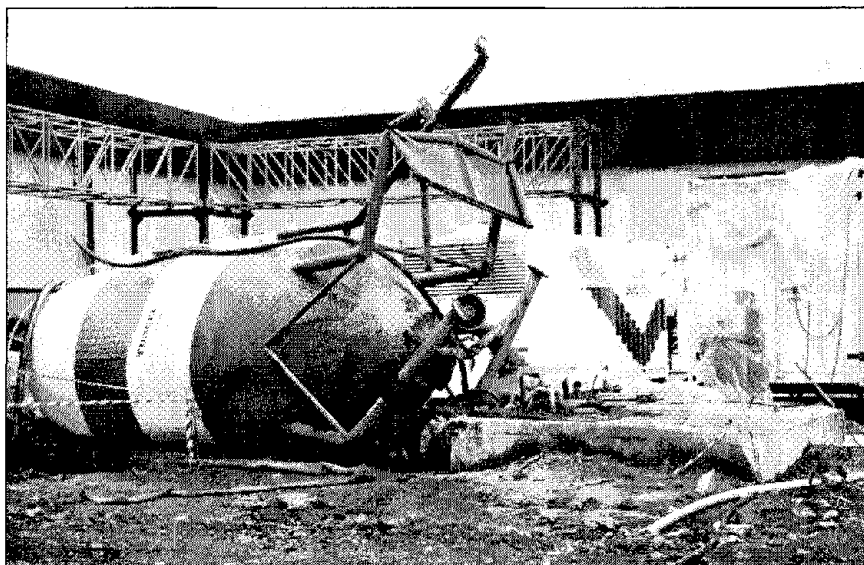
Figure 4-23 Overturned reservoir

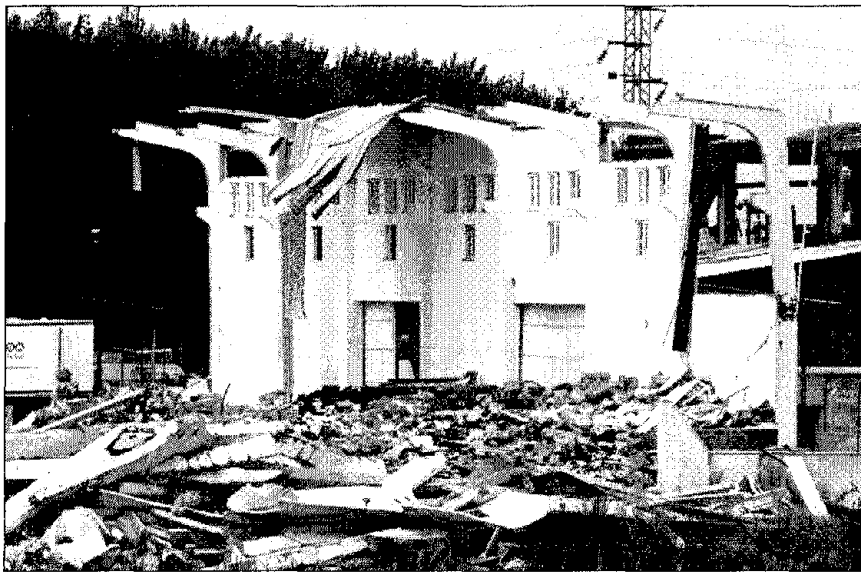
Damage to buildings of other construction materials was also observed throughout the affected area. For example, many industrial facilities of pre-cast concrete collapsed as a result of failures at the beam to column connections (Figure 4-24). Damage to unreinforced masonry buildings was also sometimes observed. For example, the building shown in Figure 4-25 suffered severe shear failure of its corner wall, as a result of bi-axial seismic action. The number of such buildings was, however, small in proportion to the overall building inventory.

Figure 4-24 Damage to a precast concrete building

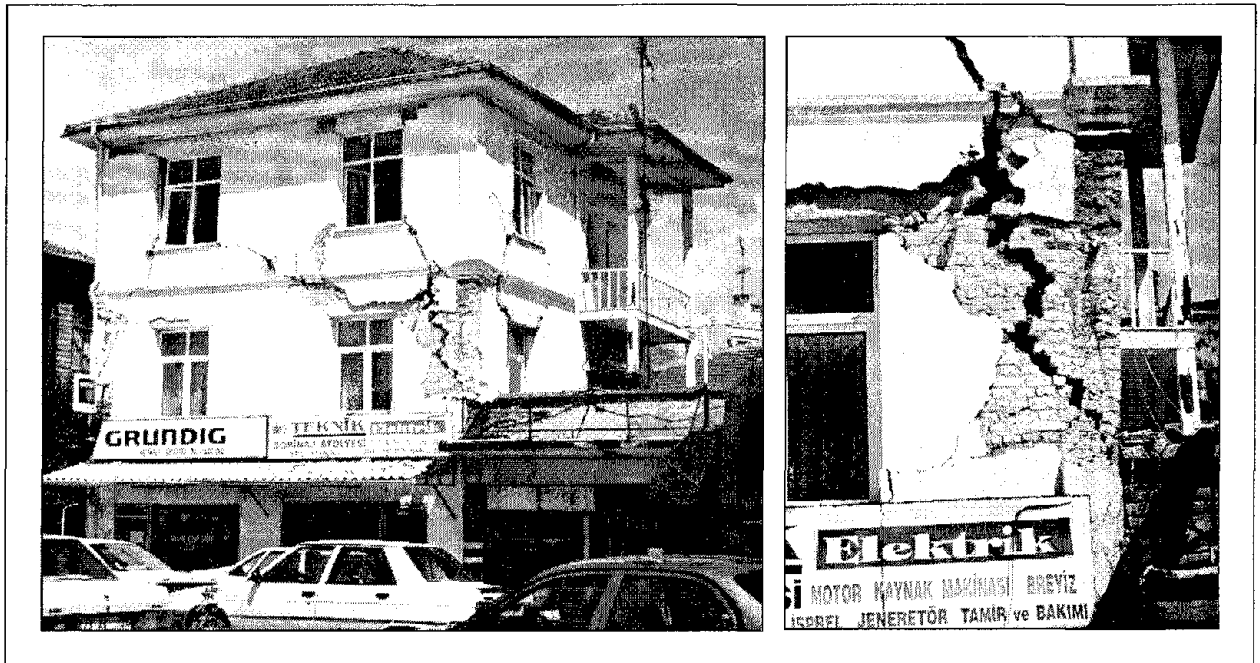
Figure 4-25 Damage to an unreinforced masonry building

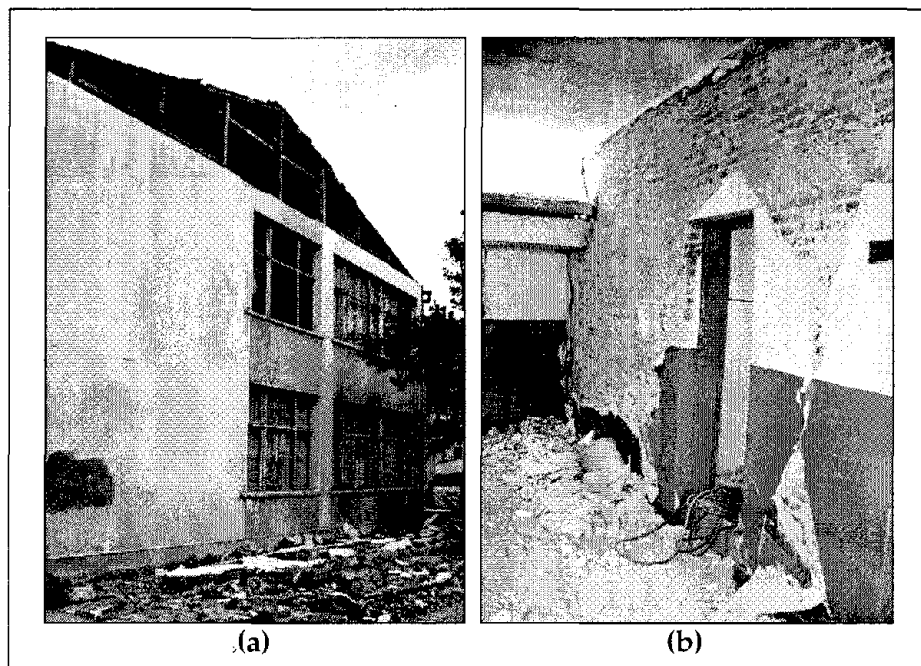
ing shown in Figure 4-26a, out-of-plane failure of an unreinforced masonry gable due to inadequate anchorage to its backing could have killed or maimed many children had this earthquake occurred at a time when the school yard was being used. Likewise, failure of the plaster wall finishes inside the corridors of the same school (Figure 4-26b) could also have hurt many small children.

Figure 4-26 Nonstructural damage to a school building

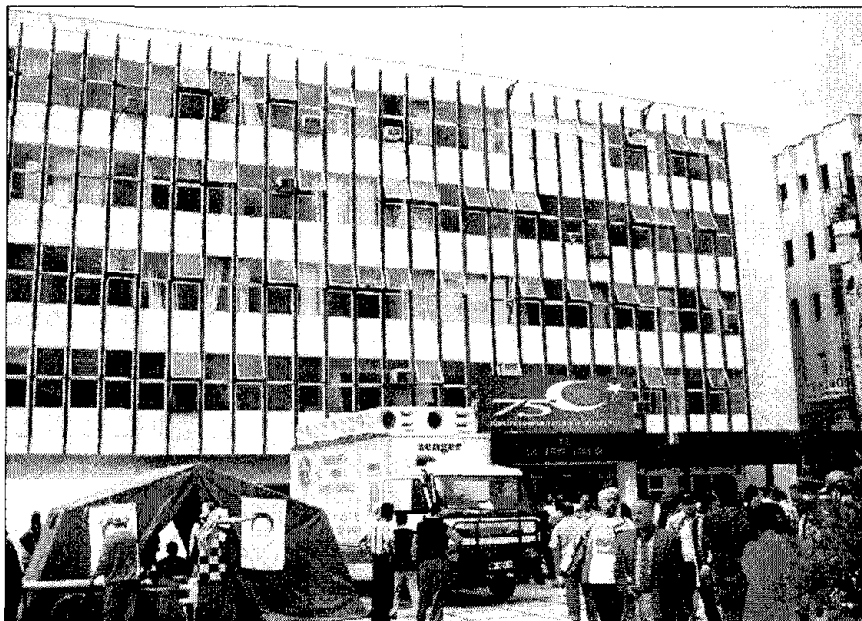
Figure 4-27 Undamaged Sakarya "province" government building retrofitted with shear walls prior to the earthquake

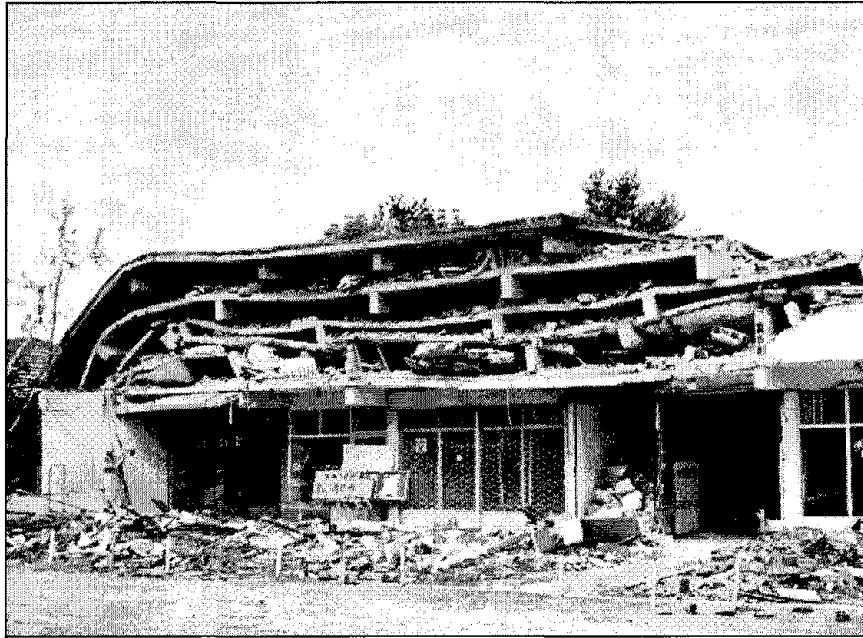
Figure 4-28 Typical building adjacent to the retrofitted Sakarya "province" government building

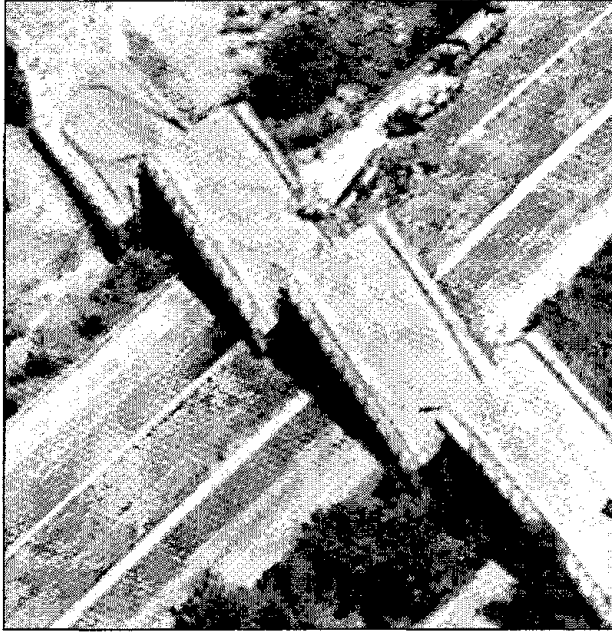
Figure 5-2 Collapse of the Motorway overpass that carries the D650 road over the E-80 Trans European Motorway (north abutment at top of photo)

essentially continuous for live load. The piers were skewed 20° . During the earthquake, the fault rupture propagated between the third pier and the northern abutment, as seen in the top left-hand corner of Figure 5-2. As the seat widths for the north span were insufficient to sustain the large (> 1.5 m) right-lateral offset movements, it unseated and fell from its support. In so falling, the fourth span, via deck continuity, also dragged the other three spans off their seats. Direct support to the soffit of the girders (south end of each girder) was lost—the deck slab possessed insufficient strength to carry the tributary weight of the span, and as a result, failed in shear. Consequently, as shown in Figure 5-2, the south end of each span fell off its seat and came to rest on the ground. Unfortunately while falling off the seat, the third span (between piers 2 and 3) collapsed onto a passing bus killing ten people.

For this particular bridge, several measures could have been taken to avoid such a failure. Design improvements that might have been made in this structure would be to ensure full continuity is provided for dead loads as well as live loads. In this way, perhaps only one span would have collapsed with the fault passing directly beneath that span. As an alternative to providing continuity, significantly increased seat width or cable restrainers that have the ability to restrain at least 50% of the weight of a span could be provided. This would stop the span from falling.

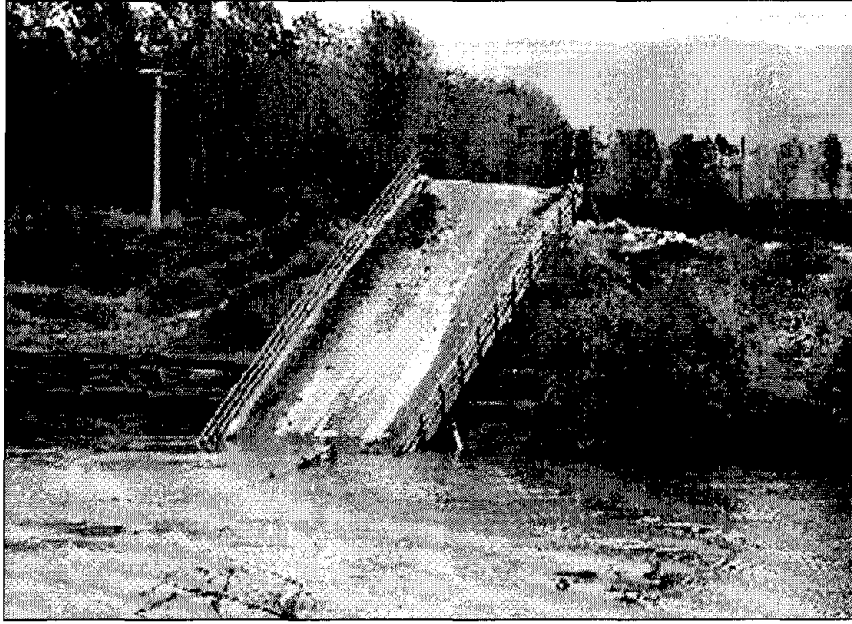
Approximately 8 km east of the D650 E-80 Motorway overpass bridge was a bridge that collapsed into a river near the town of Akyazı (see Figure 5-3). Little is known about the owner or details of this structure. The bridge was a three-span steel girder with concrete slab deck. The piers consisted of a relatively lightweight steel frame located on both banks of the river. Evidently the piers had insufficient axial capacity to sustain the ground shaking and permanent ground displacement as a result of the fault rupture. Both piers failed by

Figure 5-3 A local river crossing near the town of Akyazı

what appears to be axial compression failure of the steel columns in the pier bents. It should be noted that near this facility the critical ground motions were in the order of at least 0.4 g. Although only a minor road, the bridge provided the only access to two small villages. As a result of the bridge collapse, the people in those villages were isolated. It appears that failure of this bridge could have been prevented if the piers were of a more substantial nature and more capable of carrying the higher vertical loads. Nevertheless, it is not surprising that the bridge failed as the fault rupture passed through the northern abutment.

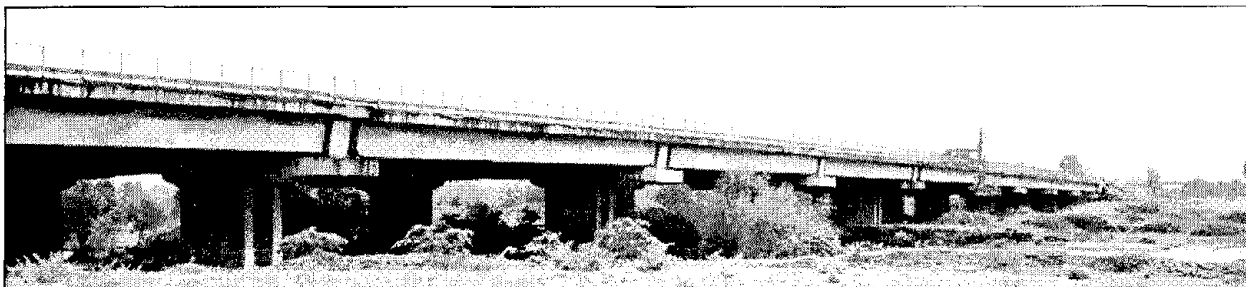
Figure 5-4 A view looking south showing the side elevation of the twin E-80 Motorway bridge over the Sakarya River

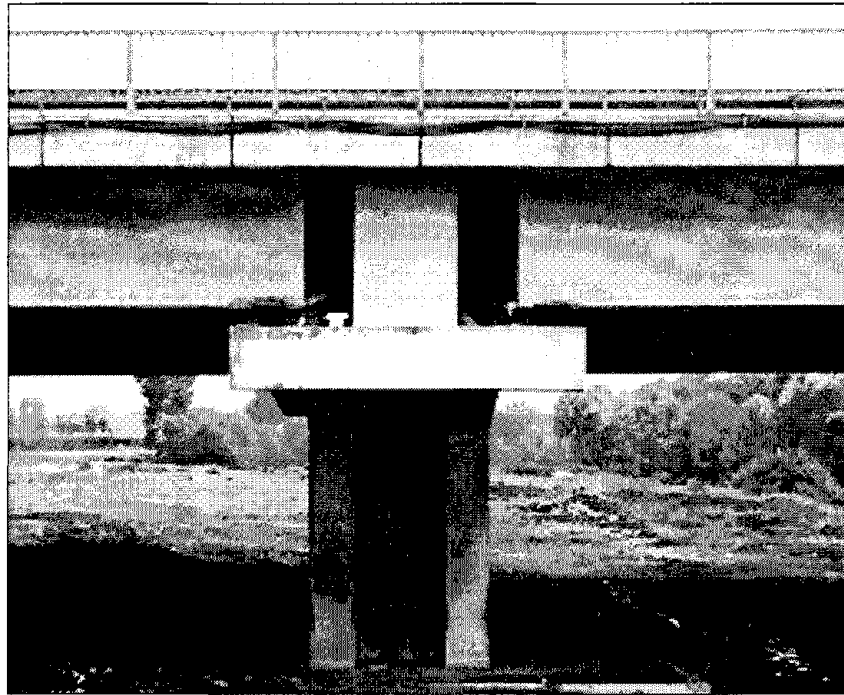
Figure 5-5 A side elevation of one of the pier of the northbound E-80 Motorway bridge over the Sakarya River. Note the concrete rubble located between the span ends and the diaphragm upstand.

shear key that is intended to inhibit transverse movement of the girders relative to the axis of the bridge. The bridge piers consist of rectangular sections that are quite stiff, as shown in Figures 5-5 and 5-7.

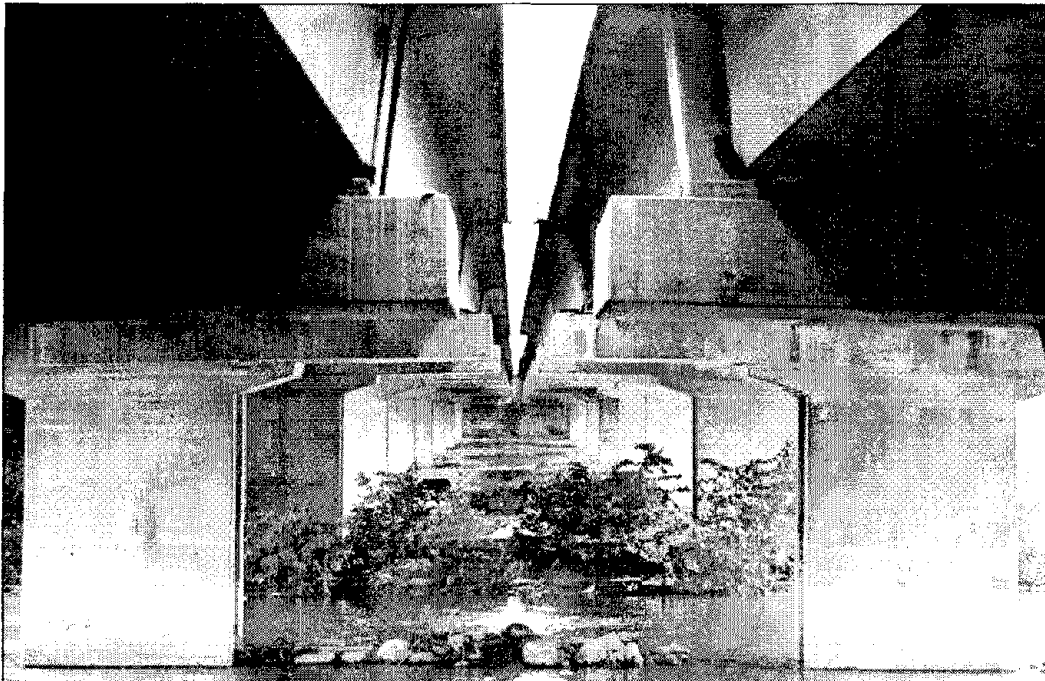
Figure 5-7 shows an underdeck view of the two bridges and their piers. On the eastbound bridge, the elastomeric bearing pads have started to “walk-out,” but were still supporting the spans. However, for the westbound bridge, the spans shifted their seating onto the shear key, many of the bearing pads being nonfunctional.

Figure 5-7 A longitudinal view of the twin E-80 bridges crossing the Sakarya River. The left bridge is the eastbound structure that showed minimal effect on the bearing seats, whereas the westbound bridge (on the right) showed considerable damage to the shear keys and bearing seats. Note the dislodged bearing and the 500 mm right lateral offset of the girder directly above the right hand pier.

It is apparent that much of the damage to these bridges could have been avoided by providing stronger shear keys. Perhaps, better still, much of the damage could have been entirely avoided if full continuity between the spans had been provided. Fortunately, the damage sustained by the eastbound bridge was insufficient to warrant closure. Immediately following the earthquake, the westbound traffic was rerouted over the eastbound bridge. The westbound bridge was considered to be sufficiently damaged to warrant closure to enable

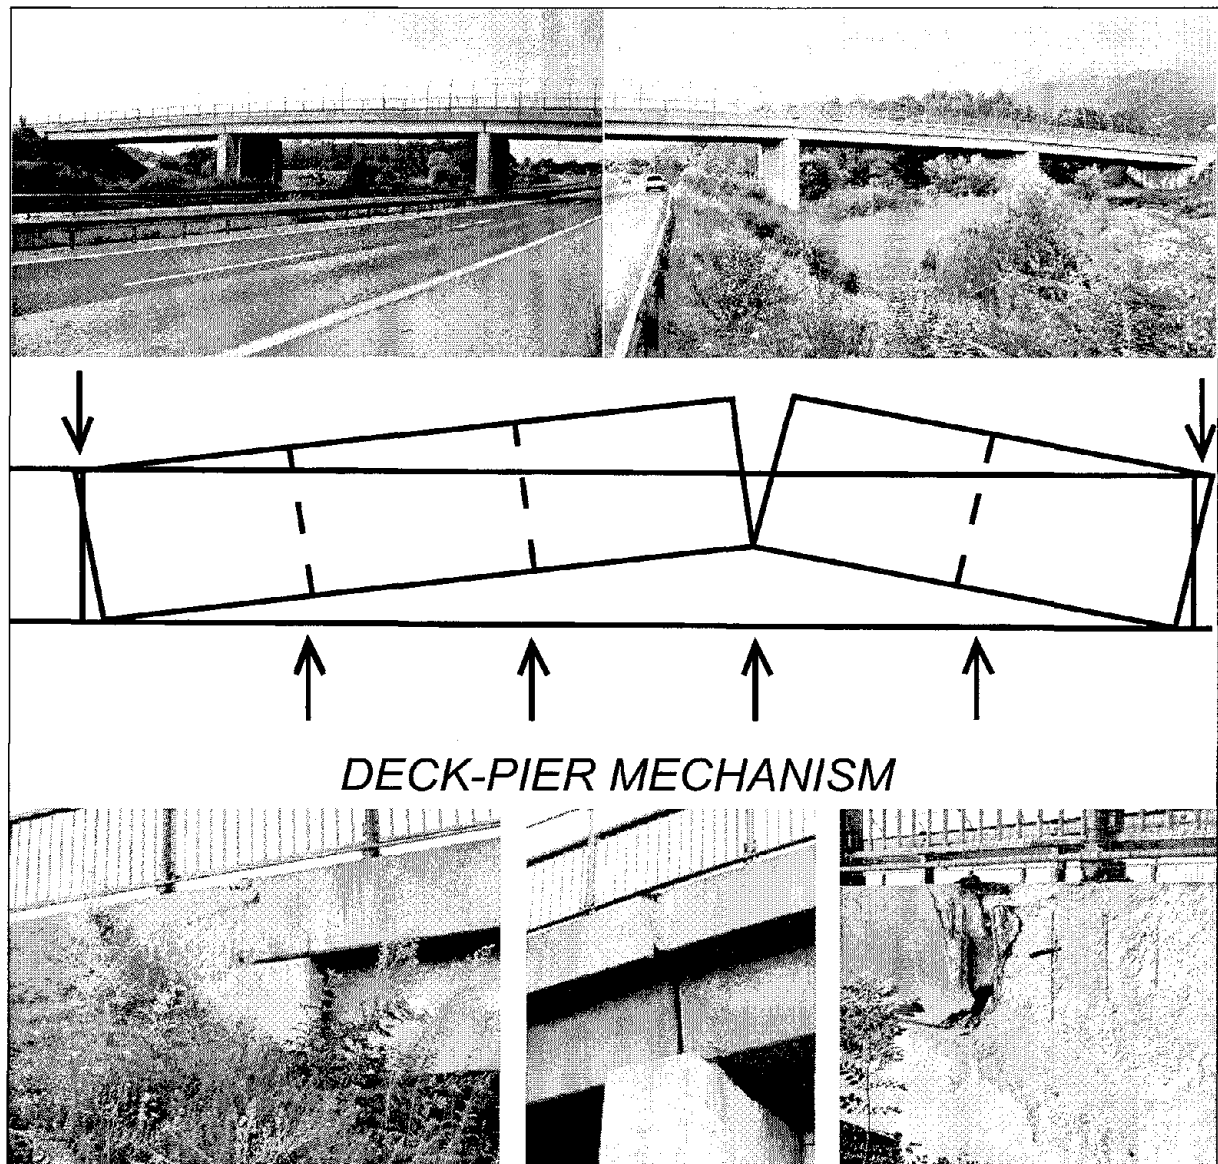
Figure 5-8 The overpass carrying the D31 road across the E-80 Motorway. The upper photograph shows a side elevation of the bridge looking eastward. In the center, a plan view sketch depicts the deck-pier mechanism that formed at the joints that were located at the abutments and the third pier. The lower photograph shows spalled concrete damage located at the deck at these joint connections.

ment of the deck segments resulting in some minor damage to the outside faces of the prestressed concrete girders. It is evident that the ground shaking caused a deck-pier mechanism to occur as shown in Figure 5-8. In addition to this damage resulting from fault parallel shaking, there is some evidence of pier tilting due to foundational settlement of the above-mentioned second pier. It is not clear whether this pier tilting has resulted from fault-normal shaking or is an outcome of the deck pier mechanism. This feature requires further analysis.

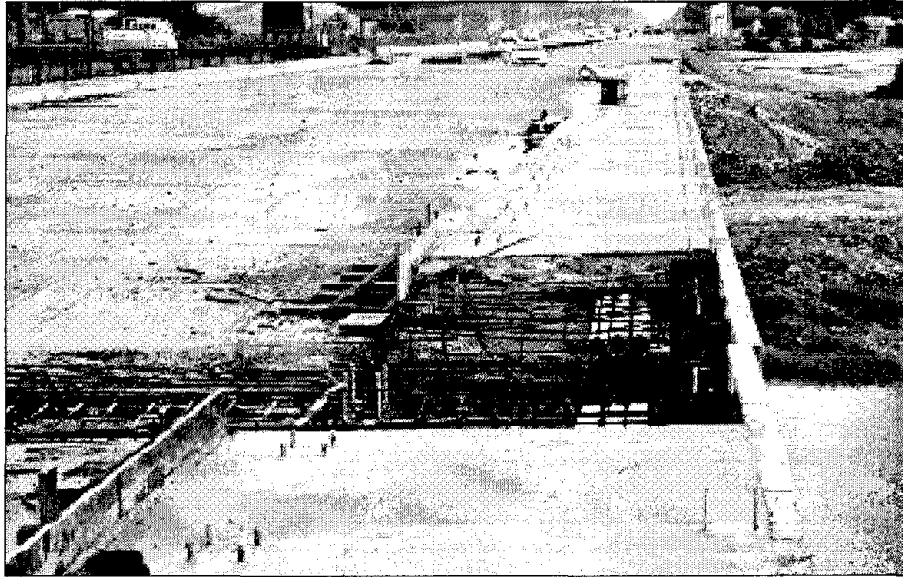
Figure 5-10 The new two-lane bridge for the D100 Highway over the Sakarya River looking east. Notice the 50 mm offset of the fascia girders. The pouring of the construction joints was incomplete at the time of the earthquake.

The new bridge, which is currently under construction, consists of closely-spaced prestressed concrete I-girders. These girders typically moved 50 mm on their bearing seats resulting in some misalignment of each of the spans. This is evident in Figure 5-10. However, as traffic was not interrupted, the damage to both of these bridges could be regarded as "slight."

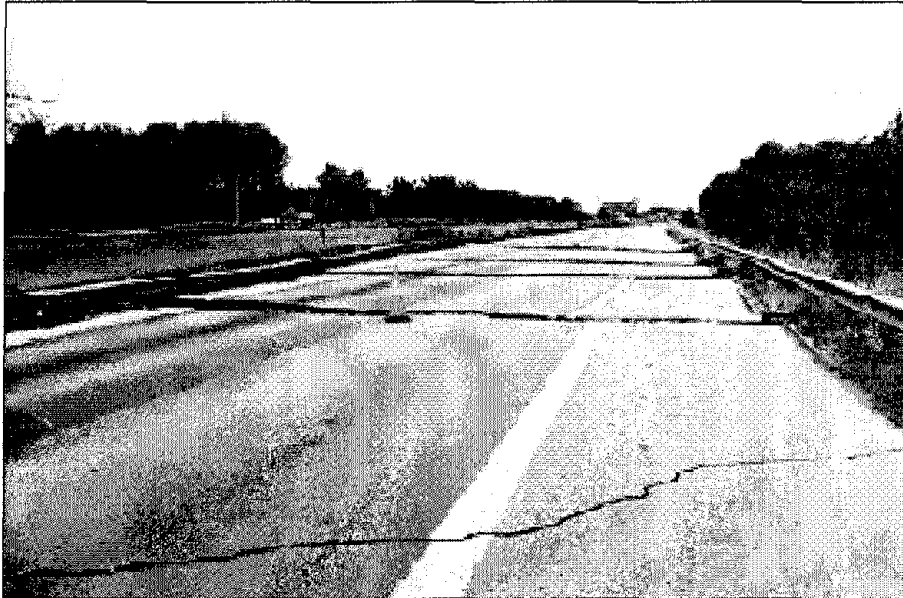
Figure 5-11 Distress to the pavement due to the fault rupture on the E-80 Motorway

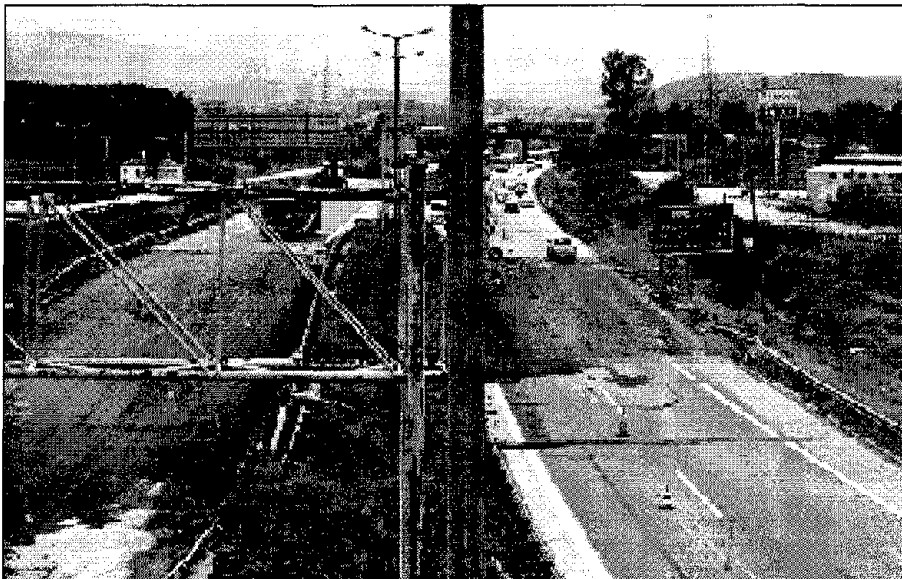
Figure 5-12 A view of the E-80 Motorway taken from an overpass near Akyazı showing the restored roadway that had been severely damaged by the fault rupture

and after the major highway debris had been cleared, asphalt was brought in and used to provide ramps onto and off the bridges at those locations where the bumps were very abrupt. Then within one week of the earthquake, major repairs were commenced. Where the bridges sat up high with respect to the surrounding roadway, the asphalt roadway was removed and the road was repaved and reprofiled to enable vehicles to travel at the regular full speed.

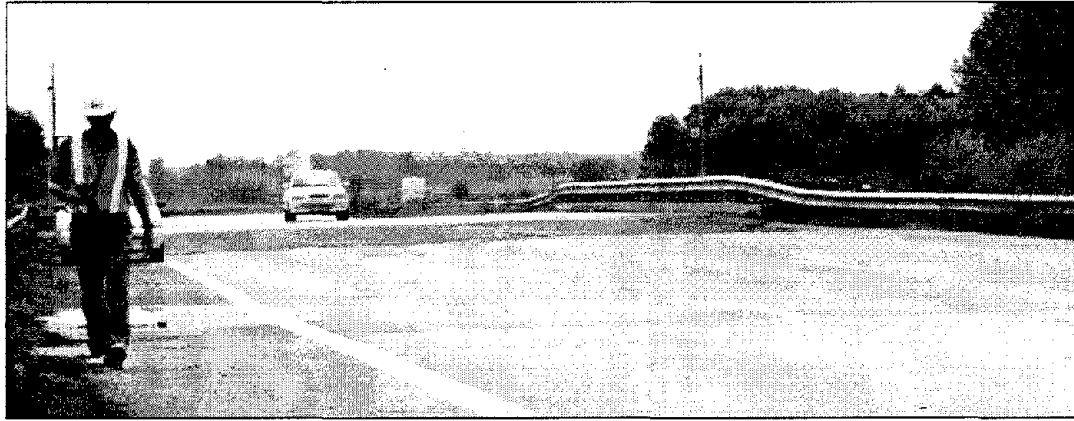
Another major problem associated with the E-80 Motorway, particularly when it runs immediately adjacent to Lake Sapanca, was related to substantial settlements sustained by the embankments. Embankment settlements of 500 mm were commonplace. This resulted in two problems. First, the roadway was left in a substantially wavy nature, and secondly, there were serious bump-onto-the-bridge problems at both culverts and single-span bridges, as shown in Figure 5-13. Immediately following the earthquake

Figure 5-13 One of the numerous bridges on the E-80 Motorway that is some 500 mm above the road surface. The severe shaking caused bearing capacity settlements of the road embankment leading to classic bump-onto-the-bridge problems.

It is difficult to speculate whether this damage was a result of a bearing capacity failure, or settlement due to liquefaction, or a combination of the two. Although the surrounding soils appeared to be quite damp over to the crossing proximity at the lake, it is considered that the cause of failure was mostly due to the former rather than the latter. It is considered that liquefaction was unlikely as there was little evidence of sand boils in this vicinity.

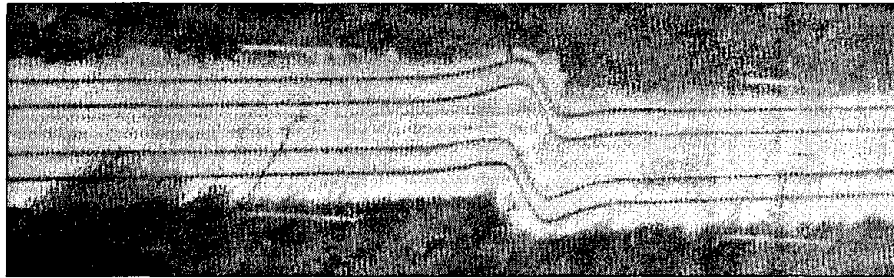
Like the E-80 Motorway, the main railway system is dual track and runs in a general east-west direction. In the Sapanca area, it runs adjacent to the E-80 Motorway. In this location, the fault rupture transverses both the highway and the railway with the damage shown by the aerial view in Figure 5-15. From this photograph, it is evident that the magnitude of the right lateral offset on the fault is about 1.5 m—this is roughly equal to the track gauge. Although the damage to the tracks is substantial as shown from the ground view in Figure 5-16, repairs were implemented rather quickly. However, in one nearby branch line near Adapazarı, an electric traction pole was brought down from the track requiring the restringing of the overhead traction wires. Such repairs to the electric

Figure 5-15 An aerial view of the railway track buckling in the Sapanca area. Note there is a right lateral offset on the fault roughly equal to the track gauge of 1.5 m.

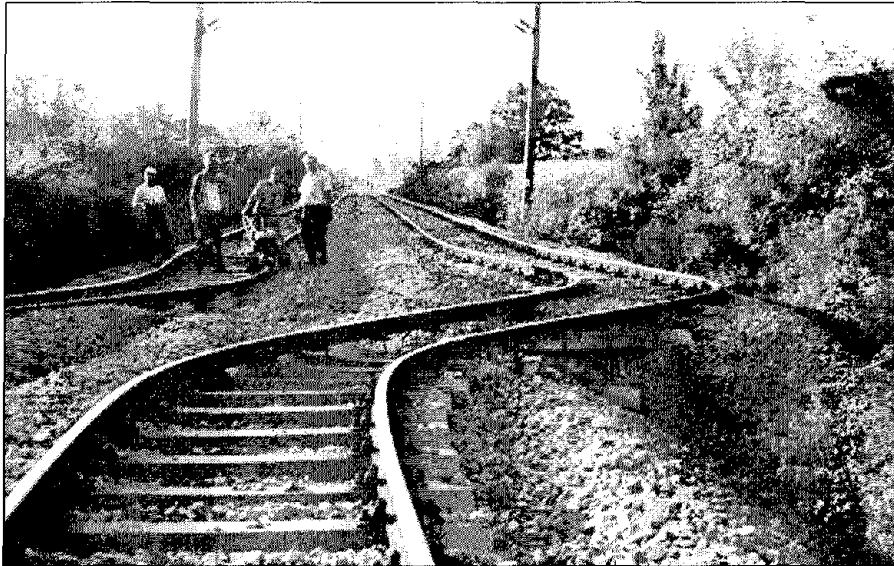
Figure 5-16 A view of the fault passing through the railway embankment showing the substantial (2 m) right lateral offset

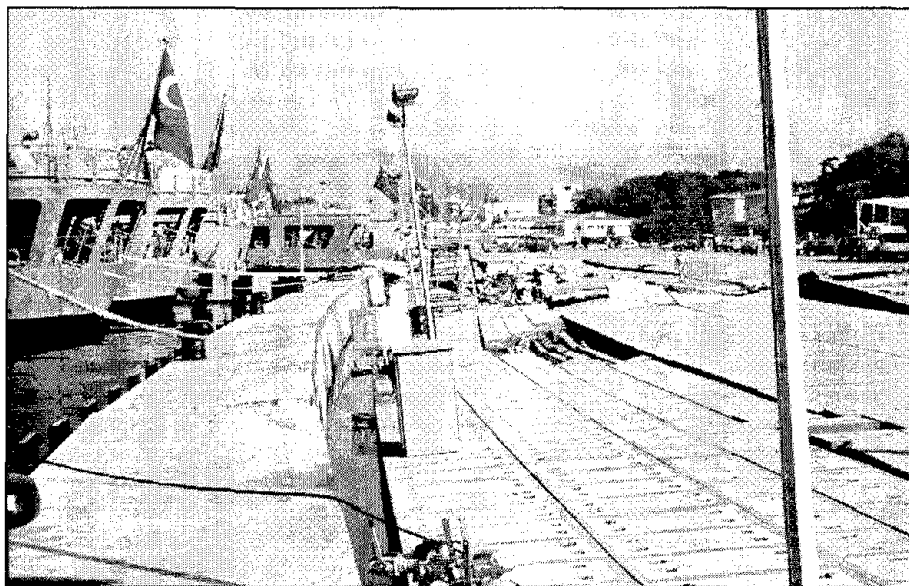
Figure 5-17 The Naval Port at Gölcük looking east. Notice the bow of the quay wall resulting from proximity to the fault rupture.

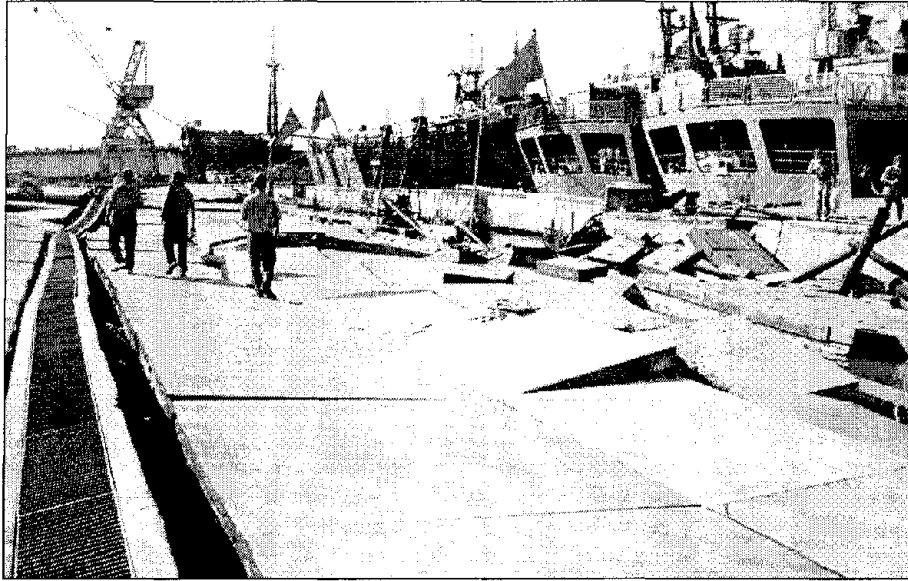
Figure 5-18 Failure of the wharf structure at the naval port at Gölcük

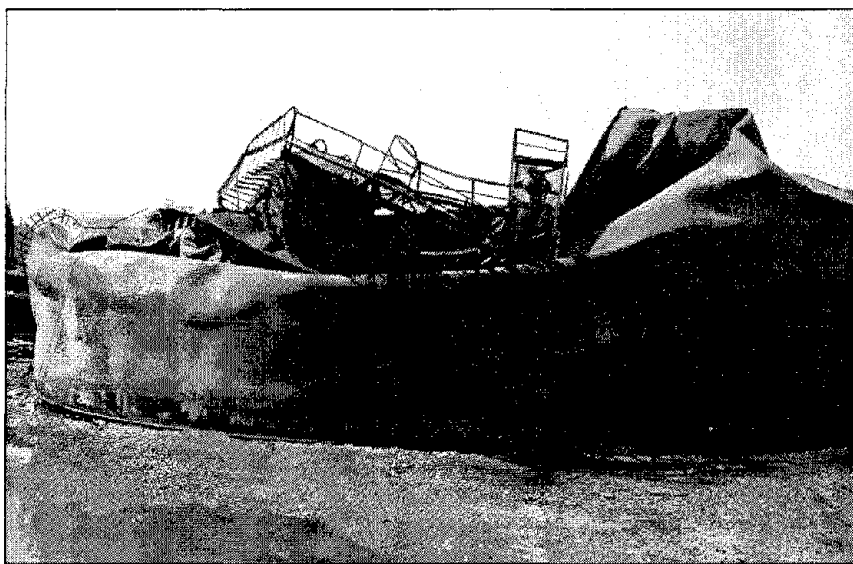
The fire and heat eventually damaged numerous tanks in the tank farm. It was reported that at least 17 tanks were considered to be total losses. These tanks were generally buckled by the intense heat, with one tank expanding as if ready to explode (Figures 6-3 to 6-5).

Figure 6-3 Collapsed tank due to fire at Tüpraş refinery

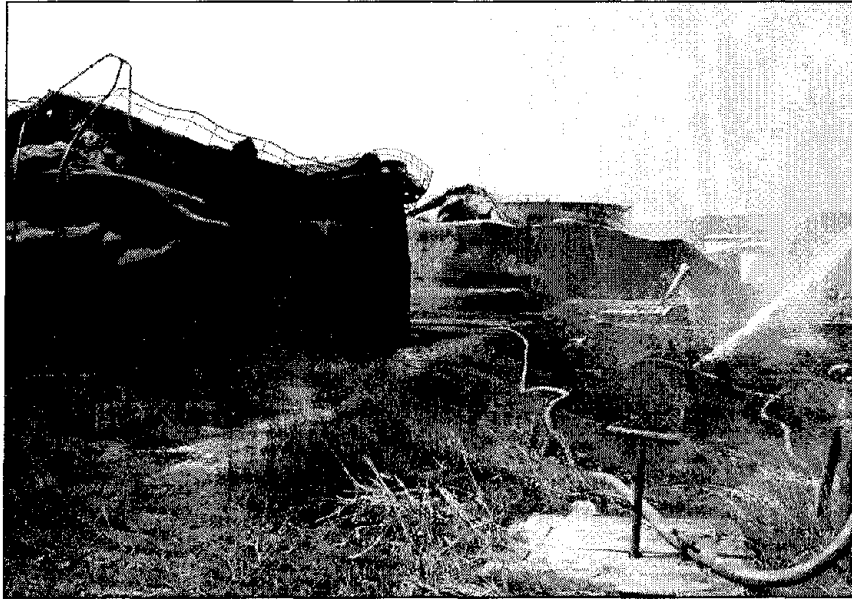
Figure 6-4 Collapsed tanks due to fire at Tüpraş refinery

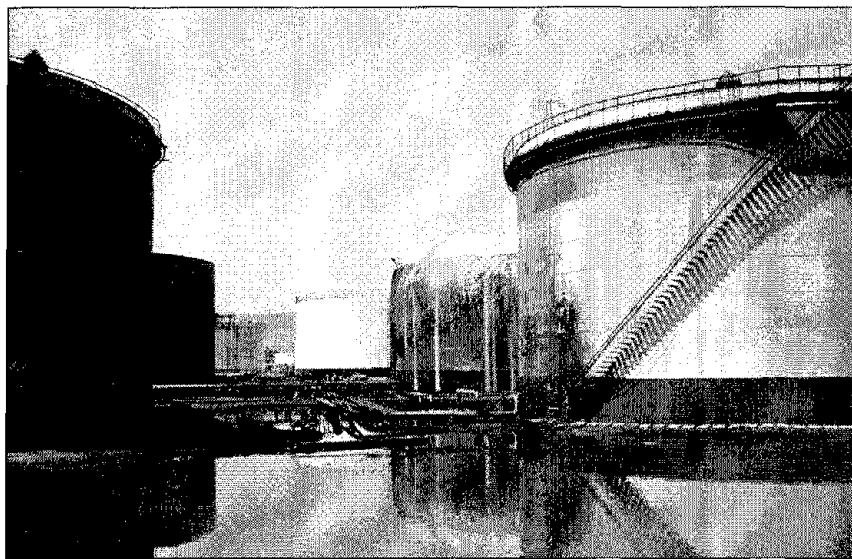
Figure 6-5 "Expanded" tank due to fire at Tüpraş refinery

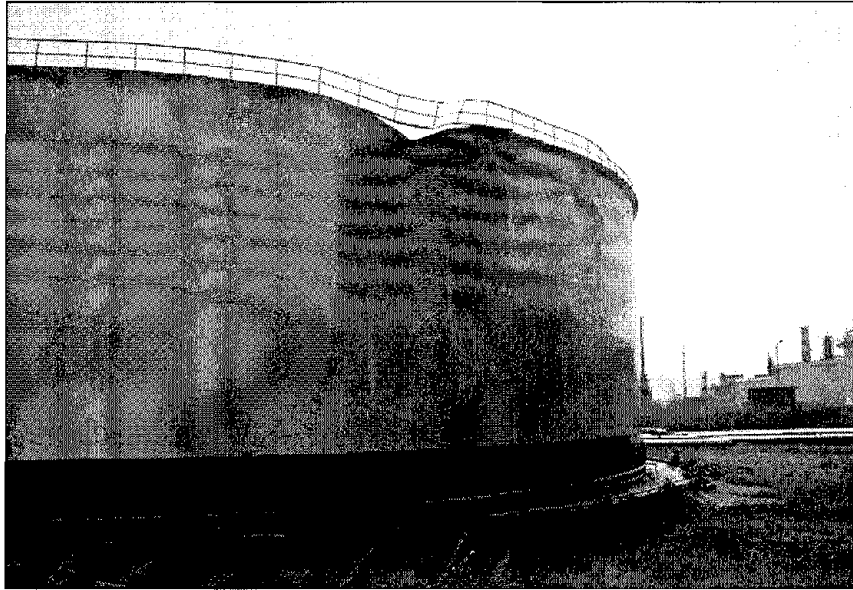
In addition to the tanks directly damaged by fire and heat, several tanks appeared to be damaged by sloshing of fluid (Figure 6-6). A few had ruptured walls near their tops and clear evidence of loss of material down the tank wall.

A large number of tanks (on the order of 50) were reported to have had floating roofs "sink." The sloshing of fluid in the tanks apparently caused damage to seals and allowed fluid on top of the floating roofs. The extra weight then caused the roofs to sink into the tank. Each of these tanks must be drained, and the roofs decontaminated and often repaired or replaced. Sloshing is a long period response, and the amount of damage was likely amplified by the long duration of shaking.

Figure 6-6 Failure at top of tank due to sloshing of fluid at Tüpraş refinery

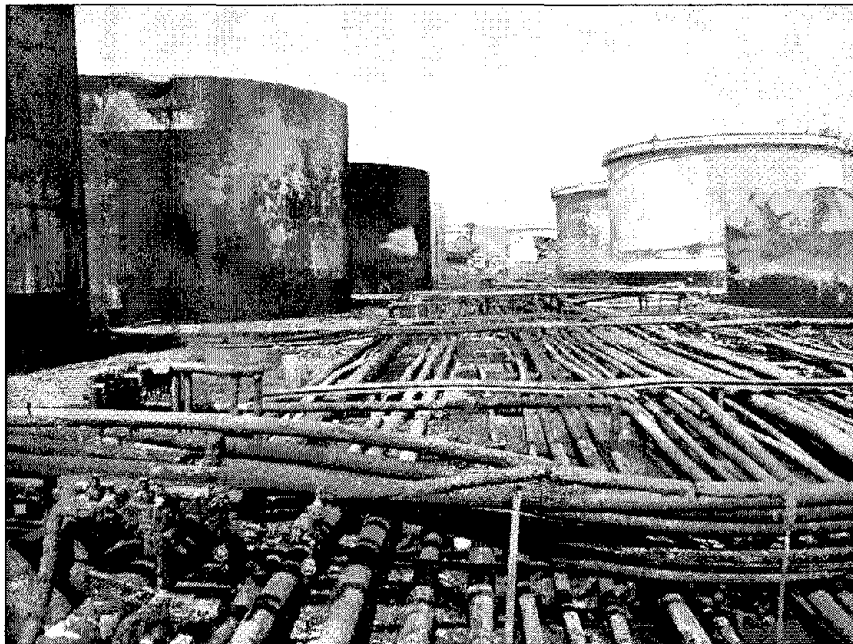
No evidence of piping rupture was observed. This is primarily attributed to the typical configuration of running piping in a flexible manner down central pipe runs between the tanks (Figure 6-7). Some leakage was reported in piping in the area of burned tanks.

Figure 6-7 Pipes between tanks in Tüpraş tank farm typically run above ground

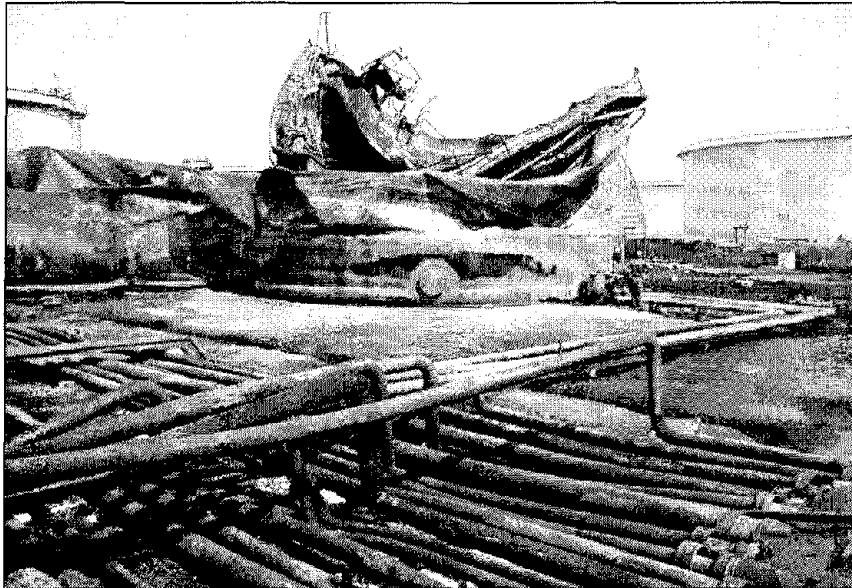
One tank that burned was observed to have a classic “elephant’s foot” bulge on one side (Figure 6-8). The other side appears to have damage that has led to draining of the tank, and

spreading of the fire to this tank and an adjacent tank. We understand that these two tanks were the last to burn, after the fire spread over or through a berm, skipping over a few tanks in the process.

Figure 6-8 Elephant's foot buckling at tank that collapsed due to fire at Tüpraş refinery

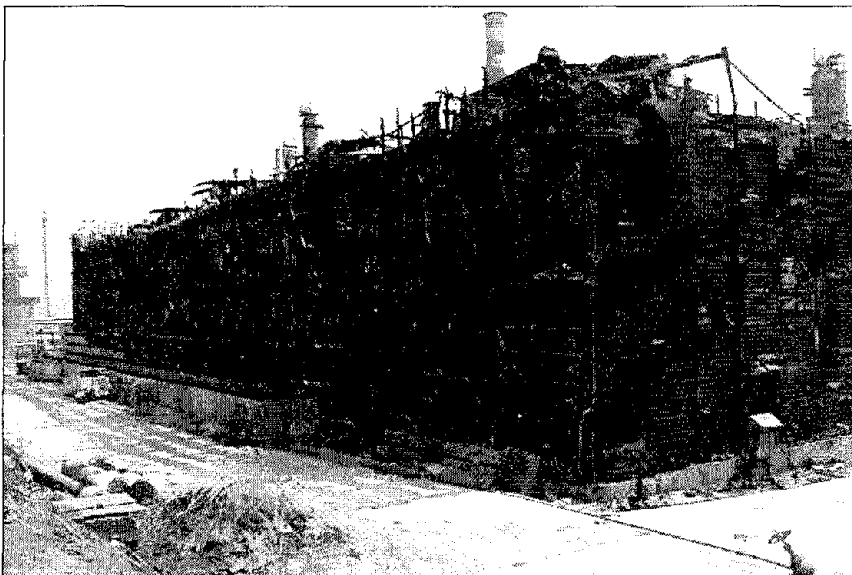
The main process units are located just beyond another berm from the tank farm. Four cooling towers, one concrete and three wood, are located at the berm. One of the wooden cooling towers was burned completely by the fire. A second cooling tower, some 50 meters away was shaken down completely, while the adjacent tower remained standing. A concrete tower on the other side of the burned tower appeared to be undamaged (Figures 6-9 to 6-11).

Figure 6-9 Burned out cooling tower just over berm from Tüpraş tank farm
