The Marmara, Turkey Earthquake of August 17, 1999: Reconnaissance Report

Edited by
Charles Scawthorn¹

Technical Report MCEER-00-0001

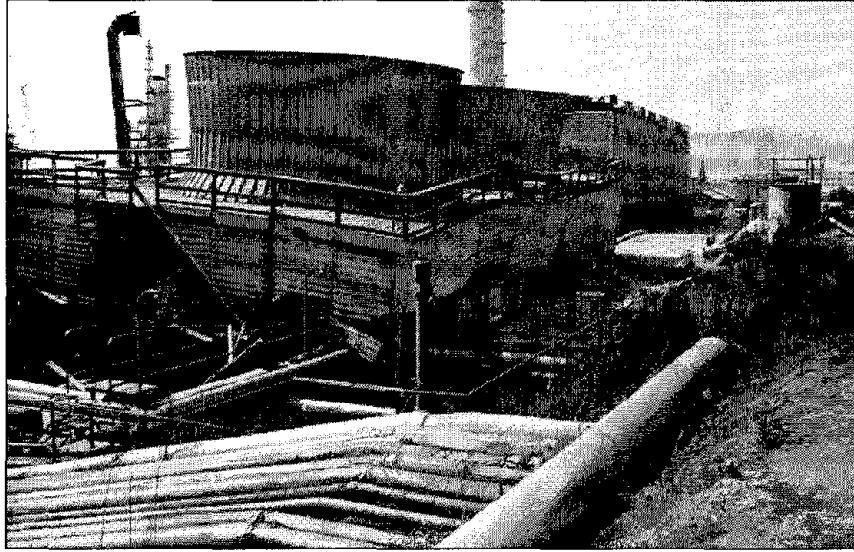
The main process units are located just beyond another berm from the tank farm. Four cooling towers, one concrete and three wood, are located at the berm. One of the wooden cooling towers was burned completely by the fire. A second cooling tower, some 50 meters away was shaken down completely, while the adjacent tower remained standing. A concrete tower on the other side of the burned tower appeared to be undamaged (Figures 6-9 to 6-11).

Figure 6-10 Collapsed cooling tower next to Tüpraş tank farm

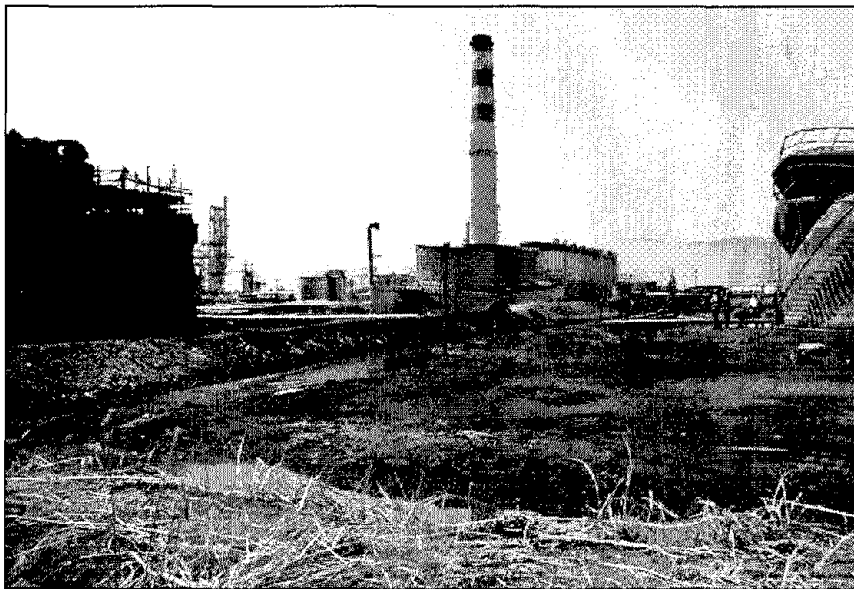
Figure 6-11 Location of burned out and collapsed cooling towers next to Tüpraş tank farm

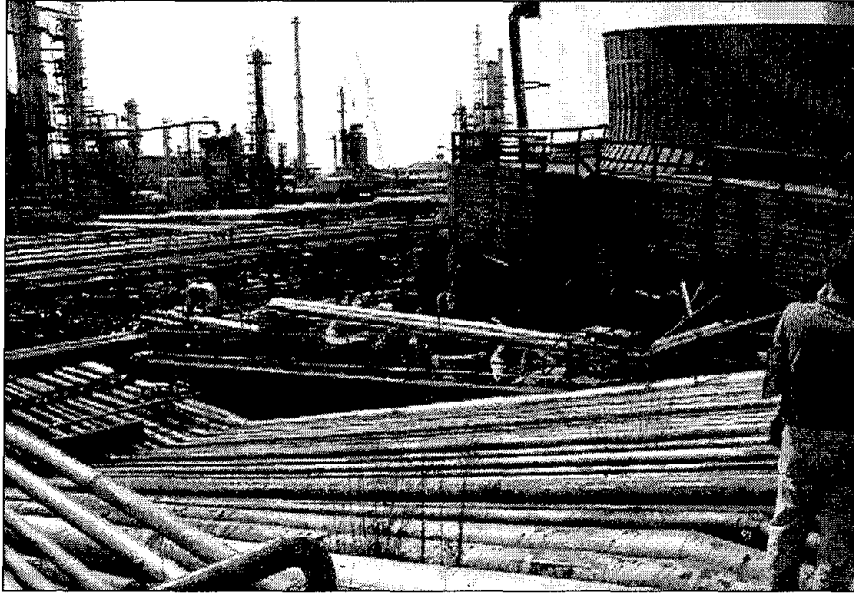
Piping runs into the units between the burned and collapsed cooling towers (Figure 6-12). It is not difficult to believe that the fire came close to burning down the entire facility, an estimated \$3.5 billion investment.

Figure 6-12 Piping between Tüpraş tank farm and process units runs between cooling towers

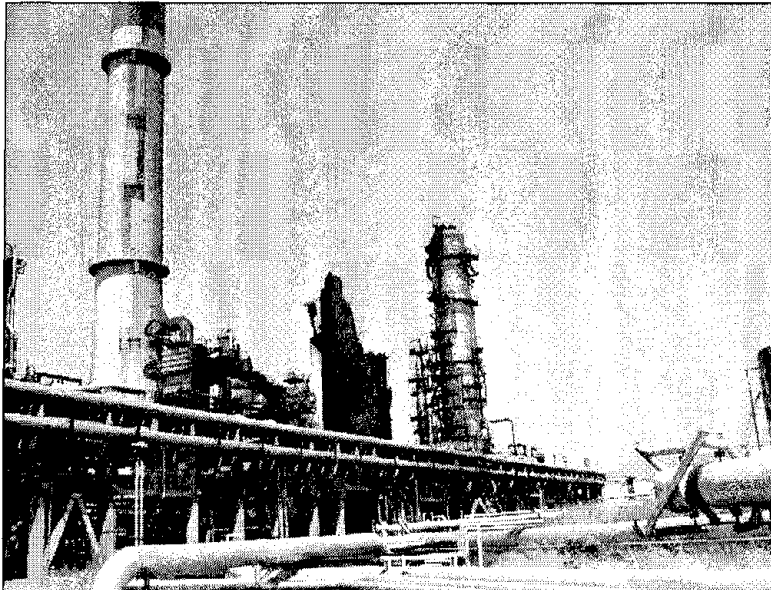
The other area of severe and spectacular damage in the Tüpraş refinery occurred in one of their three crude units, when a 90-meter high reinforced concrete heater stack collapsed. The break appeared to occur at about the height of a penetration of the stack for a large

diameter heater duct. The cause of the failure was not immediately obvious from sifting through the rubble of the stack (Figures 6-13 to 6-15).

Figure 6-13 View from a distance at 90 m high stack collapse in Tüpraş crude unit

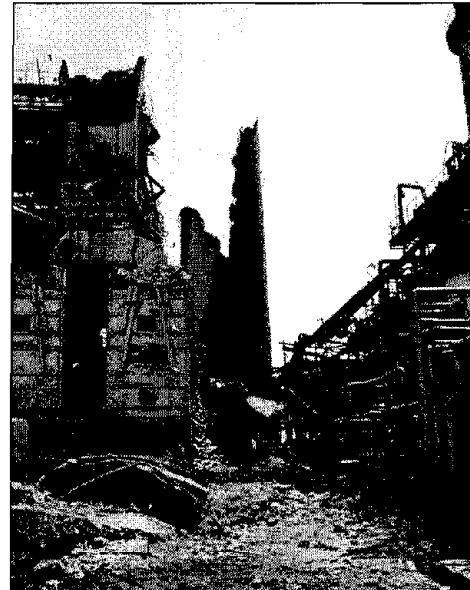
Figure 6-14 Collapsed stack in background was attached to furnace in foreground by a large duct

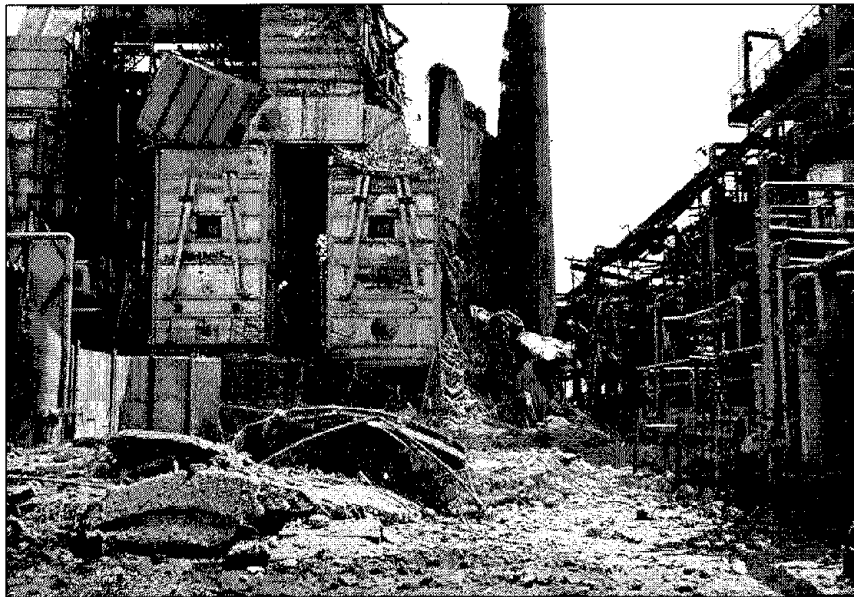
The top of the stack fell into the unit, destroying the heater, while the bottom portion fell into a pipeway running around the perimeter of the unit. The destroyed pipeway was

Figure 6-15 Top of stack collapsed into unit, severely damaging heater unit. Top of stack is in foreground of photo.

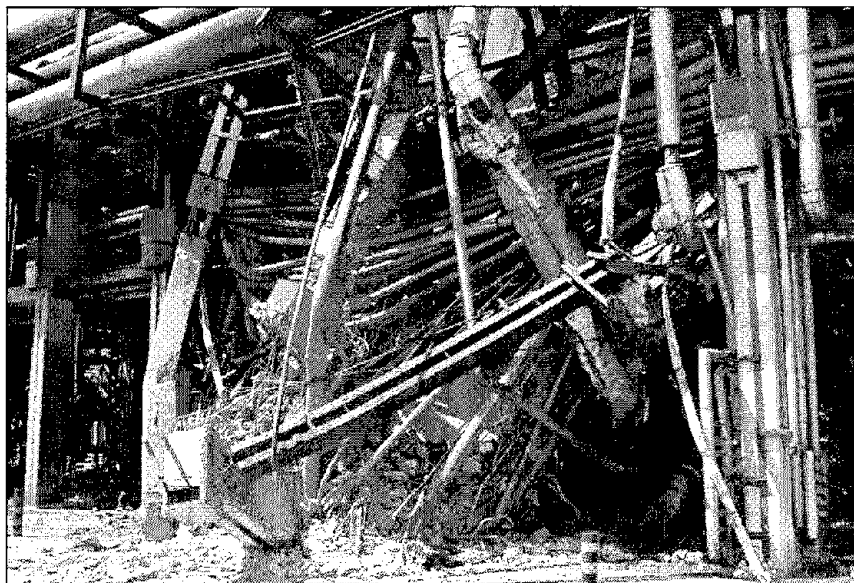
One of the pipes broken by the stack collapse was a naphtha line from the original burning naphtha tank in the tank farm. A fire started when the collapse occurred, and although it was extinguished relatively quickly, it flared up several times because of the new fuel from the broken pipe. The supply could not be stopped because the two block valves were at the tank, inaccessible because of the fire, and downstream from the crude unit.

Figure 6-16 Bottom portion of stack fell backwards into pipeway

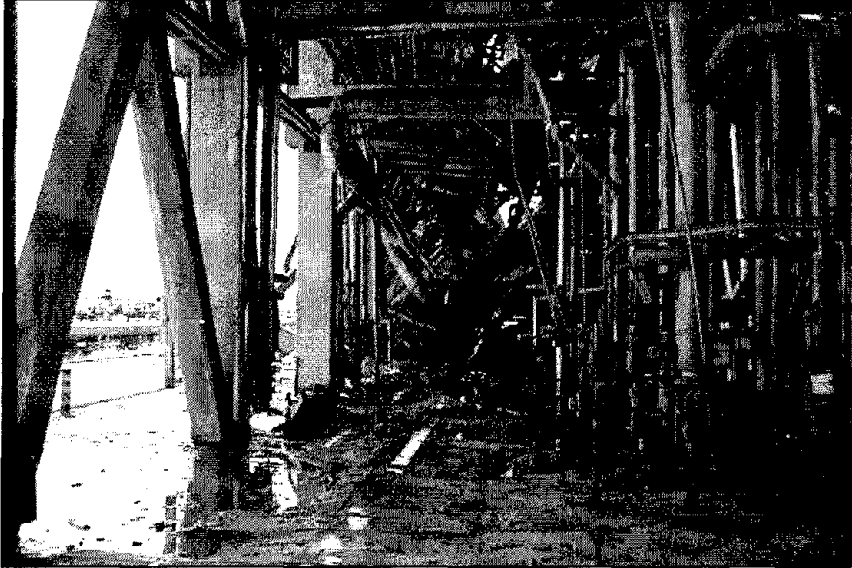
heavily congested with piping from all over the refinery. It is likely to take several months to identify, isolate, and repair damaged piping in this area (Figures 6-16 to 6-17).

Figure 6-17 View showing congestion of piping in destroyed pipeway

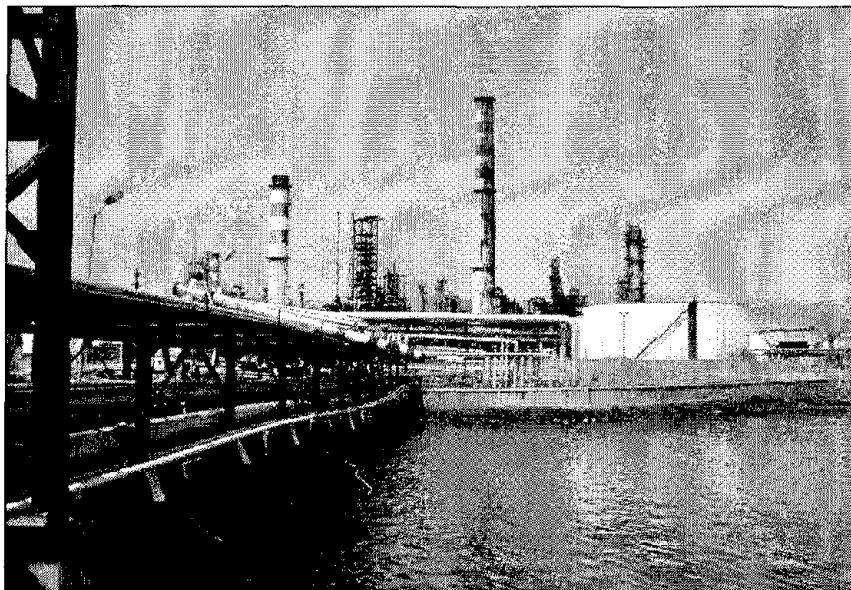
There was evidence of ground failure at the approach to the wharf. A steel frame pipeway on the wharf structure extending out from the shore partially collapsed, with broken frame connections and severely bent members (Figures 6-18 and 6-19). Damage was reported to supply and return lines due to this support damage.

Figure 6-18 Pipeways collapsed and leaning on wharf approach to shore

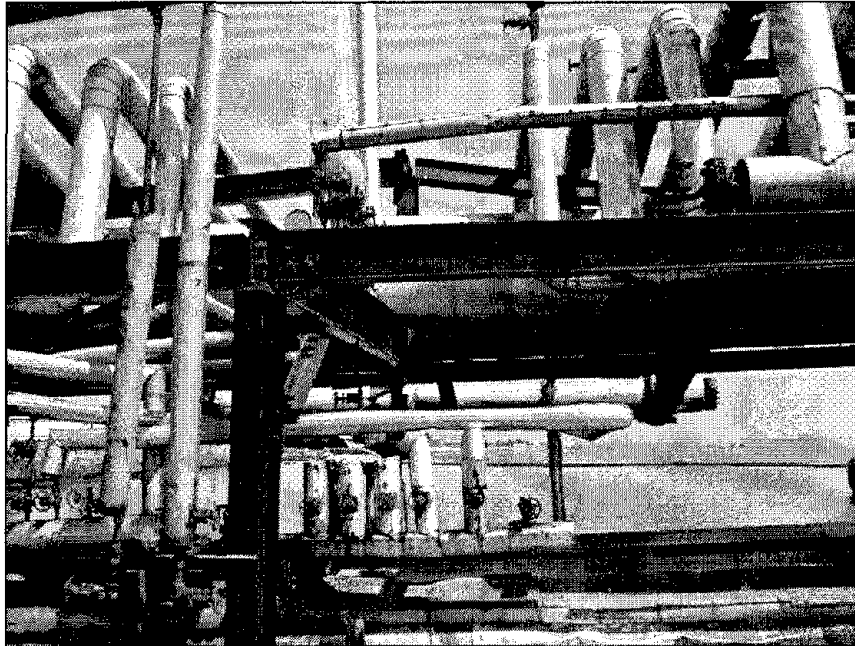
Figure 6-19 Pipe supports bent and broke at welded connections

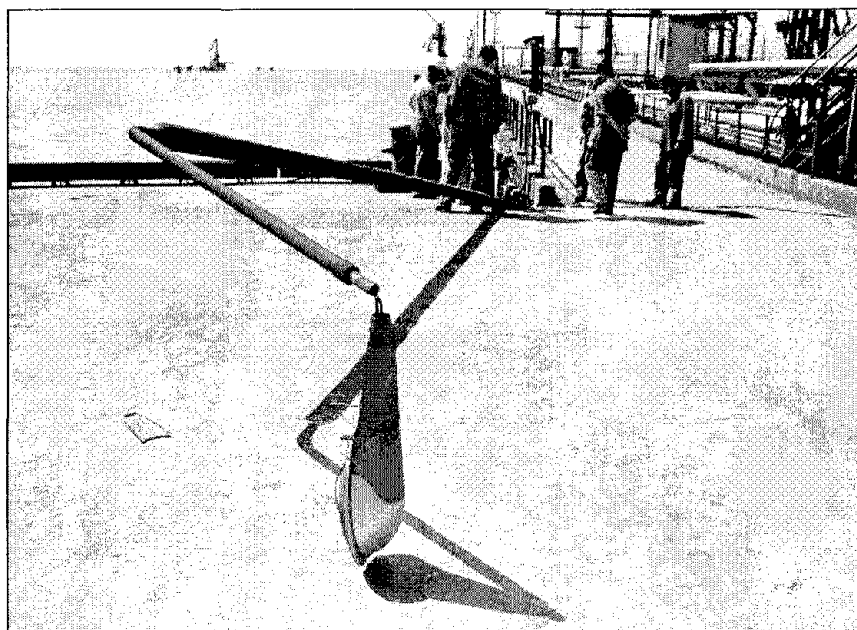
The loading jetty is a separate structure oriented parallel to the shore. It separated from the wharf structure, as evidenced by dropping of connecting grating into the water below. Other nonstructural damage at the wharf included a fallen light standard (Figure 6-20).

Figure 6-20 Fallen light standard at Tüpraş port

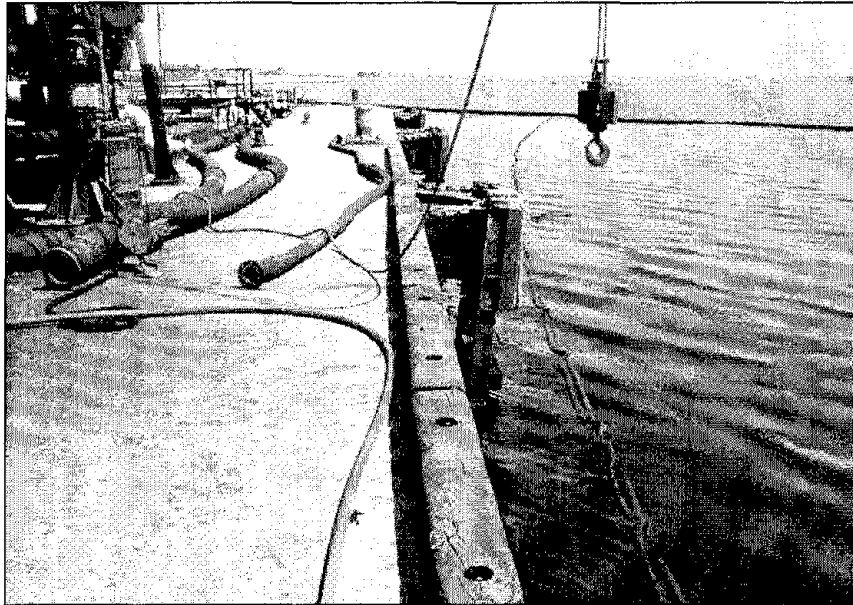
An oil spill occurred at the port. When the earthquake occurred during transfer operations, a vessel pilot moved his vessel away from the dock, ripping the transfer hose

before the manual valve could be shut down (Figures 6-21 and 6-22). The damaged piping on the wharf also contributed to the oil spill, as well as overflow of the drainage system for the tank farm, made worse by emulsion from the fire fighting efforts.

Figure 6-21 Hoses used for transfer operations at port

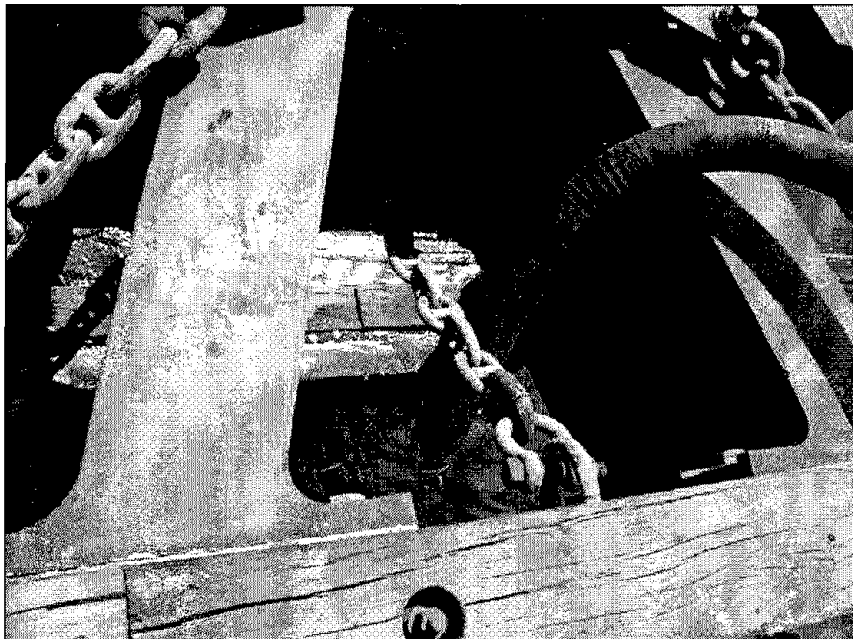
Figure 6-22 Hose reportedly broke when vessel pilot pulled away during earthquake without disconnecting. Caused oil spill at Tüpraş port.

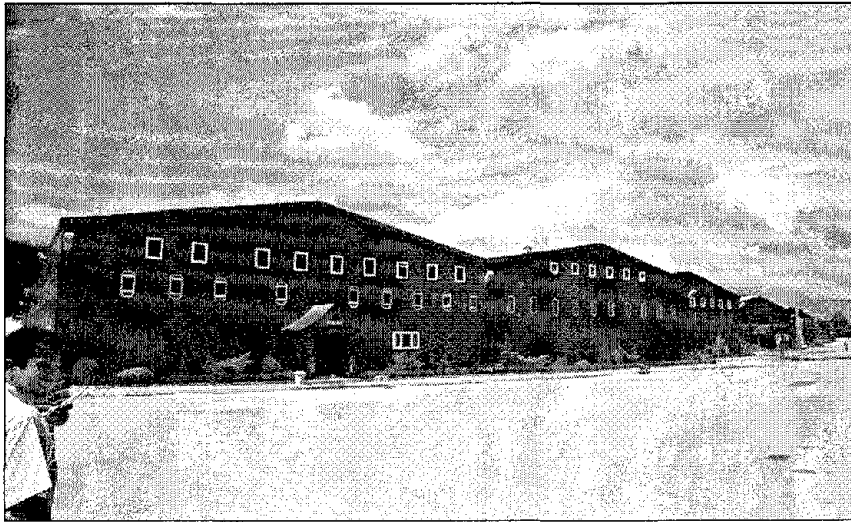
Figure 6-23 One of two identical buildings at Çap textile plant

One site with particularly poor performance of these structures was the Çap textile plant. This plant had one building completely collapse, and another experienced significant permanent drift, causing partial collapse of the roof (Figures 6-23 to 6-25).

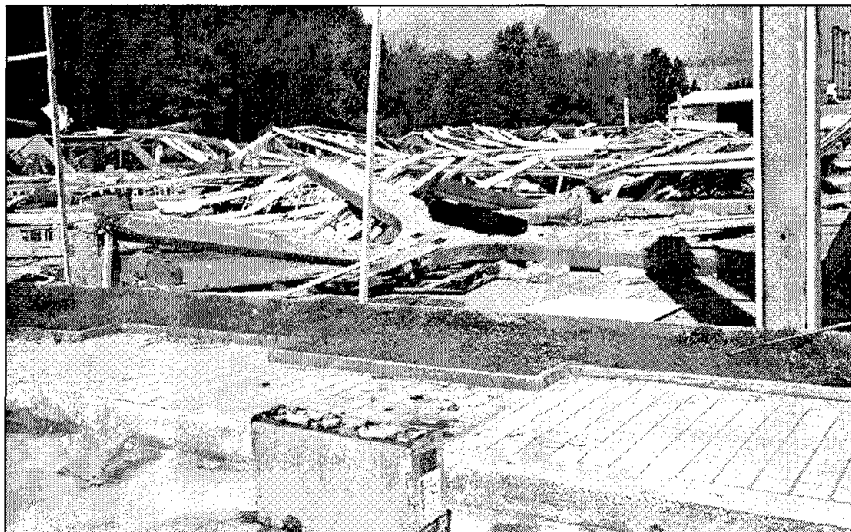
Figure 6-24 One building at Çap textile plant completely collapsed.

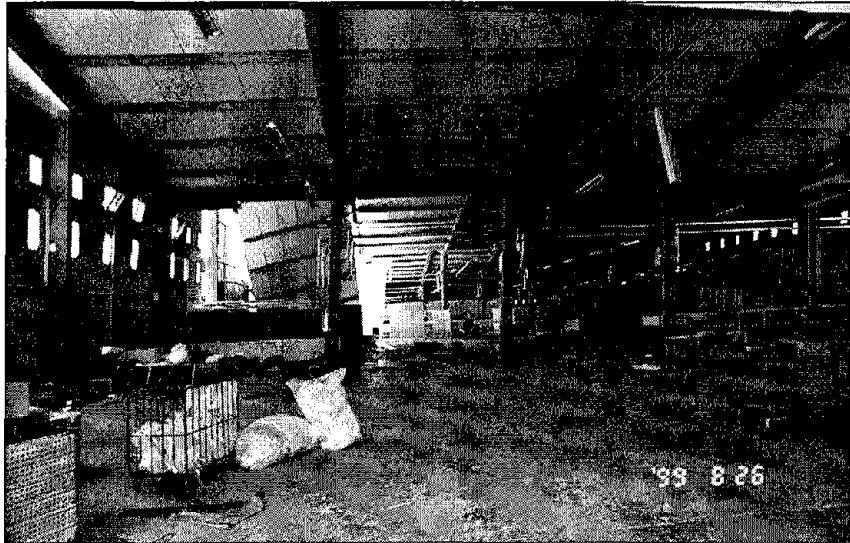
Figure 6-25 One building at Çap textile plant had hinging of columns, large permanent drift, collapsed walls, and fallen roof panels

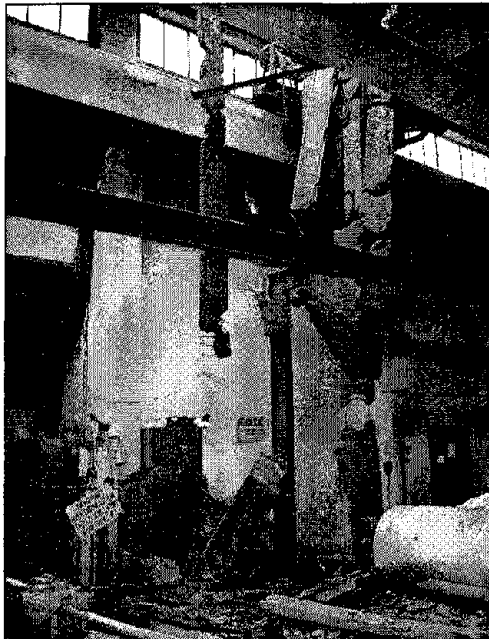
Collapse or partial collapse of roof diaphragms was observed at other industrial facilities also. At the SEKA paper mill in İzmit, several buildings lost sections of reinforced concrete plank roofs (Figure 6-26). Roof damage was also noted at the İGSAŞ fertilizer plant and other facilities (Figures 6-27 and 6-28).

Figure 6-26 Precast concrete roof planks fell in several SEKA buildings

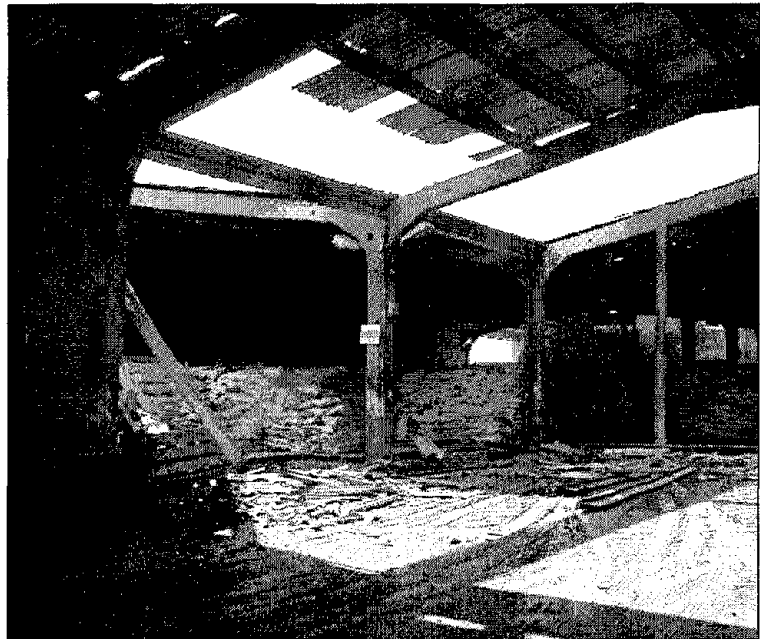
Figure 6-27 Warehouse roof collapse at İGSAŞ

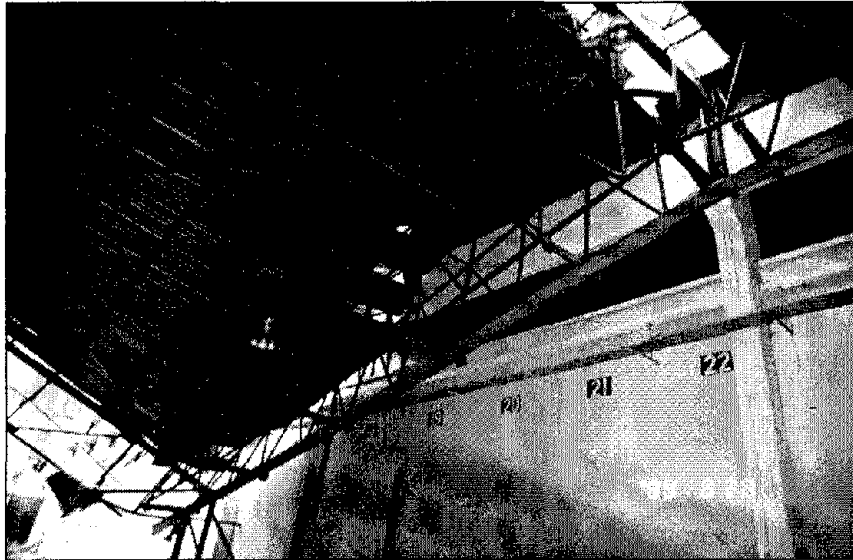
Figure 6-28 Collapsed roof in storage structure at KordSA

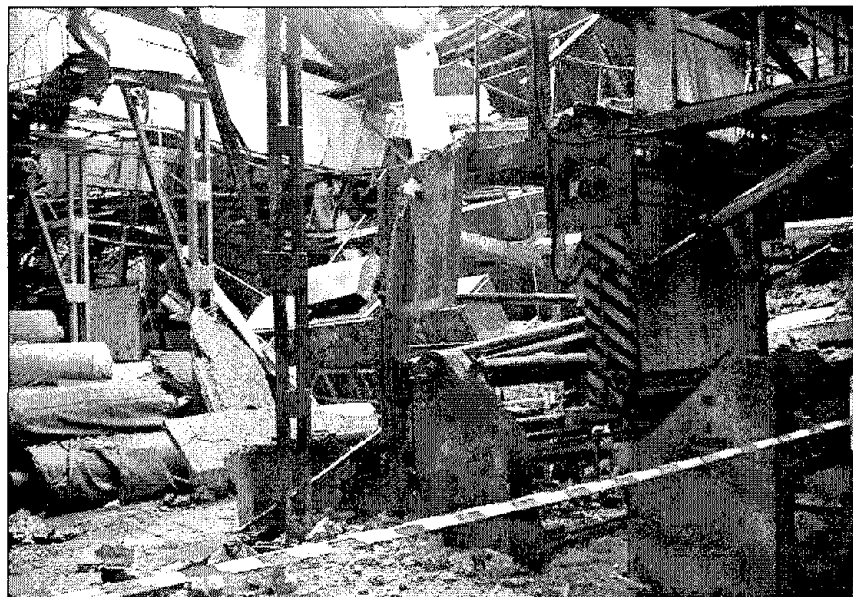
One other complete building failure was at the Pirelli tire factory in İzmit. One of the older buildings at the plant, constructed in the 1960s, totally collapsed, killing one worker and injuring twenty (Figures 6-29 and 6-30).

Figure 6-29 Collapsed building at Pirelli tire plant

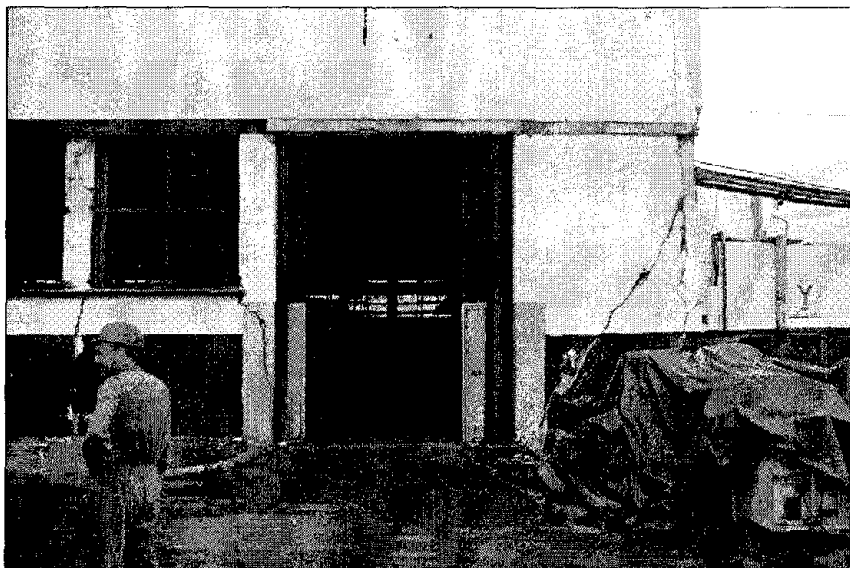
Numerous office buildings were damaged (Figures 6-31 to 6-33). The İGSAŞ fertilizer plant had severe damage to one of their four-story office buildings, with a collapse of the entire first story. According to facility staff, the building was identical to an adjacent building, which appeared to be undamaged. They indicated that the building did not contain

Figure 6-31 Other buildings at Pirelli did not collapse but had significant damage

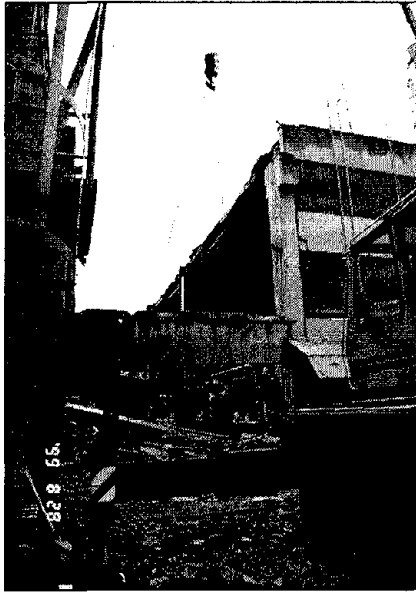
Figure 6-32 Collapsed portion of main plant at DuSA

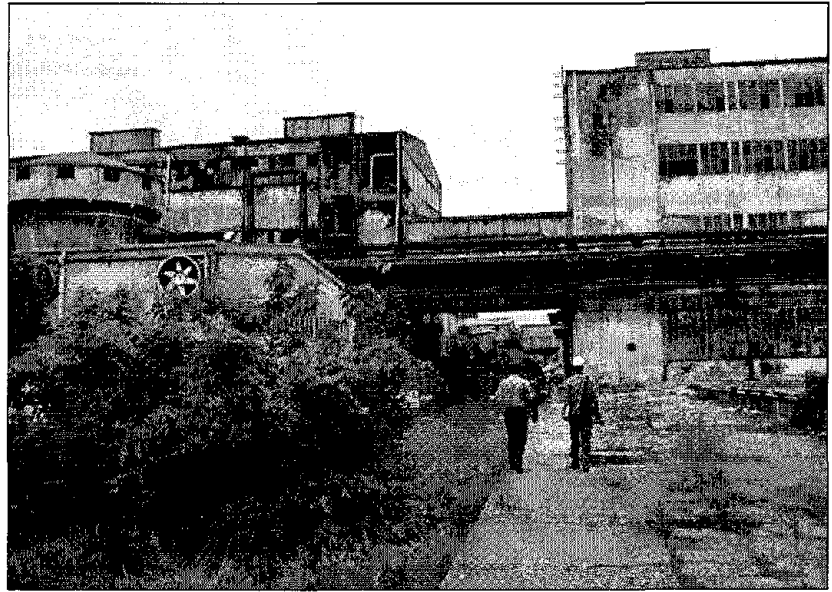
Figure 6-33 View of buildings at SEKA paper mill. Wall panels have fallen on upper floors of building to left.

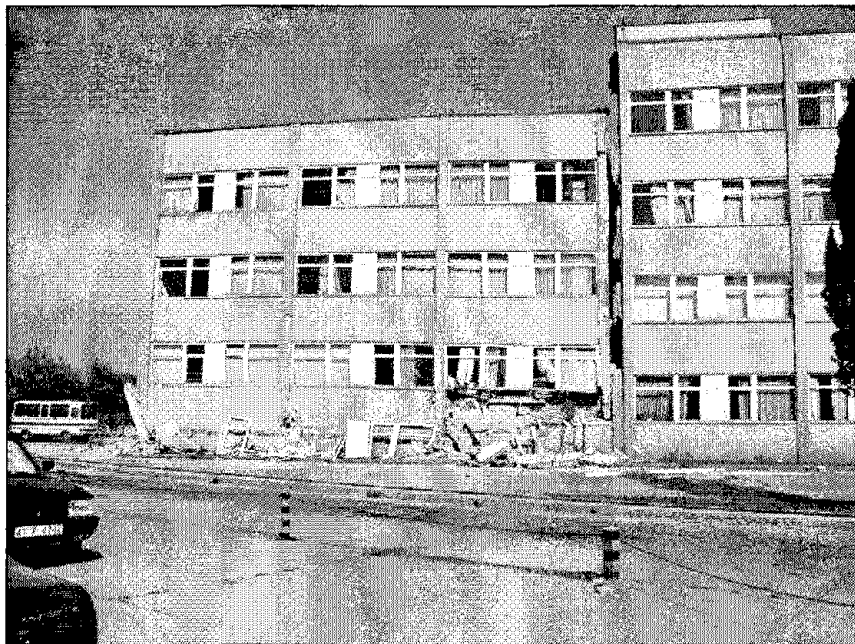
car ports, large openings, or other features to suggest a soft story or weak story collapse mechanism (Figure 6-34).

Figure 6-34 Failed first floor in İGSAŞ office building

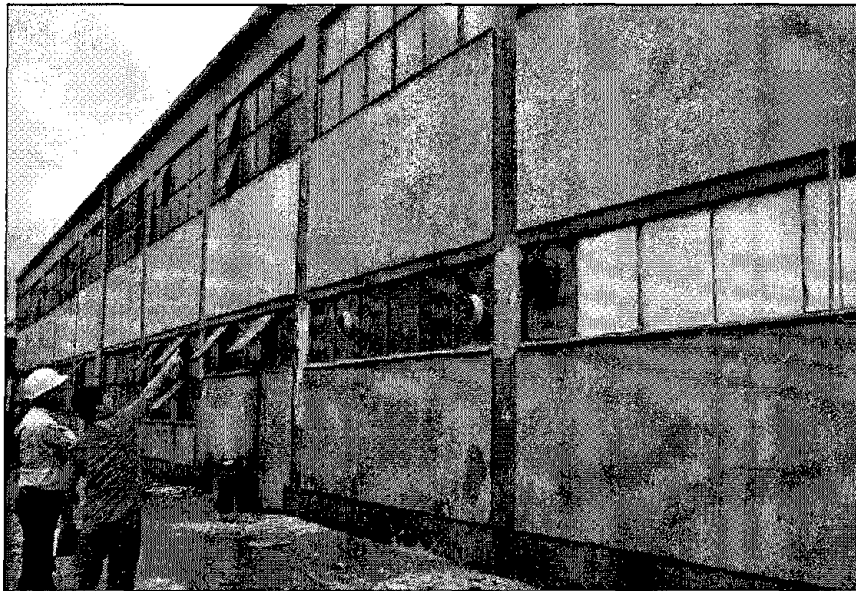
Damage was observed at several buildings at the Mannesmann Boru steel pipe factory, often associated with reinforced concrete frame structures with partial height masonry infill. "Short column" damage was especially noticeable on two buildings, a production

building and a warehouse, where adjacent building sections had very different window opening heights (Figure 6-35). The shorter columns experienced much more severe damage than the adjacent taller columns.

Figure 6-35 Short columns failed in bays next to longer columns at Mannesmann Boru steel pipe factory

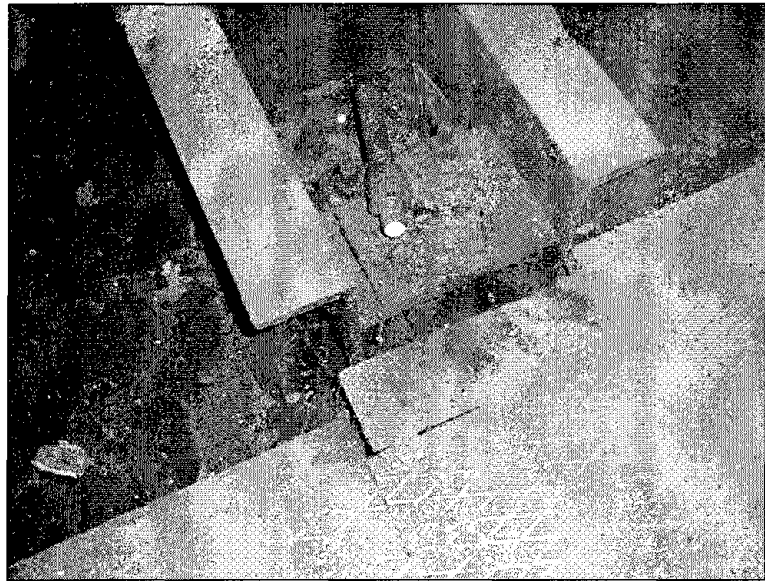
One steel frame production building at the Mannesmann Boru large pipe area uses steel moment resisting frames. Anchor bolts on these columns stretched and fractured. It was

noted that some torsional effects may have added to the column response in the longitudinal direction due to inclusion of diagonal braces on only one truss face. This 100 m wide by 600 m long main plant had two steel moment frames in the longer direction and several shorter frames in the other direction. Since shorter frames were not placed symmetrically, they also apparently caused some damage due to torsional effects (Figures 6-36 and 6-37).

Figure 6-37 Sheared bolts at base of column at Mannesmann Boru large pipe factory

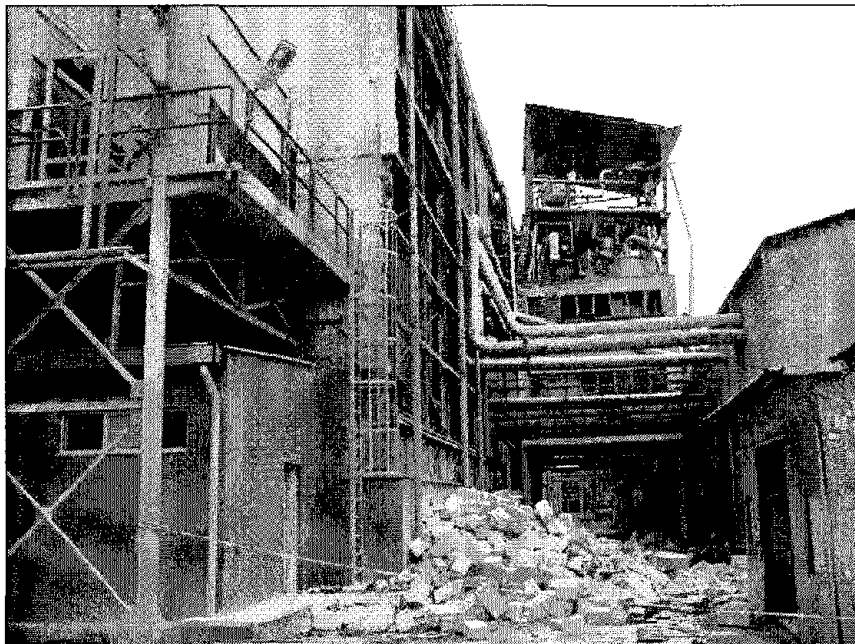
One failure of a steel frame structure took place at the Pakmaya food processing plant in İzmit, very close to the failed Pirelli tire building. At Pakmaya, a two-story steel frame with masonry infill was built on the roof of a concrete frame structure. The two story steel frame was severely damaged, with columns hinging at top and bottom. The failure appeared to only be attributable to inertial loads, as the tanks housed in the building do not penetrate to the upper floor and could not have knocked down the structure (Figures 6-38 to 6-40).

Figure 6-38 Fallen walls and damaged steel penthouse building at Pakmaya food processing plant

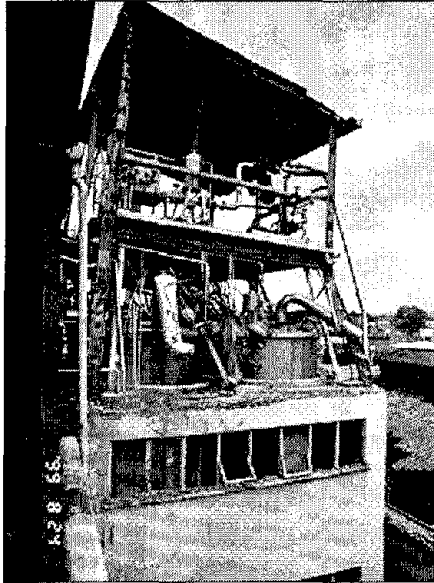
Figure 6-39 View of large displacements on steel penthouse at Pakmaya

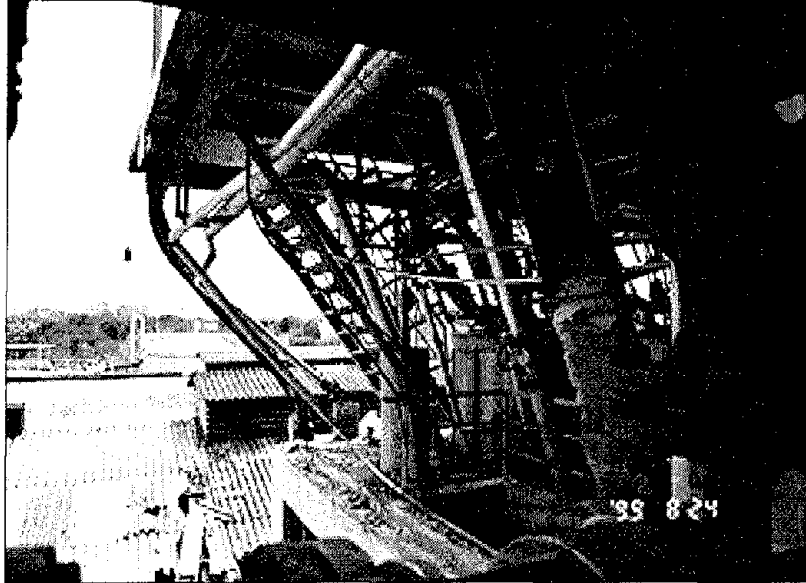
Figure 6-40 Columns on steel structure at Pakmaya hinged top and bottom causing several feet of interstory drift

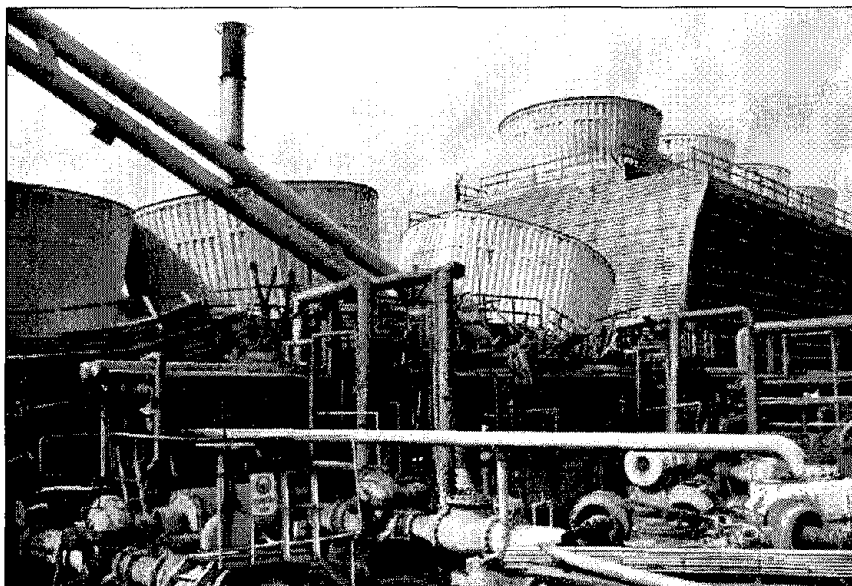
Wood cooling towers collapsed at the Petkim petrochemical plant as well as the Tüpraş refinery (Figure 6-41). These failures are unusual in that the towers shook down completely. It is believed that the duration of ground shaking contributed to the severity of this damage.

Figure 6-41 Collapsed cooling tower at Petkim

In past earthquakes, heavy damage to wood cooling towers has primarily been caused by the poor condition of the wood prior to the earthquake. According to management, that was not the case for these cooling towers.

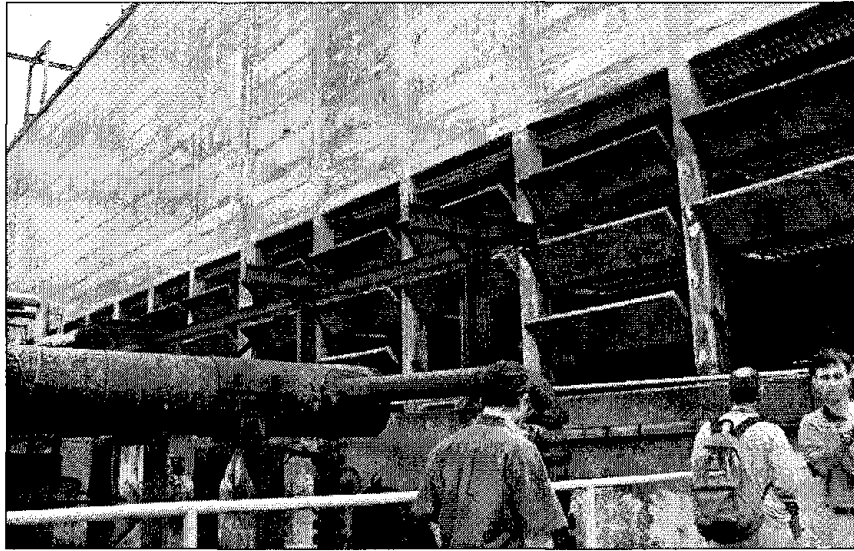
A concrete cooling tower at Petkim was also severely damaged due to short column effects. Every exterior column around the entire perimeter of the tower hinged at the base. Examination of the interior columns revealed no damage. This is likely attrib-

Figure 6-42 Severely damaged concrete cooling tower at Petkim

able to the length of the interior columns, not supported on shear walls. It is likely that the shorter, stiffer exterior columns attracted more load (Figures 6-42 and 6-43).

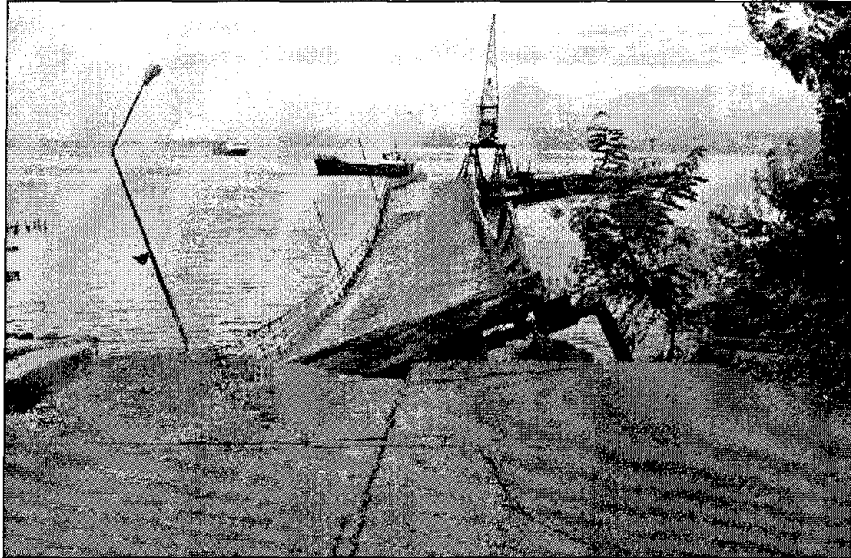
Figure 6-44 The approach to the port at the SEKA paper mill is completely unusable

Numerous ports in the area were damaged, either structurally or by ground settlement or spreading. The port at the SEKA paper mill was severely damaged by the total failure of the approach bridge. The approachway was supported on single reinforced concrete piers that failed along the entire length of roadway (Figures 6-44 and 6-45). A second wharf there was also severely damaged (Figures 6-46 and 6-47).

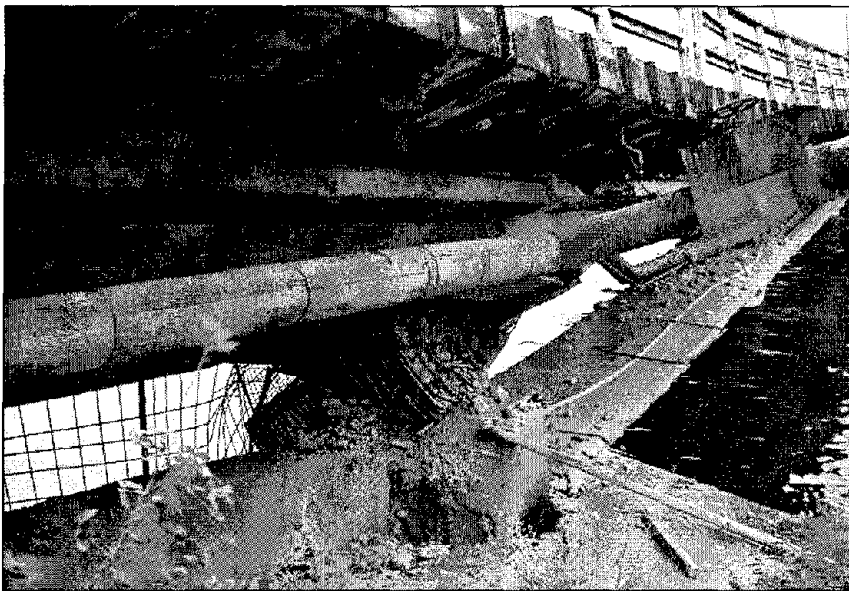
Figure 6-45 SEKA port support structure has collapsed single reinforced concrete columns

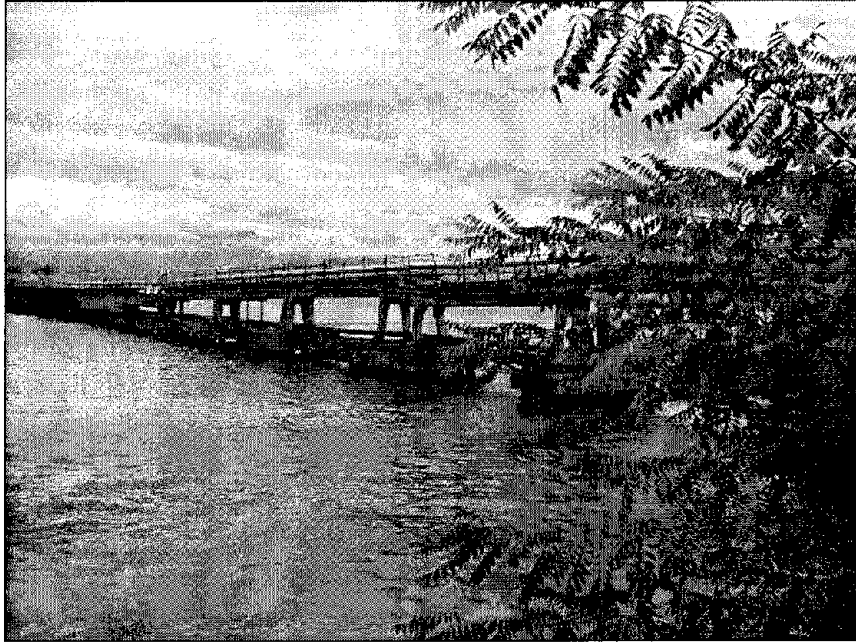
Figure 6-46 One section dropped a foot or more relative to other sections on the second wharf structure at SEKA

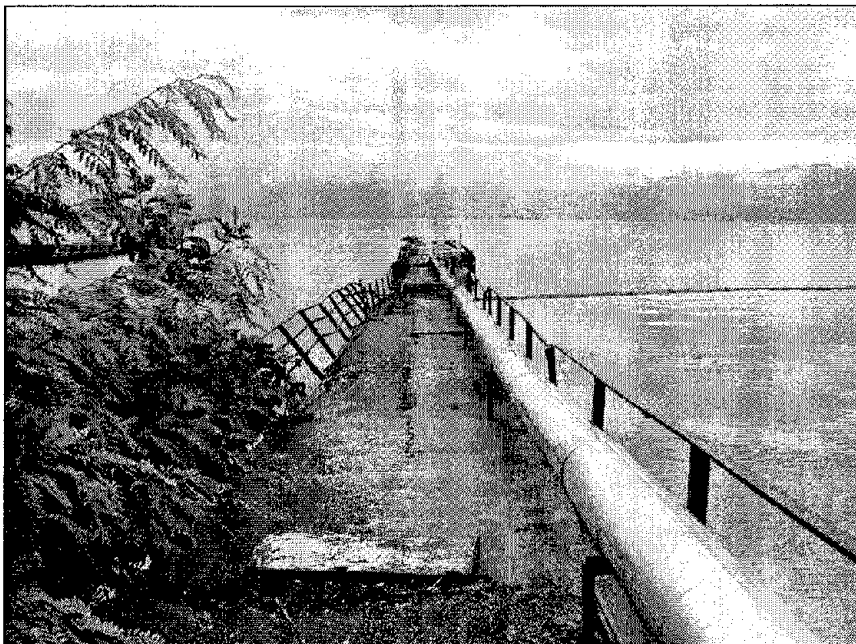
Figure 6-47 Pipelines did not appear to be damaged, but second port structure at SEKA is also unusable

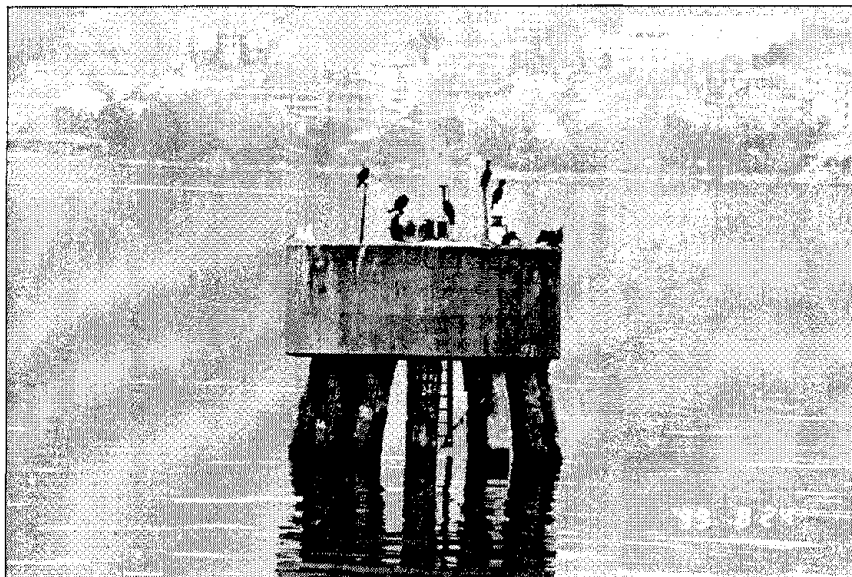
The wharf structure at Petkim had severe damage to 10 battered piles. Every pile was also severely damaged on both dolphins (Figures 6-48 and 6-49).

Figure 6-49 All piles severely damaged on dolphins at Petkim port

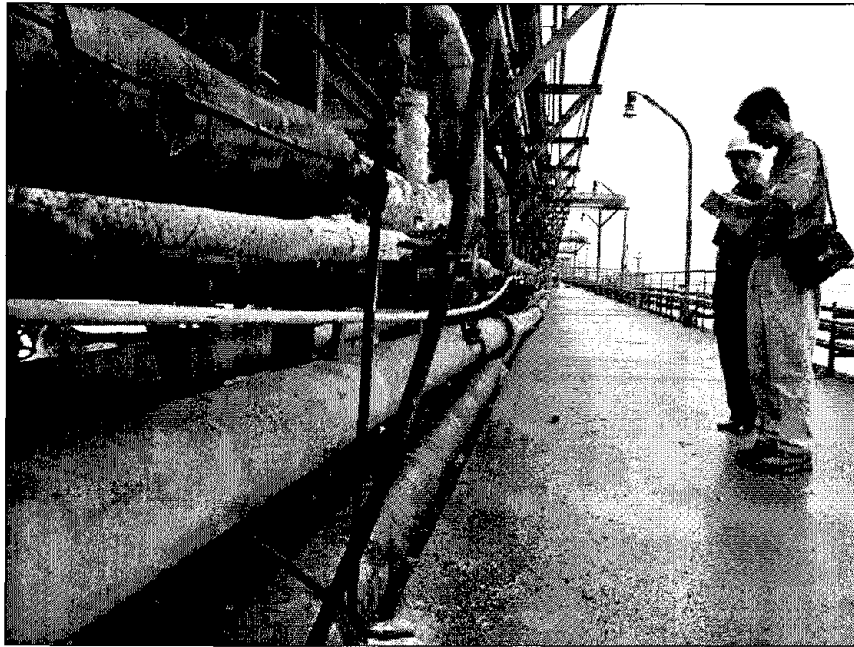
Petkim also had severe damage to pipeways at the wharf. Fractured cantilever supports dropped over 100 meters of fire protection pipe onto the deck, although the pipe itself was undamaged (Figures 6-50 and 6-51).

**Figure 6-50 Fallen fire protection line at Petkim port.
Piping was not damaged.**

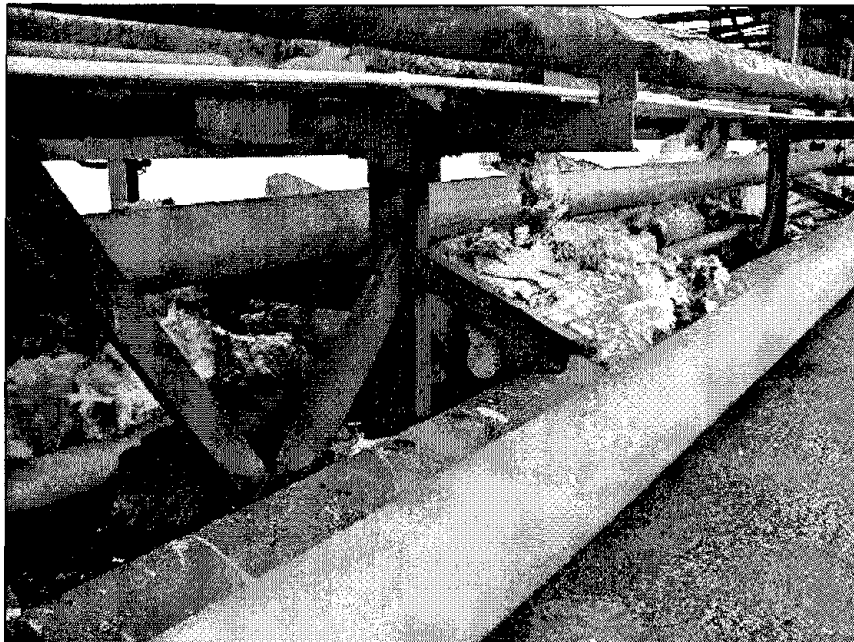
**Figure 6-51 Pipe support failure that led to falling of fire
protection pipeline at Petkim port**

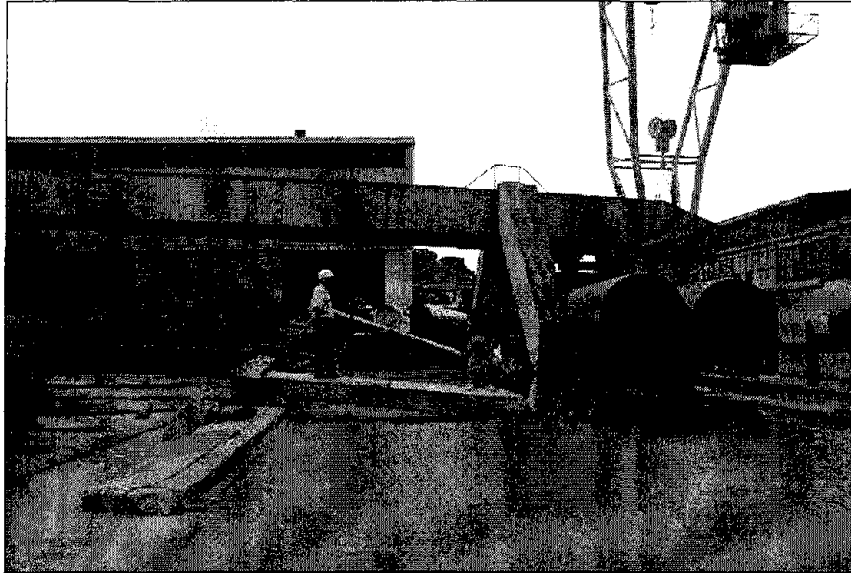
The port at the Gölcük naval base was heavily damaged by fault rupture throughout the wharf area. A crane jumped off its base at this location also. Cranes also jumped off their rails at Petkim. Two identical cranes collapsed at the Mannesmann Boru pipe factory (Figures 6-52 and 6-53).

Figure 6-52 Collapsed crane at Mannesmann Boru large pipe factory yard

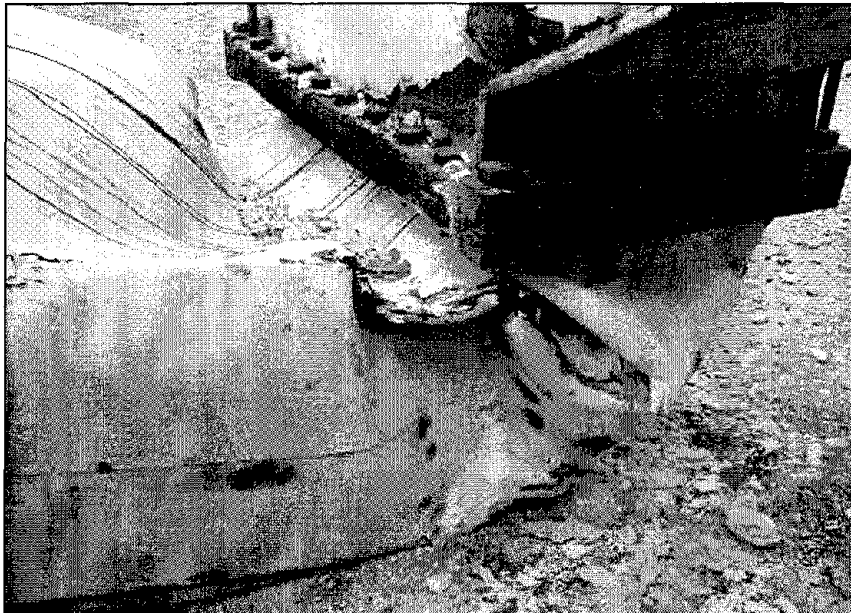
Figure 6-53 Box section of crane leg buckled Mannesmann Boru. A second crane experienced an identical leg failure but did not fall.

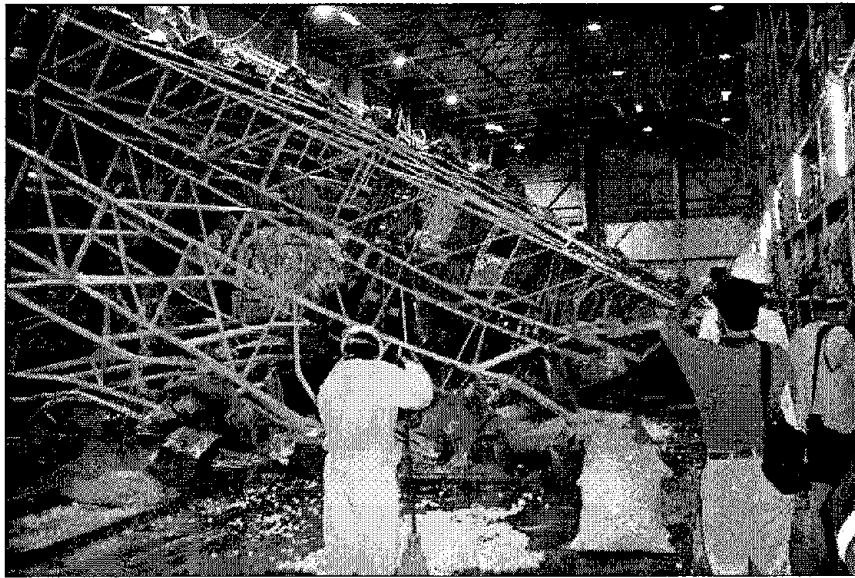
Storage racks collapsed at the Toprak pharmaceutical plant and the Toyota factory, both in Adapazarı (Figures 6-54 and 6-55).

Figure 6-54 Collapse of storage racks at Toprak İlaç pharmaceutical plant in Adapazarı
