The Marmara, Turkey Earthquake of August 17, 1999: Reconnaissance Report

Edited by
Charles Scawthorn¹

Technical Report MCEER-00-0001

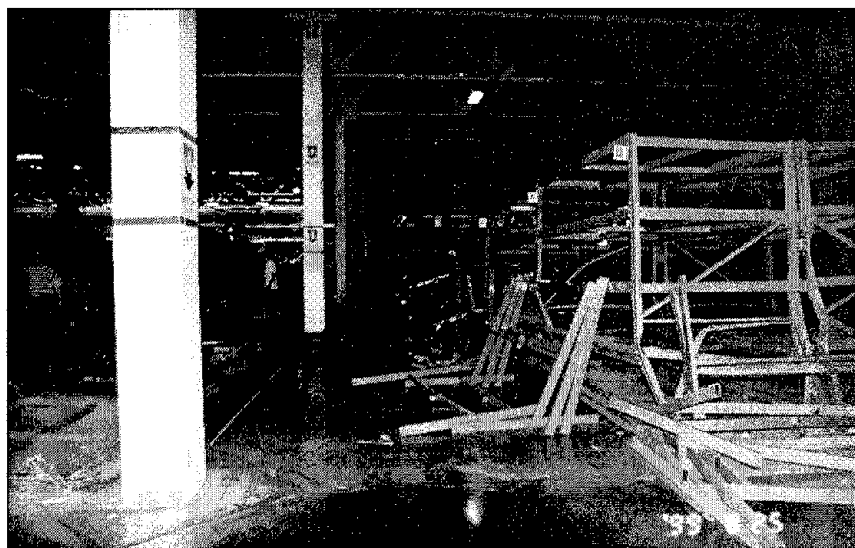
Figure 6-55 Collapsed storage racks at Toyota plant

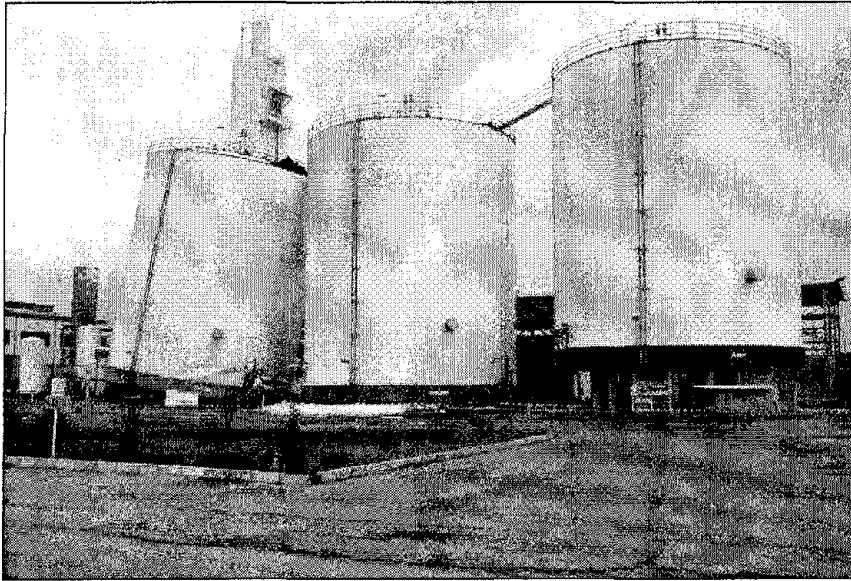
Figure 6-56 Three identical tanks at Habaş. Tanks to left were full of liquid oxygen. Third tank to right was apparently 1/4 full of liquid nitrogen and did not collapse.

The Habaş plant in İzmit provides liquefied gases to commercial plants and medical facilities. The major damage observed at Habaş was the collapse of two out of three large storage tanks (Figures 6-56 and 6-57). Three identical 48 foot diameter tanks were built in

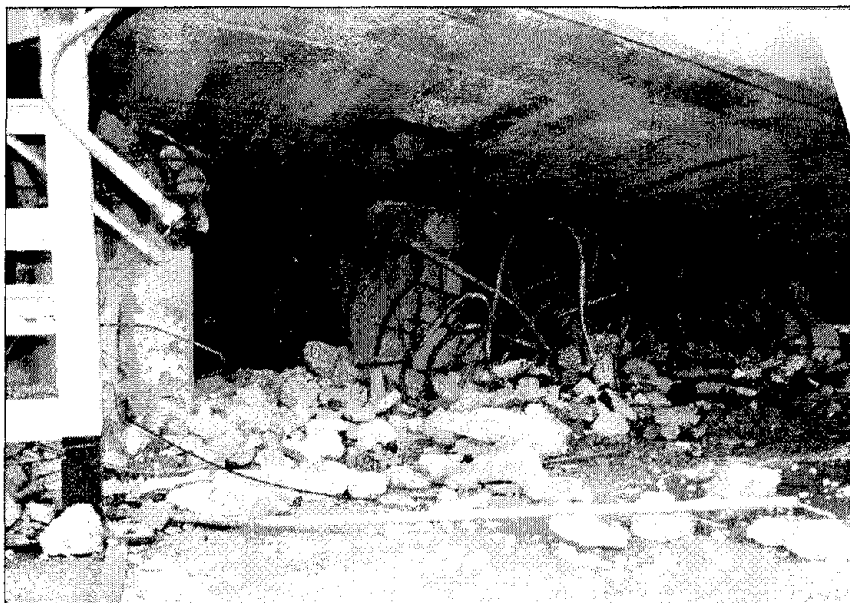
Figure 6-57 Tanks at Habaş collapsed due to failure of reinforced concrete columns and support base. Support structure was built in 1995.

1995 and consisted of stainless steel shells with an interior diameter of 42 feet. The tanks were each supported on a 42 inch deep reinforced concrete platform, with sixteen 20-inch diameter reinforced concrete columns, 100 inches tall. Two of the three tanks were filled with liquid oxygen at the time of the earthquake. Their column supports were not strong enough to resist lateral loads induced by the earthquake under high axial load leading to collapse of the entire support frame in a brittle manner. An identical third tank is immediately adjacent to the collapsed tanks. This tank was reportedly 1/4 full of liquid nitrogen and had no apparent damage.

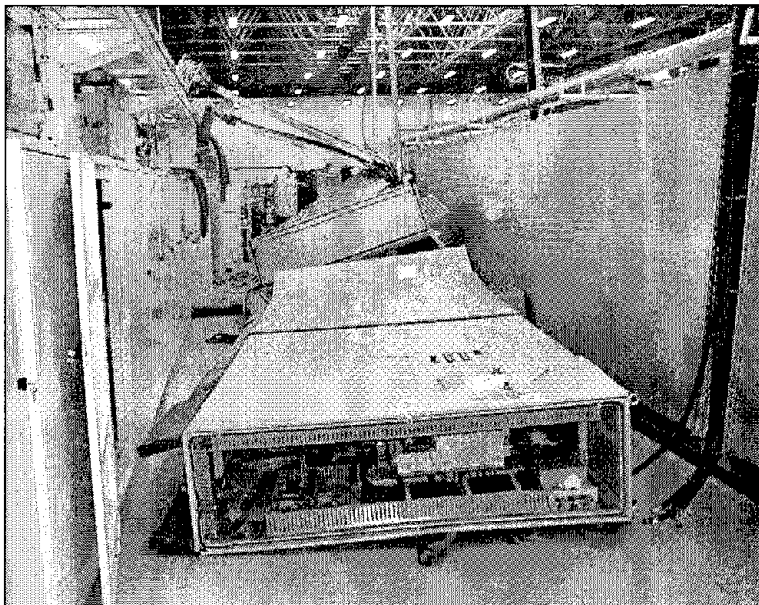
Most of the equipment damage observed was to unanchored equipment. Examples include the electrical equipment and small tanks at the Toprak facilities in Adapazarı (Figure 6-58).

Figure 6-58 Unanchored electrical cabinets fell at Toprak Sağlık's paper products plant in Adapazarı

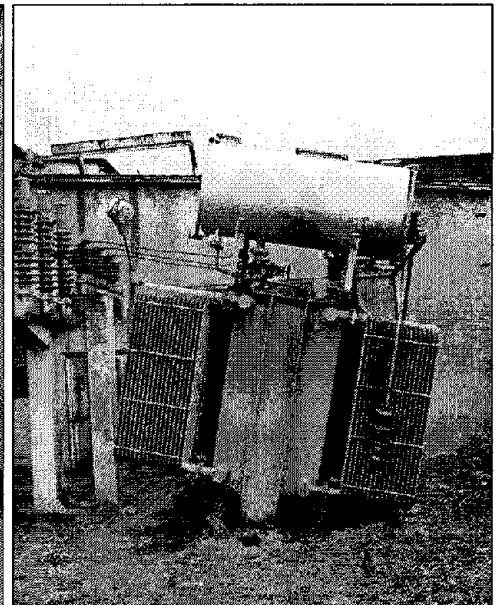
Transformers were damaged in several locations, including the SEKA paper mill, Toyota car factory, EnerjiSA power plant, Adapazarı substation, and Ambarlı power plant (Figures 6-59 to 6-61).

Figure 6-59 Damaged transformer at SEKA plant 4 will cause the plant to be shut down for two months

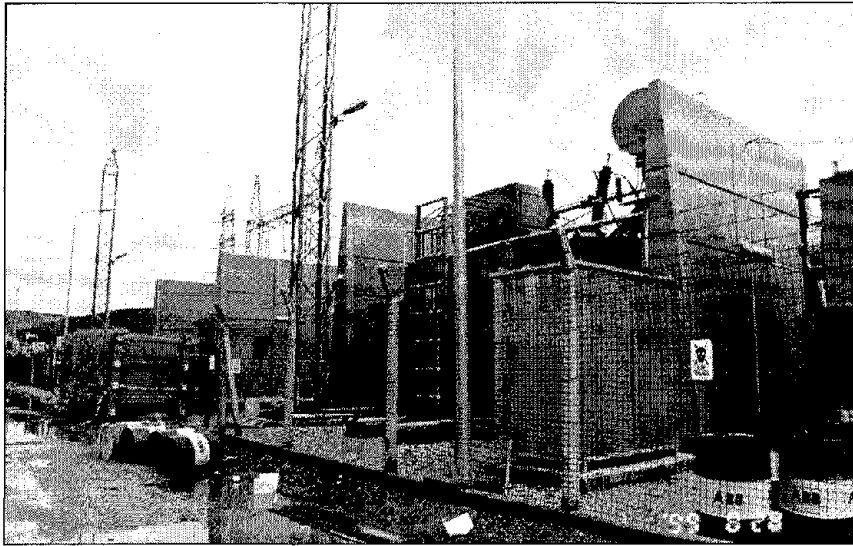
Figure 6-60 Transformers at EnerjiSA. End transformer rolled and tipped.

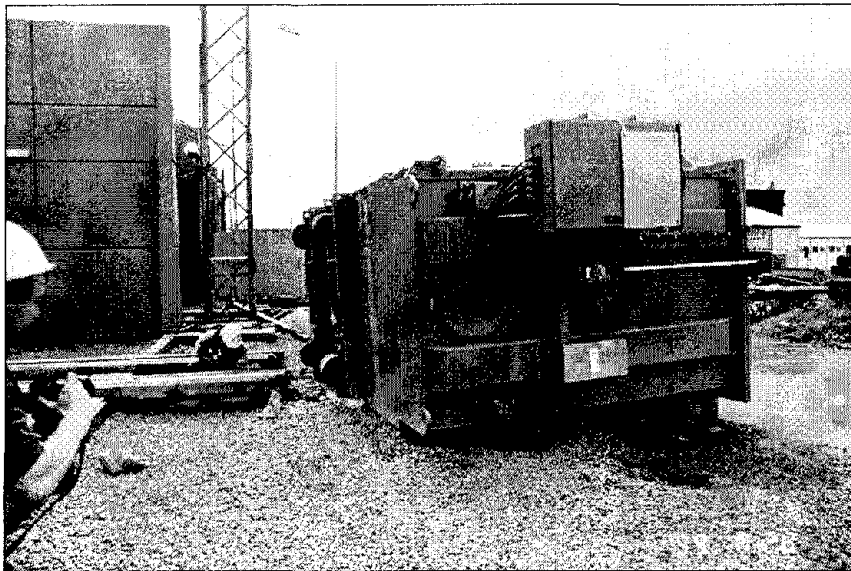
Figure 6-61 Transformer at EnerjiSA rolled several feet and tipped on its end

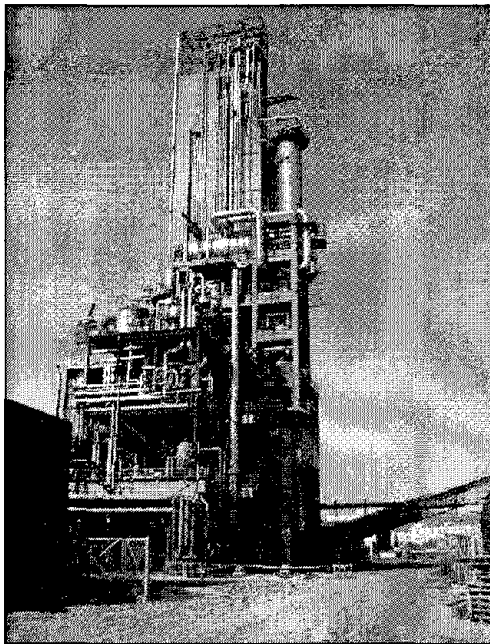
An elevated reactor vessel at the İGSAŞ fertilizer plant had broken steel braces hanging from the vessel near the top of its concrete frame support structure. Because of the Tüpraş

fire, İGSAŞ had not yet had the opportunity to inspect the structure and vessel at the time of the site visit. The concrete support frame itself was reported to be severely damaged (Figure 6-62).

Figure 6-62 Severely damaged reinforced concrete reactor support structure at İGSAŞ. Braces near top of reactor are hanging disconnected after earthquake.

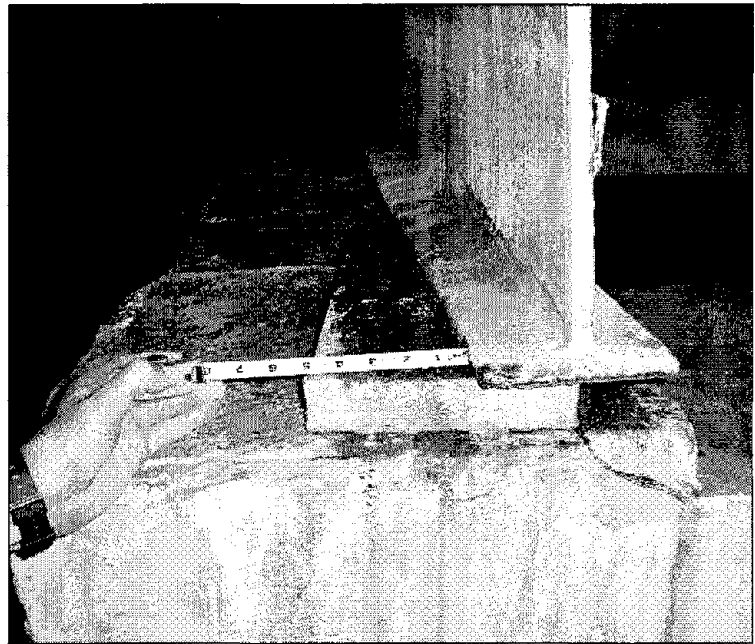
Pakmaya had numerous bioreactor vessels, unanchored on pedestals in their process building. Several of these vessels appeared to have shifted many inches on their supports, buckling skid beams and shifting supports (Figure 6-63). Piping was reportedly damaged due to shifting of the vessels.

Figure 6-63 Skid beams buckled and shifted due to displacement of large bioreactors at Pakmaya food processing plant

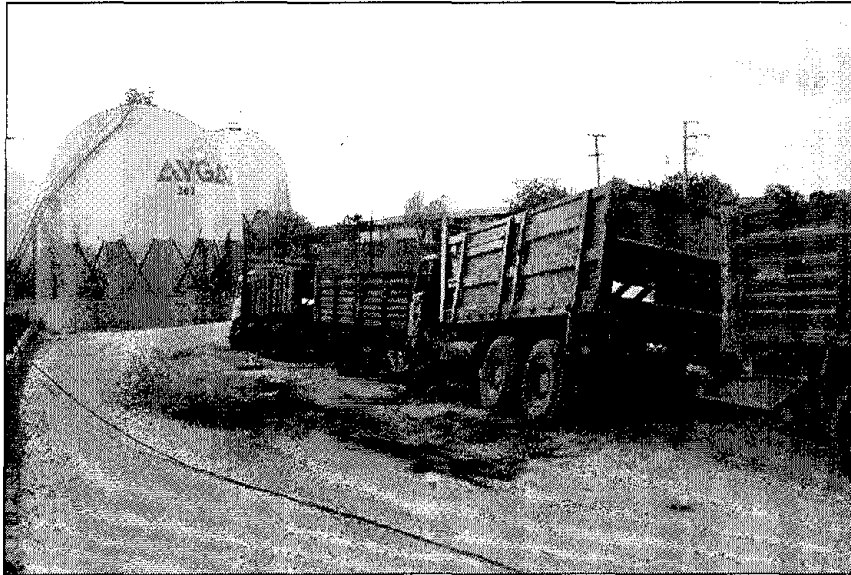
Although no major structural damage was observed at LPG plants in the epicentral area, two truck drivers were killed in a fire ignited by driving through a gas leak from one of the facilities. Security cameras at one facility captured the drivers leaving the facility across the street, beginning to run down the road on foot, changing their minds and returning to their trucks, and driving away. The remains of their burned out trucks and a burned out building in the facility could be found less than a mile down the road (Figures 6-64 and 6-65).

Figure 6-64 Burned out trucks drove through gas cloud leaking from facility

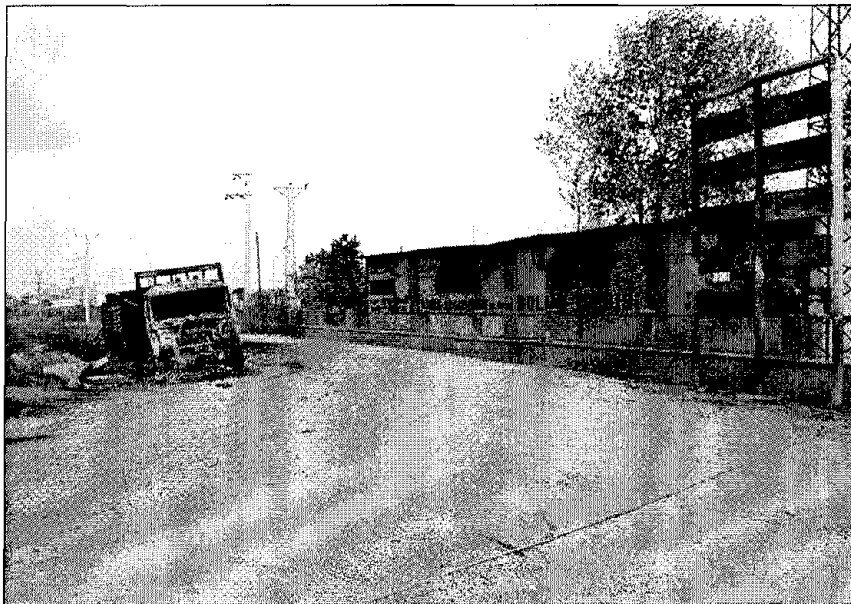
Figure 6-65 Fire from trucks burned down building at facility (to right) and killed drivers

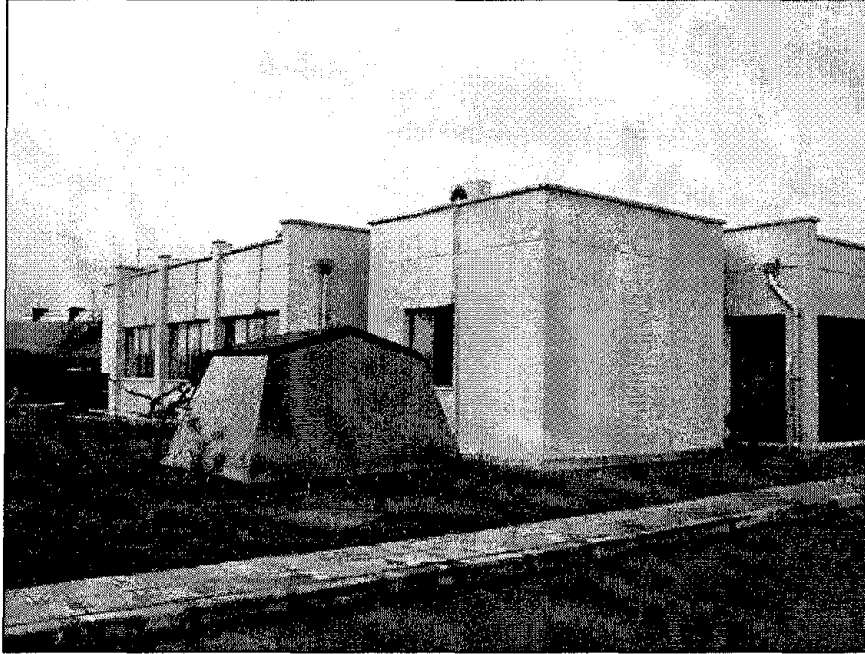
Figure 7-3 İzmit Water Project

undamaged (see Figure 7-3) with the exception of fiberglass piping in the clarifiers, which are cantilevered downward approximately 3 m. In basins which were not in use at the time, and empty, these 'trident' pipes cracked and/or broke at their upper (base) end. However, sufficient capacity remained for the plant to operate. Daily demand at the time of the earthquake is 2,500 l/s but, following the earthquake, demand increased to 3,200 l/s, which was attributed to leakage along the transmission line. Downstream of the plant, water is conveyed to retail customers via a 2.2 m spiral-welded steel pipe, which was

reportedly undamaged except at clean-out connections at low points, where flanged fittings appear to have cracked at perhaps a dozen locations. The transmission line was being scheduled for a one day outage for Aug. 26 (i.e, nine days after the earthquake) for repair of these leaks.

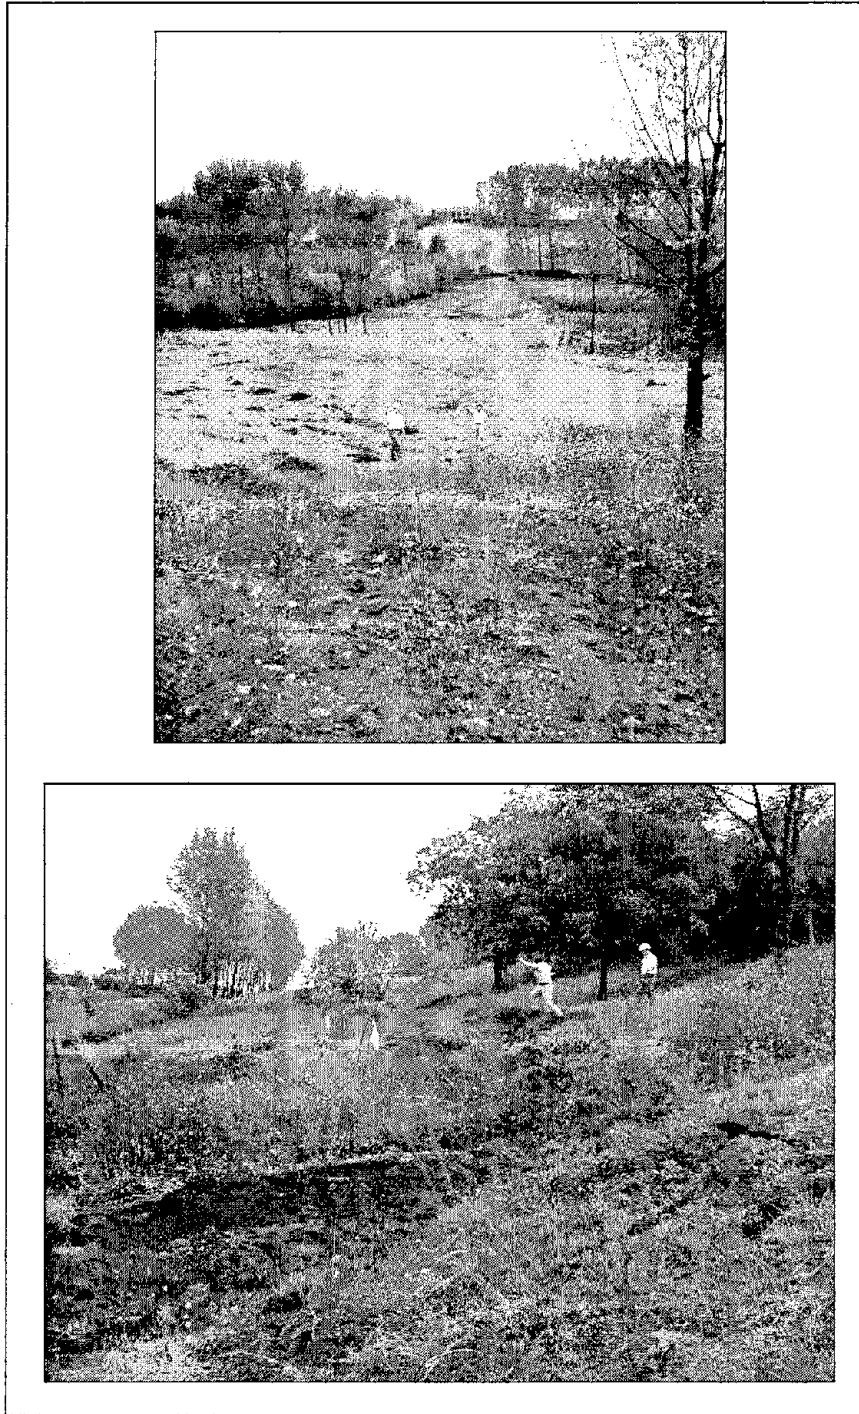
Approximately one km downstream of the plant, the steel transmission line crosses the fault trace. This location was inspected and found to have approximately a 2 m right lateral offset but, while some water flowing to the surface was observed (it was raining at the time, however), the pipe was reportedly undamaged at this location¹ (see Figure 7-4).

¹ Subsequent to the author's field visit, it has been reported that this pipe was excavated and found to have sustained some damage, which was repaired.

Figure 7-4 Top photo was taken looking north along pipeline alignment. The two men are at the location of the pipe-fault intersection, showing the approximately 2 m fault offset. Bottom photo taken looking east along the fault, with the pipeline alignment in foreground. The man is leaping across fault scarp, to east of pipeline. Note that the scarp appears to alter alignment northwards right at pipe (in foreground).

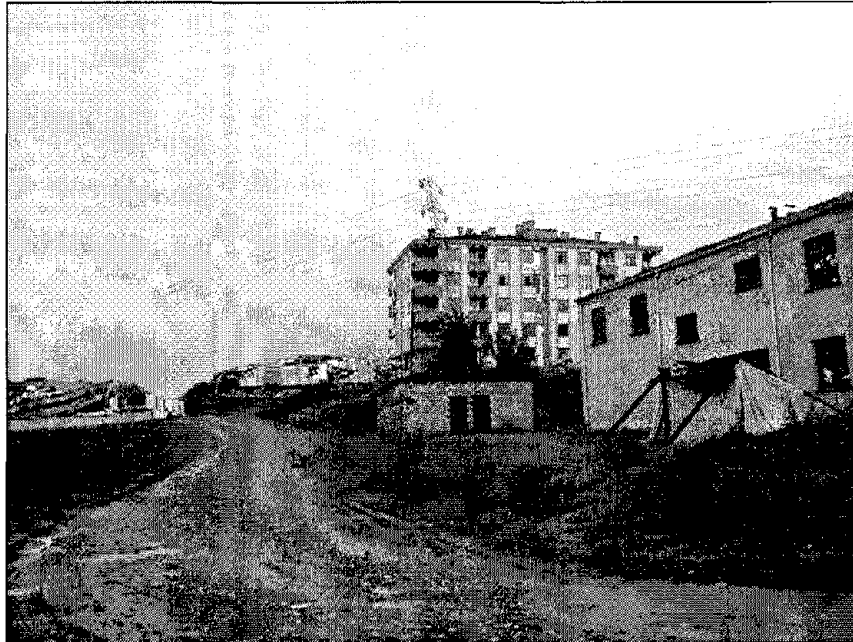
Figure 7-8 Electric transmission tower pulled to left (north) due to conductors being put in tension due to right lateral fault displacement (fault is to north, or left, of the tower)

Transmission lines and towers did not appear to be damaged, except where the lines crossed the fault. Figure 7-8 shows a tower leaning over due to the conductors being put in tension at the fault crossing. Distribution within the high intensity shaken area was heavily damaged, due to building collapse and other damage.

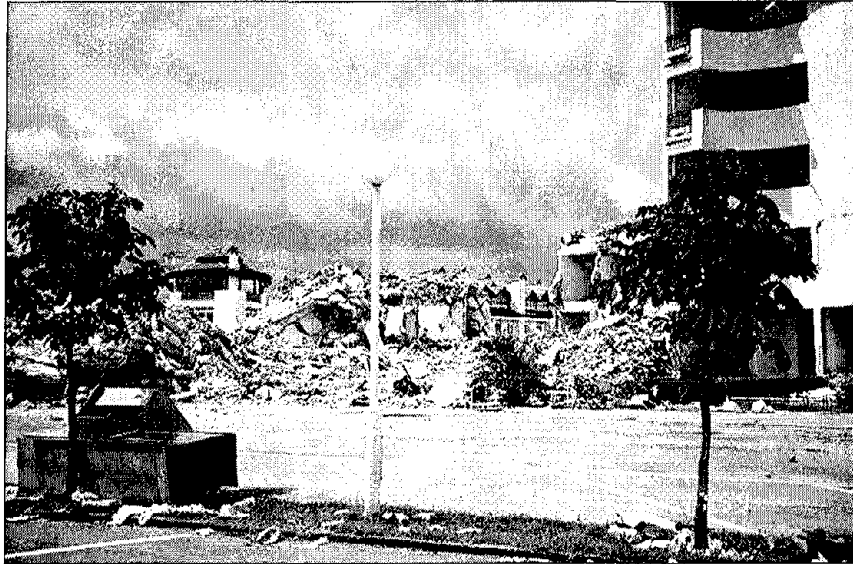
Deaths and injuries occurred when apartments collapsed (see Figures 8-3 and 8-4). Injuries were mostly orthopedic, neurological, and cuts, scratches, and bruising. Obviously, emotional trauma and shock were noted. Victims were taken to hospitals and medical clinics by ambulances, private cars, trucks, buses, taxis, boats, and helicopters. First aid was slow to be organized, but within 48 hours, it was available to many. Field hospitals were set up in the city soccer stadiums at Yalova, Adapazarı, İzmit, and Avclar.

Figure 8-3 Totally destroyed apartment building near Karamursel

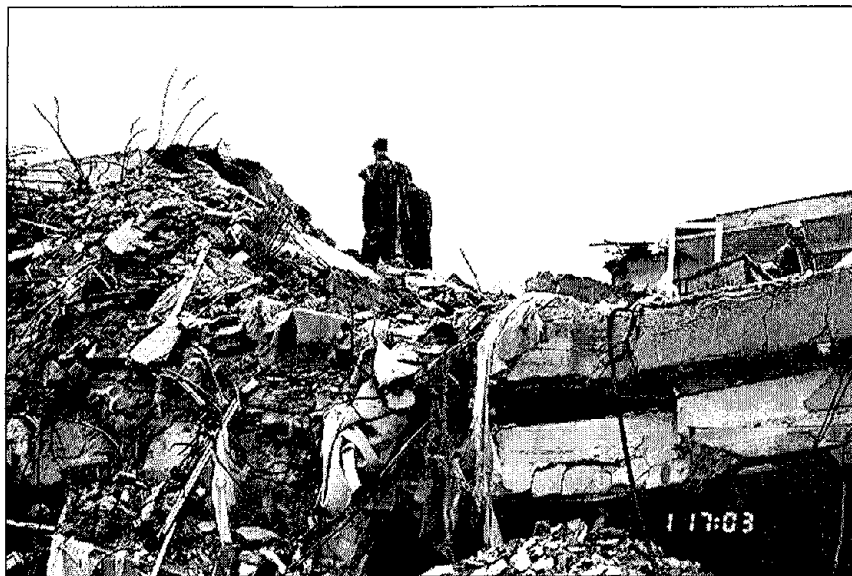
Figure 8-4 Collapsed apartments in Gölcük

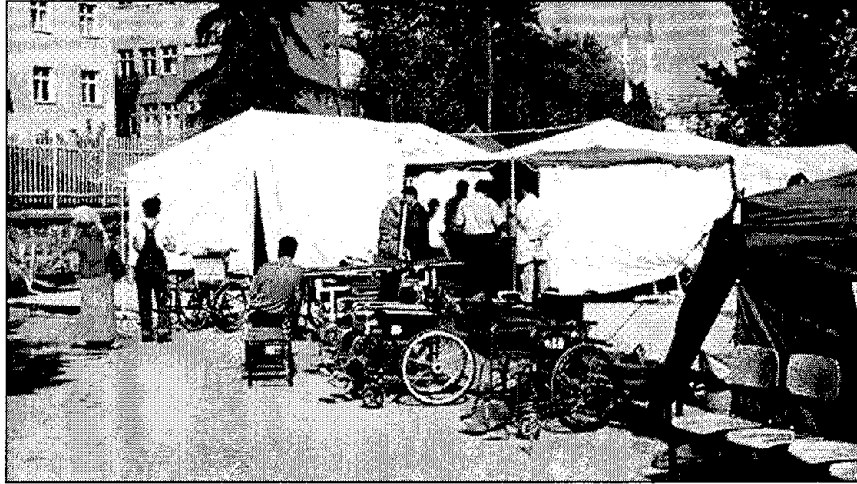
In both İzmit and Adapazarı, several hospital buildings experienced major physical damage during the earthquake. At a hospital in İzmit, for example, two buildings and the pedestrian walkway connecting them sustained serious damage from the shaking. Immediately after the earthquake, medical staff were forced to evacuate the building and move existing patients outside. As people began bringing the injured to the hospital's emergency department, it quickly became congested and overcrowded. To alleviate the crowding, hospital staff began assembling the injured in a school yard across the street, sorting and tagging them by severity of injury, and transporting them to other regional facilities. Similarly, existing patients who could not simply be discharged early were also transferred to other facilities.

What is most interesting about this particular hospital is that even five weeks after the earthquake, staff still had not yet reentered the buildings. On two occasions they tried to reenter, but when major aftershocks occurred, they returned outside. Because they were forced to set up operations in tents in the parking lot (shown in Figure 9-9), the hospital

Figure 9-9 A hospital in İzmit

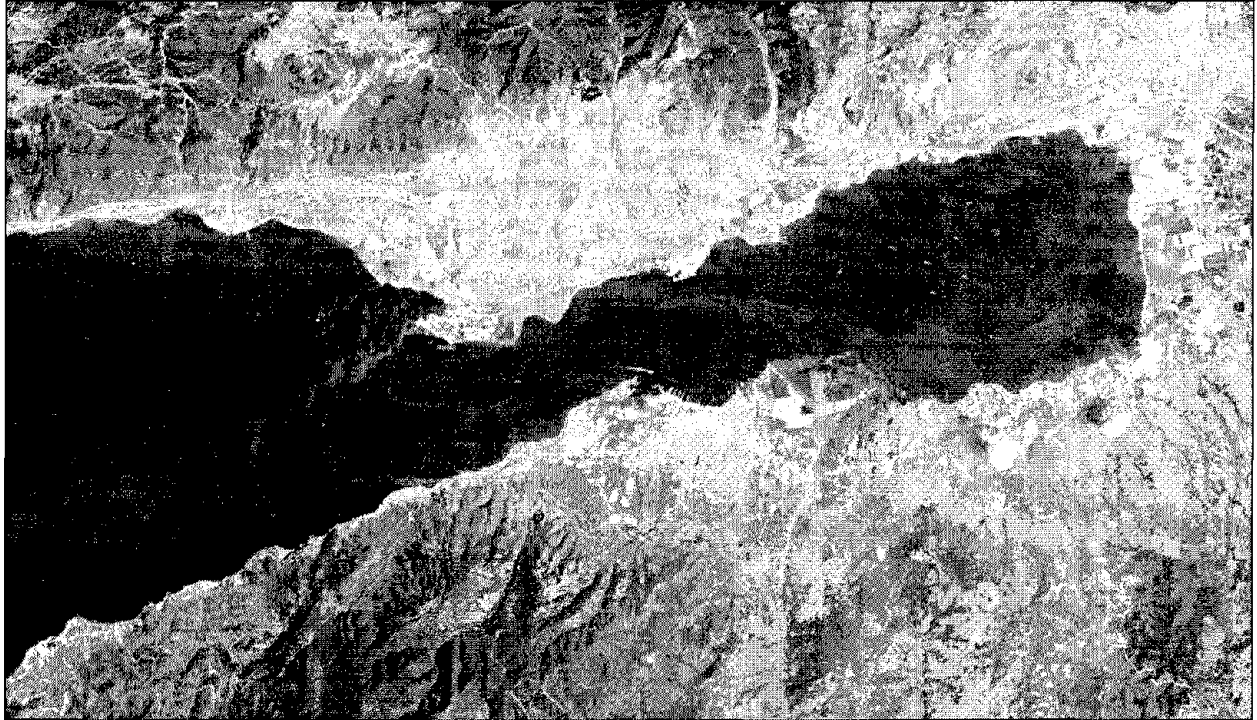
Figure 10-1 Landsat 5 Image of İzmit Bay taken on August 19, 1999. Note the fire and smoke plume originating from the Tüpraş Refinery, seen at the center of the figure.

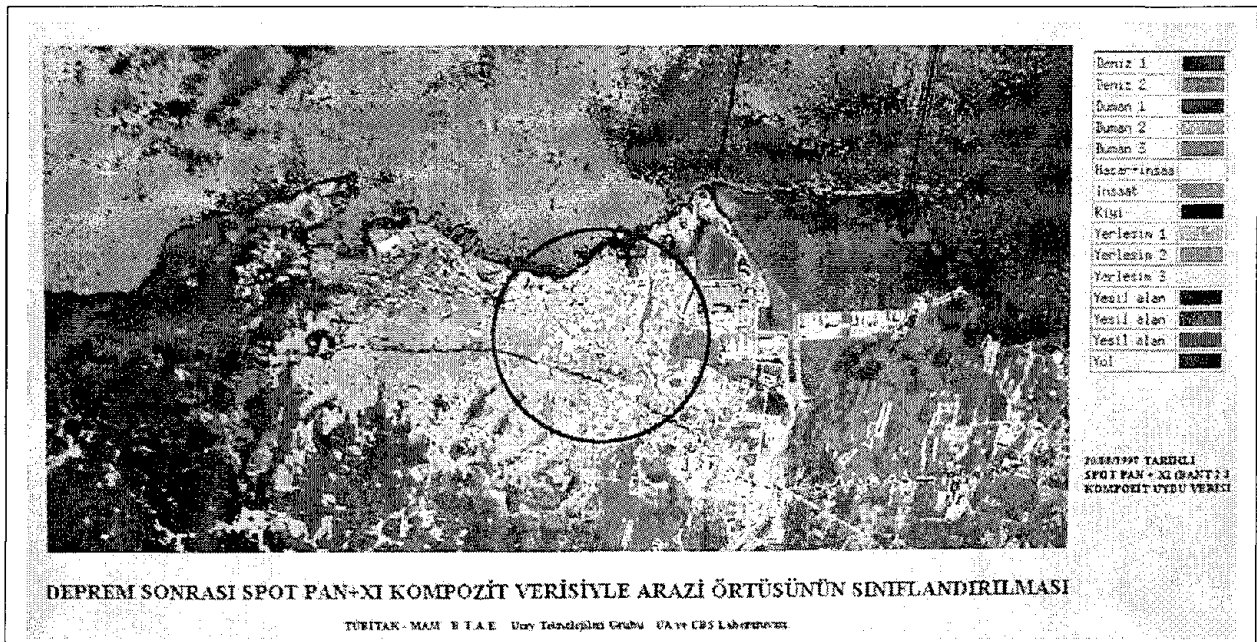
One analysis, which was based on a comparison of pre- and post-earthquake SPOT¹ images, showed large areas in Gölcük that were clearly affected by the earthquake. Several of these images are shown in Figures 10-2 and 10-3. In addition, other satellite-derived images showed extensive areas along the shore near Gölcük that were inundated as a result of ground subsidence caused by liquefaction. Figure 10-4 shows an aerial view of the inundation area.

Figure 10-3 Image of Gölcük created after the earthquake. (SPOT image taken on 8/20/99). Note that the white or light areas identify city blocks where significant damage to buildings occurred.

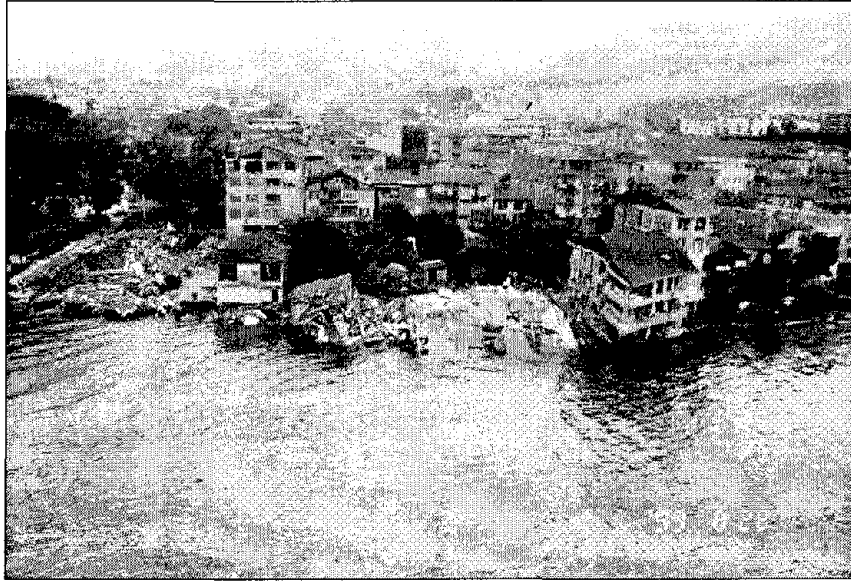
Figure 10-4 Aerial view of earthquake damage in Gölcük. This area was affected by ground subsidence caused by liquefaction.

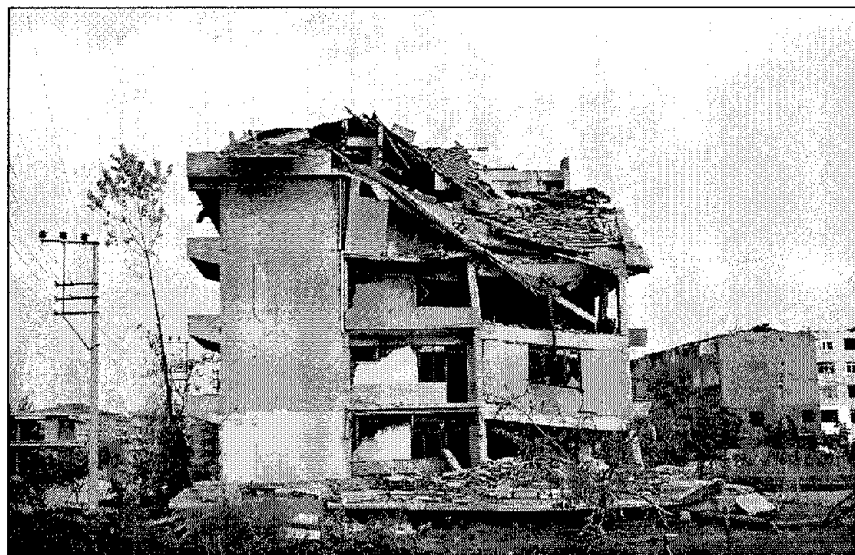
Figure 10-8 Isolated building in Seymen. This building experienced first floor collapse and well as damage to the top floor. This building should be visible from aerial photos; it may be detectable using radar pre- and post-event images.

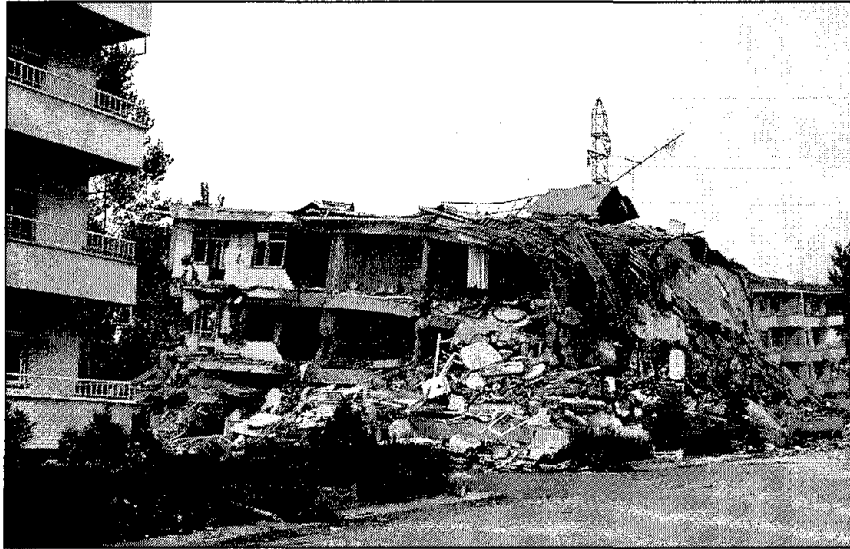
Figure 10-9 Near complete collapse of a five-story concrete structure. Should be visible from both aerial photos and SAR imagery.

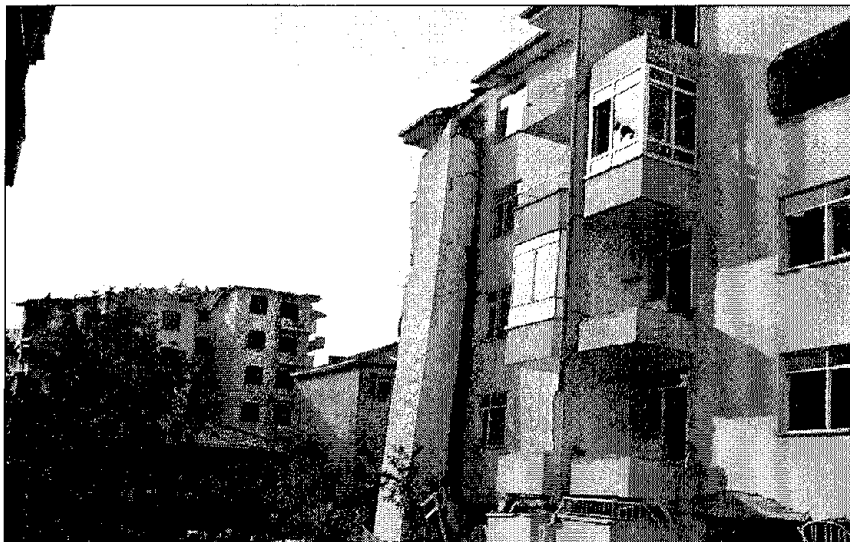
Figure 10-10 Severe damage to multi-story apartment buildings. Lower floors have “pancaked” and building is not tilted. May be visible from aerial photos; collapse of lower floors may be detectable from radar imagery.

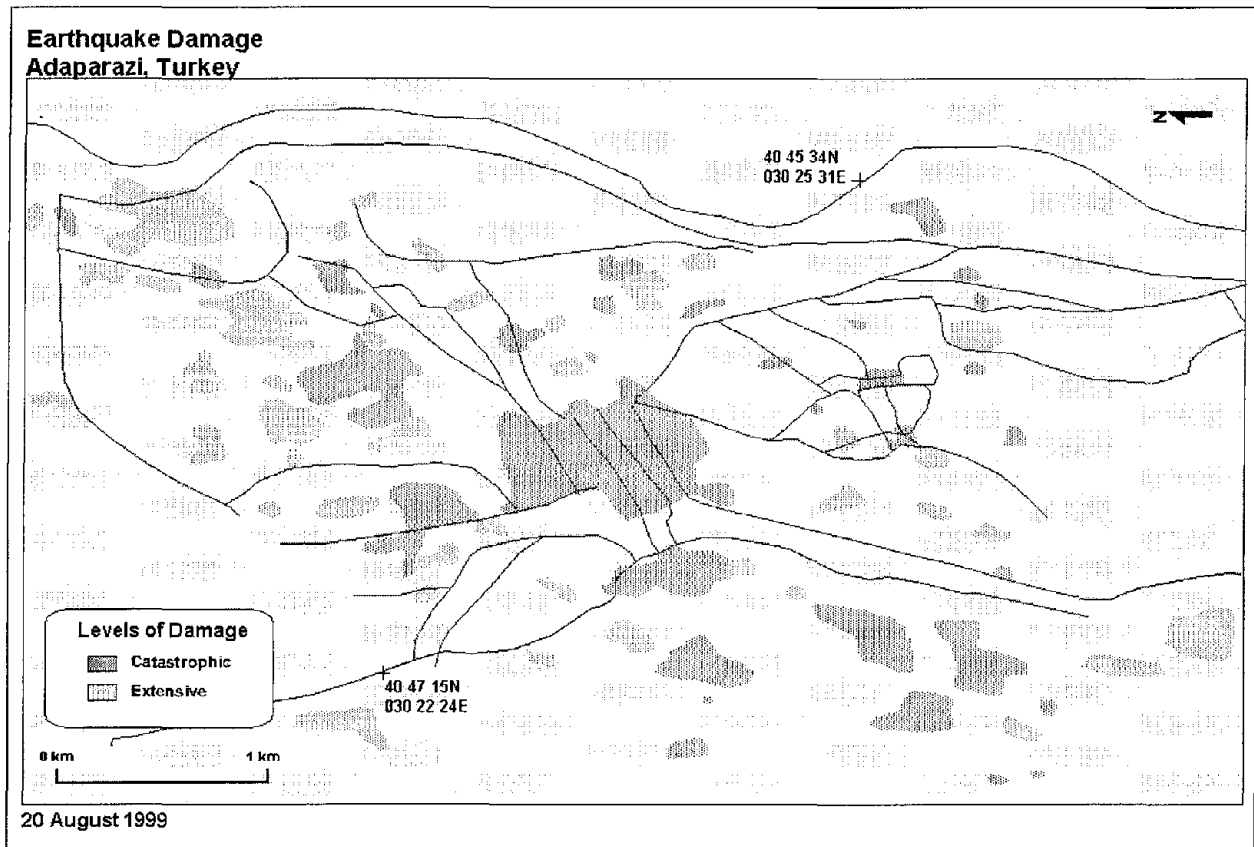
One example of the type of map distributed by the State Department is seen in Figure 10-11 for the Adapazarı area. The map identifies areas of catastrophic and extensive damage. This map was put on the Internet on August 20, 1999, three days after the earthquake. According to officials at the State Department, high-resolution satellite images were used to classify the town into these two damage categories. Our purpose in validating these maps was to create a "ground truth" database that could eventually be used to calibrate a series of interferograms developed from this earthquake.

Unfortunately, the scale and projection of these maps was a little misleading. When compared directly with Landsat images – which were in a valid geographical projection – many of the obvious features (roads, rivers, and city boundaries) – did not match. The State Department maps appeared to present a distorted image of the affected areas.

Figure 10-11 Earthquake damage map produced by the U.S. State Department for the Adapazari region (August 20, 1999) - uncorrected

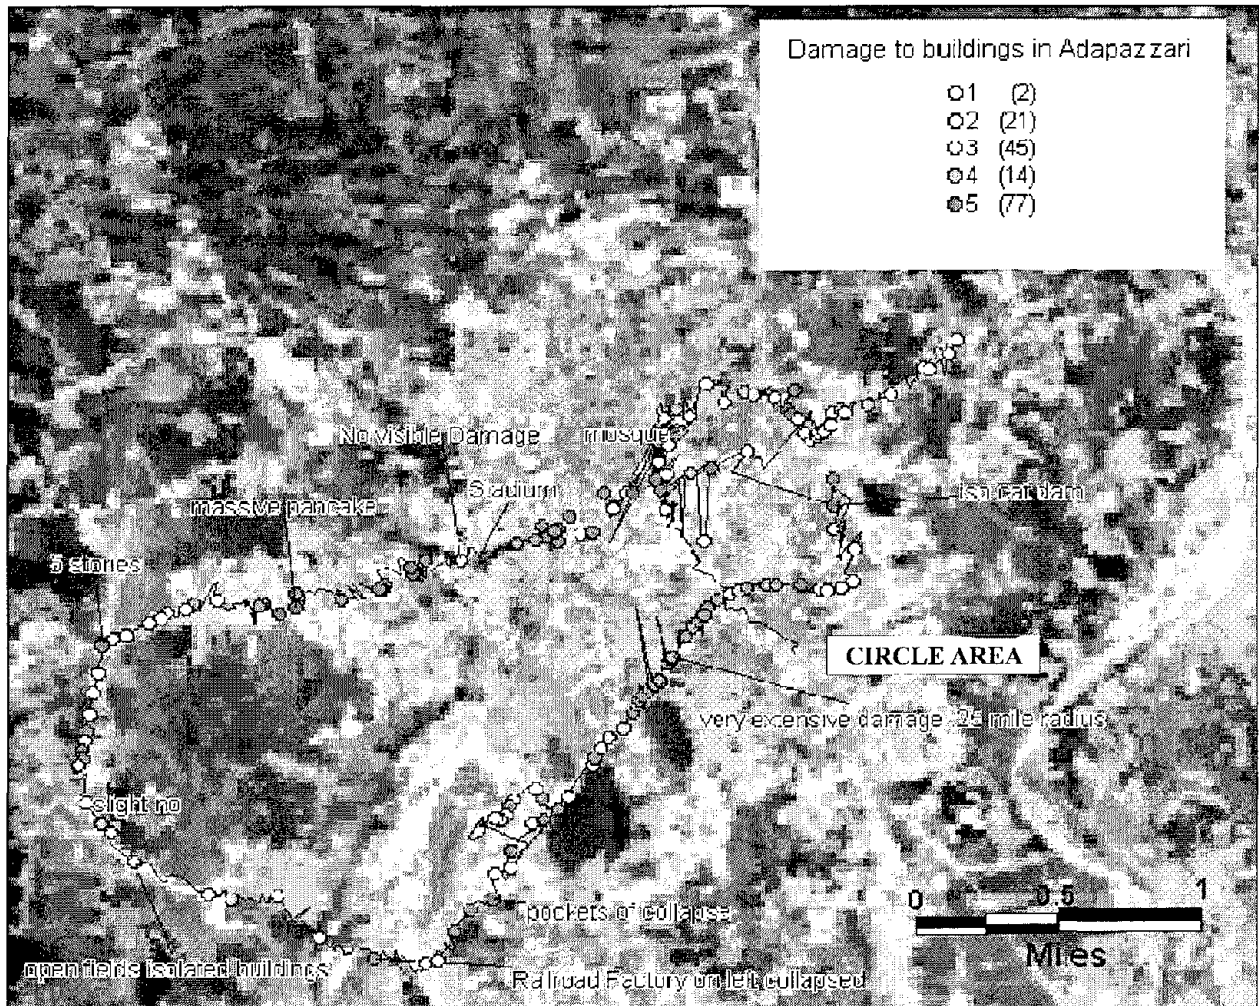
The route, shown in Figure 10-12 as a black line, began near the Mosque (center of the figure) and proceeded in a counterclockwise direction. Also noted on Figure 10-12 are color-coded circles that represent various levels of site damage (on a city block level), ranging from none or slight to catastrophic damage. Unlike the Avcilar survey, we did not have access to Differential GPS. Therefore, some wavering of the route trace is noted. In theory, the coordinates that are registered are within a block of the actual location.

Figure 10-12 Landsat 5 image showing Adapazari (light area in center of figure) and the route taken by the MCEER/EDM team on October 2, 1999 (route shown as a continuous black line). Also seen are individual damage assignments that were made along the route. Note: A damage index of 1 is associated with an observation of slight to no damage; an index of 5 reflects catastrophic damage.

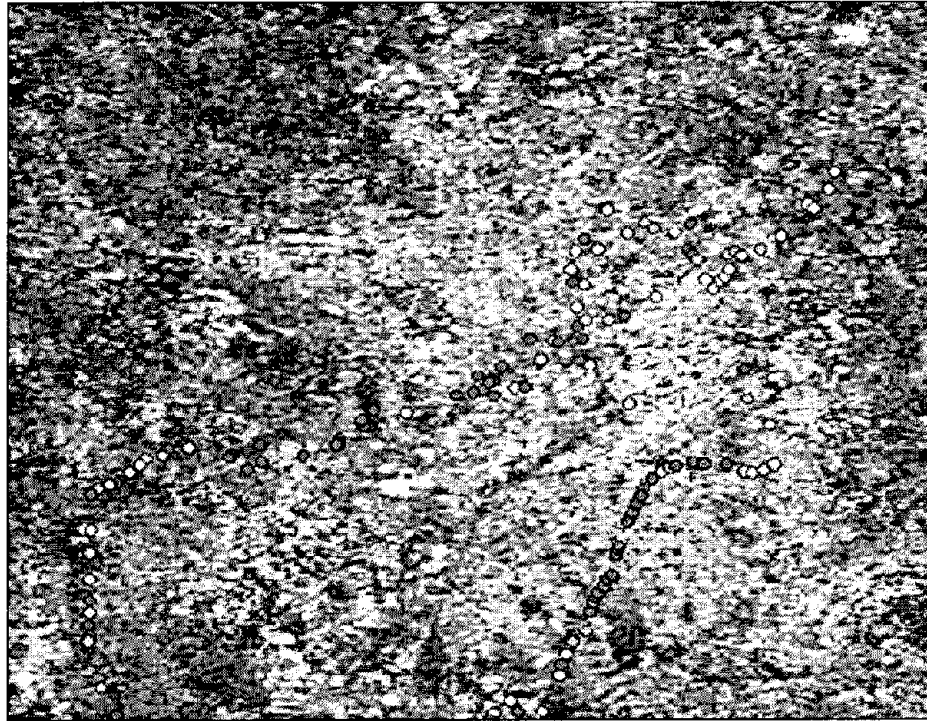
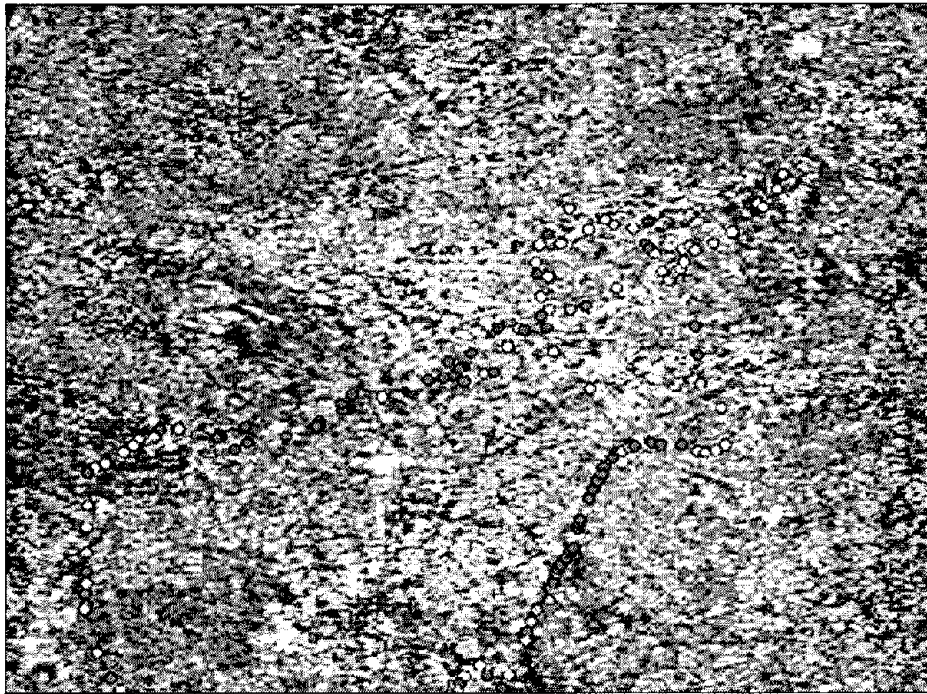
In general, pixel intensity will depend upon vegetation level, the density of buildings and their shapes, moisture levels, season, etc. Brighter areas are those that reflect more of the radar energy sent down from the sensor. In Figures 10-13a and 10-13b, the brighter areas are associated with the built-up area of Adapazarı. Both images were exported to MapInfo where they were geo-referenced to the Landsat 5 data. Since the resolution of these images is fairly coarse, we generally see only the major features of the region, e.g., major roadways and streets and some very large buildings. A cursory examination of both images does show some differences between the two figures. In order to view these changes in detail, we must concentrate on smaller portions of these images.

Figure 10-13 Intensity images of Adapazarı based on before and after earthquake SAR data (Data Source: ESA). The light areas correspond to built-up areas, which generally demonstrate a higher degree of reflectance or brightness. A median and Frost filter were applied to reduce white noise and maintain edges.

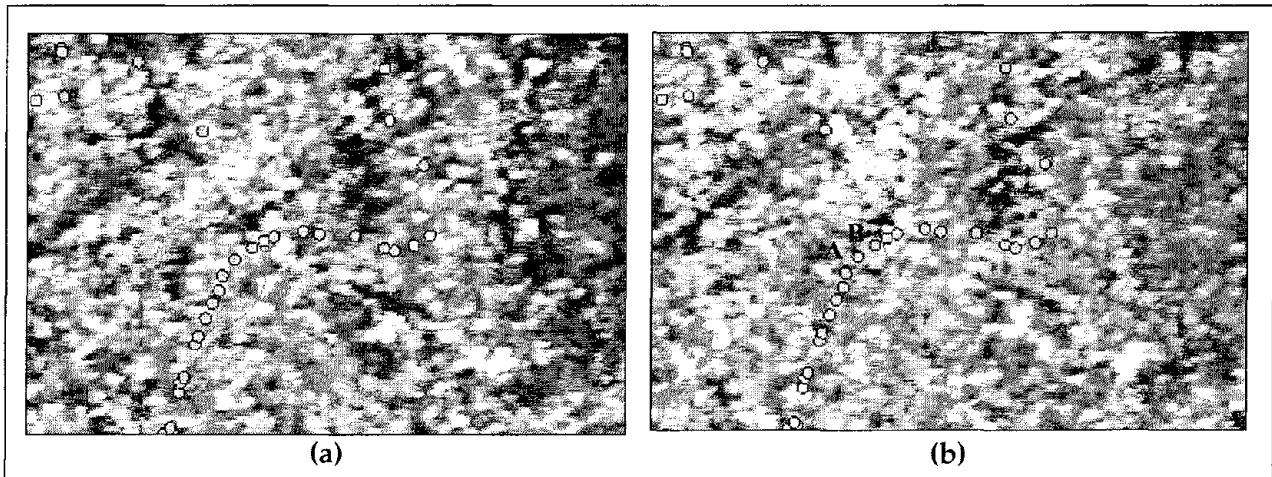
Figure 10-14 Close-up of "Circle Area" in Adapazarı (see Figure 10-12 for location). Note the designations (a) and (b) in Figure 10-14b which refer to photographs (a) and (b) in Figure 10-15. North is up. Raw data supplied by ESA.

between the two images, we drew a circle of 0.25-mile radius around this area. Comparison of the two images reveals that the after-earthquake image (Figure 10-14b) contains fewer bright spots. As was explained before, many of the buildings in this area had either completely failed (total collapse) or were severely damaged (many tilted buildings). It is expected that this type of damage would result in more scattering and thus, duller images.

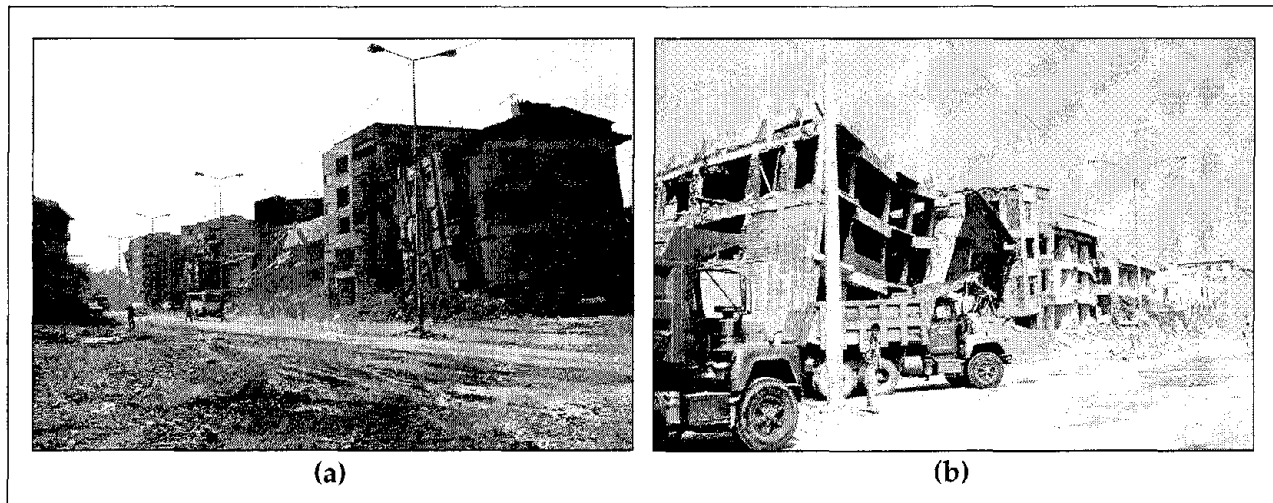
Figure 10-15 shows two photographs of damage in the "Circle Area." The first photograph (Figure 10-15a) is taken looking west along the main road. The second photograph is taken from the same location, looking northeast. Note that many of the damaged buildings have been torn down and the debris hauled away (Figure 10-15a). Since the second image was taken about one month after the earthquake, it is possible that the bare ground was being imaged at that time. At any rate, the second image was able to pick up this change.

Figure 10-15 Damage to apartment buildings in the "Circle Area" of Adapazarı. Left image is view (a) in Figure 10-14b. Right image is view (b) in Figure 10-14b.
