Quindío, Colombia Earthquake of January 25, 1999: Reconnaissance Report

Alejandro P. Asfura¹ and Paul J. Flores²

Technical Report MCEER-99-0017

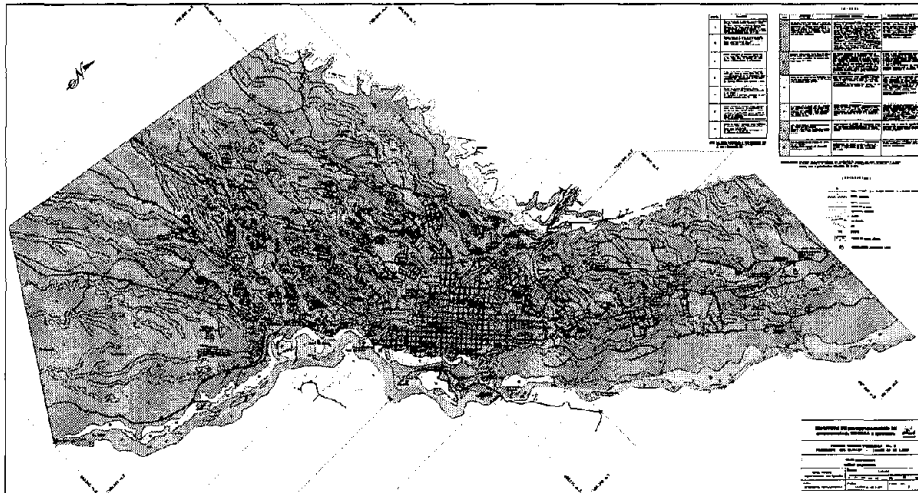
Most of the structural damage was concentrated mainly in the areas with deep layers of volcanic ash and volcanic sedimentary deposits or man-made non-engineered fill (see figure 3-1).

Figure 3-1 Geotechnical Map of Armenia

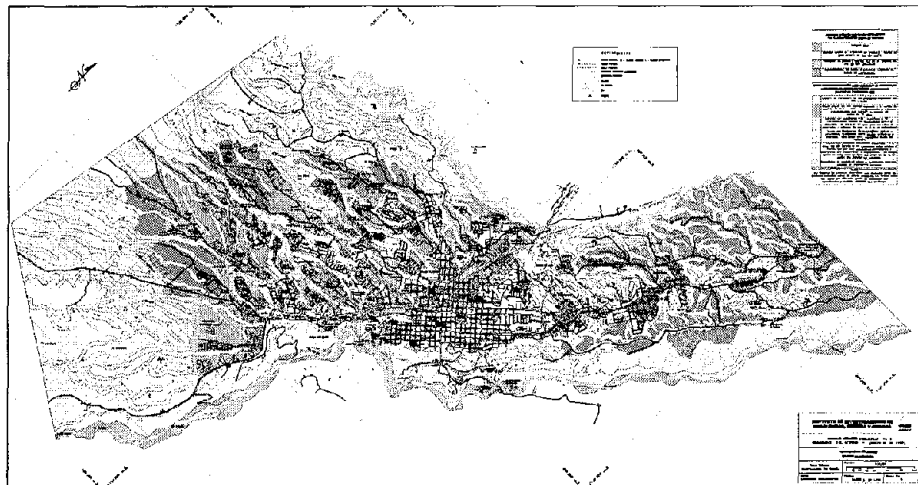
In Armenia, the damage was concentrated in the southern and central part of the city in a very close correlation with the quality of the soil (see figure 3-2). In those sectors, the destruction was widely spread. In neighborhoods such as Brasilia toward the south of Armenia, the initial estimate of the destruction level was 95% (Figure 3-3). Most of the damage was to one and two-story houses and apartment buildings of four or five stories.

Figure 3-2 Armenia Damage Zonation Map

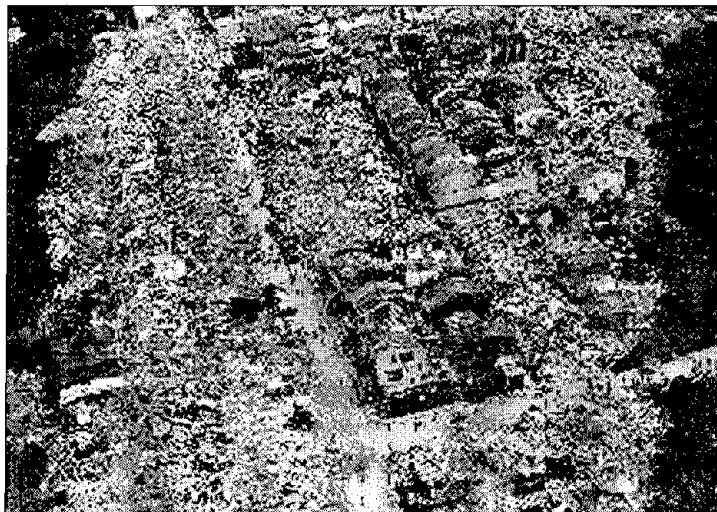
Figure 5-1 Debris Blocking Streets in Brasilia, Armenia

The debris on the streets of Armenia was so extensive that during the first few days after the earthquake, the only way for emergency personnel to get around was by using motor scooters. Even though the debris began to be removed almost immediately after the earthquake, the streets remained heavily congested (see figure 5-1). For security reasons, traffic into the city's downtown area was restricted, further adding to the congestion. At the time of the team's visit, debris was being removed and temporarily stored in several

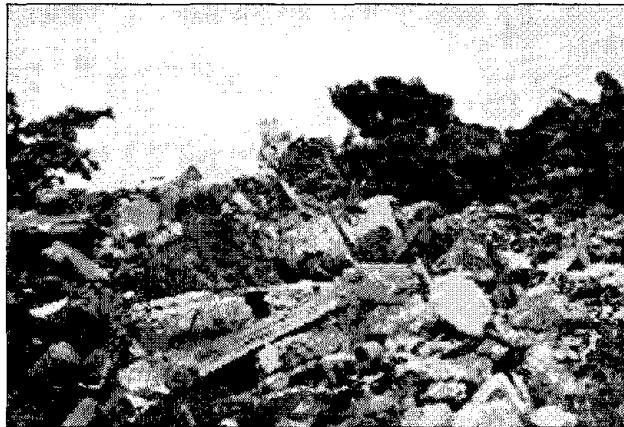
of the many ravines that transect the city (see figure 5-2). The earthquake produced over 1 million cubic meters of debris. According to city officials, the debris will eventually be removed from these ravines and recycled.

Figure 5-2 Debris Storage Area in Armenia

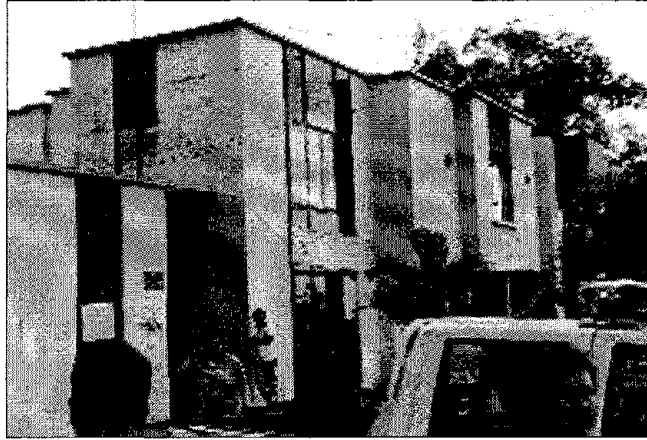
Further adding to these problems, the city's municipal government building ("city hall") was evacuated due to uncertainty about its structural safety. This is the building that housed the COLPAD. Not until the third day following the earthquake was a temporary Emergency Operations Center (EOC) established at the Civil Defense headquarters to better coordinate emergency operations (see figure 5-3).

Figure 5-3 The Civil Defense Building in Armenia Temporarily Housed Key City Agencies

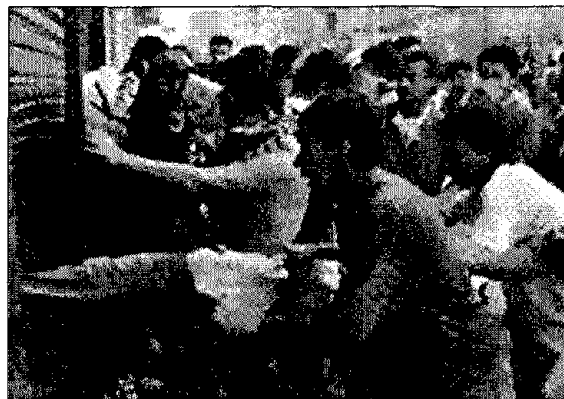
The looting that followed the earthquake is a phenomenon rarely seen in disasters (see figure 5-4). By all accounts, the "looters" were from outside the city and took advantage of the crippled status of the city's police force. The Colombian President's decision to deploy national military personnel into Armenia was effective in quickly restoring law and order and protecting major commercial centers, such as downtown.

Figure 5-4 Looters Attacking a Red Cross Food Storage Facility

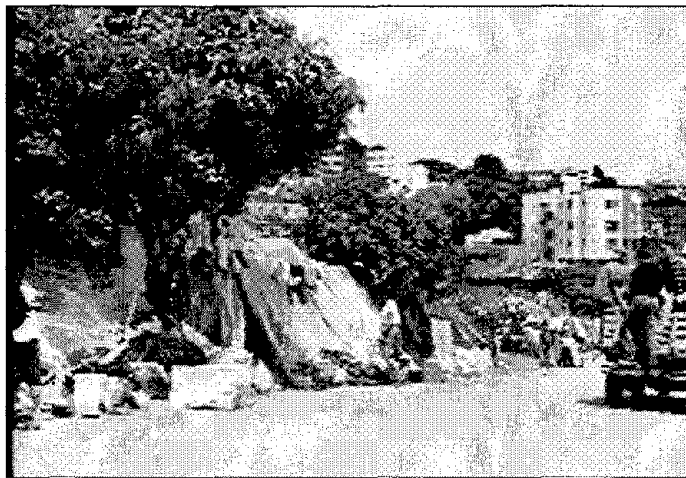
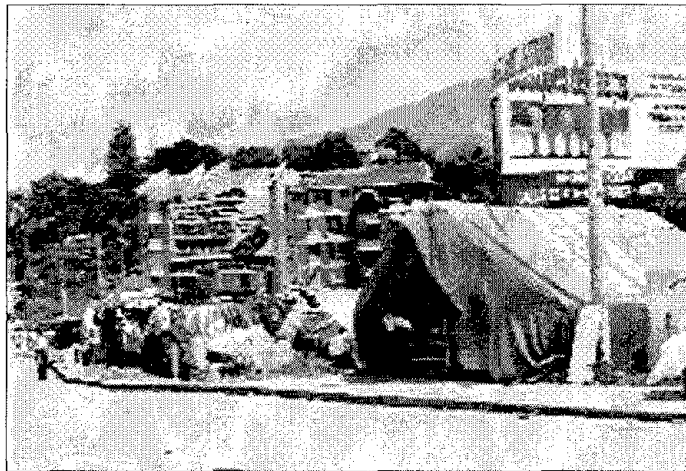
The provision of emergency shelter to those displaced by the earthquake damage, is perhaps the most critical issue currently facing the city. Approximately 90,000 families were displaced by the earthquake. In the City of Armenia alone, the number of displaced persons is conservatively estimated to be over 100,000. While many of the displaced have found shelter with unaffected family members or friends, many had no place to seek shelter or refused to leave their damaged property. This led to the creation of spontaneous emergency shelters (see figure 5-5). Most of these shelters are tents or lean-tos that displaced persons have constructed on sidewalks, roadsides or parks in the vicinity of their destroyed homes, using plastic sheeting and materials recovered from the debris.

Figure 5-5 Spontaneous Shelters, Downtown Armenia
