The Chi-Chi, Taiwan Earthquake of September 21, 1999: Reconnaissance Report

Edited by
George C. Lee¹ and Chin-Hsiung Loh²

Publication Date: April 30, 2000

Technical Report MCEER-00-0003

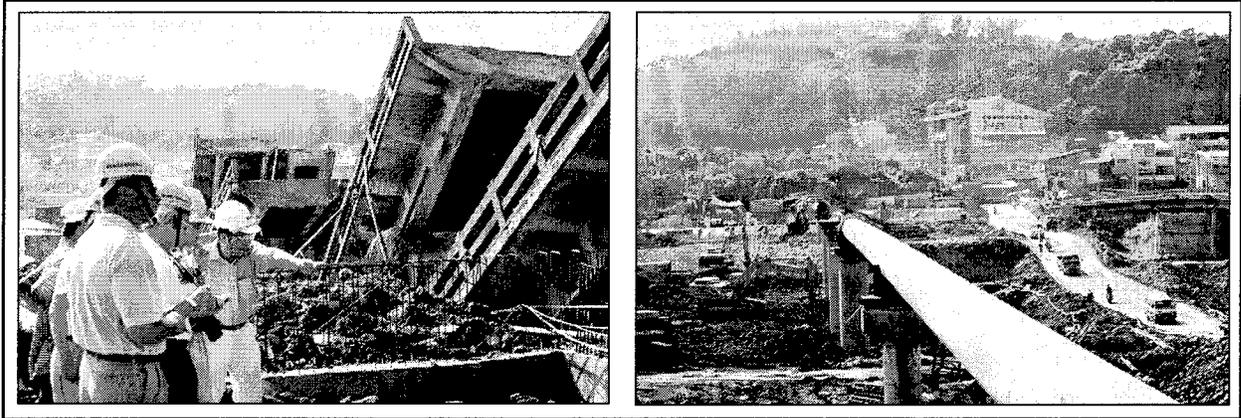
Figure 1-1 The reconnaissance team visited the Yijiang bridge; note the emergency bypass and parallel severed water line.

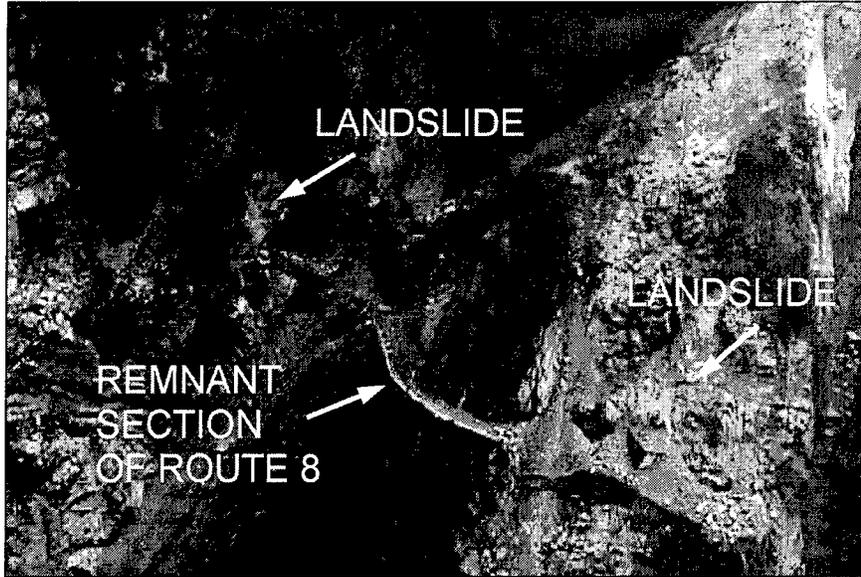
Figures 3-2 and 3-3 show aerial views of the landslides along Route 8. As indicated in the photos, there was substantial destruction of the highway, with relatively long sections of road both undermined by landslides and blocked by landslide debris. Figure 3-3 shows that the portal of one of the Route 8 tunnels was partially collapsed and was blocked by landslide debris.

Figure 3-2 Landslide along Route 8

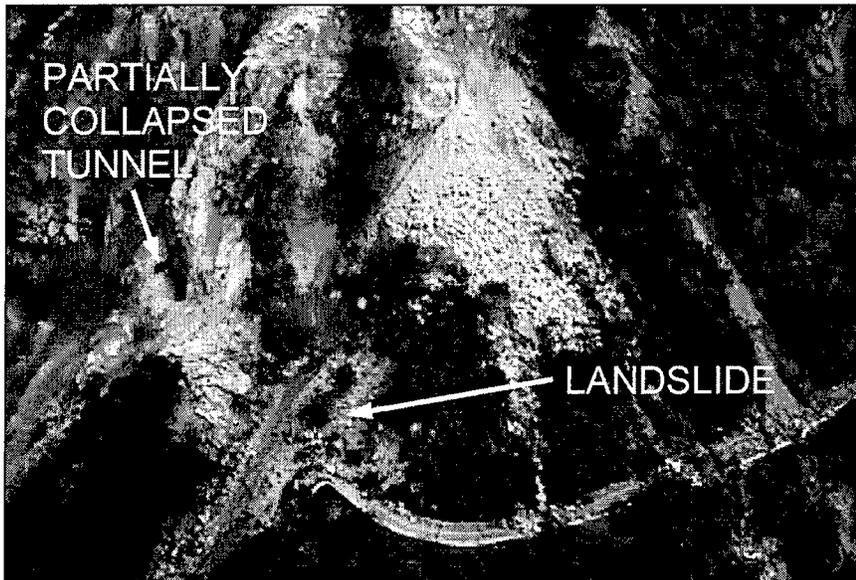
Figure 3-3 Landslides and partial tunnel collapse along Route 8

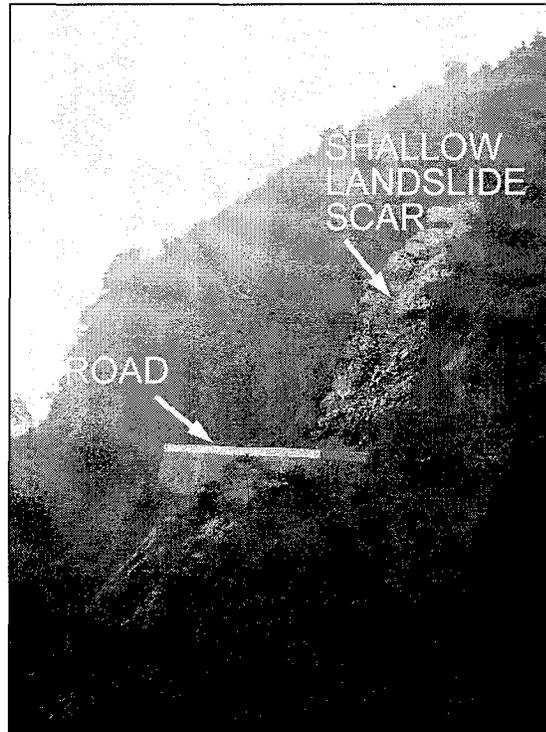
Figure 3-4 shows landslide scars typical of most soil and rock falls along the highway system in the mountains. The slides were relatively shallow, extending through the soil mantle into the weathered rock. Debris, cascading from higher elevations, blocked roadways in hundreds of locations.

Figure 3-4 Typical shallow landslides intersecting a mountain road

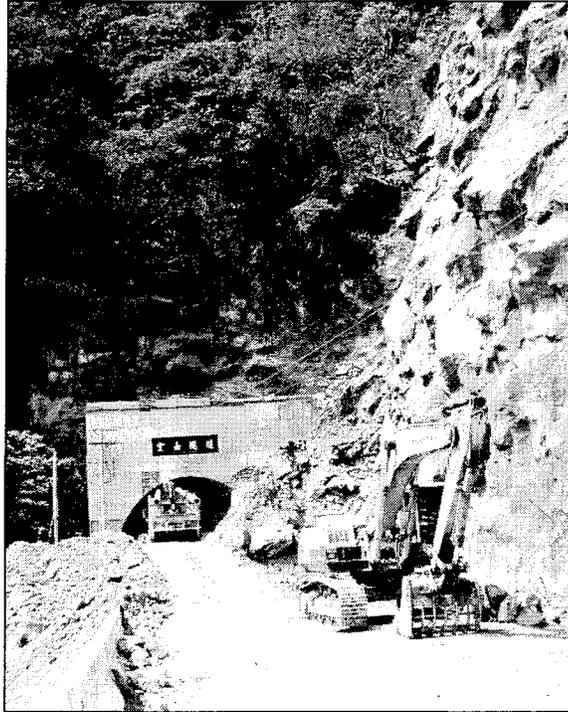
Figure 3-5 shows a landslide location near the Yun-Chia Tunnel in the Tsao-Ling area. Although some instances of tunnel collapse were reported along Route 8, most ground failures at tunnels were confined to soil and rock falls near tunnel portals.

Figure 3-5 Landslide at portal of Yun-Chia Tunnel near Tsao-Ling

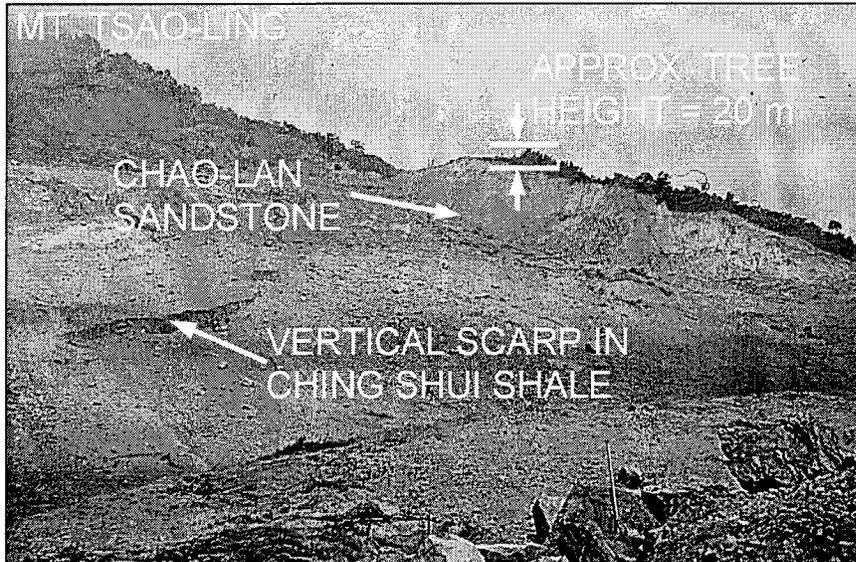
Figure 3-7 Eastern boundary of Tsao-Ling landslide

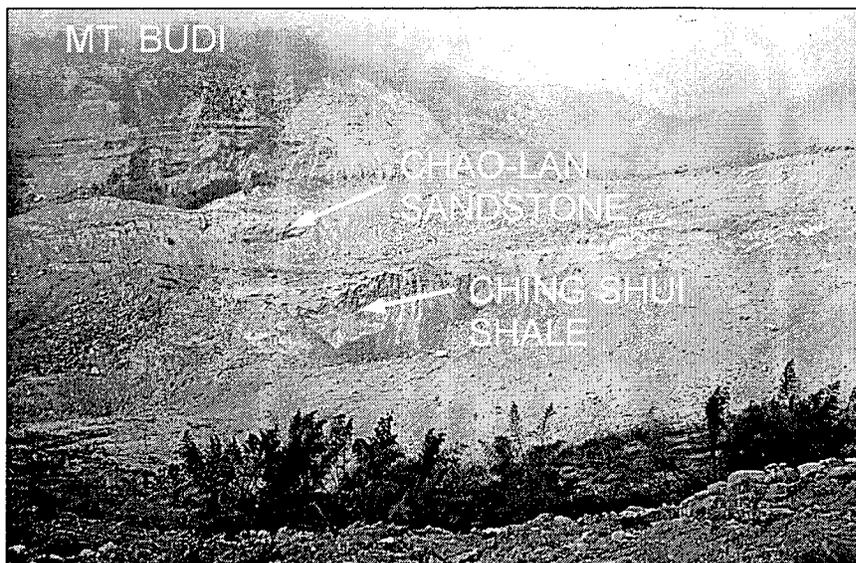
Figure 3-8 Western boundary of Tsao-Ling landslide

The landslide triggered by the Chi-Chi earthquake appears to have mobilized a volume of failed material similar to that involved in the 1941 earthquake. The landslide was generated primarily by failure of the Chin-Shui Shale Formation that underlies the Chao-Lan Sandstone (see Figures 3-8 and 3-10). The shale is a friable, silty mudstone with weak cementation that deteriorates readily upon wetting and drying. The shale exhibits very low compressive strength that is highly dependent upon time of submergence in water (Lin and Hung, 1982).

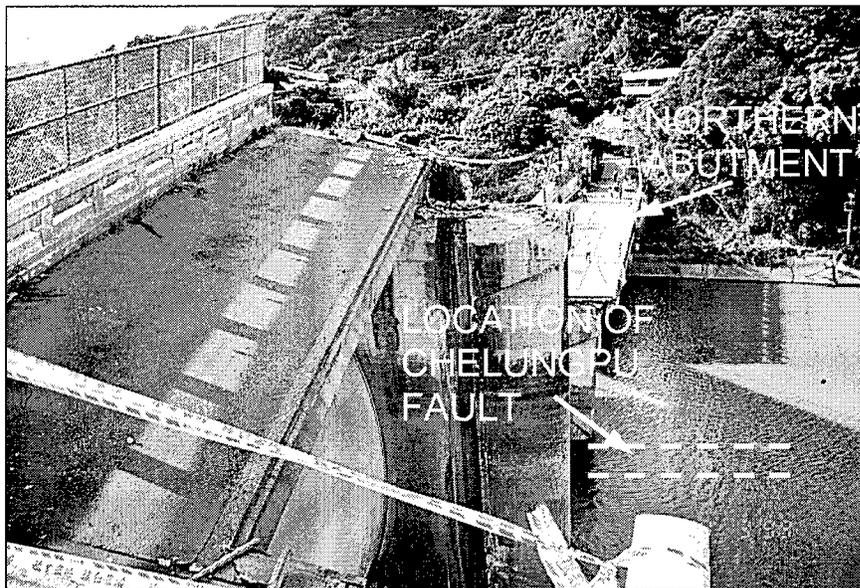
Fault rupture with a vertical offset exceeding 9 m was responsible for failure of the Shih-kang Dam and subsequent release of approximately two million m³ of water. This loss represents 40% of the raw water supply for Taichung County. Figure 3-11 is a photograph of the northern abutment area taken downstream of the dam, and Figure 3-12 is a photograph of the northern abutment from the vertically displaced southern part of the dam.

Figure 3-12 View from upthrust side of Shih-kang Dam looking north

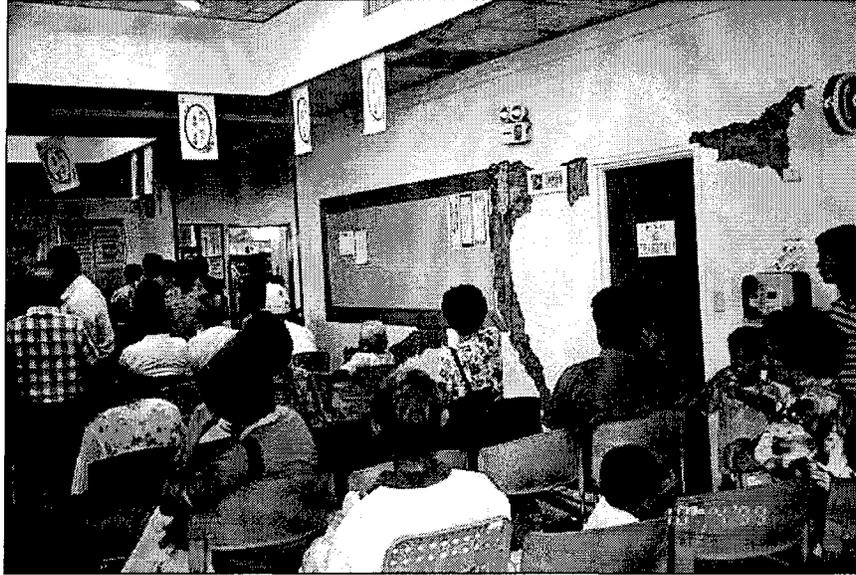
- New section sustained considerable damage from the main event on 9/21/99. Out of safety concerns primarily due to nonstructural damage (water damage, equipment failure, etc.), the building was evacuated with patients housed in tents on the hospital ground. The building was immediately inspected and considered safe. Upon interior cleaning, patients were returned to the building.
- The building suffered significant nonstructural damage again from the 9/27/99 M6.8 aftershock. Patients were again evacuated and housed in temporary trailers with considerably reduced capacity (about 50 beds), with overflow transferred to other area hospitals.

Figure 4-2 The first floor of the Christian Hospital remained open though the hospital suffered extensive interior damage.

- The first floor of the building remained open and was being used for emergency care, patient registration and processing, command post, etc. (Figure 4-2).

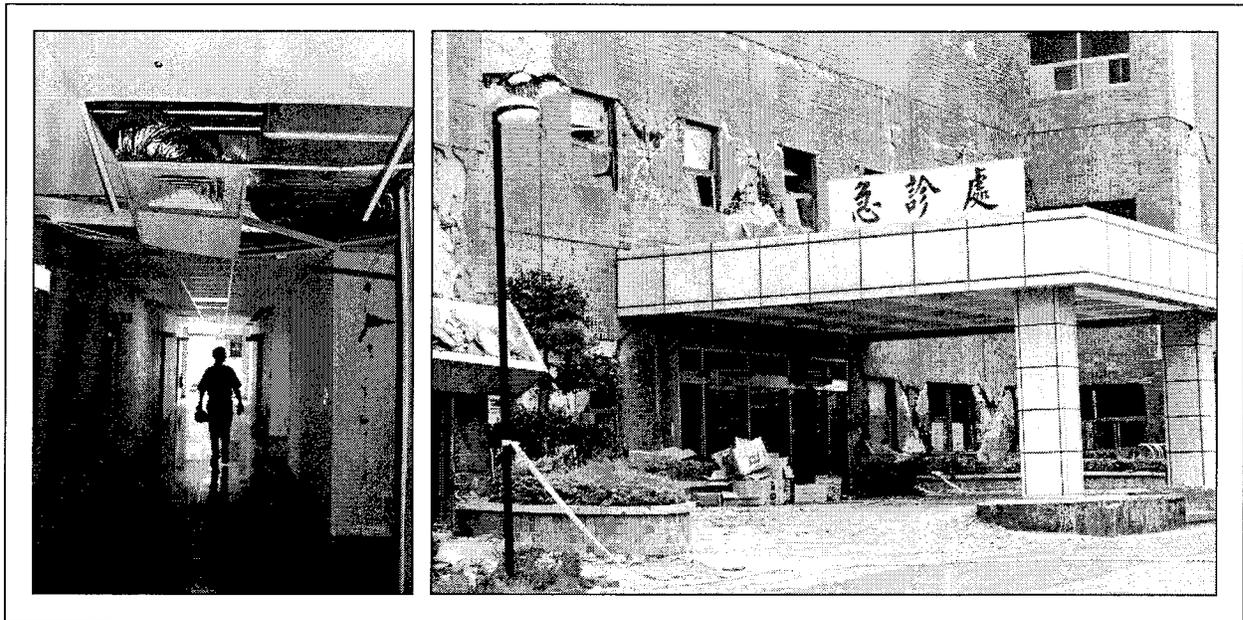
Another major hospital in Puli, the Veterans Hospital, is a 450-bed facility with two main RC buildings (the Medical Center and the Administration Center), built about three years ago and several older (about 25 years old) and smaller buildings (Figures 4-3 and 4-4).

Figure 4-4 The Veterans Hospital sustained both exterior damage (left) and interior damage (right) to the newest buildings of the medical center.

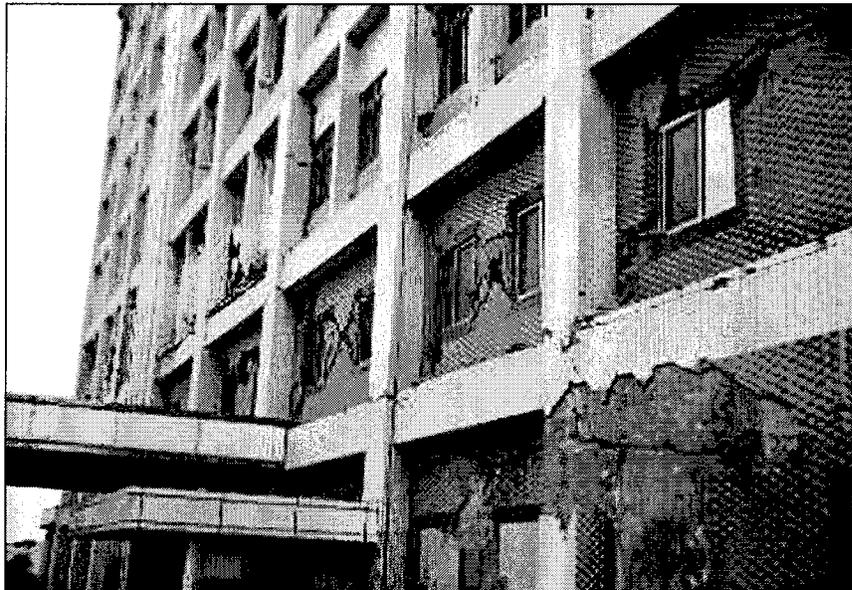
- Structurally intact, it suffered considerable nonstructural damage as in the case of the other two hospitals (Figures 4-5 and 4-6). Interior damage was most severe at the second- and third-floor levels where, unfortunately, some of the major facilities, such as operating and recovery rooms, were located. Patients were moved to open hospital ground and subsequently transferred to other hospitals.
- Hospital closed.

Figure 4-6 Damage to an exterior wall of the Shiu-Tuan Hospital in Nantou county

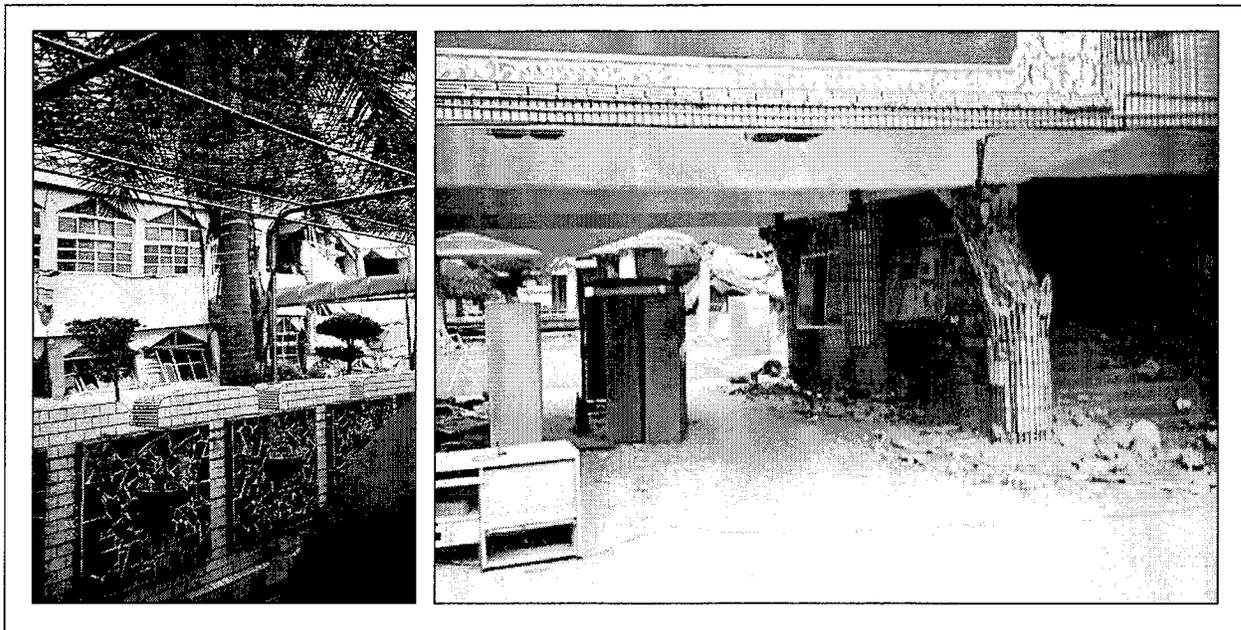
School buildings sustained severe damage, reaching as far as the city of Taipei, 150 km from the epicenter. As in the 1998 Chia-Yi/Ruei-Li earthquake, the severity of damage to school buildings, as demonstrated in Table 4-2, again exceeded that of other structures due primarily to the commonality of their weaknesses in construction. The common problems associated with school buildings appeared to be, on the one hand, short-column effects which led to shear failure in columns and, on the other, eccentricity of most school buildings associated with cantilevered corridors at upper floors (Figure 4-7). It is estimated that restoration, repair and reconstruction costs associated with school buildings can reach US \$1.3 billion (Ministry of Education, 1999a).

Figure 4-7 Typical damage to schools due to short-column effect and eccentricity

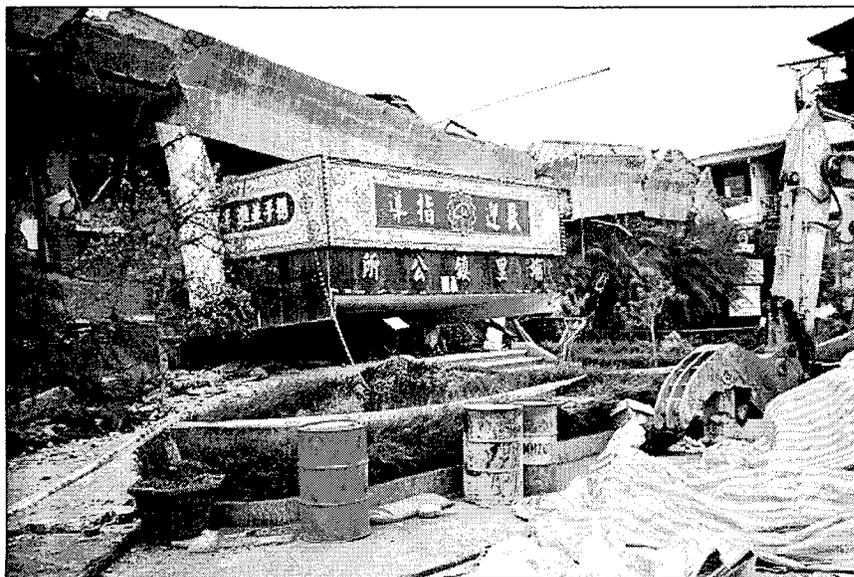
Figure 4-8 Total collapse of Puli Town Hall

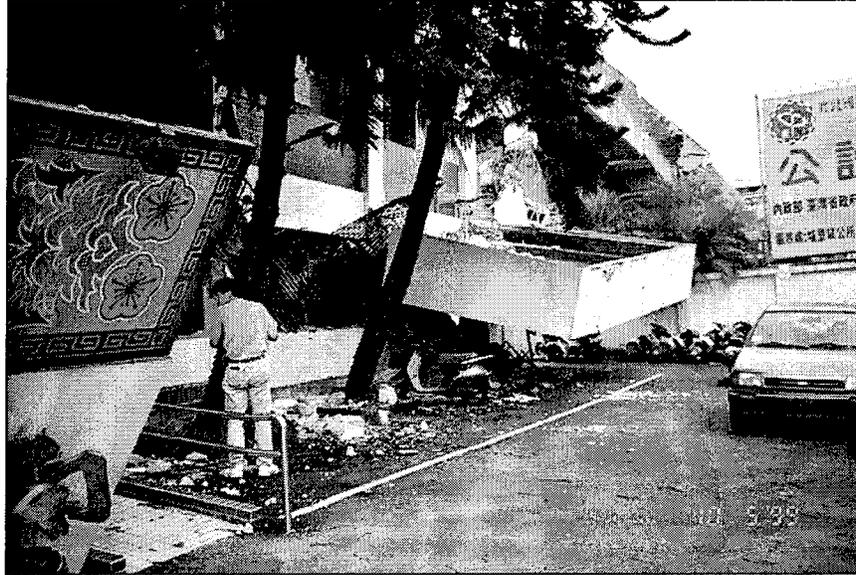
Figure 4-9 Heavily damaged Puli Police Station

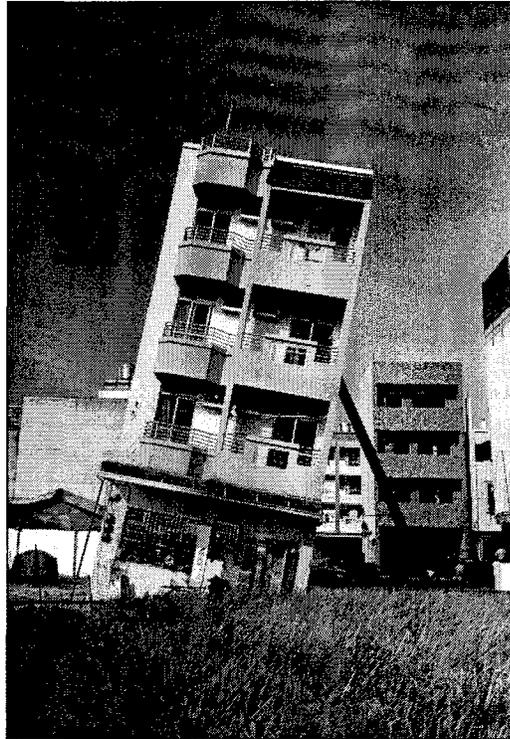
Numerous instances of geotechnical failures that had an impact on the seismic performance of buildings were also observed, such as settlement due to liquefaction (Figure 5-3); however, these are not discussed in this chapter.

Figure 5-3 Damage due to settlement caused by liquefaction

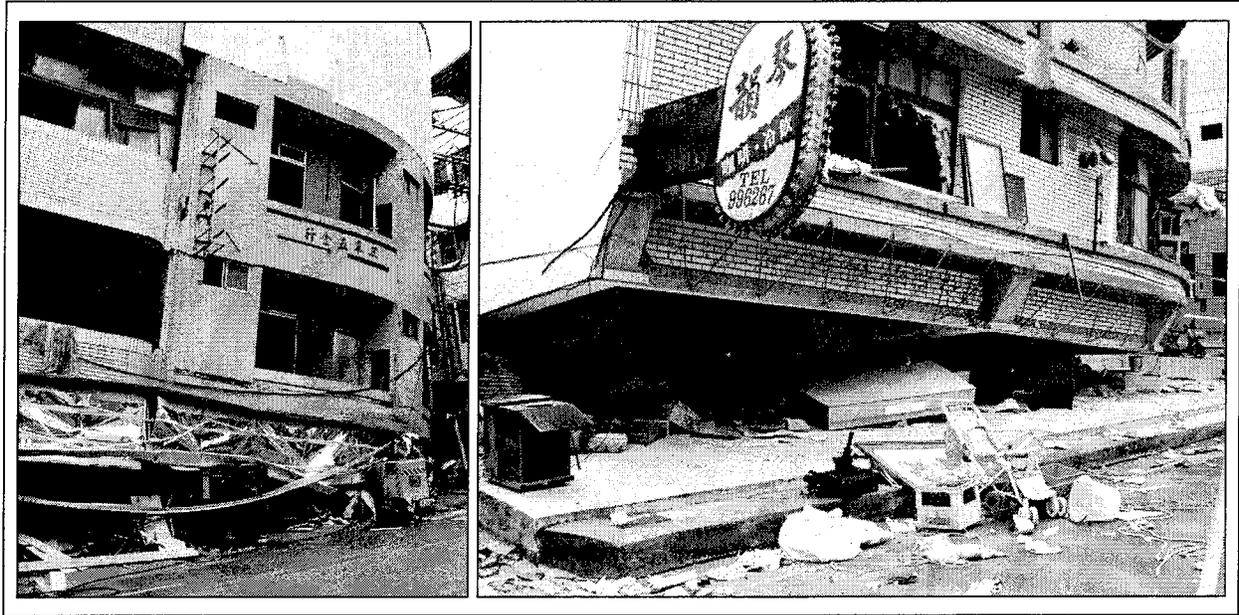
Figure 5-8 Buildings located on street corners toppled toward the intersection as a result of soft-story damage

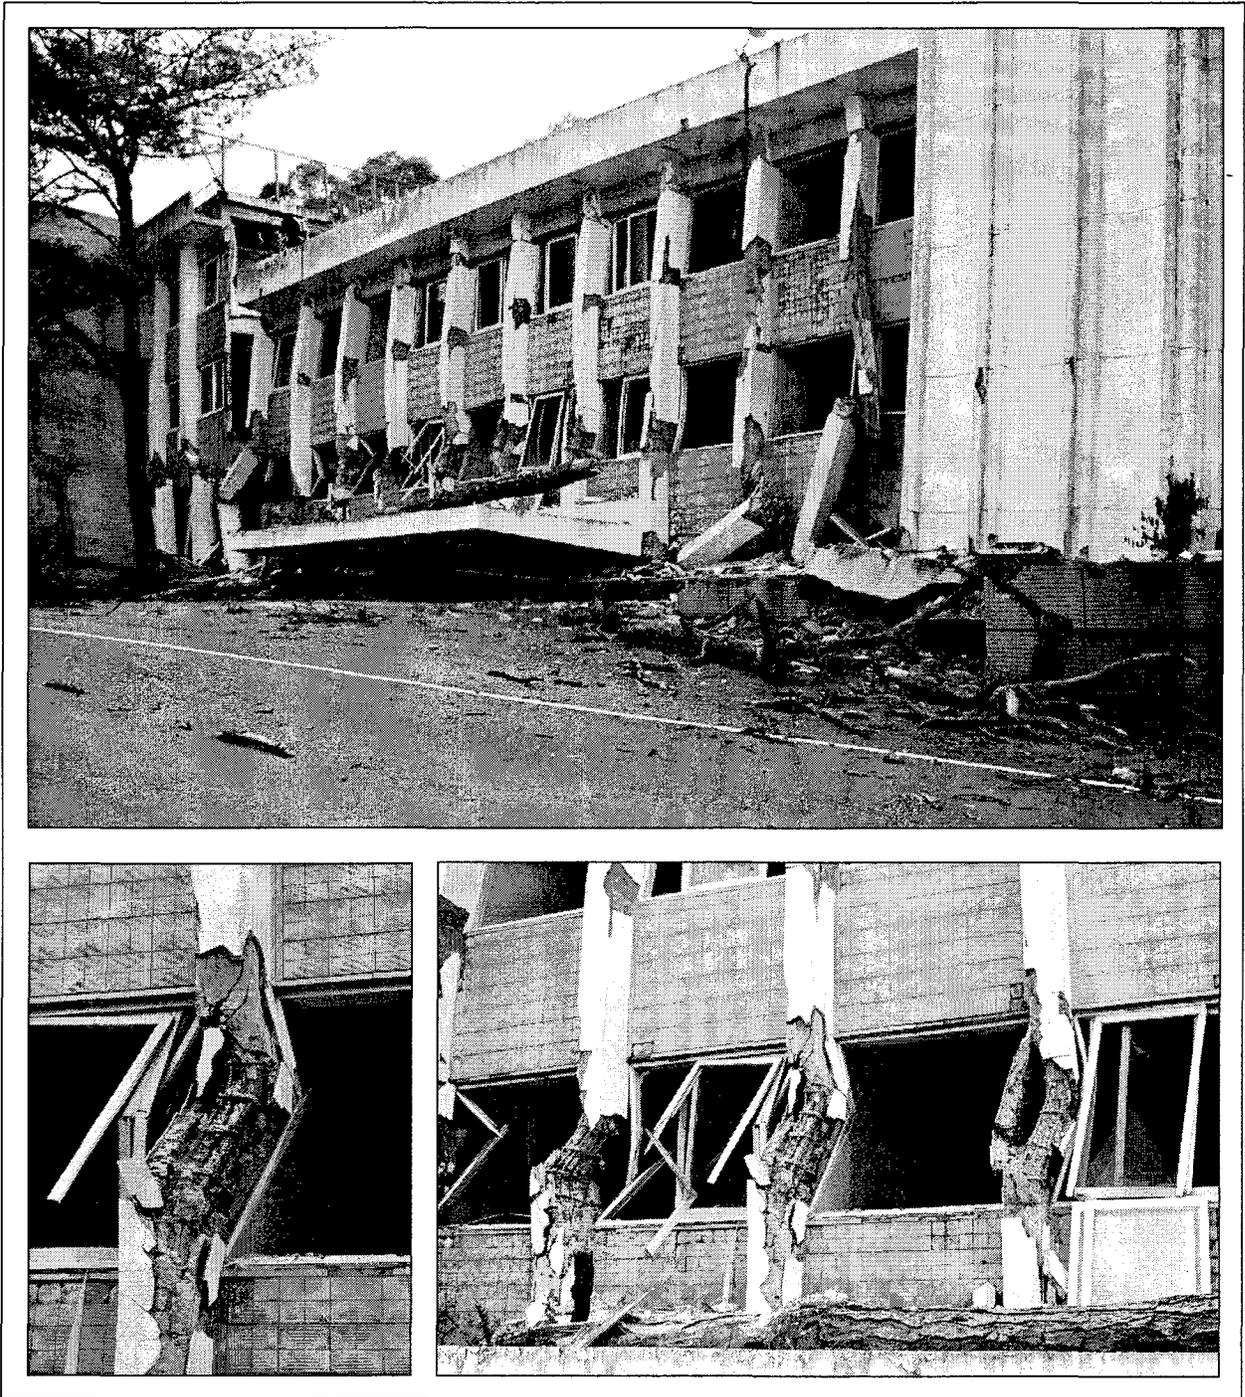
In other instances, although trapped columns may develop flexural plastic hinging instead of shear failures, it remains that damage in columns is not desirable. The partial height infills thus promote the strong-beam weak-column behavior described earlier. Examples of such failures are shown in Figure 5-9 for a column having moderate stirrup spacing that provided sufficient transverse reinforcement, along with a favorable column

geometry, to prevent this shear failure. Also note on that figure the conspicuous asymmetric column cover concrete in that instance.

Figure 5-9 Damage due to trapped columns having “moderate” stirrups spacing

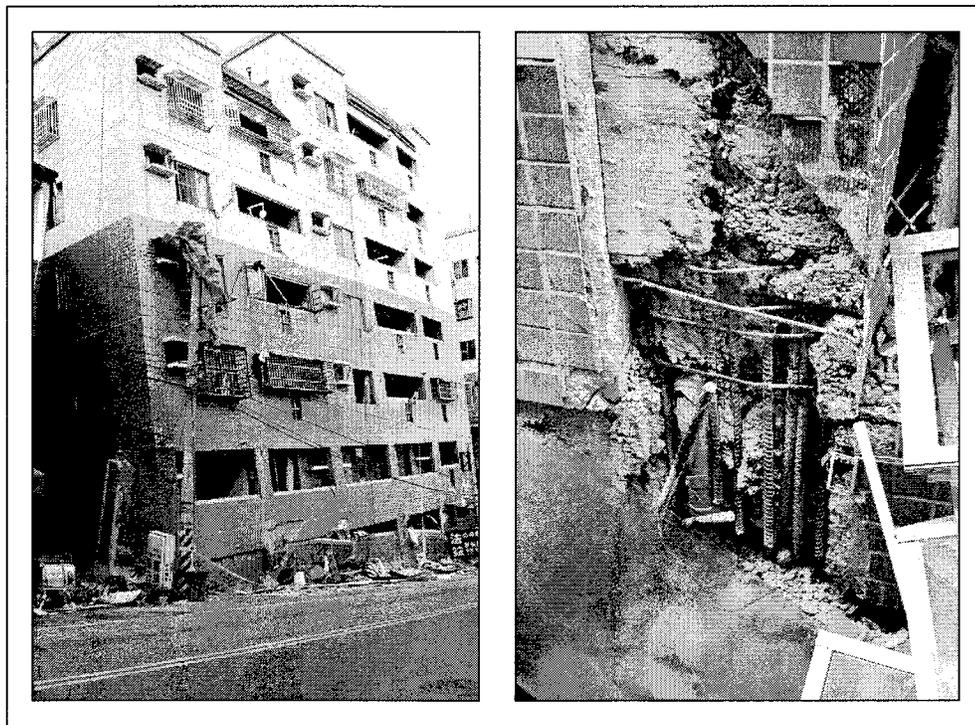
Figure 5-12 Example of collapsed building with column bars spliced within the joint

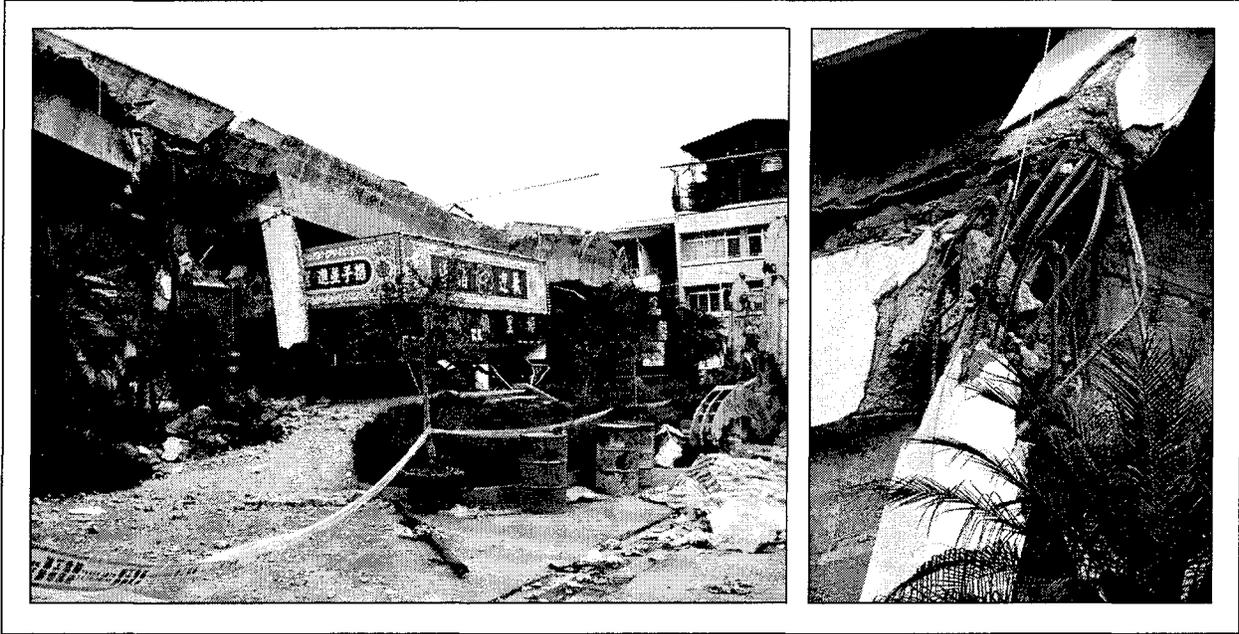
Figure 5-13 Example of collapsed building having no transverse joint reinforcement

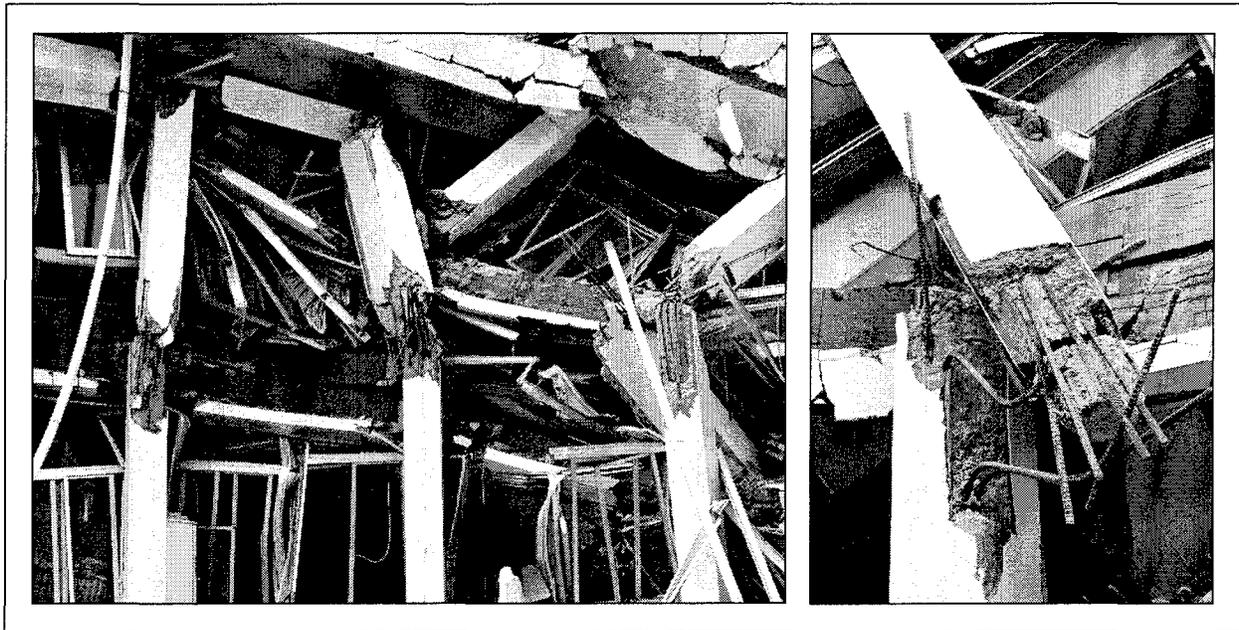
Figures 5-10 to 5-14 illustrate some examples of such undesirable detailing practices. The columns shown in Figure 5-10 had widely spaced stirrups and were therefore poorly confined, which led to their rapid degradation in the hinge region. Poor transverse reinforcement detailing also led to the shear failure and soft-story failure of the building shown in Figure 5-11. A closer look at another building that experienced soft-story failure and shown in Figure 5-12 revealed the presence of poor detailing, with columns bars spliced in the joint region. An example of total absence of transverse joint reinforcement (among other things) is shown in Figure 5-13. And, of course, some buildings suffered from many (if not all) of the above deficiencies, as shown in Figure 5-14.

Figure 5-14 Damage due to poor detailing

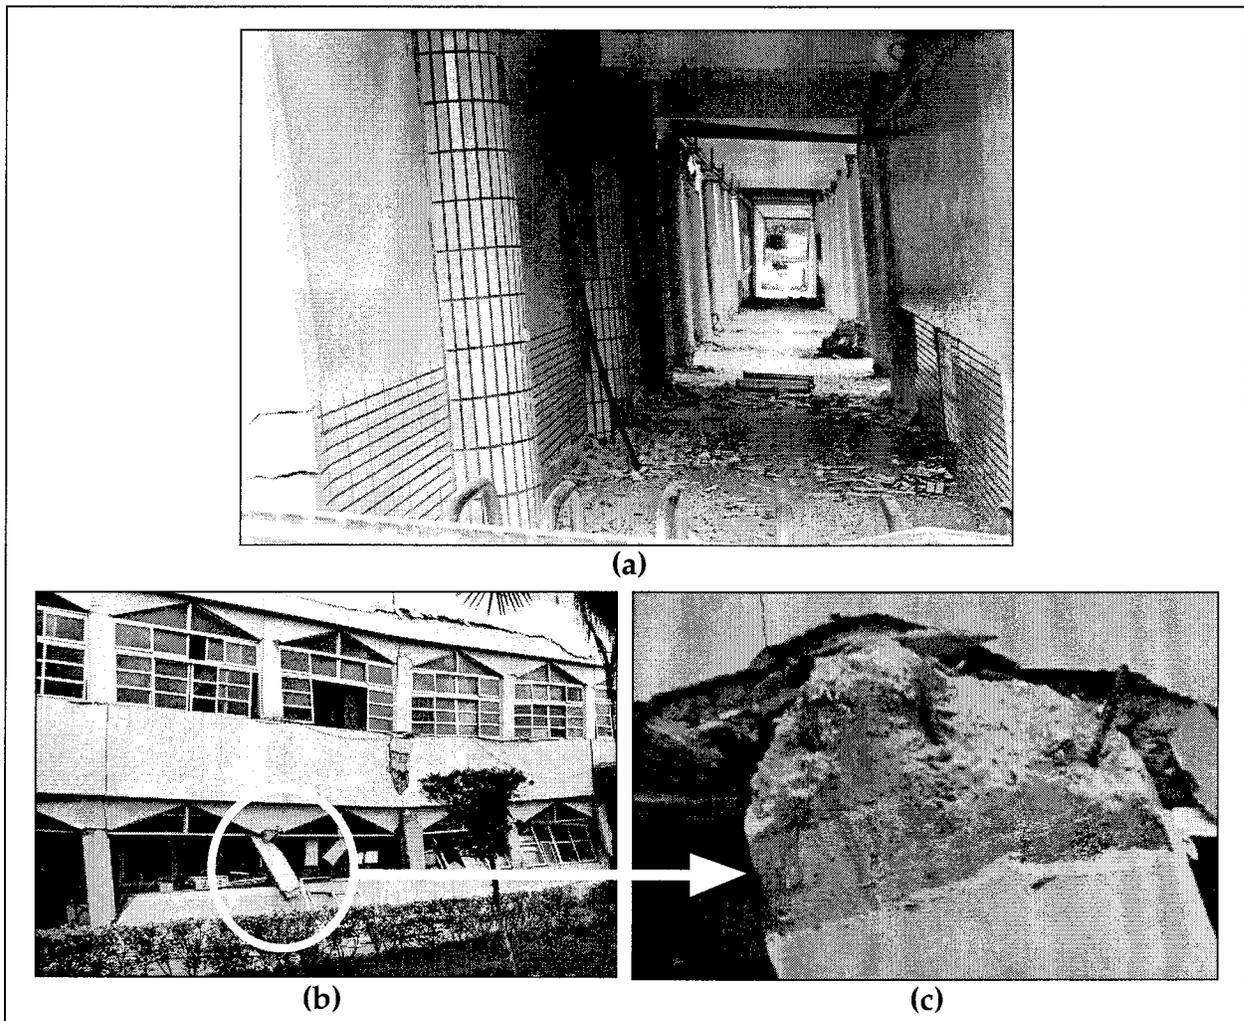
This earthquake also provided reminders of the significance of recognizing compatibility of deformations during the design process. Some engineers, when conducting structural analysis and design of buildings, systematically de-couple the structural elements that are part of the lateral-load resisting system from the others intended to solely provide gravity-load resistance. While this is convenient, it is important to verify that the gravity-load resisting structural element can displace without undesirable damage to the same maximum seismic-induced lateral drifts calculated for the lateral-load resisting system. Even in buildings having the most ductile lateral-load resisting systems, failure to perform this verification may jeopardize the ability of the structure to sustain its gravity loads, with dire consequences. Damage to the building shown in Figure 5-15 illustrates this behavior. The large residual lateral displacement of the first floor due to column damage is clearly visible on that figure. The small columns between windows along the

Figure 5-15 Example of damage to gravity-only columns (i.e. columns assumed not part of lateral load resisting system); (a) residual drift; (b) circled area is a typical gravity-only column; (c) close up view

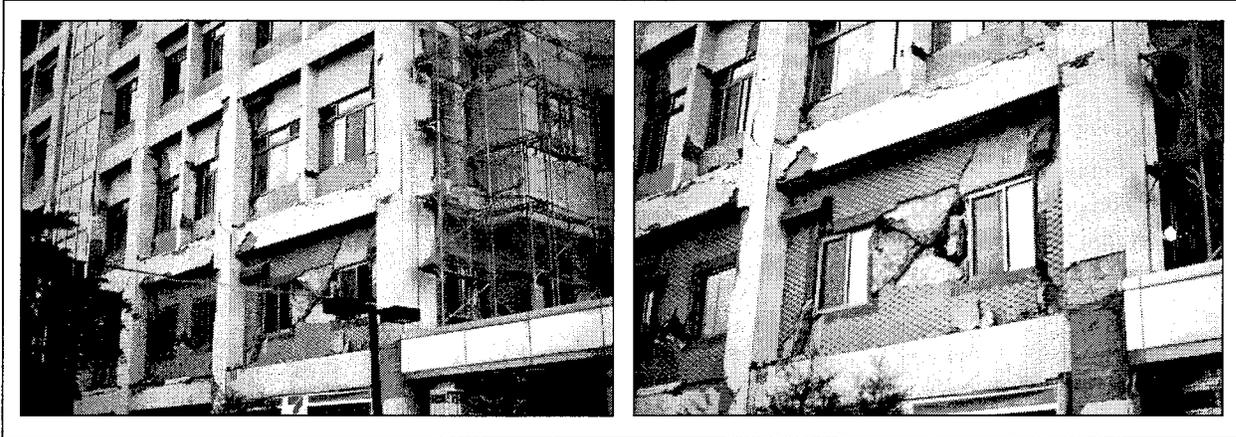
Figure 5-17 Hospital with severe damage to nonstructural infill walls but minor (cosmetic) damage to structural elements

In other instances where large columns were used, as shown in Figure 5-17, these columns only suffered minor cosmetic damage in spite of extensive infill damage. In such cases, although the infills may not have totally prevented undesirable frame behavior, they stiffened the more flexible frames and provided energy dissipation, thus significantly contributing to seismic survival.

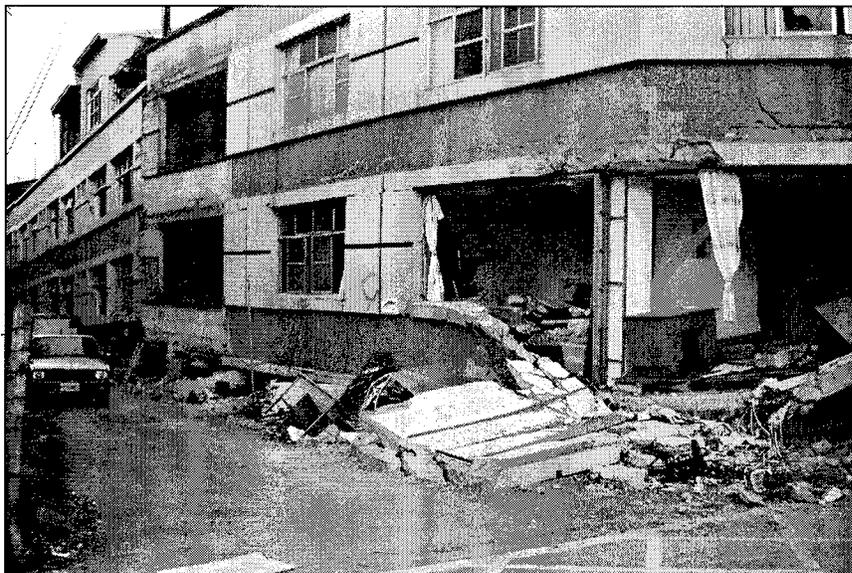
Infills that were not adequately tied to the surrounding frames, even though they may have partly contributed in the manner described above, were not as effective, and were sometimes dislodged by out-of-plane seismic excitations. Figure 5-18 illustrates one such infill panel that fell outward as a result of being poorly tied to its surrounding frame. Another example is shown in Figure 5-19 in a building adjacent to one that completely collapsed as

Figure 5-18 Out-of-plane collapse of an infill panel poorly tied to the surrounding frame

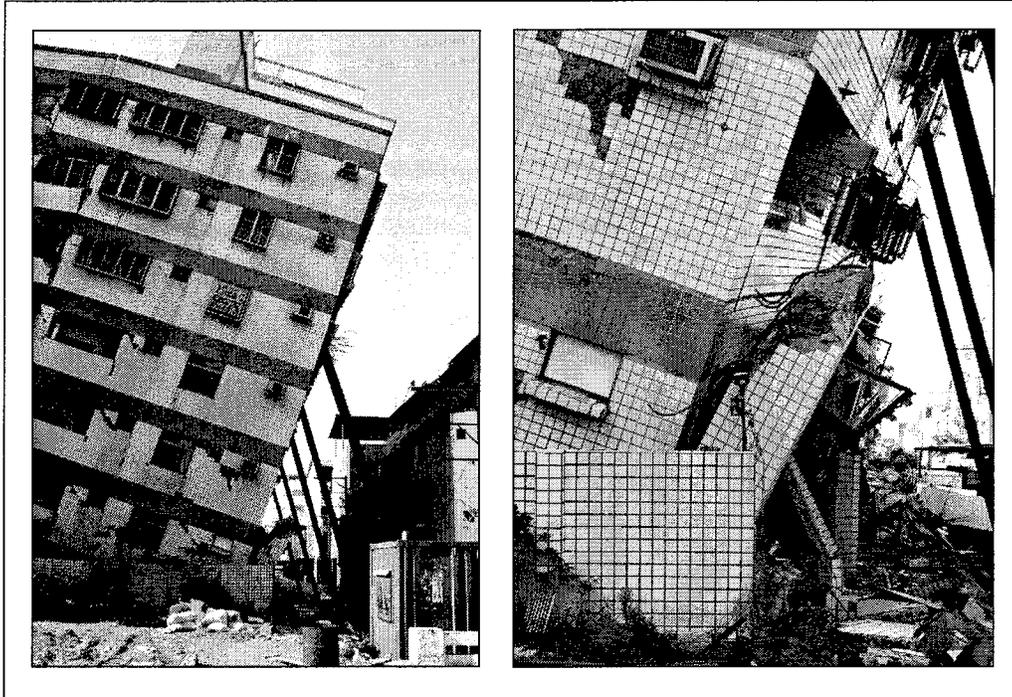
a result of damage at that same story. Note however, that although this absence of continuity between the infills and frame did not help, discontinuous infills are not inferred to have been the cause of the observed collapse. These buildings suffered from many other poor detailing practices, as shown in Figure 5-20.

Figure 5-20 Collapse due to poor detailing practice

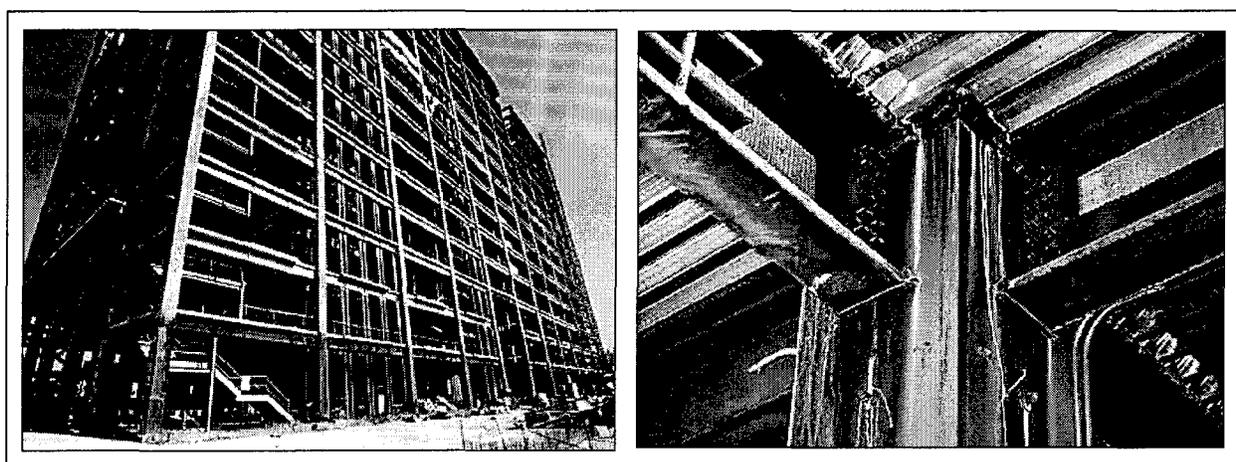
In Taichung City, about 50 km northwest of the epicenter, where the recorded peak ground accelerations obtained from the main shock range between 0.2 and 0.3 g, several tall steel buildings have been constructed in the past decade. During the Chi-Chi earthquake, there were two steel buildings under construction, one 14-story (MRF) department store (Figure 5-21) and one 45-story (MRF/EBF dual system) office/hotel tower. Before the earthquake, most of the steel frames in these two buildings had been completed and the concrete slabs were poured. However, fire proofing, window walls and partitions were not installed yet and all the steel beam-to-column joints were still visible following the earthquake. Note that the 14-story building adopted the typical details described above and the 45-story structure employed reduced beam sections with radius cut details. Detailed inspections conducted for these two buildings following the earthquake indicated no apparent connection damage.

Figure 5-21 14-story steel building under construction with undamaged moment-resisting steel frames

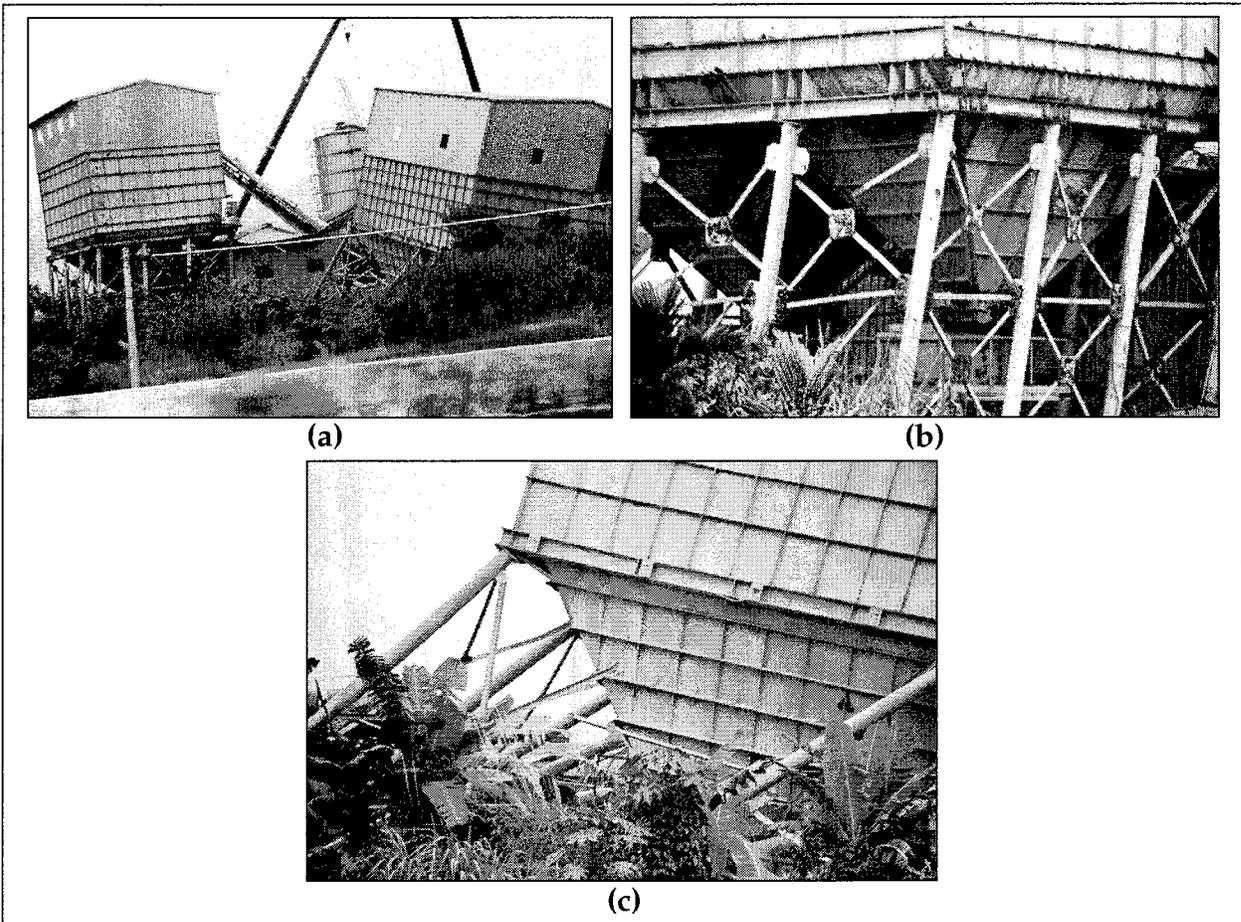
Brace fractures and other damage was observed to bin and tank supports in many aggregate-producing plants. Damage to the elevated bins shown in Figure 5-23 illustrate well the typical progression of failure observed in many such structures. First, as shown in Figure 5-23b, fracture of non-ductile braces developed at their bolt holes. Because net section fracture occurs before gross section yielding of the brace, this occurs without any effective global structural ductility. Without braces, the remaining structure now behaves as a moment frame, but its column-to-beam connections do not have the details and strength (let alone the ductility) necessary to resist the seismically induced forces. As a result, significant damage occurs at the column connections (e.g., Figure 5-23c), and collapse

Figure 5-23 Collapse and damage of non-ductile steel structures supporting elevated industrial bins

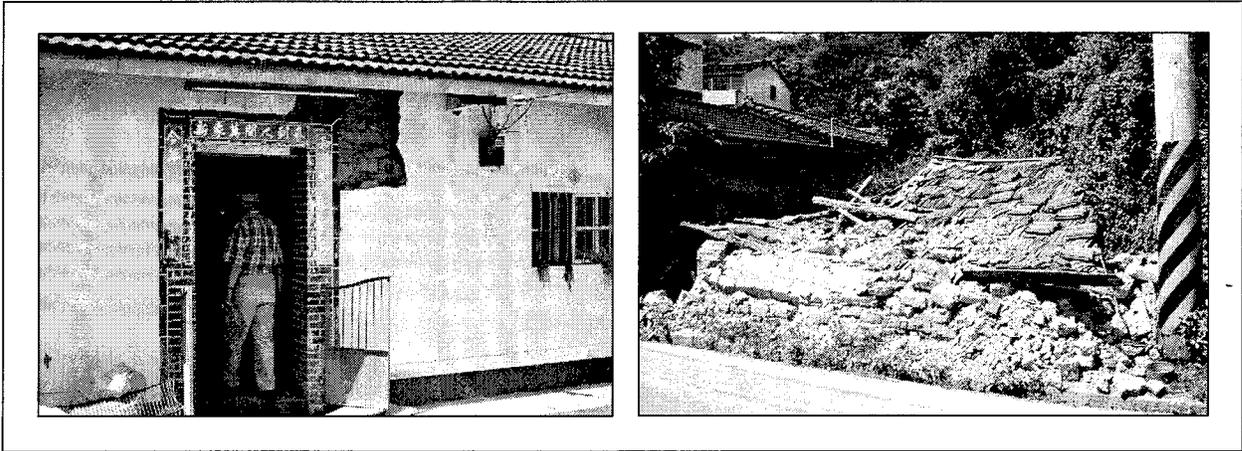
Unreinforced masonry was often used in small villages. Behavior of these non-engineered buildings constructed using bricks of miscellaneous quality (for example, standard clay brick for exposed finishes and mud-bricks for walls hidden by stucco finishes, as shown in Figure 5-25) varied considerably. The two buildings shown in Figure 5-25 were approximately 15 feet from each other; one survived with cosmetic damage, the other collapsed.

Figure 5-25 Cosmetic damage (left) and complete collapse (right) of unreinforced masonry structures located 15 feet apart

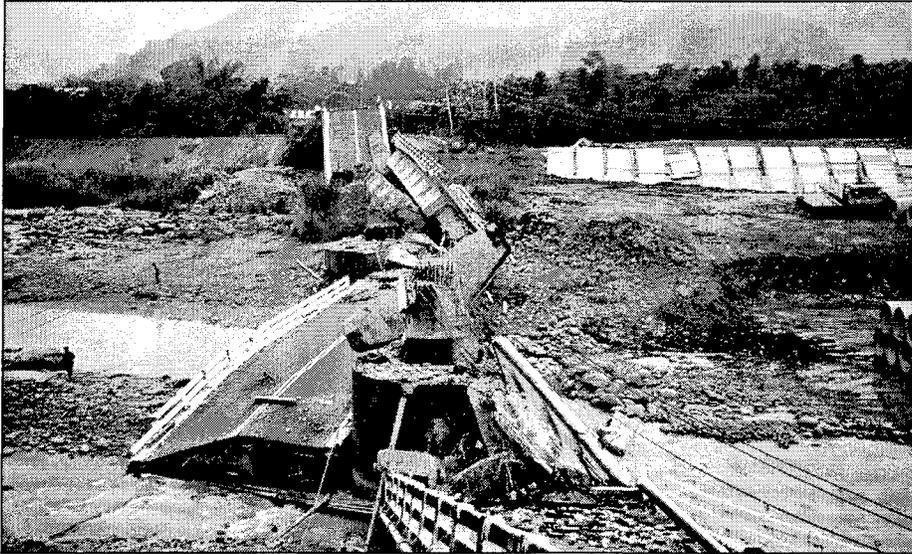
All four simply supported spans of the *Tong-tou bridge* on Route 149, (Figure 6-2) collapsed due to shear failures in the single column bents comprising the three river piers (Figure 6-3). These columns were supported on large diameter caissons, which extended well above the river bed thus shortening the overall height of the columns themselves. The columns appeared to have been shear critical but did not fail simultaneously. Instead, one probably failed before the other, leading to an asymmetrical collapse of spans 2 and 3

Figure 6-3 Collapse of the Tong-tou bridge due to shear-critical columns

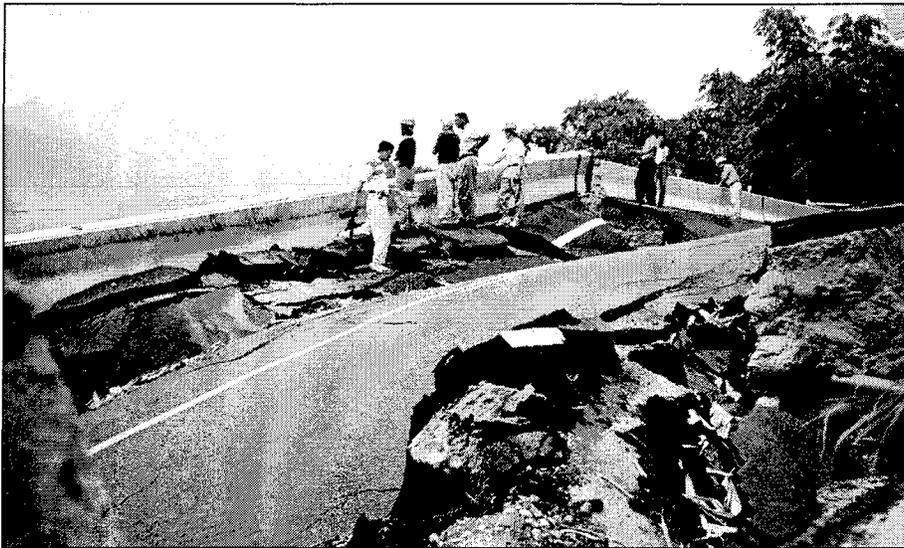
(one fell upstream and the other downstream of the bridge centerline). In addition, the northern abutment suffered considerable structural damage that appears to have been due to large earth movements arising from either fault rupturing or ground failure behind the abutment, or both. Significant settlement of the approach pavement occurred (Figure 6-4).

Figure 6-4 Failure of the approach-fill behind north abutment of Tong-tou bridge
