The Chi-Chi, Taiwan Earthquake of September 21, 1999: Reconnaissance Report

Edited by
George C. Lee¹ and Chin-Hsiung Loh²

Publication Date: April 30, 2000

Technical Report MCEER-00-0003

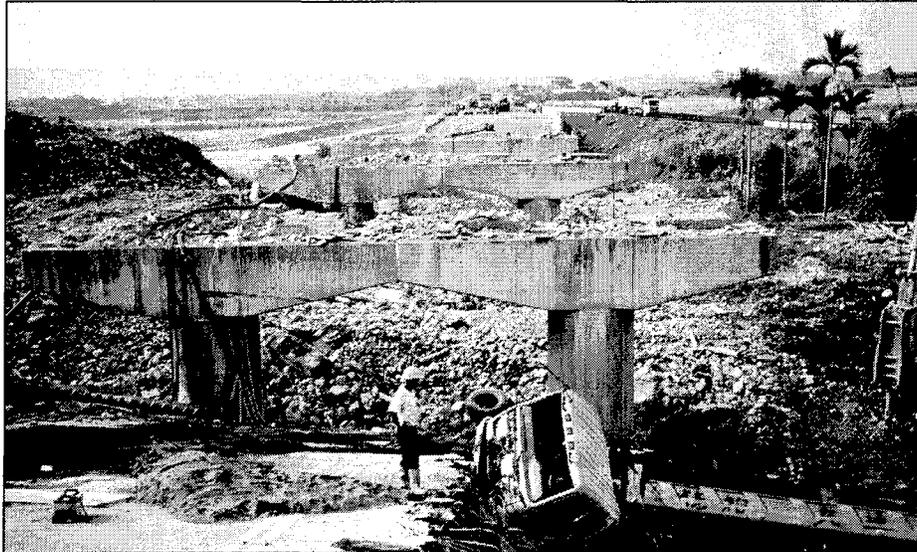
Constructed in 1990, the *Ming-tsu bridge* on Route 3 comprises 28, 25 m spans for a total length of 700 m. Figure 6-5 shows that the fault rupture passed the southern end of the bridge and caused eight of these spans to collapse (Figure 6-6). Although the superstructure comprised multiple spans of simply supported girders, they had been made continuous by a cast-in-place reinforced concrete deck slab which was continuous over intermediate bents. Thus the bridge was a series of continuous segments, and at least two of these segments collapsed at the south end of the structure. At the time of our site visit, the northern-most segments had been demolished and only the southern segment remained 'standing'. Whereas liquefaction may have been responsible for pier tilting and collapse of the northern segments, the spans in the southern segment became unseated when the southern abutment failed. During strong longitudinal motion the superstructure impacted the back-wall of the south abutment, which was unable to arrest the motion. The wall and its back-fill failed and were driven back about 0.5 m into the back-fill, followed by the superstructure (Figure 6-7). This longitudinal movement was sufficient to cause unseating of the adjacent spans comprising this segment.

Figure 6-6 Ming-tsu bridge after removal of many of the collapsed spans

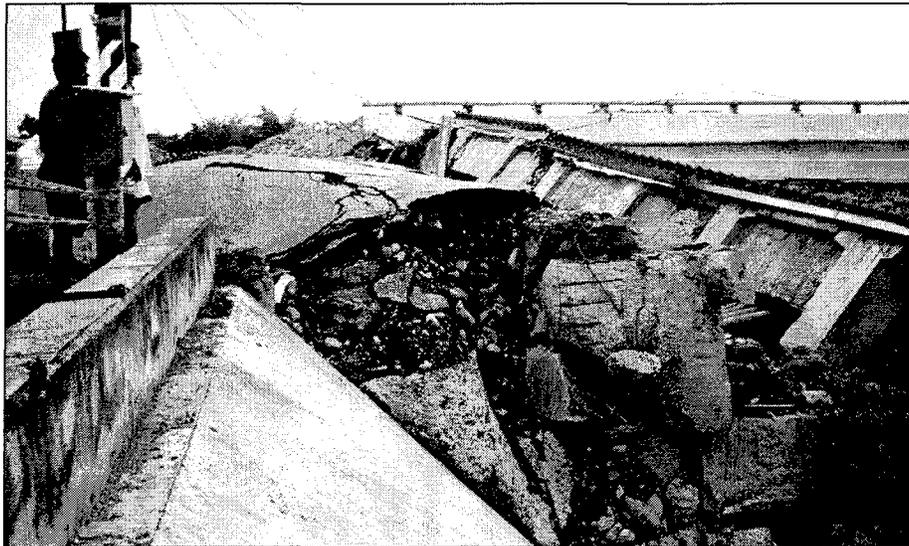
Figure 6-7 Failure of the back-wall and back-fill behind south abutment of the Ming-tsu bridge, leading to the unseating of adjacent spans

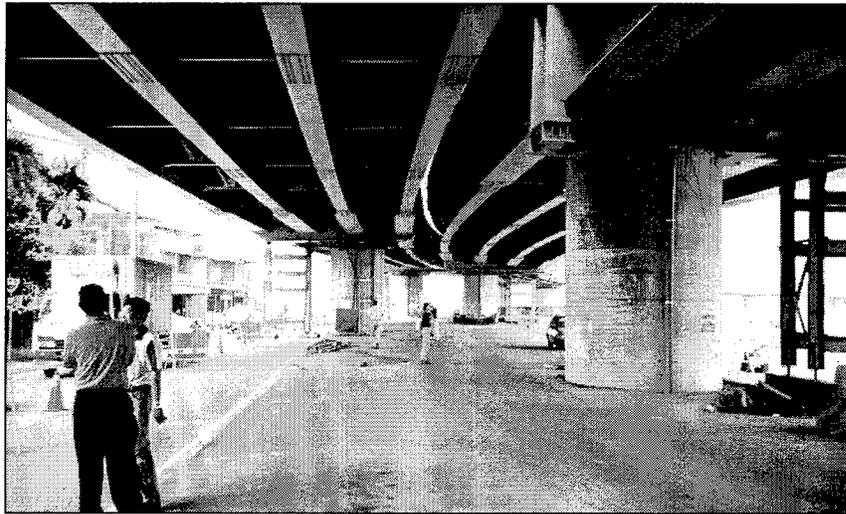
The *Mao-luo-shi bridge* on Route 3 is a multiple-span viaduct comprising a set of continuous segments, each constructed from steel plate girders supported on concrete, single-column bents. In one 8-span segment (Figure 6-8), four of these bents are 'C-bents' where the column is eccentrically connected to the cross-girder. Although there were no collapsed spans in this viaduct, all of the eccentric connections showed distress, particularly in the column. Shear cracking was evident in the upper third of each column and increased in severity with increasing eccentricity (Figure 6-9). Despite the absence of gross deformations in the superstructure, the cross-girders were been temporarily shored and the bridge closed until permanent repairs could be made.

Figure 6-8 Mao-luo-shi bridge, showing single-column concrete bents supporting continuous steel girders

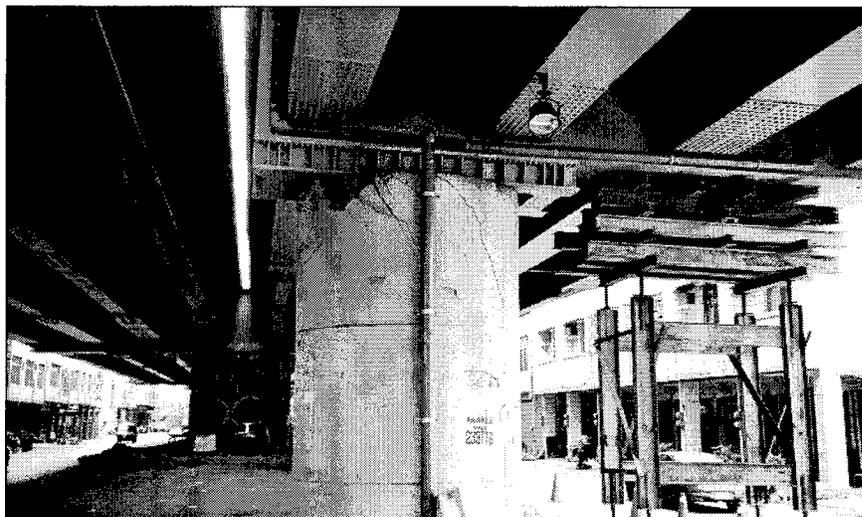
Figure 6-9 Typical distress in an eccentric, column-to-cap beam connection in the Mao-luo-shi bridge

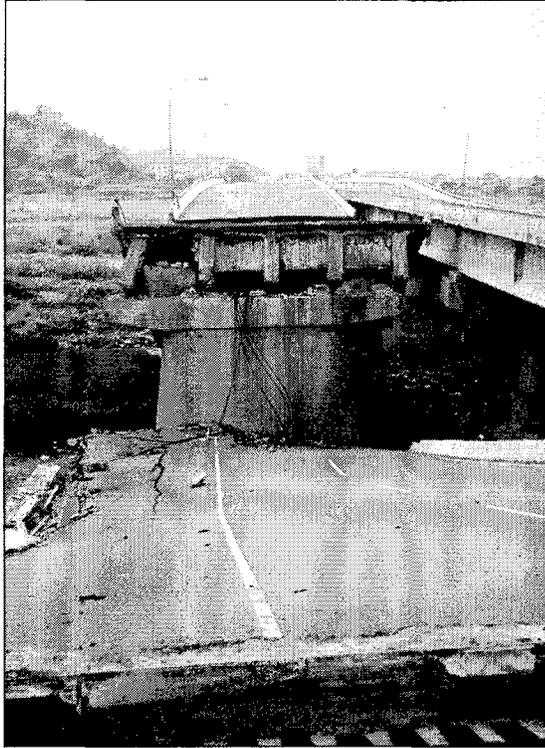
The *Wu-shi bridge* on Route 3 (Figure 6-10) is in fact two bridges on a parallel alignment (Figure 6-11). Both are 18 spans long for a total length of 624 m. The first bridge was constructed in 1981 and the second one, two years later, in 1983. Both were of similar design (simple spans supported on wall-type piers) with one exception. The piers of the second bridge were not as wide as those of the first and in some cases (e.g., at Pier 3) they were about one-half of this width. Despite the fact that both bridges experienced similar ground motions, they failed in different ways. Ground failure occurred behind and under the northern abutment of both bridges, triggered by fault rupture parallel to the abutments. Soil deformation at the base of these wall-abutments was approximately 0.3 m towards the river. There was similar ground deformation under the first and second piers, but of lesser magnitude (perhaps 0.2 m). The two bridges accommodated this movement in different ways, as described below.

**Figure 6-11 Collapsed span in the
Wu-shi bridge (east)**

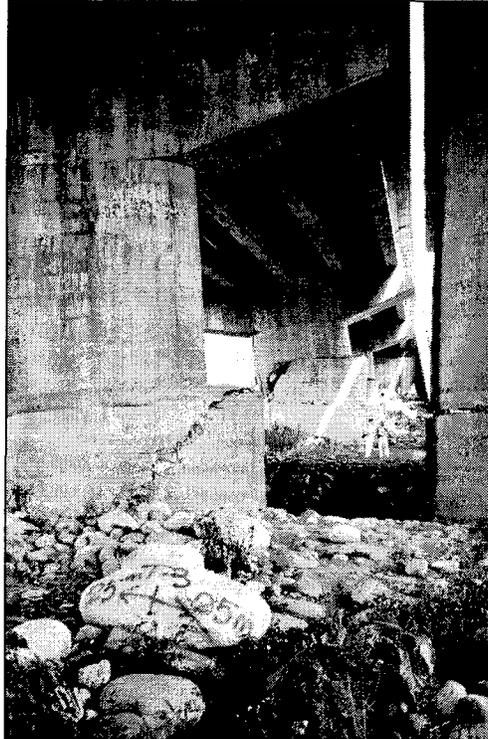
In addition to the ground failure, there was strong ground shaking transverse to both bridges, which caused massive shear failures in the first five piers and/or caissons of the second bridge (Figure 6-12). This did not happen in the first bridge, possibly due to the greater shear capacity of its wider columns. Instead, the first two spans of this bridge became unseated at Piers 1 and 2, due to the movement of these piers towards the river. Lesser soil deformations were experienced at the remaining piers and these were accommodated at the pier caps without unseating. But the shear keys at these caps were heavily damaged due to the transverse motion, and at Pier 2 they failed completely (Figure 6-13). As a consequence, although the superstructure was not unseated at this pier, it came to rest with a permanent transverse offset and with the outside girder overhanging the pier cap. In the second bridge, the longitudinal movement of the foundations under Piers 1 and 2 did not lead to span collapses. Instead, this movement was accommodated within the plane of the massive shear cracks in both piers. Examination of these cracks showed longitudinal offsets of about 0.15 m (in addition to large vertical and transverse offsets), which was sufficient to allow the girders to remain on their seats.

Figure 6-12 Shear failures in the columns and caissons of the Wu-shi bridge (west)

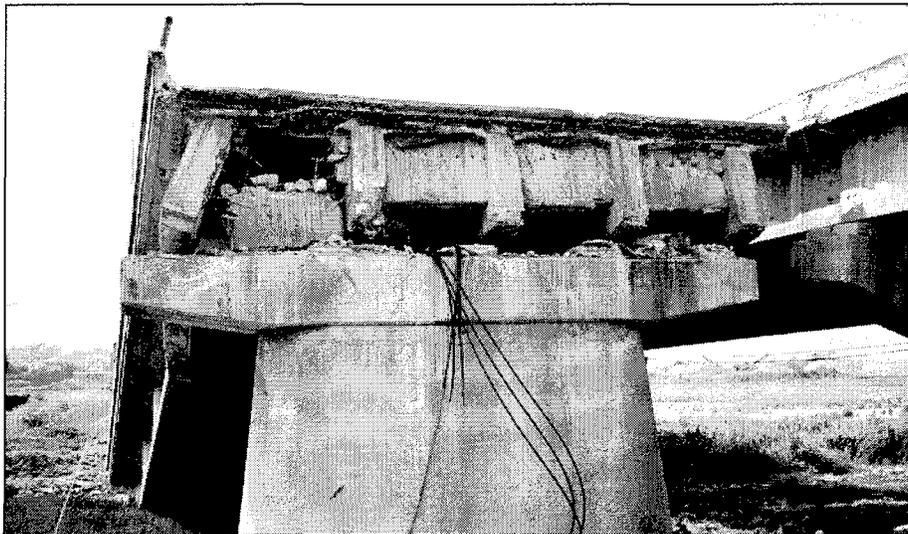
Figure 6-13 Diaphragm and shear key failures at Pier 2 of the Wu-shi bridge (east)

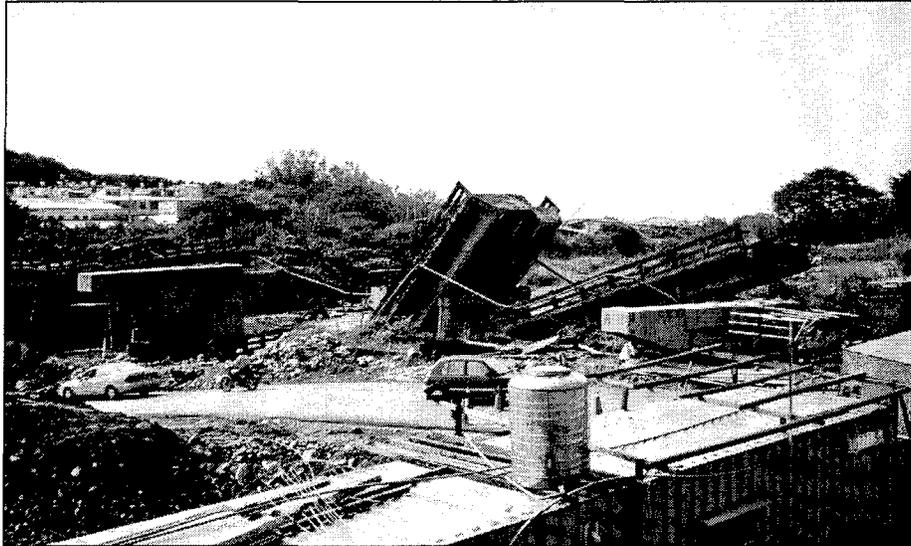
Constructed in 1972, the *E-jian bridge* on Route 129 has 24, 11 m spans providing a total length of 264 m. The superstructure comprises a pair of simply supported, reinforced concrete, double-T girders. Each pier is an unreinforced concrete wall on a spread footing. The structure was being widened at the time of the earthquake and new piers had been constructed, but at a different spacing than for the original bridge. During the earthquake, fault rupturing occurred under the north abutment with about 1.5 to 2 m of uplift (Figure 6-14). Consequently, twelve spans collapsed from the northern abutment to the center pier of the bridge (Figure 6-15). The remaining twelve spans to the south abutment remained standing with little apparent damage. Examination of the collapsed girders showed little distress and the field evidence suggests that collapse was due to large movements of the pier foundations towards the center of the river channel. At or near the abutment, where uplift occurred, these unreinforced piers were crushed, or snapped at mid height, but the remaining piers moved as rigid bodies towards the river or rotated with their footings due to slumping

Figure 6-15 Collapsed spans of the E-jian bridge due to massive ground movement towards the river (left)

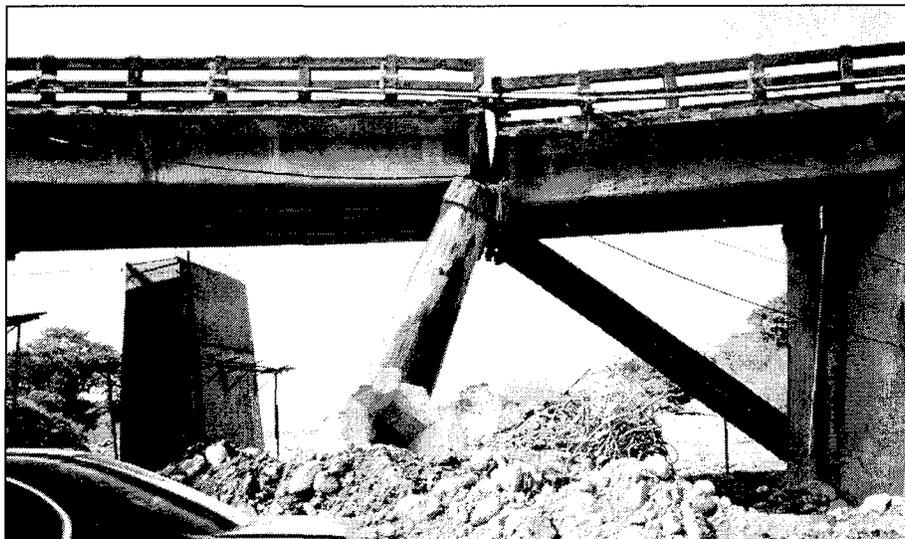
and flow of the uplifted material (Figure 6-16). In doing so, the piers were driven in under the adjacent 'downhill' span while unseating the adjacent 'uphill' span. Corresponding overhangs of the superstructure girders occurred, which at Pier 9 measured 3 m. There is little evidence of residual displacements in the southern half of the bridge (which remains standing), and this appears to confirm the scenario that the collapses were due to gross movements of the northern foundations rather than unseating due to structural vibration. The extent of these movements appears to have been of the order of 5 m near the abutment, decreasing to about 3 m near the river channel.

Figure 6-16 Tilting of Pier 10 of the E-jian bridge due to ground movement towards the river (left)

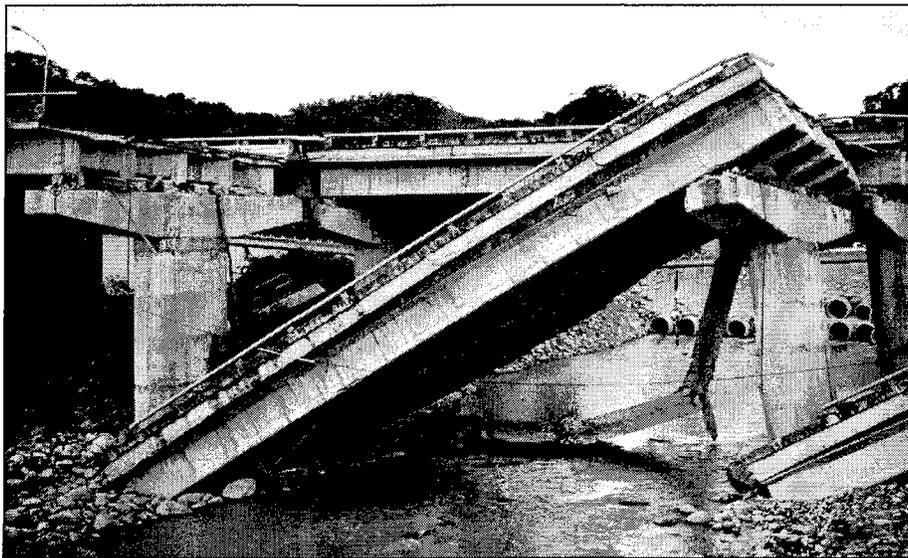
second pier (column and caisson) in both bridges tilted away from the abutment by approximately 10 to 15 degrees (Figure 6-18). There was no sign of abrasion on the vertical faces of either column to indicate sliding of the span down the face of the column. It therefore appears that tilting happened first, followed by the 'free' fall of the end spans. The reason for the collapse of the middle span of the second bridge is not so clear, but it may have been due to the skewed nature of this span (Figure 6-19). Since the bridge is curved, there are angle changes between the straight girders in adjacent spans at common piers and thus the middle span, of both bridges, has skewed supports. Such spans are known to exhibit excessive in-plane displacements due to rigid body rotations of the spans about a vertical axis during strong earthquakes. Unless generous seat widths are provided, collapse is likely. The fact that the middle span of the second bridge did not collapse may have been because it is on the 'inside' of the curve with shorter girders, and the displacements due to skew would not have been as large.

Figure 6-18 Collapse of the middle span of the Shi-wei bridge and tilting of Pier 2 (right); span to the right has also collapsed

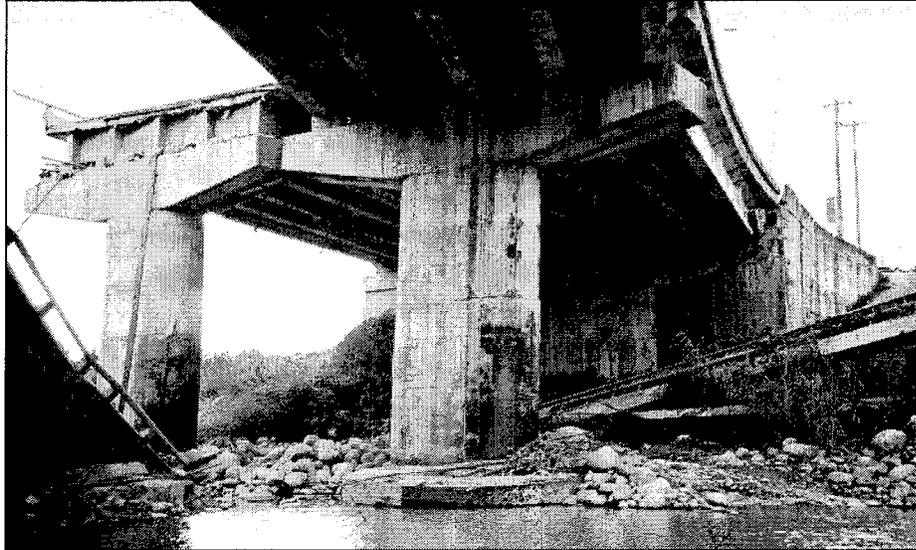
Figure 6-19 Shi-wei bridge showing curvature and skewed alignment of superstructure girders

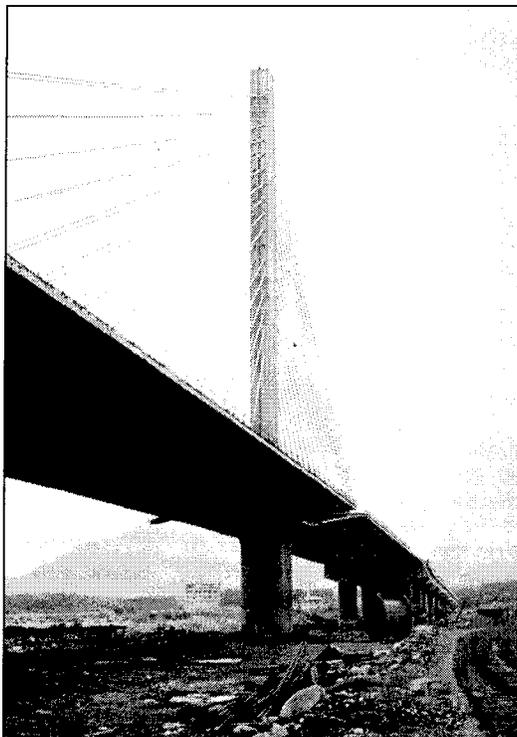
Damage to the structure included a fractured cable, flexural and torsional cracking at the base of the tower and in the superstructure, and vertical and lateral pounding of the superstructure into the 'abutment' substructures (Figures 6-21, 6-22, and 6-23). These substructures provide the transition between the cable-stayed spans and the approach spans and consist of two-column bents with a cap beam. It is not clear why this structure should suffer such distress, but the missing section of the superstructure (Figure 6-22) and the loss of one cable would lead to unbalanced loads and reduced stiffness, which in turn would generate asymmetric response and potentially large excursions of the girder in both torsion and in-plane flexure. Furthermore, the severity of the ground motions, particularly in the vertical direction, could have been responsible for the vertical pounding at the abutments, as evidenced by shear cracks in the abutment cap beams (Figure 6-23).

Figure 6-20 Ji-lu cable-stayed bridge; empty cable socket visible mid-height of the tower

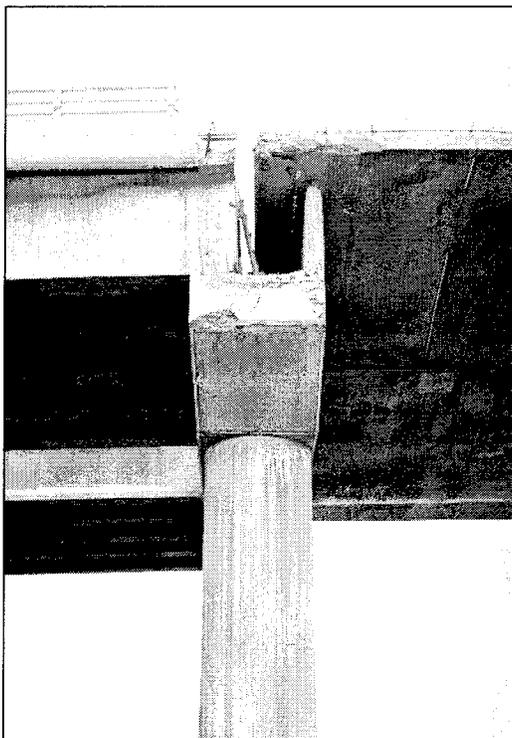
Figure 6-21 Damage at bent cap of south abutment, Ji-lu bridge; bent cap wall has been knocked off

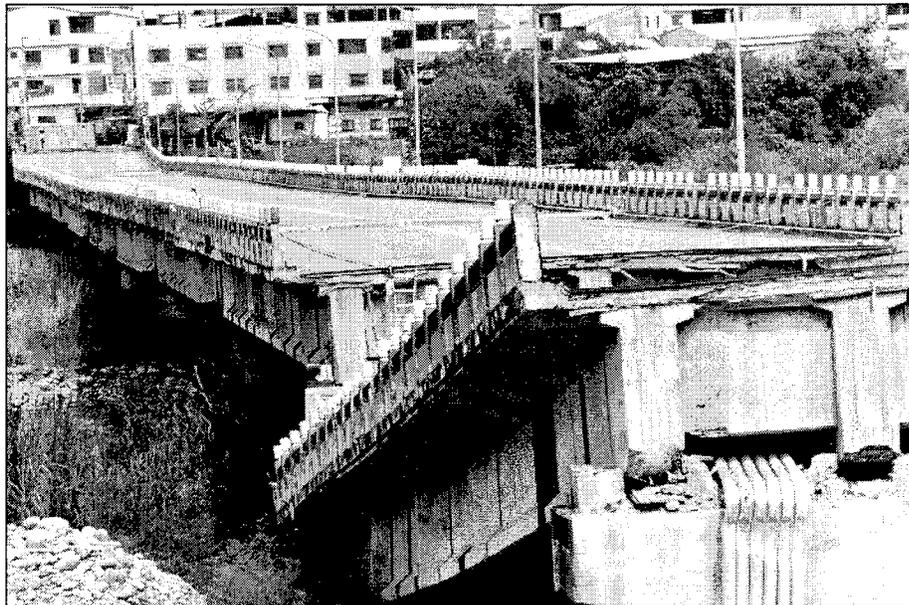
Figure 6-26 Collapse of span of Chang-gang bridge due to unseating of girders triggered by fault dislocations

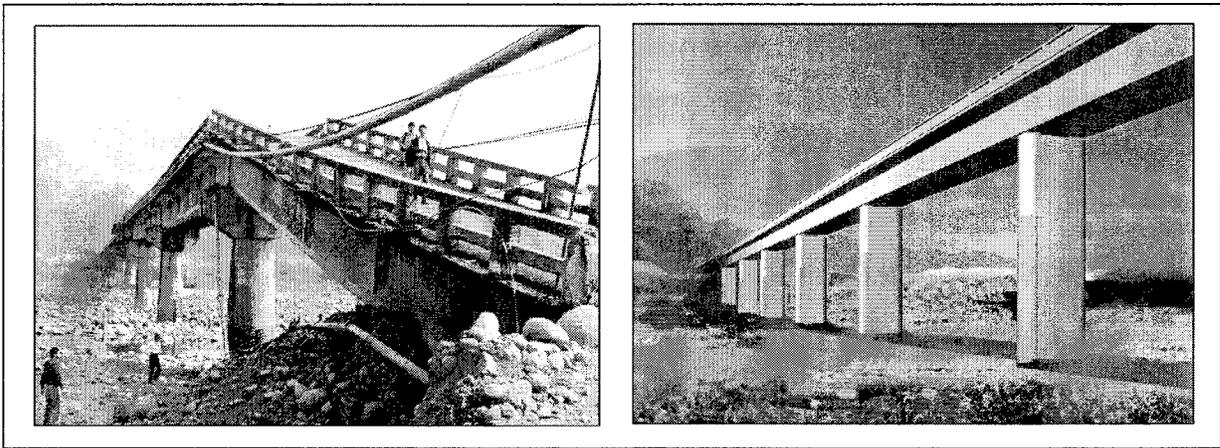
The Long-men Bridge (figure 6-27) is a 500 m long, 8.6 m wide bridge with 13 spans of PC box girders with reinforced concrete piers and pile foundations. The Li-yu Bridge is very similar, at 575 m long, 8.6 m wide, with 15 spans. Both bridges were opened to traffic on 5/31/2000, after 123 days and 131 days, respectively, total construction time.

Figure 6-27 Long-men Bridge after earthquake (left) and after reconstruction (right)

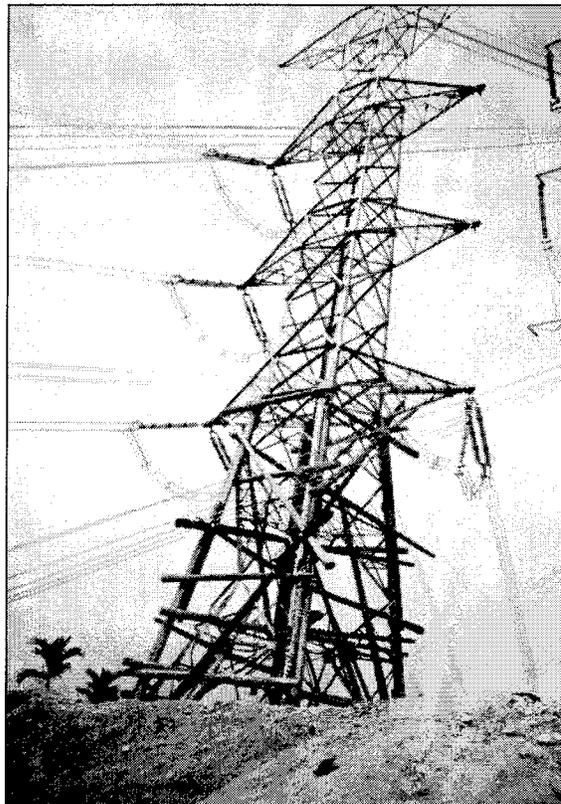
Regarding the 345 Kv transmission system, a significant number of transmission towers suffered from structural problems, and were tilted and displaced (Figure 7-1) causing a large number of transmission lines to fail (marked with an X in Figure 7-2). This in turn caused the initial blackout throughout the middle and northern areas of Taiwan. In addition, 161 Kv (Figure 7-3) and 69 Kv transmission systems in the affected area also suffered from similar failures. Figure 7-4 shows a damaged transmission tower and Figure 7-5 shows a temporary tower standing next to one that was damaged.

Figure 7-1 Transmission tower tilted and deformed

1. A large number of transmission tower failures were apparently due to the fact that they are constructed, obviously by necessity, over rugged mountainous areas with steep slopes susceptible to ground failure. It might be well advised to design, construct, and retrofit tower foundations with this in mind.

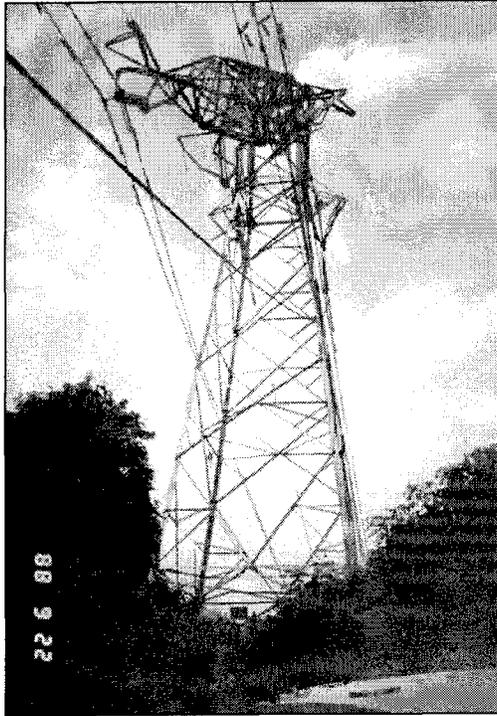
Figure 7-4 Transmission tower with top portion collapsed

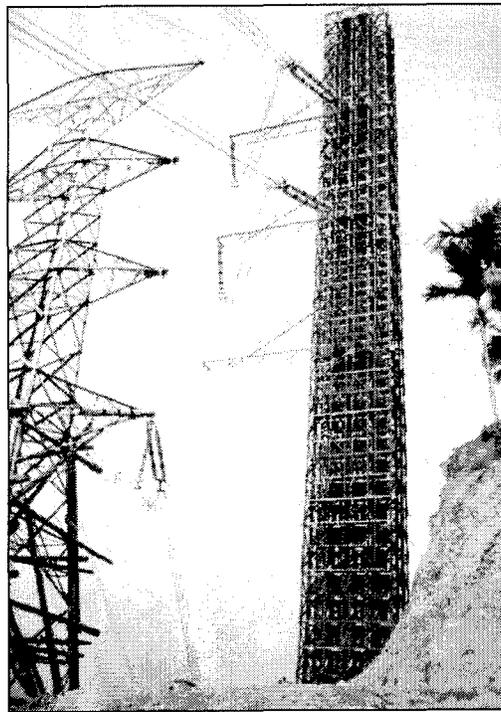
Figure 7-5 Failed transmission tower replaced by a temporary tower

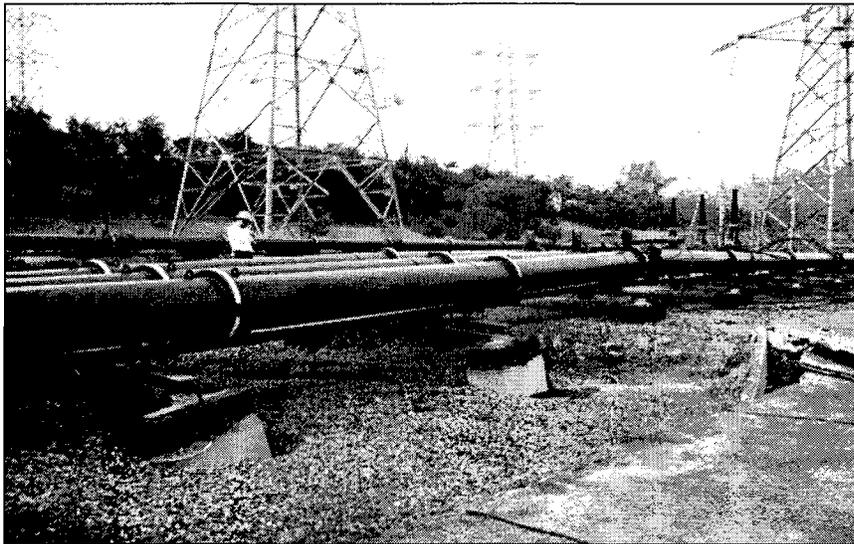
Figure 7-7 Failure of 345 Kv gas insulated line due to liquefaction induced settlement

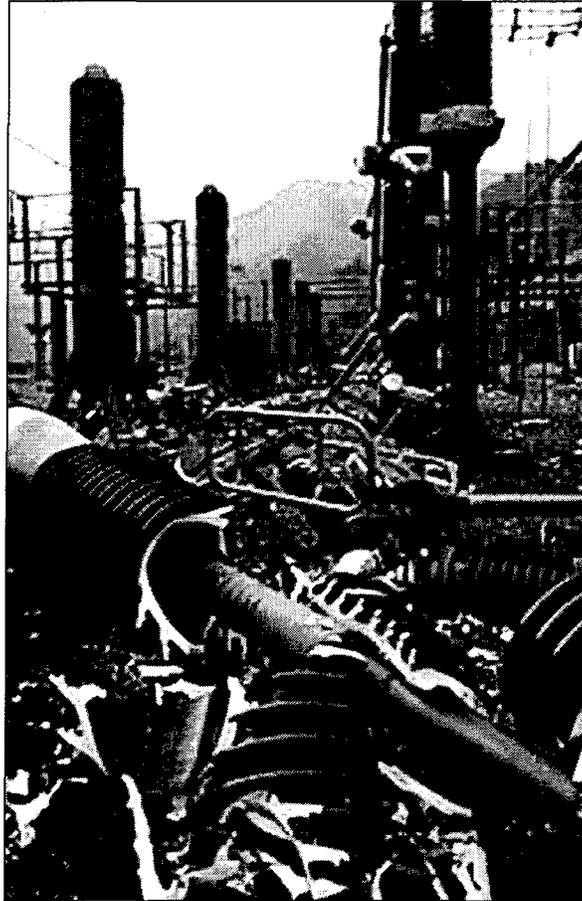
Figure 7-8 Damage at Tien-lun substation

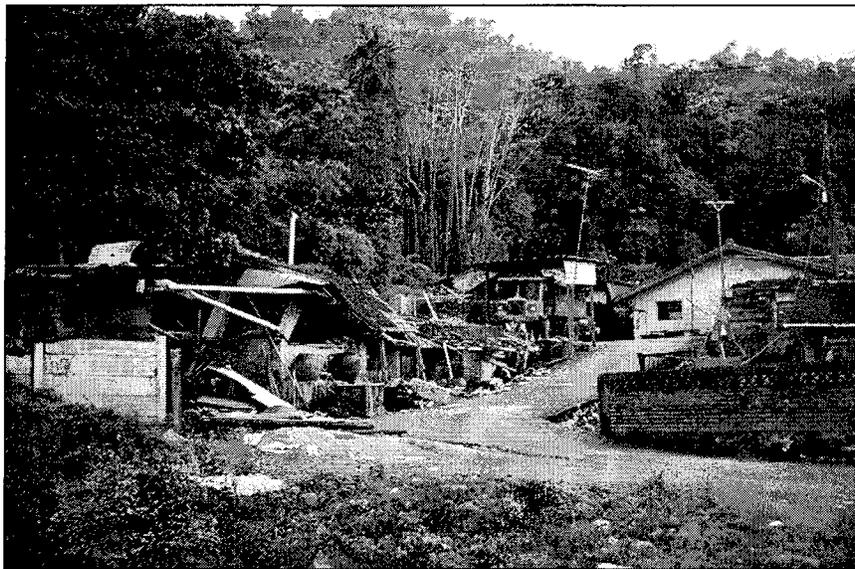
**Figure 9-2 Damaged farm structures outside Chusan,
Nantou county**

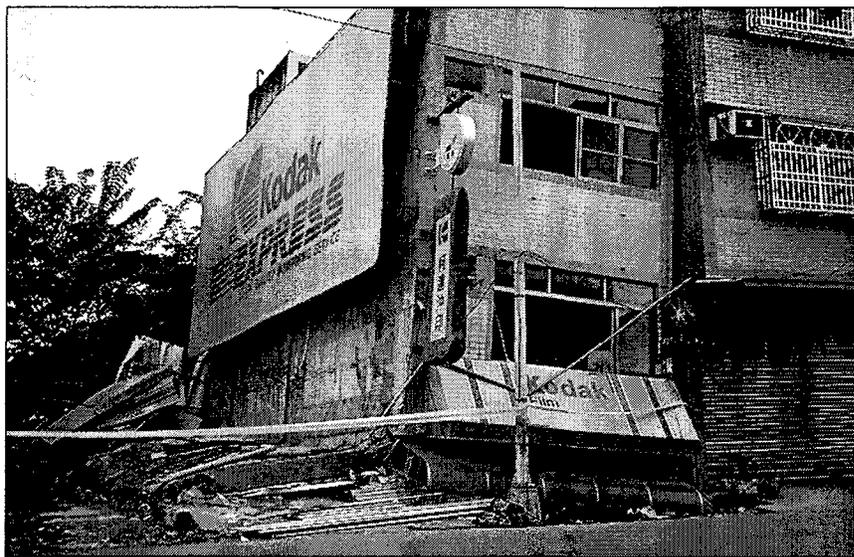
Figure 9-3 Structural collapse destroying ground-floor store in Ji-Ji, Nantou county

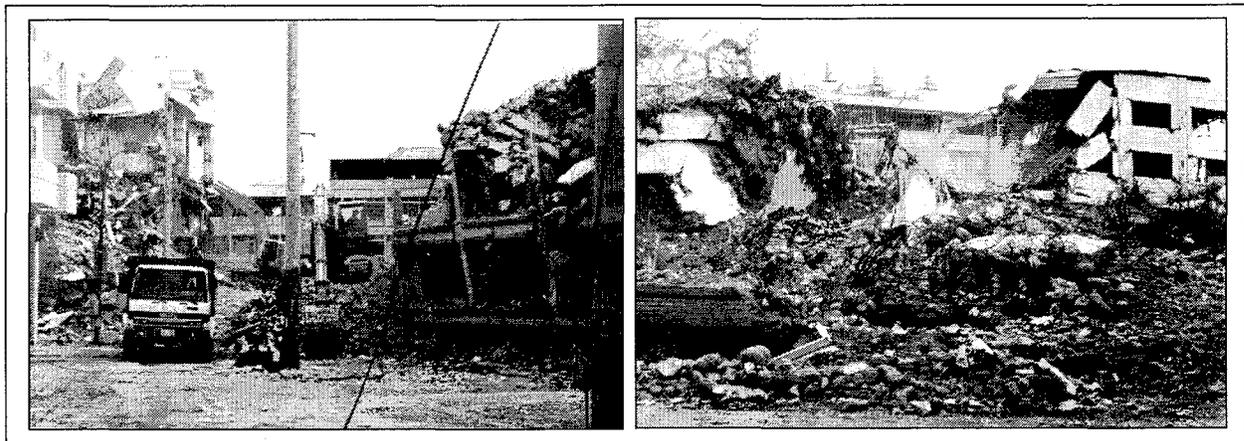
Figure 10-6 Demolition of severely damaged multi-family apartment complex

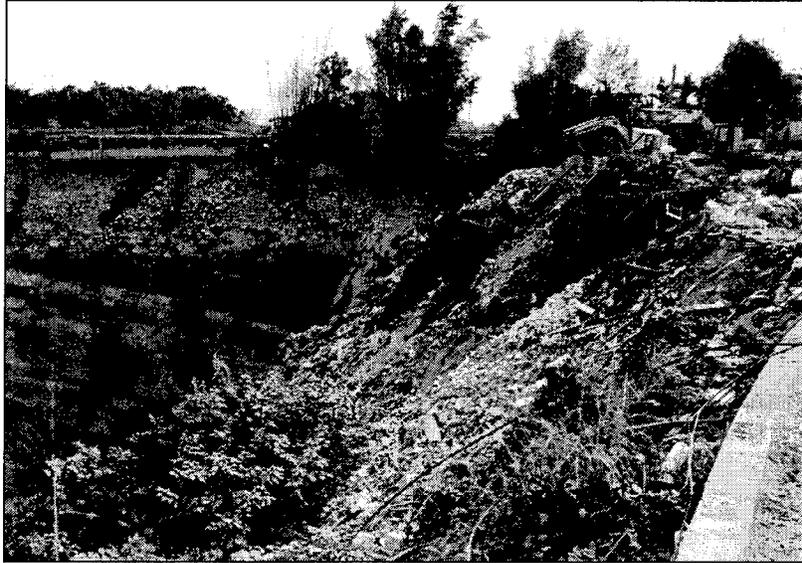
Figure 10-7 Debris from demolition work was brought to sites like this for disposal

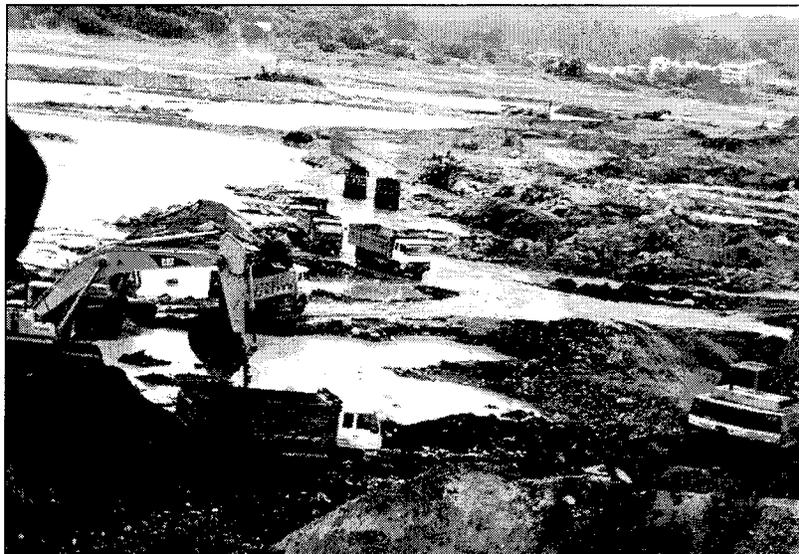
- The restoration of reservoirs, dikes, embankments, regional flood prevention and drainage structures. The restoration work underway at the Shih-kang Dam that failed due to surface faulting exemplifies the monumental work that lies ahead (Figure 10-8).

Figure 10-8 Restoration work underway at Shih-kang Dam

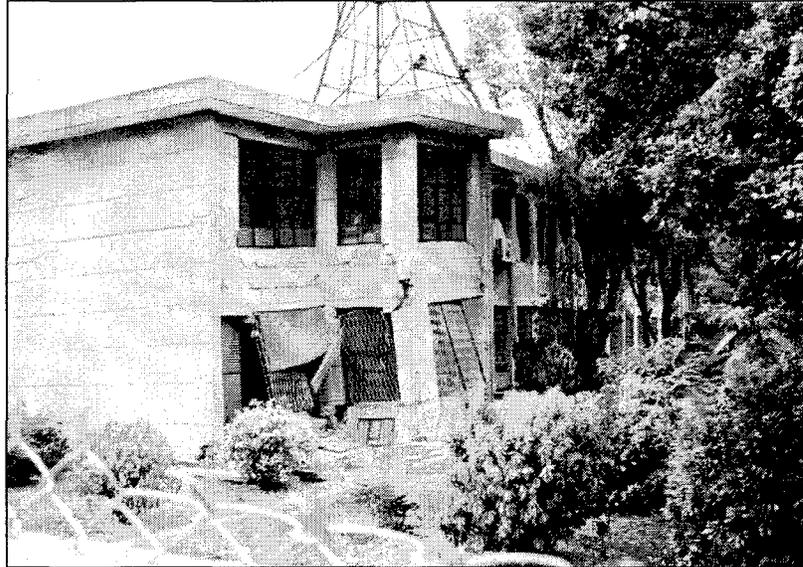
Figure 10-9 Damage to secondary school in Wu-feng Hsiang City, Taichung County

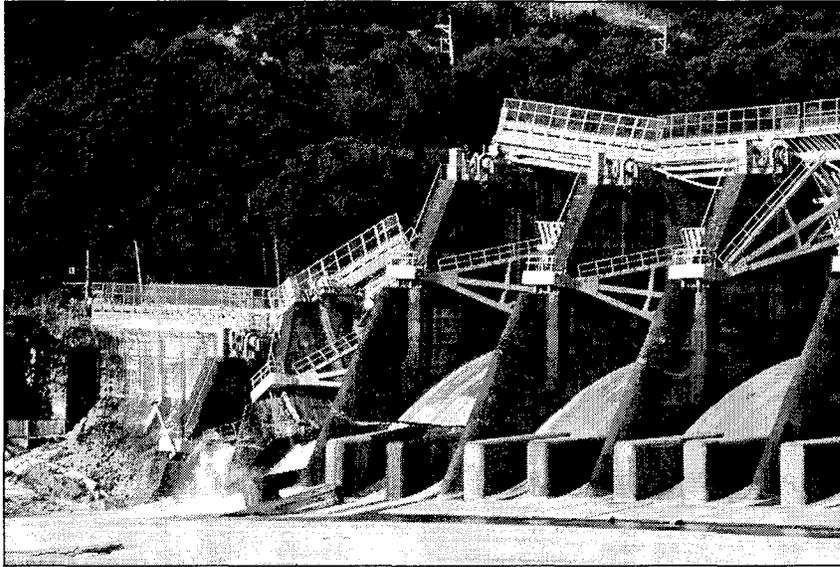
Figure 11-1 Surface faulting caused major damage to the Shih-kang Dam

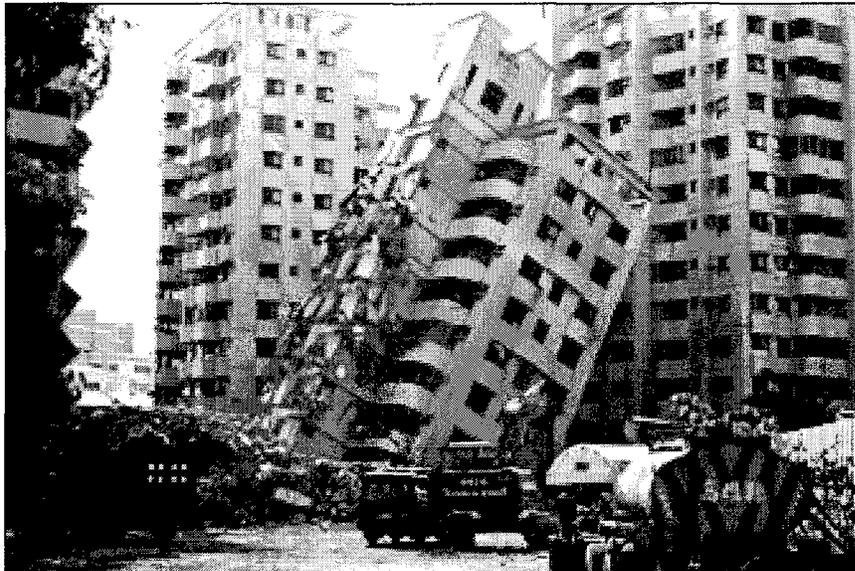
Figure 11-2 Newly constructed buildings suffered severe damage

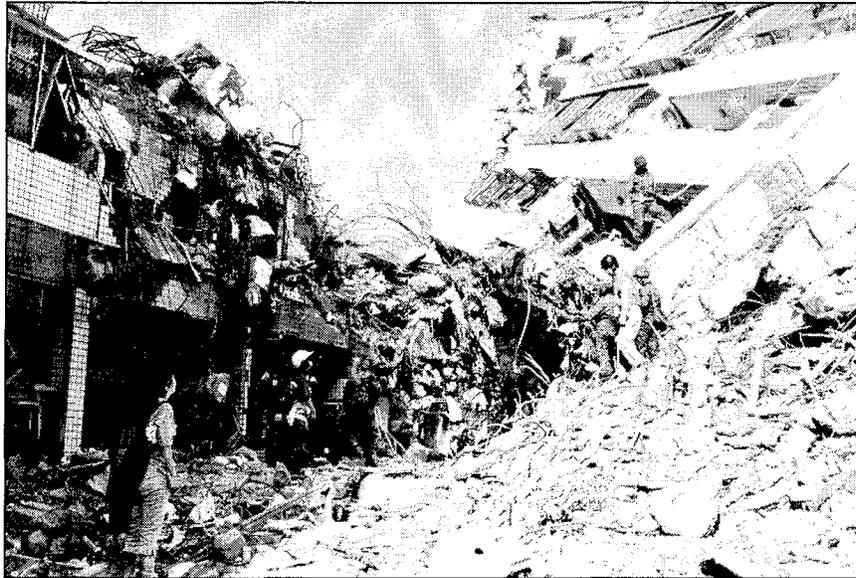
Figure 11-3 Damage to buildings and bridges was widespread throughout the epicentral area

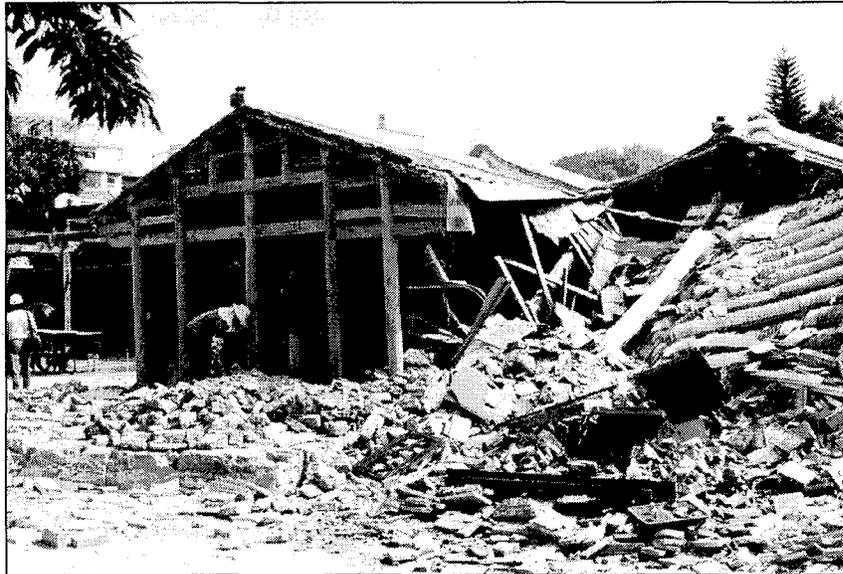
Figure11-4 The beautiful historic site of Lin's Garden was completely destroyed

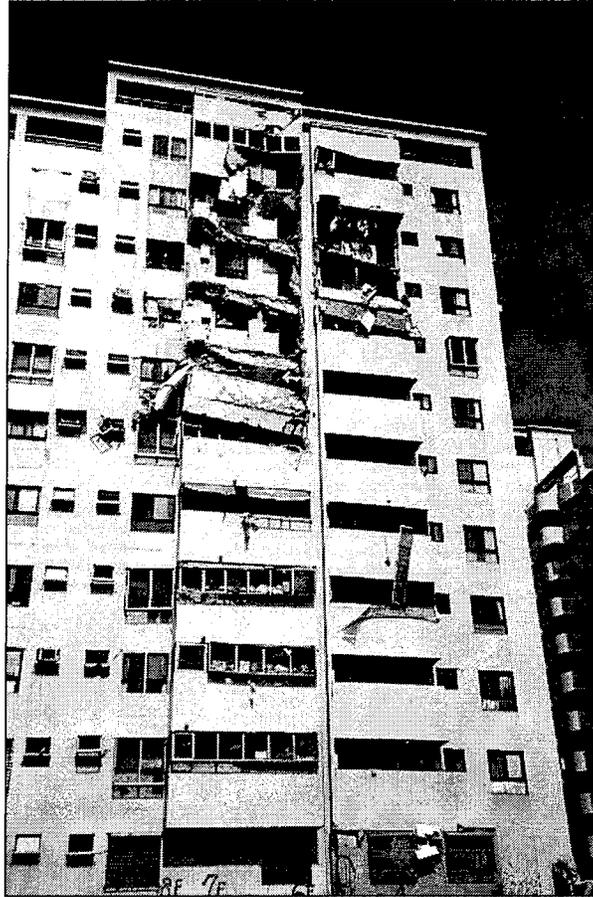
Figure 11-5 Reliable methods to evaluate the extent of damage are needed

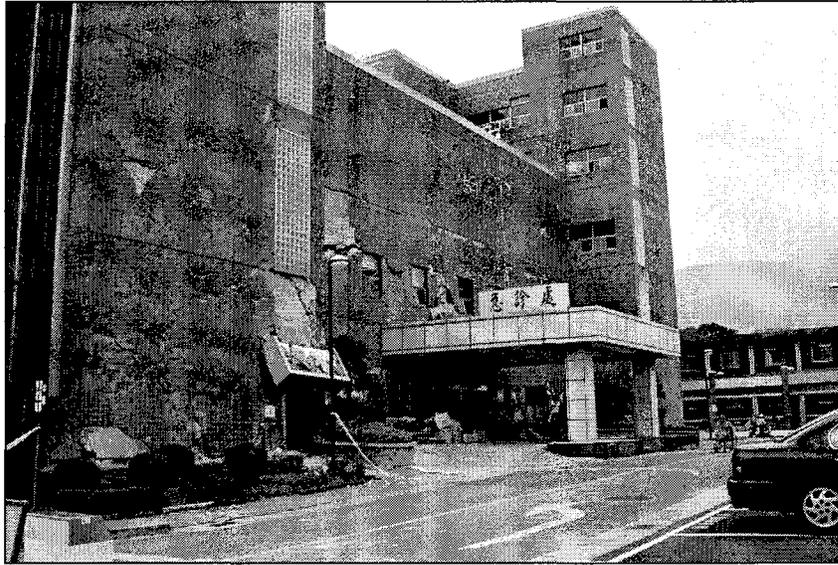
Figure 11-6 Damage to the Veteran's Hospital in Puli reduced its capacity to about 50% at a time when demand was highest

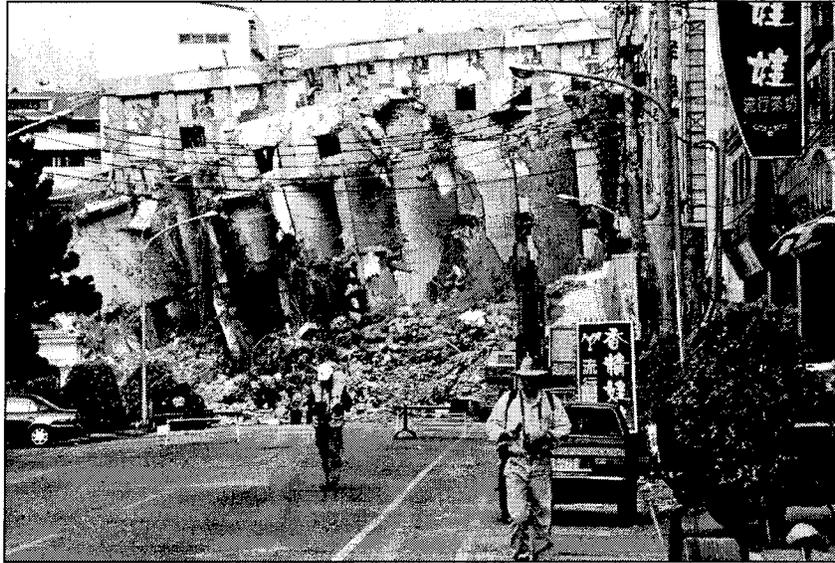
4. One of the most pressing issues in short-term restoration is that of construction quality (Figure 11-7). This has always been an ill-defined factor that makes the evaluation of existing damaged facilities more difficult. It also becomes a factor of importance in the time immediately following an earthquake, as reconstruction begins. Other issues such as public education, research, institutional effectiveness and building code improvements are longer term efforts. However, working with the real estate and construction industry can and should begin immediately with the restoration efforts. A workshop might be organized to review the current practice in building inspections (see item 2 above) and construction monitoring. Additional guidelines or recommendations would be issued as necessary. Building inspection and construction quality assurance should be examined from the overall perspective of planning, design, construction, decision-making processes (in the case of public works) and cost.

Figure 11-7 Construction quality both prior to an earthquake and during the reconstruction phase is an important issue
