Seismic Rehabilitation of Concrete Bridges: Verification Using In-Situ Tests at South Temple Bridge on Interstate 15

Final Report

Research Report UUCVEEN 00/1
Department of Civil & Environmental Engineering
University of Utah
Salt Lake City, UT 84112

July 2000

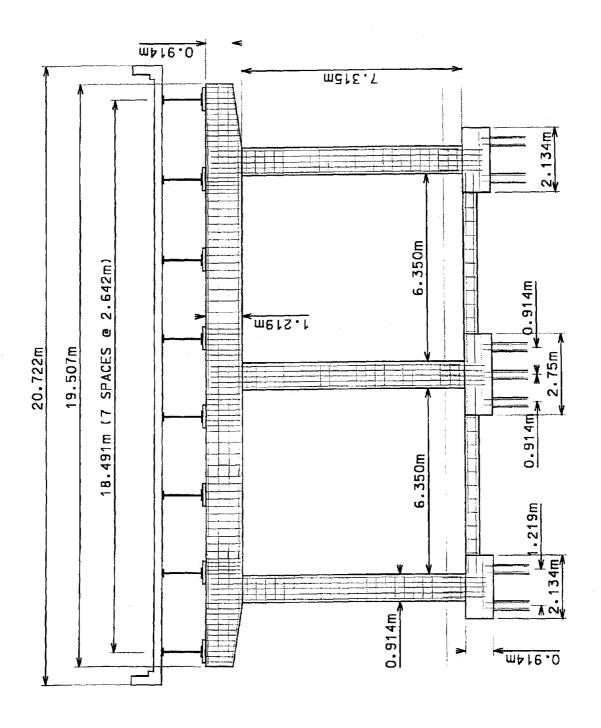
Figure 54. As-built Bent #5 dimensions and support conditions

By performing a static pushover analysis for the bent, an estimate of the peak lateral load and the maximum horizontal displacement were determined. The yielding sequence of the structural members was observed, and member forces were calculated at the ultimate displacement. This information was necessary for the rehabilitation design of Bent #6 using FRP composites. To construct the 2-D model of the structure, the existing conditions had to be evaluated and compared with the original design plans. The reinforcement details of the bent were presented in Fig. 4; the columns had a reinforcement ratio of 1.6%. It can be seen that the column transverse reinforcement was inadequate in the lap-splice region, and the anchorage of the longitudinal reinforcement in the pile cap and in the cap joint was insufficient. In addition, there are no transverse hoops in the column cap-beam connection. Since the lap splice in the column base is mostly unconfined, it would break down under cyclic inelastic action. The spacing of ties in the plastic hinge region at the top of the columns was insufficient. In addition, the anchorage of the piles into the pile cap was insufficient. These deficiencies are identified in Fig. 55.

The support conditions after implementing the modifications, described in Fig. 12 were neither fixed nor pinned. These modifications involved anchoring of the piles to the pile cap by epoxying a 32-mm Dywidag bar into the four corner piles of each footing. Therefore, the tension-compression resistance of the piles was modeled using axial spring elements. The location of these elements corresponded with the piles, and the spring constant values were estimated based on the axial stiffness of the Dywidag barpile system. Values ranging from pinned to fixed support conditions were assumed. From the results of the analysis it was obvious that the values of the spring constants have a great influence on the outcome. After testing Bent #5, and based on the maximum observed pile cap vertical movement (3.8 mm), the spring constant values (K₁ and K₂ in Fig. 4) were calibrated to provide a more realistic model. This soil spring calibration was done by matching the measured pile cap rotations at any force level, with the pile cap rotations from analysis.

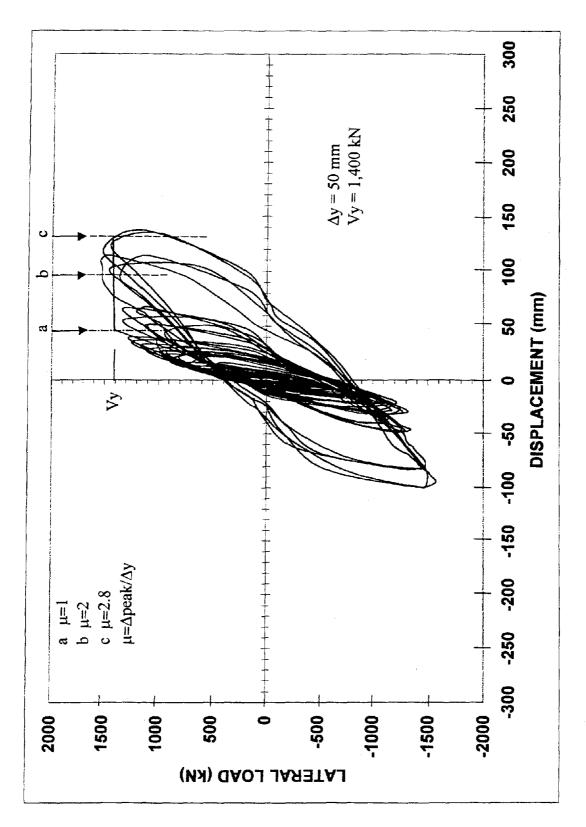
Figure 62. Hysteresis curves for Bent #5

The load-displacement hysteresis curve for Bent #5 is given in Fig. 62. The first yielding occurred at the top of the middle column. The first yielding of the column occurred at a lateral displacement of 29 mm (1.14 in.), corresponding to a lateral load of 801 kN (180 kip). These values are within 4% and 9% of the values obtained form analysis, respectively. From a bilinear approximation of the load-displacement behavior, the displacement ductility of the bent at the end of the test was found to be equal to 2.8, as shown in Fig. 62. This is reasonable for bridges of this type built in the 1960's, which were not designed for earthquakes. However, the bridge was designed for lateral wind loads.

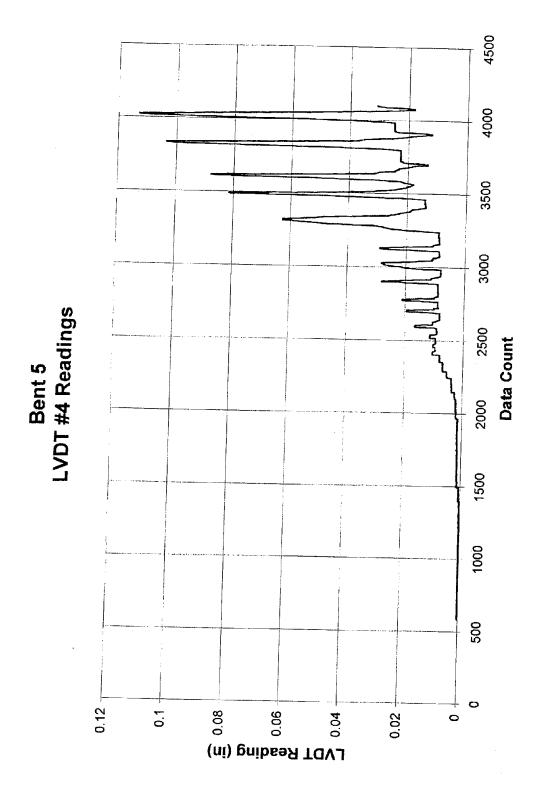
Figure 68. Displacement of diagonal along exterior beam cap – column joint on Bent #5 (1 in. = 25.4 mm)

The actual distortion of the beam cap – column joints was determined from the LVDT measurements. Figure 68 shows the diagonal displacement of the beam cap to column joint nearest to the actuator. The maximum diagonal measurement was 3 mm (0.12 in). The shear strain in the same joint is shown in Fig. 69; the maximum strain is 0.003 in compression. The principal tensile stress in the interior beam cap – column joint was evaluated as shown in Fig. 70. The horizontal and vertical shear forces in the joint are: $V_{jh} = 1109 + 511 = 1620 \text{ kN}$; $V_{jv} = 3118 - 784 = 2334 \text{ kN}$. The corresponding horizontal and vertical joint shear stresses are:

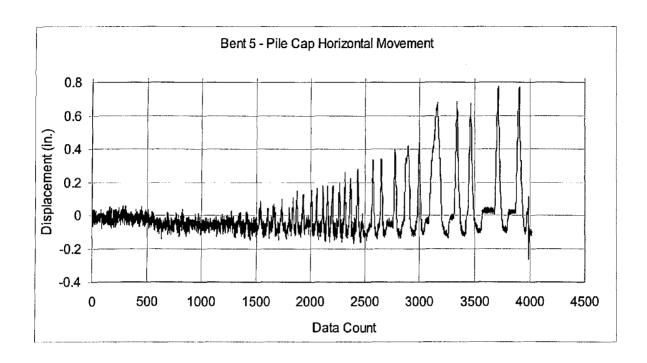
Figure 77. Horizontal movement of pile cap of Bent #5 (1 in. = 25.4 mm)

It must be noted that the data presented to this point do not include the effect of soil-pile-structure interaction, which as shown in Fig. 77 are significant. Figure 77 shows the displacement of the pile cap for Bent #5 which reveals that a maximum displacement of 0.8 in (20 mm) was reached. This is approximately 13 percent of the displacement reached at the beam cap of Bent #5. The topic of soil-pile-structure interaction is treated in detail in a companion report (Cook, Lawton and Pantelides 2000).

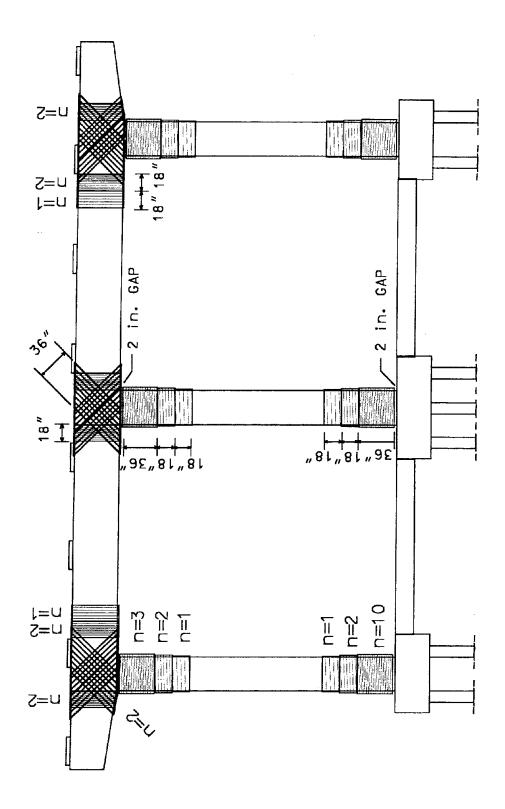
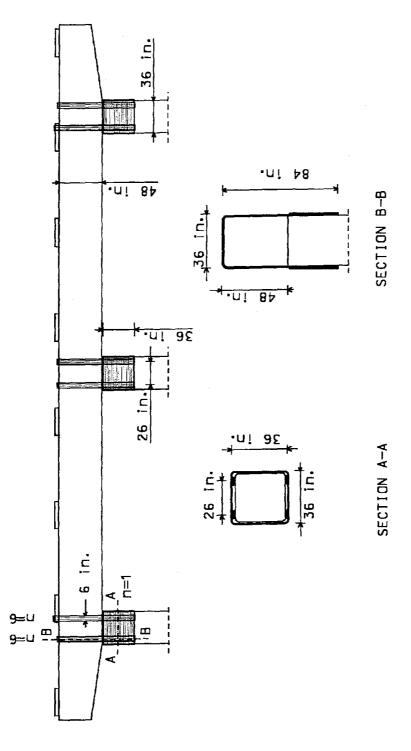
The composite layout for the retrofitted bent is shown in Fig. 86 and Fig. 87. The required thickness was divided by the thickness of one layer which was 1.32 mm (0.052 in.). In Fig. 86 there are ten layers extending to a distance of 914 mm (36 in.); the majority of these layers is for lap splice clamping, with the remainder contributing to flexural plastic hinge confinement and shear strengthening. Next, two layers were placed for a distance of 457 mm (18 in.) for flexural plastic hinge confinement and shear strengthening, and finally one layer was placed for a distance of 457 mm (18 in.) for flexural plastic hinge confinement. The jacket for the top of the column is similar to the jacket for the bottom of the column, except that there is no requirement in this case for lap splice clamping. However, an additional six layers of 152 mm (6 in.) wide CFRP composite sheets (tapes), shown in Fig. 87, were provided in order to decrease the level of stresses in the column longitudinal steel reinforcement extending into the joint. In addition, this steel reinforcement had insufficient development length in the joint. These CFRP composite tapes were clamped down using a single layer of fibers, which was placed over the tapes in the transverse direction as shown in Fig. 87. The beam cap required two 457 mm (18 in.) wide layers of unidirectional fibers on either side of the column, as shown in Fig. 86, for flexural plastic hinge confinement.

Four layers of unidirectional fibers were provided on both sides of the beam cap at \pm 45° in the joint region, as shown in Fig. 86. A 51 mm (2 in.) gap was left between the column and the pile cap, and the column and the beam cap, as shown in Fig. 86 to avoid any strength and stiffness increase from the retrofit. In addition, the corners of the beam cap and columns were rounded to 51 mm (2 mm) to provide better anchorage and confinement. Figure 88 shows the overall retrofit of the bent. The details of the retrofit at the top of the exterior columns were slightly different, only at the beam cap.

The composite layout for the repaired Bent #5R was identical to that for Bent #6 and is shown in Figs. 86 and 87 in section 7. There were some additional difficulties present in the application of this FRP composite as compared to those encountered in retrofitting Bent #6, due to the presence of cracks which resulted from the first testing of Bent #5. These cracks were filled to a great extend using a resign grout.
