MCEER SPECIAL REPORT SERIES
Engineering and Organizational Issues Before,
During and After Hurricane Katrina

Damage to Engineered Buildings and Lifelines
from Wind, Storm Surge and Debris in the
Wake of Hurricane Katrina

Gilberto Mosqueda and Keith A. Porter

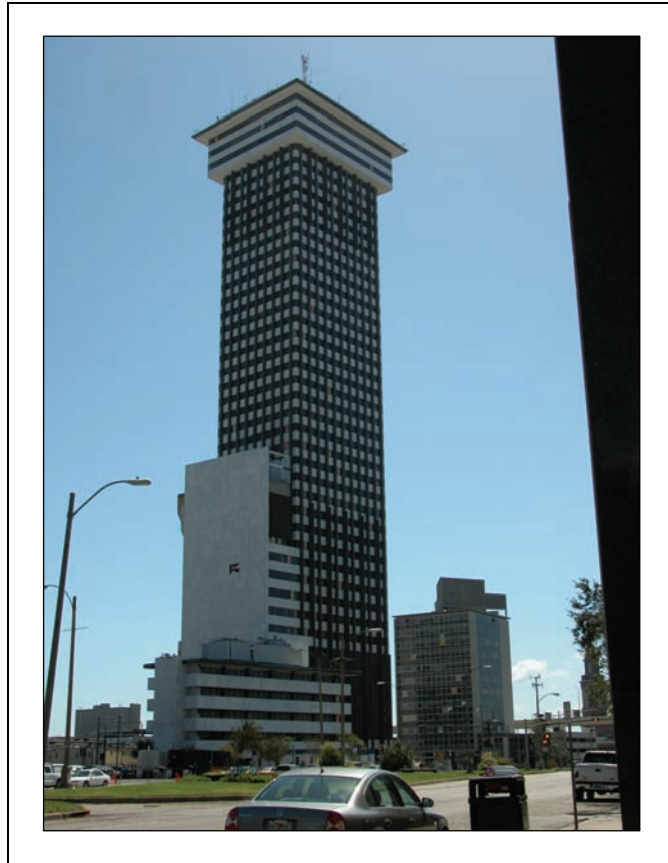
The 41-story Plaza Tower located at the intersection of Howard and Loyola is a reinforced-concrete-frame building with various vertical setbacks up to the 16th level and with a mushroom top extending the square footage of the top three stories. This high-rise building shown in Figure 3-10 was isolated from other tall buildings that could generate any rooftop debris by at least two city blocks. The south side of the building houses an eight-level parking structure with sheet metal cladding, where five of the metal sheets were missing. On the north facade, at least one precast cladding panel had been lost (note the spot around 10th floor level). Broken windows were spotted around the building, with the majority concentrated on the lower stories of the north and west facade. The building appeared closed at the time of investigation.

Figure 3-10. Office building in the New Orleans Business District at a distance from other high-rise structures.
