REPORT NO.
EERC 76-22
OCTOBER 1976

EARTHQUAKE ENGINEERING RESEARCH CENTER

RESPONSE OF THE OLIVE VIEW HOSPITAL MAIN BUILDING DURING THE SAN FERNANDO EARTHQUAKE

by
STEPHEN A. MAHIN
VITELMO V. BERTERO
ANIL K. CHOPRA
ROBERT G. COLLINS

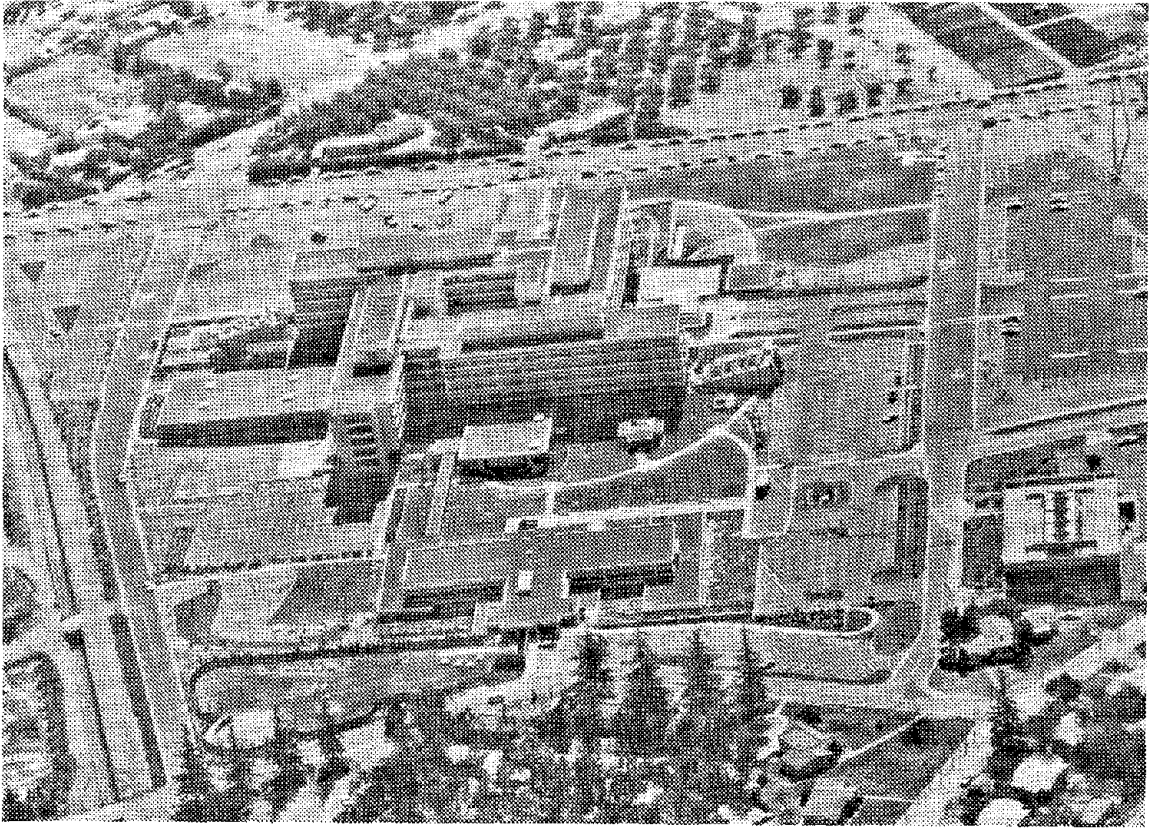
(a) OLIVE VIEW MEDICAL CENTER AS VIEWED FROM THE NORTH

This report examines an analytical investigation of the seismic behavior of the Main Hospital building. This six-story, cast-in-place, reinforced concrete building was the largest in the medical complex (Figs. 1.2 and 1.3). During the earthquake it sustained such extensive damage, as can be seen in Fig. 1.4, that it had to be demolished. While the building's stairtowers, Figs. 1.3 through 1.5, were part of the main building, the collapse of these appendages was significant enough to warrant a separate investigation [1.2]; therefore, only those features of their design and response essential to the evaluation of the remainder of the main building will be discussed. Preliminary results of this investigation on the main building have been reported [1.3], and several other investigators have studied the building [1.4-1.6]. An experimental study of spiral columns like those found in the building has been conducted [1.7]. In addition, several other buildings of the Medical Center have been studied, including the ambulance canopy [1.8], warehouse [1.9], psychiatric unit [1.10], and exhaust pavilion [1.11], and the principal results of these studies have been summarized [1.12, 1.13].

FIG. I.4 GENERAL FEATURES OF DAMAGE TO OLIVE
VIEW MEDICAL CENTER

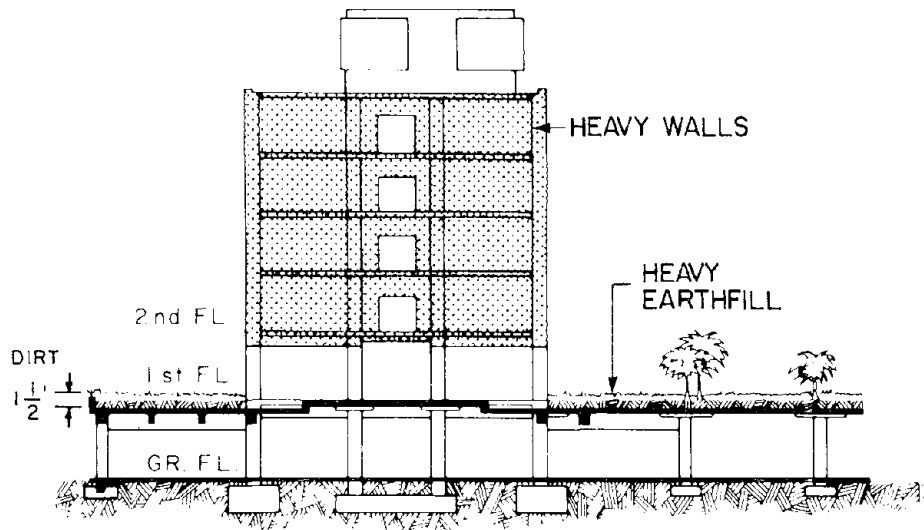
(a) ELEVATION OF OLIVE VIEW MAIN TREATMENT BUILDING ILLUSTRATING PRESENCE OF UNNECESSARY MASSES

FIG. 2.19 ILLUSTRATION OF INADEQUATE STRUCTURAL CONCEPTS

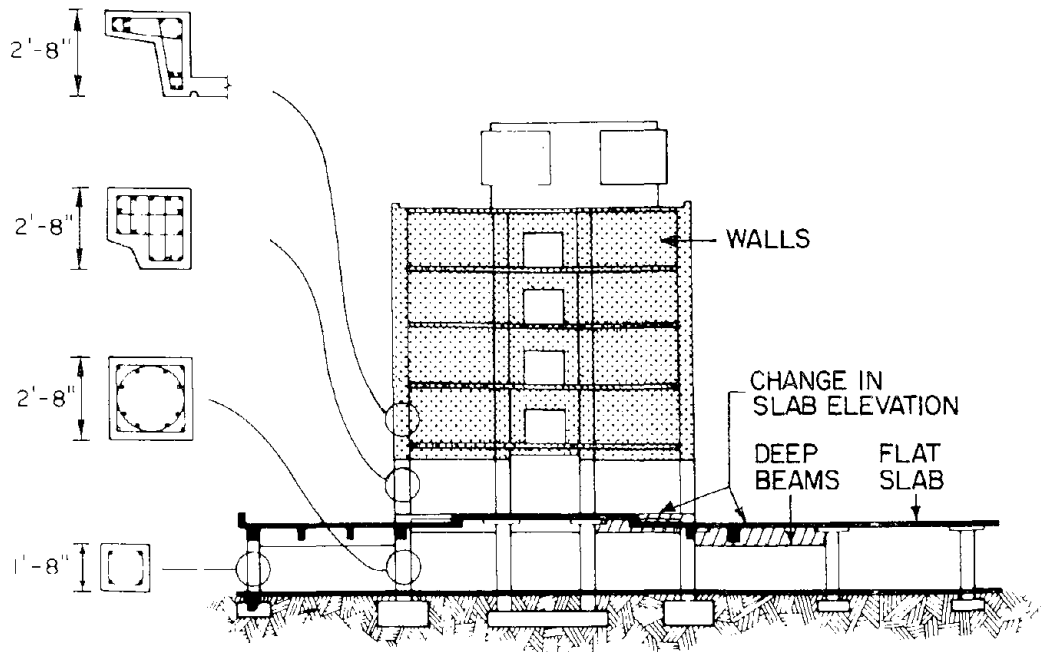
(b) ELEVATION OF OLIVE VIEW MAIN TREATMENT BUILDING ILLUSTRATING DISCONTINUOUS STIFFNESS, STRENGTH, AND DUCTILITY

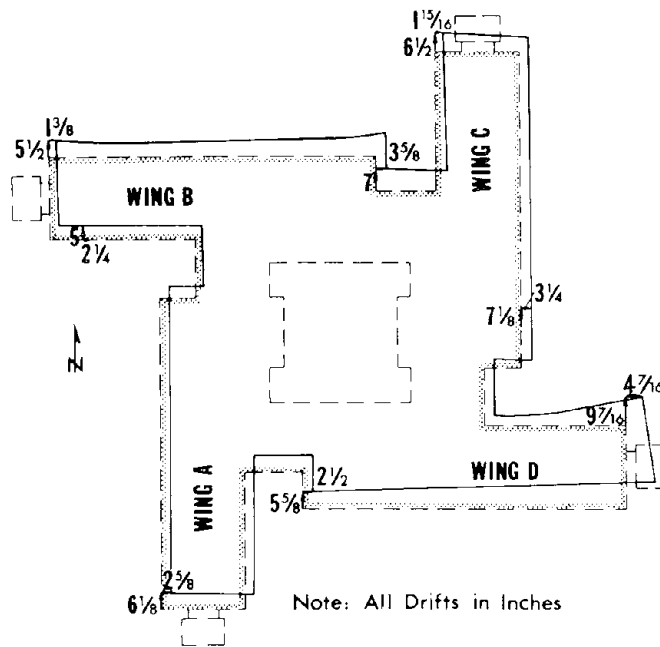
The envelopes of maximum inelastic floor displacements and story drifts computed for the standard nonlinear Wing D model subjected to simulated record number 6 are shown in Fig. 6.10. While the maximum roof displacement of 4.12 in. was considerably smaller than the residual displacements observed in the building (Fig. 3.2-3.4), the pattern of displacement indicates that large story drifts [Fig. 6.10(b)] were concentrated in the lower two stories. The structural walls in the upper four stories successfully limited the drifts in these stories. However, the computed drifts in the lower two stories were similar in magnitude, in contrast to the permanent drifts due to the earthquake which were much larger in the first story than in the ground story (see Figs. 3.2 and 3.3).

the first story in the failure model against the warehouse retaining wall spring limited the ground story drifts resulting in relatively larger maximum drifts in the first story. While the maximum computed northward drifts are similar to the permanent drifts observed in the first story, they were smaller in the ground story. This was a consequence of the elastic behavior of the warehouse spring; the actual warehouse was substantially damaged and displaced permanently, significantly to the north [Figs. 3.3 and 3.7(b)].

FIG. 3.3 PERMANENT STORY DRIFTS IN GROUND STORY

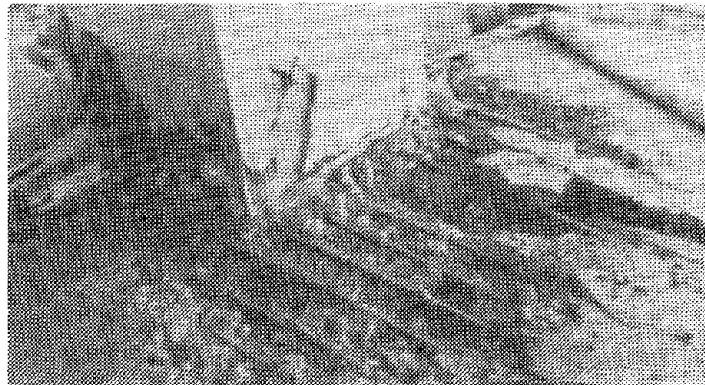
(b) SLAB NEAR COLUMN H-26 AFTER RUBBLE REMOVED

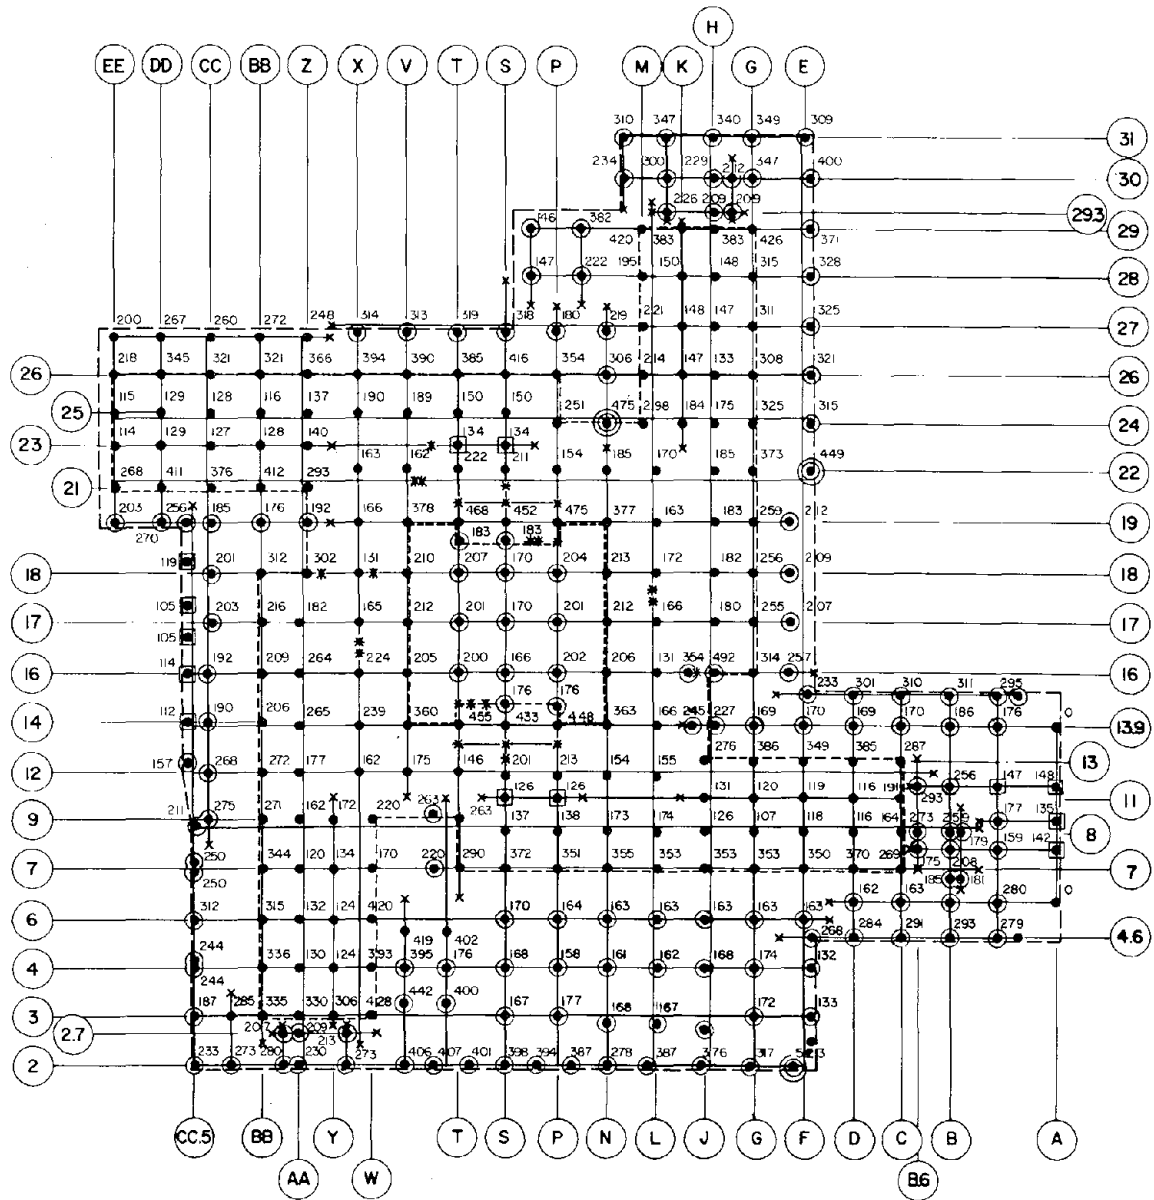
- (a) The numbers indicate the elastic shear stress (psi) in the columns at $t = 2.30$ sec.
- (b) Assuming the tied columns had a maximum shear capacity of 155 psi, the tied columns marked as indicated below failed during the model's displacement peak at: $t = 2.05$ sec., \odot ; $t = 2.35$ sec., \otimes ; and $t = 2.70$ sec., \odot .

FIG. 5.14a SHEAR STRESSES AND FAILURES IN GROUND STORY COLUMNS DUE TO NORTH-SOUTH DISPLACEMENT OF THE MODEL

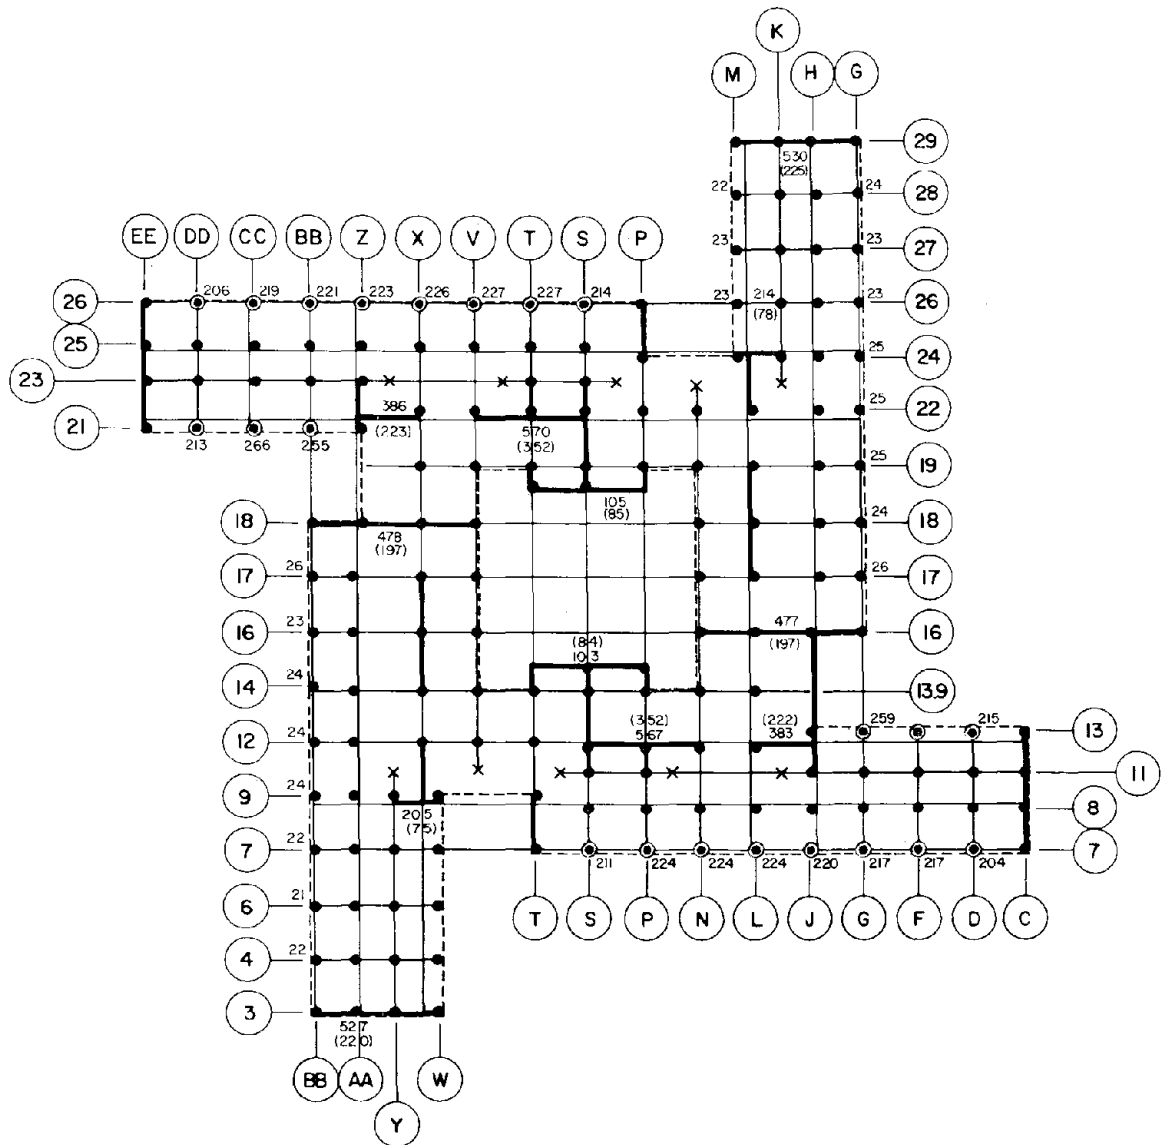
- (a) The numbers indicate the elastic shear stresses in the third story channel columns and second and third (in parenthesis) story shear walls at $t = 2.30$ sec.
- (b) Assuming the channel columns had a maximum shear capacity of 135 psi the channel columns marked as indicated below failed during the model's displacement excursion which peaks at: $t = 2.30$ sec. (X)

FIG. 5.15 SHEAR STRESSES AND FAILURES IN UPPER STORY CHANNEL COLUMNS AND SHEAR WALLS DUE TO NORTH-SOUTH DISPLACEMENTS OF THE MODEL

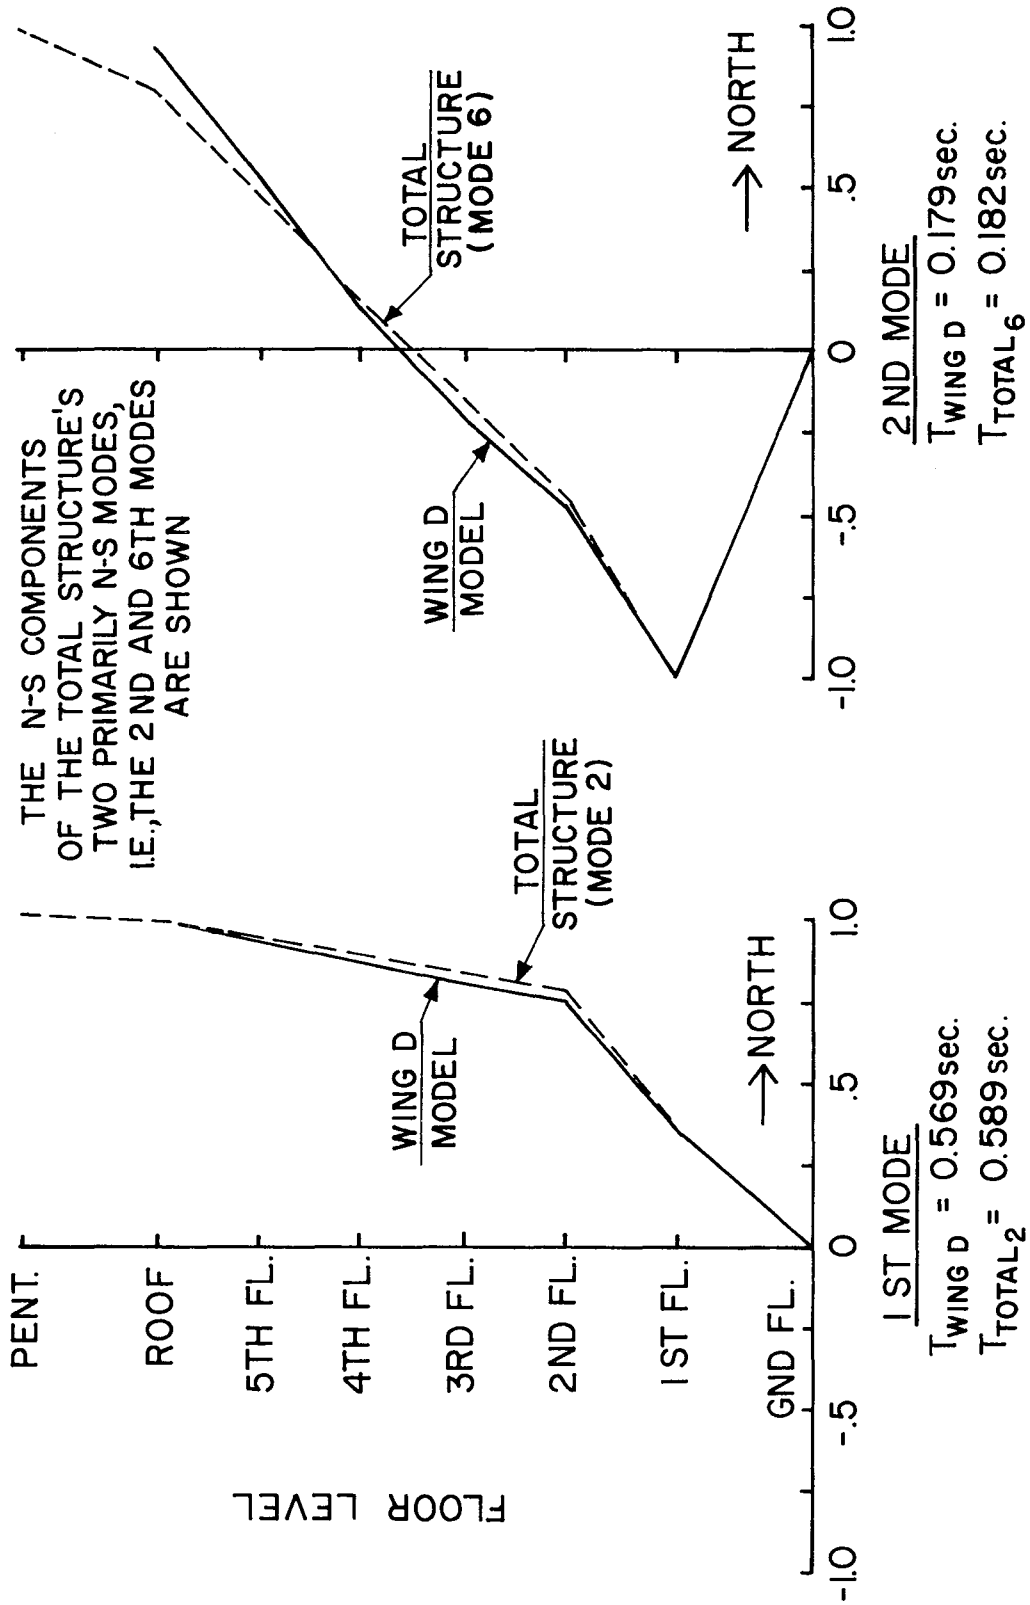
shapes for the alternative structural systems did not exhibit the abrupt change in shape that was detected for the original Wing D model (Fig. 5.18).

FIG. 5.18 MODE SHAPES AND PERIODS FOR WING D AND TOTAL STRUCTURE MODELS

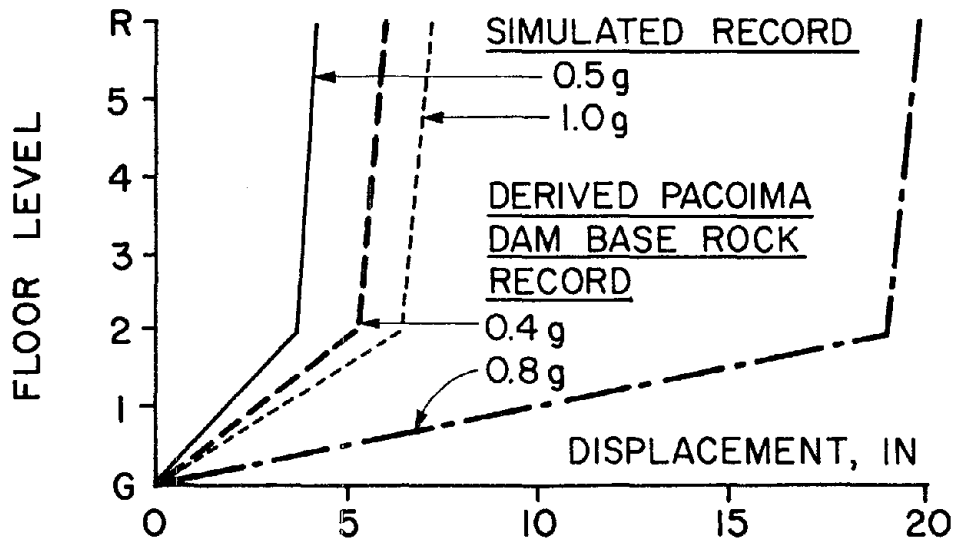
The maximum lateral displacements developed by the model for the derived Pacoima Dam base rock record at 0.4 g are substantially larger than those based on the simulated record as shown in Fig. 6.14. They are still considerably less than the actual residual displacements observed in the building. When the ground motions are arbitrarily amplified by a factor of two, the displacements for the amplified simulated record (1.0 g) are just larger than those for the unamplified Pacoima Dam base rock record. Doubling of the intensity of the

FIG. 6.14 COMPARISON OF MAXIMUM FLOOR DISPLACEMENTS FOR DIFFERENT GROUND MOTION RECORDS - STANDARD NONLINEAR MODEL

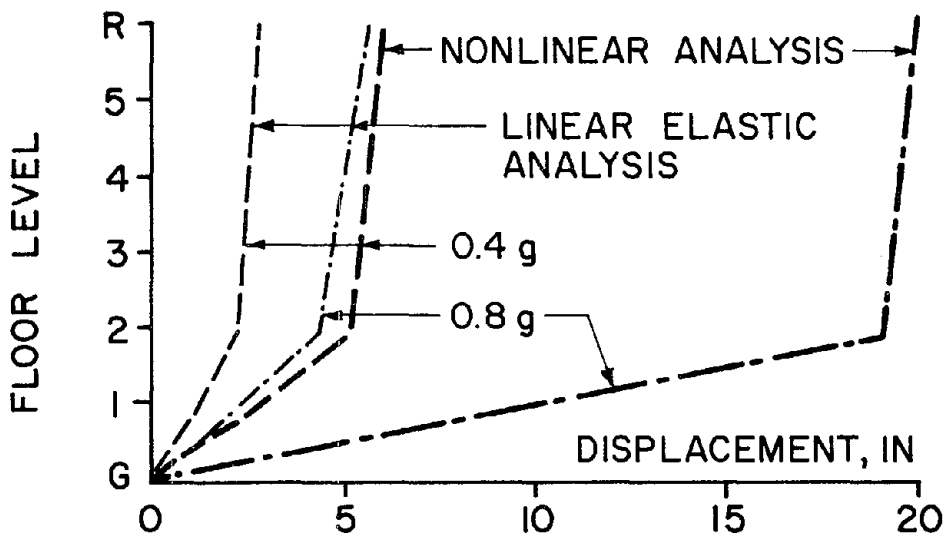
It is interesting to note that unlike the responses for the simulated record, there are significant differences between the elastic and nonlinear responses for the derived Pacoima Dam base rock record. This is illustrated in Fig. 6.15. The maximum nonlinear displacements are more than twice as large as the elastic values at a peak acceleration of 0.4 g, and when the acceleration amplitudes are doubled, the difference increases to a factor of almost four.

FIG. 6.15 COMPARISON OF LINEAR ELASTIC AND NONLINEAR RESPONSES TO THE DERIVED PACOIMA DAM BASE ROCK RECORD

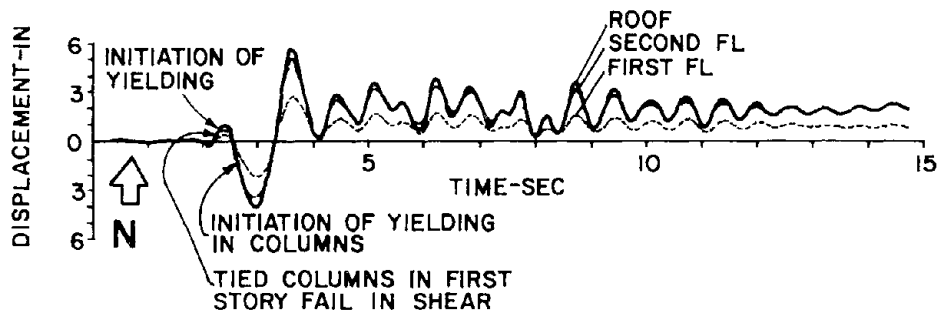
The displacement response histories for the derived Pacoima Dam base rock record and the amplified records are shown in Figs. 6.16 through 6.18. It is interesting to note that the response to the Pacoima record is dominated by a single large displacement cycle early in the response that results in a small permanent northward displacement (Fig. 6.16). While these displacements are still smaller than the permanent drifts observed, the presence of a single large excursion agrees with the observed damage. The large cycle corresponds to the long-duration acceleration pulses in the beginning of the record (Fig. 4.10) that were discussed in Section 4.6.

FIG. 6.16 DISPLACEMENT RESPONSE TO DERIVED PACOIMA DAM BASE ROCK MOTION (0.4g)

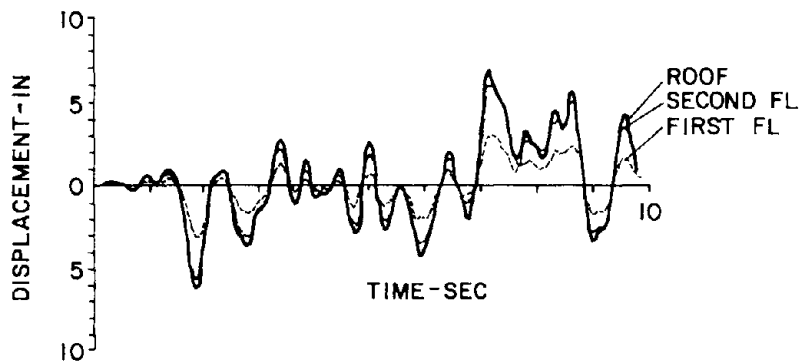
Even when the simulated record is amplified, the displacements (Fig. 6.17) remain relatively small and oscillate numerous times with reversal. On the other hand, the response for the amplified Pacoima record exhibits a single large displacement excursion. However, the largest displacement is to the south (rather than to the north as in the actual structure) where reversal of displacement occurs, bringing the building back to about its original position. The response of the structure when a collapse mechanism occurs is very sensitive to the shape and duration of the acceleration pulse(s) immediately thereafter, to the response of the structure leading up to the formation of the collapse mechanism, and to the strength and stiffness characteristics of the structure. Thus, slight modifications to the

FIG. 6.17 DISPLACEMENT RESPONSE TO AMPLIFIED SIMULATED GROUND MOTION (1.0g)

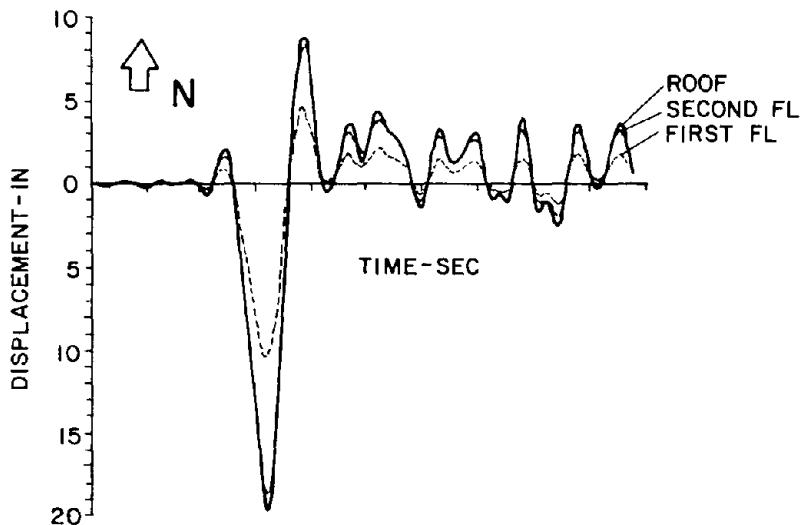
accelerogram leading up to the pulse and to the pulse itself could result in larger transient or permanent displacements to the north, in larger southward displacements, or any other desired response. It is believed, however, that strong, long-duration acceleration pulses like those of the derived Pacoima Dam base rock record or the Van Norman Dam record were the cause of the large lateral drifts observed in the building. While the computed responses do not exactly reflect the observed damages, it is clear from the drifts computed in the nonlinear analyses (Fig. 6.19) that the response would result in undesirably large amounts of structural and nonstructural damage. Drift indices ranging from 1 to 5 percent are too large, particularly for hospital or other essential facilities.

FIG. 6.18 DISPLACEMENT RESPONSE TO AMPLIFIED DERIVED PACOIMA DAM BASE ROCK MOTION (0.8g)

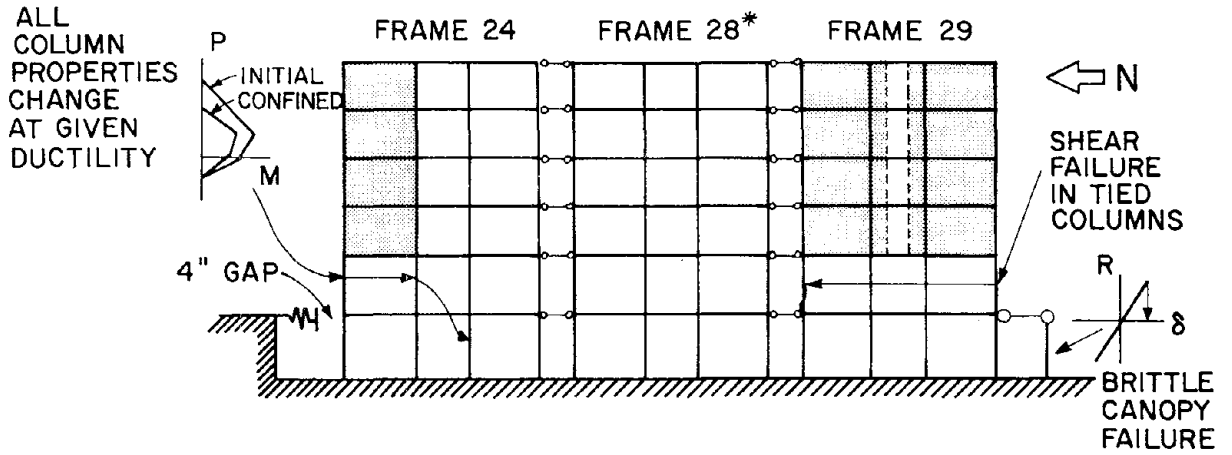
The model used is schematically illustrated in Fig. 6.23. The model incorporates options for: (1) brittle failure of the terrace canopy; (2) shear failure of the first story tied columns; (3) spalling of the concrete cover from the columns; and (4) hammering against the warehouse and retaining walls. The failure of the slabs were not accounted for. Details regarding the modeling assumptions are discussed below.

FIG. 6.23 SCHEMATIC REPRESENTATION OF FAILURE MODEL

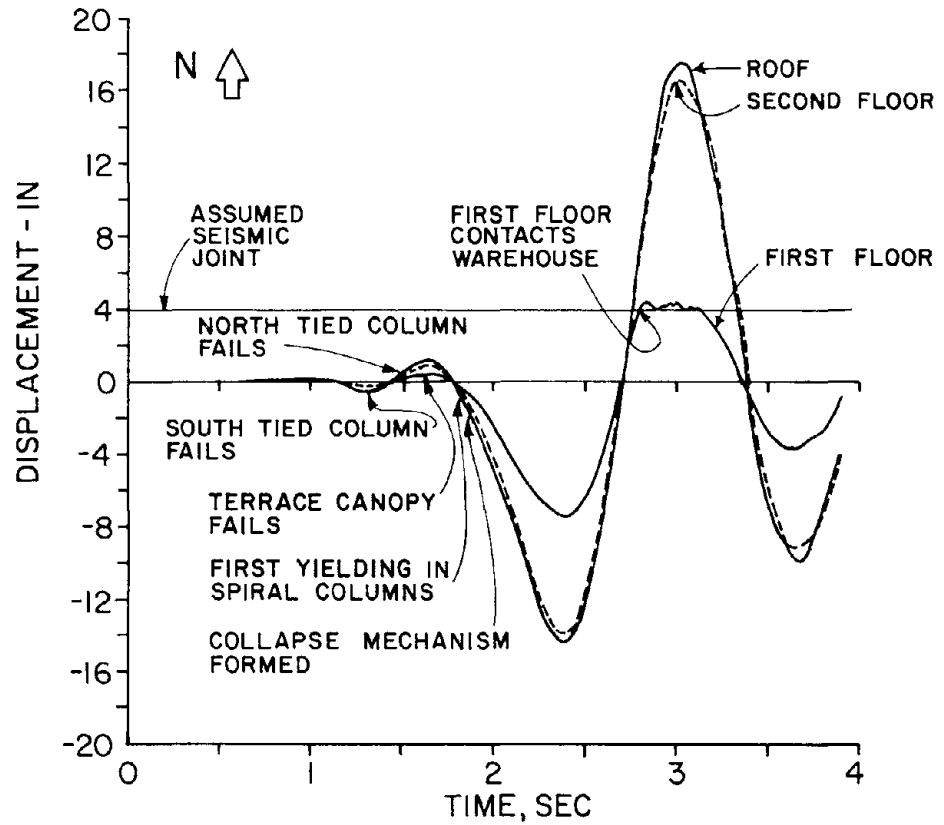
The displacement time histories and the time when significant events occur during the response are shown in Fig. 6.24. The maximum northward and southward displacements are both large in this case.

As shown in Fig. 6.24, the tied columns on the first story failed very early in the response. The terrace canopy fails soon thereafter, prior to the imposition of large, long-duration acceleration pulses. While some slab yielding in the first floor occurred during the northward displacement excursion at 1.70 seconds, spiral column yielding did not occur until the arrival of the first major acceleration pulse which resulted in a southward deflection of the building. During this first pulse, yielding rapidly propagated throughout the lower two stories so that the analysis indicates that within 0.12 seconds of the first yielding in a column, a complete soft story (panel) collapse mechanism formed. Spalling was predicted in all of the columns within 0.1 seconds after the formation of the collapse mechanism. During the second major acceleration pulse the building displaced towards the north and the first floor impacted against the warehouse spring. While this spring precluded further significant northward deflection of the first story, the upper stories continued to move toward the north, significantly increasing the drifts in the first story. Subsequent acceleration pulses moved the structure toward its original base line and the first floor moved away from the warehouse spring.

FIG. 6.24 RESPONSE HISTORY FOR FAILURE MODEL SUBJECTED TO FILTERED PACOIMA DAM BASE ROCK RECORD

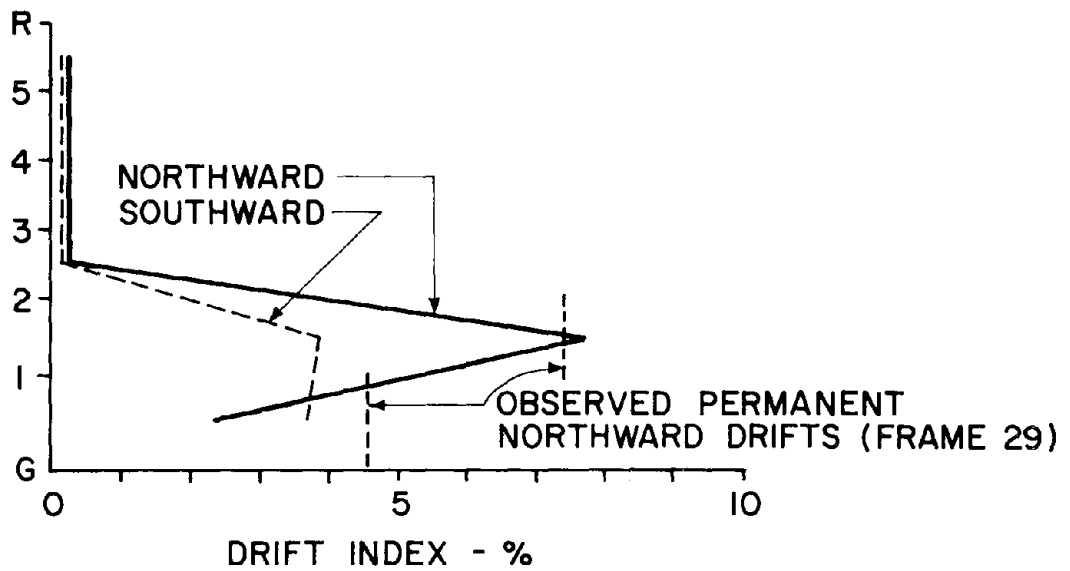
The maximum floor displacement envelopes for the failure model are shown in Fig. 6.25. In this case the displacements to the north are generally greater than those developed toward the south. At the first floor, northward displacements are limited to about the width of the seismic joint so that the first floor deflects further to the south than the north. The displacement pattern to the north is close to that observed in the actual building. The actual permanent drifts in the first story were substantially larger than those developed in the ground story as shown in Figs. 3.2, 3.3 and 6.26. The impact of

FIG. 6.25 ENVELOPES OF MAXIMUM NORTH AND SOUTH DISPLACEMENTS FOR FAILURE MODEL SUBJECTED TO FILTERED PACOIMA DAM BASE ROCK RECORD

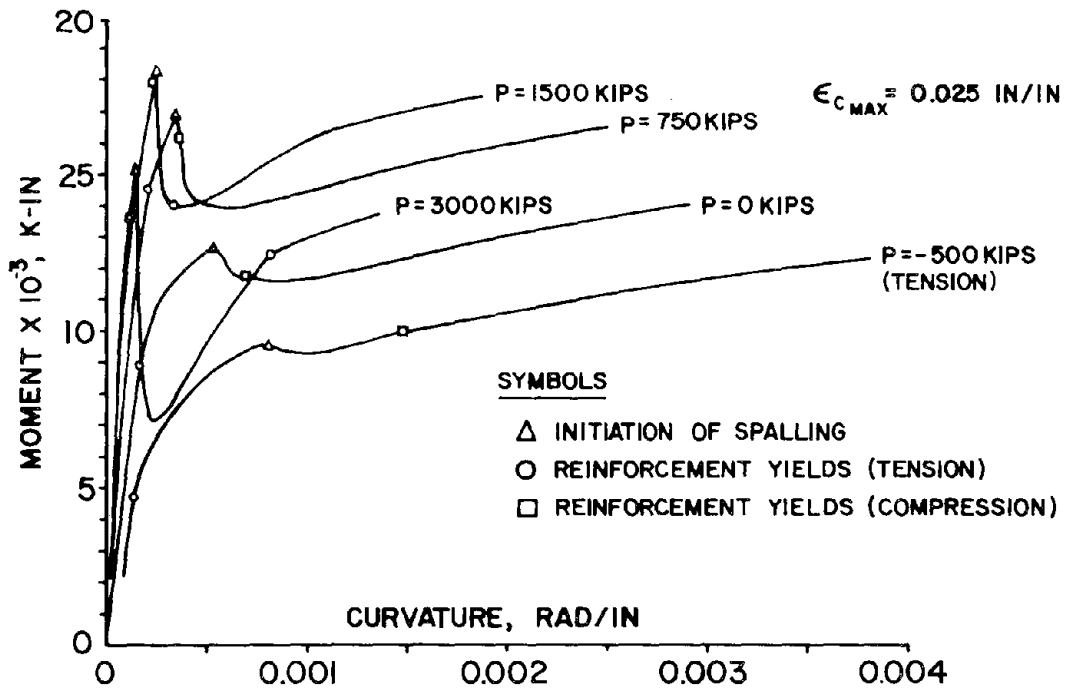
Moment-curvature relationships generated for this section under different axial loads are shown in Fig. B.3. A number of observations can be made regarding these results. The curves clearly do not have an ideal elasto-plastic shape as assumed in the non-linear dynamic analyses, and there were significant differences between the shapes of the curves for various axial loads. The initial cracked stiffness of the section, measured as the initial slope of the M- ϕ curves, increased with increasing axial loads. A substantial increase in moment capacity after the first yielding of the reinforcement is observed since the reinforcement is not concentrated at the extreme tension and compression faces. With the onset of spalling, however, the strength of the section drops, especially in the case of high axial loads, and only after substantial strain-hardening does the section regain its initial strength. The effect of spalling is particularly significant for this type of cross-section due to the large fraction of the initial area taken by the unconfined cover.

to spalling. The behavior of the section at low axial loads is exemplified by the $M-\phi$ curve shown in Fig. B.3 for zero axial force.

FIG. B.3 MOMENT-CURVATURE RELATIONSHIPS FOR FIRST STORY SPIRAL COLUMN K-28

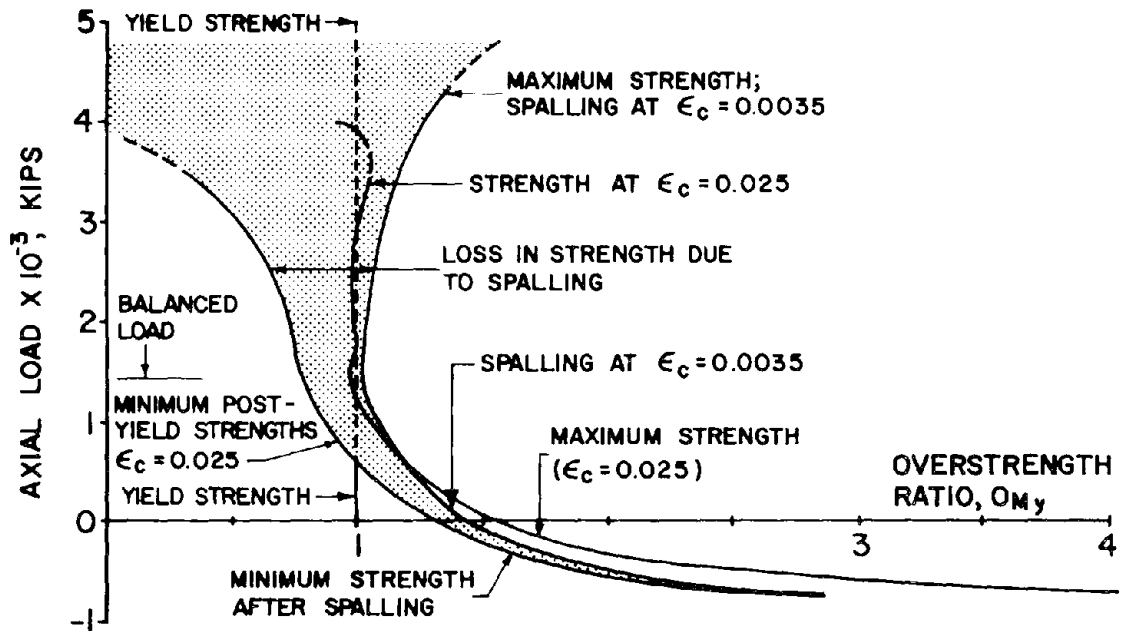
to a particular post-elastic state (e.g., spalling) to the yield moment for various axial loads. This ratio, $O_{M_y} = M/M_y$, will be described as an over-strength ratio, although values less than unity can occur. The yield moment used in this definition is taken as the minimum moment necessary to yield any of the reinforcement in either tension or compression. Curves of over-strength ratios are shown in Fig. B.4 corresponding to the critical moment values for (1) the minimum post-yield strength, (2) the strength at the onset of spalling (i.e. $\epsilon_c = 0.0035$ in./in.), (3) the minimum strength developed after the onset of spalling, and (4) the maximum strength developed by the section.

FIG. B.4 OVERSTRENGTH RATIOS FOR FIRST STORY SPIRAL COLUMN K-28

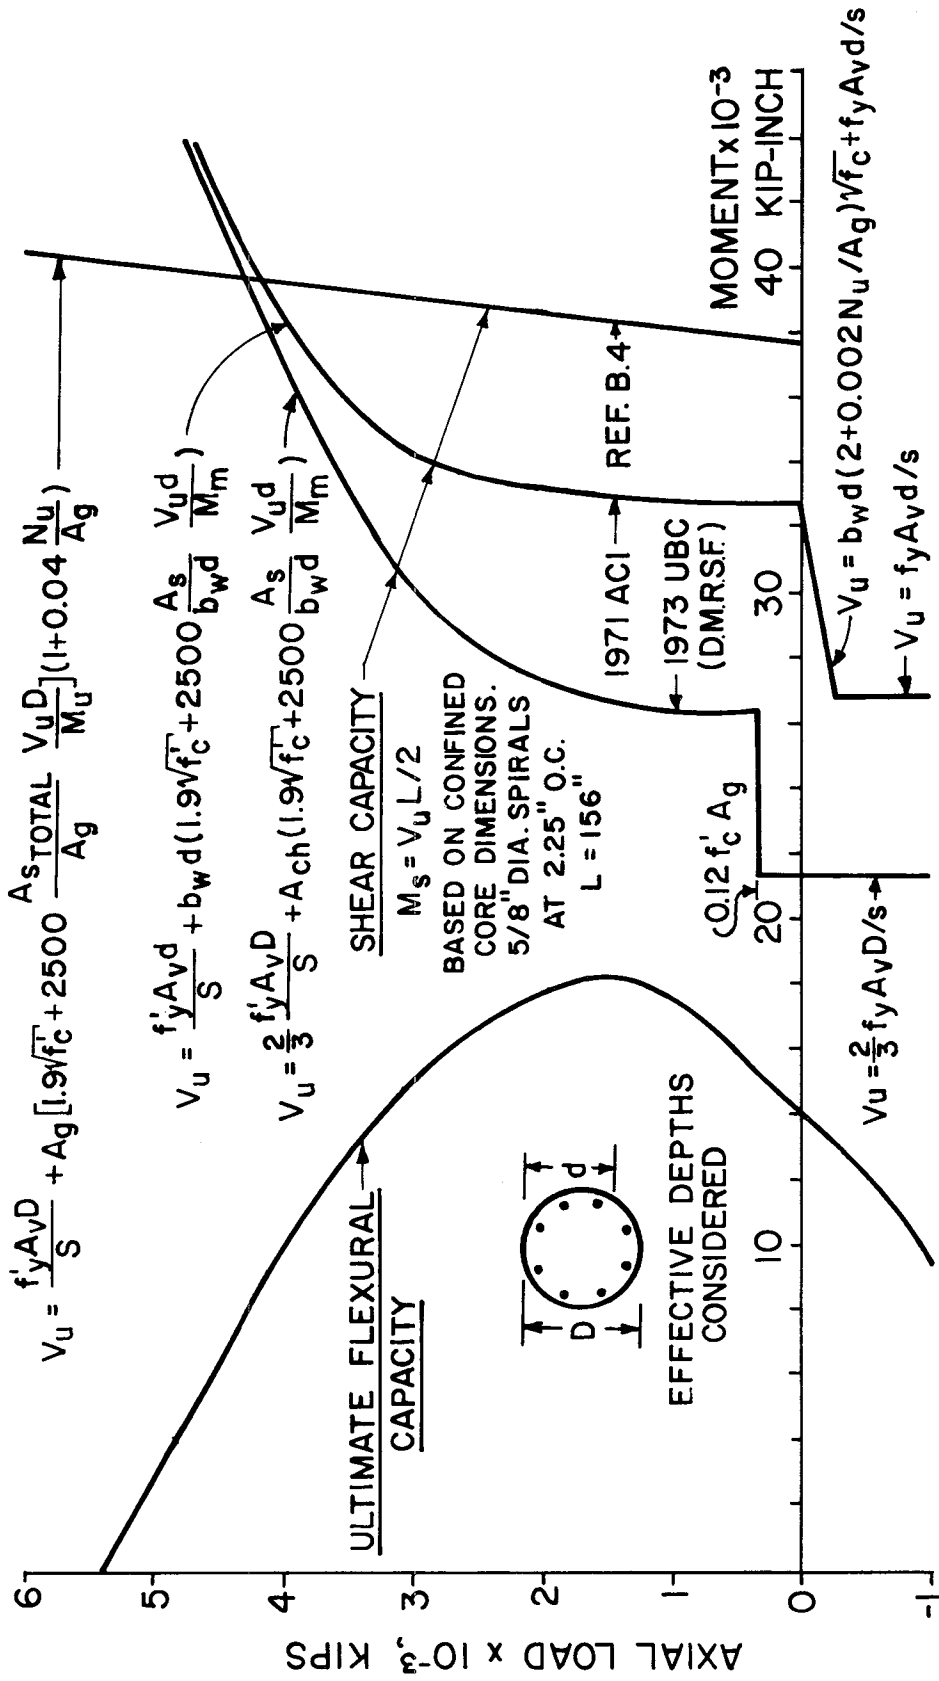
FIG. B.9 COMPARISON OF SHEAR AND FLEXURAL CAPACITIES OF FIRST STORY SPIRAL COLUMN K-28

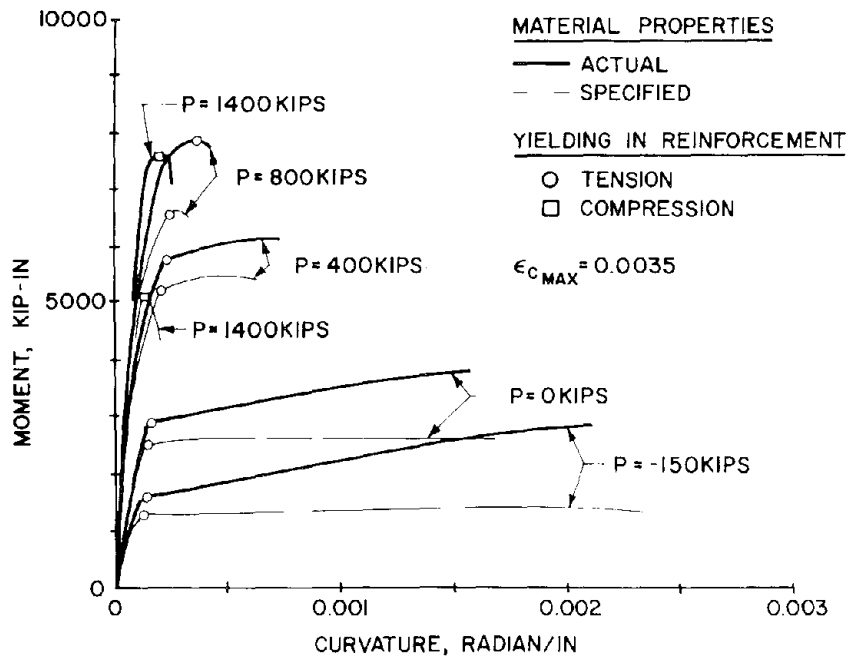
FIG. B.11 MOMENT-CURVATURE RELATIONSHIPS FOR UNCONFINED SECTION-GROUND STORY TIED COLUMN P. 5-29

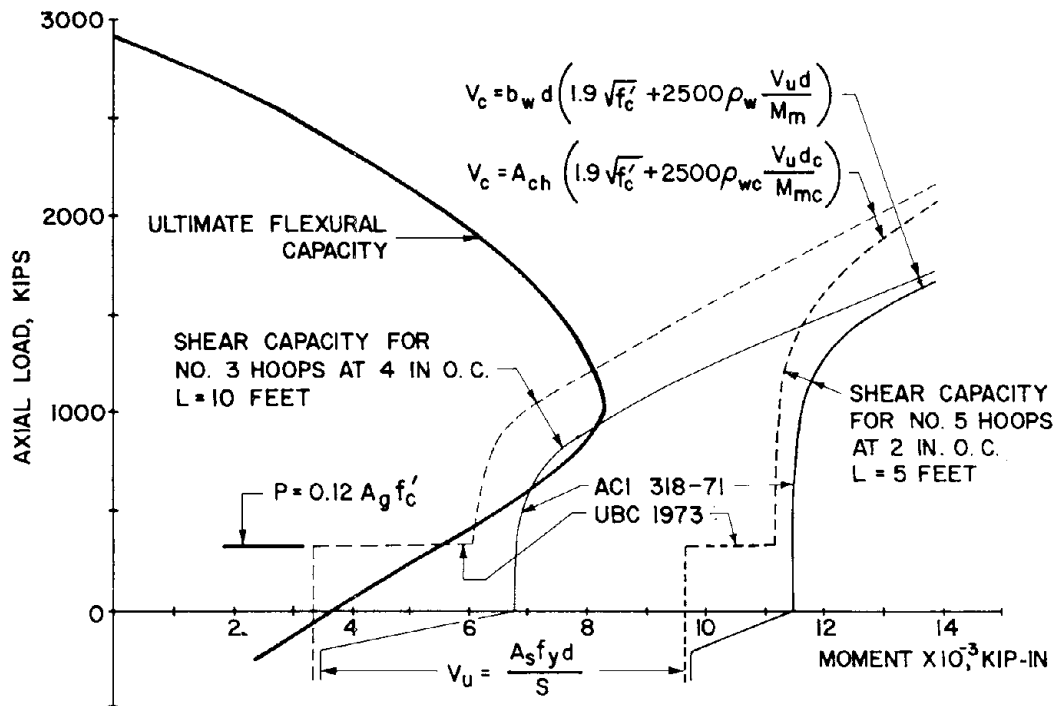
FIG. C.6 COMPARISON OF SHEAR AND FLEXURAL CAPACITIES FOR DIFFERENT AMOUNTS OF TRANSVERSE REINFORCEMENT-TIED COLUMN EXAMPLE

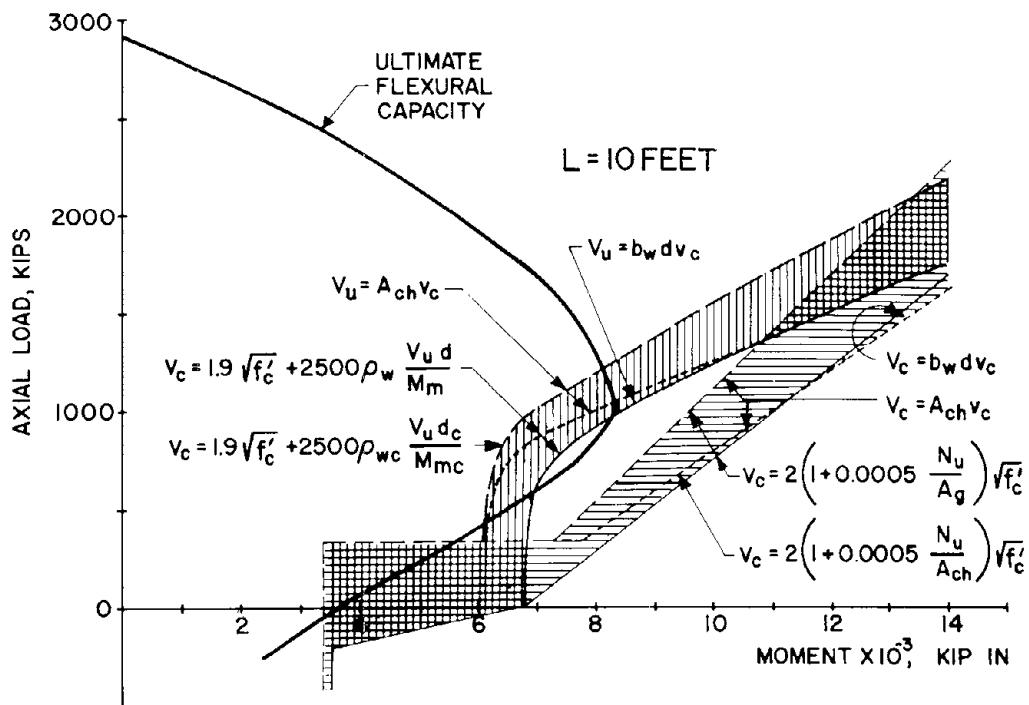
members. Of particular concern are the various equations contained in current codes for determining the shear strength of members subjected to axial load which resulted in substantially different strength values. Moreover, uncertainties regarding the appropriate cross-section to be used for shear computations, and regarding the effective contribution of the concrete to the shear resistance after cycles of inelastic reversal, indicate the need for further experimental research in this area. Nonetheless, it is clear from these results that increased ductility and shear capacity resulting from special transverse reinforcement of the type recommended by the ACI [B.3] and UBC [2.5] could have significantly improved the structural behavior of the main building.

FIG. C.7 COMPARISON OF SHEAR AND FLEXURAL CAPACITIES USING DIFFERENT METHODS FOR COMPUTING SHEAR STRENGTH-TIED COLUMN EXAMPLE

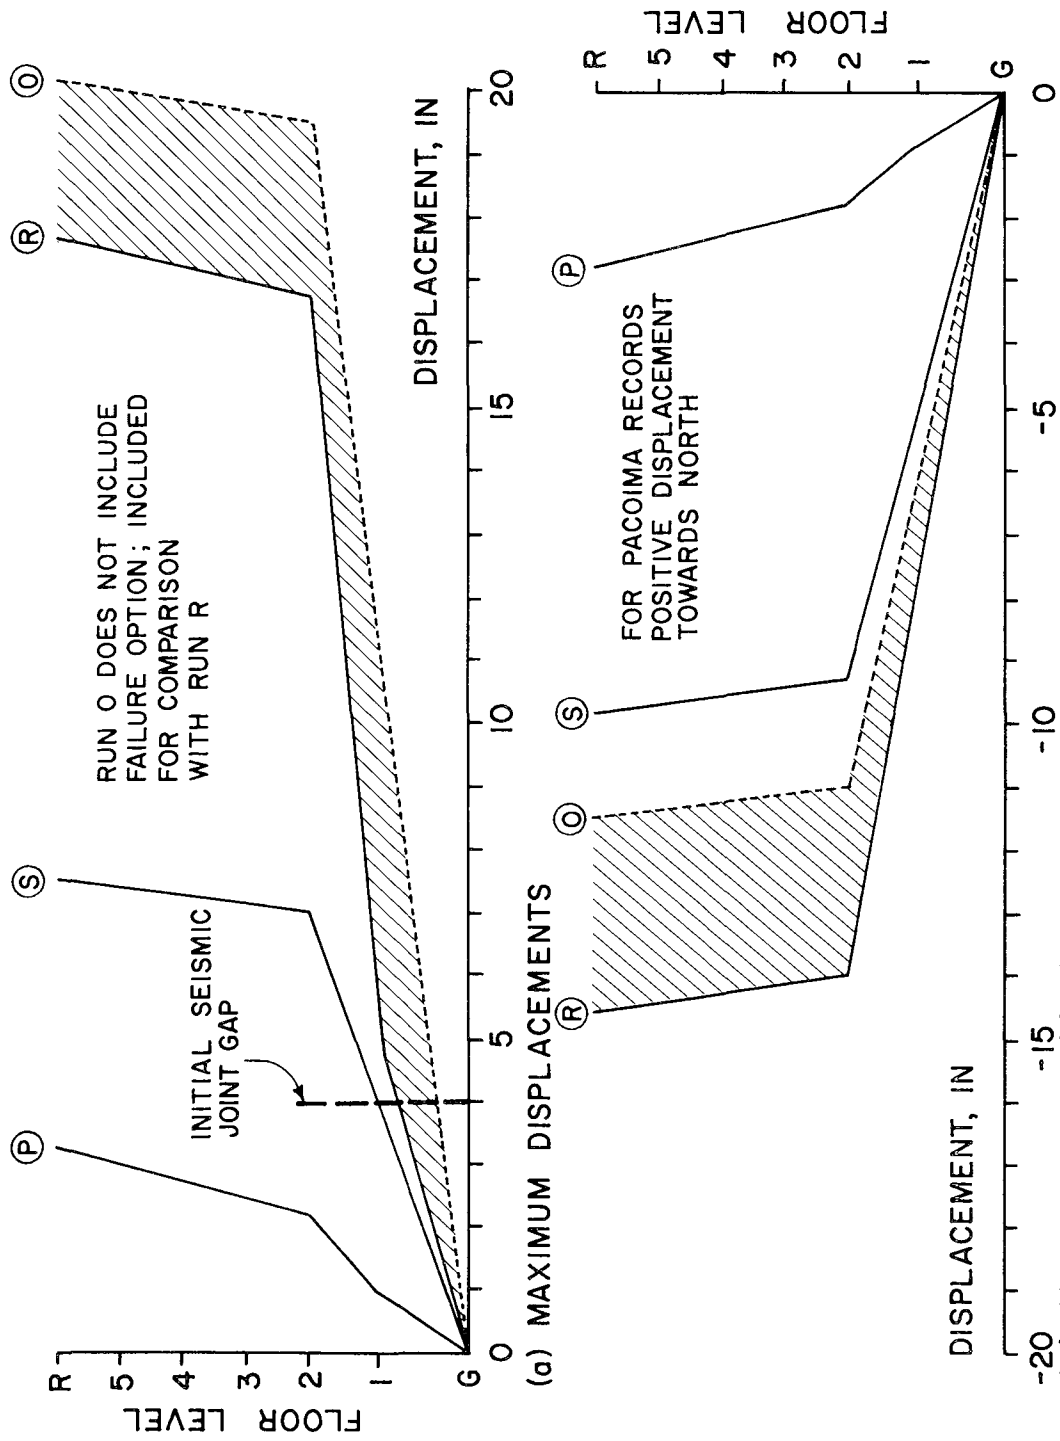
FIG. D.3 ENVELOPES OF MAXIMUM AND MINIMUM DISPLACEMENTS FOR NONLINEAR ANALYSES INCLUDING MEMBER FAILURE
