THE ROLE OF CORROSION IN THE SEISMIC
PERFORMANCE OF BURIED STEEL PIPELINES
IN THREE UNITED STATES EARTHQUAKES

J. Isenberg

Grant Report No. 6

JUNE 1978

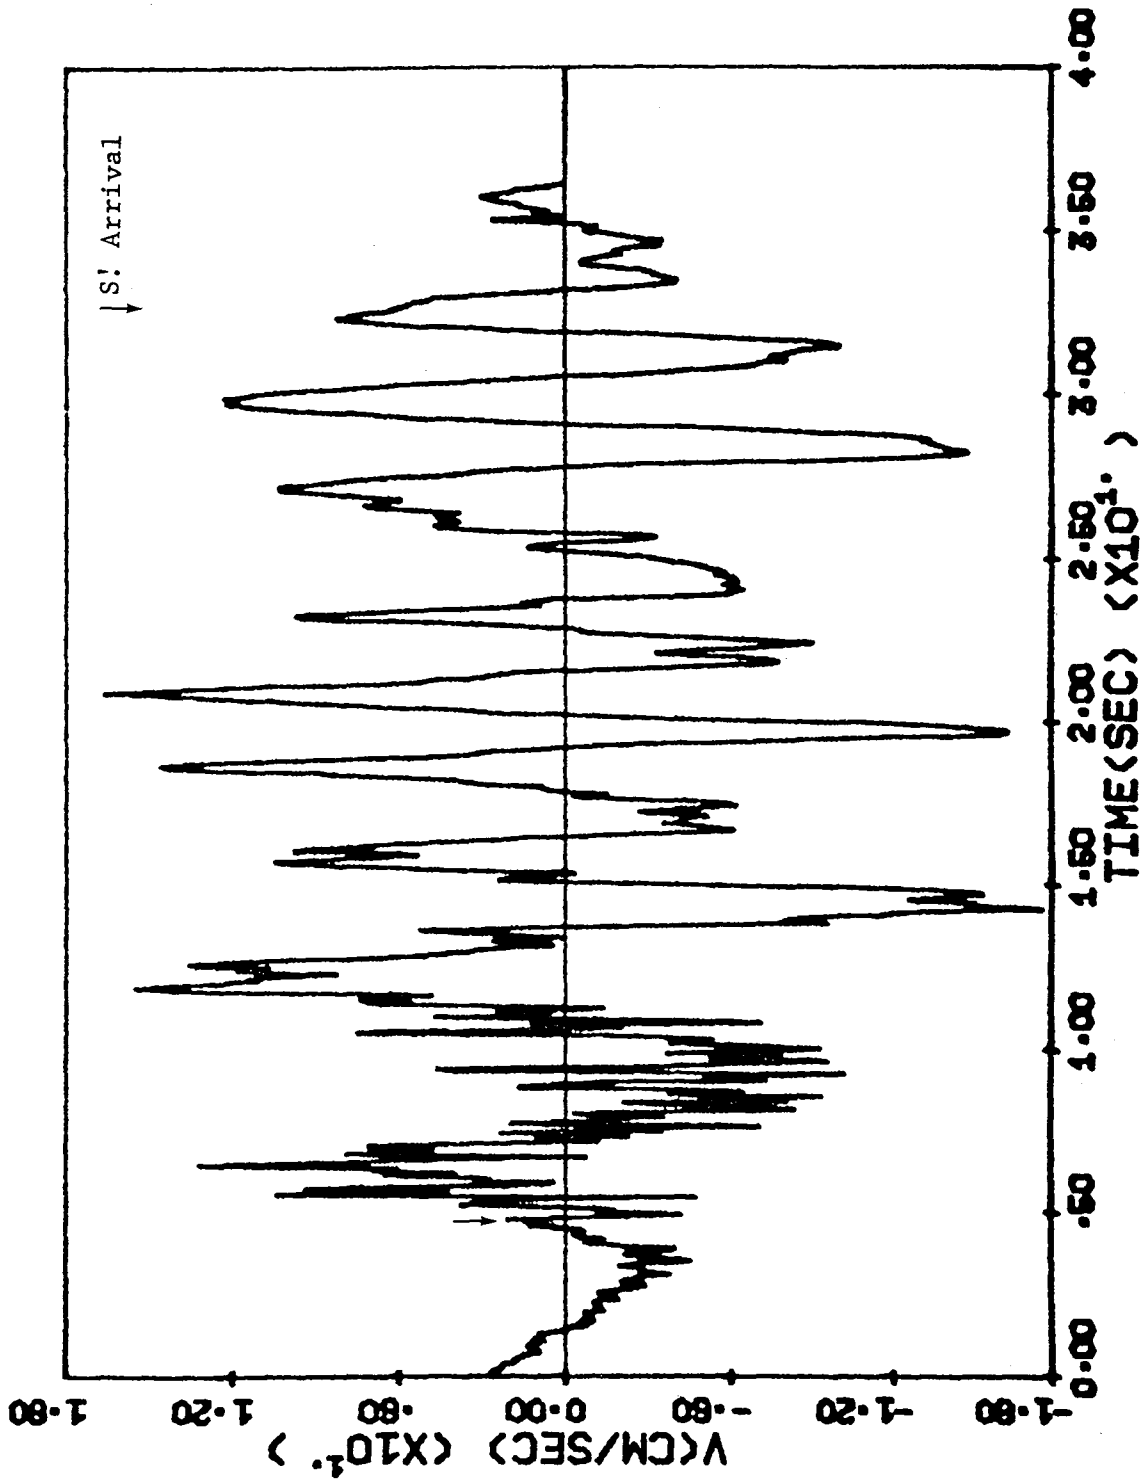
The three velocity-time histories for the records listed above are shown in Figures 2 through 5. Following the examples in Reference 5, it is easy to identify S! arrivals in records I137 and H115, as is shown. Identifying S! arrival in Q233 involves some guesswork; fortunately the peak relative displacements are rather insensitive to reasonable variations in the assumed S! arrival time.

Figure 3. Absolute Velocity-Time History, EERL-CIT Record Q233, N78W Component at 14724 Ventura Boulevard
1971 San Fernando Earthquake

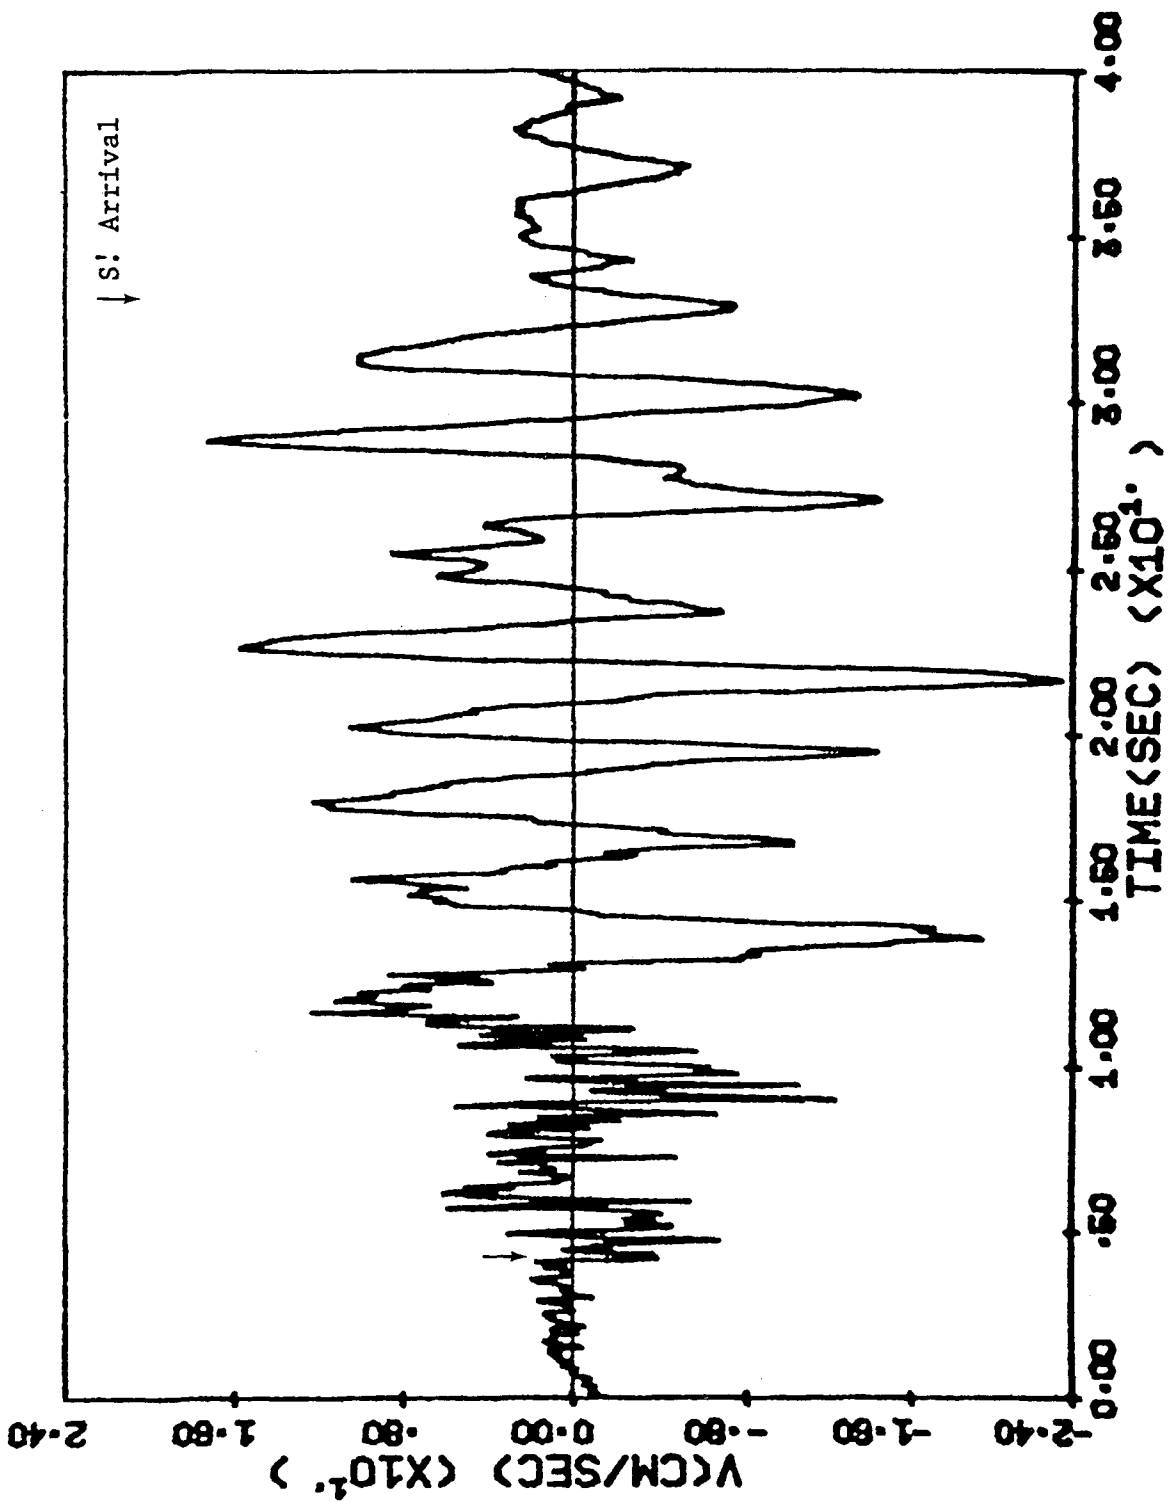
Figure 4. Absolute Velocity-Time History, EERL-CIT Record H115, N76W Component at 15250 Ventura Boulevard, 1971 San Fernando Earthquake

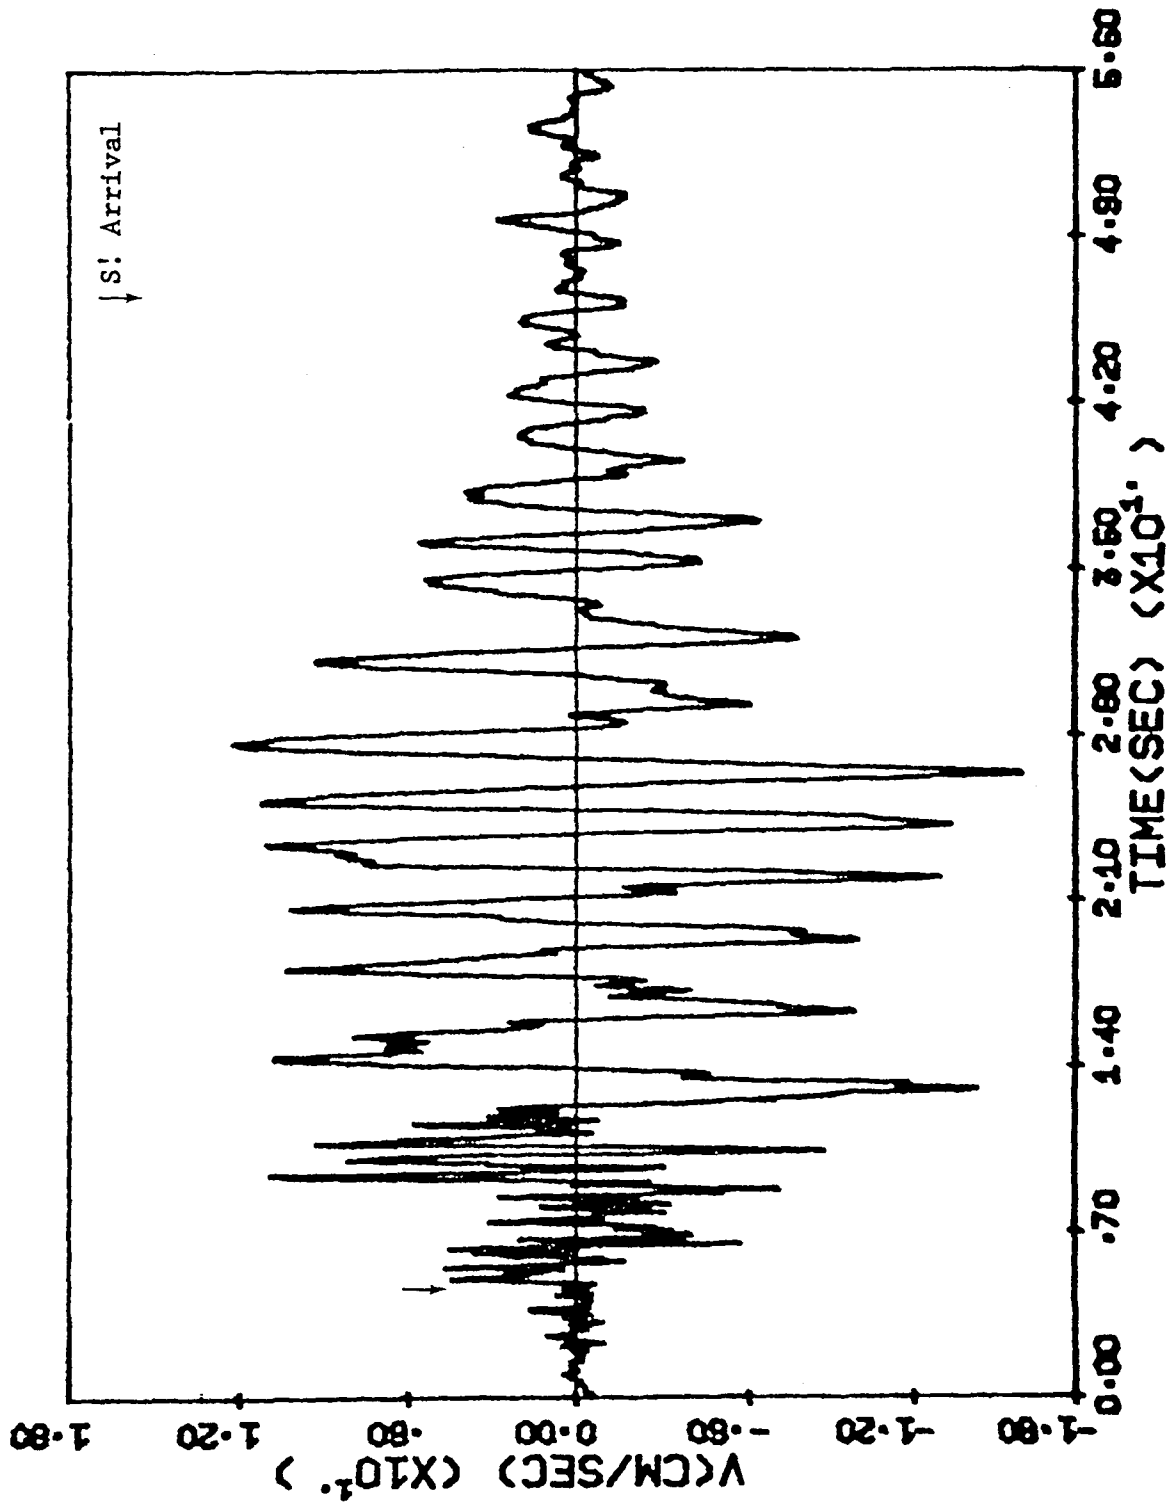
Figure 5. Absolute Velocity-Time History, EERL-CIT Record I137, S81E Component at 15910 Ventura Boulevard, 1971 San Fernando Earthquake

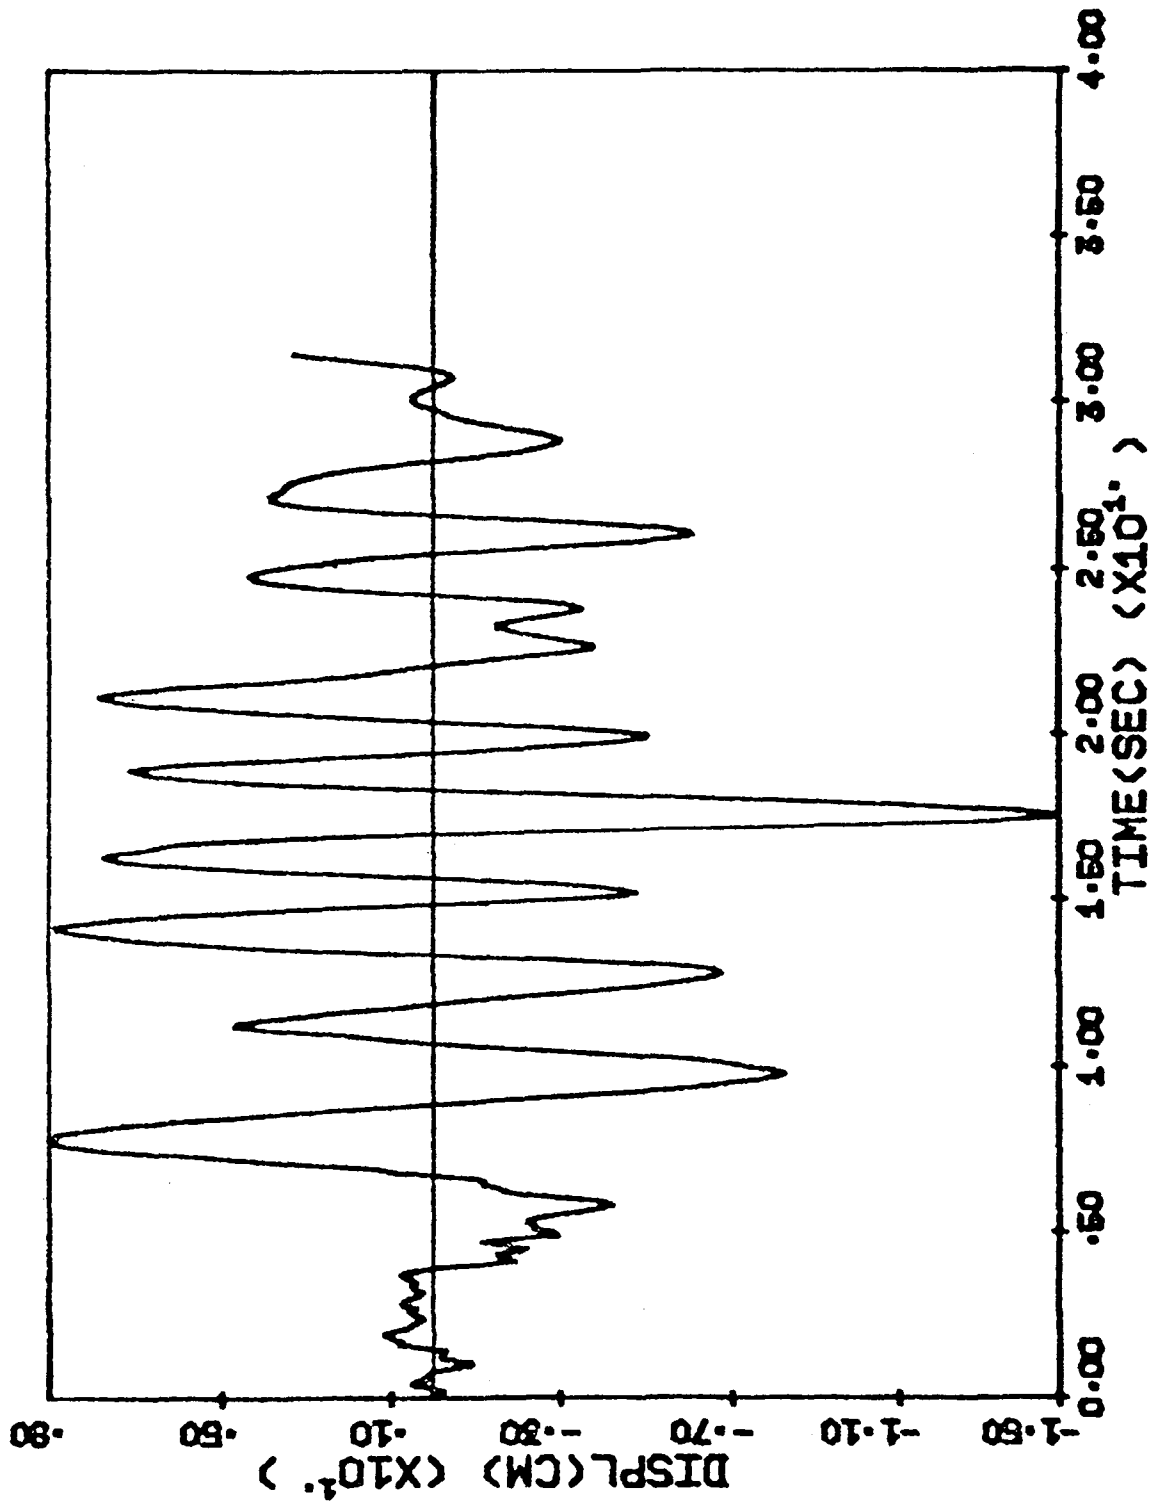
Relative displacements between I137 and H115 and between H115 and Q233 can now be obtained by subtracting the absolute displacements at the same time. Time histories of relative displacement, shown in Figures 6 and 7, indicate that the maximum relative displacements are of order 10 to 15 cm. Assuming that the relative displacements are uniform over the distances between stations leads to a range of strains from 0.6×10^{-4} to 2×10^{-4} . Considering the uncertainties associated with these estimates, it appears reasonable to assume that a peak value of average ground strain of 10^{-4} exists for the duration of the strong shaking. This value may be influenced by the local geology which includes an alluvial wedge that becomes thinner toward the southern edge of the San Fernando Valley (Figure 8; Reference 6).

Figure 6. Relative Displacement-Time History, EERL-CIT Record H115 Minus I137, 1971 San Fernando Earthquake

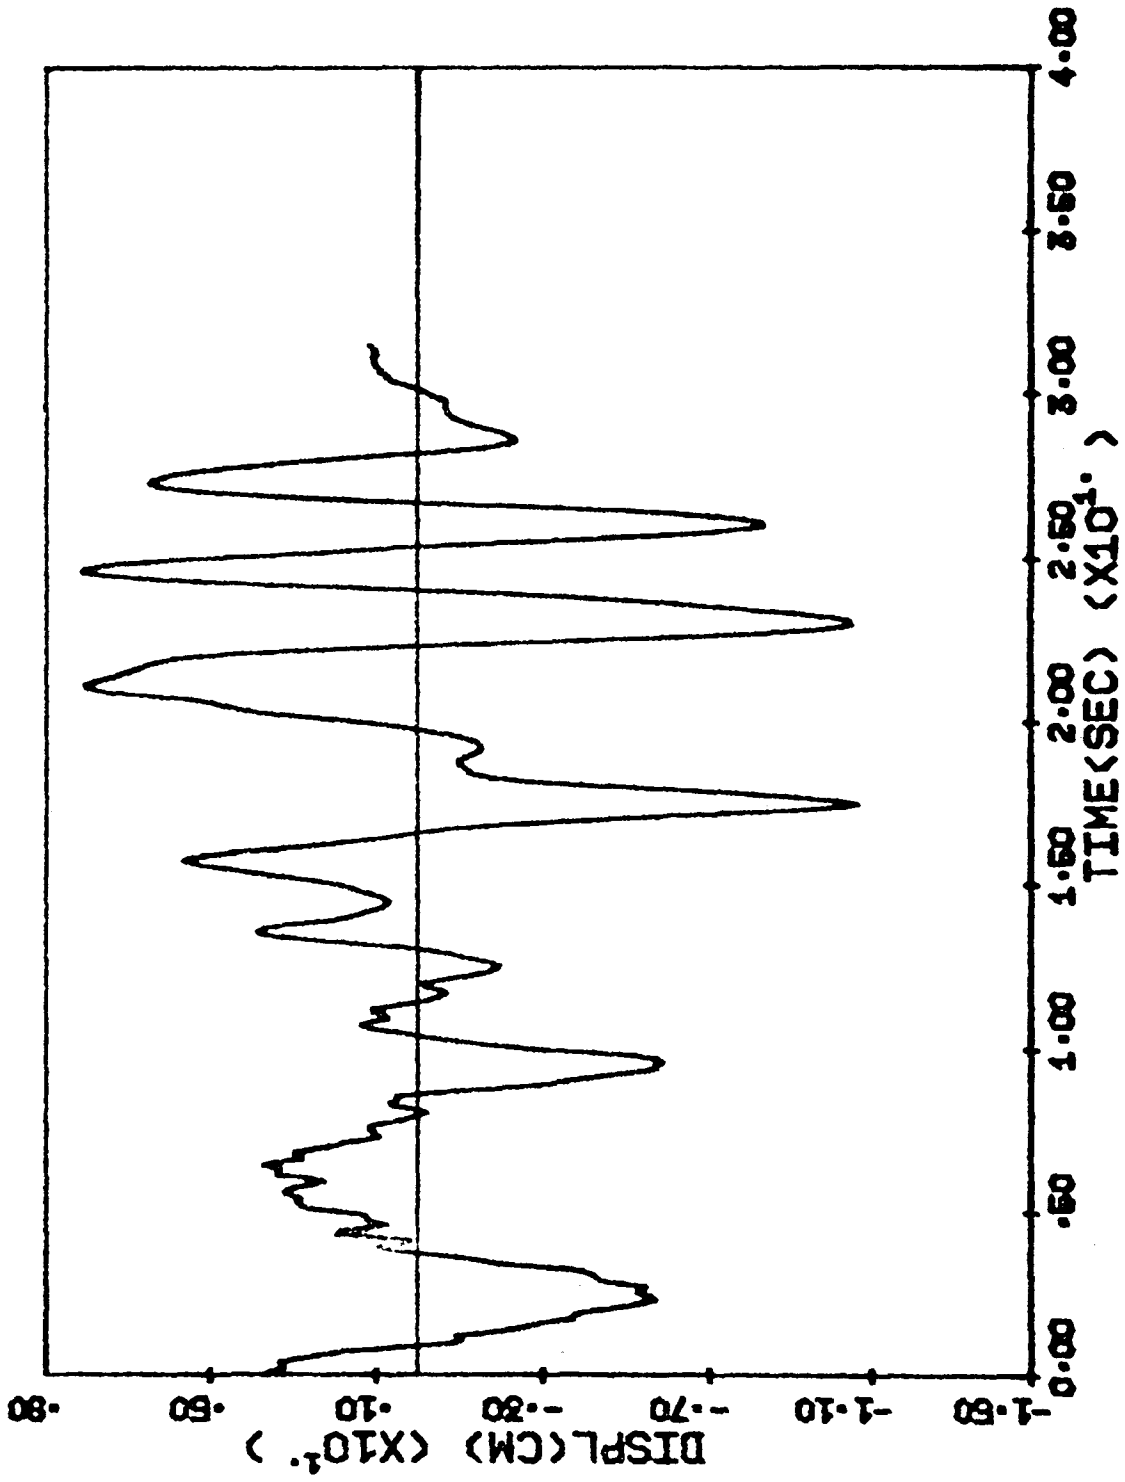
Figure 7. Relative Displacement-Time History, EERL-CIT Record H115 Minus Q233, 1971 San Fernando Earthquake

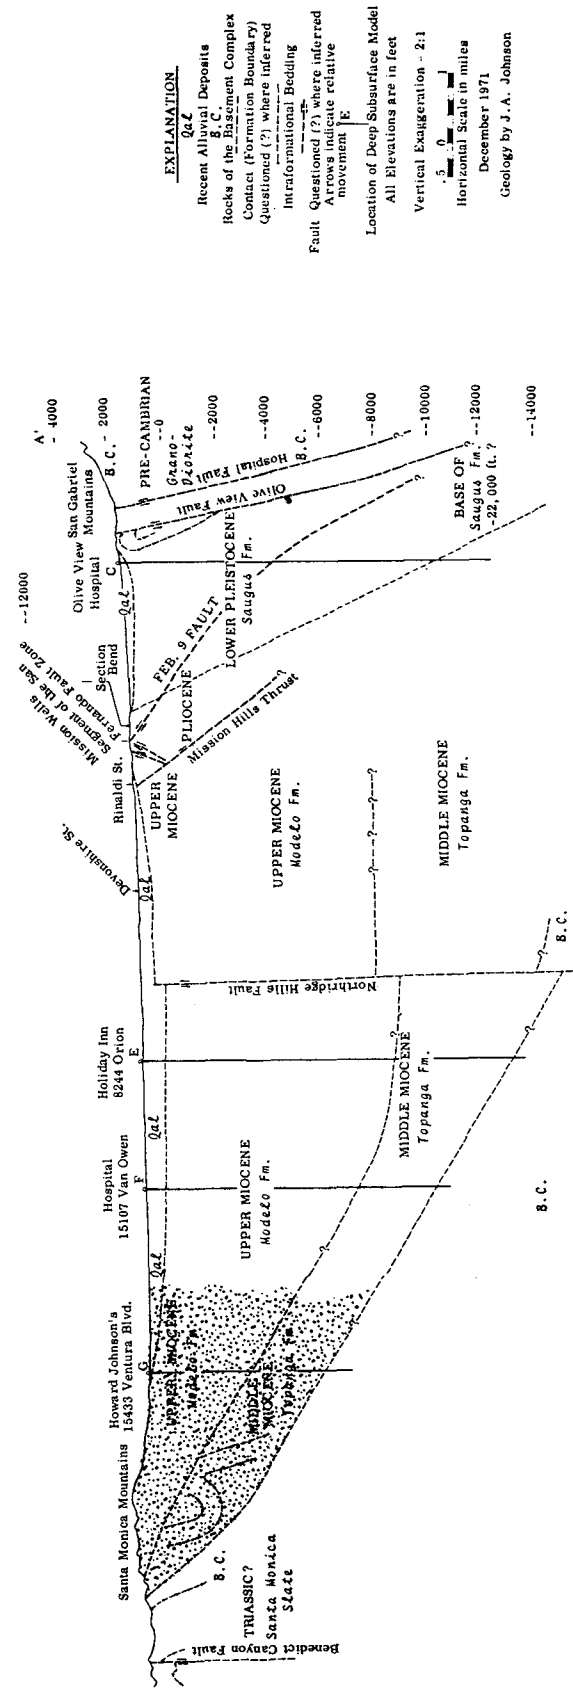
Figure 8. Geologic Cross Section--Southern San Fernando Valley. Shaded Region Indicates a Soft Dipping Layer Overlying the Stiff Basement Complex Where Focusing may Occur. From Reference 2

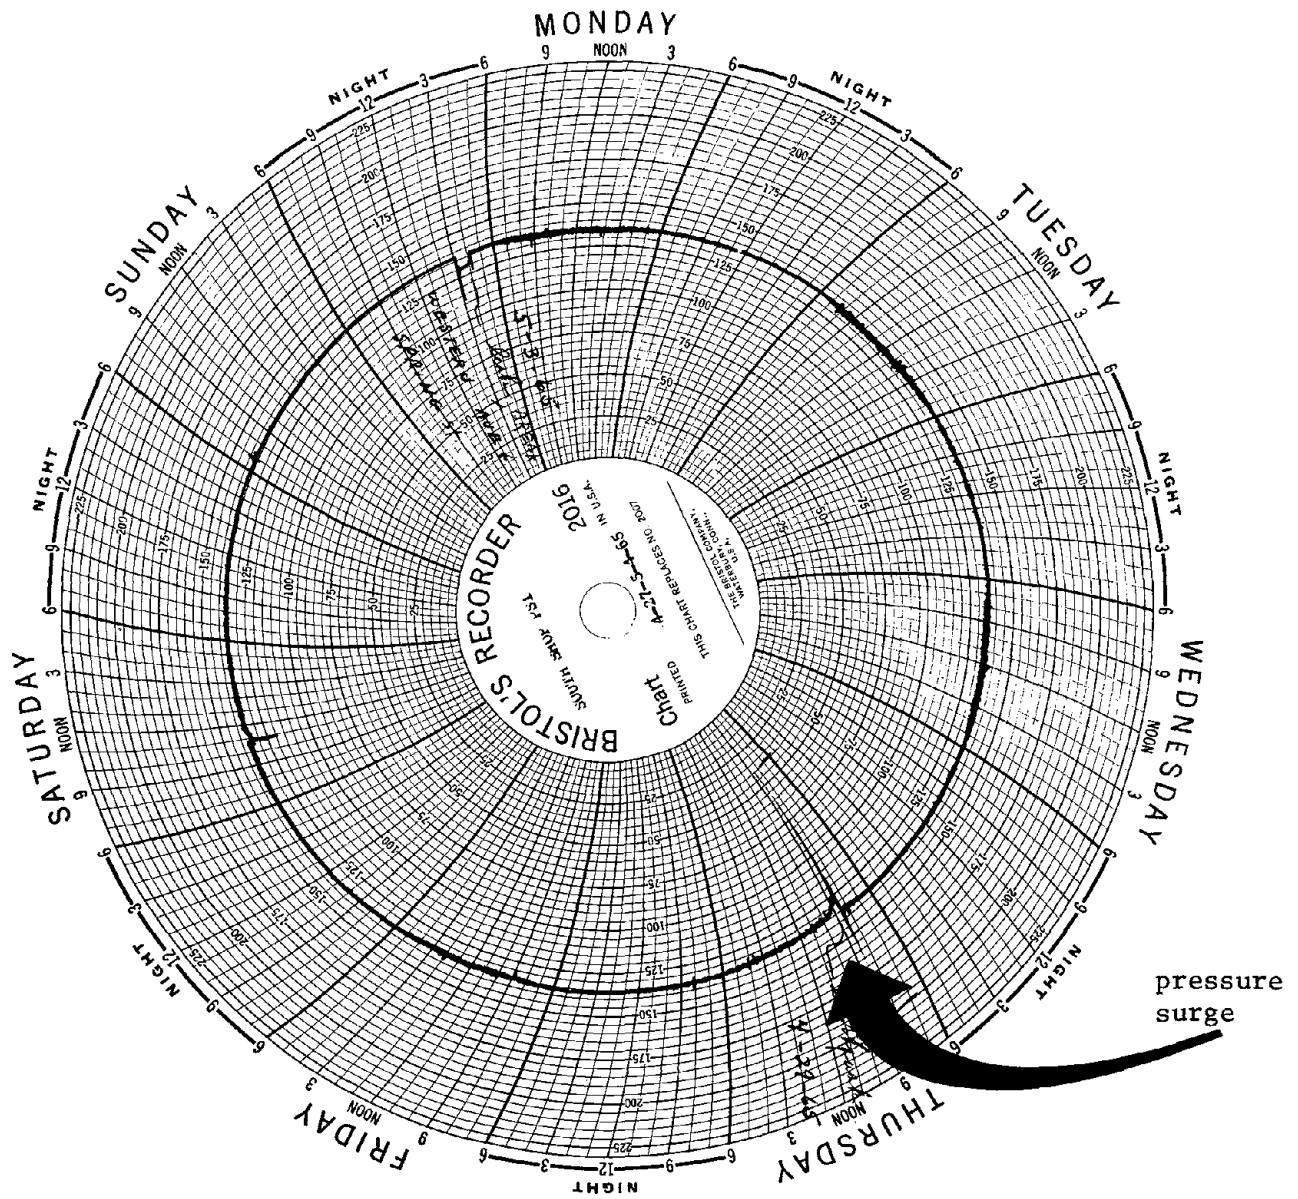
However, a possible contributing factor, in addition to ground strain, is excess internal pressure due to surges induced in the mains by ground shaking. A number of records are available which shows that surge pressures in the South District Distribution System exceeded the normal pressures by 50 percent to 100 percent. A typical measurement showing the earthquake-induced surge is given in Figure 10. It is likely that the surge pressures were even greater than those shown in such records because of the coarse sampling rates (once every 15 seconds or once every minute, depending on the instrument). Surge pressures are considered capable of damaging mains, but would be greatly diminished in small pipes, such as service laterals. Significant surges were also observed in the February 9, 1971, San Fernando earthquake, Reference 11; however, no attempt has yet been made to correlate surge pressures with pipe leaks there.

Figure 10. Example of a Surge in Pressure Caused in a Water Main of the Seattle Water Department due to April 29, 1965, Puget Sound Earthquake
