Earthquake Engineering  
Research Institute

**Reconnaissance Report**  
**MINDANAO, PHILIPPINES EARTHQUAKE**  
**August 17, 1976**

**August 1977**

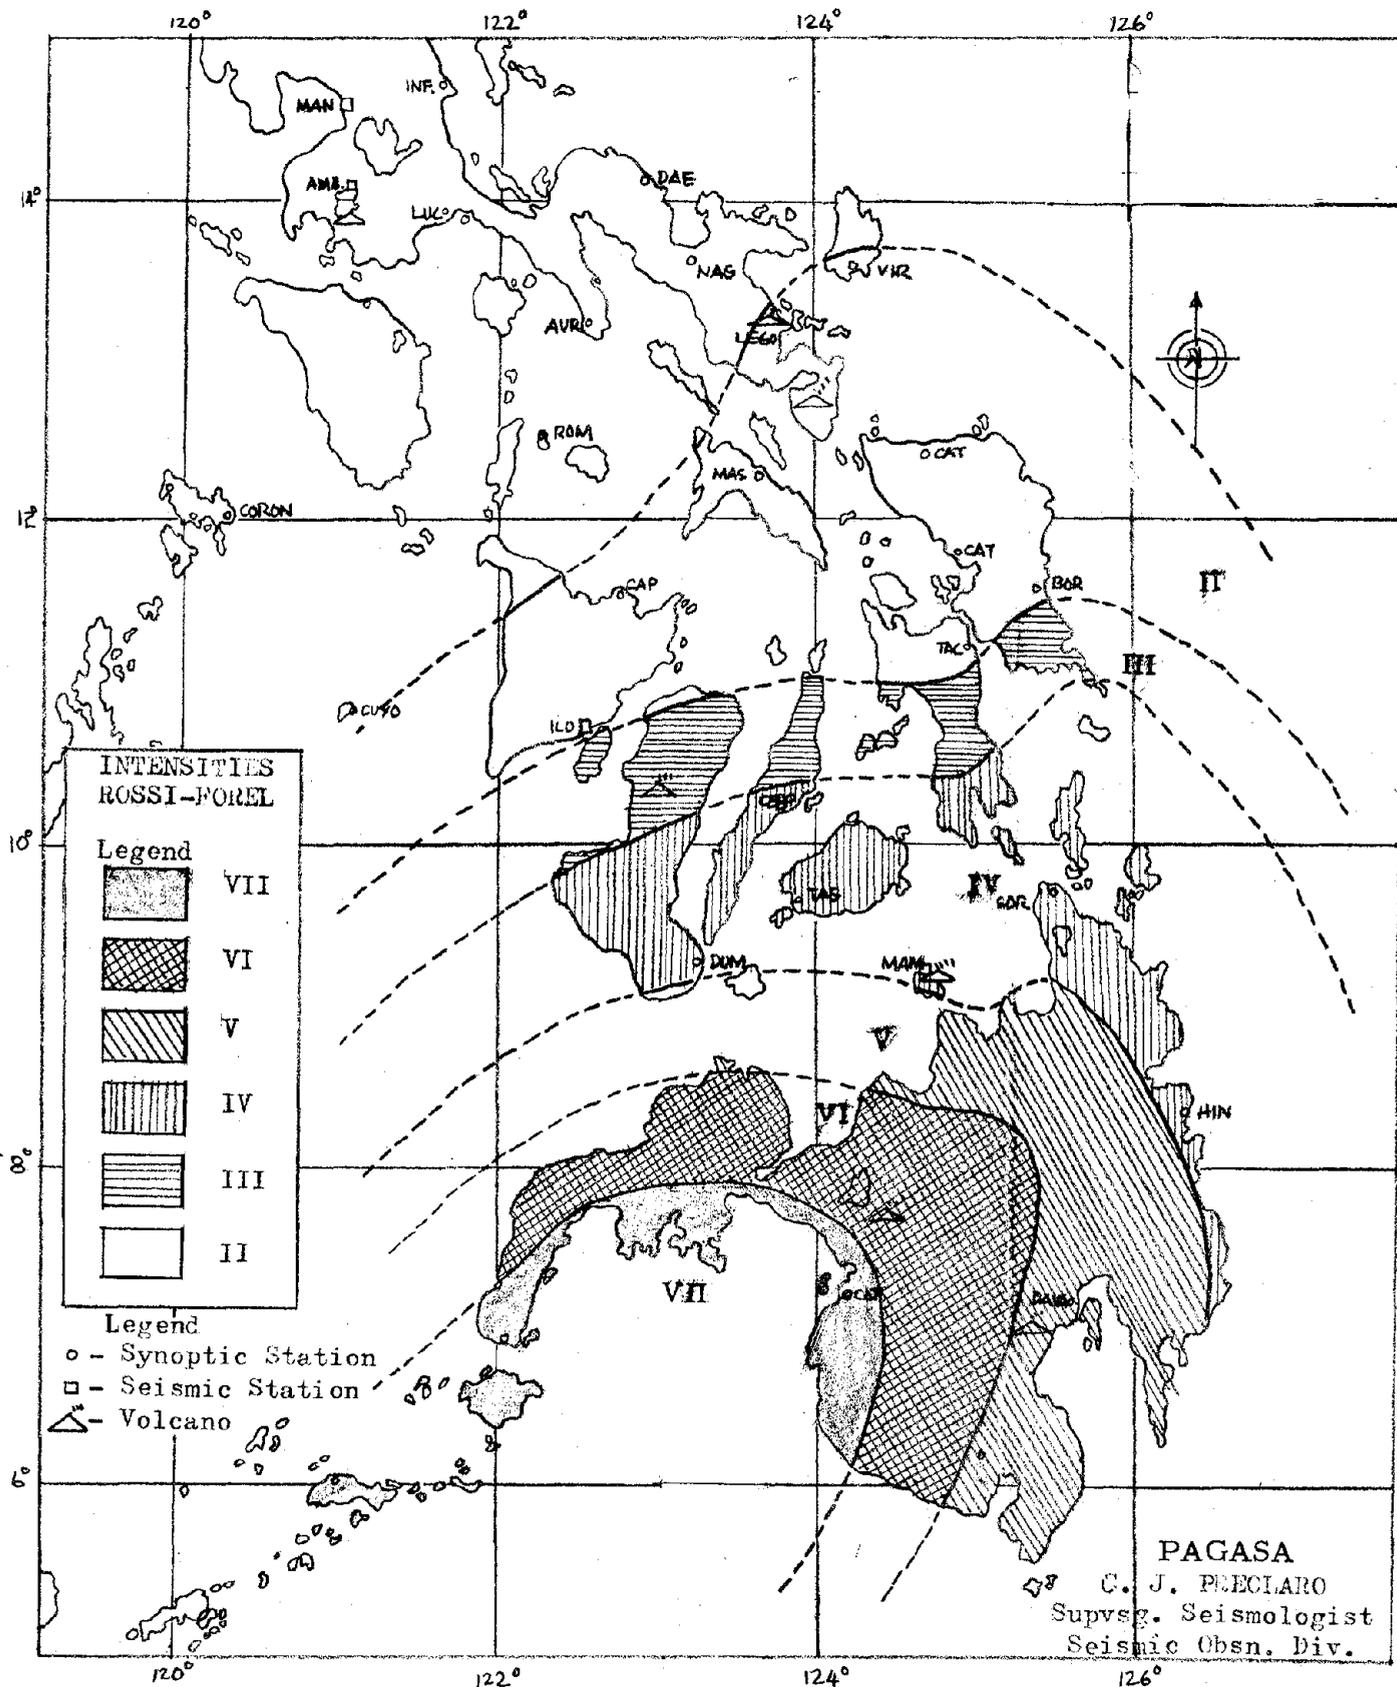
Figure 2. Isoseismal Map of August 17, 1976 Earthquake

An isoseismal map using Rossi-Forel intensities is shown in Figure 2. A summary of PAGASA field reports is provided in Table 2.

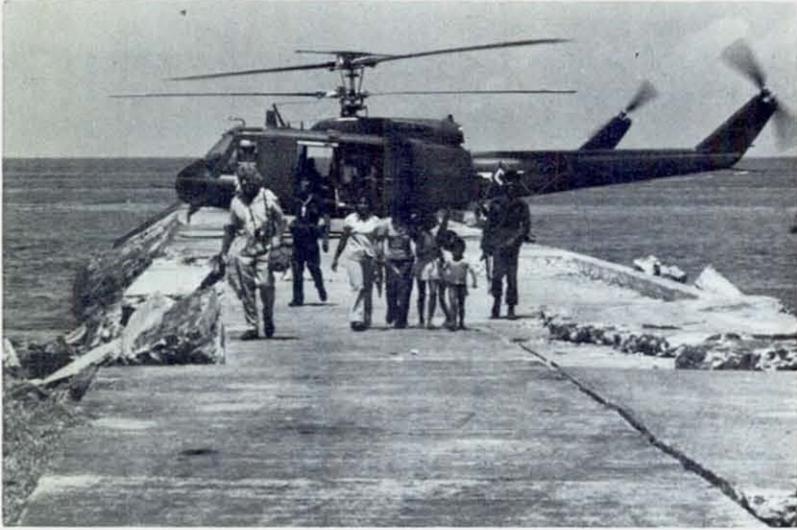
Figure 5. Balabagan Wharf

The streets in the city appear in outline form in Figure 3. They were essentially cleared of rubble by August 27. Longitudinal buckling occurred opposite the Harvardian College and on the pavement of the highway to the airport, and was promptly corrected. No earthquake-caused problems with the airport were uncovered by the team. As discussed in the previous section, several wharves on the Rio Grande experienced settlement or vibrational damage. Damage to the wharf near Balabagan was mentioned.

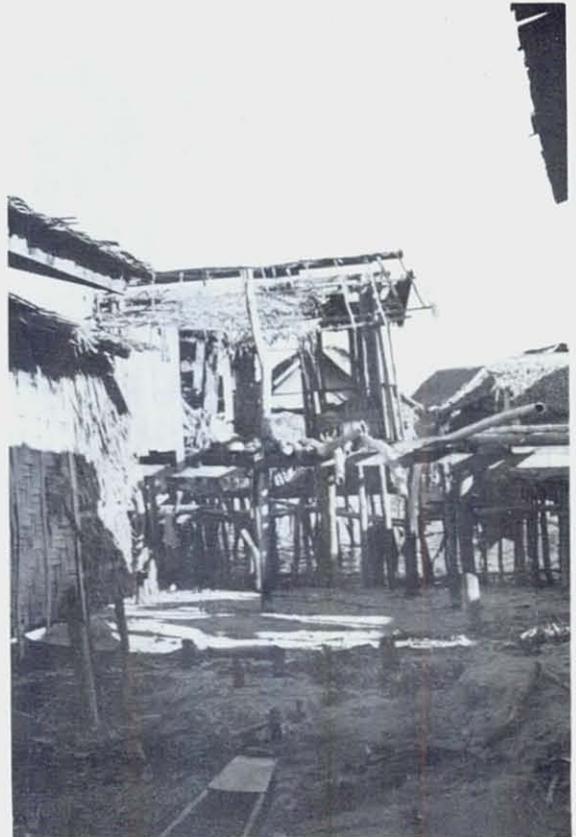
Figure 11. Protected Huts, Zamboanga

Tsunami damage was also observed at villages on the Moro Gulf coast approximately 30 km north of Zamboanga City. The northernmost village visited was Bolong. This village was sparsely populated, and minor damage was visible. Huts were battered, boats displaced, and debris generally scattered. Overgrowth, some 75 m from the shore, was heavily pounded by the waves (Figure 10). The other village, San Golli, was more densely populated, with huts closely grouped. The outer huts offered some protection to the ones more inland (Figure 11). Some indication of the apparent wave height may be obtained from the figure.

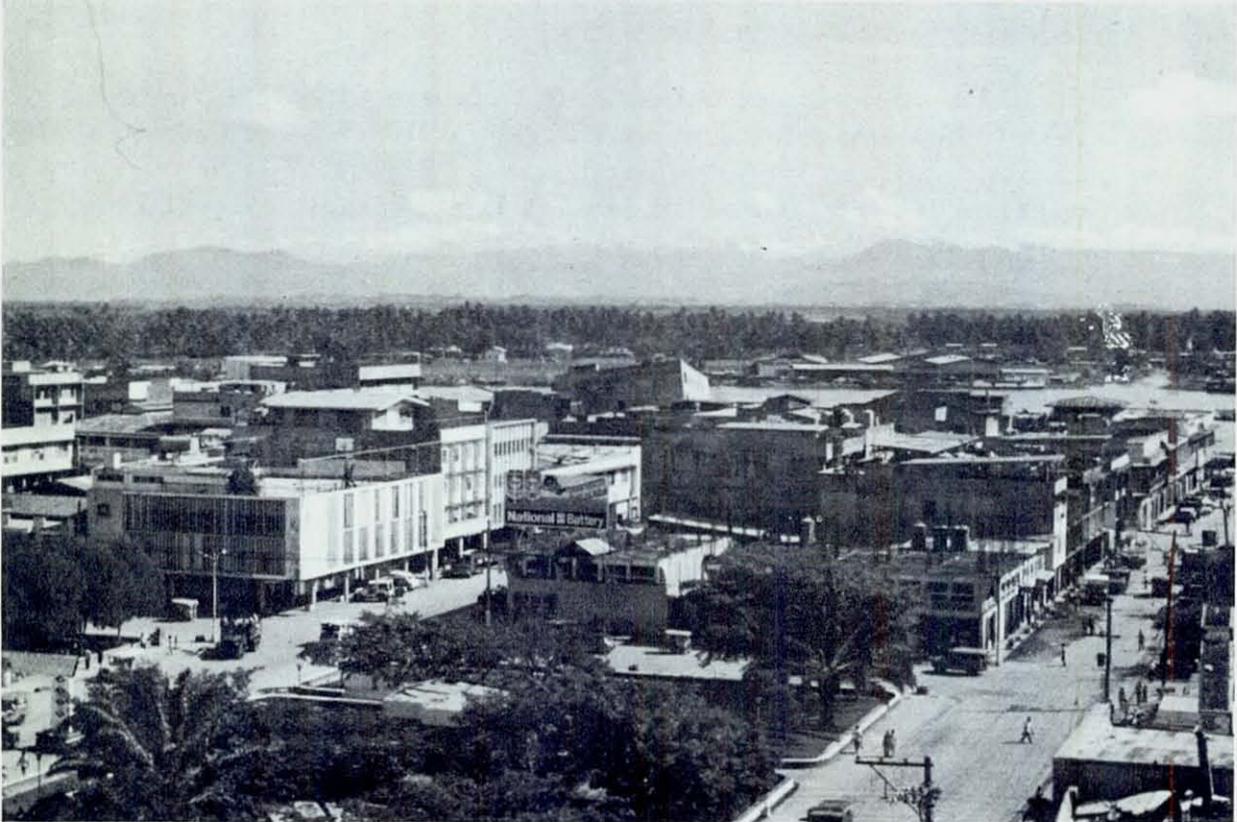
Figure 12. Panoramic View of Cotabato City

Approximately 30% of the commercial buildings in Cotabato City were reported by Philippine engineers to be damaged. The undamaged facilities were used to shelter victims whose buildings suffered from the earthquake. Figure 12 is an overview of the city after the earthquake; the extent of damage is not clearly evident except for the tilted New Society Hotel (Bldg 11).

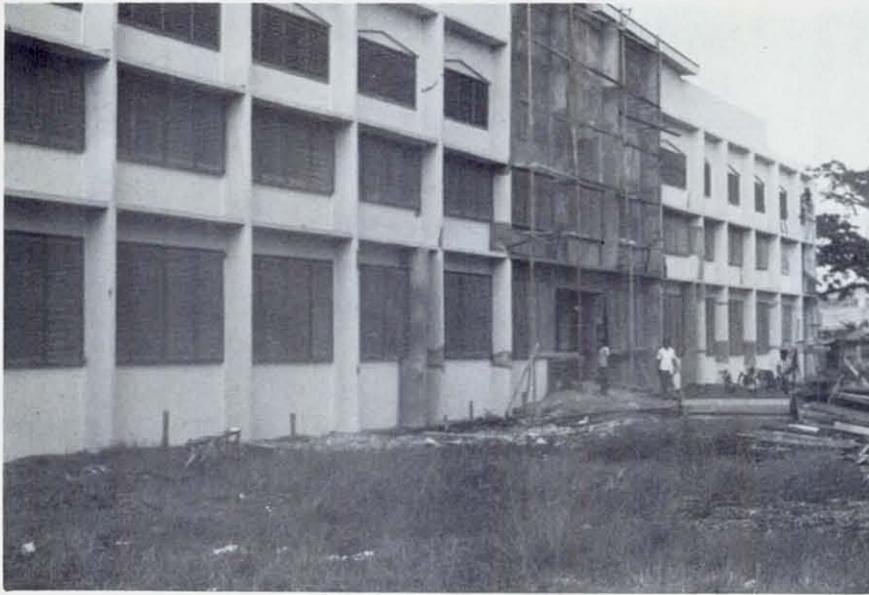
Figure 13. Notre Dame Residence Hall

The New Residence Hall (Bldg 1) is a rectangular, three-story structure (Figure 13). Its construction consists of concrete exterior columns and thin concrete exterior walls. Midheight windows run the full width of each bay throughout most of the building. There are some solid panels, especially at the south end. Interior columns and floor systems are wood, and the roof employs galvanized iron sheeting. For the most part, the interior partitions are constructed of plywood. Architectural vertical fins are located opposite all exterior columns, with a thin exterior floorline slab (15 x 61 cm wide) accenting horizontal lines. The team noted that the building had little, if any, built-in seismic resistance. Construction of the building was nearing completion, and the building was unoccupied at the time of the earthquake.

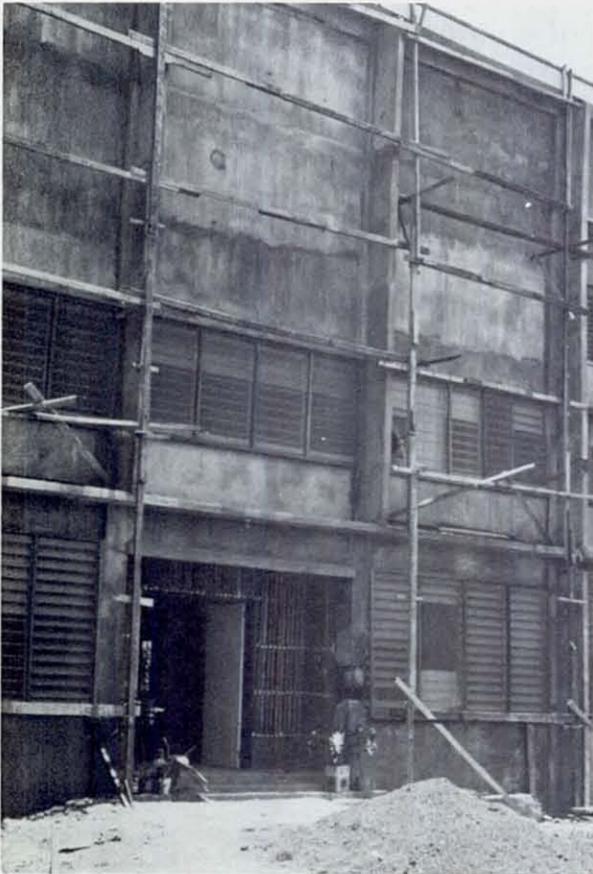
Figure 14. Residence Hall Exterior

Damage to the building was light. The architectural fins were cracked at the floor line, and some columns were damaged at the sill line, showing column damage (Figure 14). Interior partitions were torn apart, and some of the ceiling panels (nailed to a suspended grid) fell (Figure 15). There was considerable cracking of the ground floor slab. At one location where two slabs were constructed with a vertical offset (46 cm), the slabs pulled apart more than 1.3 cm (Figure 16).

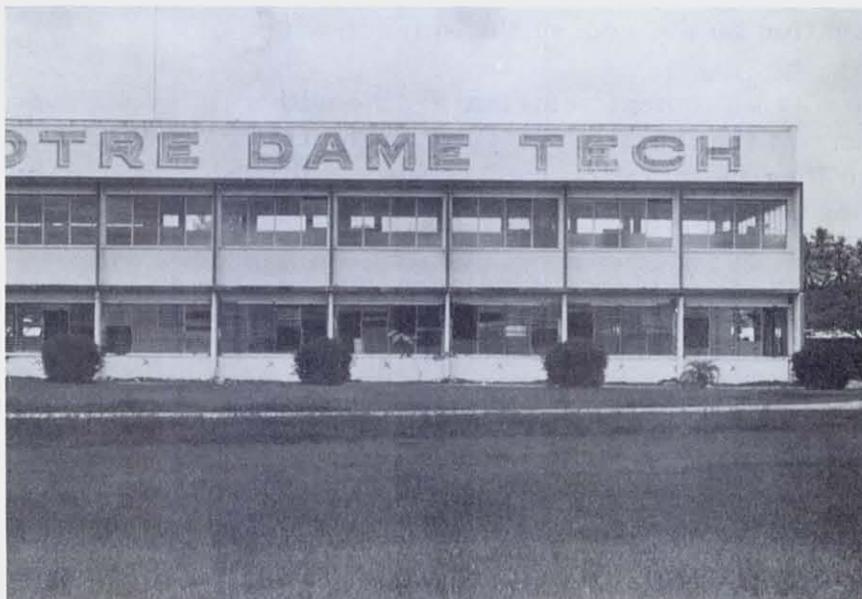
Figure 17. Notre Dame Technical Building

The Technical School (Bldg 2) (Figure 17) is a two-story building approximately 10 x 30 m (Figure 17). Built in 1965, it has a concrete frame consisting of column line girders and columns, with a concrete two-way slab floor. The columns are approximately 36 cm square reinforced with nine bars with plain ties at 23 cm spacing (No. 7 and No. 3, respectively). The exterior had windows running from column to column, with a 1.07 m sill height constructed of hollow block infill panels. Architectural concrete fins were poured adjacent to each column along one longitudinal side. This building is linked to an adjacent building by a common wood canopy.

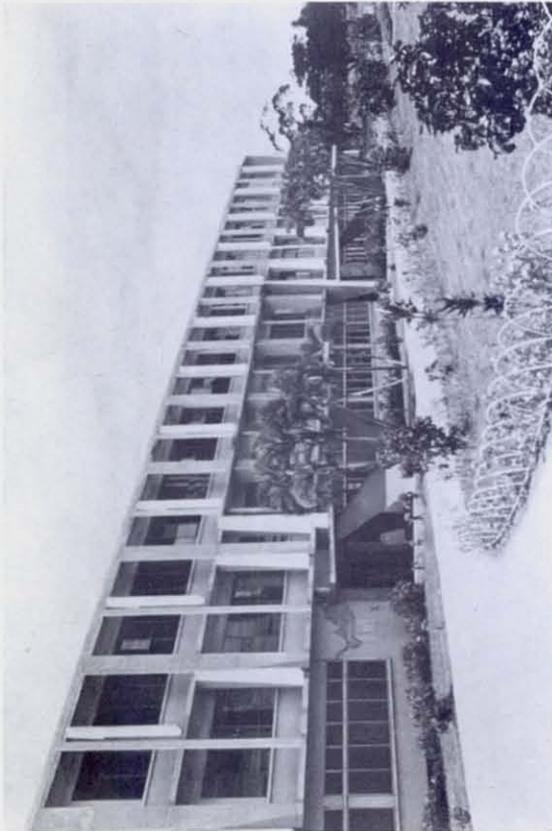
Figure 19. Notre Dame Administration Building

The Administration Building (Bldg 3) is a rectangular three-story structure constructed in the early 1960's (Figure 19). It has an aspect ratio of 8:1. The building has a reinforced concrete frame of columns and girders with concrete floors. One longitudinal side has midheight windows the full width of each bay with sills about 76 cm high, made up of hollow block panels. There is a 3 m concrete panel at the entrance, which was severely cracked (Figure 20). The other longitudinal wall is set in from the edge, allowing for an exterior corridor. This wall has a 38 cm and a 76 cm high louver running continuously between columns at the top and bottom, respectively. The balance of the wall is hollow block. This side has a one-bay projection at midlength equal to approximately one-third the building's length. There are two longitudinal interior walls along a corridor constructed similarly to the louvered rear wall. The end walls are solid.

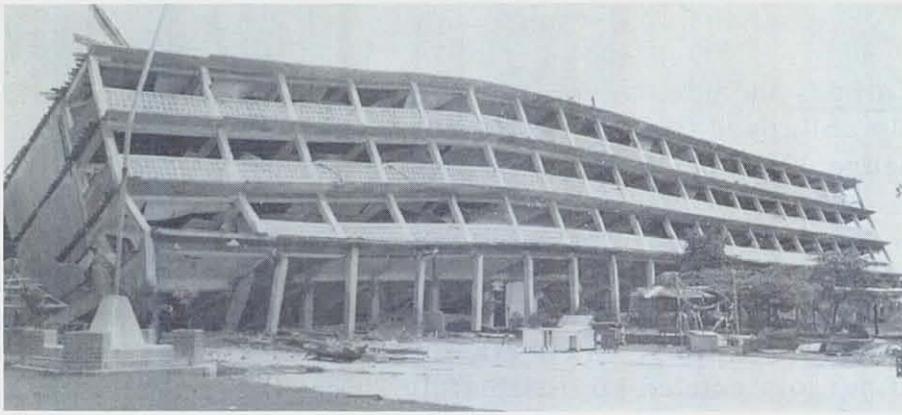
Figure 30. Harvardian College

Harvardian College Campus includes several buildings. The EERI team only investigated a partially collapsed five-story structure (Bldg 5) at the southeast corner of the site (Figure 30).

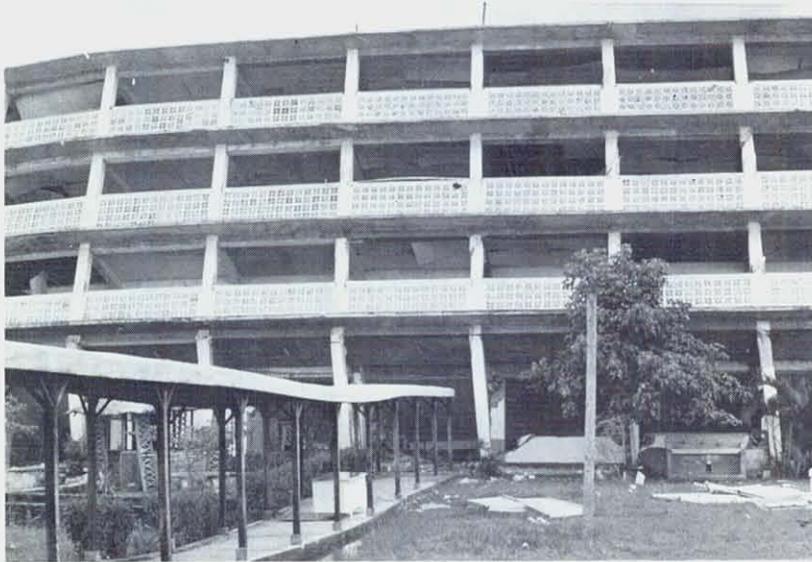
Figure 31. Harvardian Walkway Settlement

Foundation settlement due to ground shaking was not detectable except at the Immaculate Conception Church (Bldg 20) and the Fire Station (Bldg 28). In buildings where column failures occurred, the undeflected column stubs were observable at grade level. Although building settlement was not an important factor in the failure at Harvardian College (Bldg 5), adjacent walkways showed signs of settlement and mud boils appeared at the site.

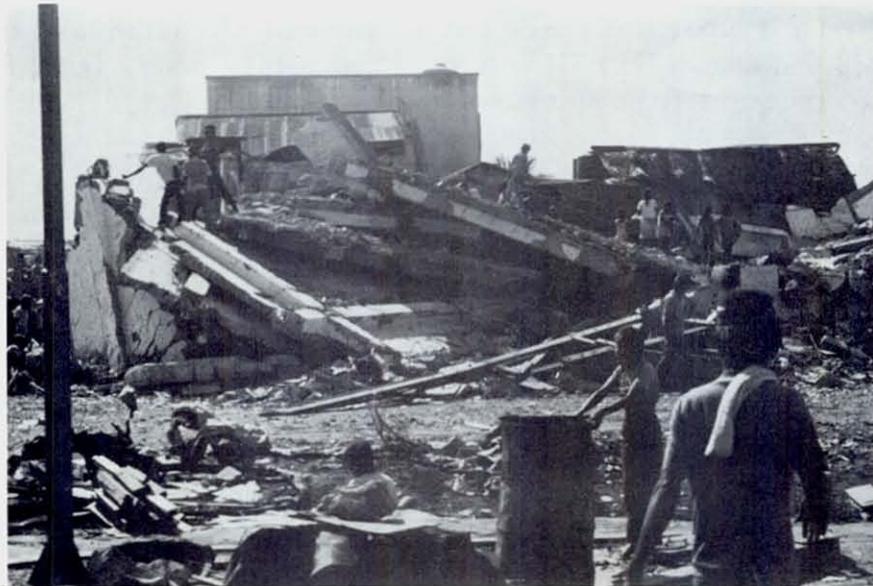
Figure 41. View of D'Max Restaurant and Amicus Building Looking East

The Amicus Building (Bldg 6), Sagittarius Hotel (Bldg 7), and D'Max Restaurant (Bldg 8) form a complex of three adjacent buildings that collapsed. The remains of these buildings, shown in Figure 40, lie to the left and below the tractor shown in the picture. All of these buildings "pancaked".

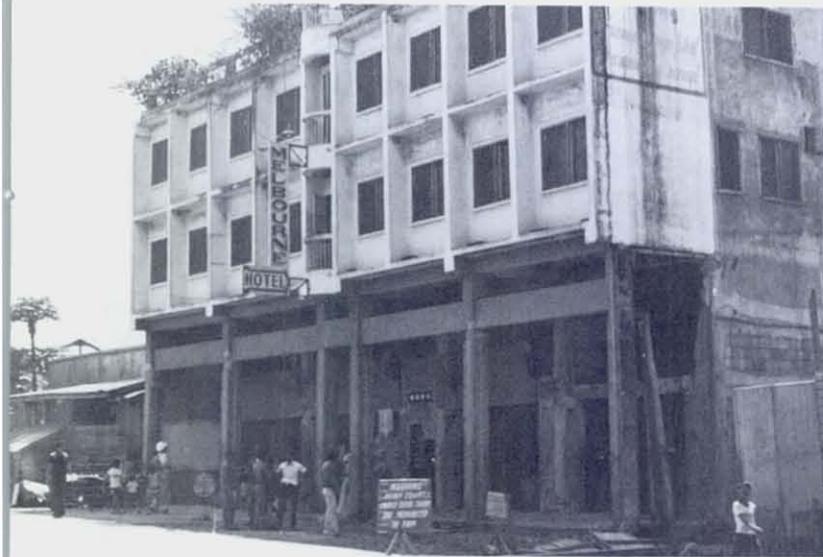
Figure 61. Melbourne Hotel

Melbourne Hotel (Bldg 16) is a three-story reinforced concrete frame with masonry infills, constructed in 1970, and has a plan dimension of 20 x 30 m (Figure 61). The four by four bay frame has a first story height of 6 m, while upper story heights are 3.5 m. A mezzanine story 3 m tall covers the full width in the north-south direction and three bays going from east to west. The front of the building is open, the back has masonry infills with openings, and the north and south exterior walls are completely infilled.

The first story columns suffered heavy damage as a result of north-south motion. A first story permanent offset of 15 cm to the south remained after the quake. At the west side of the building, the tall first story columns hinged at the base and

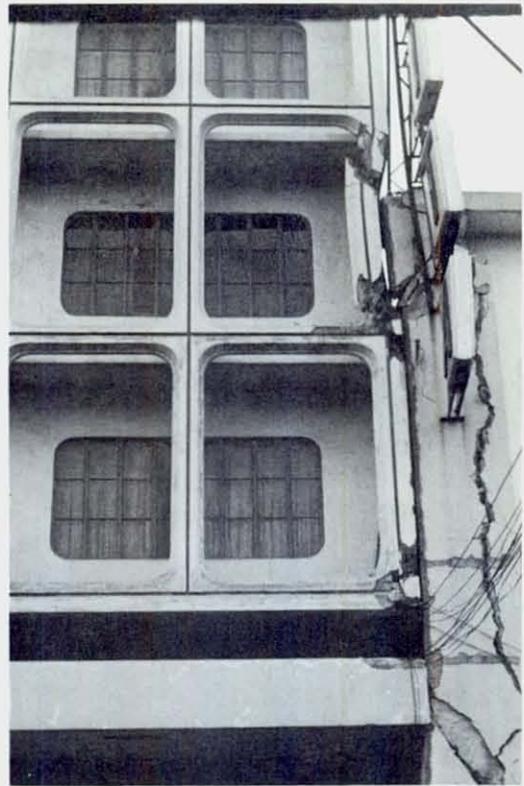
Figure 67. Rita Theater Hammers Against Imperial Hotel 2

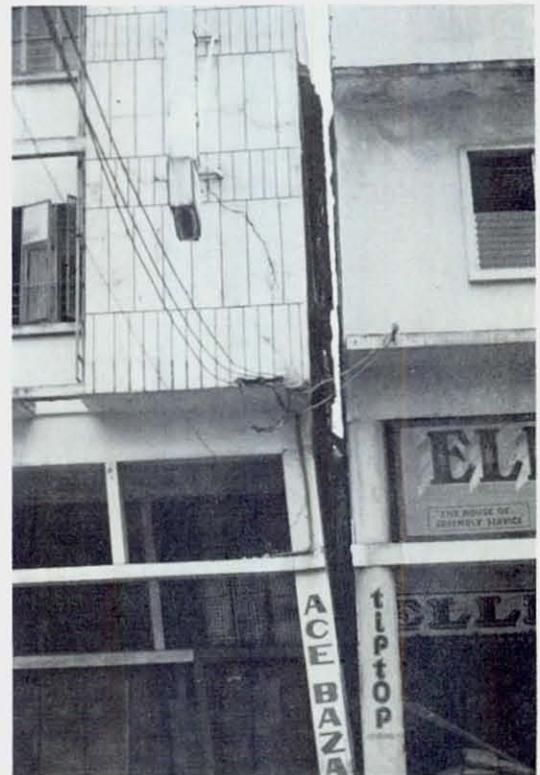
Figure 68. First Story Drift of Imperial Hotel 1

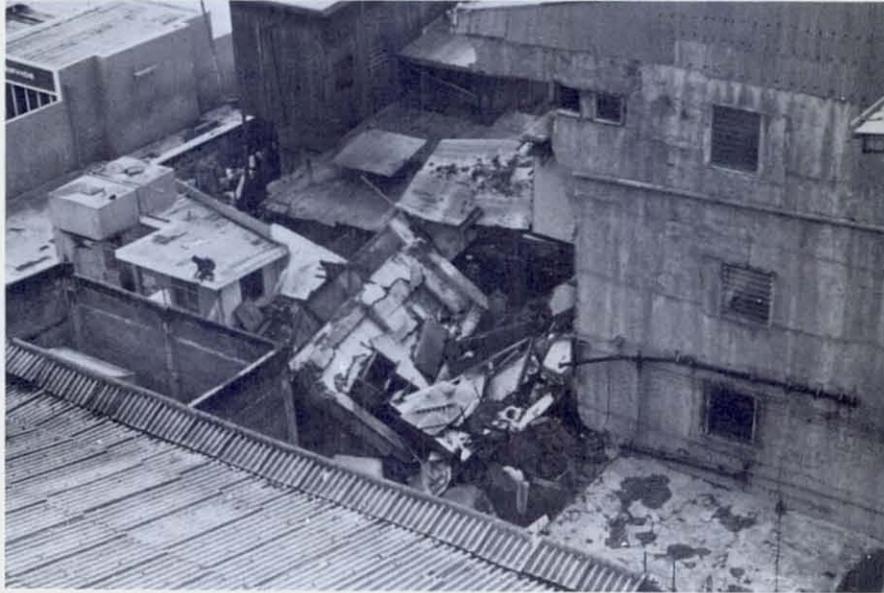
Figure 69. Rear Collapse at Imperial Hotel 1

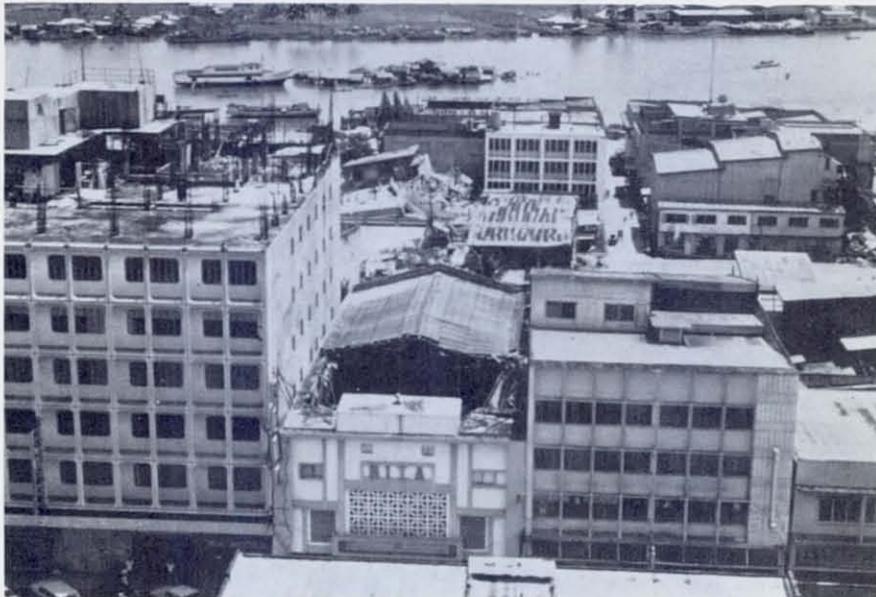
Figure 70. Roof Collapse at Rita Theater

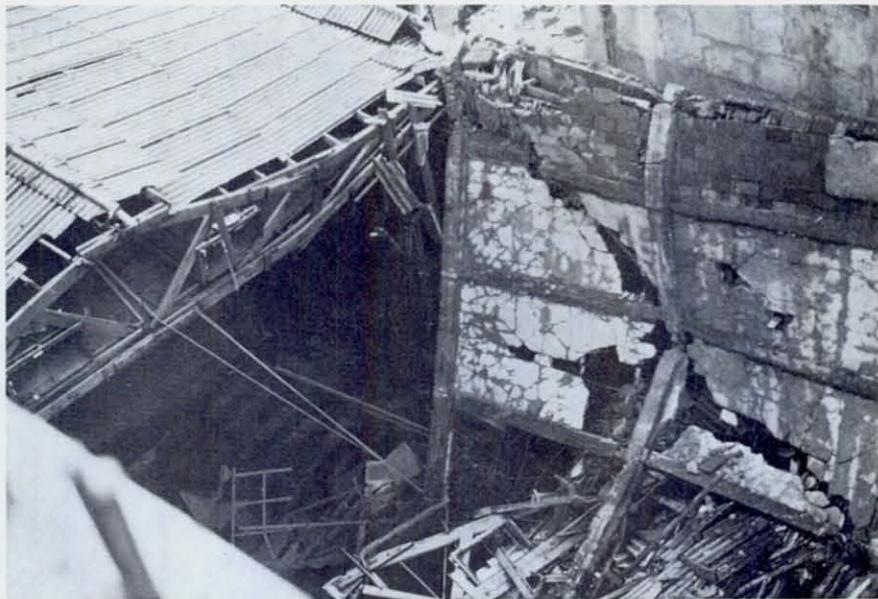
Figure 71. East Wall and Roof Collapse

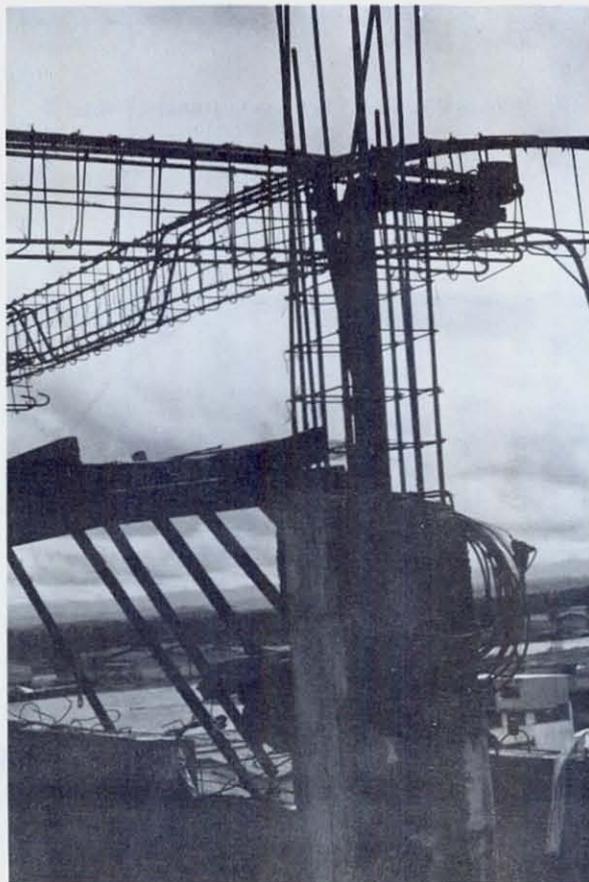
Figure 72. Reinforcement Details, Imperial Hotel 2

- 5) Large torsional eccentricities caused some buildings to fail. They were not designed to resist seismic torsional forces.
- 6) Reinforcement detailing was done without apparent consideration of load paths in the structure and elements. Among the serious problems noted were a) splicing of column reinforcement below the soffit of the beam, b) cast iron downspouts in the columns and joints (Figure 117 and Figure 118), c) excessive column tie spacings not based on seismic shear and confinement requirements, and d) beam reinforcement not anchored for seismic building response.

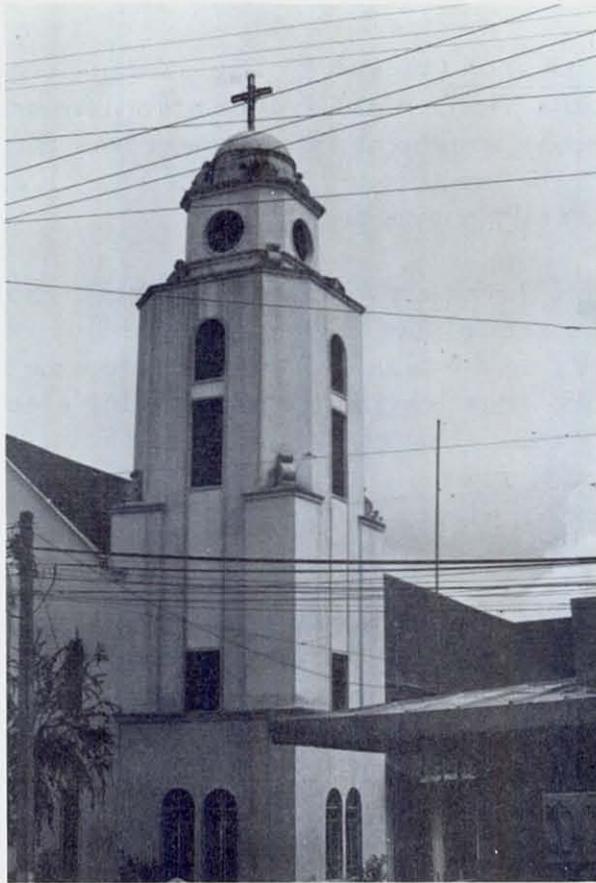
Figure 73. Immaculate Conception Church

Immaculate Conception Church (Bldg 20): The only noticeable damage to this church across the street from the Tison Building was a settlement of about 15 cm of its tower (Figure 73). A loose ornament on the tower was thrown to the west a distance of about 3 m from the top (Figure 74). The church grounds were very soft, and the tower was apparently not on piles.

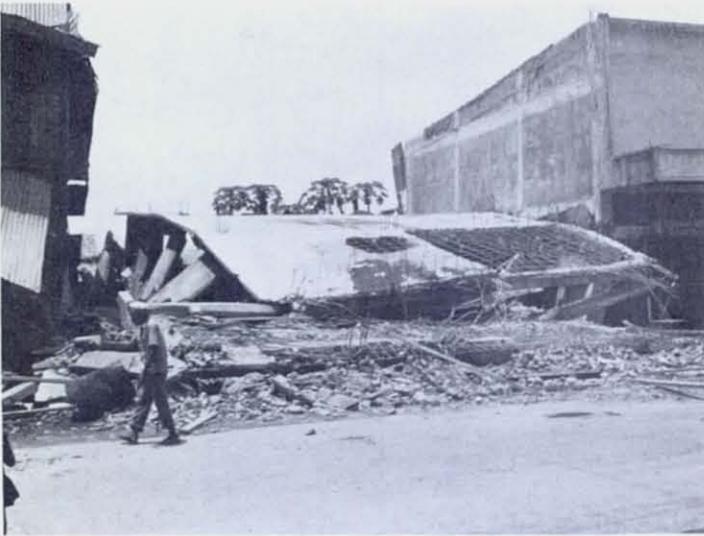
Figure 75. Melineen Building

Melineen Building (Bldg 21) was a two-story reinforced concrete structure that pancaked. Very little is known about this structure since demolition was well under way when reviewed by the team. The concrete was being knocked off the reinforcing steel by hand, thus leaving the reinforcing steel intact. The slabs had one layer of reinforcing consisting of light bars at 15 cm on center each way. It is suspected that continuity over the supporting girders was minimal. Columns were light (26 cm square). Figure 75 is a view of the structure from across the street.

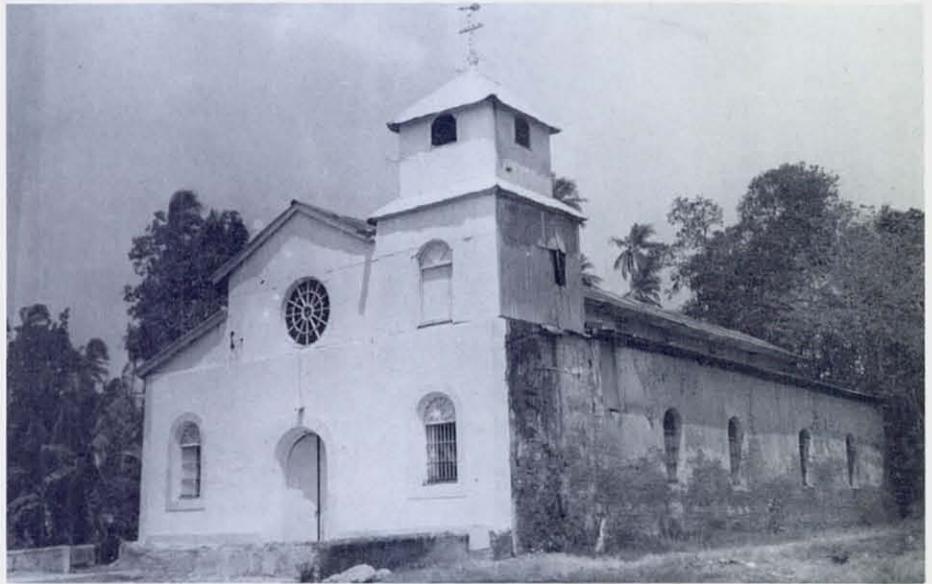
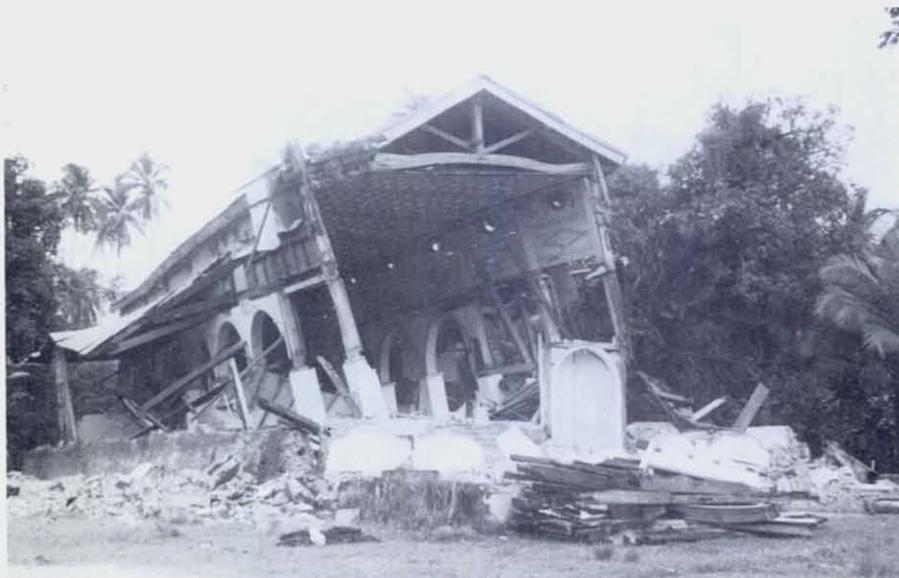
Tamontaka Catholic Church (Bldg 22) was reputed to have been built by the Spaniards 104 years ago. It was the only structure noted to be constructed of unreinforced brick walls with interior timber columns and wood roof. Figure 76 is a "before" picture which shows some structural cracking due either to previous earthquakes or differential settlement. Figure 77 shows the destruction caused by the earthquake. The severely damaged church was located near the Tamontaka River and Bridge and founded on soft marshy soil.

Figure 76. Tamontaka Church  
Before Earthquake

Figure 77. Tamontaka Church  
After Earthquake

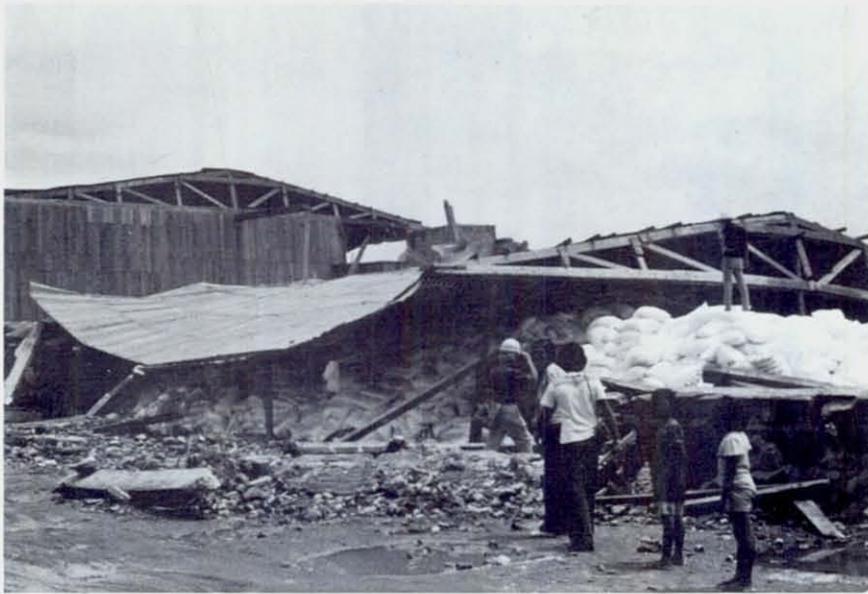
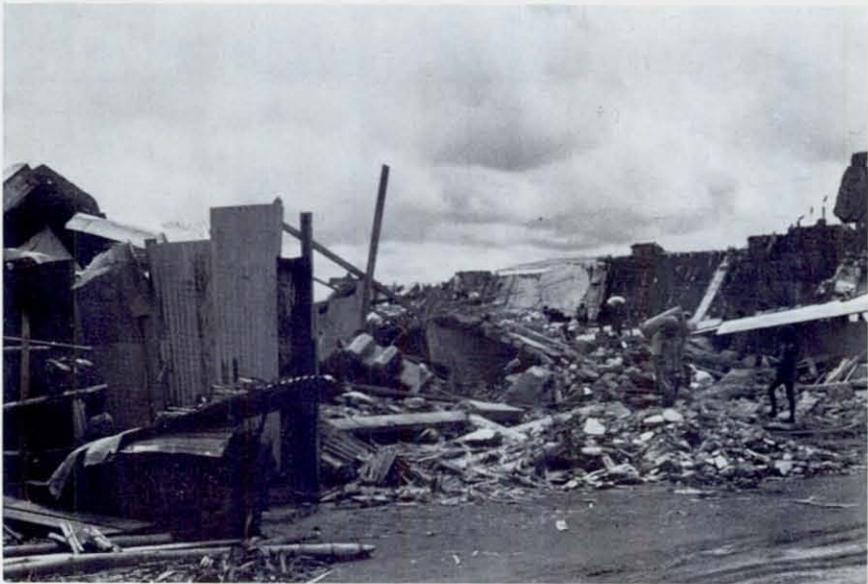
Figure 78. Waterfront Warehouses

Waterfront Warehouses (Bldg 23) in large numbers were located at the edge of the Rio Grande west of the Manday River. This area is called Lugay Lugay and is in a Moslem zone. Practically all of the warehouses collapsed (Figures 78 and 79). They appeared to be constructed of masonry walls, timber trusses, and corrugated metal roof (no diaphragms). They were poorly built, apparently non-engineered structures, except perhaps for wood trusses, and most certainly had no seismic resistance.

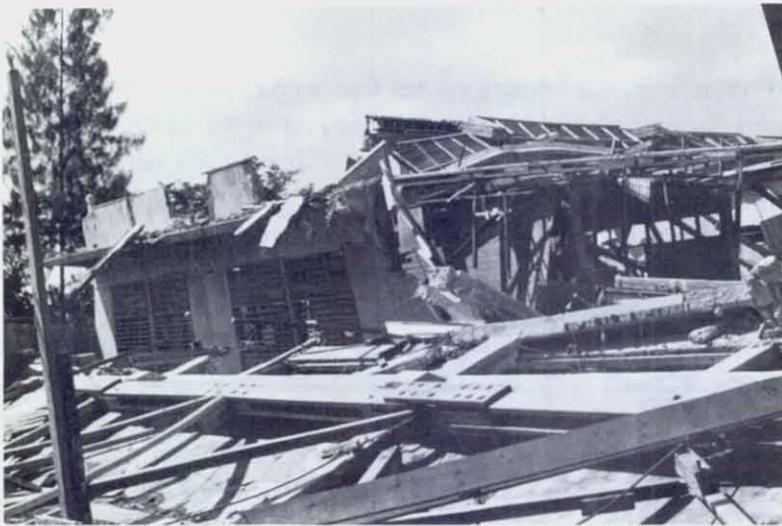
Figure 80. Cotabato Chinese School Gymnasium

Cotabato Chinese School Gymnasium (Bldg 24) is a reinforced concrete plus wood structure constructed in 1962. The four outer walls have reinforced concrete columns, reinforced concrete beams, and wood beams. Masonry infills were used in the outside walls. The roof is "rod and block" wood truss with galvanized sheet iron covering. The stands inside are wood. During the earthquake, the walls fell outward and the roof fell in (Figure 80).

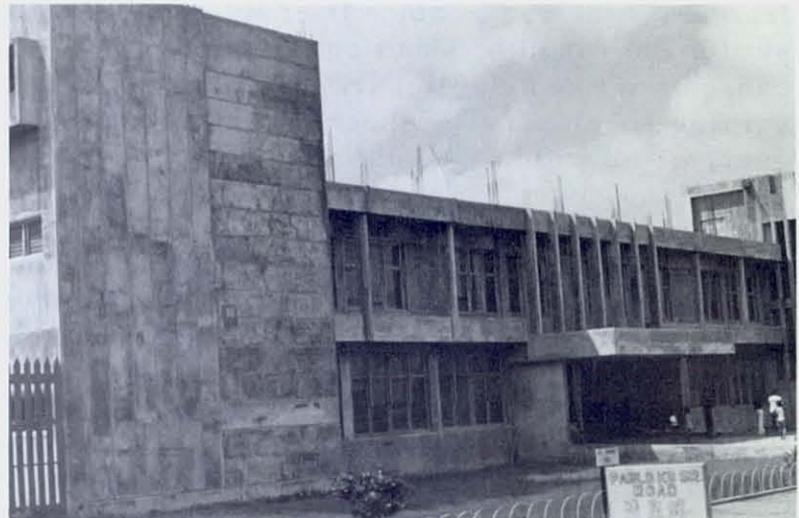
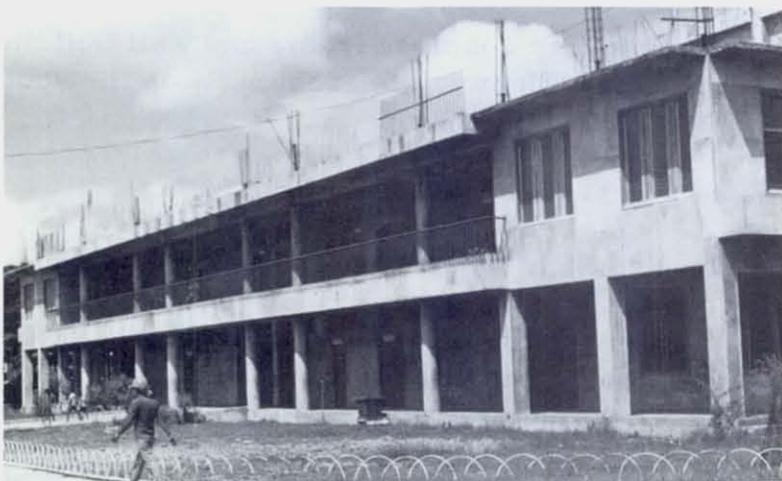
Figure 82. Cotabato Chinese School Administration Building

Cotabato Chinese School Administration Building (Bldg 25) is a two-story reinforced concrete frame (Figures 81 and 82). The building suffered minor damage on some of the masonry frame infills. It was reported that the building was designed for three stories. A pile foundation had been used. The building was less than 3 years old. The EERI team concluded that the structure performed well during the earthquake.

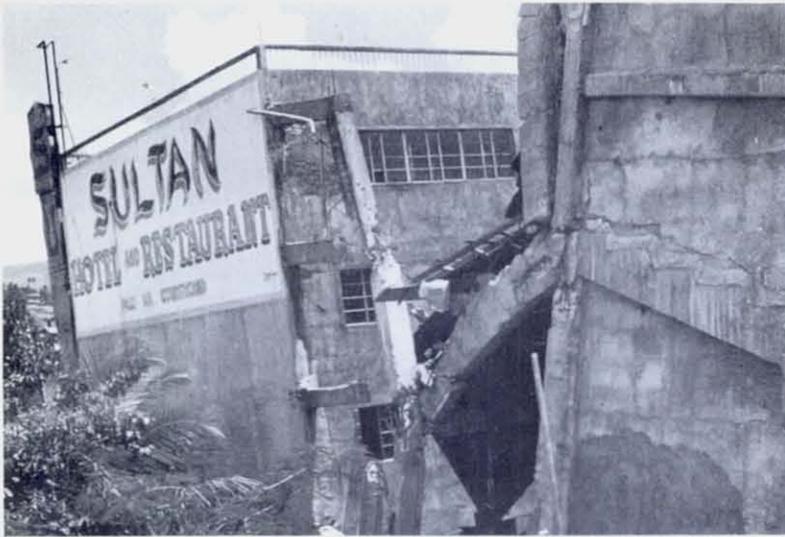
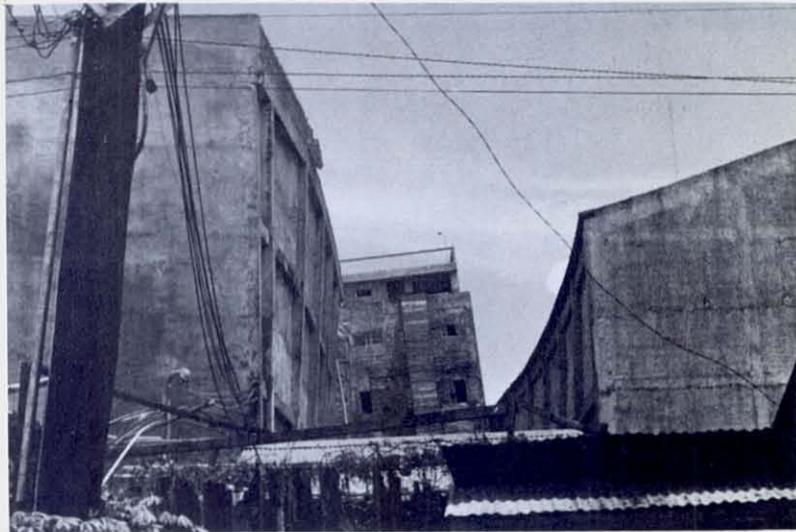
Figure 83. Cotabato  
Movie Theater

Cotabato Movie Theater (Bldg 26) is a large structure to the rear of the Sultan Hotel. The hotel and the theater were somehow connected; however, due to lack of drawings it was not possible to determine exact configurations. Figure 83 does show that when the hotel portion collapsed it caused severe structural damage to the theater complex. It could not be determined whether collapse of the hotel caused failure of the theater or merely contributed to an already damaged structure. Figure 84 shows the theater from the rear, and the hotel can be seen leaning at the front of the theater. Note that the side walls of the theater are leaning dangerously. The theater complex suffered severe structural damage.

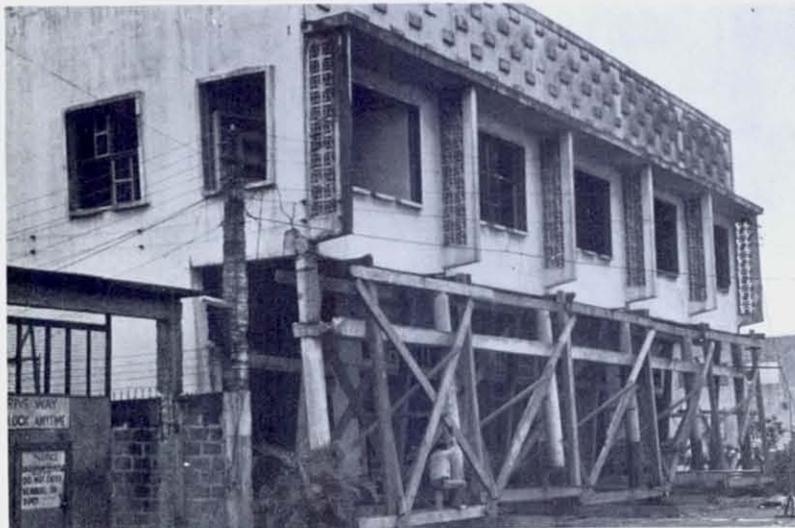
Figure 85. Boston Bakery

Boston Bakery (Bldg 27) is a two-story reinforced concrete building constructed in 1965. The plan dimensions are 15 x 20 m. The building experienced 60 cm drift to the west in the first story (Figure 85).

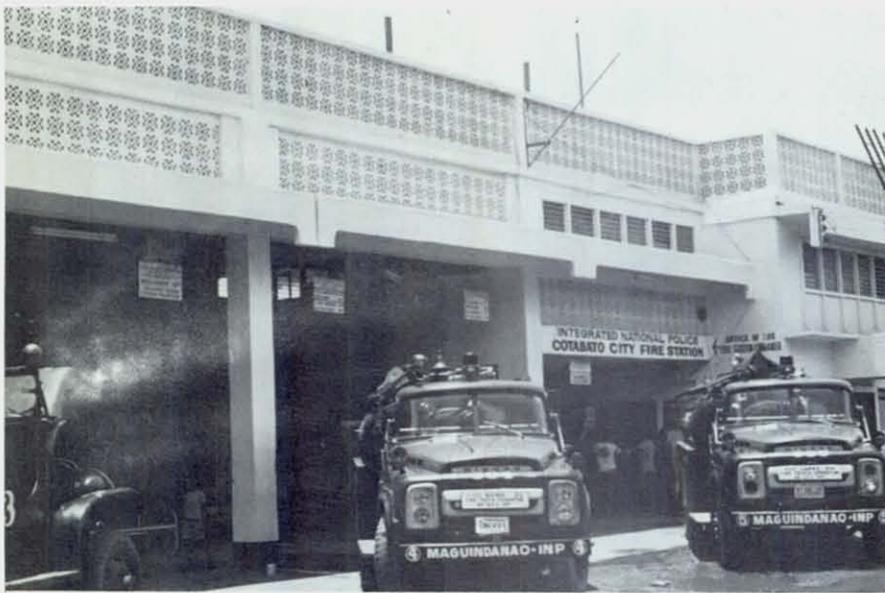
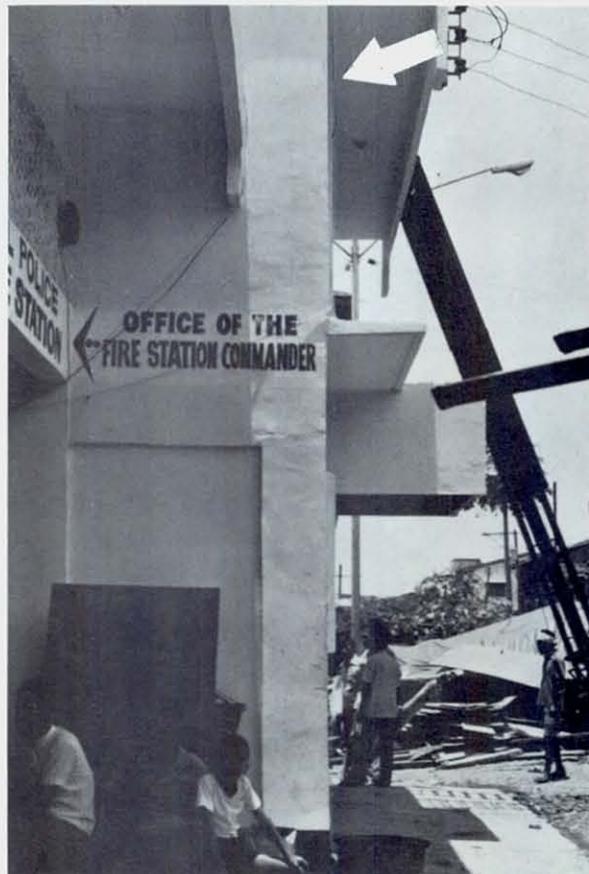
Figure 86. Cotabato City Fire Station

Cotabato Fire Station (Bldg 28) (combined with the police station) settled toward the river during the earthquake (Figure 86). Figure 87 shows a plumb bob suspended from near the roof. Since the height and depth of the structure are the same, the settlement would be about equal to the out-of-plumb dimension. This settlement caused the fire chief to park all of his equipment outside the fire station to avoid damage should an aftershock cause the station to collapse. The firemen did, however, sleep within the confines of the building. Although the station settled slightly toward the river, no structural failures were noted in the structure itself.

Figure 87. Plumb Bob Shows Tilt of Structure

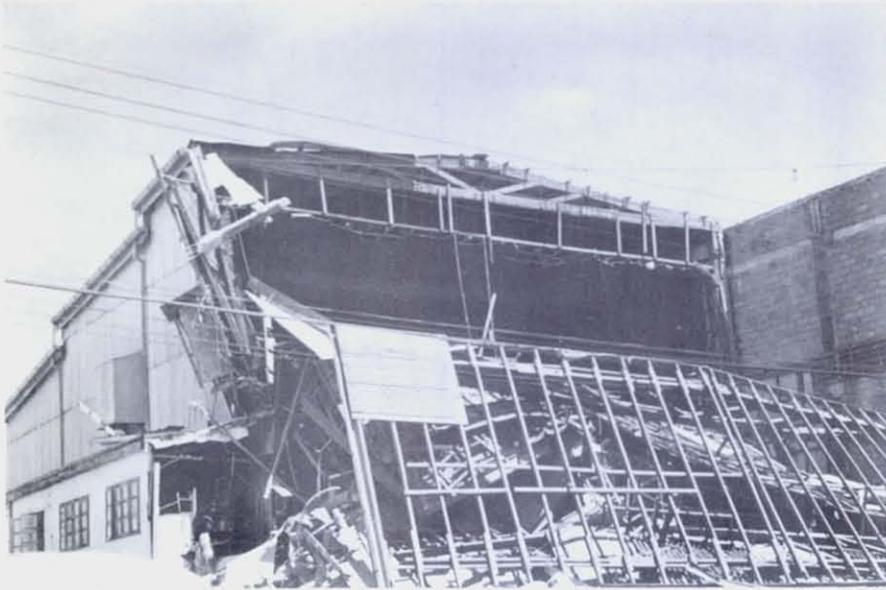
Figure 88. Francel Theater

Francel Theater (Bldg 29) was a reinforced concrete plus wood building constructed in 1966 (Figure 88). The reinforced concrete frame portion of the building collapsed, causing a failure of the "rod and block" wood truss roof.

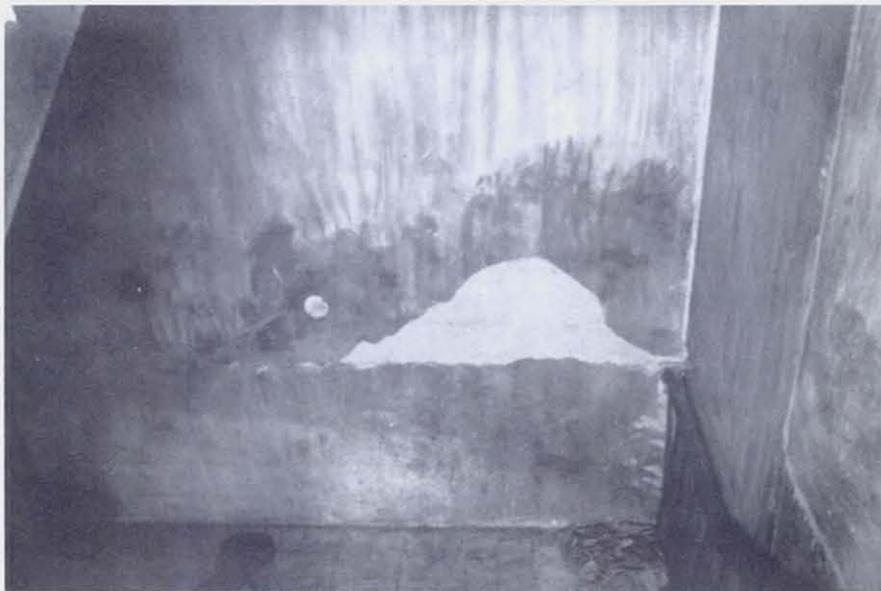
Figure 89. Tan Bo Building

Tan Bo Building (Bldg 30) is a four-story building constructed in 1971-72. It was designed and built using a local engineer and contractor. The structure is a reinforced concrete frame with hollow block infilled walls and was built on timber piles 7.6 to 9.1 m long. Although the team had limited access to the building, it was able to climb the stair tower and found little or no damage. The only damage noted was the cracked infilled panels at the stair core (Figure 89).

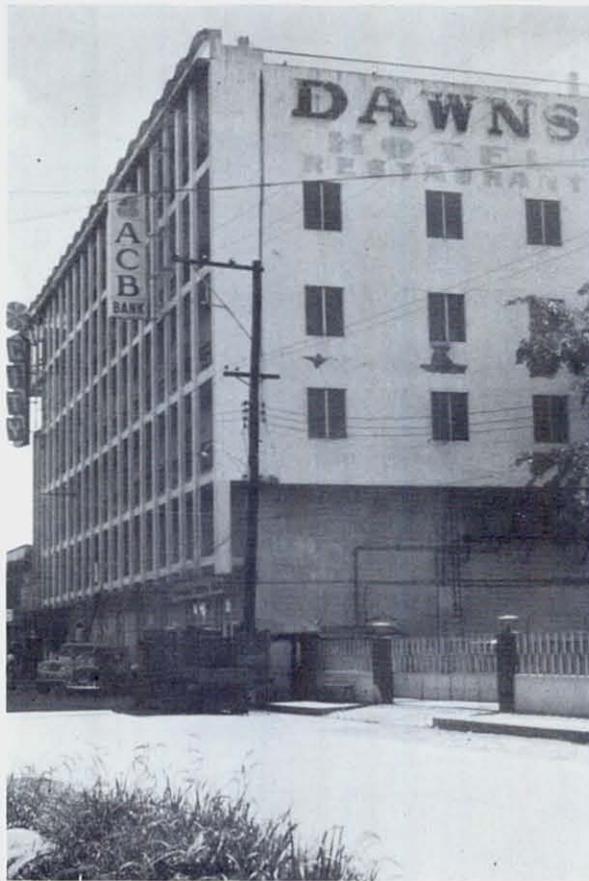
Figure 90. Dawns Hotel

Dawns Hotel (Bldg 31) is a six-story reinforced concrete frame and wall building. The only damage of note was a working of the floor joints of the wall on the south side of the building (Figure 90).
