Earthquake Engineering  
Research Institute

**Reconnaissance Report**  
**MINDANAO, PHILIPPINES EARTHQUAKE**  
**August 17, 1976**

**August 1977**

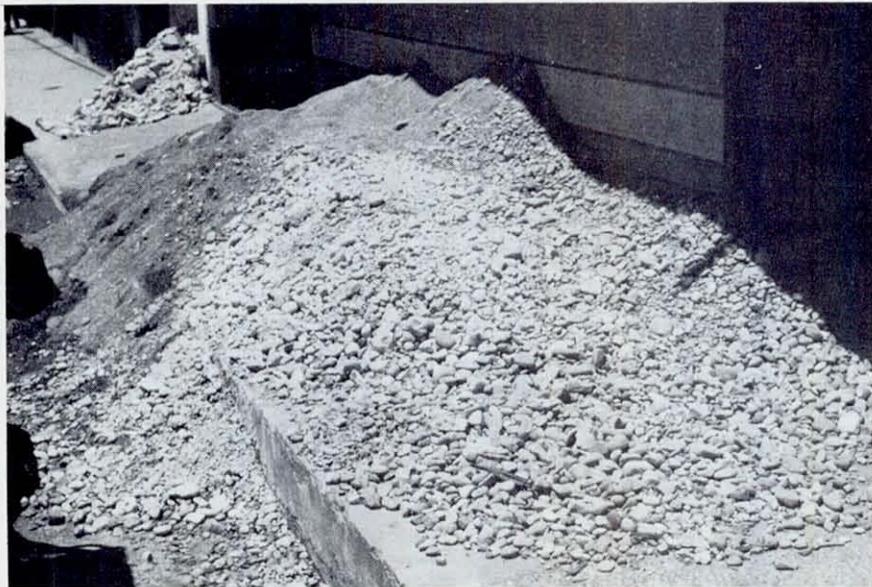
Diamond Bazaar is of three-story concrete frame with masonry infill panels. Damage was to the second story exterior columns and to the adjoining architectural block screen (Figure 91). The sand aggregate mix used in the structure was very poor. The same may be said for that used in the repair work (Figure 92).

Figure 92. Diamond Bazaar Repair Materials

It was interesting to see that a majority of the damaged structures had been "repaired" by the time the EERI team arrived in Zamboanga City, 10 days after the earthquake. Repair work consisted primarily of plastering over the cracks. It was not apparent that there were design schemes conceived in order to maintain structural integrity prior to doing the work; hence, the structures remained in a weakened state, subject to cumulative damages in future earthquakes.

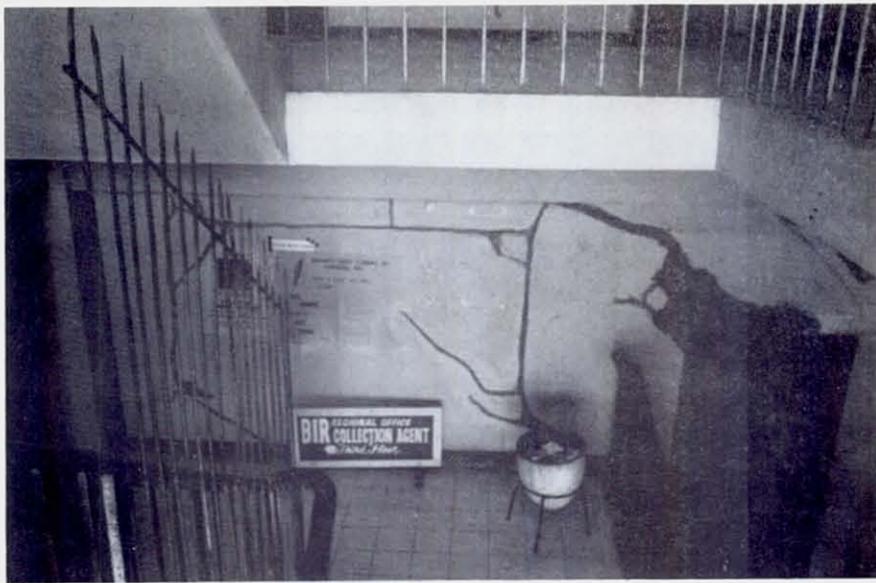
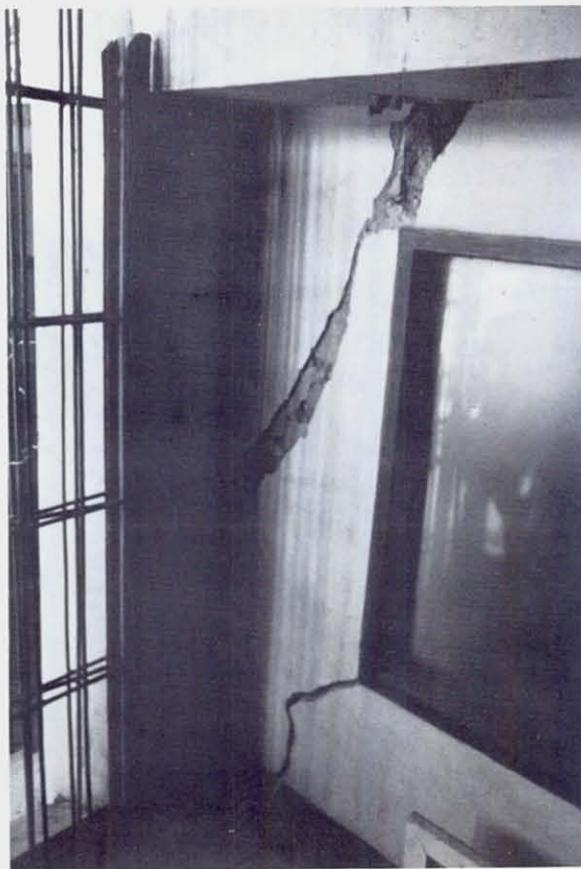
Figure 95. Mendoza Building

Mendoza Building (Shopping Center) was constructed in 1970. It has three stories with a reinforced concrete frame and slabs. It houses retail shops at the street level with office space above. Damage occurred at the wall panels, especially adjacent to the open stair, and at the windowed interior panels (materials unknown) (Figures 95 and 96).

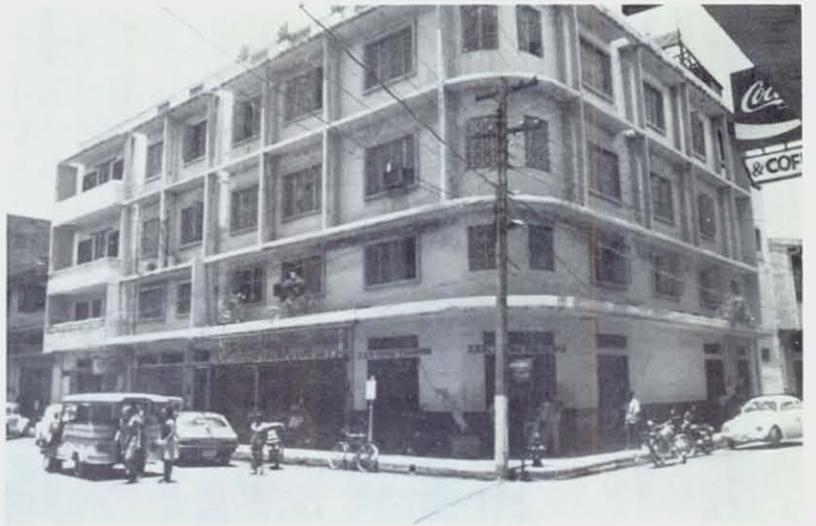
Figure 98. To Tek So Building

To Tek So Building is a four-story reinforced concrete structure (Figure 98), located on a corner site. The first story corner piers and columns experienced shear cracking (Figures 99 and 100).

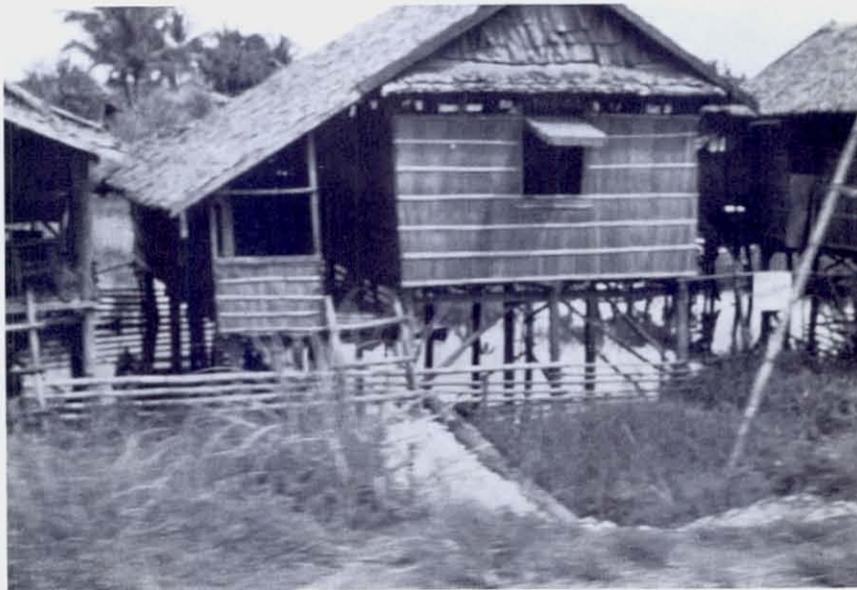
Figure 101. Typical Wood Residence

The typical residence seen in the Cotabato City area was built above the ground on polelike foundations (Figure 101). The superstructure was framed from native timber poles approximately 10 cm round and covered with palm leaves or similar thatching, or with sawn lumber covered with Philippine mahogany. At construction projects where the workers lived at the site, homes were built of scrap form-wood. To add to their stability, the pole structures were braced. It was noted that the bracing's primary purpose was not structural in nature but to keep livestock from beneath the home.

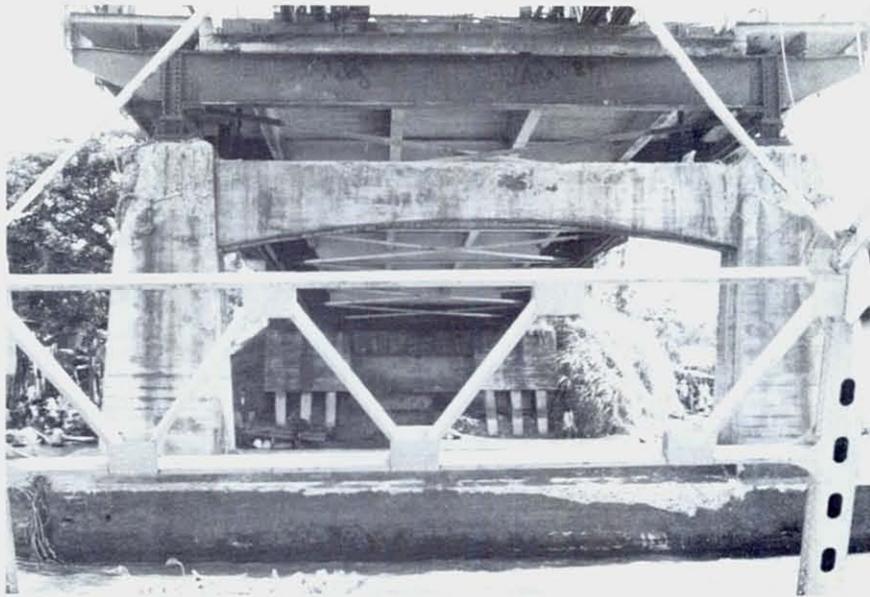
Each span was supported on rollers at one end and pinned at the other. The collapse was caused by the second span sliding off its bearing plates in the easterly direction (Figure 105). Lack of consideration of seismic forces was obviously the reason for this failure.

Figure 105. Quirino Bridge Collapsed Span

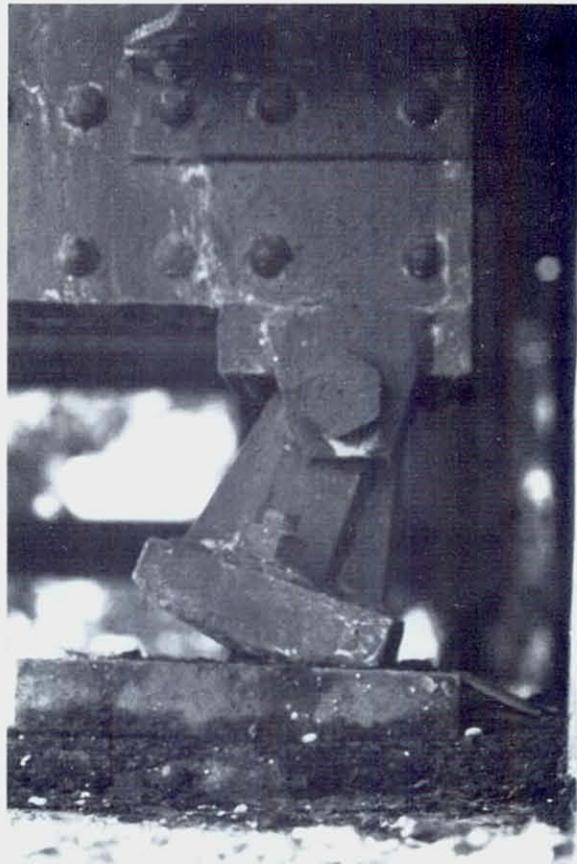
As noted in other portions of this report, the predominant motion seemed to be in the east-west direction. However, the effect of motion in the north-south direction is also noticeable, as shown by the positioning of the rockers at the north abutment (Figure 106). It could not be determined whether this motion was caused by the earthquake or was a result of the collapsed span. It appeared that the northerly pier could be leaning slightly toward the north.

Figure 106. Rocker at North Abutment of Quirino Bridge

- 4) Piers must be designed to take lateral loads that are transferred to the pier by the type of anchorage of the span.
- 5) It would appear that in a multispan bridge the end abutments should receive the fixed supports, while the rollers would be placed at the first pier. This would simplify the resistance of lateral forces in the longitudinal direction. (It is simpler to resist lateral forces at end abutments rather than interior piers.) At the Quirino Bridge, rockers were used at end abutments (Figure 106).

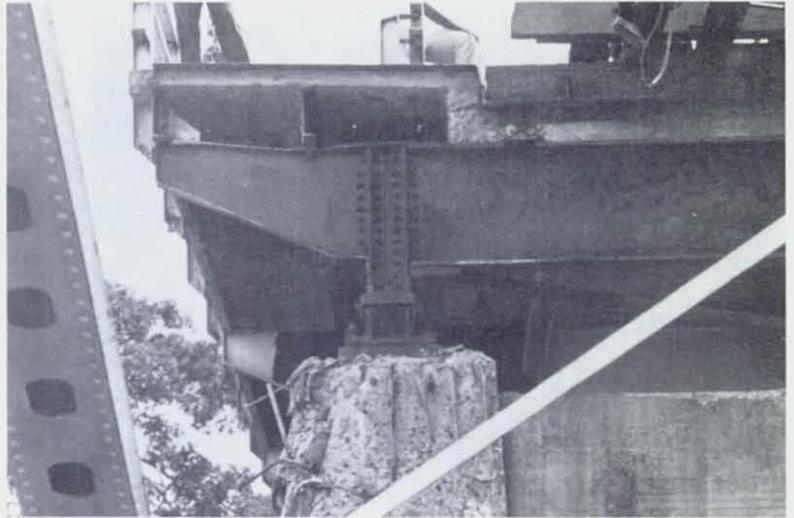
Figure 107. Quirino Bridge Pier

The failure occurred by the span sliding to the east off the dumbbell-shaped supports. The supports as constructed would not allow for much east-west movement before the spans would collapse. Figure 107 shows the pier, and it appears that a motion on the order of 60 cm would be sufficient to cause this collapse. Other notable damage is the near collapse of the third span from the south. Figure 108 shows new piling plus the tying together of spans two and three to prevent further damage. Figure 109 shows damage to the piles at the base of the south abutment. Shear cracks appear several centimeters below the base.

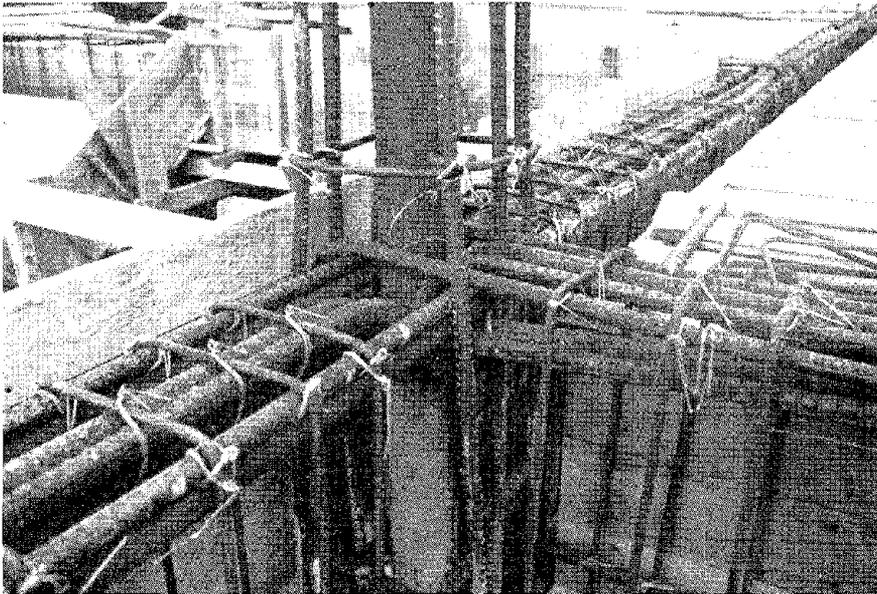
Figure 117. Downspout in Concrete Column

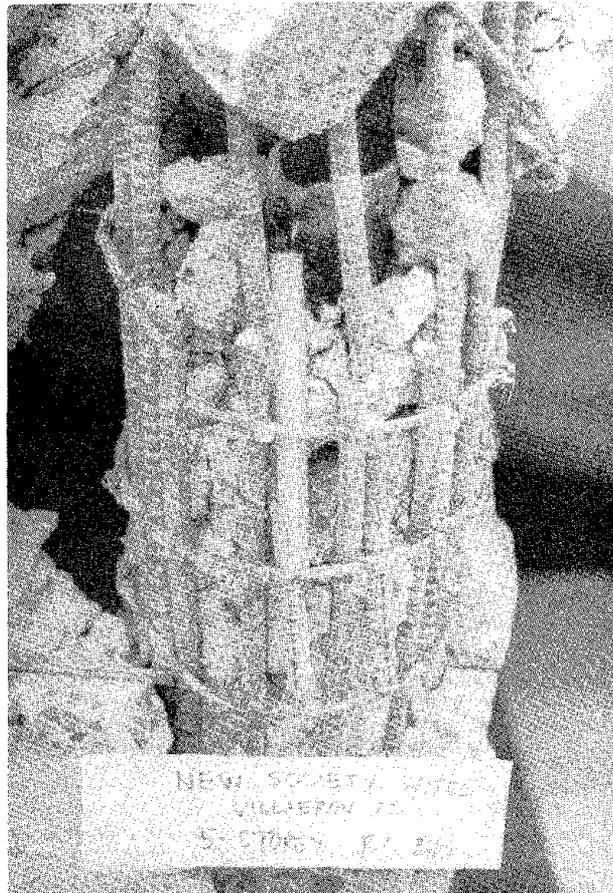
Figure 118. Downspout in Reinforcing Splice
