ENGINEERING REPORT
on the
MANAGUA EARTHQUAKE
of
23 DECEMBER 1972

a report
by
Meté A. Sozen
University of Illinois
and
R. B. Matthiesen
U.S. Geological Survey

submitted to the
Committee on Natural Disasters
Commission on Sociotechnical Systems
NATIONAL RESEARCH COUNCIL

NATIONAL ACADEMY OF SCIENCES
Washington, D.C.
1975

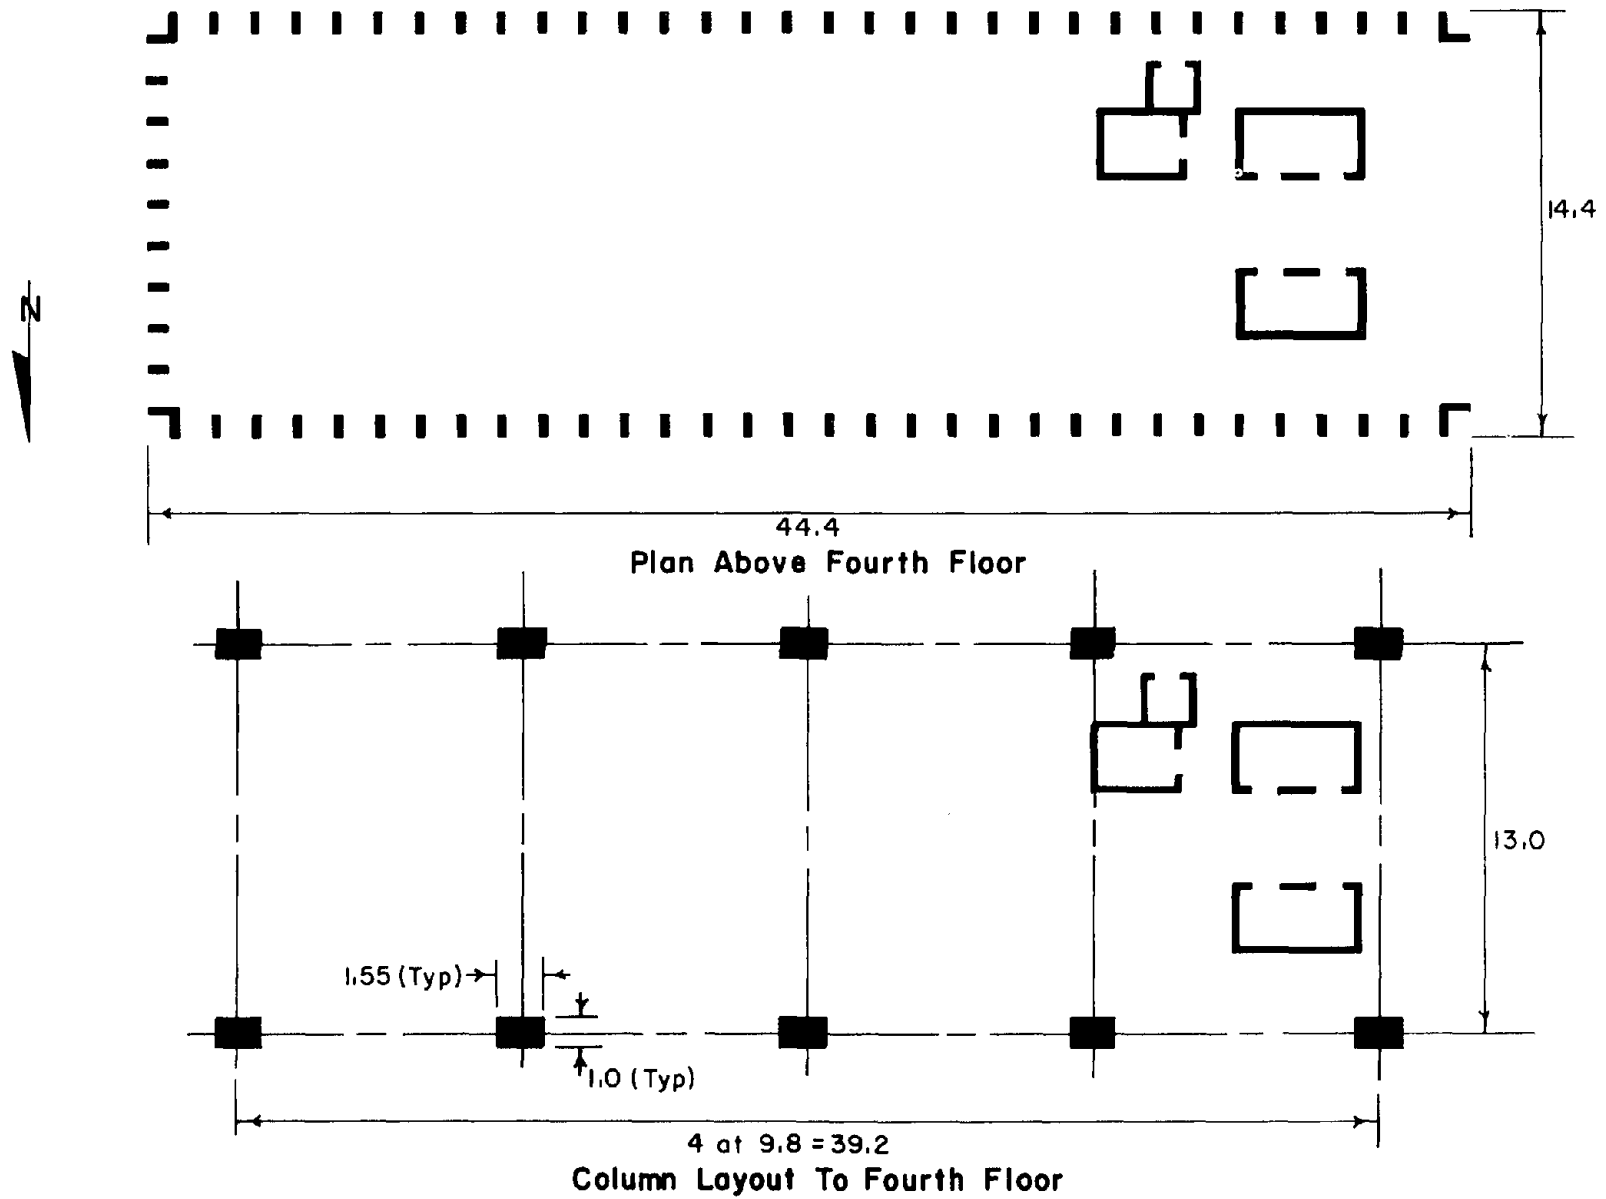
FIGURE II-42 Banco Central Building (Section).

The major example derives from the relative performance of the buildings for the Banco Central and the Banco de America (Figures 20, 21 and Figures 42-49). As shown in the figures, the lateral resistance for Banco de America was provided primarily by four shear cores whereas the lateral resistance for Banco Central was provided primarily by frame action. Both buildings survived the earthquake with some damage (8, 15, and 16). However, the interior of Banco Central was in shambles while the interior of Banco de America was virtually intact.

One of the subtle phenomena observed in the Banco Central Building was the jamming of emergency exits. A building with a flexible structural system is not likely to return to its original geometry after a damaging earthquake and it takes little distortion to jam a stiff door. Had the earthquake been followed by a fire, the jamming of these exits during working hours, with the elevator system inoperative, would have been catastrophic.
