**THE VERACRUZ EARTHQUAKE OF
28 AUGUST 1973**

by
H. Max Irvine

EERL 73-06

Pasadena, California
October, 1973

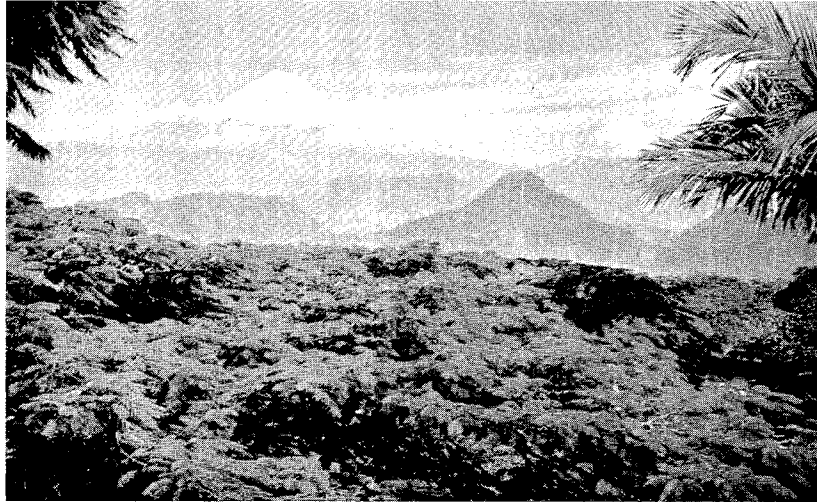
Figure 2 Typical view of the countryside in the damaged area of the state of Veracruz. Orizaba Peak (5,700m.) is in the background.

The damaged area in the State of Veracruz is in a tropical, mountainous region. Dense rainforest covers the slopes; coffee and sugar cane are farmed extensively. Figure 2 shows a typical view of the countryside, with the highest mountain in Mexico, Orizaba Peak (5,700m.), in the background. The earthquake occurred during the rainy season, and this naturally hampered rescue work. Serdán, in the State of Puebla, has a much dryer climate, as it is in the rainshadow on the other side of the mountains. The main crop there is corn.

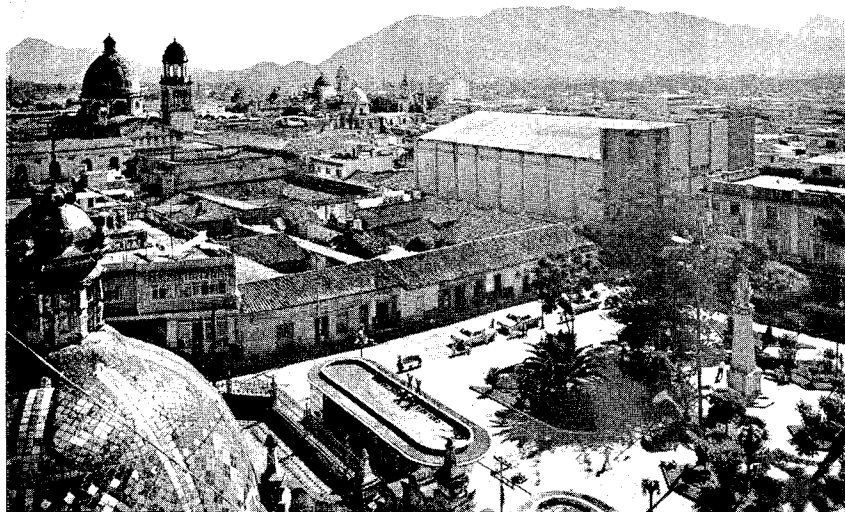
Figure 7 View of Orizaba taken before the earthquake.

There was quite extensive damage to a variety of buildings in Orizaba (110,000 pop.). Many houses collapsed but, since these failures were, in general, similar to those mentioned earlier, they will be passed over in order to concentrate on descriptions of larger, more modern buildings which often fared badly in the earthquake. Figure 7 (p. 3) shows a general view of Orizaba taken before the earthquake.

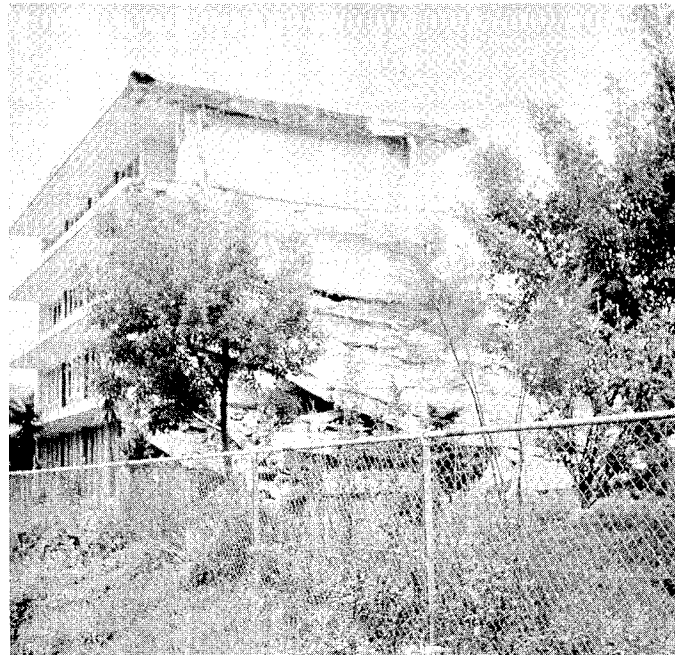
Figure 17 Building A, Technologico of Orizaba.

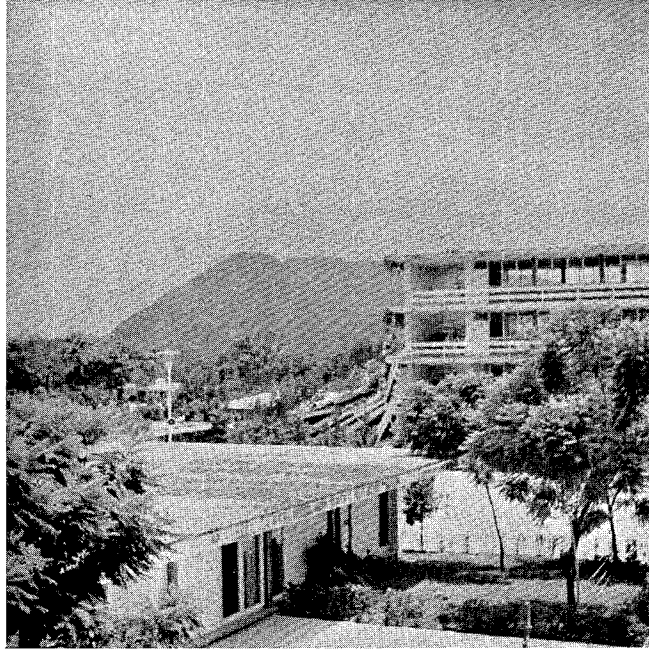
Figure 18 Building A, Technologico of Orizaba.

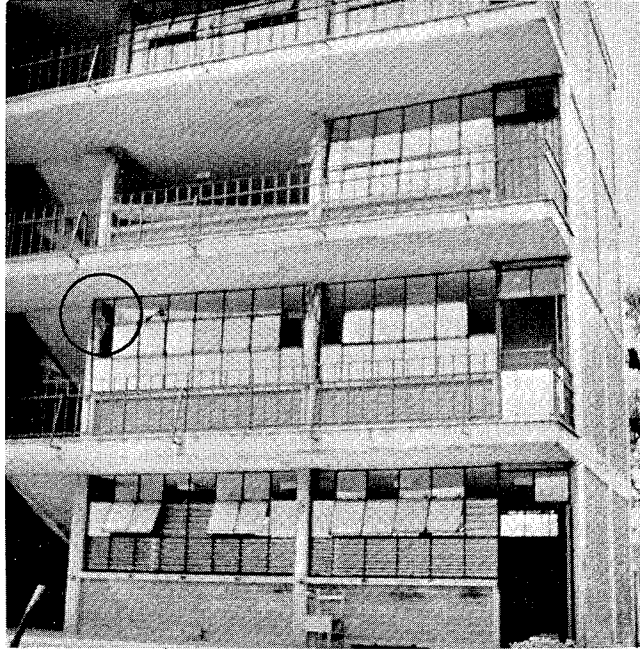
The other four-story building (Building B) remained standing, although it is likely that it will have to be completely rebuilt (see Figure 21, p. 25). Superficially, this building appeared to be similar to Building A; it was of the same height and plan area and stairways separated the building into two parts. However, closer examination revealed major structural differences. The center of mass of the building was towards the left-hand end, while the center of stiffness was nearer the stairway (see Figures 21 and 22, pp. 25, 26). Hence, the building responded primarily in torsion. Good evidence of this is provided by Figure 23 (p. 26) which shows classical torsional cracking of a second-story column located adjacent to the stairway.

Figure 22 Building B, Technologico of Orizaba
(circle gives location of Figure 23).

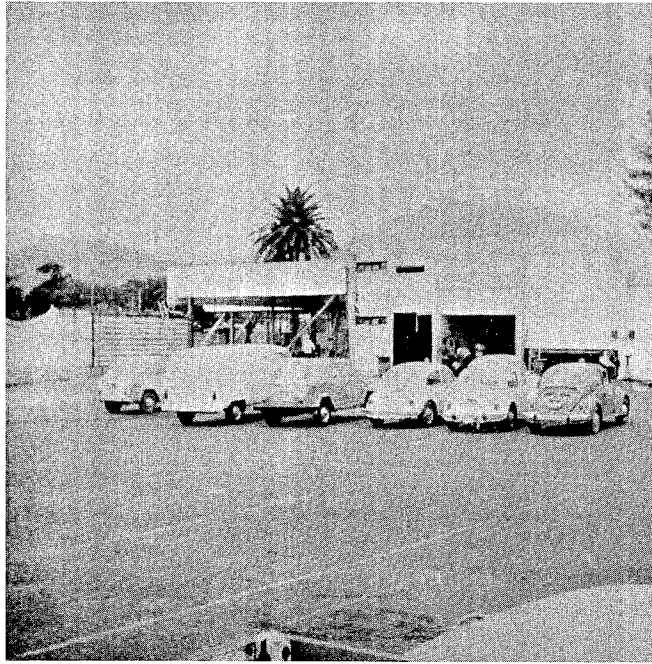
D. VW Garage Showroom. — This building, which was still under construction at the time of the earthquake, consisted of workshops and a service area of brick and mortar with a plate glass showroom facing the highway (see Figure 24, p.27). The single-story showroom consisted of several bays of tapered, post-tensioned, concrete I-beams supporting a continuous reinforced concrete roof slab, and supported by steel RHS columns at each end. Effectively, the roof beams were simply supported over a span of approximately 15 m. (see Figure 25, p. 27). Extensive vertical tension cracks at the mid-span

Figure 24 VW Garage Showroom, Orizaba.

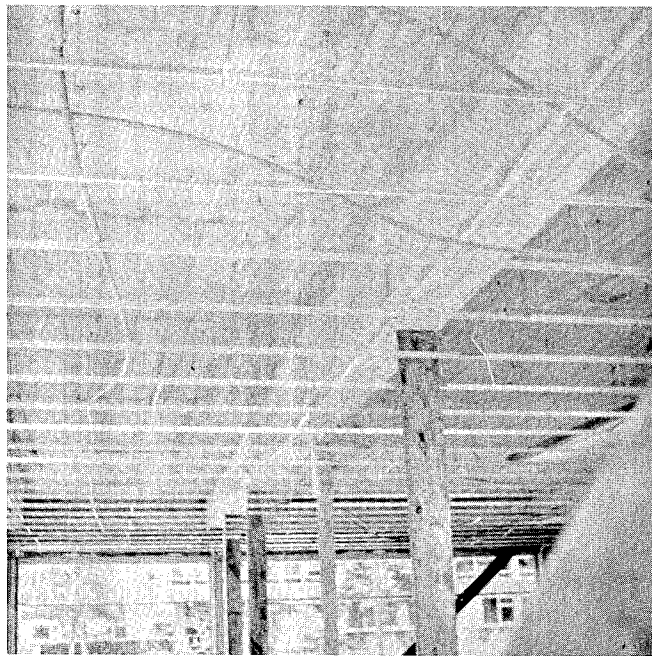
Figure 25 View of prestressed roof beam and roof slab, VW Garage Showroom, Orizaba.

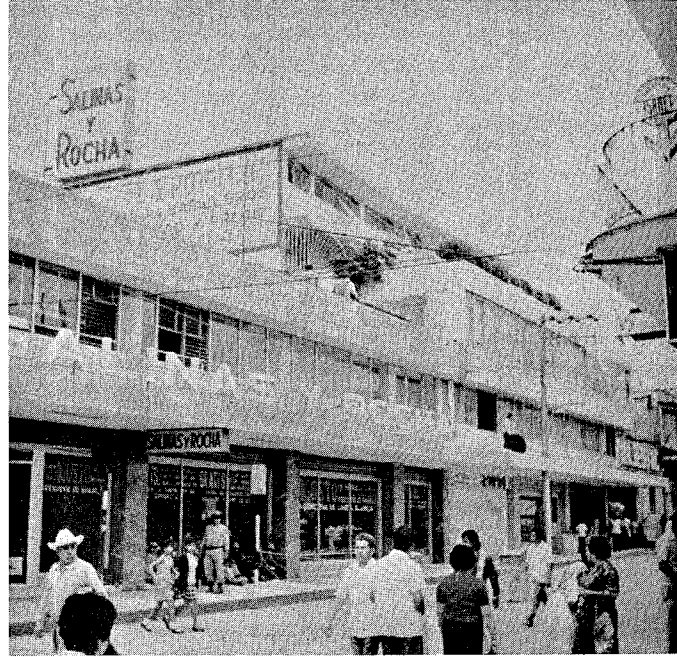
A. Five-Story Business House. — The failure of this building was one of the most interesting, from an engineering standpoint. This building, which had a reinforced concrete frame with brick filler walls, is owned by Mr. Kushida, a Japanese businessman, and was built in 1968. The bottom three floors house shops, offices and warehouses, whereas the top two floors, which are set back (see Figure 30, p.30), are occupied by Mr. Kushida and his family. The overturning moment resulting from the motion of the top two floors caused axial compression failures of columns on the third floor (see Figure 31, p.30). The upper floors had dropped approximately 30 cm. Damage to the

Figure 30 Five-story business house, Córdoba.

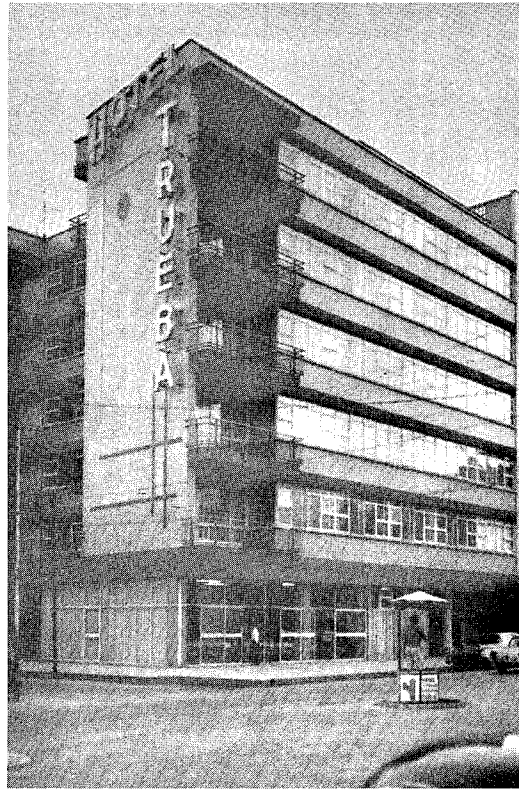
For whatever reason, the behavior of the wall is peculiar since Figure 34 (p.32) shows an obvious zone of weakness at the level of the ground floor columns. Yet inspection showed no sign of damage to these columns. It can only be concluded that sufficient stiffness was present in the ground floor to avoid damage there. Figure 36 (p.33) shows a typical interior beam-column joint. Since many of the rooms in the hotel were uninhabitable owing to broken partition walls, the owner was very keen to have repairs made as soon as possible. Unfortunately, the philosophy behind the repair scheme left much to be desired, as Figure 37, (p.33) shows.

Figure 34 Hotel Trueba, Córdoba,
before the earthquake.

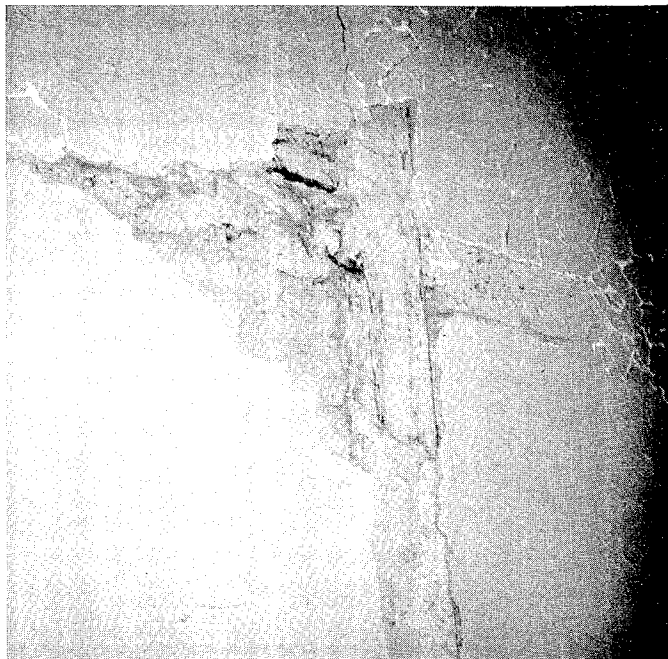
Figure 36 A typical interior beam-column joint, Hotel Trueba.

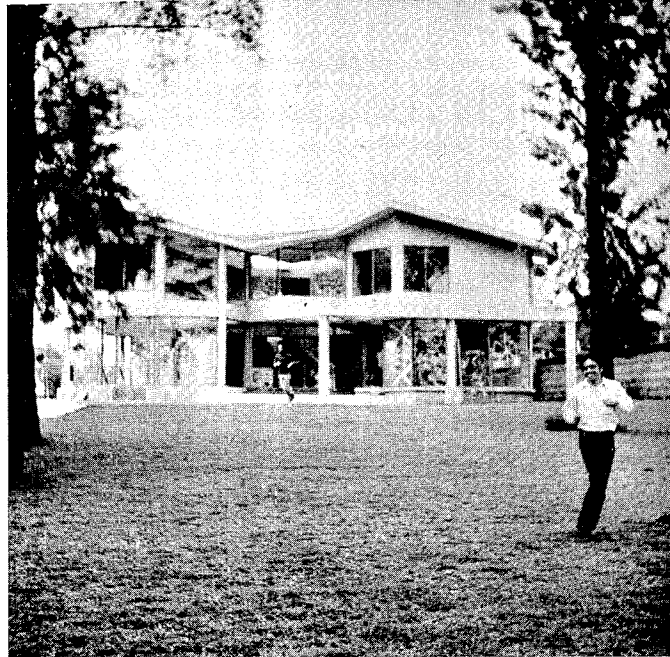
Figure 43 (p. 36) shows typical damage to one of the better constructed houses in Córdoba. The next three views (Figures 44, 45 and 46, pp. 37, 38)

Figure 44 View of a modern house under construction in Córdoba.
