***Landslide of  
April 25, 1974  
on the  
Mantaro River, Peru***

LANDSLIDE OF APRIL 25, 1974 ON THE MANTARO RIVER, PERU

report of inspection

Kenneth L. Lee  
University of California, Los Angeles

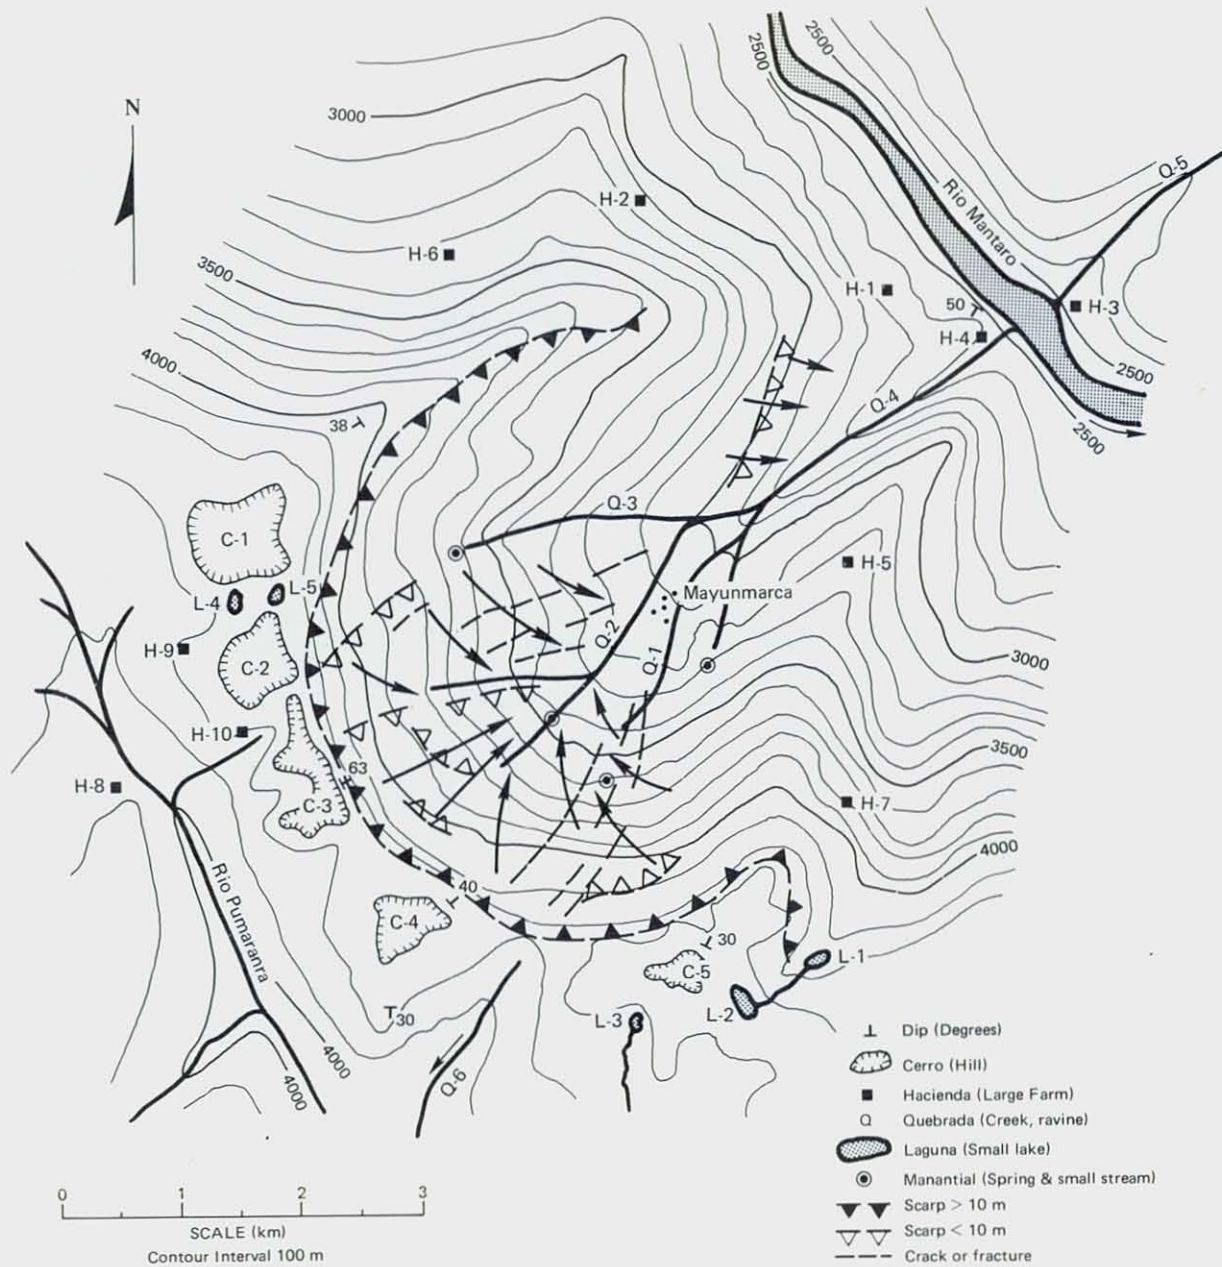
A topographic and location map of the landslide area is shown in Figure 3. The Mantaro river, located in the upper right hand corner which flows from north to south is a major topographic feature in the area. Two creeks running down narrow side valleys or ravines (Quebradas) flow into the Mantaro river at approximately the same location, suggesting the existence of a fault along these creek beds, although no fault is shown on published geological maps. Similar geological features exist at other locations along the river, suggesting that there are many faults which run approximately perpendicular to the Mantaro river valley, which is also probably fault related.

The place names indicated only by letter symbols on Figure 3 are defined fully on Table 1. Note that at the mouth of these two ravines there were two large farms H3 and H4, which involved homes for many people. Approximately midway between the Mantaro river and the crest of the mountain was located the town or village of Mayunmarcha, also involving many homes.

FIGURE 3. Plan of the area showing the major topographic features prior to the landslide of 4/25/74. (After Galdos Bustamante, 1973, Ref. 8)

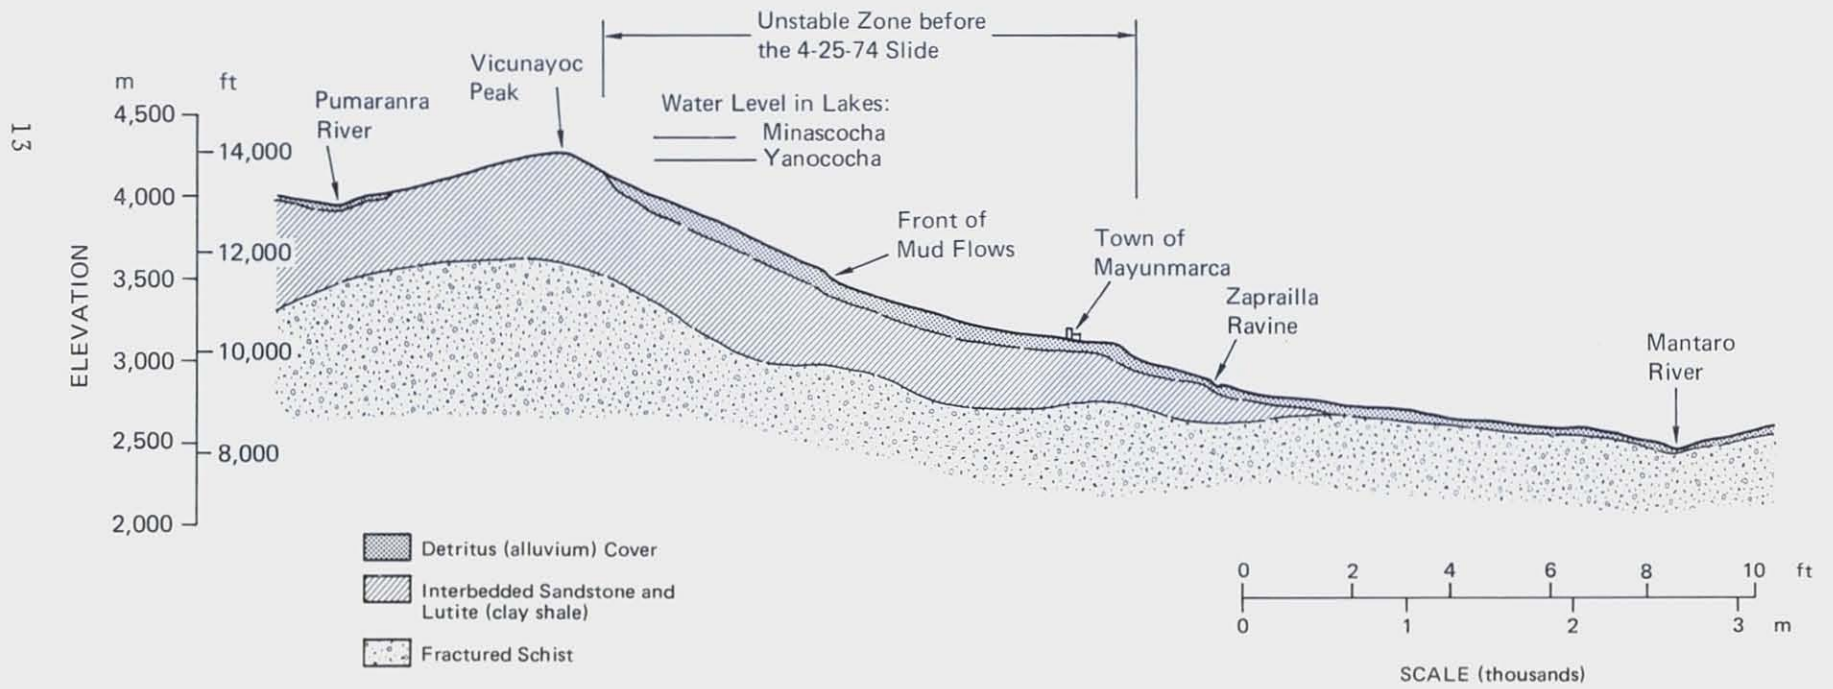
A cross section along the Quebrada Ccochacay (Q4) running southwest from the Mantaro river up and over the mountain peak is shown in Figure 4. Except near the crest of the mountain the slope is covered with a thick (100-200 m estimated) layer of weathered alluvium or detritus. This material is of variable texture and includes cobbles, gravel, sands and clays without significant cementation. Below this upper detritus cover and exposed near the top of the slope are extensive layers of interbedded

sandstones and clay shales. The mountain is an anticlinal feature so that the bedding in this sedimentary rock zone dips approximately parallel to the ground surface. The materials exposed near the crest of the slope are intensely fractured, providing a source of local instability, and an aggravation to the overall stability by providing ready seepage paths for ground water percolation.

FIGURE 4. Geological cross section of Mantaro River slide area prior to the 4/25/74 slide. (After Galdos Bustamante, 1973, Ref. 8)

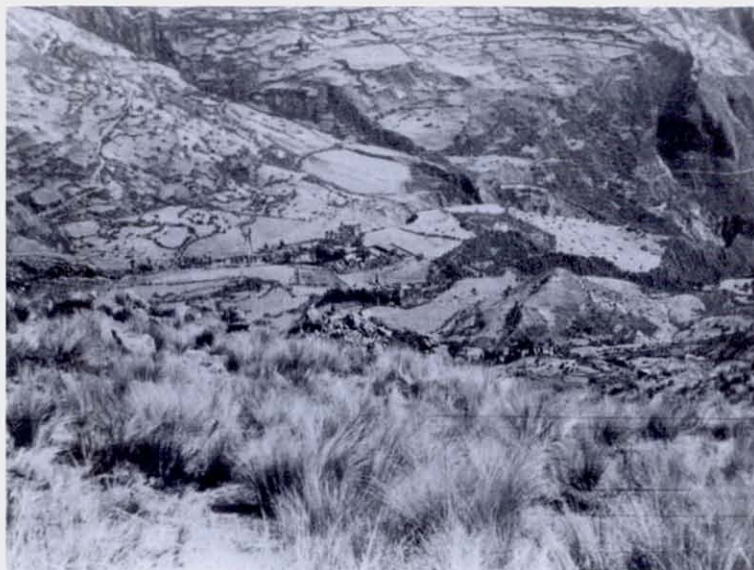
Figure 8 is another panoramic view of the area showing the fluvial-alluvial terraces on which the town of Mayunmarca and the surrounding farms are located. A fairly large old landslide scarp in the upper right corner of the photograph gives another indication of the local marginal stability of these soils.

FIGURE 8. Panoramic view from SE looking NW showing the fluvial alluvial terraces on which the town of Mayunmarca was located. (Photograph courtesy of Galdos Bustamante)

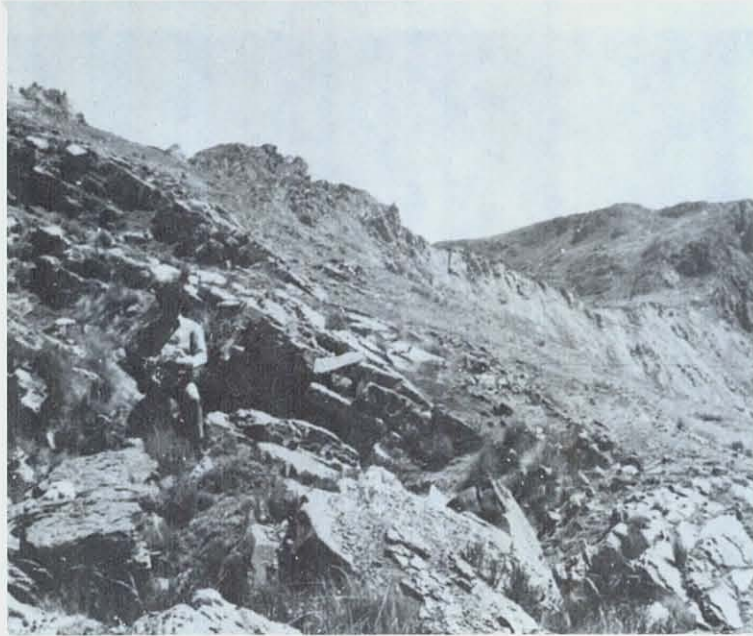
Figure 9 is a view taken along the major old scarp near the top of the slope looking southwest. The peak of the Vicunayoc hill (C4) at elevation 4300 m is seen in the background. The area shown in the photograph is just above the zone of detritus cover shown in Figure 4. The undisturbed material in the foreground is composed of sandstone with some layers of highly compacted clay shale. This is the northeast side of the Pumarana anticline indicated in the section on Figure 4. The bedding slopes NE at  $40^{\circ}$  to  $45^{\circ}$  with respect to the horizontal in the same direction as the ground surface. The natural instability of this formation is clearly indicated by the extensive fractures and amounts of broken rock and by the old landslide scarp in the background.

FIGURE 9. View from the SE looking towards the Vicunayoc hill near the crest of the Pumararra anticline. Part of the old scarp is visible in the distance, and blocks of the sandstone and shale layers which dip NE at 40 to 45 degrees are seen in the foreground. (Photograph courtesy of Galdos Bustamante)

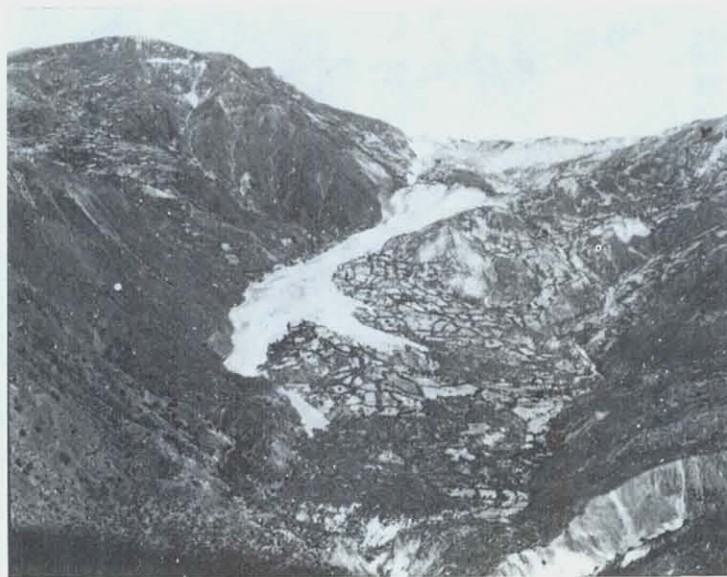
FIGURE 10. View of a typical side valley dipping into the main Mantaro river valley, and located near the Ccochacay ravine. No information is available concerning the slide shown here.

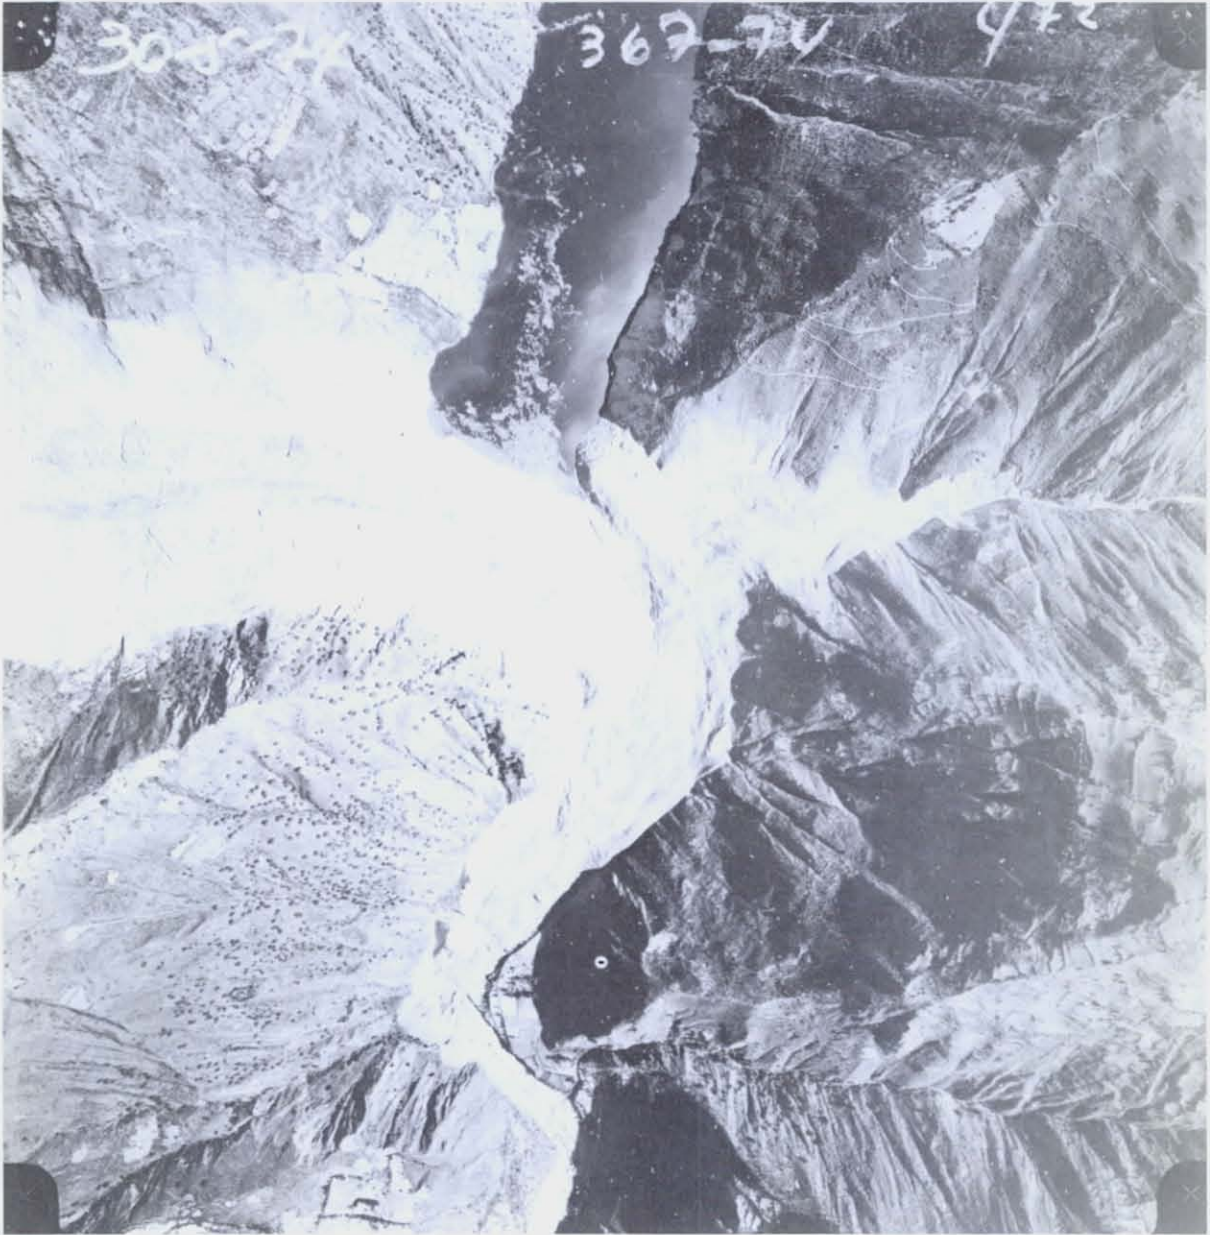
FIGURE 14. Vertical air photograph of the debris dam taken May 30, 1974 some nine days prior to the dam being overtopped. (Defensa Civil Photograph)

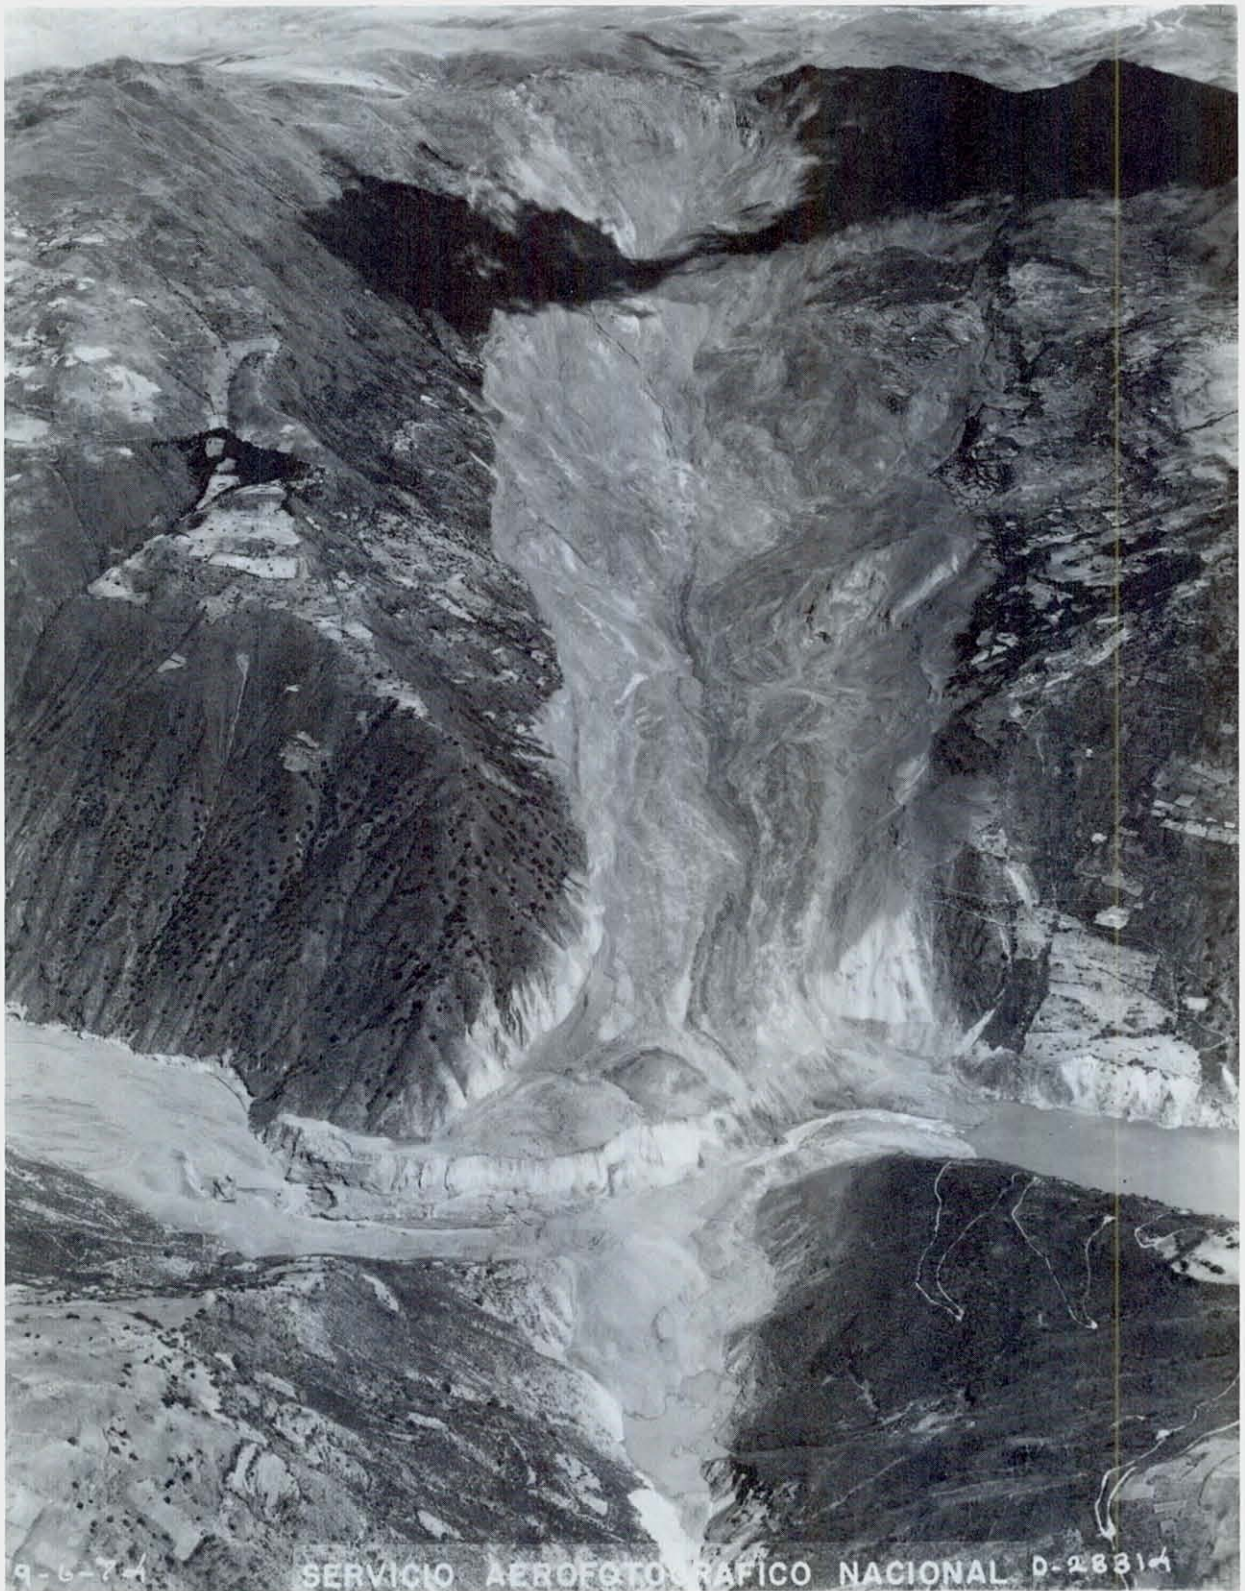
FIGURE 15. Oblique air photo taken June 9, 1974, the day following the major flooding from overtopping. (Servicio Aerofotografico Nacional, Peru)

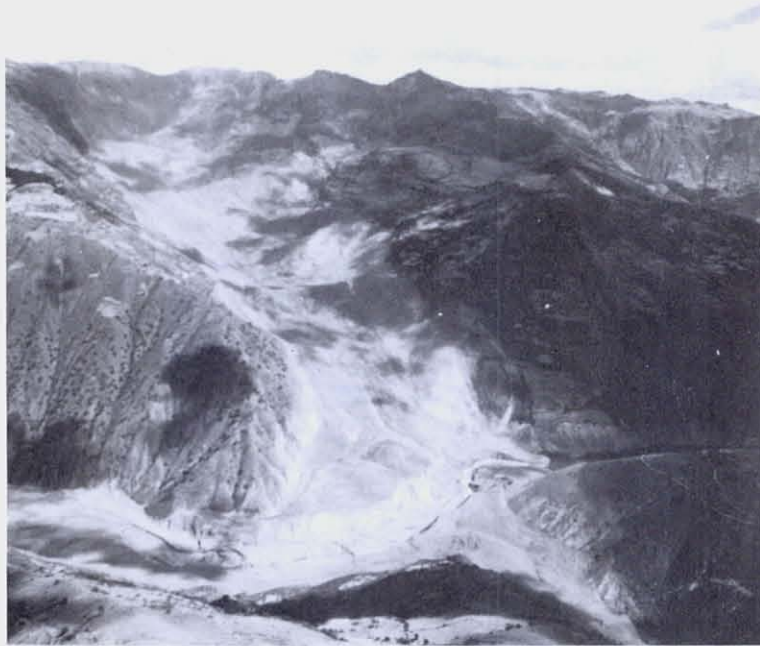
FIGURE 16. Oblique air photo taken July 7, 1974, about one month after overtopping.

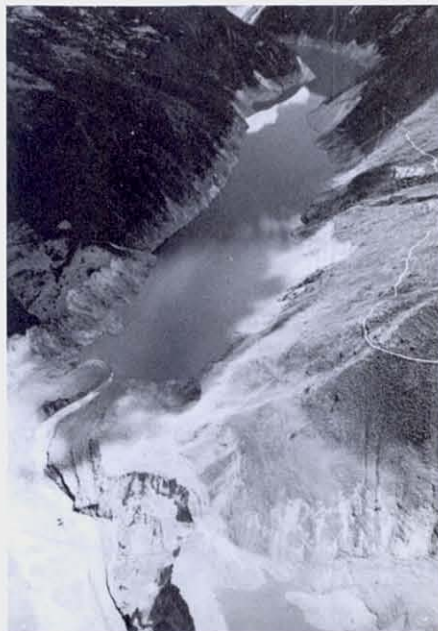
FIGURE 17. Air photo taken July 7, 1974 looking upstream from the debris dam showing the debris fall back zone and some areas of mud splatter in the foreground.

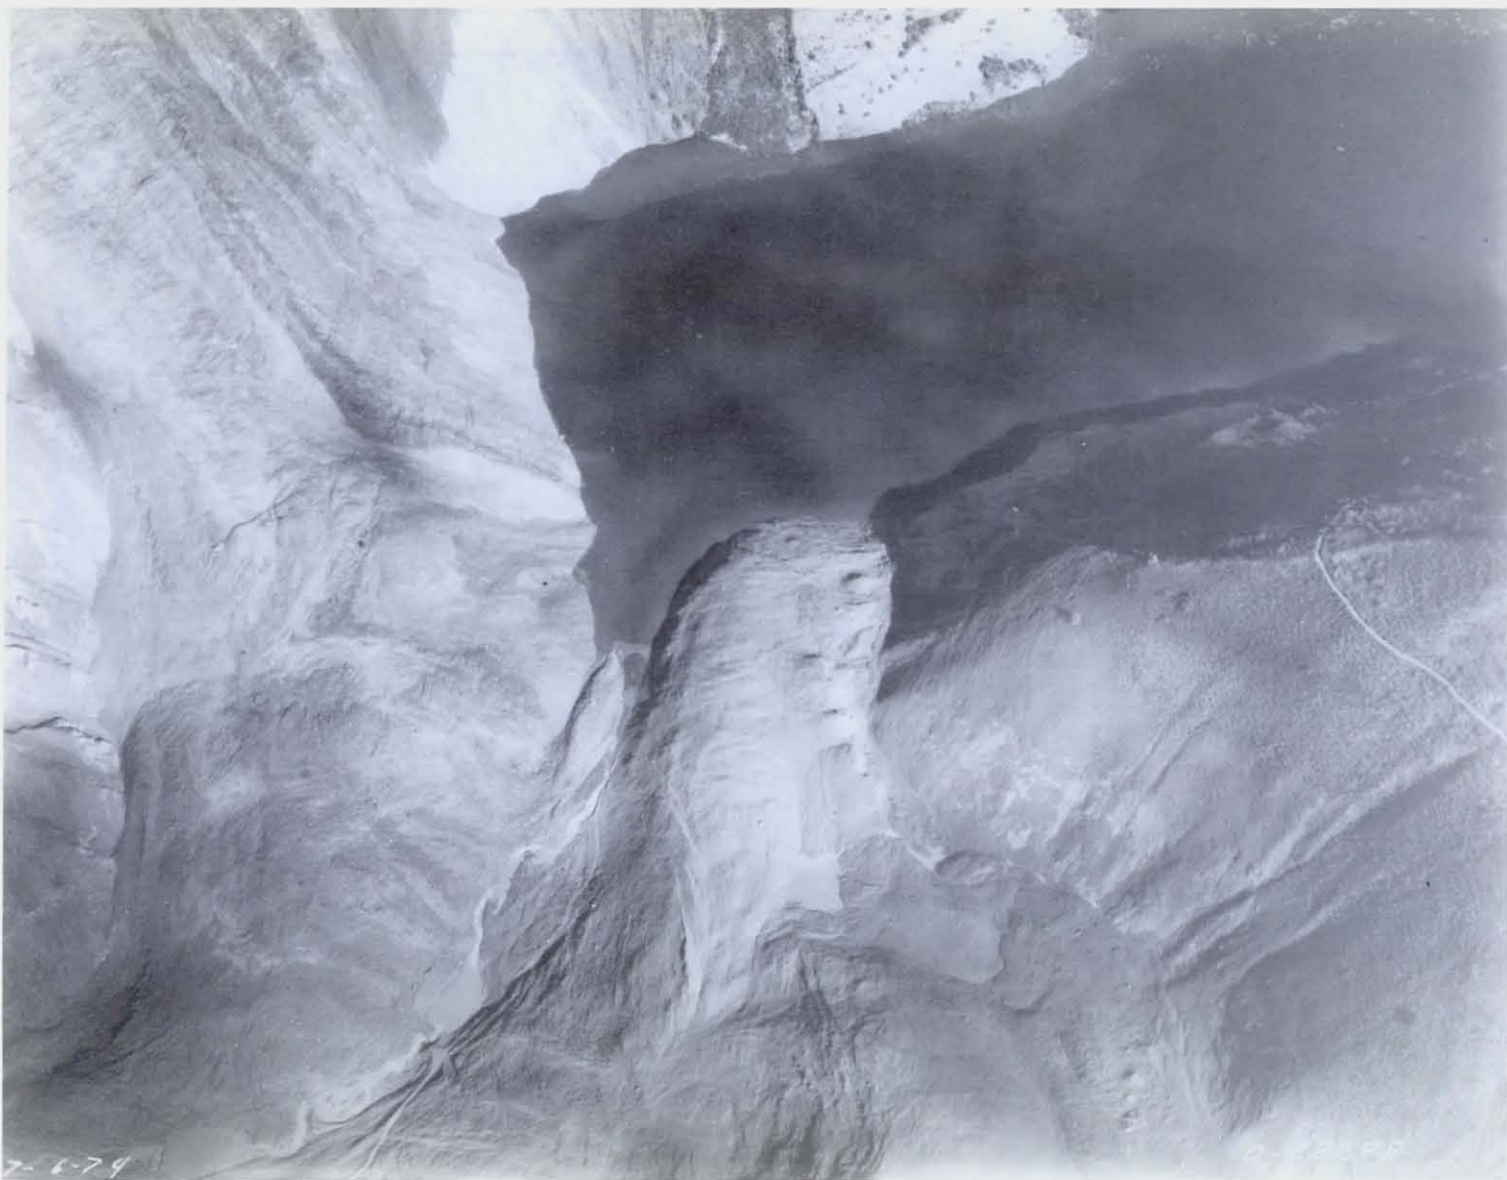
FIGURE 31. Air photo taken June 7, 1974, just as the water began to trickle over the debris dam.  
(Defensa Civil Photograph)

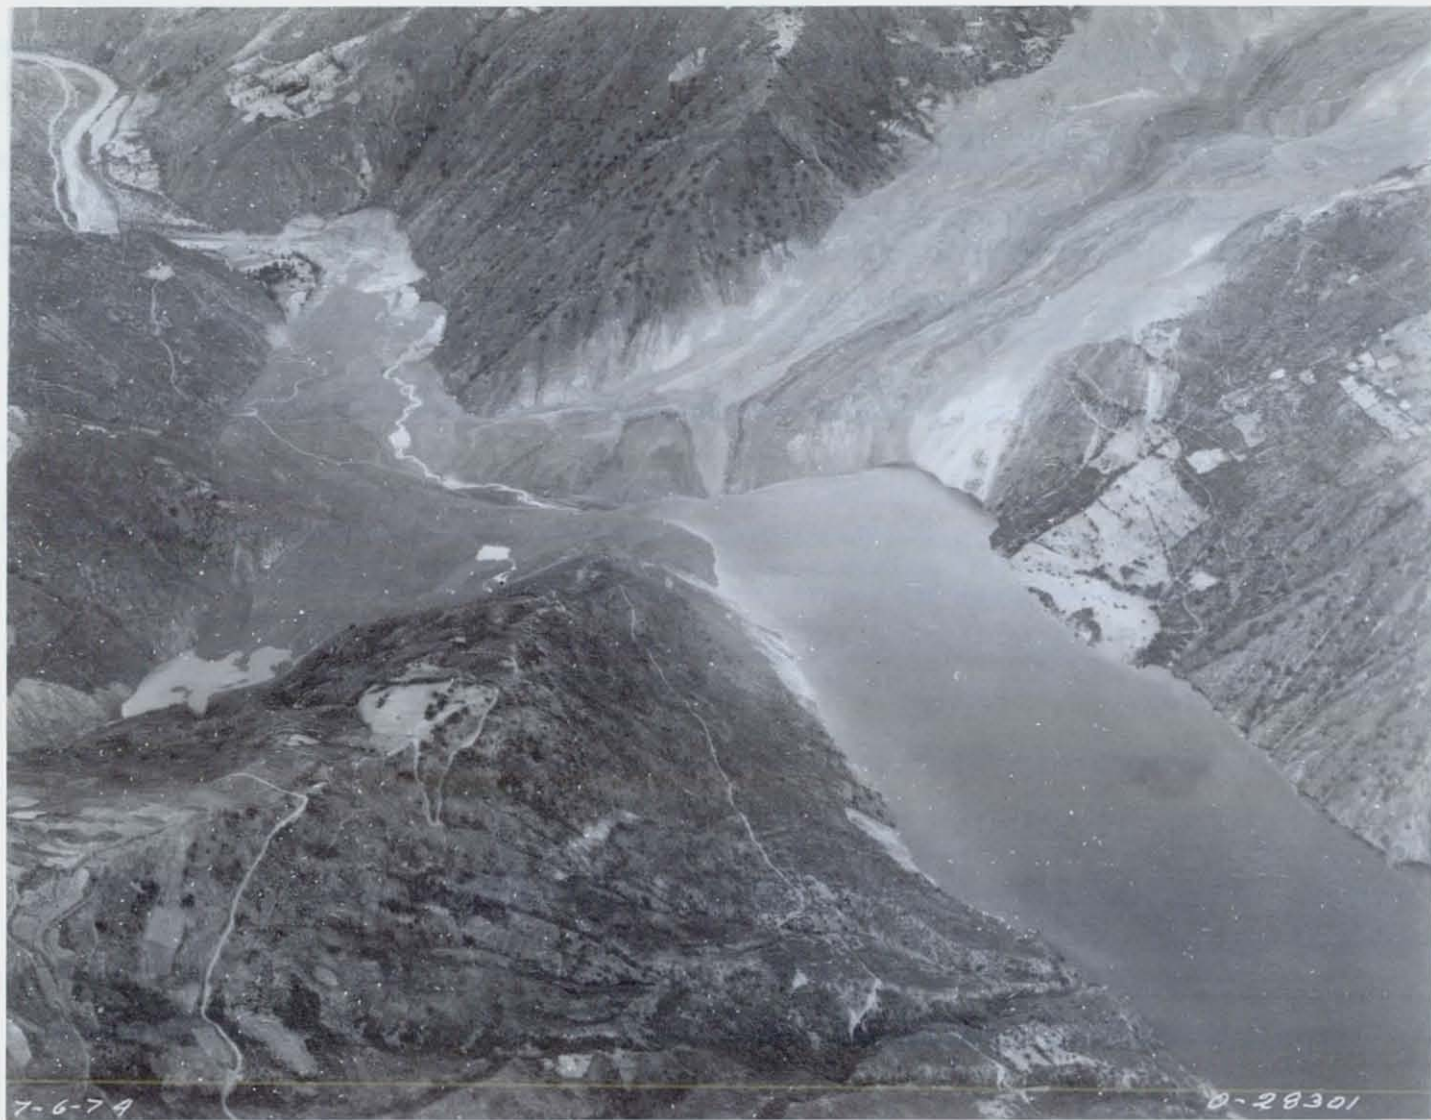
FIGURE 32. Oblique air photo taken June 6, 1974, showing water as it begins slowly to flow over the debris dam. (Defensa Civil Photograph)

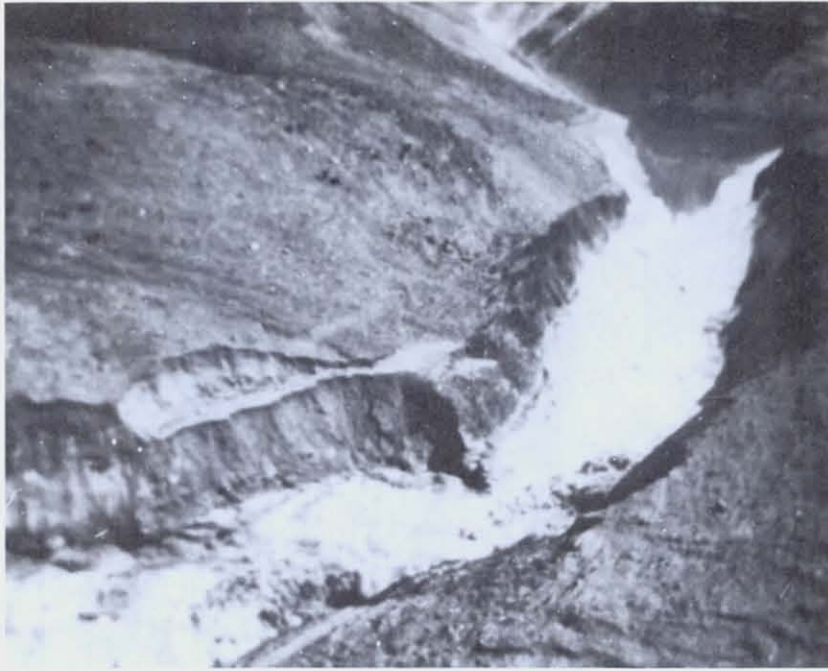
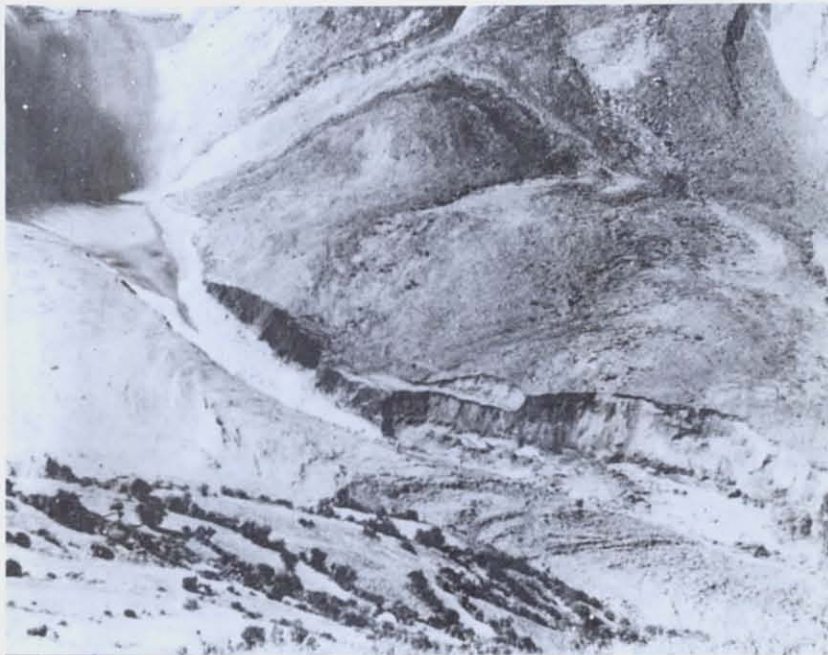
FIGURE 33. Two views of the Mantaro River flood over the debris dam during periods of high flow rate.

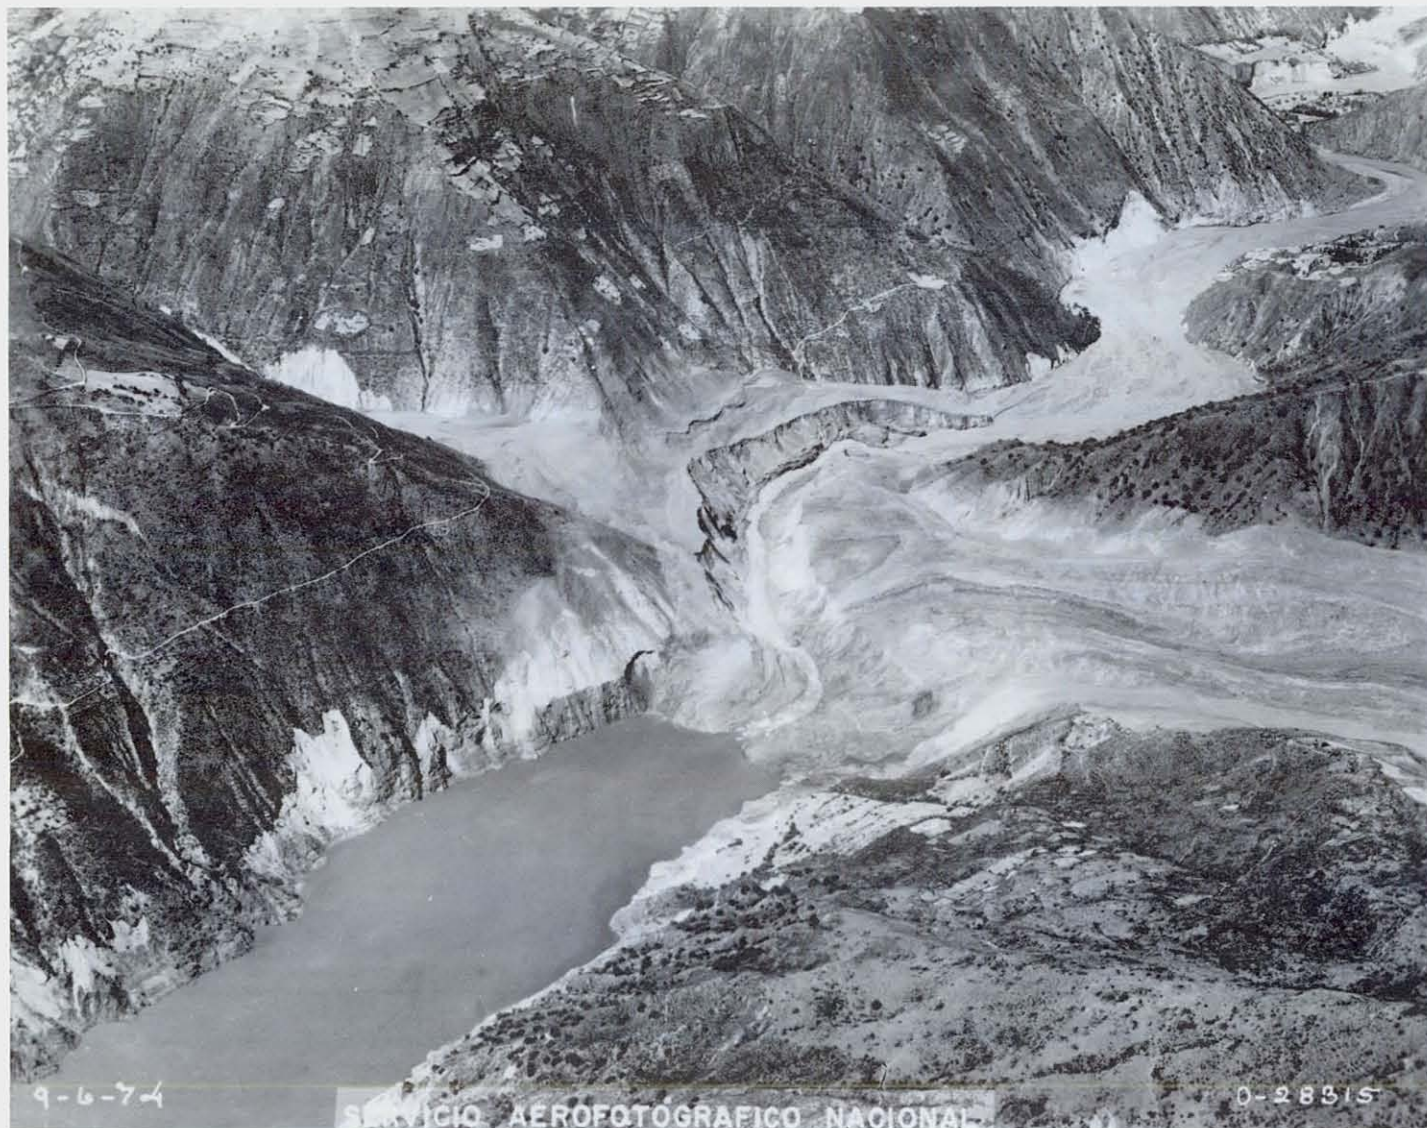
FIGURE 34. Oblique air photo looking downstream across the debris dam, taken June 9, 1974, the day after the flood. (Defensa Civil Photograph)

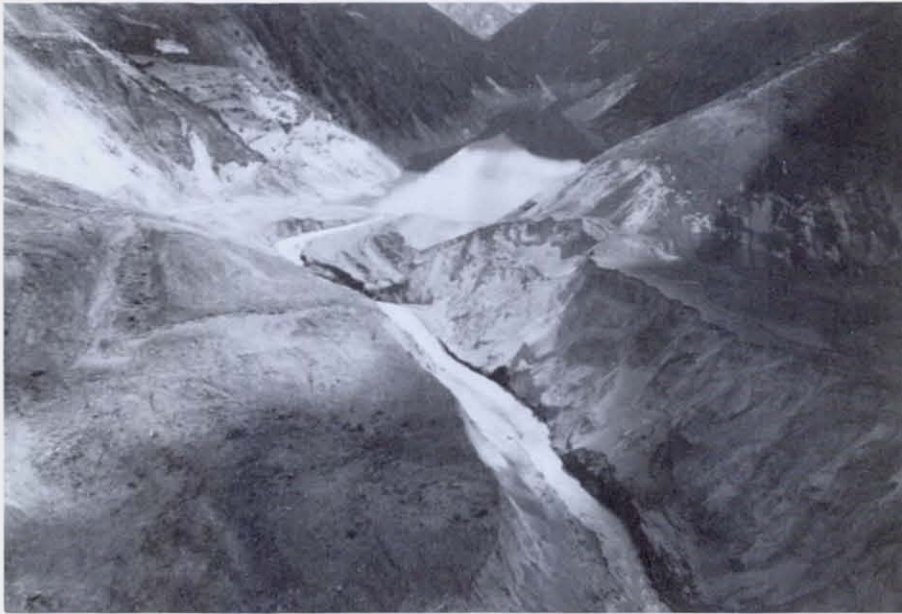
FIGURE 35. Air photo looking upstream across the debris dam, taken one month after the flood.

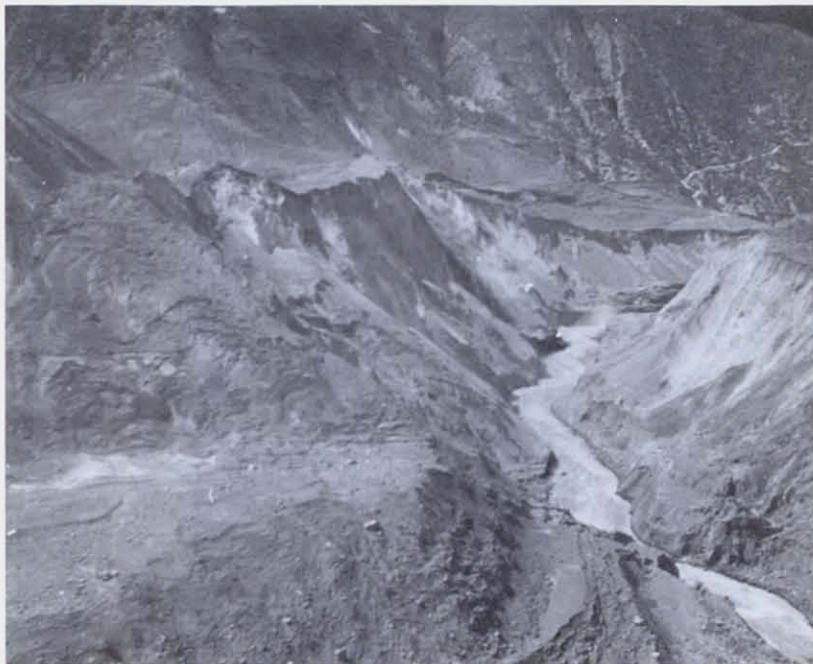
FIGURE 36. Air photo looking downstream along the erosion channel, taken one month after the flood.

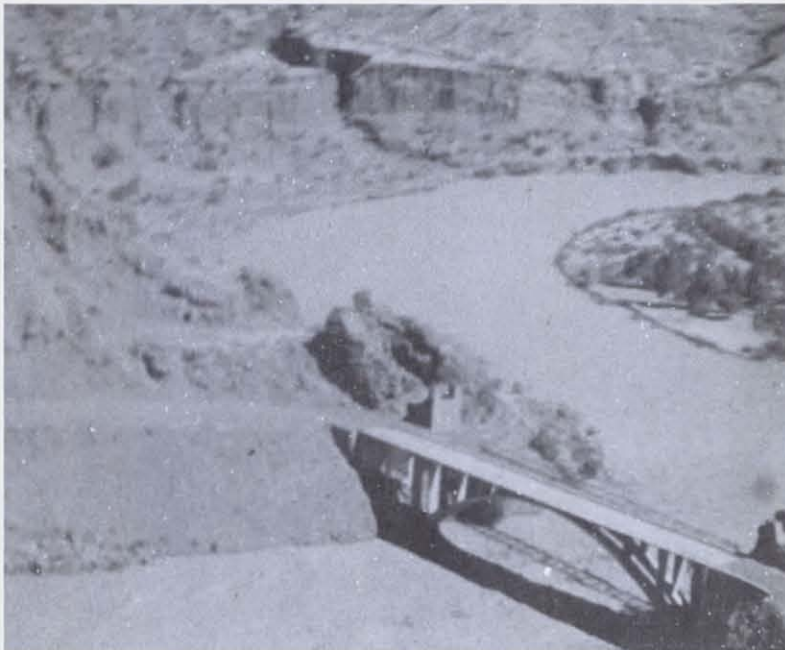
Because the inhabitants of the region had all been evacuated from the lower ground by the river prior to overtopping, the flood passed without causing any loss of life or human accident. However, there was considerable property damage. Upstream in the lake areas new slides developed as the lake level was rapidly lowered. Downstream, farmlands, houses, towns, and bridges were destroyed. A photograph of a concrete arch bridge at the town of Mayoc taken before the flood is shown in Figure 38. Another photograph of the same bridge taken just after it was destroyed during the flood is shown in Figure 39.

FIGURE 38. Mayoc bridge across the Mantaro River taken as the flood waters were rising. (Photograph courtesy of General Rodolfo Acevedo del Campo)
