# Miyagi-Ken-Oki, Japan Earthquake, June 12, 1978 Reconnaissance Report

# EARTHQUAKE ENGINEERING RESEARCH INSTITUTE RECONNAISSANCE REPORT

PETER I. YANEY, EDITOR

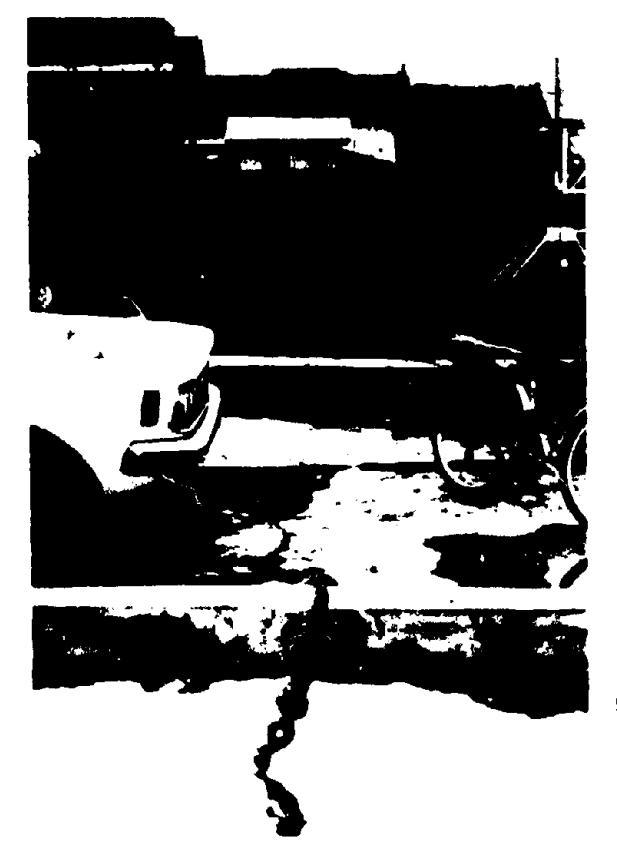
Figure 5 Site 2, Natori River

5c View west across tributary of Natori River. Dike section shown in Figures 5s and 5b is to right of houses in background of this figure. Note crack in concrete pavement in foreground is aligned with crack in retaining well in background.

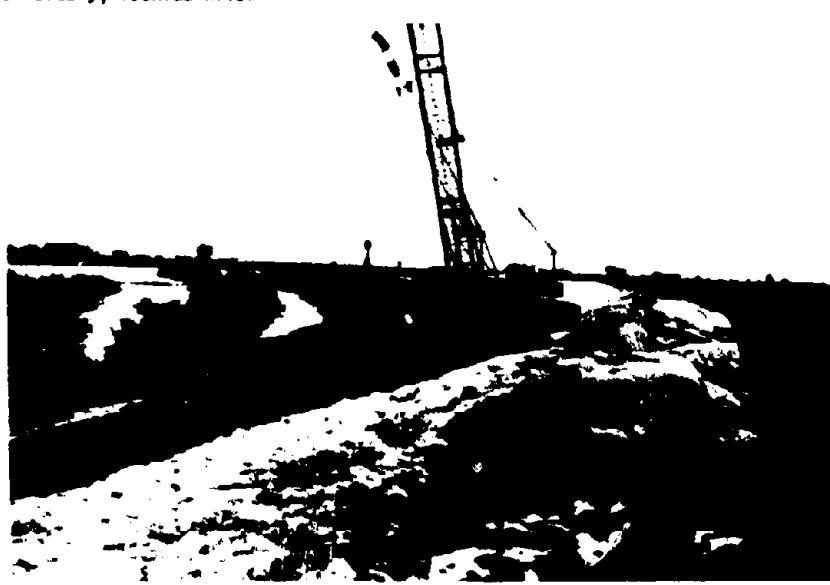
Figure 6 Site 3, Yoshide River

Yoshida River (Site 3). This was one of the most severely damaged sections of dike in Hiyagi Prefecture. Settlements of up to 1 m occurred over a distance of 5 km, longitudinal fissures opened (Figure 6), bulges appeared in some of the lower slopes, and sand boils were associated with fissures in some places. The fissures and bulges indicate that lateral spreading and slumping took place. The damaged section rests on the fan-delta of a small stream, and a boring near this site penetrated 15 m of silt, 2 m of fine sand, and 5 m of coarse sand (Tohoku Regional Construction Bureau, PMRI, unpublished data; Hase 1967). Bedrock lies at an average depth of 35 m.

6e View east (downstream) along section of dike where repairs are under way. Dike crest settled as much as 1 m over a length of 5 km. Note sand bags used in repair process.

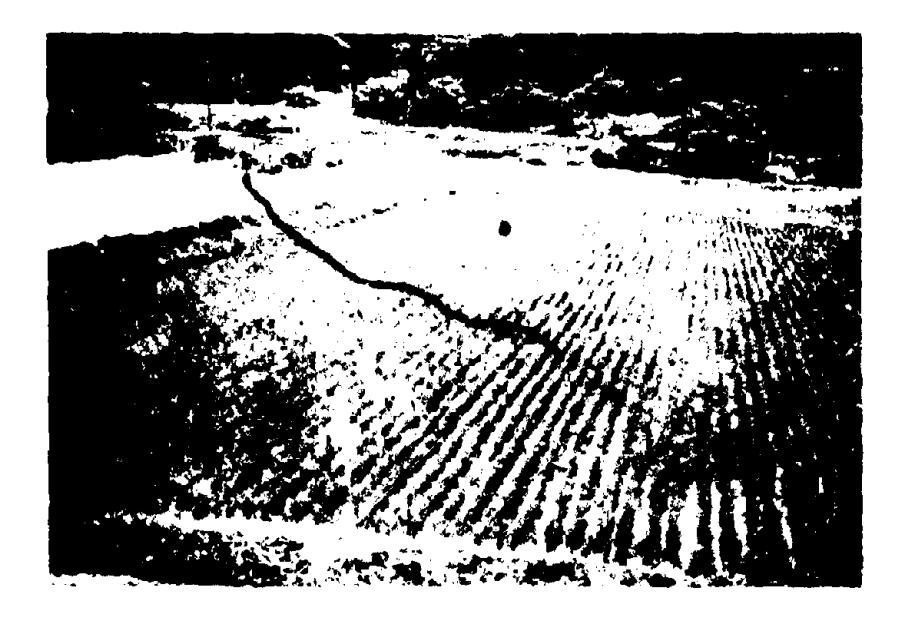
Eal River (Site 4). Sand boils were common in an old river channel at Site 4, on the right bank of the Eai River (Figure 7). A concrete block fonce near this channel was cracked by lateral spreading toward the old channel bank (Figure 8). Damage to the dike on this side of the river was minor. Across the river from Site 4, cracks up to 80 cm deep and 10 cm wide affected a 2-km-long section of the dike. In this area, the foundation material apparently contains much soft clay. Some layers of silt and sand may also be present. The dike was built relatively slowly, and significant settlement took place during construction (K. Kawashima, PWRI, oral communication).

Figure 8 Site 4, Eal River: View southwest from crest of dike. Crack (indivated by heavy line) in fence and rice field caused by lateral spreading toward bank of old channel in background.

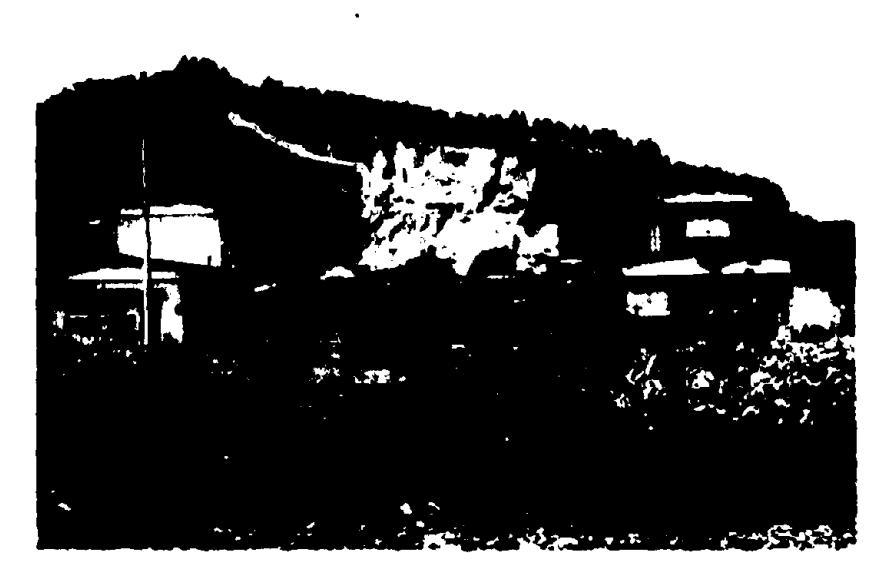
Site 1. Two of the largest rockfalls from the earthquake occurred near Matsushima town west of the Takagi River as failures on steep (greater than  $45^{\circ}$ ) natural slopes. The larger of these (Figure 2) occurred in an extensively weathered and jointed Niocene pumice tuff breccia (from Geologic Map of Niyagi Prefecture, legend in Japanese) exposed in a  $45^{\circ}m$  scarp. The slope affected is approximately 110 m wide, and the volume of debris produced is about 6,000 m<sup>3</sup>. The rockfall damaged four houses built next to the slope (Y. Tsuruya, 1978, unpublished data). As seen two weeks after the earthquake, the landslide had clear plastic tarps stretched across the upper parts of the scarp to protect against rainfall infiltration and possible further movement.

Figure 2 Rockfall on steep slopes near Matsushima town. Fallurc is in Hiocene pumice. Photograph was taken approximately two weeks after the earthquake. Tarps were already stretched over most of the slope to protect against further movement arising from rainfall infiltration (photograph by David Keefer).

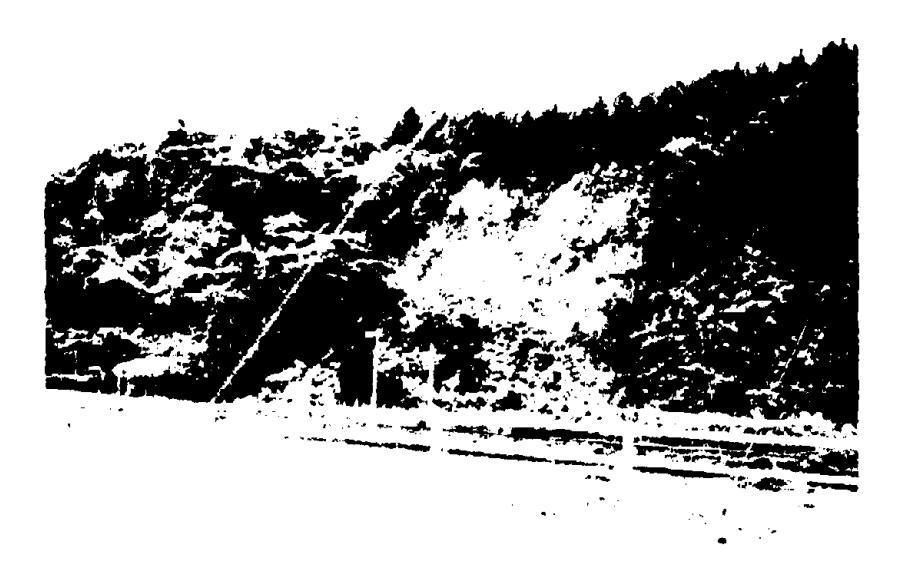
and about 50 m wide (Figure 3). This rockfall produced blocky debris with boulders up to 0.5 m in diameter. The scarp reveals extensively flactured bedrock. The fracture surfaces probably provided planes of weakness along which the rock failed.

Figure 3 Rockfall on steep slopes in volcanic clastic sediments (photograph by David Kaafer).

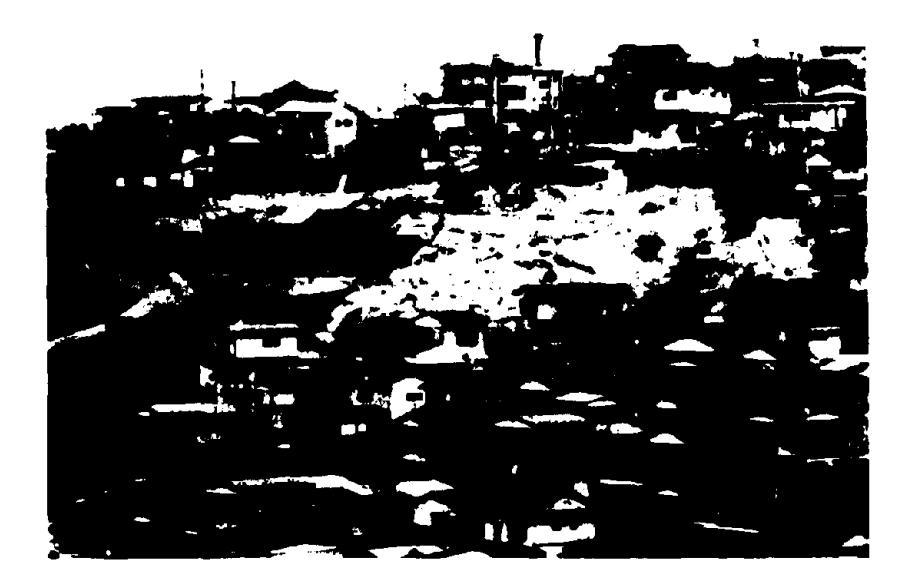
Site 7. Many slope failures took place in artificia: fiel within the city limits of Sendai. These were mainly rotational slumps. In the neighborhood of Midorigaoka, a large rotational slump occurred in a fill slope of about 15°, composed of gravelly clay. From headwall scarp to toe, the slide extends approximately 70 m horizontally and 20 m vertically (Y. Matsuzaki, 1978, unpublished data); it is approximately 30 m wide and about 14 m in maximum thickness, and the volume is thus approximately  $30,000 \text{ m}^3$ . The bulk of the slide occurred above and to the right of one of the 1,400 concrete slope-protection dams (sabo works) in Sendai (Figure 10). The entire slide had been covered with nylon tarps at the time the photograph was taken to prevent rainfall inflltration. Many houses had been removed from this slope in past years due to rainfall-induced slumping; as a result, only one house, near the headwall scarp, was severely damaged by the seismic-induced sliding. Figure 11 shows the area originally occupied by this house, which was removed. The fence in the figure clearly shows the rotational component of slide movement. About 5 m of horizontal displacement (Y. Matsuzaki, 1978, unpublished data) occurred, placing the toe of the landslide mass no more than several meters from houses below, as shown in Figure 12. The house shown in Figure 12 was subsequently evacuated because of the threat of recurrent movement of the landslide mass.

Figure 10 Rotational slump in artificial fill in Sendai (area covered by tarps), which destroyed one house and is threatening others. To left of slump is concrete slope-protection dam (sabo works) (photograph by David Keefer).

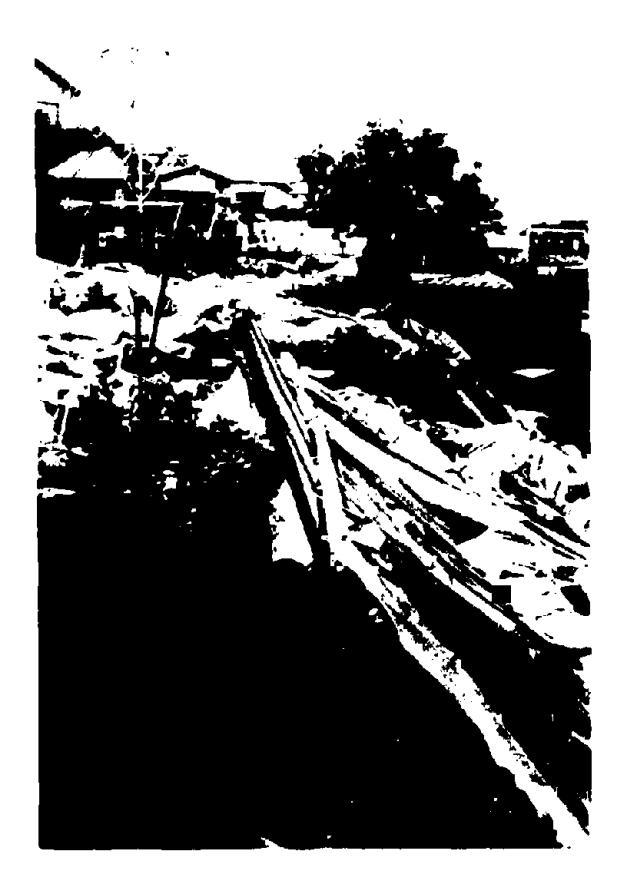
Figure 11 Area near head of rotational slump where a severely damaged house had to be removed. Fance shows rotational component of slump movement.

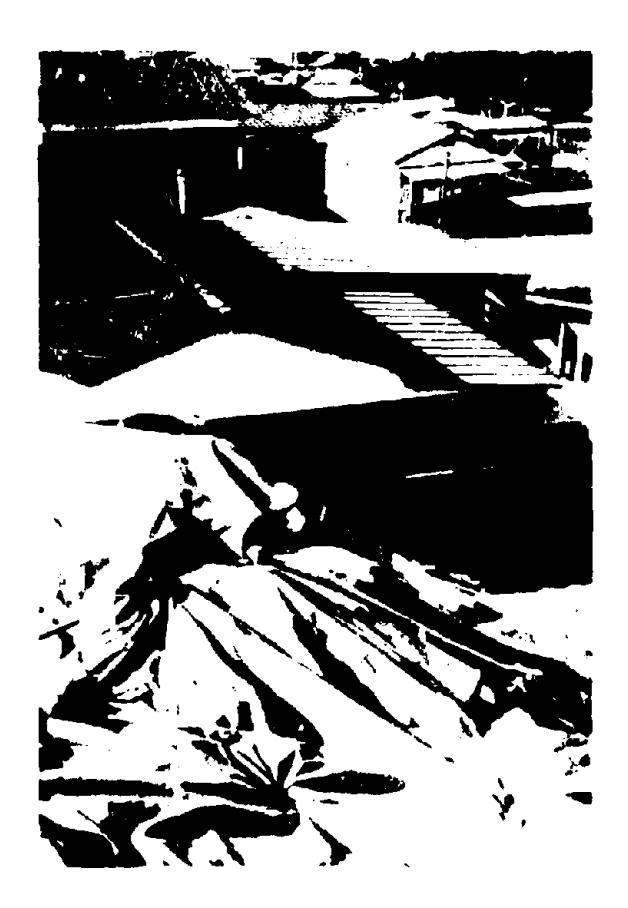
Figure 12 The of slump and house below in danger of being overridden by slide mass. House had been evacuated.

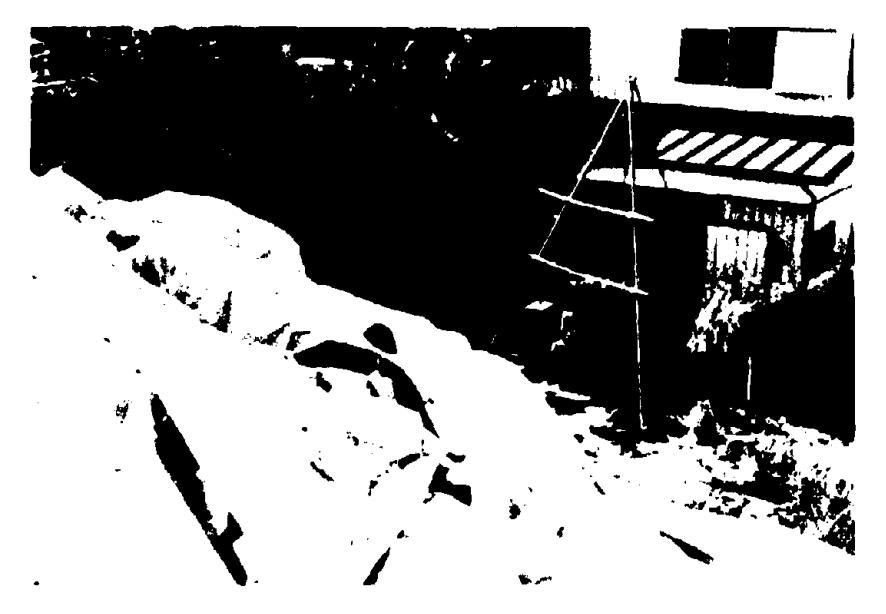
Engineers from the Sabo Section of the Miyagi prefectural government were engaged in an extensive geotechnical investigation of the landslide mass and surrounding area. Many boreholes had been drilled in the slide material, as shown in figure 13, to establish the depth of the failure surface, to provide samples for strength testing, and to emplace slope inclinometers to monitor any continuing movement. Adjoining areas were also being drilled and monitored to detect any movement that might be precipitated by the slide, such as deformation downslope from the toe in response to the weight of the ancroaching slide mass and retrogressive slumping upslope from the headwall scarp.

Figure 13 Area near slump toe showing borehole being drilled as part of geotechnical investigation of the failure and surrounding area.

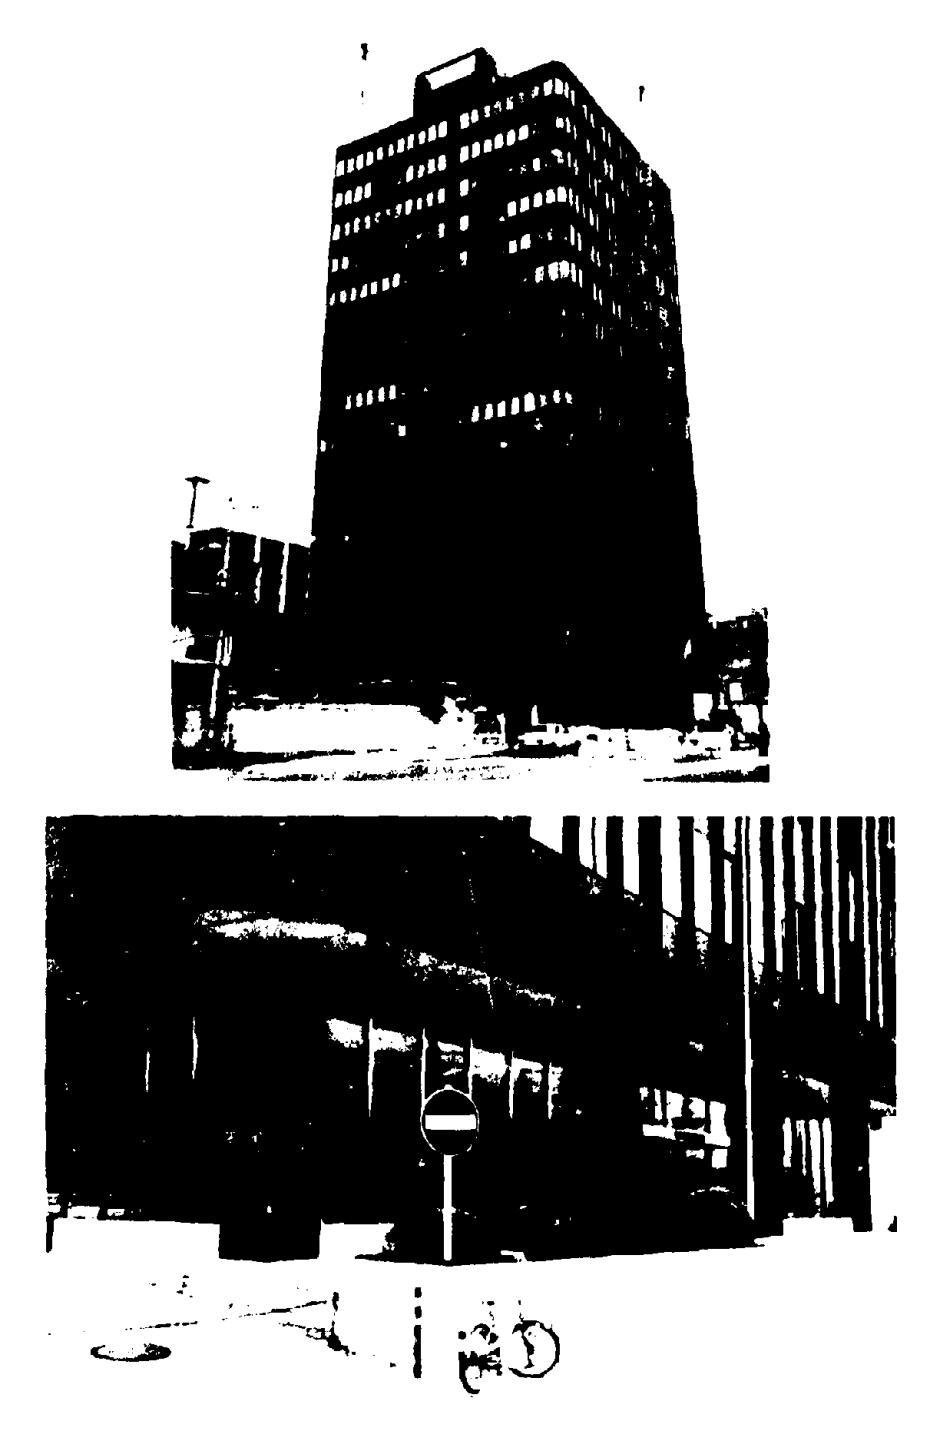
Figure 6 Sendai Second Government building. This 17-story, steel frame structure in downtown Sendai was built in 1973. The building was designed using dynamic analysis and has a raft foundation. Ground conditions are considered to be good. The building is instrumented (fifteenth floor, second basement, and downhole at -40 m). There was no apparent structural damage.

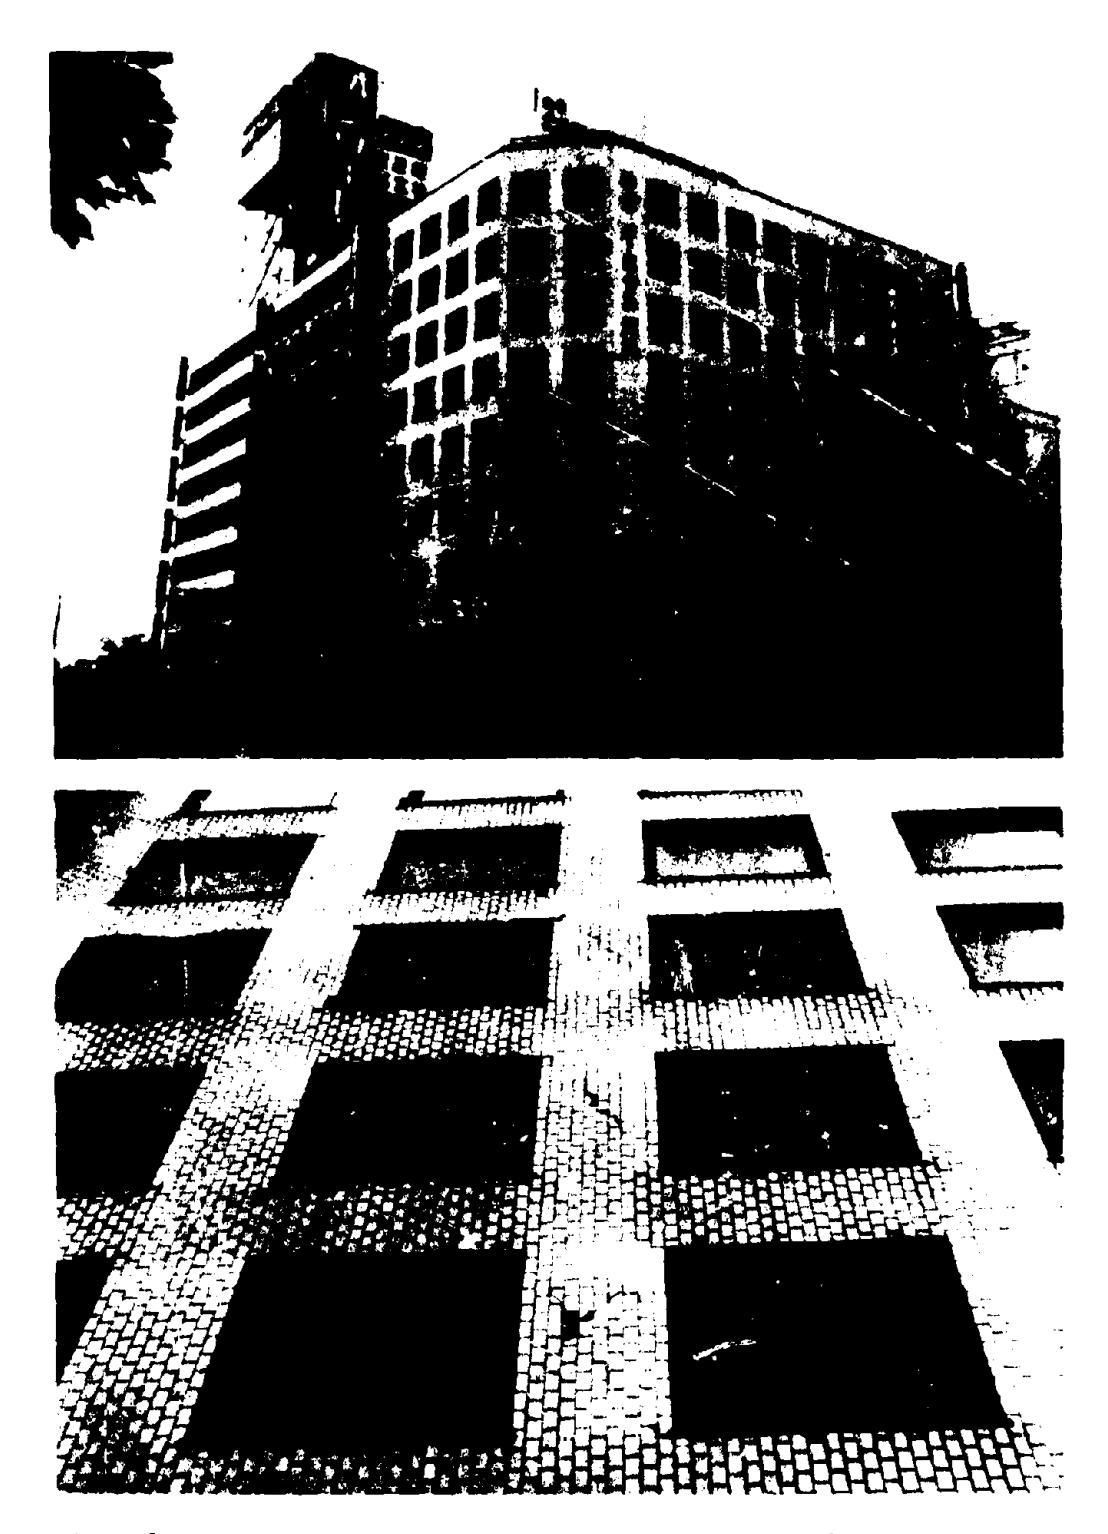
Figure 8 Second Eastern Building Company building: a typical modern, 8-story building in downtown Sendai. The only apparent damage to the exterior, which is veneered with glazed tiles, was cracking through the spandrels and the shear walls (on the sides opposite those illustrated).

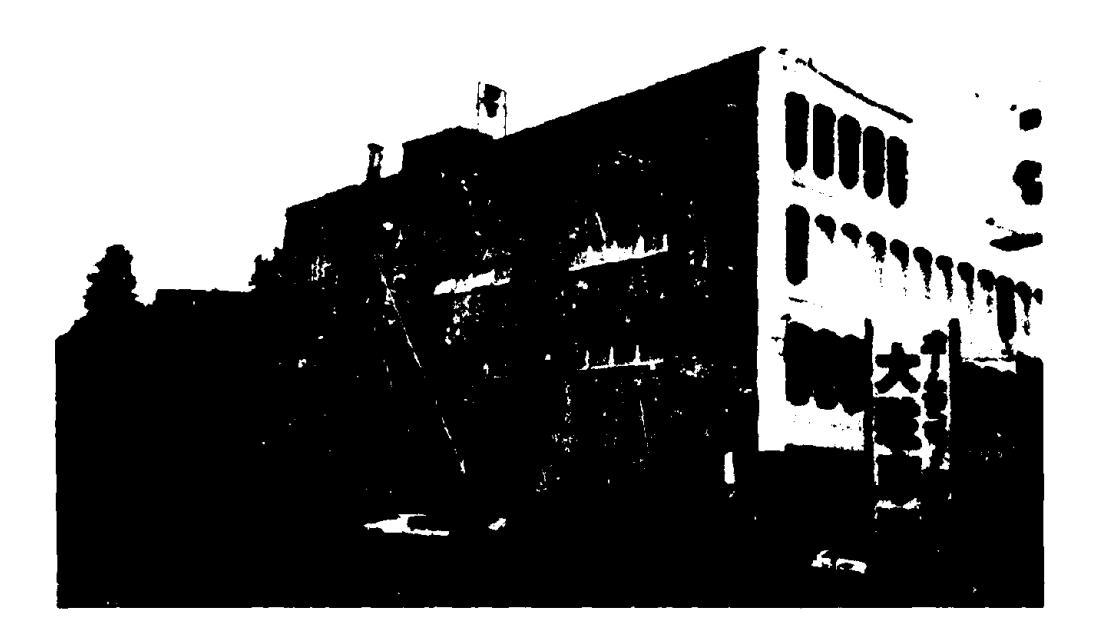
Figure 9 Sasaki building, outskirts of Sendai: a damaged 4-story steel-framed building. The exterior precast concrete panel anchorages falled. (Kawahoku Newspaper Co. photograph)

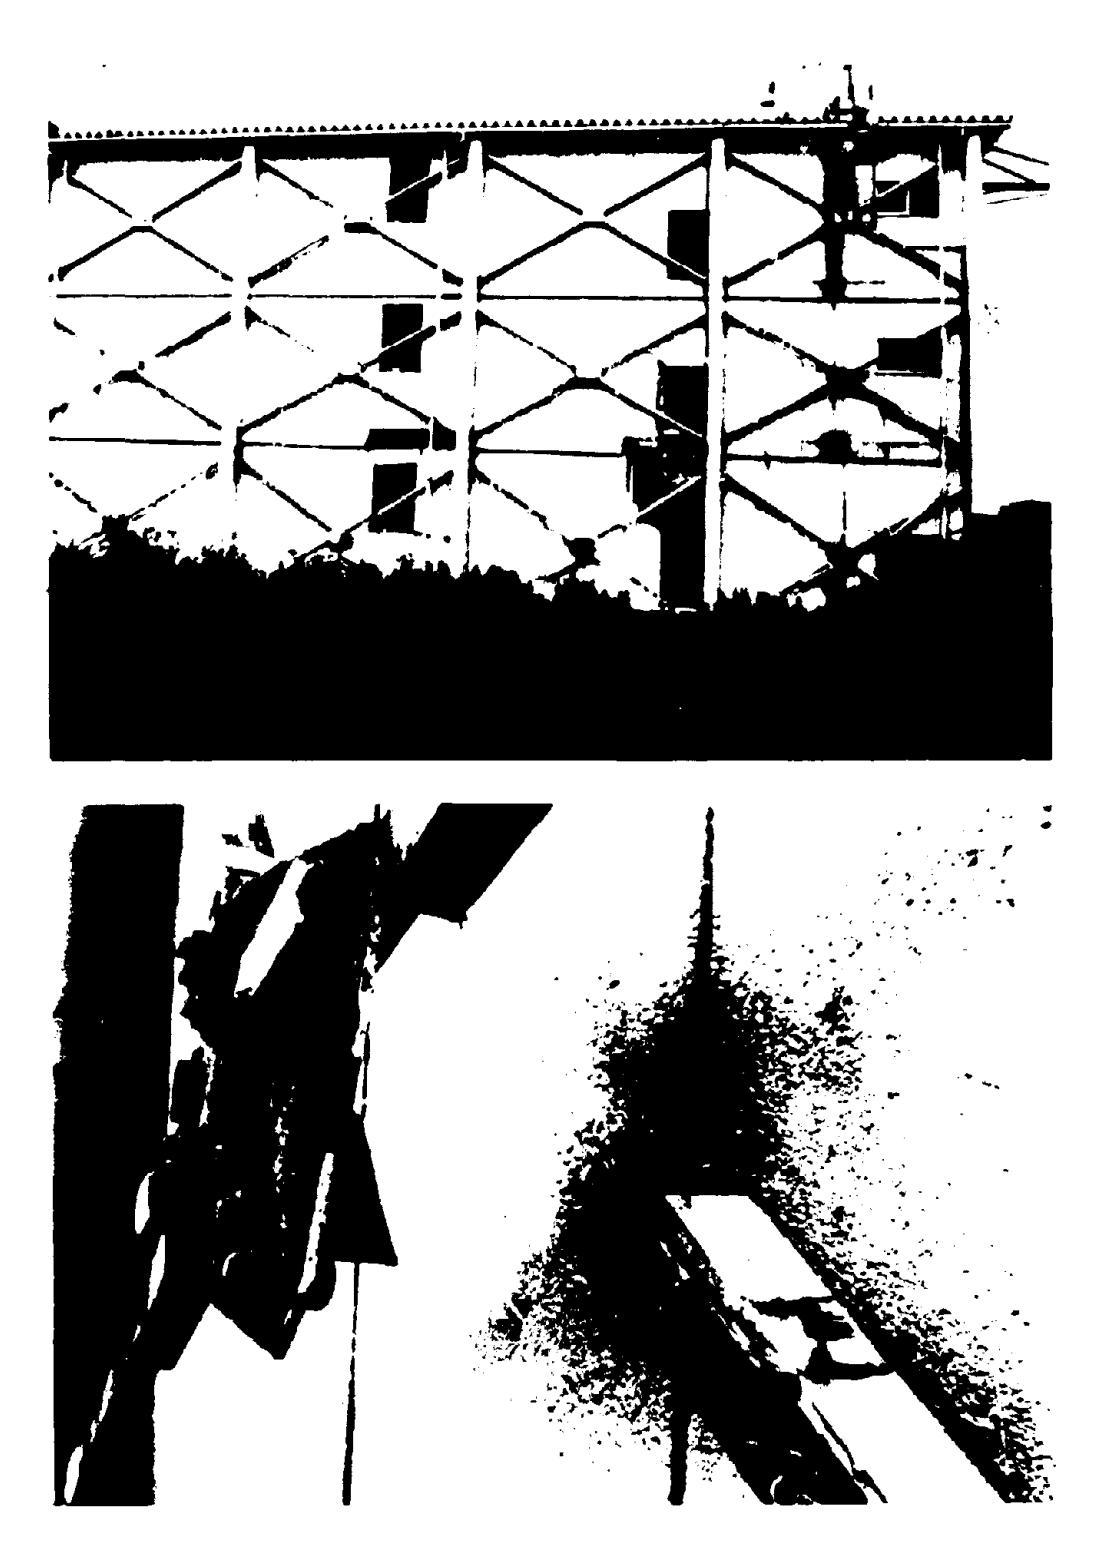
Figure 10 Outskirts of Sendai: a damaged steal-frame furniture warehouse. Some of the transverse diagonal braces failed at their midheight connections. Generally, rupture occurred at the bolt holes. (Courtesy of Professor Lemura, University of Kyoto)

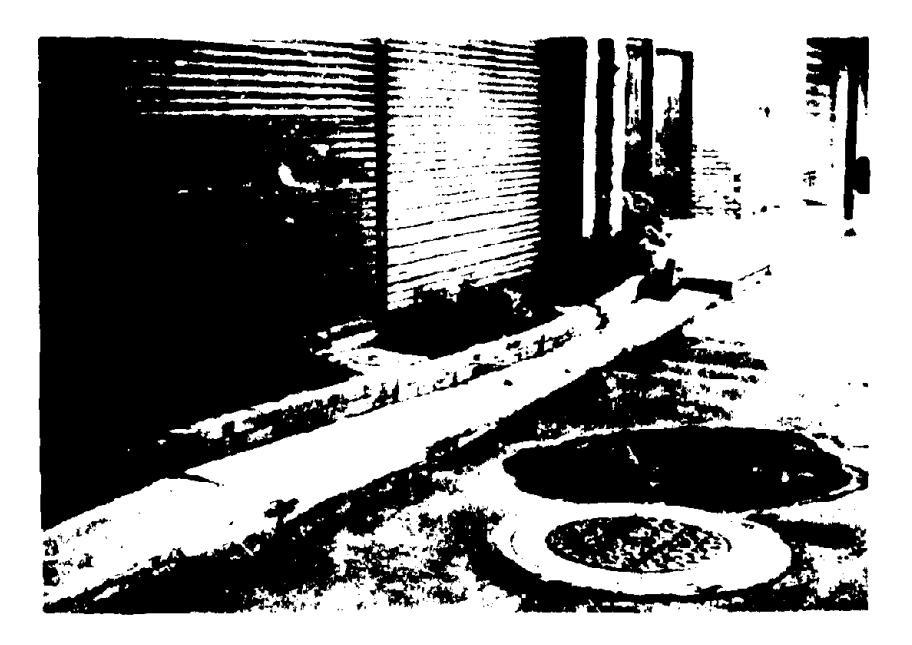
Figure 11 Droshicho area, Sendal: sidewalk and other damage from ground settlement and deformation.

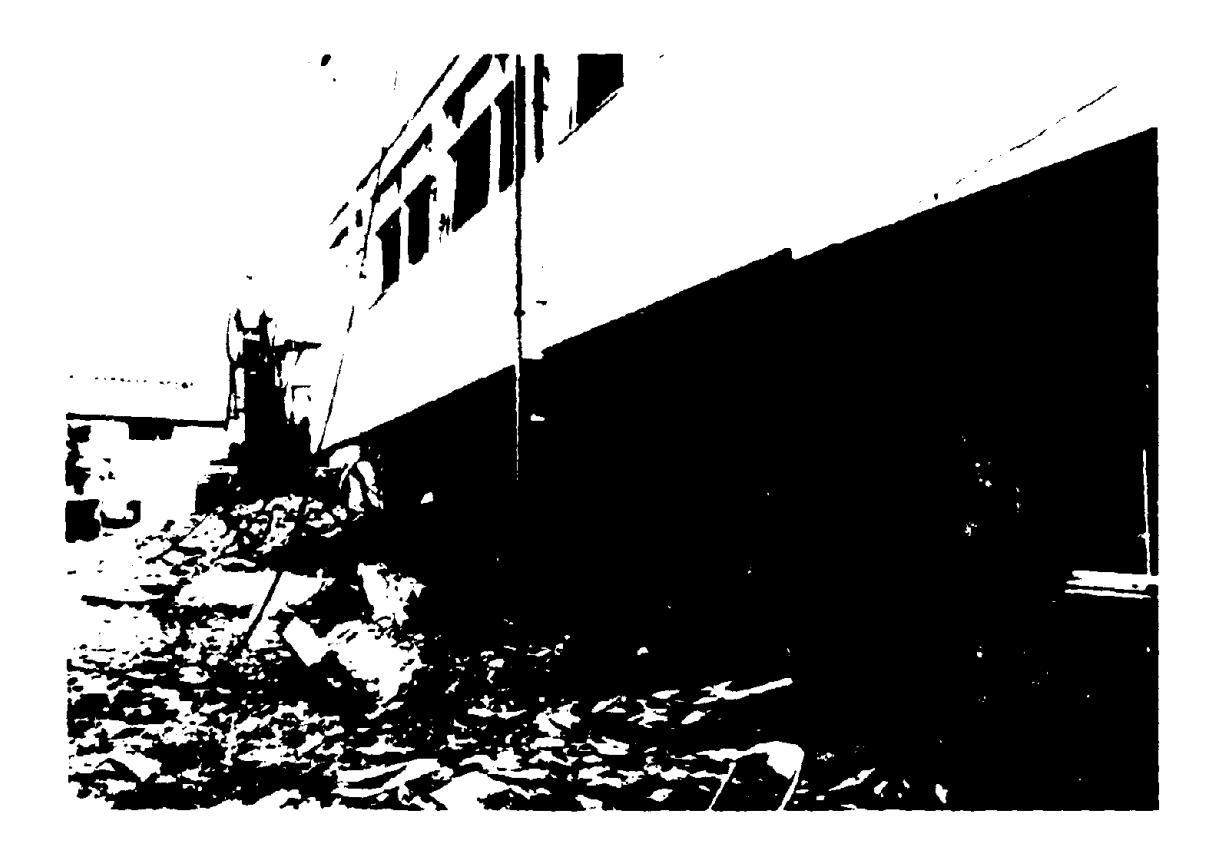
Figure 12 Maruyoshi bullding, Oroshicho area, Sendai: view from the north. This 3-story reinforced concrete frame building, one span by three, suffered almost total collapse of the first floor.

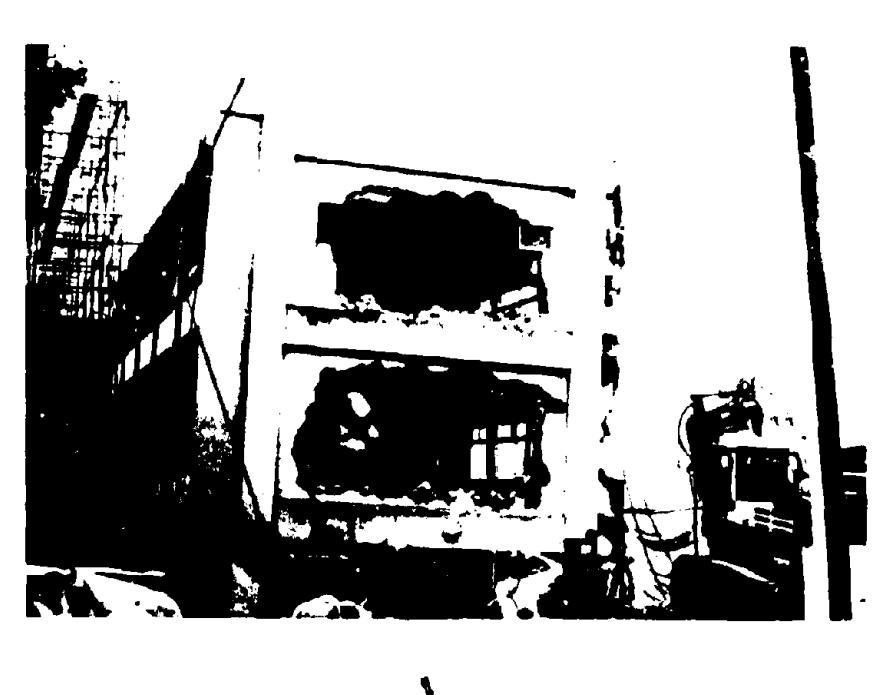
Figure 13 Maruyoshi building, Oroshicho area, Sendai: view from the east. Failure of the first-story columns in shear caused the collapse. The end walls (the shear walls on the ground floor) are being demolished. Detail photograph of joint at top of first-story column shows shortening and the use of undeformed bars, a common practice in the Oroshicho area.

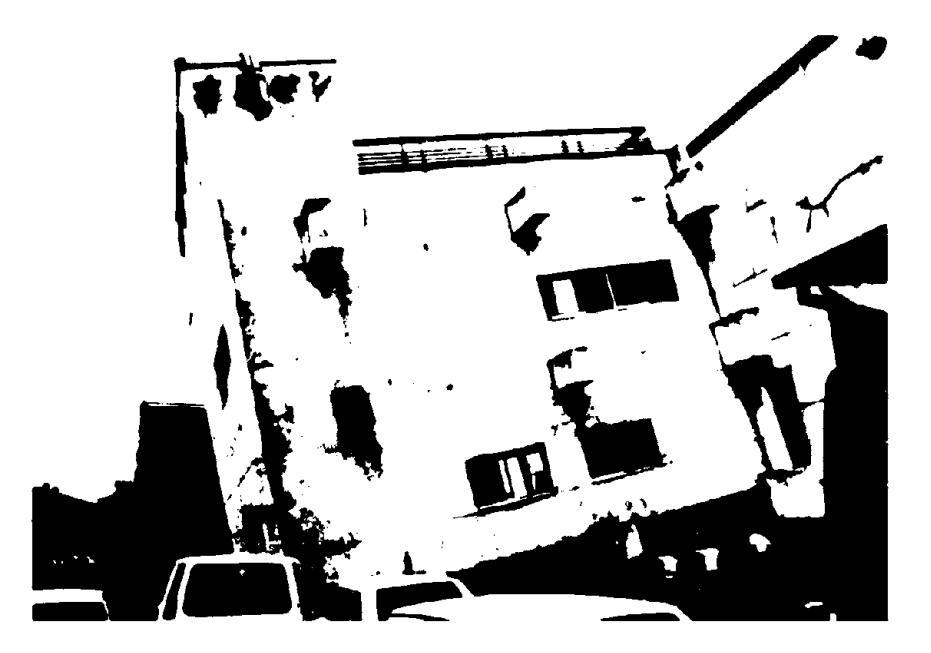
Figure 15 Obisan building, Oroshicho area, Sendal: view from the south. The upper stories rotated as a rigid body when the first-floor column support was lost.

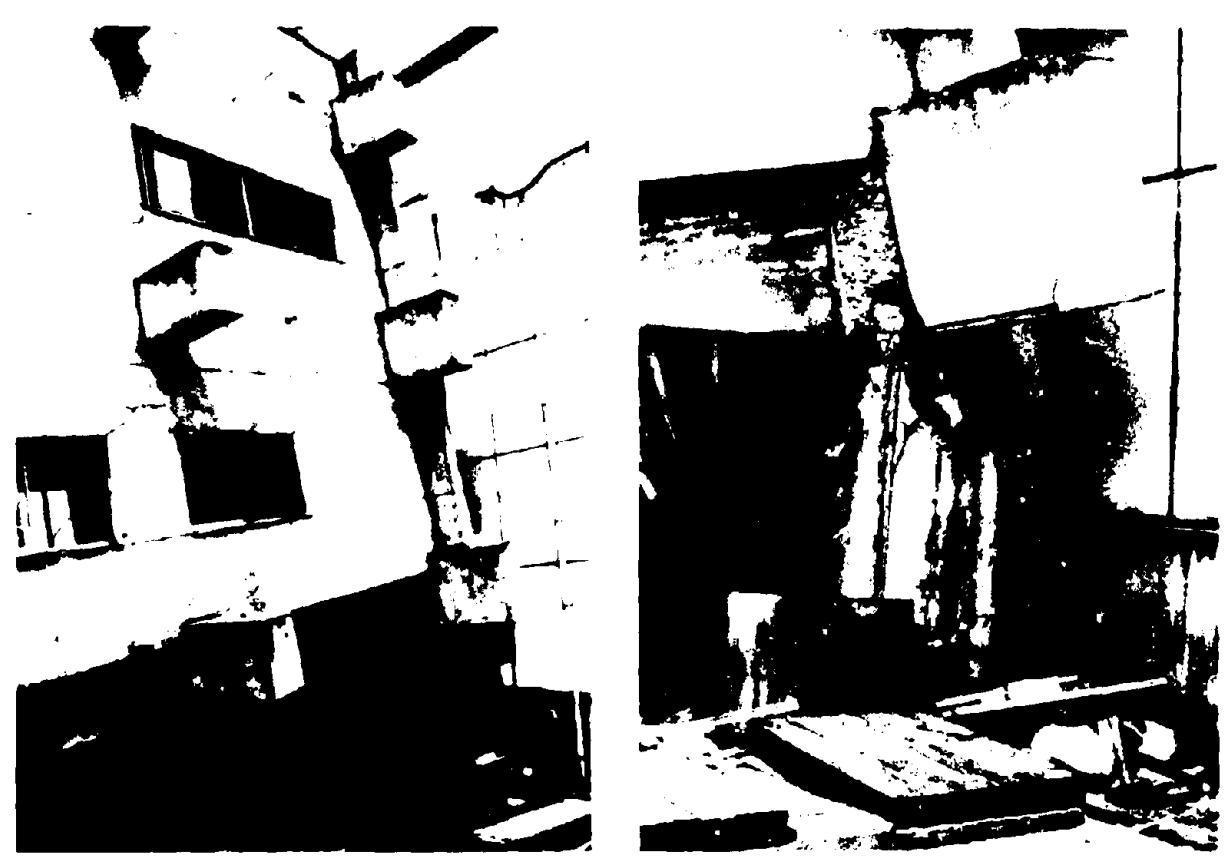
Figure 16 Oblsam building, Oroshicho area, Sendai. Rotation of the structure led to a disintegration of the four corner columns. The reinforcing bars that can be seen are undeformed.

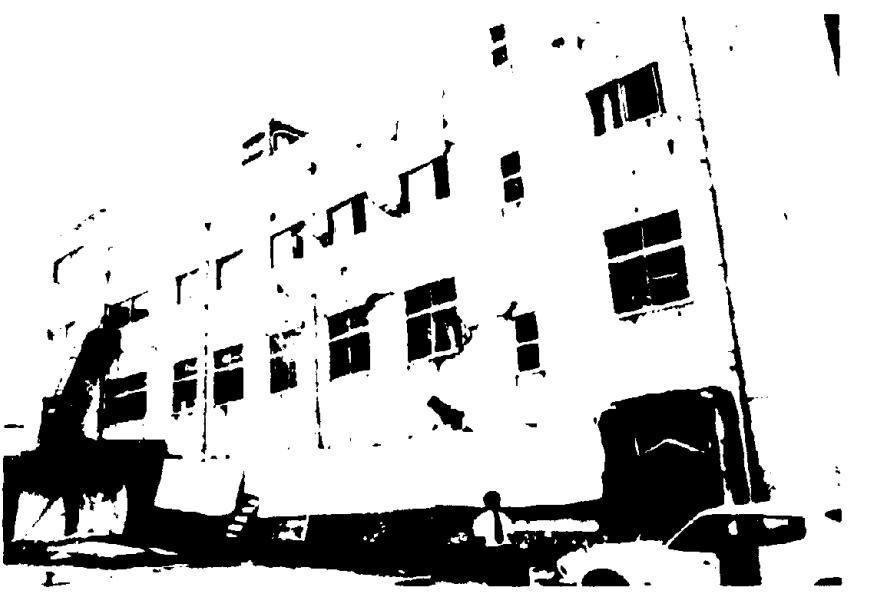
Figure 17 Kinoshita building, Droshicho area, Sendai: view from the east (rear). This 3slory reinforced concrete building is two spans by six. The transverse foundation of the structure settled 10 to 15 cm along a middle column line, contributing to the extensive diagonal cracking.

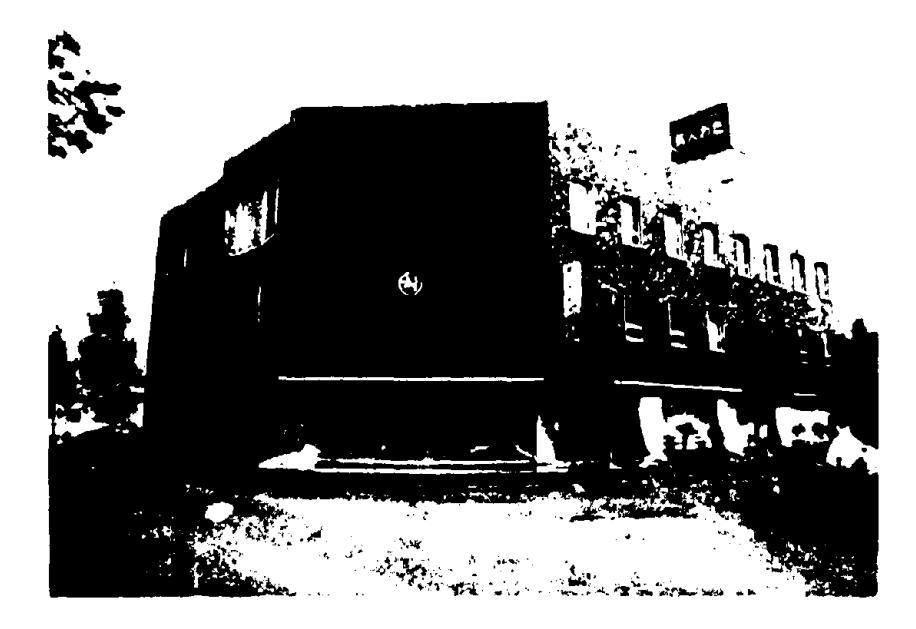
Figure 18 Kinoshita building, Oroshicho area, Sendai: west face. This face suffered less apparent damage. The 2-story reinforced concrete penthouse also suffered extensive damage.

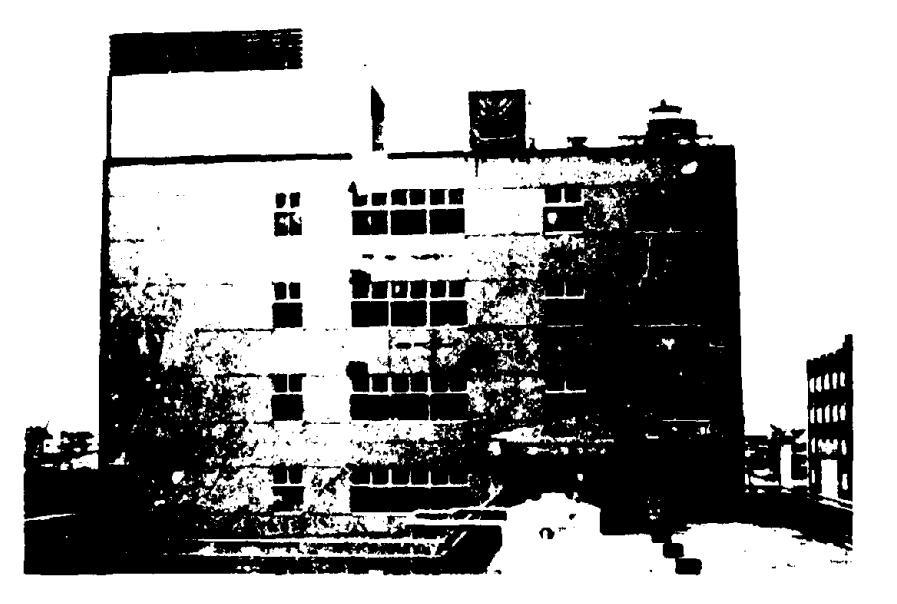
Figure 19 Maruhong building, Droshicho area, Sendai: east building, east face. This 6-story reinforced concrete building shows extensive shear cracking in the panels between winnow openings. The east and west buildings are separated by a 3-cm construction gap; there is no evidence of pounding between the buildings.

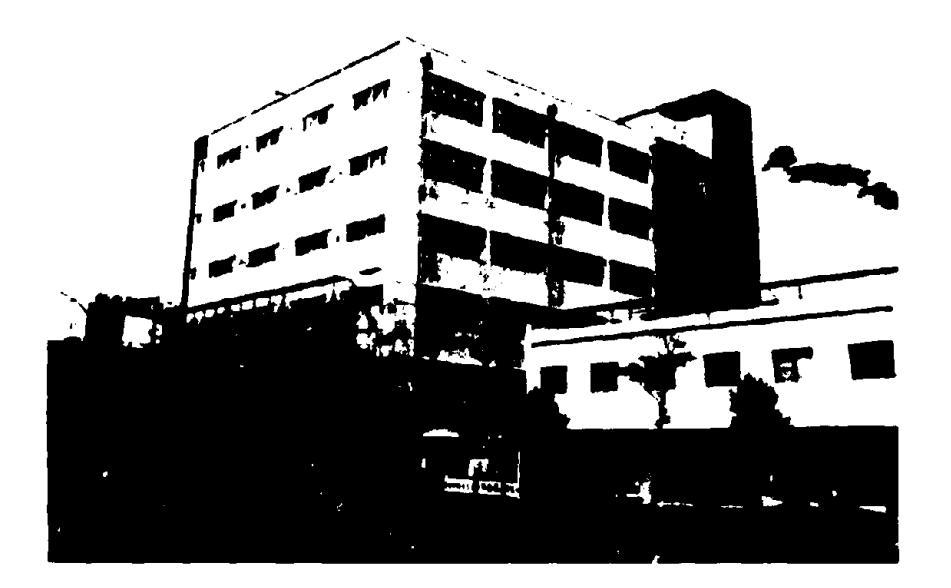
Figure 20 Maruhong building, Oroshicho arma, Sendai: west building, wast face. Extensive cracking of nonstructural curtain wall panels and shear cracking between windows was observed. The decorative ceramic brick facing on the north wall did not appear to have been damaged.

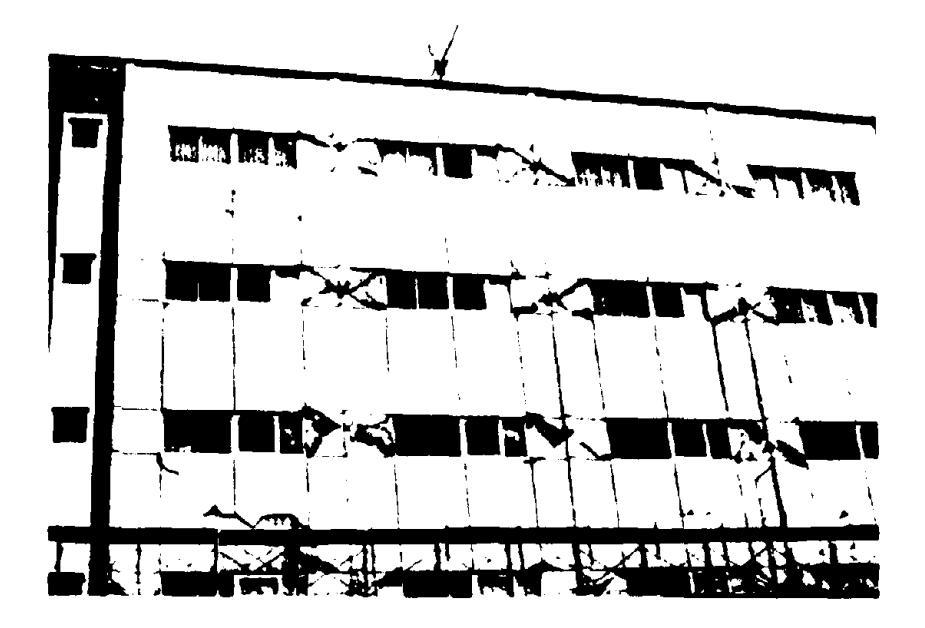
Figure 21 Maruhong building, Oroshicho area, Sendai: west building, west face. Details of damage to the nonstructural window spandrels can be seen.

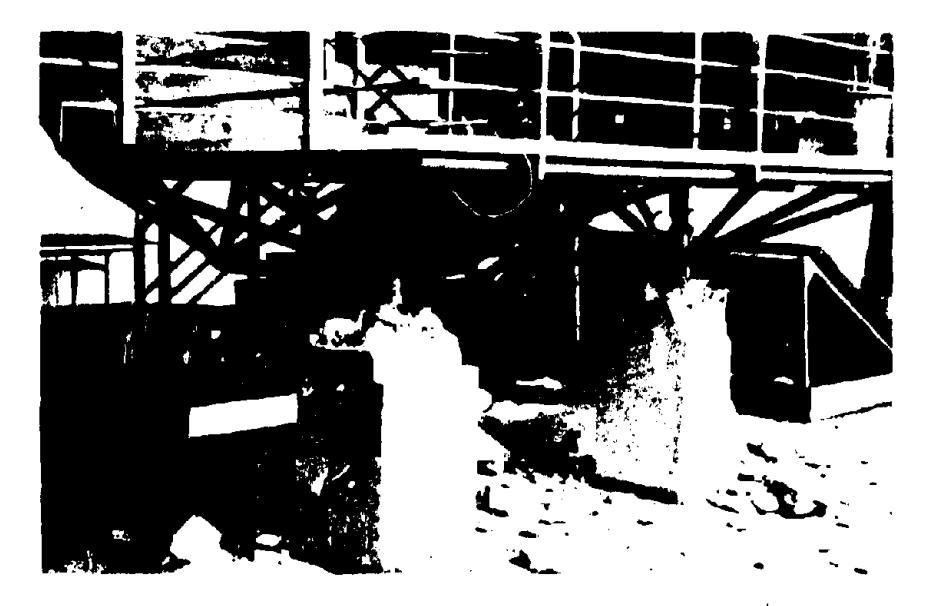
Figure 24 Yazaki Industries buildings, Droshicho area, Sendai: interior damage in the steel-frame 2-story building; caused by the collapse and impact of the failed 4-story concrete structure shown in Figure 23.

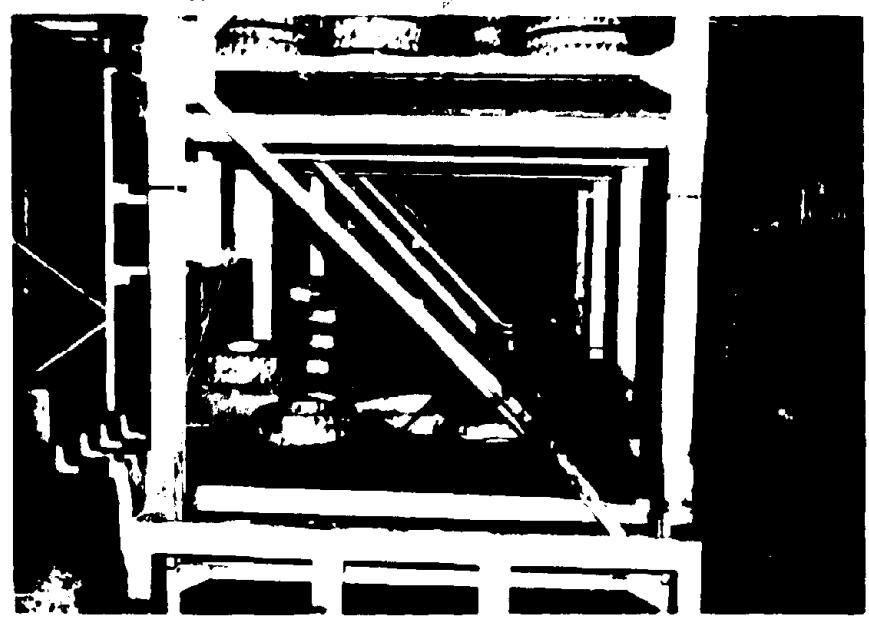
Figure 28 Yazaki industries building, Oroshicho area, Sendal. The steel-frame warehouse contains a number of multilevel, tubular-steel storage racks for storing heavy gasmetering equipment. They are either bolted down or are welded to steel plates embedded in the concrete floor. The racks were damaged at the ground-level, transverse braces, but none collapsed, probably because of the extensive use of diagonal bracing.

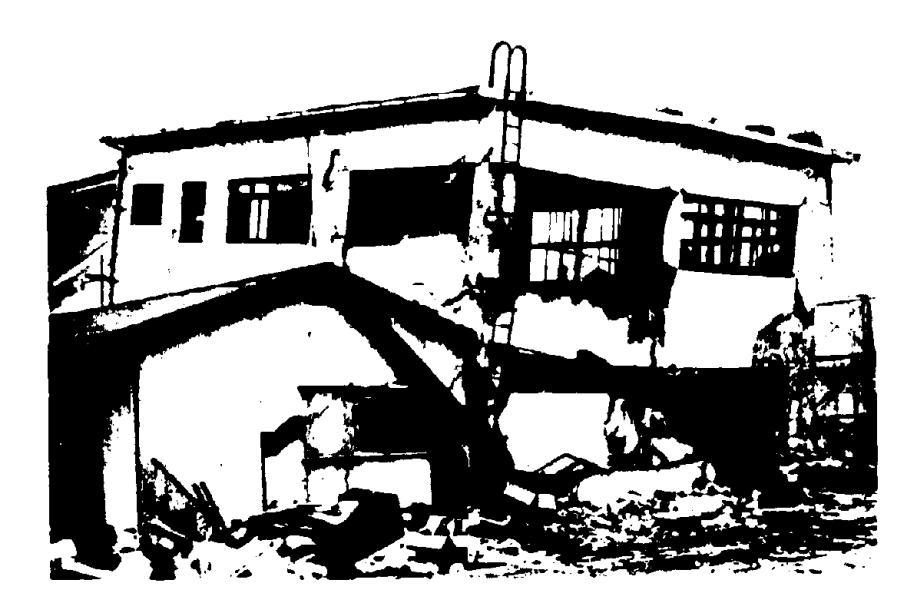
Figure 29 Paloma Building, near the Oroshicho area of Sendal: a 2-story, reinforced concrete building. The structure has two spans by three. There is a shear wall at one end; failure occurred at the opposite end, which is supported only by columns. The exposed concrete in the failed columns appeared to be of inferior quality. Column stirrups, 9 mm in diameter, were spaced 30 cm on centers.

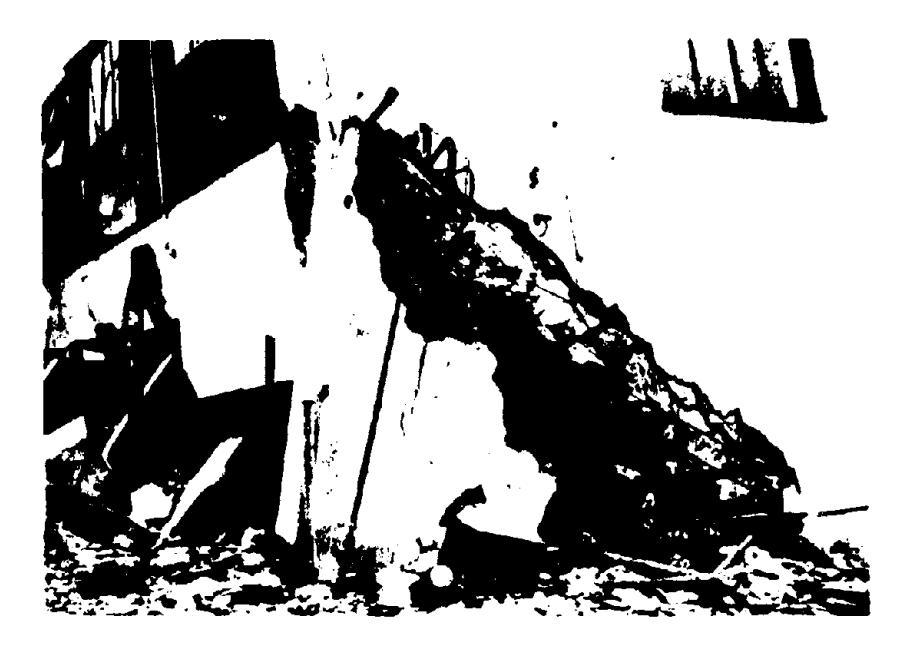
Figure 30 Paloma Building, near the Oroshicho area of Sendal: detail of the failed wall.

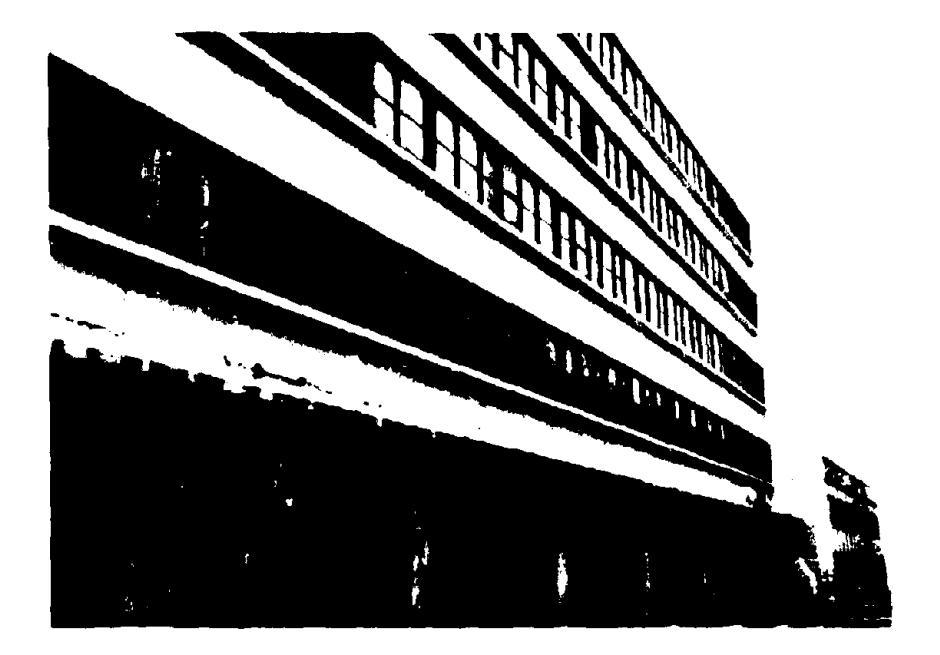
Figure 34 Tohoku Institute of Technology, Building 5: partial view of the north facade. The most serious damage to the framing occurred on this side; most columns have failed in shear.
