# Miyagi-Ken-Oki, Japan Earthquake, June 12, 1978 Reconnaissance Report

# EARTHQUAKE ENGINEERING RESEARCH INSTITUTE RECONNAISSANCE REPORT

PETER I. YANEY, EDITOR

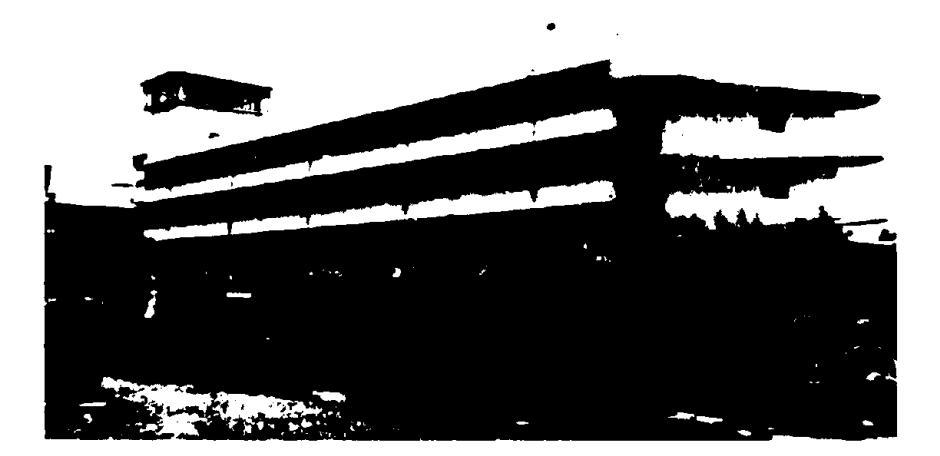
Figure 40 Tohoku Institute of Technology, Building 3: a general view of the 4-story building that was damaged severely. It was designed under the pre-1972 code for a ground acceleration of 0.20g.

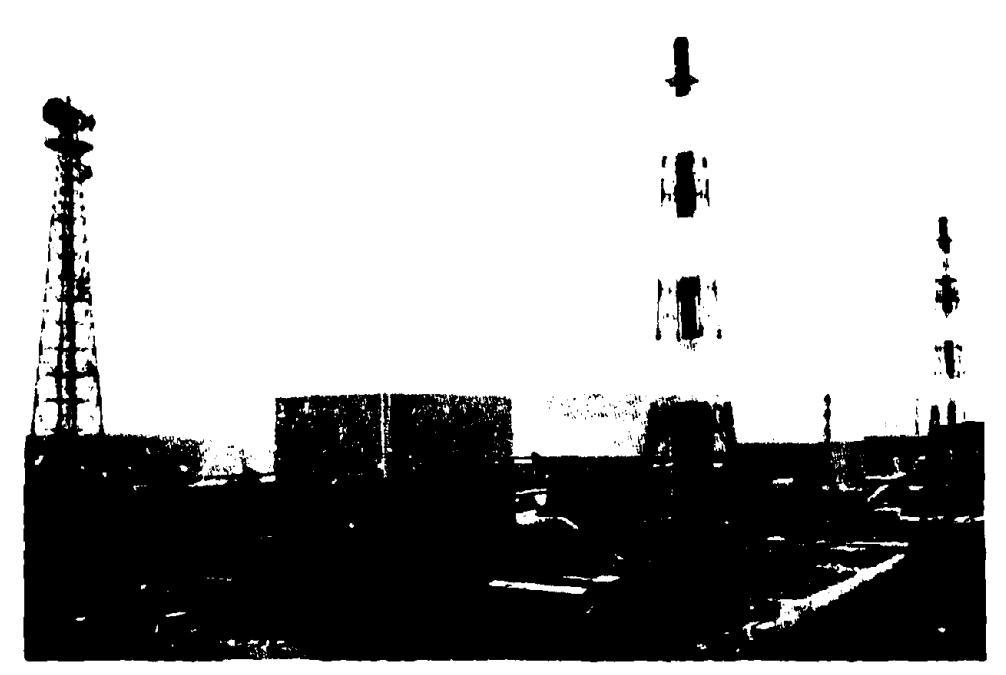
Figure 56 Fukushima Nuclear Power Plant: the containment structures of Units 1 through 4. None of these structures showed damage. (Tokyo Electric Co. photograph)

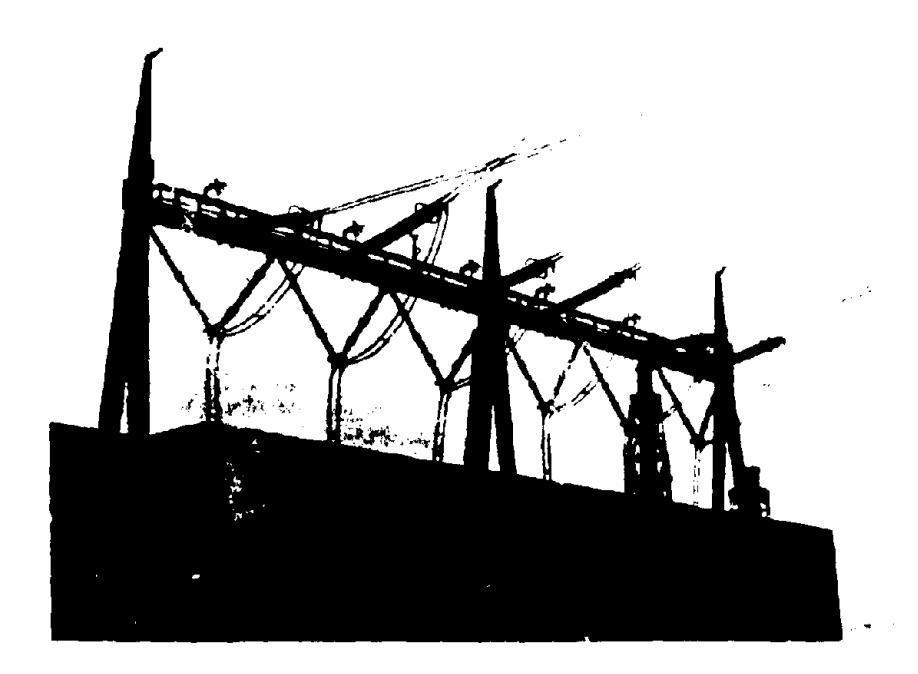
Figure 57 Fukushima Nuclear Power Plant. A broken ceramic insulator in Unit 1 was the only damage reported for the site. The damaged insulator had been replaced, as illustrated above, before the reconnaissance visit.

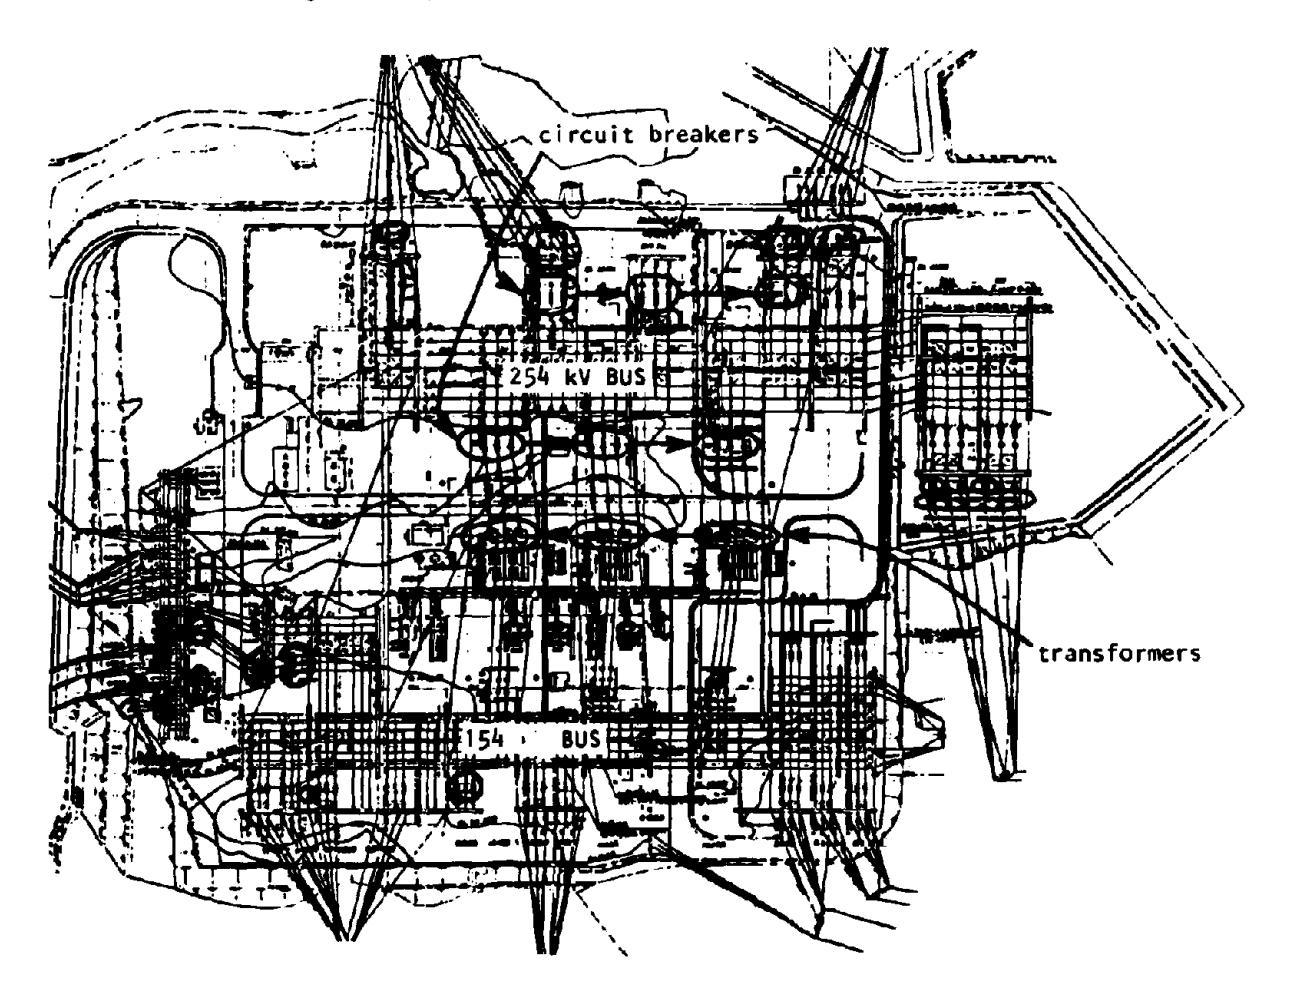
Figure 67 Sendal Substation, Tohuku Electric Power Company, Izumi: plan of the facility showing the location of damaged equipment (circled).

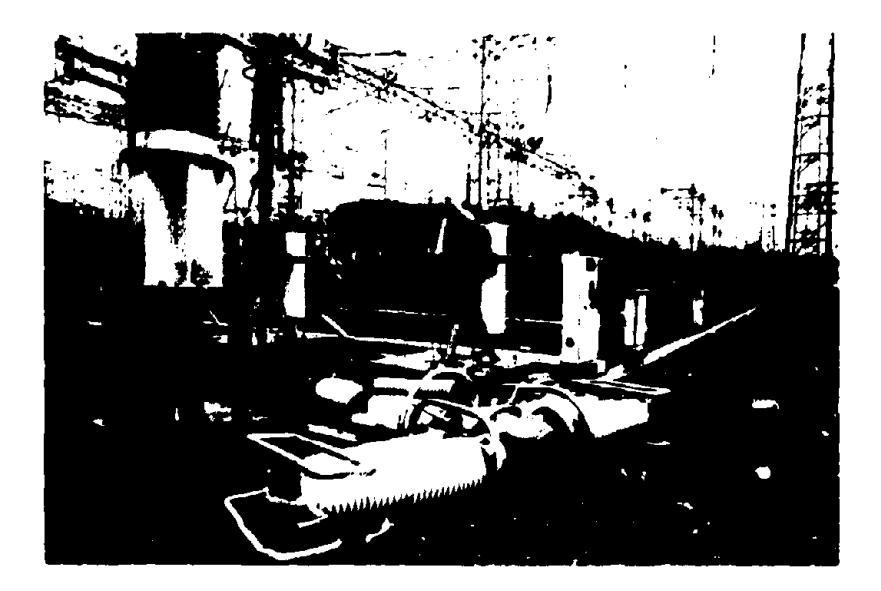
Figure 68 Sendai Substation, Tohoku Electric Power Company, Izumi: one of many broken Tshaped, three-phase circuit breakers. The photograph was taken immediately after the earthquake, before repairs were initiated. (Tohoku Electric Power Cc photograph)

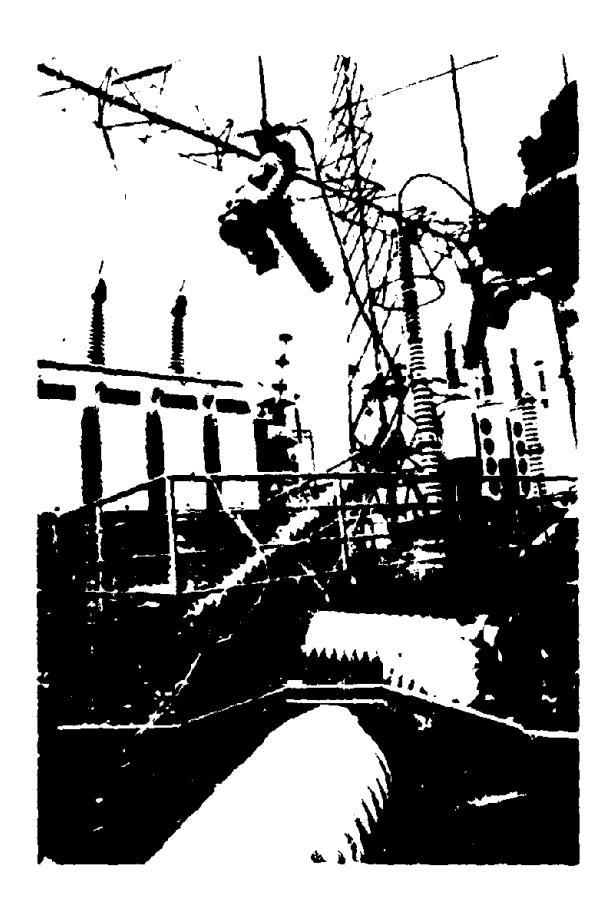
Figure 70 Sendai Substation, Tohoky Electric Power Company, Izuml. damaged equipment, including circuit breakers (with the porcelain broken through) and a lightning arrestor in the background.

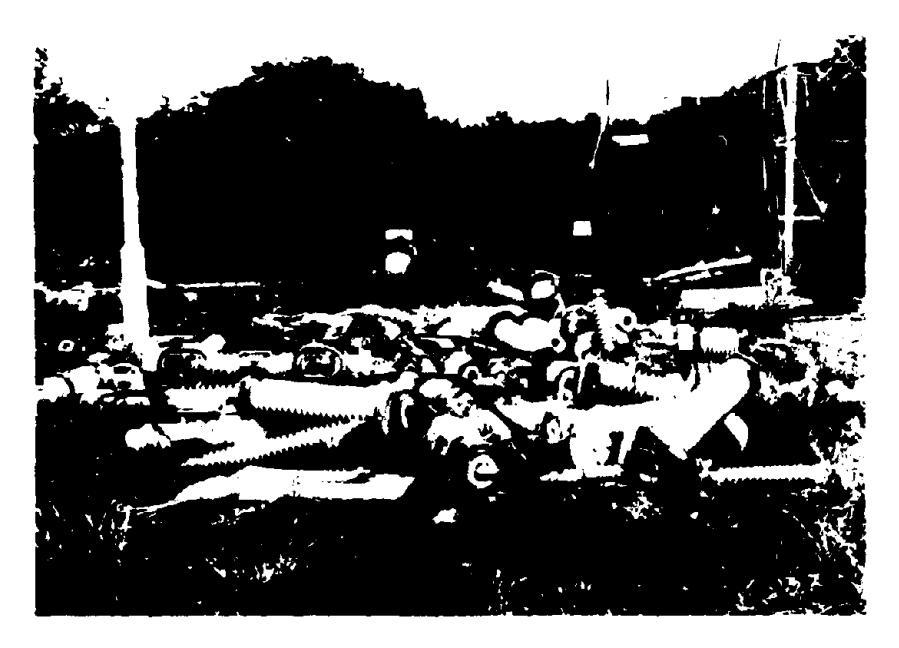
Figure 73 Sendal Substation, Tohoku Electric Power Company, Izumi. One of several piles of broken equipment.

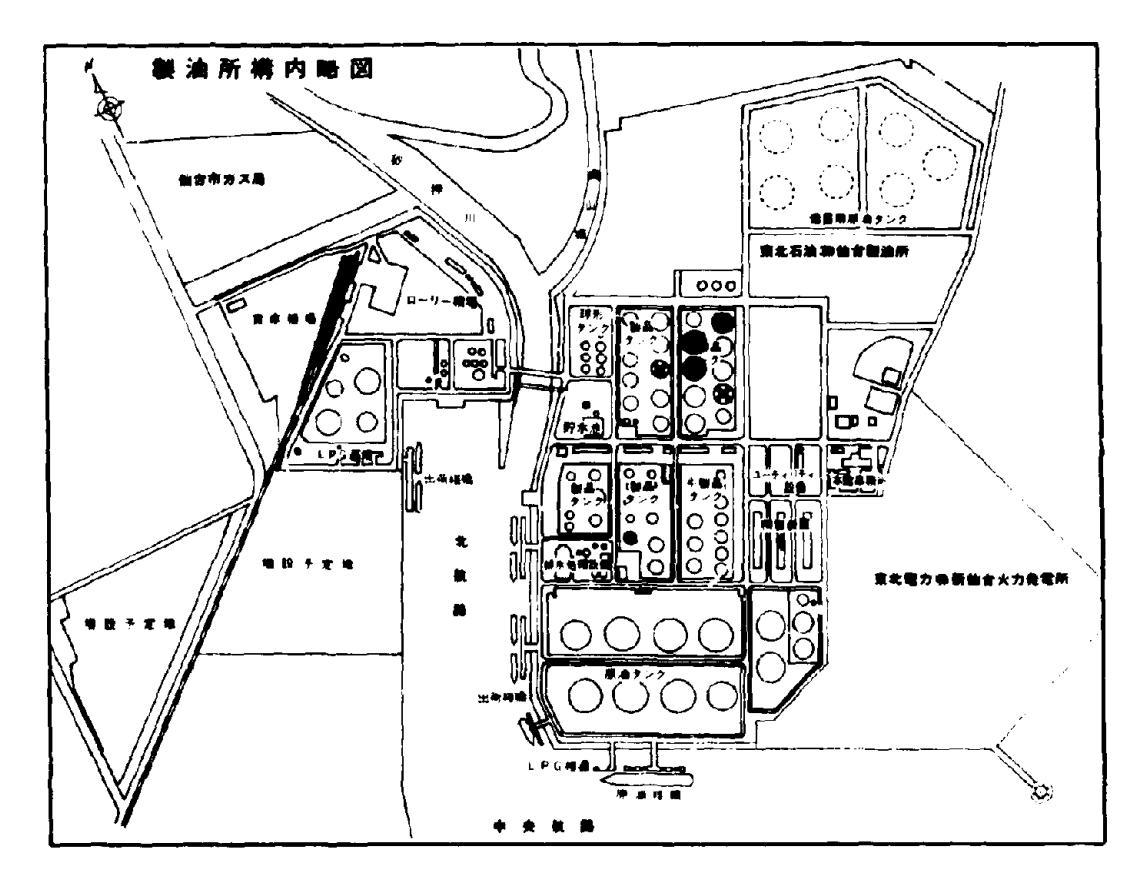
Three large tanks containing topped refined fuel called Top Crude (TC) failed, spilling approximately 68,100 kl of oil. The surrounding dike could accommodate only 35,000 kl. The oil overtopped the dike, inundated much of the refinery area, and spilled over into the port. Three other tanks suffered damage but did not fail. Many parts of the facility were still covered with oil at the time of the investigation. The refinery was not in operation because of the very great damager of fire. The facility had been shut down for annual maintenance and checkup and had not yet resumed operation at the time of the earthquake. Thus a serious fire hazard from the spilled oil fortuitously was averted

Figure 79 Plan of the Sendal Refinery, Tohoku Oil Company, Ltd. The New Sendai Power Plant is shown on the lower right in the plan. Tanks are shown as circles in the plan. The circles that represent the three failed TC tanks have been blackened; ones that represent the three other damaged tanks are warked with an X. The refinery structures are located to the right of the tank farms.

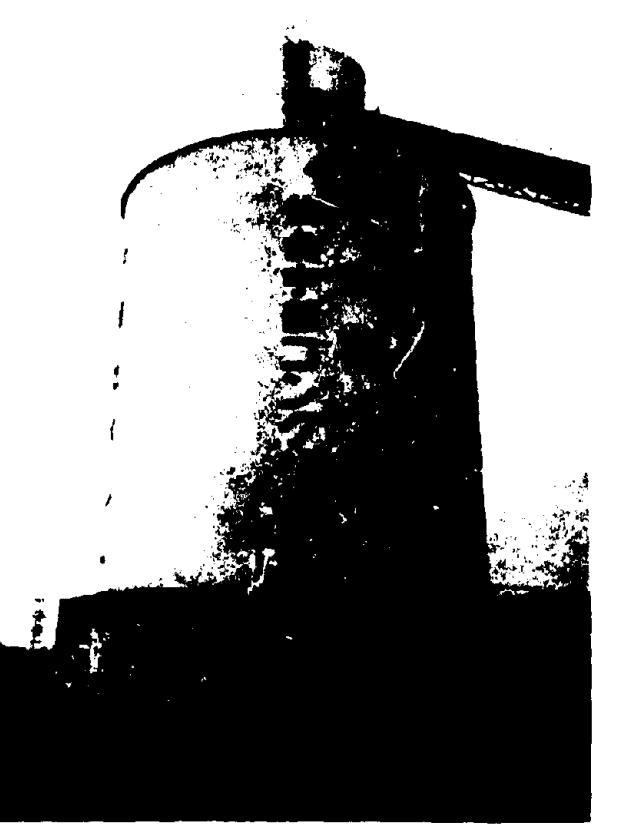
Figure 88 Concrete Batch Plant, Sendai. A large gravel-and-sand-storage tank experienced buckling of the steel plate at its base -- at the extreme left side and at two separrate locations on the right side.

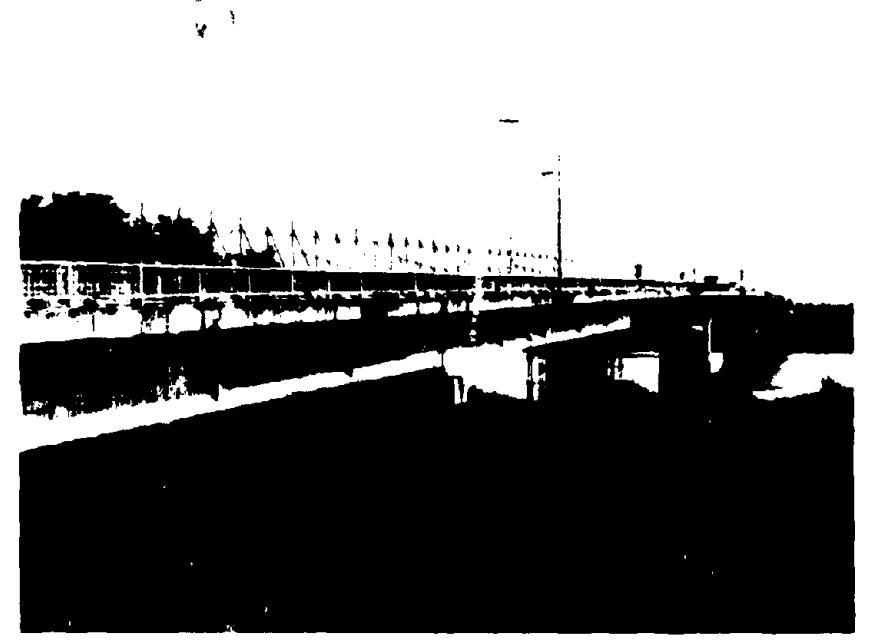
Figure 95 Yuriage Bridge: general view showing the first two columns, which were heavily damaged.

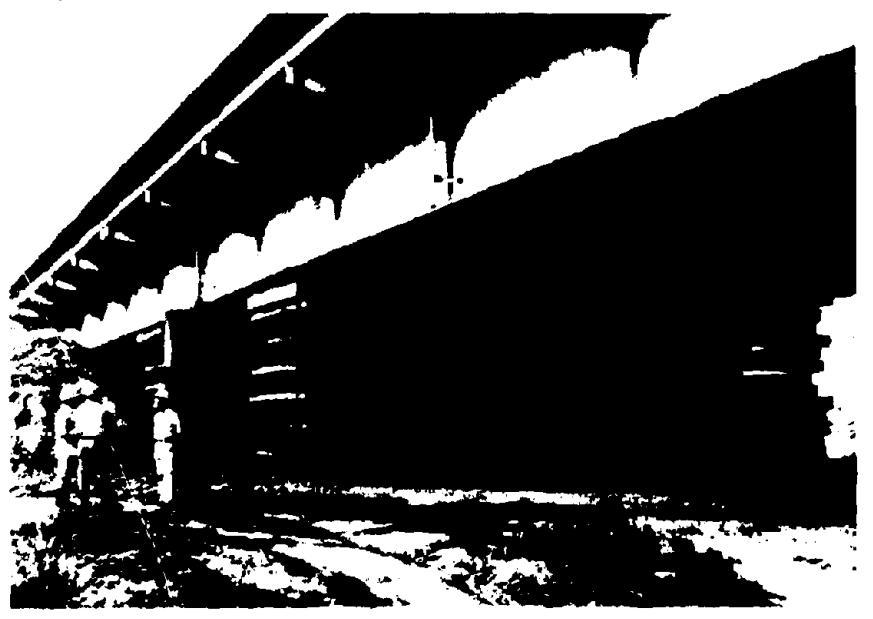
Figure 100 Sendai Ohashi Bridge: temporary cribbing used to support the steel place girders.

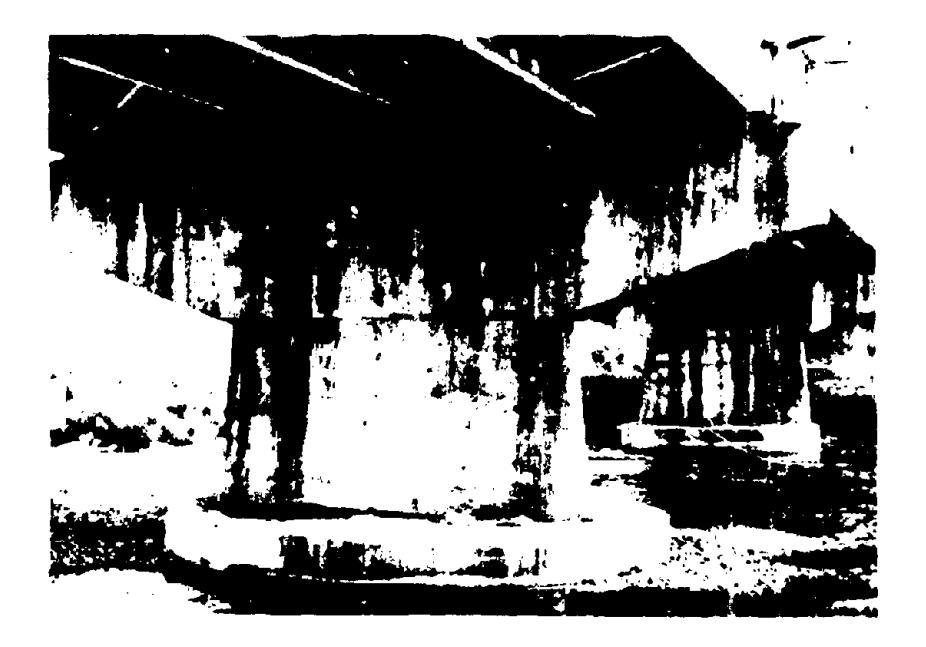
Figure 101 Sendai Ohashi Bridge: typical pier configuration. The cross-pier dimensions are approximately 5 m by 2 m. The piers have cassive caps.

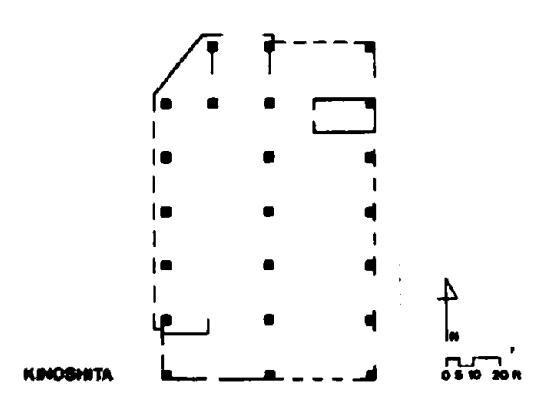
Underlying some of the failures of structural details are some architectural issues. Although the direct cause of failure may be in the detail design and construction of column reinforcement, the indirect cause originates in building configuration. The architectural configuration is such that earthquake forces are concentrated into certain structural details that become overstressed and fail. The failure of the Obisan building (Engineering Aspects, Figure 14) originates in the torsion caused by the architectural planning of staircase location. The shear failures in the Kinoshita building (see Engineering Aspects, Figure 17) or urred along a face with no shear walls at a point where a heavy concrete canopy cantilevers over the building corner.

Figure 10 Kinoshita Building: plan. Note disposition of solid walls, open front, and canopy cantilever at corner.

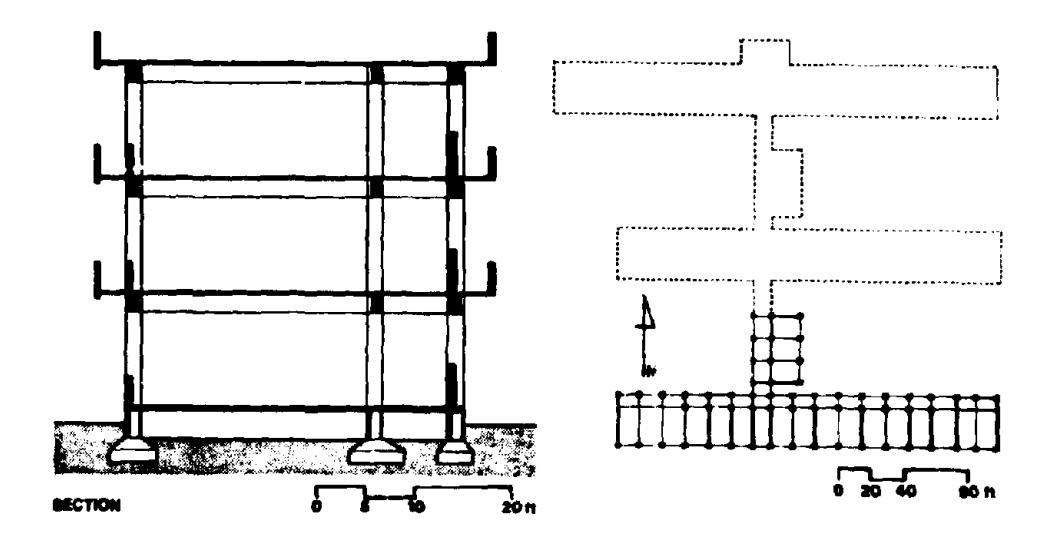
Shear failures in columns at Tonan High School, Tohoku Institute of Technology, and Izumi High School (Engineering Aspects, Figures 46, 43, and 51, respectively) occurred where the architectural configuration created short columns due to deep infill concrete spandrals and where this condition occurred on one facade of the building but not the other. In addition, these heavy, frame buildings had limited (or no) shear walls in the north-south direction (the direction of main emphasis of the earthqueke) because of the architectural need for full daylighting to classrooms. The interaction of architectural and structural factors is very clear in these examples.

Figure 11 Flan and section of izumi High School. Note in plan the absence of shear walls in the east-west direction and the termination of north-south shear walls at the corridor. The section shows how deep poured concrete spandrels on the right create short columns, which failed. Even though the main emphasis of the earthquake was in the north-south direction, in this instance failure occurred in the east-west direction.

It is interesting that both Tonan High School and Izumi High School suffered column failures even though the latter was built after a code change that resulted in increased shear reinforcing. Although the failures at izumi were much less severe than at Tonan, it is clear that the basic problem lies in the configuration rather than in the structural detailing. Identical Configurations, Selective Failure. An interesting case was observed in two buildings of identical configuration, one of which failed completely, the other showing incipient failure.

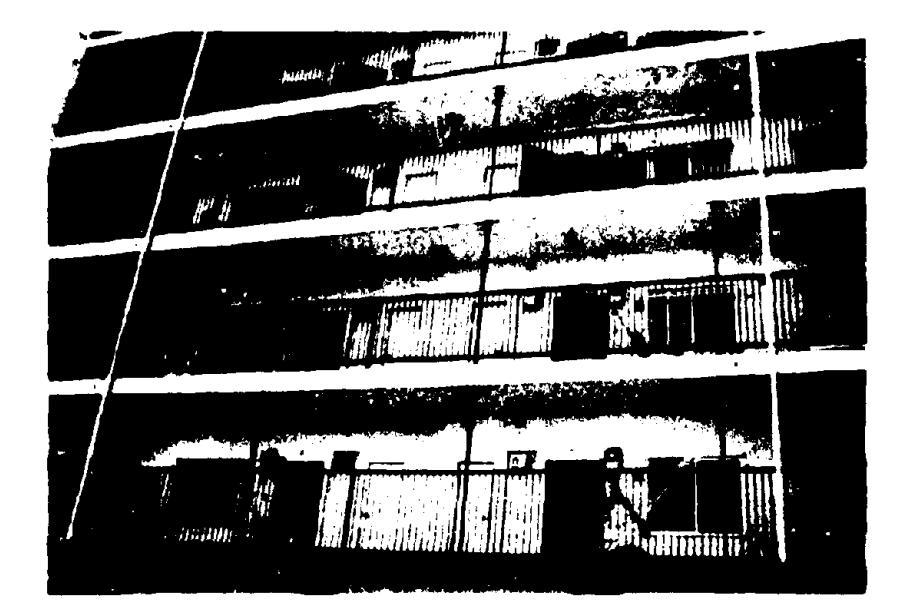
<u>An L-Shaped Building</u>. The Sunnyheights condominium project is a 17-story L-shaped reinforced concrete building. The building is separated by a seismic joint into two rectangular buildings. The apartment party walls act as effective shear walls in one direction, but in the other the concrete wall is perforated by doors, windows, etc. The building with its shear walls aligned with the north-south axis was virtually unscathed. This building is a good example of the principle of separation of the elements of an L-shaped building to eliminate torsion.

Figure 25 Sunnyheights building: elevation of damaged wall. Shear failure caused distortion that resulted in inoperable doors for 57 of the 190 units.

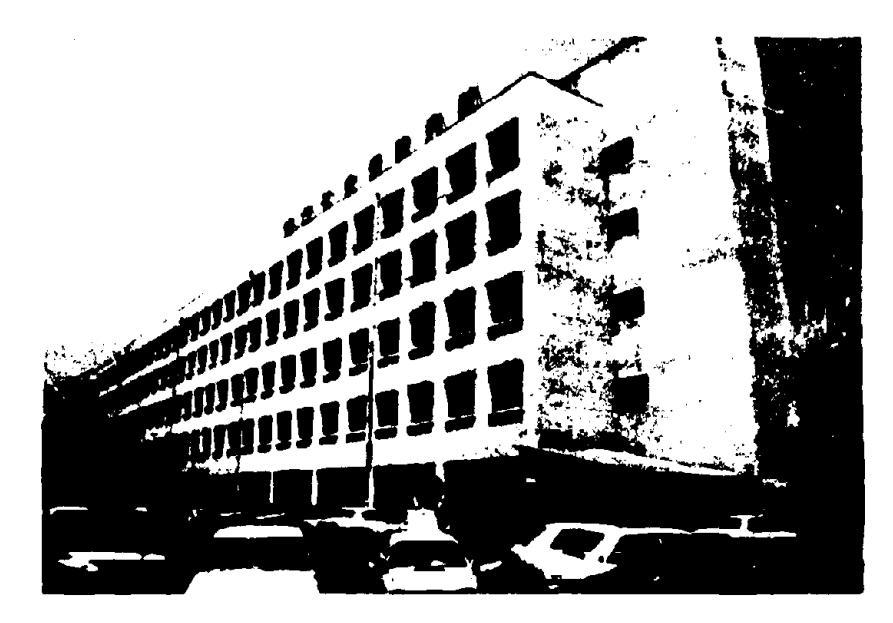
Figure 30 Sendal Social Insurance Hospital.

The main building of the Sendal Social insurance Hospital is a 5-story reinforced concrete from structure built in 1968. Administration is housed in a temporary 2-story light steel pretabricated building while a new building is under construction. The building is owned by the government; a private organization runs the hospital.

No damage beyond slight cracks along the staircase was suffered by the building. Elevators suffered no damage although they stopped because of power failurs. (No one was in the cars at the time.) The building's emergency power system is sufficient for lights and for the operating room but not for the elevators. Because of the earthquake, two additional emergency patients entered the hospital. Electricity was available for life support systems. In the pharmacy, some bottles and an ice maker fell down and were damaged, but no dangerous items were involved.

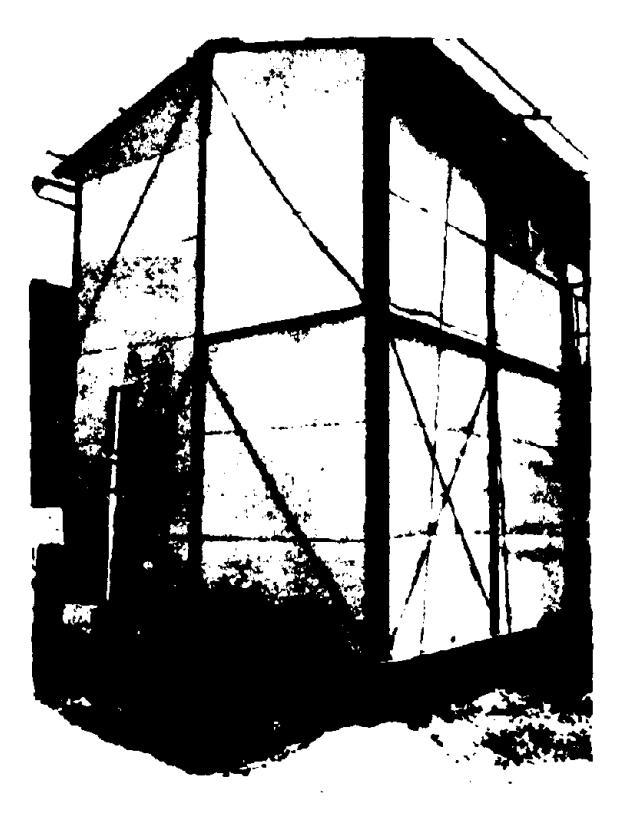
Figure 33 Temporary structure, Sendai Social Insurance Hospital. Note distortion of bracing and foundation posts.

Structures similar to those shown in Figure 33 were in frequent use as construction shacks around Sendai. The demountable light steel frame is wire braced and has a nonstructural infill panel. The structure shown at the Social Insurance Hospital was a contractor's shack. A similar structure was in use as a 2-story administration wing for the hospital while a new building is being completed.
