CSCPRC REPORT NO. 8

Earthquake Engineering and Hazards Reduction in China

**A Trip Report of the American Earthquake Engineering and
Hazards Reduction Delegation**

Edited by Paul C. Jennings

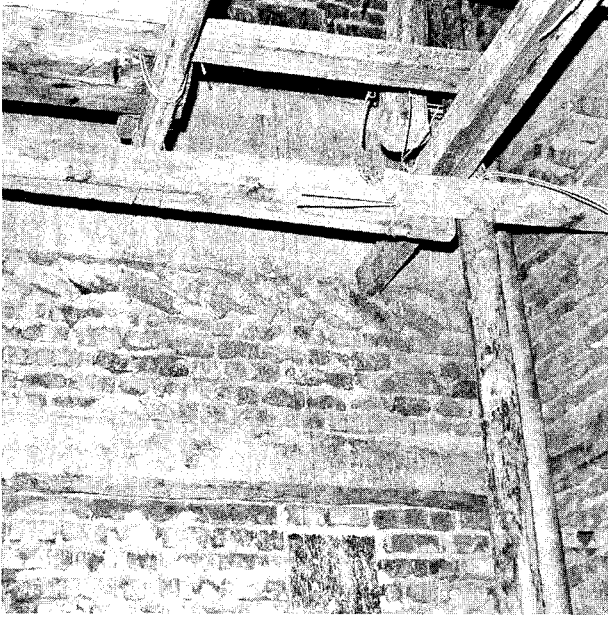
cavity walls as shown in Figure 3.21 with one wythe of brick on the exterior and a lightweight concrete block on the inside; the exterior will be plastered. The interior nonstructural walls are of brick of low quality. For example, Figure 3.22 shows the walls around the elevator enclosure. Note the "leaning soldiers" under the concrete floor beam; this detail was seen often in construction throughout China.

FIGURE 3.22 Interior of elevator shaft of Peking Duck Restaurant showing brick filler walls. Note "leaning soldier" bricks at top, a method of filling space, not a module of brick dimensions.

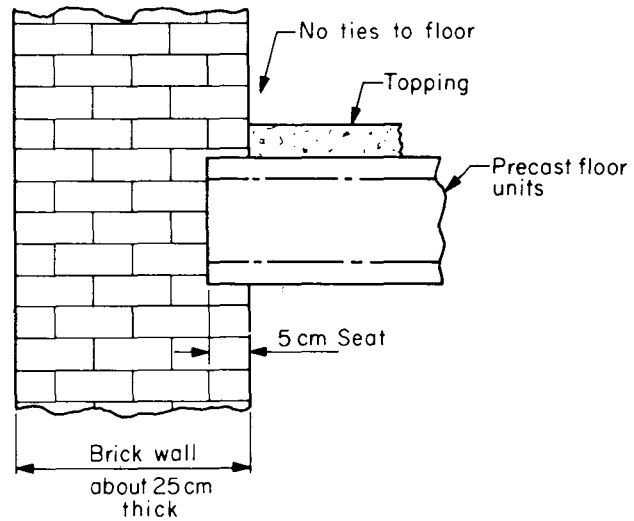
FIGURE 3.24 Typical detail of floor-wall connection in Harbin electronics factory.

The floors were precast concrete; there were apparently no ties between wall and floor construction. The typical detail of the floor-wall connection is shown in Figure 3.24. The roof is made of precast channel members supported on steel trusses shown in Figure 3.25.

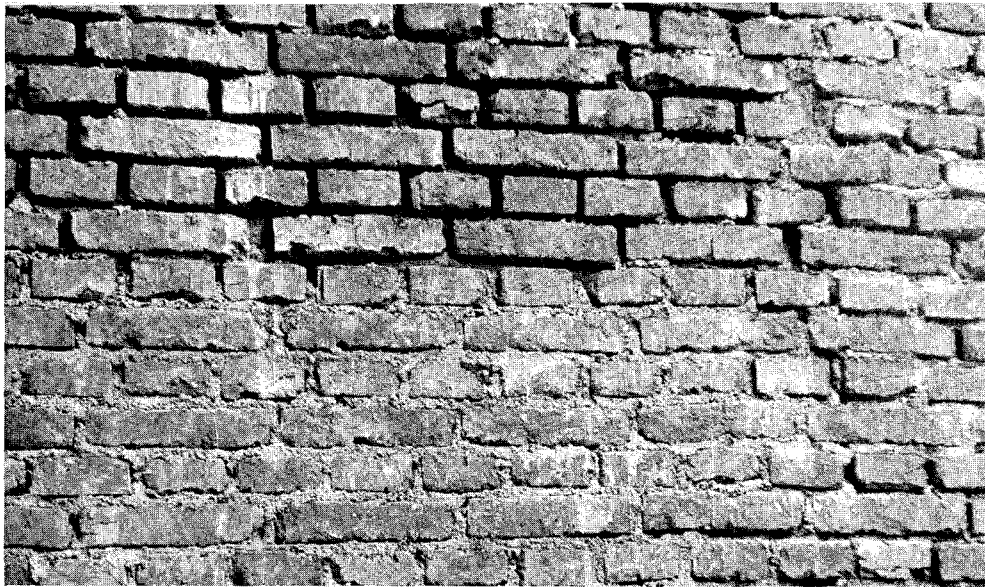
The third project was an almost complete six-story apartment house shown in Figure 3.31. It was a part of a large complex of about a dozen similar buildings. The construction was similar to that discussed above, namely, unreinforced brick bearing walls, precast floor units, precast stairs, etc. A portion of one of the walls is shown in Figure 3.32, illustrating the variability of workmanship in the construction of the wall.

FIGURE 3.32 Apartment building shown in Figure 3.31. At lower left, joints are filled. In upper portion, head joints are open, and bed joints only partially filled.

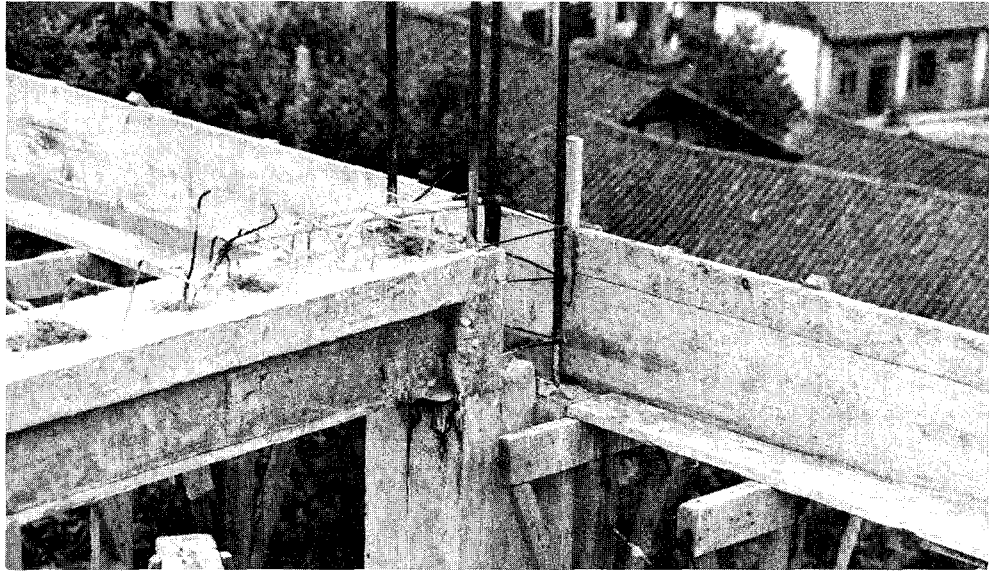
Figures 3.43 and 3.44 show a cast-in-place column and beam and the forms for the cast-in-place spandrel beam that will be poured next. This sequence results in construction joints through the structural joint itself. There is no provision for shear in the joint, and the detailing provides for little ductility.

FIGURE 3.43 The columns and transverse beams have been cast in place in this detail of an upper floor. Forms are in place for the cast-in-place spandrel beam. The joint is integral but a construction joint goes through the center.

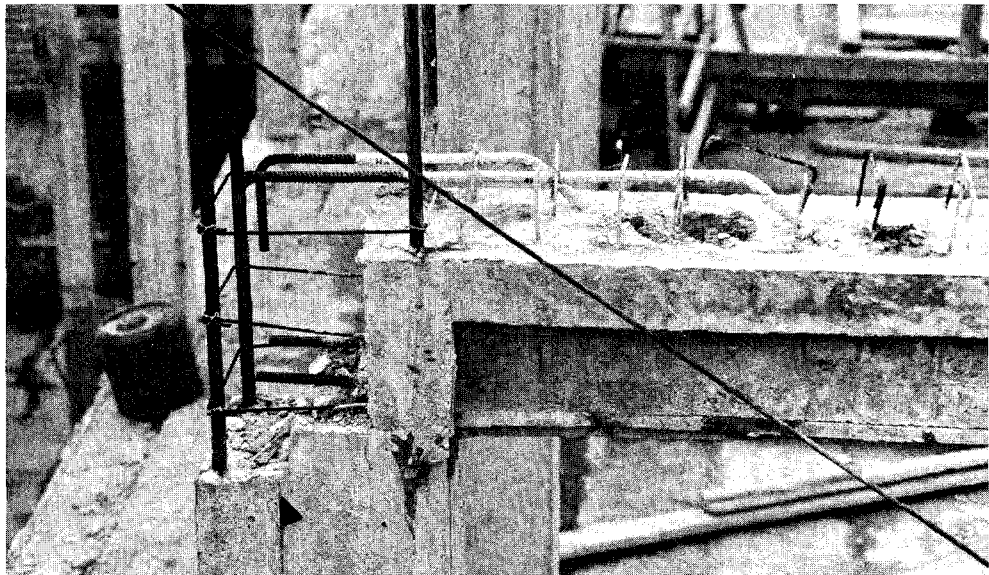
FIGURE 3.44 Upper floor detail of the Chengtu office and storage building. This is the same joint shown in Figure 3.43.

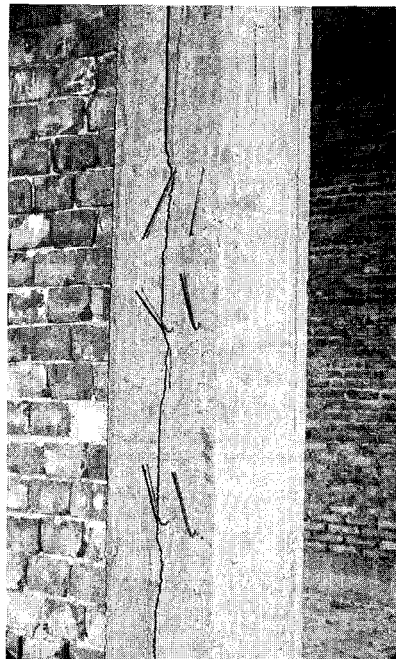
case there are dowels to column but no keys. The construction is illustrated in Figures 3.45 and 3.46. In response to a question about the amount of inspection that is customary, we were told that on this particular project they took samples of the concrete and mortar at each floor and that the job superintendent has special personnel to check the placement of the reinforcing steel. In addition, the design office has three men on the job at all times to inspect the work.

FIGURE 3.46 Brick shear walls in the Chengtu office and storage building had dowels protruding from adjacent columns, but shear keys were not provided.

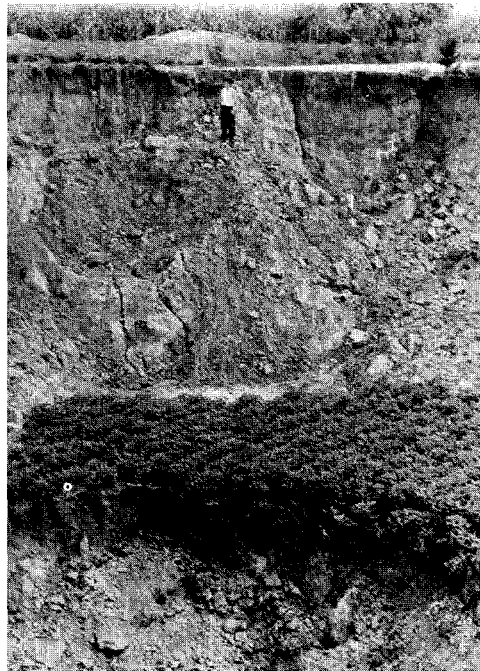
An unusual feature of the Tangshan earthquake was the formation of craters in the countryside. An example of a crater of moderate size is shown in Figure 4.7. A partial view of a very large crater is shown in Figure 4.8. These craters were not associated with the extensive underground excavation for coal mining, but they have not yet been studied thoroughly and the reason for these ground collapses has not been established; one suggestion was that limestone karsts may have been responsible.

FIGURE 4.8 View of the interior of a very large crater formed near Hsiaotun, Chengchaungtze Commune, north of Tangshan.

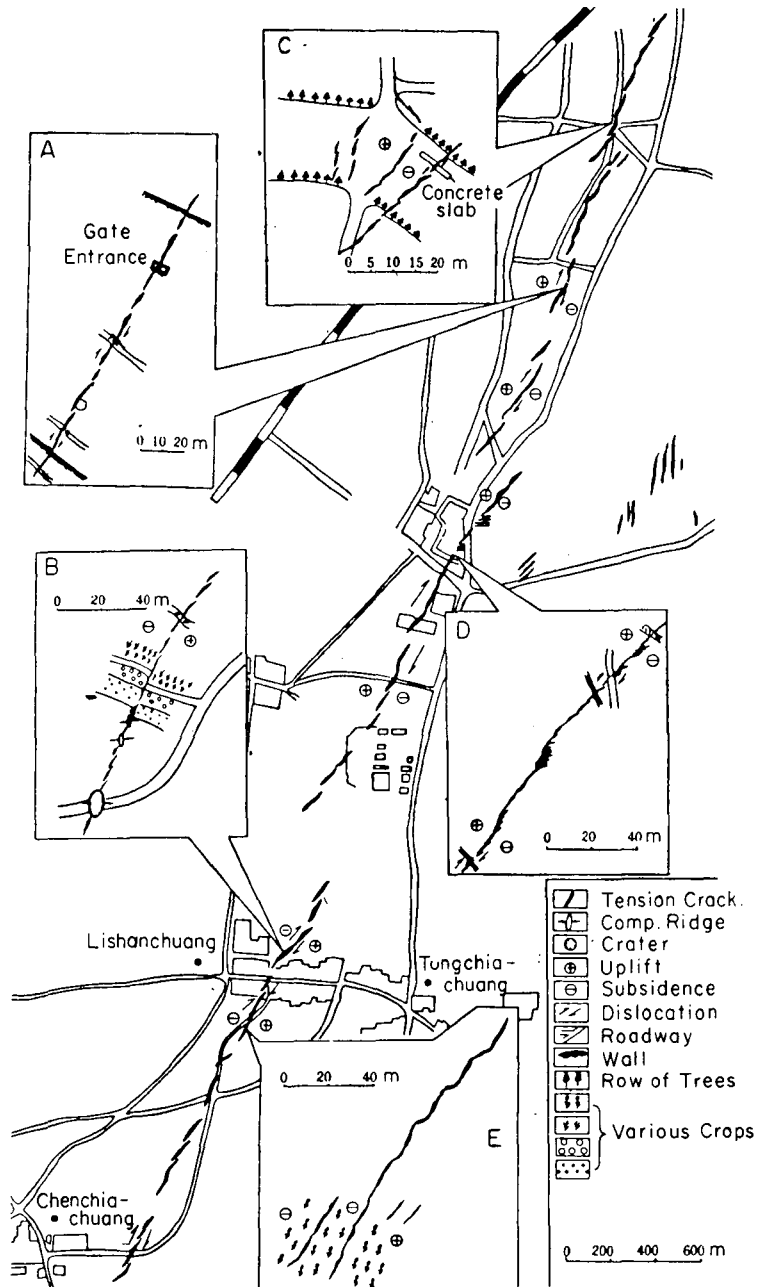
Surface faulting occurred within the city of Tangshan over a length of between 8 and 10 km. Maximum displacement reached 3 m in a right-lateral strike-slip sense. The northwest side was usually raised, and extension of the ground surface over a width of 300 m was as much as 0.5 m. Buildings on the faults were damaged by the slip, whereas farther out, damage was lighter. Damage also was lighter at the ends of the fault segments. The surface faulting developed in five en echelon segments as shown in Figure 4.17. The individual surface breaks had an approximate strike of N40°E, and the overall zone of surface breaks trended roughly N30°E. This zone followed essentially the southwestern section of the Tangshan-Kuyeh fault, and surface breaks were developed in the loose Quaternary sediments. Roads and rows of trees were offset (Figures 4.17, 4.18, 4.19, 4.20), and compressional ridges were seen that were consistent with the ENE compressive axis and the NNW tensional axis.

FIGURE 4.17 Surface faulting observed in the city of Tangshan. (A) Tangshan 10 high school; (B) North Lishanchuang; (C) Intersection of Yunhung Road and Hoping Street; (D) Tangshan native product warehouse; (E) South Lishanchuang.

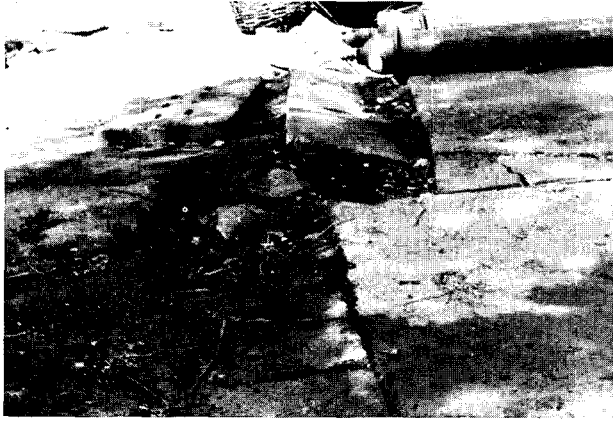
FIGURE 4.18 Surface breaks and compressed pavement over drainage trench in Tangshan.

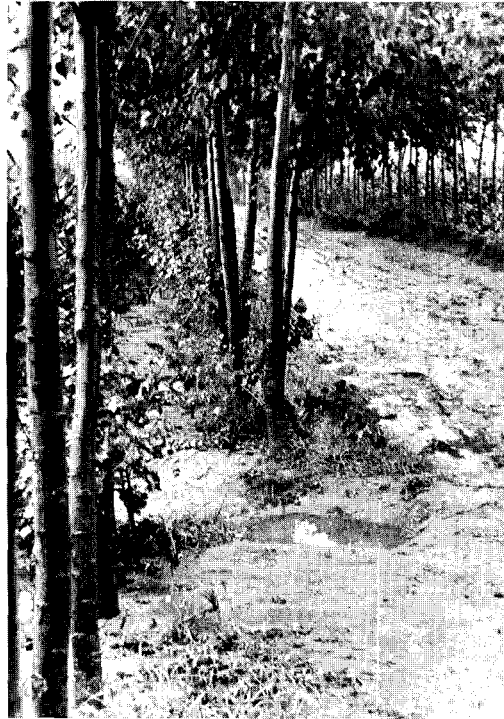
FIGURE 4.19 Offset in row of young trees by surface break near Laoting Hsien (direction $N40^{\circ}W$, maximum displacement, 0.8 m).

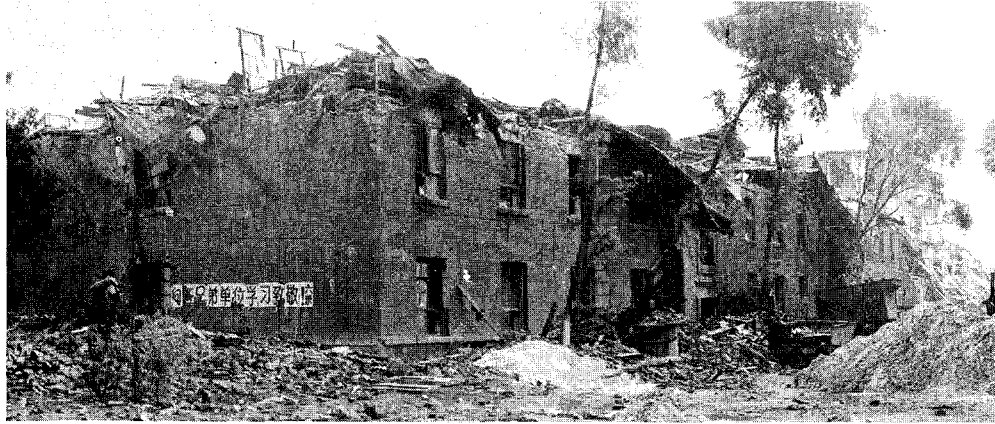
FIGURE 4.25 Collapsed top story of the three-story Kailuan coal mine dormitory, Tangshan.

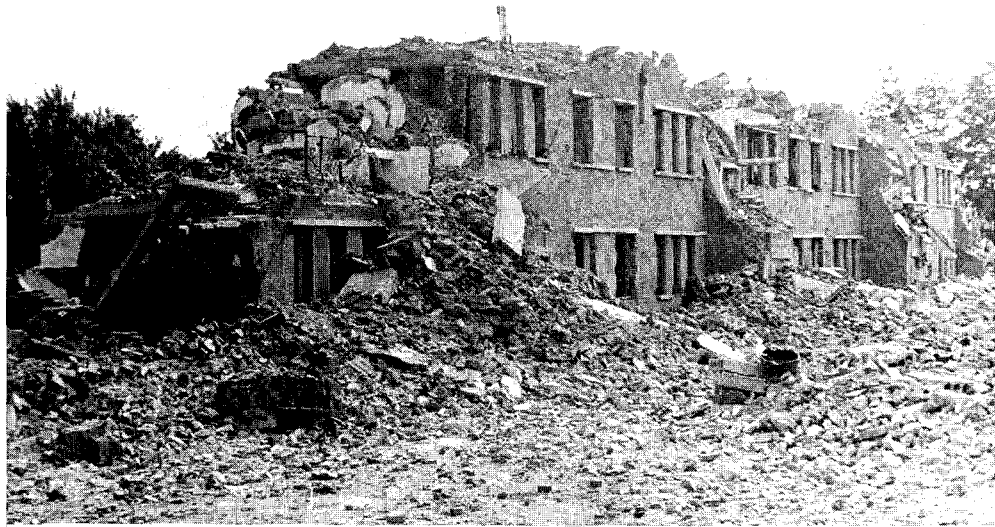
FIGURE 4.26 Collapsed four-story Tangshan Mine-Metal Institute residence building.

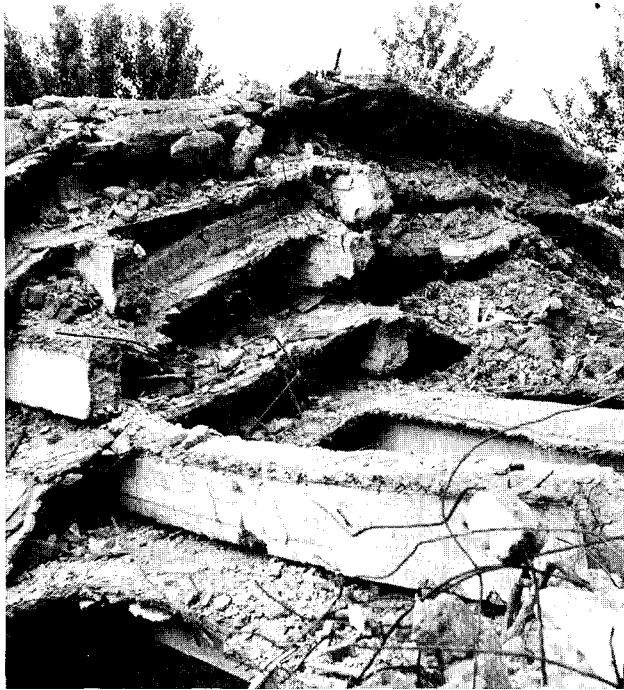
FIGURE 4.27 Collapsed five-story physics-chemistry building of the Tangshan Mine-Metal Institute.

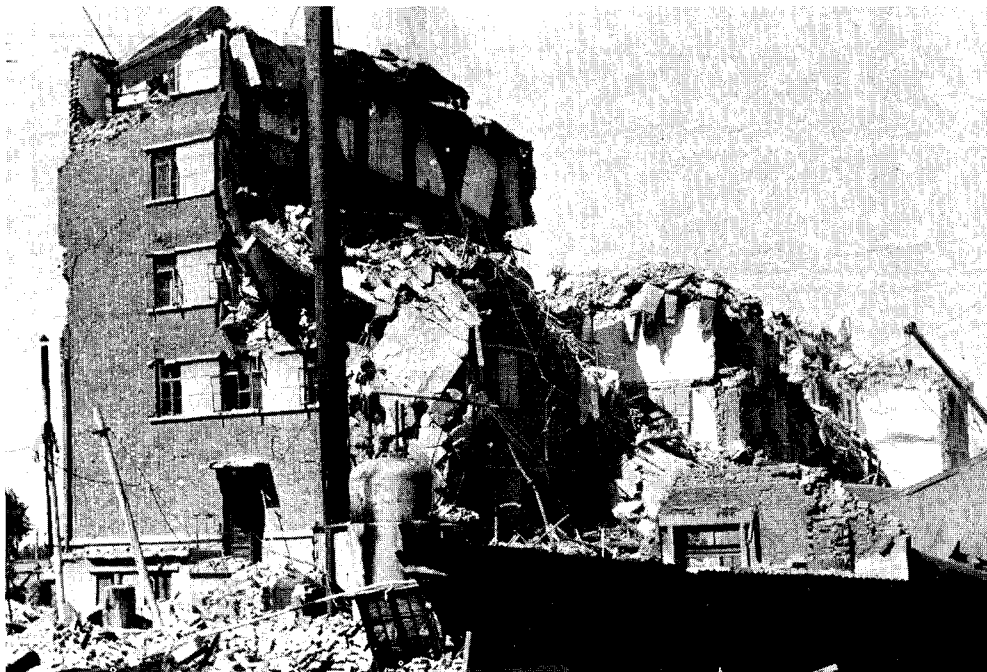
FIGURE 4.29 Collapsed five-story office building, Tangshan. The lower three stories had concrete columns, and the upper two stories were unreinforced brick without concrete columns.

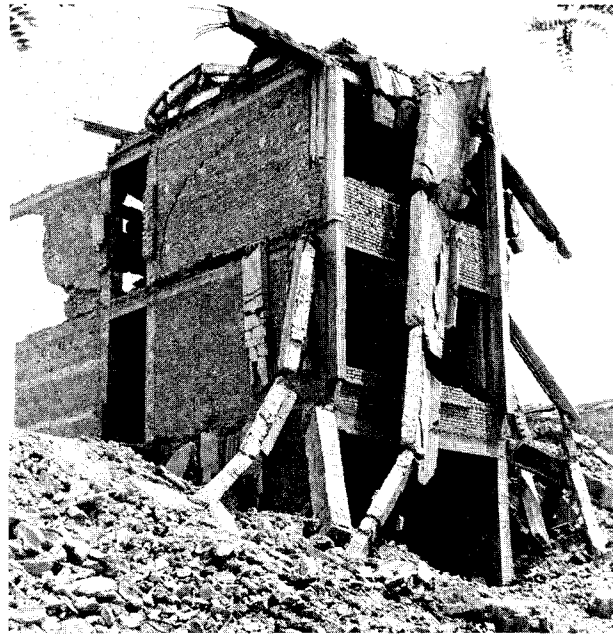
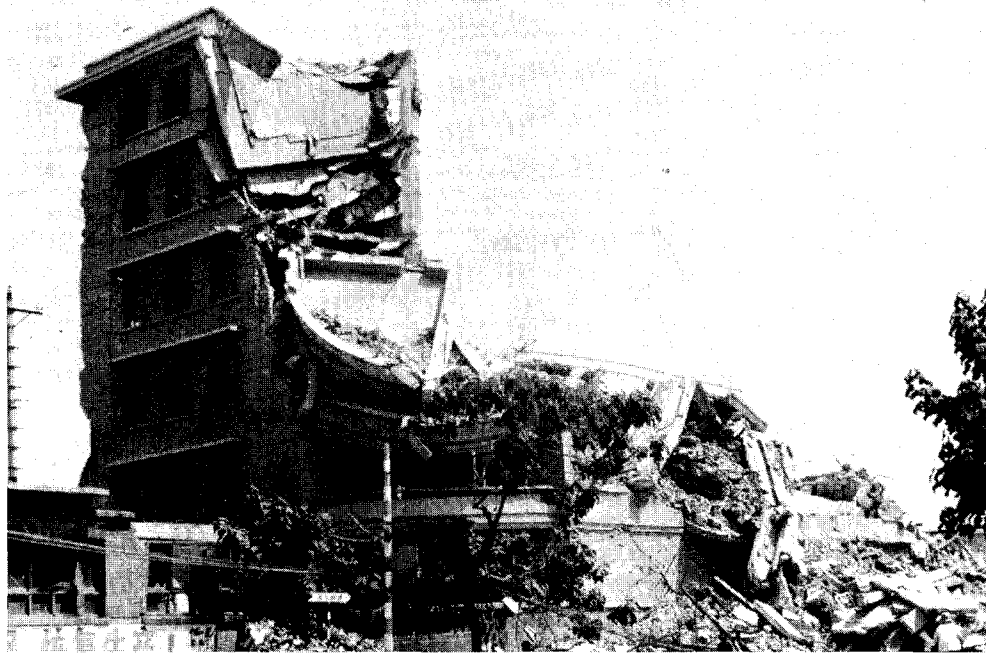
FIGURE 4.30 Collapse of six-story building at the Kailuan coal mine hospital, Tangshan.

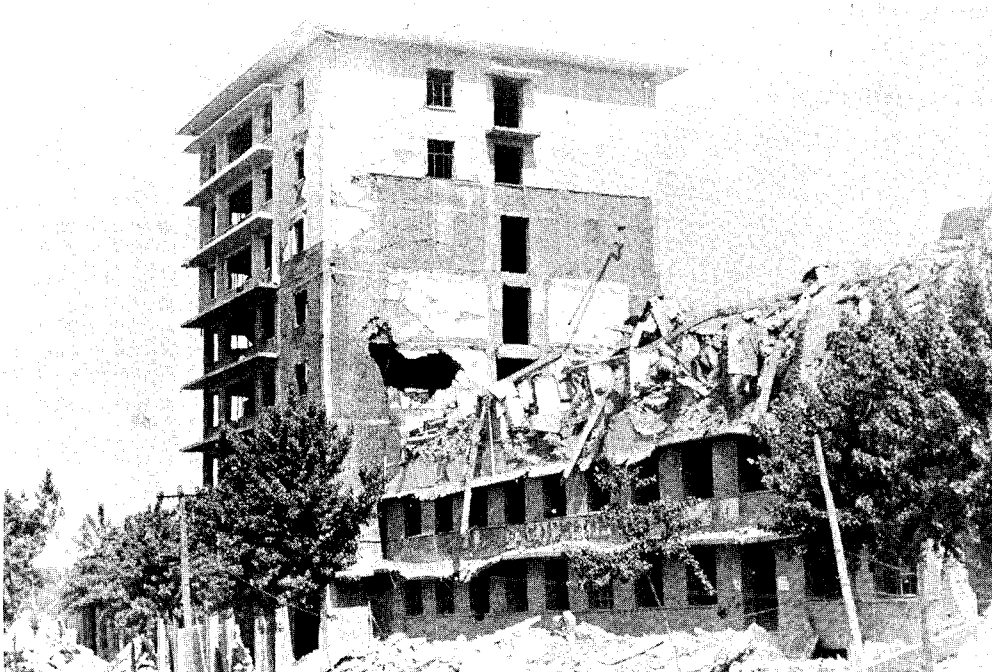
FIGURE 4.33 Collapsed workers' cafeteria building of the Chinkechuang coal mine.

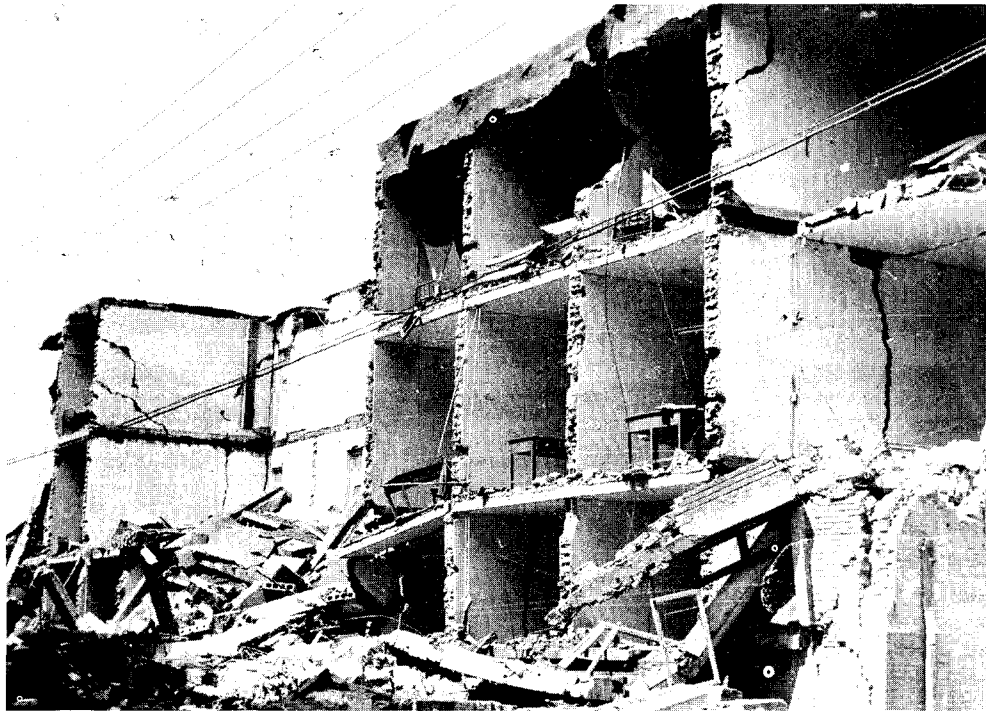
FIGURE 4.34 Partly collapsed residence building showing the type of construction: unreinforced brick bearing walls and precast concrete floor slabs.

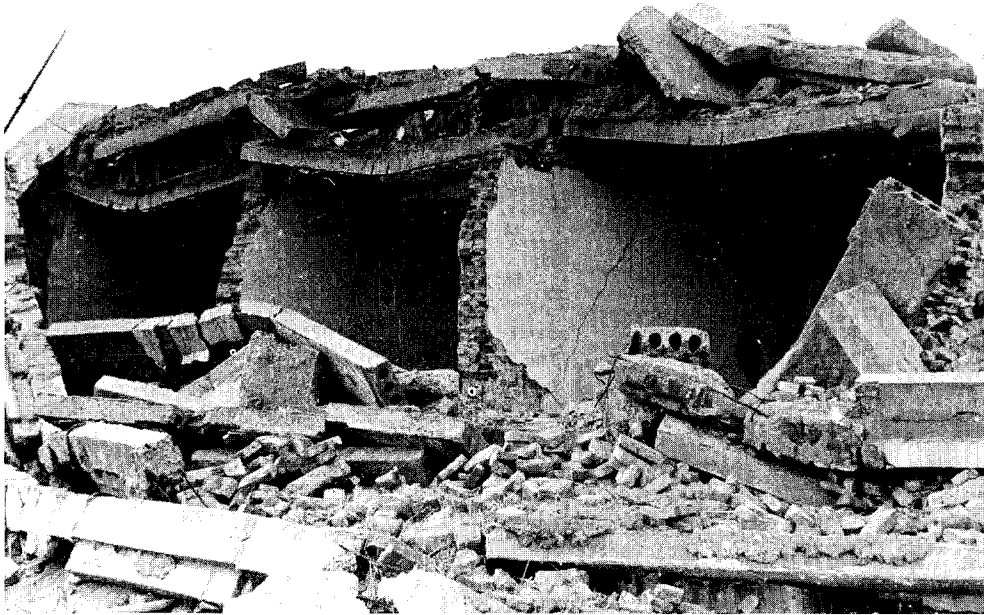
FIGURE 4.35 Collapsed building showing the type of construction: precast concrete floor slabs made of four-hole beams, simply supported on bearing walls.

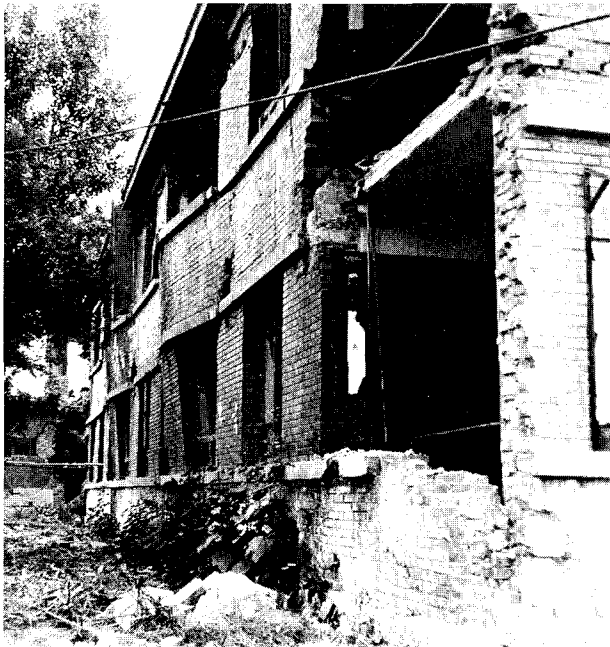
FIGURE 4.36 Badly distorted brick building on the verge of collapse. The second floor appears to be of precast concrete slabs supported on precast concrete beams, which, in turn, are supported on unreinforced brick piers.

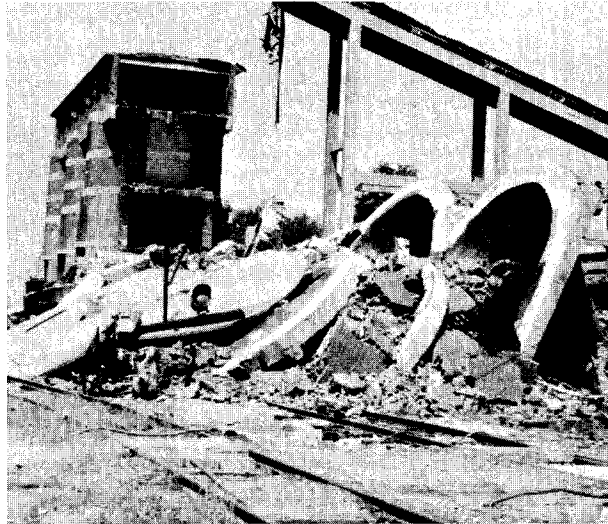
FIGURE 4.37 Collapsed brick cylindrical storage bin at the Fanke-chuang mine.

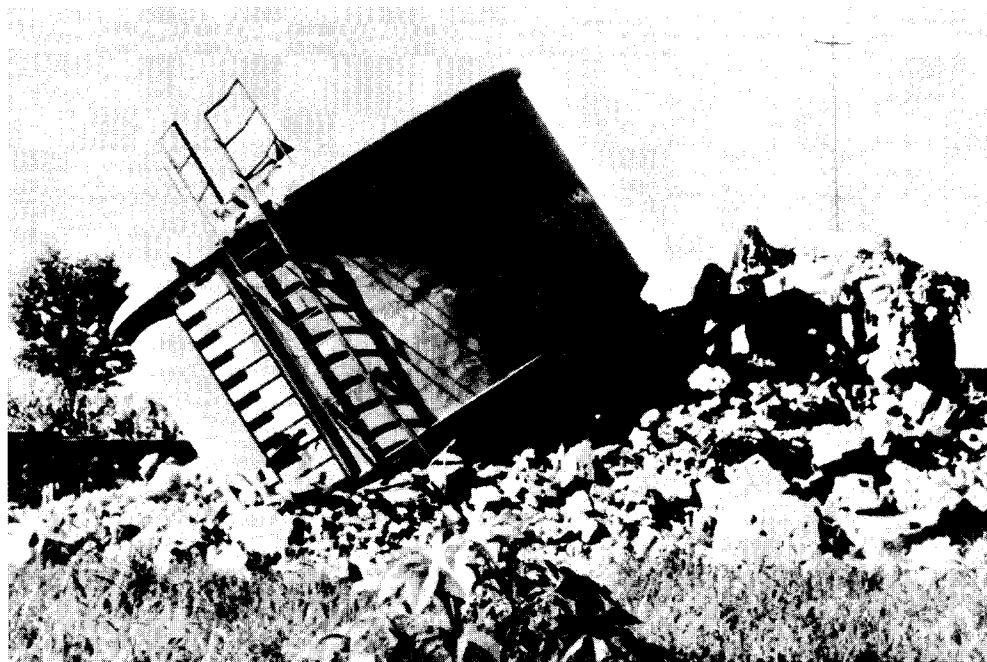
FIGURE 4.38 Collapsed elevated storage tank that had been supported on a brick cylindrical tower, Tangshan scale factory.

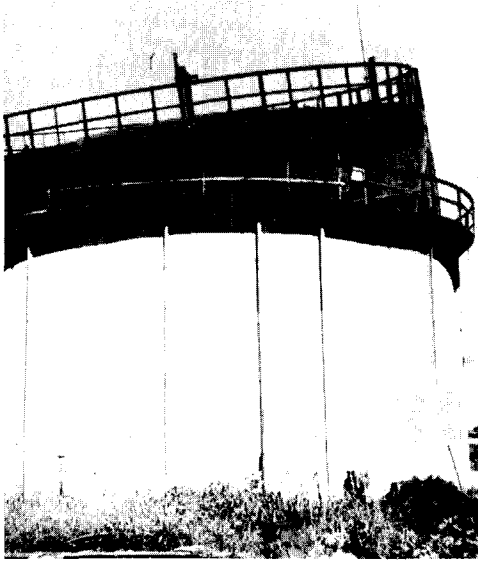
FIGURE 4.39 Damaged gas holder at Tangshan fertilizer factory.

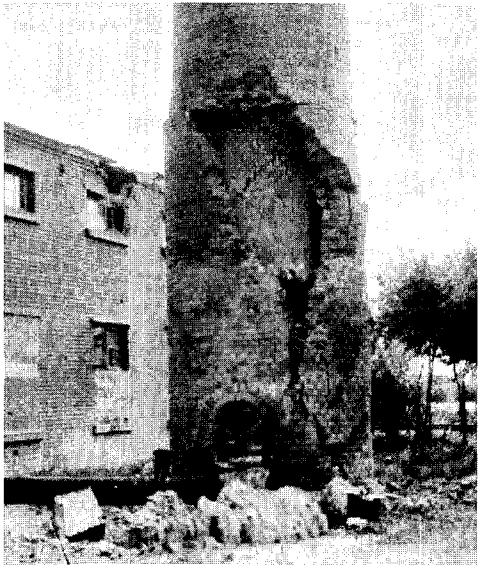
FIGURE 4.41 Damaged brick chimney.

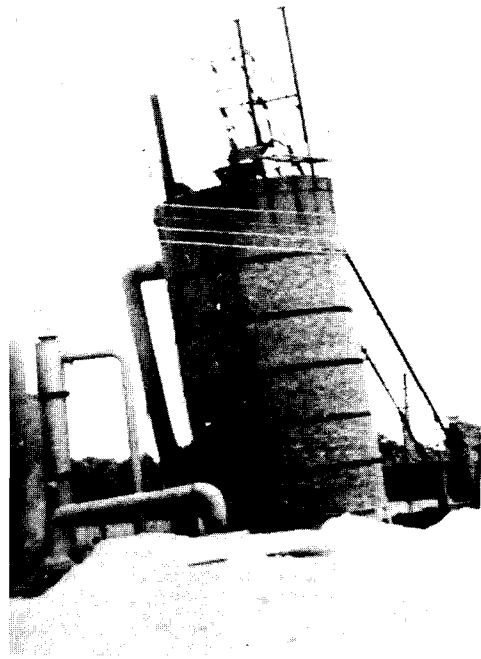
FIGURE 4.43 Tilting of a lime firing tower.

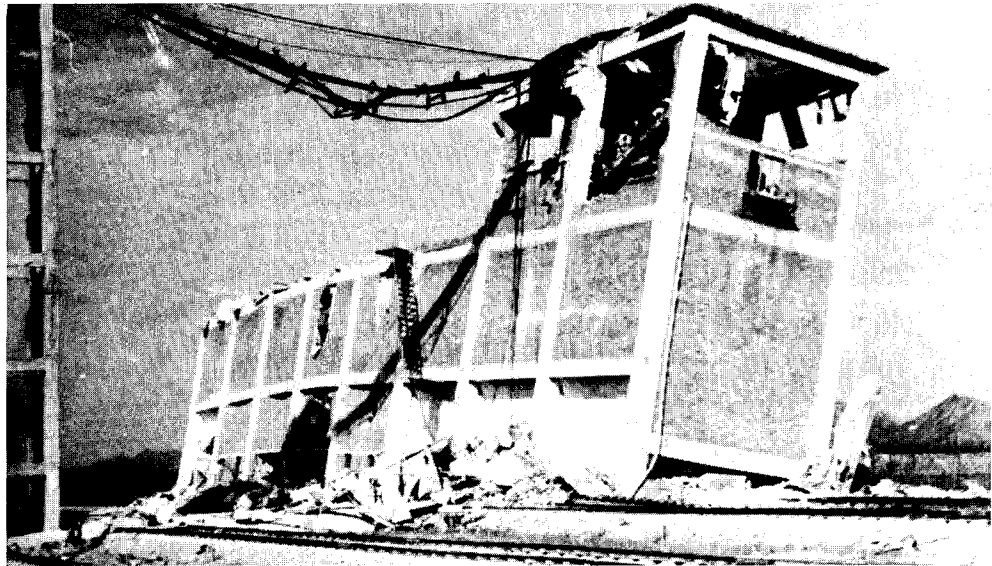
FIGURE 4.44 Collapsed coal storage structure at Chinkechuang.

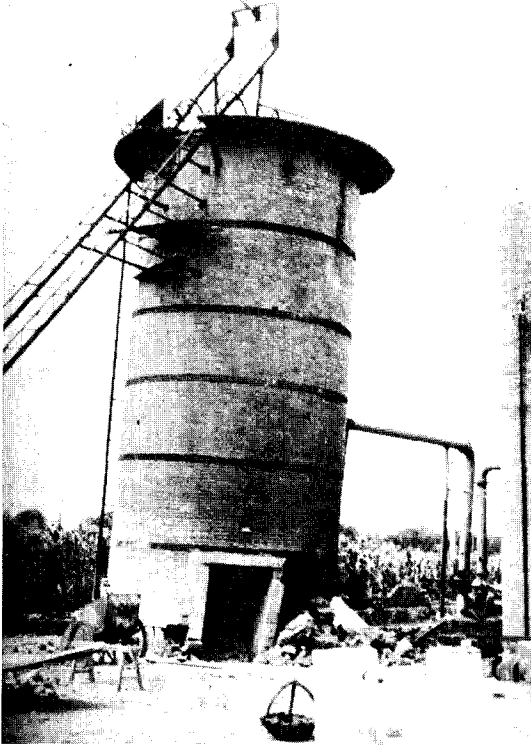
FIGURE 4.45 Tilting of brick cylindrical storage bin.

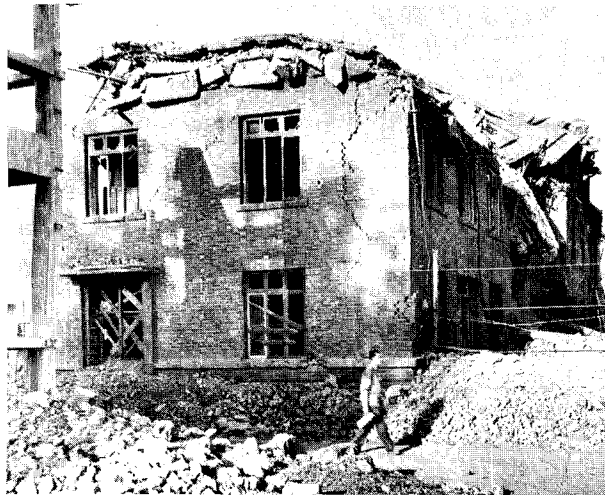
FIGURE 4.46 Partly collapsed five-story building at Coal Mine Design Institute in Tangshan.

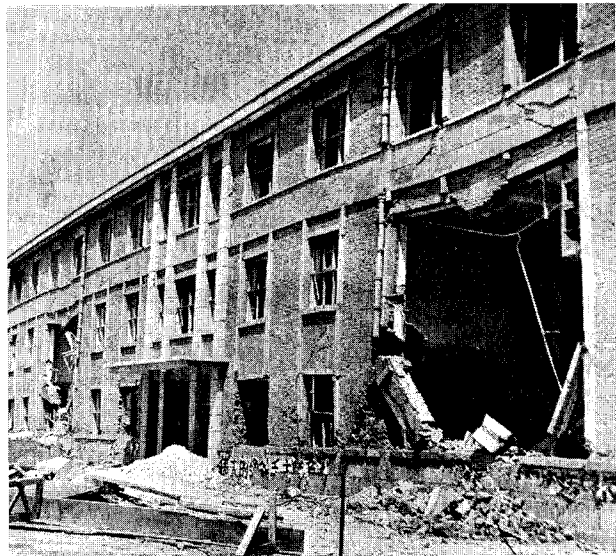
FIGURE 4.48 Damaged building at Kailuan coal mine general hospital in Tangshan.

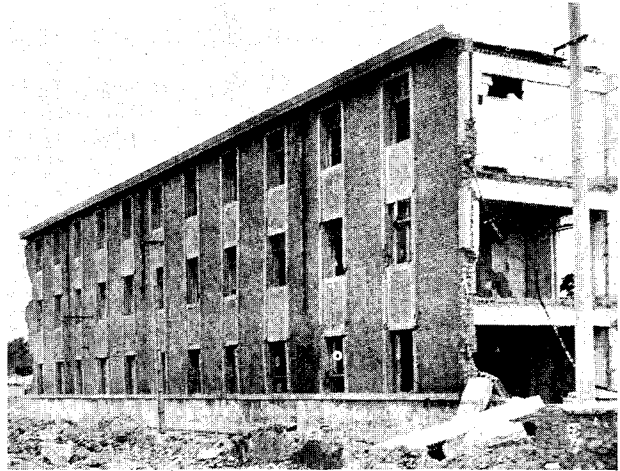
FIGURE 4.51 Damaged car factory dormitory building in Tangshan. The first story was most severely damaged but the building remained standing.

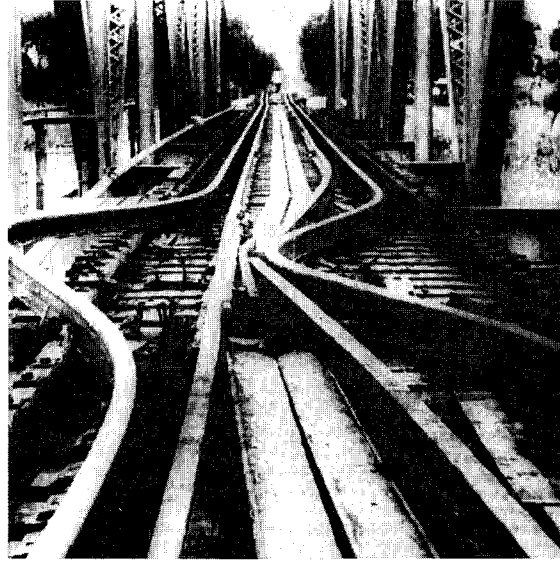
This bridge crossed the Chi Canal at a location where the earthquake intensity was IX. During the earthquake both abutments moved inward and shortened the distance between them by 2.1 m. This compressive movement caused buckling of the steel rails (Figure 4.58) and fracturing of a supporting pier (Figure 4.59).

FIGURE 4.58 Buckled steel rails on railway bridge on Peking-Shanhaikuan line.

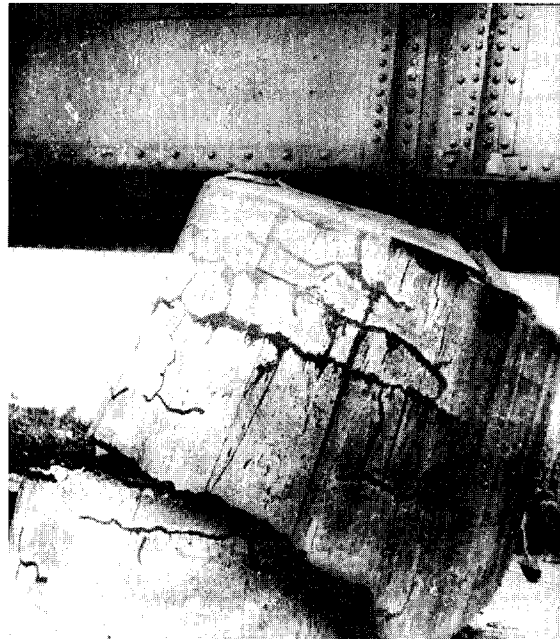
FIGURE 4.59 Broken pier of railway bridge 55 on the Peking-Shanhaikuan line.

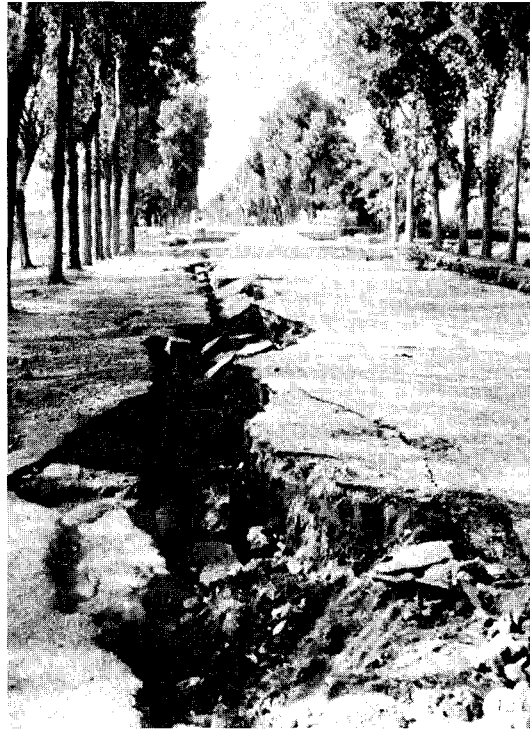
FIGURE 4.63 Damage to a road caused by soil failure.

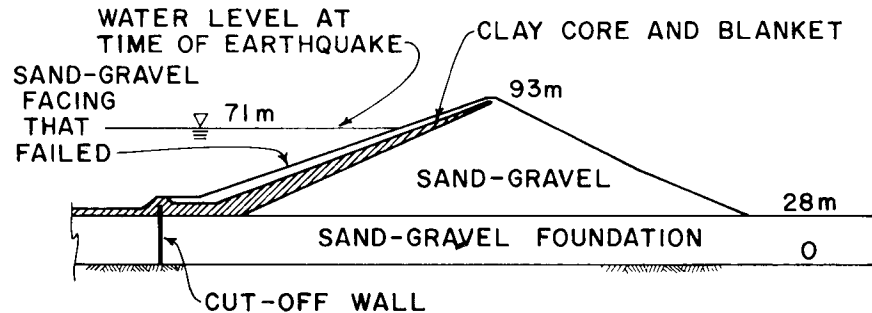
FIGURE 4.65 Cross section of Paiho main dam at Miyun reservoir. During the earthquake the sand-gravel facing on the upstream face of the dam slumped down.

northeast of Peking and about 150 km from the epicenter of the earthquake. The dam was built between 1958 and 1960 and had a maximum height of 66 m and a total crest length of 960 m. It had a thin upstream-sloping clay core with a blanket of sandy gravel 3-5 m thick. A schematic cross section is shown in Figure 4.65. At the end of the earthquake the water level was 21.6 m below the crest. The sand-gravel facing over the clay core failed over almost the entire length of the dam. The upper scarp was close to the water line, ranging as much as 2-5 m above or below the water line. The total volume of slide material was 150,000 m³. The sliding surface was essentially within the sand-gravel layer; the clay core was exposed and scraped only at a few spots. The slope of the clay core beneath the failed facing was 2.8 on 1 while that of the upstream slope was 3 on 1 and then 3.25 on 1. The slide material came to rest on the bottom of the reservoir within 40 m of the heel of the dam. According to witnesses, the failure occurred during the earthquake. Earthquake-induced settlements of the crest reached a maximum of 59 mm, and permanent horizontal displacement had a maximum of 28 mm. This failure is of special interest because strong-motion recordings were made at the dam. According to reports furnished to the delegation, on the ground surface below the downstream toe the peak horizontal accelerations were 0.097 and 0.058g and the peak vertical accelerations were 0.065g. The corresponding peak horizontal accelerations on the crest were 0.128 and 0.16g. The accelerograms recorded on the crest showed apparent periods of about 0.6 s.

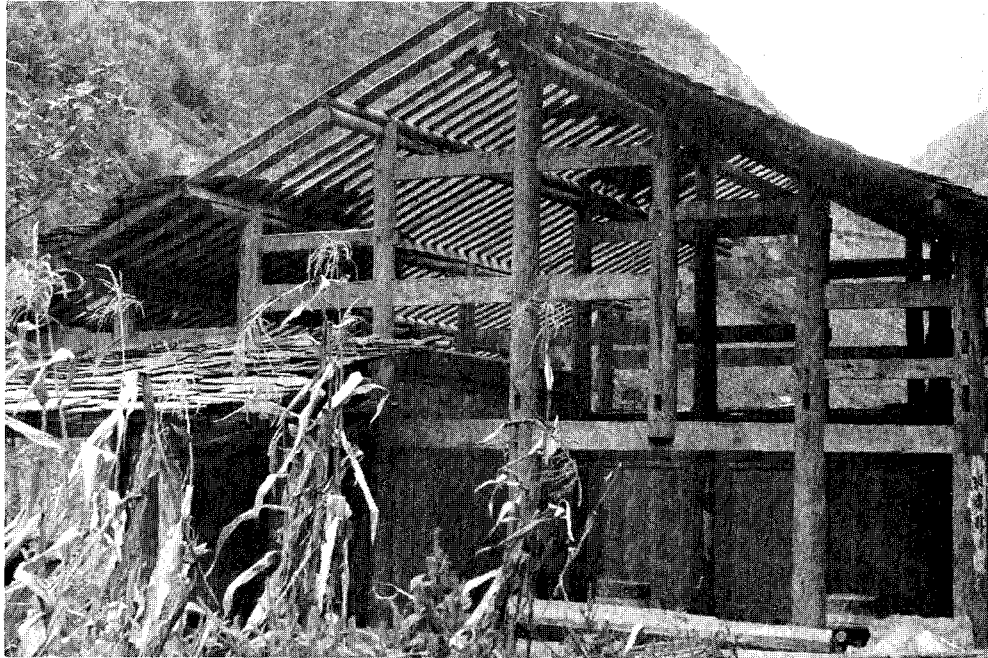
FIGURE 5.11 Wood framing is the most common residential construction in the mountainous epicentral area of the Sungpan-Pingwu (SP) earthquakes.

construction, using dowels of a special type. The infilled walls are generally of wood in the mountainous epicentral area; a few walls are of stone. The roofs are usually of tile, with wood sometimes used. Most of these structures in the Intensity IX zone were damaged, with a few partial collapses. The most common damage was described as a single inclination of the structure (this type of frame would be very flexible). In the Intensity VIII areas, only a small number of such buildings with wooden infilled walls inclined, and there was no damage to this type of construction in areas of Intensity VII. For infilled walls of stone, some walls fell out even in zones with intensities as low as VII. The reasons given for the generally successful performance of this type of housing were its light weight and high ductility. Also, the quality of the construction in the mountainous areas, where lumber originates and is plentiful, is usually better than it is in the cities. The resistance is apparently not a by-product of design for heavy snow loads, as we were told that there is not much snow in this region.

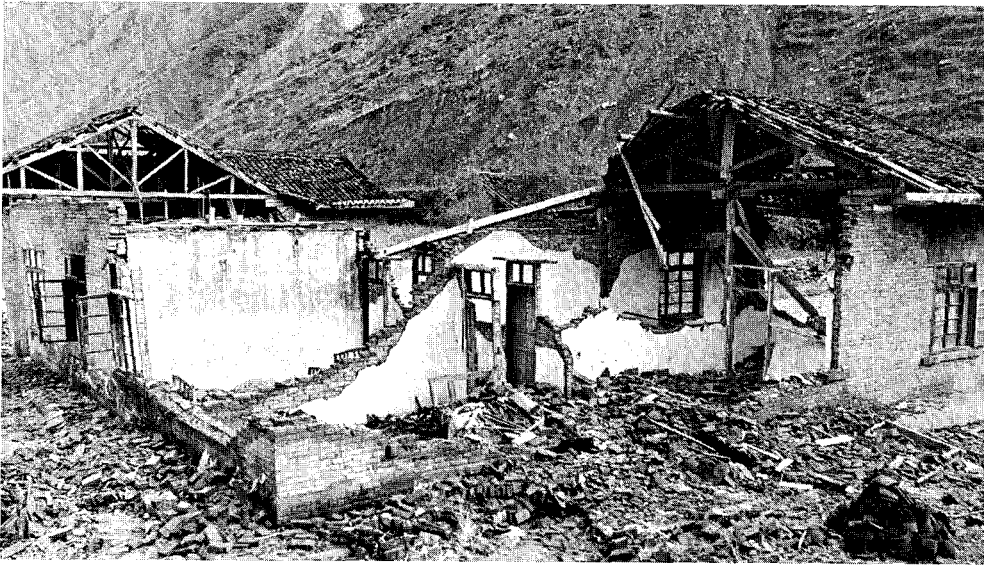
There were a small number of brick buildings in the area of strongest shaking. This second type of construction has a timber roof, brick columns, and brick walls, as shown in Figure 5.12. The external and internal walls were about 12 cm thick and were constructed with lime mortar. The damage to this type of construction was rather heavy: most collapsed in areas of Intensity IX. A small portion suffered partial collapse in areas of Intensity VIII, and most were heavily damaged. Most of this type of construction were cracked in areas assigned as Intensity of VII. The buildings were not designed to resist earthquakes, and were reported to

FIGURE 5.12 A second less common and less resistant type of construction consists of brick columns and walls, with wooden roof trusses.

have low-strength brickwork and construction defects; much earthquake damage was also attributed to the effects of openings for windows and the settlement of foundations.

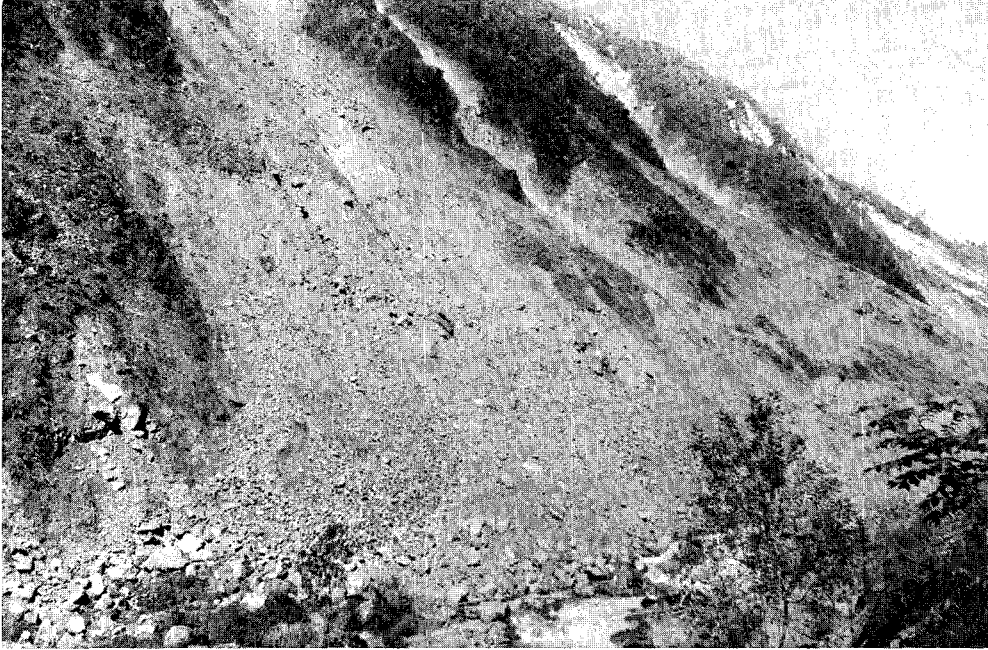
A primary feature of the earthquakes was the large number of rockfalls, landslides, and mud flows that occurred. The mountainous epicentral region is high, over 5,000 m in some places, and steep. The potential for slides was increased by the occurrence of heavy rains between the three earthquakes. The slides disrupted communications in many cases and also caused damage to structures. Some of these effects are shown in Figures 5.13-5.19.

FIGURE 5.14 Rockslide in a canyon, SP earthquake.

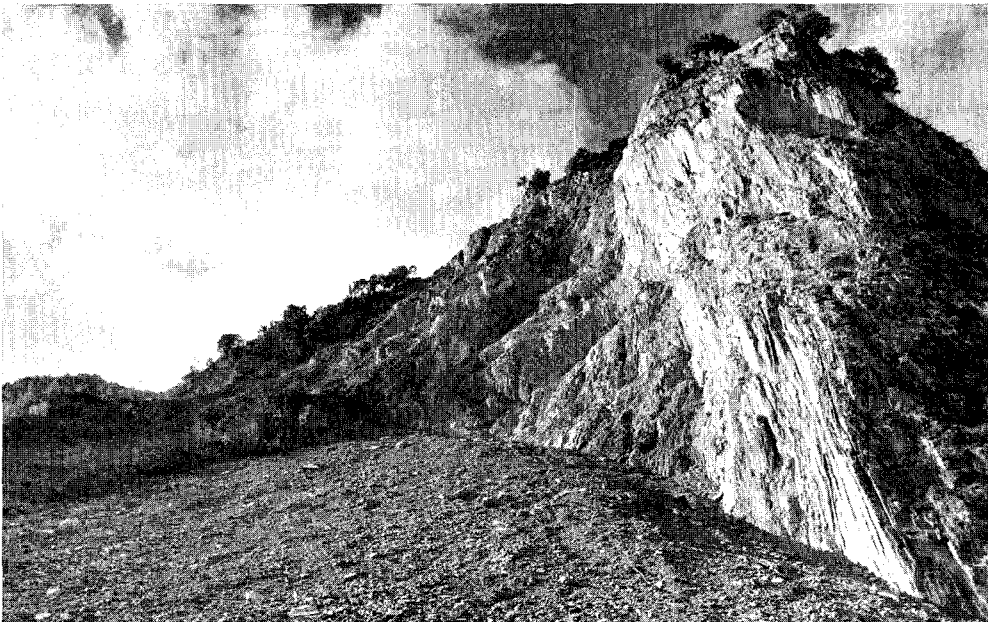
FIGURE 5.15 The head of a rockslide in the mountainous terrain, the SP earthquakes. Slides, without earthquakes, are common in this region.
