INFLUENCE OF SITE CHARACTERISTICS ON BUILDING DAMAGE DURING THE OCTOBER 3, 1974 LIMA EARTHQUAKE

Report No. UCB/EERC-80/41

September 1980

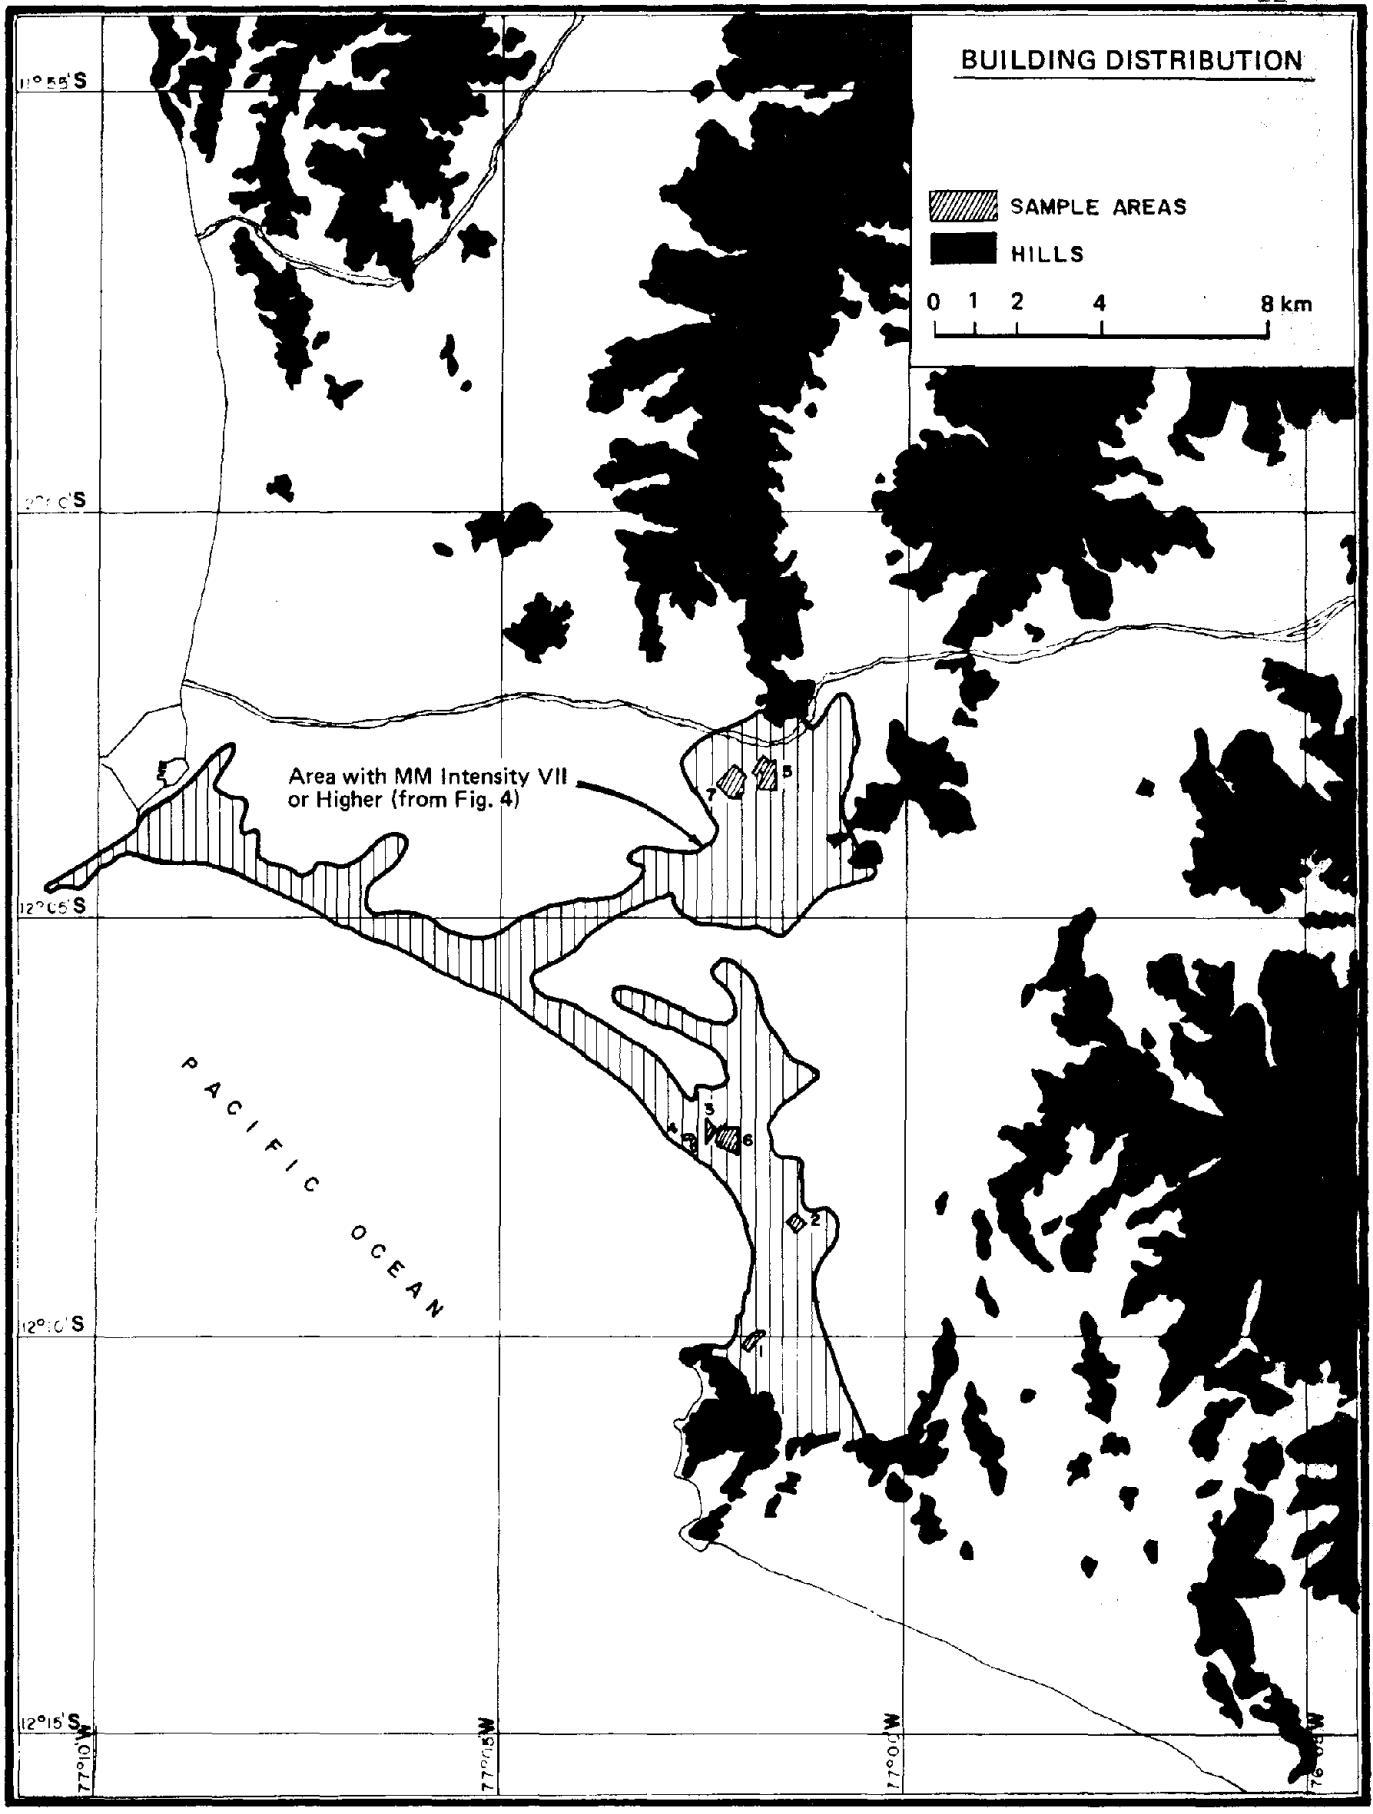
Fig. 5 - SAMPLE AREAS LOCATION, GREATER LIMA

throughout the MM Intensity > VII region. The locations of these zones are shown on Figure 5. Data were gathered on the damage characteristics and on the statistics of the various construction types. (Sample Areas 6 and 7, also shown in Figure 5, were used for a separate purpose, which will be discussed later in this report.)

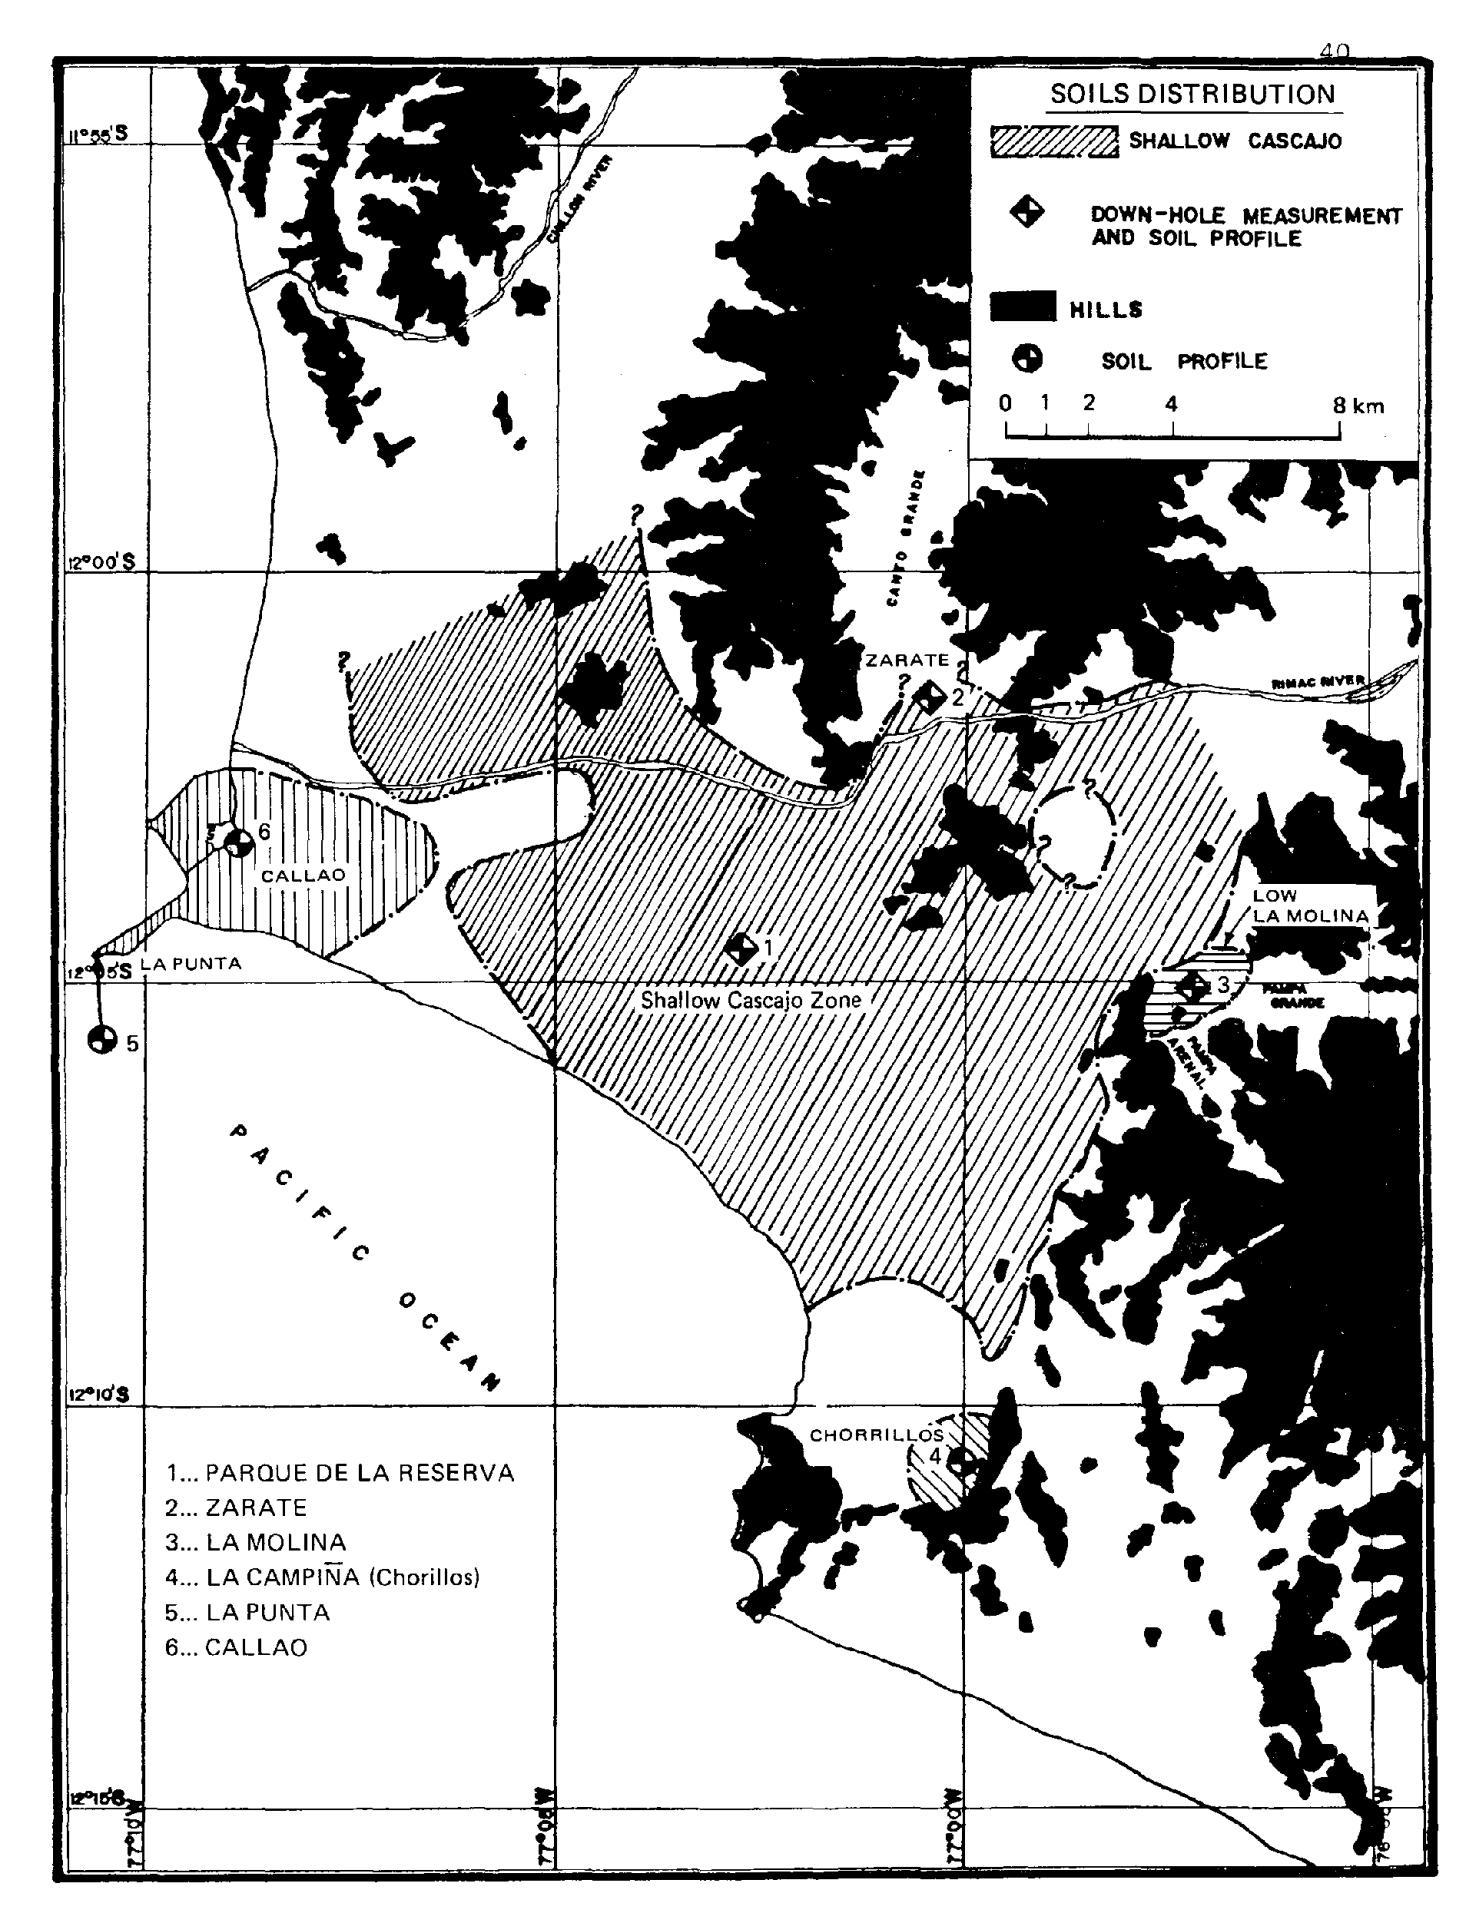
Fig. 9 - SOILS DISTRIBUTION, GREATER LIMA

To obtain a more accurate picture of the distribution and properties of the various subsurface soils in Lima, the files of geotechnical consulting engineers and the available records on numerous water wells throughout the city were consulted. On the basis of the information obtained, the following well-defined subsurface conditions have been identified in the area (Figure 9):

- A large central area underlain by cascajo, which consists of a medium dense to very dense coarse gravel and sand with cobbles, extending from the ground surface to rock.
- Canto Grande (Zarate), deposits, consisting of dense to very dense sands and gravels extending from the ground surface to rock--and very similar in characteristics to the cascajo formation.
- 3. Callao-La Punta deposits, to the west of the city, consisting typically of sands, silts and clays, underlain by cascajo at

depths varying from 10 to 30 m, with some hard marine clays at considerable depths in some locations. At La Punta, an open graded cascajo redeposited by the ocean is found at the surface.

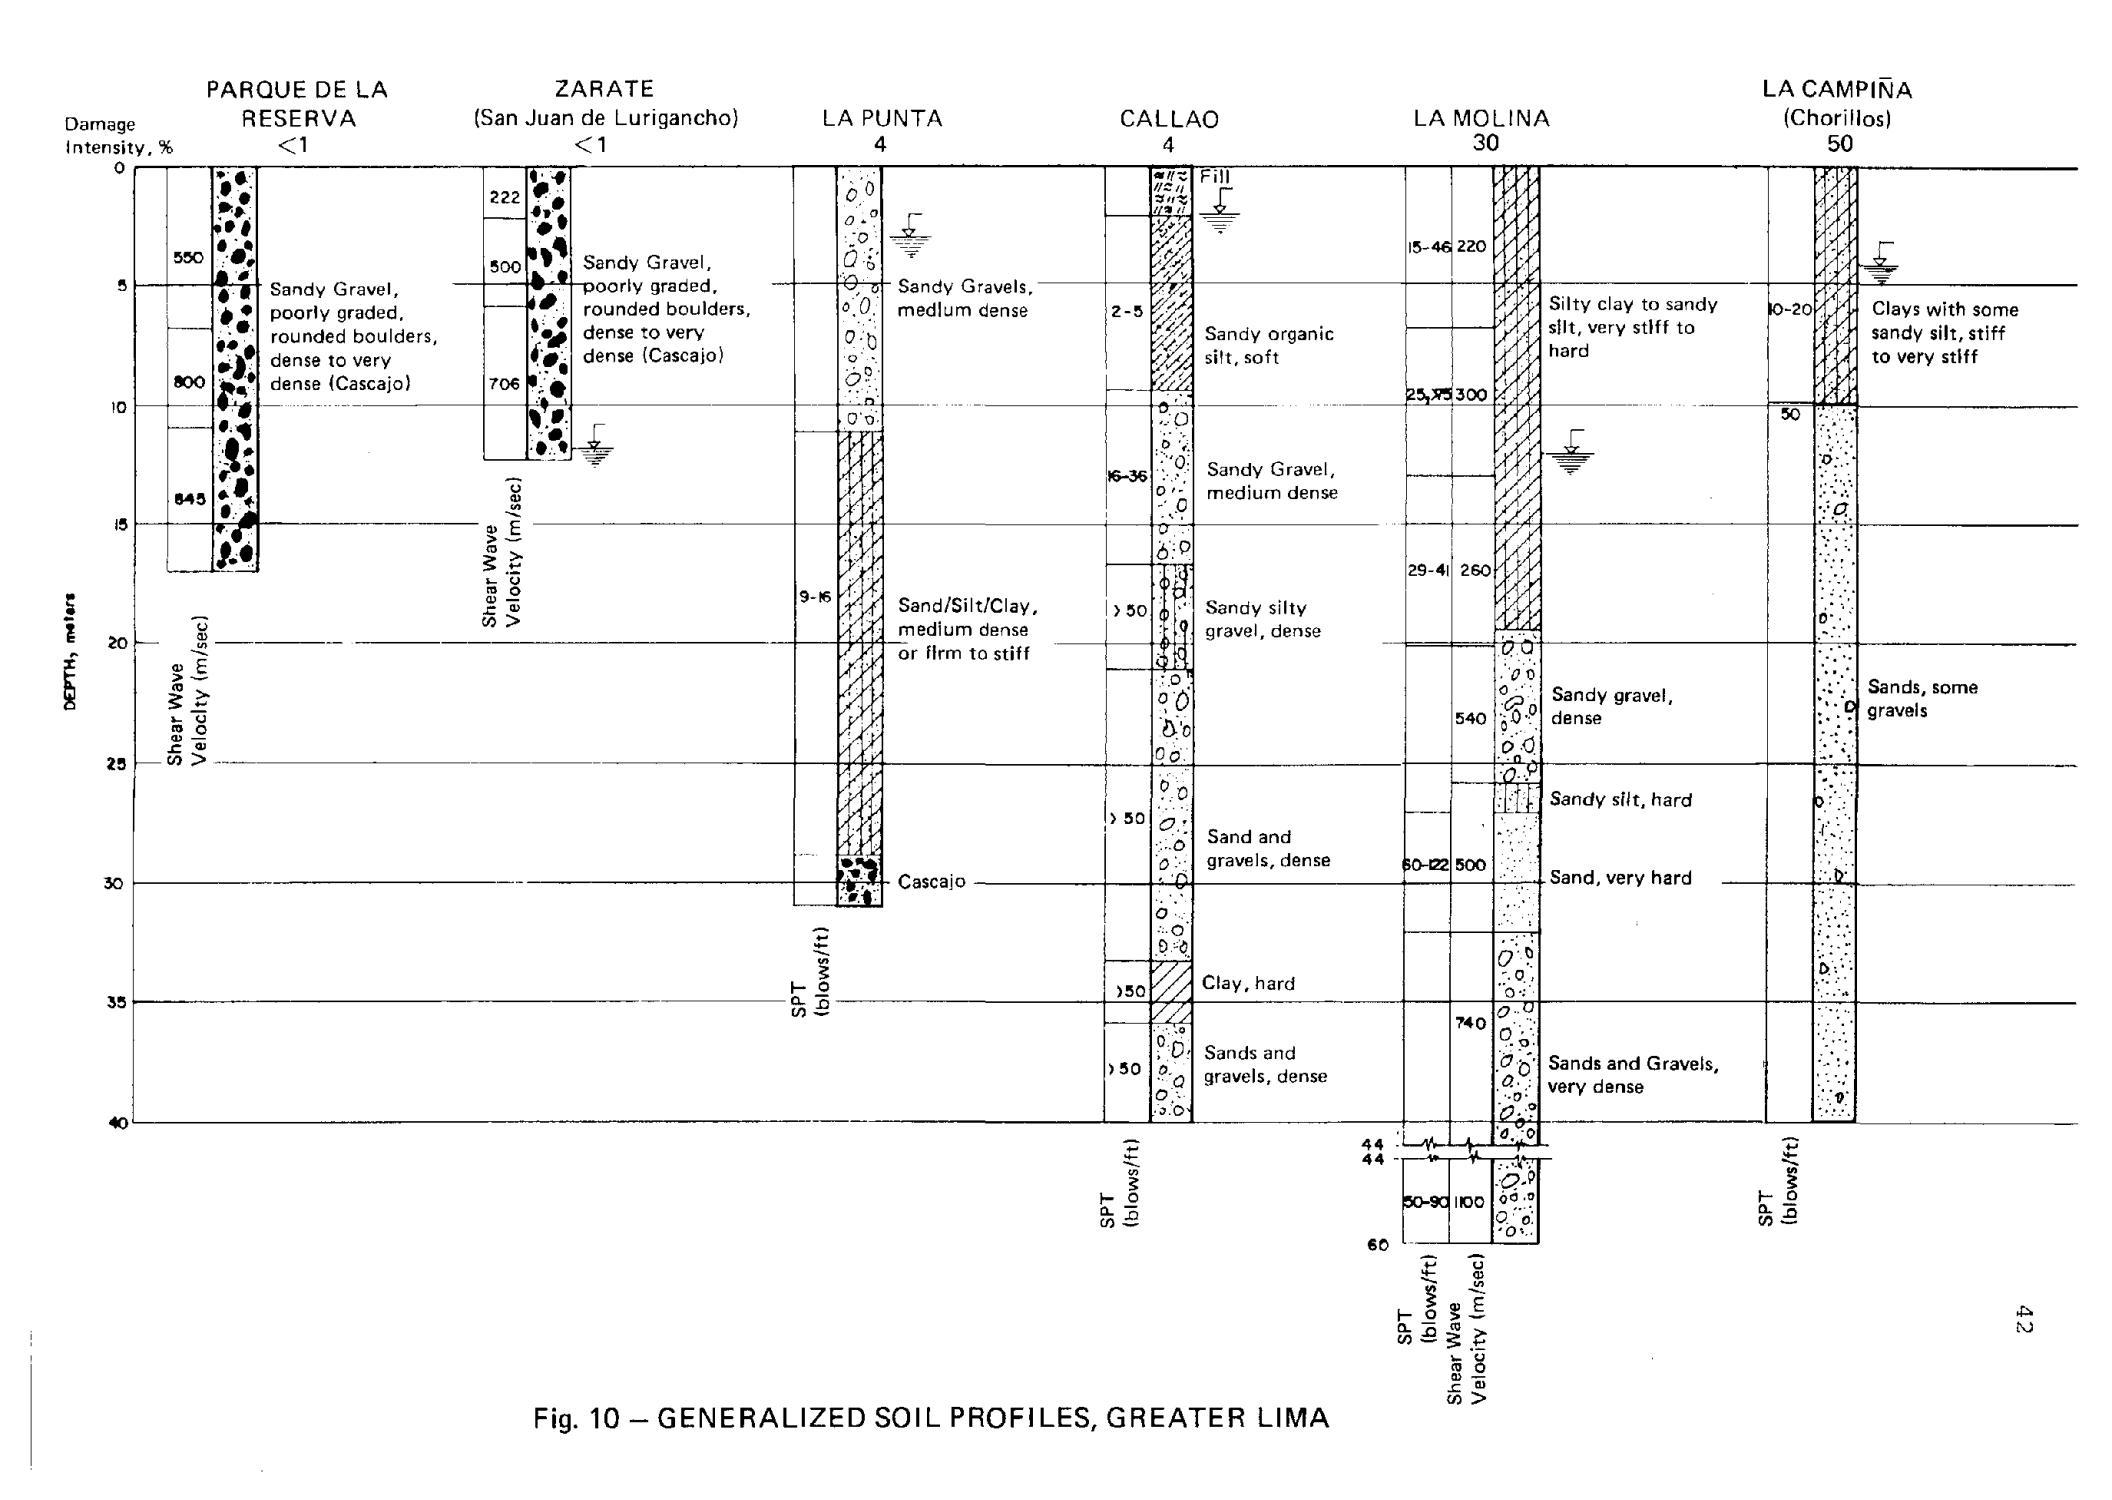
Typical logs of borings depicting the subsurface conditions described above are presented in Figure 10, which also shows the structural damage intensity in the different zones. It is clear that there is a marked difference between the soil conditions in central Lima (and all the cascajo area) where structural damage intensities were very low (much less than 1%) than in the other three areas where deposits of gravel, sand and clay extend to depths of at least 30 m below the ground surface and structural damage intensities range from about 4 to 50 percent.

It became clear during the investigation and from the data shown in Figure 10, that the dominant subsurface material in Lima is apparently the cascajo formation and that an important key to the determination of earthquake damage to engineered structures is whether a site is underlain by cascajo or by other materials. While in some areas, such as central greater Lima, cascajo extends from base rock to within 0.5 m from the ground surface, in others such as La Molina, the cascajo either does not exist or is deeper than 30 m; at El Callao - La Punta it is 10 to 30 m or more in depth; and at La Campina (Chorrillos) it is practically nonexistent. Clearly, the areas of greater Lima, where the concentrations of structural damage were identified (Figure 7), correspond with the areas where the cascajo is underlying 30 or more meters of finer sediments. Thus, the higher damage incidence in these areas may well be attributed to the differences in the response of cascajo, compared to the other sediments, during the earthquake shaking.

Soil profiles and standard penetration resistance values, taken at the areas of concentrated structural damage suggest that the shear wave velocity of the sediments at La Campina may be expected to be about the same as those at La Molina, and that the sediments near Callao would probably show somewhat lower values than at La Molina. Clearly, there is a pronounced velocity contrast between these three areas and the zone underlain by the cascajo. This is readily apparent in the generalized soil profiles presented in Figure 10.

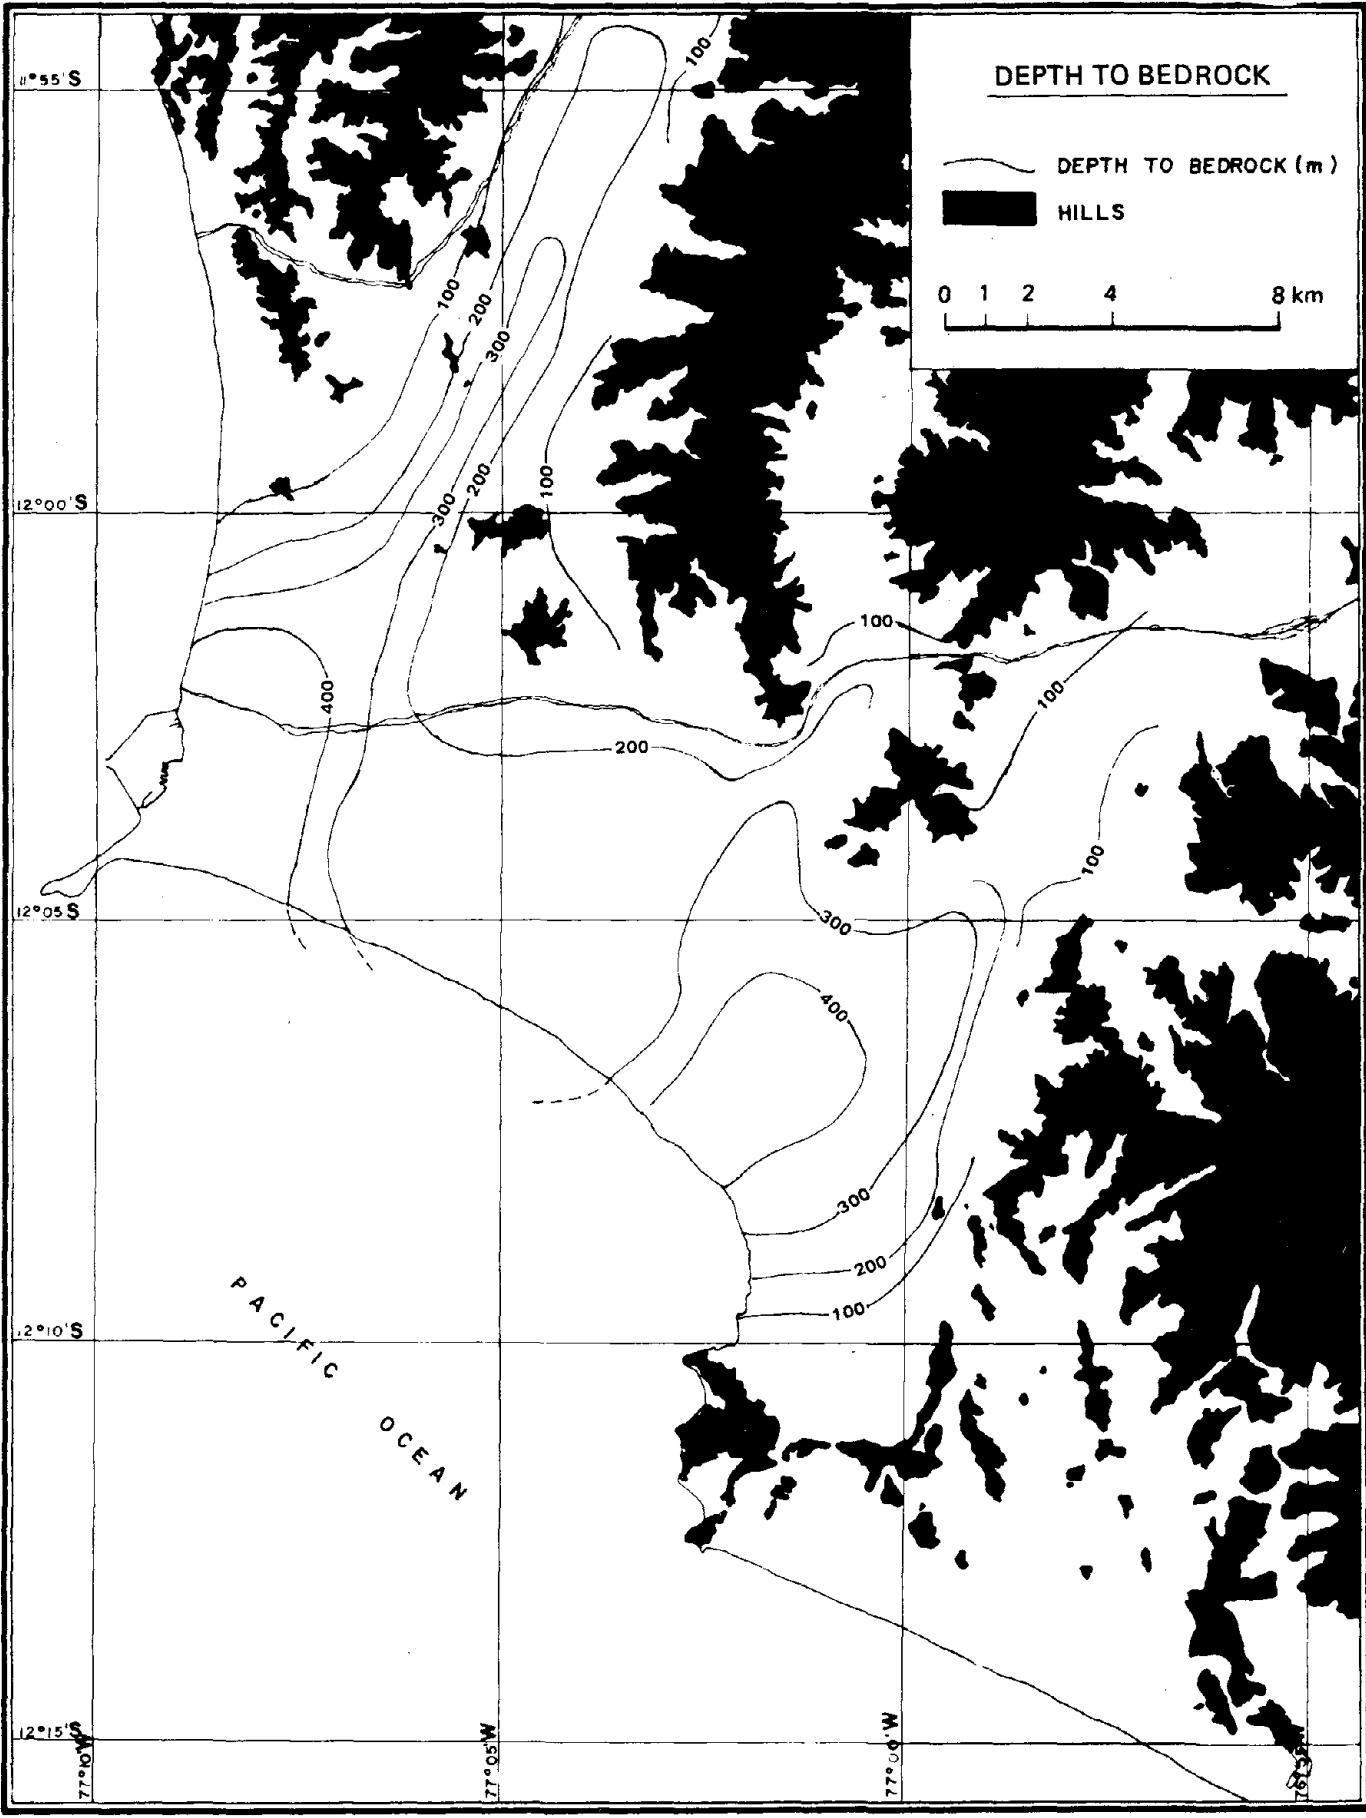
Fig. 11 – DEPTH TO BEDROCK, GREATER LIMA

It is interesting to note that there is no apparent correlation of structural damage intensity in the Lima area with the depth to bedrock (shown in Fig. 11) or the depth of the water table (shown in Fig. 12). The reason for the lack of correlation with depth to bedrock, as will be seen from the following section of the report is that the cascajo behaves for practical purposes, as if it were bedrock. Depth to water table is not usually a significant factor unless soil instability (liquefaction) is involved, and this is not likely to occur in the stiff clays and dense cohesionless soils underlying most of the greater Lima area.

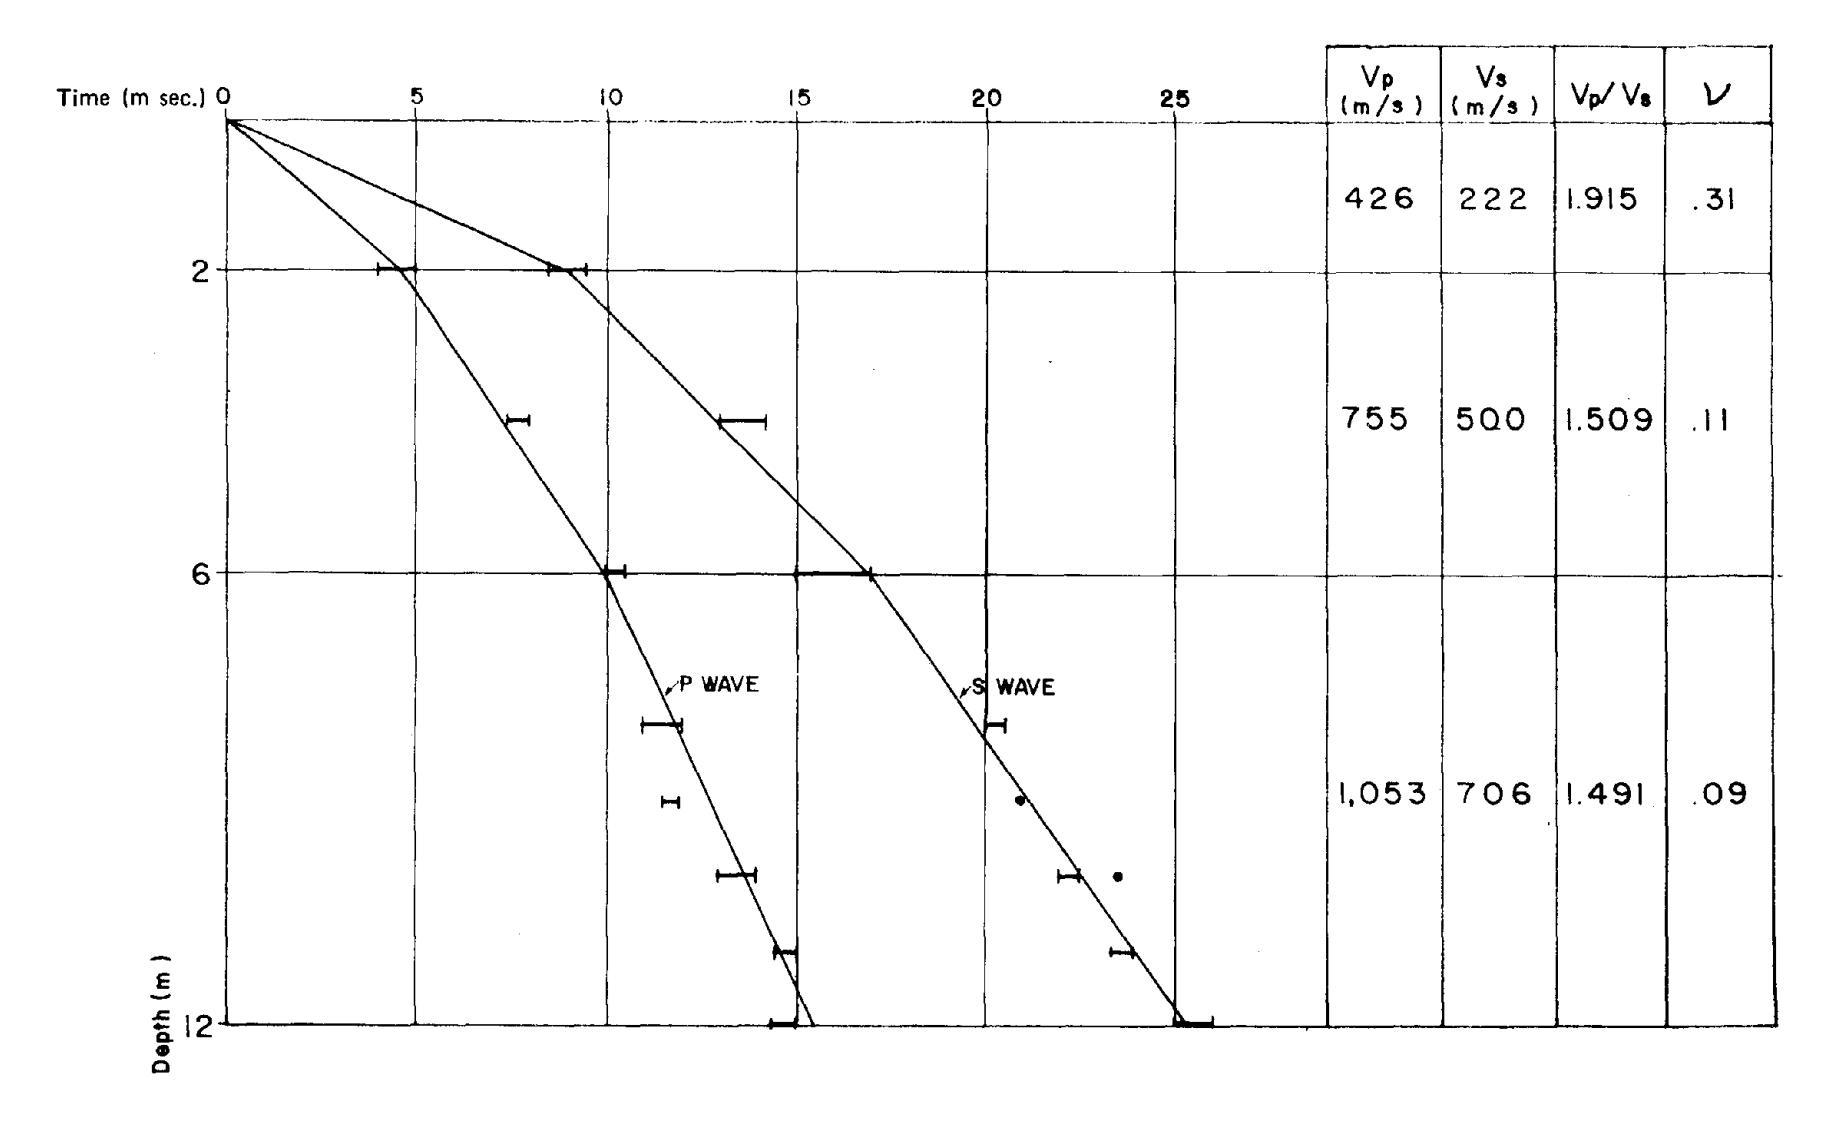
Fig. 14 - DOWN-HOLE MEASUREMENT - ZARATE

For the cascajo, Figures 13 and 14 show an average shear wave velocity of 525 m/sec at a depth of 4 m below ground surface, increasing to 700 m/sec at depths as shallow as 6 m below the ground surface. Test results at La Molina, Figure 15, show that the shear wave velocity of the sediments overlying the cascajo increase from a value of 200 m/sec at a depth of 3 feet to 700 m/sec at a depth of about 40 m.

The Zarate boring log (Figure 10) and the wave velocities from Figure 14, were obtained 20 m away from the site formerly occupied by the dismantled Zarate station. Again, rock-like velocities were measured beginning at 6 m below the ground surface.

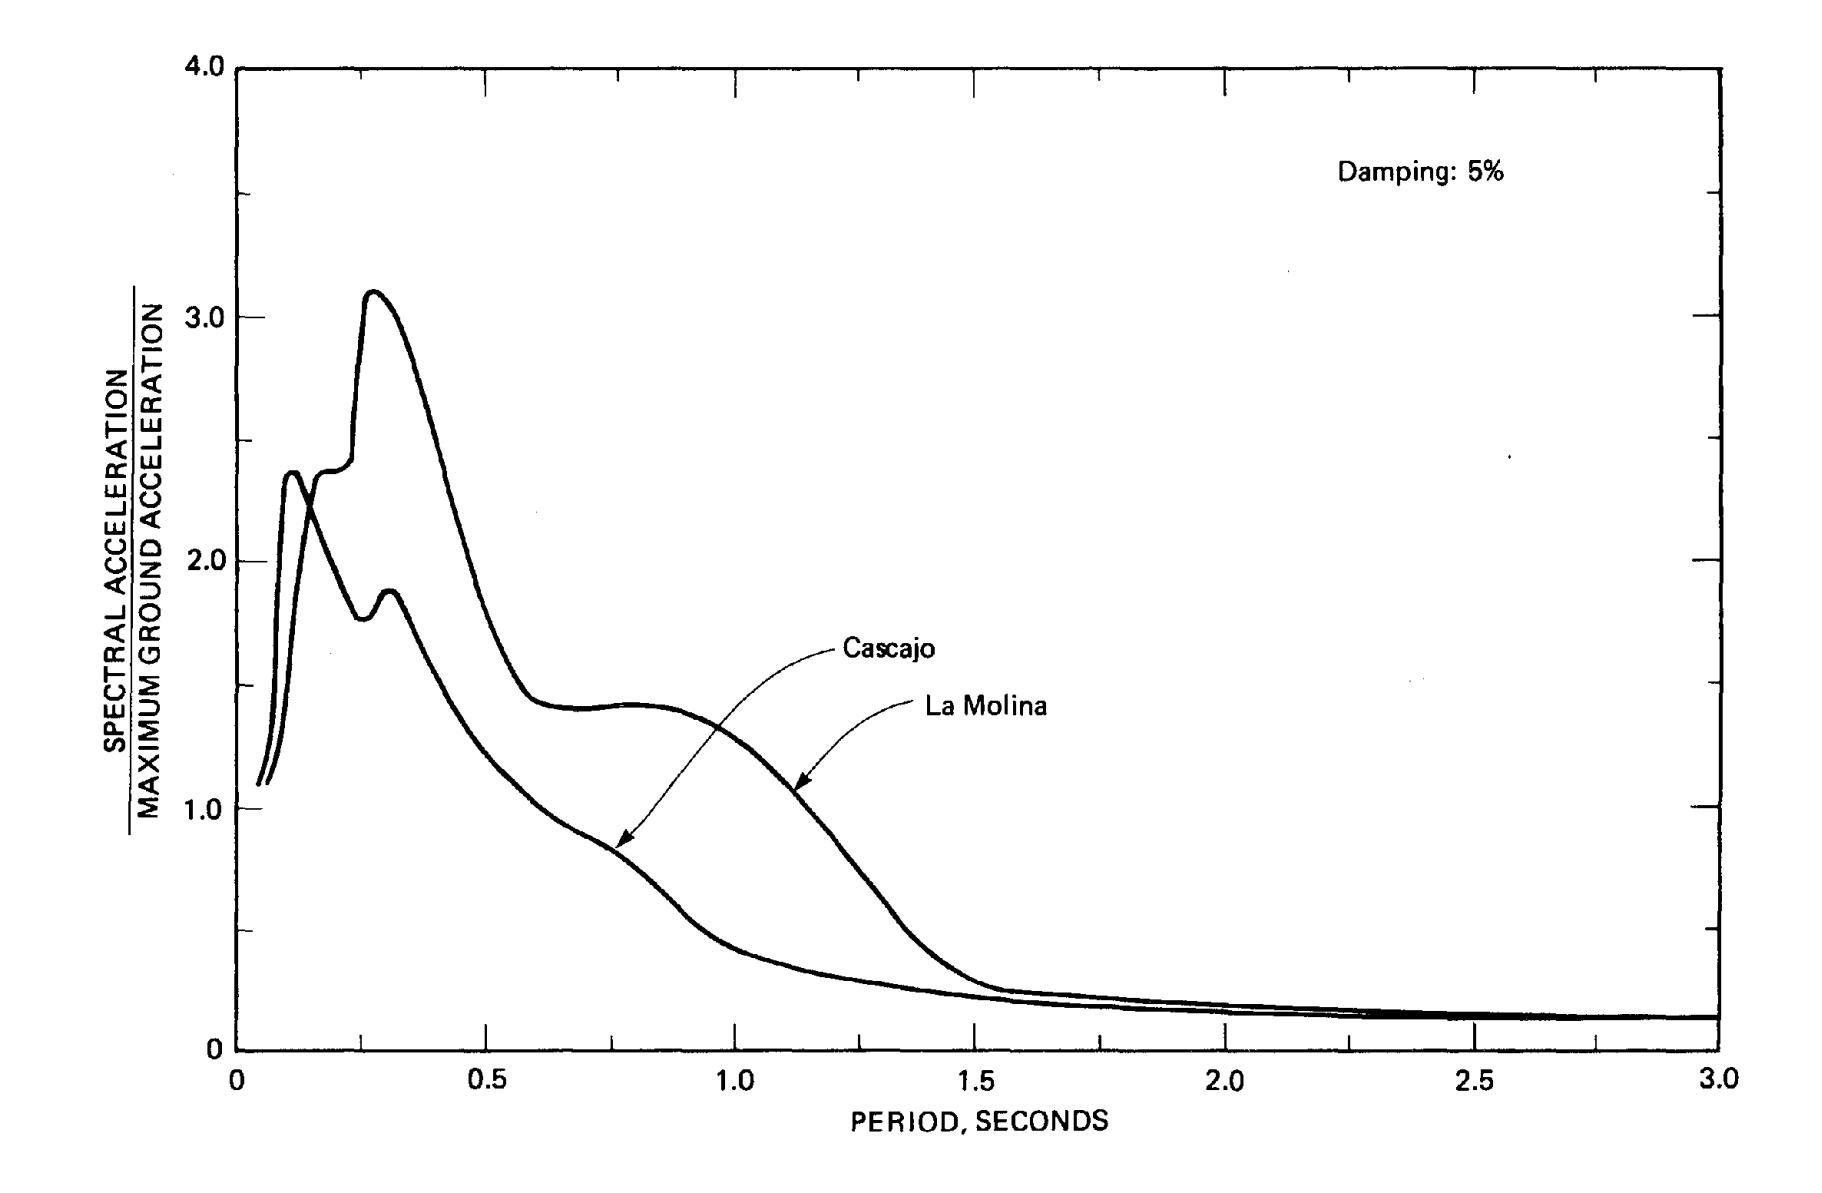
Fig. 17 – AVERAGE ACCELERATION SPECTRAL SHAPES FOR DIFFERENT SOIL CONDITIONS, GREATER LIMA

Normalized acceleration response spectra were first determined from all the motions in each group, and these were then averaged to obtain the mean spectral shapes, which are presented in Figure 17. It is readily apparent that there is a difference in spectral shapes depending on site conditions, particularly for periods between about 0.15 seconds and 1.5 seconds. Above 0.15 seconds, the spectral accelerations are much higher for the stiff soil conditions at La Molina than for the rock-like velocity material, cascajo.

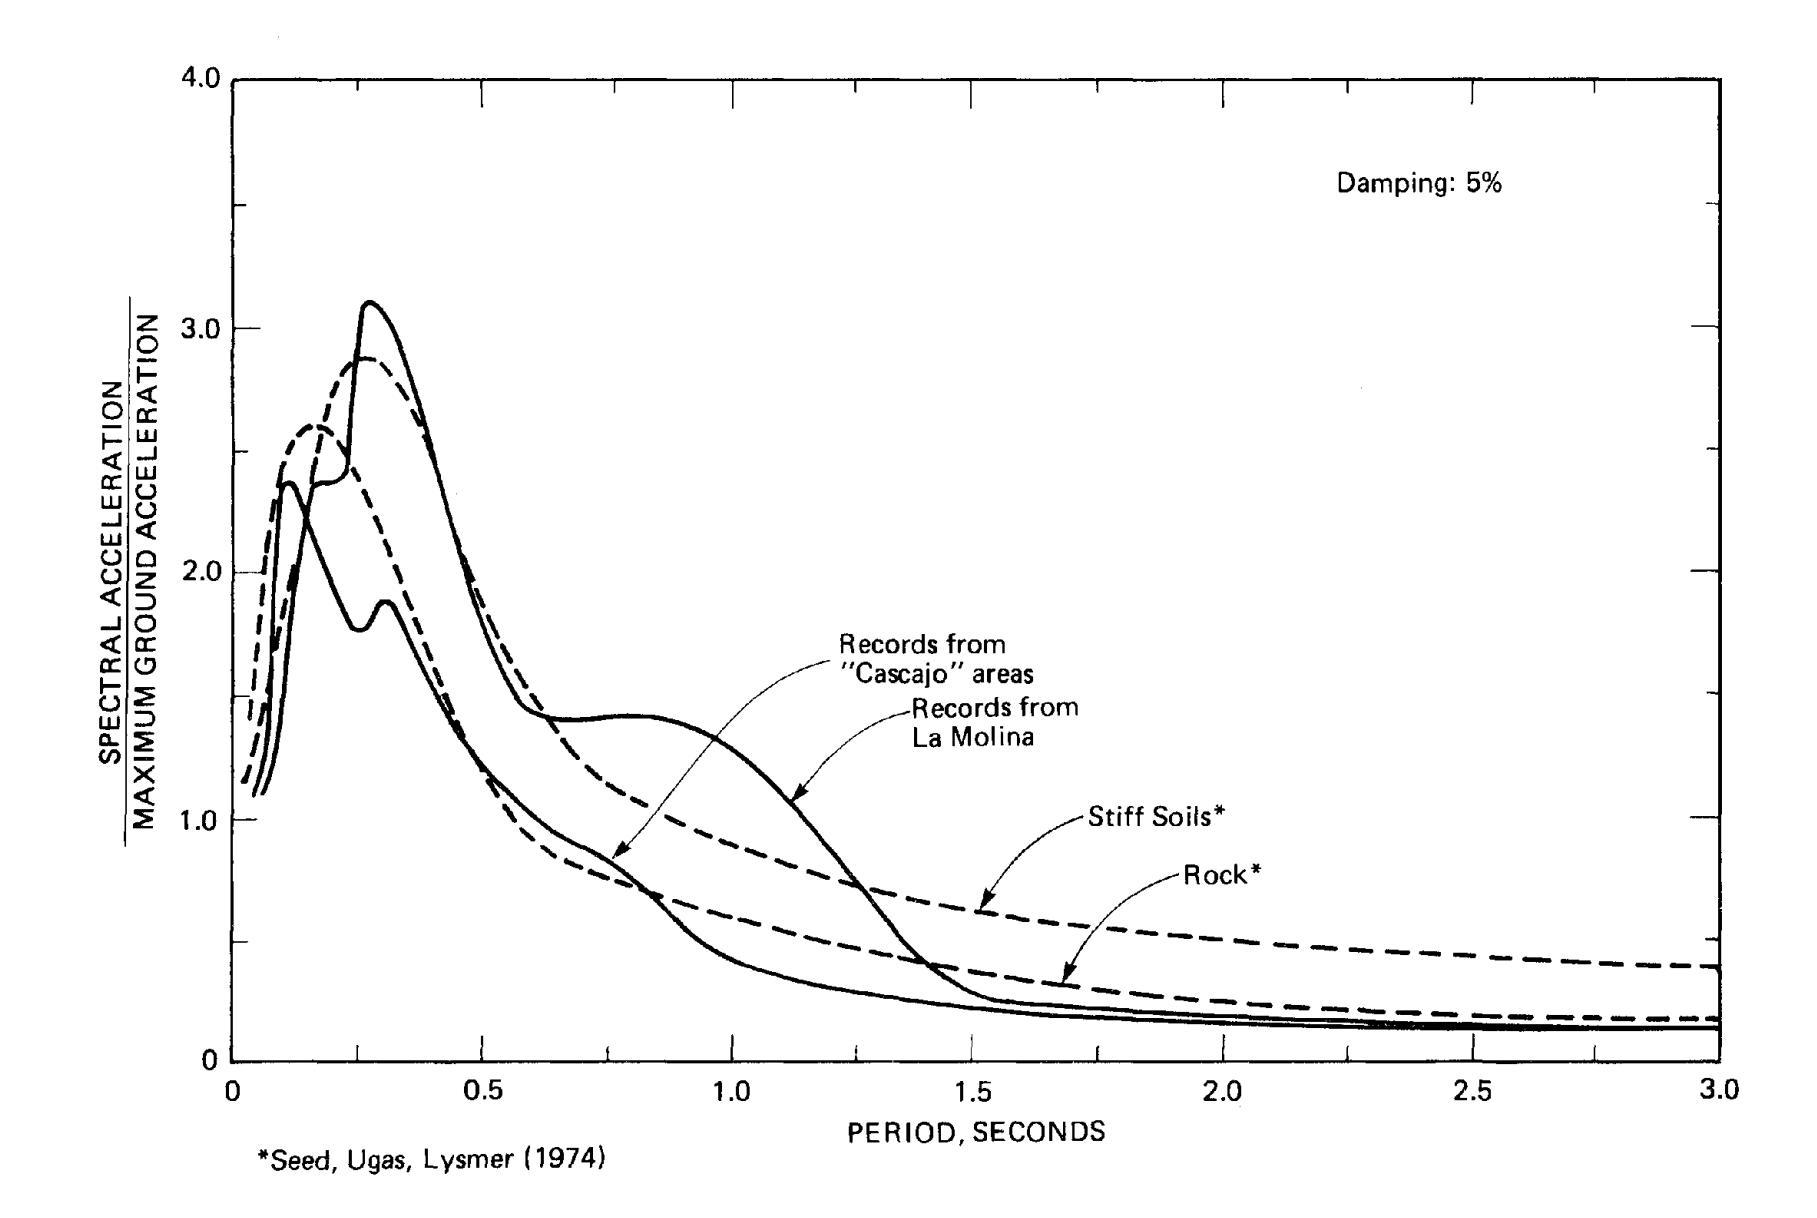
Fig. 18 – COMPARISON OF AVERAGE SPECTRAL SHAPES FOR LIMA SOILS AND FOR SOILS FROM OTHER AREAS

The representative site-dependent spectral shapes for rock and stiff soil conditions from Figure 16 are plotted with the Lima average spectra in Figure 18. In spite of the different sources of the readings, there is a good agreement between the spectral shapes obtained from the two independent data sets up to periods of about 1.25 seconds. For periods greater than about 1.5 seconds, the spectral accelerations for the Peruvian earthquakes are lower than the corresponding spectral values proposed by Seed and others. The Peruvian spectra were derived from motions generated by earthquakes on subduction zones, while the shapes proposed by Seed et al. were primarily based on data from continental earthquakes. Studies by Idriss (5) indicate that records from subduction zone earthquakes are generally deficient in long period waves, thus corroborating the

relative values shown in Figure 18 at the long period end of the spectra.

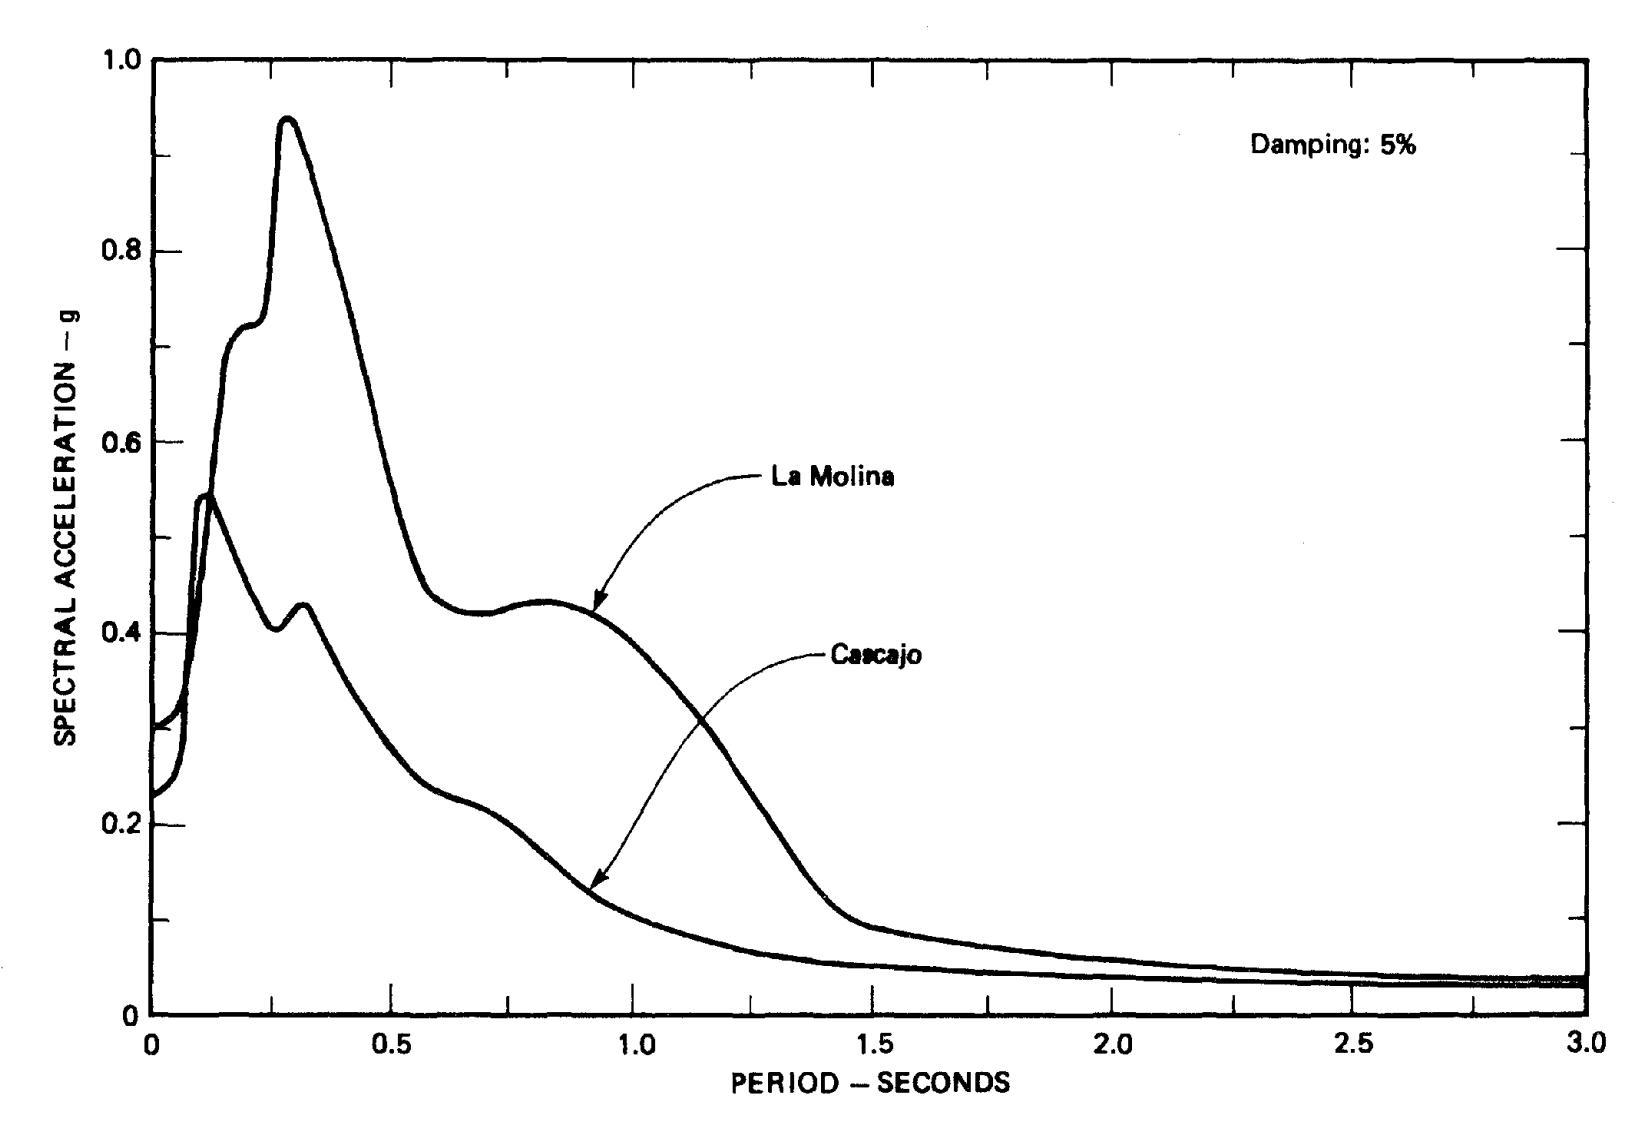
Fig. 19 – PROBABLE REPRESENTATIVE ACCELERATION SPECTRA FOR DIFFERENT SOIL CONDITIONS IN GREATER LIMA – OCT. 3, 1974 EARTHQUAKE

The relative values of the spectral amplitudes of the mean spectra for the different areas of Lima shown in Figure 19, explain why low period, 1 to 4 story structures, such as the brick-bearing wall and R.C. frame dwellings which are so prevalent in the city of Lima, perform better in the areas of the city underlain by cascajo than in areas such as Molina with generally deeper but stiff soil conditions. In an undamaged condition,

1 story structures with periods of the order of 0.10 second may be expected to have approximately the same dynamic response in all areas. However, once cracking of such a structure begins to develop, causing the structural period to increase to values, say 50 to 100 percent larger than its original value, the force developed on a structure constructed on a stiff soil deposit would be almost twice that for a similar structure located on a cascajo site. For 2 to 4 story structures, the response on stiff soil sites such as La Molina would be about twice that for similar structures on cascajo, even without cracking. As shown in Figure 9, most of metropolitan Lima is founded on the area underlain by the cascajo formation. It is not surprising, therefore, that damage due to earthquakes in this city is not so severe as the damage observed in other cities where subsurface conditions are closer to those encountered outside the cascajo area of Lima. It is also understandable why damage to buildings on the stiff soil areas of La Molina, Callao and Chorillos would be greater in the earthquake of October 4, 1974, than in the main part of the city of Lima.
