# INVESTIGATION OF REINFORCED BRICK MASONRY BUILDINGS UNDEMANAGED BY THE SAN FERNANDO EARTHQUAKE

May 1981

AGBABIAN ASSOCIATES  
El Segundo, California

<b>REPORT DOCUMENTATION PAGE</b>		1. REPORT NO. NSF/CEE-81014	2.	3. Recipient's Accession No.
4. Title and Subtitle Investigation of Reinforced Brick Masonry Buildings Undamaged by the San Fernando Earthquake		5. Report Date May 1981

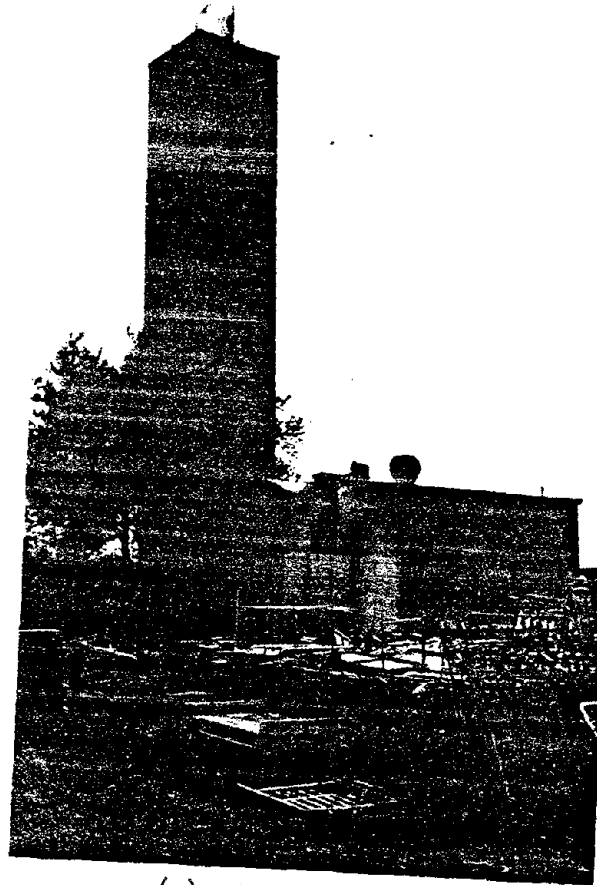
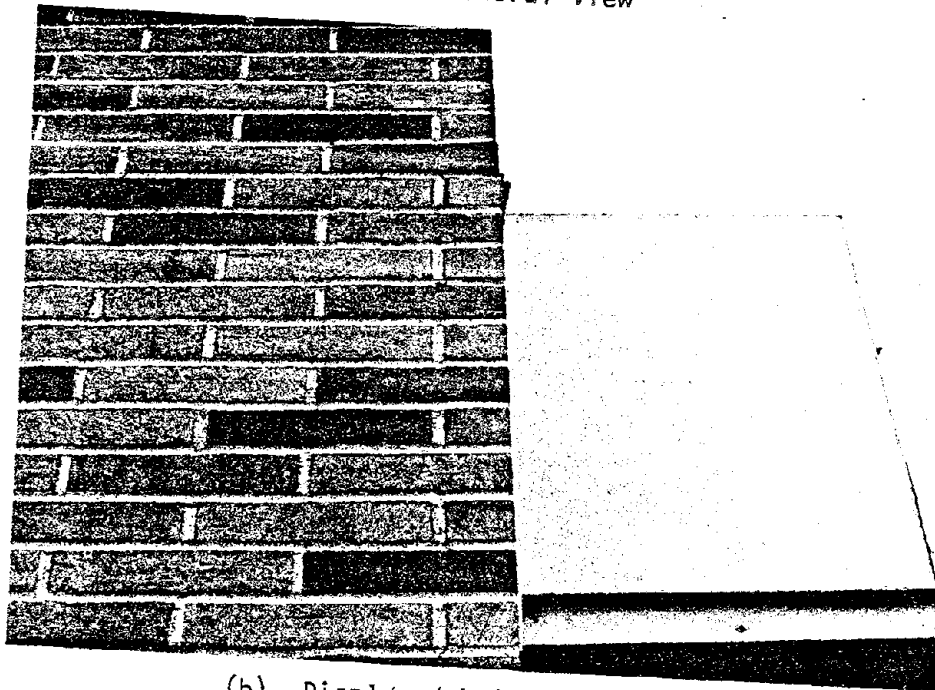
FIGURE 1-4. INCINERATOR BUILDING (NO. 43)

Building 3 (see Section 3 for details). Visible cracks were also reported in the reinforced concrete frames supporting the boiler house roof (see Section 4 for details) and the chimney of the incinerator (Building 43) as illustrated in Figure 1-4.

(a) General view

(b) Displaced brick — chimney

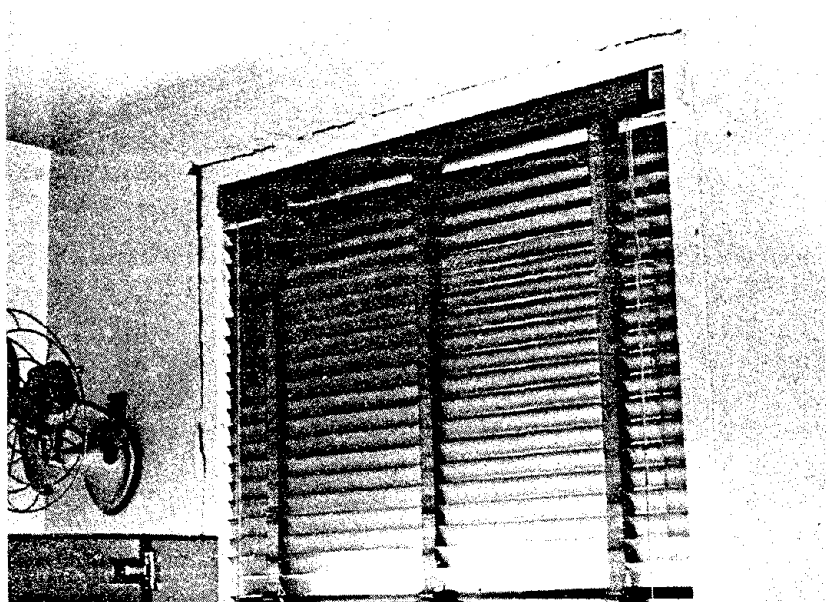
FIGURE 3-16. WINDOW JAMB IN SIXTH FLOOR JOLTED OUT OF PLACE BY STRONG SHAKING OF BUILDING 3

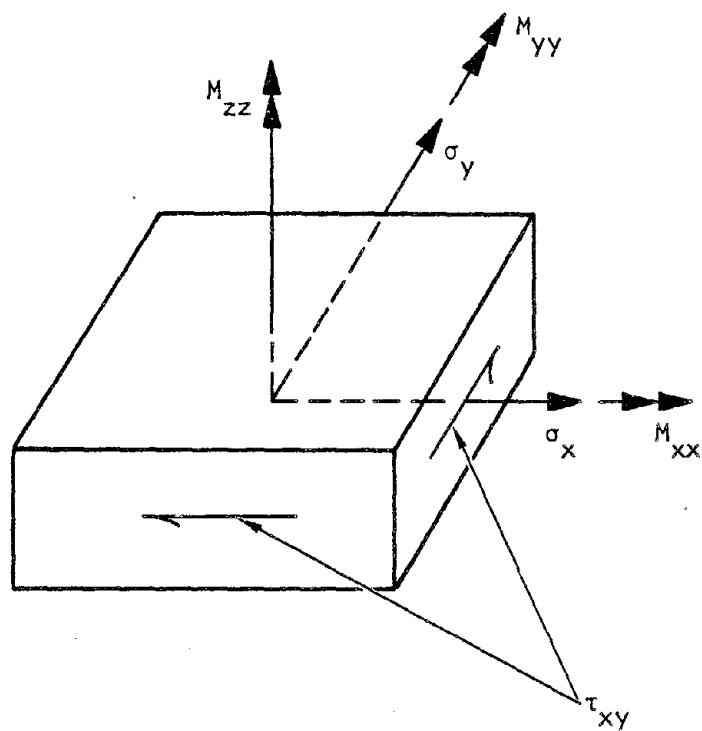
FIGURE 7-1. PLATE ELEMENT MOMENTS AND STRESSES  
(POSITIVE DIRECTIONS SHOWN)

Analysis results of Building 10A indicate that flexural moments  $M_{xx}$  and  $M_{yy}$ , shown in Figure 7-1, are very small and would not create significant stresses.

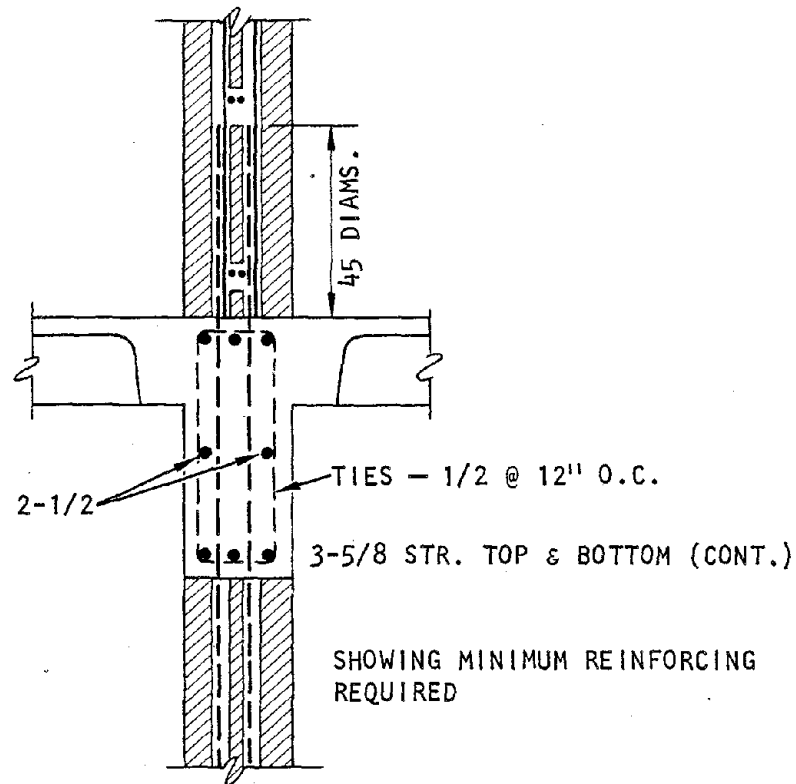
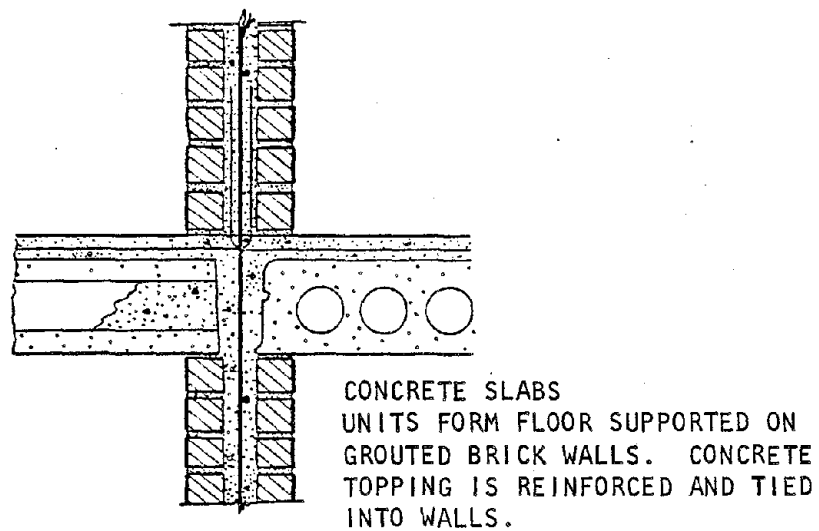
FIGURE 7-3. WALL BEAM DETAIL (INTERIOR WALL)

A qualitative assessment was made of connections and construction details by reviewing the available drawings. Some selected details are shown in Figures 7-3 through 7-10. Figures 7-3 and 7-4 illustrate interior and exterior wall-to-beam connections as built (1954). These figures show continuity of wall reinforcement in the beams. Figure 7-3b illustrates the current code of practice and indicates that connections of Figure 7-3a and 7-4 satisfy the current code of practice.

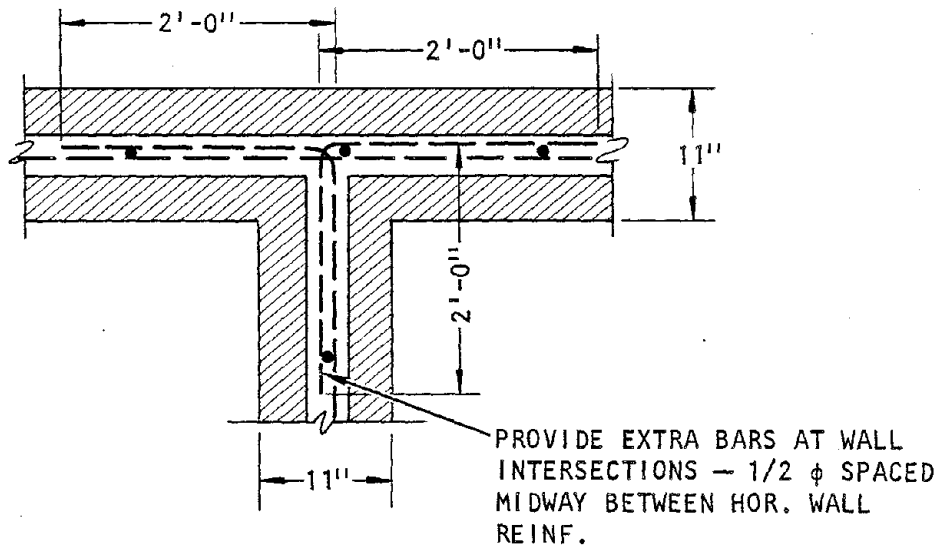
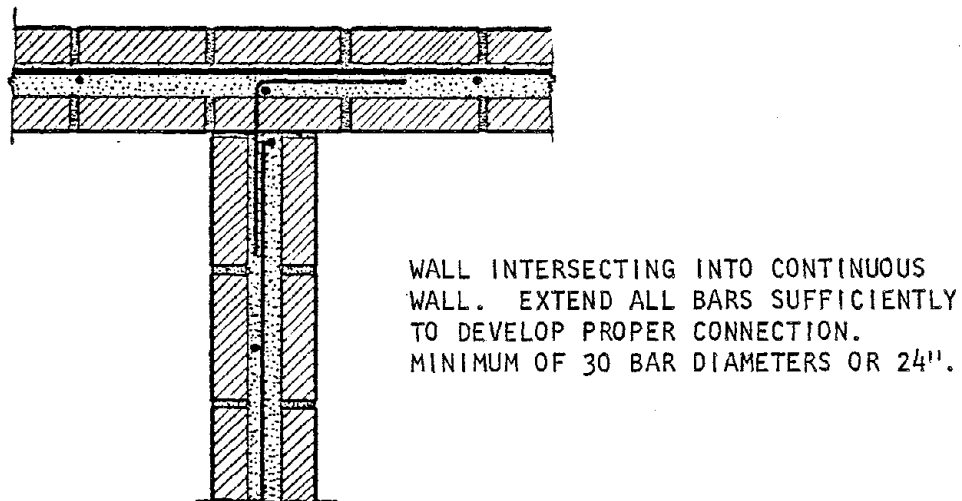
FIGURE 7-5. WALL INTERSECTIONS DETAIL

Figures 7-5 and 7-6 provide a comparison of wall-to-wall connections for the 1954 hospital construction and the present code of practice. The requirements of current practice are satisfied.

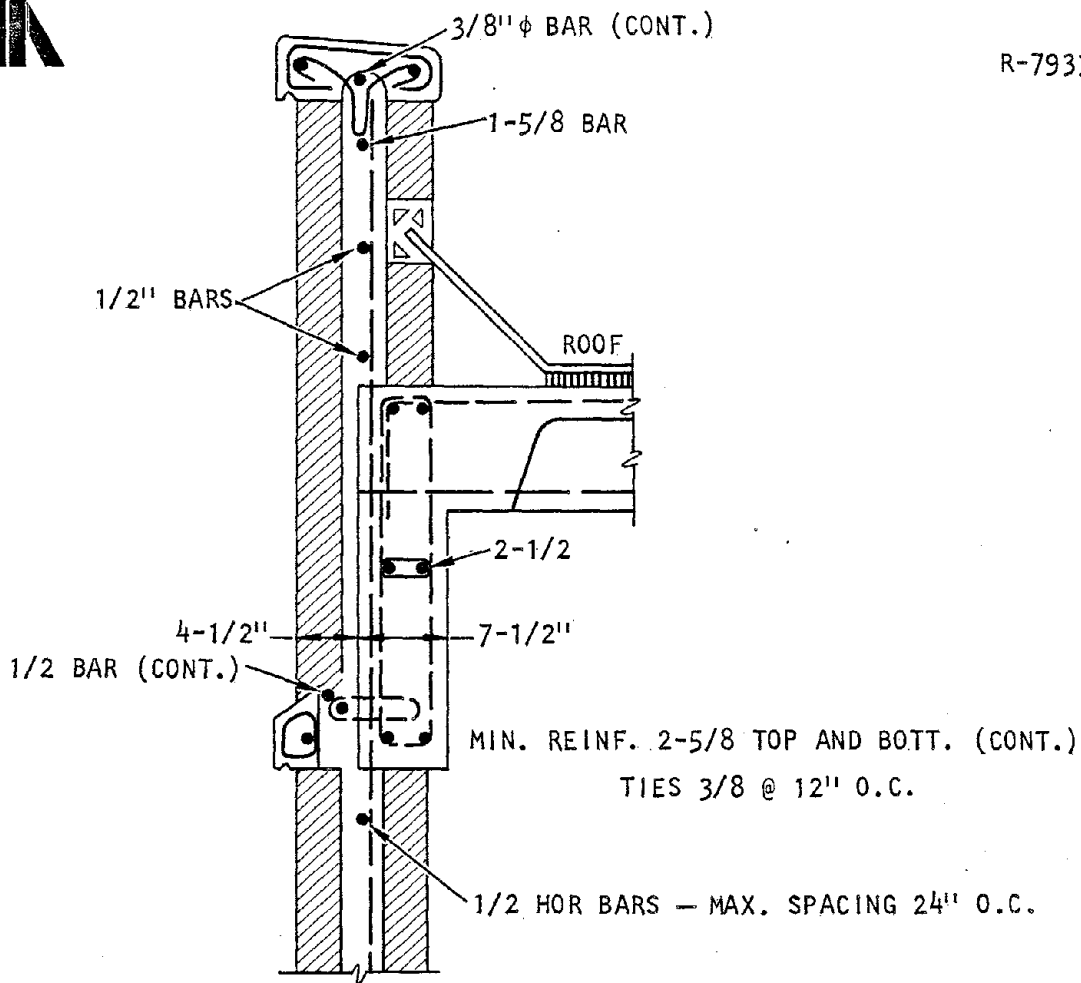
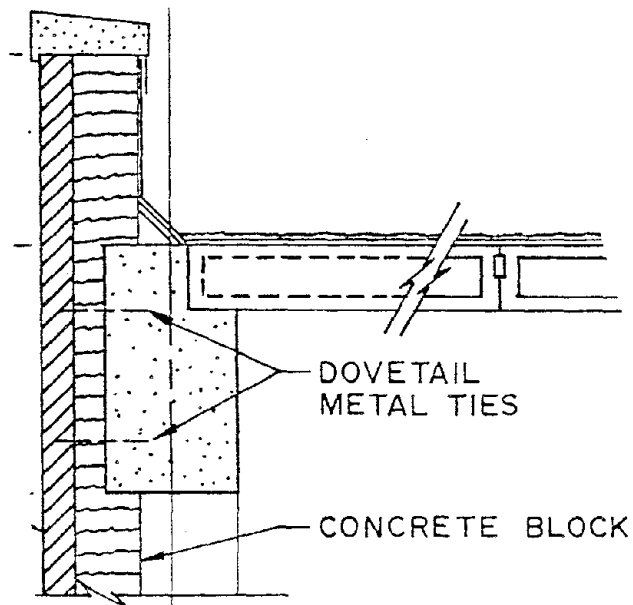
FIGURE 7-7. PARAPET DETAIL

Figure 7-7 indicates adequate detail of parapets. Figure 7-8 shows wall reinforcement details, which illustrate adequate reinforcement around openings and the 45-bar diameter embedment for dowels. Minimum steel reinforcement ratio to gross area of section in shear walls was found to be 0.0007 in the horizontal direction and 0.0017 in the vertical direction. These two ratios add up to a total of 0.0024, which is larger than the 0.002 required by the 1979 Uniform Building Code. Figure 7-9 shows pier reinforcement including additional reinforcement at edge of pier.

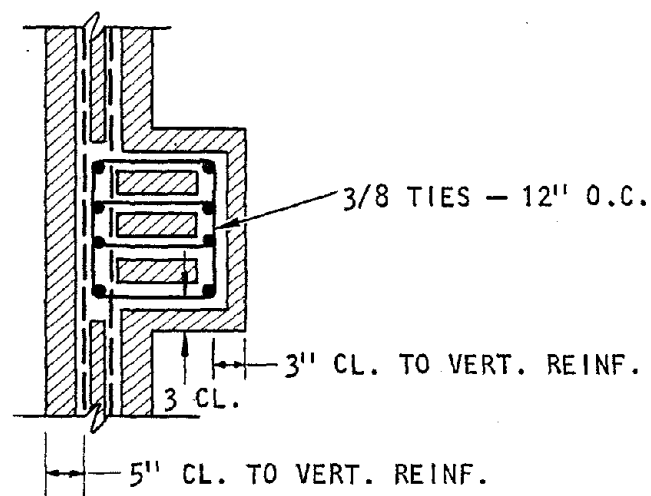
FIGURE 7-10. TYPICAL DETAIL OF INTERIOR BRICK WALL COLUMN (AS BUILT, 1954)

Reinforcing steel in columns contributes to the load-carrying capacity of the member because the ties prevent it from buckling. The code requires that the minimum steel shall not be less than four No. 3 bars in a column. The maximum steel ratio shall be no more than 0.04 (4%) and the maximum size bars shall be No. 10. For these cases, steel ratio is the area of steel divided by the gross area of column. Figure 7-10 shows adequate detailing for a typical interior brick wall column as built in 1954.

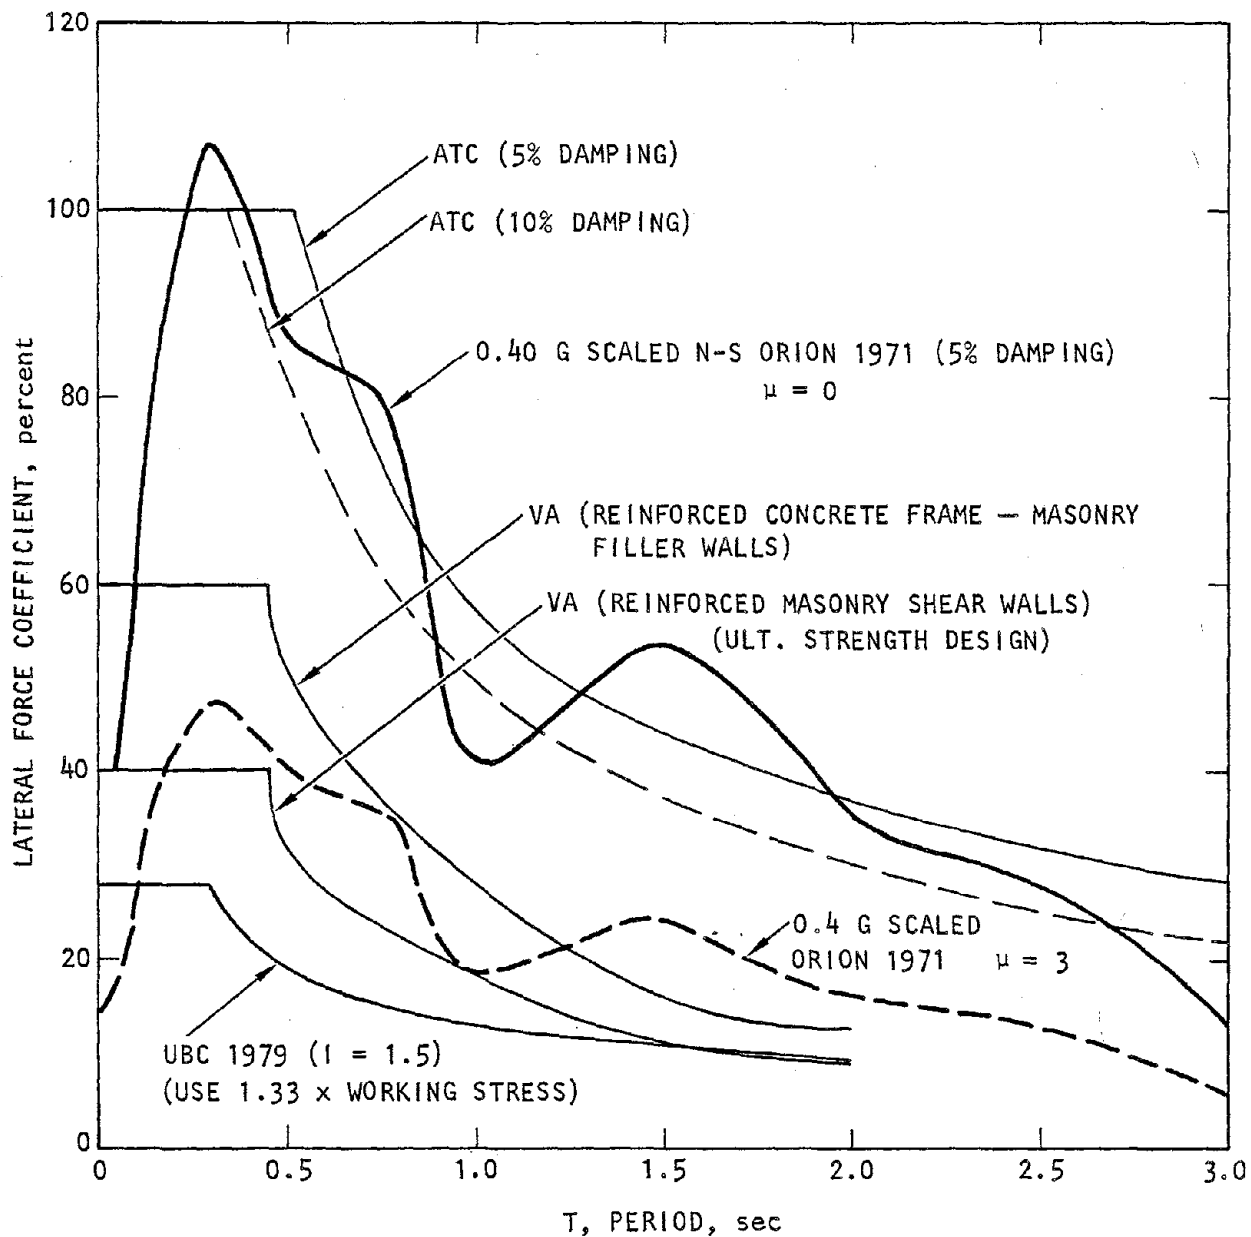
FIGURE 7-11. COMPARISON OF SEPULVEDA HOSPITAL DERIVED, 1971 SEISMIC INPUT AND ATC, VA, AND UBC SEISMIC DESIGN REQUIREMENTS

N-S 1971 Orion record used for seismic input to the analyses performed in this study. This spectrum was adjusted by ductility factor for masonry shear walls and compared to the VA and UBC criteria. Culver et al. (1975) provided a ductility factor (Table 3-21 of this reference) of 5 for average masonry construction. However, this factor is associated with extreme damage to the shear walls and should be reduced to 3 at the Sepulveda hospital because of life safety and function considerations. Based on the empirical equations recommended by Newmark (1970), a ductility modification factor of  $1/\sqrt{2\mu-1}$  would be used. The resulting modified spectrum is compared in Figure 7-11 to the VA seismic criteria for reinforced masonry structural walls.

It is noted that the UBC represents a lower-bound loading condition, in contrast to the VA criteria. This is consistent with the philosophy of the UBC which is to provide minimum requirements for life safety. Also, the allowable UBC stresses are increased by a factor of 33% for seismic conditions as compared to the VA criteria which is based on ultimate strength considerations. The 0.4 g scaled 1971 Orion, adjusted by a ductility factor of 3, provides a good correlation with the VA criteria.

According to Equation 7-7, reinforced masonry bearing walls were designed for 0.20 g lateral force. This can be visualized as a horizontal line going through 20% in Figure 7-11. These design requirements were associated with a 33% increase in allowable stresses. The hospital design criteria (1952) is lower than the current design requirements particularly in range of periods below 1.0 second. However, it is evident that the quality of construction, connections, and detailing allowed the hospital buildings to resist the 1971 earthquake forces with only minor damage.
