# THE 1976 TANGSHAN, CHINA EARTHQUAKE

Papers Presented at the  
2nd U.S. National Conference  
on Earthquake Engineering  
Held at Stanford University  
August 22-24, 1979

The severe disaster of Tangshan earthquake ranked it among the most serious ones which have ever been recorded in history. In this paper the catastrophe and its causes are outlined. Emphasis will be laid on damages on buildings, life lines and equipments as well as aseismic experience, secondary disasters and related problems in urban planning. Developments in repairing and strengthening of existing buildings, aseismic design and research work after 1976 shock in our country will also be included.

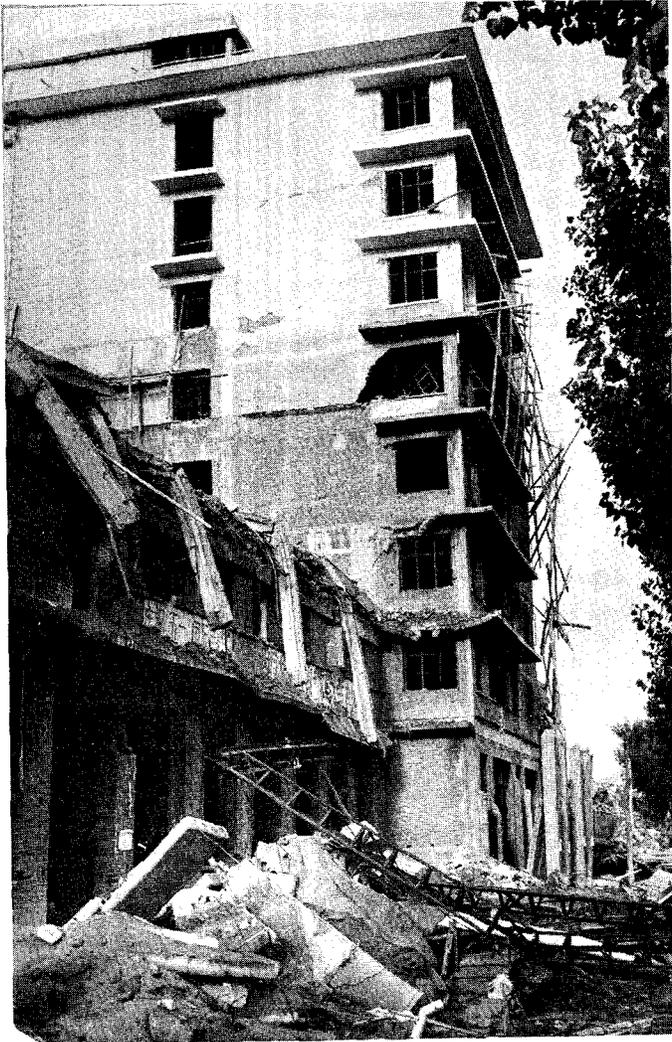
Fig.4 Multi-storey brick building with reinforced concrete columns and tie beams

a few brick buildings did not collapse, because reinforced concrete columns, connected with closed ring-beams at each floor, were provided at the junctions of

longitudinal and transversal walls.(Fig.4) Model test of wall elements and whole building conducted by several institutions after the earthquake also showed that

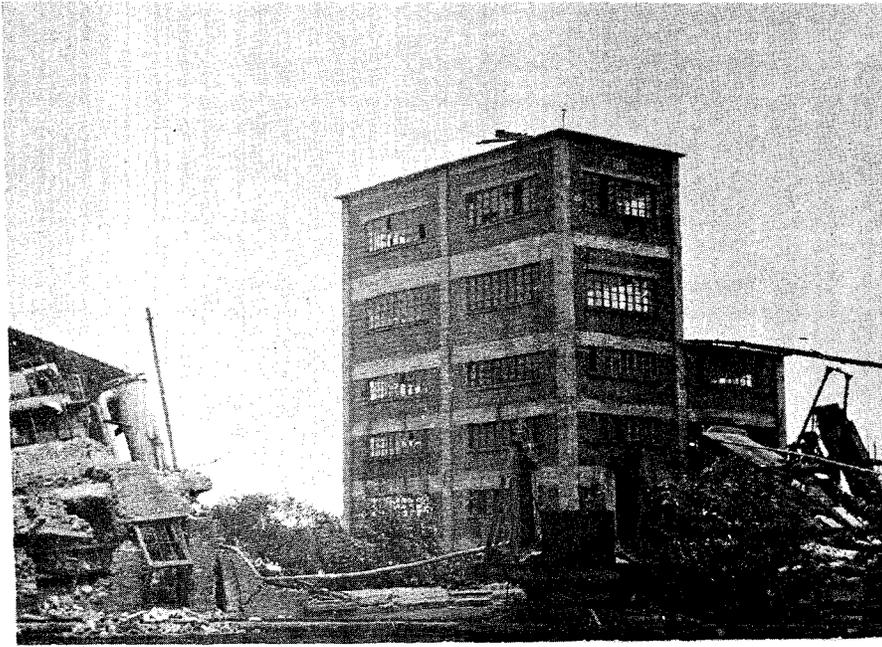
Fig.12 Multi-storey reinforced concrete  
frame structure filled with brick  
wall

concrete covers ( Figs. 10 ,11 ). A few frame structures either filled with solid brick walls or reinforced concrete panels, which acted as shear walls, did not collapse. (Fig.12) In a two-storey flat slab structure supported by columns with spiral reinforcements, the ground floor did not fail, showing the aseismic effect of the spiral reinforcements(Fig.13).

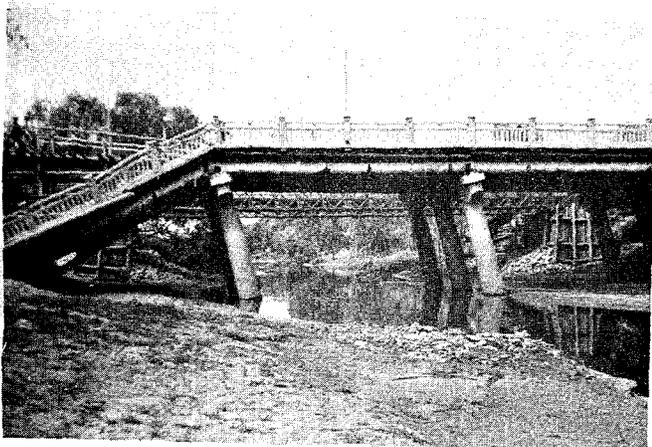
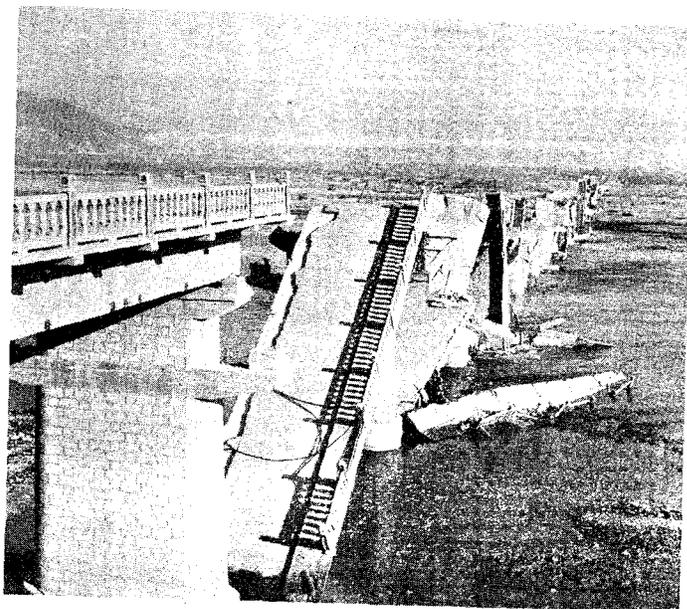
Fig. 17 Bridge beams fell down

The main reason of traffic interruption was damages of roads and bridges. Embankment settlements and landslips occurred on roads, and bent of rails in railways. About 69 and 171 km of main lines of Jing-Shan and Tung-Tuo railways were destroyed respectively. Bridges were severely damaged, with abutments pushed toward the river, piers broken, beams displaced and fallen. (Figs. 16, 17, a, b) The bridges on Giyumho Canal and Luanho River, as gates of Tangshan, were destroyed.

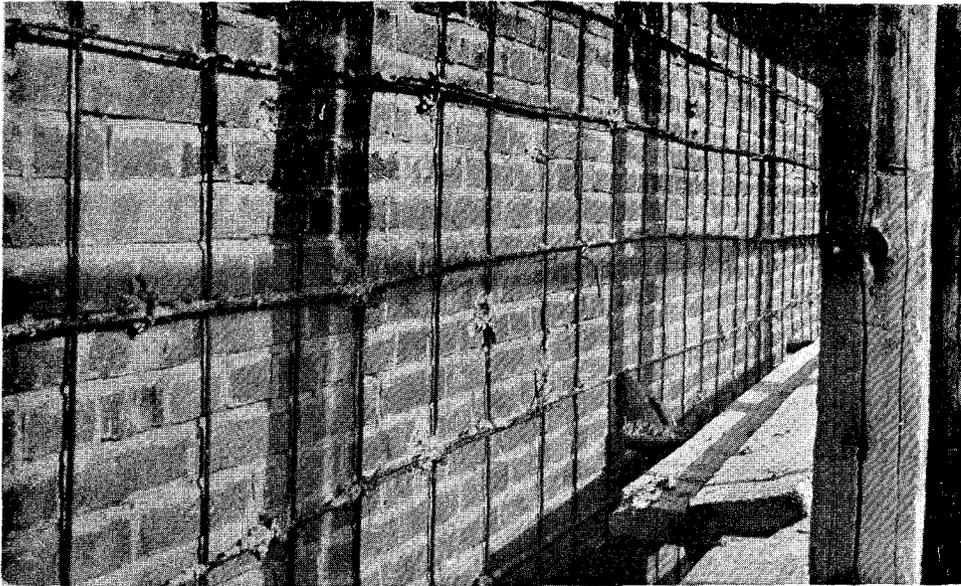
Fig.20 Reinforcing meshes with cement mortar added to the wall surface

Research on strengthening measures has become the most urgent subject after Tangshan event, with stress on multi-storey brick buildings and single-storey industrial buildings. The methods for strengthening multi-storey brick buildings widely used in our country are: addition of brick walls, reinforcing meshes with cement mortar to the wall surfaces, ring beams, rods and columns with tie beams. (Figs.20,21)

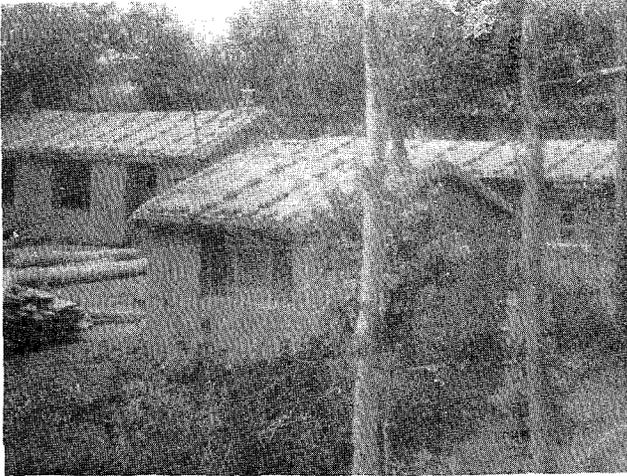
Photo 1. Undamaged Adobe Houses,  
Ning-he County, Intensity IX.

During the 1975 Haicheng earthquake, it was found that a special site condition, i.e. a sufficiently hard layer of clayey soils over a liquefiable sand or soft layer, may reduce the ground surface motion and thus protect the structures above. There were some examples in the Tangshan earthquake again, as shown in Photo 1, which shows some of the village adobe houses in Ning-he County of intensity IX with almost no damage.

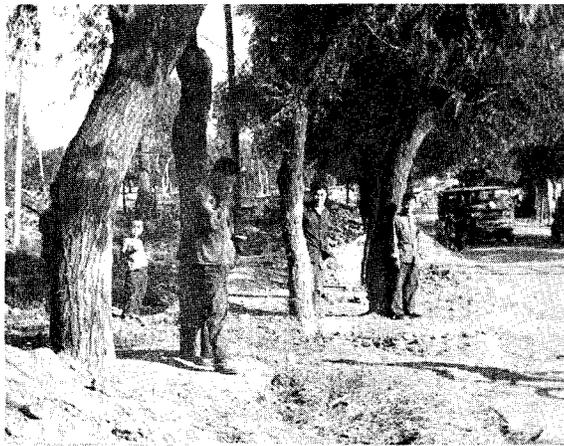
Fig. 7

These ground breakages generally coincided with the major axis of meizoseismal area. Right-lateral strike-slip was indicated by en echelon fractures at many locations. Rows of trees (Fig. 7 and 8), pavements (Fig. 9-11), property walls (Fig. 12-13), highways, underground pipe lines (canals) (Fig. 14-15), and roads acrossing the ground breakages were all off-set in right lateral sense. The slip-pages ranged from tens centimeters to 1.53m horizontally, and at some places were accompanied with vertical displacements about 0.5-0.8m in maximum. Generally, the southeast fault block was dropped down relative to the adjacent northwest fault block. The greatest slip-page occurred in the middle part of the ground breakages near Jixiang Road, and gradually decreased in both directions. Although the greatest horizontal slippage was 1.53m on the ground surface, the amount of slippages in space varied greatly in a short distance. For instance, the off-set of a water pipe located 40 cm under the ground surface along Jixiang Road was only 40 cm horizontally (Fig. 16). The feature of en echelon fissures appeared as V-shape along their depth (Fig.17) on Jixiang Road, and disappeared at about 2.3m in depth. It may be doubtful if the off-set of the causative fault was through to the surface (overburden).

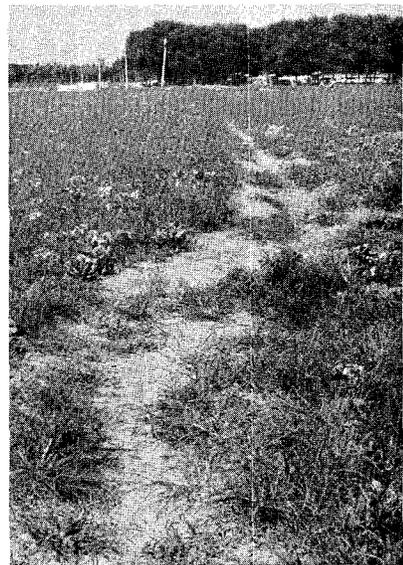
Fig. 18

In addition to off-set and fractures mentioned above, conspicuous horizontal ground deformations without fractures were also observed at some places along the ground breakages (Fig. 18).

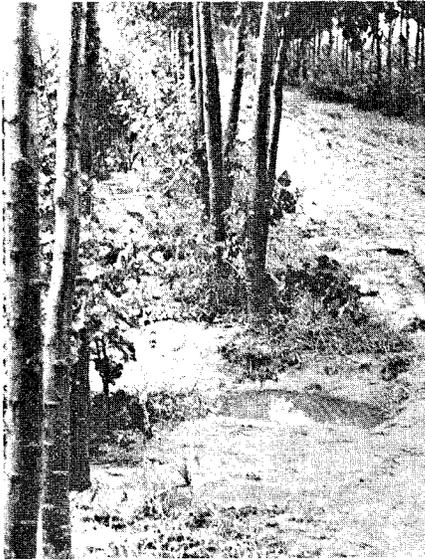
Fig. 19

Moreover, pavements, rows of trees and corns were off-set horizontally by right-lateral strike-slip of ground fissures in Zhaotan (Fig. 19) and Wanggezhuang (Fig. 20) of Laoting County. The strikes and maximum horizontal displacements were  $N40^{\circ}W$  and 0.8m in the former case, and  $N50^{\circ}W$  and 1.5m in the latter. Both villages were approximately 70km from Tangshan City, and were located in the area of intensity VII. According to the investigation of Exploration Company, Ministry of Metallurgical Industry, these ground fissures were in accordance with the trend of old channels.

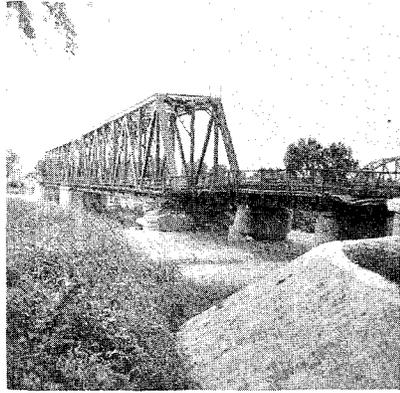
Fig. 37

Five railway bridges on rather stiff clay located in meizoseismal area suffered slight damage where the intensity rating reached X and XI, while those located on silty clay and silty-sandy clay were seriously damaged, such as Ji Channel Bridge (Fig. 37), Dou River Bridge on Tang-Zun line (Fig. 38). Field observation showed that damage to culverts of various sizes was rather slight. A reinforced concrete culvert with two cavities in Tangshan City was intact.

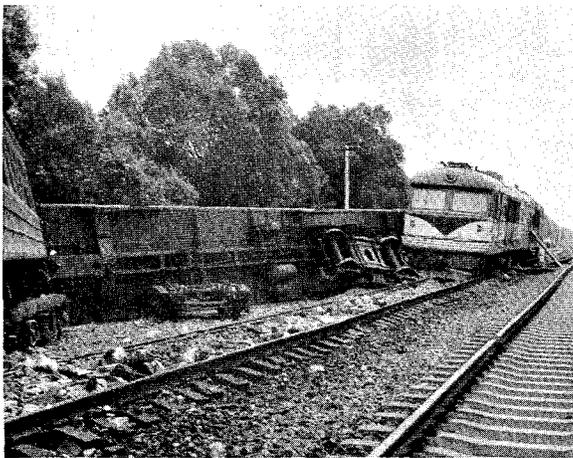
Fig. 41

There were 28 trains passing in the destructive area when the main shock occurred. Seven of them (two carriages and five freight trains) were overturned or derailed (Fig. 41-42), individual locomotives were set on fire.

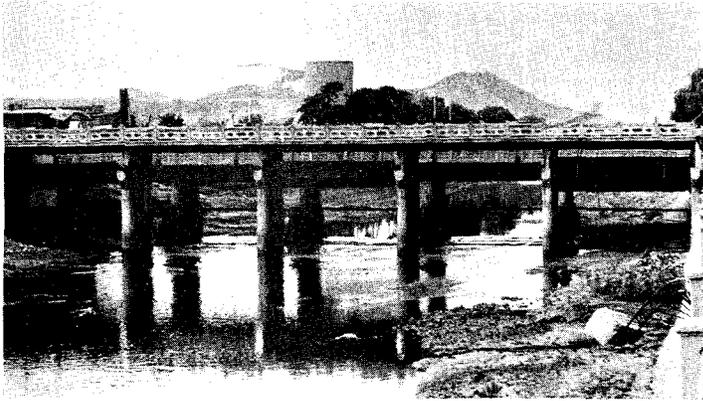
Fig. 43

Various degrees of highway bridge damage observed in the meizoseismal area (Fig. 43-44) were also apparently correlated with the soil conditions. Shengli Bridge (66m long) was shortened by 2.6 m due to the sliding and tilting of the abutments and river banks, and was seriously damaged, but the deck of the bridge remained on the piers, it fell into the river during the main aftershock.

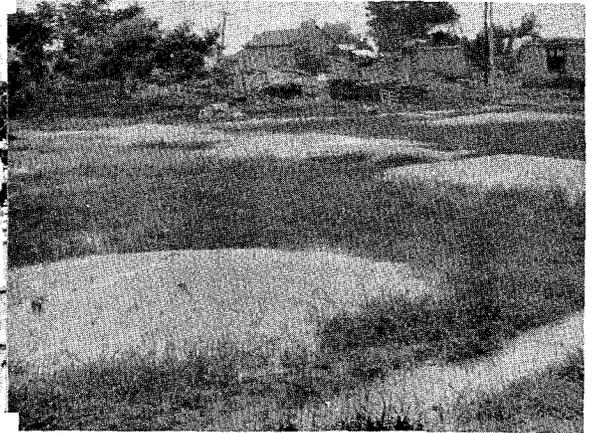
Fig. 45

Sand blows covered an area of more than 24,000 km<sup>2</sup>, and nearly 3,000 km<sup>2</sup> of which were serious in amount of sand blowing. Sands blown from underground blocked irrigation canals, water wells etc., and buried a lot of cultivated fields (Fig. 45-46). In the meizo-seismal area, sand blows occurred only along the Dou River near the Shengli Bridge, but were not so serious as those in the wide coastal region.

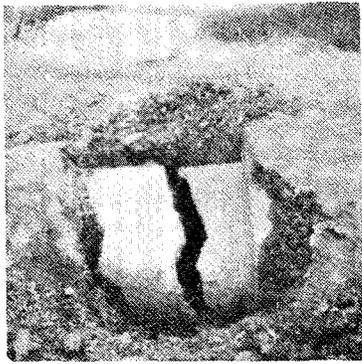
1. Pipe body ruptures.

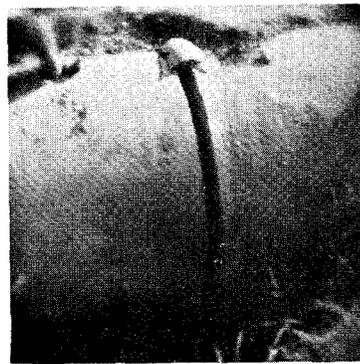
4. Cement mortar drops and sewer pipe joint parts.

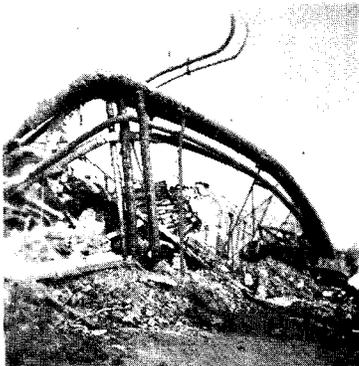
2. Elevated gas pipe twists and tilts.

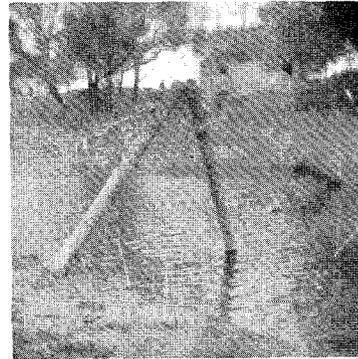
5. Pipeline pulls up toward stream.

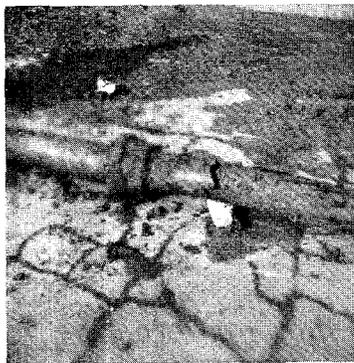
3. Cast iron pipe cracks.

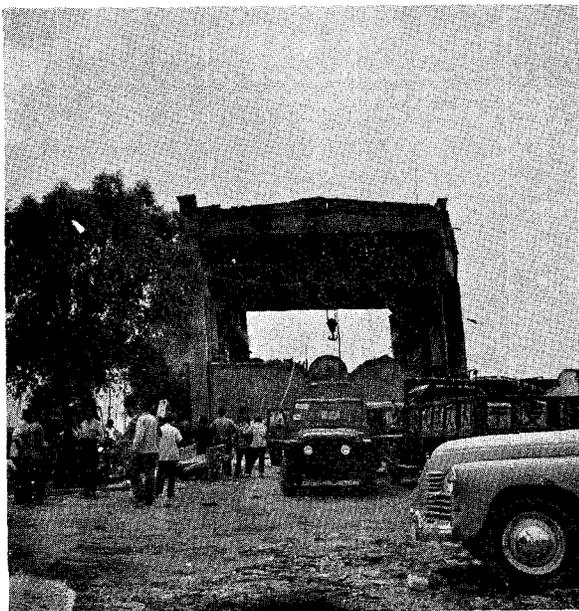
Fig. 2 shows a mill in Hangu that tilted; the columns leaned about 40 cm at the top because of sand liquefaction. Fig. 3 is a water tower in the area of Intensity VII. It leaned about 30 cm — also due to sand liquefaction. Fig. 4 is another water tower in the Intensity VII area which tilted significantly because of sand liquefaction. Oil tanks in Tanggu District fell down because of sand liquefaction, as shown in Fig. 5. Fig. 6 is an observation tower of the Hangu Fire Brigade in an Intensity IX area that tilted due to sand liquefaction.

Fig. 2. Leaning Mill in Hangu, a Suburban Town.

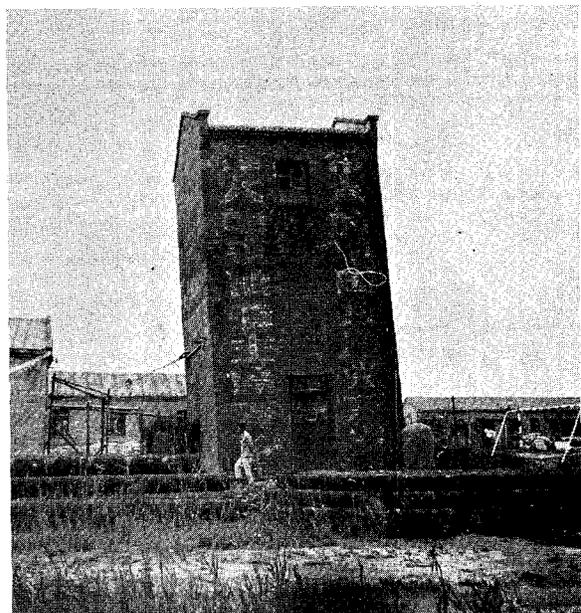
Fig. 3. Leaning Water Tower in Southern Suburb of Tianjin.

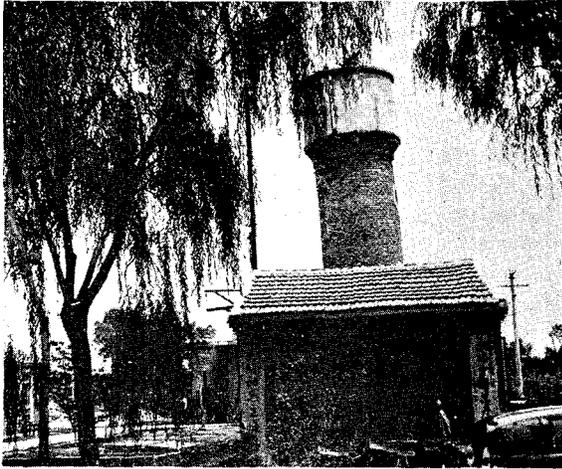
Fig. 4. Leaning Water Tower in Tanggu.

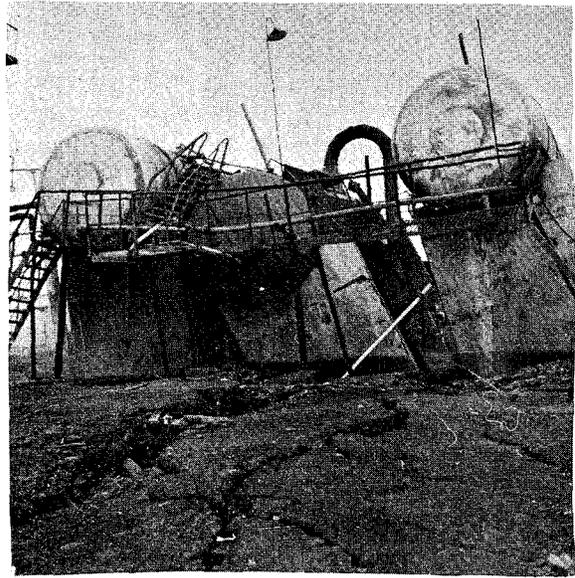
Fig. 5. Collapsed Oil Tanks in Tanggu.

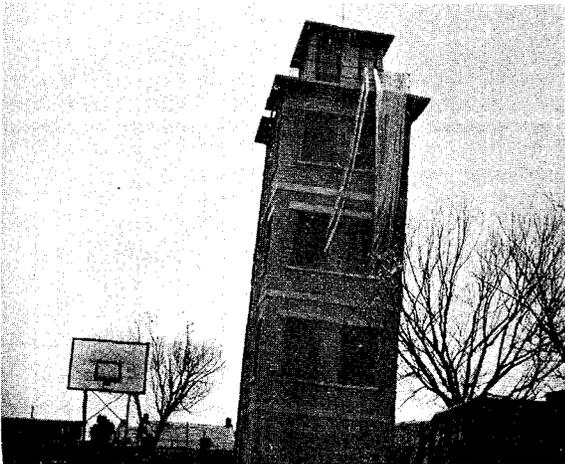
Fig. 6. Tilted Observation Tower of Hangu Fire Brigade.

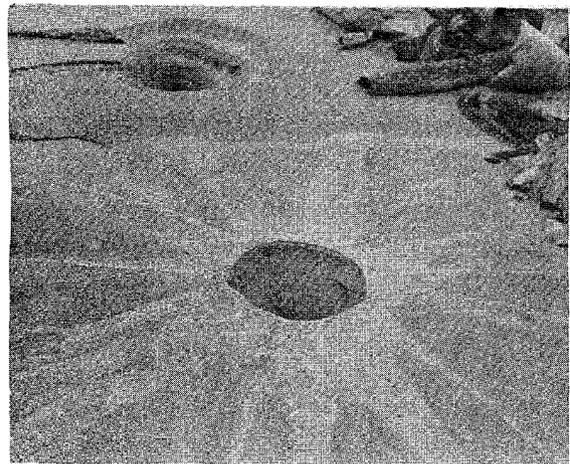
Fig. 7. Sand Blow.

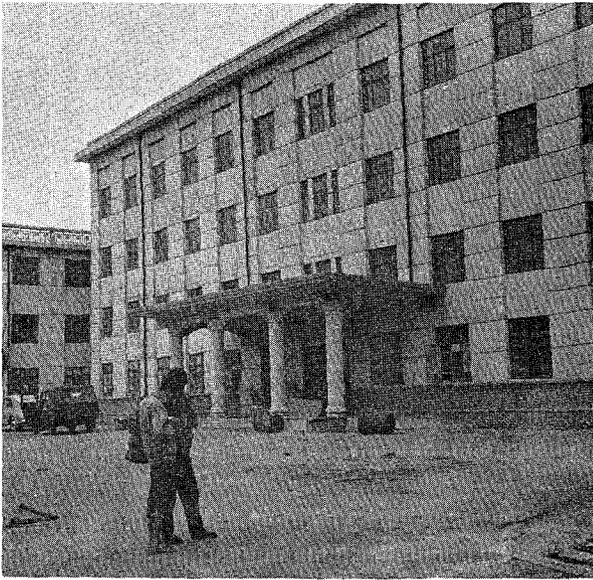
Fig. 8. Four-Story Brick Building Settled, Cracking Canopy Column.

Settlement. Buildings settled significantly because of the soft soil foundation conditions in Tianjin. Fig. 8 shows a four-story brick building in an area of Intensity IX which settled approximately 30 cm during the earthquake; the settlement cracked the canopy column in front of the door.

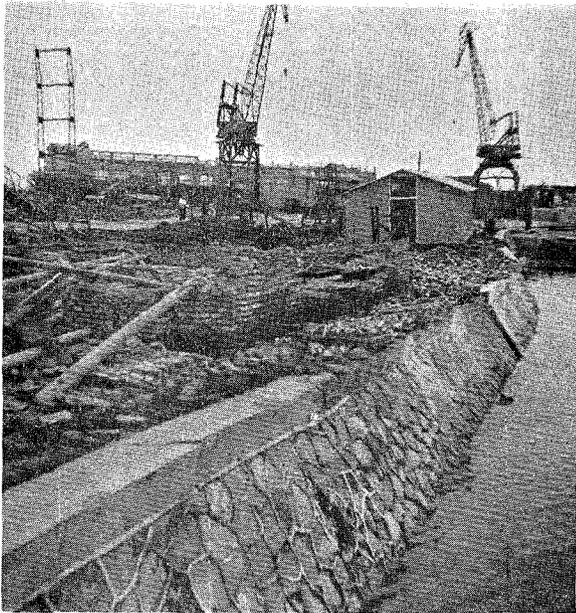
Flow Slides. Many buildings were damaged by numerous ground cracks which occurred simultaneously with flow slides along the two sides of the Haihe River and the seashore. Fig. 13 shows a typical flow slide along the river.

Fig. 13. Flow Slide in Tanggu.

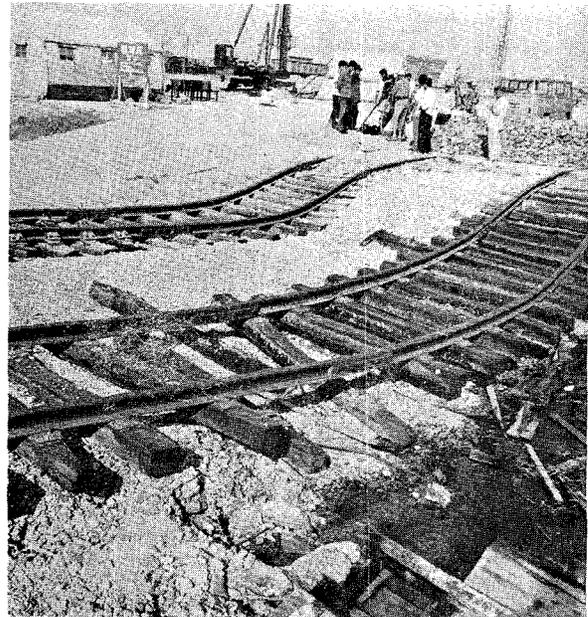
Ground deformation was severe during this earthquake. Fig. 14 shows rails in the area of Intensity IX bent by ground movement. Phenomena like this were commonplace.

Fig. 14. Curved Rails in Tanggu.

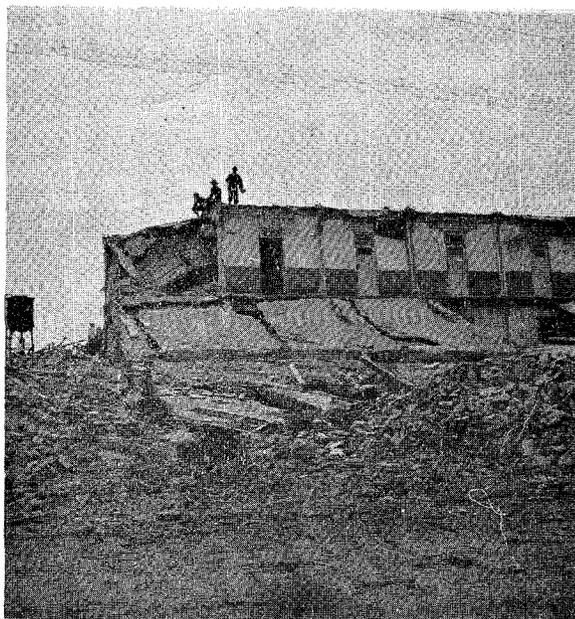
In areas of Intensity IX nearly all brick buildings were damaged. A five-story restaurant with concrete floors and brick walls fell down on account of the high intensity of the earthquake and low strength of the brick walls (Fig. 15). Even the reinforced concrete mill buildings did not survive. Fig. 16 shows a fallen mill building whose columns inclined and roof and walls collapsed completely.

Fig. 15. Collapsed Five-Story Concrete Floor/Brick Wall Restaurant Building.

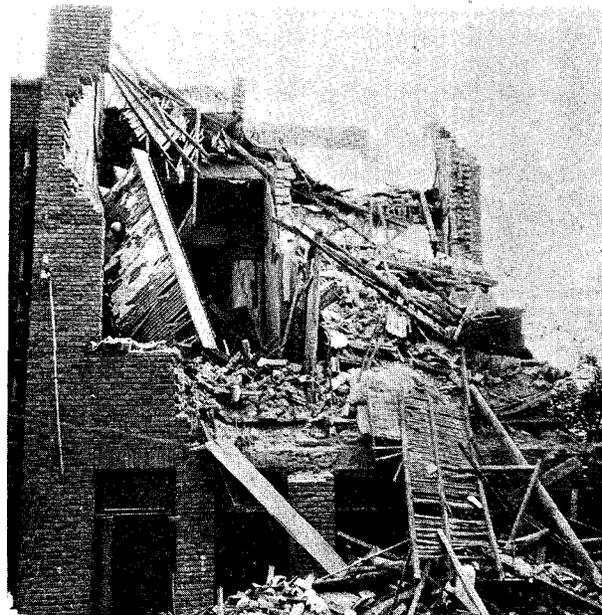
Figs. 17 and 18 show old brick buildings with timber floors severely damaged because connections between wood floors and brick walls were weak, mortar strength low, and the buildings very old. Many such buildings failed completely as a result of tilting or collapse of walls.

Fig. 18. Collapsed Facade Wall of Three-Story Brick Building With Timber Floors.

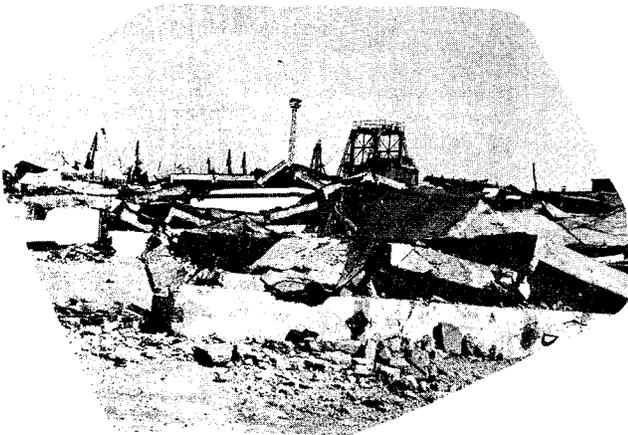
Fig. 32 shows a warehouse with reinforced concrete columns, roof trusses, and roof slabs entirely collapsed during the earthquake due to fracture of columns with low carrying capacity.

Fig. 32. Collapsed Warehouse in Tanggu.

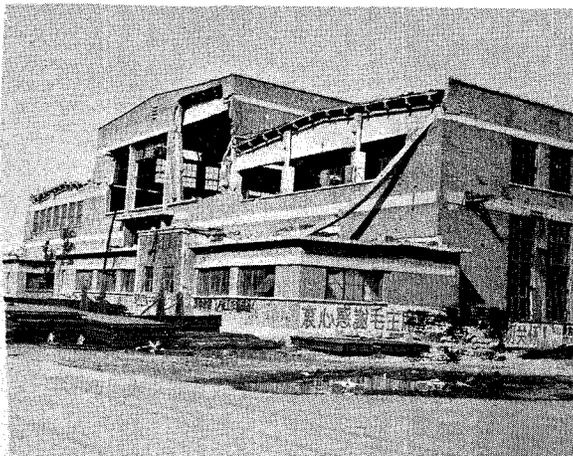
Infilled walls of many mill buildings collapsed because the connections between walls and columns were weak. Figs. 35 and 36 are damaged infilled walls of mill buildings. Fig. 37 shows the damage of vertical bracing between columns.

Fig. 36. Damaged End Walls in Factory.

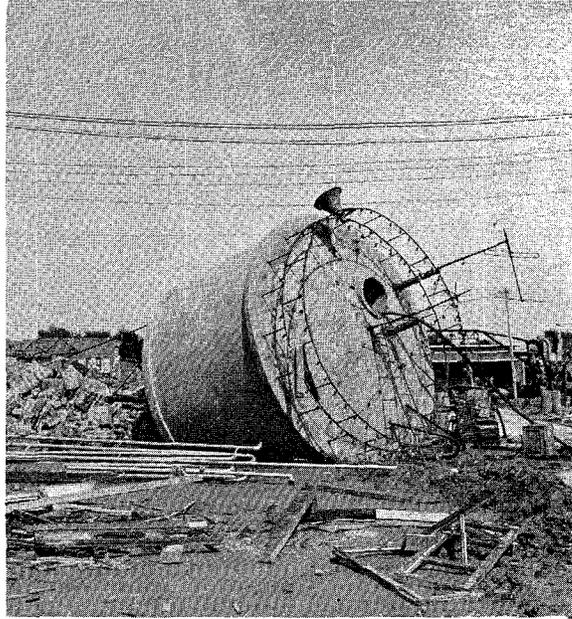
Many water towers broke or collapsed in areas of Intensity VIII and IX. Fig. 40 shows a water tower in an area of Intensity IX which collapsed due to its low strength.

Fig. 40. Collapsed Water Tower in Hangu.

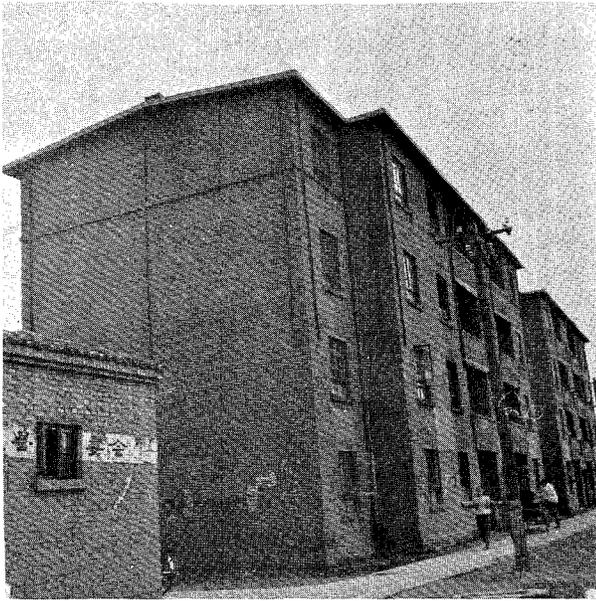
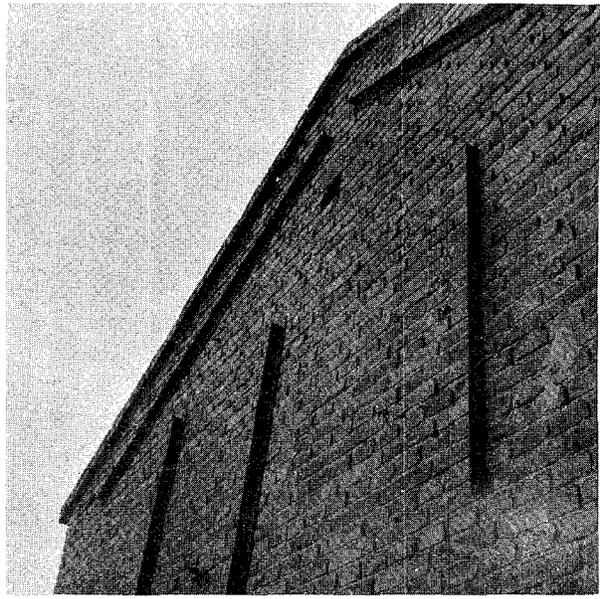
Fig. 42. Strengthened Buildings in Hexi District.

aged. The method of strengthening was to connect exterior and interior walls in single and multiple story brick buildings with steel rods, as shown in Fig. 42. This decreased the probability of collapsed walls during the earthquake, and is a simple but effective method.
