EARTHQUAKE IN ROMANIA MARCH 4, 1977

An Engineering Report

National Research Council
and
Earthquake Engineering Research Institute

Glen V. Berg, University of Michigan, Ann Arbor
Bruce A. Bolt, University of California, Berkeley
Meté A. Sozen, University of Illinois, Urbana
Christopher Rojahn, U.S. Geological Survey, Menlo Park

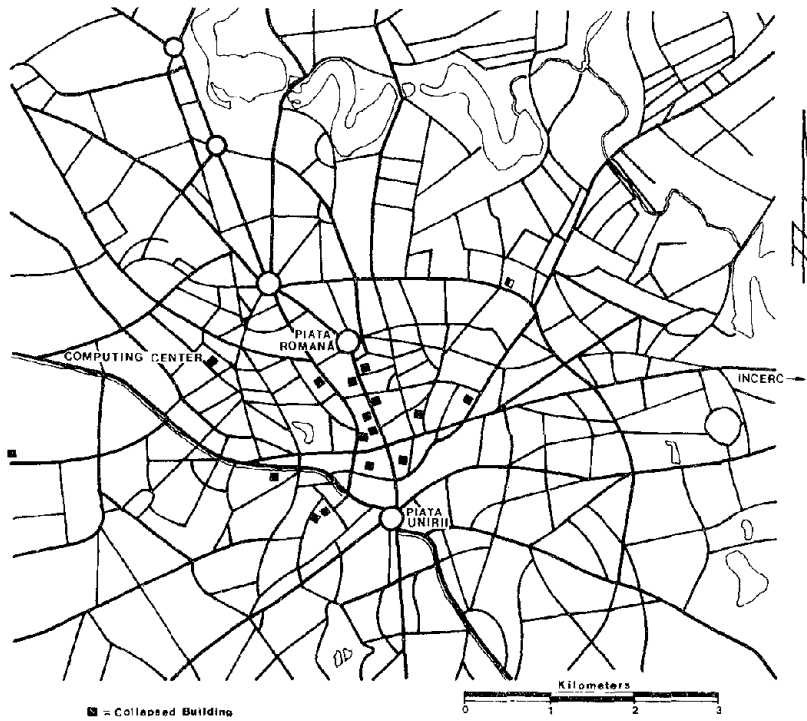
Figure 6 Street map of Bucharest showing collapse locations.

Most of the earthquake damage was concentrated in the city of Bucharest. Thirty-five buildings collapsed, most of them near the heart of the city. Figure 16 shows one collapsed structure, and the street map of Figure 6 locates many of them. All but three of the

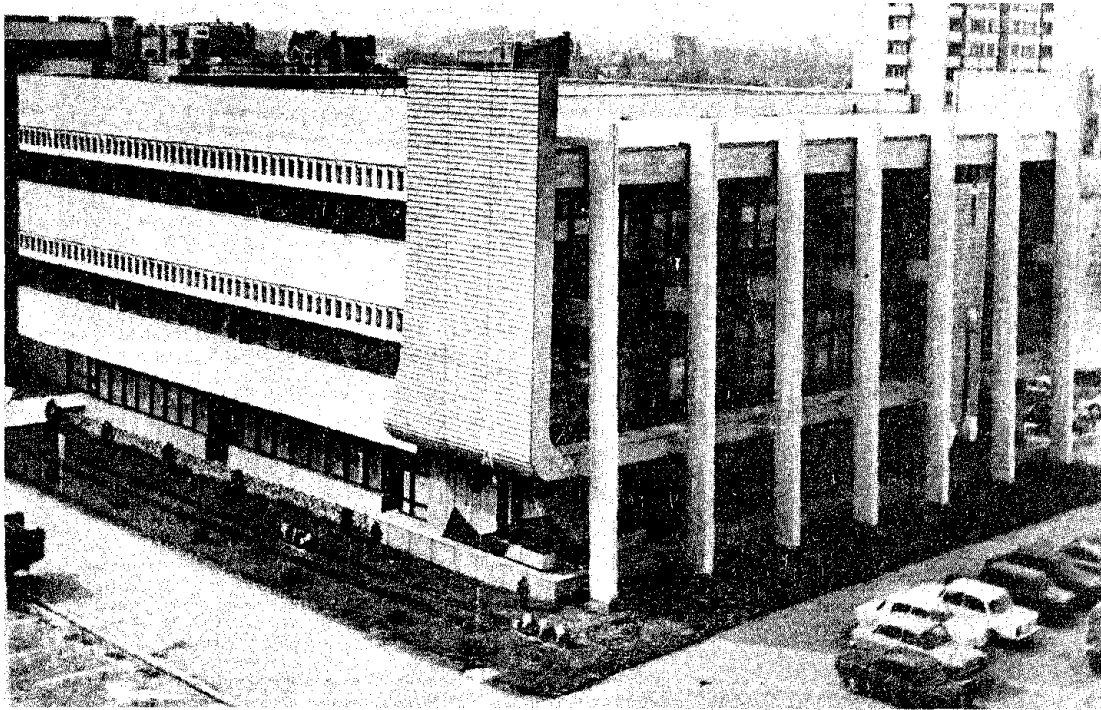
Figure 23 Computing center before the earthquake.

The most instructive building collapse in Bucharest was the new computing center, built in 1967, shown in the pre-earthquake photo, Figure 23. This was a three-story building comprising a central structure 30 m square with service towers at both ends structurally separated from the central building. It was designed according to the Romanian seismic code; the design base shear was 6 percent of the weight of the building. The central part of the building collapsed; the service towers did not. Figure 24 shows the collapse.

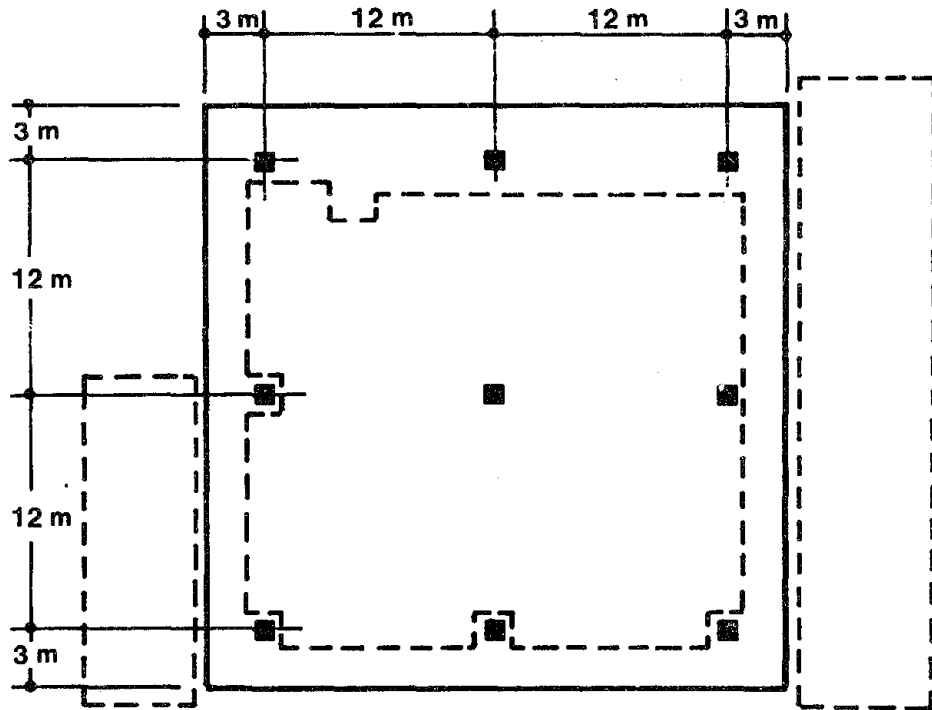
Figure 25 Computing center, ground-floor layout.

The central building was cast-in-place reinforced-concrete construction with precast concrete exterior walls above the ground story. No shear walls were in the central building. The upper stories had continuous bands of windows separating the precast wall units. The ground story was enclosed by walls set in from the exterior building lines and capped with a continuous band of sash. Figure 25 shows the ground-floor layout. The building above was supported entirely on nine columns spaced 12 m center to center in both directions, with the slabs cantilevered 3 m beyond the outside columns on all sides. Note in Figure 25 that the nonstructural exterior walls run around the columns; no column in the ground story had lateral restraint of any kind.

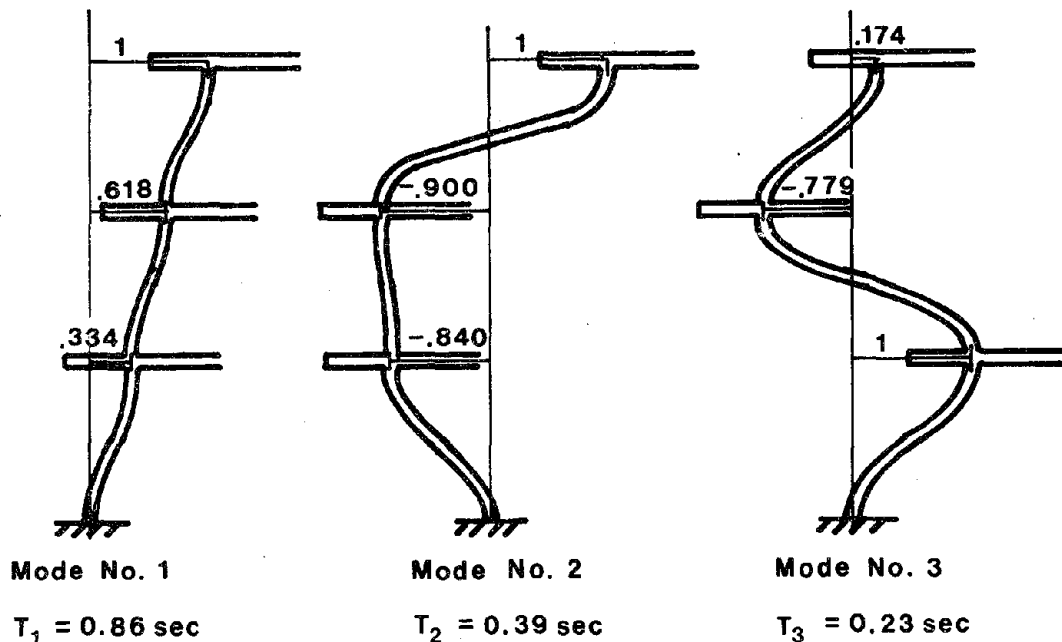
Figure 28 Computing center, mode shapes and periods.

The main building was structurally separated from the service towers, and nearly all of the lateral stiffness of the main building derived from the columns. If only column stiffness is considered, the column bases are treated as fixed, and the floors are taken to be rigid, then the three modes of vibration and their periods are as shown in Figure 28. Thus the fundamental mode period for this idealization is in the range of very strong spectral acceleration for both horizontal components of the ground motion recorded in Bucharest. Any flexibility of the floor system or column footings, or any structural damage, would lengthen the period and put it in the range of even greater spectral acceleration. The exterior walls were of virtually no benefit because they were isolated from the ground-story columns and contained a band of steel window sash in each story, which separated them structurally from the story above.

subject to a different interpretation according to whether this was a monumental building or an ordinary building, and whether it should be classed as a reinforced-concrete frame structure or an inverted pendulum. The base shear coefficient could be as low as 0.025 or as great as 0.075, depending on the interpretation. We were told that the design was in fact for a base shear coefficient of 0.06. If the lateral force were resisted by the columns alone, the concrete and steel stresses for this base shear would be within code limits. Response to the ground motion recorded in Bucharest is quite another matter. The fundamental mode alone, calculated on the basis of elastic behavior from the response spectrum for 5 percent of critical damping, would produce theoretical stresses of nearly four times the cube strength of the concrete and three times the ultimate strength of the steel.
