DESTRUCTIVE EARTHQUAKES IN BURDUR AND BINGÖL, TURKEY - MAY 1971

report and recommendations

W. O. Keightley
Montana State University

1975

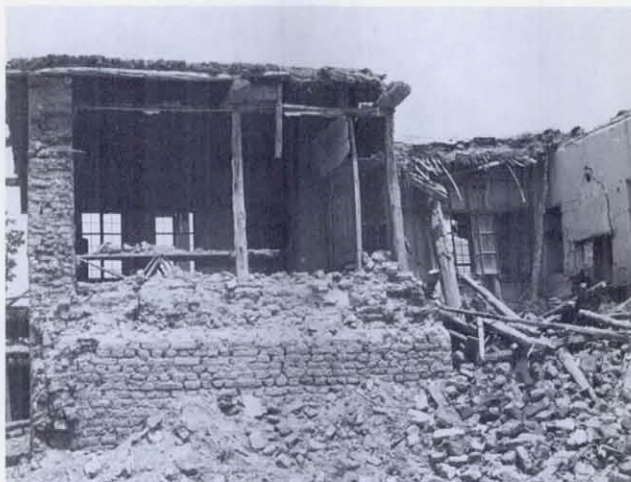
FIGURE 15 A lesson concerning adobe house construction is illustrated in this figure. The roof is at least partially supported by wood columns, and although the front wall collapsed, the roof did not.

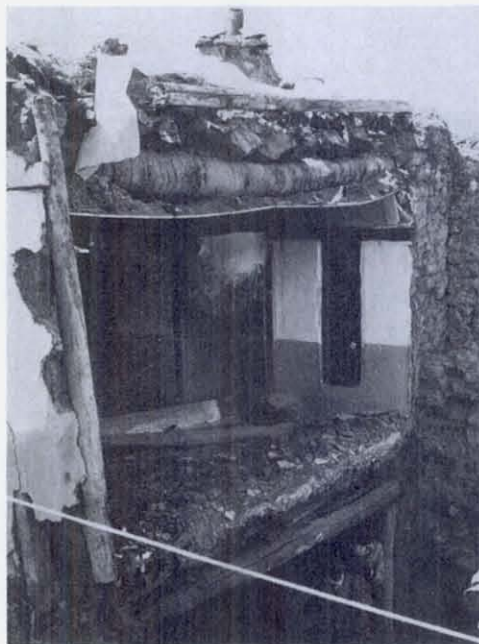
FIGURE 20 A close-up view of the house in Figure 19, showing the heavy roof and the walls of uncemented stone and adobe.

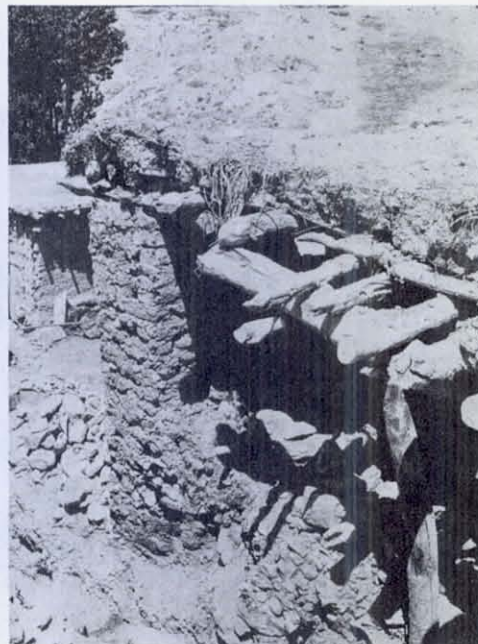
FIGURE 21 Showing the construction of a mud roof on an adobe house. Successive layers of logs and poles, at progressively closer spacing, support finally twigs and leaves, with mud on top. More mud is added over the years to keep the roof watertight.

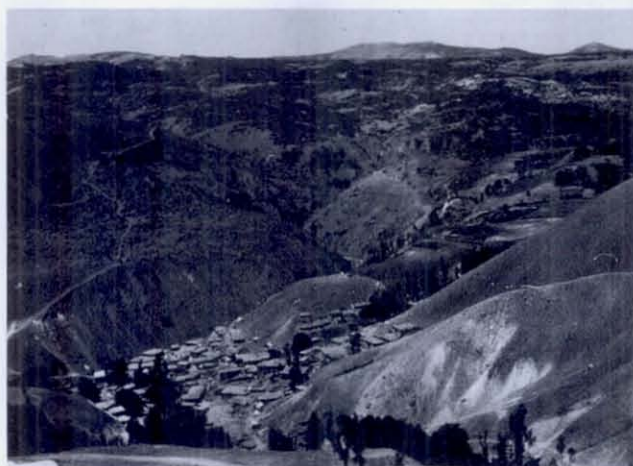
FIGURE 25 The village of Hacilar, 36 km NE of Bingöl, is typical of many Turkish villages - accessible only by rough roads suitable for 4-wheel drive vehicles, and without electricity. The economy is based on grazing, small farms and gardens, exported workers, and rugs woven by the women. Cash for such things as cement and sawed lumber is scarce, so construction makes use of local stone, mud, and poplar poles. Winters here are as severe as Montana's. Note the poplar trees growing in the draws.

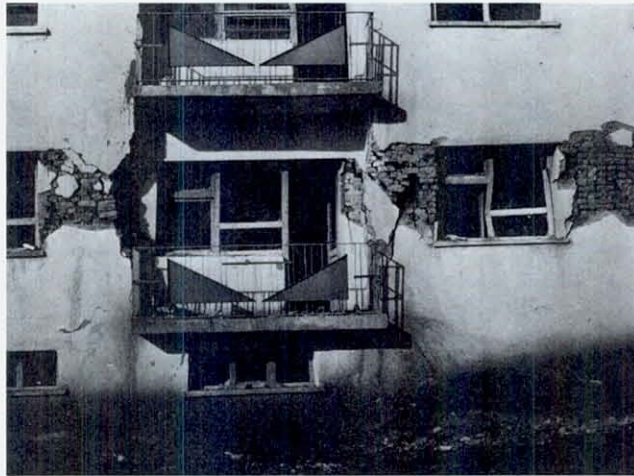
FIGURE 42 A closer view of the east balcony on the same (north) side of the building shown in the previous figure.

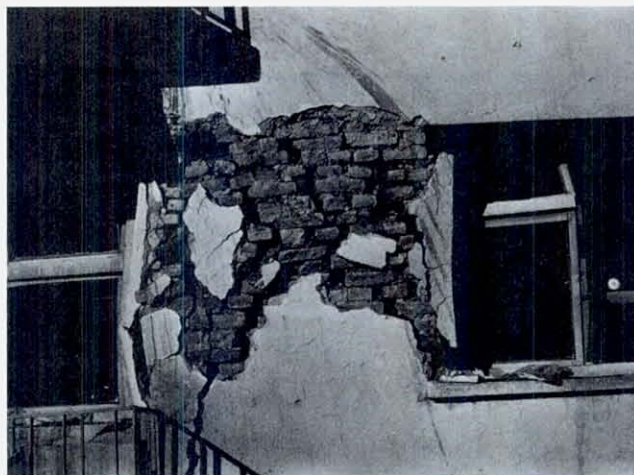
FIGURE 43 A close-up of the pier west of the west balcony, north side. Bricks in the Bingöl region were soft, but mortar was of good quality.

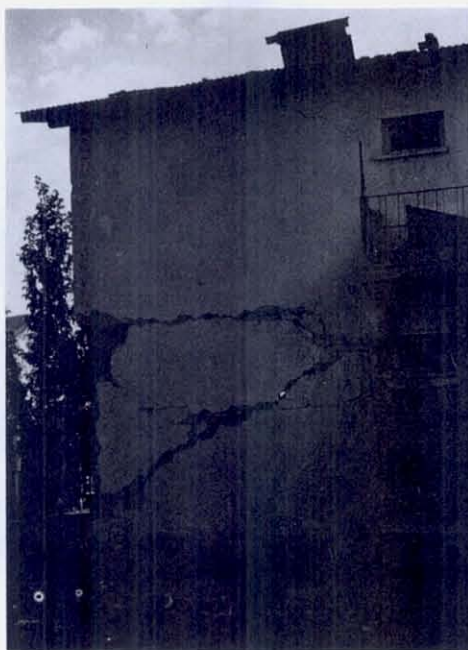
FIGURE 45 Both stories of the south face, southwest corner.

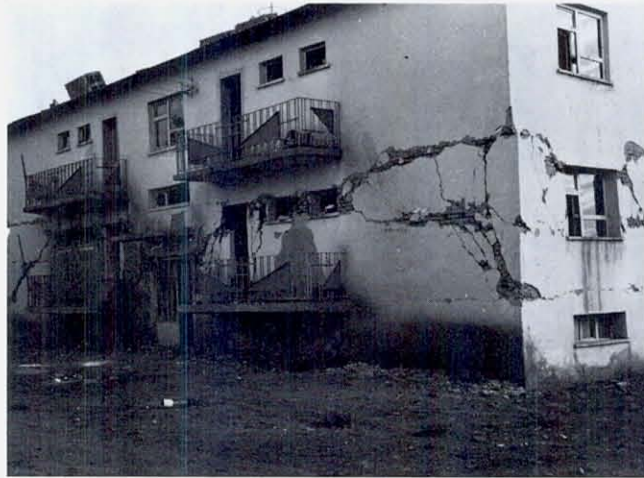
FIGURE 46 The south face, at the southeast corner.

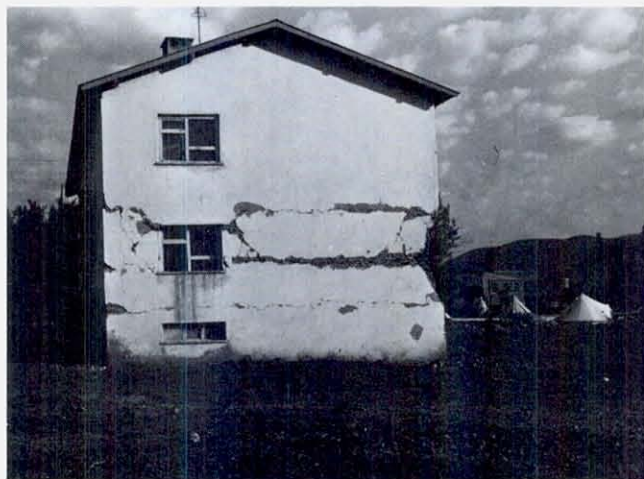
FIGURE 47 The east face.

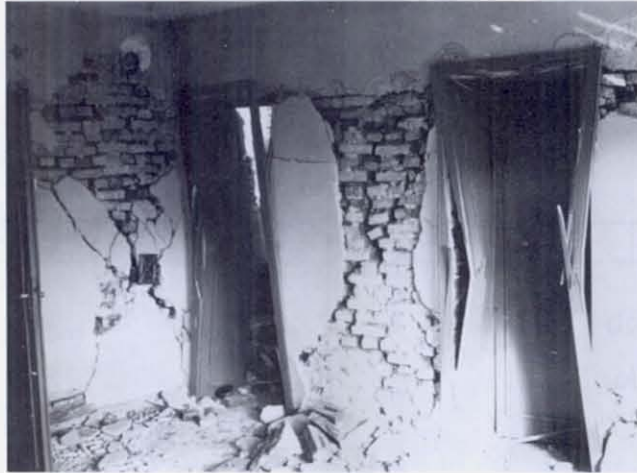
FIGURE 48 Interior walls of the building shown in the preceding figures were just as badly shattered as exterior walls.

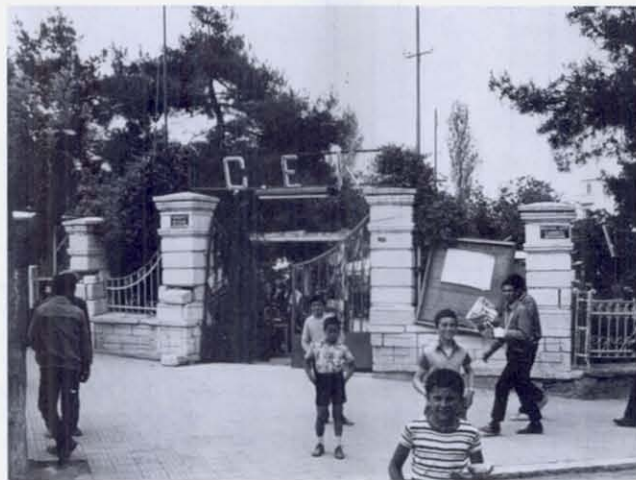
FIGURE 49 Gate posts at the park entrance in Burdur were shattered, whereas across the street, some 200 feet distant, rather tall chimneys in the government building (Figure 51) did not fall.

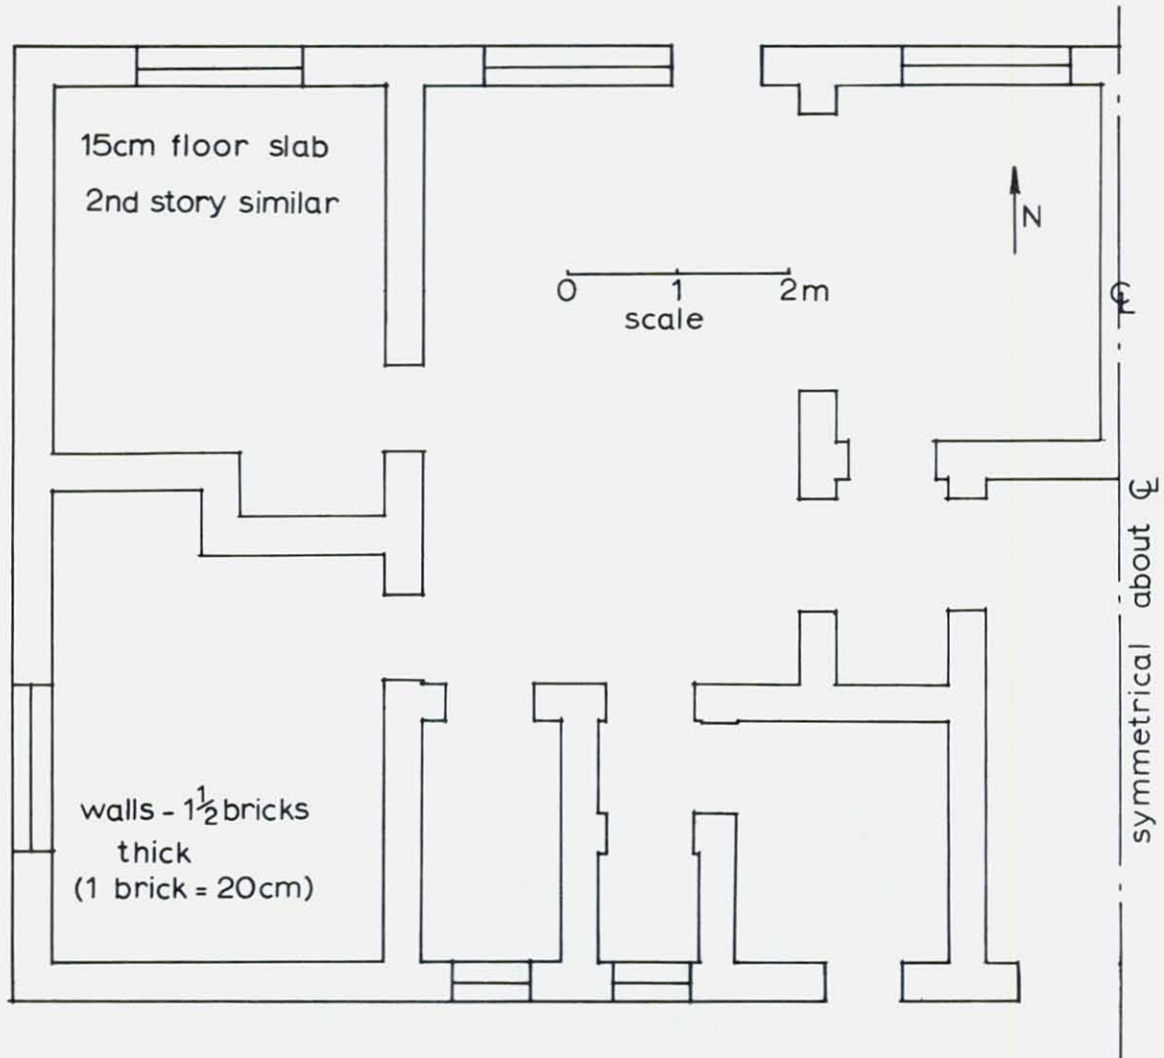
FIGURE 50 A floor plan of the shattered two-story apartment building shown in the previous figures. Note that openings occupy about 55% of the length of the north wall, greater than the 40% maximum prescribed in the Turkish code, and in the east-west direction, the lateral resistance provided by interior walls is scant.

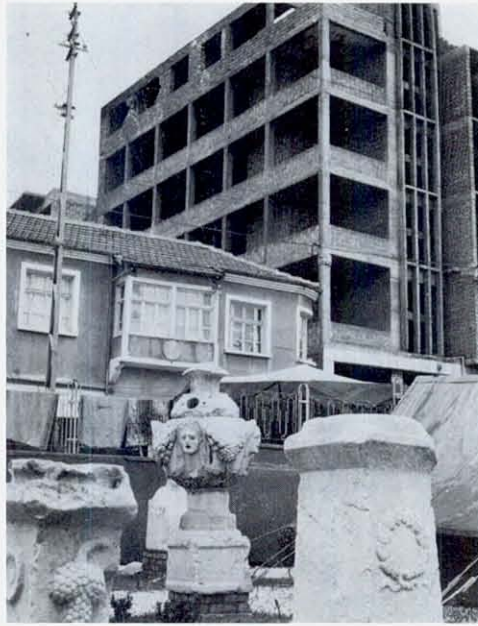
FIGURE 54 A top-heavy stone carving, about 2 m tall, probably originally a fountain, could be easily rocked by hand, but was not toppled by the earthquake. In the background is seen the bus station building, under construction, which suffered fallen brick walls in the penthouse.

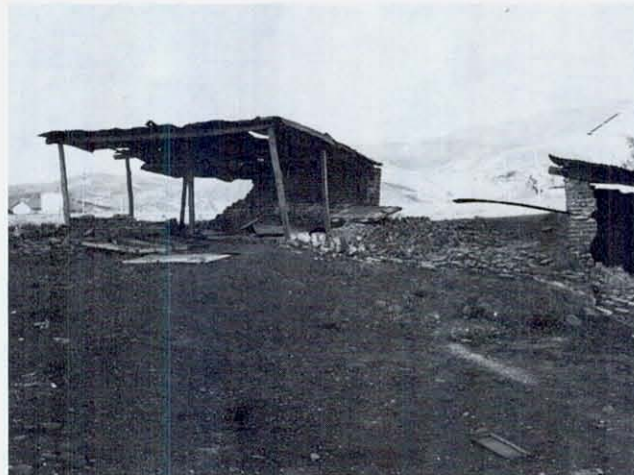
FIGURE 55 This crude shed in Bingöl illustrates a principle. The brick walls collapsed, but the roof, supported on wood columns, even though they were unbraced, did not fall. On the right, not completely shown, a roof supported on only brick walls came down with the walls. Braced frames which could carry roof loads, even though masonry walls fall, would offer considerable added safety in masonry structures.

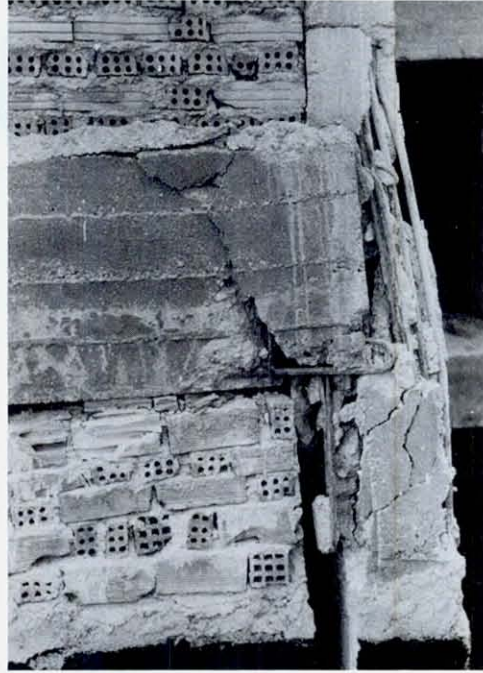
FIGURE 71 Just a few hundred feet from Burdur's badly damaged hospital and across the street from the new school building shown earlier, stands the Medical Technology School under construction. Workmanship and concrete were of average quality, and exterior columns were weaker in the longitudinal direction of the building. The structure had shear walls at each end, and also midway between the ends, but no longitudinal resistance other than the columns. Some masonry wall panels cracked, but structural damage was slight.

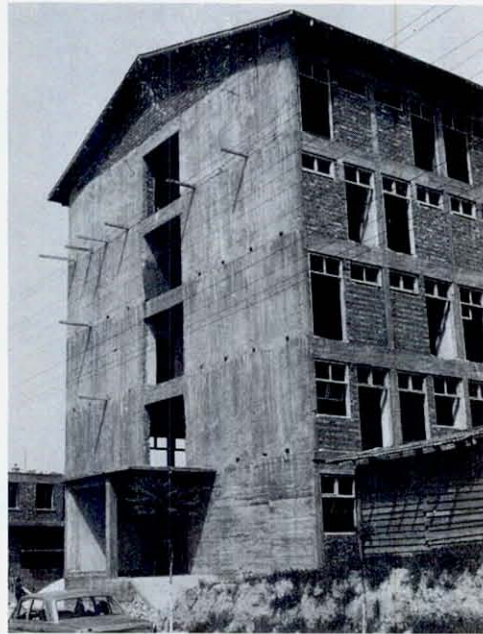
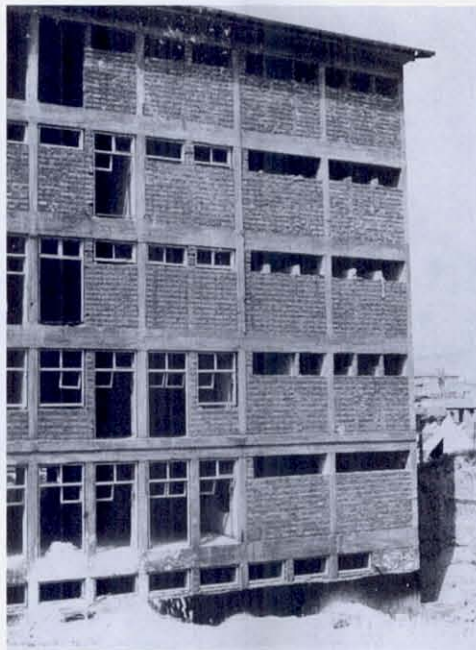
FIGURE 72 Several brick wall panels unattached to the structural frame fell out in the Medical Technology School, but had been replaced by the time this photograph was taken. There were very few instances of panels falling out in Burdur, even though in other buildings many panels were heavily cracked. This building, like the school across the street, had exterior basement columns fixed by basement walls over most of their height, but in this case there was no damage to them. Note the poor placement of concrete in the corner column.

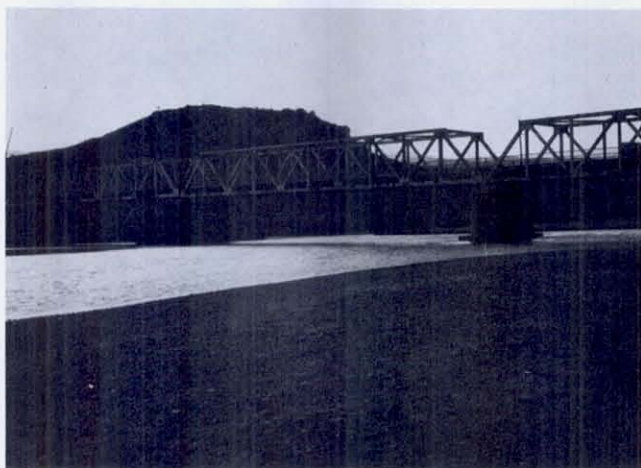
FIGURE 73 Looking upstream (north) at the steel bridge across the Murat River, 17 km SE of Bingöl, near Genc. Spans are numbered from left to right as 1, 2, 3, and piers as 1, 2. Pier spacing is 55 meters. The right end of each span is anchored so as to permit rotation only, whereas the left end of each is on rockers, which permit some longitudinal movement, but which are unstable, as shown in the following figure.

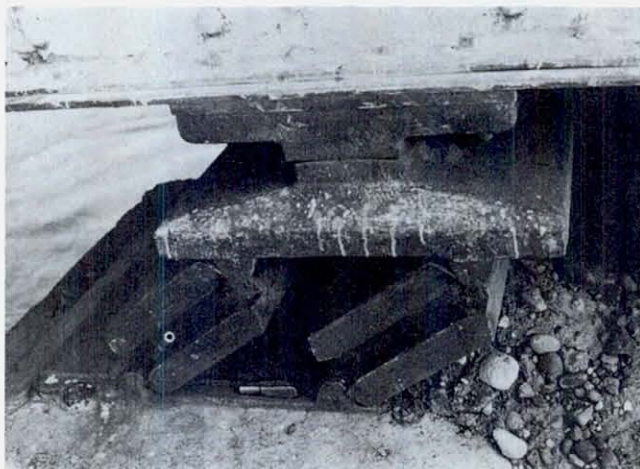
FIGURE 74 Rocker supports on the west end of span No. 3. This pier (No. 2) apparently shifted to the left (east) by about 15 cm, causing the relative displacement shown. The rockers did not fall completely because of restraining knobs on the base plate, but are obviously not now supporting the span. It is probably supported by interference of the bridge structure with span No. 2. The fixed support of the east end of span No. 2 pulled it to the east when the pier shifted, causing the railing to buckle (next figure) and pulling the span completely off its rocker support on pier No. 1. Sideways movement of some 20 cm of span No. 2 permitted the rockers to slide completely off the base plate on pier No. 1, dropping the end of the span 22 cm. The knife in the figure is 8.5 cm long. The need for bridge bearings which can accommodate pier displacements is obvious.

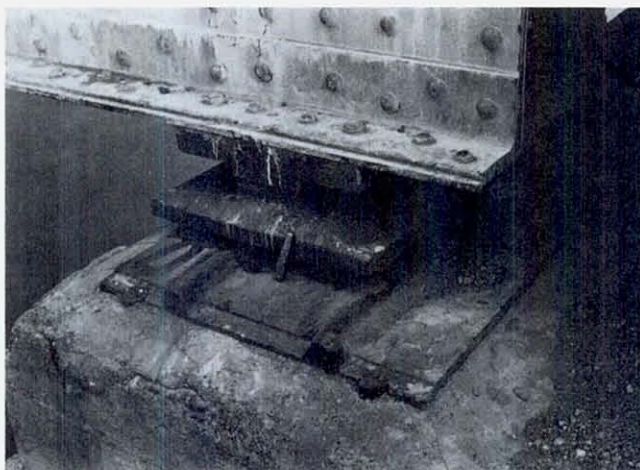
FIGURE 75 The west end of span No. 2 on top of pier No. 1, looking downstream. Sideways displacement of the span permitted the rockers to fall completely off the pier, dropping the span 22 cm vertically onto its base plate. The displacement here is about 20 cm downstream and 12 cm to the east.

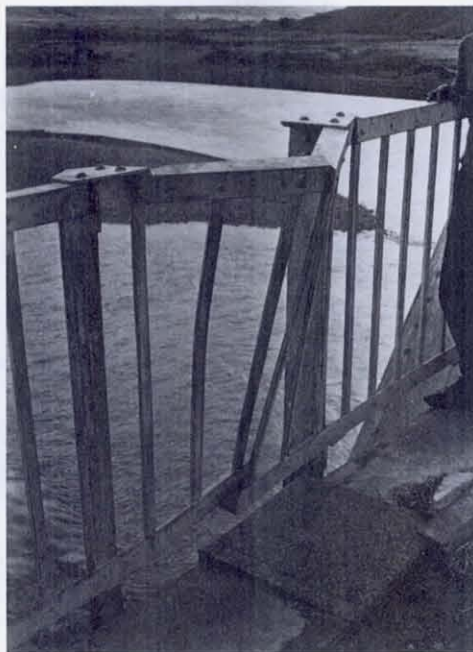
FIGURE 76 Looking downstream (south) at the buckled railing, span No. 3 on the left, span No. 2 on the right. Span No. 2 was dragged into span No. 3, which is fixed to the east abutment, by the shifting of the pier below.

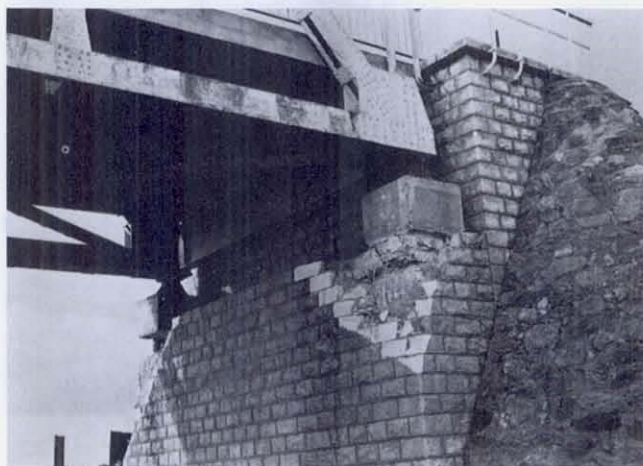
FIGURE 77 The east abutment, showing the end of span No. 3. The facing stone has been broken away to permit inspection of the structural damage. The horizontal failure plane in the concrete appears to be a construction joint. Consideration should be given in design to the possibility of construction joints in piers having to withstand lateral as well as vertical forces.

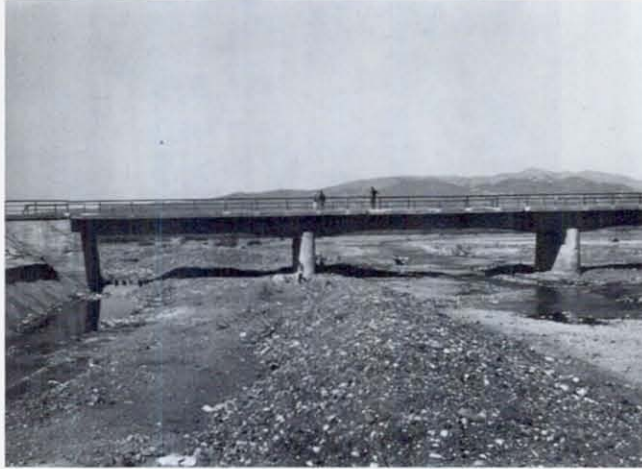
FIGURE 78 Looking south at one half of the 5-span concrete bridge across the Göynük River at Köprübaşı, 10 km east of Bingöl. An extension of the line of the 8 km earth crack in the Göynük River bottom passes near here, but no crack was actually observed at this location. The center span and the end span both are continuous across their piers to support a simple span in the second bay from the abutment, the joints of which are visible at deck level. Pier spacing is about 24 meters.

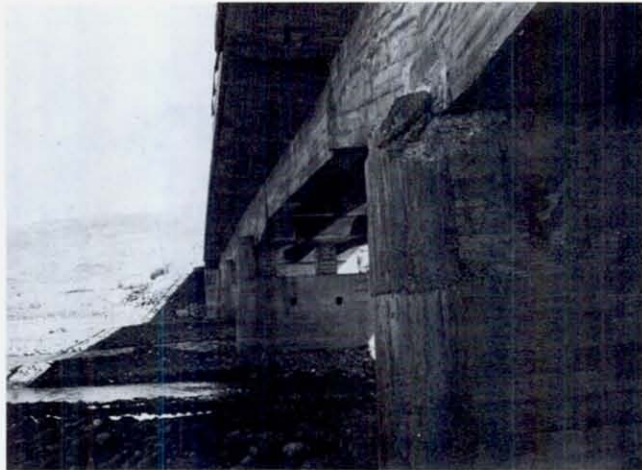
FIGURE 79 The south side of the bridge, showing lateral movement of the simple span relative to the adjacent continuous spans, and failure at the tops of the piers due to sideways force from the superstructure. The nearest pier here is the left-most pier in the previous figure.

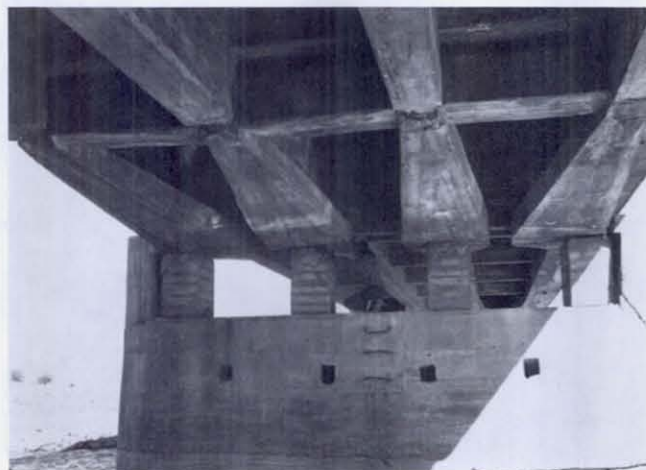
FIGURE 80 Damage to the second pier from the west abutment and to the junction of the simple span with the central continuous span. The cause of the large crack near the bottom of the pier is not known.

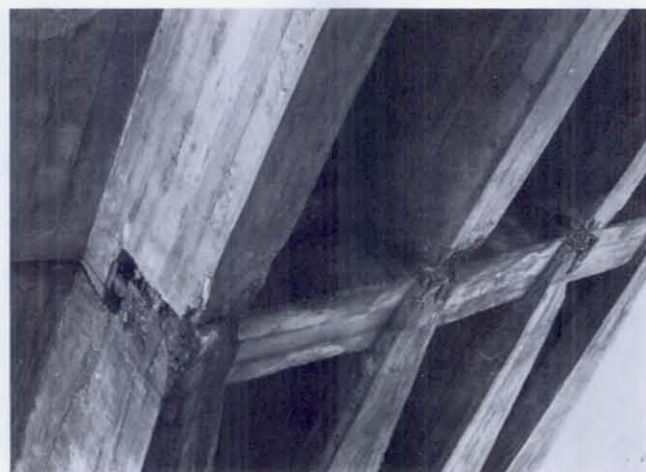
FIGURE 81 Damage to the south roller support for the simple span, which rests on the overhang of the central continuous span. Only the two outer girders carry the reaction. The beam which distributes the loads from the inner girders to the outer girders can be seen faintly under the deck. Note the concrete cracking in the overhanging lip of the simple span.

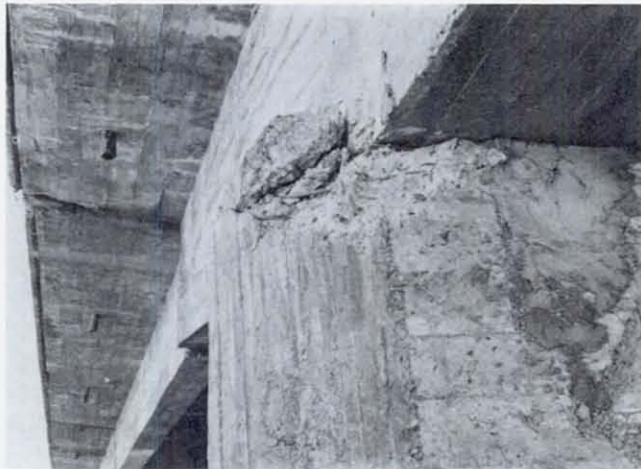
FIGURE 82 A close-up of damage at the top of the westmost pier. Note the poor placement of concrete and the patching. Diagonal steel extending into the shoulder at the top of the pier would have increased its strength.

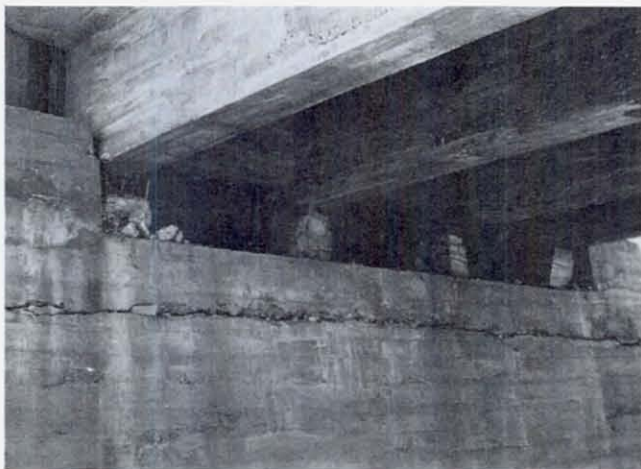
FIGURE 83 The west abutment was severely cracked, probably along a weak poor joint. The blocks under the girders, intended to provide a sliding joint, were rotated and badly disintegrated by the earthquake, almost permitting the bridge to drop unevenly on the abutments.

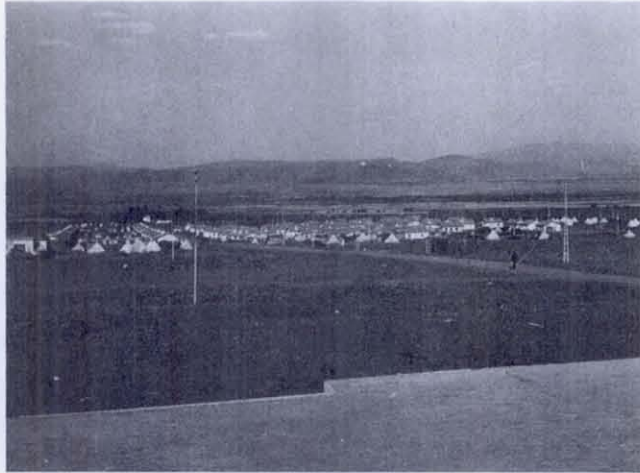
FIGURE 84 On the east edge of Bingöl stands a settlement of 88 houses recently built by the Ministry of Reconstruction and Resettlement for residents of Bingöl living in a landslide area. The plain shown slopes to the rear to the Göynük River, about 6 km away, along which it is believed faulting occurred. Approximately 1 km to the right of this project, on the same plain, lies a military post which suffered heavy damage to reinforced concrete buildings. No damage at all was reported to these settlement houses.

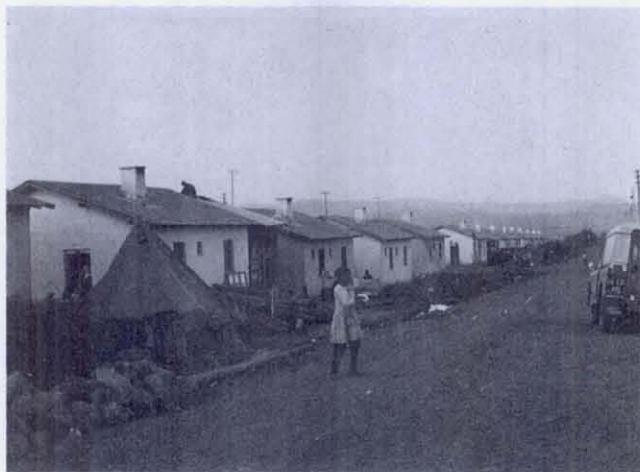
FIGURE 85 A closer view of the undamaged resettlement houses. The houses are of masonry, contain 55 m^2 gross area, and are on lots of 450 m^2 . They cost \$1,300, payable over a 20-year period with no interest charge. Water piped to a house costs \$35 extra, and electric service is \$40 extra. The chief complaint voiced by the owners of the houses is their small size. One resident is seen on the roof of an addition he is just completing. The complete absence of damage suggests that ground motion here was not as strong as in surrounding areas.

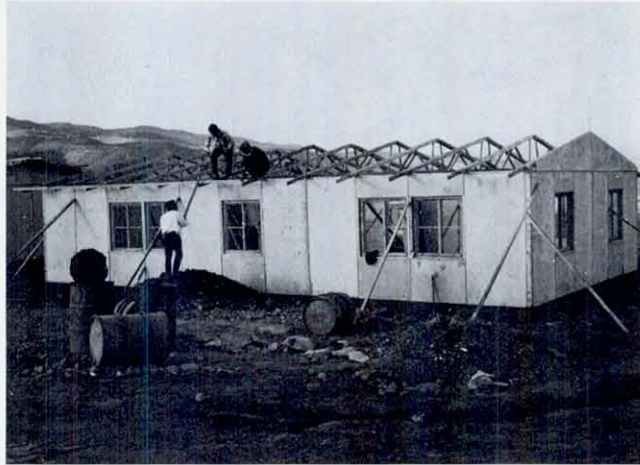
FIGURE 86 Buildings in Bingöl of prefabricated wall panels and roof trusses to be used as offices for resettlement construction. The walls consist of a 3-cm exterior layer of cement-asbestos, 5-cm of fiber glass, and an interior surface of 1-cm wood chip board. The walls are attached to a concrete floor slab by bolting to punched galvanized steel angles. This type of building has been suggested as housing for villagers, but it is doubtful if it would prove warm enough for Bingöl's cold winters (sometimes as low as -30°C) or sturdy enough to stand up under the rough usage conditions of village life.

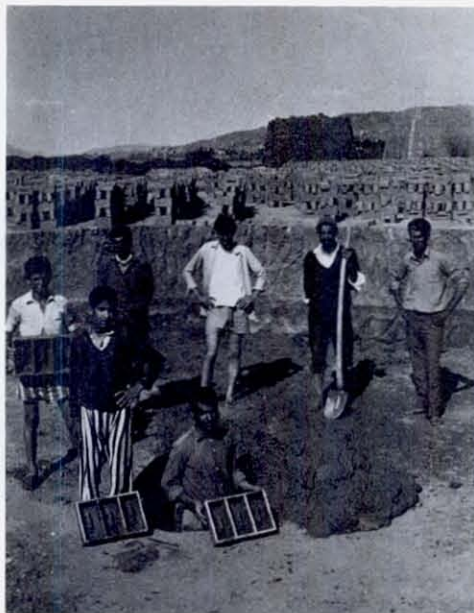
FIGURE 90 A brickyard in Genç, near Bingöl. Mud, soaked for 12 or so hours, is brought to the man in the pit who fills the molds, using fine sand to prevent the mud from sticking to the molds. The bricks are dumped on the ground for air drying and later piled into small stacks. As shown in Figure 91, a large burning stack is constructed of air-dried bricks, with finely crushed coal sprinkled between layers of bricks, and then plastered over with mud, ignited, and left to smolder for 15 or so days. Bricks made in this manner are soft and relatively weak. Sometimes the bricks are roasted a second time to improve the quality.

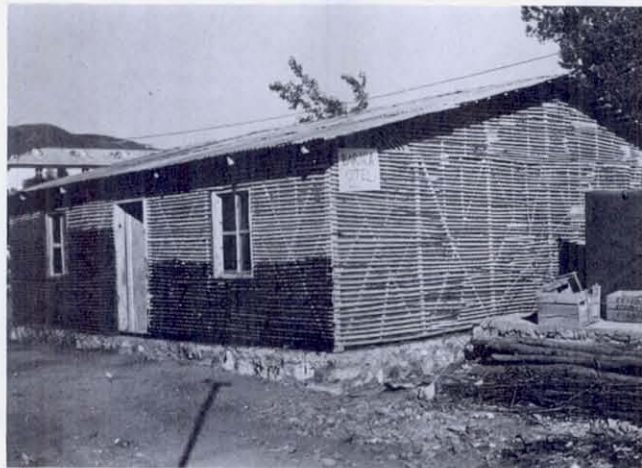
FIGURE 93 This structure, erected in Bingöl after the earthquake, suggests a possible construction type for villagers and others who build their own homes. The columns are 10-cm square, and insulation consists of small pieces of mud poured into the wall voids as the lath application proceeded upward. Plastered inside and out, this structure would be weathertight, moderately warm, and safe during an earthquake. The major cash outlays would be for nails, corrugated steel roofing, and the sawing of the lumber.
