ENGINEERING REPORT
ON THE
MURADIYE-ÇALDIRAN, TURKEY, EARTHQUAKE
OF
24 NOVEMBER 1976

P. Gülkan, A. Gürpınar, and M. Celebi
Middle East Technical University, Ankara, Turkey

Committee on Natural Disasters
Commission on Sociotechnical Systems
NATIONAL RESEARCH COUNCIL

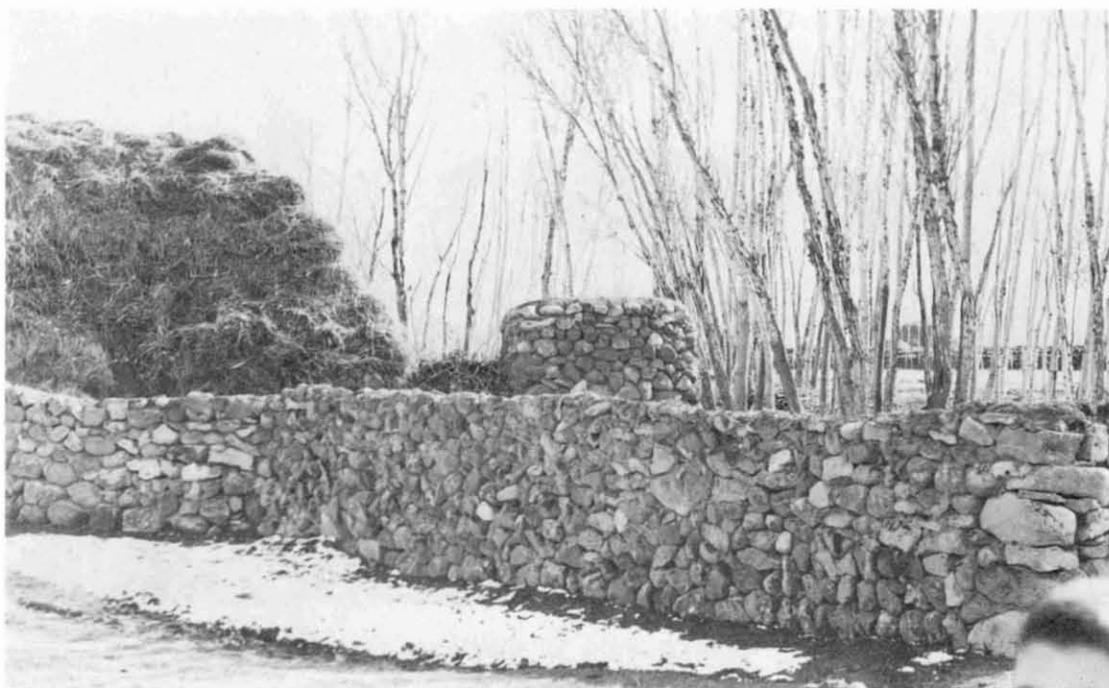
10. Rubble Wall 30 km from Epicenter

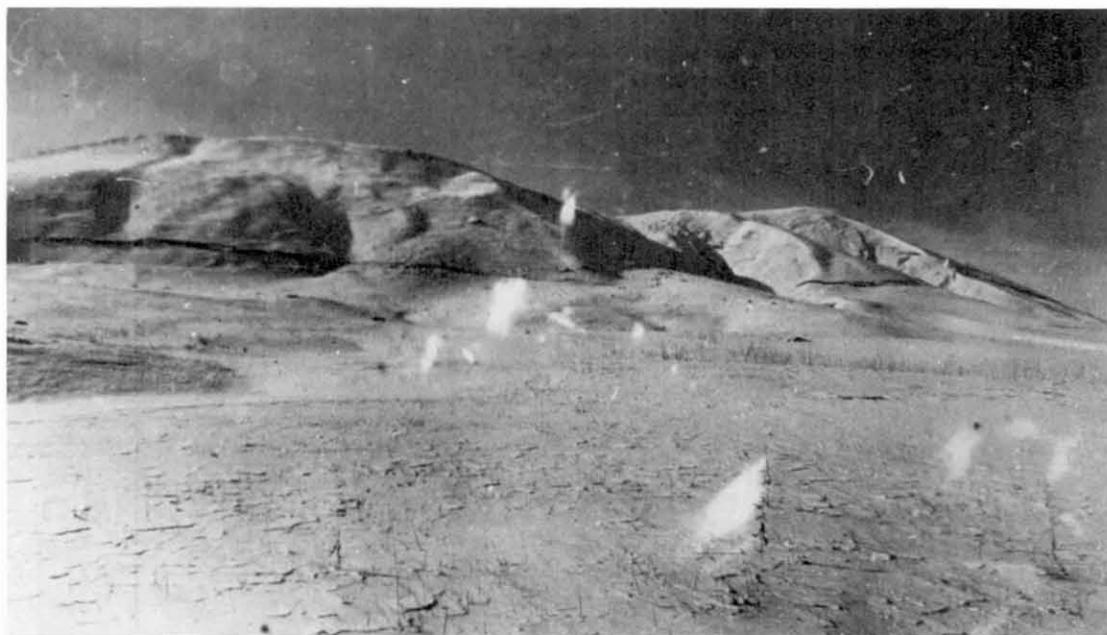
23. Fault Scarp between Eşekbatan and Alaçayır

Although the fault scarp defines a fairly linear, single line as shown in Figures 23 and 24, on close inspection it really consisted of a large number of small scale tension cracks and compression bumps. Figure 25 depicts this situation. Perfect examples of a rightward slip could be observed along the fault in many locations. Samples in the Çaldıran plain west of the town (Figures 26 and 27) and in the snow covered eastern edge (Figures 28, 29, and 30) are textbook perfect.

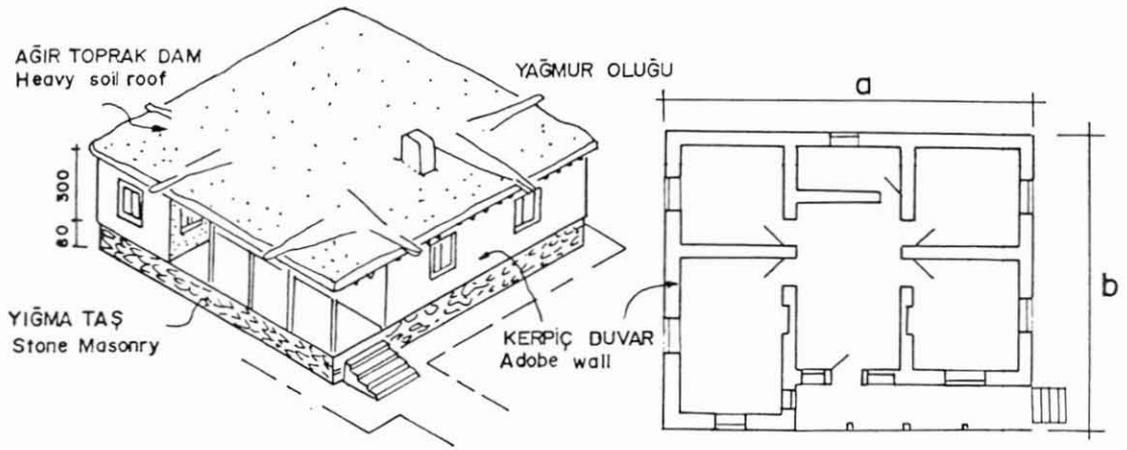
32. Typical Rural Dwelling

The "traditional" type of dwelling in the area, a sketch of which is shown in Figure 32, has almost no resistance to lateral loads. In Çaldıran and the villages in the immediate vicinity of the fault rupture these buildings collapsed totally and caused by far the largest number of deaths. A two-storey reinforced concrete building in Çaldıran serving as the headquarters of the local military unit survived the earthquake with some structural damage but was in no danger of collapse. Considering the proximity of this building to the fault and the fact that it was not designed particularly against earthquake effects, its survival points to the advantages of well-designed reinforced concrete structures for the saving of human lives. Other reinforced concrete structures in Muradiye also exhibited similar behavior. Masonry buildings showed a more erratic damage distribution. For example, a three-storey building in Çaldıran, only a few hundred meters away from the fault trace, showed no outward signs of structural distress, while a very similar building in Muradiye, 25 km to the south, suffered significant damage. The scarcity of a large number of engineered buildings in the area makes it difficult to derive lessons of structural importance from the earthquake effects.

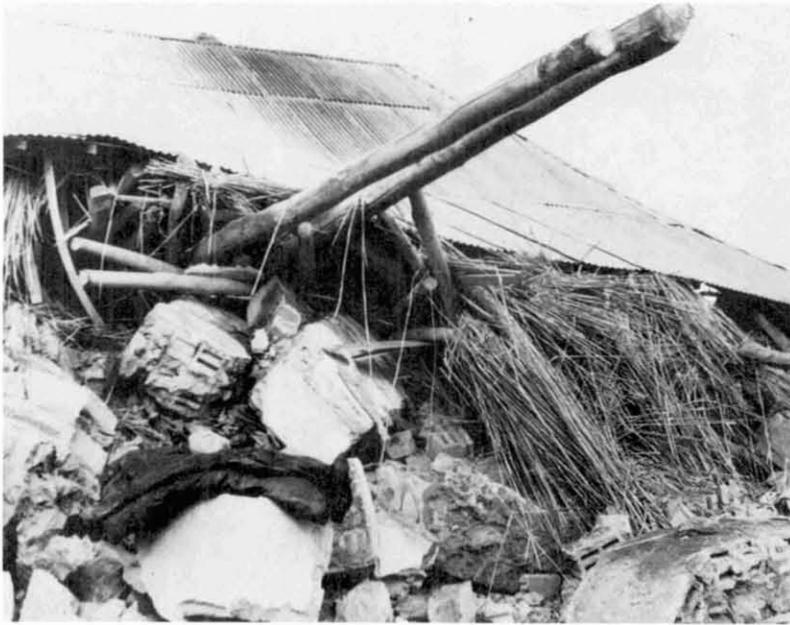
34. Collapsed Dwelling, Çaldıran

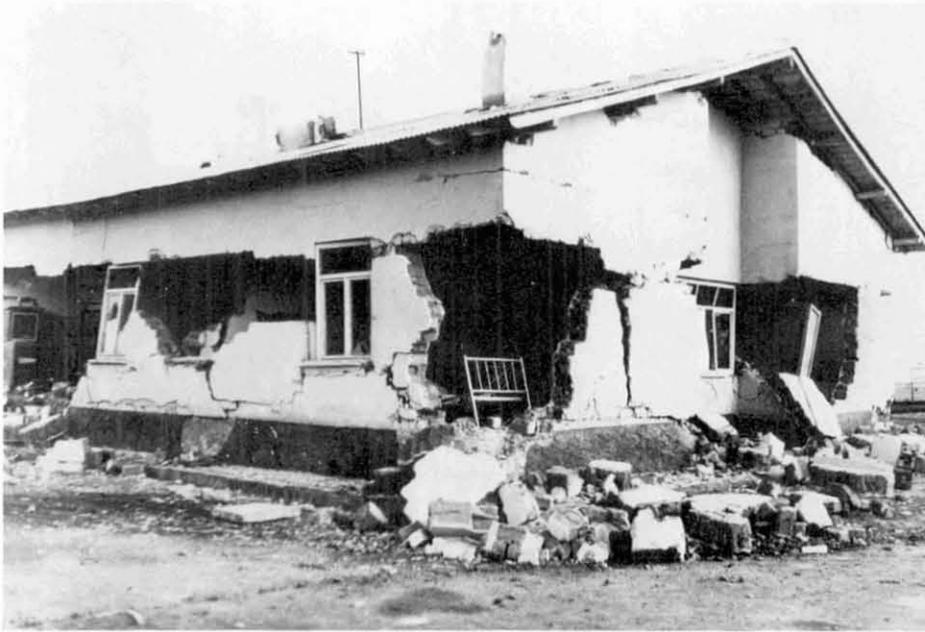
56. Health Center, Çaldıran

Health Center, Çaldıran: - The one-storey concrete-block health center which served as the local hospital was located on alluvial deposits close to a small stream passing from the south of the town. The center and the adjacent lodging unit for its personnel both suffered heavy damage. Figure 56 depicts the health center after the earthquake. Naturally, no relief or care for the injured could proceed in the building; being an essential facility, it should have remained functional.

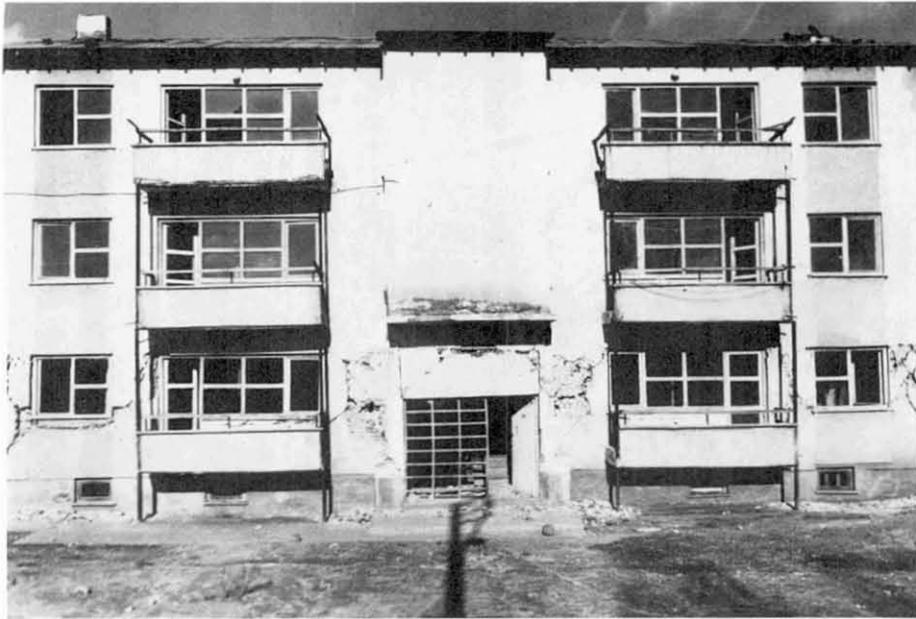
57. Government Employees' Lodging, Muradiye

Government Employees' Housing Muradiye: - This three-storey brick masonry building, very similar to the officers' lodging building in Çaldıran shown in Figure 51, suffered far greater damage in spite of the fact that the intensity rating for Muradiye was judged to be two units less. Figure 57 shows a general view of the building. Shear failure in the upper ends of the brick wall panels of the ground floor destroyed structural continuity, as shown in Figure 58. A second floor balcony turned downward a full right angle and its parapet wall fell on the balcony below (Figure 59). The poor behavior of this building can be partially explained in terms of the excessive openings for windows (see Figure 58). Single-storey units nearby, built reportedly in 1946 for government employees, came through without damage (Figure 60).

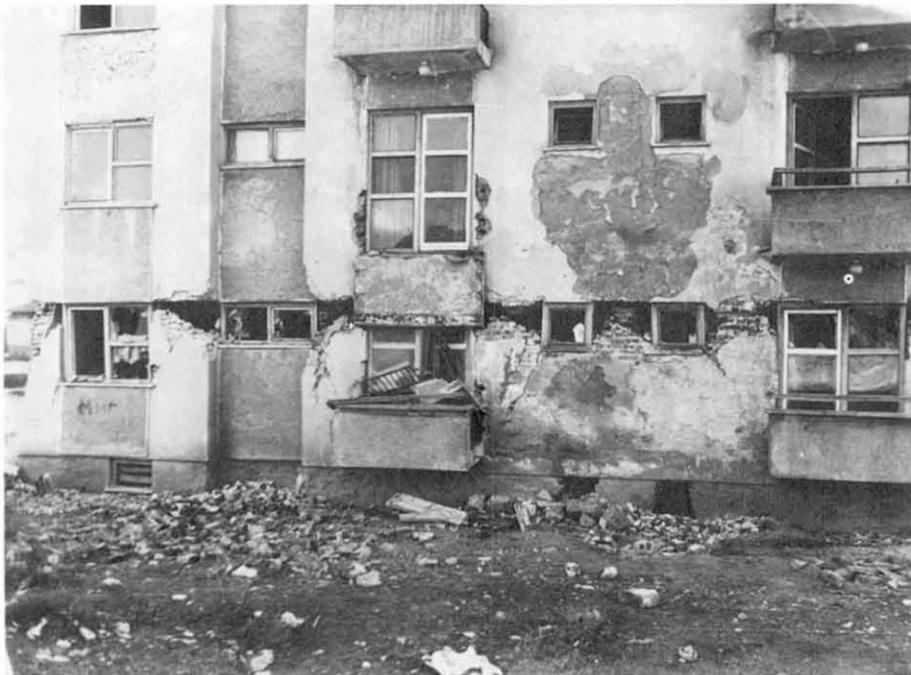
58. First-Storey Wall Panels of Employees' Lodging, Muradiye

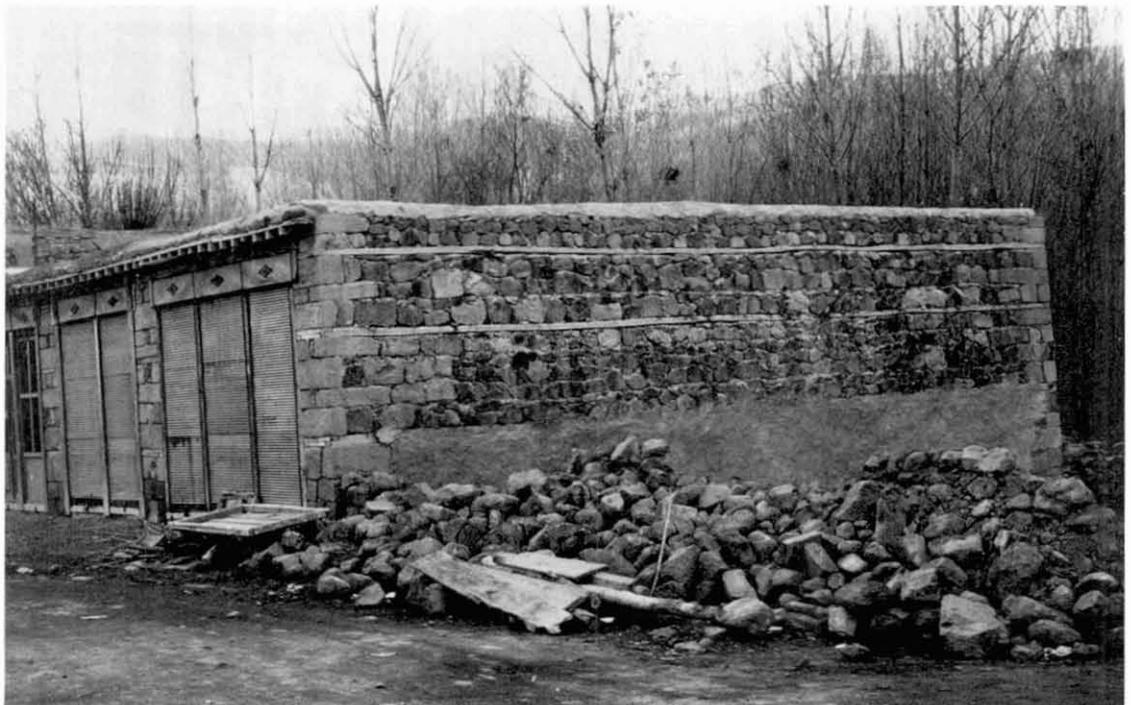
62. Stone Masonry Store Building, Muradiye
