THE CENTRAL GREECE EARTHQUAKES OF FEBRUARY-MARCH 1981

A Reconnaissance and Engineering Report

James O. Jirsa (Team Leader), Professor of Civil Engineering, University
of Texas at Austin

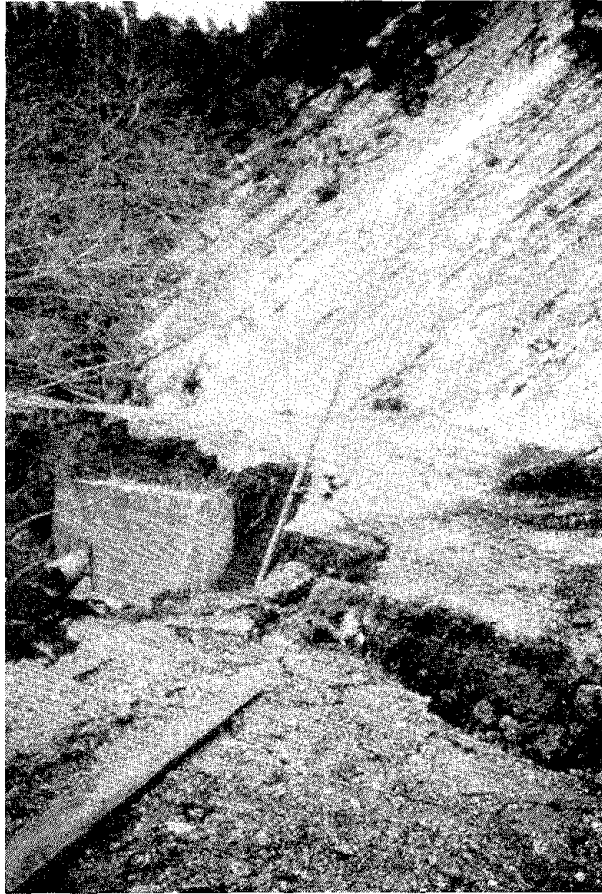
FIGURE 2.6 Ground rupture in alluvium near the base of a limestone fault surface on the Pisia trace.

preferred focal plane solution of the mainshock dips 46° , suggests that the Pisia rupture trace is the main fault and that the Shinos rupture trace is probably the result of splaying of the fault plane.

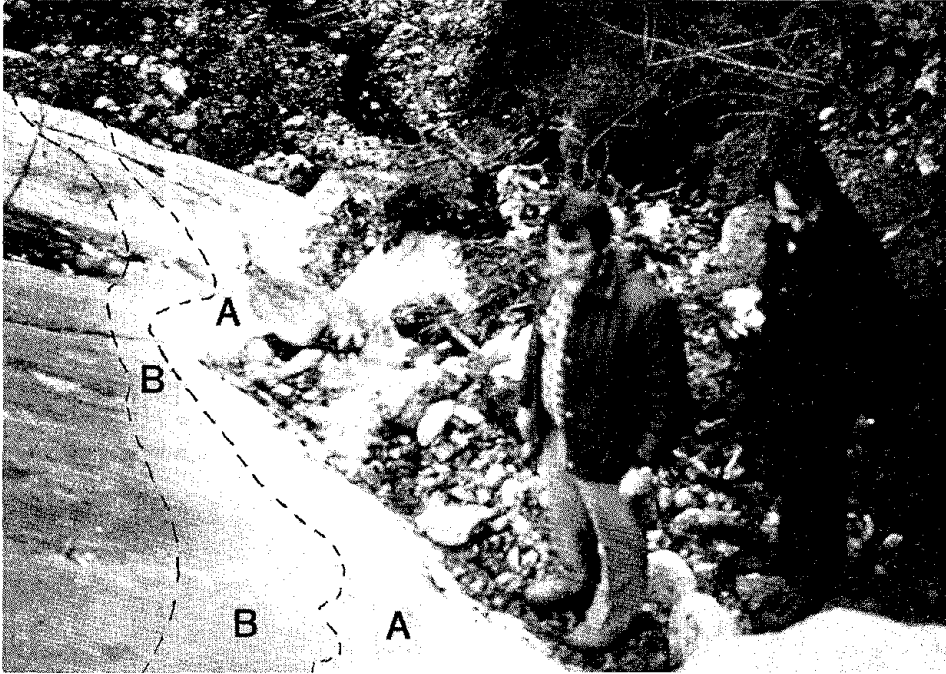
FIGURE 2.7 Dip-slip movement along the base of a limestone fault surface, Pisia trace, prior to the earthquakes of February 24 and 25. The formerly soil-covered part of the rock face is labeled "A." Weathering characteristics in area "B" indicate that at some time in the past the soil covered this area as well. This locality, then, records two recent episodes of surface rupture and dip-slip movement.

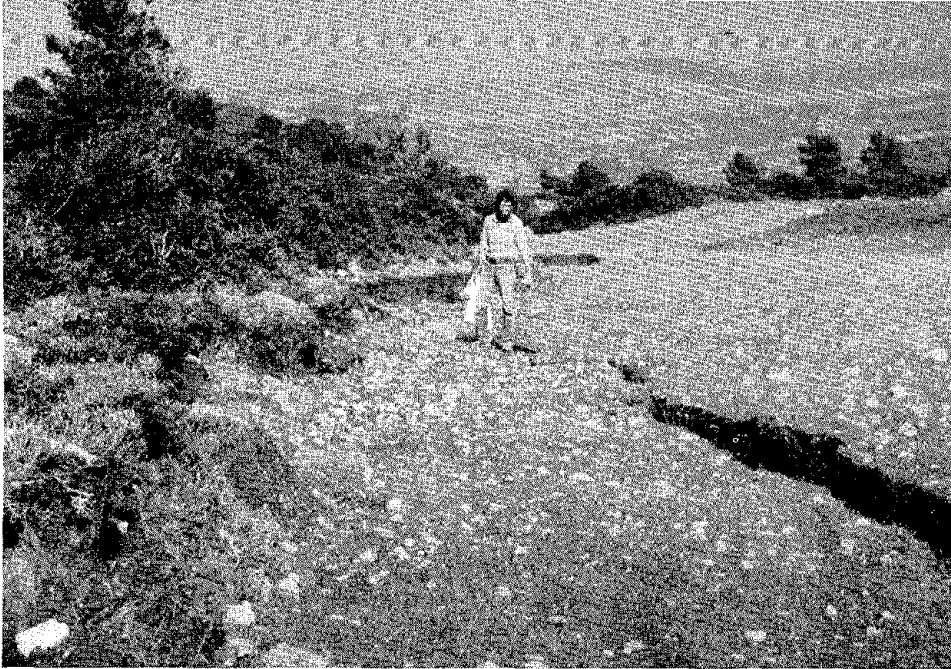
FIGURE 2.9 Eastern end of the Kalamaki trace at the location where ground motion was observed during a magnitude 5.7 earthquake on March 7, 1981. The main rupture trace is on left side of the photograph. The smaller rupture on the right is a secondary, near-surface cantilever failure in the soil, which appeared several days after the original surface break. This pattern is analogous to the relation between the southern and northern earthquakes and surface ruptures.

On March 7, 1981, a field party was investigating the Kalamaki rupture trace on the north side of the Gulf of Corinth (see Figure 2.9). In the early afternoon the field crew was mapping the rupture in a recently planted field. At that location the vertical offset generated by the 6.2 magnitude earthquake on March 4 was 35 to 40 cm and the fracture was open 10 to 15 cm, except where wedge-shaped blocks had broken from one side of the fracture to close it up. At 1:35 p.m. an earthquake, reported later to have a Richter magnitude of 5.7, occurred in the region. At the instant of onset, two investigators were standing by the

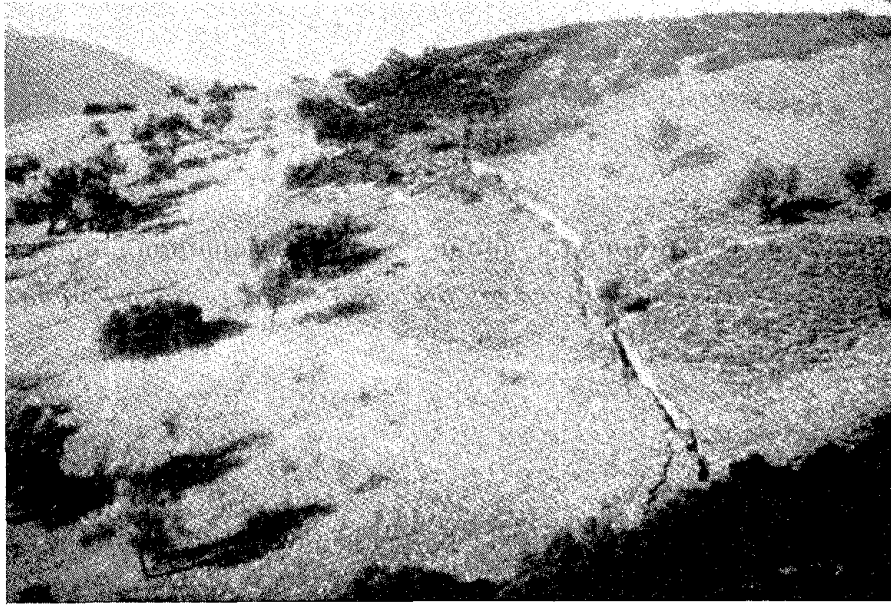
spectacularly follows the northern side of a wide valley, trending east-west. The surface rupture usually occurs in the soil material either on the side of the hill or just along the base (Figure 2.10). On several steep hills, series of parallel fractures were observed, suggesting that gravity slumping also occurred. The fault plane is nearly vertical, although separation between the hanging wall and the foot wall is common. In some locations a smooth limestone cliff, 1 to 3 m high, marks the fault trace. Offsets vary from 10 cm to 1 m.

FIGURE 2.10 Ground rupture along the western end of the Kapareli trace, looking west. The average displacement is about 1 m.

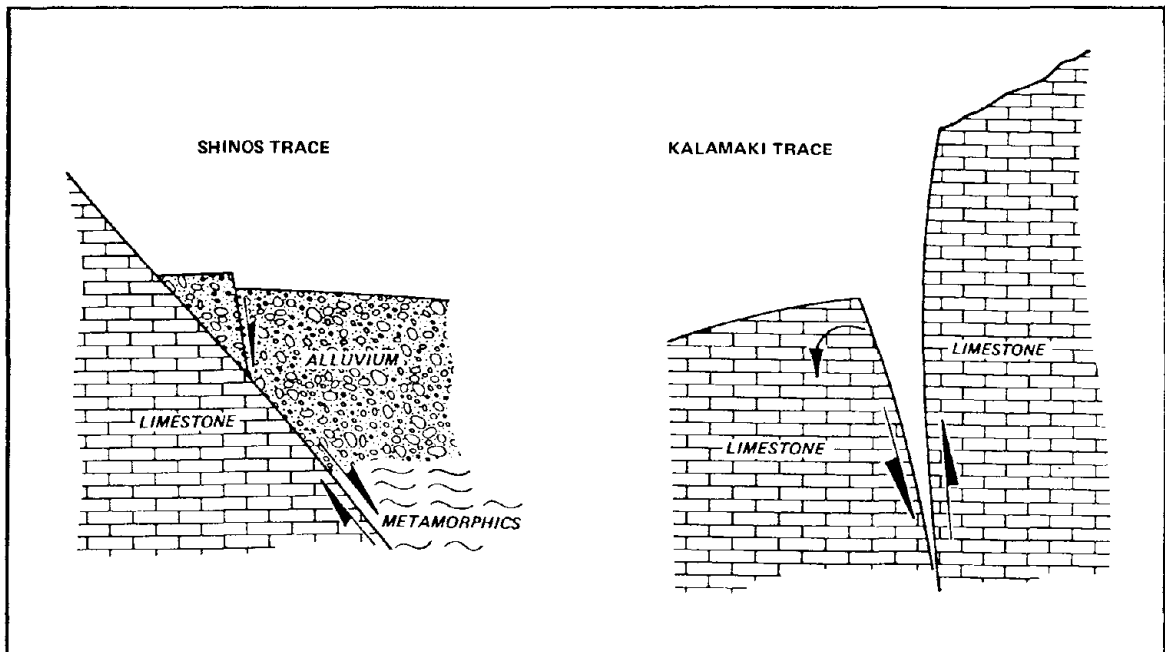
The nature of the surface expression of the northern ruptures differs strikingly from that of the southern ruptures. The southern fault zone exhibits pure dip-slip motion, with striking dip-slip deformations on the fault surface. The northern surface ruptures characteristically exhibit a rotation of the hanging wall in a direction perpendicular to and away from the foot wall (as shown in Figure 2.11) and lack dip-slip compressive fault surface fractures. This rotation has resulted in the opening of a wedge-shaped fissure along these rupture traces except where slumping along either side of the fault has

FIGURE 2.11 Close-up schematic cross section illustrating differences in the style of offset between the Shinos/Pisia and Kalamaki/Kapareli traces.

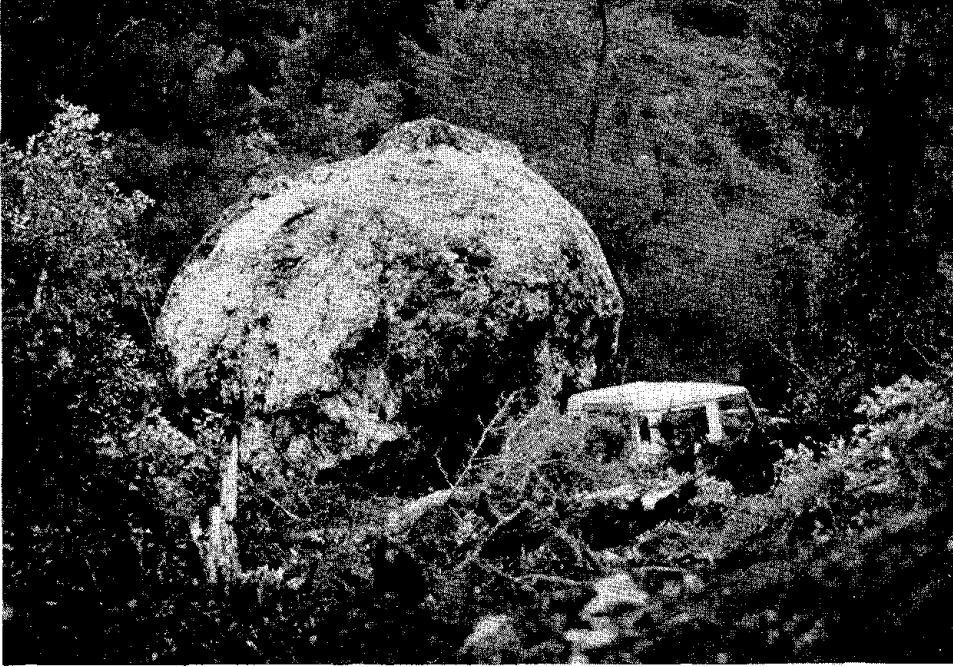
boulders as large as 40 to 50 m³ rolled downslope, leaving a path of destruction in their wake. The boulders hit trees, walls, and buildings, leaving craters where they struck the ground (Figure 2.14).

FIGURE 2.14 Large boulder heaved from the side of the mountain south of Shinos. This photograph was taken standing uphill within the swath cut by the rolling, bouncing rock.

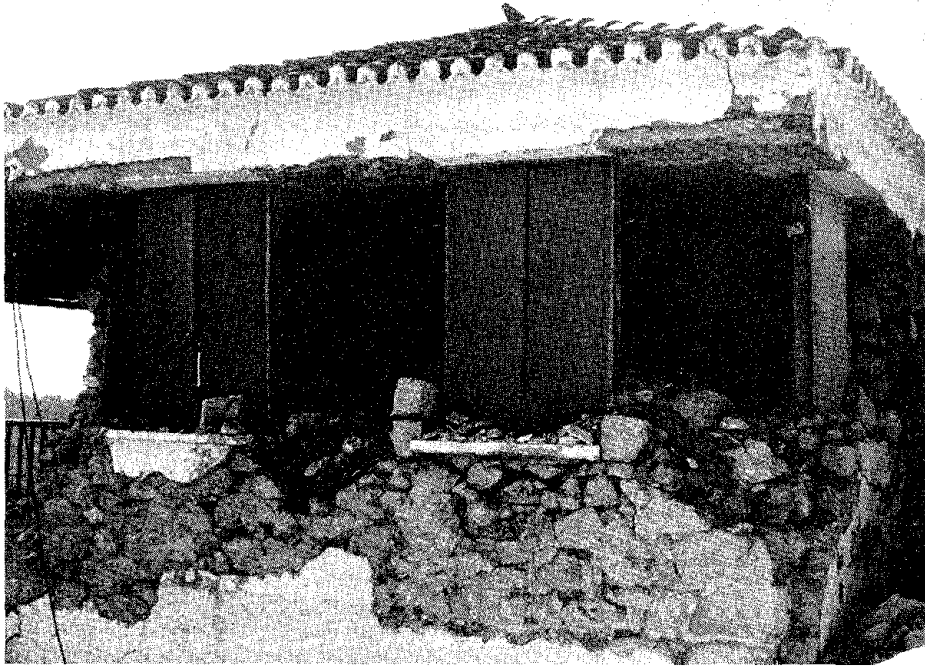
FIGURE 4.1 Tile roof supported by timber frame in Perahora.

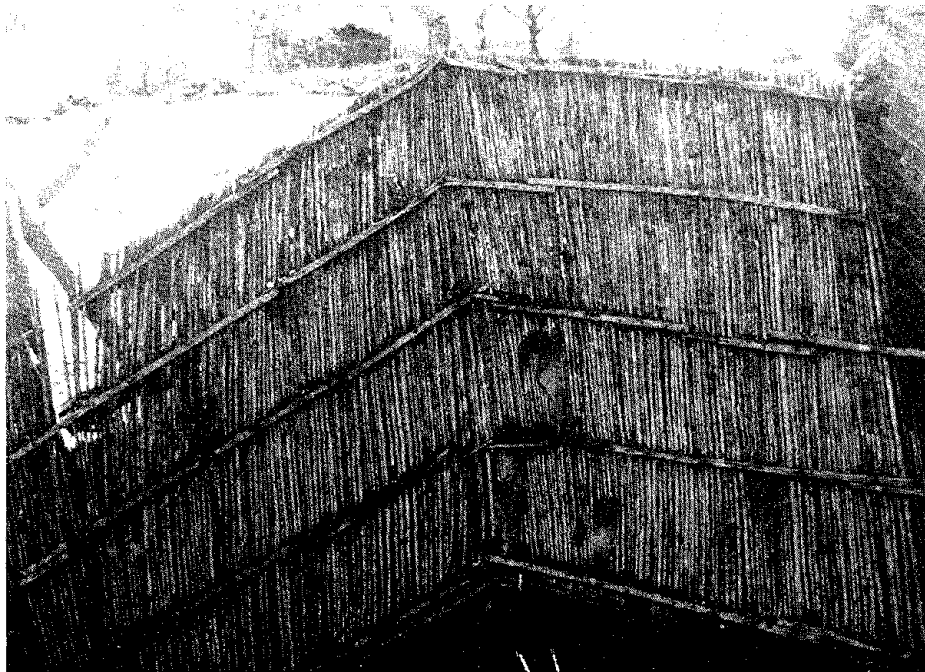
FIGURE 4.2 Timber roof supporting tiles in Perahora.

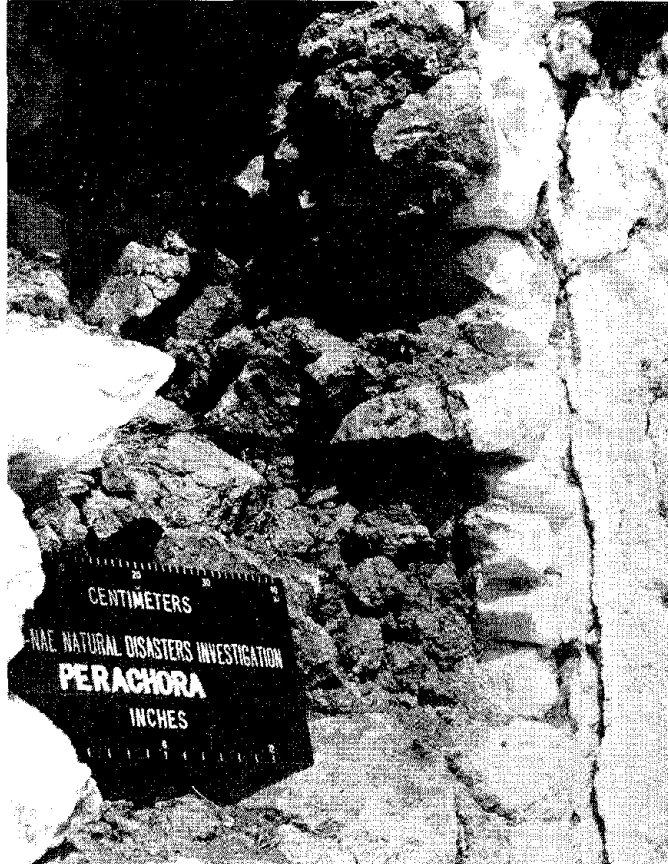
walls must be constructed carefully, and the mortar must be of good quality. In Perahora many of the masonry walls were constructed as two separate faces without any connection and the cavity was filled with rubble and earth. Earth mortar without any cementing material was used (Figure 4.3).

FIGURE 4.3 Stone and mud walls in Perachora.

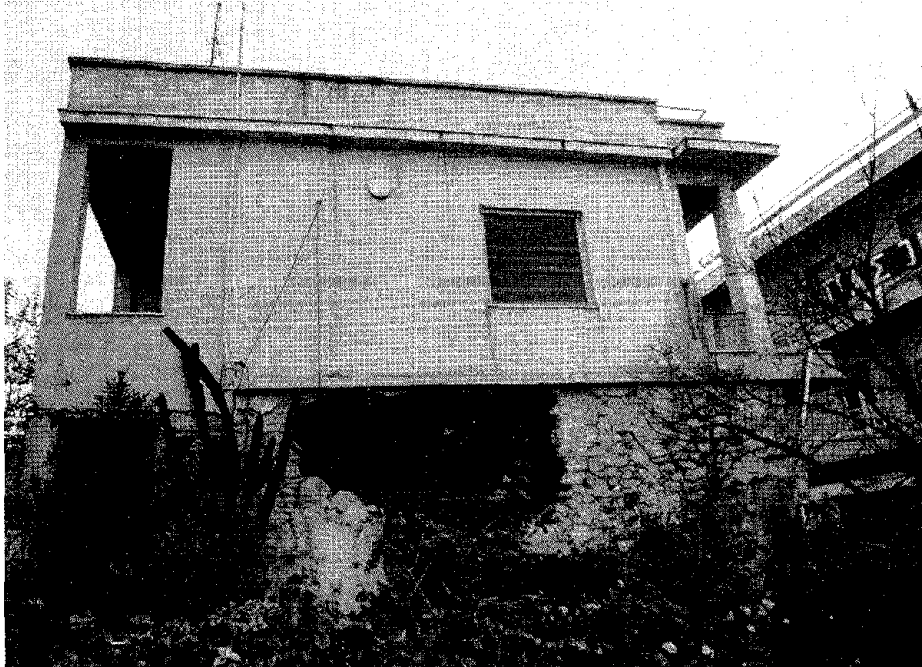
FIGURE 4.5 Addition to an existing stone masonry building (Megara).

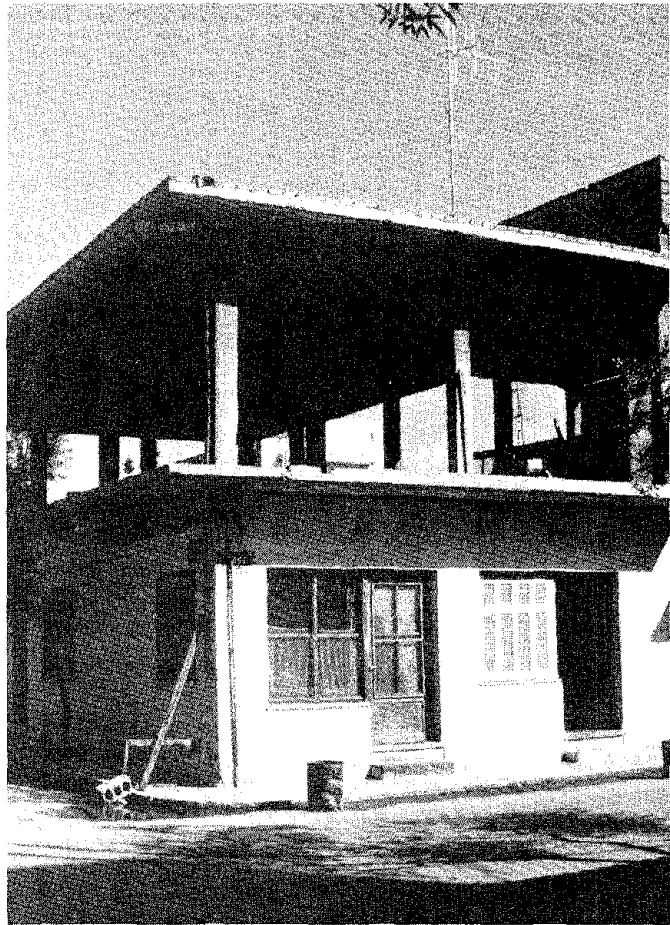
FIGURE 4.6 House with upper floor added.

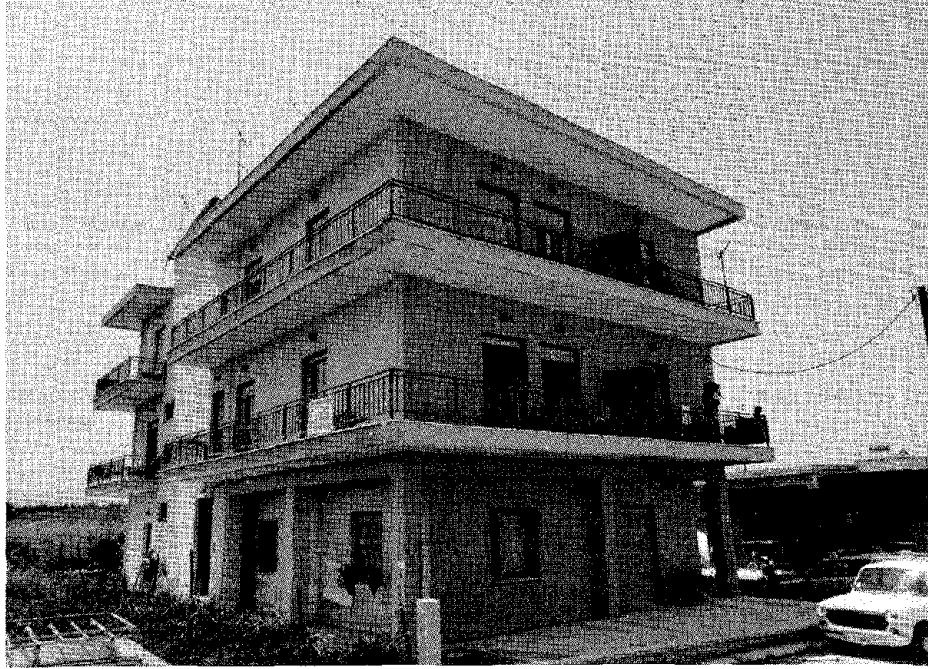
FIGURE 4.7 Undamaged building in Vrahati, founded on silty soil and mud. There is a small brook at left. The building is an addition to an old one in height and length. The old one is made of very good quality concrete blocks, produced locally by the owner. The mortar used for the masonry of these concrete blocks is cement and sand.

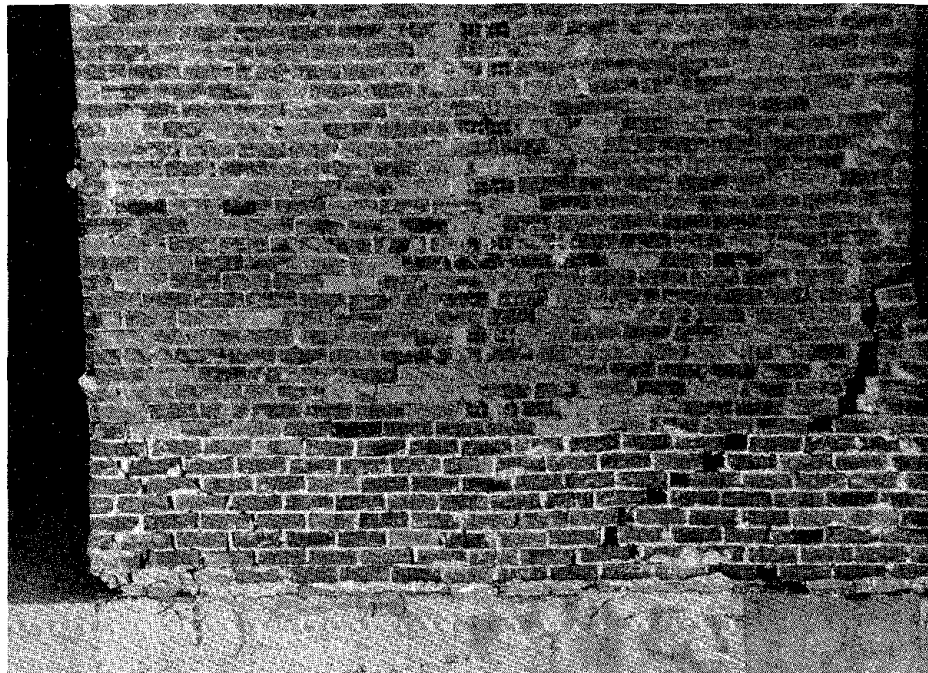
the reinforcing elements as well as the floors and roofs consist of reinforced concrete. The partitions are thin (7 to 9 cm in thickness) hollow brick walls. As shown in the 1981 earthquake and other earthquakes, the behavior of the structures with solid brick walls (Figure 4.8) was superior to that of the structures with hollow brick walls. The quality of modern bricks generally has been inferior to that of traditional solid bricks, as indicated by the nature of local damage in walls. In some cases the infill walls did not develop typical diagonal cracks (Figures 4.9 and 4.10) but failed by crushing along the reinforcing elements (Figures 4.11 and 4.12).

FIGURE 4.8 Solid-brick wall.

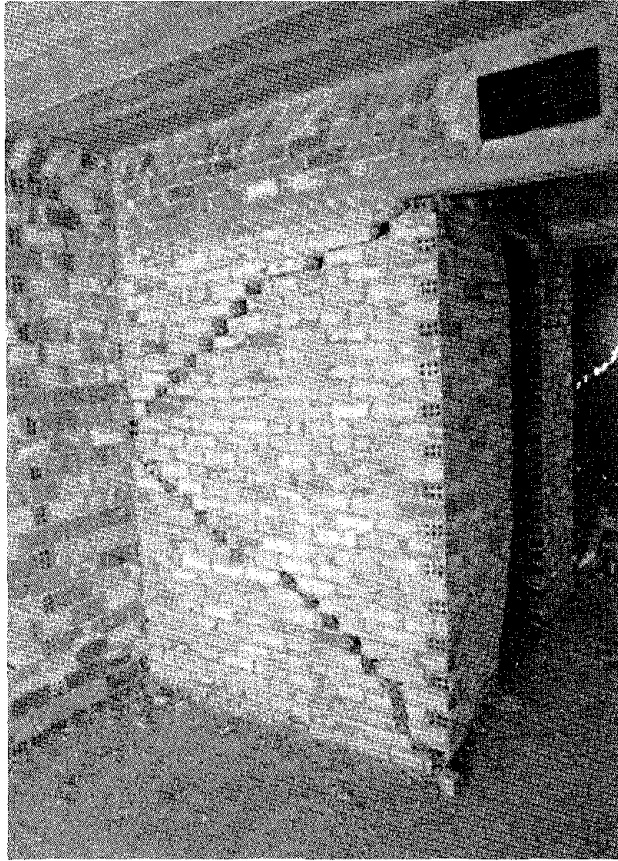
FIGURE 4.9 Unreinforced hollow brick wall in an apartment building.

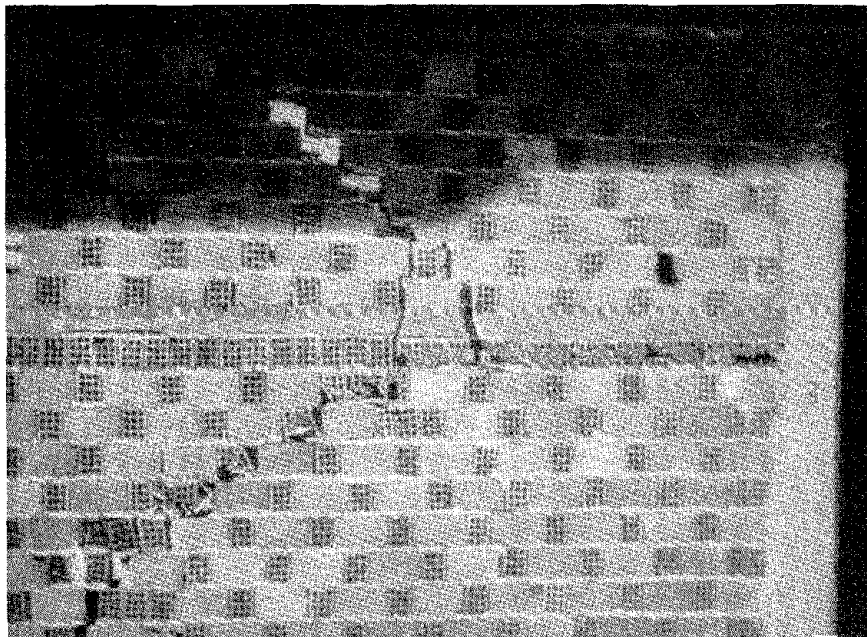
FIGURE 4.10 Hollow-brick wall with a reinforced concrete beam at the midheight of the story.

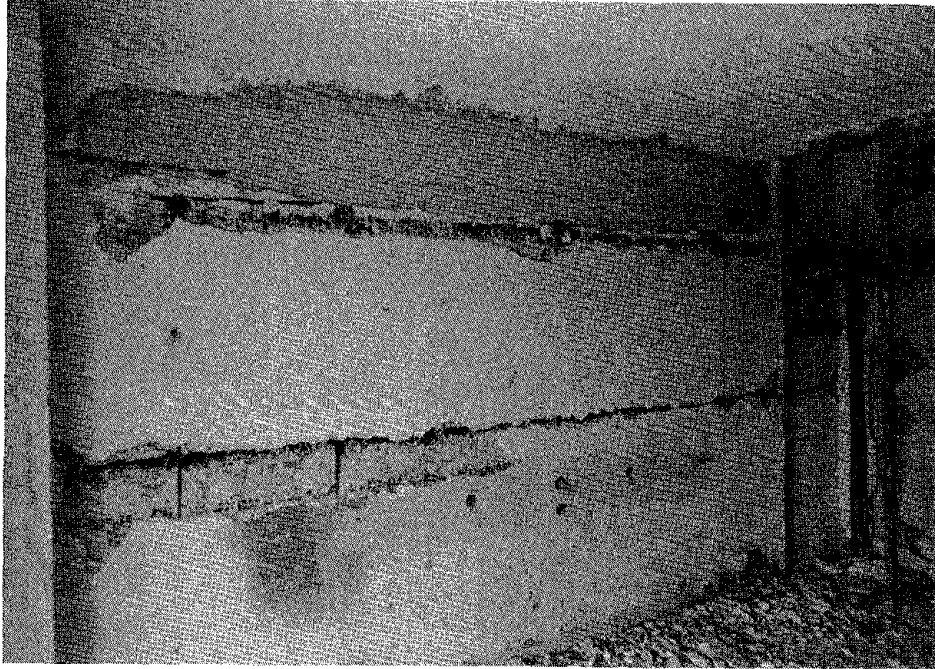
FIGURE 4.11 Brick wall reinforced by a concrete beam. The bricks under and over this beam as well as the ones at the top of the wall are crushed.

- o Action of infill walls with the adjacent vertical or horizontal elements of the framing system (Figures 4.10, 4.11, 4.12).

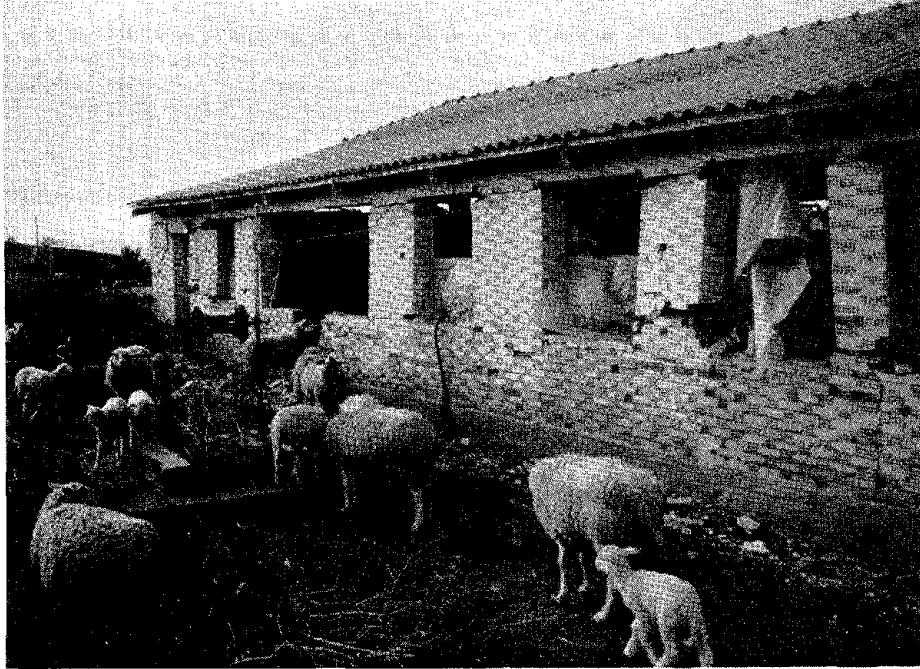
In some cases concrete blocks were used for agricultural buildings or nondwelling additions to existing buildings. With light roof construction and minimal lateral force requirements, these structures performed reasonably well (Figure 4.13).

FIGURE 4.13 Farm building of block construction with light metal roof.

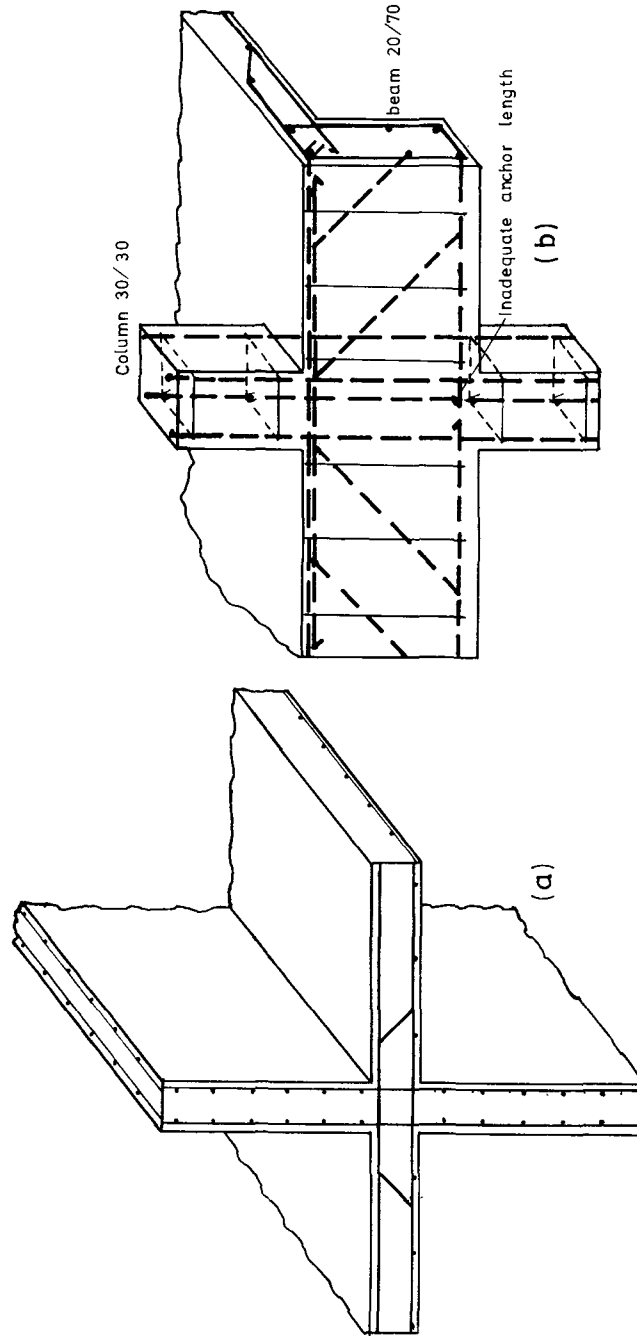
FIGURE 4.14 Typical joint between vertical and horizontal elements as usually constructed in the area. (a) Wall-slab joint. The bottom reinforcement is insufficient to resist the positive moment at the support produced by lateral forces. (b) Column-beam joint. The anchor length is inadequate because the bottom bars are not continuous through the joint.

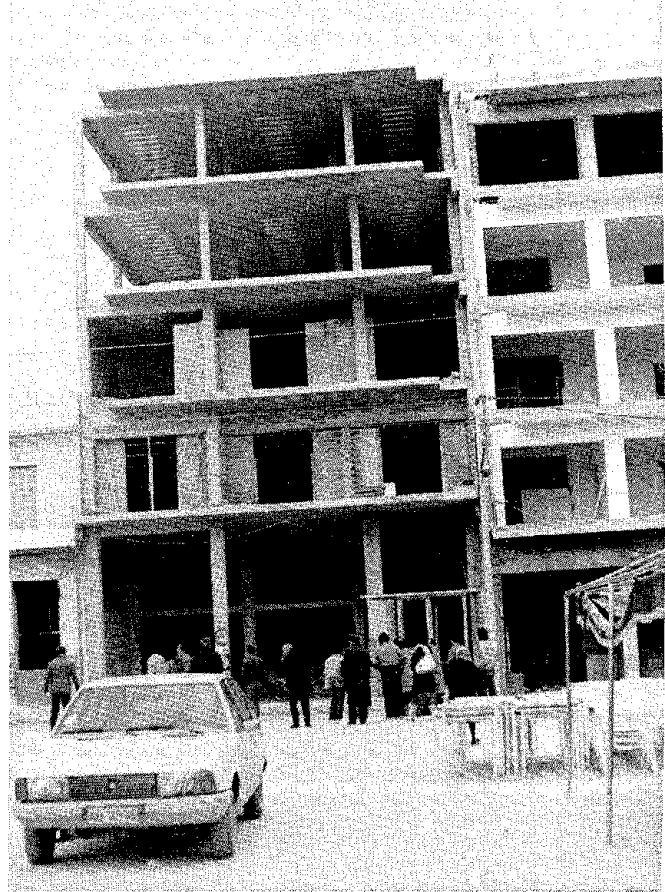
FIGURE 4.17 Flat slab construction without any stiffening walls in Megara. The brick walls were constructed afterward. The building suffered considerable damage with permanent deformations.

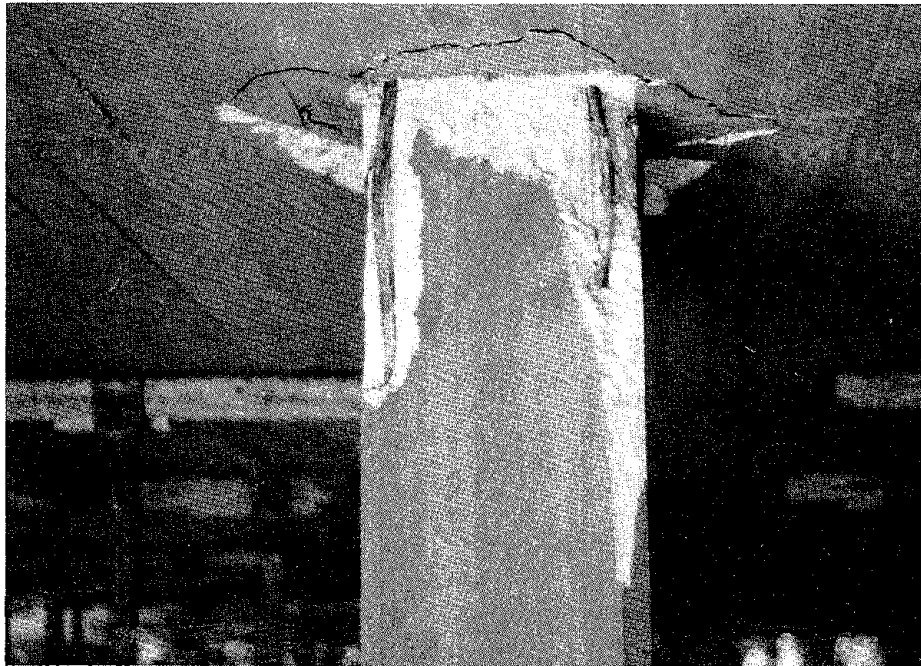
(Figure 4.16). For example, there are six- to eight-story buildings with slabs supported by reinforced concrete walls having a thickness of no more than 20 cm. The rigidity of the structure varies drastically in orthogonal directions. Sometimes prestressed concrete beams and slabs are used to achieve large openings without vertical elements. This is done especially in the central areas of cities. The vertical elements are placed on the line separating adjacent properties, with the weak axis parallel to the facade. In some cases flat slab construction is used without walls (Figure 4.17). Serious distress at the slab-column connections of such structures was observed (Figures 4.18 and 4.19).

FIGURE 4.18 Typical damage of column-to-slab connections. This shows detail of damage to the building on the left in Figure 4.17.

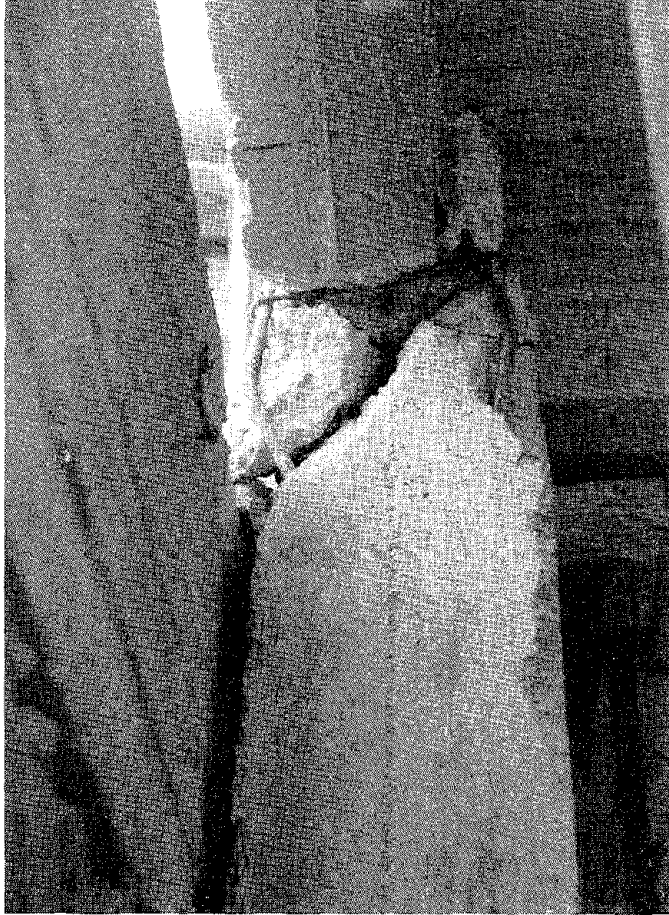
In the old centers of villages and cities there is no separation between contiguous buildings. Therefore the lateral loads from the more flexible structures within a block are transmitted to the relatively more rigid structures. In a block there may be 3 to 10 buildings. The corner buildings of a block showed more damage than did the inner buildings. Away from the centers of villages and cities, where there are gardens and more free space is allowed, the buildings are separated by an open strip of more than 2 m. In some cases there was also a disparity between floor levels of adjacent structures (Figure 4.17). In such cases, hammering between buildings led to column damage (Figures 4.20 and 4.21).

FIGURE 4.21 Detail of the damaged column in Figure 4.20. Note the gap between the two buildings after the earthquake.

- o Hammering between adjacent buildings due to inadequate free space between them (primarily local damage) (Figures 4.20 and 4.21).
- o A domino effect produced by collapse or heavy damage of adjacent buildings.
- o Inconsistency between the deformability of a structure and its materials and connections (Figure 4.32).
- o Flat slab reinforced concrete construction without shear walls or stiffening elements (Figures 4.17, 4.18, and 4.19).
- o Lack of redundancy in the framing system.
- o Drastic change in the plan area, especially in penthouses (Figure 4.15).
- o Eccentricity between center of torsion and center of mass due to geometry of structural system.

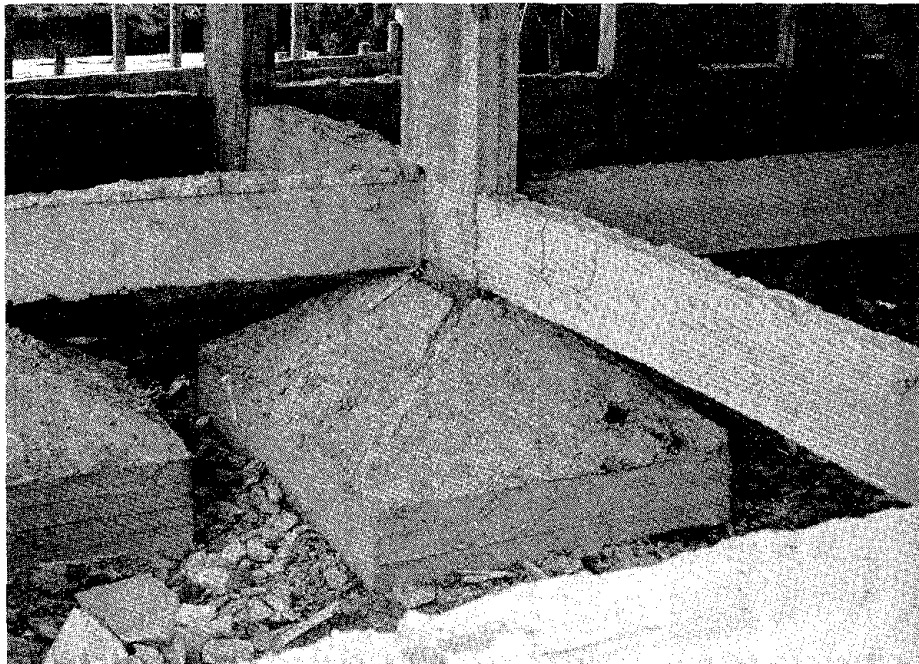
of high seismicity and poor soils, grade beams between the bottom of the foundation and the lower part of the column at the level of the ground floor are recommended by the code and used in most structures (Figure 4.22).

FIGURE 4.22 Spread footings with grade beams.

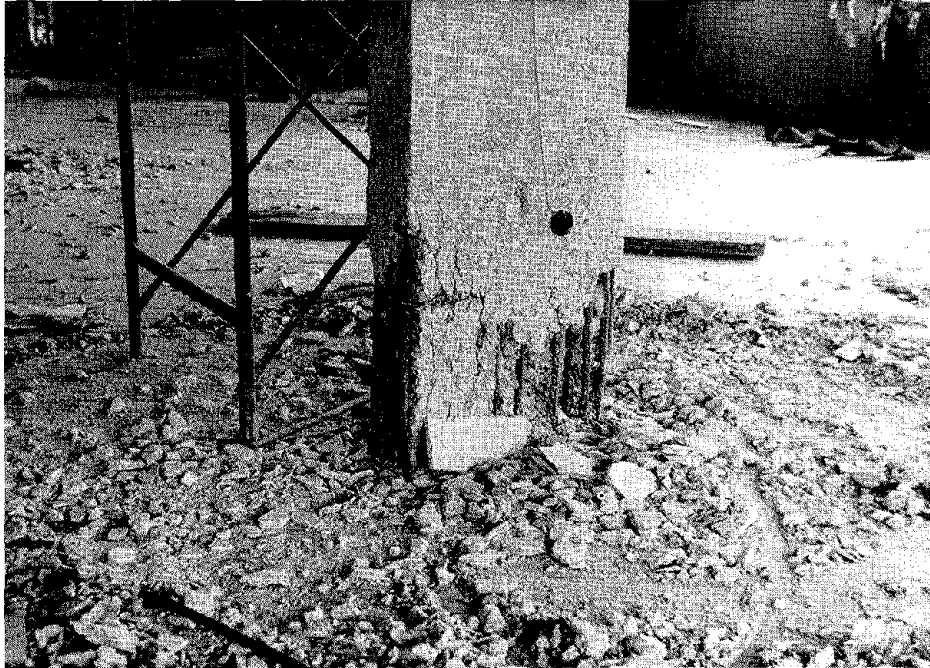
Local failures at the ends of columns and in joints were observed in many structures. These failures can be attributed to poor construction practices--in some cases poor-quality concrete, but in others lack of attention to details. Figure 4.23 shows a failure at the bottom of a column. Note the closely spaced column bars and lack of transverse ties. Figure 4.24 shows a local column failure initiated by an anchorage detail. Columns from the lower story extend through the floor and terminate in hooks when mild steel (22 to 34 kg/mm^2) is used. Under lateral forces the hooked bars opened and caused spalling of the concrete that was not confined by lateral ties. Nearly complete deterioration of column bars due to rust is shown in Figure 4.25. Figure 4.26 shows a construction joint at the middle of a column containing rubbish. The consequences of inadequate transverse reinforcement in the joints of frames is illustrated in Figure 4.27. Figure 4.28 shows the manner in which utilities (electrical conduits) were installed in an infilled frame structure.

FIGURE 4.23 Poor quality concrete, too many bars, inappropriate aggregate gradation, and poor consolidation.

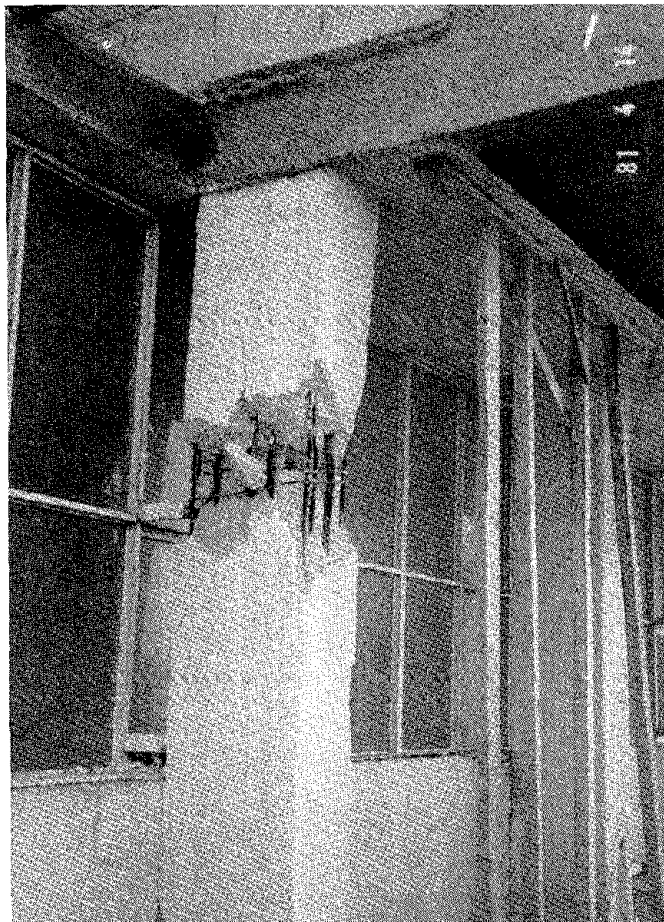
FIGURE 4.26 Typical case of damage to construction joint in the block of flats in Loutraki. Various kinds of rubbish were found in these joints in addition to steel and concrete.

- o Inadequate dimensions of cross sections of the members of the framing system, beams, columns, walls, connections, etc.
- o Inadequate number and/or size of longitudinal or transverse reinforcing bars in members or joints (Figures 4.27 and 4.34).
- o Poor quality of materials and workmanship (Figures 4.24 and 4.25).
- o Poor installation techniques for utilities (Figure 4.28).
- o Improper formation of construction joints in concreting, in extending the reinforcing bars, or in changing the shape and diameter of reinforcement (Figures 4.24 and 4.26).

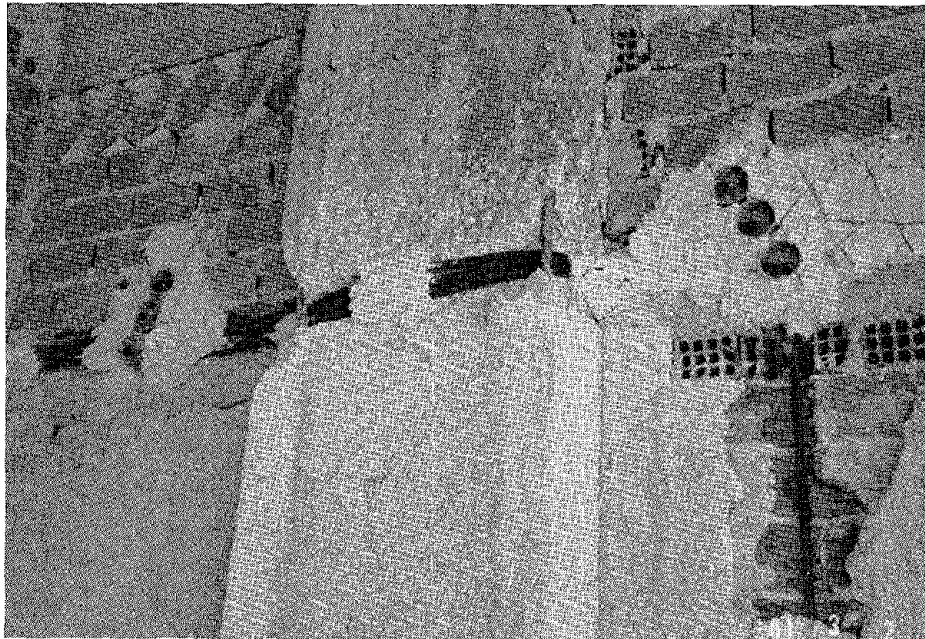
FIGURE 4.28 Conduits for electric cables pass through the column just inside the reinforcing bars and along the brick walls through channels chipped into the column and walls.

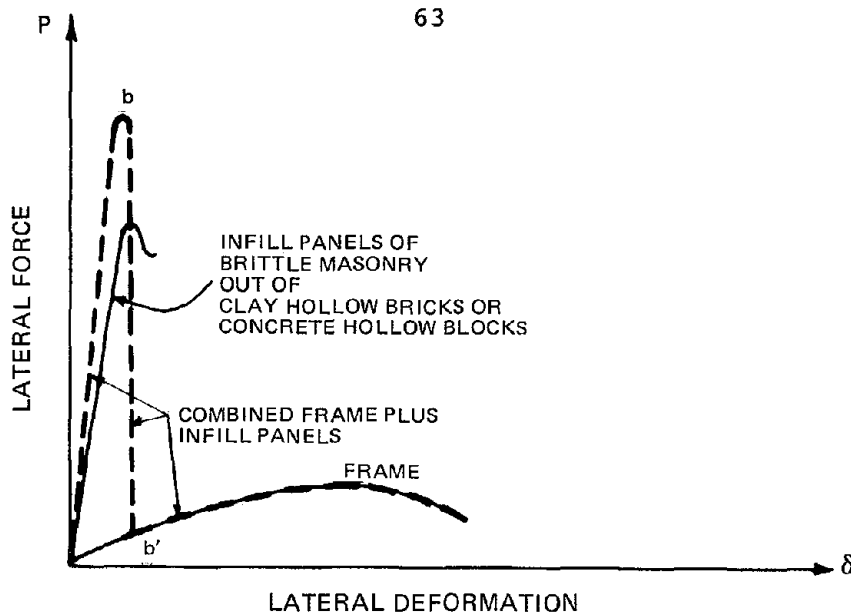
In the case of the apartment buildings with partitions extending throughout the height of the structure, good-quality infill walls often improve the overall response of the structure. The walls absorb a considerable amount of energy and may act as the primary system for transmitting earthquake forces to the ground. However, the response of the frame and masonry walls combined will not be favorable if the seismic forces exceed the strength of the masonry. Under initial seismic motions, high loads may be developed in the structure due to temporarily high stiffness, as shown in Figure 4.29. When the brittle

FIGURE 4.29 A combined reinforced concrete flexible frame plus brittle infill panels produces a stiff and brittle structure.

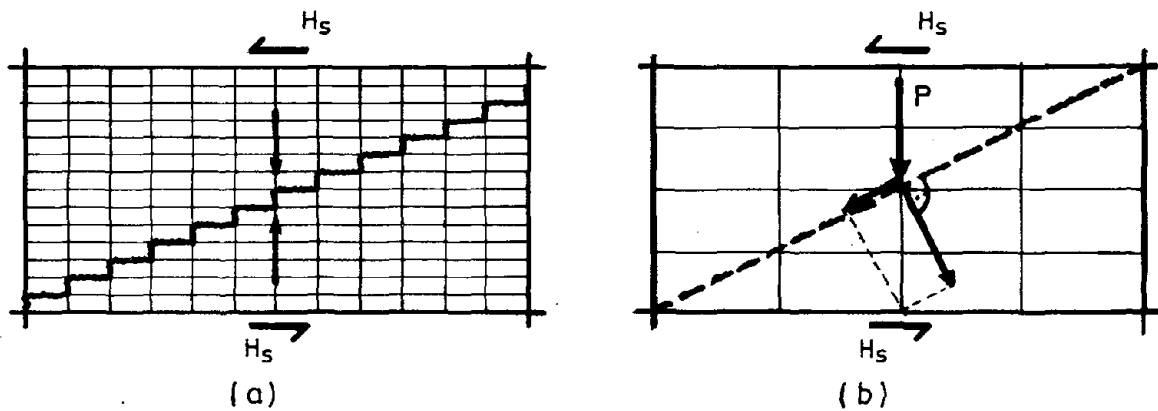
The size and quality of the bricks or blocks, the quality of the mortar used, and the manner in which they are joined are of primary consideration. Generally, it was observed that the smaller the size of the bricks or blocks, the better the performance. With small good-quality bricks or blocks, shear cracks followed the mortar along the horizontal and vertical joints instead of forming a diagonal crack through the bricks (Figure 4.31).

FIGURE 4.31 Infill panels with (a) small-sized good-quality bricks or concrete blocks, with cracks in joints (vertical loading transmitted to foundation), and (b) large and/or poor-quality bricks or concrete blocks, with diagonal cracks (vertical loading produces sliding forces).

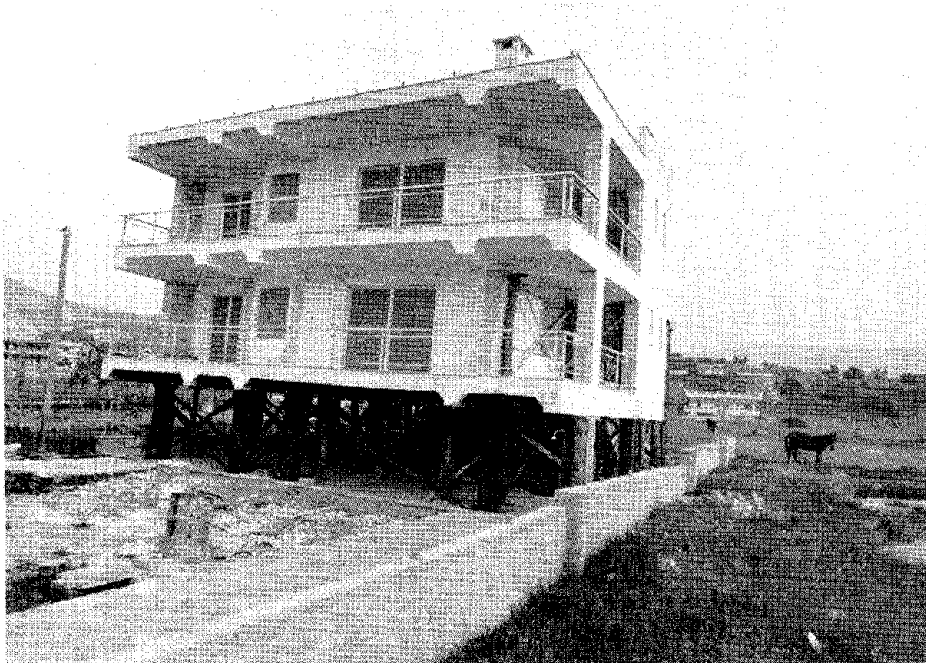
FIGURE 4.33 Modern resort apartment building in Alephori with open first story. The damage was limited to the lower story. The heavy scaffolding (placed after the earthquake) consists of H-shaped steel beams.

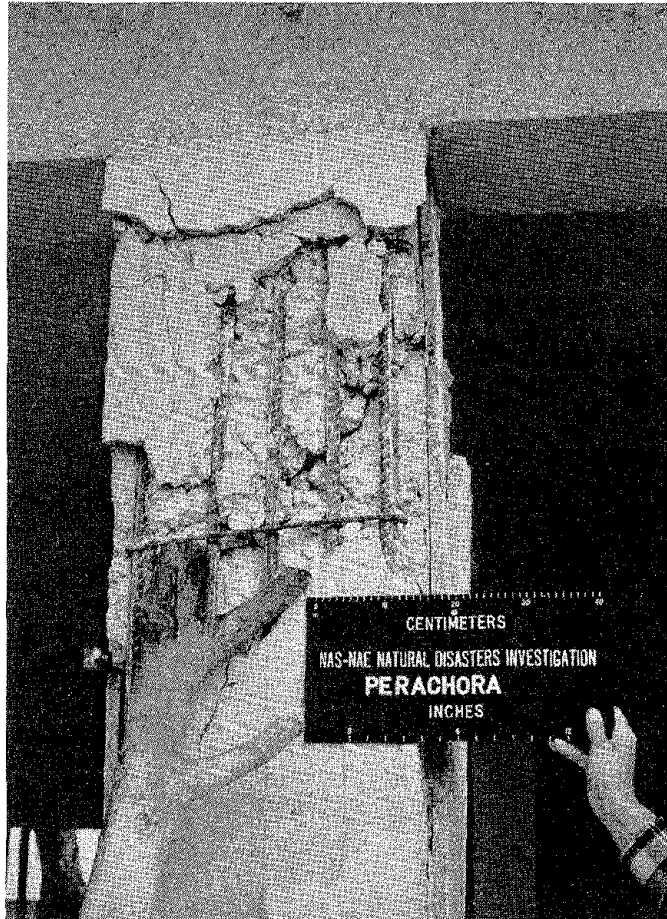
FIGURE 4.34 Column shear failure in first-floor column.

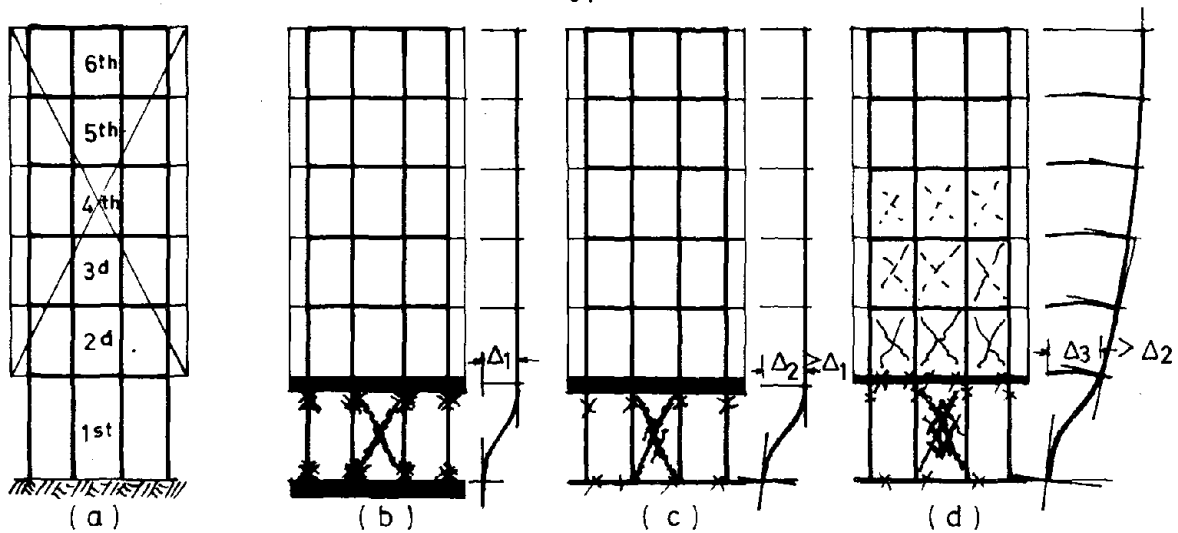
sometimes to the third and upper stories, and to the foundation as well, as shown in Figure 4.35.

FIGURE 4.35 Typical deformation damage pattern of structures with flexible reinforced concrete frame, masonry infill panels, and an open first story: (a) elevation view; (b) strong top and bottom beams, with extended damages in the first story only; (c) strong top and weak bottom beams, with more damage in nonstructural elements and concrete walls, less damage in top parts of the columns of the first story only, and damage in the foundation; and (d) weak top and bottom beams, with more damage in nonstructural elements and concrete walls than in case (c), less damage in columns than in case (c), and extension of damage in upper stories.

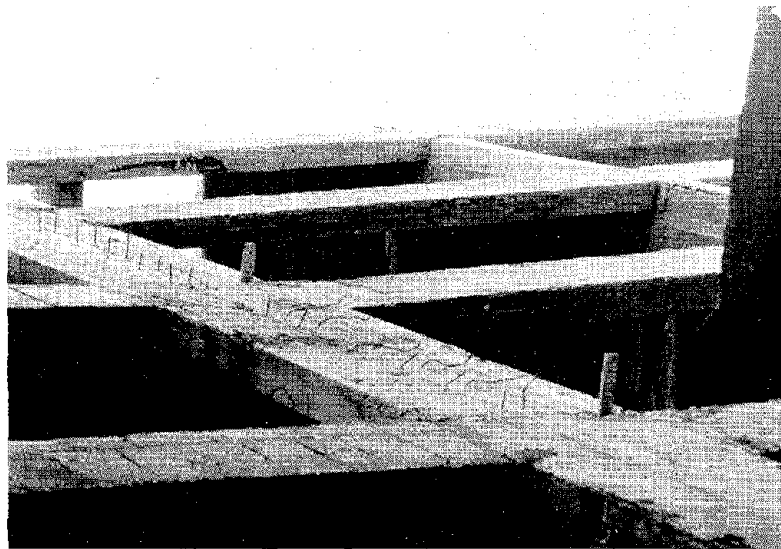
As indicated above, the response of structures with a reinforced concrete frame and infill panels was influenced by many factors. For such a structure to be earthquake resistant requires sound design and good construction techniques (Figure 4.36). The construction of buildings with a flexible reinforced concrete frame demands quality design, detailing, and execution. The cost of such construction will

FIGURE 4.36 Poor construction quality in reinforced concrete frame. The columns run from lower right to upper left. The beams are roughly horizontal in this photograph.
