THE CENTRAL GREECE EARTHQUAKES OF FEBRUARY-MARCH 1981

A Reconnaissance and Engineering Report

James O. Jirsa (Team Leader), Professor of Civil Engineering, University
of Texas at Austin

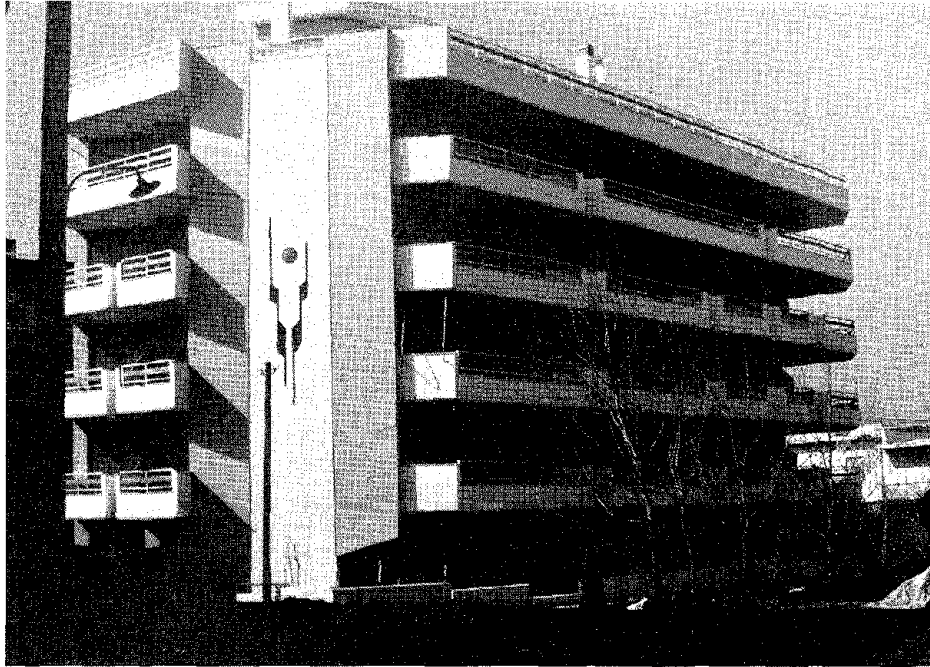
Another new apartment building in the same region, shown in Figure 5.4, suffered damage to the wide columns in the first story. This building was constructed in the "pilotis" scheme with the lowest floor relatively free of partitions; in the floors above, the concrete frame was infilled with very stiff unreinforced masonry walls. The wide column shown in Figure 5.5 was stiffer than adjacent columns and attracted a greater portion of the lateral force, which resulted in the shear cracking shown.

FIGURE 5.4 New apartment building with "pilotis" construction in Loutraki.

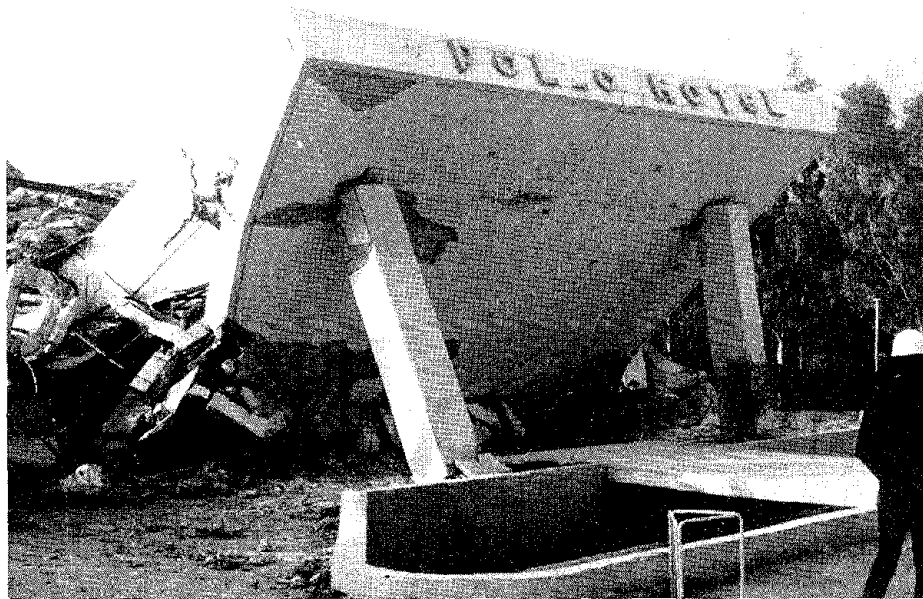
Figure 5.6 shows the Contis Hotel, which collapsed in the central part of the city. The structure consisted of slab and beam construction, and the failure of the columns caused a total collapse of the building. The columns contained smooth reinforcing bars and widely spaced wire ties. The Apollo Hotel south of Loutraki was a large eight-story resort hotel that totally collapsed (Figure 5.7). The destruction was so complete that the structural system could not be easily identified. It appeared to be a reinforced concrete frame with infill walls. Both hotel failures are described in more detail in Chapter 6.

FIGURE 5.7 Collapse of Apollo Hotel in Loutraki.

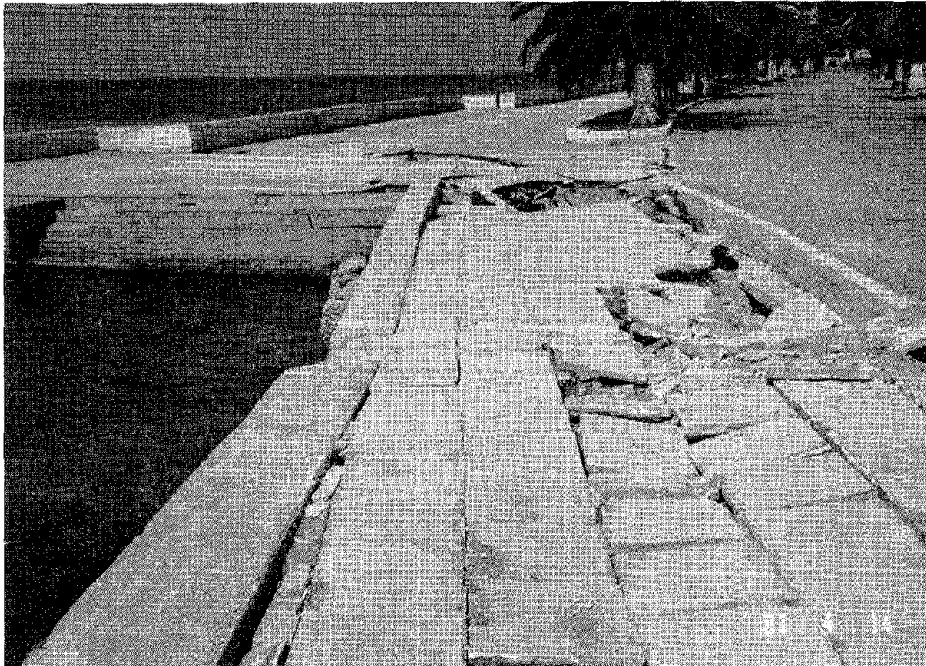
Along the seashore, damage to quays was observed. Figure 5.8 indicates the substantial settlement that occurred.

FIGURE 5.8 Quay wall in Loutraki. The earthen embankment has settled quite substantially.

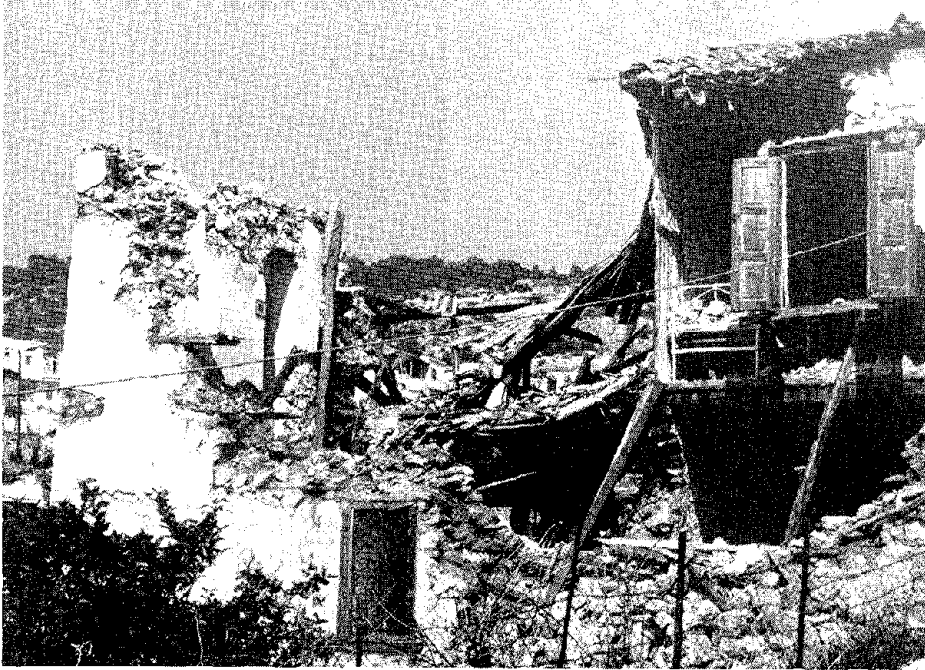
Above Loutraki in a small plain in the mountains is the village of Perahora. Of the approximately 500 houses in the village, 150 collapsed. Only three or four people were killed. The typical older houses were constructed of stone and mud with thick walls and tile roofs over wood framing. The collapse of many of these buildings was almost total, as shown in Figure 5.9. Damage to a three-story reinforced concrete frame house is shown in Figure 5.10. The structure was built on a hillside with the footing at the back, so that it functions as the axis of rotation. Figure 5.11 shows the complete collapse of a reinforced concrete house in the village of Shinos, which is near Perahora. Figure 5.12 shows three identical structures located near the seashore. Damage was least to the structure nearest the sea while the one farthest from the sea collapsed (Figure 5.13).

FIGURE 5.9 Stone houses in Perahora.

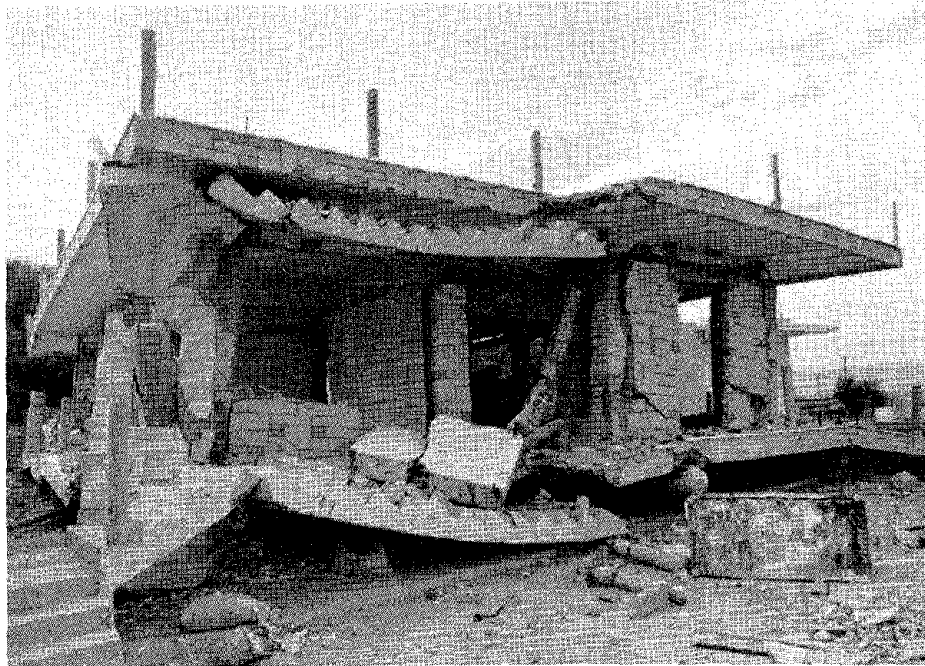
FIGURE 5.11 A two-story building in Shinos.

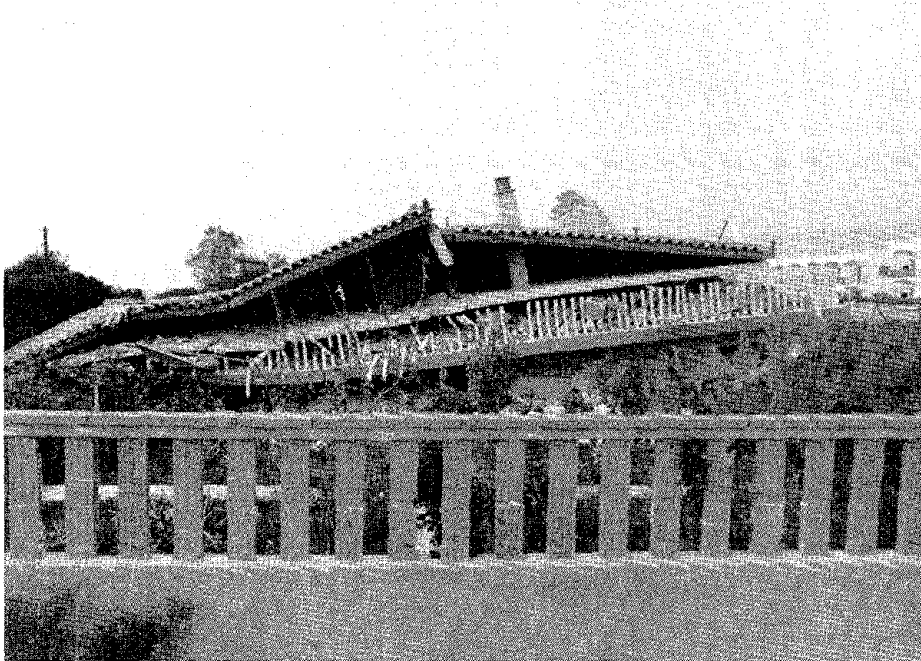
FIGURE 5.12 Three identical two-story buildings in Alepohori showed quite different behavior. The degree of damage increases from left to right. The left building is closer to the sea--no more than 60 m away--and suffered little damage to its first story. The third building collapsed totally (see Figure 5.13).

FIGURE 5.13 One building, identical to the others shown in Figure 5.12, collapsed totally.

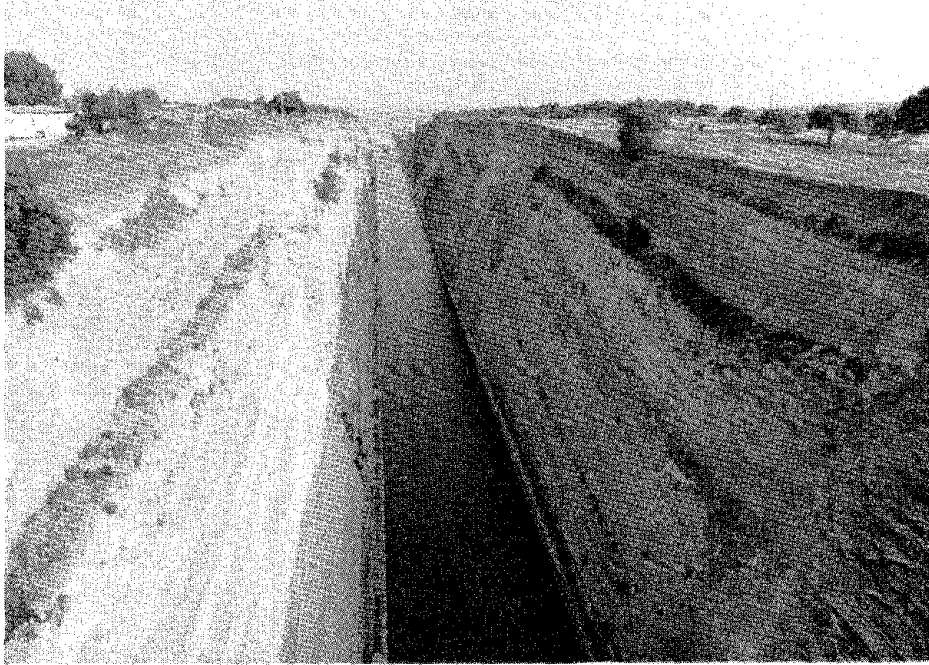
Between Loutraki and Corinth the highway crosses the Corinth Canal, which was built in 1893. The canal is 6,400 m long and only 24.6 m wide at sea level. The steep walls rise more than 80 m with an 80° slope. Numerous fault breaks can be seen in the walls of the canal (Figure 5.14). In some of the breaks, small relative motions were observed at the ground surface, which caused some damage to pavements and farm structures. Three bridges cross the canal. One is a railway bridge (Figure 5.15) and the other two are highway bridges. The construction of the railway and one of the highway bridges was completed in 1948. The second highway bridge was constructed about eight years ago. Some of the piers of the hinged supports of the railway bridge on the side toward Beotia cracked, with some minor fault breaks in the rock strata below (Figure 5.16). The older highway bridge suffered some damage to the main load-carrying system near the hinged support on the side toward Beotia. Some deformation, slip, and failure of the rivets were observed, and the heads of most of the rivets near the supports were loosened (Figures 5.17 and 5.18)

FIGURE 5.14 Corinth canal looking east from the road bridge. Note the descending beddings. At each change of elevation there is a fault.

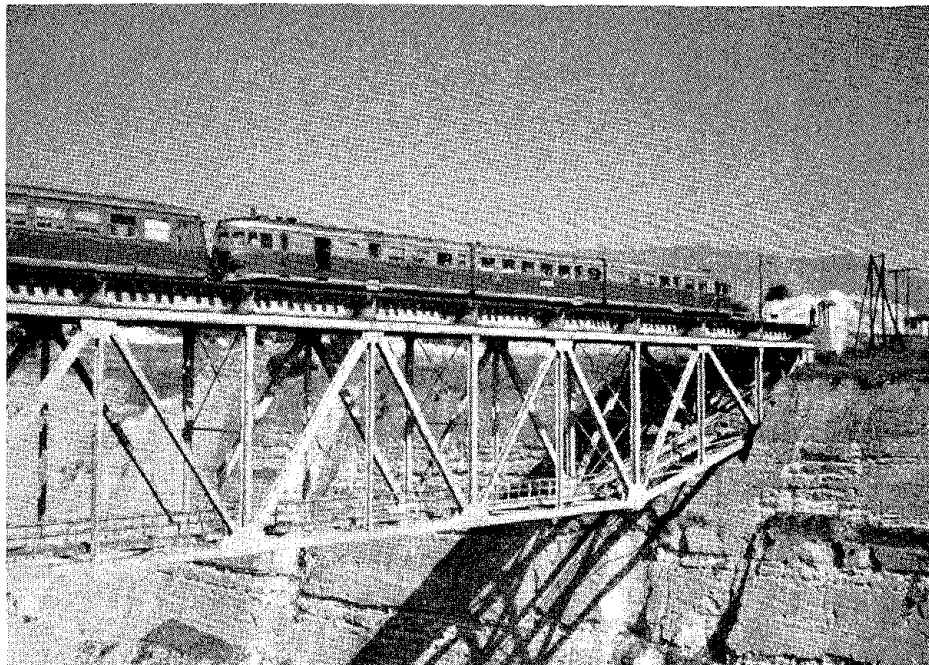
FIGURE 5.15 The railway bridge over the Corinth Canal was out of service for a few days after the earthquake for inspection.

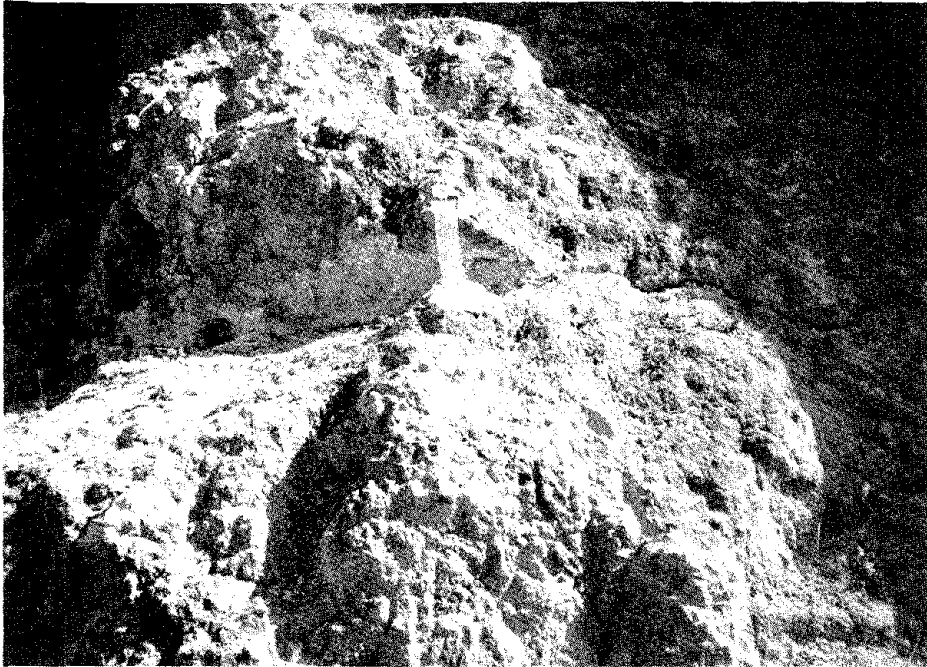
FIGURE 5.16 A witness of glass to check the relative motion of the various minor faults in the Corinth Canal. This shows a breaking below the pier of the railway bridge on the Beotia side. The glass broke during the aftershocks.

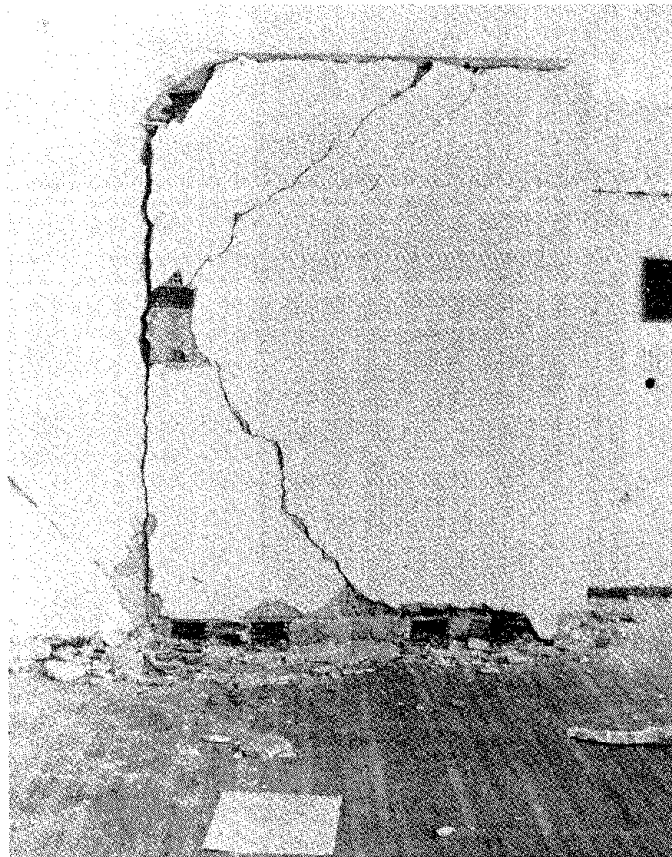
The present town of Corinth is situated on the coast and has a small port facility. The town is a seasonal resort with numerous 6- to 10-story apartment buildings and resort hotels. The damage to the modern town consisted of nonstructural damage to unreinforced tile and masonry infill walls in the concrete frame buildings. The building shown in Figure 5.19 exhibits no apparent distress, but inspection of the interior revealed numerous cracks in the infilled masonry walls (shown in Figure 5.20).

FIGURE 5.20 Infill wall damage.

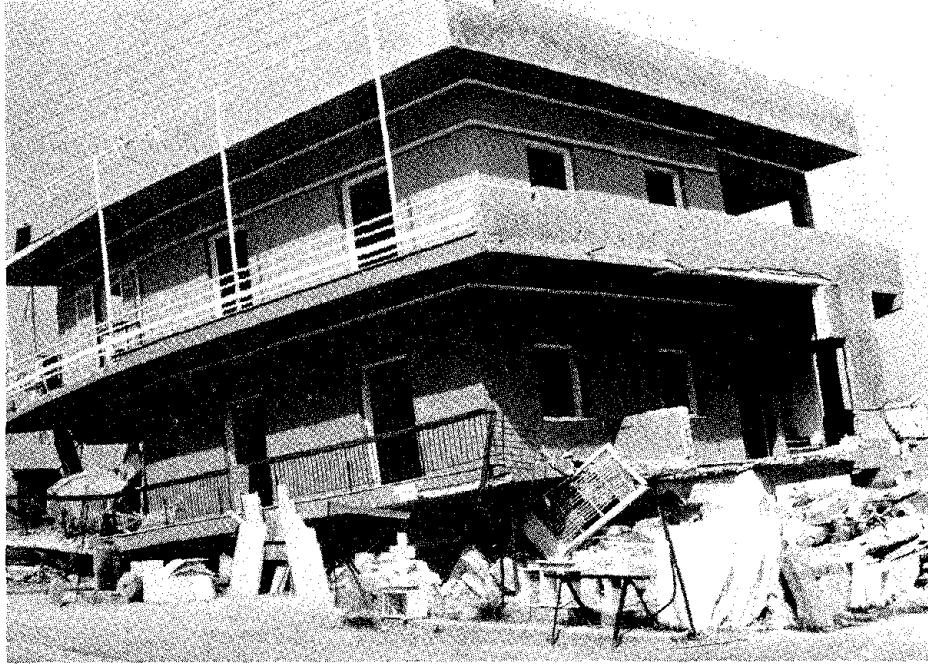
West of Corinth several buildings were reported collapsed in the towns of Vrahati and Kiato along the coast. When the first-story columns failed in the three-story house shown in Figure 5.21, occupants "rode" the building down. The construction had a concrete frame with smooth reinforcing bars and widely spaced wire ties. The upper two floors had infilled masonry walls that made them very stiff and heavy. The lower story was relatively free of walls and thus flexible. It should be noted that in addition to the destroyed dwellings, many residents lost their business or trade as well. The uninhabited first stories of many residences served as stores, shops, or open space. In many villages farmers and tradesmen lost tools and equipment when the first floor of their homes collapsed. Older buildings with stone and mud walls suffered heavy damage to the walls, as shown in Figure 5.22.

FIGURE 5.21 Collapse of three-story house in Kiato. (Lower floor was stone mason's shop.)

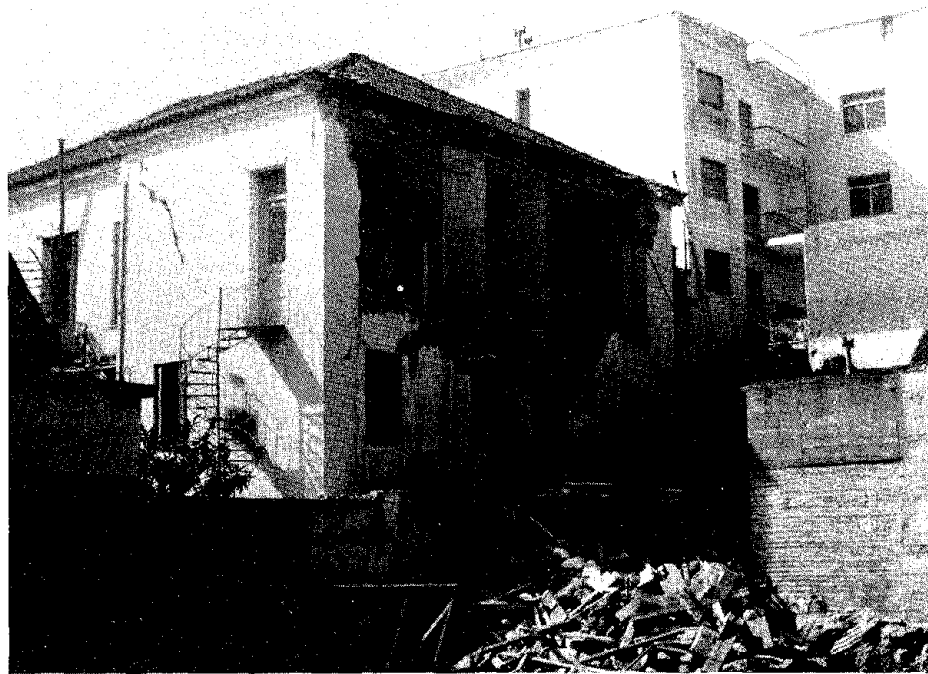
FIGURE 5.22 Older stone wall buildings in Vrahati.

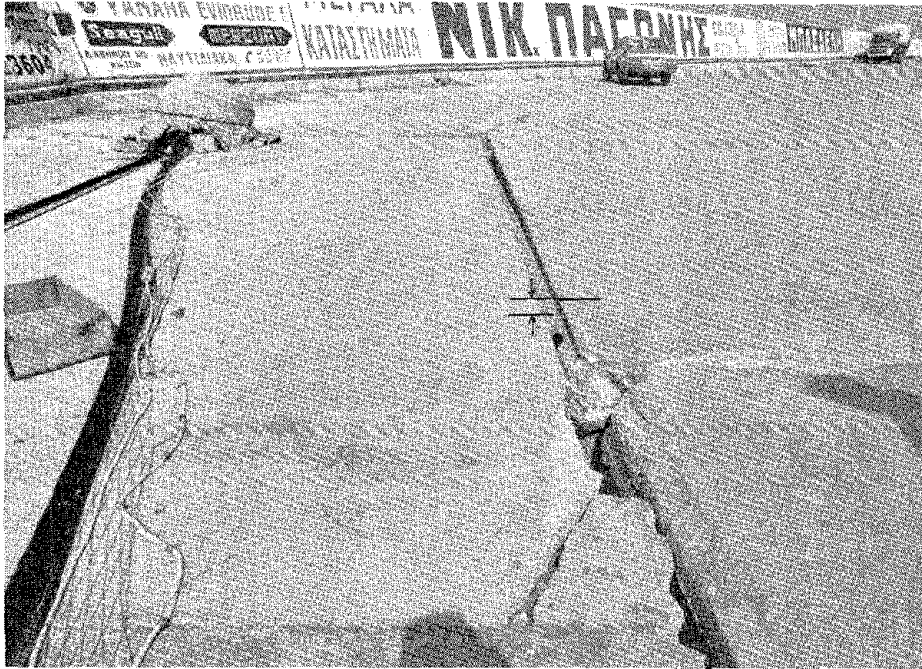
In contrast, a very large church in the same area had no damage even to the very elaborate masonry arches and facade shown in Figure 5.23. The jetty in Kiato settled considerably during the earthquakes, with differential settlements of as much as 20 to 30 cm (Figures 5.24 and 5.25).

FIGURE 5.25 Jetty in Kiato. The expansion joints between the concrete blocks have been damaged. Note the differential settlement of about 20 to 30 cm.

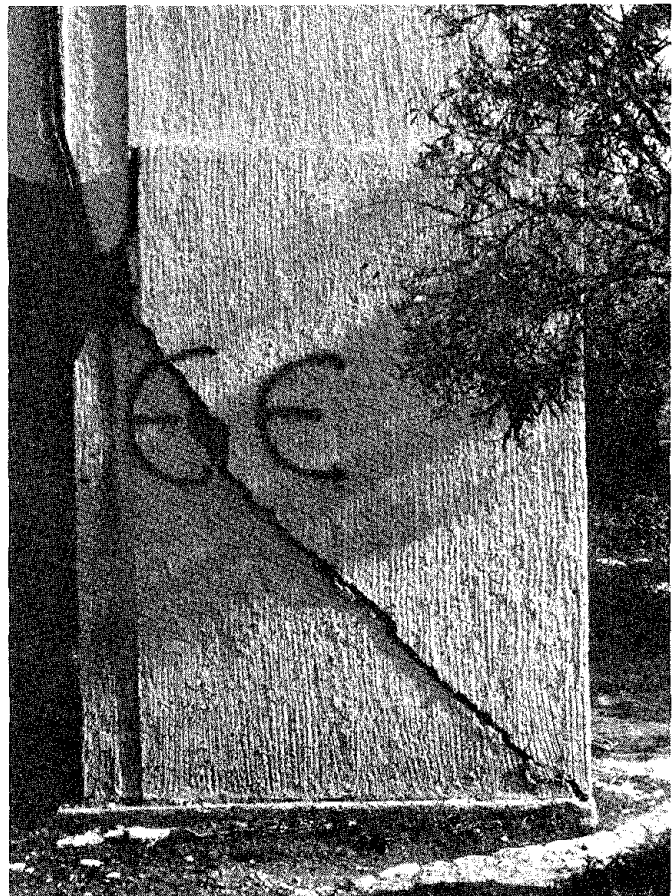
FIGURE 5.32 Damage to bungalows. EE is a designation by government officials for buildings not to be occupied.

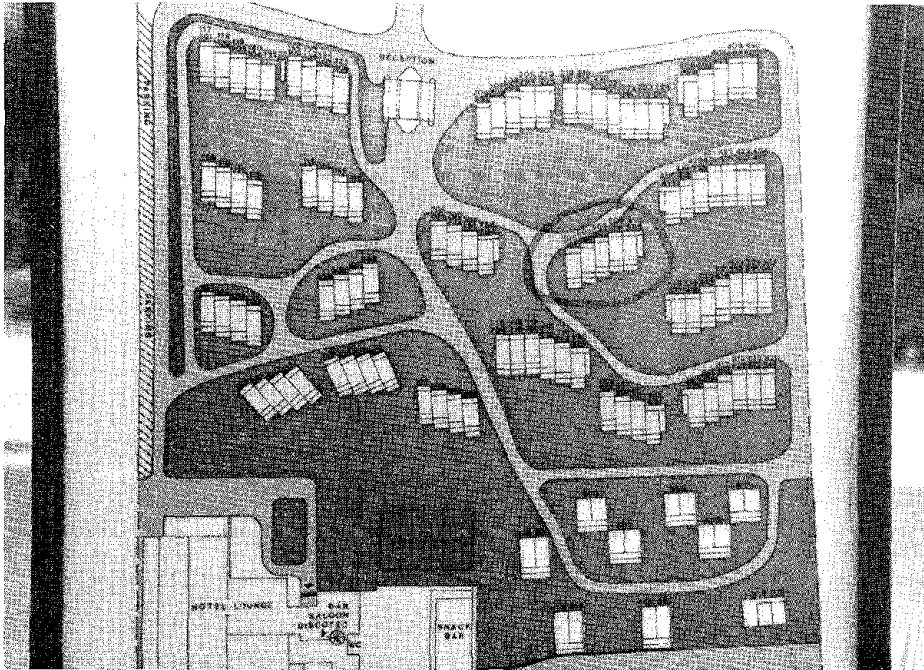
FIGURE 5.33 Map of bungalow development (circled units collapsed).

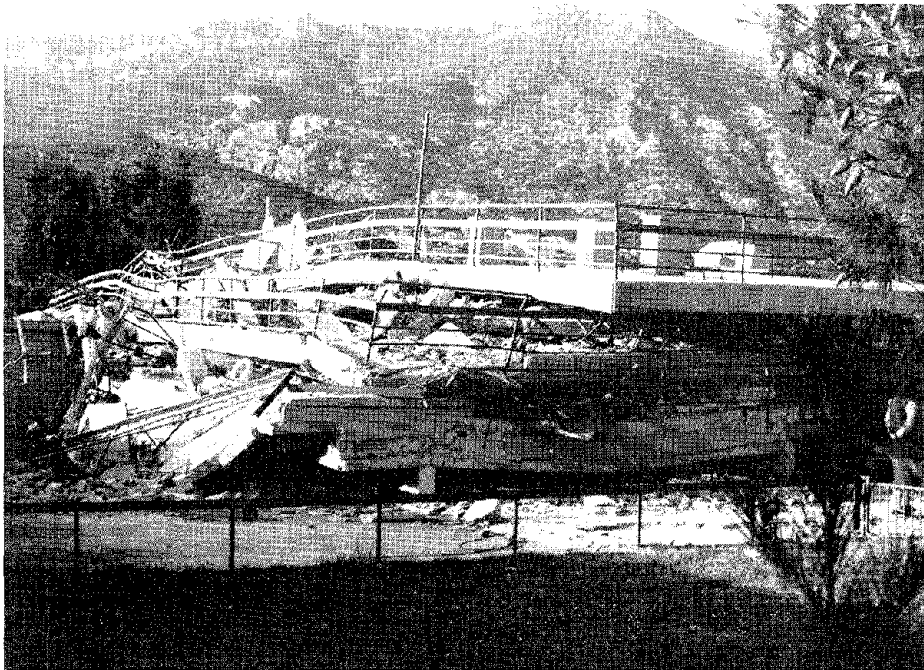
Nearby a four- or five-story hotel collapsed (Figure 5.34). The concrete frame had smooth reinforcing bars and widely spaced wire ties. The lack of ductility and apparent lack of strength (Figure 5.35) caused the failure of all the columns and stacking of the floors and roof. A view across the roof (Figure 5.36) shows column stubs projecting up for future stories planned for the hotel. The house in the background was undamaged.

FIGURE 5.34 Collapsed hotel in Kineta.

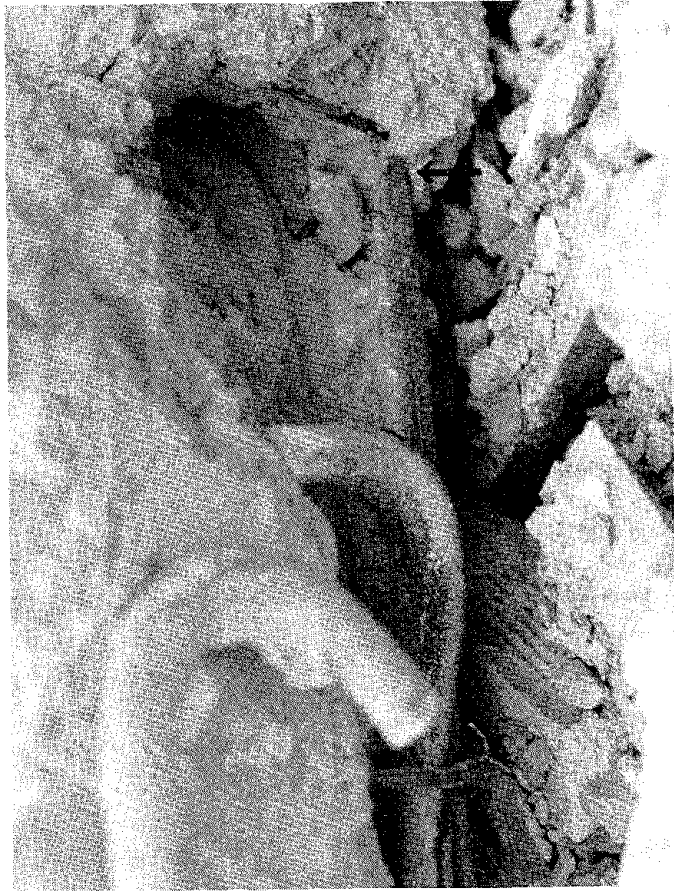
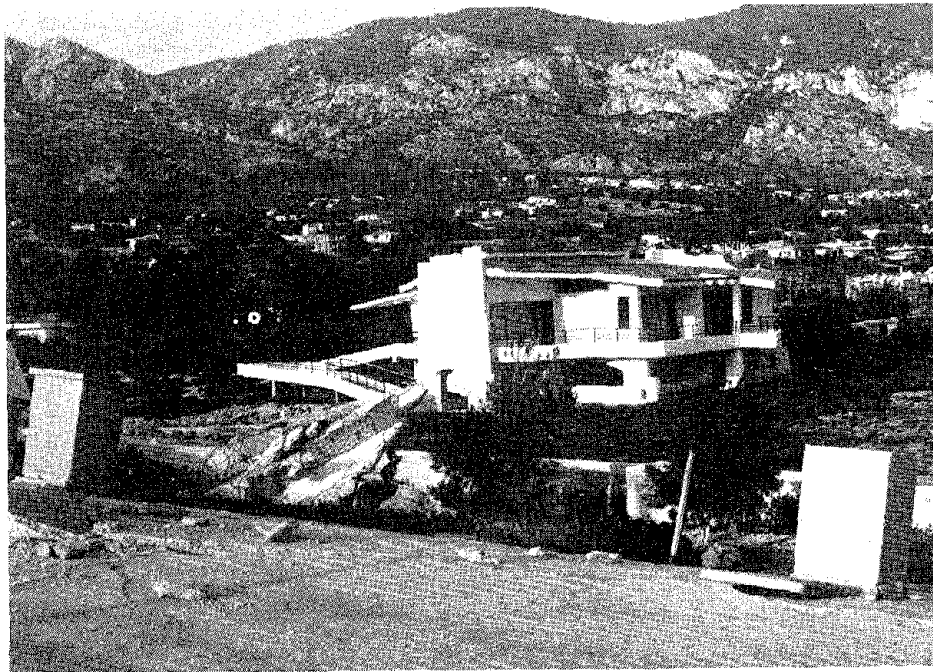
FIGURE 5.35 Detail of the collapsed hotel in Kineta. Note the slip of the hook and necking of the longitudinal bar (arrow).

FIGURE 5.36 Column stubs on roof of Kineta hotel to accommodate future expansion. Home in background was undamaged.

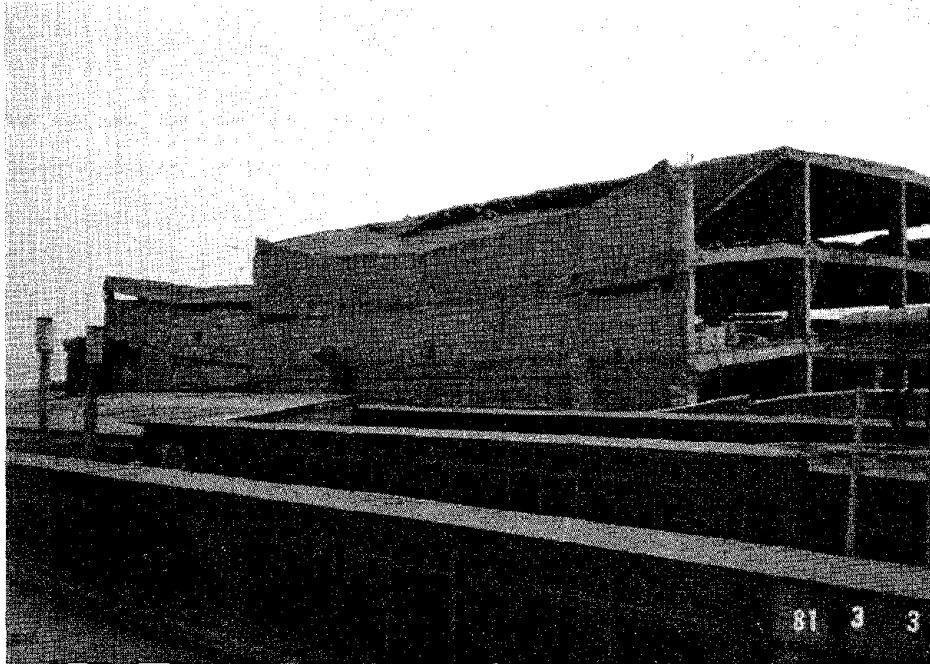
A large ceramics factory building near Isthmia collapsed, as shown in Figures 5.37 and 5.38. The factory structure consisted of a three-span concrete frame in the short direction and solid walls with long slotted windows in the long direction of the building. The short piers between the windows apparently failed and caused the progressive

FIGURE 5.37 Ceramic factory near Isthmia (side view).

failure of the building. Note the slope of the floor and roof in the outer spans. After columns at lower levels collapsed, the upper floors settled a distance equivalent to the window height.

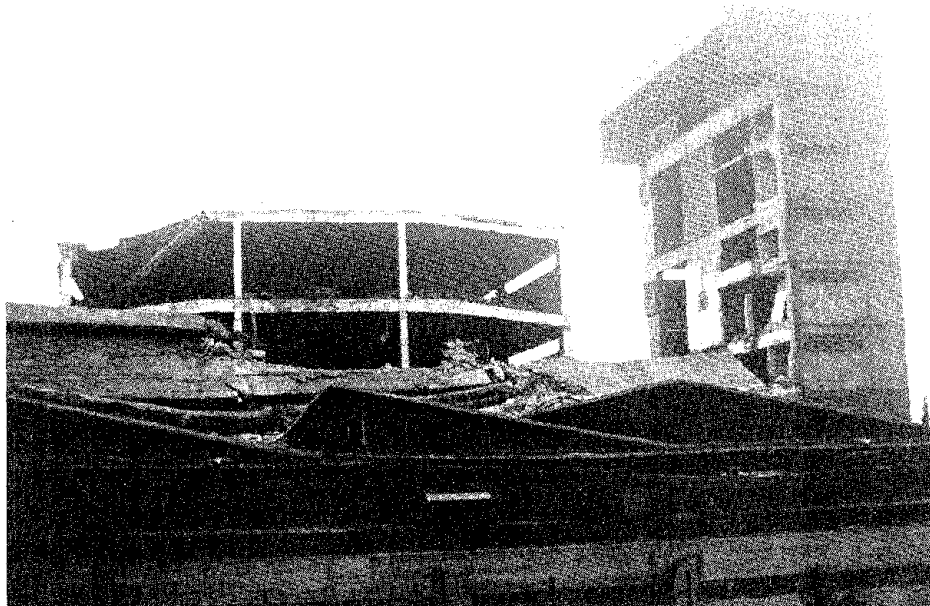
FIGURE 5.38 Ceramic factory near Isthmia (front view, with elevator shaft on right).

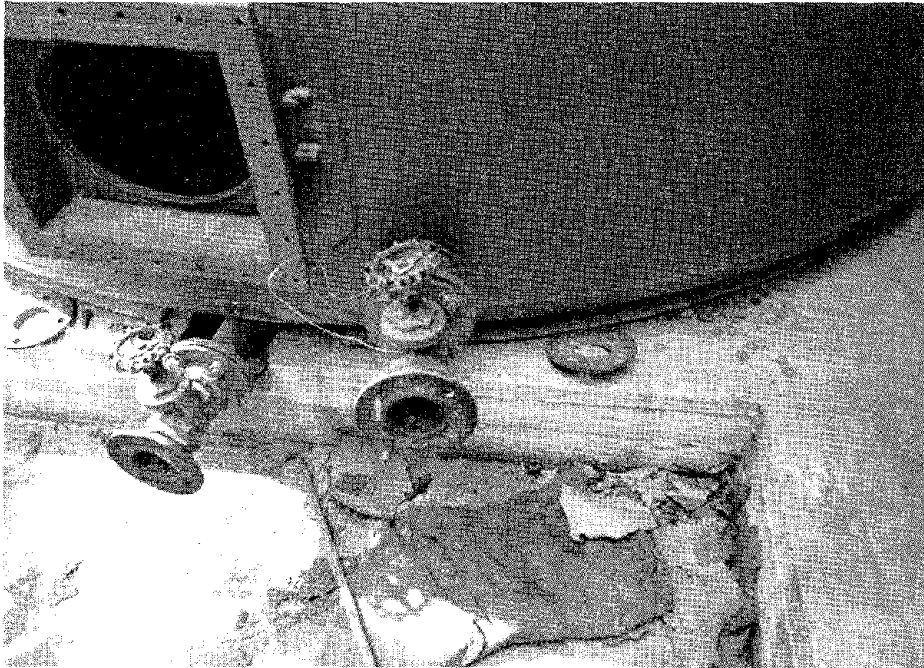
FIGURE 5.39 Winery tank in Megara. The tank tilted a little and was displaced about 3 to 4 cm. The tank overrode the steel washer.

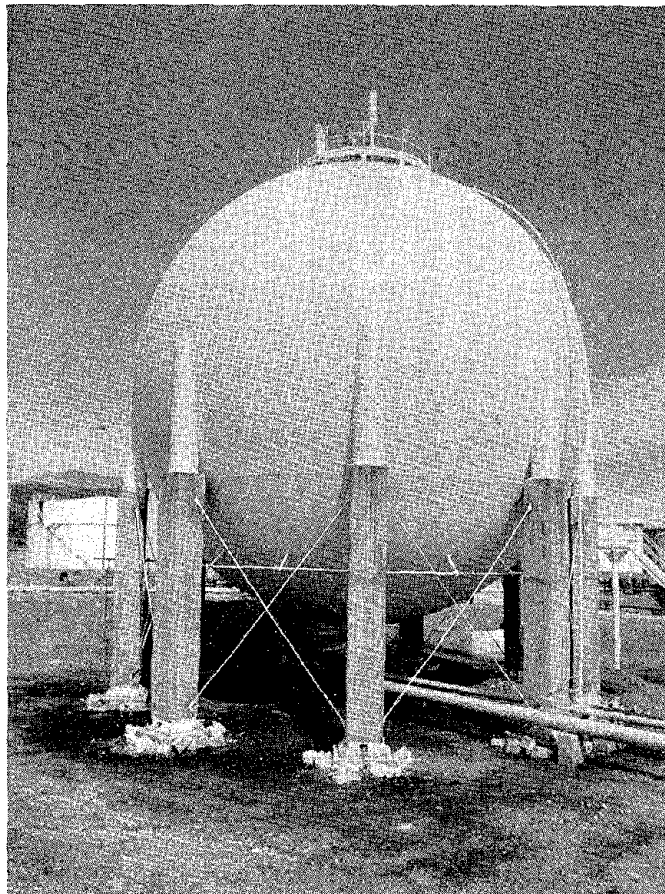
Elsewhere along the coast, there were a number of refinery and heavy industrial facilities that suffered very little damage. The only damage observed was to anchors to footings and to diagonal steel ties (Figures 5.40 and 5.41).

FIGURE 5.40 A huge liquid gas storage tank at the "Motor Oil" refinery suffered limited damage in the anchors of footings and the diagonal tension bars.

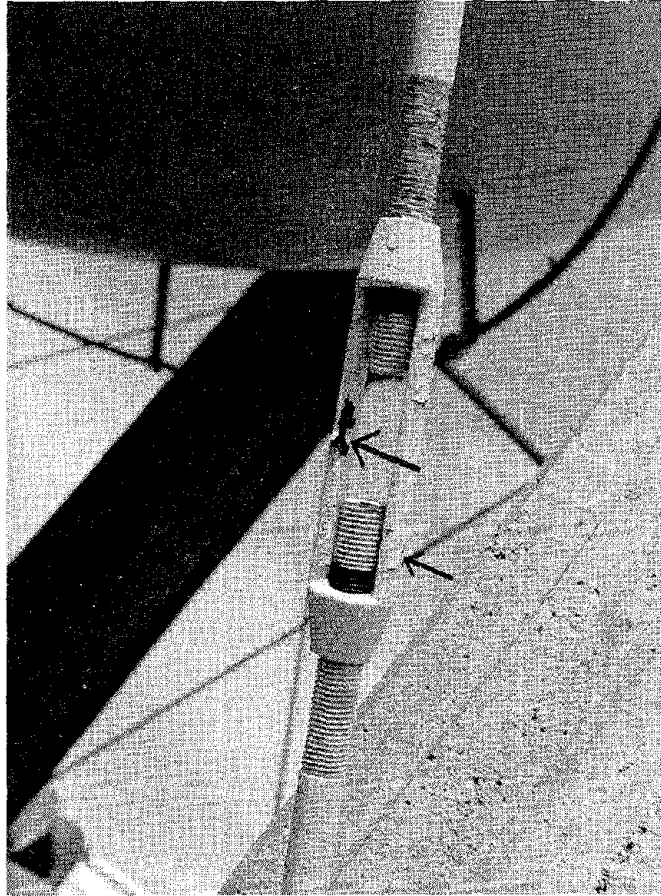
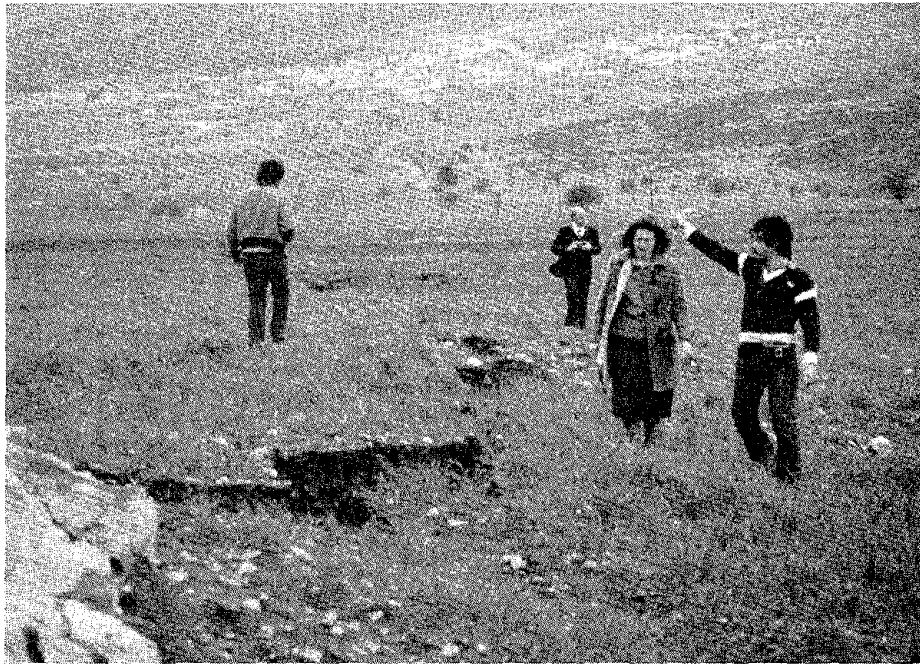
FIGURE 5.41 The diagonal tension bars of the liquid gas storage tank at the "Motor Oil" refinery extended beyond their elastic limit and stressed some bolts (see arrows).

FIGURE 5.42 Village of Plataeae at end of Kapareli fault.

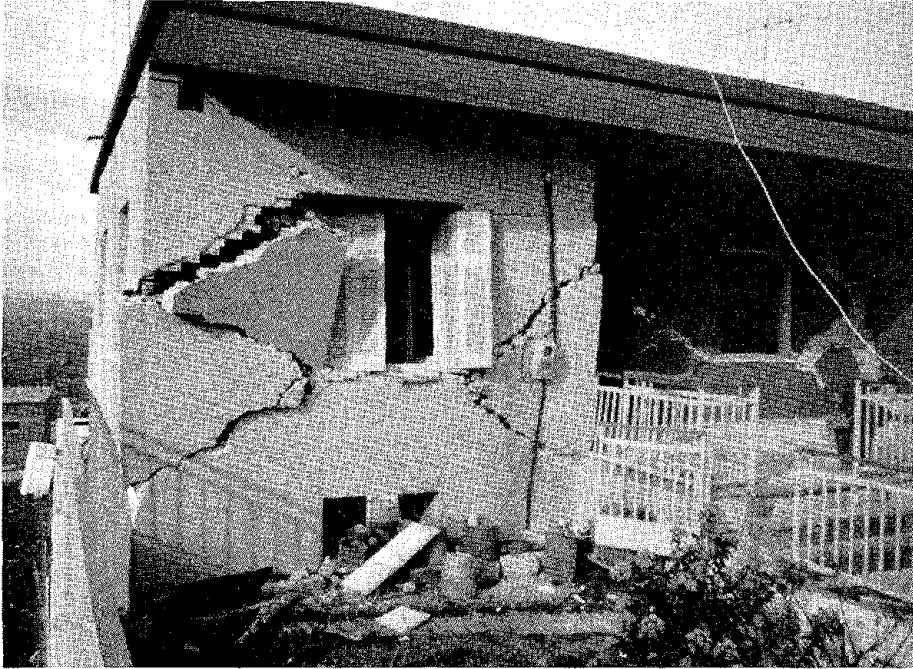
FIGURE 5.43 Damaged home in Plataeae.

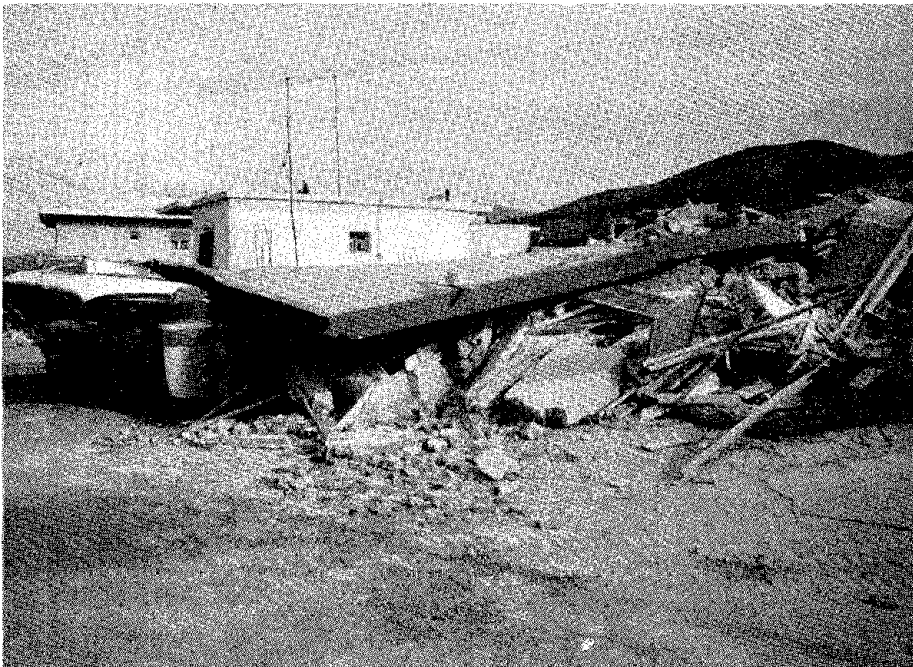
FIGURE 5.44 Building collapse on bus in Plataeae.

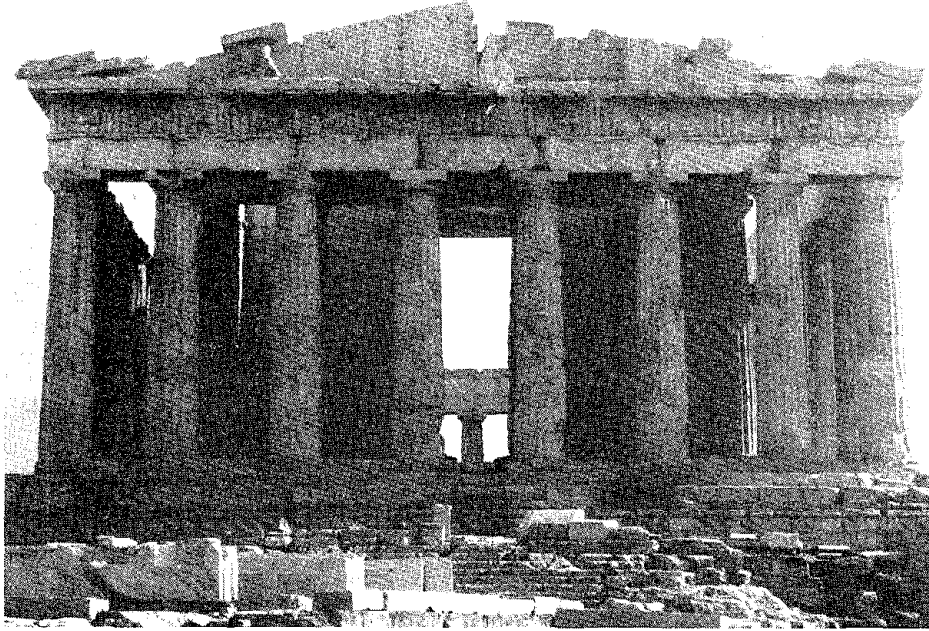
The Parthenon temple atop the Acropolis (Figures 5.49) suffered some significant cracks, but none of the huge stones was dislodged. The superintendent of the Acropolis reported that in addition to causing the cracks in the Parthenon, the earthquake shattered 50 of the 5,000 priceless vases in the Erechtheum and 10 others in the Acropolis museum. Because of its historic significance, a more detailed description of damage to the Parthenon is given in Chapter 6.

FIGURE 5.49 Parthenon on the Acropolis in Athens.

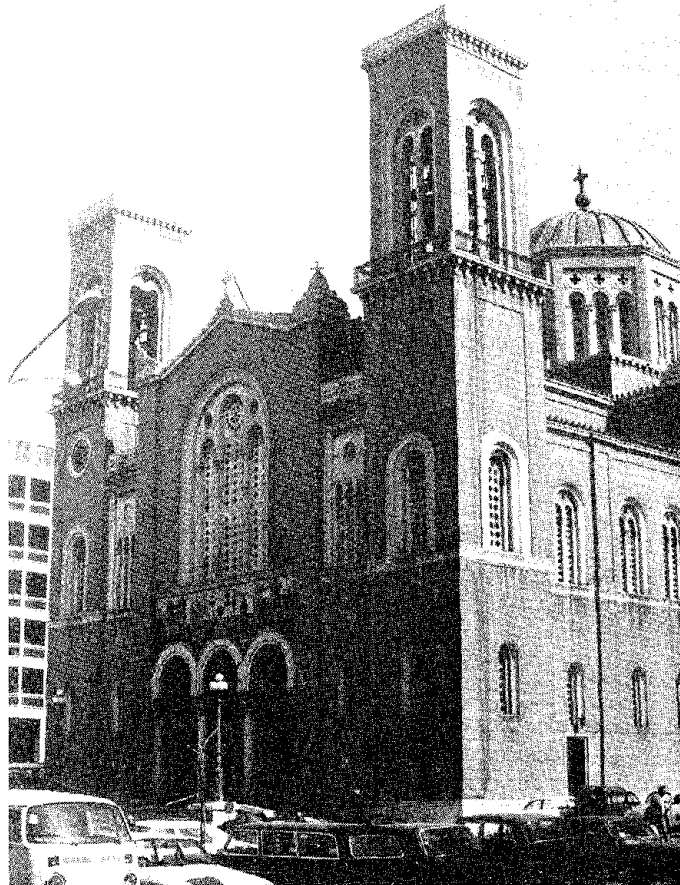
The historic Athens Cathedral suffered numerous cracks over the arches, and masses had to be discontinued until the damage could be repaired. None of the parapets or ornamentation shown in Figure 5.50 was damaged. The cathedral was built 140 years ago and had not been seriously damaged in previous earthquakes. It has been reported that in the 1894 earthquake, when all the surrounding buildings collapsed, the cathedral was the only building not damaged.

FIGURE 5.50 Athens Cathedral.

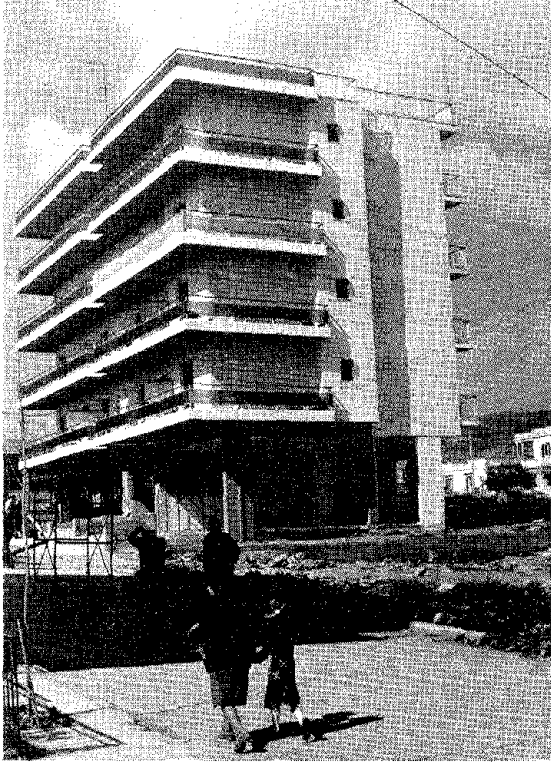
Recently constructed high-rise office buildings designed to have ductile moment-resisting frames were reported to have performed without any problems. A new apartment building (Figure 5.51) in a suburb of Athens suffered severe damage to some of its first-story columns. Above the first story the building had extensive masonry partitions. The building was of typical "pilotis" construction with wide and thin columns oriented primarily on one of the major building axes. The column shown in Figure 5.52 was the only one oriented longitudinally on the front face of the building, and it had to carry about half of the total building shear in the longitudinal direction. The overloaded column failed in shear.

FIGURE 5.51 New apartment building in Athens (Anthoupolis region).

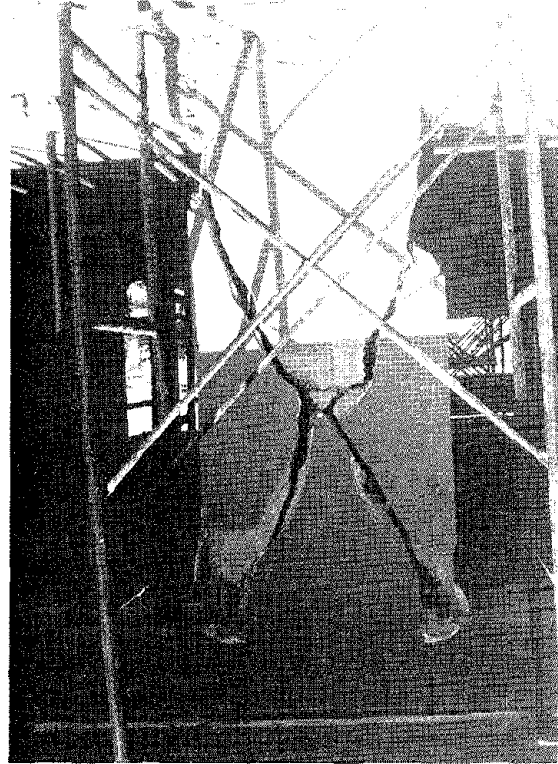
FIGURE 5.52 Heavily damaged stiff column at corner of apartment building shown in Figure 5.51.

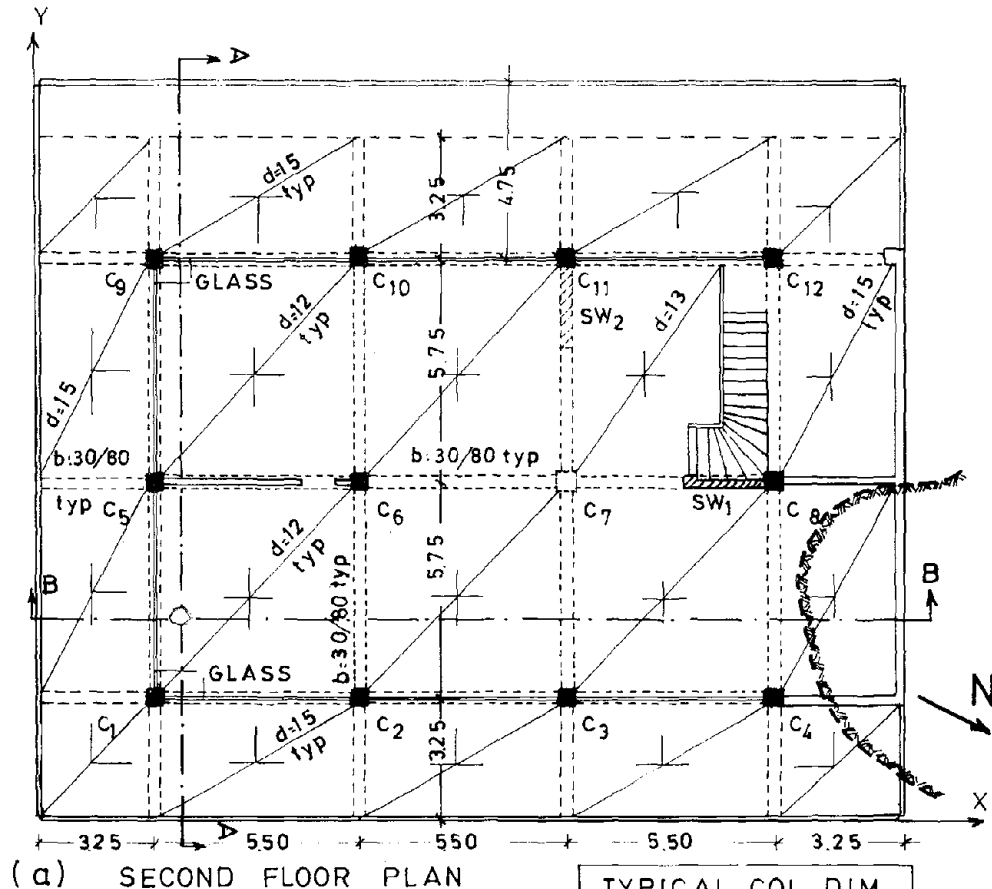
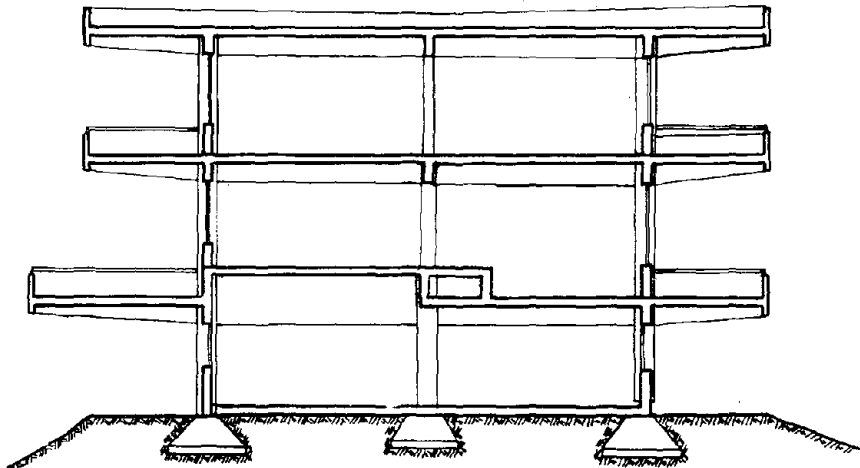
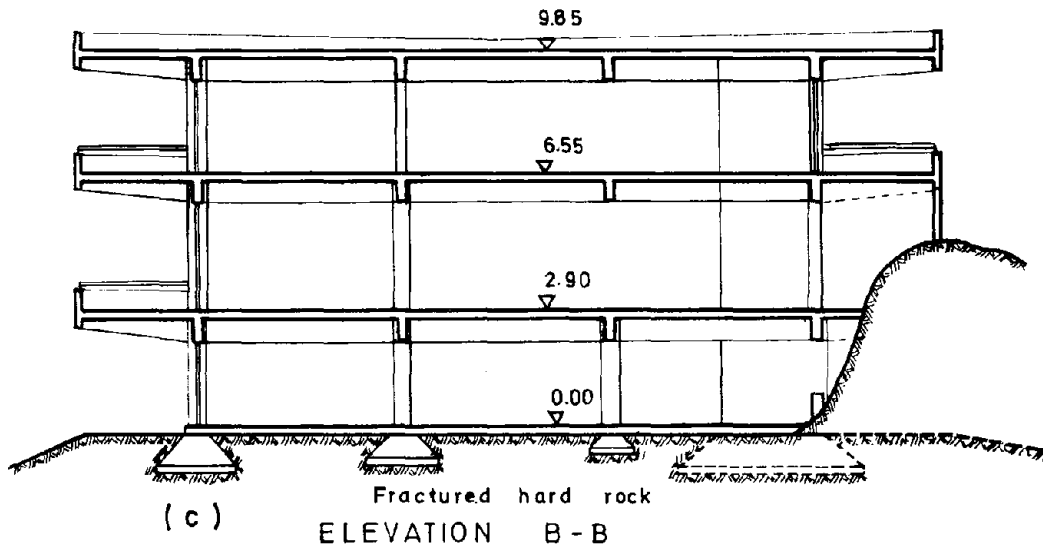
FIGURE 6.1 Vip's Hostel in Perahora. General drawings.

The framing system is simple, as shown in Figure 6.1. To drain the roof, plastic tubes are embedded into the outside corners of each of the four corner columns (Figure 6.1d). The quality of construction is good. In the x direction the building is structurally symmetric (Figure 6.1a); in the y direction the shear wall SW₁ introduces a very small eccentricity. The second story has some brick partitions, while the first story and, especially, the third story have a number of brick walls. The walls produce a stiffness discontinuity in the second story.

For architectural reasons the northern part of the building was built around a natural rock outcropping that penetrates to the second story, as shown in Figures 6.1, 6.2, and 6.3. The north end of the floor slab for the second floor was cast on this rock. A part of the rock extends through the second floor (Figure 6.3). This rock produces an eccentricity in lateral resistance that may have initiated the destruction.

TYPICAL COL. DIM.	
FIRST FL. :	50 / 50
SECOND FL. :	45 / 45
THIRD FL. :	40 / 40

C₇ missing in second and third
floorsSW₂ only in first floor
