THE CENTRAL GREECE EARTHQUAKES OF FEBRUARY-MARCH 1981

A Reconnaissance and Engineering Report

James O. Jirsa (Team Leader), Professor of Civil Engineering, University
of Texas at Austin

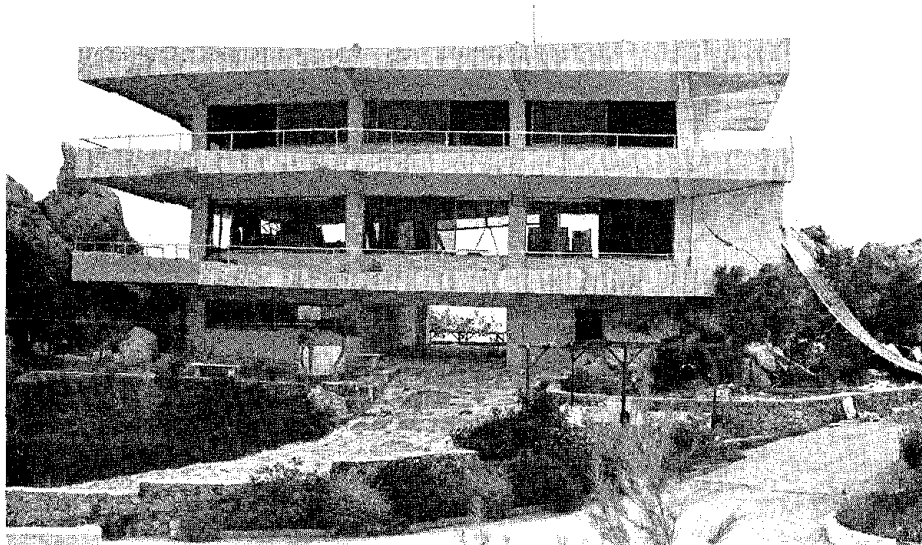
Long cantilevers are also present all around the building. The cantilevers (spandrels) support the heavy vertical parapets on their free ends (see Figure 6.2), which are faced with thick marble panels. The long heavy cantilevers created large torsional moments about the

FIGURE 6.2 Vip's Hostel in Perahora. Northeast view of the building soon after the earthquake.

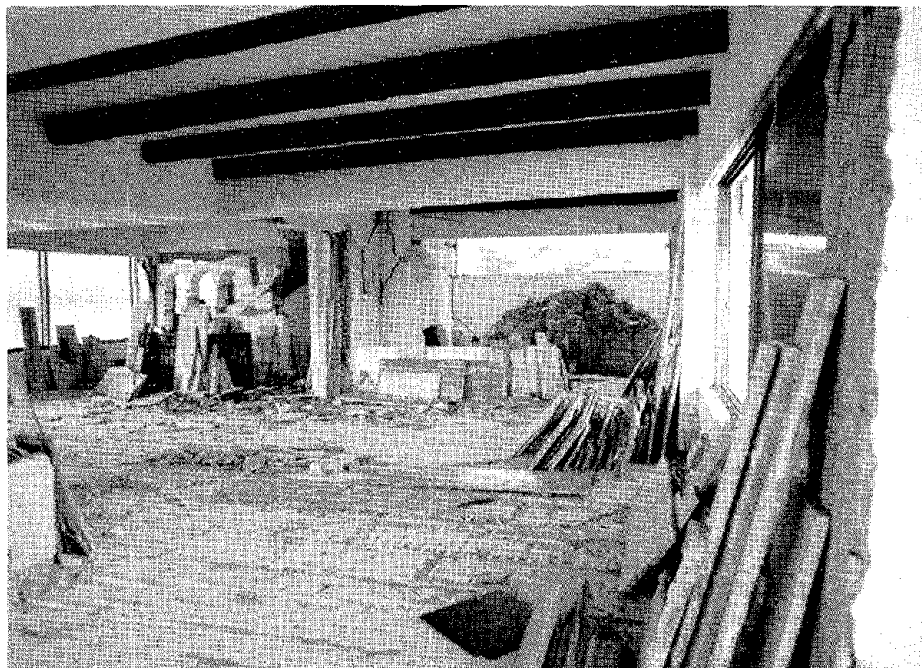
For architectural reasons the northern part of the building was built around a natural rock outcropping that penetrates to the second story, as shown in Figures 6.1, 6.2, and 6.3. The north end of the floor slab for the second floor was cast on this rock. A part of the rock extends through the second floor (Figure 6.3). This rock produces an eccentricity in lateral resistance that may have initiated the destruction.

FIGURE 6.3 Vip's Hostel in Perahora. The natural rock outcrops over the second story in the far northwestern side and northern corner of the building.

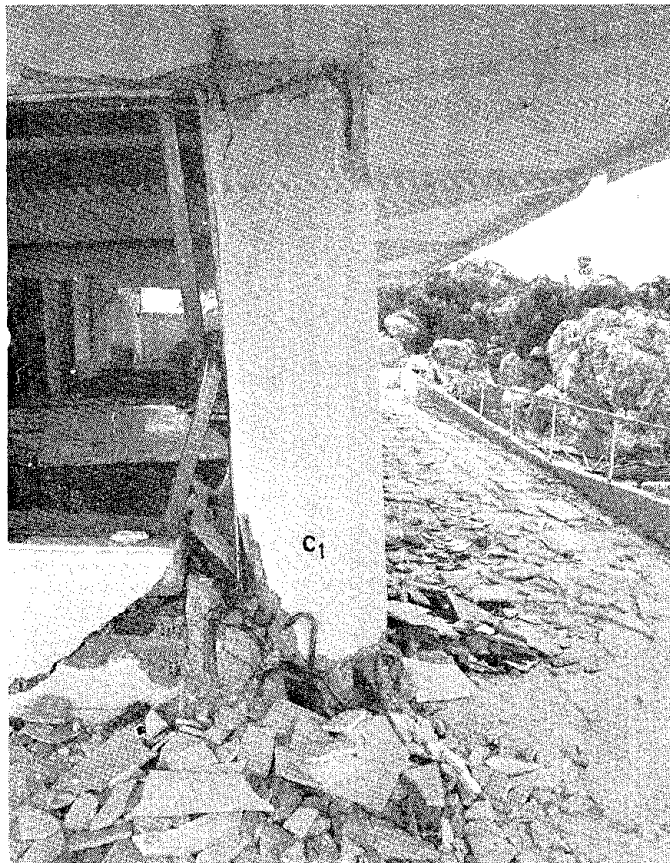
Damage was concentrated in the south end of the building's second story, as shown in Figures 6.4 and 6.5. Figures 6.5 and 6.6 show the large lateral deformations and shortening of columns c_1 and c_5 , which deformed horizontally about 40 cm at their bottom ends. Column c_9 shortened about 70 cm at the second level, as shown in the sketch of Figure 6.7.

FIGURE 6.5 Vip's Hostel in Perahora. Column c_1 on the second story, viewed from the southeast.

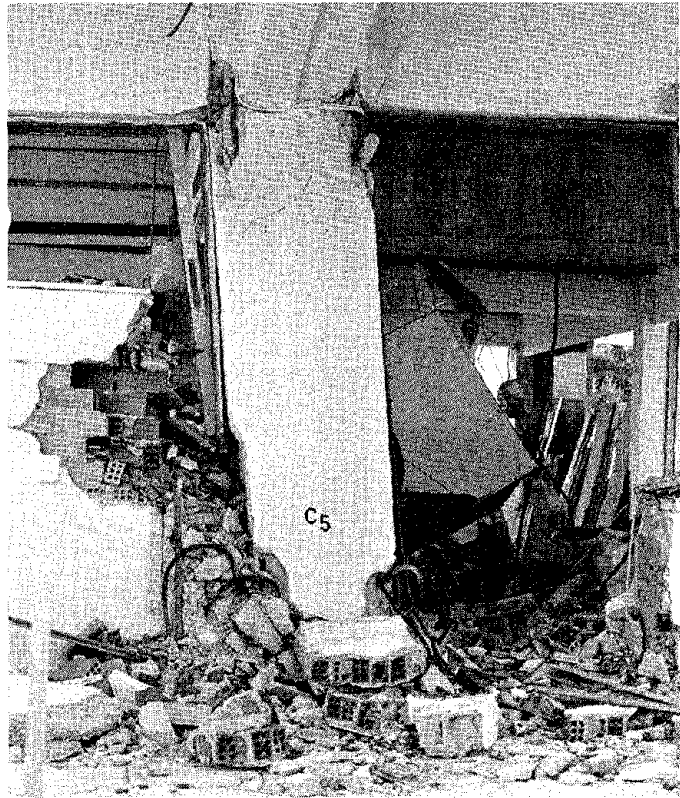
FIGURE 6.6 Vip's Hostel in Perahora. Column c_5 on the second story, viewed from the southeast.

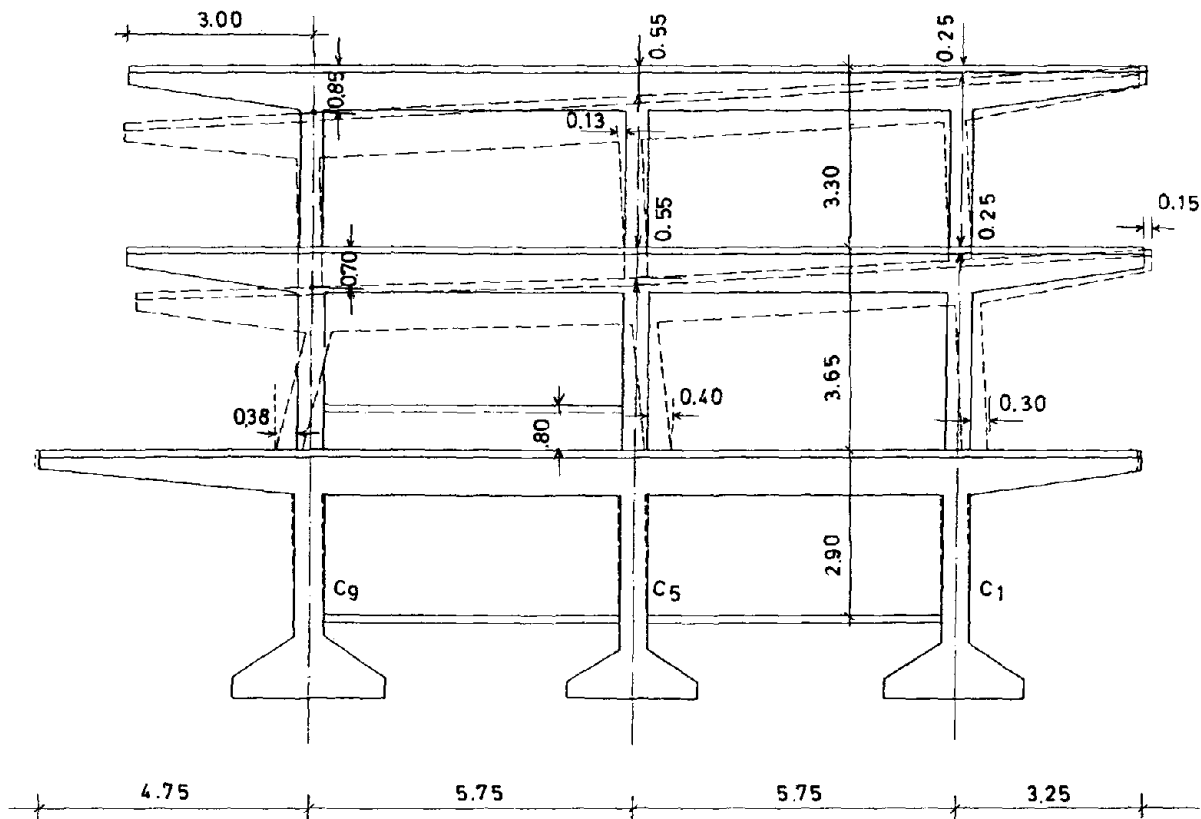
FIGURE 6.7 Vip's Hostel in Perahora. Deformation of the south-eastern elevation of the building.

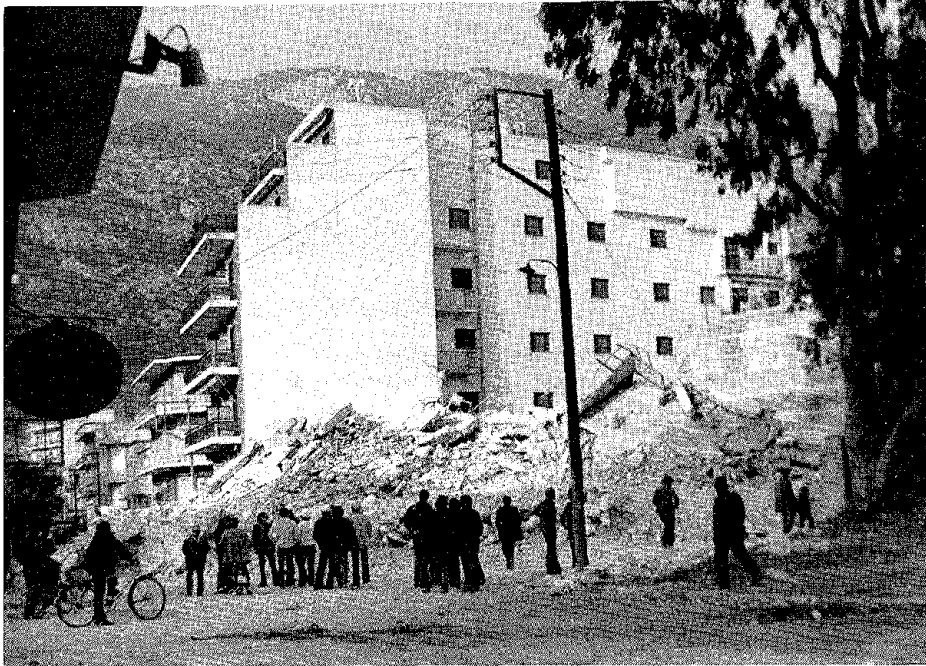
The Contis Hotel in Loutraki was a seven-story reinforced concrete frame structure that collapsed totally, as shown in Figures 6.8 and 6.9a. The site is about 150 m from the sea in the middle of the city (number 1 in Figure 5.1). Construction started in 1966 and was completed in 1972. The building was constructed in four stages because of various extensions and additions to the original building. The first permit, issued in 1966, refers to the construction of the lower three stories and includes provision for adding two stories in the future. Four stories were subsequently added, as shown in Figure 6.9b. The foundation plan is shown in Figure 6.10. As can be seen, the structure was quite irregular in plan. The footings were connected by tie beams at the grade level (Figures 6.11 and 6.12). However, many of the beams had large openings at the columns to accommodate utility lines.

FIGURE 6.8 Contis Hotel in Loutraki. Southwest view one week after collapse. Photograph courtesy A. Manis.

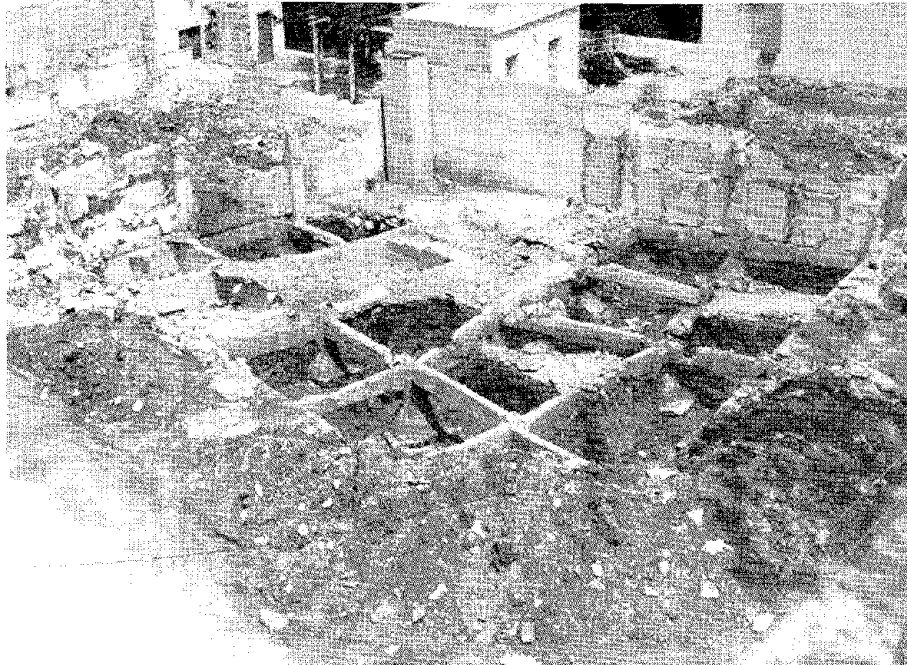
FIGURE 6.11 Contis Hotel in Loutraki. General southwest view of the foundation after removal of the debris. The tie beams are 15 by 40 cm.

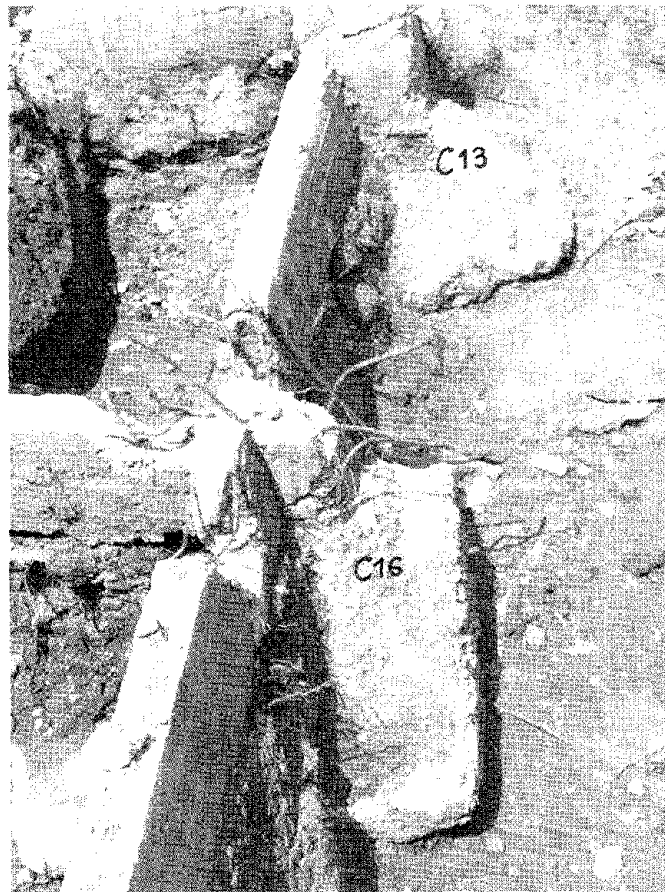
FIGURE 6.12 Contis Hotel in Loutraki. Most of the tie beams around the columns are discontinued to accommodate wastewater pipes.

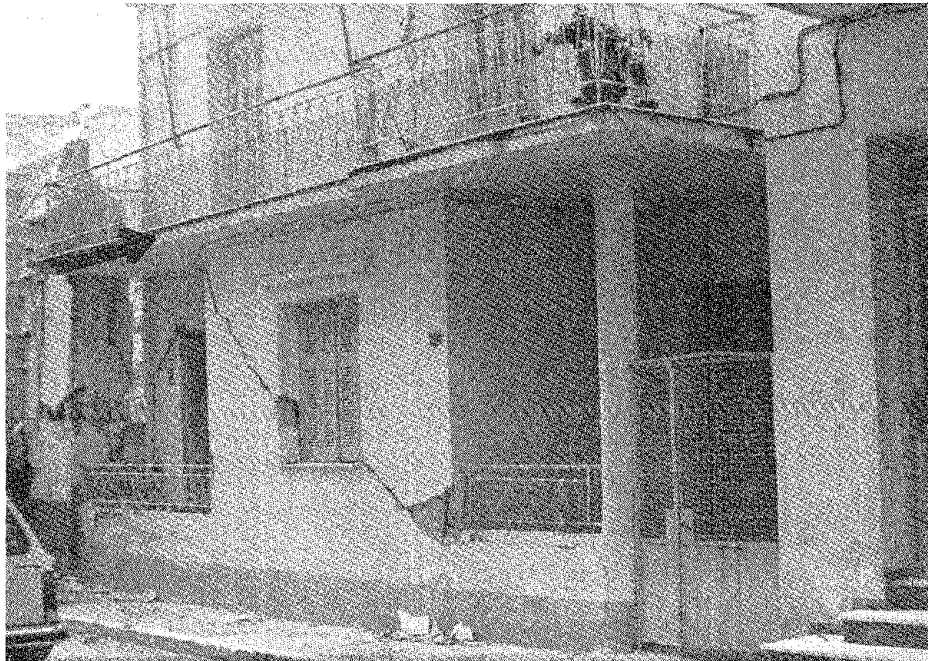
According to witnesses, the collapse started from the third story toward the small southwest face of the structure. The building likely underwent some torsional deformation, rotating about the inside corner of the structure. Damage to the adjacent structures is indicated in Figures 6.9 and 6.13. These adjacent buildings were seriously damaged and had to be demolished.

FIGURE 6.13 Contis Hotel in Loutraki. South view. A two-story building was located adjacent to the hotel. The arrow shows the excessive forces transmitted to this structure by the hotel during the rebound. Photograph courtesy A. Manis.

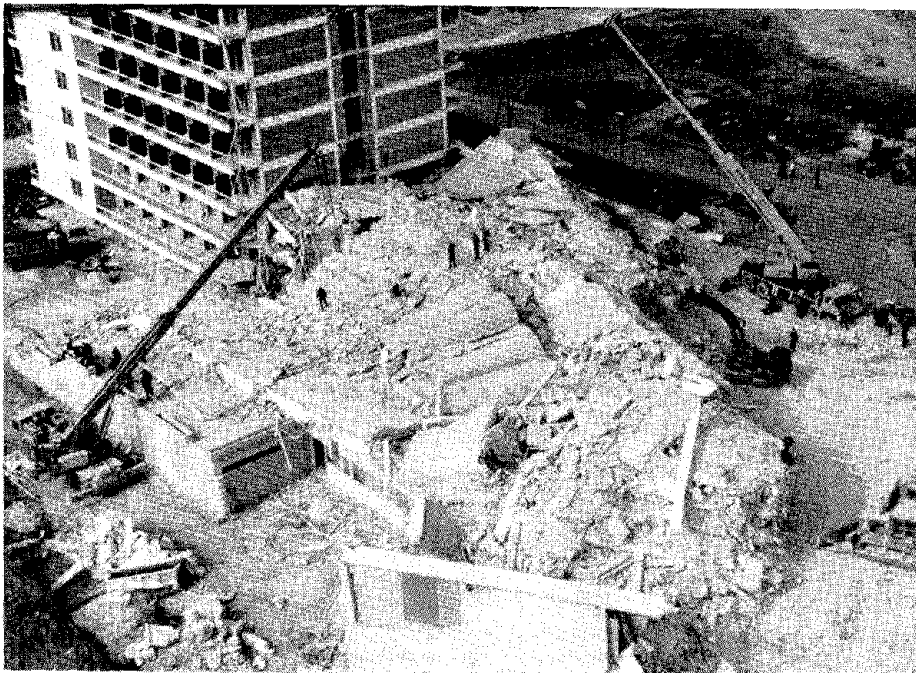
Sections I and II of the hotel collapsed almost inside the plan of the building, as seen in Figures 6.19 and 6.20. The two-story southern wall and the west and east parts of the ground floor are still standing. The wall between sections II and III can be seen in Figure 6.21. Figure 6.22 shows the search for victims in the rubble.

FIGURE 6.19 Galaxy Hotel in Vrahati. Aerial view from the south of the collapsed sections I and II (see Figure 6.14) a few days after the earthquake. Photograph courtesy Tachydromos magazine.

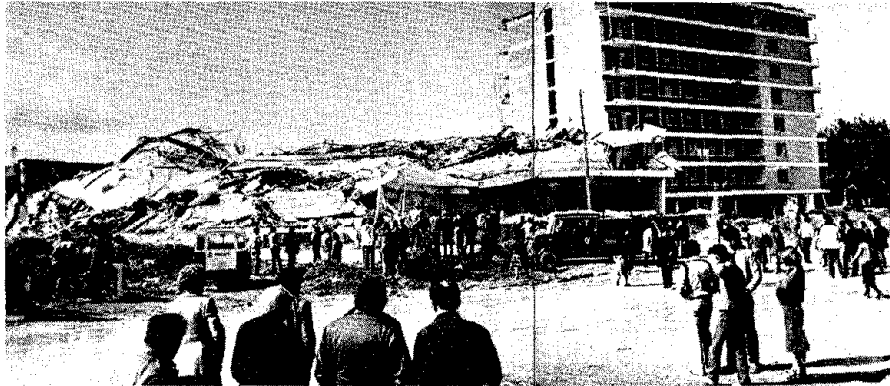
FIGURE 6.20 Galaxy Hotel in Vrahati. View from the east one day after the earthquake and collapse. Photograph courtesy N. Floros.

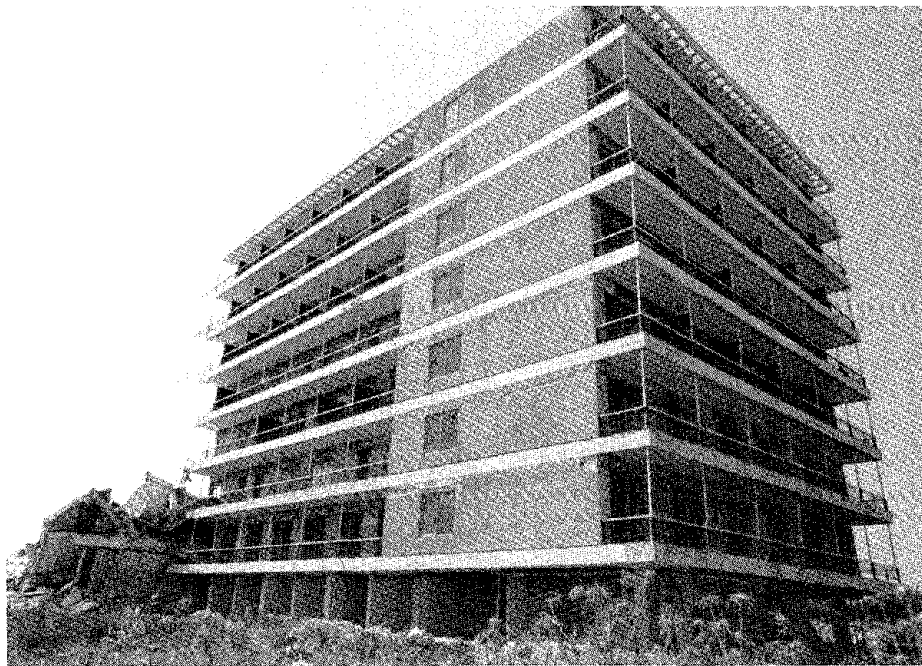
In section III thicker brick walls throughout the height of the structure resulted in a relatively stiffer and stronger structural system than in sections I and II, enabling section III to survive the earthquake (Figure 6.23). The appearance of the walls in section III is shown in Figures 6.24 and 6.25. The collapse did not extend to the ground floors in section I and II except at the curved east corner (Figure 6.14a), where the most severe collapse was observed.

FIGURE 6.23 Galaxy Hotel in Vrahati. North view of section III. Columns and walls in the first floor were heavily damaged.

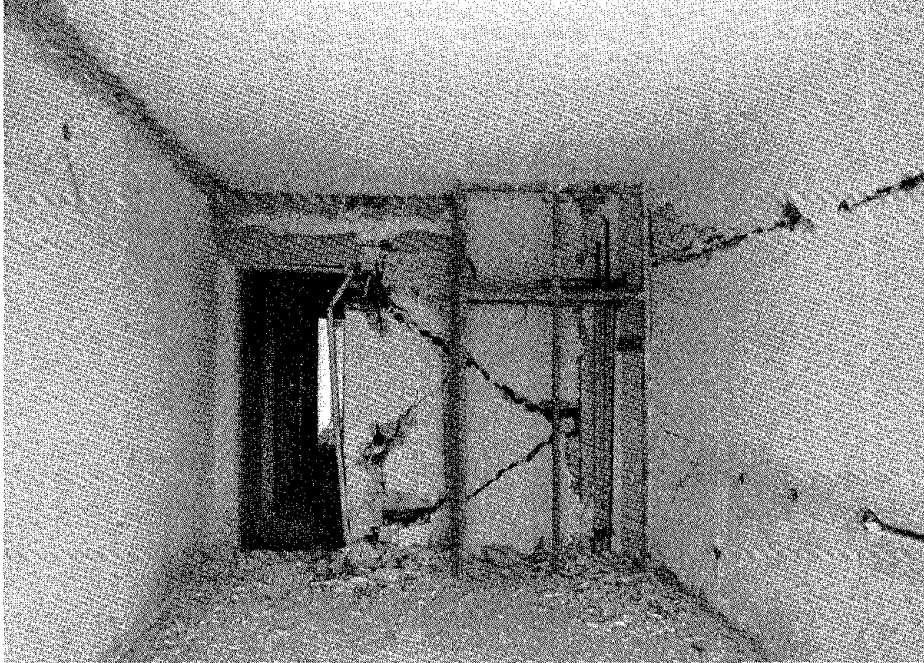
FIGURE 6.24 Galaxy Hotel in Vrahati. Inside view of a room in the second story of section III. The front brick wall extends along the long axis of section III (northwest to southeast).

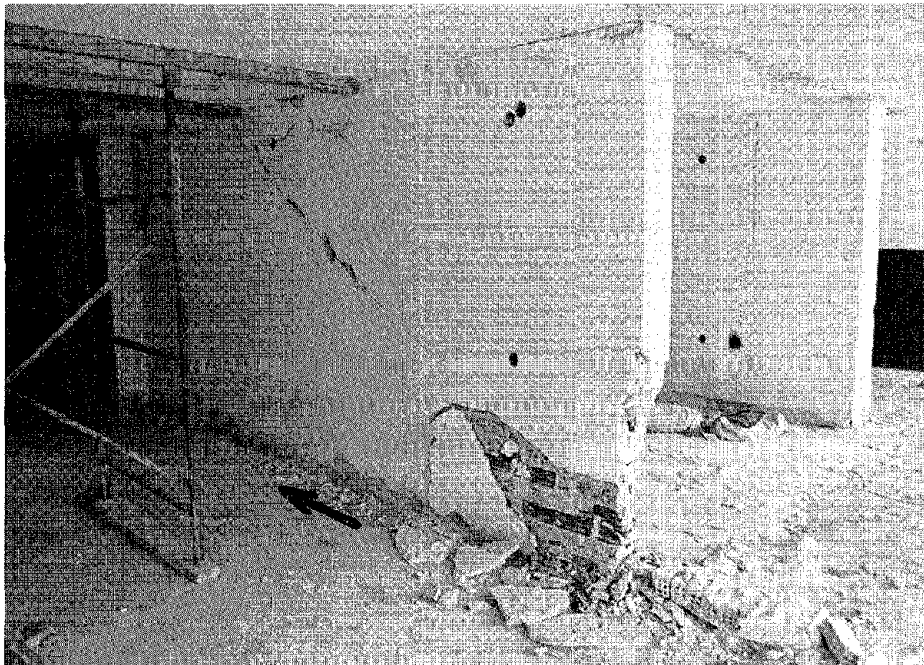
FIGURE 6.25 Galaxy Hotel in Vrahati. West view of the first story. The cracked walls are directed southwest to northeast.

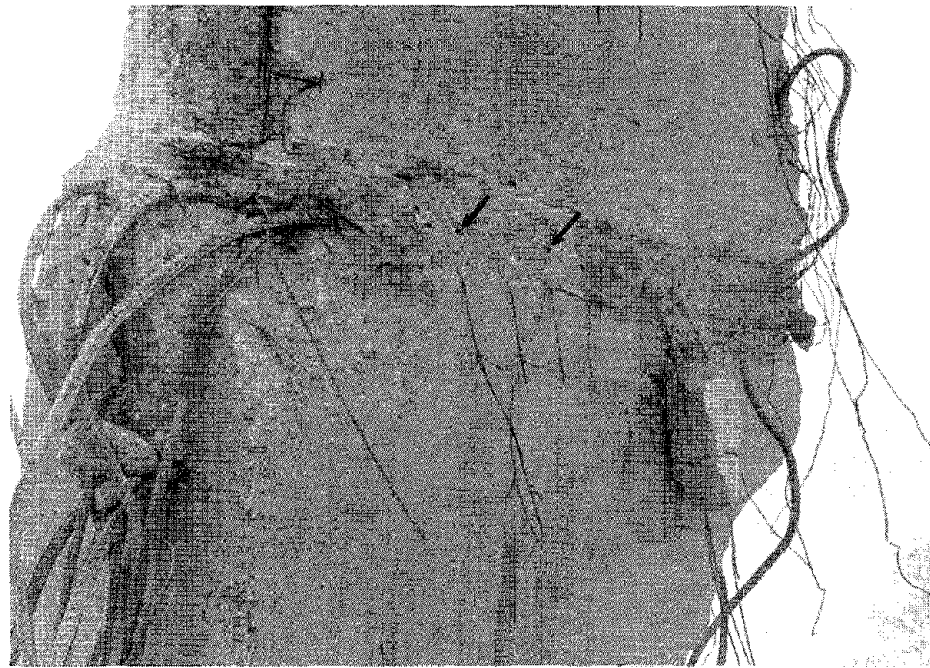
- o Above the first floor the columns became "shear walls," as shown in Figure 6.31.
- o No transverse beams were provided perpendicular to the plane of the "walls."
- o The slabs were supported directly by the "walls" and on beams in the plane of the "walls," as shown in Figures 6.32 and 6.33.
- o The slab reinforcement was a 6-mm-mesh wire that pulled out or fractured, as shown in Figure 6.33.
- o The slabs were sheared from the columns (probably in a progressive manner) and collapsed in a nearly vertical direction, as indicated by the "pancaked" layers of floors.

FIGURE 6.32 Apollo Hotel in Loutraki. Detail of the joint between shear wall and horizontal diaphragm. Note the slip of the horizontal reinforcing mesh wires of the slabs from the walls (arrows).

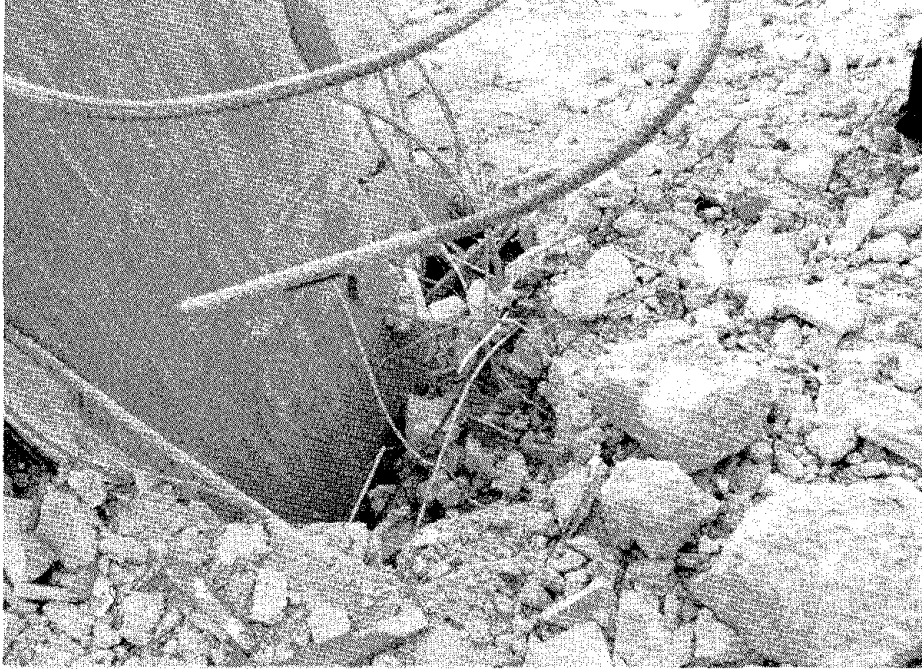
FIGURE 6.33 Apollo Hotel in Loutraki. The slabs sheared away from the column walls and came down one on top of the other.

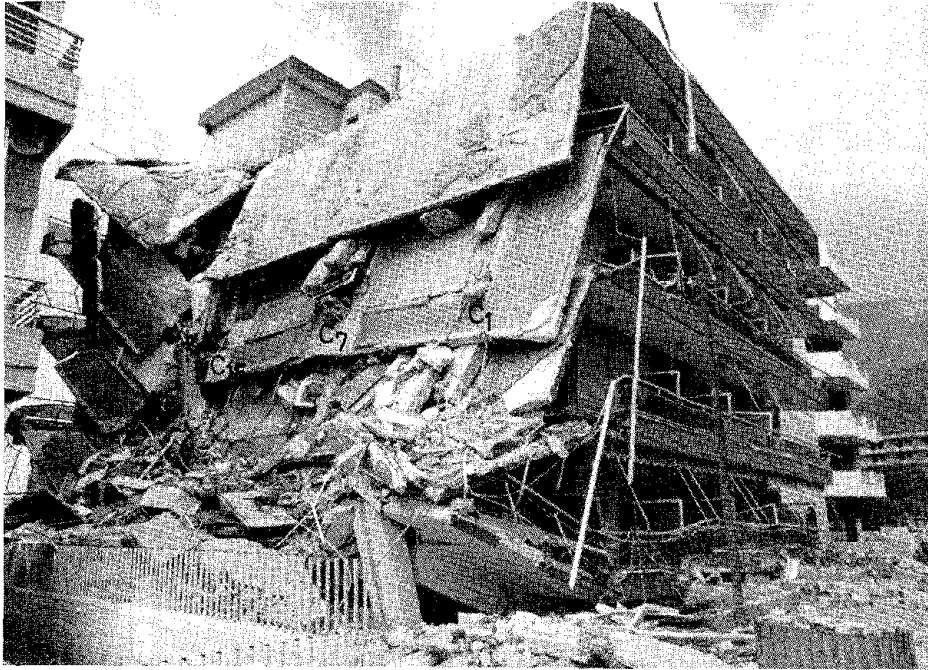
Construction started about the beginning of 1974. Figures 6.34 and 6.35 give some general structural details. The building had an open and rather weak first story that "disappeared" when the upper levels collapsed onto the first level (Figures 6.36, 6.37, and 6.38). A low wall, constructed as a kind of retaining wall, formed short columns in the open first story around the periphery of the structure. Heavy beams supported the first floor, as shown in Figures 6.39 and 6.40. The structure above the first story was stiff due to the presence of brick partition walls. Columns c_1 , c_7 , and c_{15} collapsed and the adjacent slabs ruptured (see Figures 6.34 and 6.36). The rupture of the slabs was due to the complete absence of reinforcement parallel to the edge at column c_{15} . It is interesting to note that corner column c_{21} did not collapse, as did column c_1 . Some of the columns penetrated the slabs, as can be seen for column c_6 in Figure 6.41.

FIGURE 6.36 Block of Flats Segas in Loutraki. The structure from the southeast.

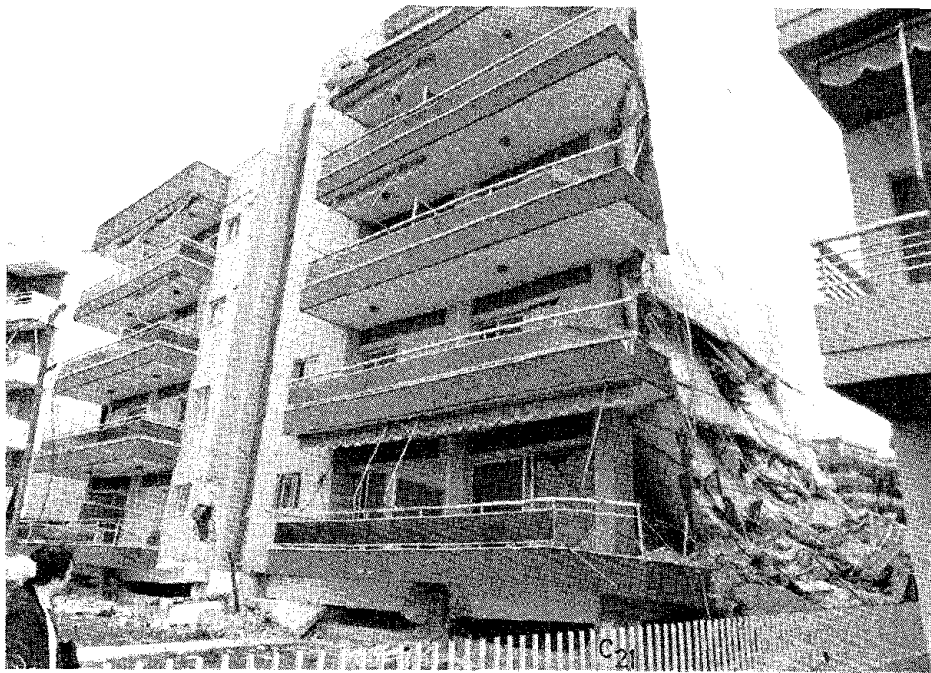
FIGURE 6.37 Block of Flats Segas in Loutraki. The structure from the west.

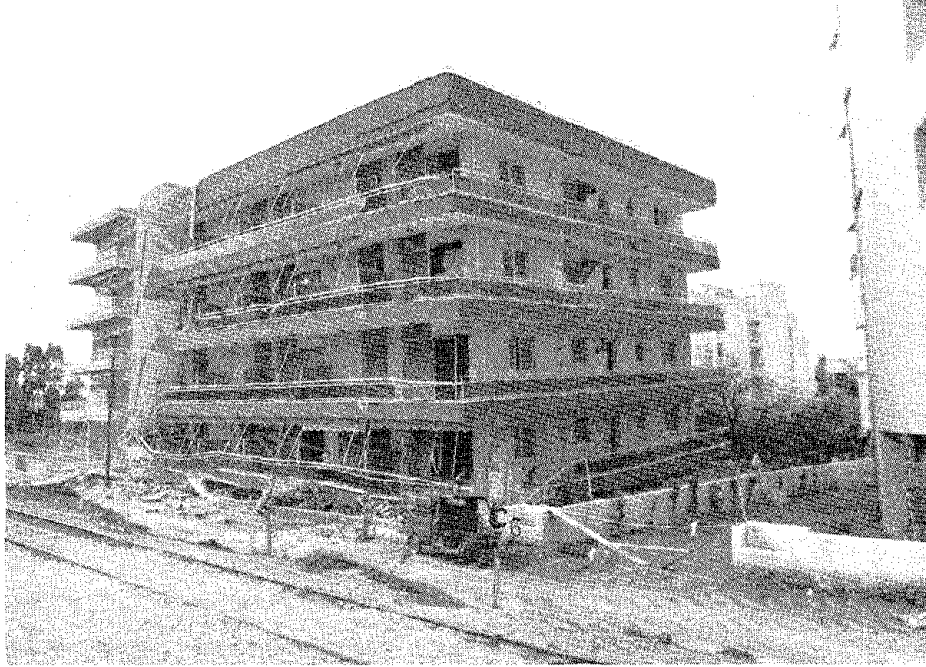
The framing system caused some columns to have little bending resistance at floor levels. For example, columns c_7 , c_{15} , c_{20} , and c_{12} had no beams normal to their edges or to the weak direction of bending. The column failures indicated a general lack of sufficient lateral reinforcement near the ends and in the joints (Figures 6.38, 6.39, and 6.40).

FIGURE 6.38 Block of Flats Segas in Loutraki. The structure from the northeast.

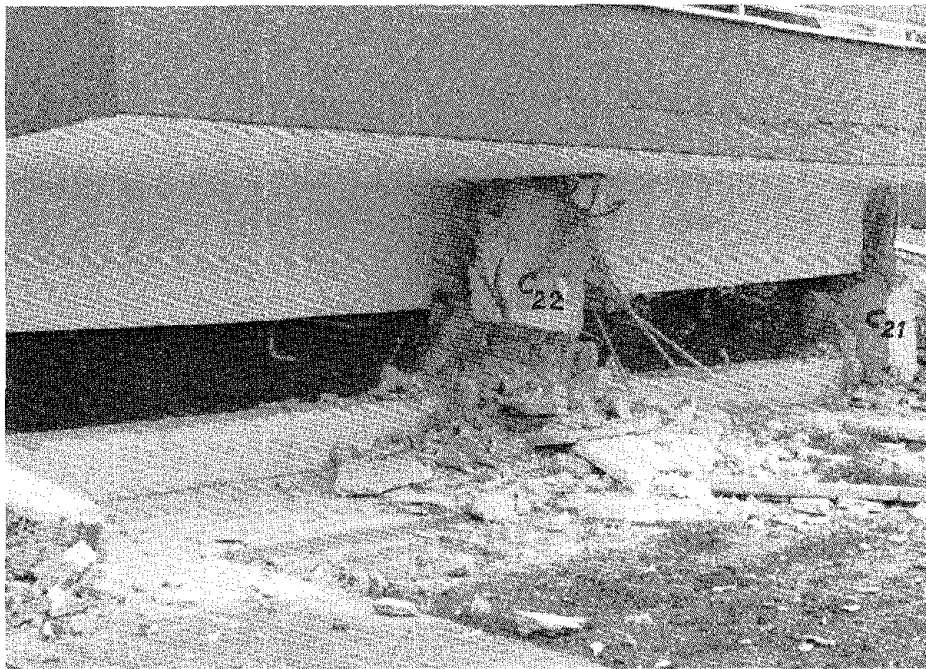
FIGURE 6.39 Block of Flats Segas in Loutraki. Columns c22 and c21 viewed from the north.

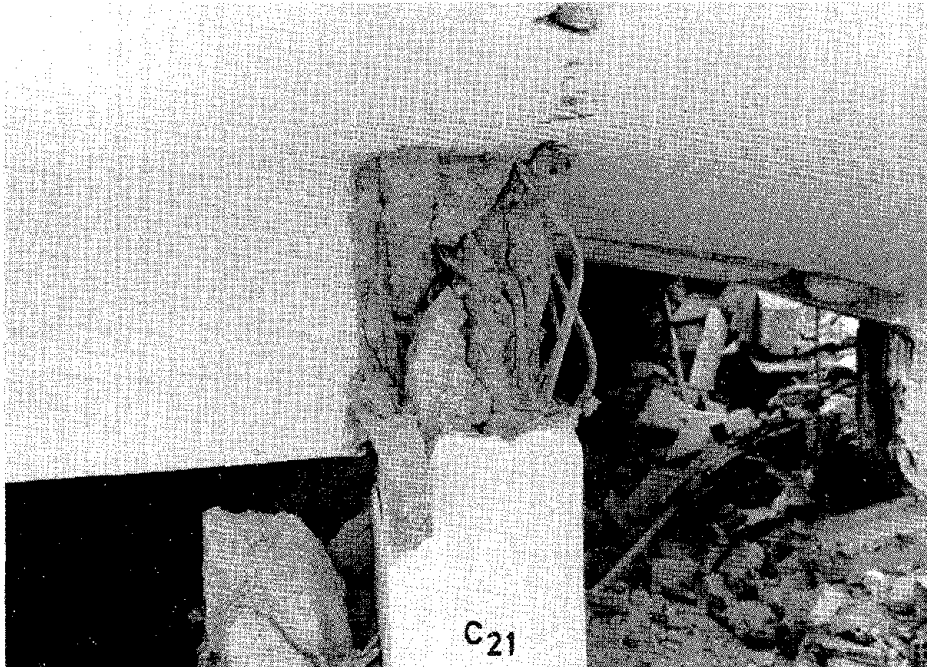
FIGURE 6.40 Block of Flats Segas in Loutraki. As shown by column c_{21} , there is no tie within the height of the column-to-beam connection.

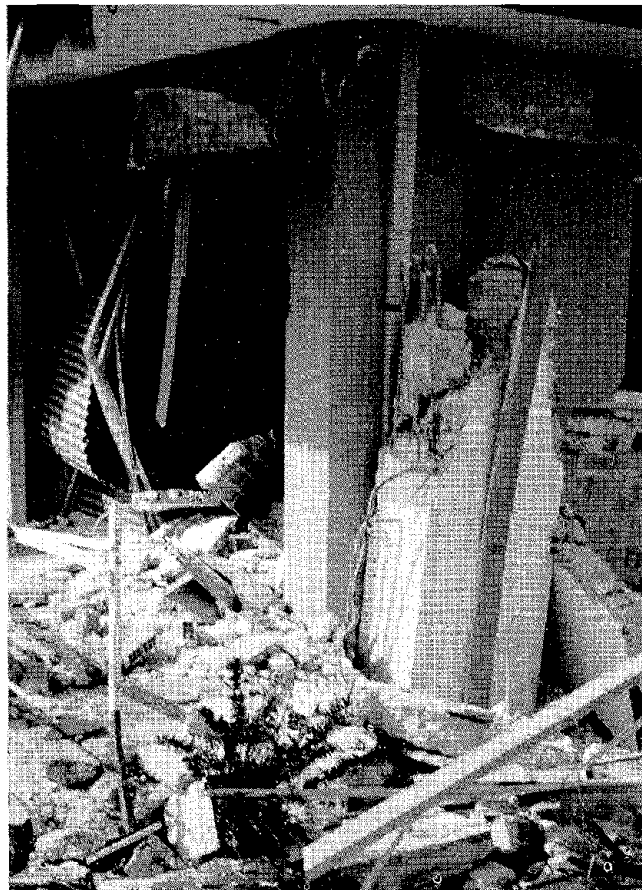
FIGURE 6.41 Block of Flats Segas in Loutraki. Column c_6 , shown here, penetrated the slab.

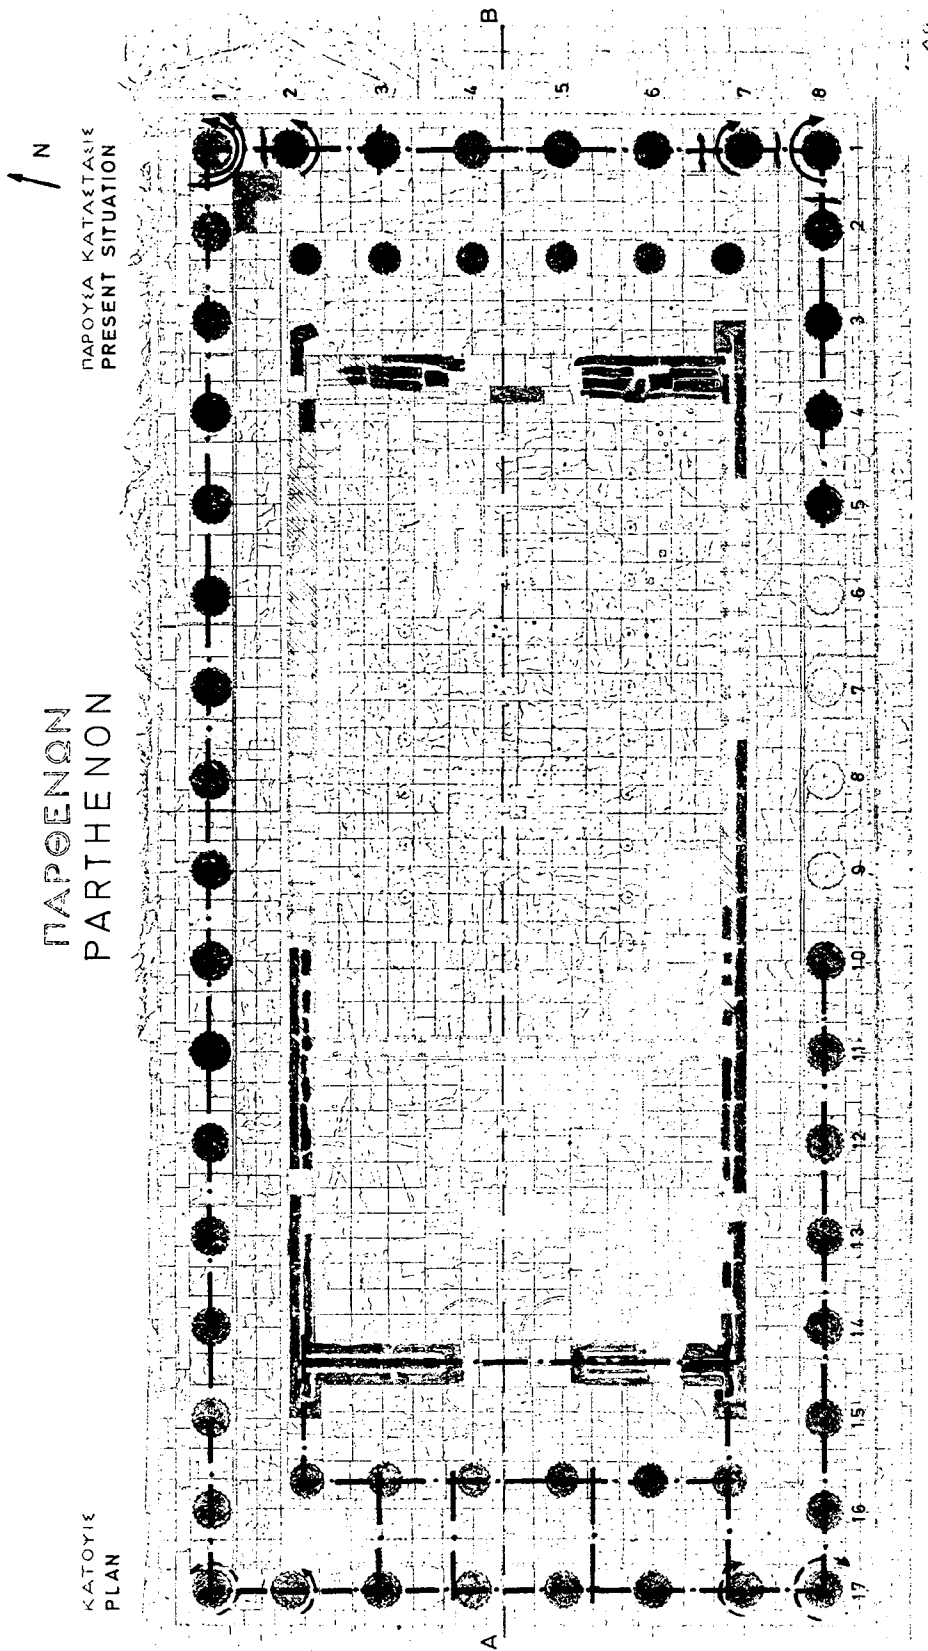
Andronopoulos and Koukis (1976) have given a brief description of the foundation geology. The monument is founded on two different soils. Limestones are under the northern part, and earthfill is under the southern part. The boundary between these two is approximately line AB in Figure 6.42. The Acropolis hill of Athens (Figure 6.43) consists in its upper part (between elevations 118 and 156 m) of upper cretaceous limestones, usually thick, platy, and in places very fractured, with obvious karst and erosion features. The limestone beds, with a maximum thickness of about 40 m, cover formations of the Athens schist series (sandstones, marls, and argillaceous schists) at the base of the hill. Near the contact of these two systems, which is, according to different opinions, normal or tectonic, the poor existing hanging aquifer is discharged regularly by three small springs, with a discharge of 0.5 to 1 liter per minute during the dry season.

The pillars around the corners of the monument rotated, as shown schematically in Figure 6.42. The biggest rotation was observed in the northeast corner pillar, which underwent extensive spalling at the lower end (Figures 6.48 and 6.49). Less rotation was observed at the southeast corner pillar (Figures 6.50 and 6.51), and very little rotation was seen at the southwest and northwest corner pillars.

FIGURE 6.42 Present condition of the Parthenon. The arcs with arrows indicate rotations of the top in relation to the bottom. The lines indicate cracks of the head beams after the recent earthquakes. The dotted and dashed lines indicate horizontal beams at the top. Source: Orlandos (1976).

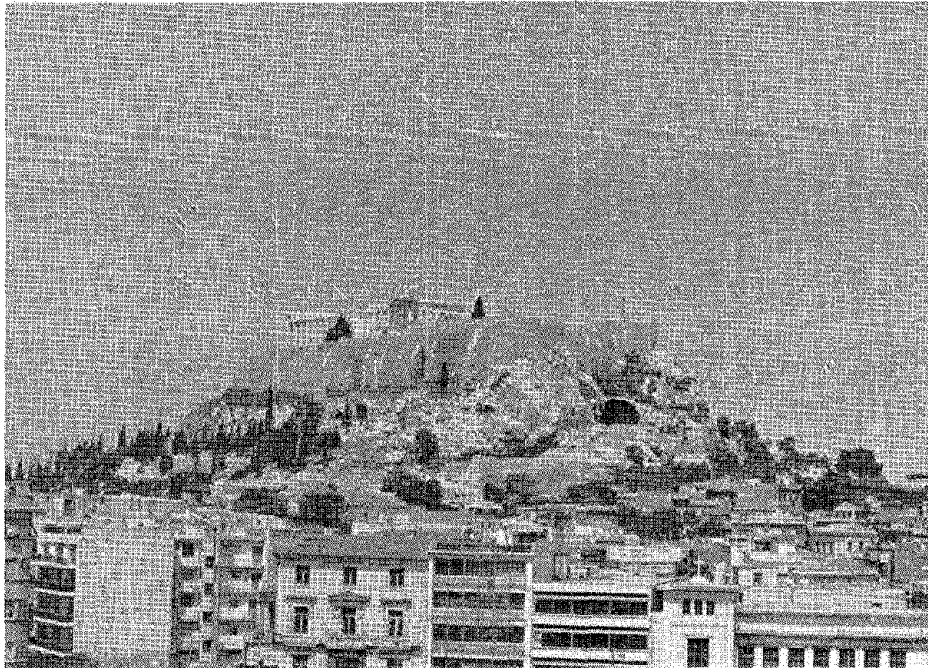
FIGURE 6.43 East view of the Parthenon on the Acropolis hill.

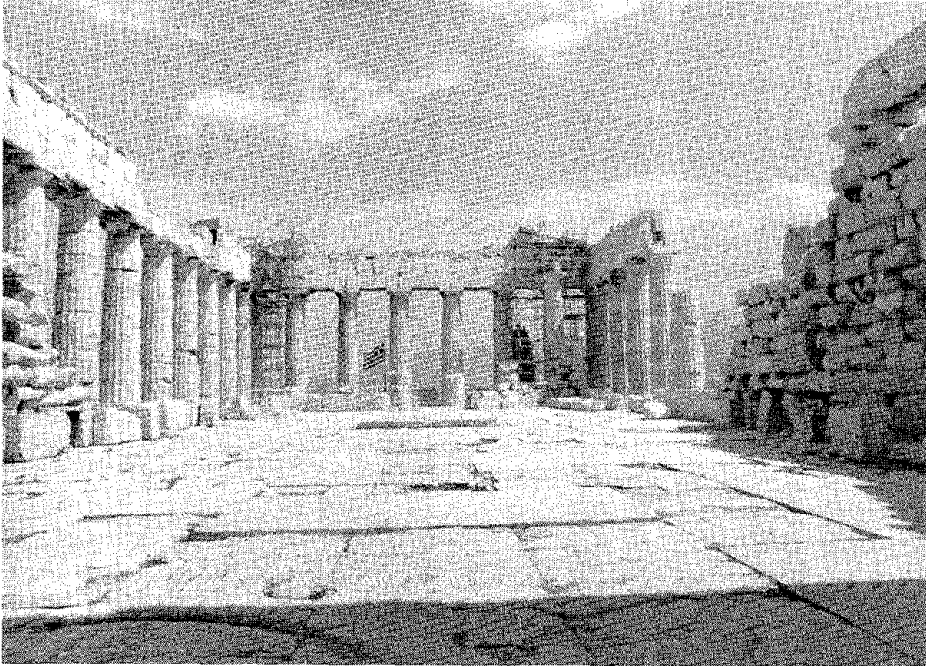
The most severe displacements and damage were observed at the east side (see Figure 6.44), where many marble chips fell. The scaffolding shown in Figures 6.44 and 6.45 was erected immediately after the earthquake to prevent further dislocations of the head beams near the corners. The east top beam at the north end displaced westward about 4 cm in relation to the ground. This total displacement is the sum of smaller displacements almost equally distributed among the 10 or 11 rigid blocks that make up each pillar.

The west side suffered much smaller displacements, which were concentrated near the bottom end of the pillars. This difference in the deformation of the pillars between the east and west sides may result from the east side having no horizontal connections between the inside and outside pillars (Figures 6.42 and 6.45), while the west side has more horizontal supports along the span (Figures 6.46 and 6.47). Under these conditions the east side shows more "bending" deformation, while the west side shows more "shear" deformation. Because the east side has no connection at the top perpendicular to the front face, the pillars form free-standing cantilevers.

FIGURE 6.45 East side of the Parthenon viewed from the inside. The head beam is supported horizontally only at its two ends. The most damage was concentrated around these two points. Source: Dontas (1981).

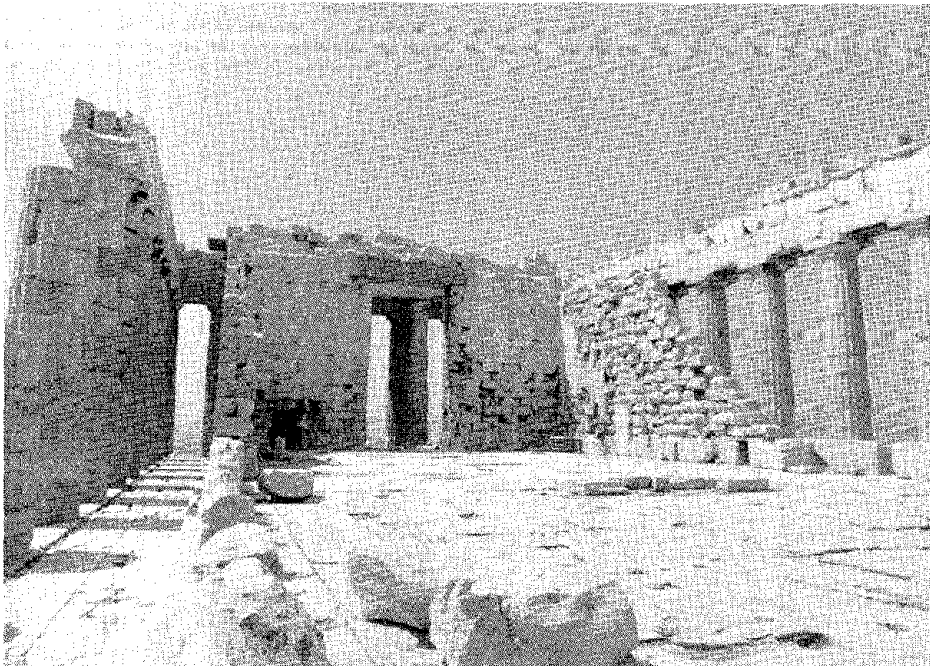
FIGURE 6.46 West side of the Parthenon viewed from the inside. The head beam in the back is connected horizontally by short beams to the inside construction (see Figure 6.42). Source: Dontas (1981).

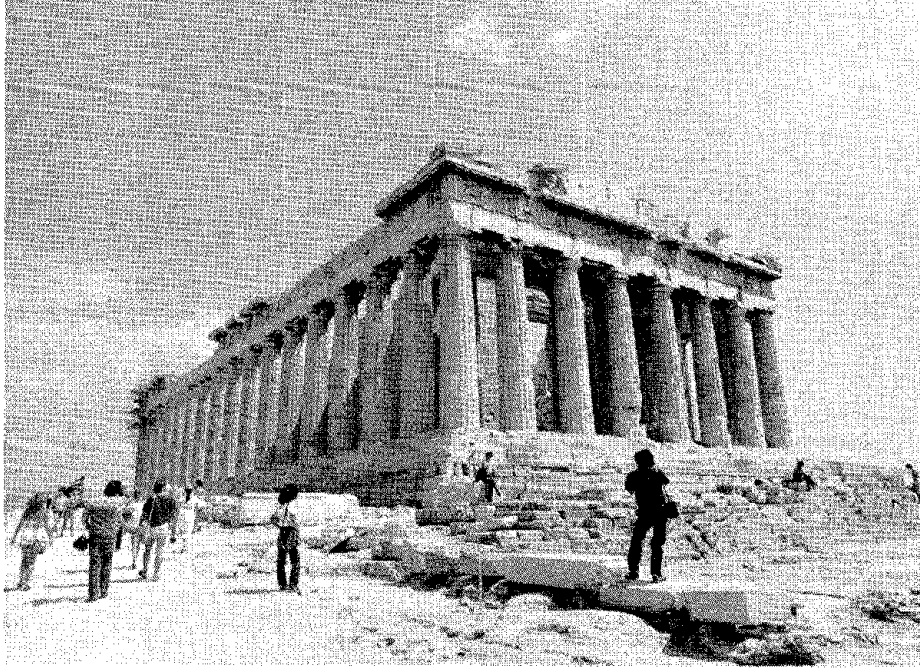
FIGURE 6.47 West view of the Parthenon as it stands now, after the earthquakes. The north and west sides are the best preserved and were least damaged by the recent earthquakes. Source: Dontas (1981).

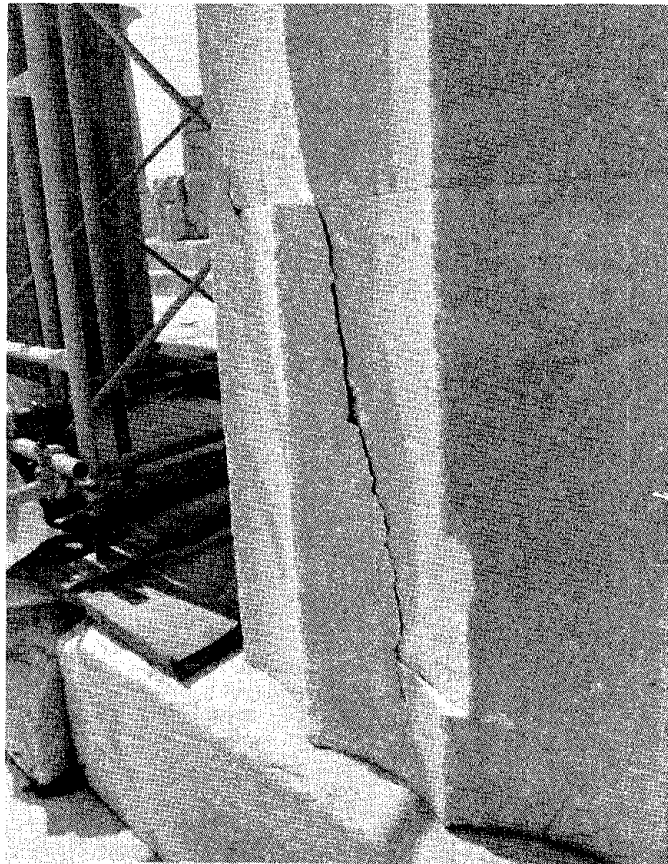
FIGURE 6.48 Pillar at the northeast corner of the Parthenon. The pillar rotated anticlockwise, which displaced its top periphery by about 5 cm. Source: Dontas (1981).

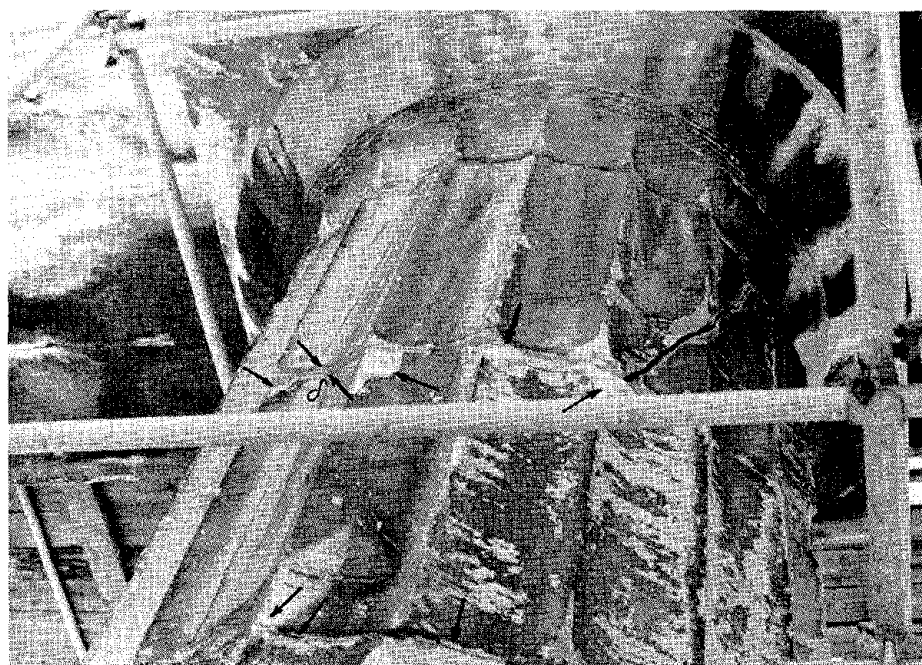
FIGURE 6.50 Upper part of the seventh pillar on the east side of the Parthenon. Arrows show spalling due to recent earthquakes. Source: Dontas (1981).
