Earthquake Resistance of High-Rise Systems

DIGESTS OF CASE STUDIES

OF TALL BUILDINGS DAMAGED IN EARTHQUAKES

Fritz Engineering Laboratory Report No. 474.6

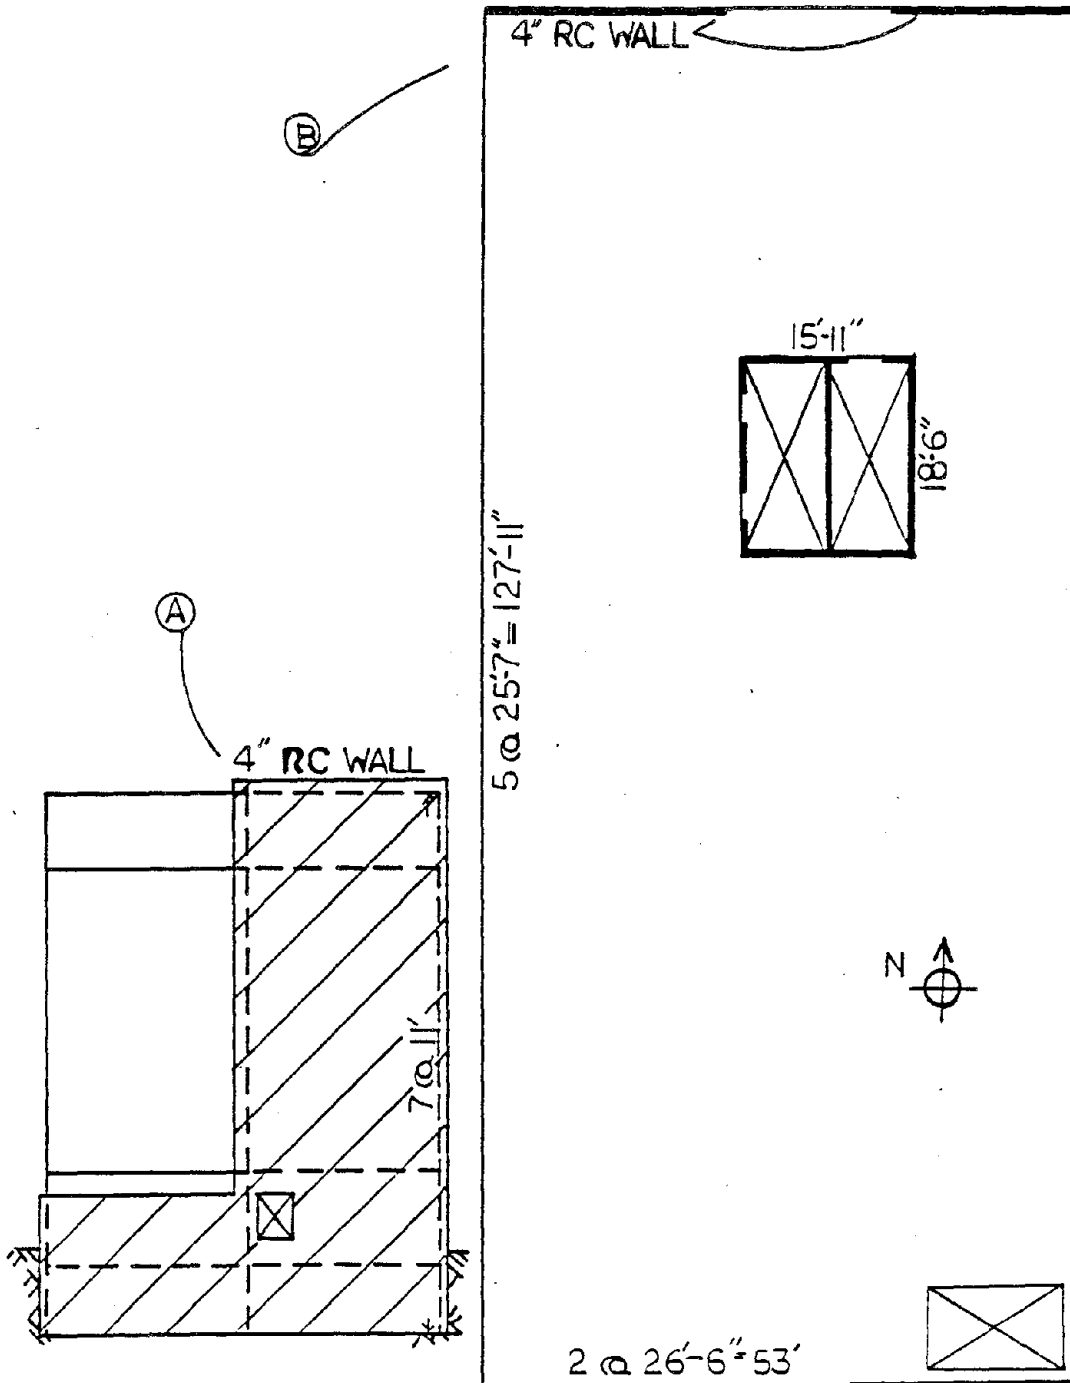
Figure 2-2: Cordova Building:  
(A) S-elevation.  
(B) Typical plan.

Most of the damage occurred in the 1st story. The core sheared at the base of the 1st story. Failure of the core at this level was complete along the N-wall and at the N-W corner. The S-E corner column buckled severely below the 2nd floor beam and shortened about 1 1/2". The midstory stair landing was anchored to this column making it much stiffer than the rest of the columns at the 1st story. The center and west columns at the S-face buckled locally at the top and bottom of the 1st story. The penthouse collapsed.

The interior reinforced concrete core appears to have initially resisted the major portion of the seismic forces. The steel frames were able to withstand the ground motion after failure of the core. The steel frame at the S-E corner wall sustained more damage because of the stiffening effect of the stairwell and because of its greater distance from the center of rigidity. The rigid S-E concrete curtain wall also resisted lateral forces until it failed, and then the S-E corner column buckled.

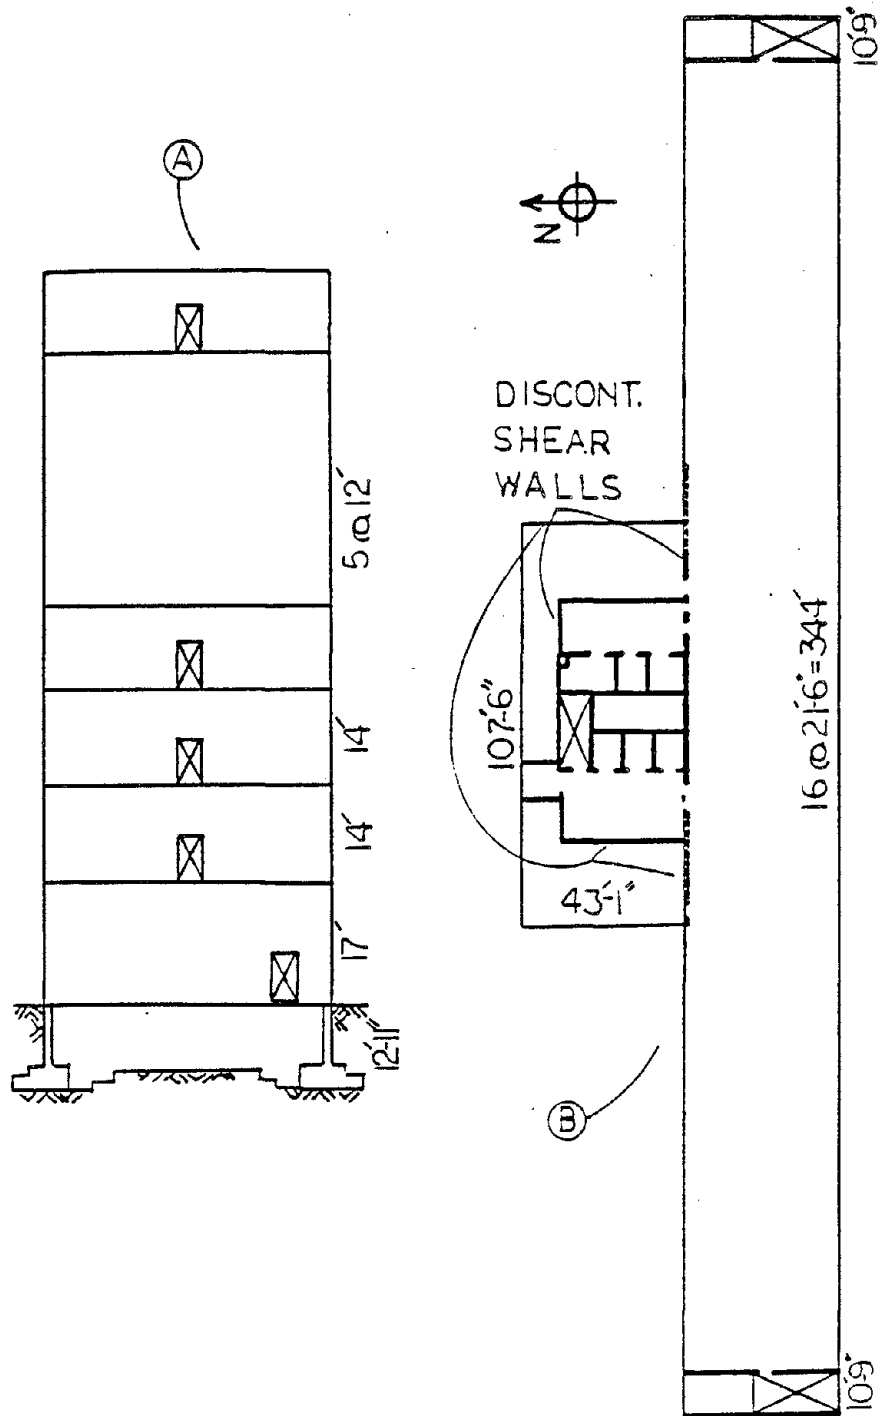
Figure 2-3: Elmendorf Hospital:  
 (A) Elevation of interior S-wall.  
 (B) Fourth floor plan of wing A and 11-story tower.

All shear walls showed diagonal hairline cracking. The coupling beams of the shear wall between wing A and central core failed on floors 1 to 5, large chunks of concrete having spalled. The spandrel beams connecting the outer frame to the central core were severely damaged and the damage increased with height. At the rear of the central core in the 1st story a column was shattered. There was evidence of movement between the concrete wall of the core and the floor slab. The re-entrant corners between the discontinued shear walls at the 4-th floor were severely damaged.

Poor construction practice and poor workmanship was the main cause of failure of the coupling beams of the coupled shear wall. The intersection of the E-W lower shear wall with the N-S upper discontinued shear walls was damaged from the concentrated overturning forces to be transferred at that point. Column ties and possibly vertical bars were fewer than those called for in drawings.

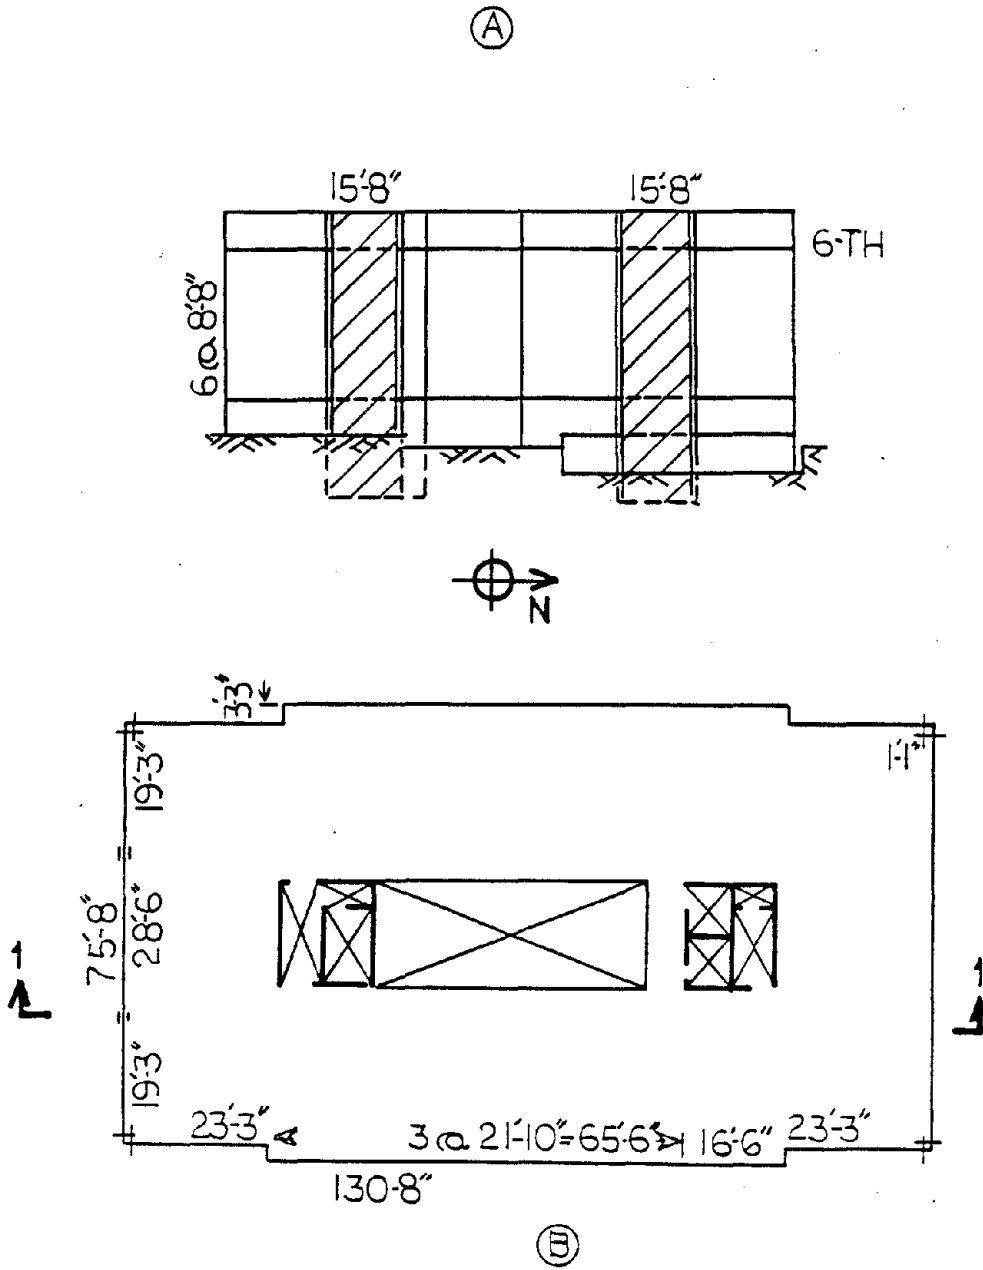
Figure 2-4: Four Seasons Apartment Building:  
(A) Elevation 1-1.  
(B) Typical plan.

The two cores were severed near their bases and overturned to the north, carrying the slabs with them. All vertical reinforcing bars in the cores were spliced near the core bases with a 20 - bar diameter lap. The splices of the #8 and #11 bars failed. while the #4 bars ruptured in a ductile manner.

The collapse of the Four Seasons apartment building has been attributed to inadequate length of lapping of the reinforcement bars at the base of the two cores. Bond failure effectively disconnected the cores from their foundations and left them free to rock and break the connections of the floor slabs to the cores. The code requirements on overlapping of bars were not adequate to prevent failure.

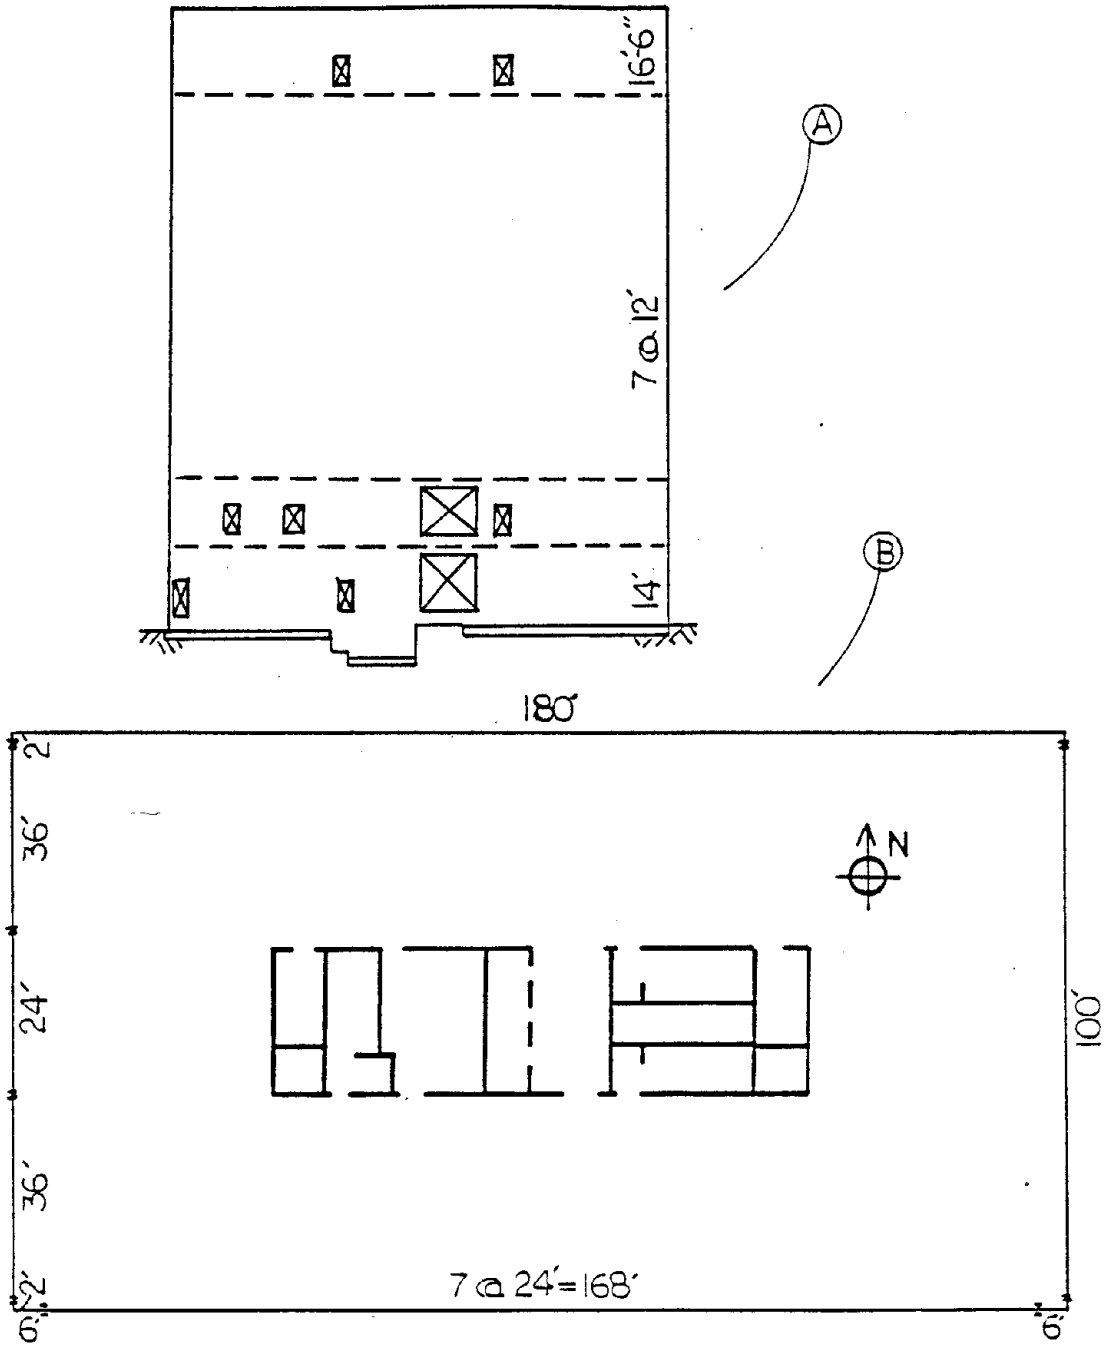
Figure 2-5: Hill Building:  
 (A) S-elevation of central core.  
 (B) Typical upper story plan.

The central cores dropped about 5" at one corner and 3" at another, reportedly as the concrete corewalls had pulverized just above footing level because of defective concrete. In addition the core walls were cracked, particularly in the lower stories, and the beams interconnecting them were damaged at all floors. A reinforced concrete column supporting the canopy roof failed at its connection. Slippage was observed along construction joints in the core walls. There was no damage to the steel frame. A number of bolts at the beam-to-column connections had sheared.

Lateral force resistance was to be provided by the central cores, the most rigid components, which also experienced the most severe structural damage. The failure of the core above footing level was due to a horizontal belt of poor quality concrete discovered during reconstruction. The settling of the core probably caused the failure of the unreinforced concrete block wall of the penthouse. The redistribution of stresses due to the "mushing" of concrete increased the damage in the 1st and lower stories. The shear failure of the floors adjacent to core walls was due to the high shear stresses developed in the transfer of vertical coupling forces between the two cores.

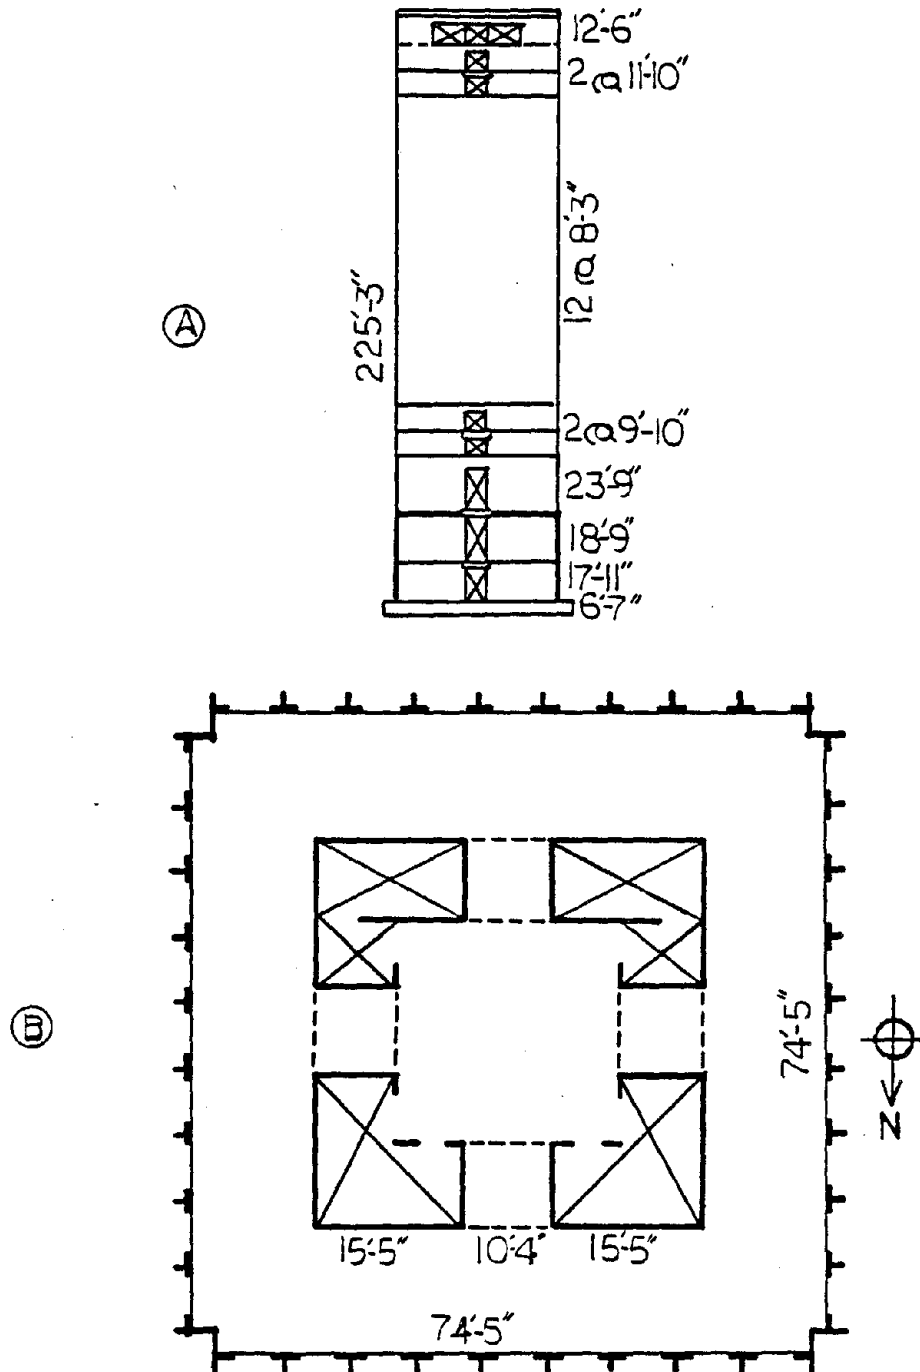
Figure 6-2: Banco de America:  
 (A) Typical elevation.  
 (B) Typical plan.

The main structural damage occurred in the coupling girders in the E-W axis of the building, which failed in shear at the duct openings. Extensive diagonal cracking occurred in the deeper unpierced coupling girders at the penthouse level. Floor slabs cracked above the failed coupling girders, at the slab - perimeter column connections, and along some of the slab - shear wall connections. In the upper stories, the shear walls suffered some diagonal and horizontal cracking and, over doorways, vertical cracking. No damage was visible in the perimeter columns.

The primary reason for the coupling girder failures was insufficient shear capacity. The girders were strong in flexure and spanned a short distance creating high shears which were not considered in design. To maintain the ductility of the system, flexural reinforcement should be reduced and shear strength increased, so that the flexural capacity can be developed without premature shear failure. This will allow inelastic flexural deformations without substantial loss of strength under large numbers of load reversals. Loss of the coupling action due to shear failure has increased the natural period, displacements, and drifts. In this specific case, this softening appears to have actually helped the building.

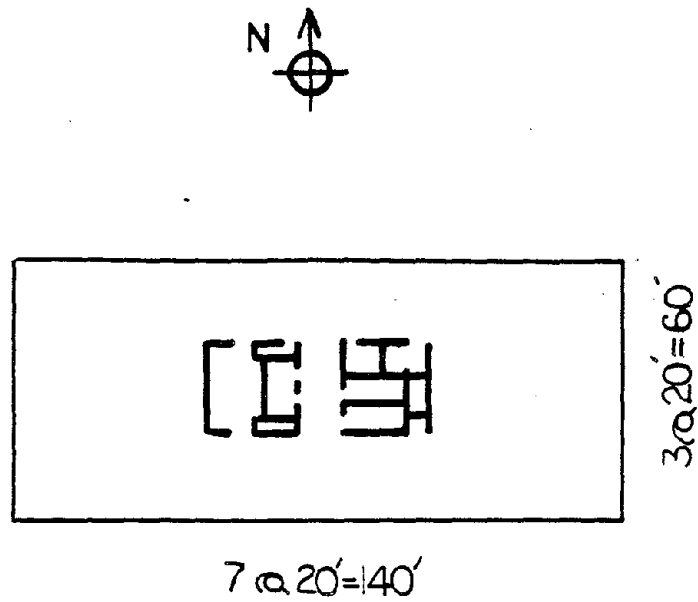
Figure 6-3: ENALUF Administration Building: Typical plan.

Overall, structural damage was slight. Exterior columns suffered minor cracking. The core shear walls in the 1st and 2nd story showed cracks, some of which were large enough to suggest possible yielding of the reinforcing steel. The columns near the cores were lightly cracked all the way up to the 4th floor.

On the whole, the performance of the building was good. There was very little architectural damage. The minor cracking of the shear cores points, in addition to possible errors in construction, to the problems associated with the design of shear walls with openings.

The concentration of damage in the 1st story can partly be attributed to the termination of the heavy curtain wall, which created a slightly more flexible story at this level. The stiffness provided by the shear walls resulted in considerably less nonstructural damage than usually was observed during this earthquake in buildings relying on frame action only.

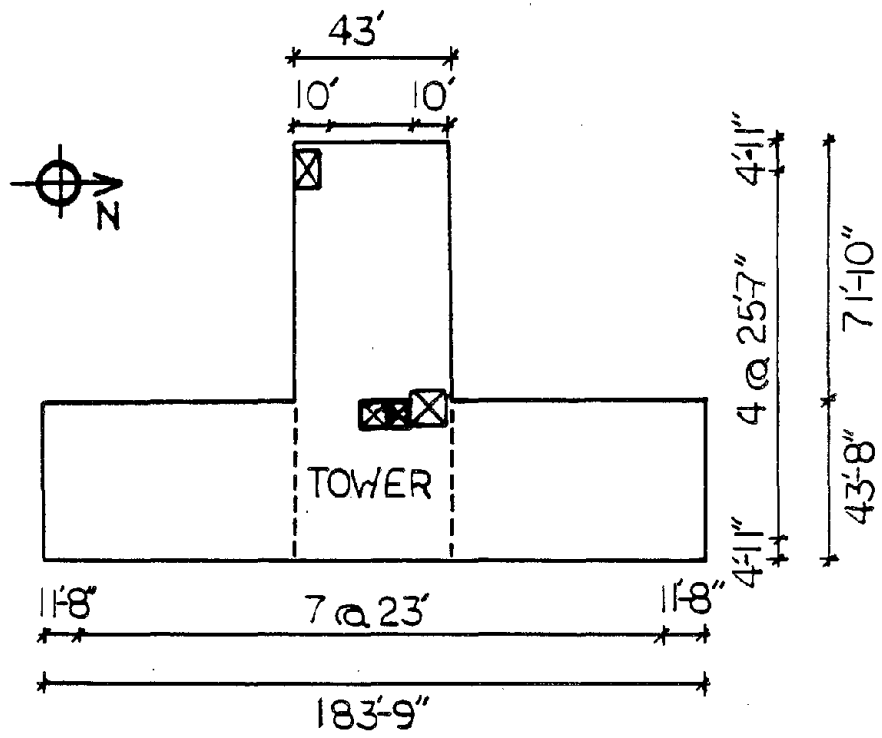
Figure 6-4: Social Services Building:  
Typical plan.

The large spiral columns showed spalling at their ends at some locations. There were numerous flexural cracks in the floor slabs. The cracks on the top of the slab were usually near the ends of the top reinforcement. There were also extensive cracks in the slab soffits. Cracks across the entire building were observed at the W- and E-face of the elevator core due to diaphragm tension and slab bending at that location. Most of the slab cracks run N-S indicating primary building response in the E-W direction (in the "T" stem). However, there were also some E-W cracks, especially at the re-entrant corners of the "T". A mechanical penthouse collapsed; apparently, anchorage of the vertical column reinforcement in the slab failed. This illustrates how spiral columns cannot perform in a ductile manner when their anchorage is inadequate to develop their flexural strength.

The interior stairways were heavily damaged due to strut action between the deflecting stories. Partitions and exterior curtain walls, although slightly damaged, performed remarkably well.

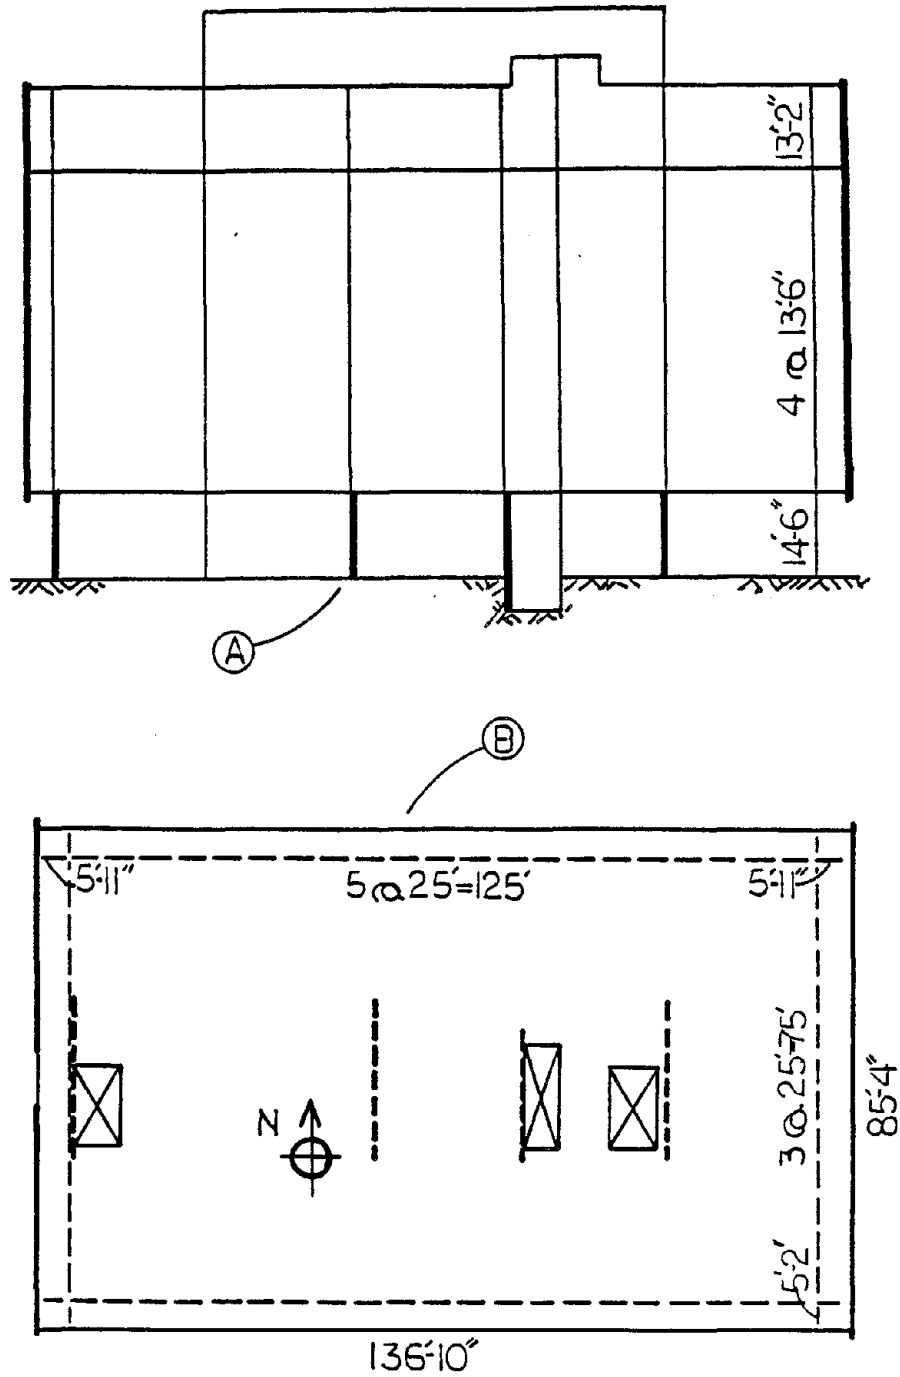
Figure 7-1: Imperial County Services Building:  
 (A) Typical longitudinal elevation  
 (B) Typical plan
